PLOTS 4, 5, 6 & 7 CASTLE TERRACE & PLOT 7 NORTHGATE STREET, PEMBROKE, PEMBROKESHIRE: ARCHAEOLOGICAL WATCHING BRIEF

Prepared by Dyfed Archaeological Trust
For: Pembrokeshire County Council

REPORT NO. 2020-18
EVENT RECORD NO. 121723

March 2020

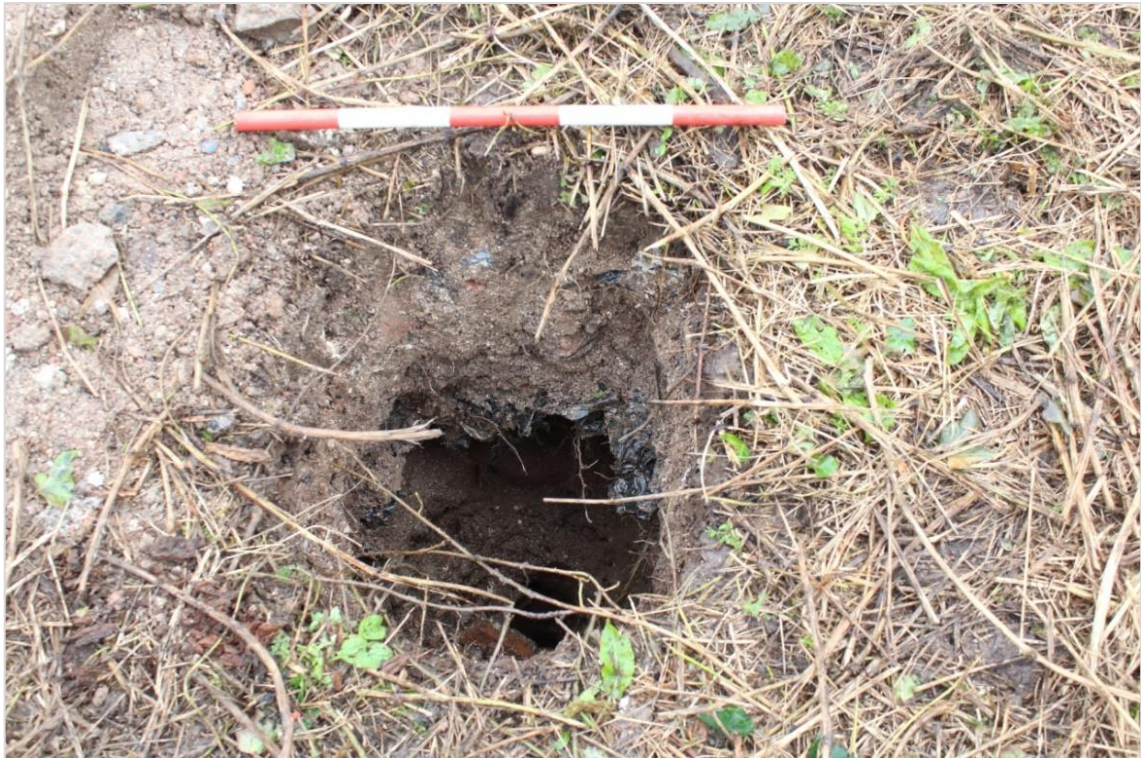
Window Space 1 (Dimensions 0.42m N/S x 0.40m E/W, by 0.8m deep)		
Context Number	Description	Depth/thickness
1005	Topsoil – Blackish brown silty clay.	0.10m thick.
1006	Mixture of light pink/grey lime-mortar & rubble layer. This layer contained some polythene sheeting and is therefore probably the remains of modern landscaping.	Varies between 0.20m and 0.30m thick.
1007	Lime mortar/rubble infill. Probable remains of landscaping	Varies between 0.40m and 0.50m thick.

Photo 1: View east of section in Window Space 1. 0.5m scale.

- 5.4 The later accumulations of made-up ground/building debris witnessed within the northern (WS1, WS3 and SA1) and eastern (WS6) portions of the site could be considered evidence for post-medieval and modern landscaping. Evidence for roofing renovations can also be found within several of the geotechnical pits (TP1, TP2 & WS5), recorded in the form of slate tip lines which are commonly found throughout towns with a period of long occupation.

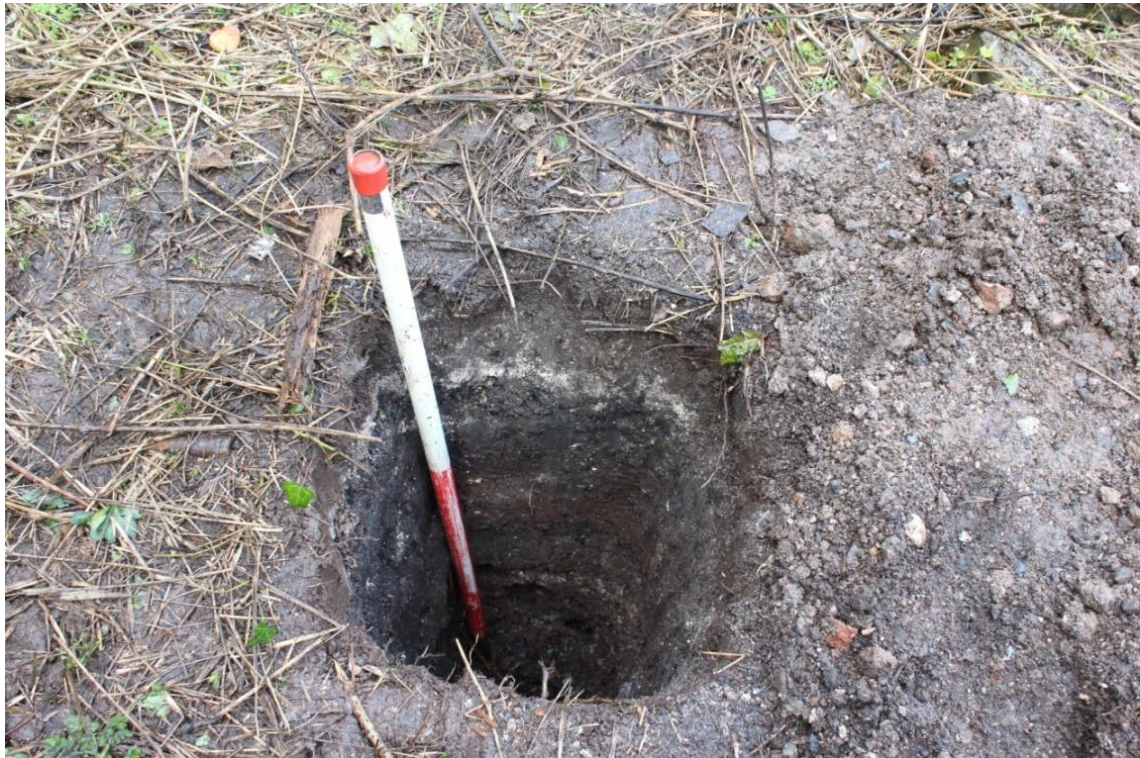
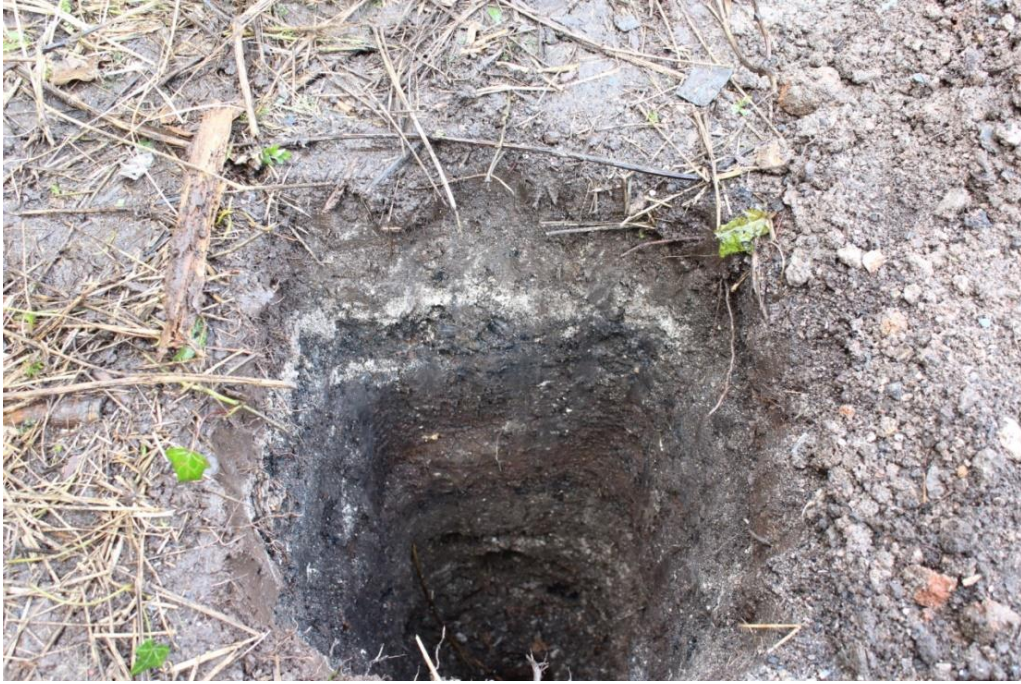
Window Space 2 (Dimensions 0.38m N/S x 0.40m E/W, by 0.88m deep)		
Context Number	Description	Depth/thickness
1011	Topsoil – Blackish brown silty clay.	0.06m thick.
1012	Mid greyish brown silty clay, which contained occasional small flecks of mortar.	0.10m thick
1013	Lens of white lime-mortar.	0.04m thick.
1014	Black ash deposit	Varies between 0.04m and 0.10m thick
1015	Blackish brown sandy silty clay. Very rich in organics.	0.28m thick
1016	Dark greyish brown silty clay. Contains occasional flecks of lime-mortar.	0.14m thick
1017	Reddish/pink clay, which contains small flecks of mortar.	0.26m thick but full extent/depth not revealed.

Photo 2: View west of section in Window Space 2. 1m scale.

Photo 3: View west of section of Window Space 2. No scale.

- 5.5 Perhaps the most interesting sequence was observed within WS2, located just to the rear of No 5 Castle Terrace. This revealed several well-stratified deposits, some of which may potentially be medieval in date due to their high inclusion rate of charcoal and the lack of post-medieval artefacts.

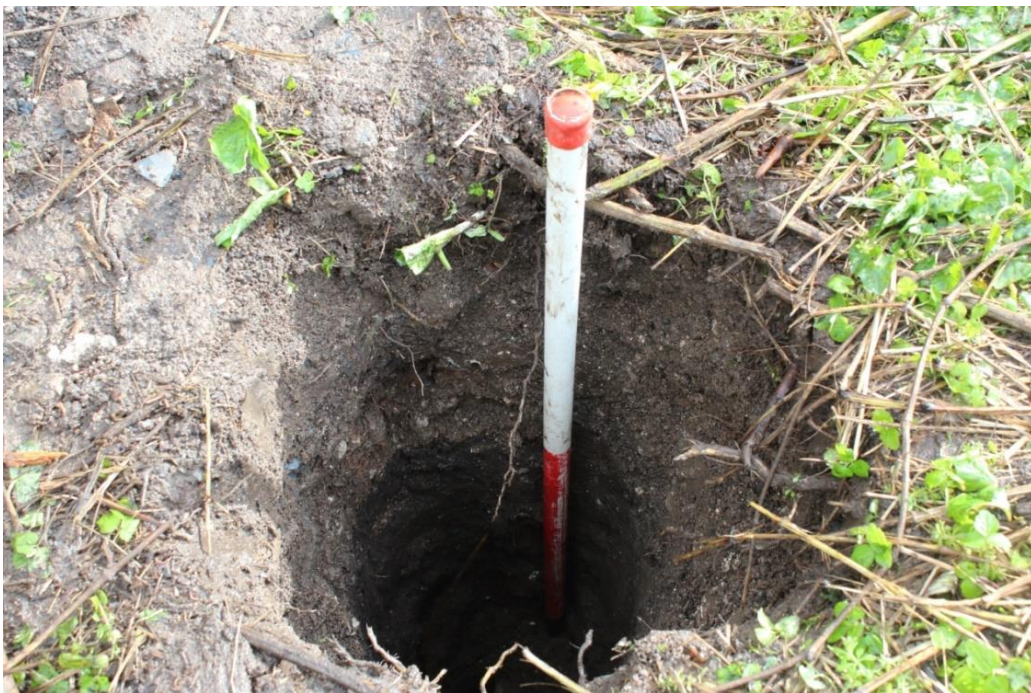
Window Space 3 (Dimensions 0.40m N/S x 0.40m E/W, by 1.0m deep)		
Context Number	Description	Depth/thickness
1024	Topsoil – Blackish brown silty clay.	0.10m thick.
1025	Dark grey waste mortar layer, which contained frequent flecks of white and grey mortar.	Varies between 0.26m and 0.30m thick.
1026	Dark brown silty clay, which appears rich in organics and is probably the remains of previous garden soil.	0.64m thick but full extent/depth not revealed.

Photo 4: View west of the section of Window Space 3. 1m scale.

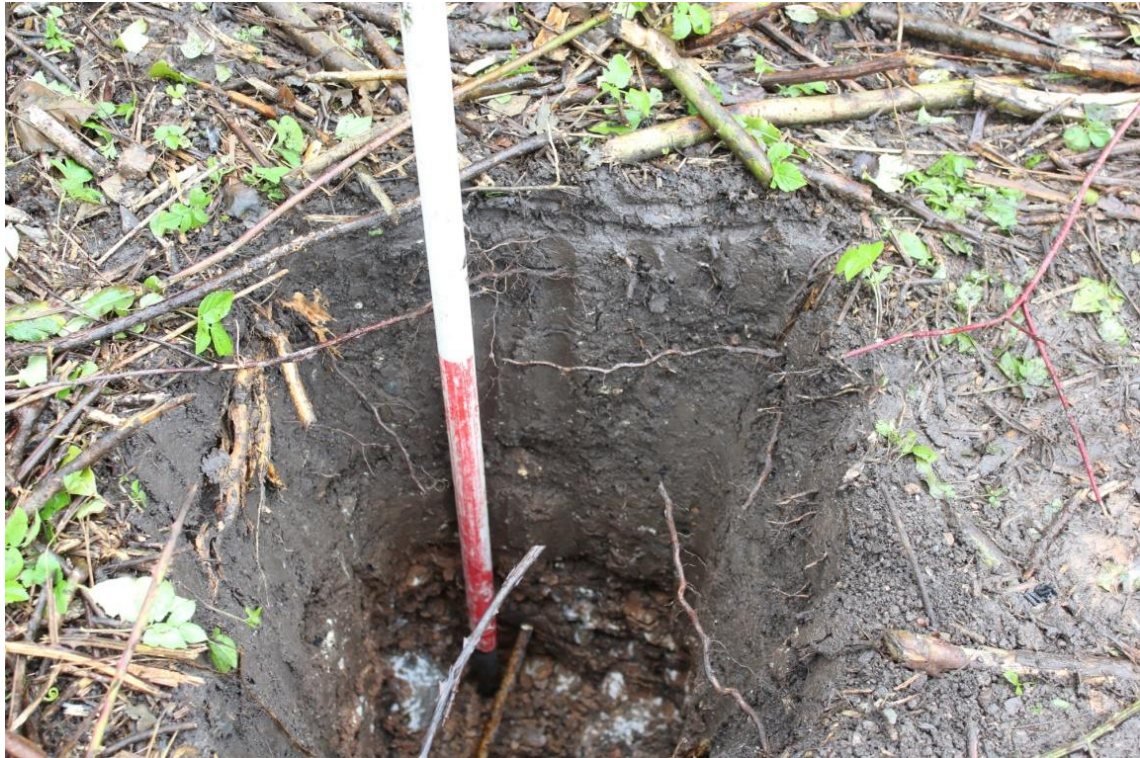
Window Space 4 (Dimensions 0.40m N/S x 0.40m E/W, by 0.68m deep)		
Context Number	Description	Depth/thickness
1035	Topsoil – Blackish brown silty clay.	0.12m thick.
1036	Light to mid grey brown silty clay, which contained frequent flecks of lime mortar and charcoal.	0.36m thick.
1037	Light reddish brown clay, which is considered to be the start of the natural soil horizon.	First viewed at 0.48m below ground level.

Photo 5: View north west of the section of Window Space 4. 1m scale.

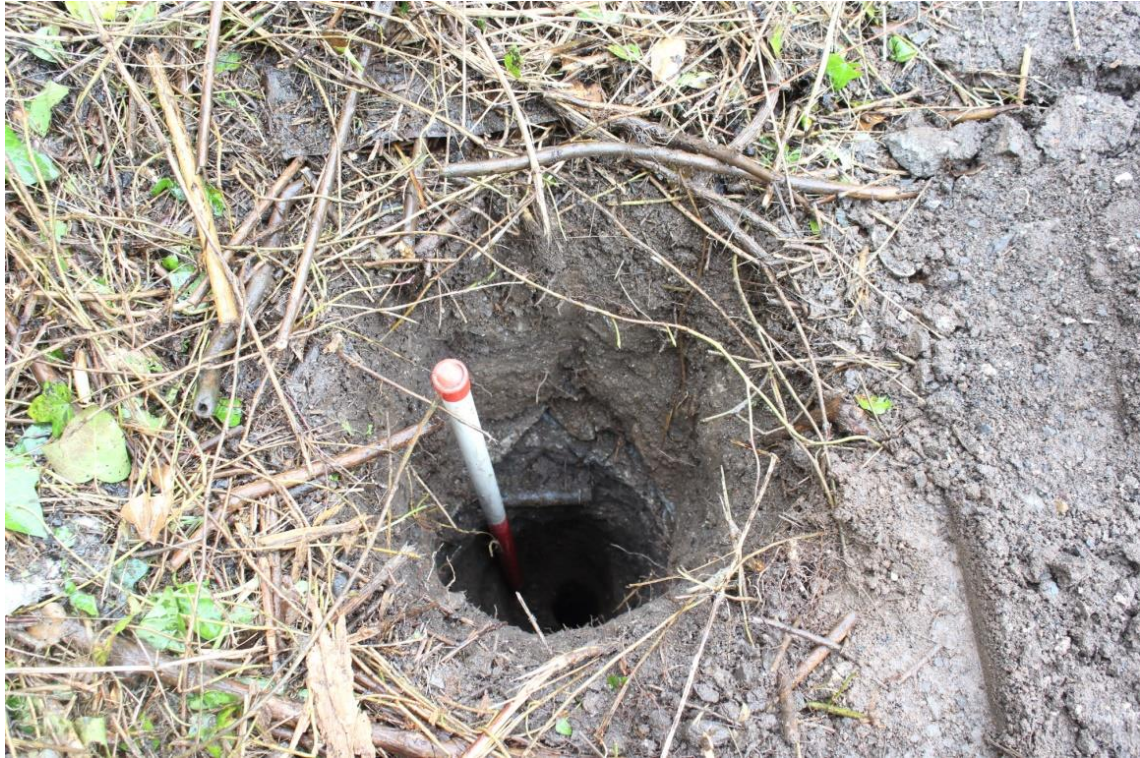
Window Space 5 (Dimensions 0.40m N/S x 0.38m E/W, by 1.08m deep)		
Context Number	Description	Depth/thickness
1020	Topsoil – Blackish brown silty clay.	0.22m thick.
1021	Light reddish brown silty clay.	0.18m thick.
1022	Waste slate layer, comprising of small sub angular slates.	0.12m thick.
1023	Dark brown silty sand.	First viewed at 0.52m below ground level.

Photo 6: View west of window space 5. 1m scale.

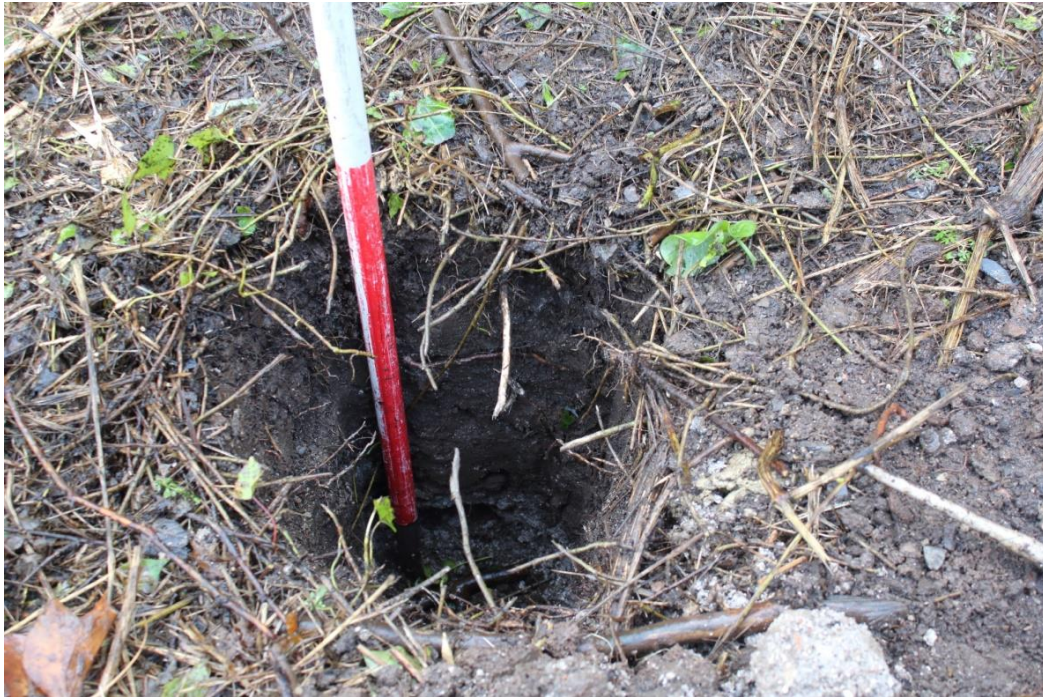
Window Space 5A (Dimensions 0.30m N/S x 0.30m E/W, by 0.54m deep)		
Context Number	Description	Depth/thickness
1024	Topsoil – Blackish brown silty clay.	0.06m thick.
1025	Dark greyish brown silty clay, which contained frequent inclusions of mortar and small sub angular stones.	0.08m thick.
1026	Mid/dark brown silty clay.	0.32m thick
1027	Rich grey mortar waste layer.	First viewed at 0.52m below ground level.

Photo 7: View west of Window Space 5A. 1m scale.

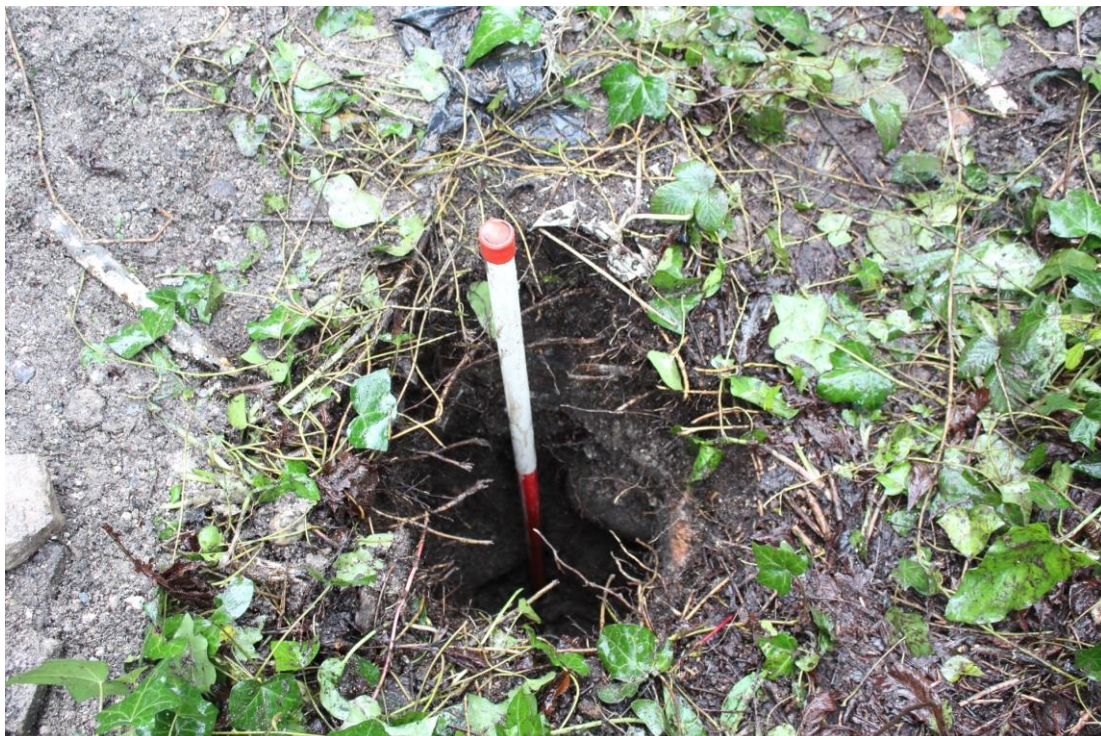
Window Space 6 (Dimensions 0.38m N/S x 0.40m E/W, by 0.92m deep)		
Context Number	Description	Depth/thickness
1018	Topsoil – Blackish brown silty clay.	0.12m thick.
1019	Mortar rubble layer, which contained some large inclusion of limestone blocks.	First viewed at 0.12m below ground level and full extent/depth not revealed.

Photo 8: View west of Window Space 6. 1m scale.

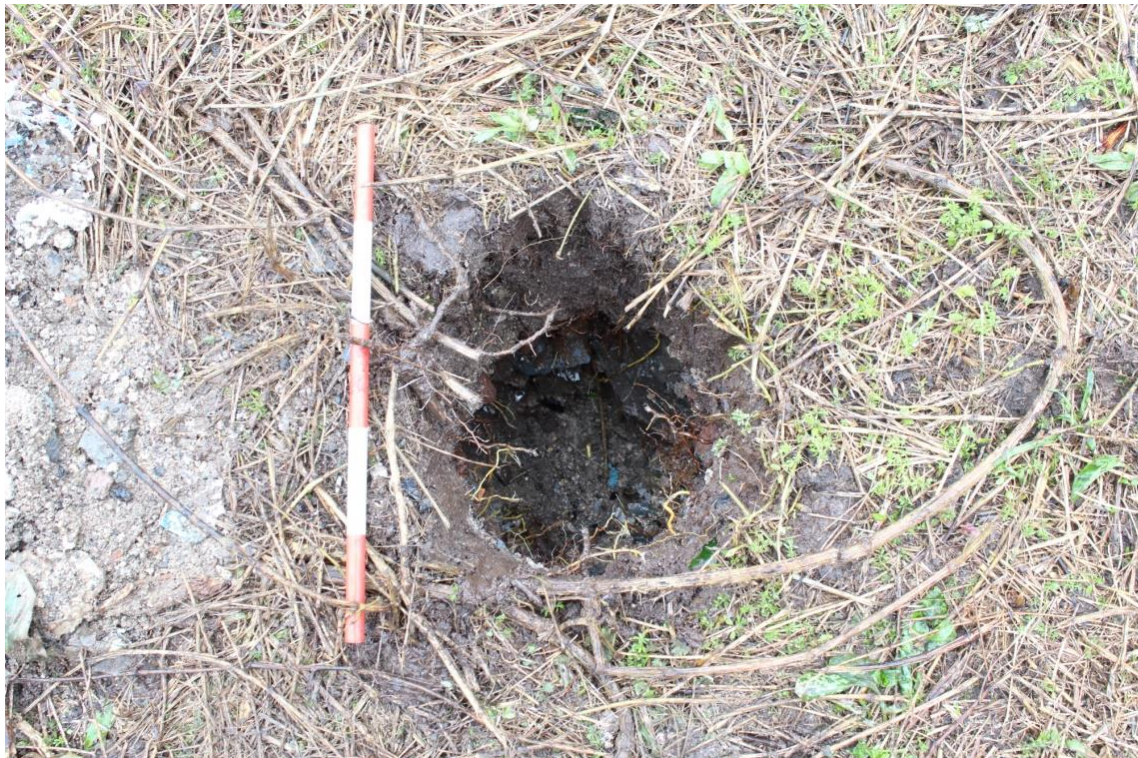
Soak Away 1 (Dimensions 0.38m N/S x 0.32m E/W, by 0.64m deep)		
Context Number	Description	Depth/thickness
1008	Topsoil – Blackish brown silty clay.	0.12m thick.
1009	Dark brown silty clay containing frequent inclusions of flecks of mortar.	0.21m thick
1010	Remains of building rubble, which contained some limestone blocks and fragments of 19 th century brick.	First viewed at 0.12m below ground level, full extent/depth not revealed.

Photo 9: View west of Soak Away 1. 0.5m scale.

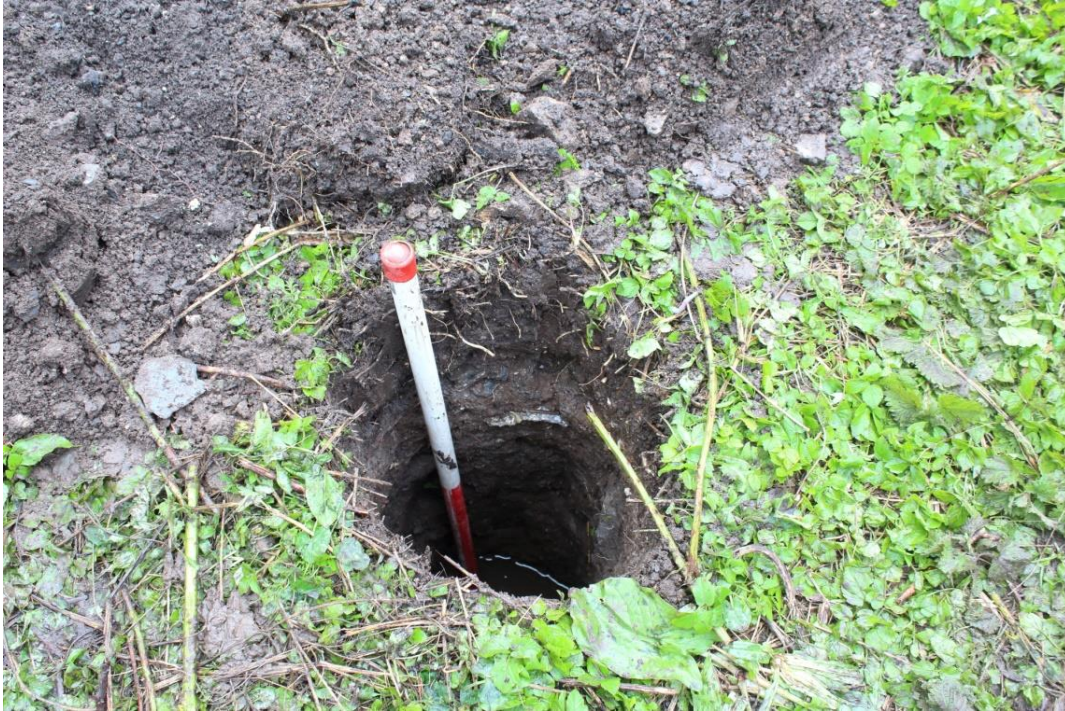
Soak Away 2 (Dimensions 0.30m N/S x 0.30m E/W, by 0.94m deep)		
Context Number	Description	Depth/thickness
1027	Topsoil – Blackish brown silty clay.	0.12m thick.
1028	Light brown clay, which is considered to be modern due to a foil crisp packet being found amongst the deposit.	0.10m thick
1029	Dark brown silty clay, probable remains of garden soil.	First viewed at 0.22m below ground level, full extent/depth not revealed.

Photo 10: View southeast of Soak Away 2. 1m scale.

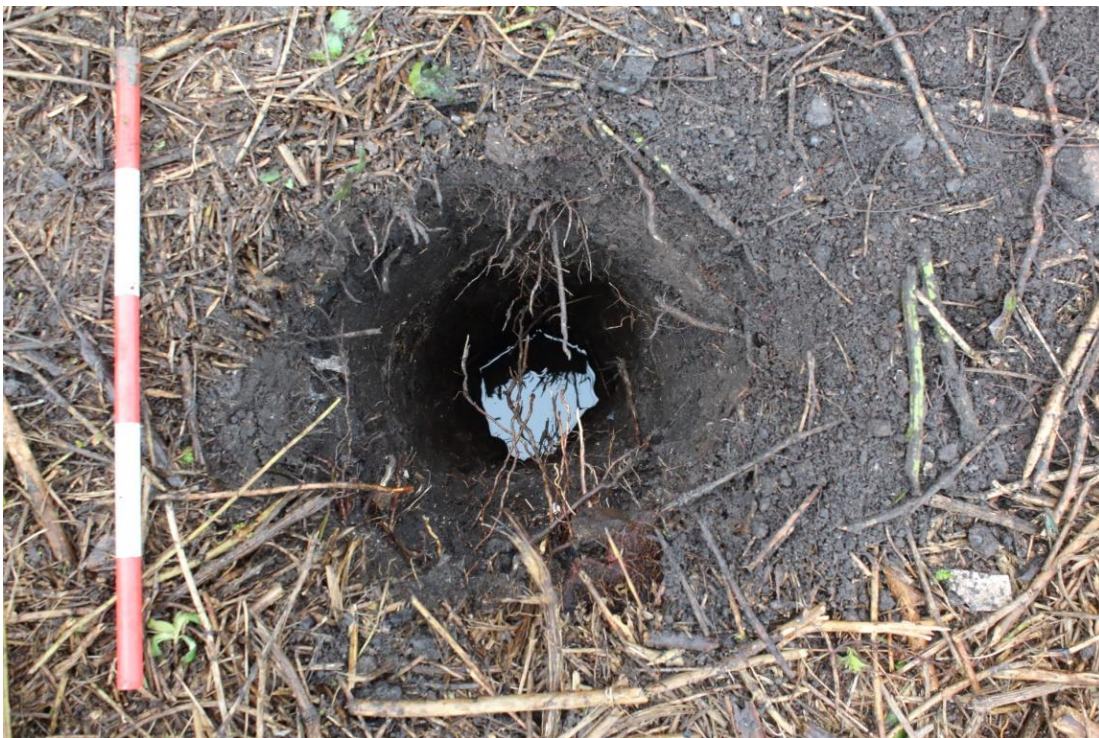
Soak Away 3 (Dimensions 0.38m N/S x 0.36m E/W, by 1.08m deep)		
Context Number	Description	Depth/thickness
1038	Topsoil – Blackish brown silty clay.	0.10m thick.
1039	Dark greyish brown silty clay. (Partially flooded due to testing during recording)	First viewed at 0.10m below ground level, full extent/depth not revealed.

Photo 11: View west of Soak Away 3. 0.5m scale.

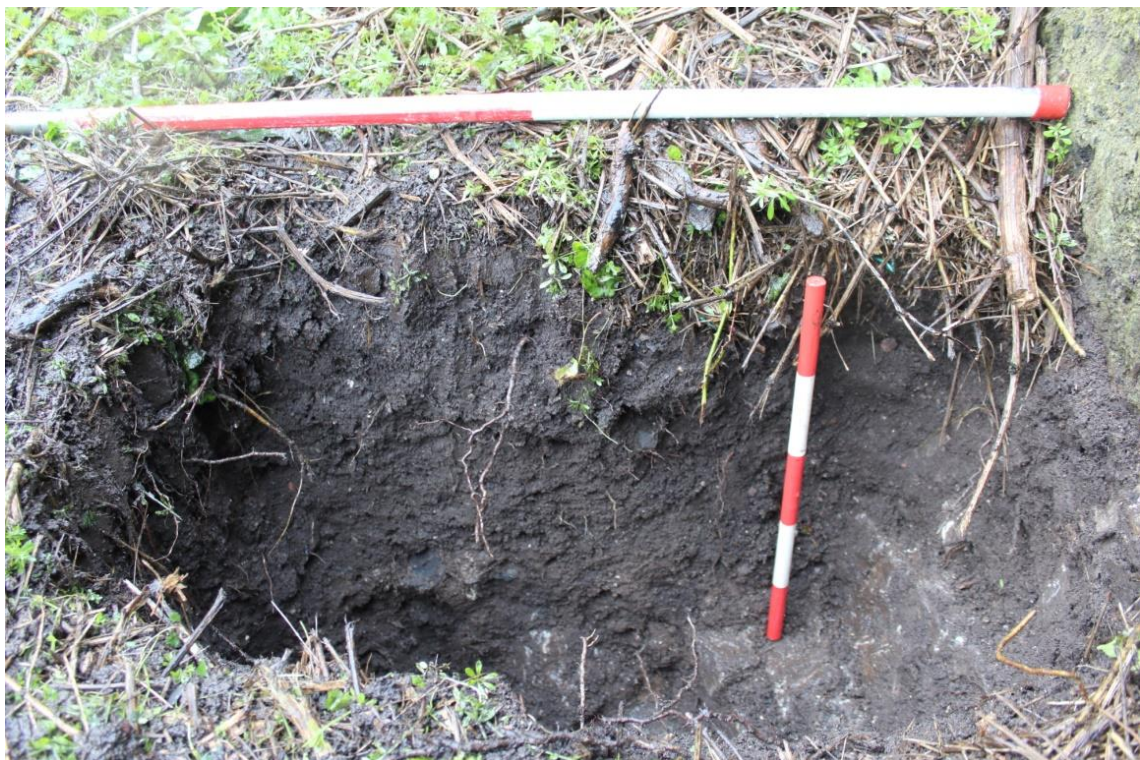
Test Pit 1 (Dimensions 0.82m N/S x 0.43m E/W, by 0.80m deep)		
Context Number	Description	Depth/thickness
1004	Topsoil – light greyish black silty clay. Heavily rooted by vegetation	0.28m thick.
1003	Mid greyish black silty clay.	0.20m thick.
1002	Mortar rich deposit containing small fragments of slate.	0.12m thick
1001	Dark brown silty sand which contained frequent flecks of lime mortar.	0.34m thick
1000	Solid Geology comprising of light grey limestone bedrock.	First viewed at 0.94m below ground level.

Photo 12: View south of the section of Test Pit 1. 1m scale and 0.5m scale

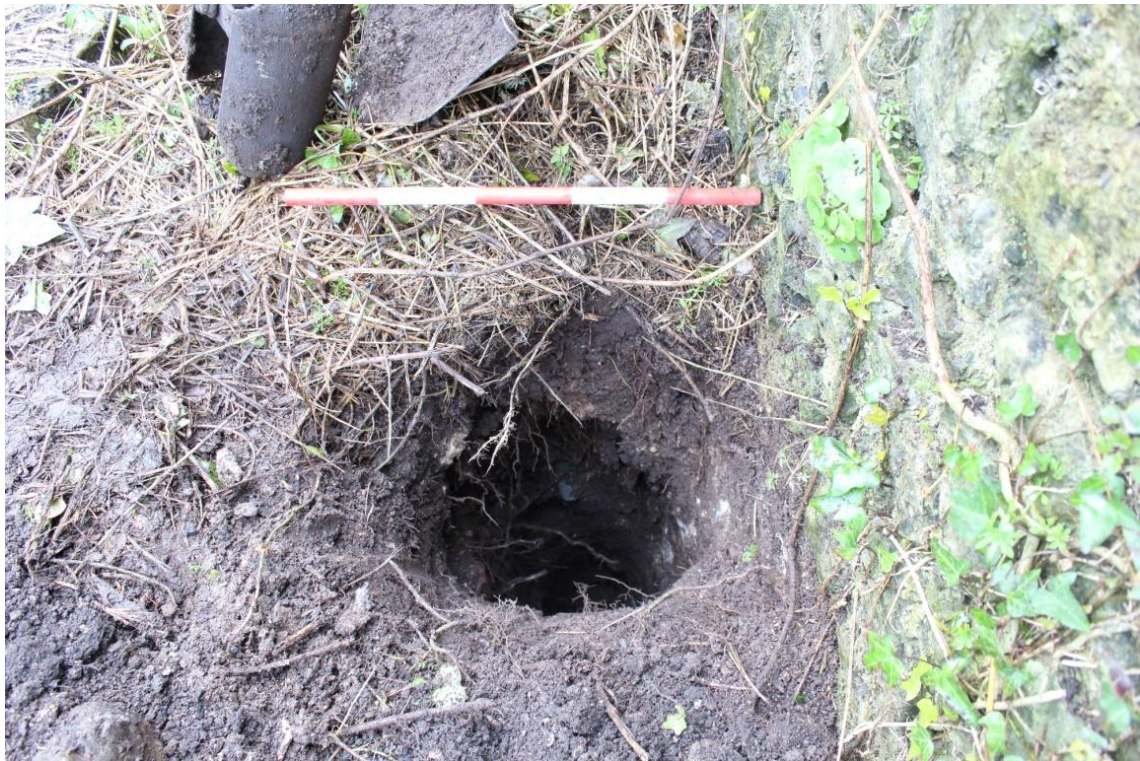
Test Pit 2 (Dimensions 0.40m N/S x 0.36m E/W, by 1.32m deep)		
Context Number	Description	Depth/thickness
1030	Topsoil – Dark brown silty clay.	0.10m thick.
1031	Light greyish brown silty clay sand.	0.18m thick
1032	Blackish brown silty clay.	0.34m
1033	Slate debitage layer.	0.06m thick
1034	Blackish brown silty clay.	First viewed at 0.62m below ground level, full extent/depth not revealed.

Photo 13: View south of Test Pit 2. 0.5m scale.
