Twentieth Century Military Sites: The Cold War

Prepared by Dyfed Archaeological Trust

DAT Event Record No. 121779

Report No. 2020/25

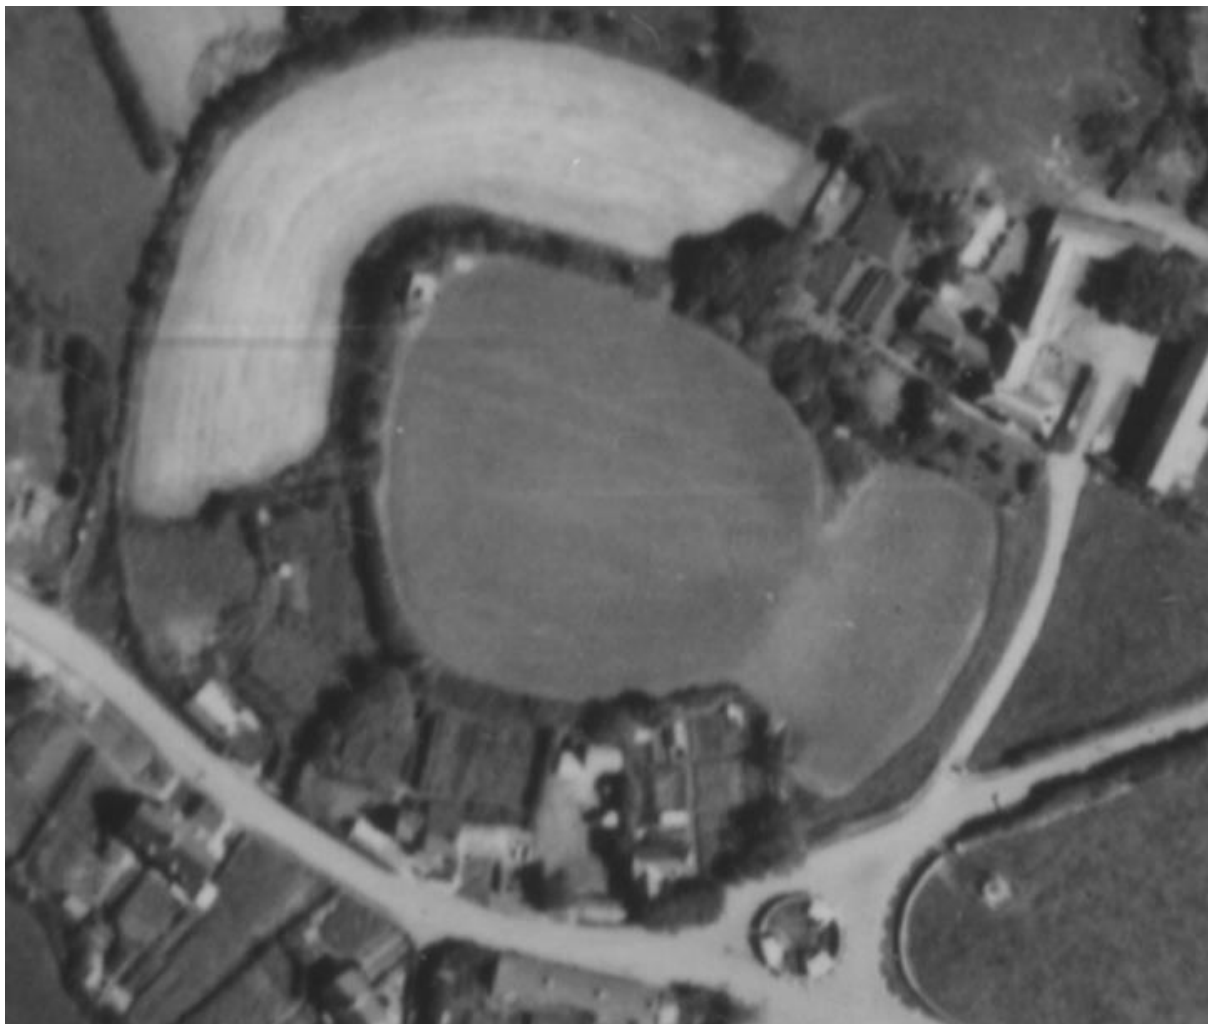
The ROC post lies in the northwest quarter of the circular hedgebank marking the Iron Age enclosure RAF Aerial photograph 106G/UK1626 7th July 1946

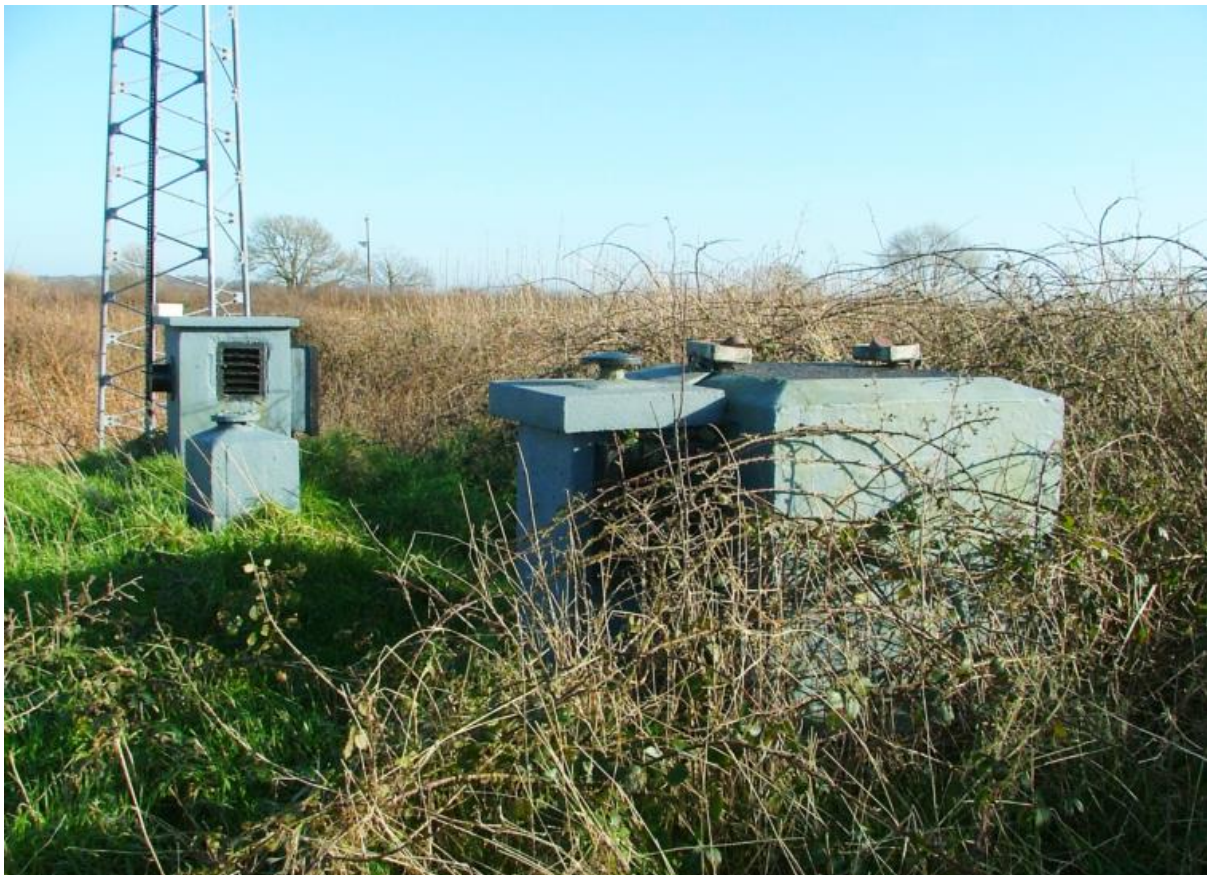
Narberth Post 13-G2 general view from the west 2007_0214 © Roger JC Thomas
