**EAST DUDWELL BARNS, CAMROSE,
PEMBROKESHIRE
ARCHAEOLOGICAL WATCHING BRIEF
(SM9100121161)**

PLANNING APPLICATION NO. 19/0093/PA

**REPORT NO. 2020-41
EVENT RECORD NO.121958**

**EAST DUDWELL BARNS, CAMROSE
ARCHAEOLOGICAL WATCHING BRIEF
(SM9100121161)**

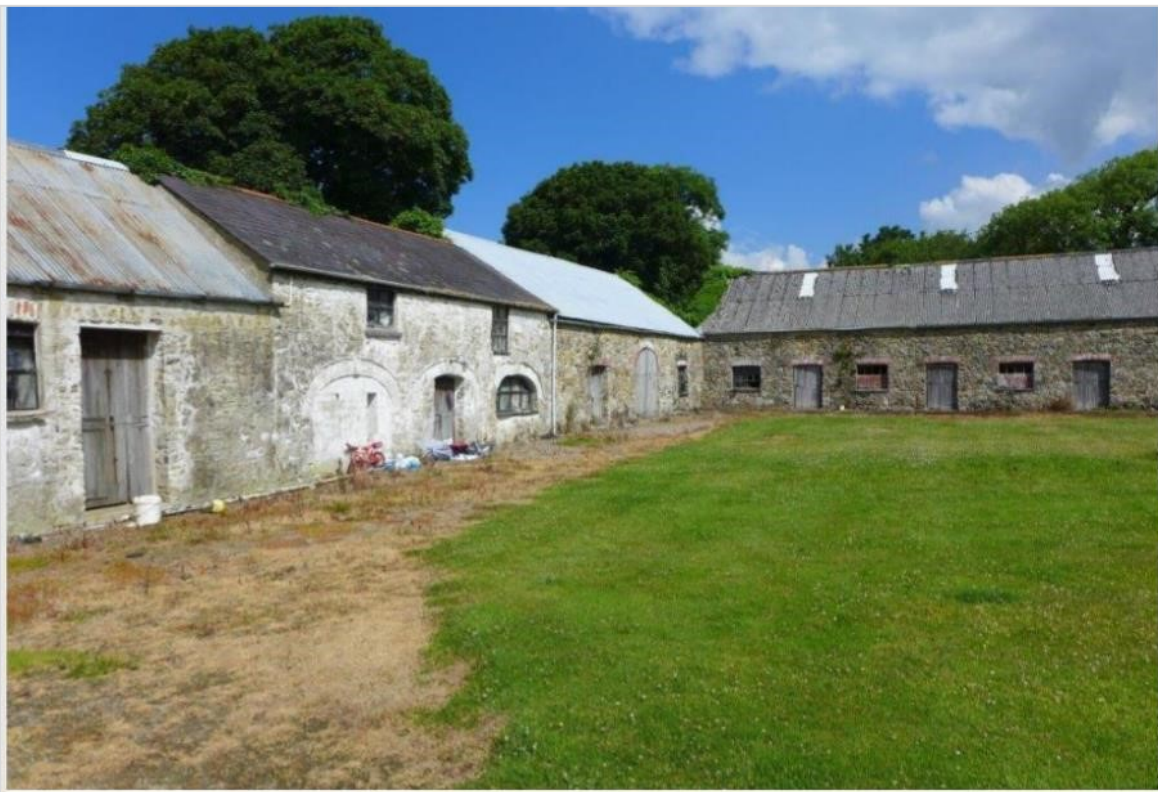
Photo 1: The buildings at East Dudwell proposed for conversion (photo taken from sales particulars from Town, Coast and Country Estates).

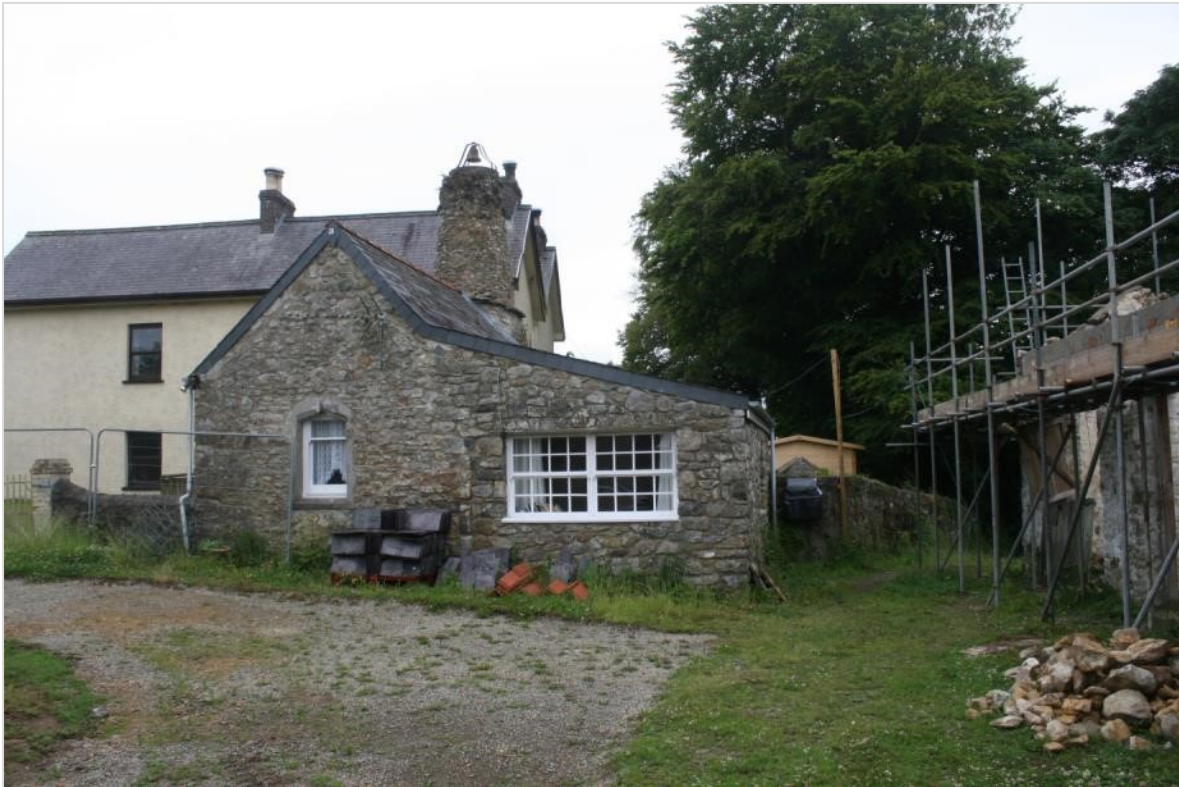
Photo 2: The small building (PRN 13246) and conical round chimney thought to be of medieval origins located at the southwestern corner of the farm yard (DAT Photo).

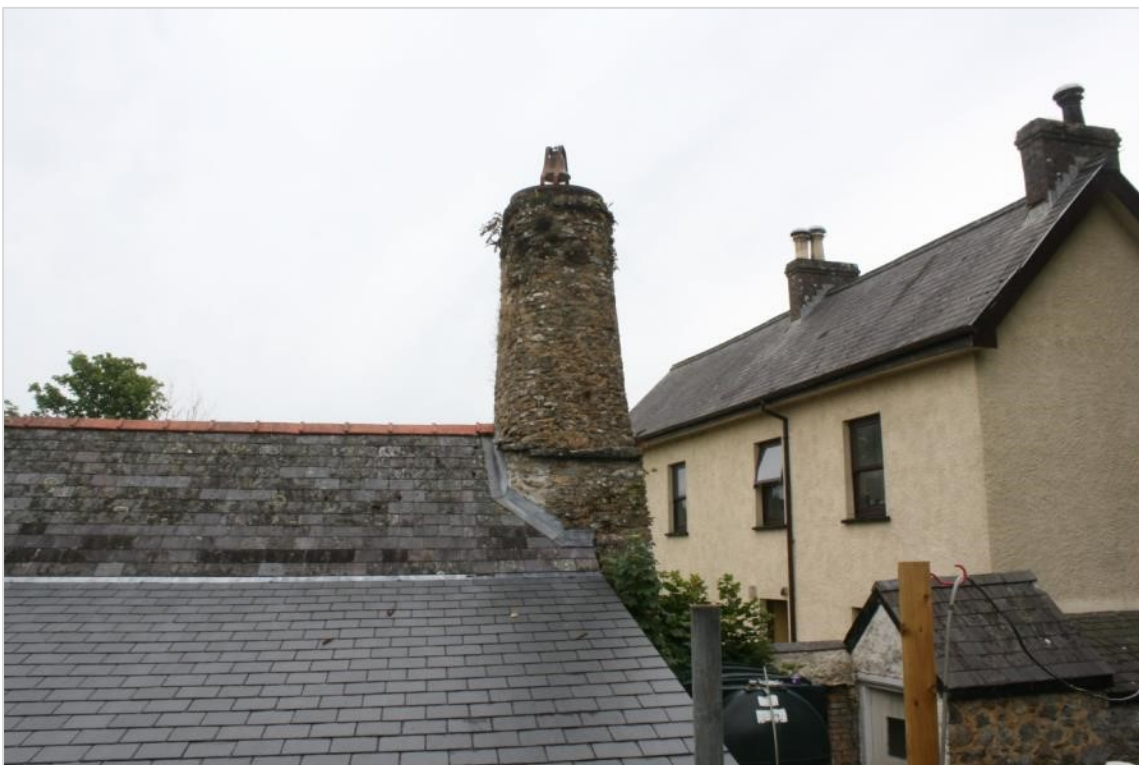
Photo 3: View facing East of the conical round chimney situated at the southern gable of building PRN 13246 (DAT Photo).

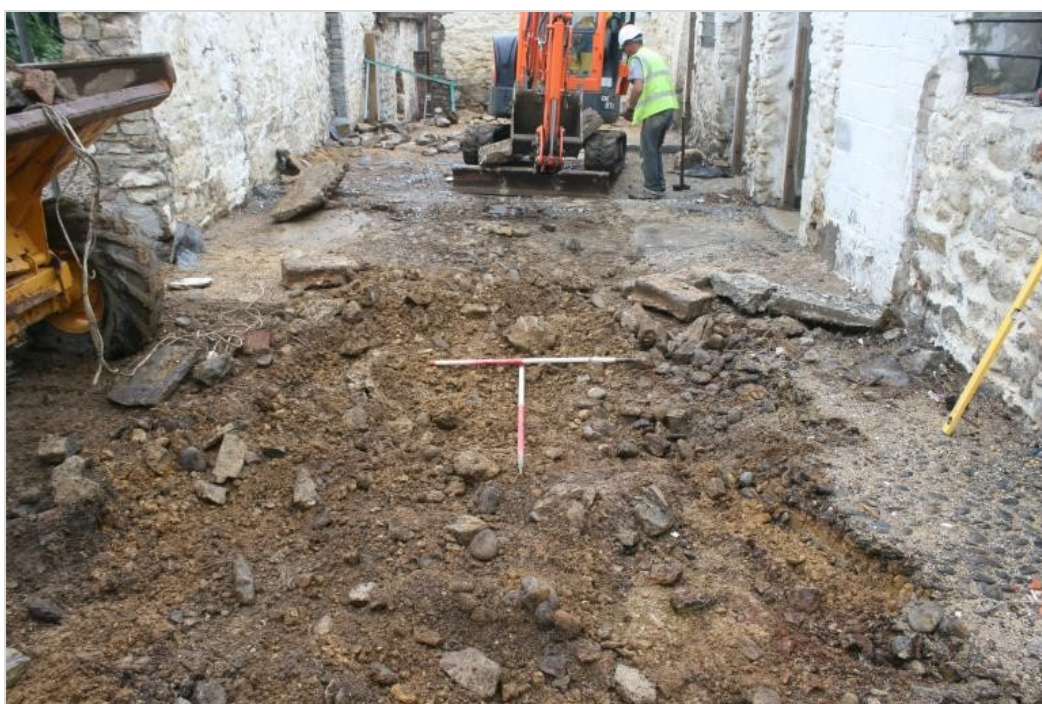
Photo 4: The disturbed floor level in Building 1 (DAT Photo)

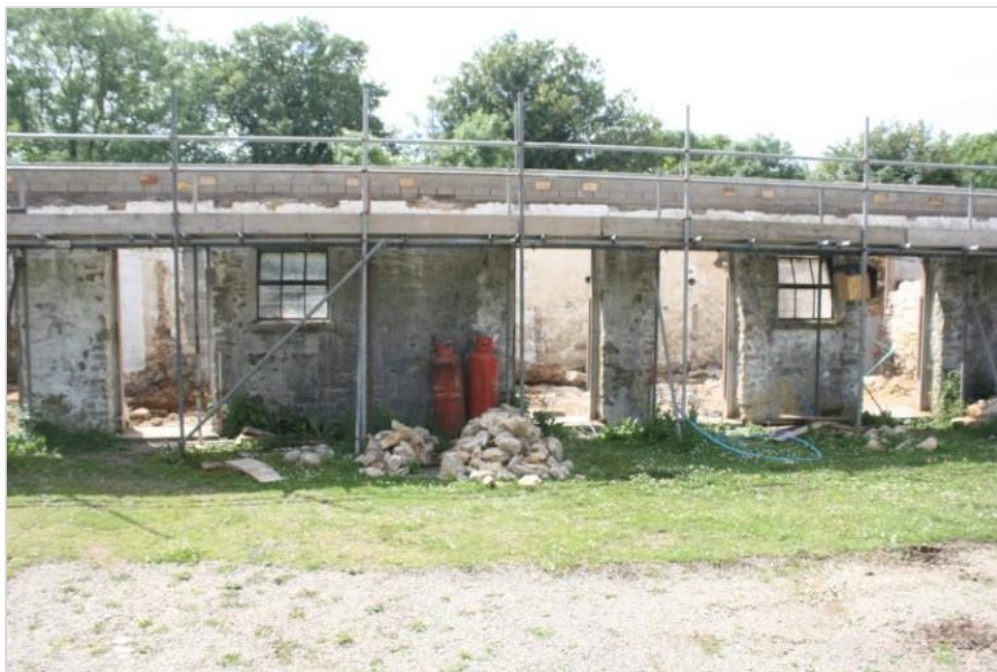
Photo 5: The central openings in the east facing elevation of Building 1 (DAT Photo)

- 5.3 Building 1 was approximately 18.85m long with four doorways, two small rectangular windows and a double width opening on the east facing elevation (Photos 5 & 6). Its' original function is unknown although it is likely that it was internally divided into stalls and is likely to have been a cow house. A small, exploratory test pit was mechanically excavated to the depth of the new foundation level. This pit was situated at the southern end of Building 1 and measured approximately 0.4m wide, 1.6m in length and 0.4m in depth (Photo 7). The pit revealed a simple stratigraphy comprising a thin layer of fine cobbling, no more than 0.1m

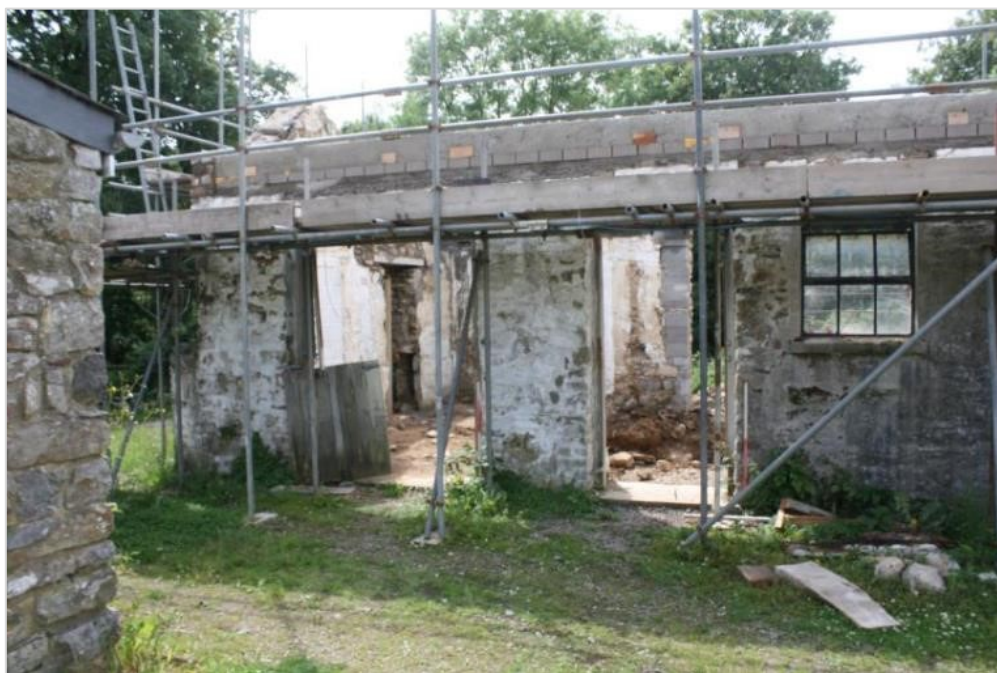
Photo 6: The southern end of the east facing elevation of Building 1 (DAT Photo)

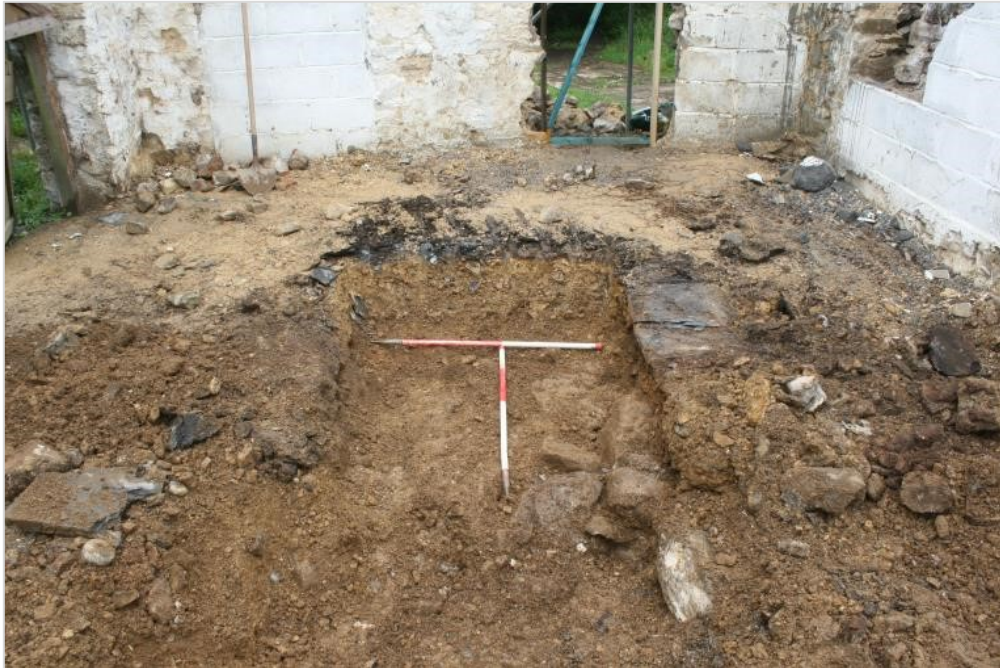
thick (100) which appeared to be set into a thin layer, again around 0.1m thick, of yellow/orange clay (101). This layer was overlying what appeared to be the redeposited natural subsoils colloquially known as "rab", consisting of unconsolidated and stony, orangey brown clay common to the area (103). At the base of the test pit was a tumble of large masonry, sub angular stones which appeared to have been included within this deposited layer (102). The test pit had truncated a later slate capped drain (104) which was cut through the cobble surface (100) and clay bedding (101) (Photo 8).

Photo 7: The exploratory test pit in Building 1. Note the masonry block tumble in the bottom right of the pit and the slate capped drain (DAT Photo)

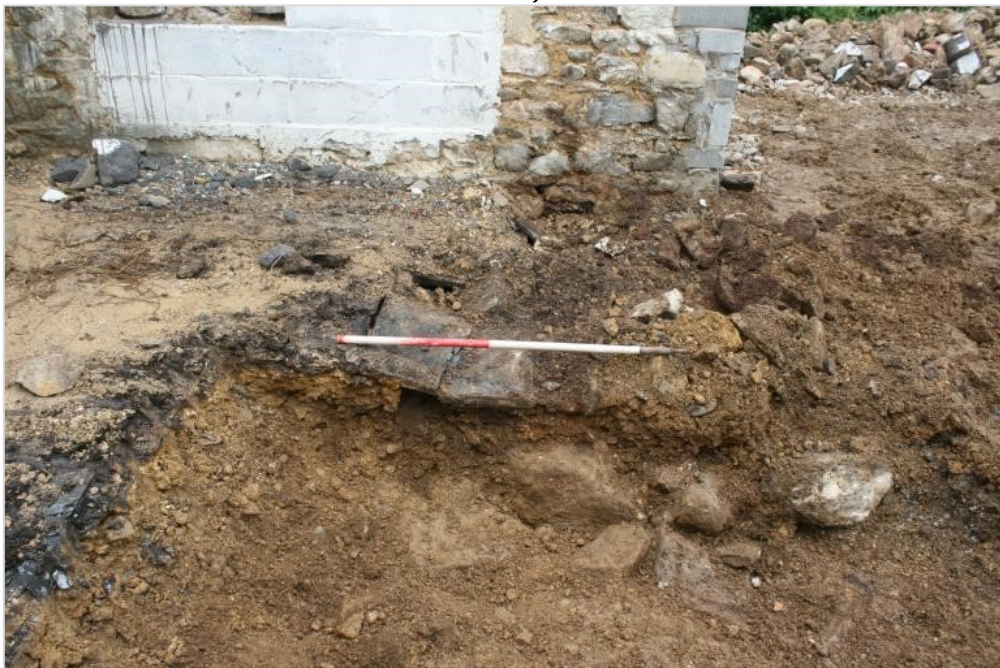
Photo 8: The east facing section of the test pit in Building 1 showing the truncated slate capped drain (104) and masonry tumble (102) (DAT Photo)

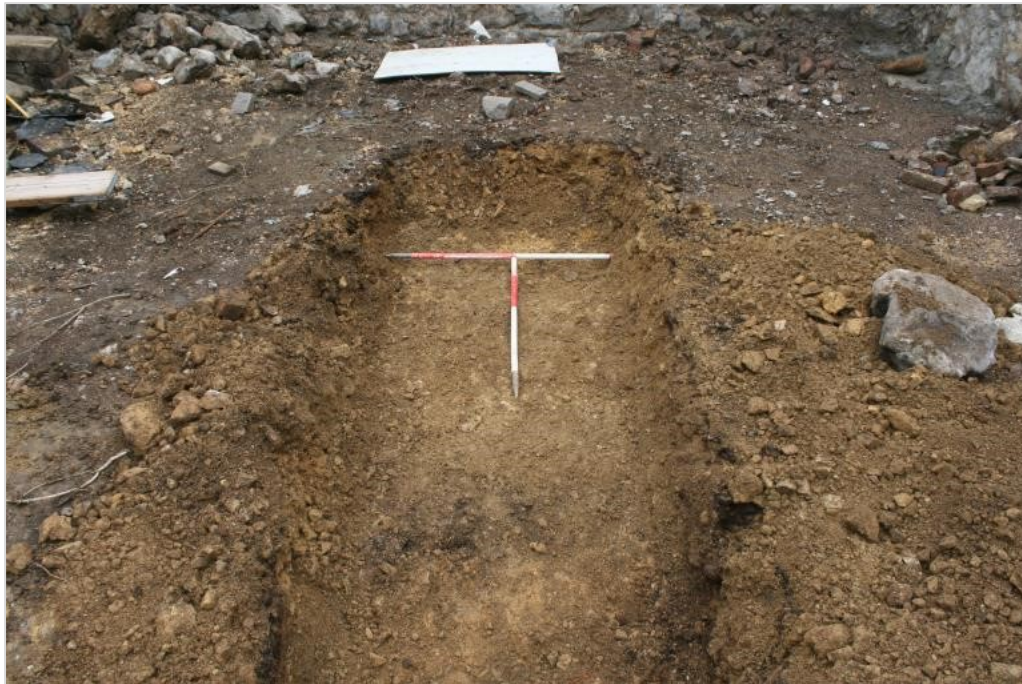
- 5.4 The test pit was then extended at this depth across the length of the barn which revealed a consistent stratigraphy as seen in the initial test pit. No other features or deposits of archaeological interest were observed (Photo 9). Whilst no surface features remained, the cobble flooring, drain and layout of the doorways and openings does suggest that it may well have been a cow shed.
- 5.5 A likely explanation for the redeposited "rab" (103) and tumble of masonry blocks is that this material originated from the original wall foundation trenches and was used as levelling material for the internal floors. The range is situated on a slight gradient which falls away to the south. Indeed, the slate capped drain located at the southern end of this building is in accordance with this topography.

Photo 9: The continued trench in Building 1 (DAT Photo)

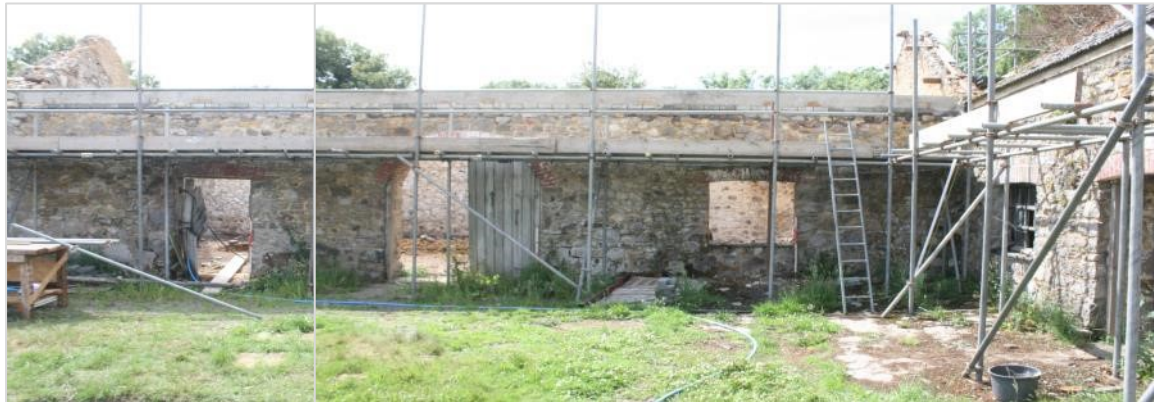
- 5.6 Floor reduction continued in Building 3 where a second initial test pit was dug to the proposed foundation depth. Building 3 was approximately 14.8m long and was the northernmost building in this range. Its' east facing elevation was dominated by a wide, arched double opening flanked by a narrow doorway and rectangular window, all with red brick voussoirs and a slate window lintel (Photo 10). A wide, rectangular opening in the northern gable end of the building provided secondary access into the range from the field without entering the farmyard (Photo 11). The wide, arched opening in the east facing elevation and gable access is more suggestive of use as a cart shed or for the housing of heavy machinery.

Photo 10: A composite image showing the east facing elevation of Building 3 (DAT Photo)

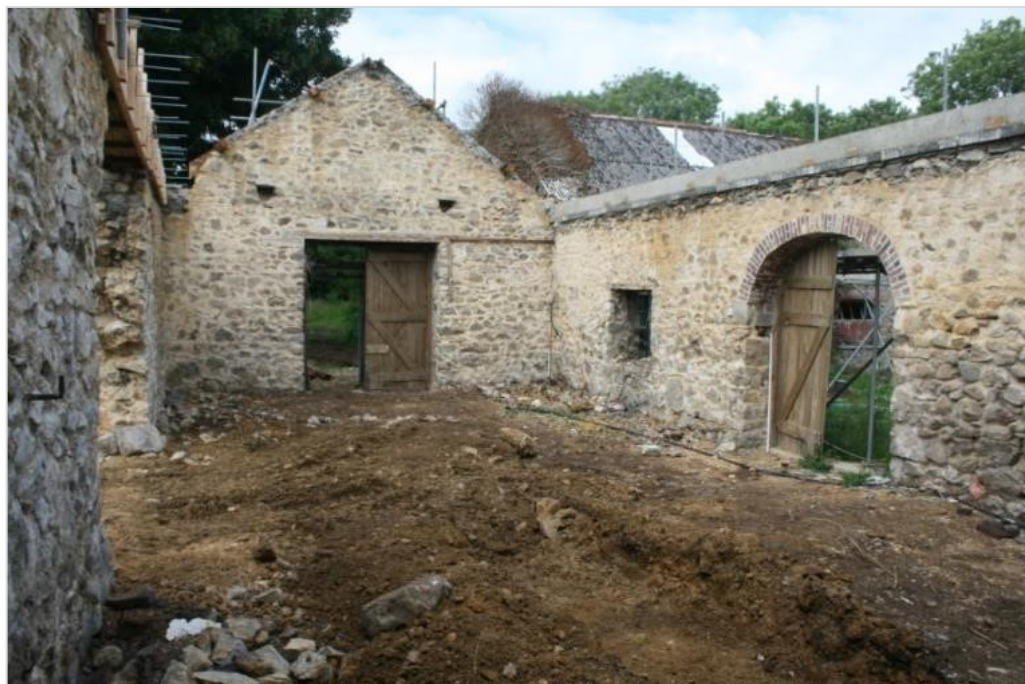
Photo 11: The two wide openings in Building 3 (DAT Photo).

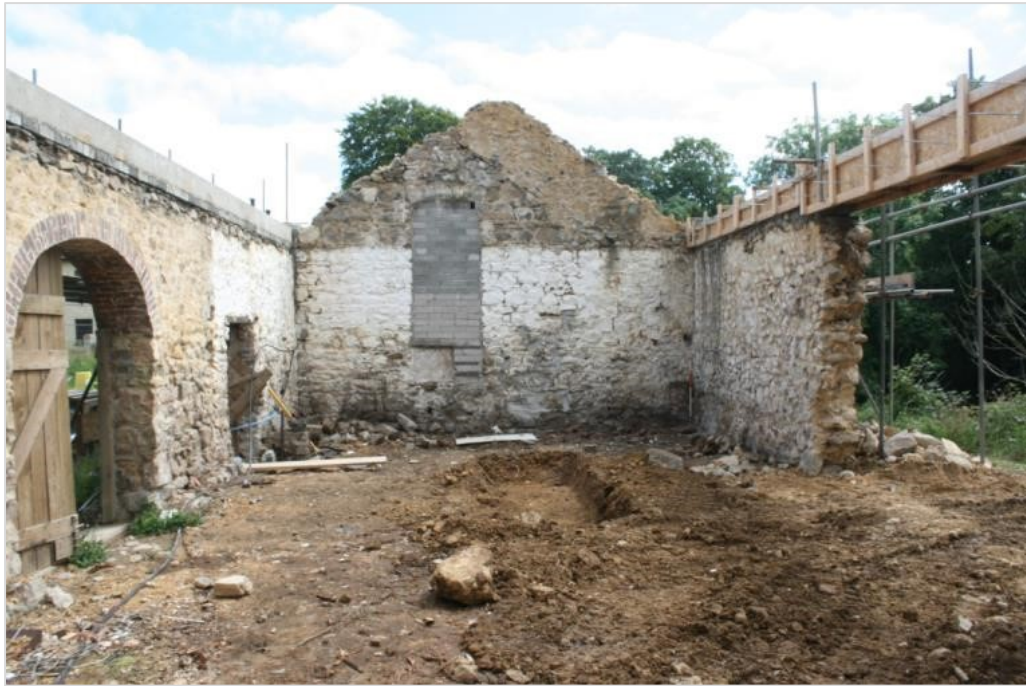
- 5.7 The test pit in Building 3 measured approximately 1.7m in length, 0.45m wide and 0.45m deep (Photo 12). Unlike in Building 1, there appeared to be no formal finished floor, just a beaten earth floor which was approximately 0.35m thick and comprised a light orange-brown, silty clay with frequent, small sub-angular stones (200). This layer contained sherd of 19th century glass and red brick fragments. As predicted by the slightly sloping topography, the undisturbed natural "rab" was reached at 0.34m depth (201).

- 5.8 Casual observations of the phasing of the buildings in this north-south range suggested that Building 3 is the latest building in this range. The significantly raised roof pitch is evident in the northern gable end of Building 2 as well as an infilled, arched window opening (Photo 12).

Photo 12: The location of the test pit in Building 3 and infilled opening in the southern gable of Building 3 (DAT Photo).

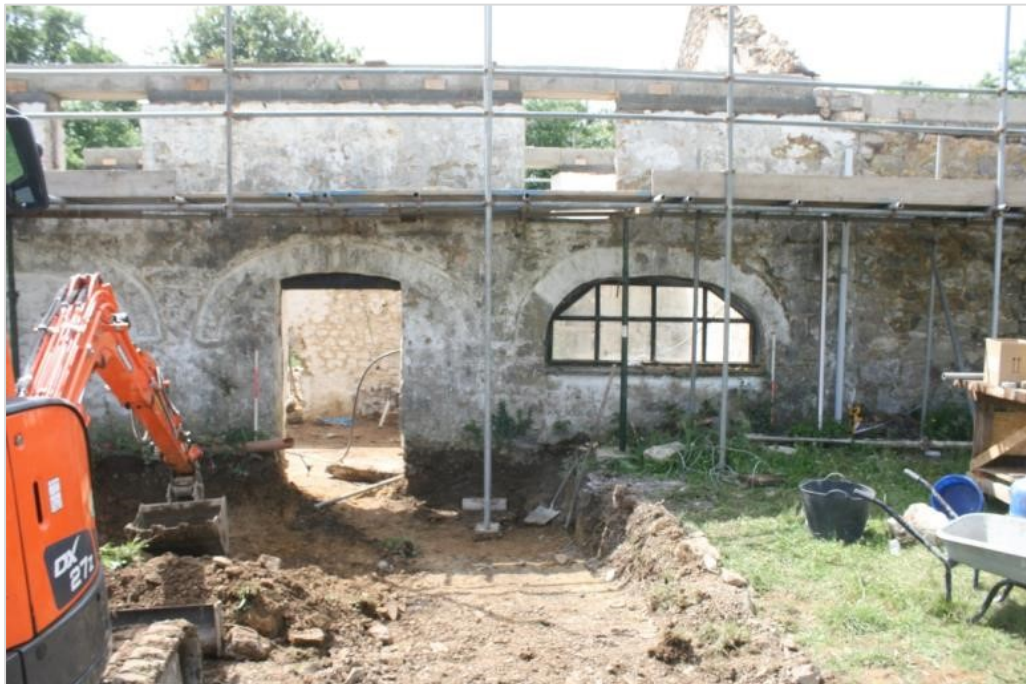
Photo 13: The central and northern infilled opening on the east facing elevation of Building 2 (DAT Photo)

- 5.10 All of three of the openings in the eastern elevation are infilled; the southernmost opening has been infilled most extensively, leaving only a narrow rectangular window. The central opening has been narrowed to a modest doorway and the northern most opening has been half infilled to create a generous window (Photos 13 & 14). It is most likely that the three infilled openings were originally open fronted and that the building served as the original cart shed with most likely a granary above which was accessed via the external entrance in the gable end. On this basis, it

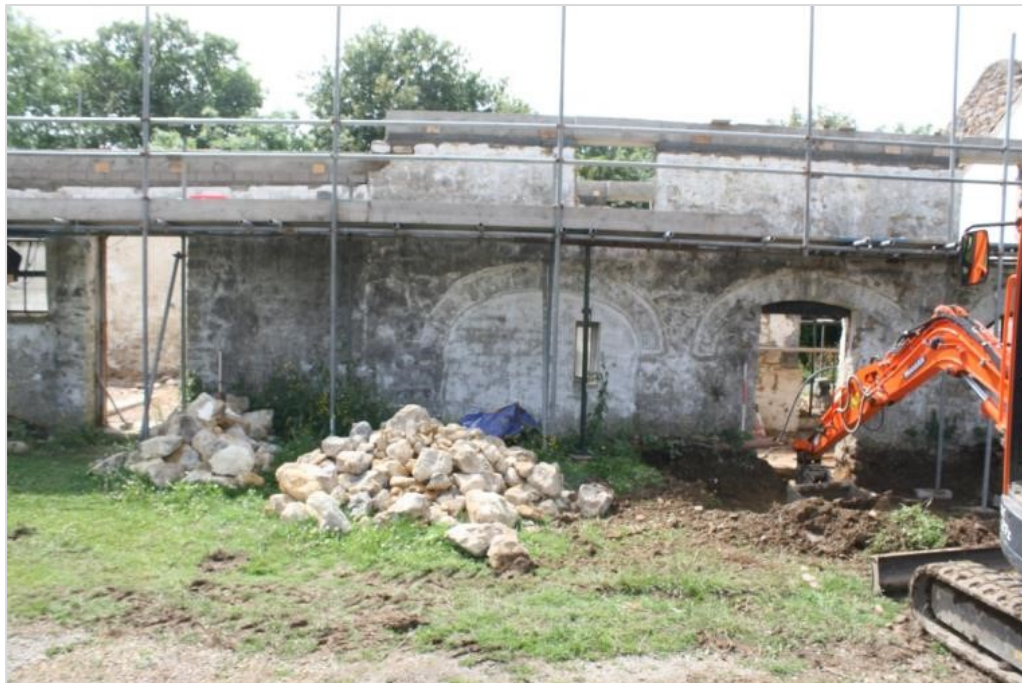
Photo 14: The southern and central infilled openings in the east facing elevation of Building 2 (DAT Photo)

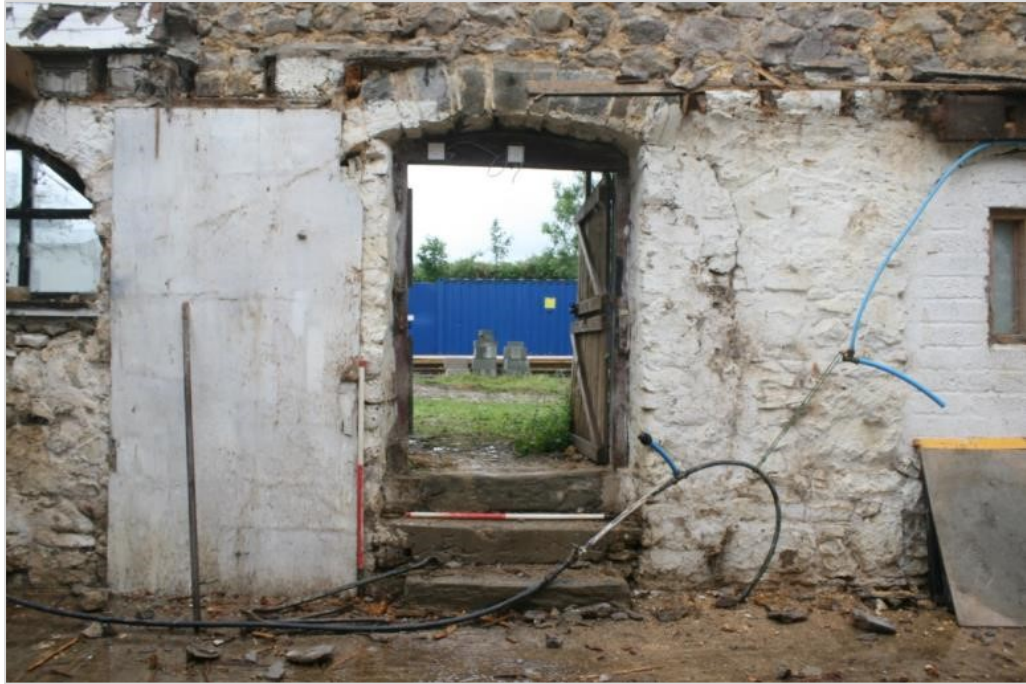
- 5.11 The floor level within Building 2 was approximately 0.5m lower than the external ground level and three stone steps had been inserted into the infilled central opening (Photo 15). These steps were removed and the ground level on the external side of the opening was excavated to the level of the internal floor, truncating a modern waste water pipe in the process (Photo 16). The section of this excavated area revealed a depth of around 0.3m of topsoil, comprising frequent sub-angular stones in a dark brown silt (300) which overlay the natural, orangey brown "rab" (301). No other features or deposits of archaeological interest were observed.
- 5.12 The infilling of the central opening, which comprised mortared rubble and occasional brick, was then removed to the opening's original width (Photo 17).

Photo 15: The internal elevation of the central, infilled opening in the east facing elevation of Building 2 showing the inserted steps and difference between the internal and external ground levels (DAT Photo)

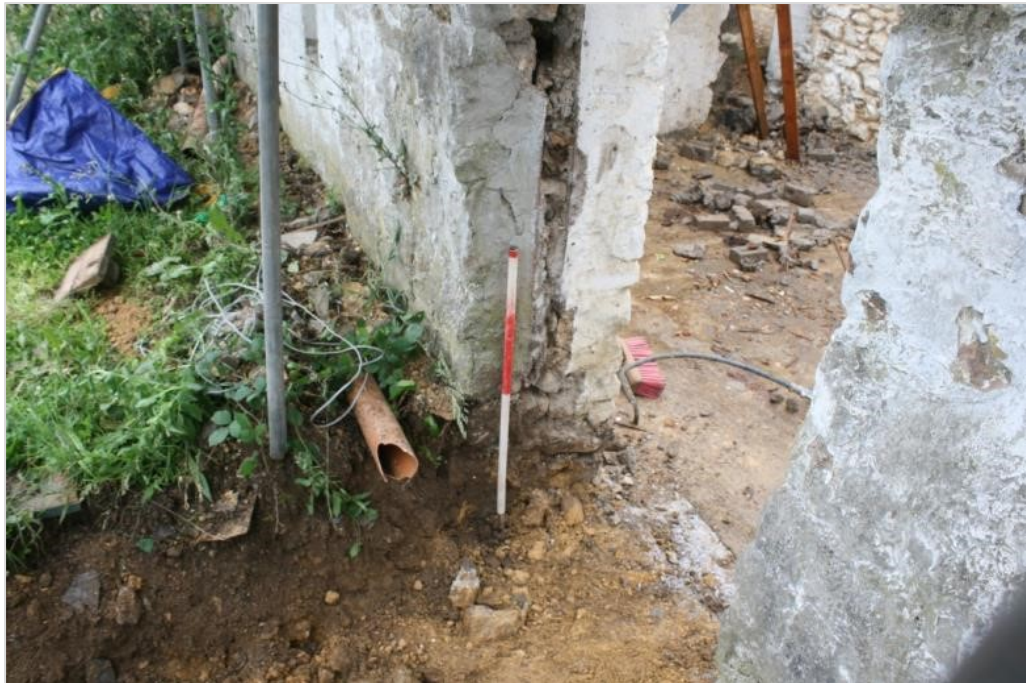
Photo 16: The reduced ground level and truncated water pipe of the central infilled doorway in the east facing elevation of Building 2 (DAT Photo)

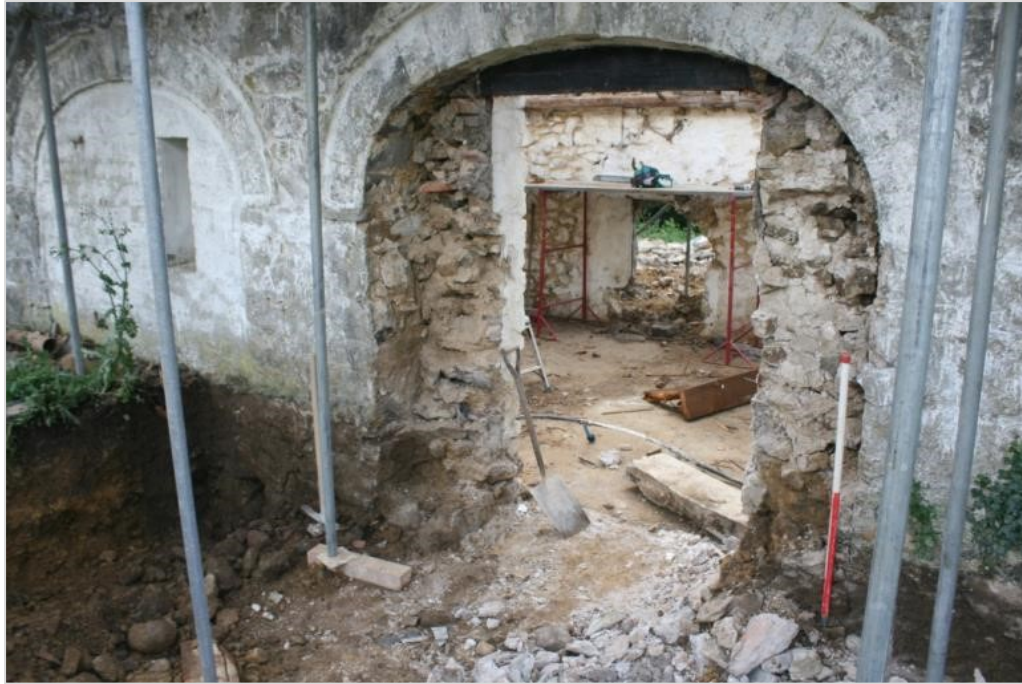
Photo 17: The partially widened central opening in the east facing elevation of Building 2 (DAT Photo)
