**LLANWNNEN PRIMARY SCHOOL,
LLANWNNEN, CEREDIGION**

**HISTORIC BUILDING RECORDING &
WATCHING BRIEF**

REPORT NO. 2020-44
EVENT RECORD No.125509

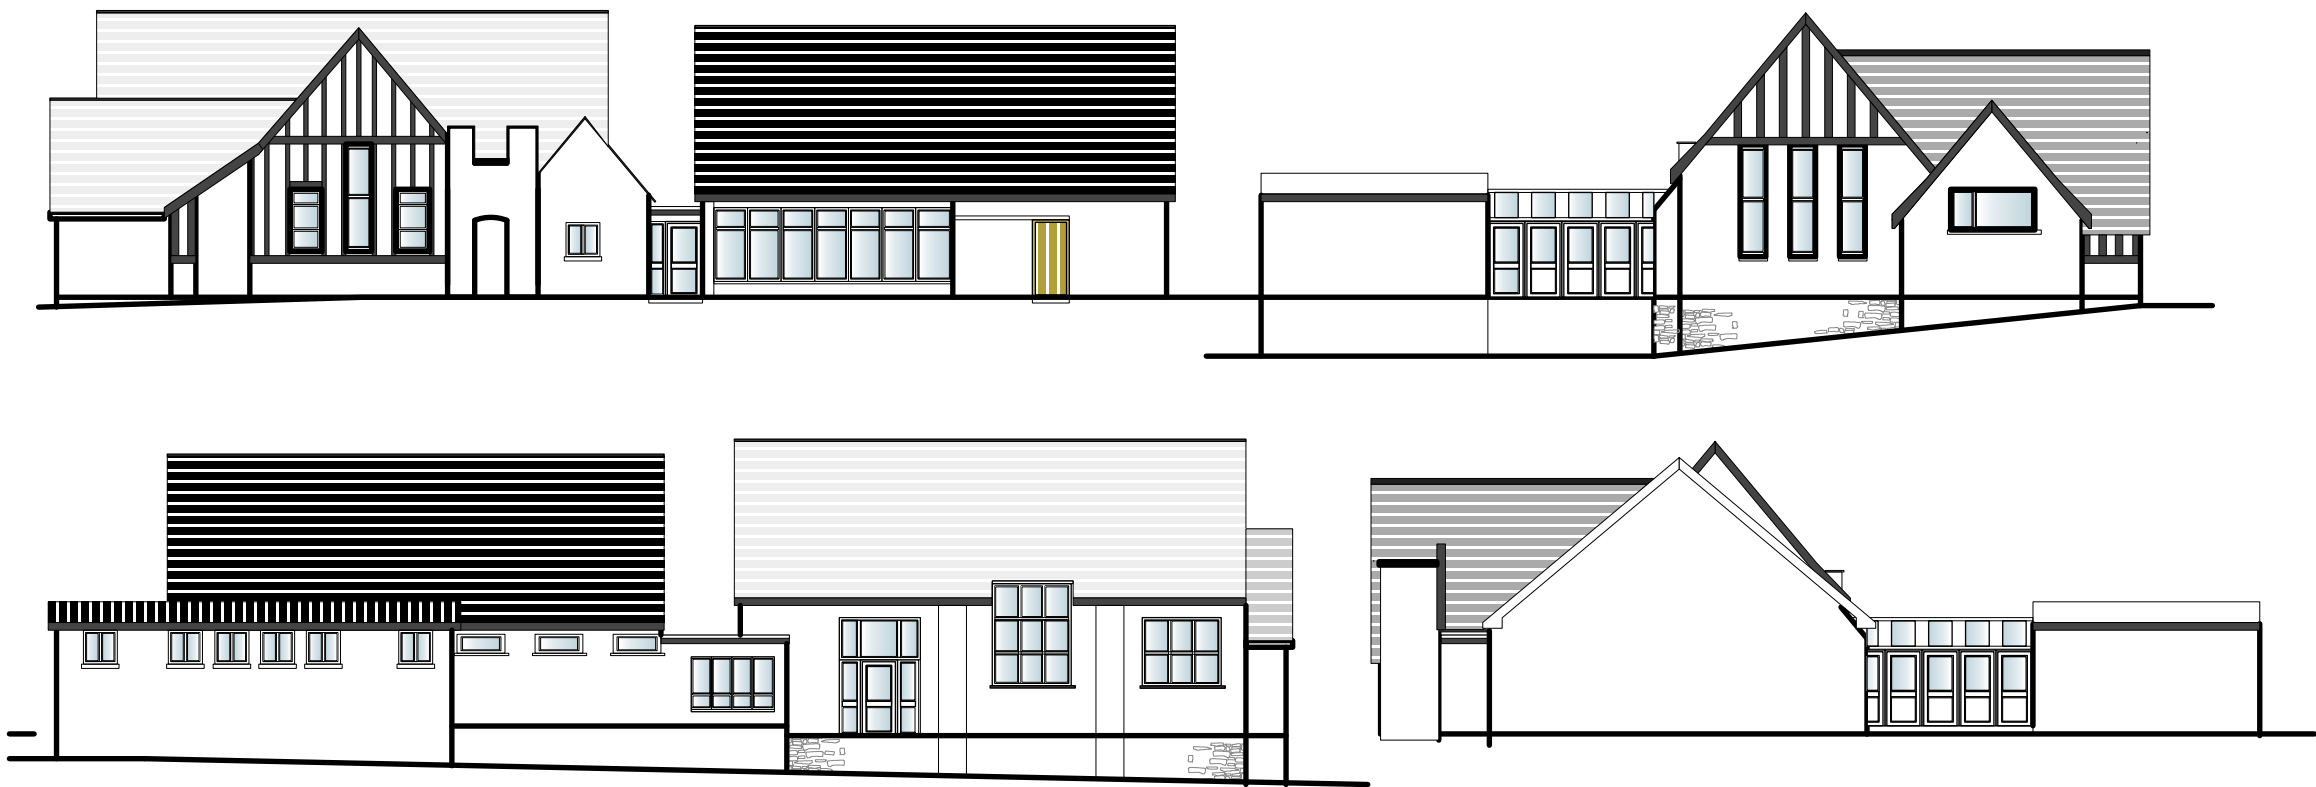
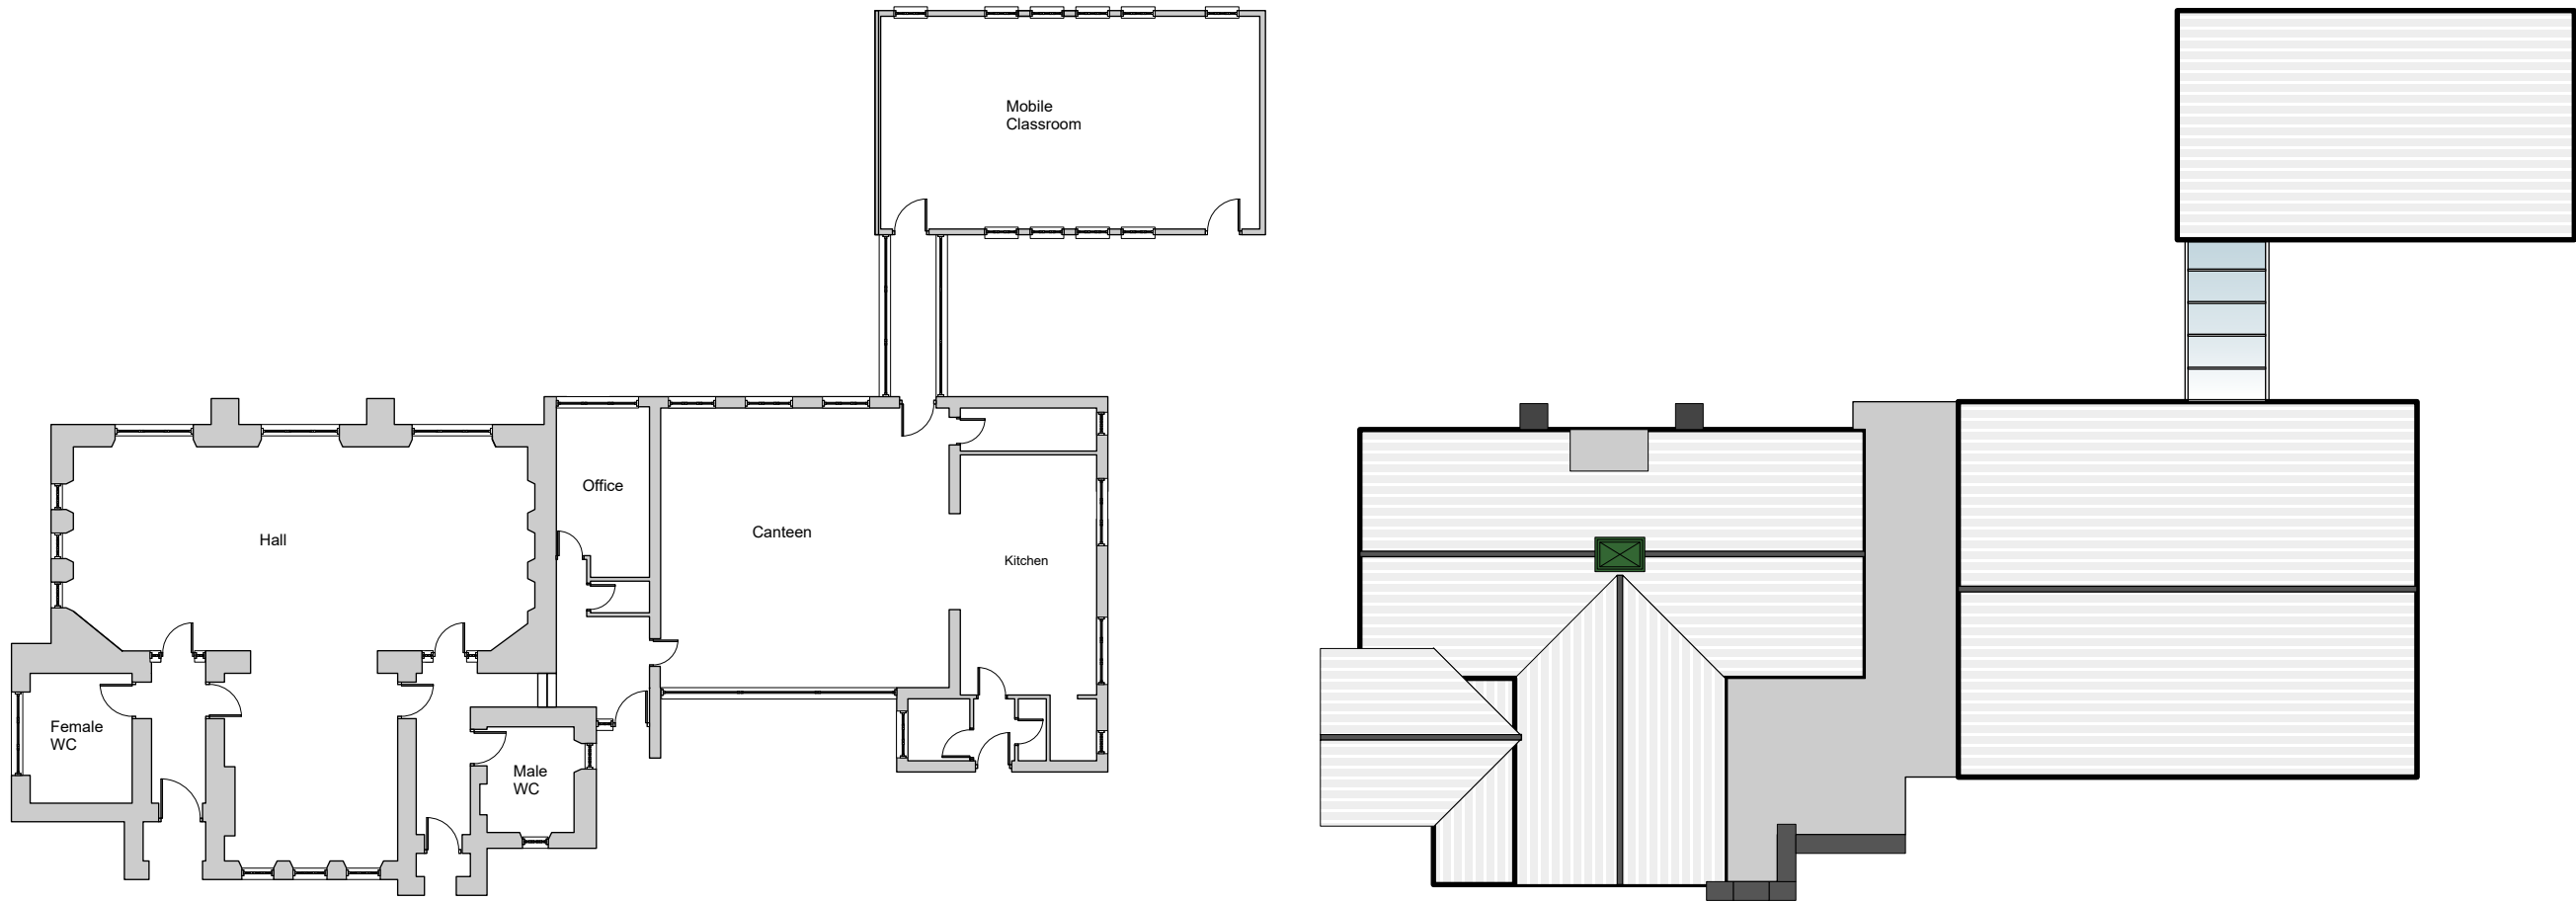
Existing elevations
Scale ~ 1:200

Existing ground and roof plans
Scale ~ 1:200

Figure 4: Plans and Elevations of Llanwnnen Primary School prior to development works.

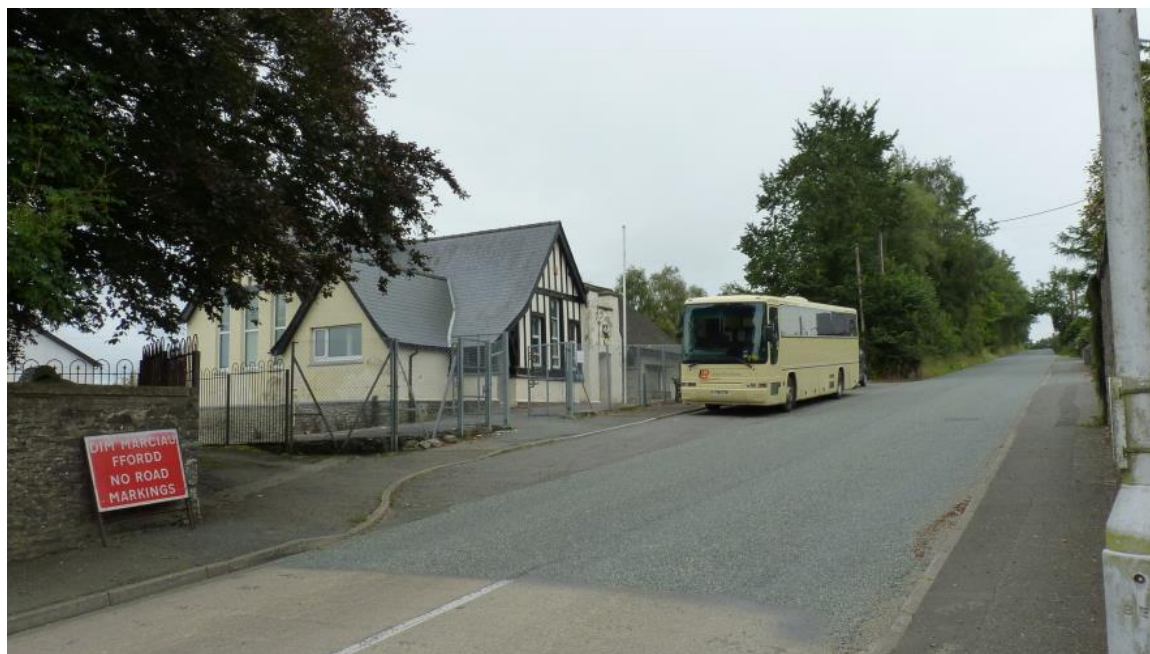
- 4.1.1 The original school building comprises a T-shaped main block, with pitched gable roof, and adjoining squared blocks with differing roof styles on either side of the northeast facing entrances. A later extension stands to the southwest.

Photo 1: Southwest facing shot of the school building and immediate setting.

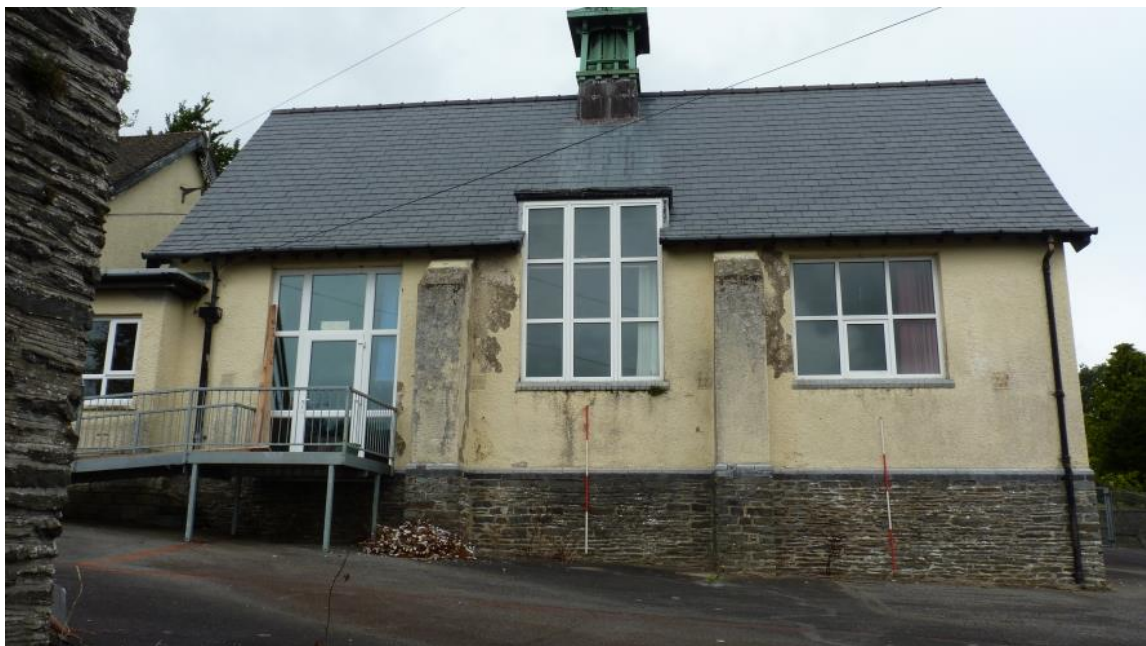
4.1.2 The original main hall block is aligned NE-SW, 13.5m by 6.5m, and 9m high to the central ridge line. The roof is clad in slate tile, capped by concrete ridge tiles, the whole replaced following a modern fire. A belfry is placed centrally along the ridge, comprising a shuttered chamber surrounded by four corner posts and low pediment, topped by a high pointed four-sided roof, clad in copper sheeting. The southeast face overlooks the rear yard, with a lower face of exposed mortared stonework, in local stone, roughly coursed, to a height of approximately 1.2m. Topped by a shaped grey-brick string line, the upper face covered in white-painted cement render. Two buttress towers, of matching material, are placed evenly on the wall face. There are three openings, a large central upright 6-pane window with grey brick sill, extending into the roofline. To the northeast is a smaller 6-pane window, with grey brick sill. To the southwest is a door with surrounding glazed panels on either side and above, up to the roofline. This opens onto a raised platform and ramp approximately 1m above rear yard level. All openings are in uPVC. The northeast gable end continues the lower stonework with render above, and black-painted timber exposed in the render on the upper gable, with three tall narrow two-pane windows, all with grey-brick sills and in uPVC. The northwest face is not exposed. Only the upper level of the southwest gable is visible, in plain white-painted render with two small windows. This face appears to have been re-rendered, presumably following the roof fire, as internally a central opening is suggested mirroring the northeast gable, which is not apparent on the external face.

Photo 2: Northwest facing shot of the rear elevation to the main hall. 2m scales.

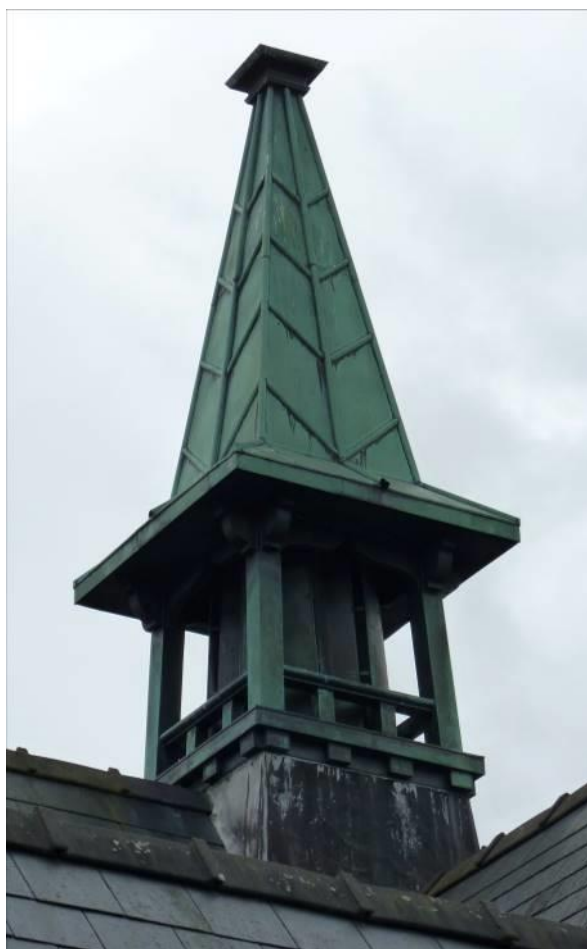
Photo 3: South facing shot of the central belfry.

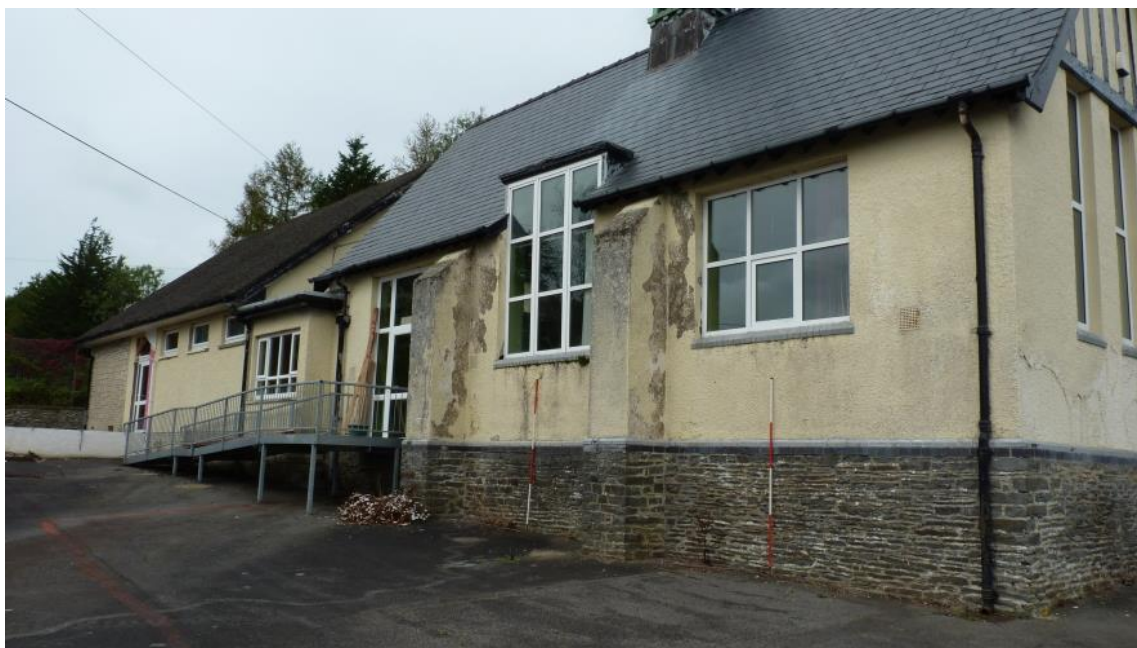
Photo 4: West facing shot of the rear elevation of the school, including original element on the right, and later extension to the left. 2m scales.

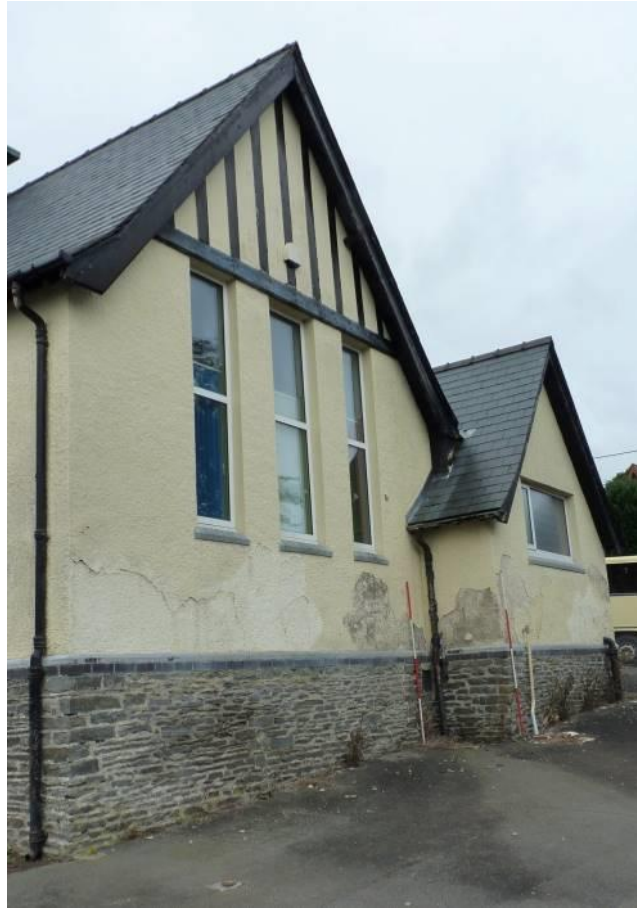
Photo 5: Northwest facing shot of the eastern gable elevation. 2m scales.

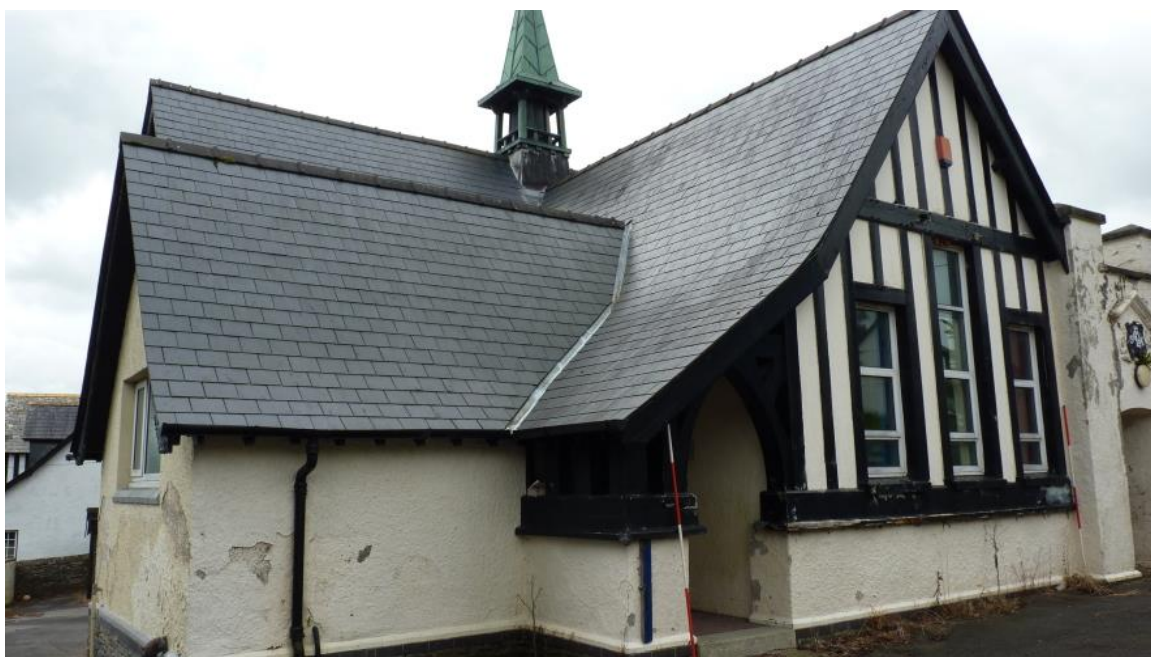
- 4.1.3 Extending to the northwest is a 9.5m by 5.5m block, 7m high to the central ridge line. The exposed northwest gable end has three windows, a tall central four-pane window flanked by two smaller three pane windows, all with grey-brick sills and in white uPVC surrounds. The wall face below the windows is the typical lower exposed stonework (only approximately 0.2m exposed due to changing ground levels) with painted render above. The windows sit on a black-painted wooden beam, with exposed painted woodwork and intervening render surrounding and above the windows. This block has flanking entranceways on both sides. To the northeast an open porch is covered by continuing pitched roofline. The wall line also continues the design of the main gable below the window beam. Above the beam the roofline is held by an open-timber arch, with squared timber supports on the wall return, all painted black. The interior face of the porch is in plain render, with red brick tiled floor in a herringbone style, with grey-brick tile surrounds, and a plain white-painted wood-slat door set within a shallow-arched opening. To the southwest a second entranceway stands in a protruding porch, flat-roofed and set between two blocks of plain-rendered masonry topped by low-pointed concrete capping. The open entrance with a shallow-arched lintel sits below a school date plaque in black-painted render, with central lettering and '1908' embossed on a shield surrounded by floral scrolls, beneath a pointed decorative plaster pediment. The white-painted plain wood-slat door is set back, fronted by a concrete floor, and plain rendered side walls, with a glazed-clay plaque on the south wall created by the former students, depicting local scenes.

Photo 6: South facing shot of the front elevation to the original school block. 2m scales.

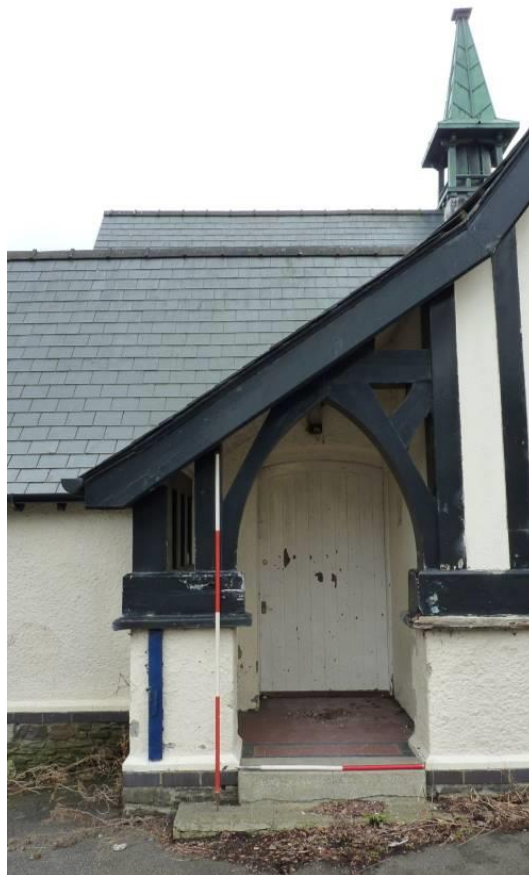
Photo 9: Southeast facing shot of the easternmost entry. 2m & 1m scales.

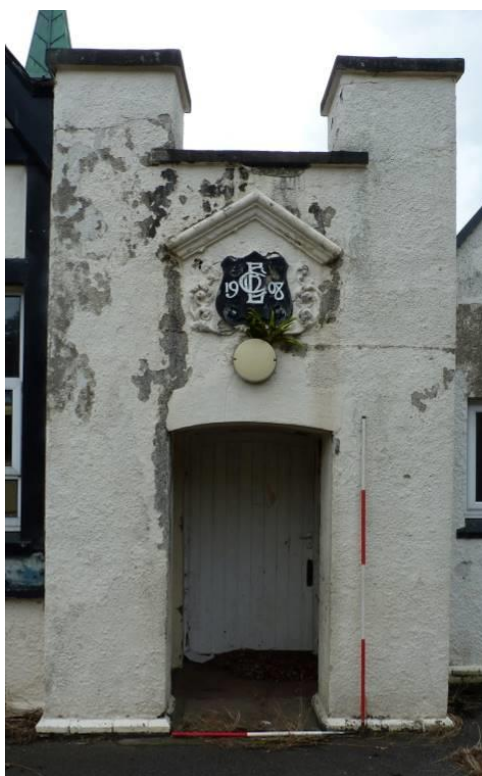
Photo 10: Southeast facing shot of the westernmost entry, with date plaque above door. 2m & 1m scale.

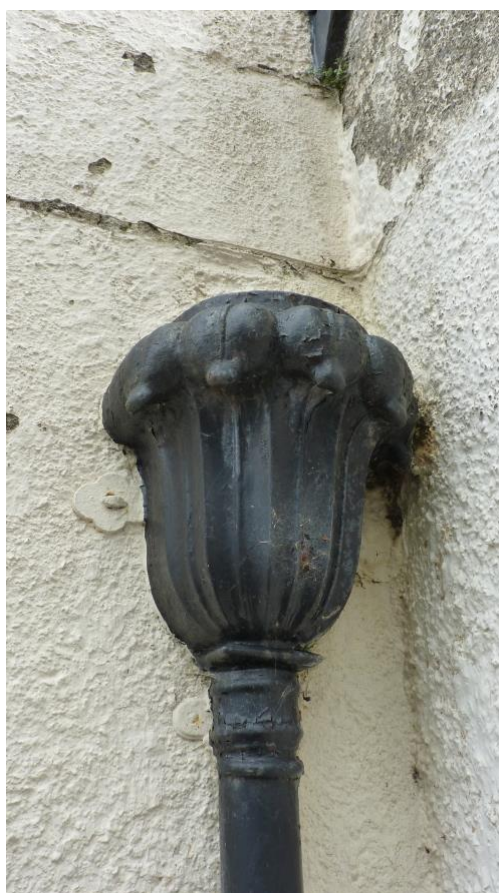
Photo 11: Detail of drain pipe hood on the easternmost entrance block.

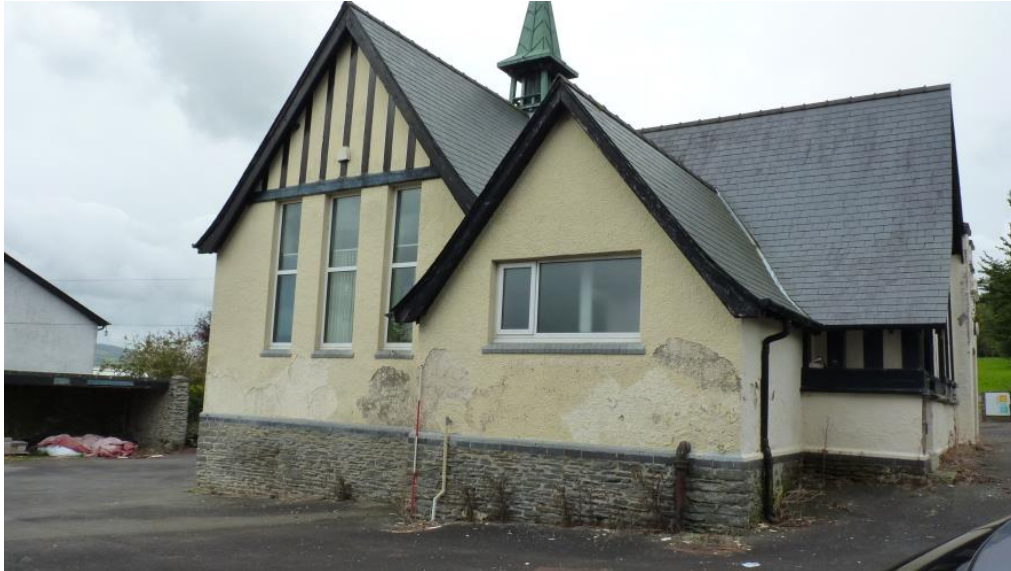
- 4.1.4 A toilet block stands in the corner between entrance and main block to the northeast, measuring 3.2m by 4.5m, topped by a SW-NE aligned gable roof matching the main block, extending 1m beyond the northeast face of the main block. The walls are of typical lower exposed stonework, with plan render above. A single centrally placed window stands in the gable end, opaque glass in a uPVC frame, with grey-brick sill.

Photo 12: Southwest facing shot of the easternmost toilet block. 2m scale.

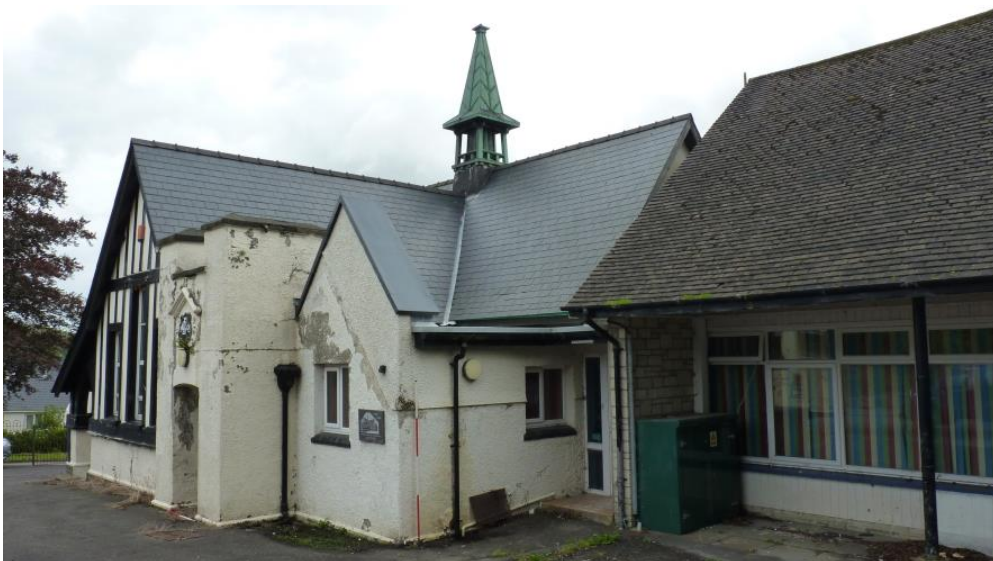
- 4.1.5 A toilet block also sits in the corner between entrance and main block to the southwest, although brought forward to accommodate an internal corridor to the rear. This block measures 2.9m by 4.6m, flat-roofed but fronted by a pointed gable in keeping with the rest of the building. The walls are plain rendered, with a small window in the northwest gable, and another in the southwest wall, both in white uPVC frames with grey-brick sills. A slate plaque stands on the gable wall, celebrating the school centenary in 2008. A former pitched gable roofline is visible in the render on the gable wall.

Photo 13: East facing shot showing the westernmost toilet block and the flat roof fronted by a gable wall.

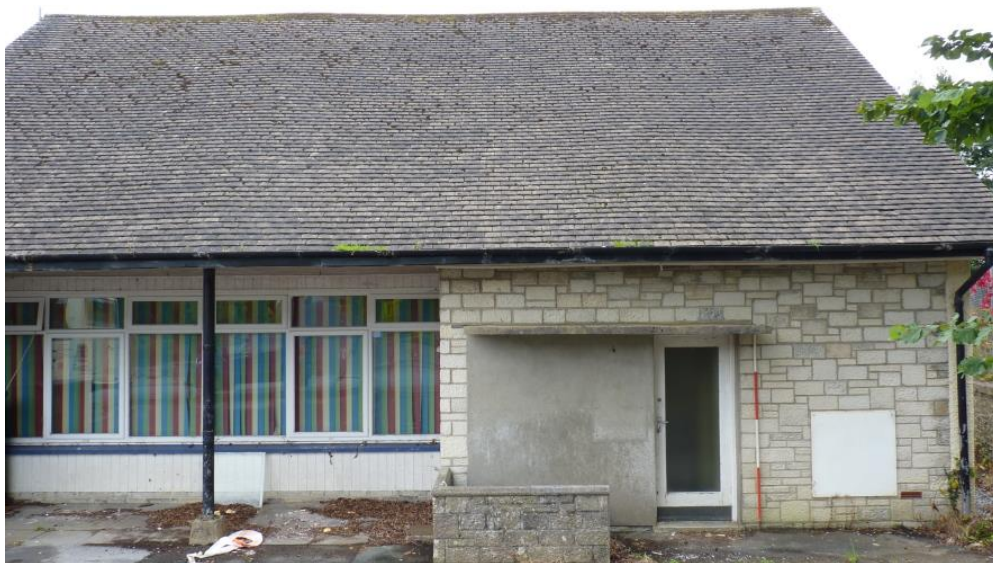
- 4.1.6 A rectangular brick-built extension was added to the southwest side of the school in the 1970s. This comprises a main block 12.3m by 7.8m, with a NE – SW pitched gable roof in concrete tile, 7m high to the central ridge. This is attached to the original school building by a 2.4m high flat-roofed element, containing a new entrance through glazed doors set in white uPVC. The front northwest face of the block is stepped, with a protruding section 5.5m by 2m at the western end, clad in stone-block-effect concrete render, with a central door under a projecting flat concrete roof. The recessed section comprises a largely glazed wall in white uPVC, above a 0.4m high sill, fronted by a projecting roofline supported by a steel post. The gable wall is in plain painted render, with four window openings. The rear southeast wall is in part plain render, with block-effect render to the southwest. There is a centrally placed doorway, set approximately 0.3m above the rear yard level, in line with the rear door in the original block. Four high level window lights lie above the door and to the northeast.

Photo 15: Southeast facing shot of the front elevation to the later school extension. 2m scale.

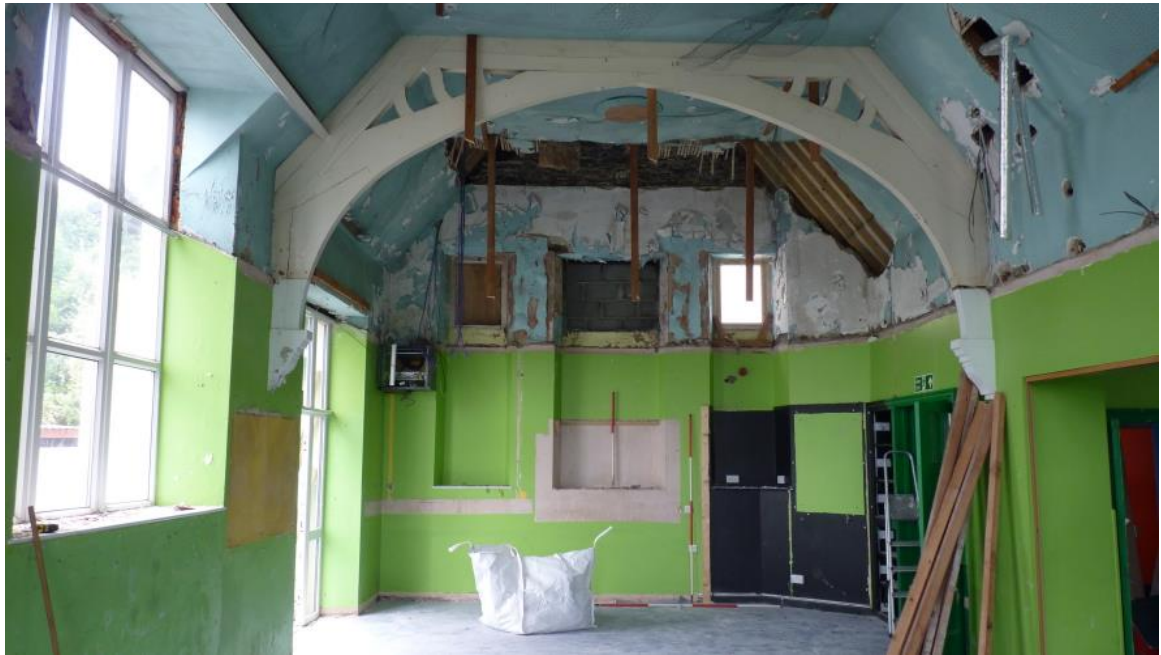
- 4.2.2 The largest room is the main hall, which occupies the main NE-SW aligned building. This comprises a single open space, a modern lowered ceiling had been removed prior to the survey to reveal the original ceiling above. This comprises a lathe and plaster ceiling, inserted midway down the roof slope, supported on two timber cross beams. The beams comprised machine-squared timber lining the angled ceiling line with two gently curving supporting joists below, resting on carved brackets. The floor is laid with linoleum, the walls are plain plaster, painted green below the lowered ceiling, blue above. The southwest gable is partly exposed below the roofline, showing a wall of roughly coursed mortared rubble. The room is lit by two windows and door in the southeast wall, three windows in the northeast gable. The openings are mirrored in the southwest gable, but have been largely infilled with breezeblocks, with small windows inserted in the upper part of the side windows, presumably contemporary to the addition of the extension to the southwest. There are three openings in the internal southeast wall. The central opening is a wide opening, closed by a concertina door, the two side openings are closed by wood-panel doors with upper glazing, in a wood surround, and appear original.

Photo 17: Southwest facing of the interior of the main hall. 2m & 1m scale.

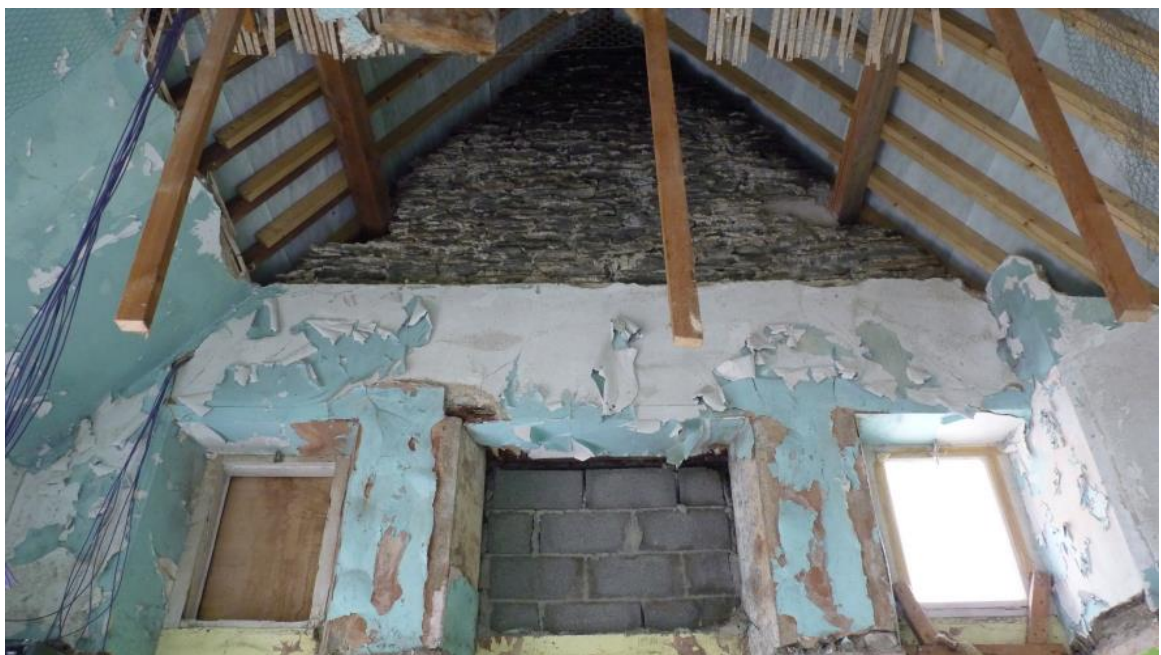
Photo 18: Southwest facing shot showing the replaced roof structure, exposed walling and partly blocked openings.

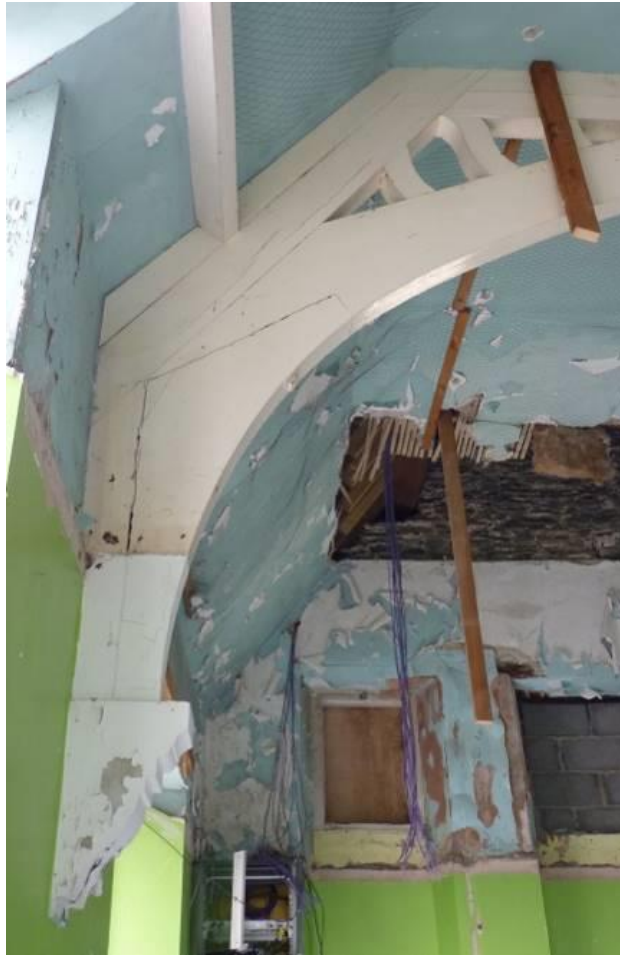
Photo 19: Southwest facing shot showing detail of the roof support beams.

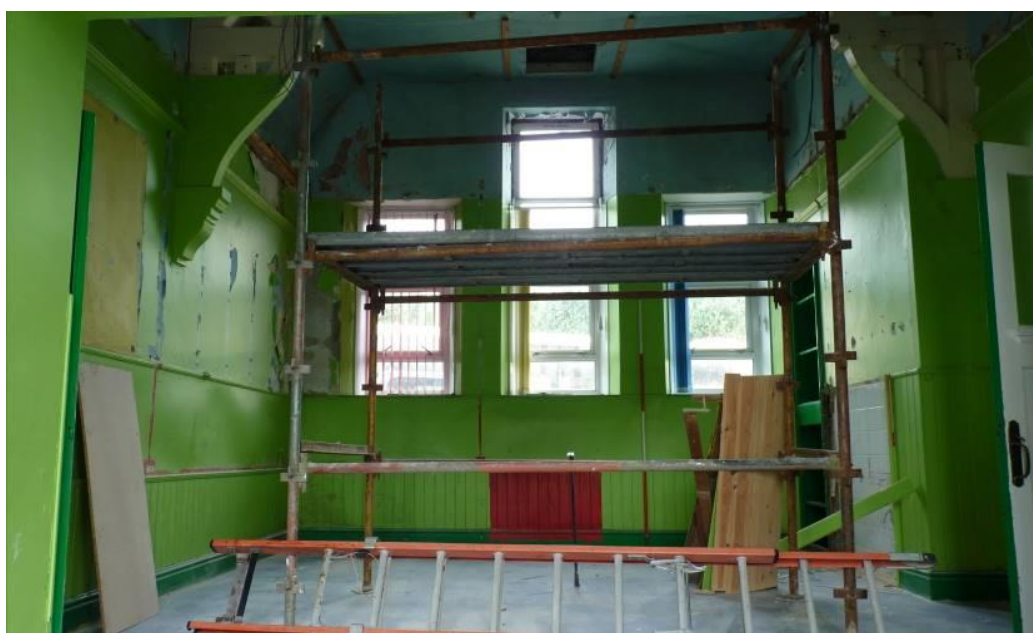
4.2.3 The large central opening accesses a small hall or classroom, placed centrally to the northwest, and laid out in the same style as the main hall, although with a single supporting roof beam and wainscot wood panelling on the walls, and an upper picture rail. The room is lit by three windows in the northwest gable wall. There is a blocked fireplace on the northeast wall (the chimney above having been removed), with an adjoining recessed cupboard. Two opposing part wood-slat and glazed doors lie opposing each other, accessing the original entrance corridors.

Photo 22: Northwest facing shot fo the interior of the small hall. 2m scale.

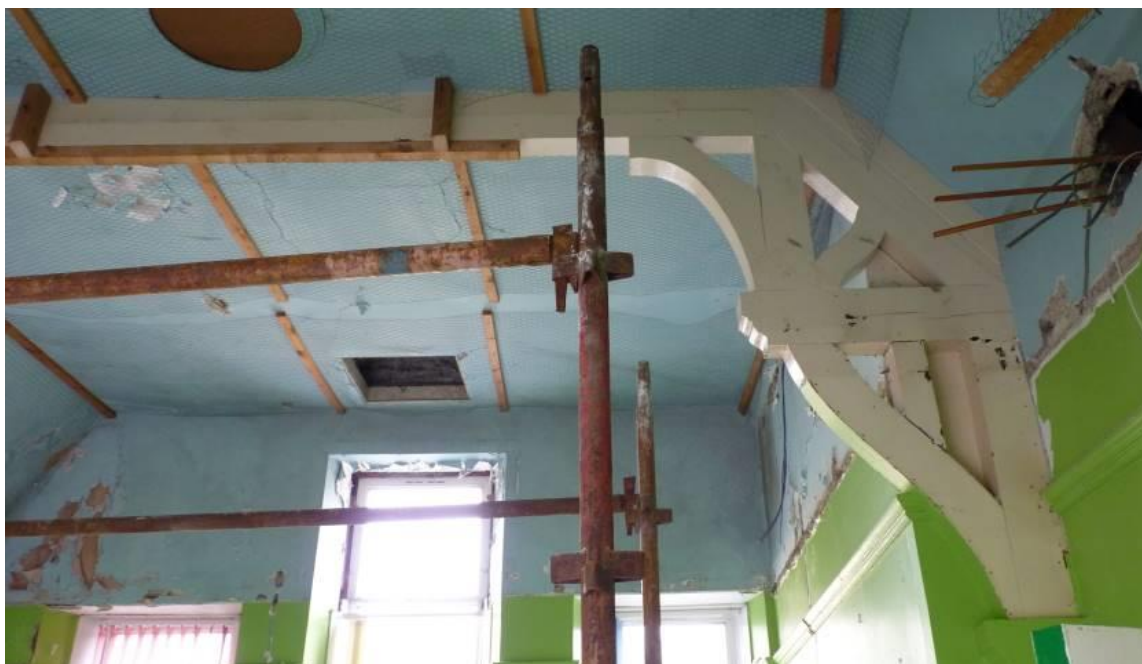
Photo 23: Northwest facing shot showing detail of the roof support beams.

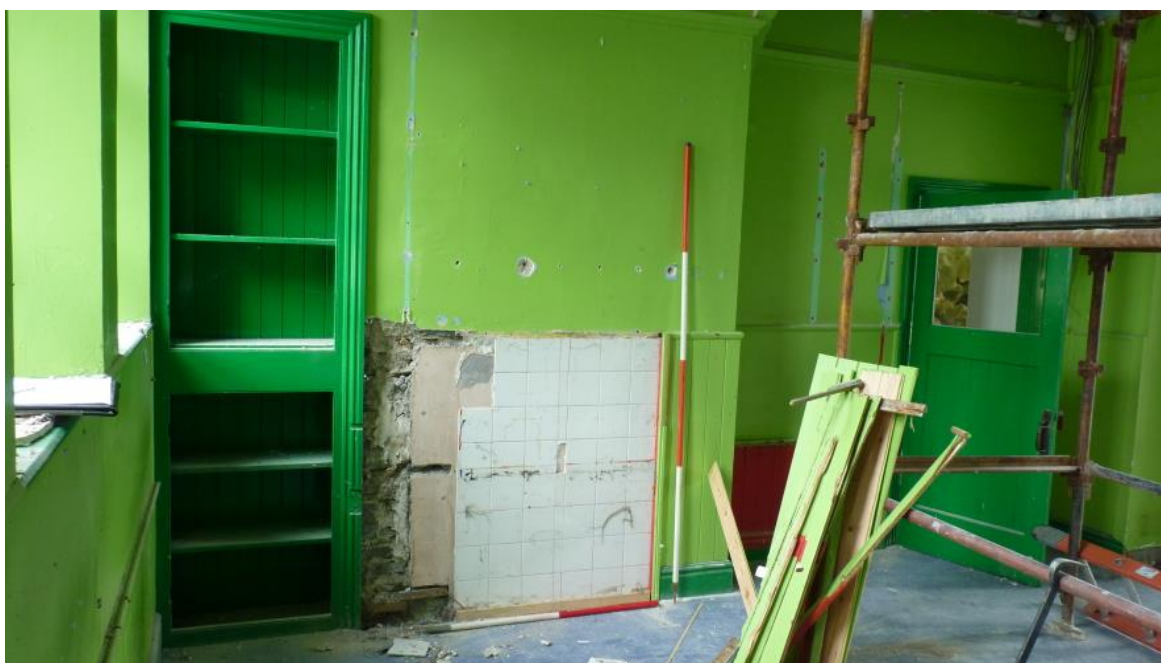
Photo 24: Northeast facing shot of the side wall to the small hall, with blocked central fireplace and inbuilt cupboard. 2m & 1m scales.

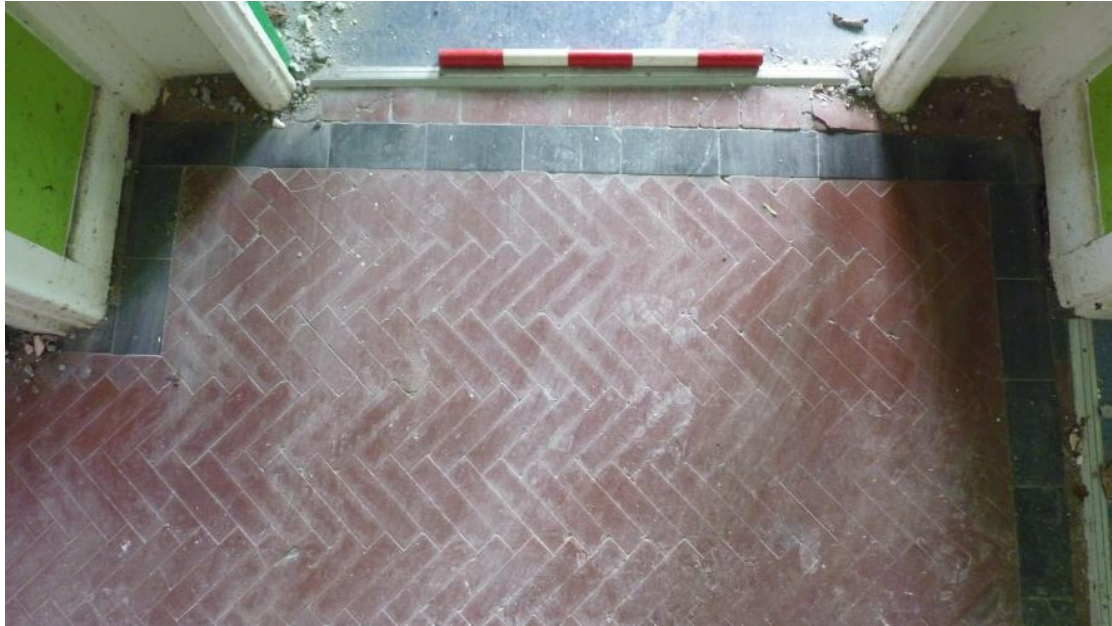
- 4.2.4 The entrance corridor to the northeast runs from the wooden door within the open porch, accessing the main hall, side hall and toilet block. The walls and ceiling are in plain plasterwork, the floor is small red-brick tile in a herringbone style, surrounded by black brick tiles, continuing the design visible externally.

Photo 27: Detail of the flooring in the easternmost corridor, adjoining the opening into the main hall. 0.5m scale.

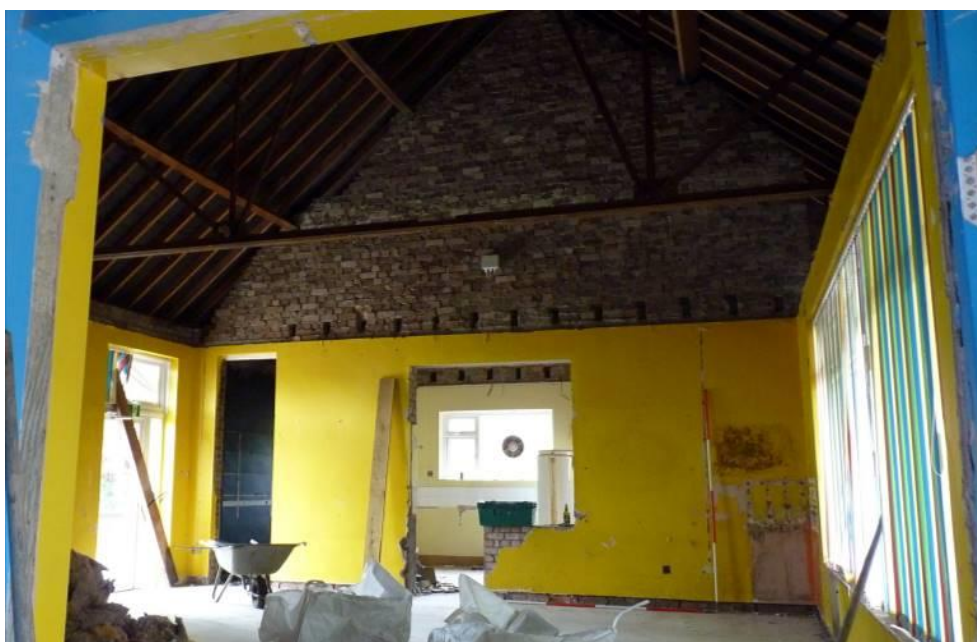
4.2.11 The canteen is a large open space, enclosed by brick and breezeblock walling, over a raised concrete floor. The ceiling has been removed, revealing exposed brickwork in an English Bond-style above (loose bricks stamped with 'Eagle'), and a pine roof supported by narrow steel beams. The room is lit by a largely glazed northwest wall, and high narrow windows in the opposing wall, with a glazed door accessing the rear yard.

Photo 36: Southwest facing shot of the canteen in the later extension, with exposed stonework. 2m scale.

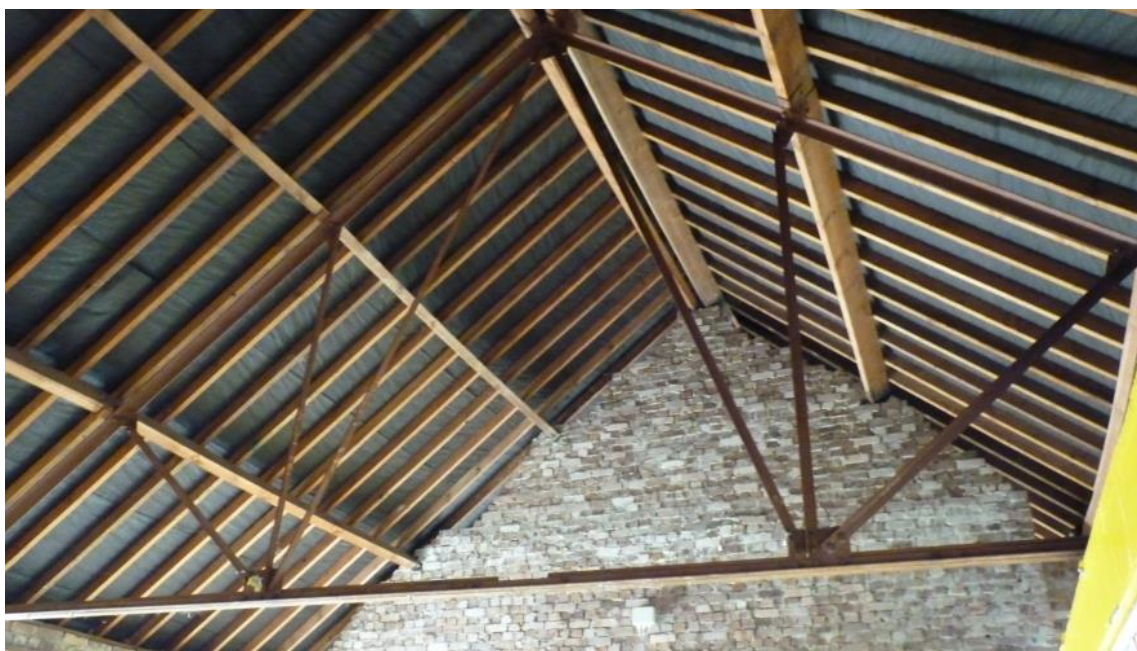
Photo 38: Detail of the roof structure in the later extension.

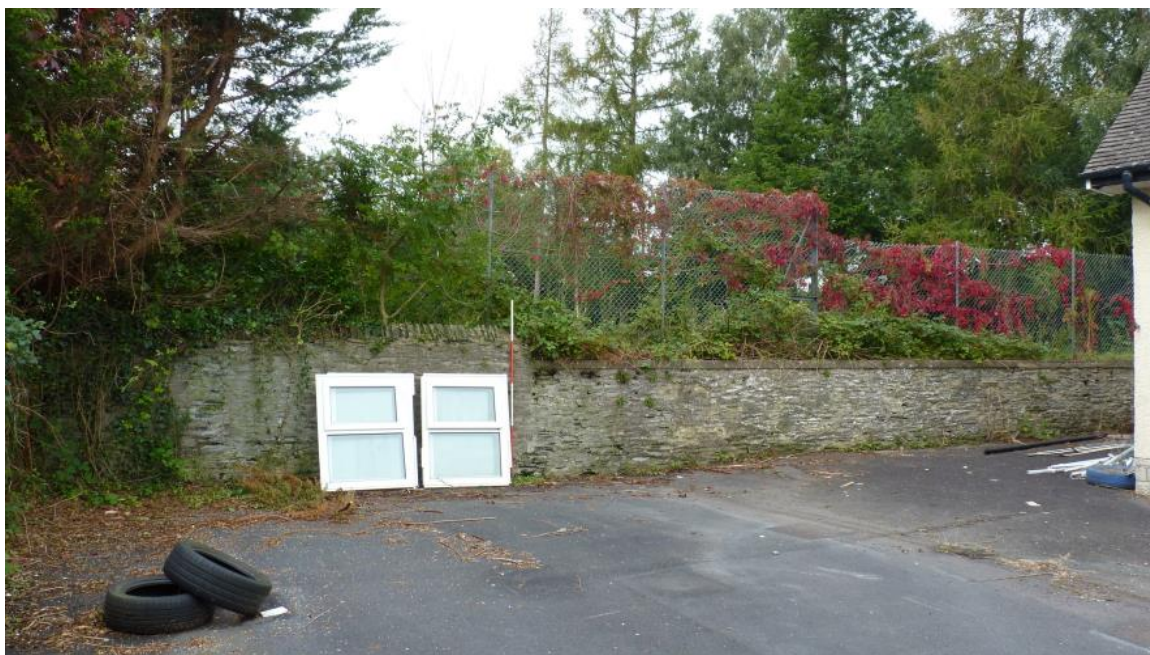
Photo 42: Southwest facing shot showing the boundary wall to rising ground, the change of height signifying a potential area of later rebuild to the right. 2m scale.

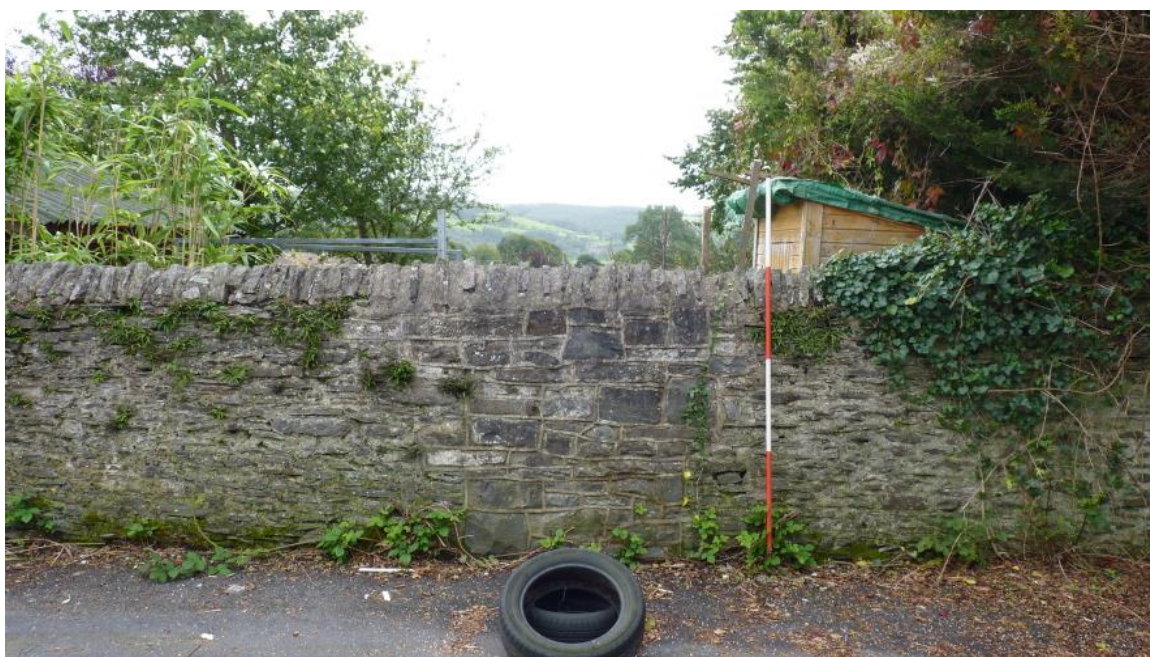
Photo 43: Southeast facing shot of the boundary wall to the adjacent property. The change of masonry potentially indicating an infilled gateway. 2m scale.

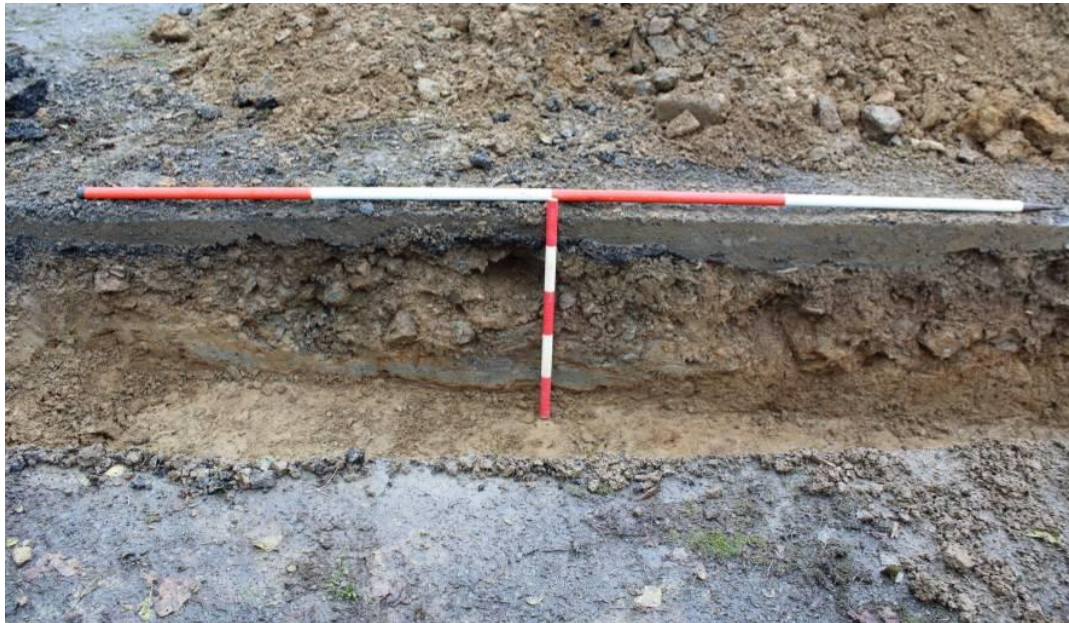
5.1.3 Overlying these deposits was a 0.15m thick deposit of imported modern hardcore (103), comprising large angular stones and gravel in a light grey-brown clayey-silt matrix. This hardcore was laid down as the base layer for the current tarmac (104), which was between 0.08m and 0.12m thick.

Photo 49: East facing shot of the section of Trench 1, towards the northern end of the trench. 2m & 0.5m scale.
