**LLANWNNEN PRIMARY SCHOOL,
LLANWNNEN, CEREDIGION**

**HISTORIC BUILDING RECORDING &
WATCHING BRIEF**

REPORT NO. 2020-44
EVENT RECORD No.125509

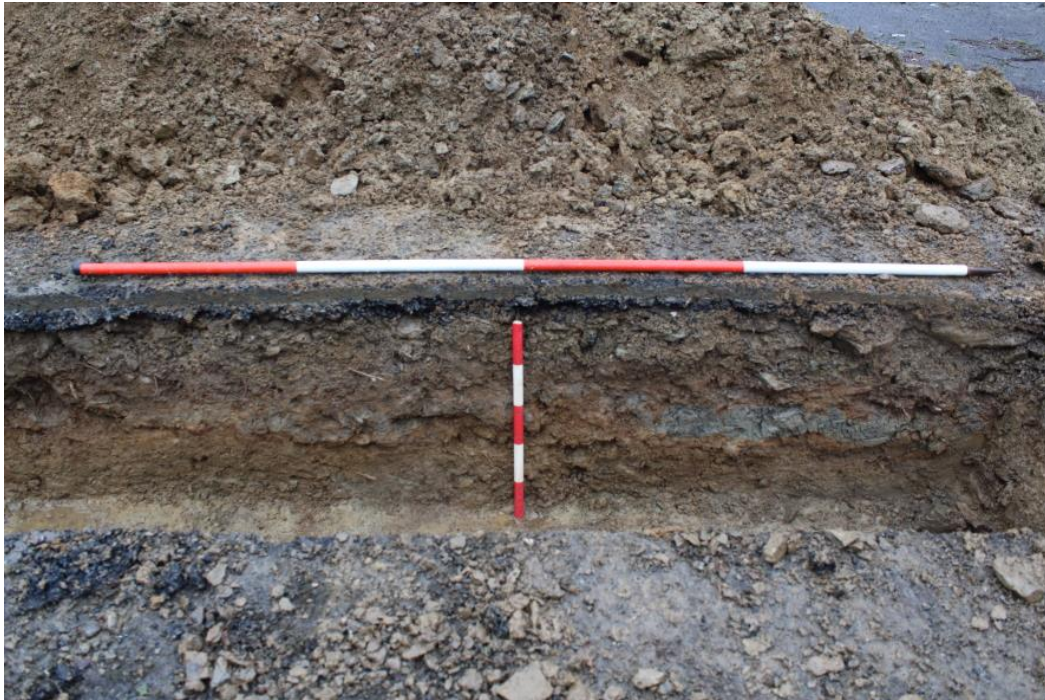
Photo 50: East facing shot of the section of Trench 1, towards the southern end of the trench. 2m & 0.5m scale.

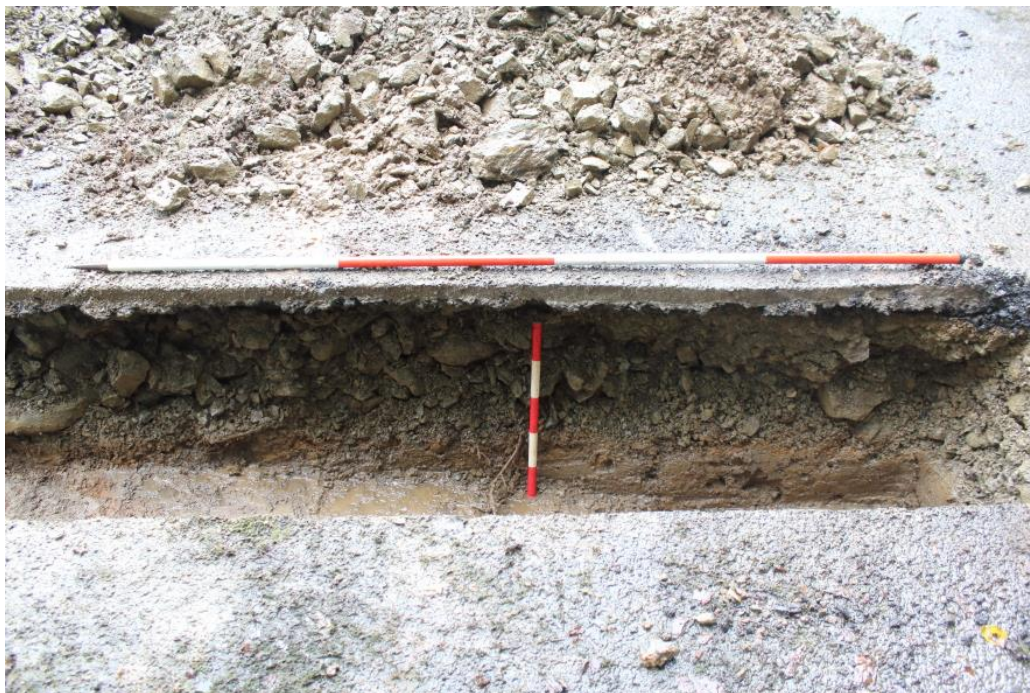
- 5.2.2 The lowest layer revealed was exposed at a depth of 0.7m at the upslope (southwest) end of the trench. This comprised firm light orange/yellow grey sandy clay (200) with few discernible inclusions. This deposit was very similar to, and a presumed continuation of layer 100 visible in Trench 1. This layer was overlain by a mottled layer (201) of mixed reddish-brown sandy clay and light grey sandy clay, where excavated was found to be 0.1m to 0.2m thick. This would appear very similar to, and a presumed continuation of layer 102 within Trench 1. At the downslope (northeast) end of the trench, the lower 1.7m of layer 201 was overlain by a firm mid brown silty clay (202) with occasional small stone inclusions. There was no evidence of archaeological material or activity within these deposits, the lower two deposits appearing to also be visible within trench 1. The fine, compact and archaeological sterile nature of deposit 202 may indicate a deposit of natural hillwash.

- 5.2.3 Overlying these deposits was the imported modern hardcore material (203), up to 0.45m thick to provide a more level surface for the overlying tarmac (204).

Photo 52: North facing shot of the section of Trench 2. 2m & 0.5m scale.

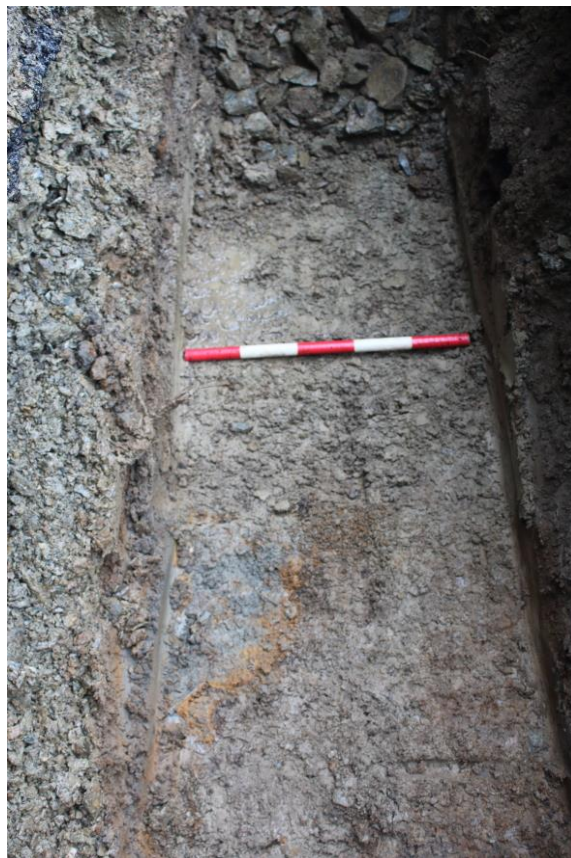
Photo 54: West facing shot of natural deposits exposed within Trench 2. 0.5m scale.

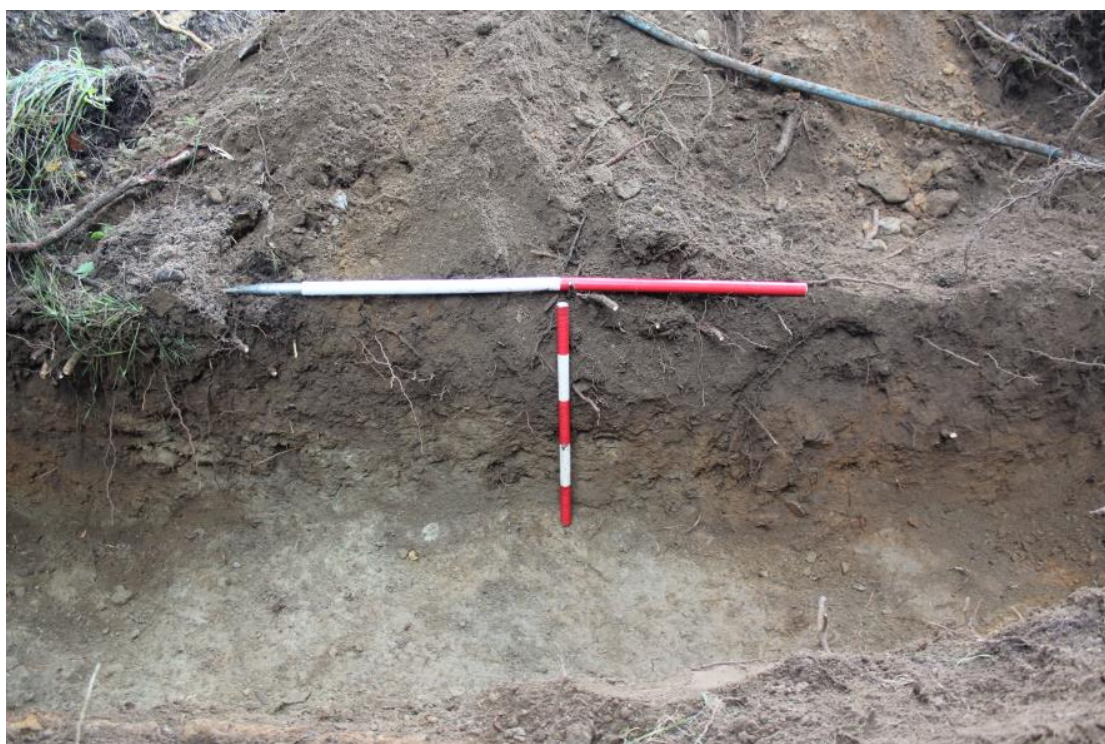
- 5.3.4 These layers were overlaid by a topsoil deposit of friable, mid grey-brown silt (302) with rare small to medium sub-angular stone inclusions. This deposit was heavily root-disturbed in this area, but was between 0.2m to 0.25m thick. A blue alkathene pipe lay within this deposit, overlain by plastic sheeting, running parallel to the hedgeline. This pipe may be associated with temporary mobile classrooms set up in the field to the southwest, or potentially with a former pond excavated to the northeast.

Photo 55: Southeast facing shot of the section of Trench 3. 1m & 0.5m scales.

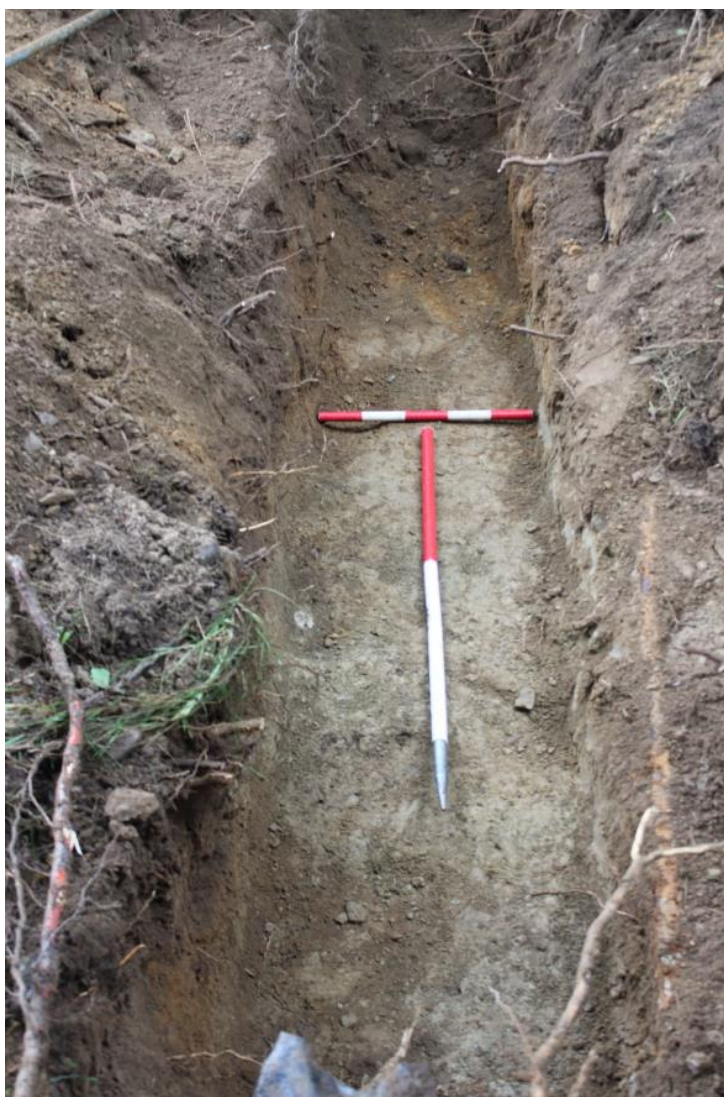
Photo 56: Southwest facing shot of Trench 3 after excavation. Metal service pipe visible on the right. 1m & 0.5m scale.
