# WEMYSS METAL MINE

## ARCHAEOLOGICAL DESK BASED ASSESSMENT UPDATE

REPORT NO 2020\_55  
EVENT RECORD NO. 125592

# WEMYSS METAL MINE ARCHAEOLOGICAL DESK-BASED ASSESSMENT UPDATE

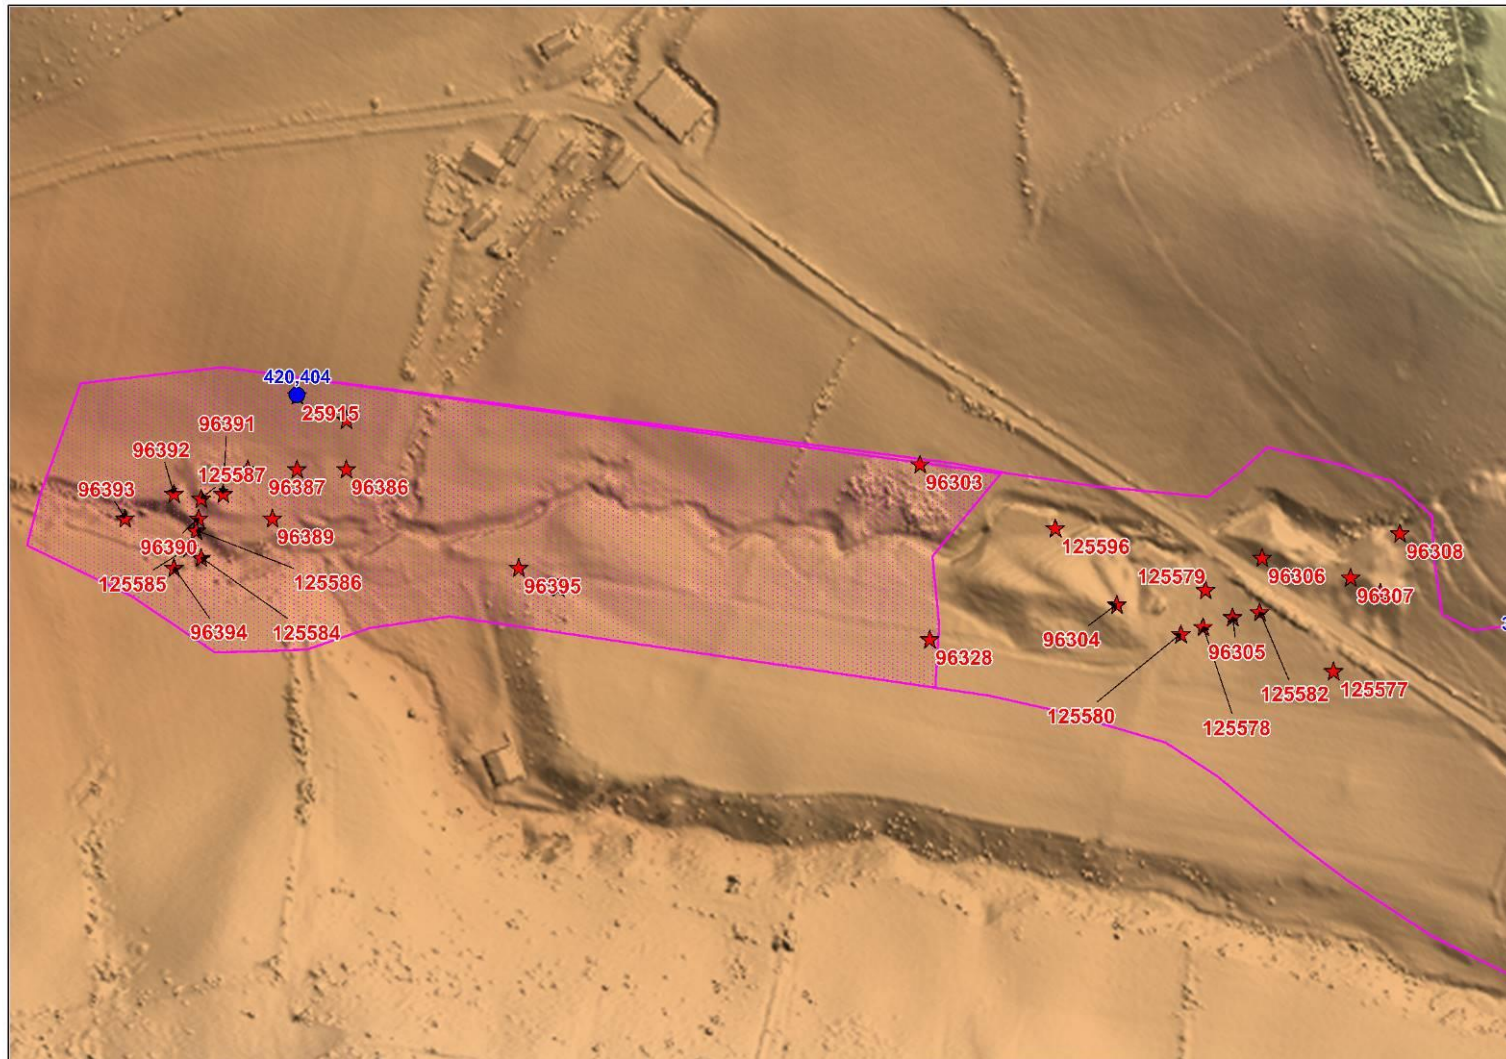
**Figure 5:** 1m LiDAR DSM (Digital Surface Model) map showing the non-designated assets recorded in the HER (red stars) and RCAHMW's NMR (blue dots) with in the Frongoch study area (hashed in pink) and immediate vicinity.

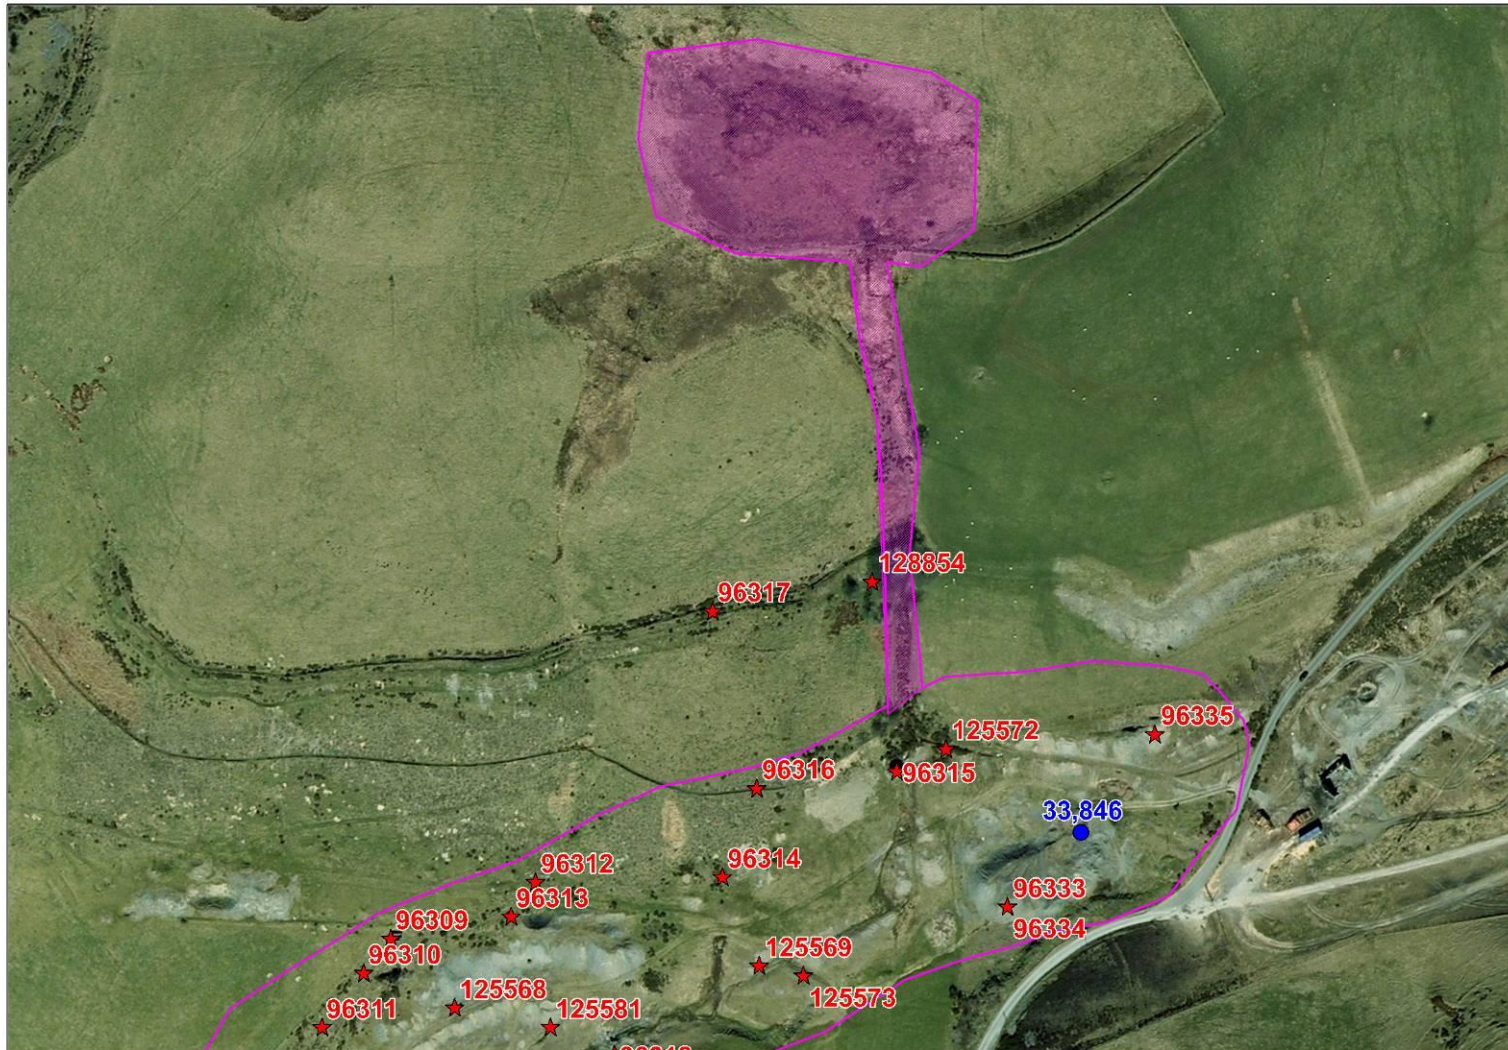
**Figure 7:** Aerial image showing the non-designated assets recorded in the HER (red stars) and RCAHMW's NMR (blue dots) with in the pond study area (hashed in pink) and immediate vicinity.

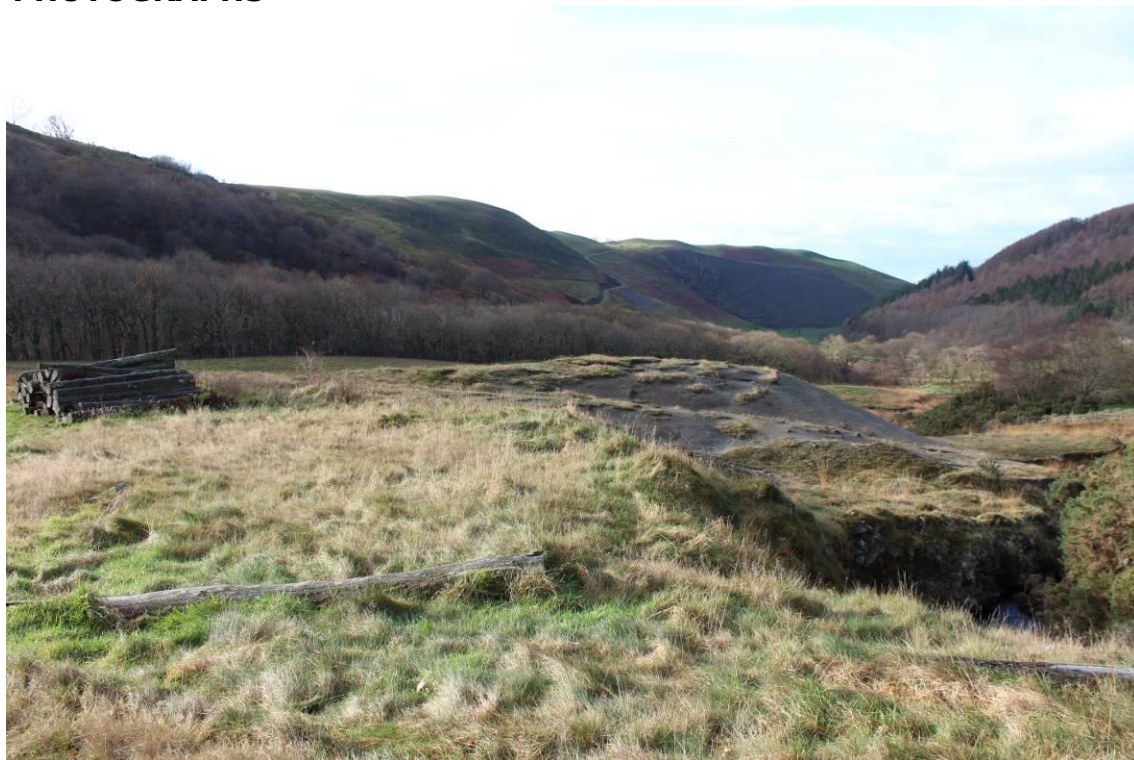
**Photo 1:** View facing southwest with fine waste tip PRN96304 in the foreground. The steep cutting of the "Mill Race Stream" can be seen at the right hand side of the photo (DAT Photo 125592\_3439)

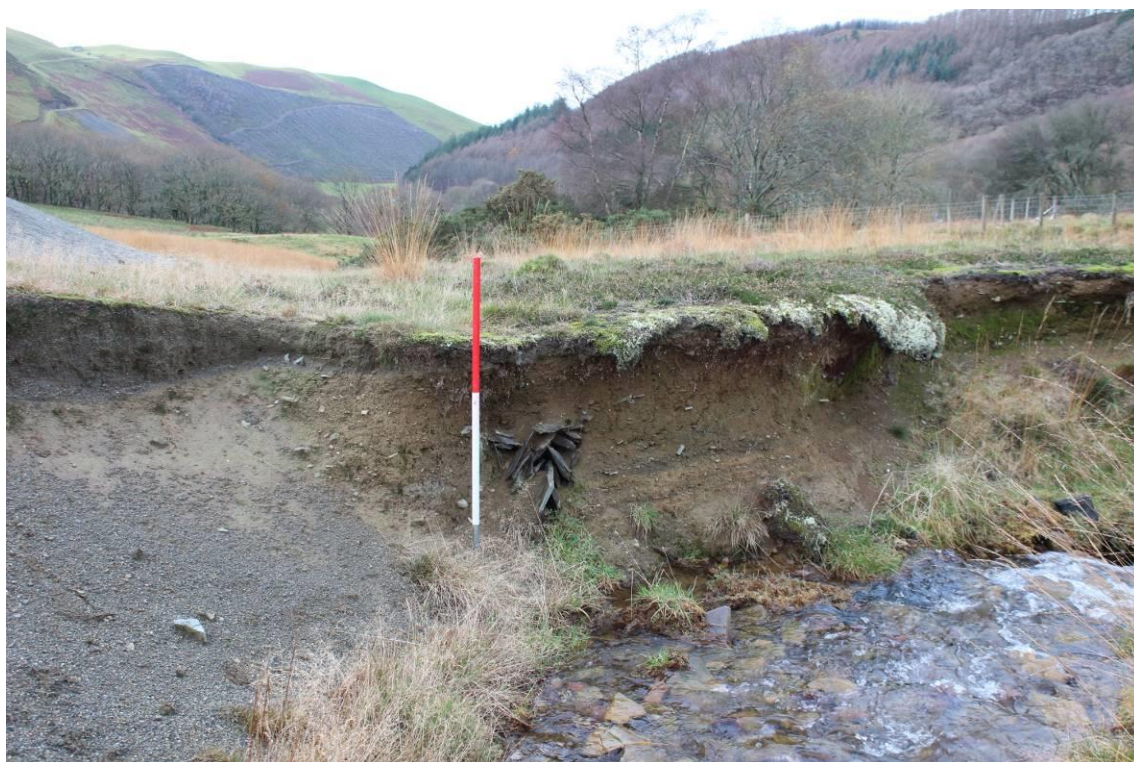
- 4.5.6 A possible stone-lined field drain (PRN12556) was found eroding from the southern cutting of the “Mill Race Stream”, at the northern fringe of spoil tip PRN96304 (Photo 2). It appeared that the opposing side had already been eroded away and an alignment could not be confirmed. No other features were noted in the bank sections further downstream. It was not possible to access wheelpit PRN69303 as recorded on the historic mapping for this was on the northern side of the stream, fenced off and engulfed in gorse (Photo 3). It was not possible to verify any visible remains of this feature.

**Photo 2:** Possible stone line field drain (PRN125596) exposed in southern cutting of the Mill Race eroding spoil tip PRN96304. 1m scale (DAT Photo 125592\_3443)

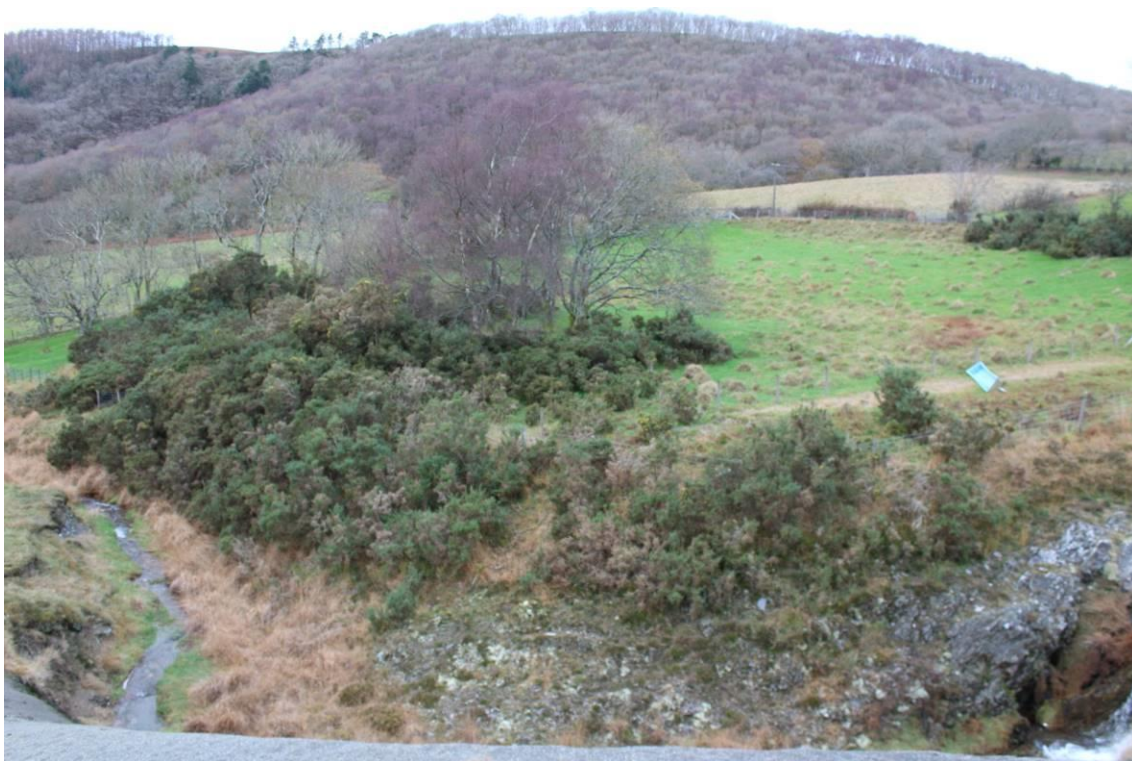
**Photo 3:** Overview of location of wheelpit PRN69303. The site is fenced off and engulfed in gorse (DAT Photo 125592\_3444)

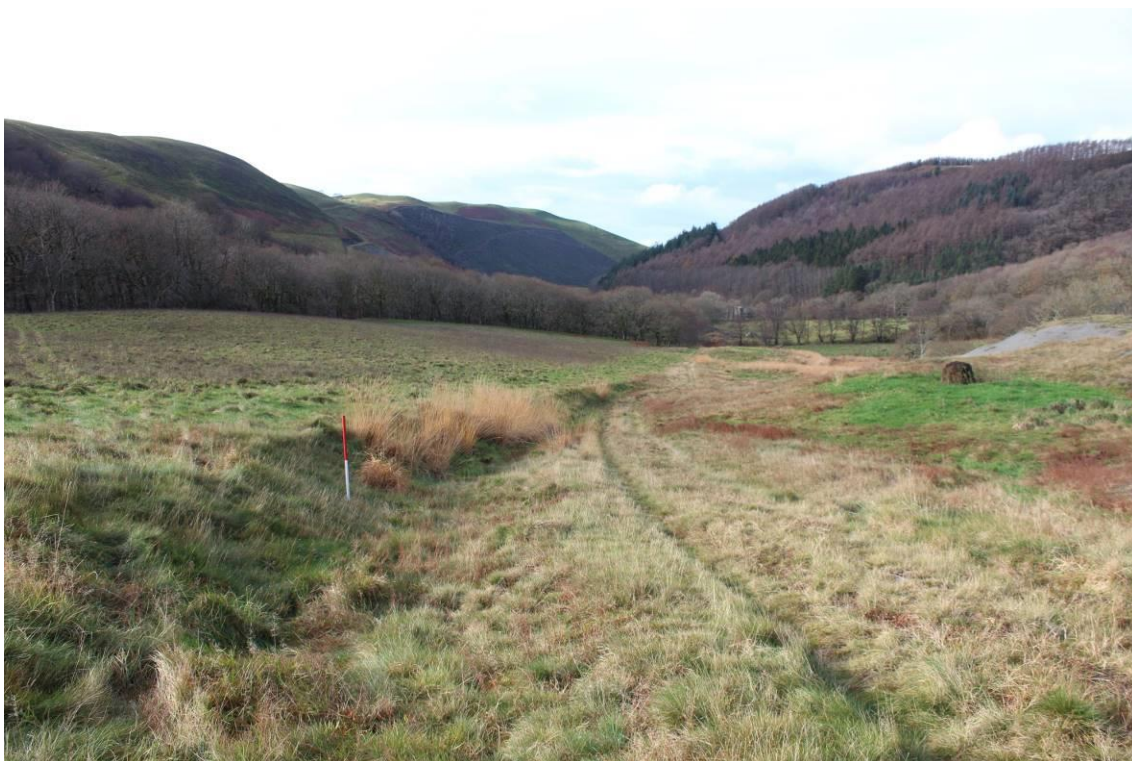
**Photo 4:** The earthwork remains of tramway PRN96328 heading west. The western end of spoil tip PRN68304 is visible at the right of the frame. 1m scale (DAT Photo 125592\_3440)

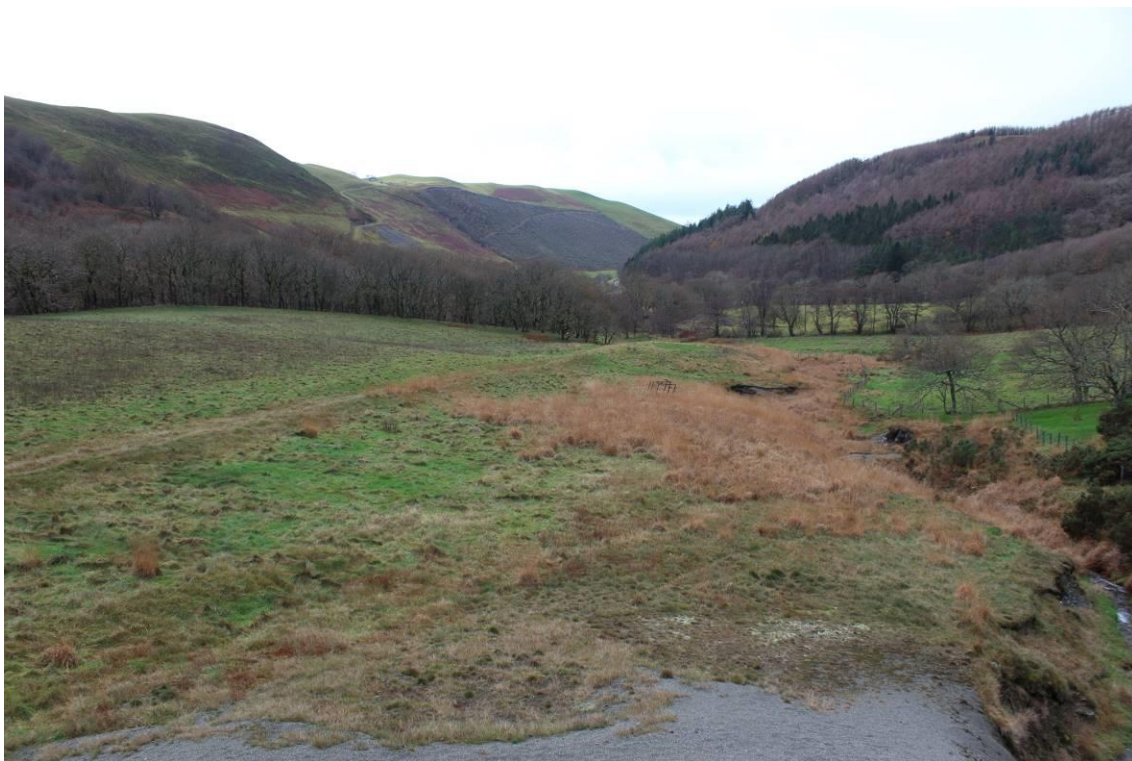
**Photo 5:** The earthwork remains of tramway PRN96328 heading west as viewed from the top of spoil tip PRN68304 (DAT Photo 125592\_3440)

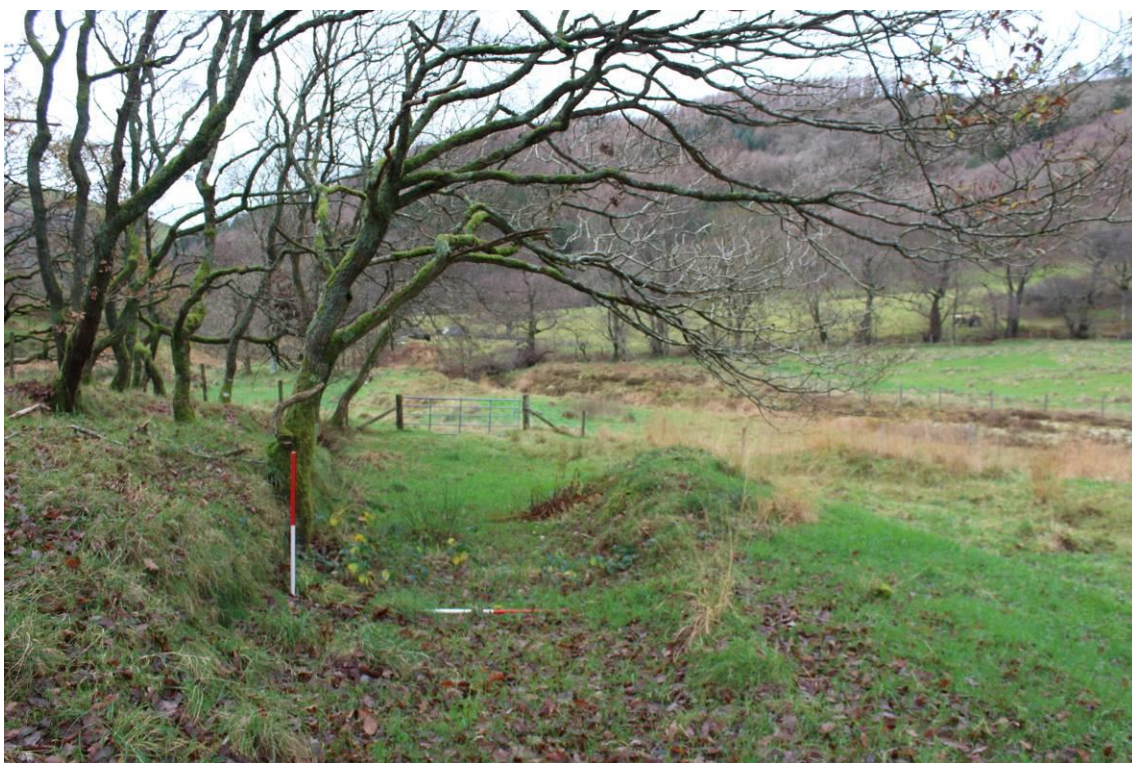
**Photo 6:** Hollow way PRN125583 at the western end of tramway PRN96328. View facing northwest. 1m scale (DAT Photo 125592\_3446)

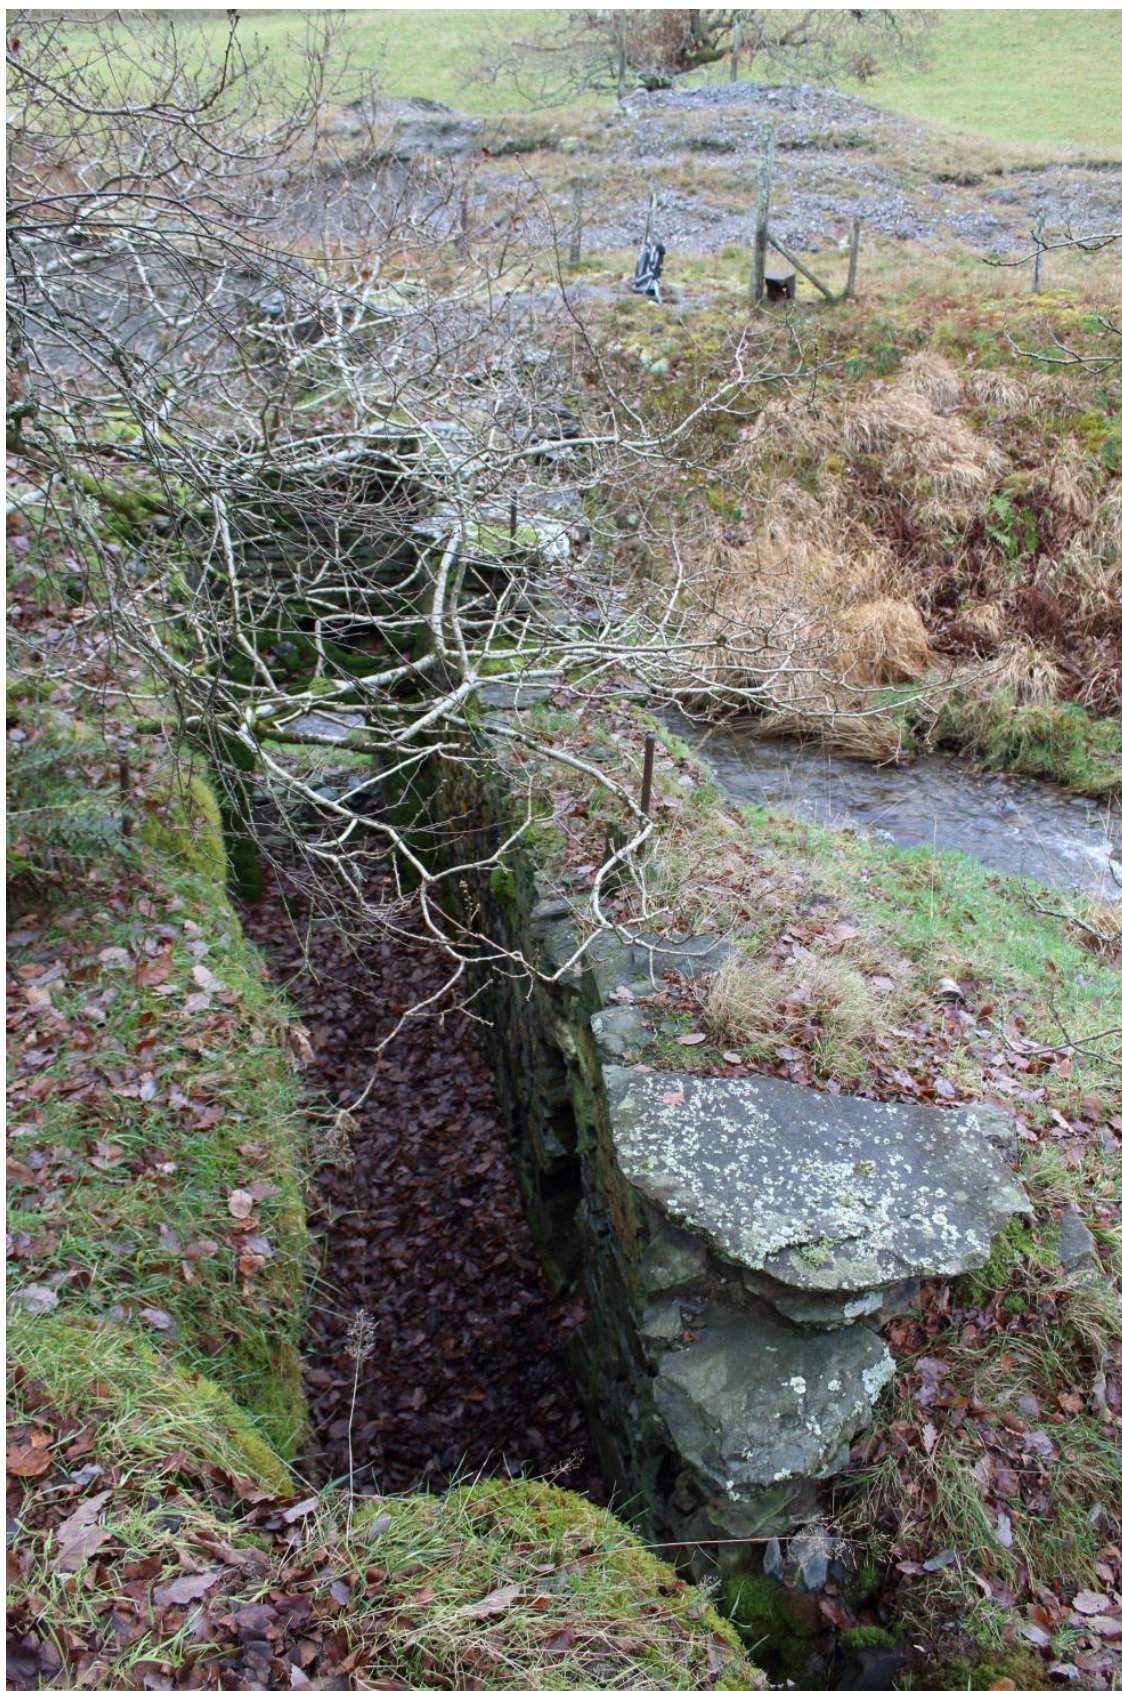
- 4.5.11 Adjoining the western side of the wheelpit is the relatively substantial remains of winding house PRN12558. Again, this appears to be of dry-stone construction and the southern gable end and western elevation survive to almost full height. The eastern elevation (for it did return) is all but gone although there was (despite the leaf litter) seemingly few tumbled stone suggesting perhaps that this has been robbed of its stone during its decay. The internal elevation of the gable appears to retain a thin limewash or plaster (Photo 11). The western elevation has two window openings although both lintels have long since gone (Photo 12). Abutting both the winding house and wheelpit, and flush with all elevations, is dry stone platform or revetement (Photo 13). This platform also has a small archway at its north eastern foot (see photo 7).

**Photo 7:** Overview of wheelpit PRN96394, facing north (DAT Photo 125592\_3447)

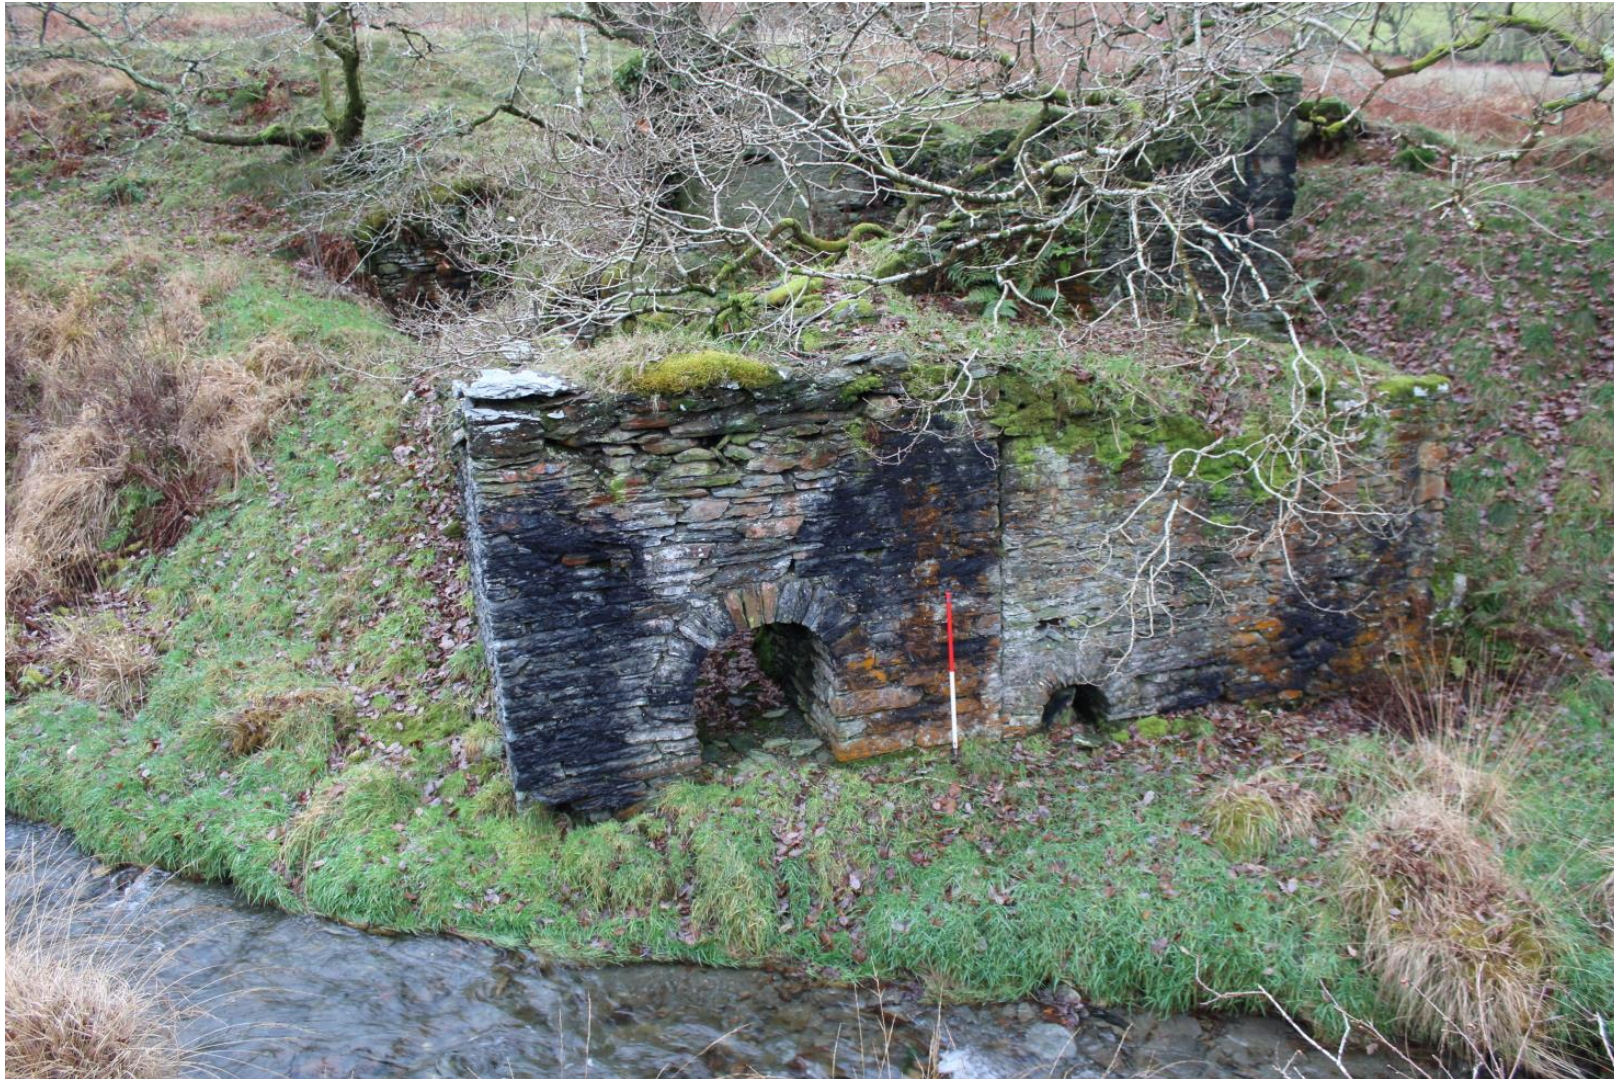
**Photo 8:** The north facing elevation of wheelpit PRN96394. 1m scale (DAT Photo 125592\_3458)

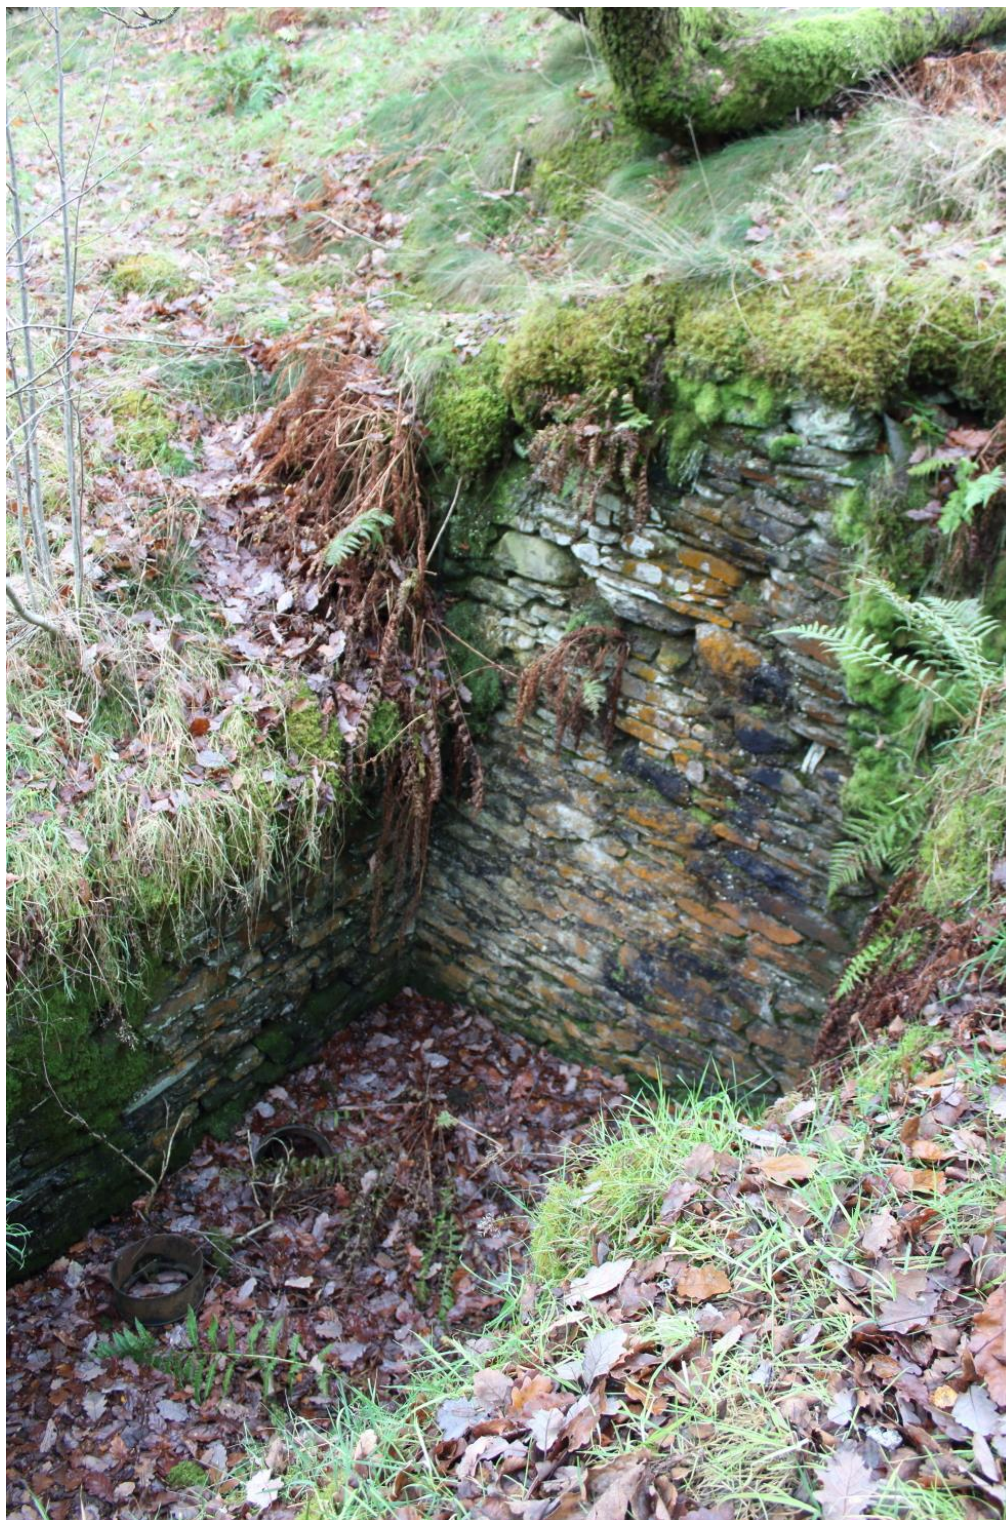
**Photo 9:** Overview of the southern end of balance bob pit PRN125584 (DAT Photo 125592\_3448)

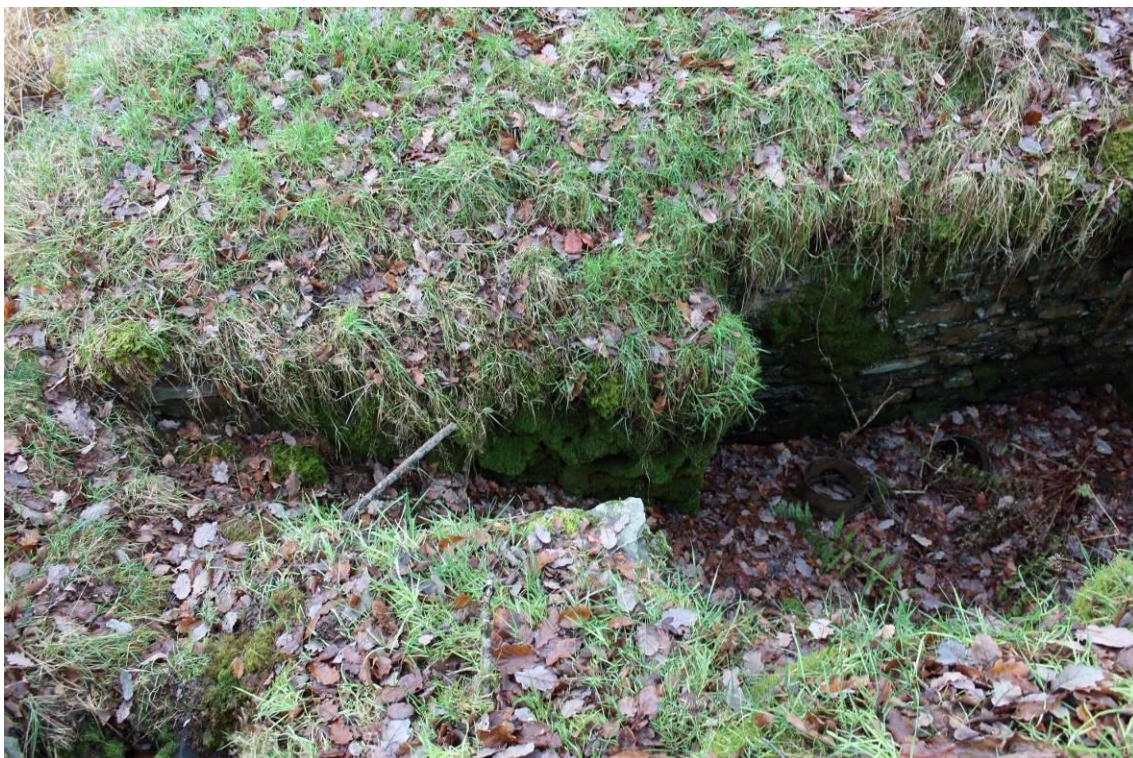
**Photo 10:** Overview of the northern end of balance bob pit PRN125584 (DAT Photo 125592\_3449)

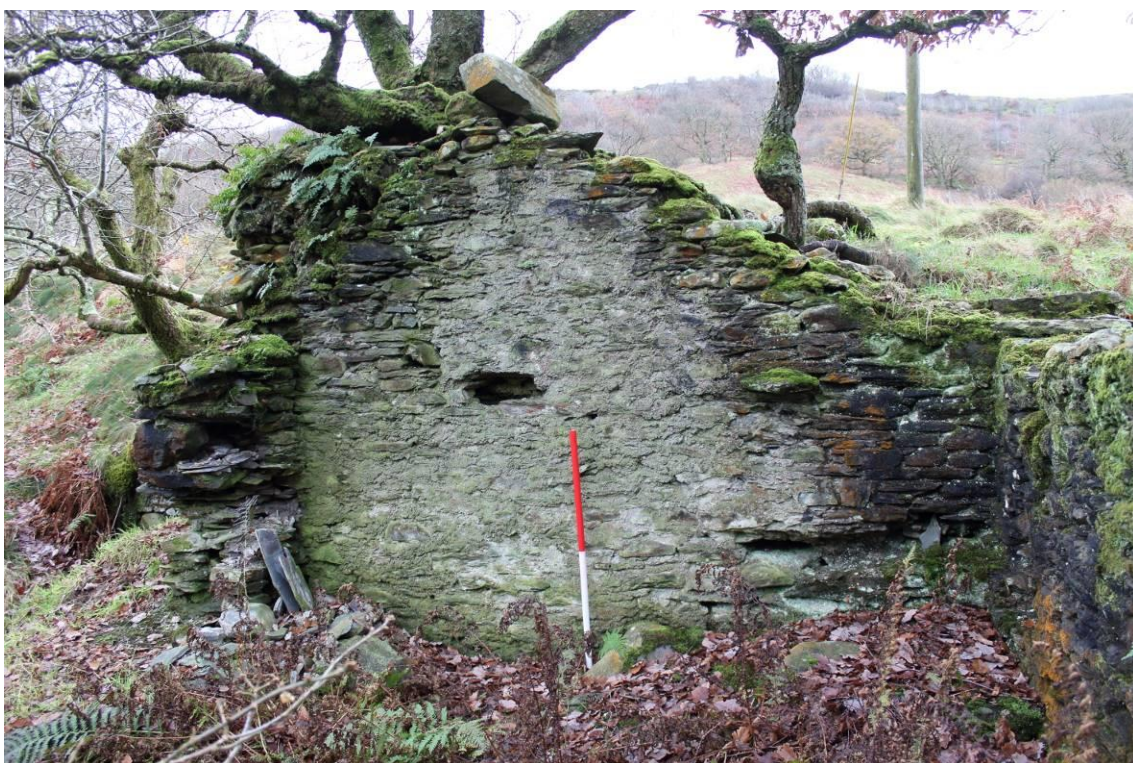
**Photo 11:** The internal elevation of the southern gable end of winding house PRN125585, with the possible remnants of a thin limewash. 1m scale (DAT Photo 125592\_3450).

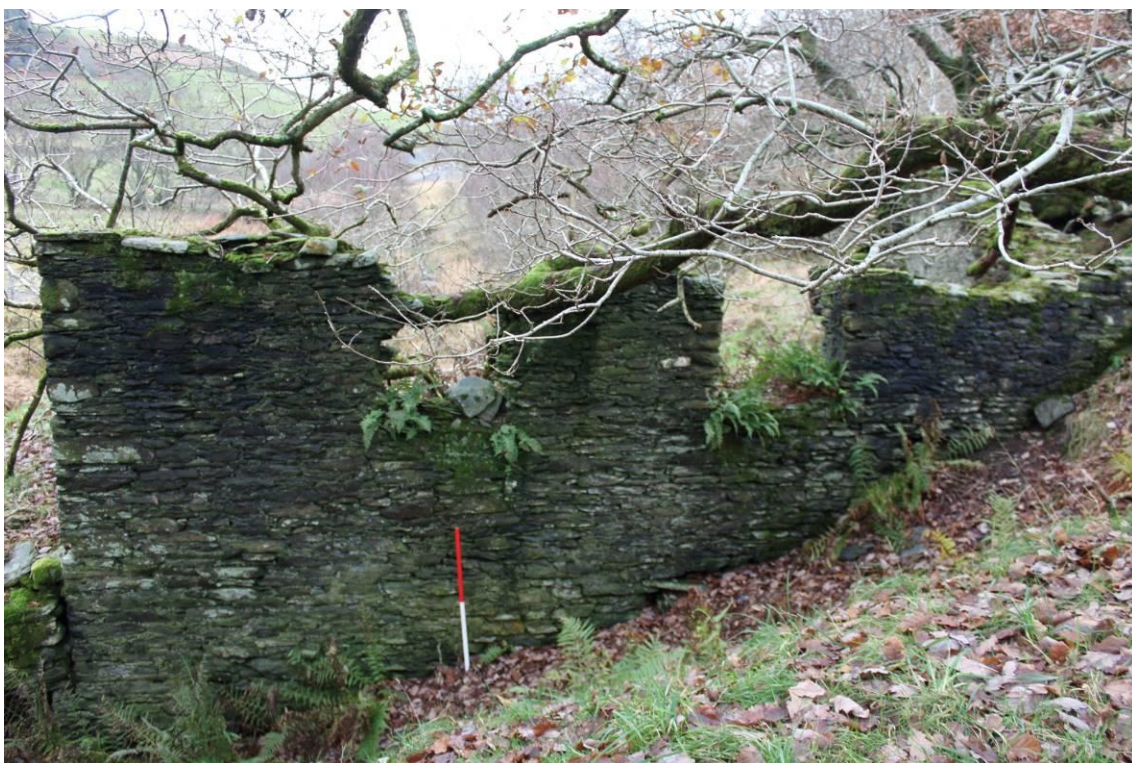
**Photo 12:** The western external elevation of winding house PRN125585. 1m scale (DAT Photo 125592\_3452)

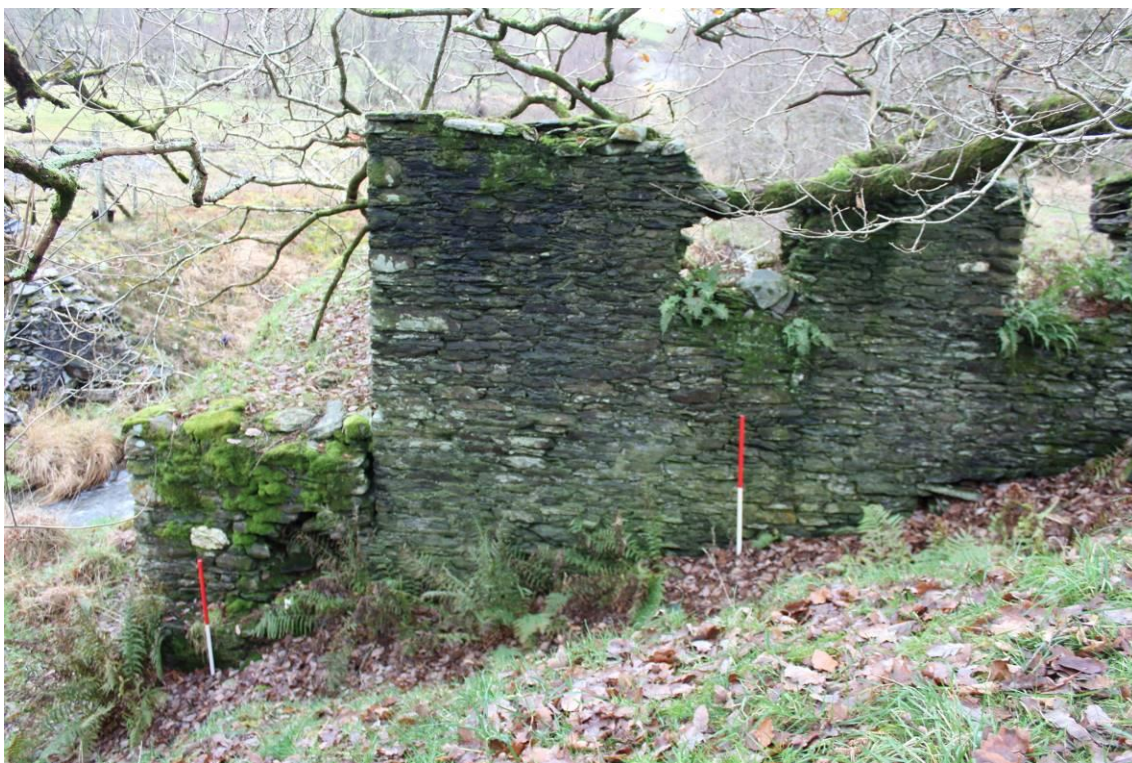
**Photo 13:** The northern end of the western elevation of winding house PRN 125585 and the abutting platform or revetement at its northern end. 1m scale (DAT Photo 125592\_3454)

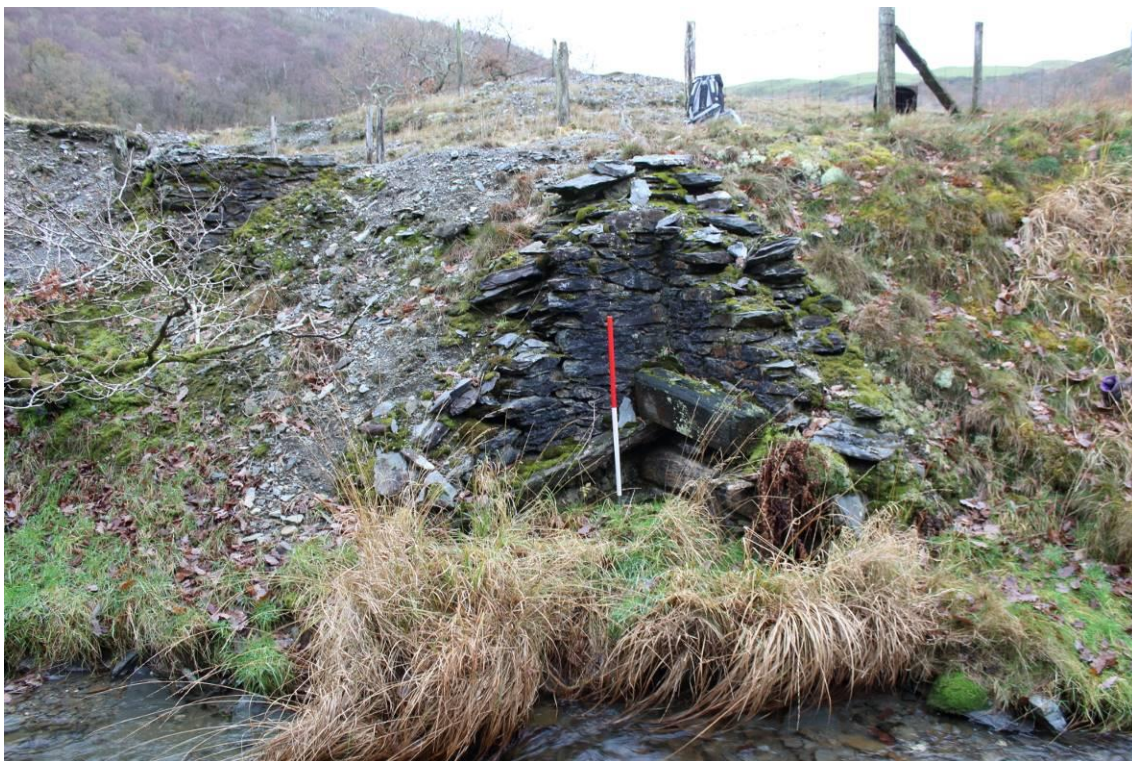
**Photo 14:** The stone and timber structure PRN125586 eroding from the tip opposite wheelpit PRN96394. 1m scale (DAT Photo 125592\_3459)

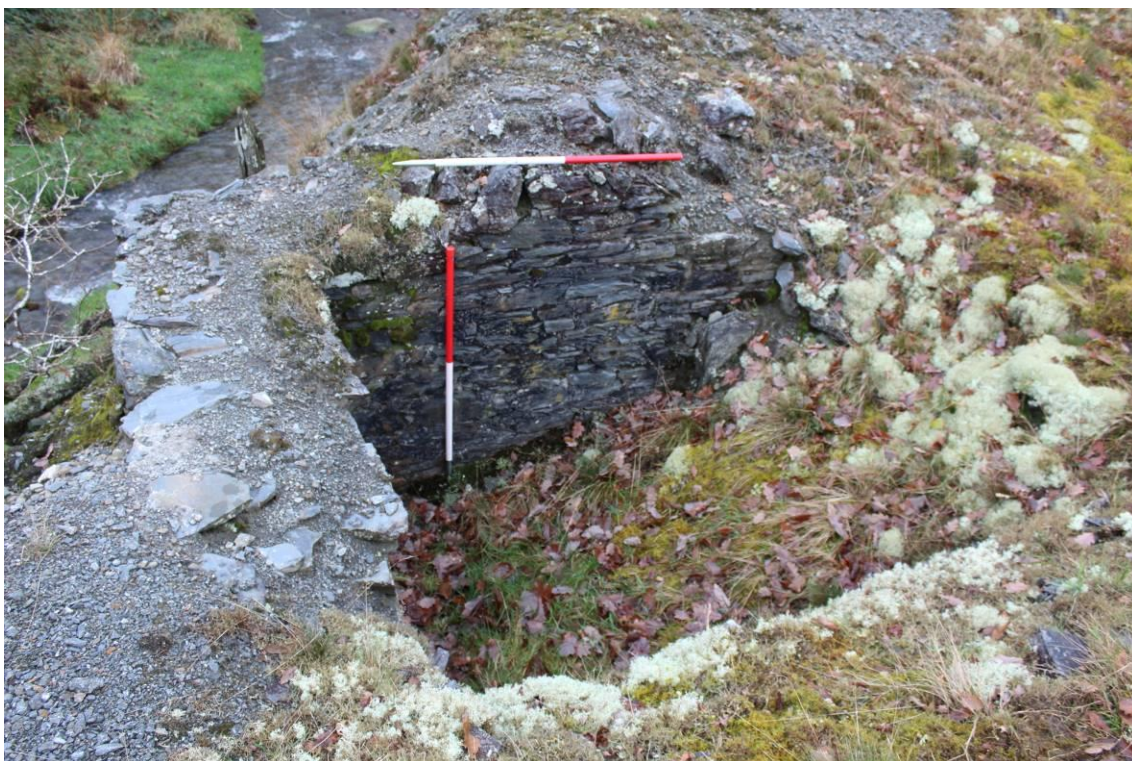
**Photo 15:** The square masonry collar for shaft PRN69390. Facing west. 1m scale (DAT Photo 125592\_3460)

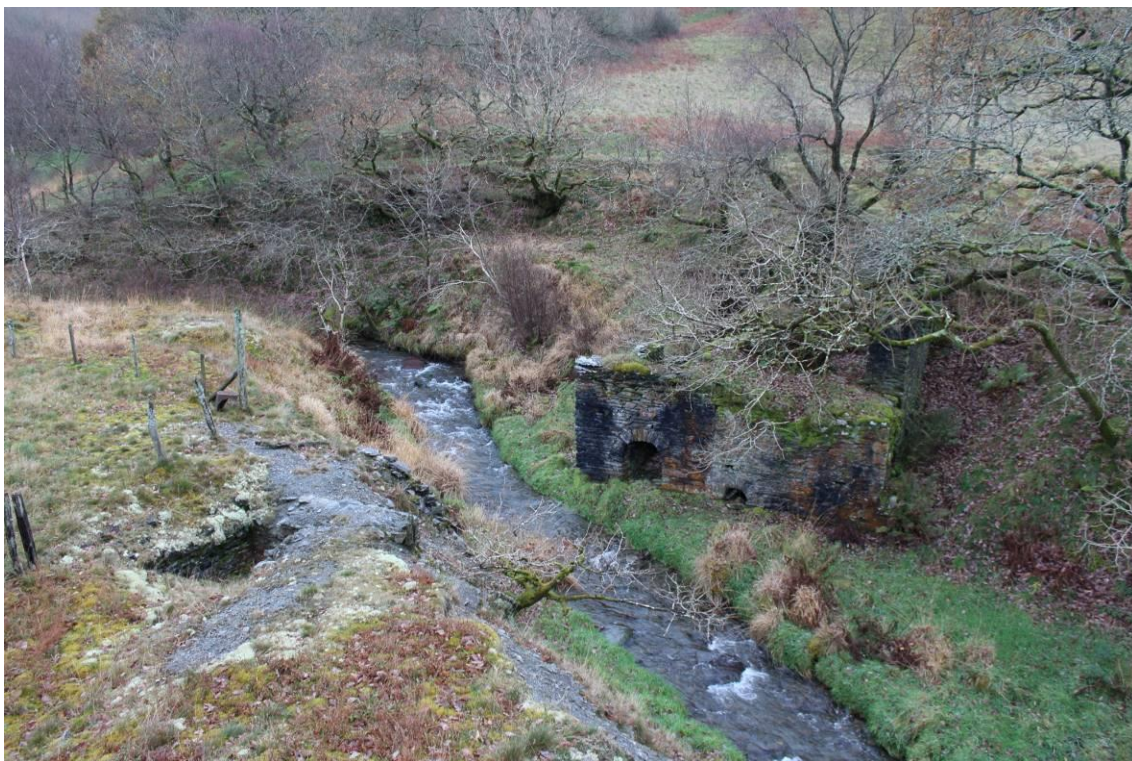
- 4.5.13 Just over 2m or so up slope from the exposed structure is the square masonry collar for shaft PRN96390 (Photo 15). This shaft has been filled in and is presently accumulating a modest scree of detritus and it is clear to see that the capping of the collar is susceptible to active weathering. This shaft is situated at the highest point of the northern bank opposite the wheelpit and winding house and corresponds to the possible balance bob pit or platform shown on the 1888, 1:2500 Ordnance Survey map (Photo 16).

**Photo 16:** Overview of shaft PRN96390 (left in the frame) and wheelpit PRN 96394 and winding house PRN 125585 at Frongoch West (DAT PHOTO 125592\_3461)

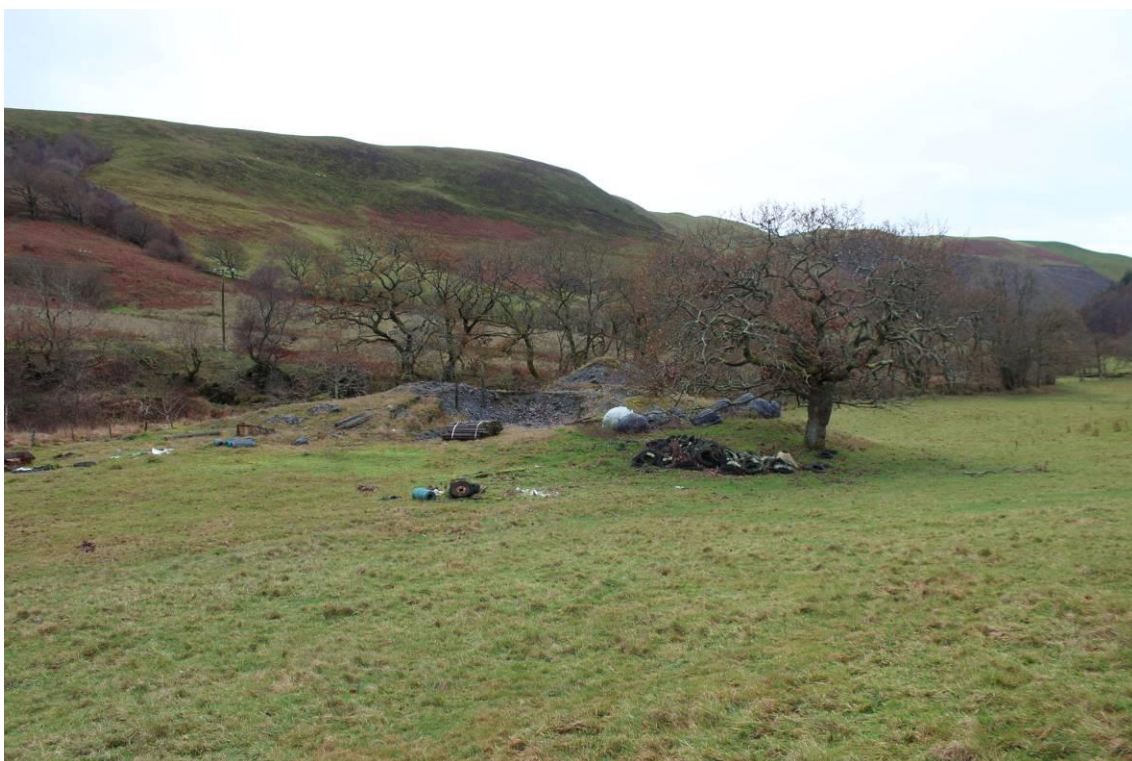
**Photo 17:** The northern side of spoil tip PRN96391 showing an area of extraction. Two wooden posts are also shown protruding from the centre of the tip (DAT Photo 1255921\_3470)

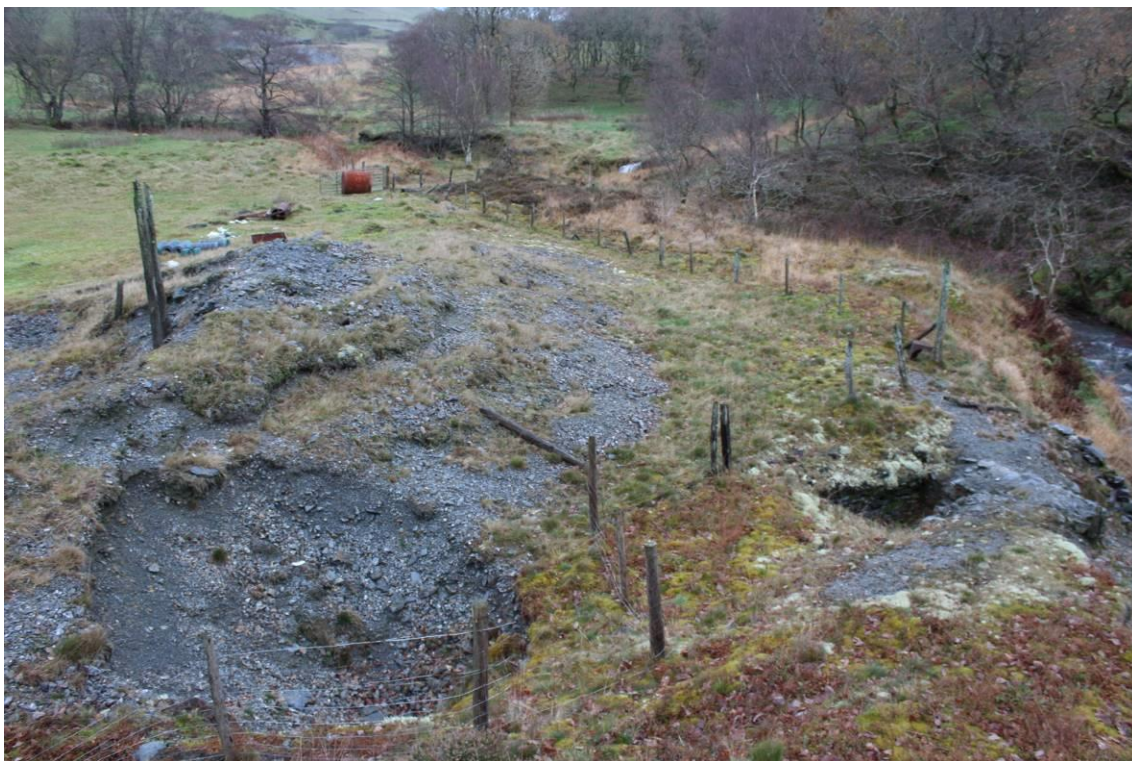
**Photo 18:** The large circular depression (PRN125587) at the western end of tip PRN96391 maybe indicative of a shaft or a continuation of shaft PRN96390 seen at the right hand of the frame (DAT Photo 125592\_3462).
