# WEMYSS METAL MINE

## ARCHAEOLOGICAL DESK BASED ASSESSMENT UPDATE

REPORT NO 2020\_55  
EVENT RECORD NO. 125592

# WEMYSS METAL MINE ARCHAEOLOGICAL DESK-BASED ASSESSMENT UPDATE

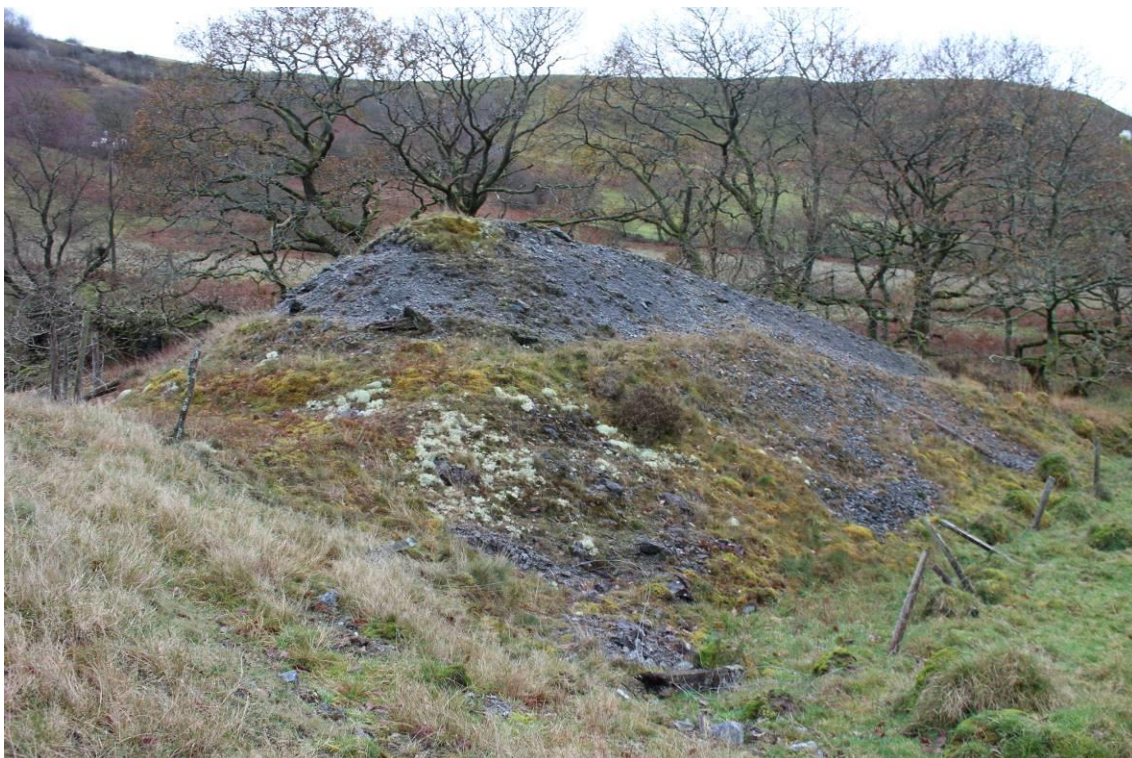
- 4.5.15 The second spoil tip is the latest of the two and is located immediately west of shaft PRN96390 (Photo 19). This development tip PRN 96393 is almost double the height of the former, is narrow and steep sided with an asymmetrical profile owing to the significant erosion of its southern slope. Here, it is plain to see active

**Photo 19:** Overview of the northern slopes of development tip PRN 96393 (DAT Photo 125592\_3469)

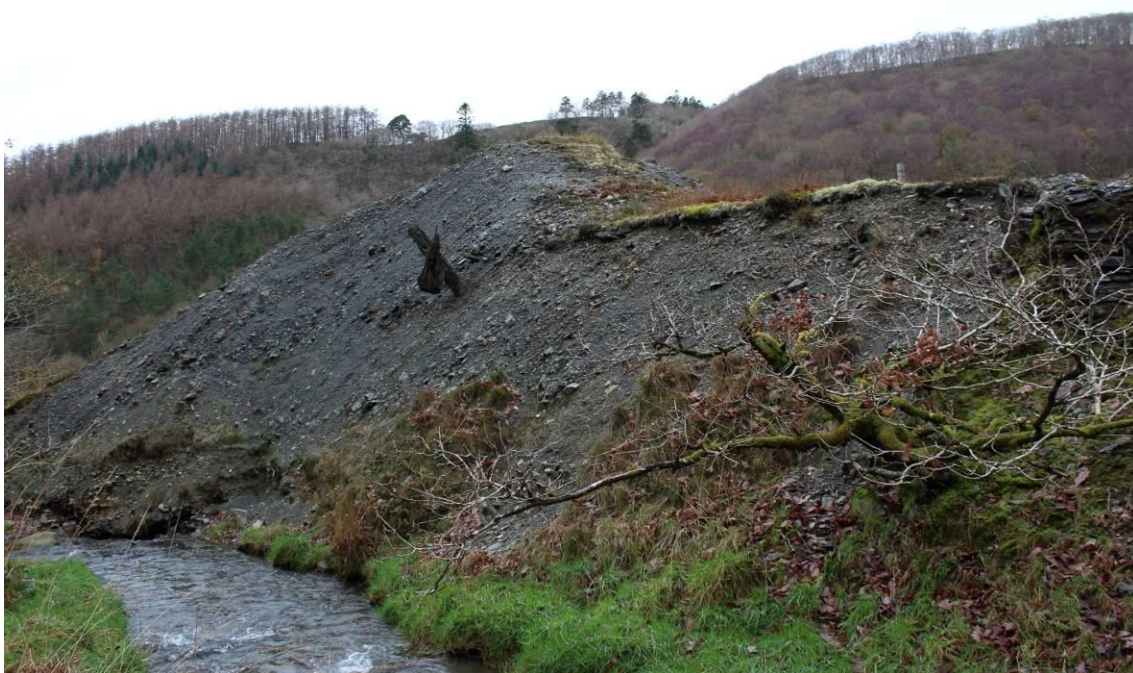
undercutting at the base of the tip by the Nant Cwmnewidion and surface erosion of the extremely loose and seemingly unstable material. A sizable, yet truncated wooden post and fragmented cross bar, protrudes at an angle from this southern slope (Photo 20).

**Photo 20:** A wooden post is seen protruding out from the actively eroding, steep southern slope of development tip PRN96393 (DAT Photo 125592\_3469)

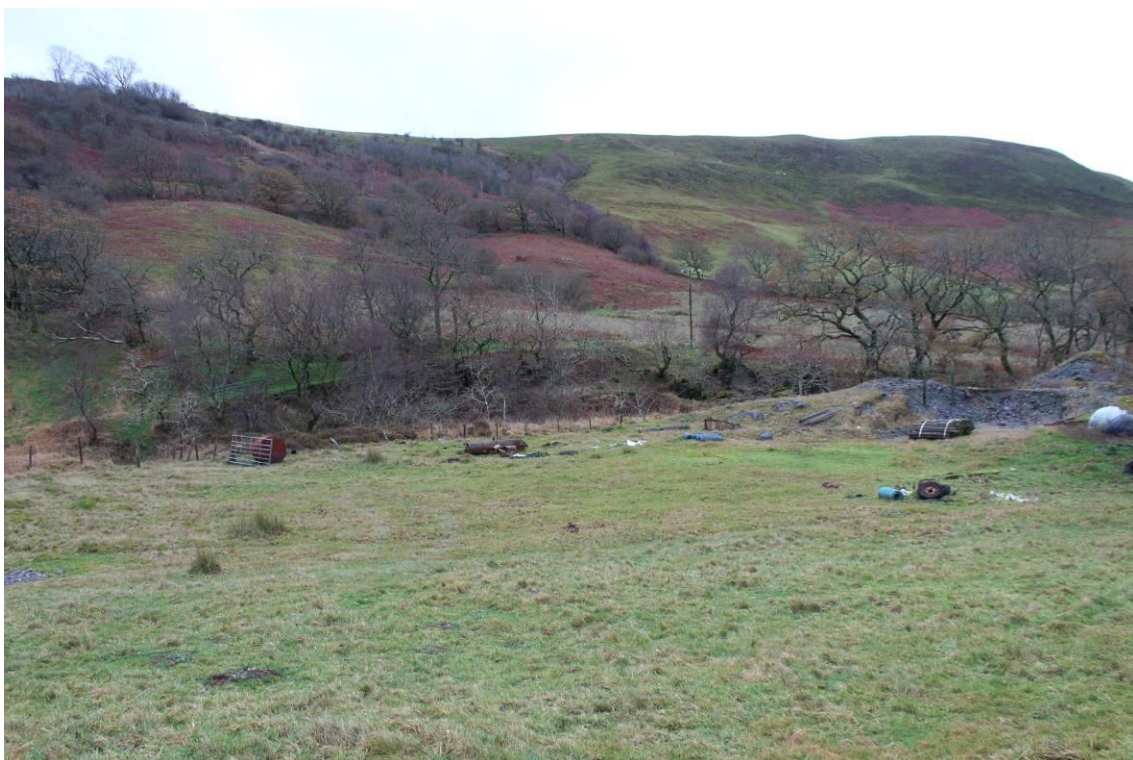
- 4.5.16 Elsewhere, there were no visible traces of shaft PRN69385 noted on the 1905 1:2500 Ordnance Survey map, nor of the hollow and level PRN96387 or indeed any remains of the two small buildings PRN 96386 shown on the 1888 1:2500 Ordnance Survey map (Photo 21).

**Photo 21:** Overview of the eastern area of Frongoch West where there are no visible traces the recorded levels, hollows and abandoned buildings (DAT Photo 125592\_3471)

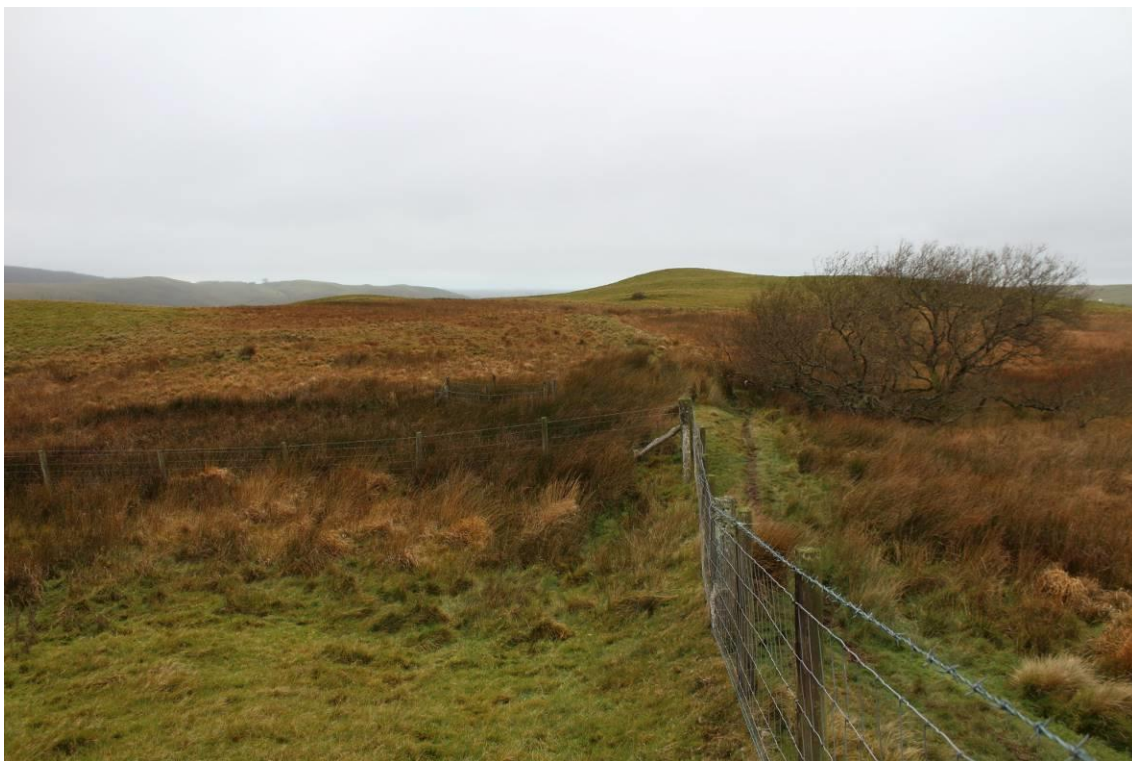
**Photo 22:** Overview (facing west) of the south eastern extent of the pond study area at the corner of the post and wire fence which follows the hedgebank, enclosing the south-eastern end of the rush filled pond and eastern side its the narrow brook (DAT Photo 125592\_3474).

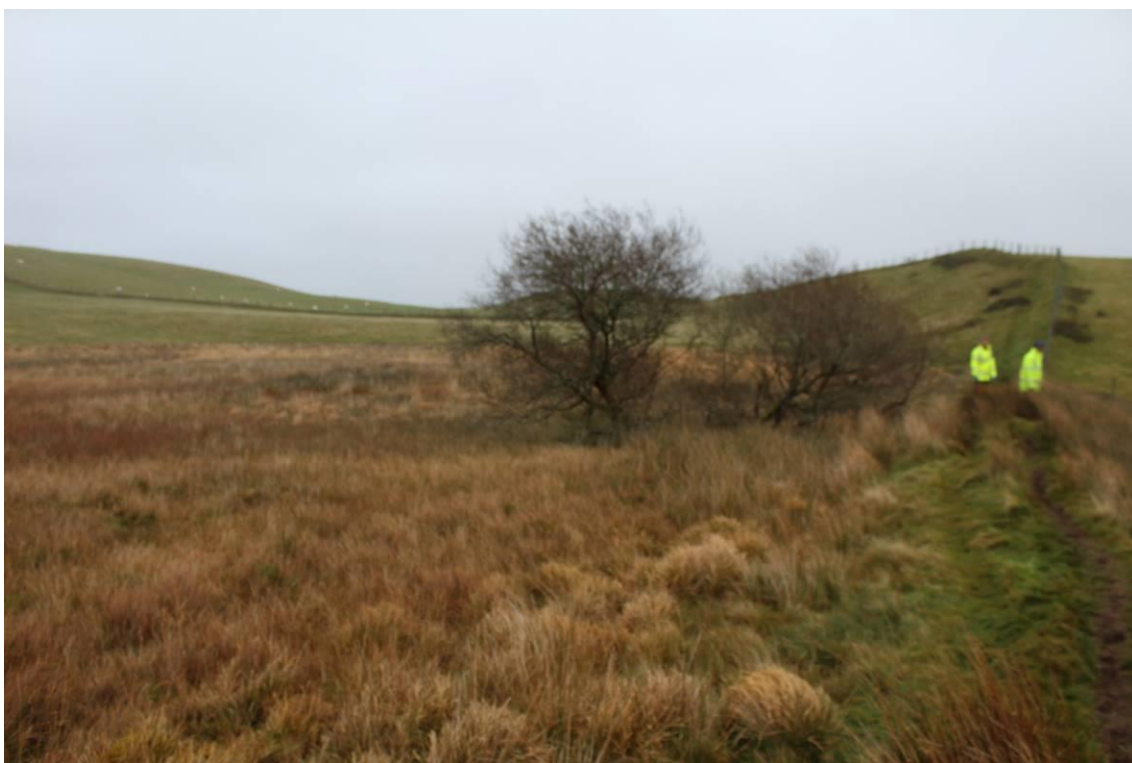
- 4.5.17 After completing the survey at the Frongoch West study area, the site visit proceeded uphill to the pond study area on Cwm Newidion. The pond feature is located on a broad plateau, roughly halfway up the hill. Entirely rush filled, it is a stark contrast to grazed pasture of the south-eastern slopes. A post and wire fence encloses the narrow brook leading from the pond and continues along the eastern extend of the well defined hedgebank/field boundary. The western side of the brook and pond remains unenclosed (Photo 22). Two hardy trees roughly mark the point where the brook leaves the pond and roughly align with the return of the post and wire fence (Photo 23).

**Photo 23:** Overview (facing east) of the western side of the pond study area. The prominent hedgebank/field boundary can be seen curving northwards in the background of the frame (DAT Photo 125592\_3476)

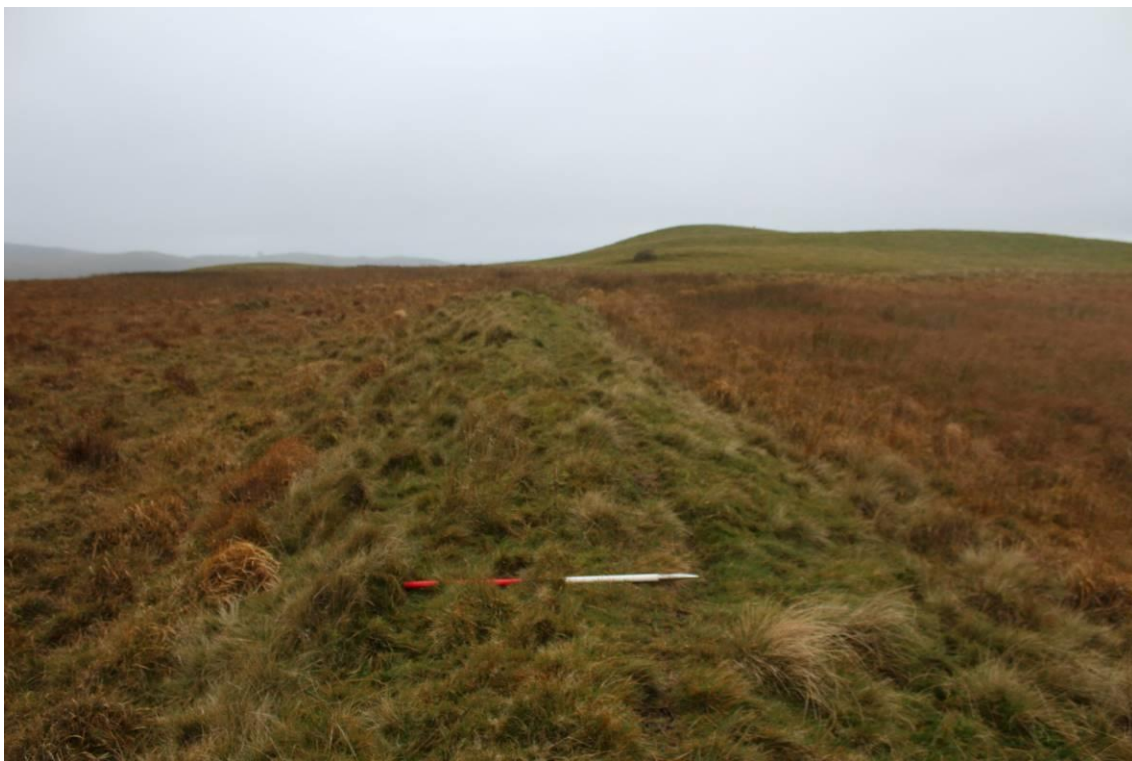
- 4.5.18 Beyond the junction with the brook, the hedgebank continues for around 66m westwards and is a discernible earthwork (Photo 24). Aside from the occasional small suspicious hollow on the south-eastern slopes of the hill, no other features of potential archaeological interest were identified in this area.

**Photo 24:** Overview of the low earthwork hedgebank/field boundary running westwards beyond the pond study area (DAT Photo 125592\_3478)

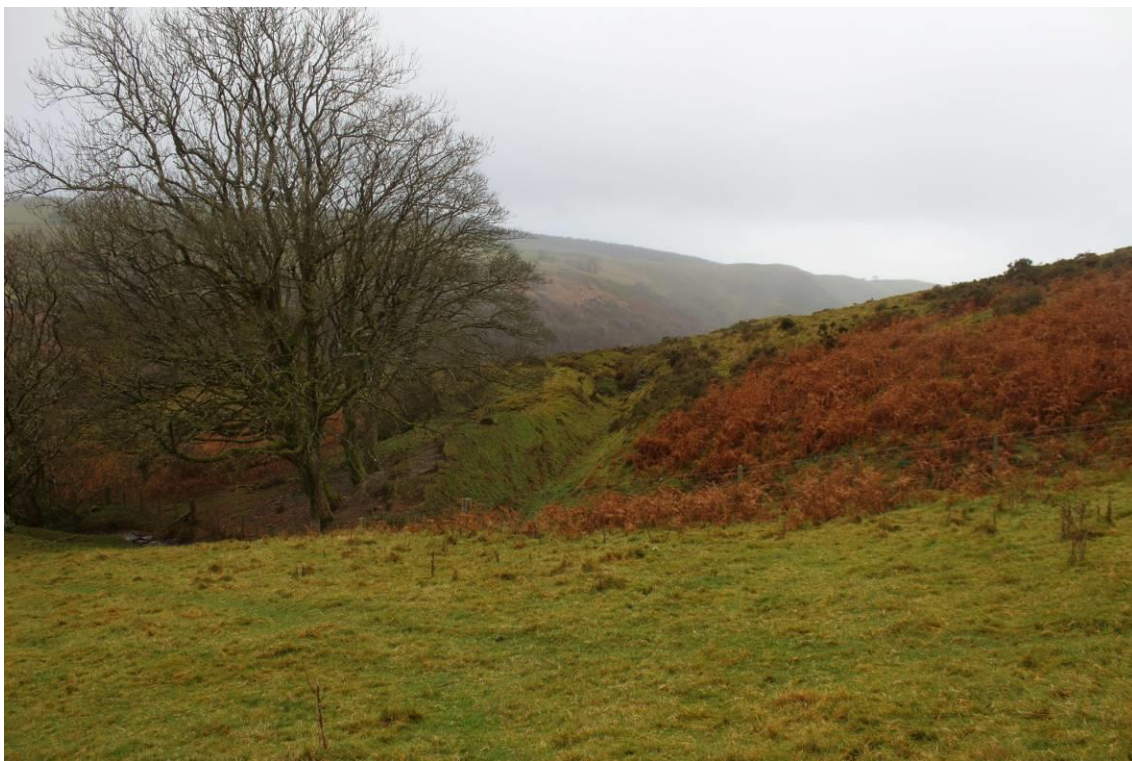
**Photo 26:** Overview (facing west) of leat PRN96317 at the point where it truncates the brook (DAT Photo 125592\_3479)

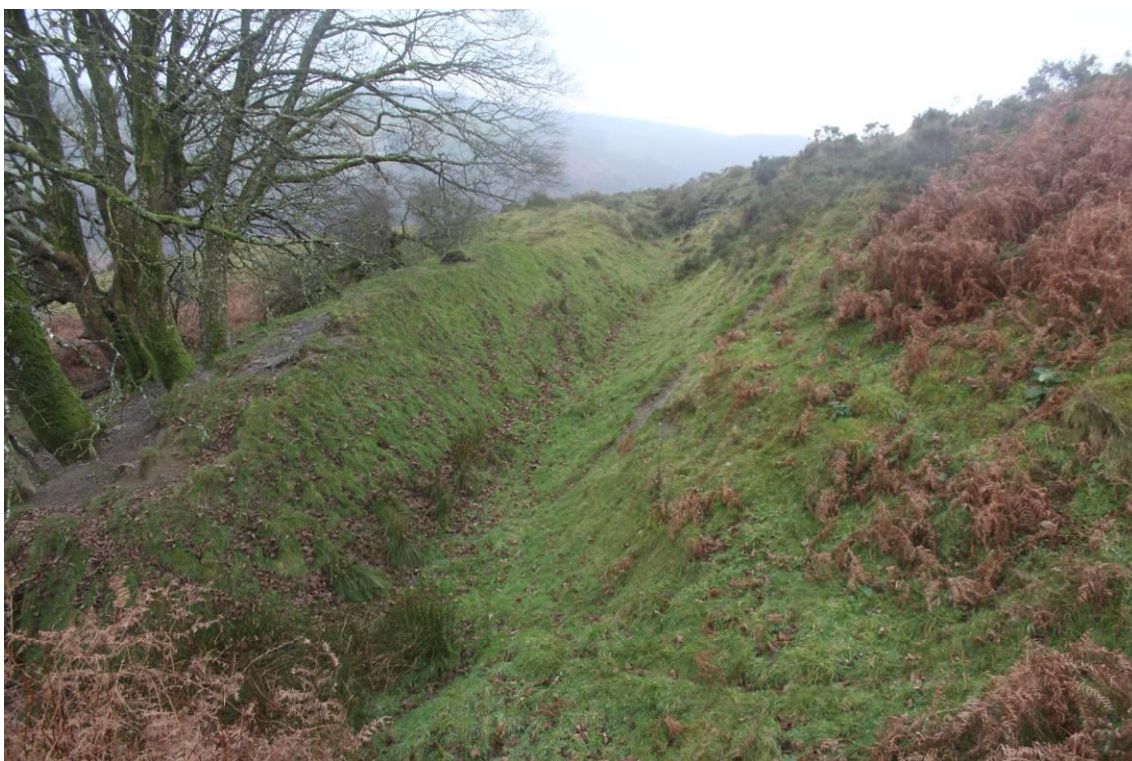
**Photo 27:** A closer view of leat PRN96317 and the cluster of trees (at the left of the frame) roughly in the area of the former Tan-Yr-Dam farmstead PRN125986 (DAT Photo 125592\_3480)

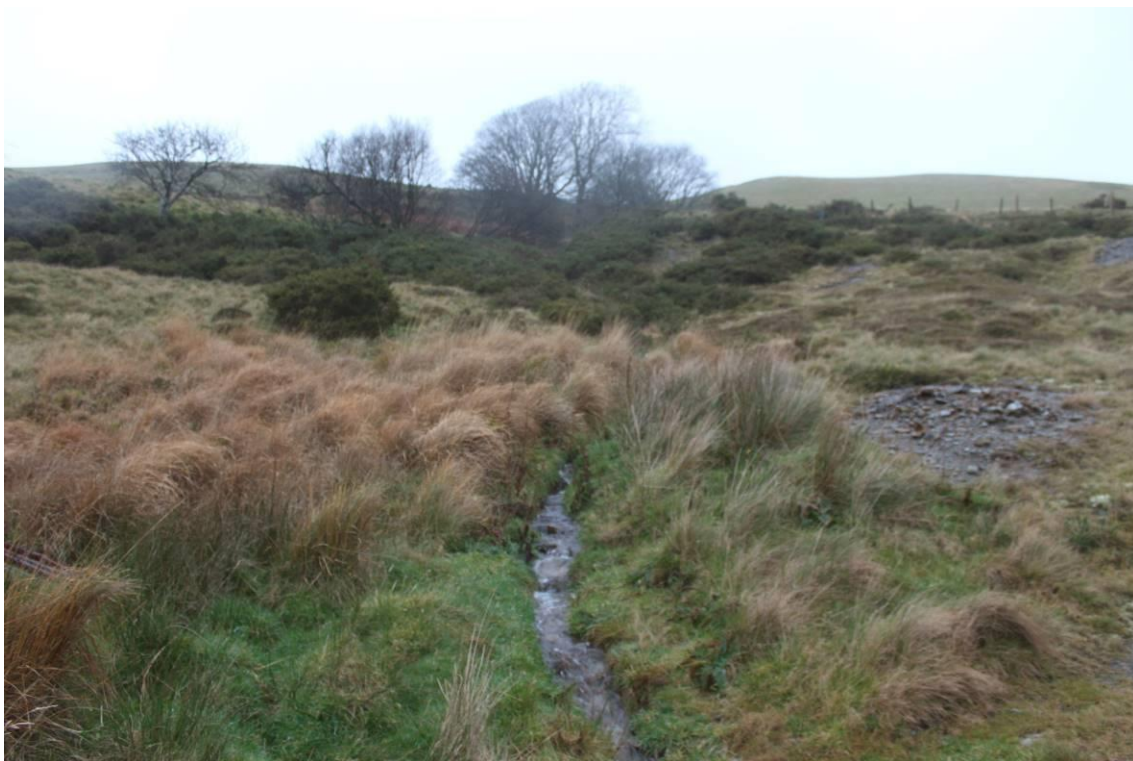
- 4.5.20 Finally, the brook joins the main area of mine workings at the eastern end of the 2016 study area just above Glanvill's Shaft PRN9615 and its spoil tip which is now covered in gorse (Photo 28).

**Photo 28:** View looking northwards towards the brook which joins the main mine workings just above Glanville's Shaft PRN96315 and spoil tip, now covered in gorse (DAT Photo 125592\_3481)
