MYNYDD Y LLAN HYDROCARBON PIPELINE REPAIR ARCHAEOLOGICAL WATCHING BRIEF

Prepared by DAT Archaeological Services
For: MLP c/o Fisher German

REPORT NO. 2020-58
EVENT RECORD NO. 125604

November 2020

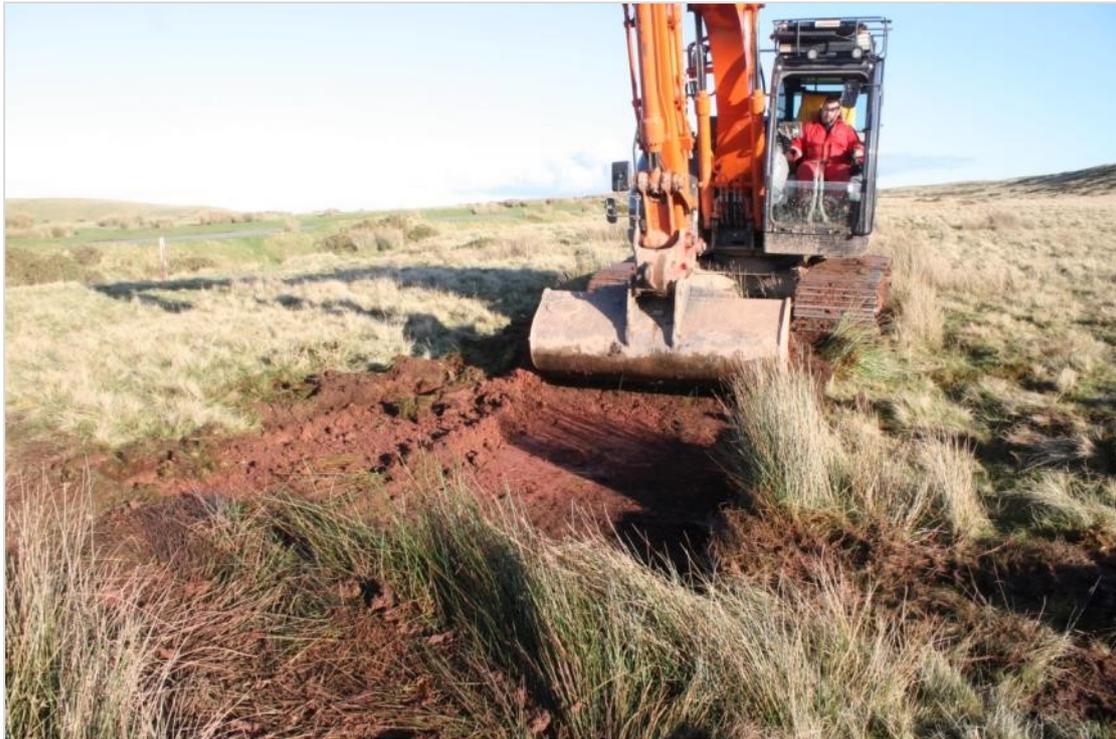
- 5.2 Initial groundworks included the removal of topsoil within an area measuring approximately 7m north-south by 24m east-west, which was located over the area of corroded pipe allowing for safe access to repair the corroded pipe welds and also acting as a workers compound in which to store both site plant and site tools safely.

Photo 5: View north east of initial removal of topsoil within footprint of the workers compound area

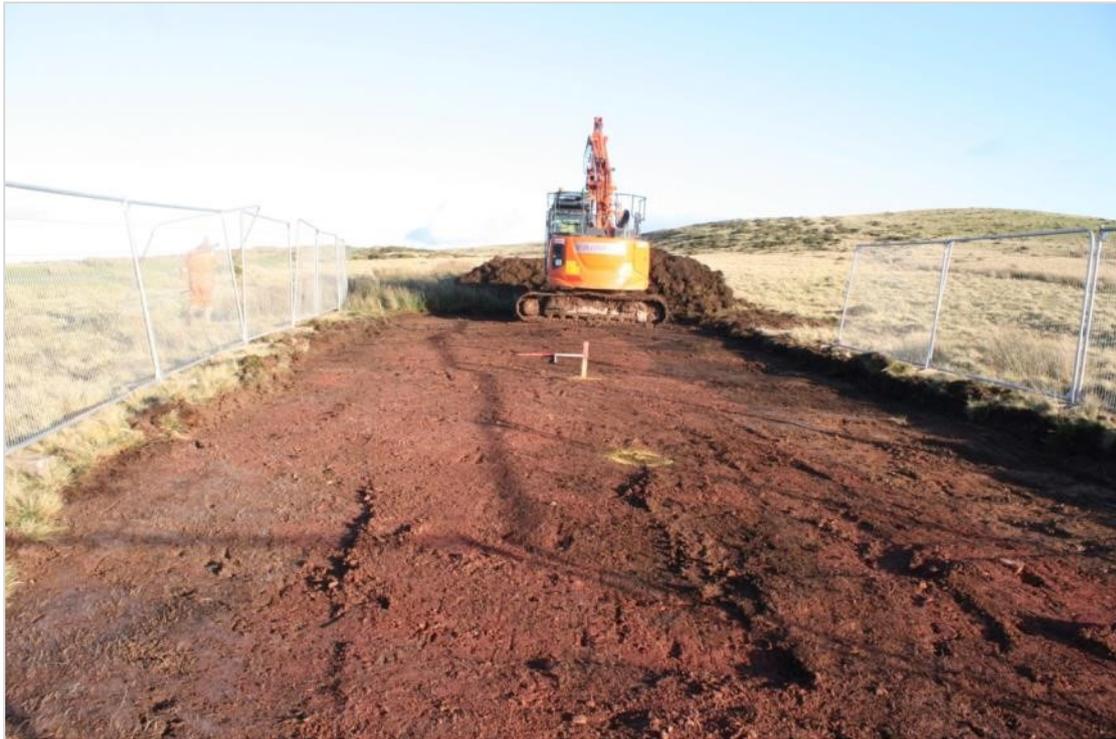
- 5.3 The excavated topsoil within the workers compound comprised black peaty loam [1000] which had an average depth of between 0.15 and 0.18m.
- 5.4 Following topsoil removal the underlying subsoil was revealed comprising mid-grey silty clay [1002] which was present on both northern and southern edges of the excavated area but was interrupted in the centre by a bright red east/west aligned linear strip of dark red sandy clay [1001]; evidently the backfilled trench which accommodated the hydrocarbon pipeline.

Photo 7: View of completed workers compound with backfilled pipe trench visible as a central red corridor of soil [1001], flanked either side by subsoil [1002]. 2 x 1m scales

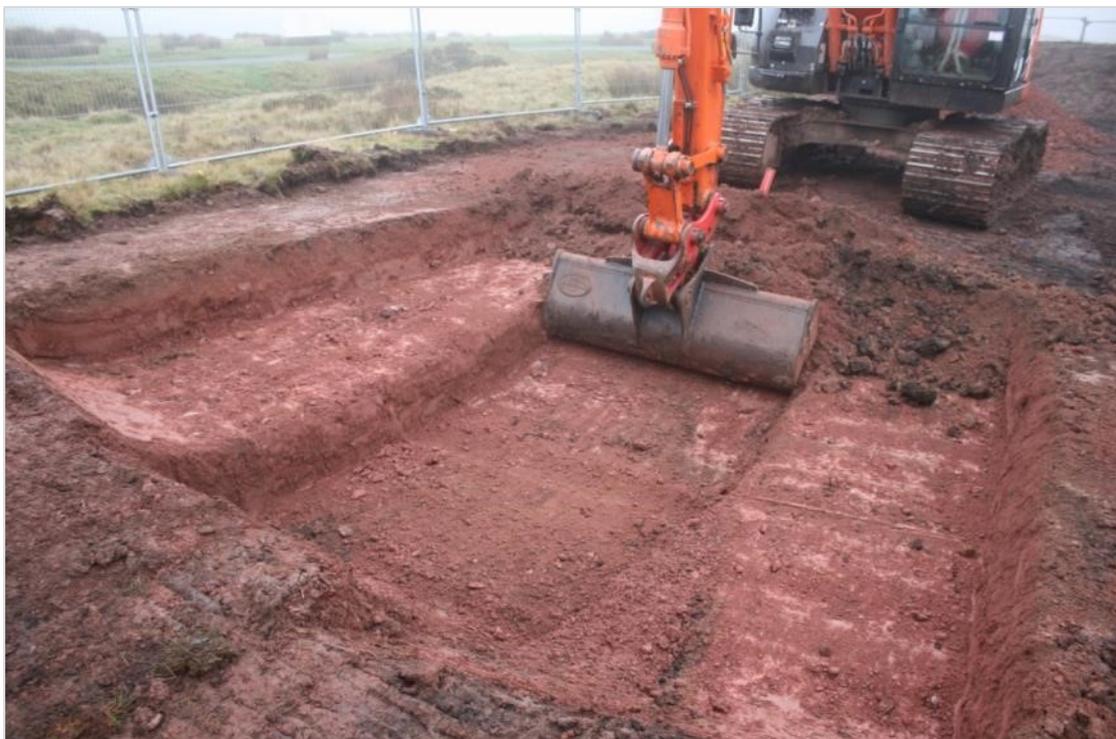
- 5.6 Within the smaller excavation area the backfill of the pipe trench was removed, and the sides of the pipe trench were benched on the northern and southern sides of the trench to allow for safe working within the confines of the excavation. Both areas of benching measured around 1.5m wide. The excavated pipe trench measured approximately 2m wide and 2m deep.

Photo 8: View north east of excavation of pipe trench and benching of both sides

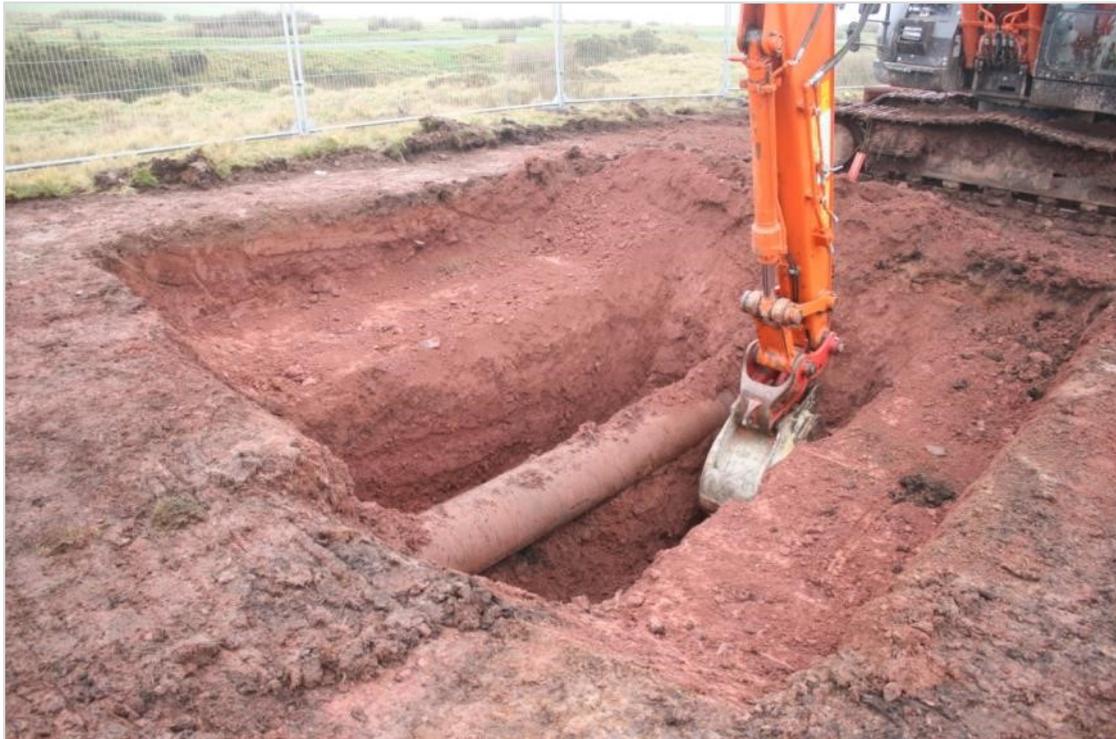
Photo 9: View northeast of excavation works completed

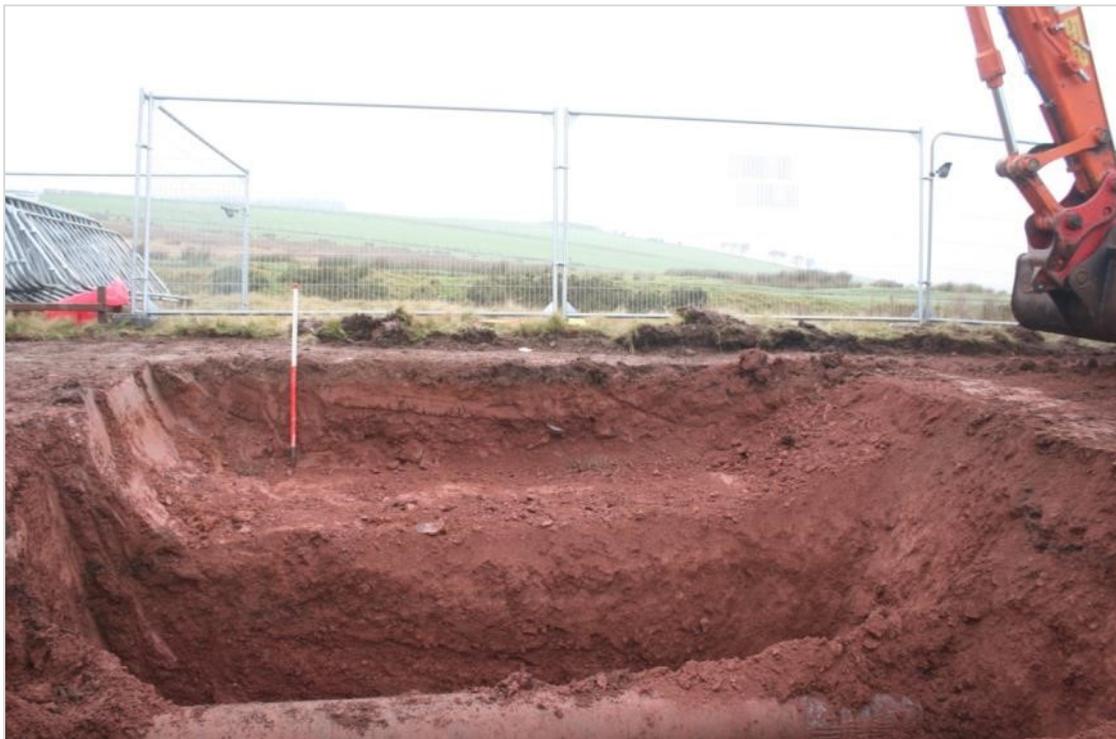
- 5.7 Due to the depth of the emptied pipe trench a clearer stratigraphic soil sequence could be seen. Beneath subsoil layer [1002] was a deposit of mid reddish brown sandy clay [1003] with an average depth of 0.28m.

- 5.8 Natural superficial geology was revealed at 0.53m below existing ground level and proved to be light red sandy clay [1004] which contained frequent inclusions of small sub angular stones.

Photo 10: View north of south facing section displaying soil sequence witnessed at the site. 1 x 1m scale

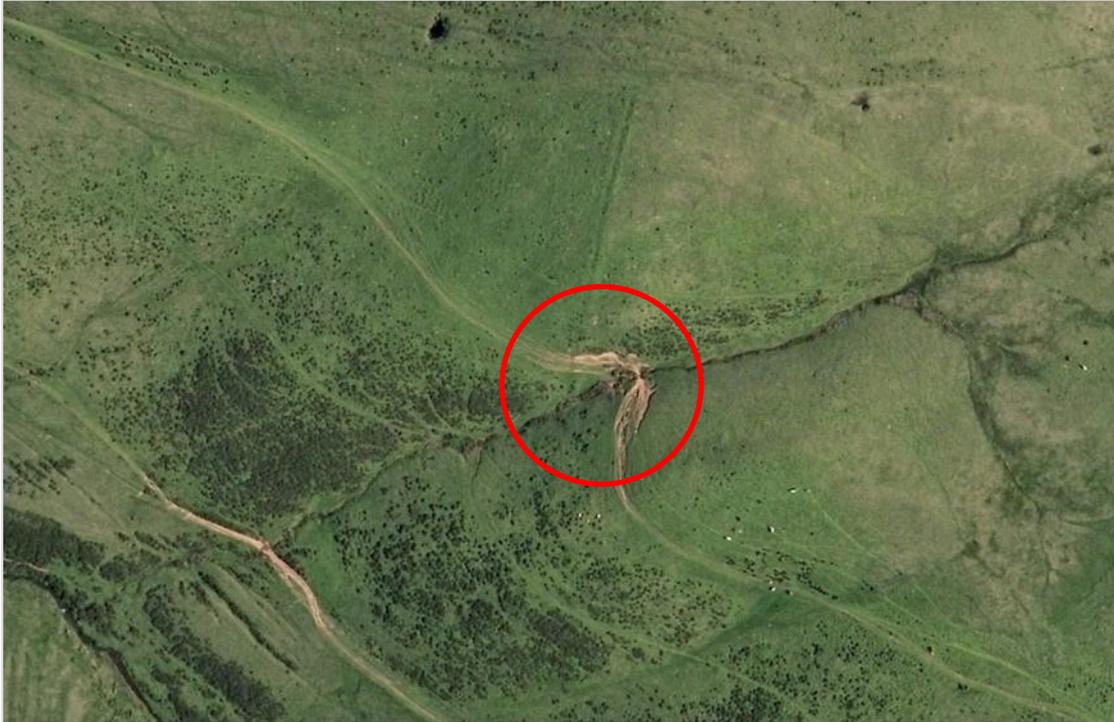
- 5.8 During the watching brief the on-site archaeologist visited the site of Carreg Lwyd Roman marching camp (CM174) and discovered an area of active erosion on the south east rampart where it crosses Cwm Holdfast at SM 79939 26240 (Photo 11). Due to the size and regularity of the erosion it is considered likely that the erosion may have been caused by grazing

livestock. The following photos below show the area of erosion which has caused the rampart to become exposed in section and possibly the south eastern edge of the camp's ditch (Photos 12, 13 & 14).

Photo 11: Ariel photograph depicting area of erosion over north western rampart of Gareg-Llywd Roman marching camp (CM174). Image obtained from DAT HER.

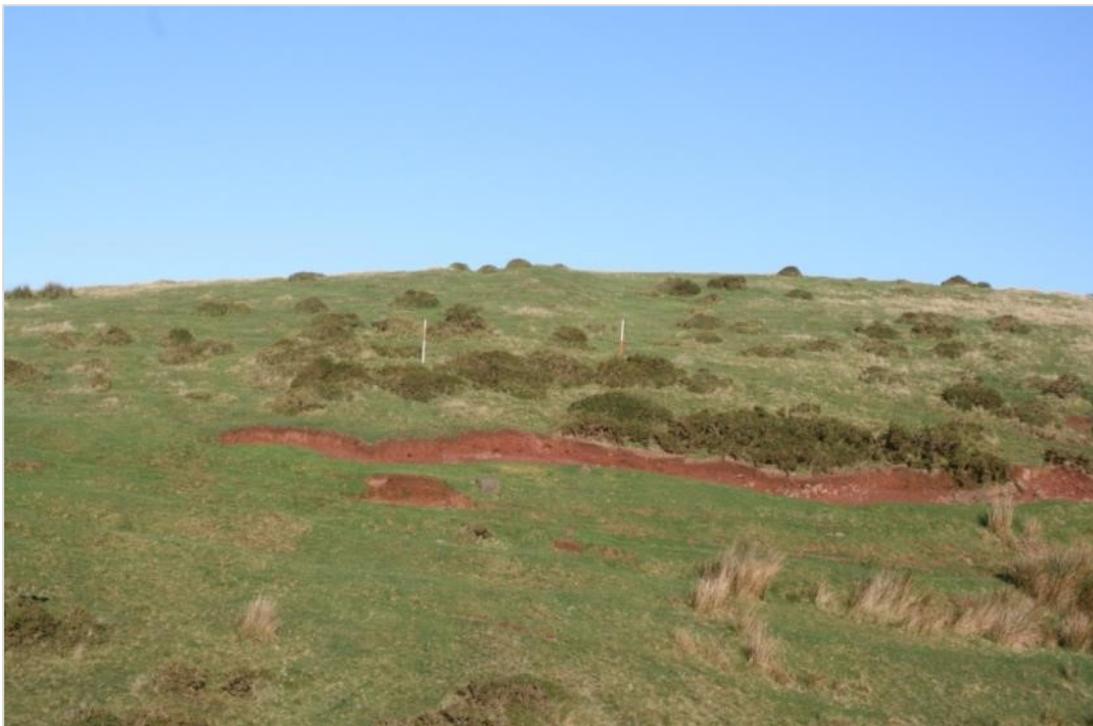
Photo 12: View north east along north western rampart of Gareg-Llwyd Roman marching camp (CM174) with ranging poles indicating the edges of the rampart. Erosion through rampart and ditch visible in foreground. 2x 1m scales

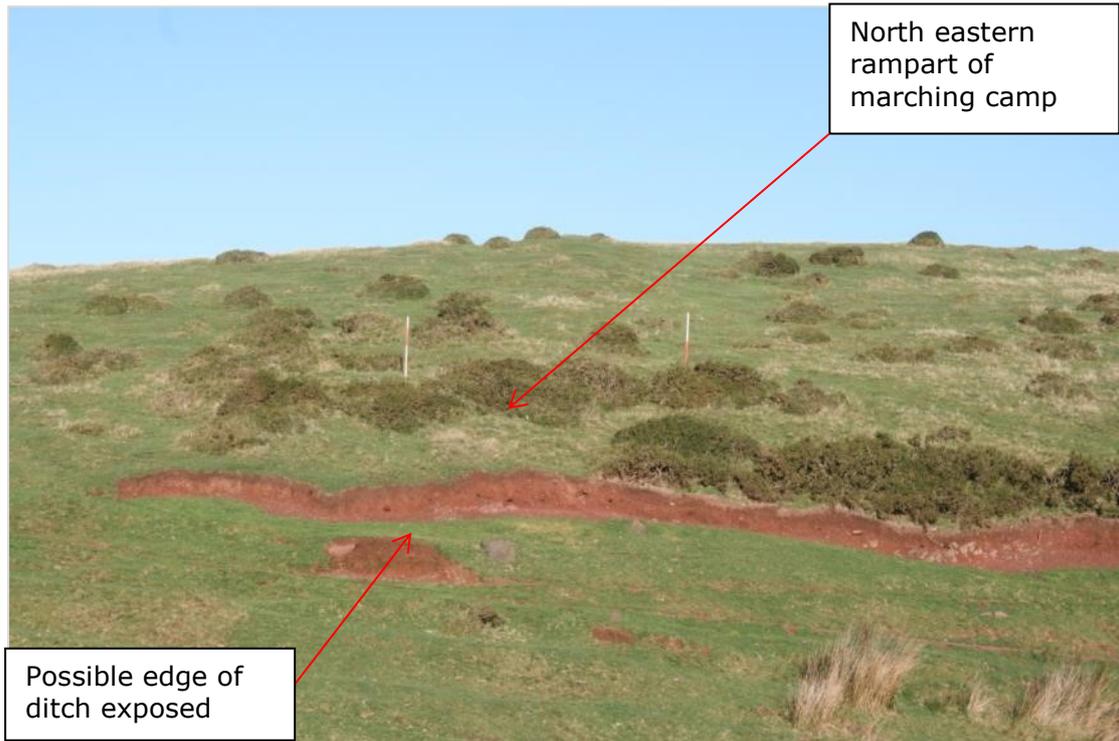
Photo 13: View north east containing greater detail of above photo. 2 x 1m scales

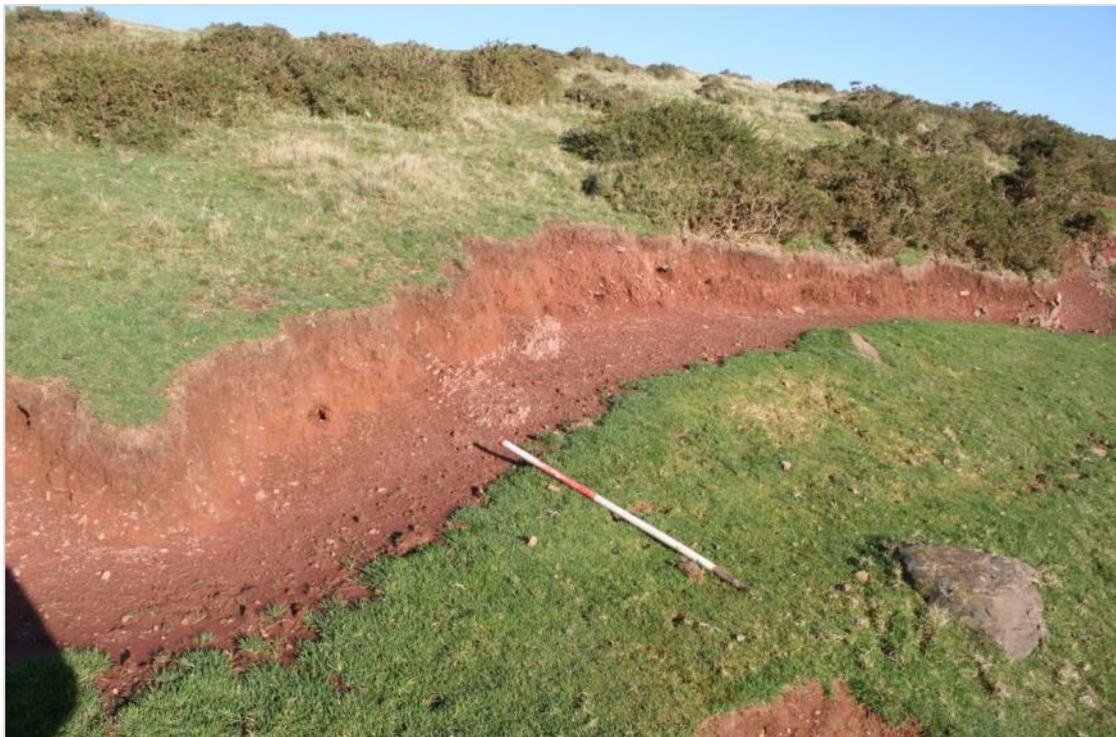
Photo 14: Close up view east of exposed edge of ditch caused by livestock track within rampart. 1 x 1m scale

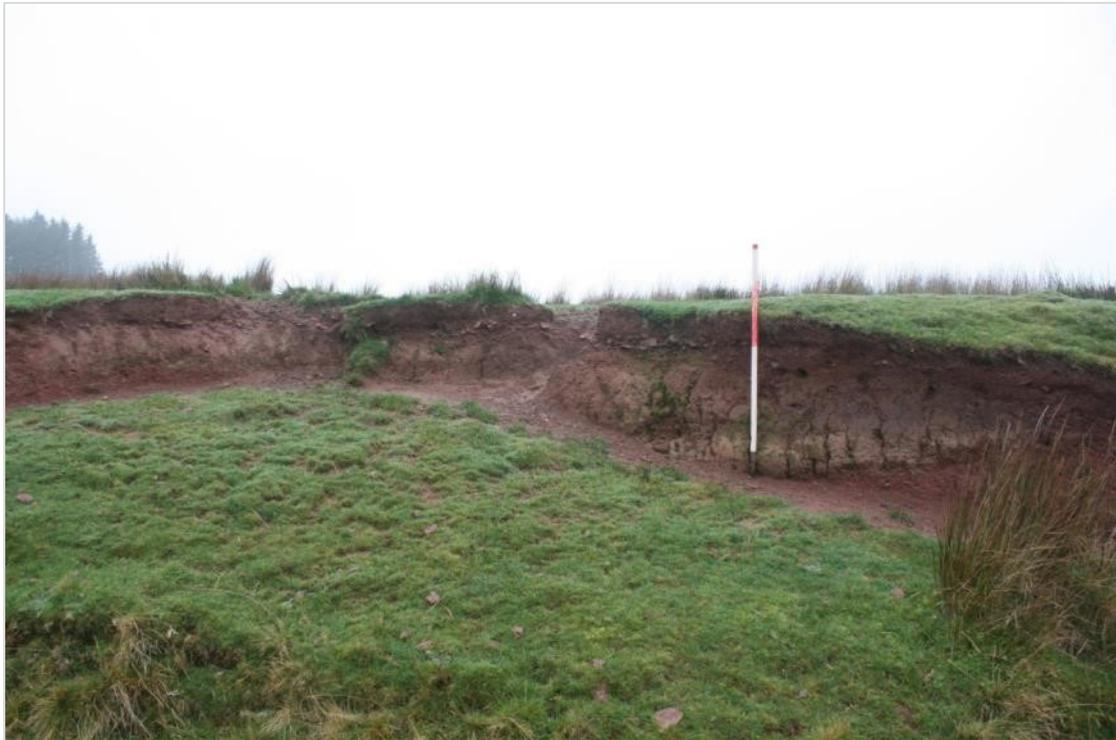
5.9 The unnamed minor road linking Twynllan with Trecastle is reputed to have Roman origins and during the watching brief the on-site archaeologist viewed an area of erosion on the southern side of the

existing road. Within the exposed section a thin deposit of gravel could be seen located at around 0.20m below the existing ground surface. The gravel appeared relatively level and regular in form and due to its vicinity to the existing roadway it could tentatively be suggested that the gravel deposit may represent the basal remains of a former Roman road. The following two photos display the exposed section (Photos 15 & 16).

Photo 15: View north of exposed section on southern side of existing roadway. 1 x 1m scale

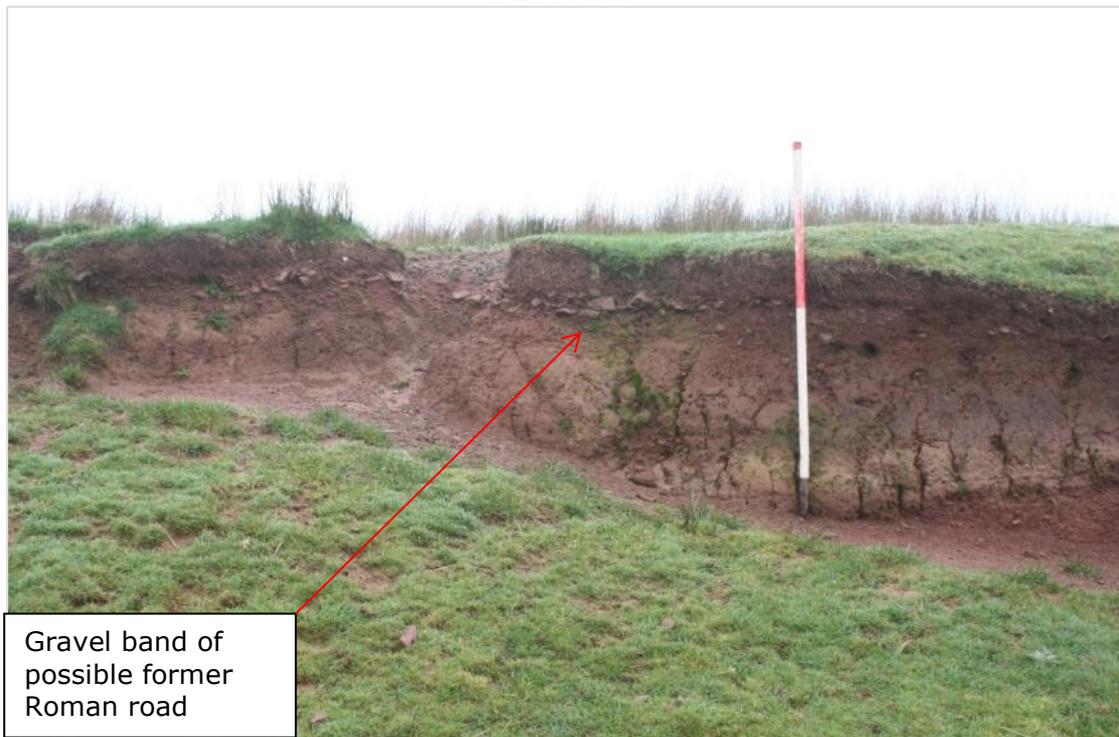
Photo 16: Close up view north of above photo with gravel deposit depicted clearly. 1 x 1m scale
