# **ABERAERON, CEREDIGION: ARCHAEOLOGICAL FORESHORE SURVEY AND WATCHING BRIEF**

REPORT NO. 2020-62

**ABERAERON, CEREDIGION :**  
**ARCHAEOLOGICAL FORESHORE SURVEY & WATCHING BRIEF**

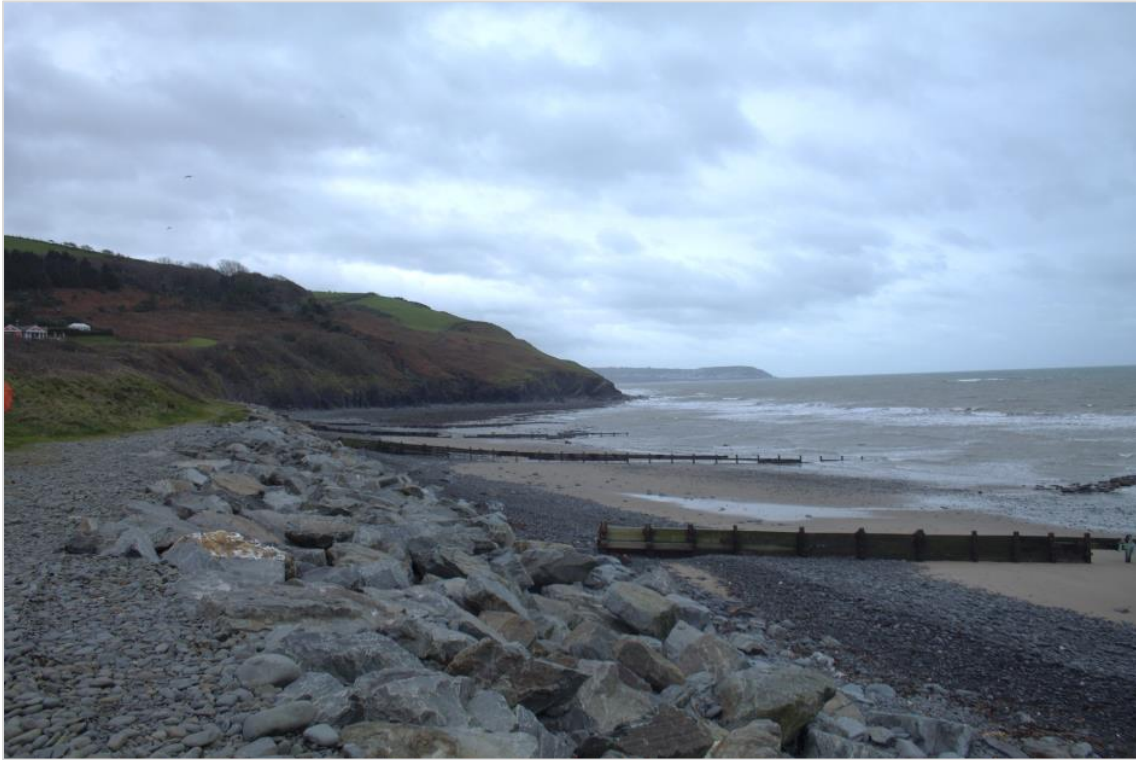
**Photograph 1:** South-western survey area. Looking south-west.

- 2.1.4 The landscape in each area varies with the south-western area consisting of a sandy beach beneath a pebble bank (Photograph 1). Above this a modern bank of boulders has been deposited to function as a sea defence. Another feature of this area is groynes, positioned approximately every 50m, designed to prevent the movement of sand. In the north-eastern area the foreshore consists of a flat, rocky, barren landscape that is constrained by modern coastal defences (Photograph 2).

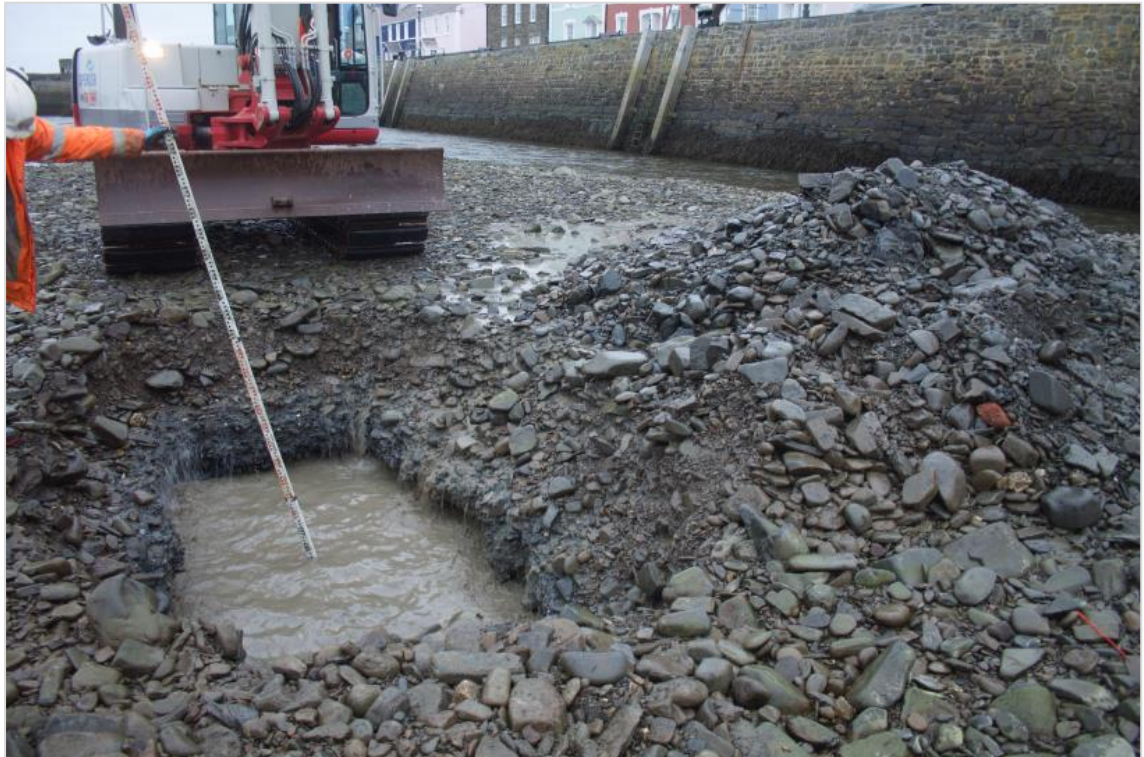
**Photograph 3:** TP111 - filled with water, with excavated material adjacent. Looking west.

- 5.3. The first observed pit was located at the southeast end of the harbour area, roughly located at TP111 on Figure 6. This pit immediately filled with water during excavation, preventing any meaningful archaeological observations being made (Photograph 3). This pit produced a mix of river gravel material and silt in the excavated material, no objects of archaeological interest were observed within it.

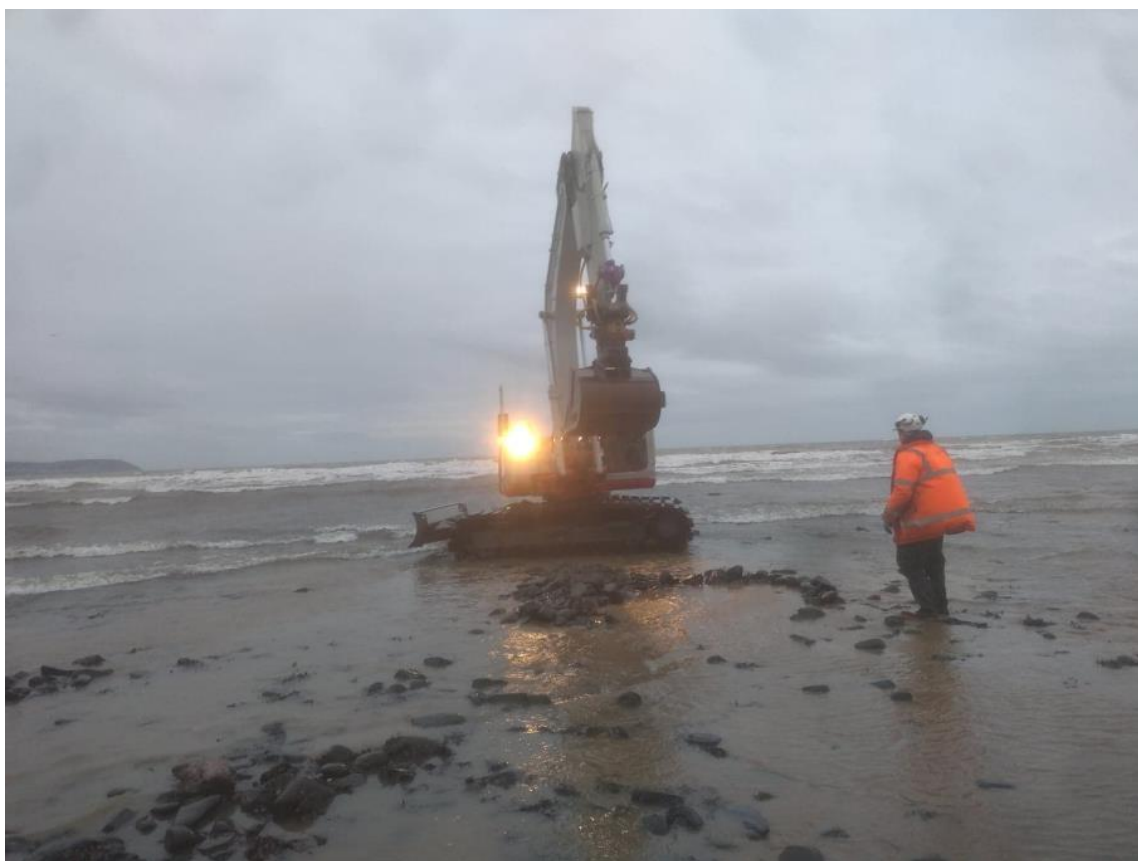
**Photograph 4:** TP106 - filled with water. Looking west.

- 5.4. A second pit was observed in the foreshore area, on the line of the proposed development, roughly located at TP106 on Figure 6. This pit also immediately filled with water during excavation preventing any close inspection (Photograph 4). The excavated material comprised finer gravels and sand, with no archaeological material observed.

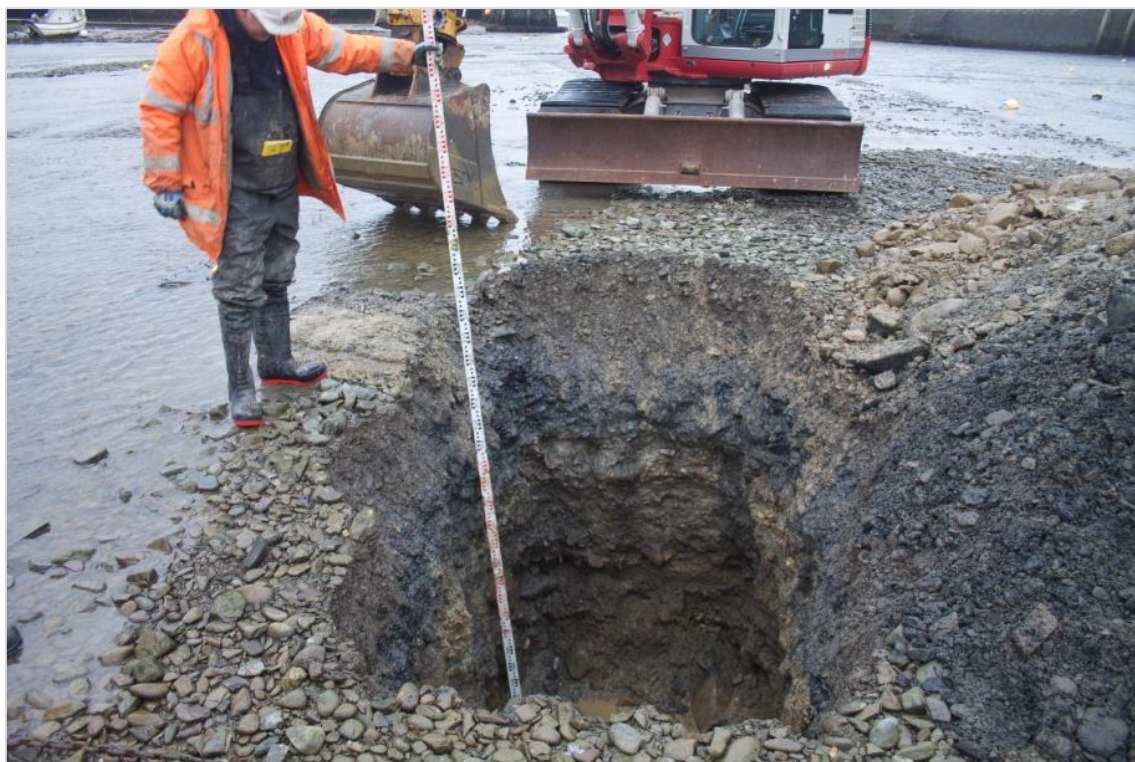
**Photograph 5:** TP110, showing river gravels and silts, and depth of dig.

- 5.5. The geotechnical pit for which archaeological observations were possible was located in the south-west part of the harbour area, roughly located at TP110 on Figure 6. This was excavated to a depth of 3.2m (Photograph 5).

- 5.6. The deposits present within this pit consisted entirely of bands of naturally deposited river gravels and silt. No archaeological deposits or features were observed.

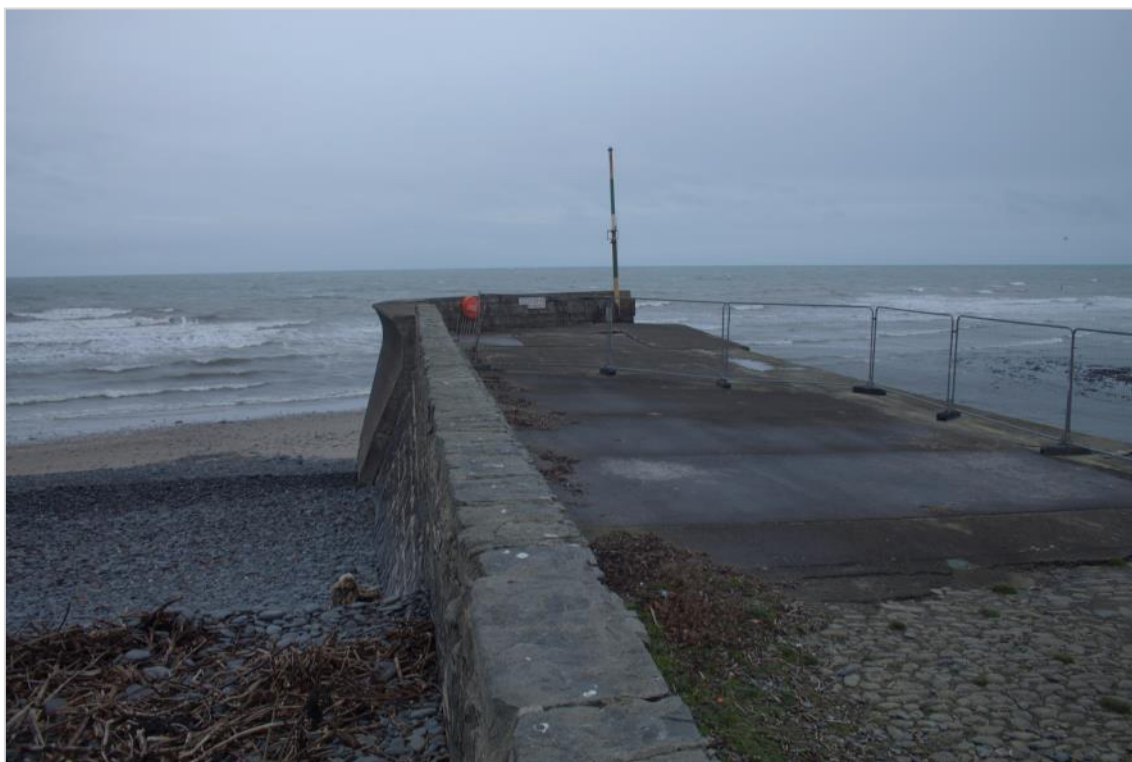
**Photograph 8:** Showing current breakwater at north-eastern end of south-western area. Looking west.

- 6.2.7 Both NPRN 518844 and NPRN 518838 were well preserved and are their condition is thought likely to be relatively stable.
- 6.2.8 At the northern end of this survey area was the south-western breakwater (LB 9979) (Photograph 8). As stated above, discussion as to the impact that any development may have will be reserved for the forthcoming archaeological desk based assessment.

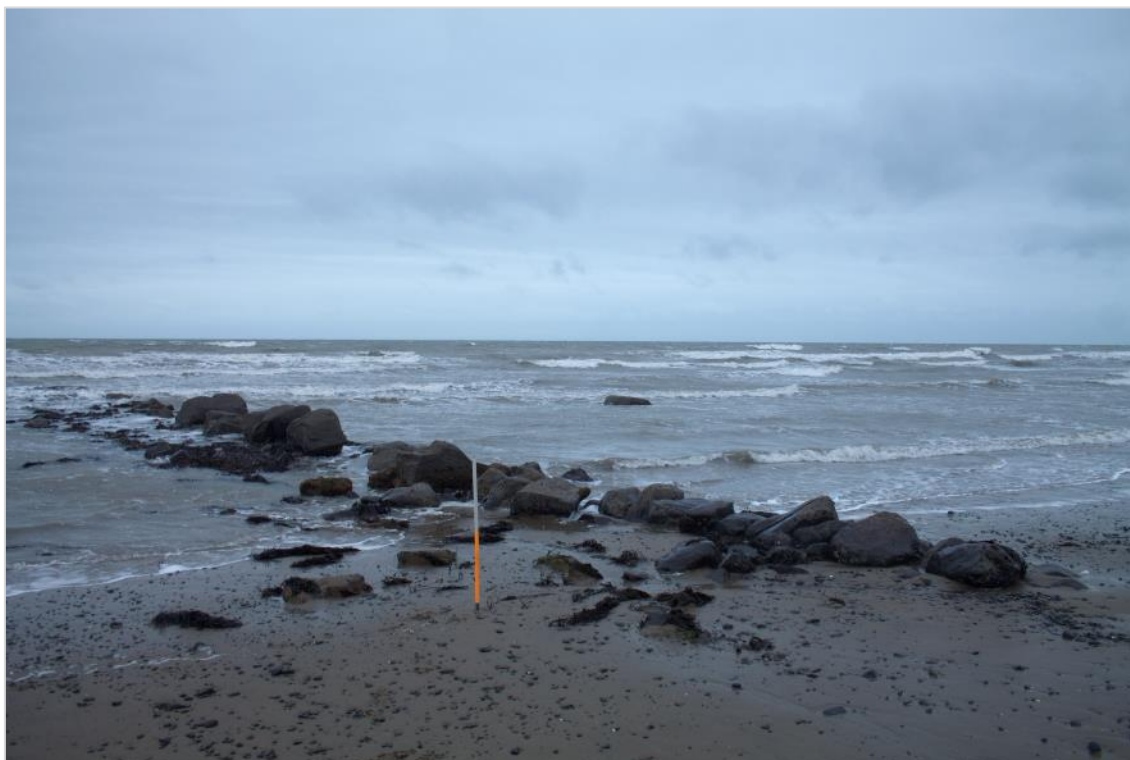
**Photograph 12:** Linear section of walling thought to represent fish trap NPRN 518838. Looking north-west, 1m scale.

- 6.2.5 In the mid-part of the south-western area was the second fish trap NPRN 518838 (Figure 3 and Photograph 12). Again this was constructed of roughly shaped boulders, presumed to be the foundational layers of a wooden structure. Given its location at a similar point on the foreshore to NPRN 518838 it is thought likely to be broadly contemporary, but there is little indication within the current structure to narrow the potential date range down. No wooden elements, or associated construction features were visible, and the form of the boulders is undiagnostic of a particular period.

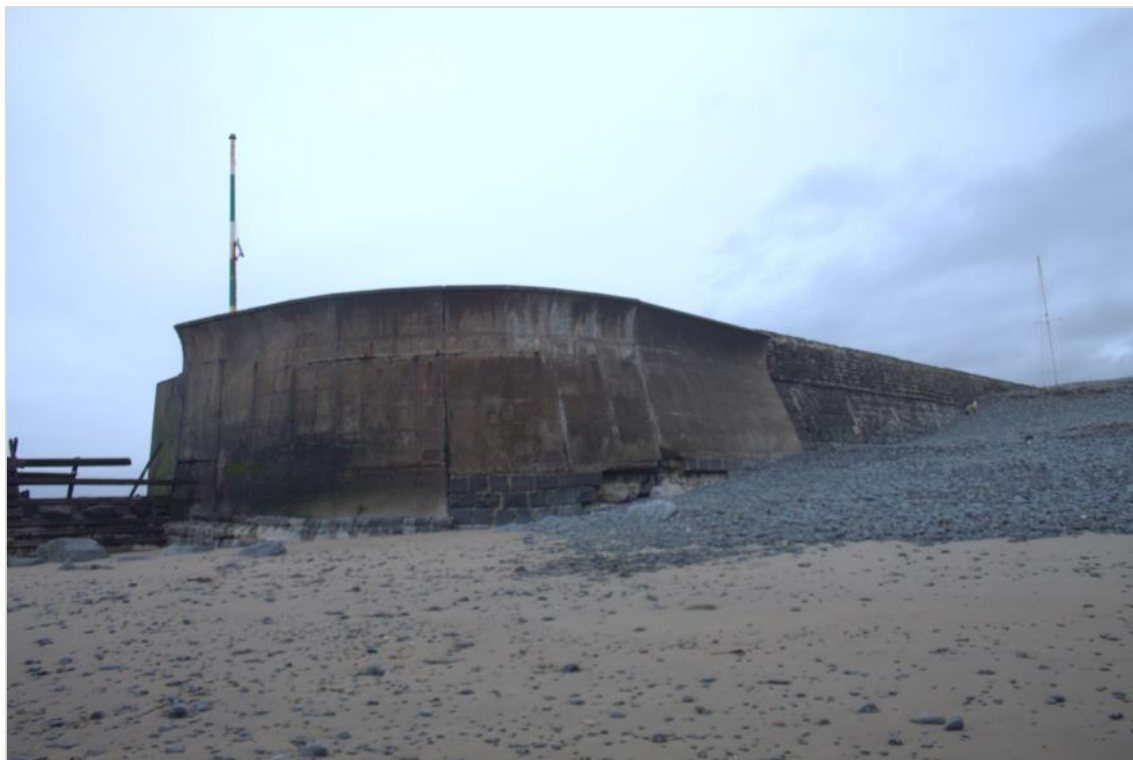
**Photograph 13:** Showing stone phase of south-western breakwater at the lower level, rebuilt in concrete. Looking north-east.

However a few notable observations were gathered from the foreshore survey. From the beach front three phases were identified. An early hewn stone phase, a concrete phase (Photograph 13), and an extension constructed of railways tracks constraining large stone boulders running west from its south western end (Photograph 14). It is thought possible that the stone breakwater collapsed and was subsequently placed with a modern concrete alternative, as it appears to have been significantly truncated prior to being rebuilt (Photograph 13).

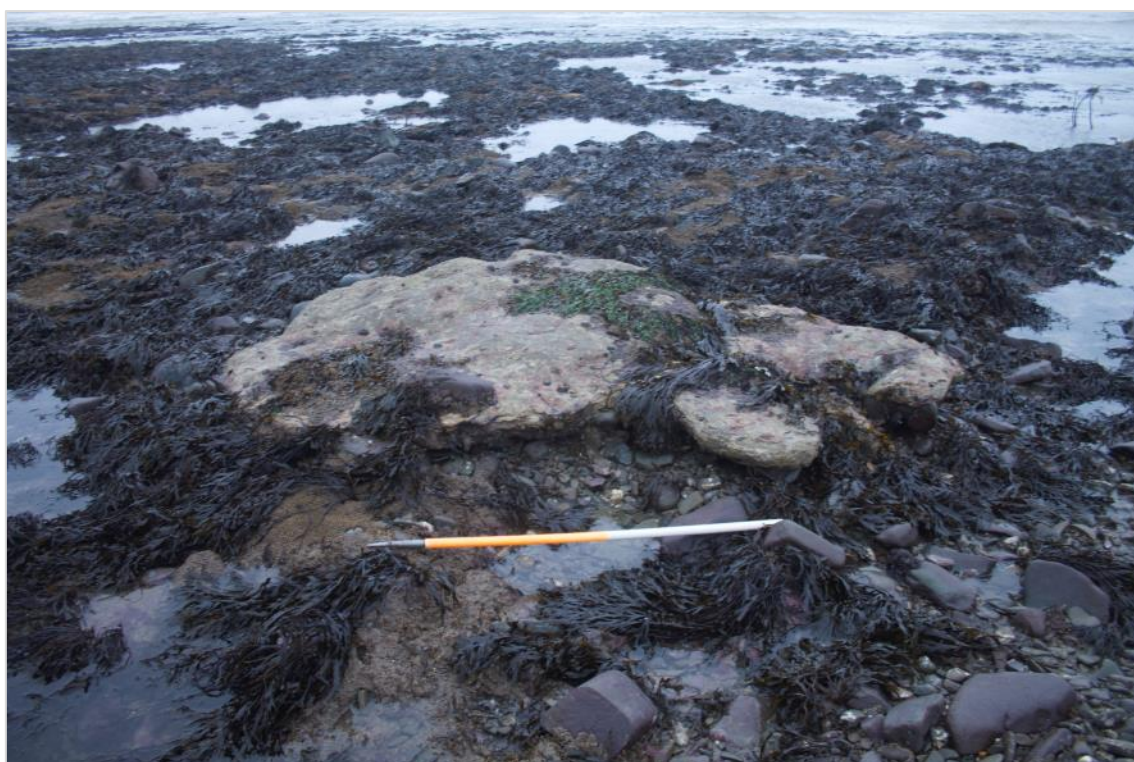
**Photograph 20:** Large lumps of concrete in south-western part of survey area.  
Looking south, 1m scale.

- 6.3.5 There were two large lumps of concrete in the north-western part of the survey area. It is not clear what these once belonged to but they are quite obviously modern and are considered to be of limited archaeological importance.
