WESTERN QUAYSIDE DEVELOPMENT, HAVERFORDWEST, PEMBROKESHIRE

TECHNICAL NOTE: INTERIM REPORT ON ARCHAEOLOGICAL INVESTIGATIONS

EVENT RECORD No.125650

Project Code FS22-064

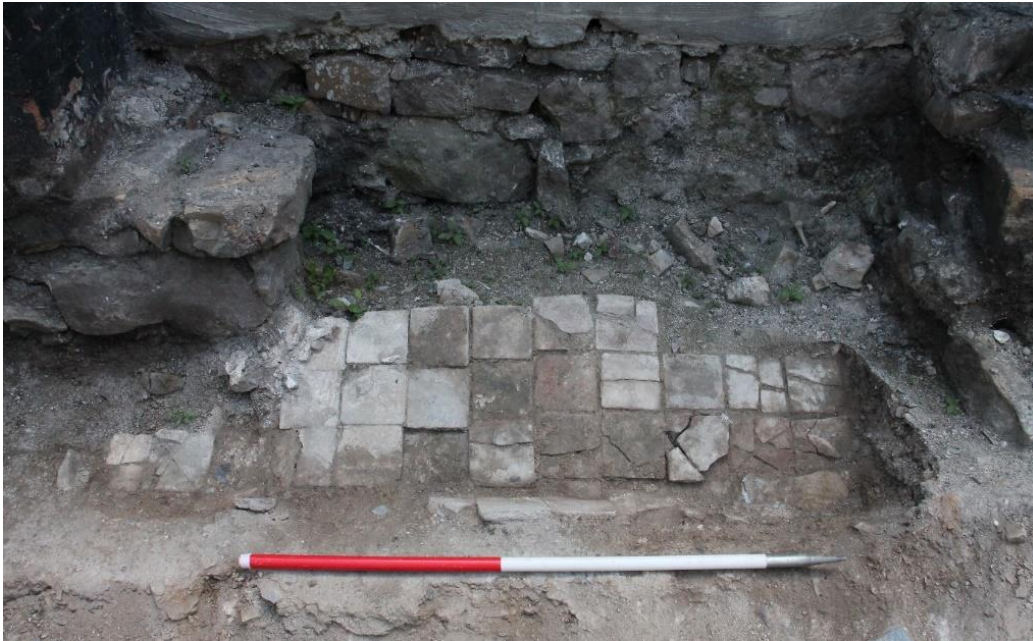
Photo 1: *Fragment of medieval tiled floor. 1m scale.*

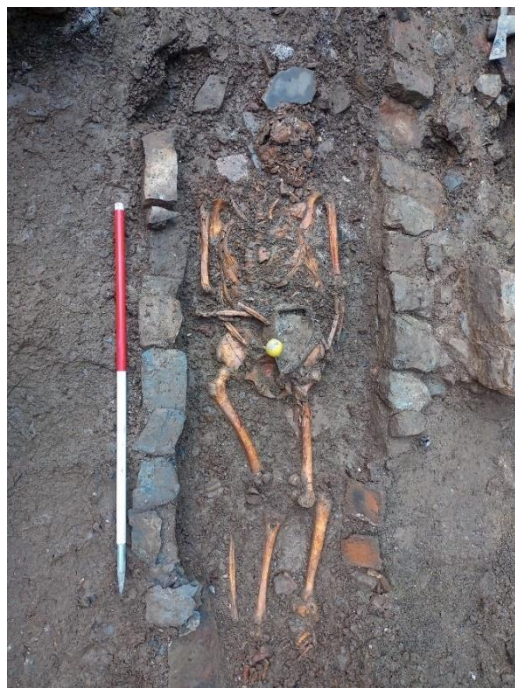
Photo 2: *Crypt [1857], with skeleton holding a lead container. 1m scale.*

- 2.14 Within the confines of the structure several stone-built crypts were revealed (Photos 2 and 3). These contained burials, but appeared to respect the boundaries of the structure, and were truncated by subsequent graves, suggesting they may have been some of the initial burials on the site, and may have lain underneath the floor of the church.

Crypt [1857], built against the corner wall, contained one burial with lead object, suggesting a significant burial.

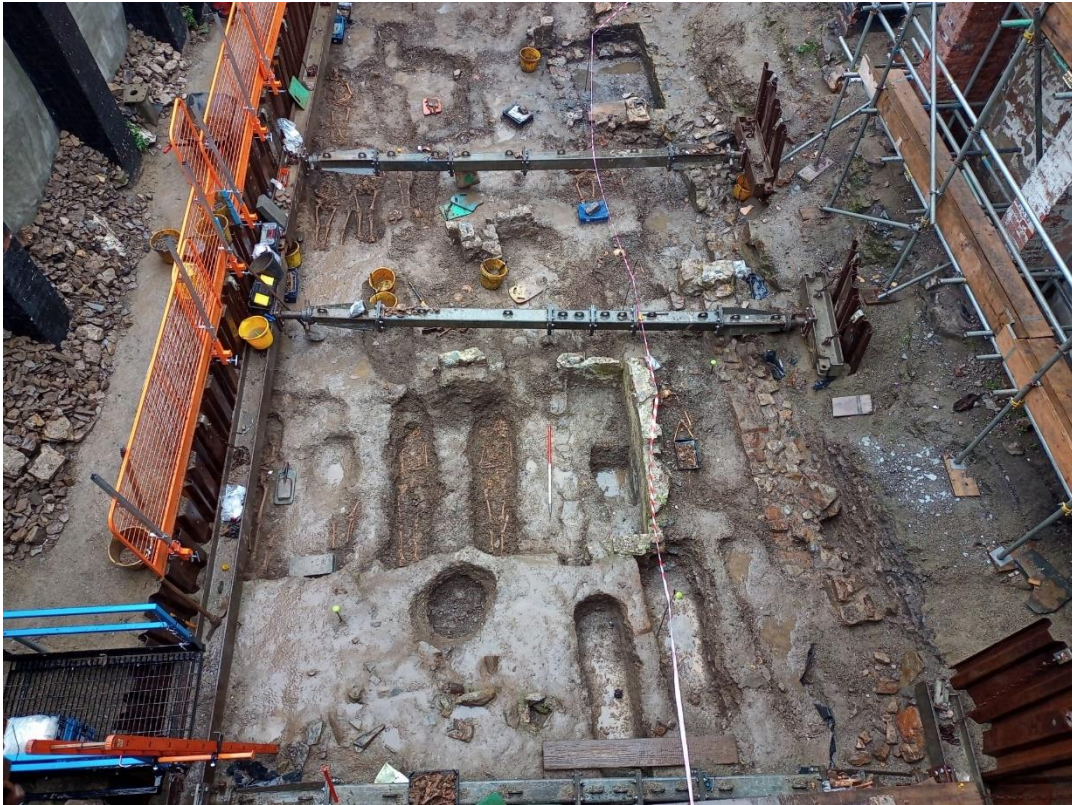
Photo 3: West facing shot of east end of Zone A3 showing some of the numerous burials under excavation. 1m scale.

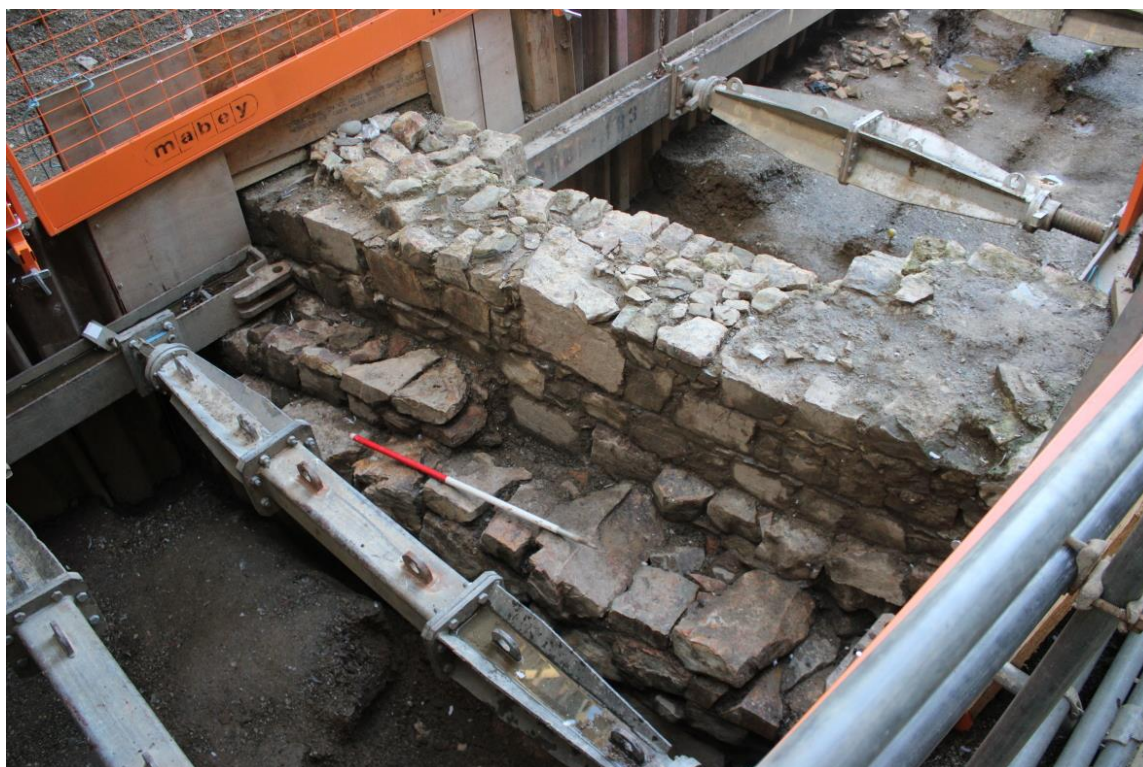
Photo 4: The medieval wall [1125] at the western end of the site, showing possible different phases of use, including the initial church and subsequent possible cloister. 1m scale.

- 2.17 This wall survived quite high in the sequence of deposits, encountered initially at between 4.6mOD and 5.14mOD, which was just below the modern surface deposits in this area. The was also true for the section revealed in the service trench, visible just below the modern surface deposits of the lane.

- 2.18 An initial working hypothesis suggests this may have formed part of an enlarged friary complex post-dating the 1256 grant and may relate to a cloistral range of buildings that may have been built to the northwest of a new church.

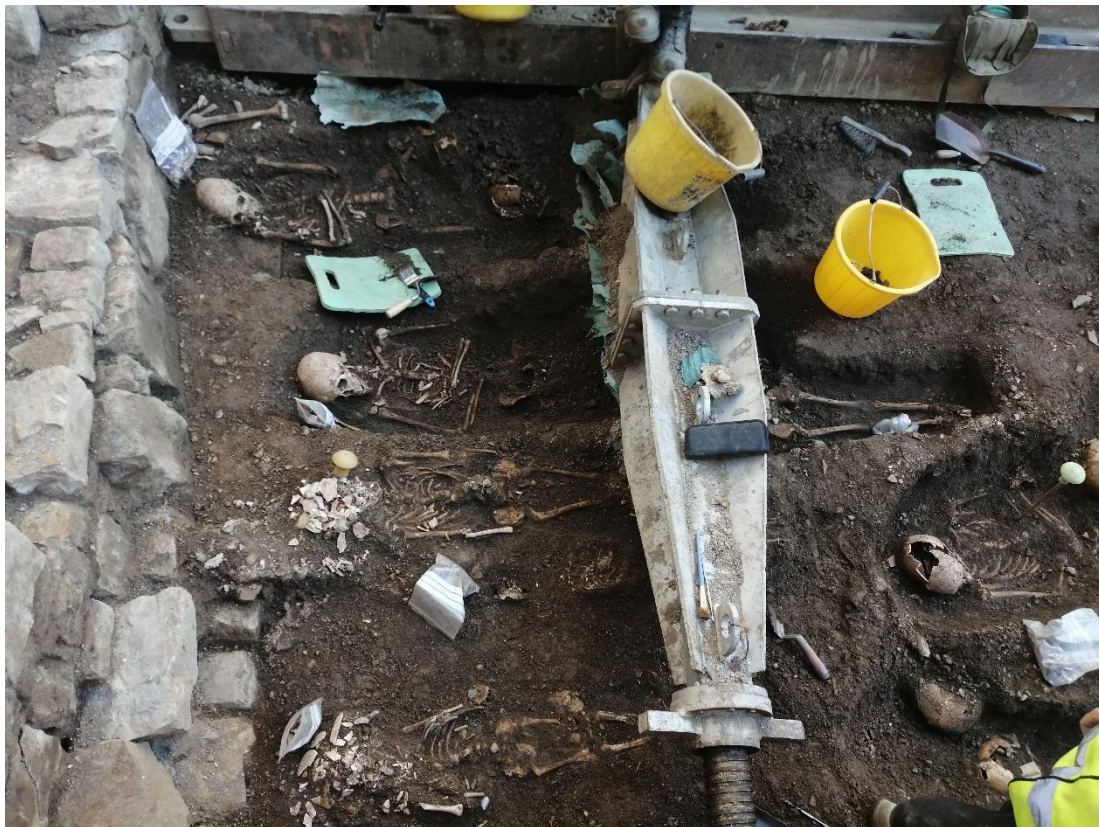
Photo 5: *Overlying and intercutting burials at west end of Zone A3.*

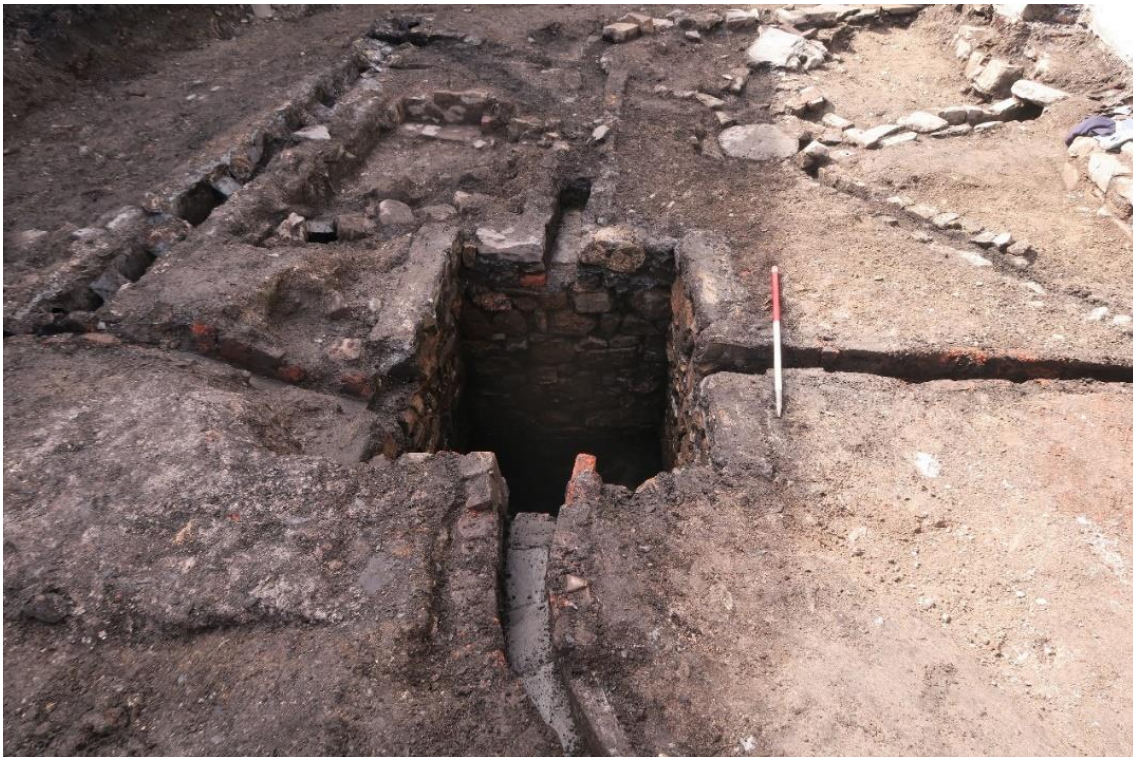
Photo 6: View southwest of cistern [1132], and remains of mortar floor [1198] to the southeast. 1x 1m scale.

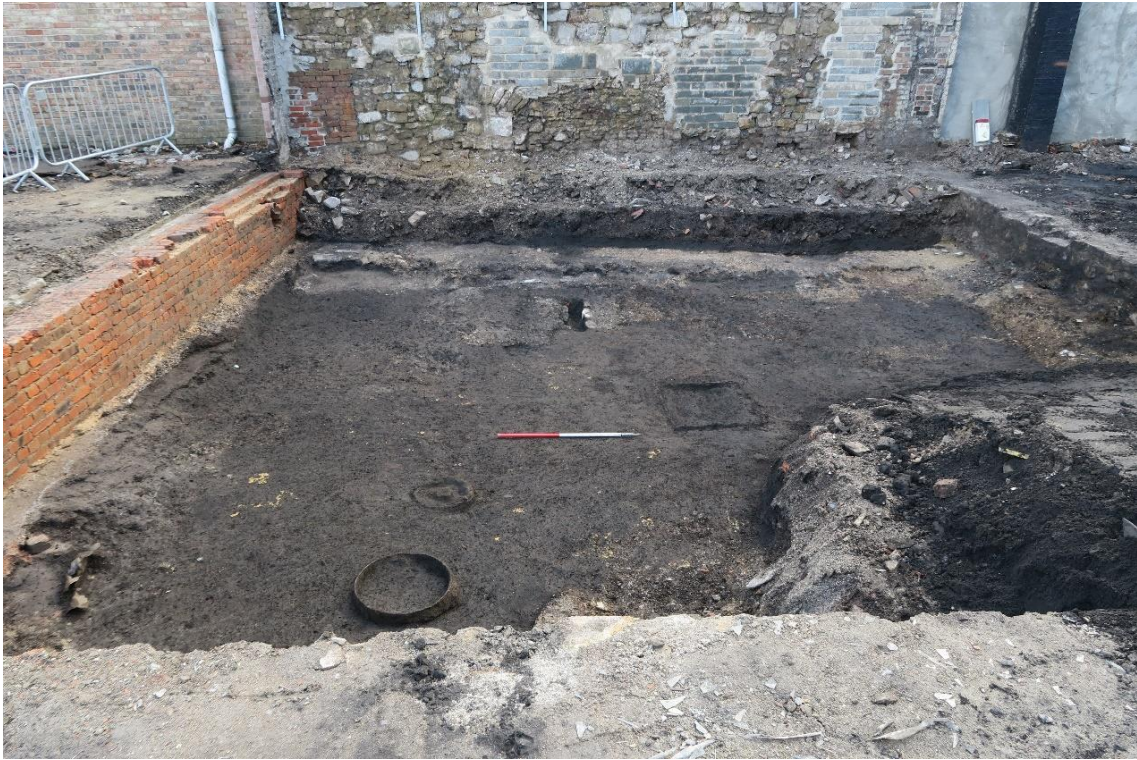
Photo 7: View south across Zone A2 as the casting pits of the iron foundry became apparent. 1m scale.

- 2.37 A large and irregular hollow [1006] covered much of Zone A2. It is assumed that this hollow may represent a series of casting pits cut into the ground during the operating life of the foundry (Photo 7). A number of individual casting pits were revealed [1027], [1028], [1039] and [1044] in this area, with an outlying pit in Zone A3 [1224].

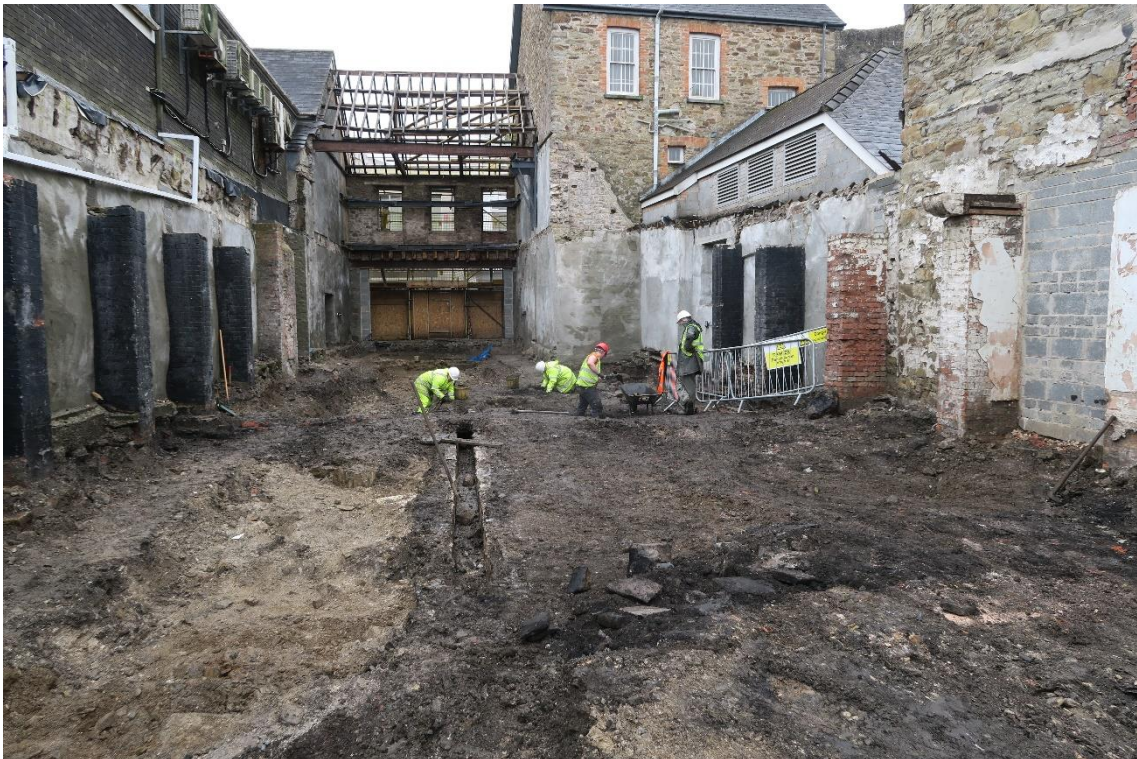
Photo 8: View west across Zone A3 as the initial archaeological layers became apparent.

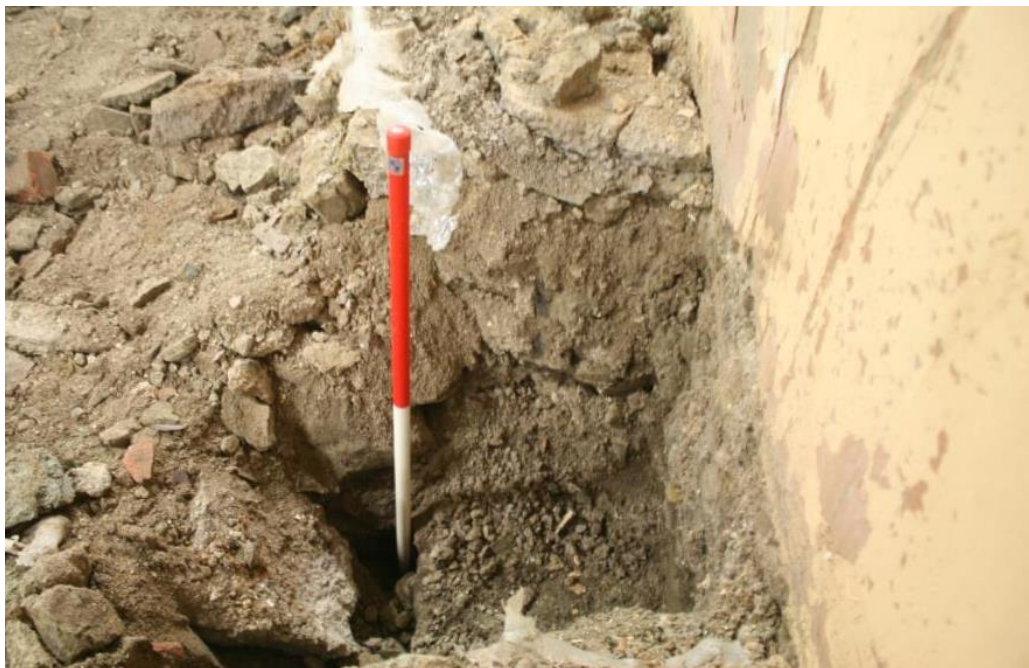
Test Pit 1 (Photo 9)

- 3.2 This small test pit was excavated against the internal face of the northeast wall within Zone B. Due to the subsequent discovery of asbestos this area was not archaeologically excavated, but material from Zone B was removed by disposal specialists.
- 3.3 The test pit was excavated to a depth of 0.8m, to a foundation step for the adjacent wall which was encountered at a depth of 0.6m. This was overlaid by a modern dark grey mortar rubble backfill of little archaeological interest. Archaeological layers were not reached within this test pit.

Photo 9: View northwest of Test Pit 1. 1 x 1 m scale

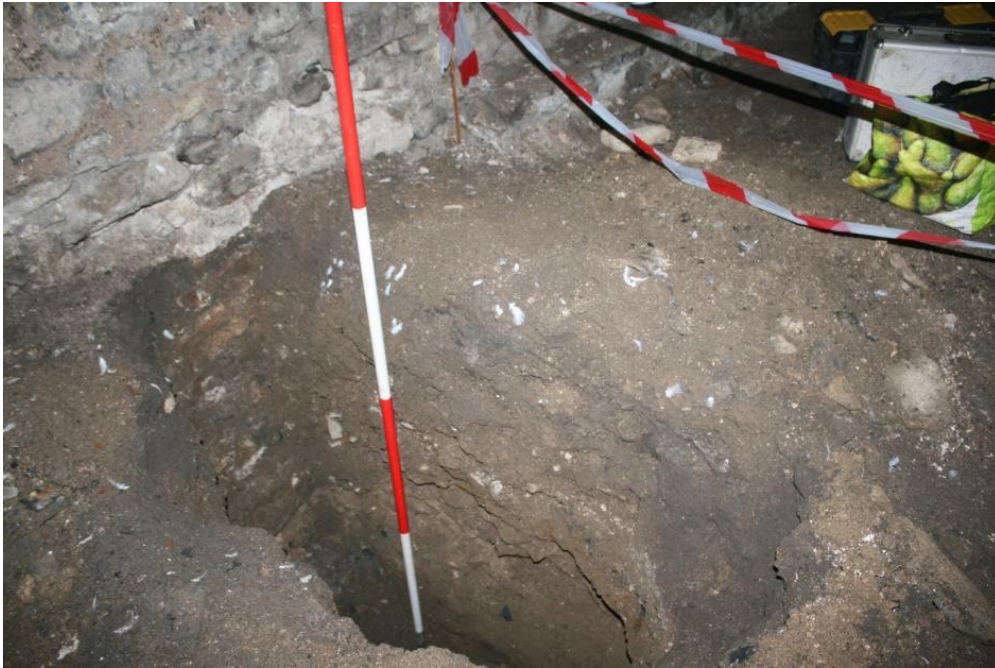
Test Pit 2 (Photo 10)

- 3.4 Located against the inner face of the south wall of the former Ocky White building, which places it within the unexcavated baulk adjacent to excavation Zone A3. The pit was excavated to a depth of 1.4m.
- 3.5 The lower 1.05m comprised a mid to dark gritty silt, with frequent mortar inclusions, and some stone. It is unclear what this layer relates to and may represent a mix of post-medieval demolition material and cemetery soils.
- 3.6 This was overlaid by an upper 0.35m of dark brown gritty clay, containing 19th century pottery and other waste, possibly relating to more recent 20th century levelling deposits.

Photo 10: View northwest of Test Pit 2. 1 x 2 m scale

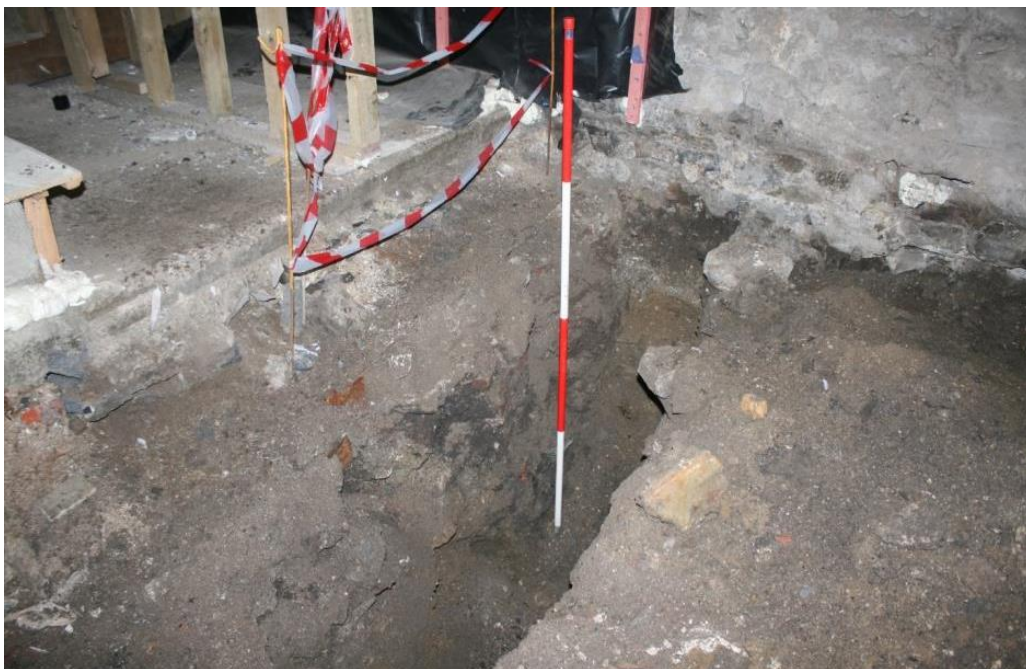
Test Pit 3 (Photo 11)

- 3.7 This was located against the inner face of the opposing wall to Test Pit 2, therefore also in the unexcavated baulk adjacent to Zone A3. The pit was excavated to a depth of 1.2m.
- 3.8 The lower 1m of deposits comprised what appeared to be a thick deposit of solidified mortar. This was initially considered to be a potential foundation deposit for the adjacent wall, but subsequent to the excavation it may be related to the possibly friary church wall which is projected to run through this area.
- 3.9 The upper 0.2m comprised a mixed black-brown silty grit with fragments of brick, mortar and stonework, potentially a demolition deposit, or disturbed material from the underlying wall.

Photo 11: View northwest of Test Pit 3. 1 x 2 m scale

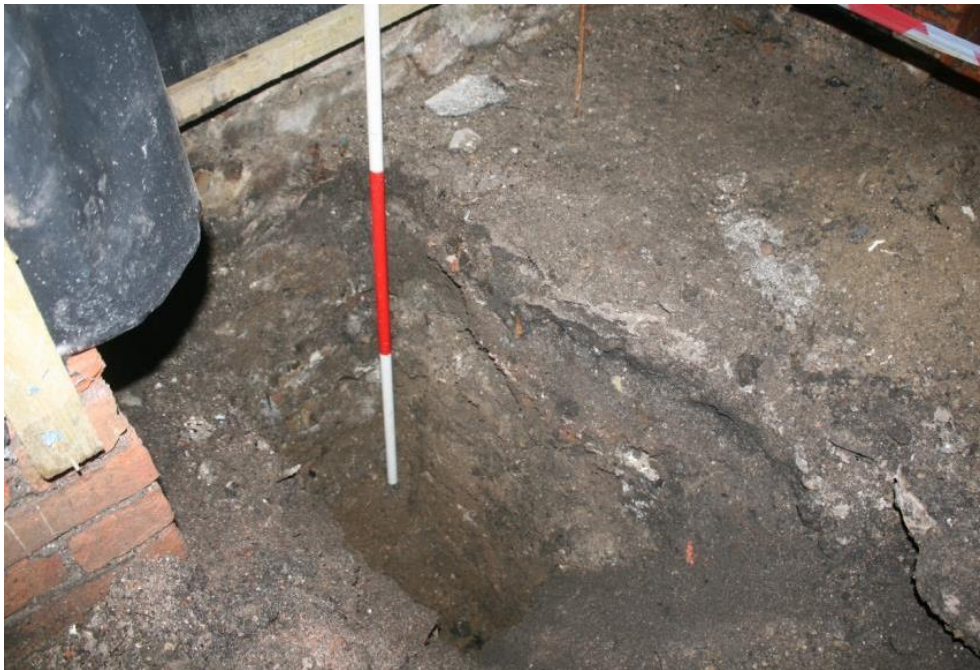
Test Pit 4 (Photo 12)

- 3.10 This pit was also placed on the inner face of the north wall, further to the east of Test Pit 3, and also in the unexcavated baulk on the northern side of excavation Zone A3. This area lay to the north of the possible friary church wall. The pit was excavated to a depth of 1.28m.
- 3.11 The lower 0.7m of the pit comprises a mid to dark brown clay, with occasional flecks of mortar and charcoal. This was overlain by 0.2m of light brown-grey mortar with the occasional stone. The date and significance of these deposits is unclear, but they could represent *in situ* archaeological levels.
- 3.12 The upper 0.4m comprised a mixed dark grey gritty silt, likely to be relatively modern in date.

Photo 12: View north of Test Pit 4. 1 x 2 m scale

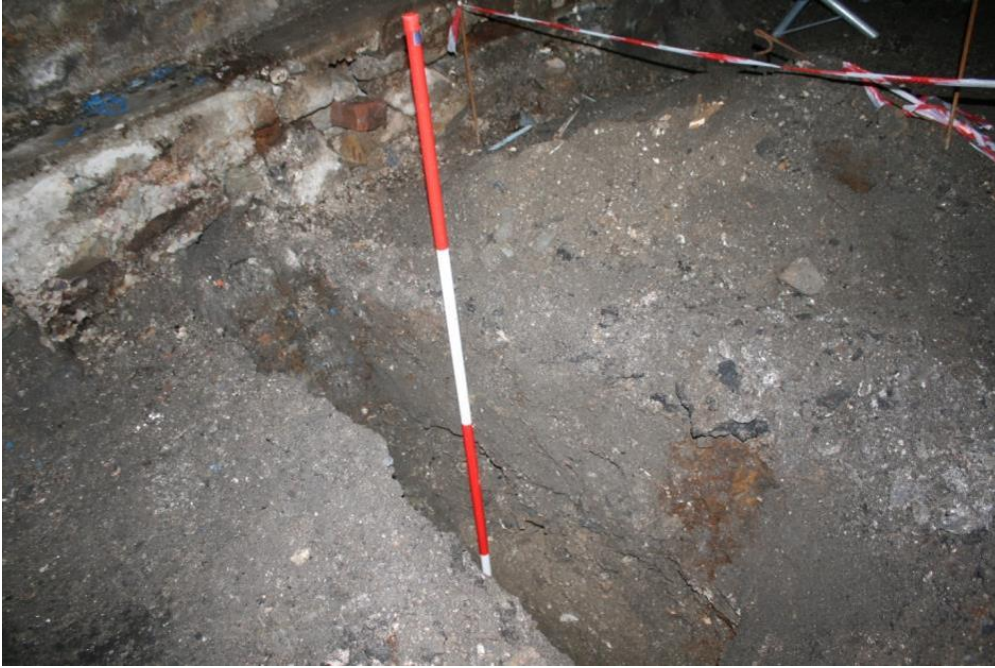
Test Pit 5 (Photo 13)

- 3.13 As with Test Pit 2 this pit was dug against the south wall within Zone A2, into what was subsequently the unexcavated baulk along the southern side. The pit was excavated to a depth of 1.73m.
- 3.14 The lower *circa* 1.2m comprised a light brownish-grey silty-clay which contained disarticulated human bones. This deposit was first encountered at a depth of 0.5m, and further bone, potentially part of *in situ* burials, were visible in the section at a depth of 0.65m. This deposit would appear to represent medieval cemetery soils, indicating (as suspected from the excavation results) that the cemetery burials continue under the current property to the south.
- 3.15 This deposit was overlaid by 0.5m of black-grey grit with coal fragments, likely related to the waste foundry deposits, and of limited archaeological interest.

Photo 13: View southeast of Test Pit 5. 1 x 2 m scale

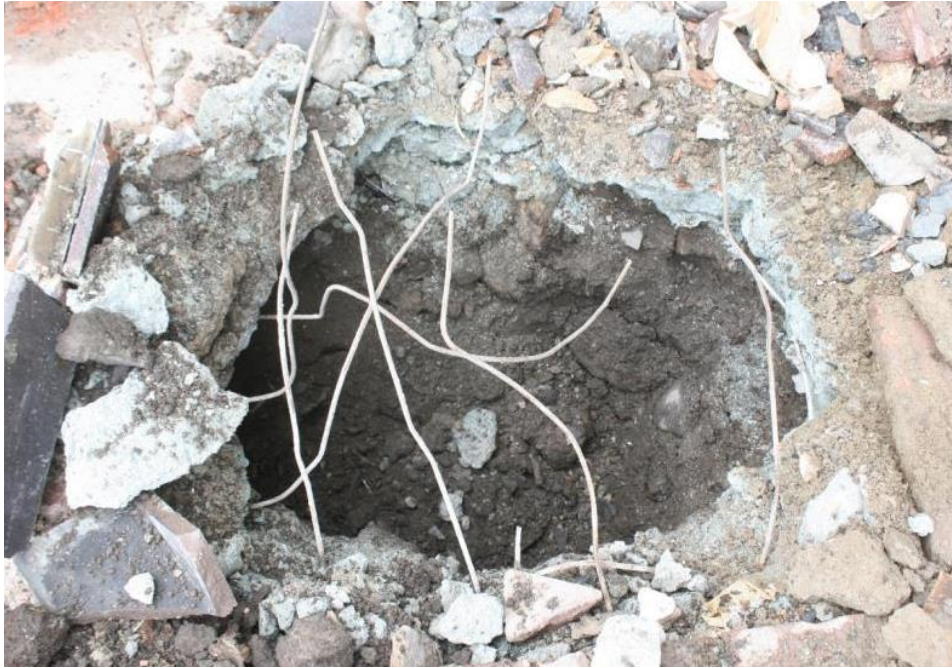
Test Pit 9 (Photo 15)

- 3.19 This pit was located in the exterior patio area. It was excavated to a depth of approximately 1m, through a reinforced concrete floor. The potential presence of asbestos within the underlying material prevented further excavation or recording.

Photo 15: View southwest of Test Pit 9.

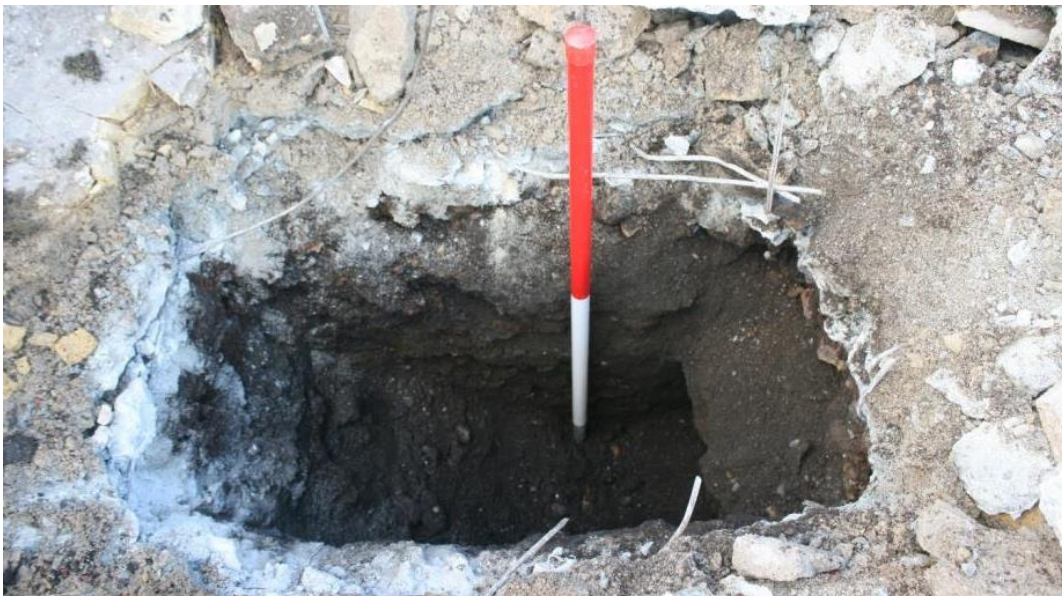
Test Pit 10 (Photo 16)

- 3.20 This test pit was located further out into the external patio area. It was excavated to a depth of 0.93m.
- 3.21 Underlying the 0.17m reinforced concrete floor was a consistent deposit of black-grey foundry waste, including brick and coal fragments. This deposit is associated with the 19th century iron foundry, possibly deposited when the site was no longer in use (i.e. the 20th century). There was no indication in this deposit of *in situ* foundry levels.

Photo 16: View southwest of Test Pit 10. 1 x 1m scale.

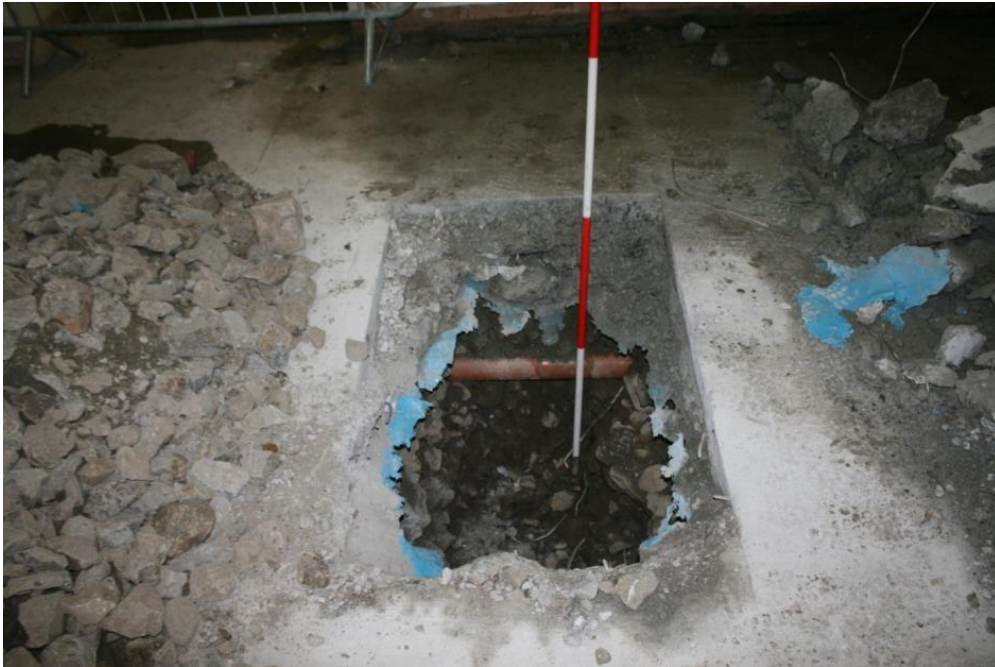
Test Pit 11 (Photo 17)

- 3.22 As with Test Pit 8, this pit was placed within Zone C. It was excavated to a depth of 1.1m.
- 3.23 The lower 0.8m of the pit contained a stony deposit that appeared to represent modern hardcore. A modern service pipe was also revealed within this deposit. This was overlaid by a reinforced concrete floor 0.28m thick. These deposits suggest modern excavation and infill in this area to the depth of the excavated area.

Photo 17: View southwest of Test Pit 11 showing modern made up ground and modern service. 1 x 2m scale.

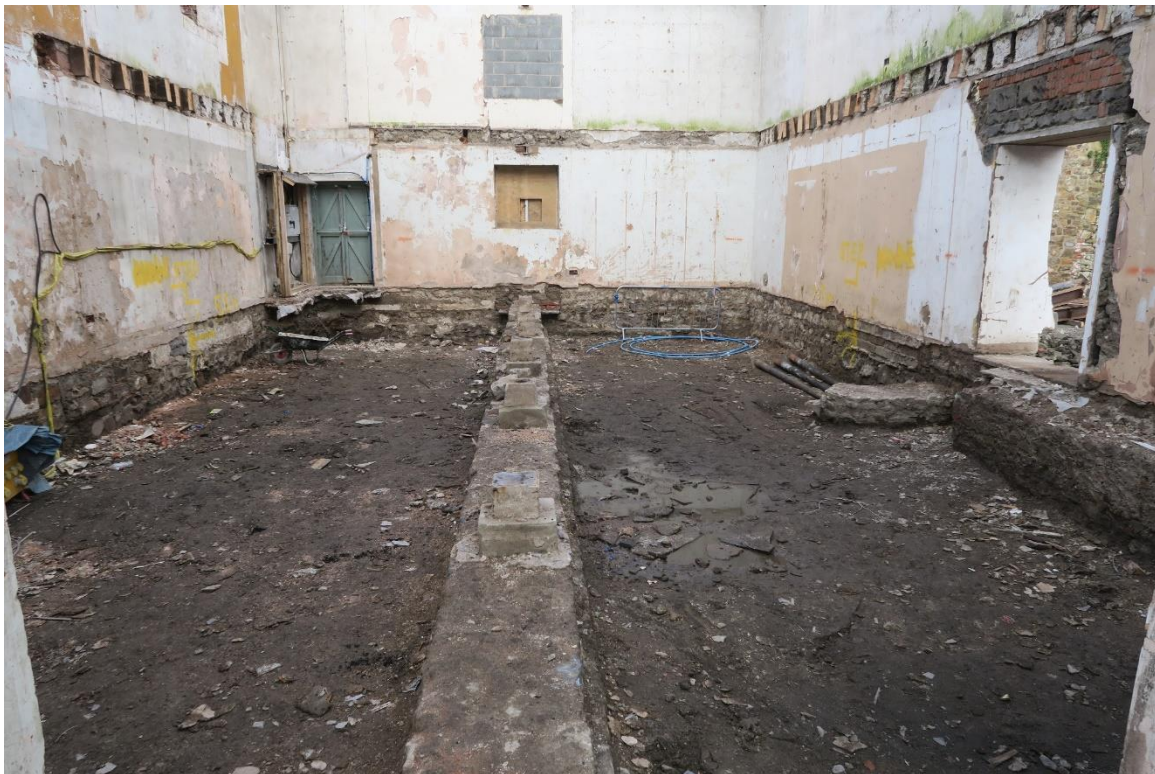
- 3.28 The area was examined once excavation had ceased and the site had been decontaminated (Photo 18). The ground was heavily disturbed and trampled, making the identification of any archaeological features or deposits very difficult. However, no clear evidence of archaeological deposits was noted, but it is possible in situ deposits may exist at lower levels.

Photo 18: View north of Zone B after excavation.

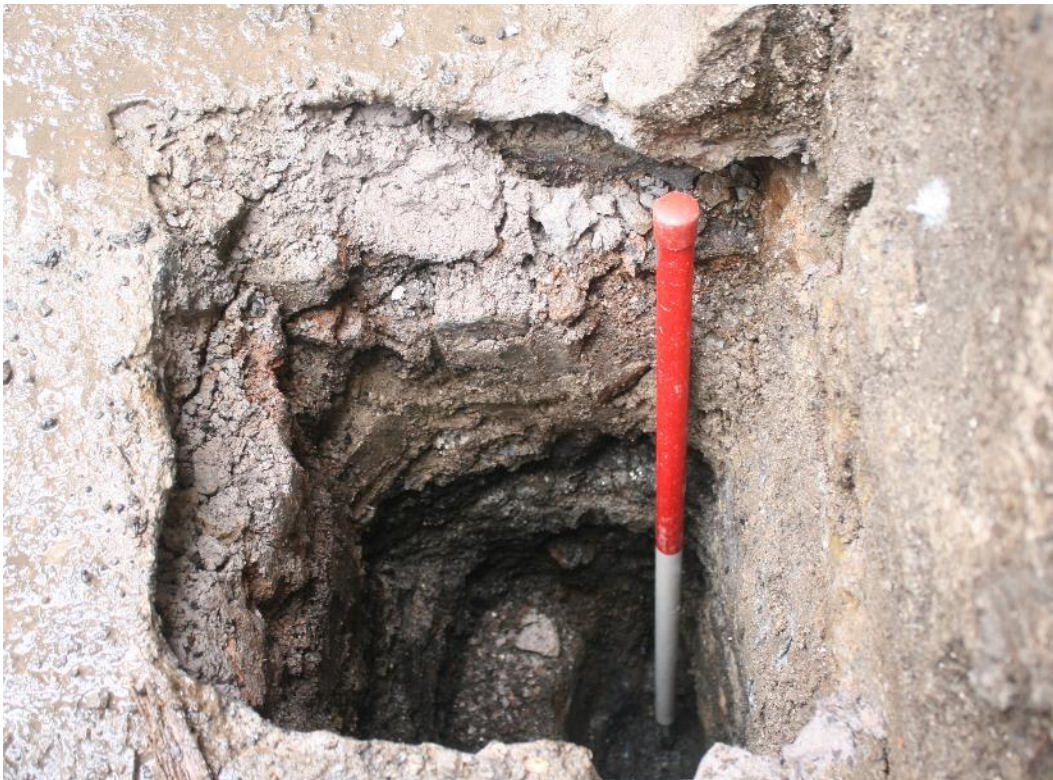
Pit 2 (Photo 19)

- 3.30 This test pit was excavated to a depth of 1.13m against the external face of the wall on the south side of the building, close to the southeast corner. The pit revealed a vertical external face to the wall to the depth of excavation. The lower 0.68m comprised an almost black ashy deposit with grey-mortar inclusions, similar to the foundry waste material revealed elsewhere on site. This was deposited against the face of the wall.
- 3.31 Overlying the probable foundry waste was a 0.16m thick sandy layer that appeared to have been a bedding layer for an overlying 0.15m thick floor of fire bricks. This in turn was overlaid with the current 0.14m thick concrete floor.

Photo 19: West facing photo showing the deposits revealed within Pit 2. The external wall face is on the right. 1m scale.

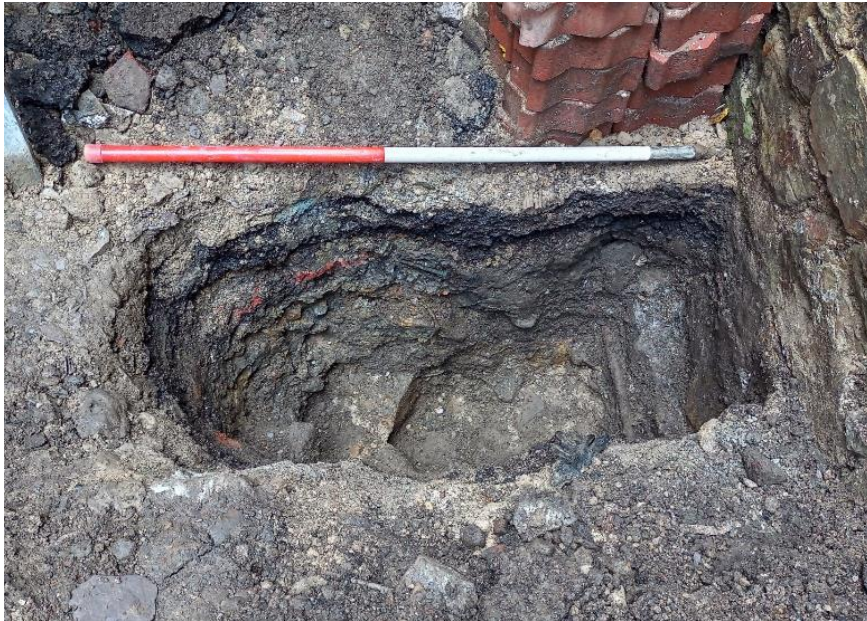
- 3.32 This test pit was excavated to a depth of 0.65m, located against the external face of the wall at the southwest end of the building. At a depth of 0.62m the pit revealed a layer of solid lime-mortared masonry which appeared to underlie the foundations of the adjacent wall. This would appear therefore to represent remains of a masonry structure pre-dating the existing foundry building, and it is possible it represents a continuation of the walling revealed in the service trench excavations along the

Photo 20: West facing shot of Pit 3, showing the masonry surface at the base. 1m scale.

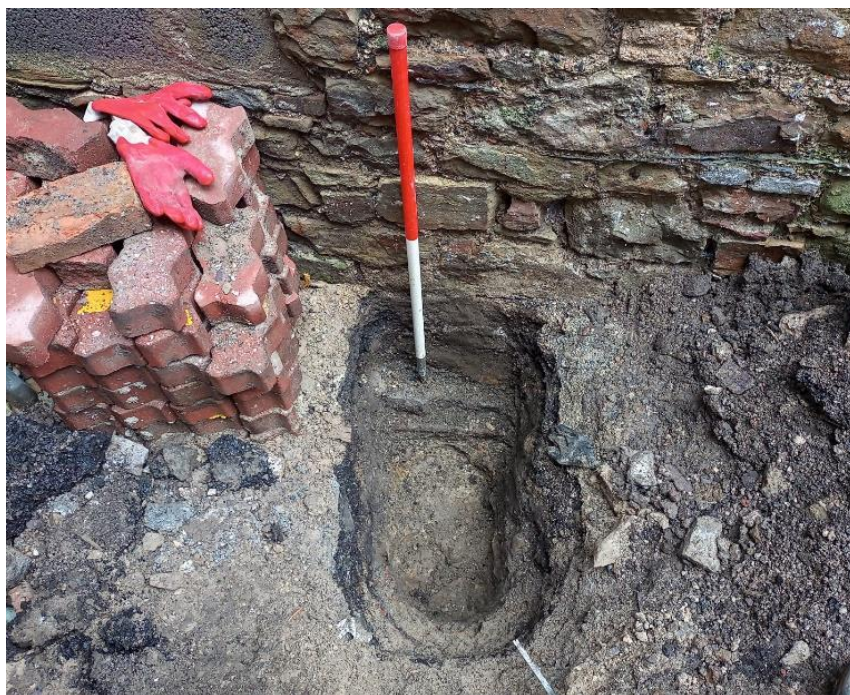
- 3.33 The current foundry building wall had a stepped foundation base at a depth of around 0.65m. Overlying the earlier masonry remains, and built up against the foundry building wall, was a mid-grey ashy rubble deposit up to 0.5m thick, with fragmentary remains of a possible brick surface at the top, set approximate 0.5m away from the foundry building wall. Above this lay 0.15m of modern concrete and tarmac.

Photo 21: North facing shot of Pit 3, showing the masonry surface and overlying foundry building wall foundations. 1m scale.

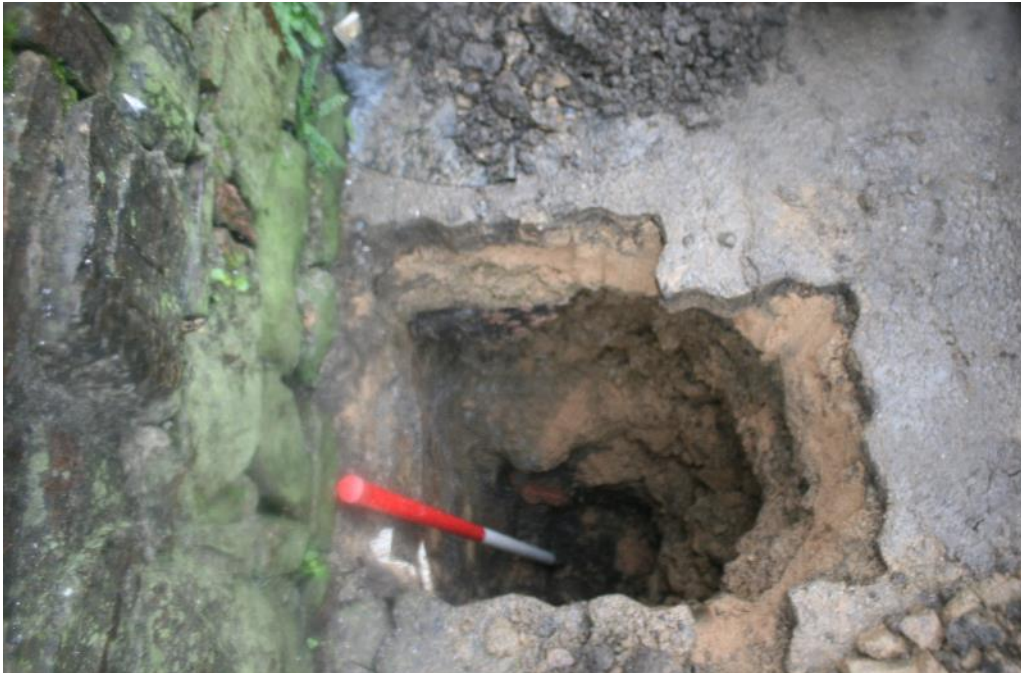
Pit 6 (Photo 22)

- 3.34 Excavated to a depth of 1.12m on the external face of the north wall of the building. At the base of the pit the wall stepped out slightly (circa 0.08m), presumably as part of the foundation of the wall. The lower 0.3m of material comprised a black silty-clay, typical of the foundry waste material seen elsewhere on site. This had built up against the lower foundations of the wall.
- 3.35 Above this sat 0.6m of modern sub-angular stone backfill, topped by around 0.2m of sandy clay and bedding sand layers overlaid by the current paving bricks. In total the upper 0.85m comprised modern material.

Photo 22: West facing photo of Pit 6. 1m scale.

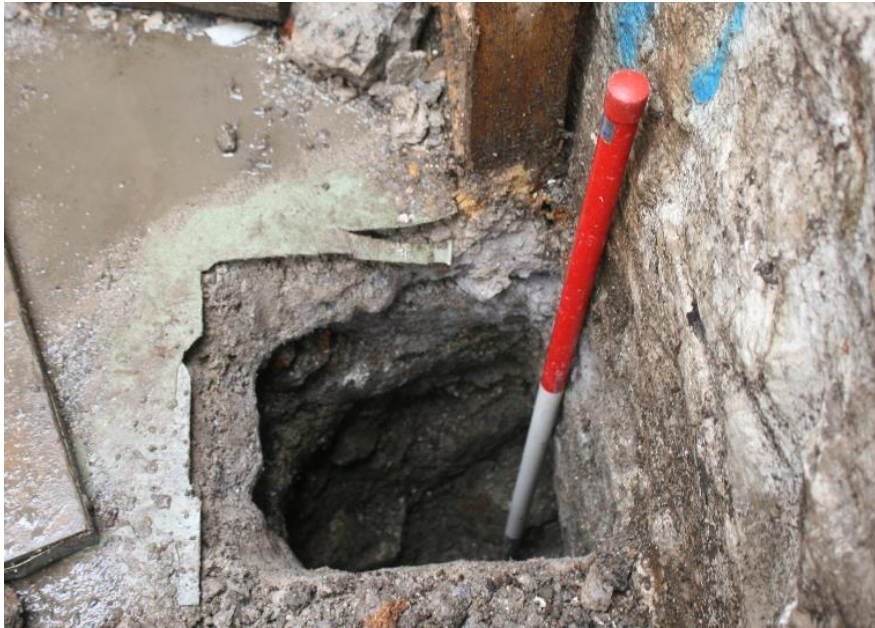
Pit 9 (Photo 23)

- 3.36 This pit was excavated to a depth of 0.8m in the interior of the building, against the face of the northern wall, and towards the western end of the building. At the base of the pit lay a mixed light grey and dark brown silty-clay, with a line of stones revealed that may represent a buried wall line. The size of the pit meant that this could not be confirmed, and a potential alignment also remains uncertain.
- 3.36 Above the potential wall line was 0.52m of dark grey ashy-rubble waste, with the occasional coal and fire brick inclusions, this was built up against the face of the foundry building wall. This was topped by a brick floor 0.16m thick, presumably a working surface for the building, with levelling deposits below. The current 0.12m thick concrete floor was laid directly over the brick surface.

Photo 23: West facing photo of Pit 9. 1m scale.

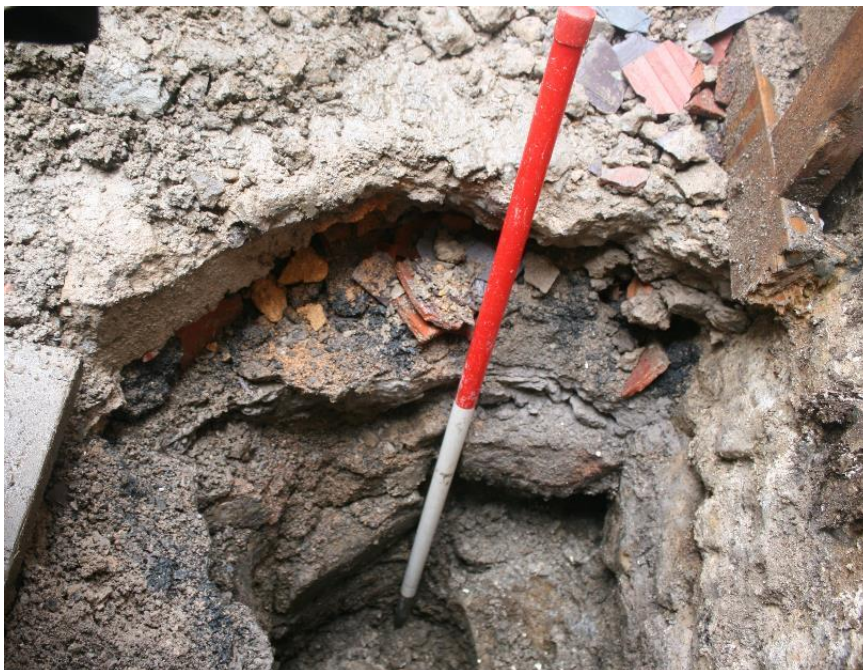
Pit 11 (Photo 24)

- 3.37 This pit was excavated to a depth of 0.9m in the interior of the building, within the southwest corner of the main room at the junction with a cross wall. At a depth of 0.67m both walls stepped out by around 0.2m to 0.25m, presumably as part of the foundations of the walls.
- 3.38 The lower 0.5m comprised a light grey mixed ash and rubble deposit, built up against the face of the wall. This was overlaid by a 0.17m thick brick floor, presumably part of a working surface within the building. A 0.11m thick modern bedding layer overlay this, topped by the current 0.13m thick concrete floor.

Photo 24: East facing photo showing the layers revealed within Pit 11. 1m scale.

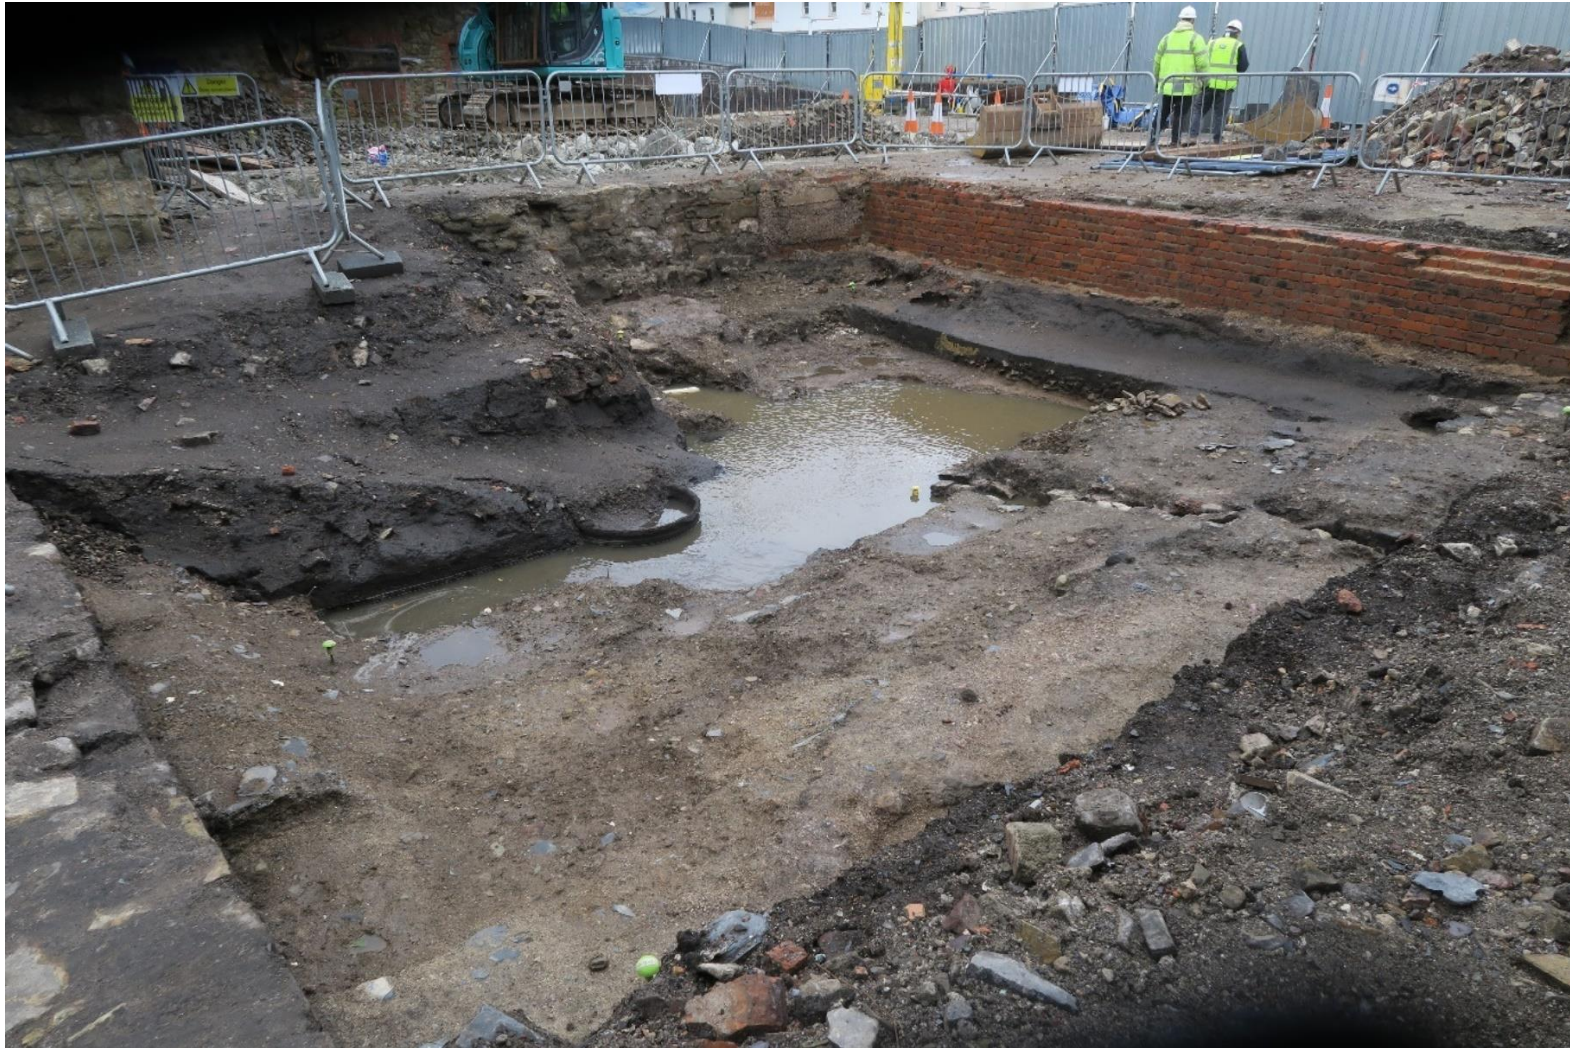
Photo 25: View northeast across the Zone A2 excavations, looking towards the Phase 2 development area. The upper archaeological layers are being revealed, relating to the 19th century foundry, overlaid by the dark foundry waste material. The sections to the Phase 2 area are both formed by walling.
