WESTERN QUAYSIDE DEVELOPMENT, HAVERFORDWEST, PEMBROKESHIRE

TECHNICAL NOTE: INTERIM REPORT ON ARCHAEOLOGICAL INVESTIGATIONS

EVENT RECORD No.125650

Project Code FS22-064

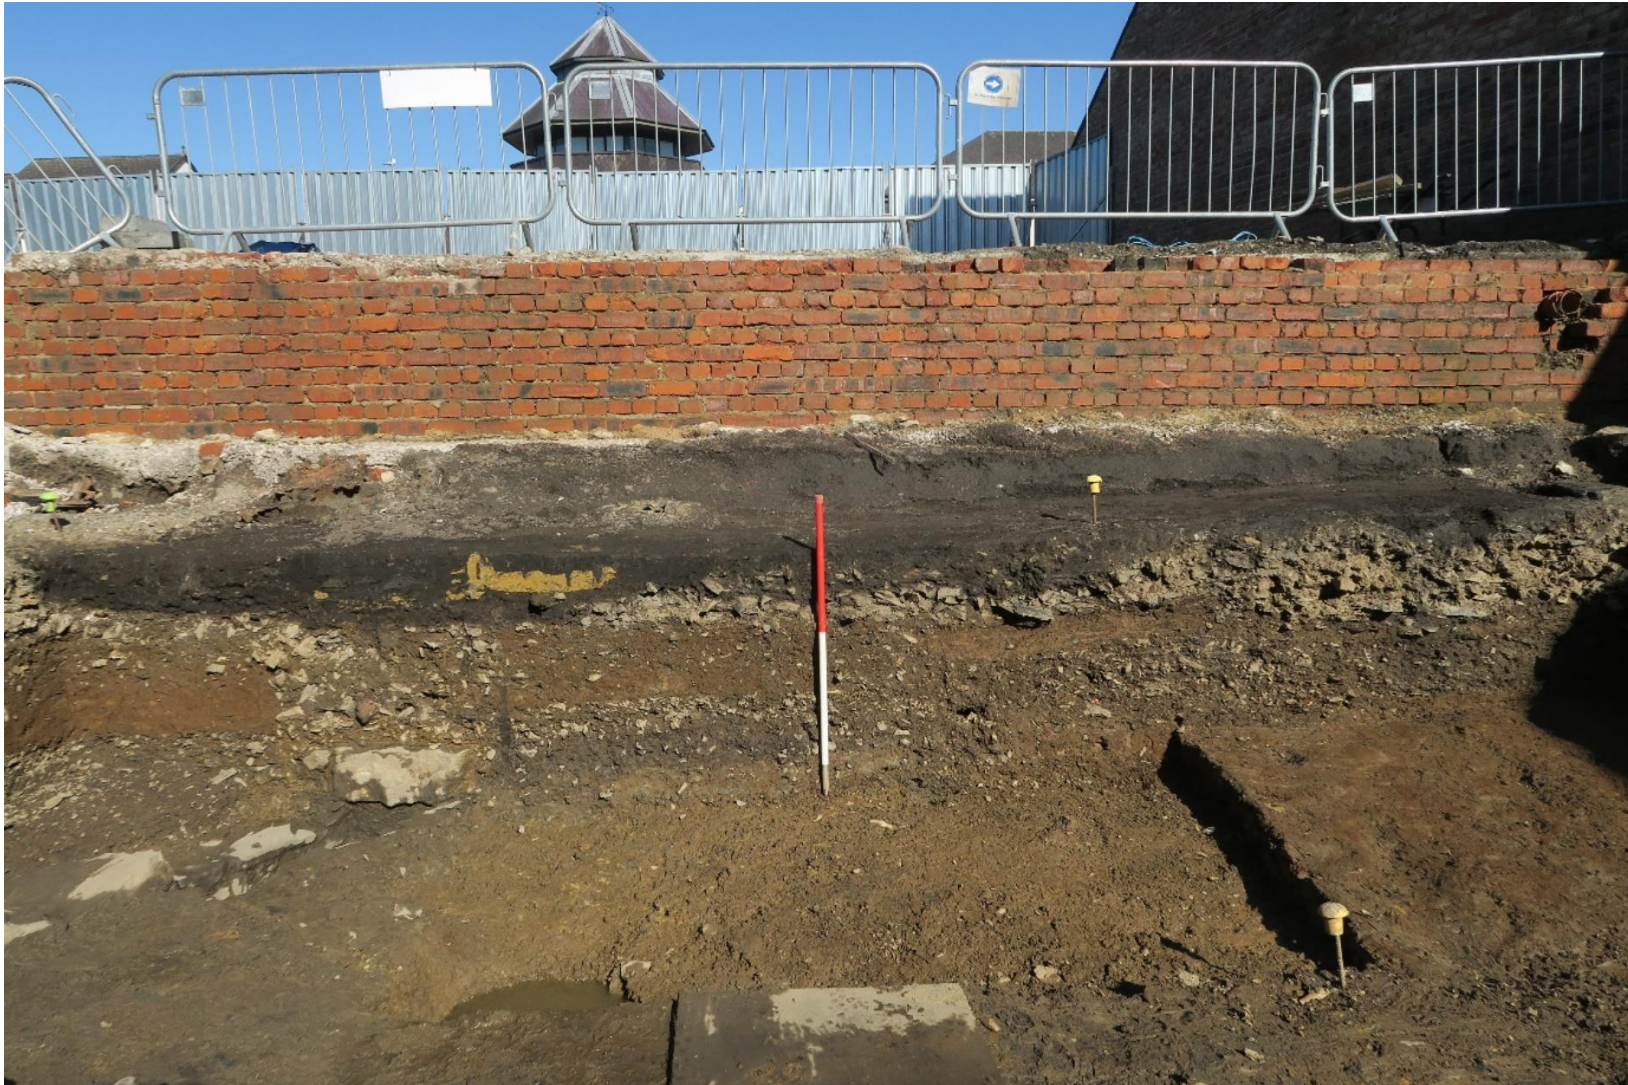
Photo 26: The eastern section of the Zone A2 excavation area, adjoining the Phase 2 development area. The modern brick wall sits on top of the dark deposit of post-foundry waste material. The dark material sits on lighter soils containing intact archaeological features and deposits, including burials. 1m scale.

- 4.9 The excavated evidence would suggest modern development and levelling deposits, and post-foundry waste deposits, may provide a buffer to intact archaeological levels potentially in the southern half of the Phase 2 area, although the potential for medieval structural remains to protrude into these upper deposits is highlighted. Archaeological investigations within the Phase 2 area are also limited to small test pits which may not be truly indicative, and no areas to the north of the foundry site have been investigated. The east and north sections of Zone A2 area of excavation, closest to the Phase 2 development area, largely comprised later post-medieval and modern walling (Photo 25) and therefore revealed little about deposits within the Phase 2 areas, although the east section did subsequently suggest the dark post-foundry waste deposits did indeed extend for some depth below current ground levels (Photo 26).
