# WEMYSS METAL MINE, CEREDIGION: ARCHAEOLOGICAL WATCHING BRIEF

REPORT NO. 2021-43  
EVENT RECORD NO. 125987

**WEMYSS METAL MINE, CEREDIGION:  
ARCHAEOLOGICAL WATCHING BRIEF**

*DAT Archaeological Services were commissioned to undertake a watching brief in January 2021 during groundworks associated with geotechnical investigational works at Wemyss Metal Mine, Ceredigion (NGR SN 71579 74089).*

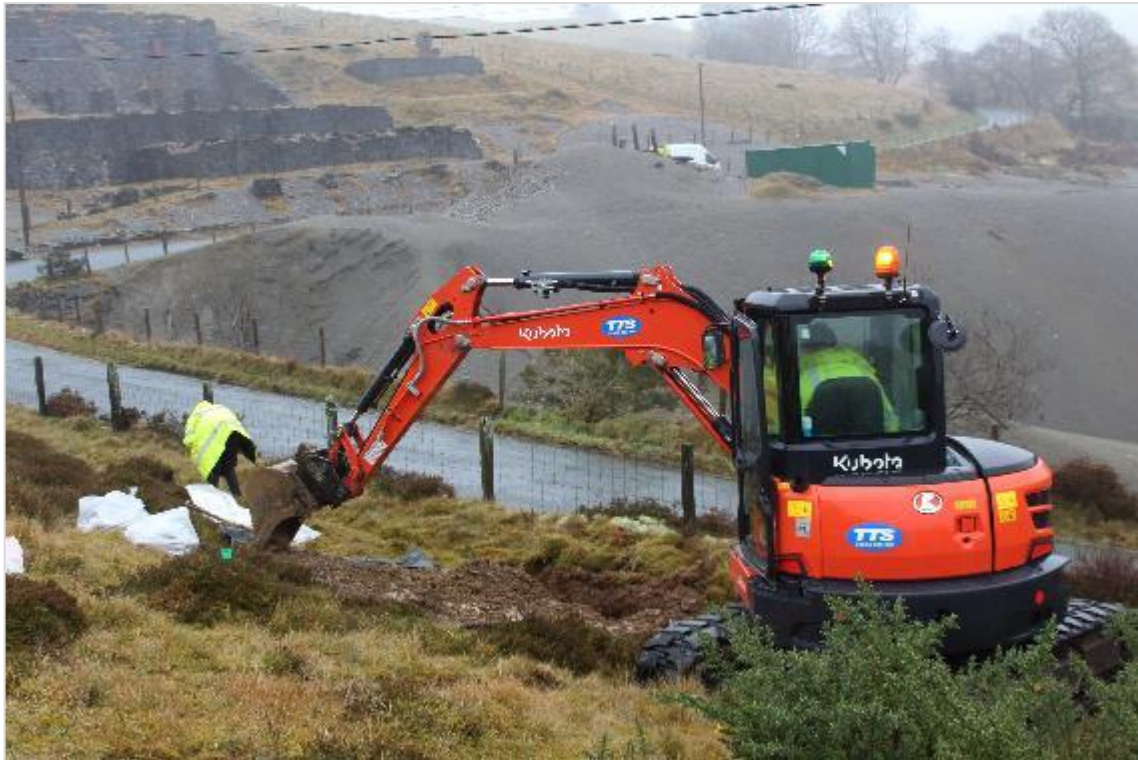
**Photograph 2:** Machine excavation of trial trenches.

- 4.1.1 A total of forty geotechnical investigations were monitored during the archaeological watching brief (due to severe water ingress FC TP4 was repositioned 2m further south and renamed FC TP4a). Thirty of these were machine-dug trial trenches using a small 360° mechanical excavator measuring approximately 2m long by 0.5m wide (Photo 2), and the remaining ten were hand-dug pits approximately 0.4m across.

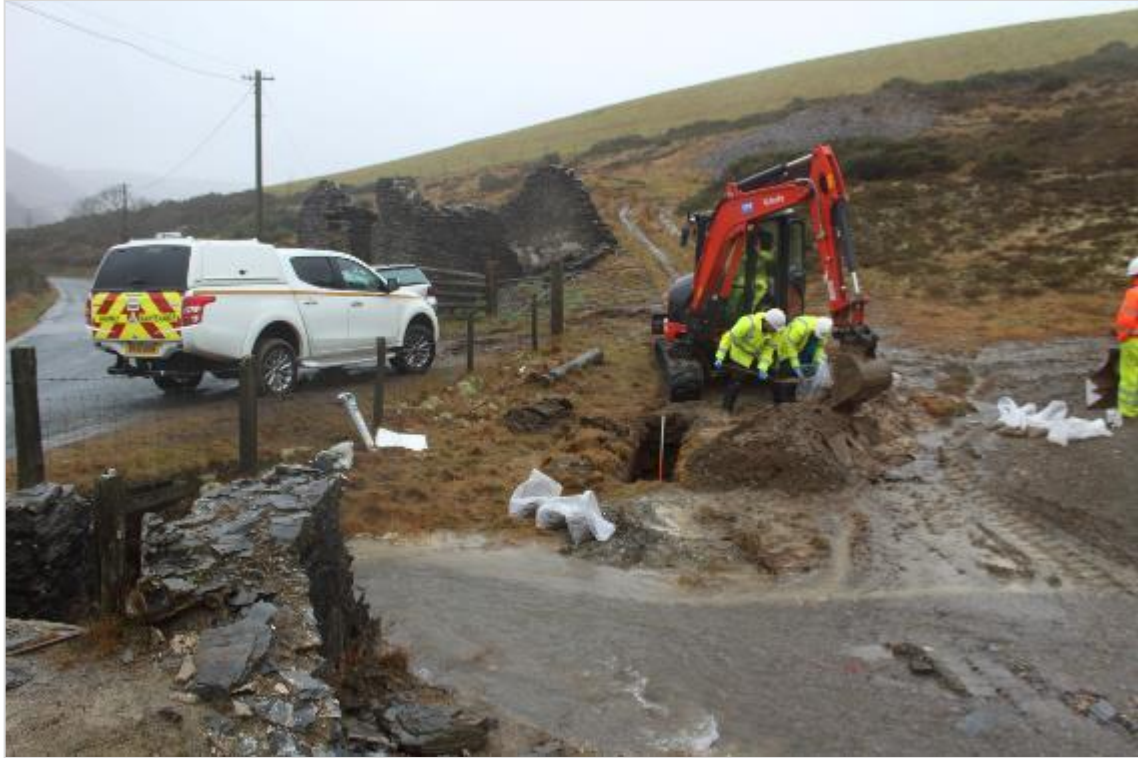
**Photograph 3:** Machine excavation of trial trenches.

- 4.1.2 Due to the presence of surface water (Photo 3) at the allotted locations for a small number of the trenches and pits it was necessary to re-locate them slightly, albeit keeping them as close as possible to their original positions.

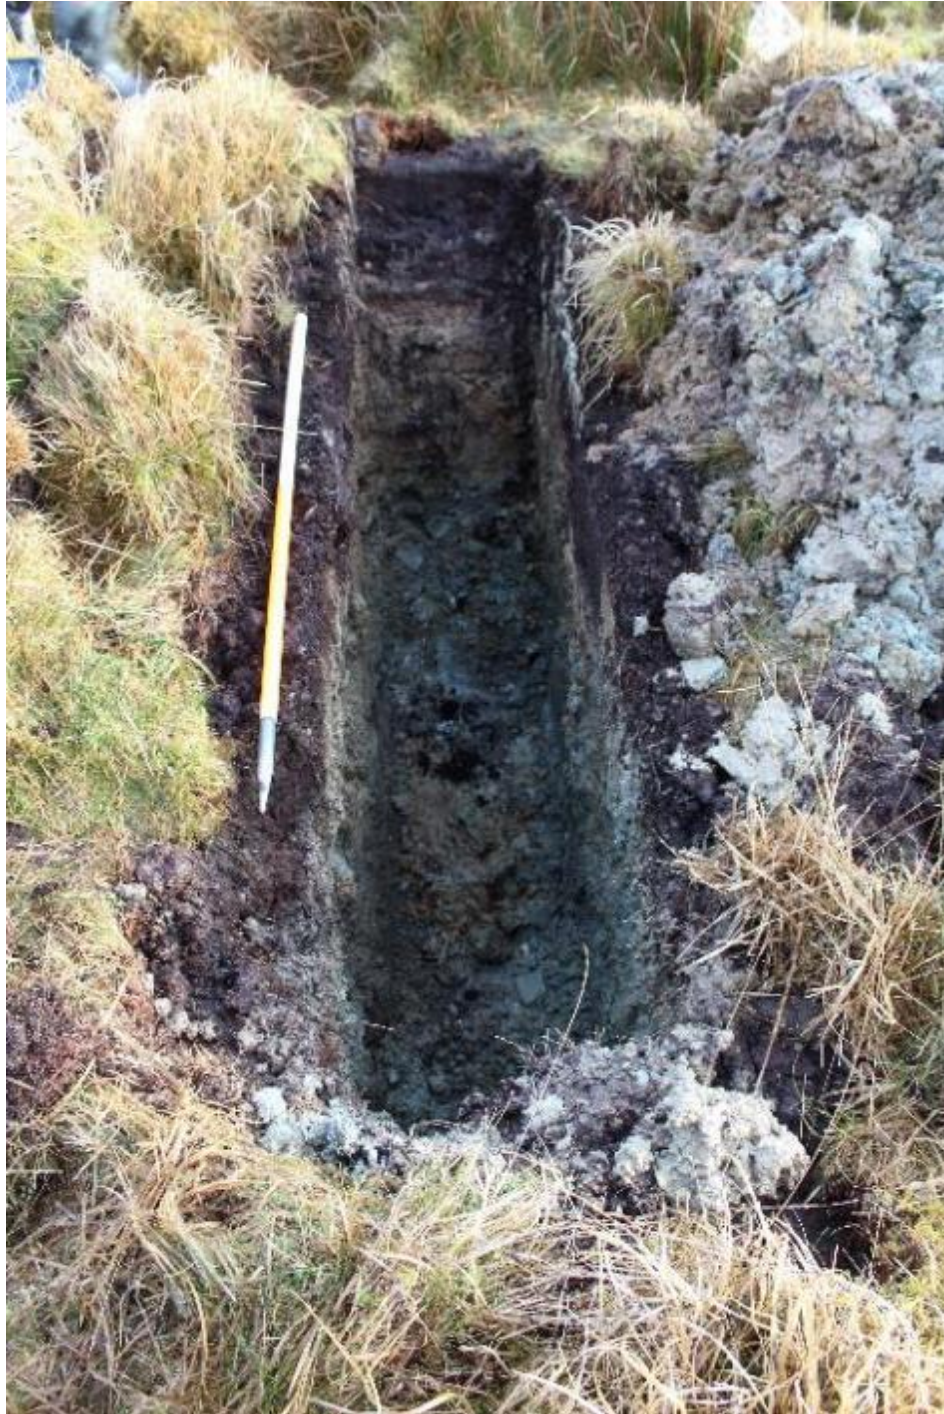
**Photograph 4:** View east: UP TP1 – 1m scale

UP TP1 (2m long x 0.5m wide x 1.4m deep) Aligned NE-SW NGR SN 271753 274546		
Context Number	Description	Depth
1048	Peat layer	0.25m
1049	Light yellow clay and gravels	0.4m
1050	Stony, grey clay with quartz pieces; bedrock possibly encountered at 1.4m.	1.4m

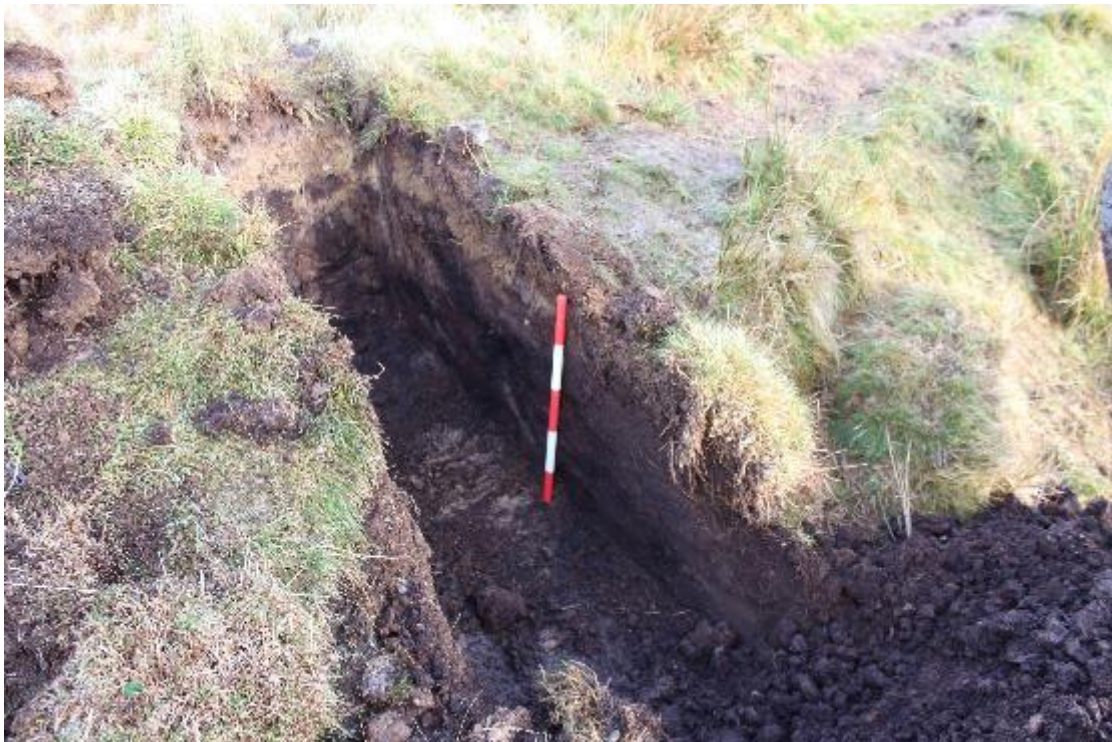
UP TP2 (2m long x 0.5m wide x 2m deep) Aligned N-S NGR SN 271757 274534		
Context Number	Description	Depth
1045	Peaty turves; material for construction of 4m wide, 0.6m high bank (half-sectioned on south side).	0.6m
1046	Yellow, stony clay	1.4m
1047	Weathered sedimentary bedrock.	Excavated to a depth of 2m

**Photograph 5:** View northeast: half section in bank showing peat turves – 0.5m scale

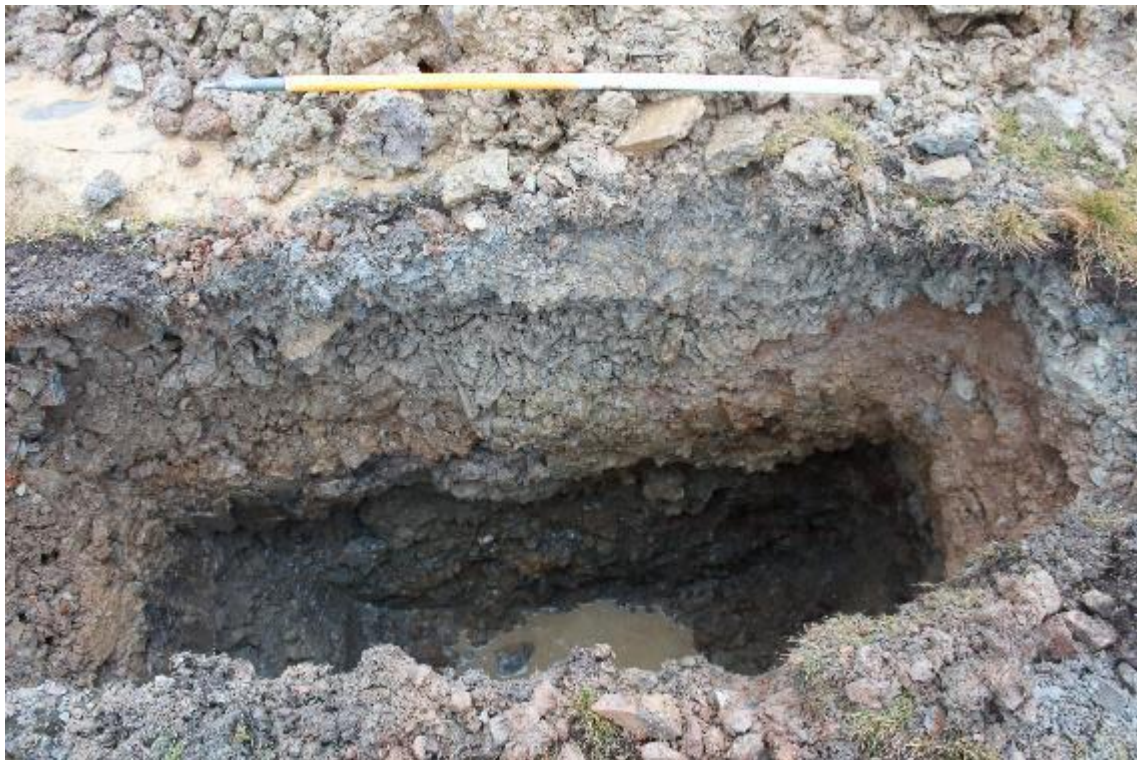
TR TP1 (2m long x 0.5m wide x 2m deep) Aligned E-W NGR SN 271789 274307		
Context Number	Description	Depth
1051	Loose, grey clayey-sand with high percentage of angular stone; upper layer of track.	0.25m
1052	Brown, clayey-sand and frequent small angular stone - ballast for track.	0.6m
1053	Loose, very stony with clayey-sand. Whether mine-waste or degraded natural is uncertain. Possible solid bedrock at 2m.	2m

**Photograph 6:** View north: TR TP1 cut into trackway – 1.m scale

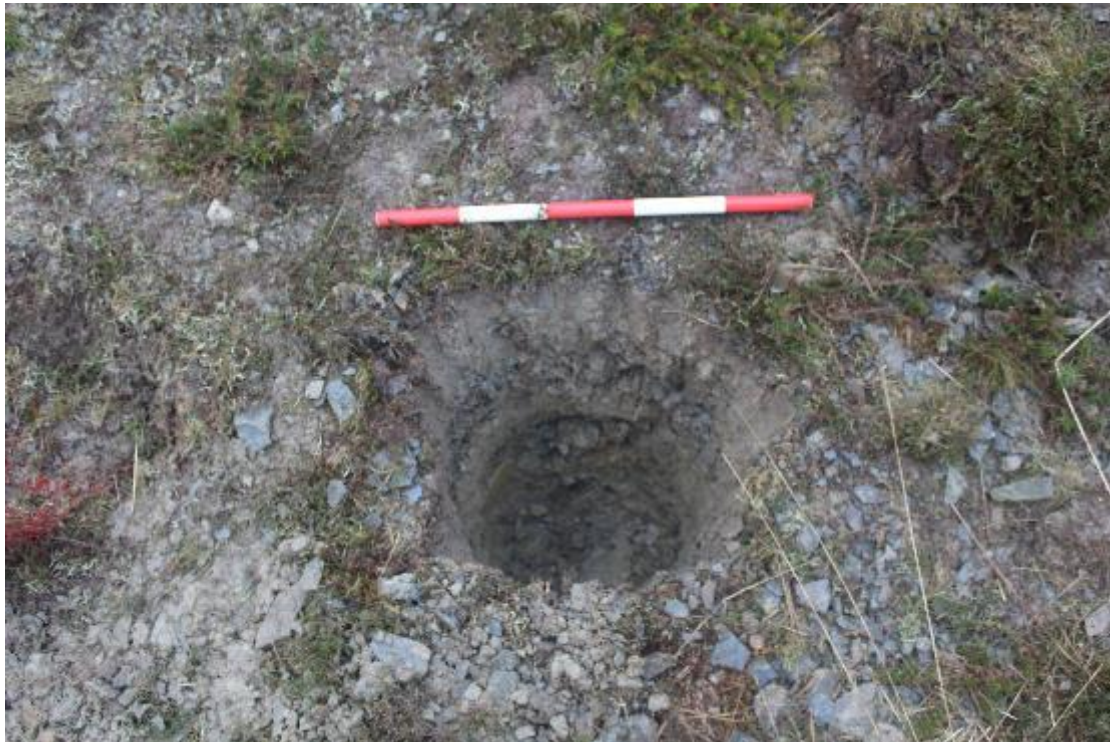
**Photograph 7:** View north: MRS IP1 - 0.5m scale

MRS IP1 (0.4m x 0.4m x 0.45m deep) NGR SN 271701 274226		
Context Number	Description	Depth
1037	Grey, sandy-clay and frequent small stones down to bedrock – redeposited material to create bank?	0.45m

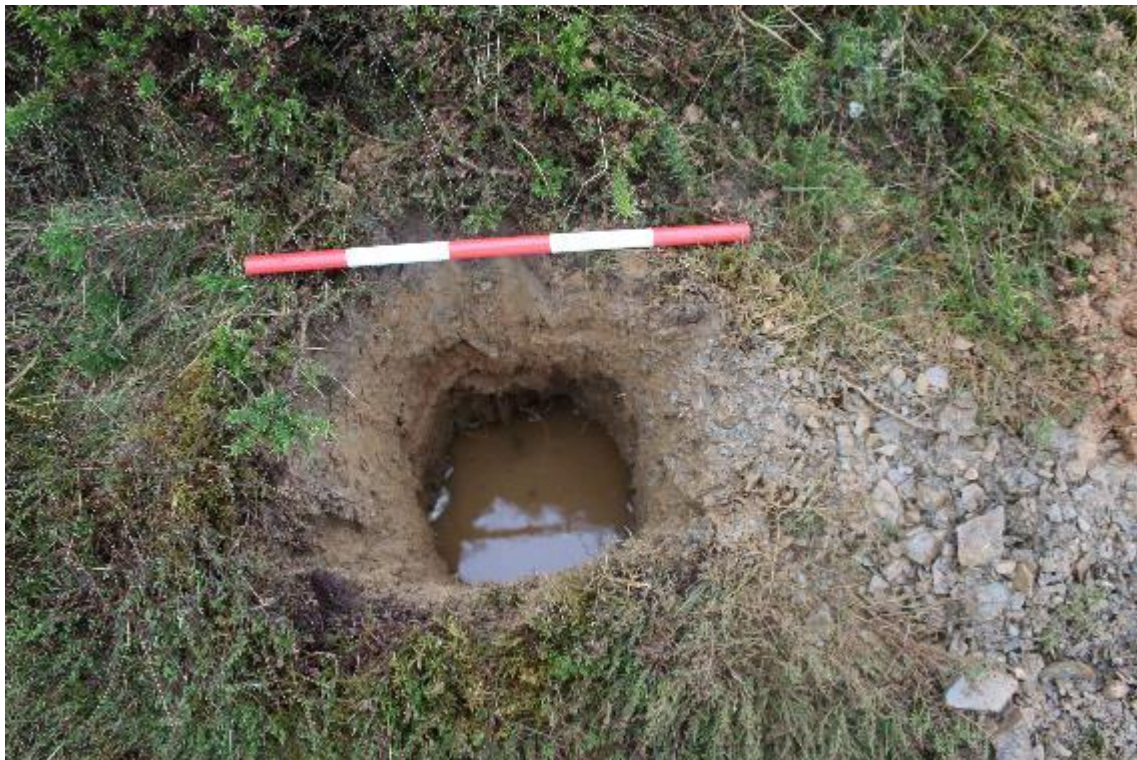
**Photograph 8:** View NNE: MRS IP2 – 0.5m scale

MRS IP2 (0.4m x 0.4m x 0.7m deep) NGR SN 271663 274209		
Context Number	Description	Depth
1038	Orange-brown, silty-clay down to weathered bedrock.	0.7m

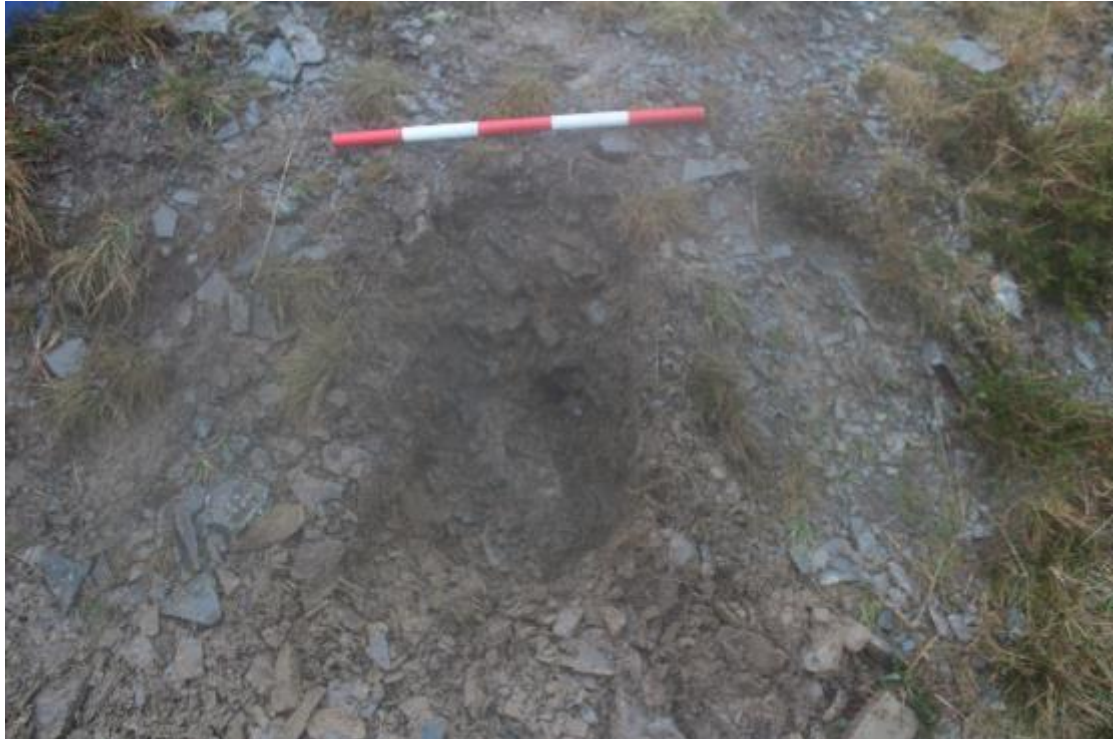
**Photograph 9:** View northeast: MRS IP3 – 0.5m scale (Figure 5)

MRS IP3 (0.4m x 0.4m x 0.35m deep) NGR SN 271645 274204		
Context Number	Description	Depth
1039	Dark grey-brown, silty-clay	0.05
1040	Weathered bedrock	Excavated to a depth of 0.35m

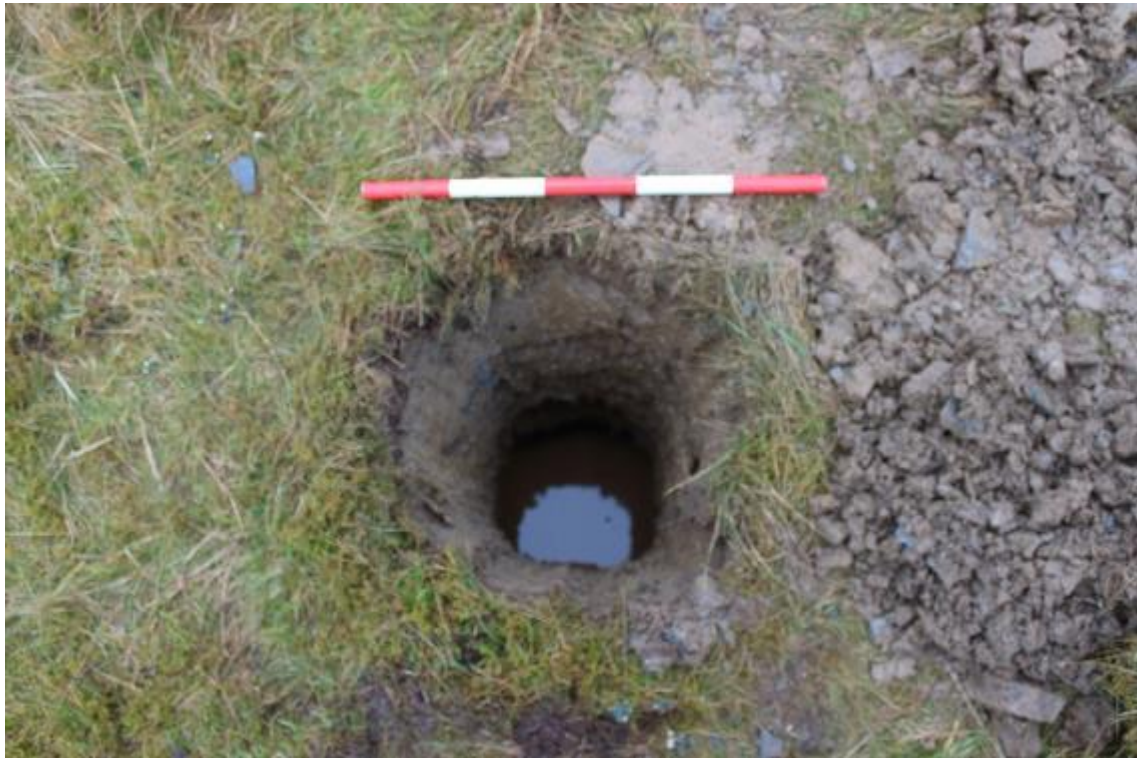
**Photograph 10:** View northeast: MRS IP4 – 0.5m scale

MRS IP4 (0.4m x 0.4m x 1.2m deep) NGR SN 271617 274209		
	Description	Depth
1041	Grey-brown, silty/sandy-clay and frequent small stones. Bedrock not encountered.	1.2m

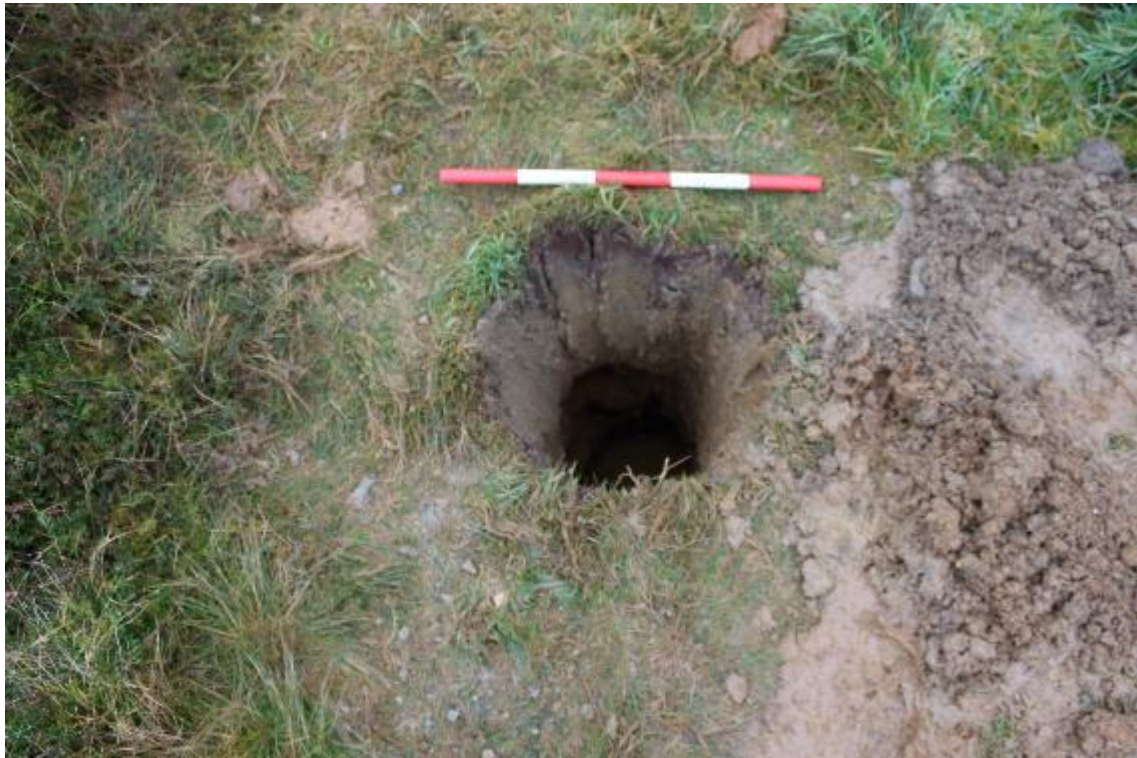
**Photograph 11:** View east: MRS IP5 – scale 0.5m

MRS IP5 (0.4m x 0.4m x 1.2m deep) NGR SN 271629 274199		
Context Number	Description	Depth
1042	Grey-brown, silty/sandy-clay and small angular stone. Bedrock not encountered.	1.2m

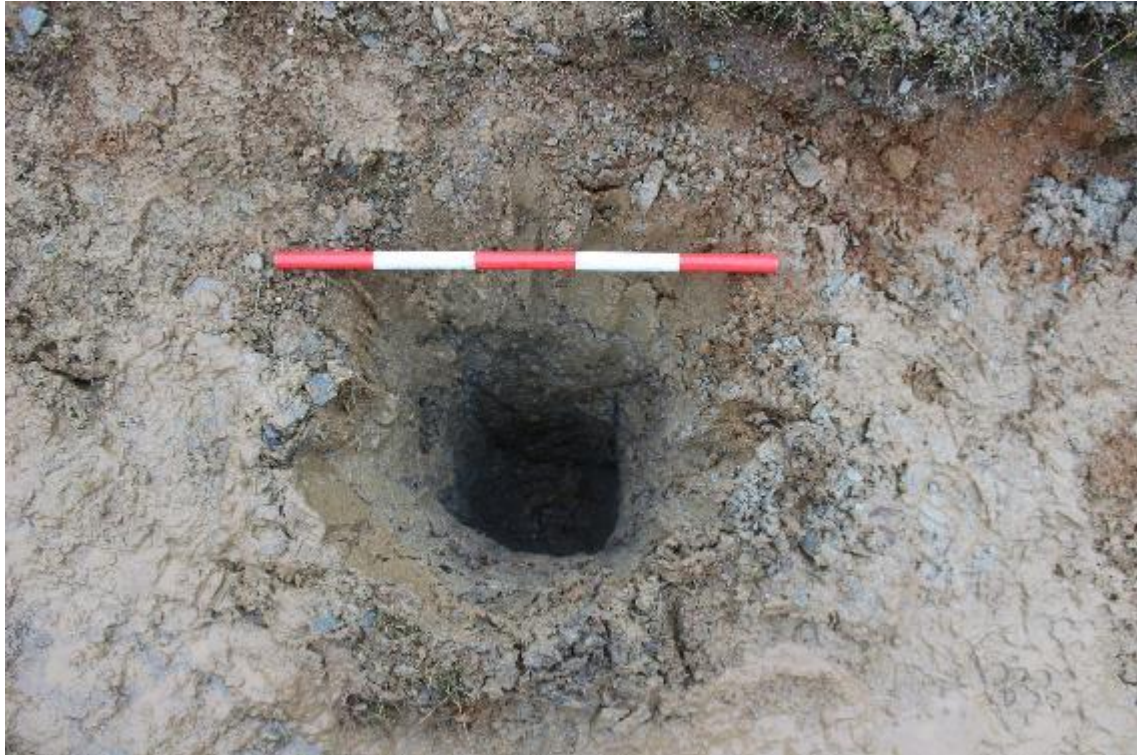
**Photograph 12:** View ESE: MRS IP6 – 0.5m scale

MRS IP6 (0.4m x 0.4m x 0.75m deep) NGR SN 271597 274199		
Context Number	Description	Depth
1043	Orange-brown, sandy-clay.	0.4m
1044	Grey clay and small stones lying above weathered bedrock.	0.75m

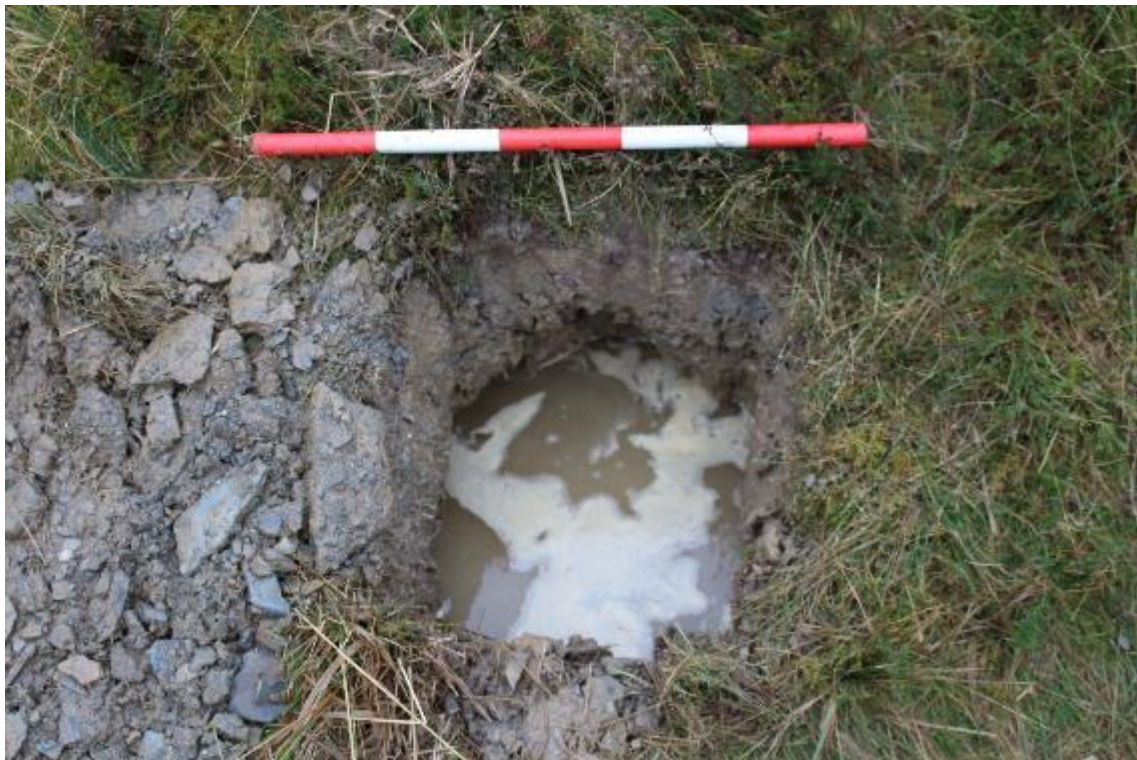
**Photograph 13:** View southeast: WPP TP1 – 0.5m scale

WPP TP1 (0.4m x 0.4m x 0.5m deep) NGR SN 271713 274232		
Context Number	Description	Depth
1035	Grey-brown, sandy-clay and frequent small/medium stone above bedrock.	0.5m

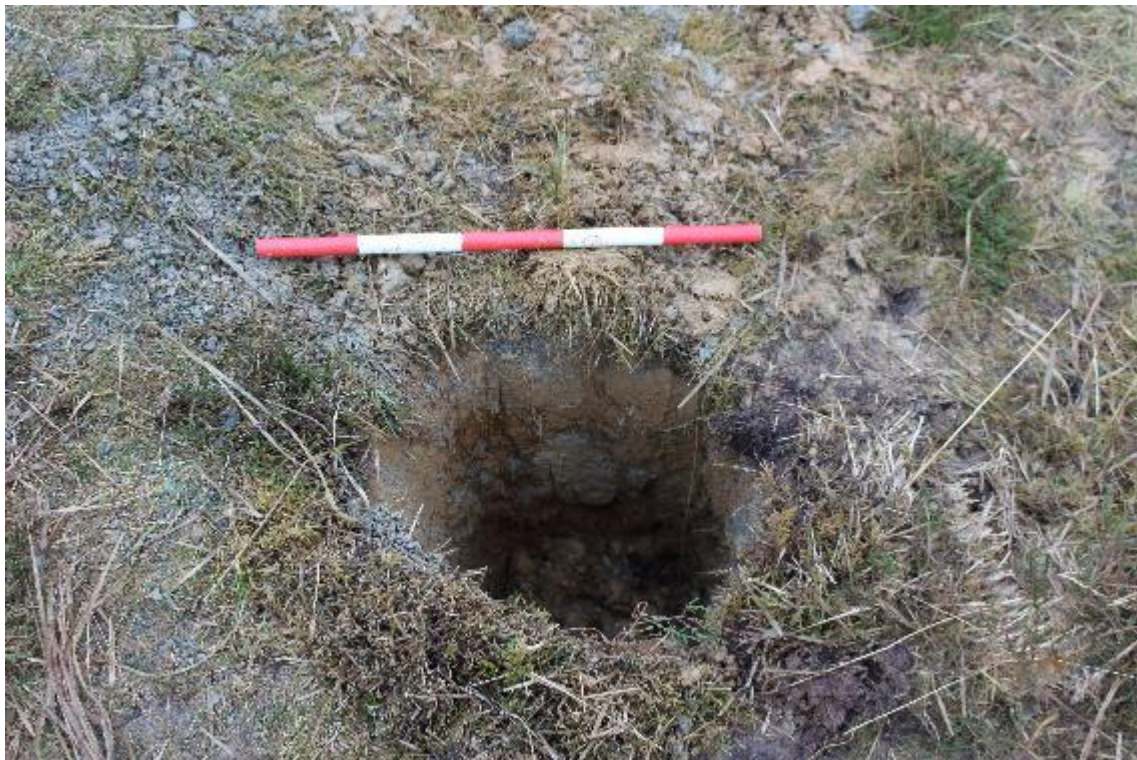
**Photograph 14:** View northeast: WPP TP2 – 0.5m scale

WPP TP2 (0.4m x 0.4m x 1.2m deep) NGR SN 271707 274239		
Context Number	Description	Depth
1036	Orange-brown, sandy-clay and small angular stone – probably natural.	1.2m

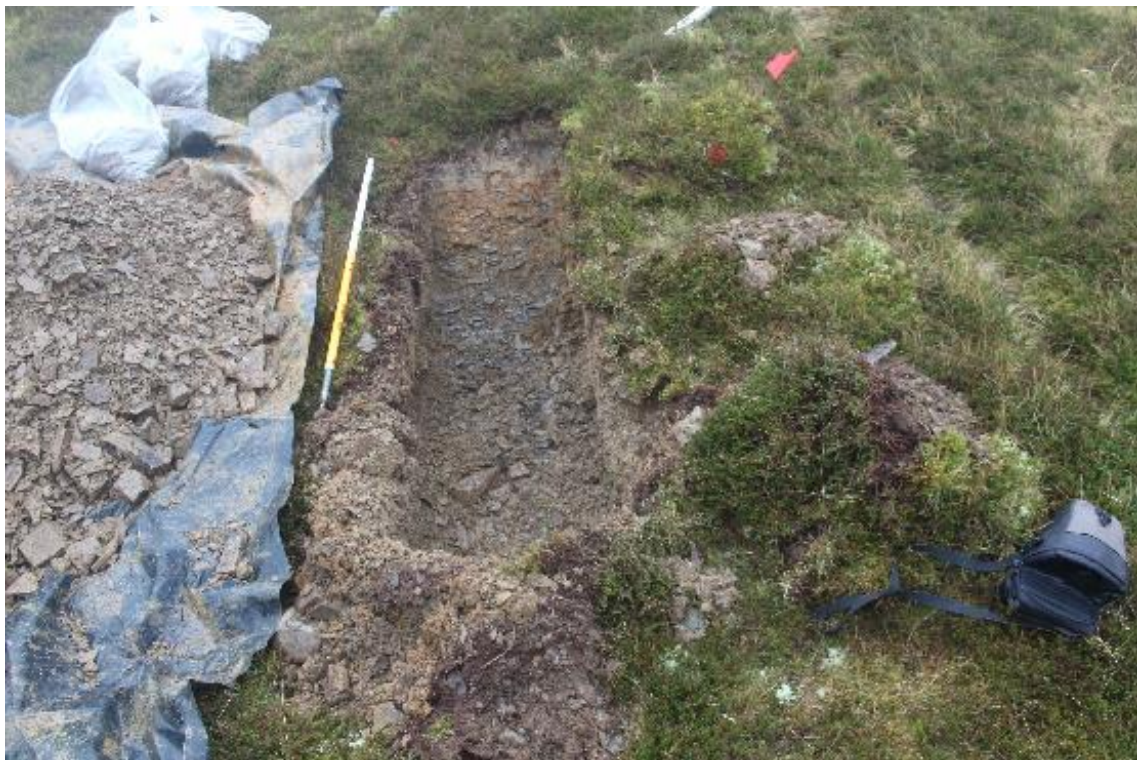
**Photograph 15:** View east: MRS TP1 - 1m scale

MRS TP1 (2m long x 0.5m wide x 0.65m deep) Aligned E-W NGR SN 271701 274226		
Context Number	Description	Depth
1012	Thin layer of grey, coarse sand/fine gravels; ore-processing waste.	0.08m
1013	Orange-brown, sandy-clay with frequent small sharp stones -possibly natural.	0.25m
1014	Grey, sandy-clay – probably natural	0.12m
	Sedimentary bedrock.	Excavated to a depth of 0.6m

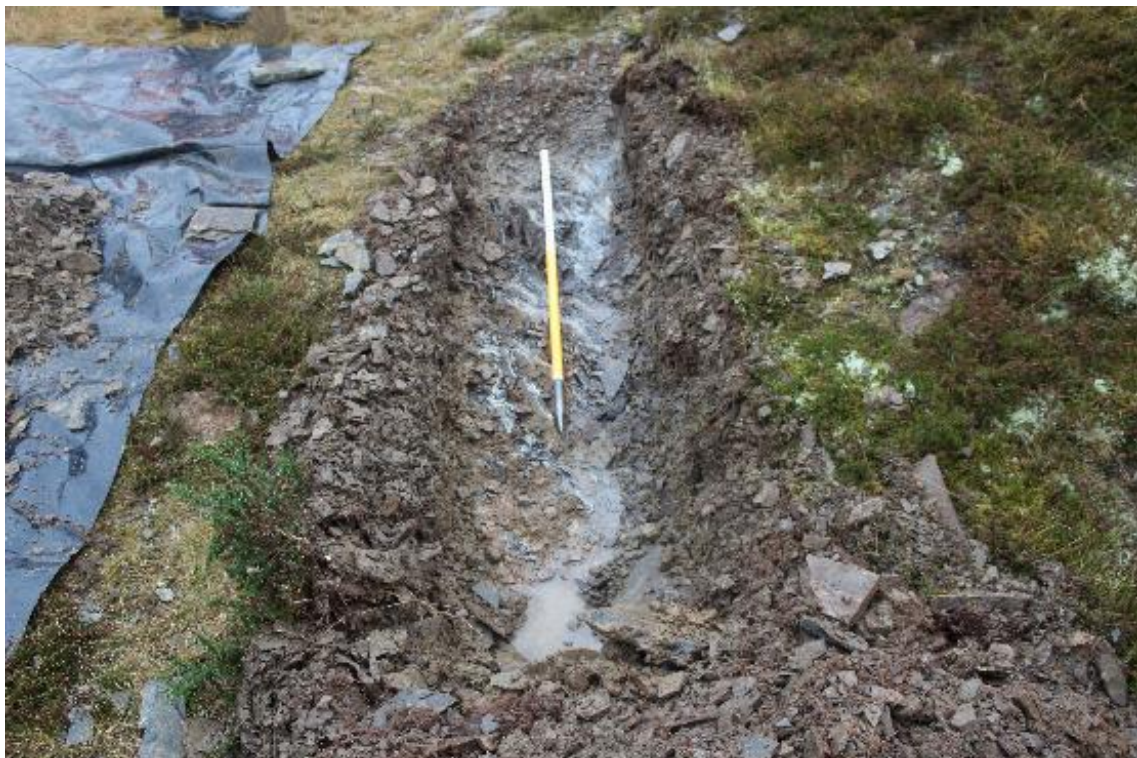
**Photograph 16:** View northeast: MRS TP2 - 1m scale

MRS TP2 (2m long x 0.5m wide x 0.25m deep) Aligned NE-SW NGR SN 271663 274209		
Context Number	Description	Depth
1016	Grey-brown, clayey-sand containing high percentage of small angular stone – probably ore-processing waste.	0.25m
1017	Sedimentary bedrock

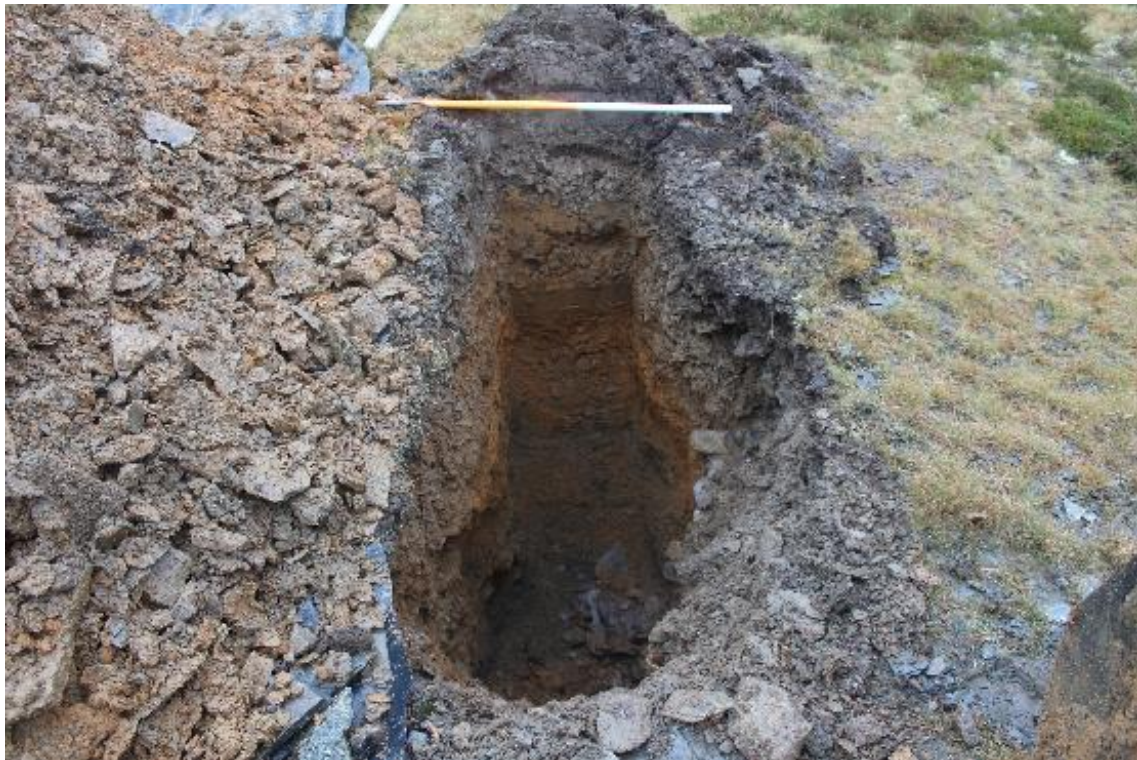
**Photograph 17:** View south: MRS TP3 – 1m scale

MRS TP3 (2m long x 0.5m wide x 2.1m deep) Aligned N-S NGR SN 271645 274204		
Context Number	Description	Depth
1018	Grey, coarse sand/fine gravels; ore-processing waste.	0.4m
1019	Loose, small/medium angular stone; some stone	0.4m
1020	Orange-brown, clayey-sands with small, angular stone probably natural.	1.7m
1021	Sedimentary bedrock.	Excavated to a depth of 2.1m

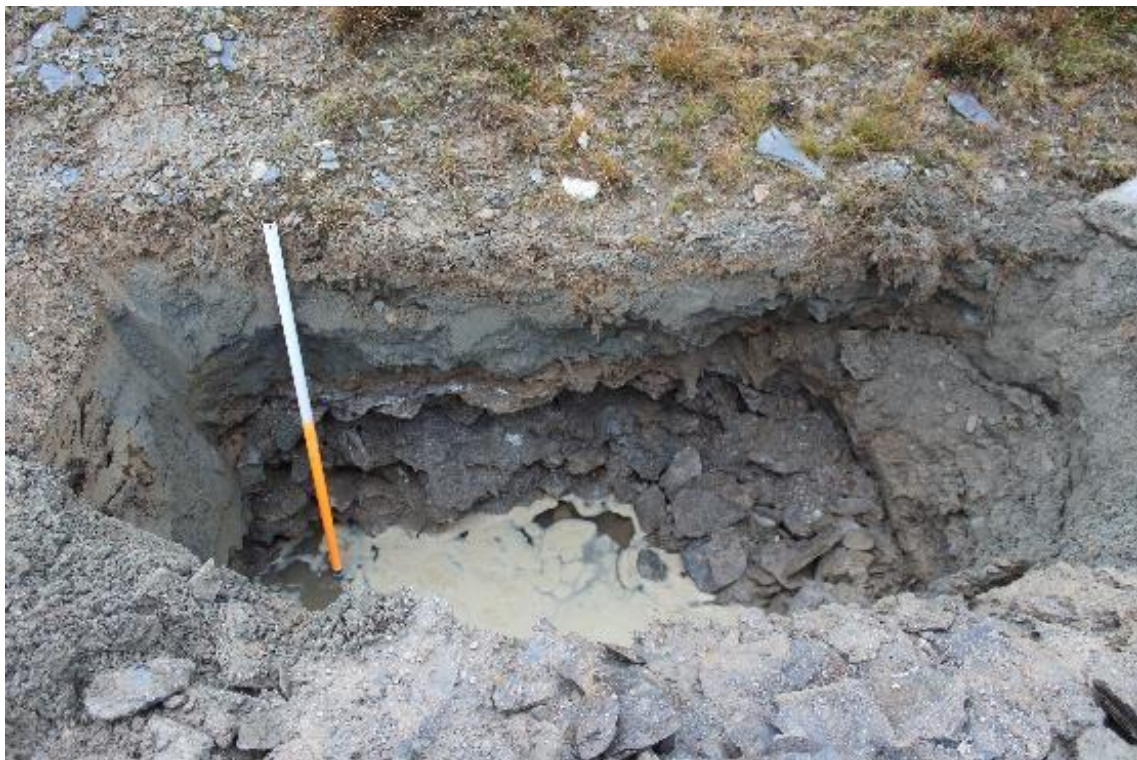
**Photograph 18:** View north: MRS TP4 – 1m scale

MRS TP4 (2m long x 0.5m wide x 1.1m deep) Aligned E-W NGR SN 271617 274209		
Context Number	Description	Depth
1022	Grey, coarse sand/fine gravels; ore-processing waste.	0.12m
1023	Loose, angular, medium sized stone, some with mortar attached. The mortared stone could have originated from a building further up the slope shown in the OS first edition map. Watered ingress prevented any deeper excavation.	1.1m

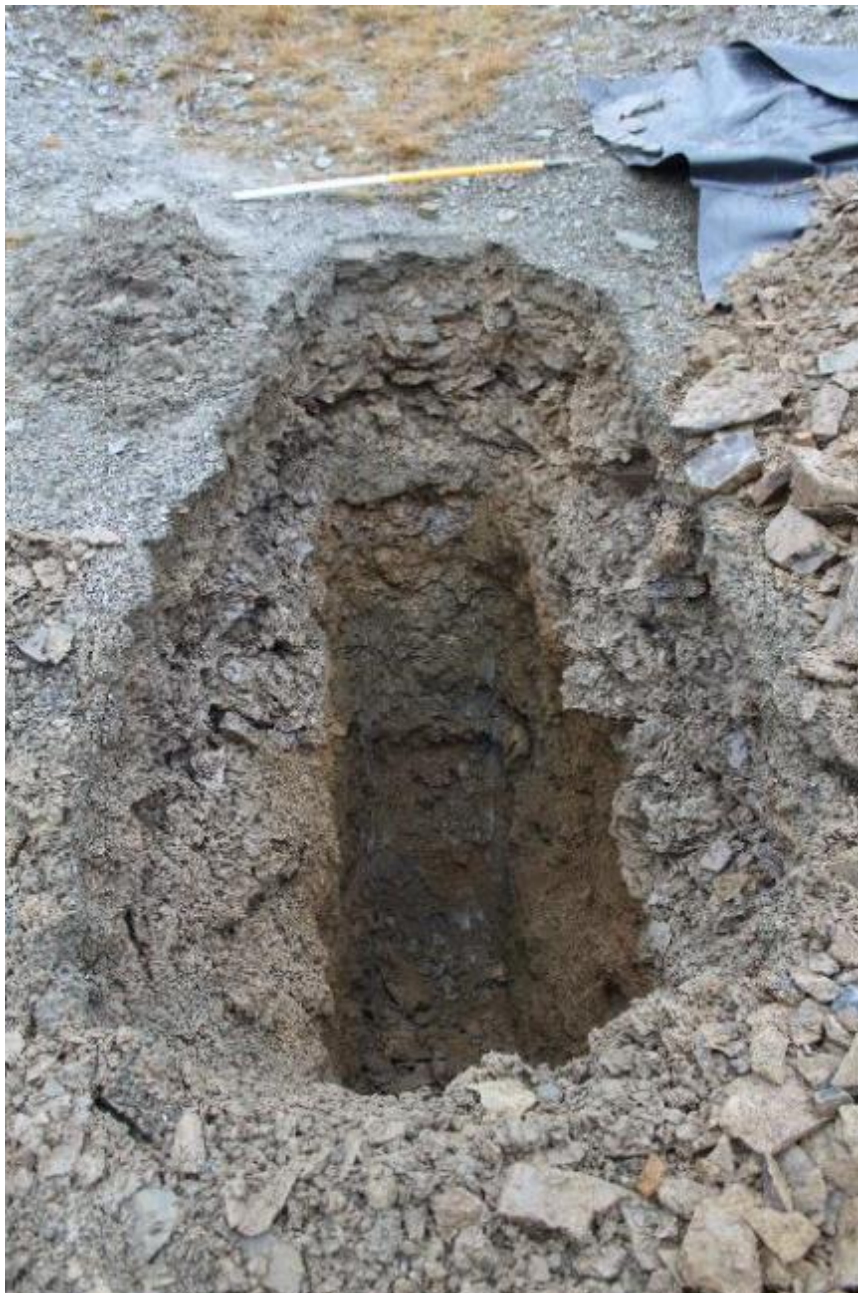
**Photograph 19:** View east: MRS TP5 – 1m scale

MRS TP5 (2m long x 0.5m wide x 2.1m deep) Aligned E-W NGR SN 271629 274199		
Context Number	Description	Depth
1024	Grey, coarse sand/fine gravels; ore-processing waste.	0.1m
1025	Loose, angular, small/medium stone	0.7m
1026	Orange-brown, clayey-sand and small angular stone – probably natural.	2.0m
1027	Sedimentary bedrock	Excavated to a depth of 2.1m

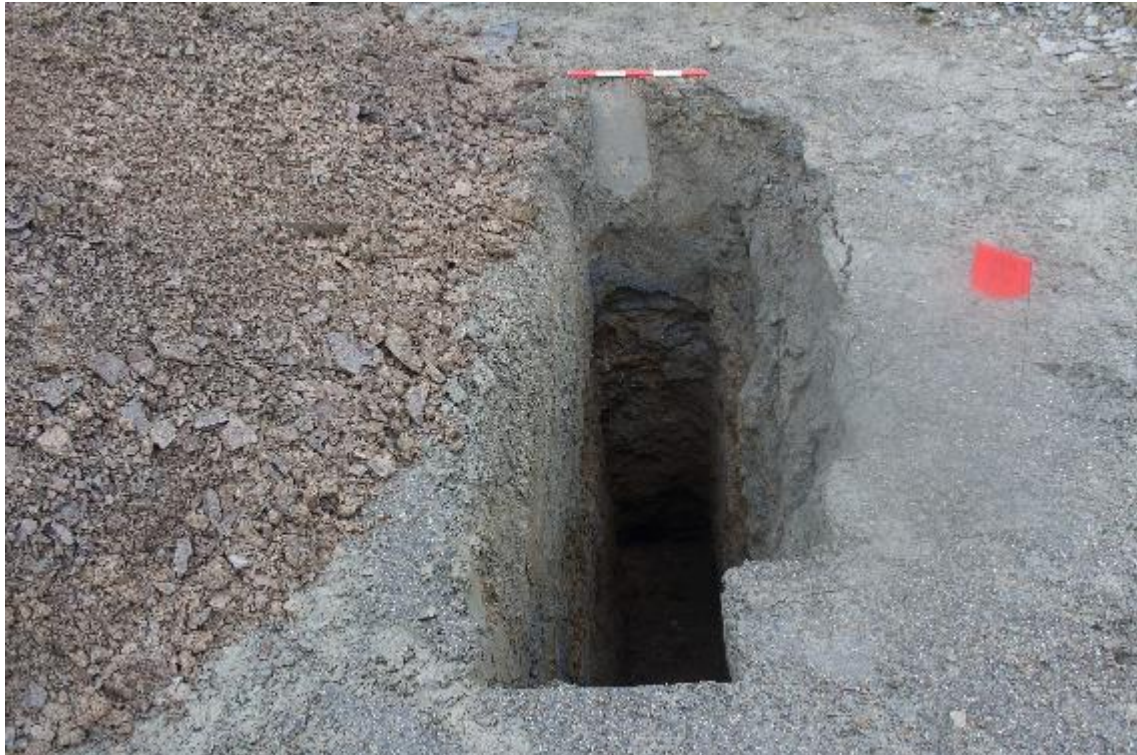
**Photograph 20:** View WSW: MRS TP6 – 0.5m scale

MRS TP6 (2m long x 0.5m wide x 2.7m deep) Aligned ENE-WSW NGR SN 271597 274199		
Context Number	Description	Depth
1028	Grey, coarse sand/fine gravels; ore-processing waste.	0.8m
1029	Orange-brown, clayey-sand and small angular stone – probably natural	2.5m
1030	Weathered sedimentary bedrock	Excavated to a depth of 2.7m

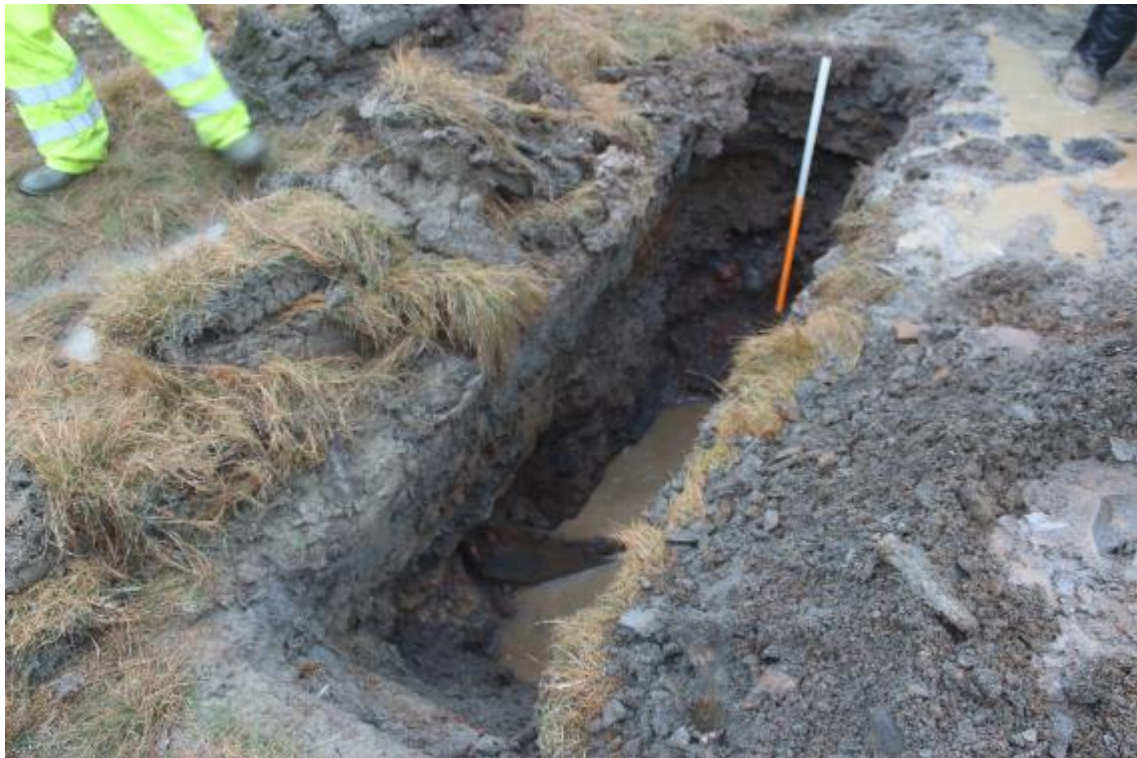
**Photograph 21:** View west: CP TP1 – 1m scale

CP TP1 (2m long x 0.5m wide x 1.3m deep) Aligned NW-SE NGR SN 271603 274188		
Context Number	Description	Depth
1088	Grey, coarse sand/fine gravels; ore-processing waste.	0.35m
1089	Loose, mixed deposit of mine-waste including large stones and brick. Water ingress at 1.3m – test pit abandoned.	01.3m

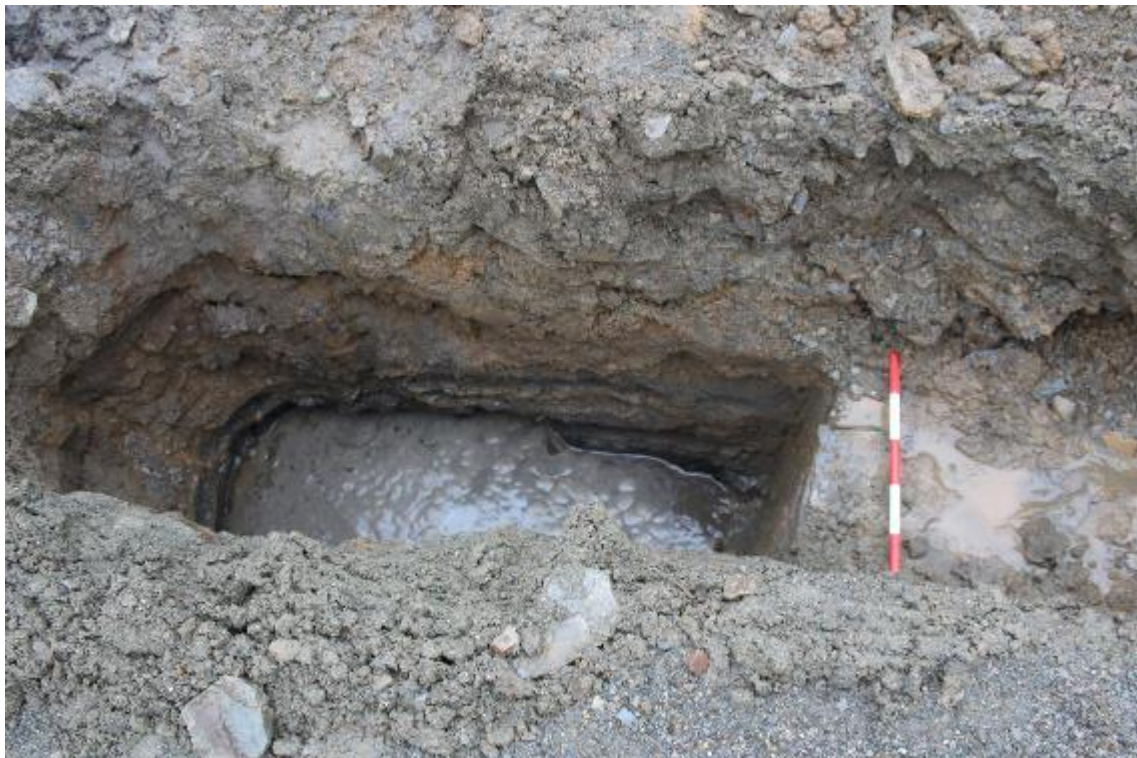
CP TP2 (2m long x 0.5m wide x 1.9m deep) Aligned NE-SW NGR SN 271600 274184		
Context Number	Description	Depth
1090	Loose, stony deposit with modicum of clayey-sand	0.7m
1091	Stone wall 0.7m below top of test pit. Aligned WNW-ESE. Approximately 0.6m wide and at least 0.8m high - possibly 1.2m high. Slight batter on exposed south elevation? Excavation of trench abandoned at north side of wall and trench extended to the south. Water ingress prevented full exposure of south elevation. On south side of wall, below (1090), a series of coarse sand/fine gravel laminations (1092).	Top of wall 0.7m below ground surface  Base of wall between 1.5m and 1.9m below ground surface.
1092	Series of orange-brown and grey laminations consisting of coarse sand/fine gravels. Water ingress obstructed view	Water ingress concealed full depth of deposit.

**Photograph 22:** View WNW: showing top of wall (1091) within CP TP2 – 0.5m scale

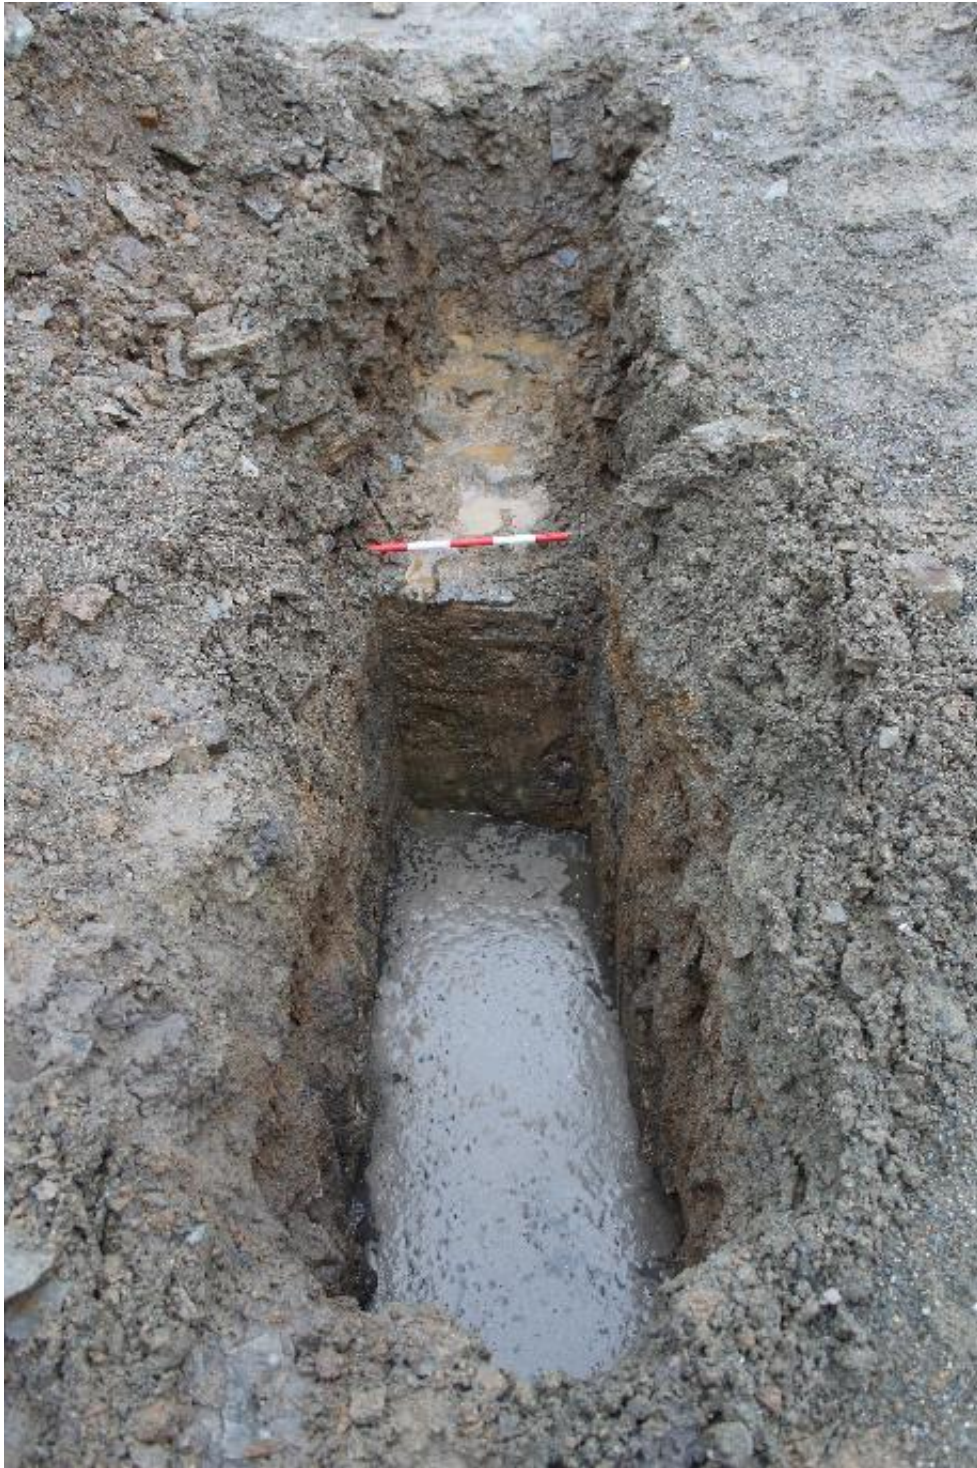
**Photograph 23:** View northeast: partially exposed southwest elevation of wall (1091) – 0.5m scale
