# WEMYSS METAL MINE, CEREDIGION: ARCHAEOLOGICAL WATCHING BRIEF

REPORT NO. 2021-43  
EVENT RECORD NO. 125987

**WEMYSS METAL MINE, CEREDIGION:  
ARCHAEOLOGICAL WATCHING BRIEF**

*DAT Archaeological Services were commissioned to undertake a watching brief in January 2021 during groundworks associated with geotechnical investigational works at Wemyss Metal Mine, Ceredigion (NGR SN 71579 74089).*

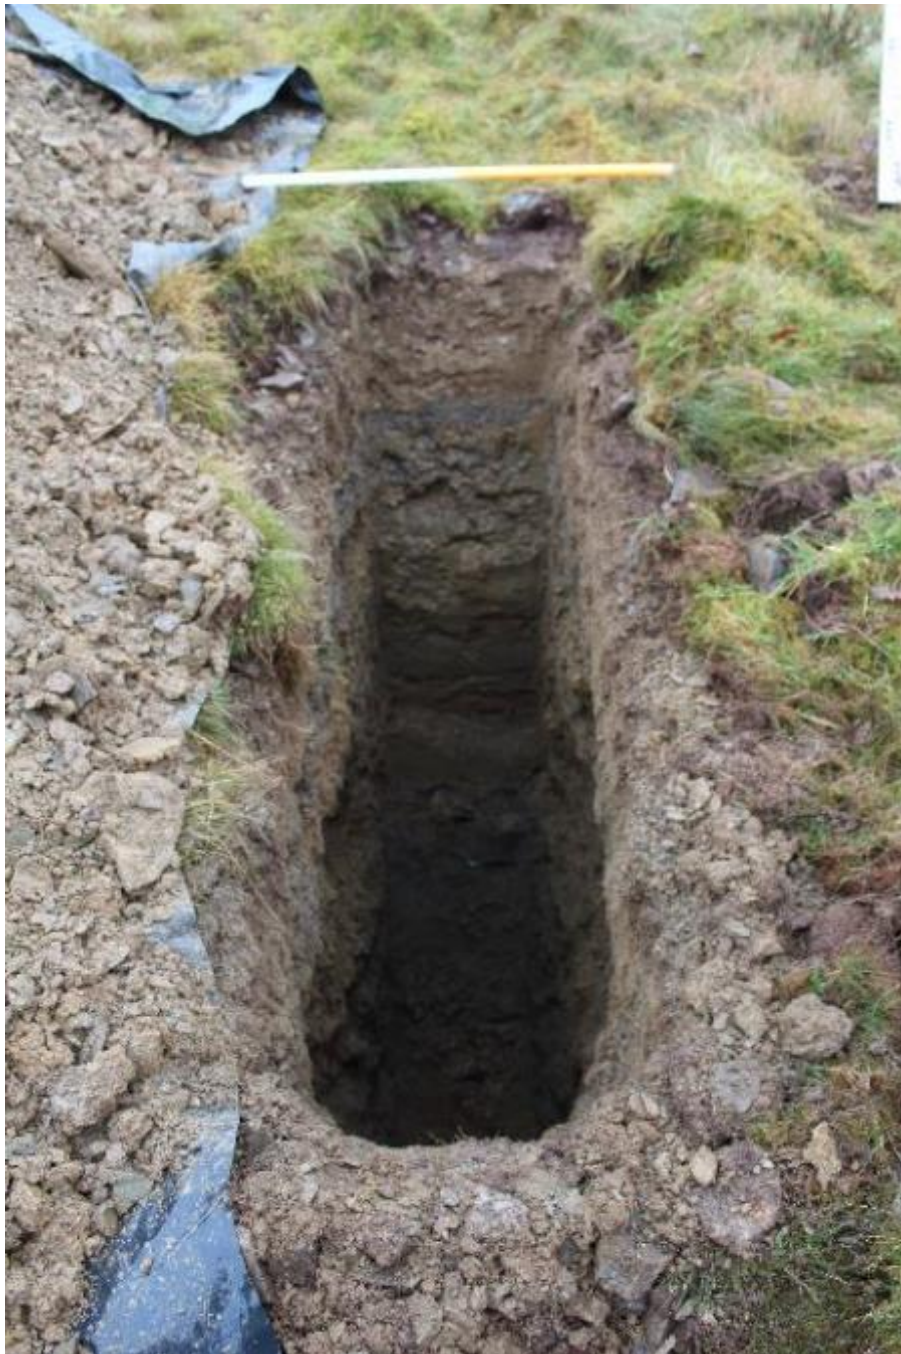
**Photograph 24:** View east: CV TP1 – 1m scale

CV TP1 (2m long x 0.5m wide x 2.4m deep) Aligned E-W NGR SN 271545 274178		
Context Number	Description	Depth
1031	Dark, grey-brown topsoil	0.1m
1032	Light brown, sandy-clay	0.4m
1033	Grey, coarse sand/fine gravels	0.5m
1034	Orange-brown, clayey-sand and frequent small/medium angular stone	2.3m
1034	Weathered sedimentary bedrock	Excavated to a depth of 2.4m

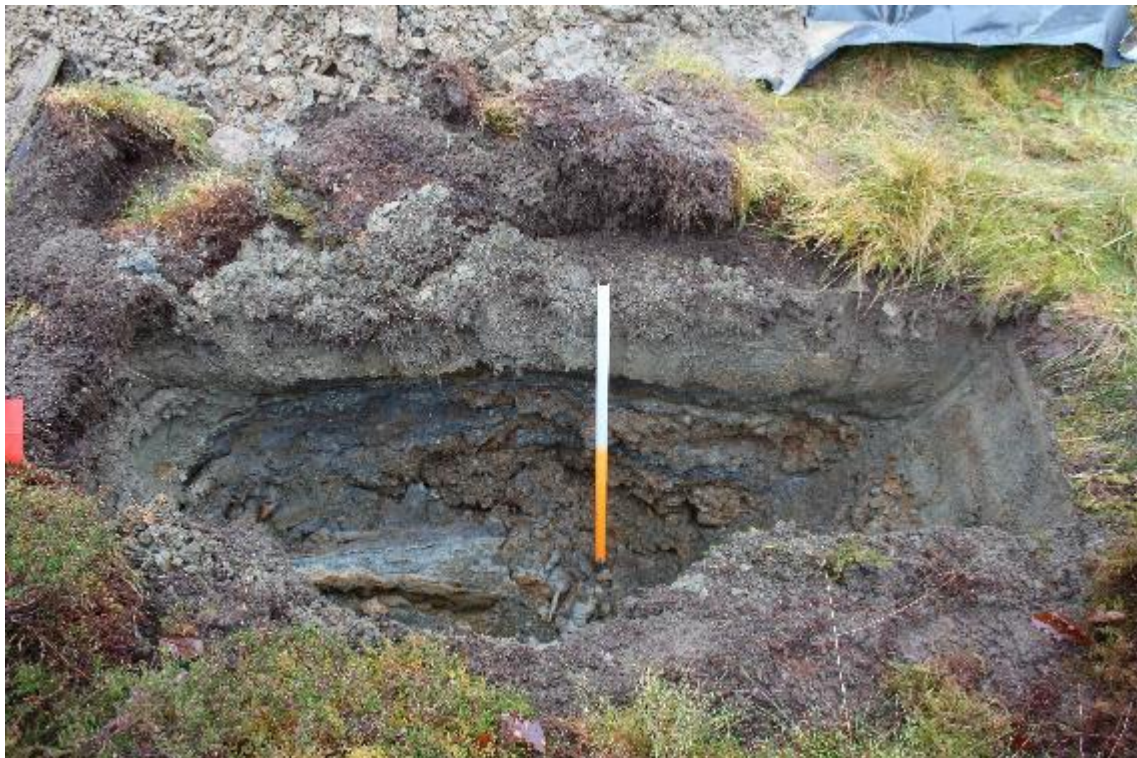
**Photograph 25:** View ESE: DR TP1 - 1m scale

DR TP1 (2m long x 0.5m wide x 1.5m deep) Aligned NNE-SSW NGR SN 271620 274036		
Context Number	Description	Depth/thickness
1000	Compact layer of grey, fine gravels/course sand or 'tailings' below turf layer; remains of ore-processing waste.	Varies between 0.25m and 0.35m
1001	Interleaving layers of course, clayey-sand and crushed shale with iron staining down to a depth of approximately 1.25m; remains of ore-processing waste.	1.25m
1002	Weathered sedimentary bedrock.	Excavated to a depth of 1.5m.

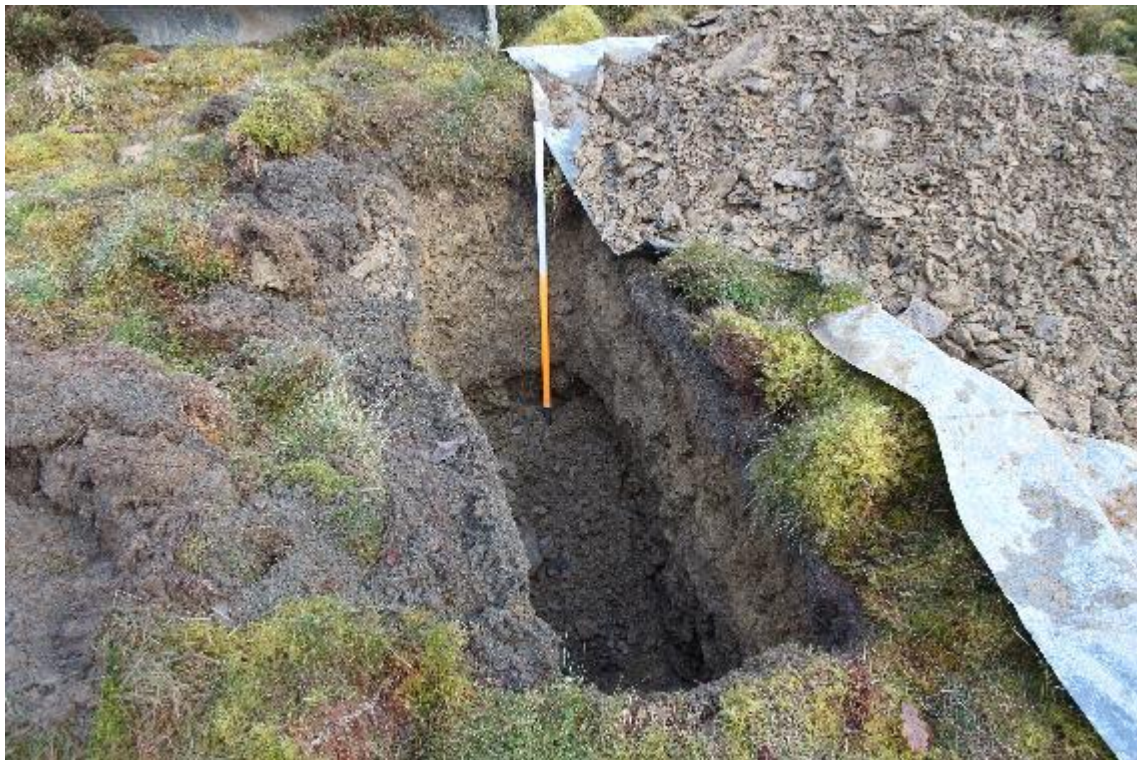
**Photograph 26:** View ENE: interior of DR TP2 - 1m scale

DR TP2 (2m long x 0.5m wide x 1m deep) Aligned NE-SW NGR SN 271612 274030		
Context Number	Description	Depth
1004	Grey, coarse sand/fine gravels; ore-processing waste.	0.05m.
1005	Small shale pieces within a light orange-brown, silty-clay – natural?	0.9m
1006	Weathered sedimentary bedrock.	Excavated to a depth of 1m.

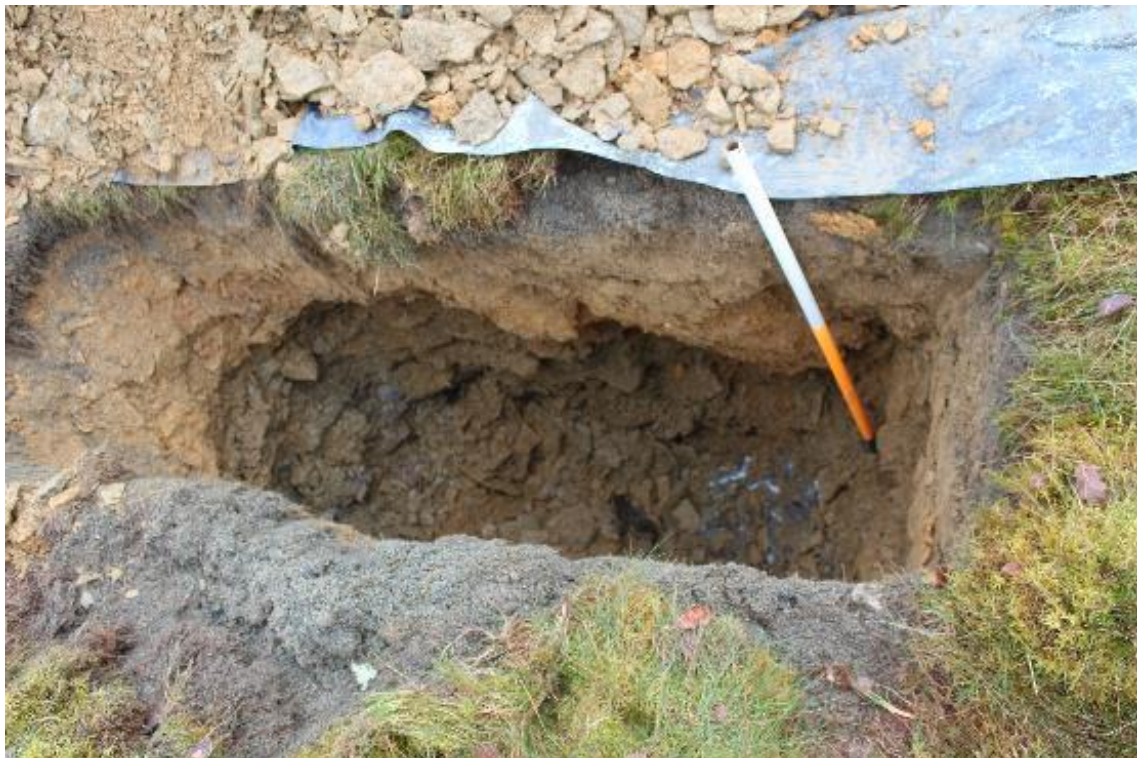
**Photograph 27:** View southeast: DR TP3 - 1m scale

DR TP3 (2m long x 0.5m wide x 1.45m deep) Aligned NE-SW NGR SN 271601 274022		
Context Number	Description	Depth
1007	Grey coarse sand/fine gravels; ore-processing waste.	0.10m.
1008	Small shale pieces within a light orange-brown, silty-clay – natural?	0.9m
1009	Weathered sedimentary bedrock.	Excavated to a depth of 1.45m.

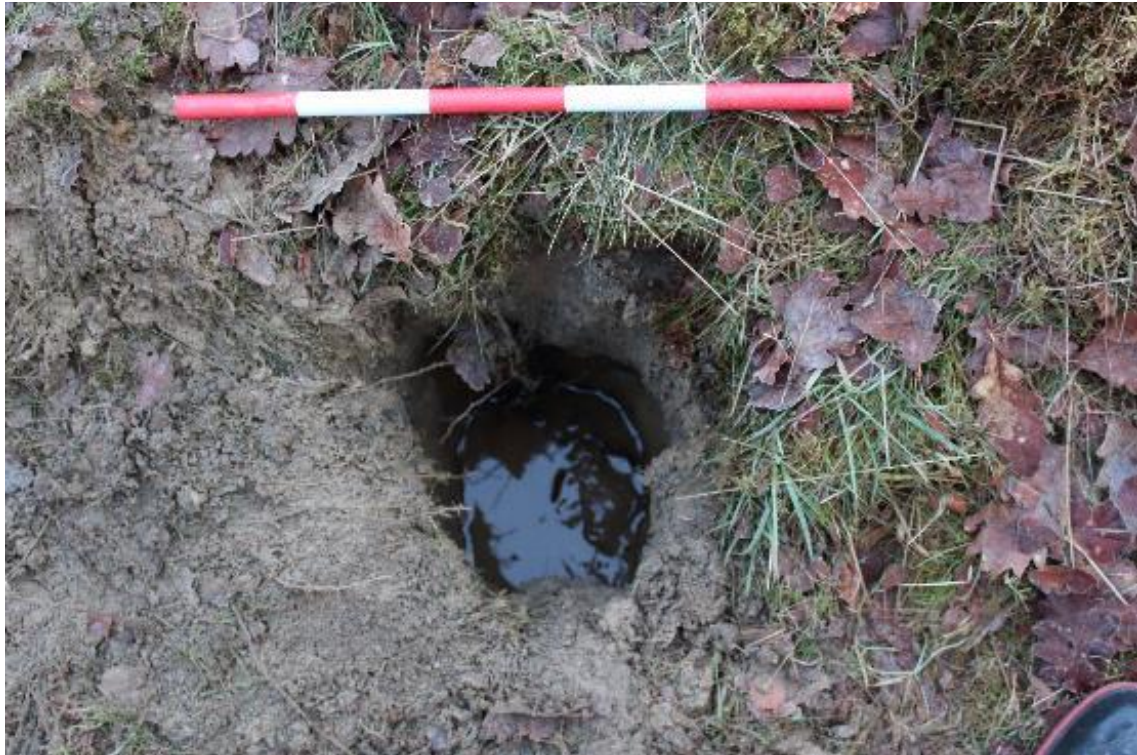
**Photograph 28:** View northeast: DR TP4 – 0.5m scale

DR TP4 Hand dug (0.4m long x 0.5m wide x 1.2m deep) NGR SN 271584 274018		
Context Number	Description	Depth
1010	Grey, coarse sand/fine gravels; ore-processing waste; water ingress at 0.5m.	1.2m

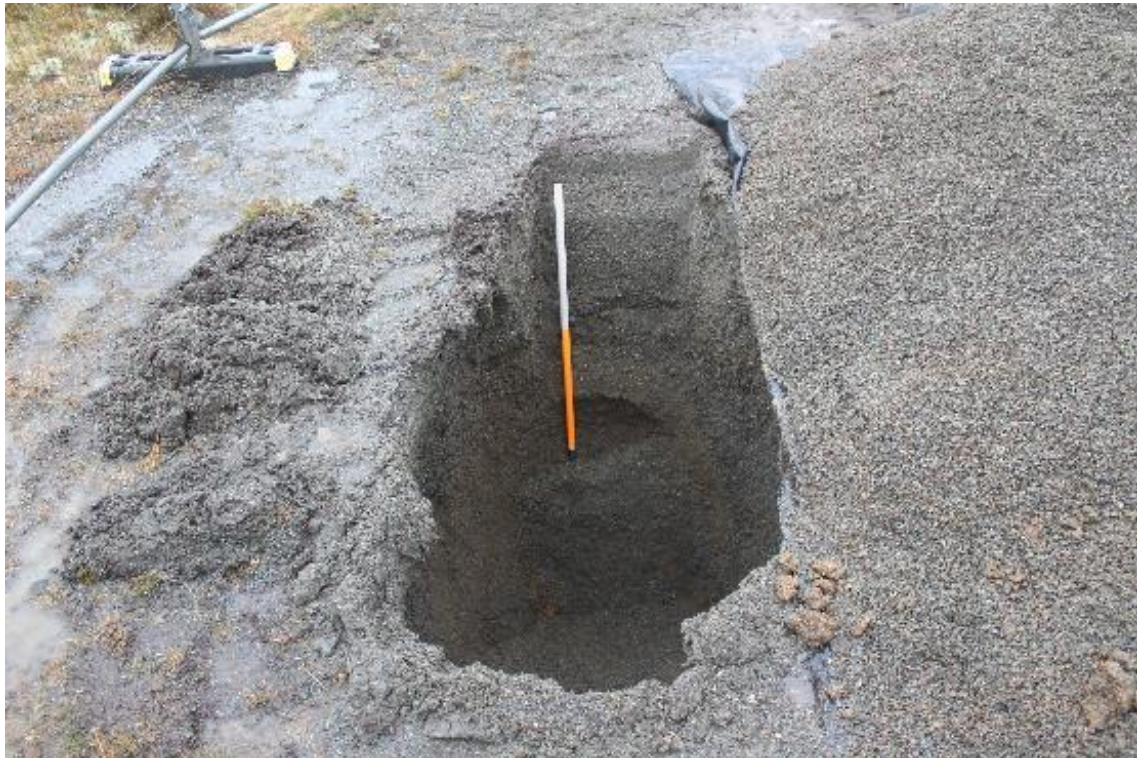
**Photograph 29:** View west: MS TP1 - 1m scale

MS TP1 (Dimensions 2m long x 0.5m wide x 1.7m deep) Aligned NNW-SSE NGR SN 271595 274131		
Context Number	Description	Depth
1011	Grey, coarse sand/fine gravels; ore-processing waste.	1.7m

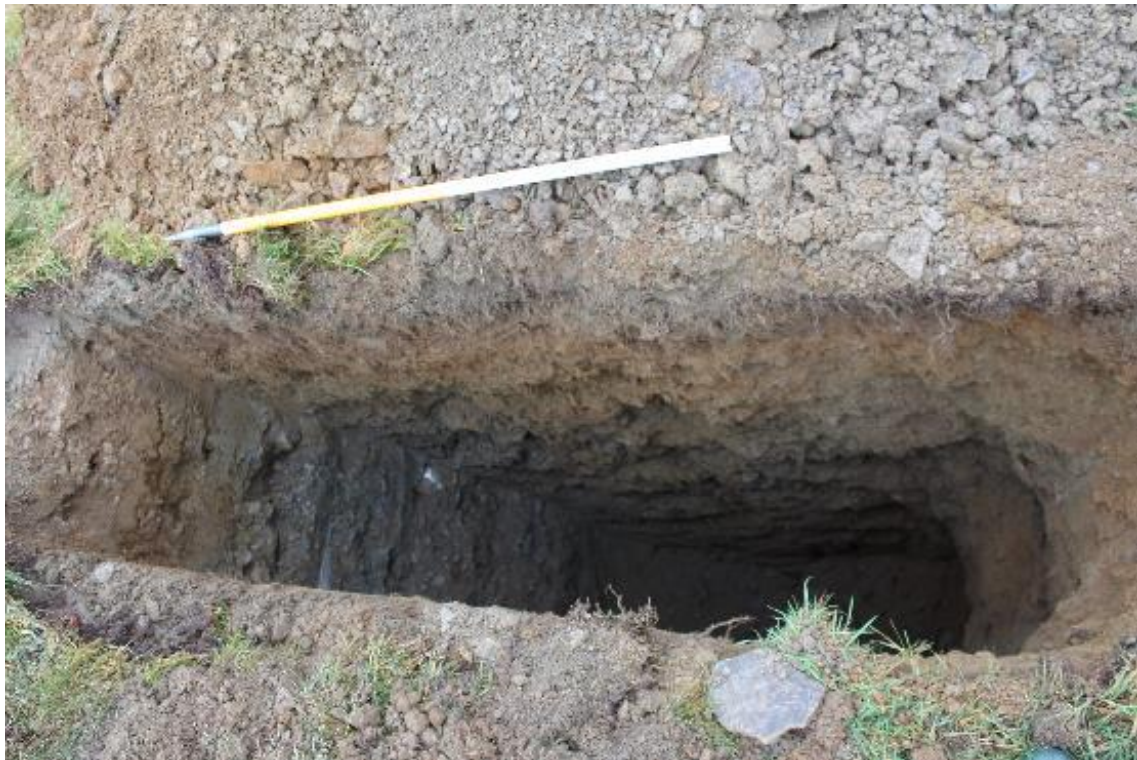
**Photograph 30:** View east: FC TP1 – 1m scale

FC TP1 (2m long x 0.5m wide x 2.9m deep) Aligned N-S NGR SN 271546 274151		
Context Number	Description	Depth
1060	Grey, coarse sand/fine gravels; ore-processing waste.	0.1m
1061	Orange-brown, silty-sandy clay with moderate small angular stone/loose, grey, silty-sandy clay with frequent small/medium sized stone – natural deposits	2.9m

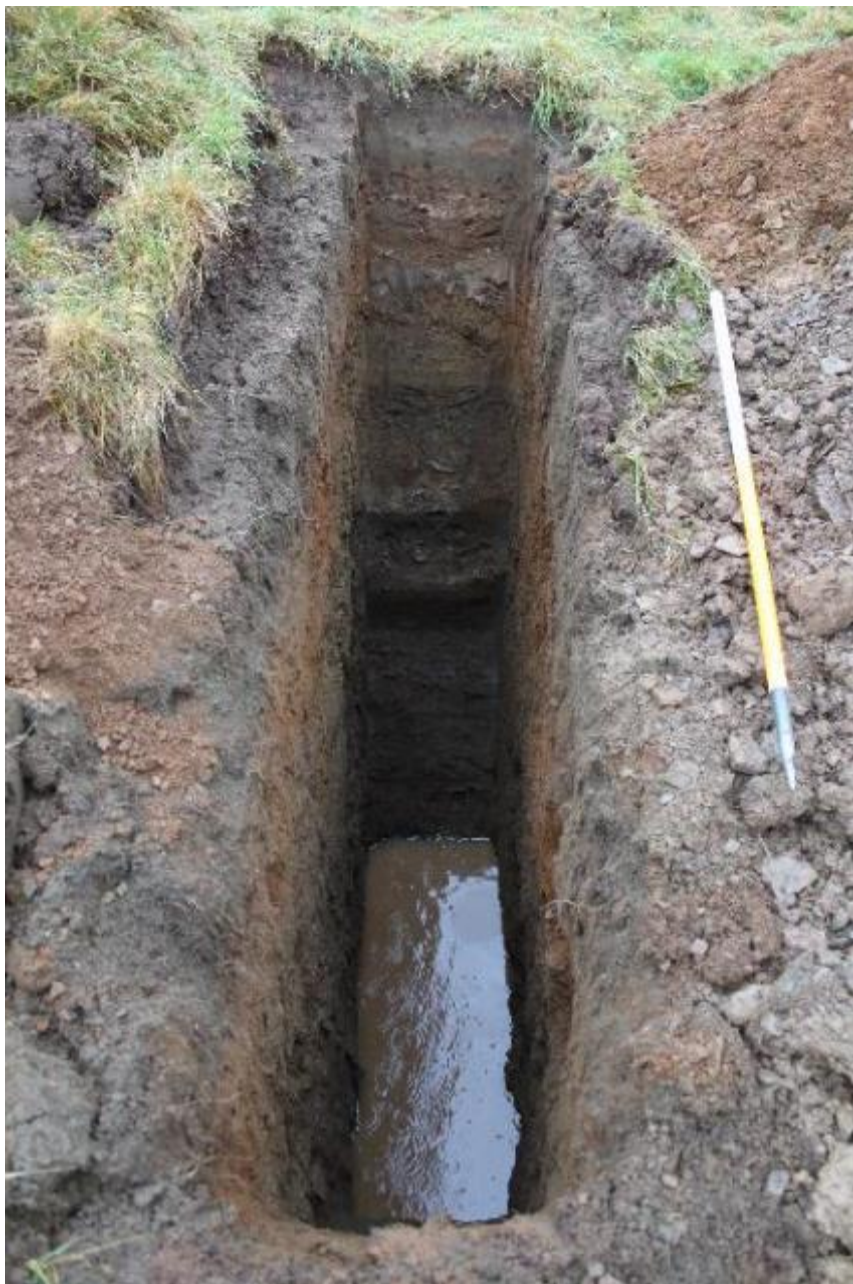
**Photograph 31:** View east: FC TP2 – 1m scale

FC TP2 (2m long x 0.5m wide x 2.7m deep) Aligned E-W NGR SN 271536 274134		
Context Number	Description	Depth
1062	Grey, coarse sand/fine gravels; ore-processing waste.	0.3m
1063	Orange-brown, silty-sandy clay with moderate small angular stone/loose, grey, silty-sandy clay with frequent small/medium sized stone – natural deposits.	2.7

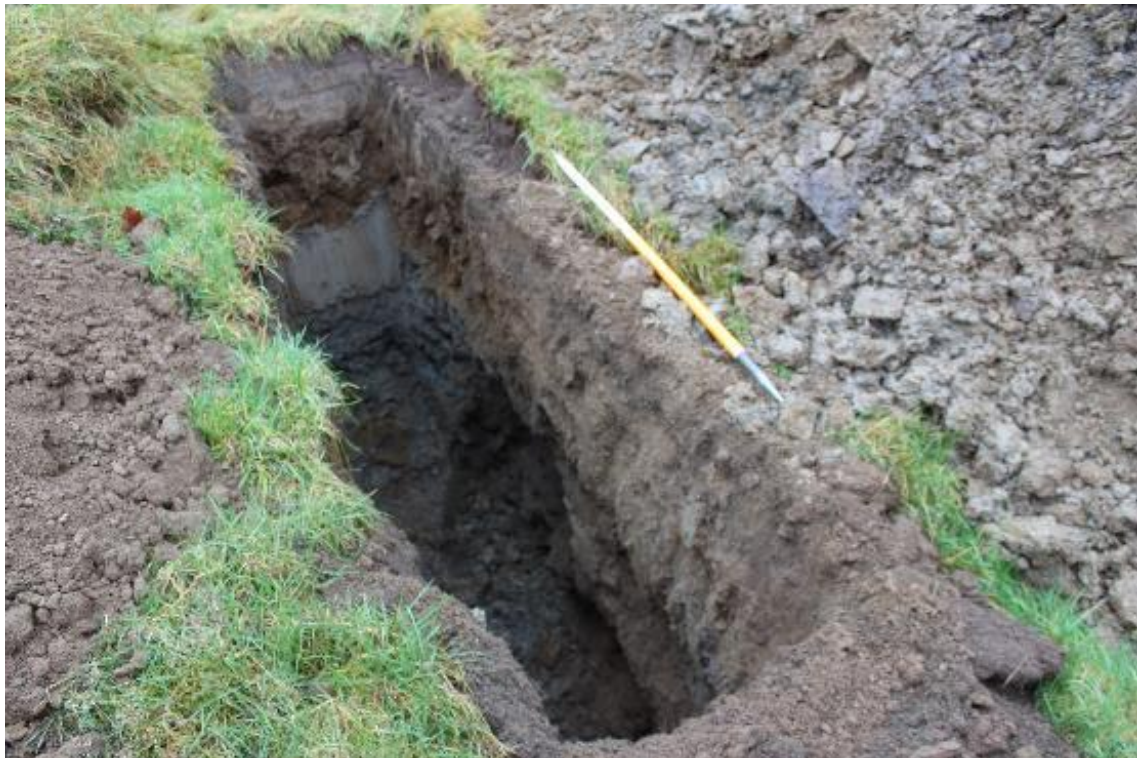
**Photograph 32:** View southeast: FC TP3 – 1m scale

FC TP3 (2m long x 0.5m wide x 1.7m deep) Aligned E-W NGR SN 271541 274111		
Context Number	Description	Depth
1064	Grey, coarse sand/fine gravels; ore-processing waste.	0.3m
1065	Loose, grey-brown, silty-sand.	0.6m
1066	Orange-brown, gravelly clay	0.95
1067	Grey, gravelly-clay with large stones and quartz lower down the layer. Water ingress at 1.7m. Uncertain whether (1066) and (1067) are mine-waste or natural deposits. Water ingress at 1.7m.	1.7m

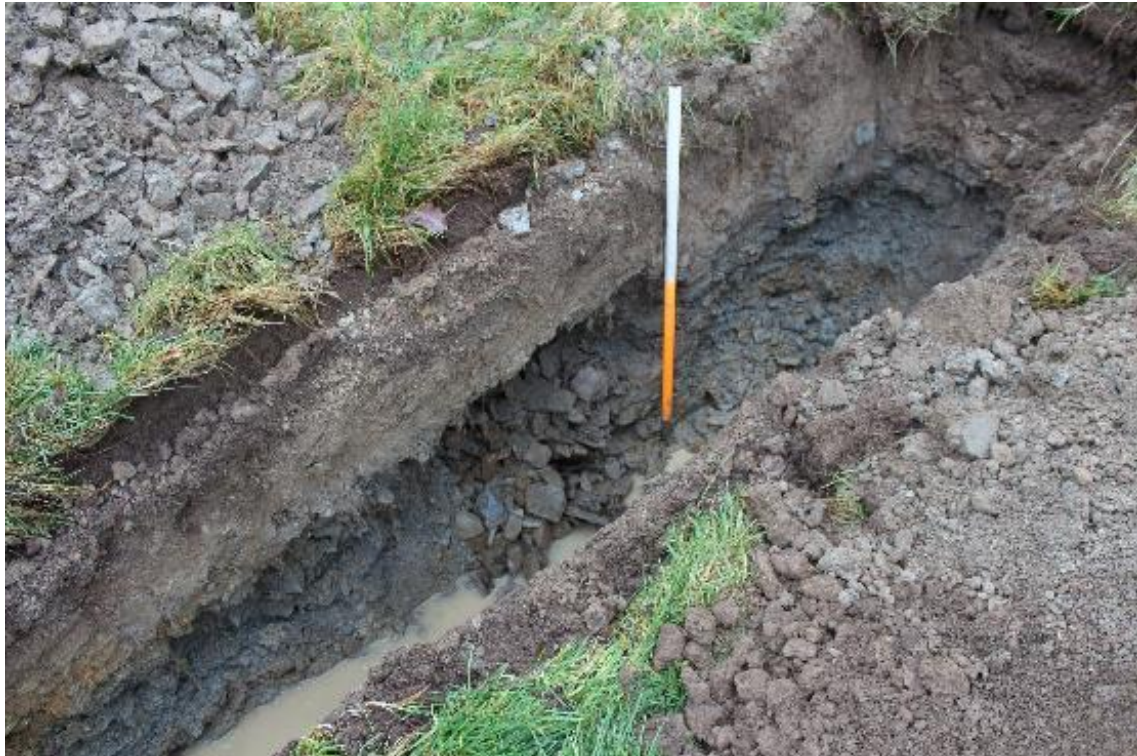
FC TP4 (2m long x 0.5m wide x 1m deep) Aligned ESE-WNW NGR SN 271529 274104		
Context Number	Description	Depth
1068	Topsoil	0.1m
1069	Grey, coarse sand/fine gravels; ore-processing waste.	0.4m
1070	Stone-filled drain, approximately 0.45m wide and 0.5m deep. Below (1069) and cut into (1071).	1m
1071	Loose, sandy-gravel deposit with frequent stone and small amount of clay. Test pit abandoned due to water ingress.	1m

**Photograph 33:** View NNE: FC TP4; stone-filled drain (in section) beside 1m scale

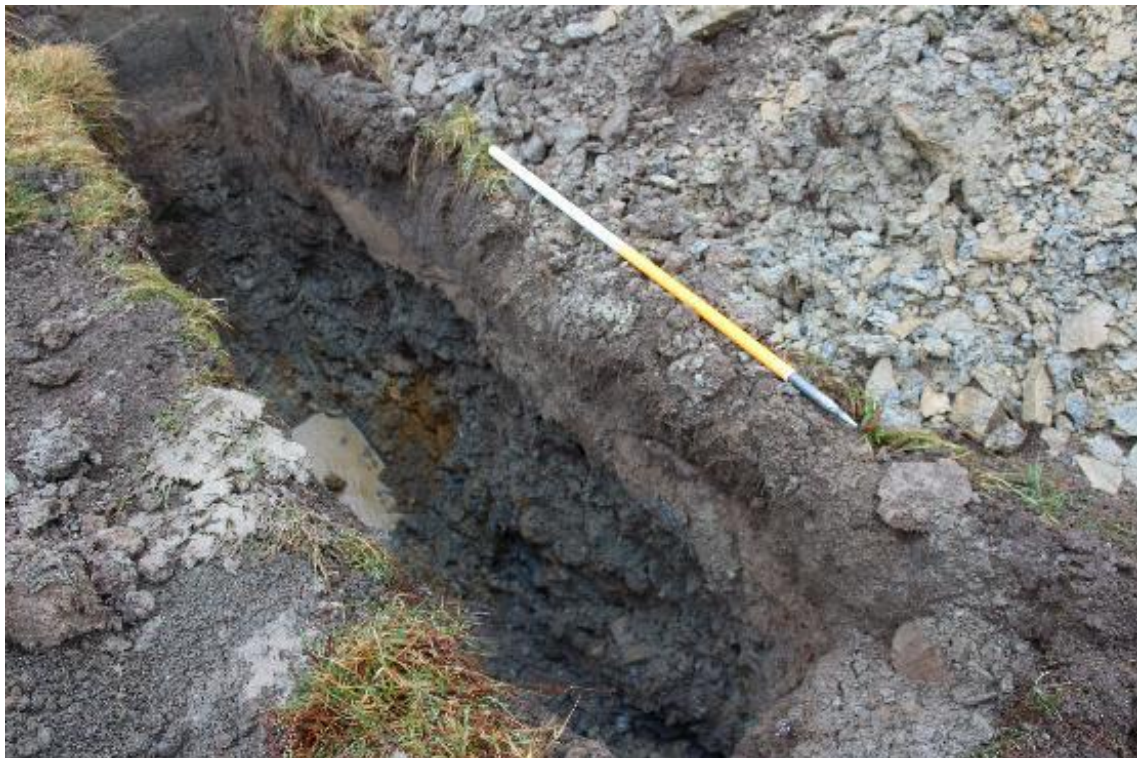
**Photograph 34:** View southeast: FC TP4a – 1m scale

FC TP4a - replaces abandoned FC TP4 (2m long x 0.5m wide x 1.8m deep) Aligned N-S		
Context Number	Description	Depth
1072	Topsoil	0.1m
1073	Grey, coarse sand/fine gravels; ore-processing waste.	0.35m
1074	Loose, sandy-gravel deposit with small amount of clay, stones and quartz pieces; probably mine-waste. Bedrock visible at 1.8m.	1.8m

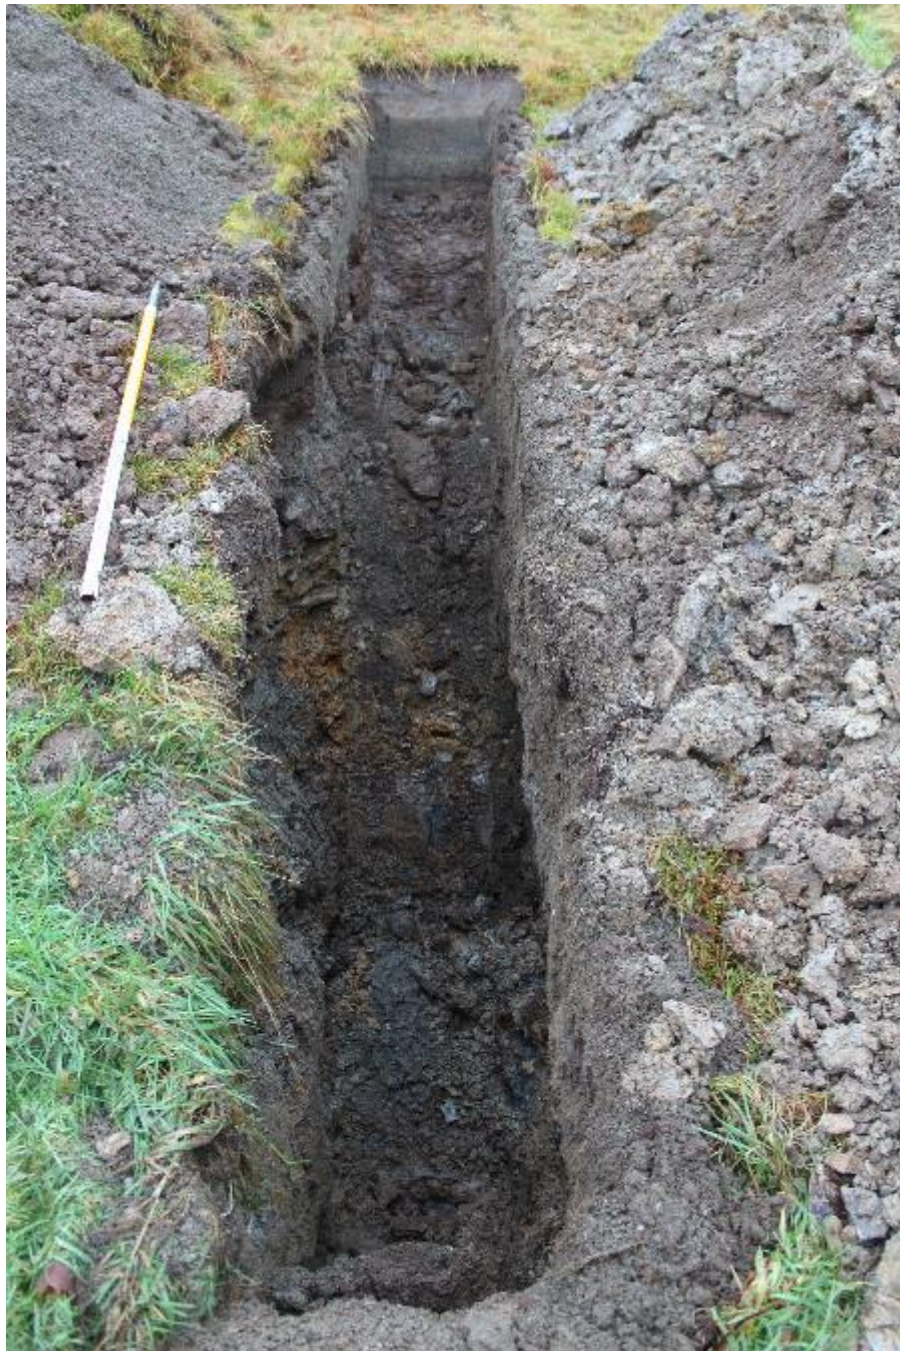
**Photograph 35:** View southeast: FP TP1 – 1m scale

FP TP1 (2m long x 0.5m wide x 1.7m deep) Aligned ESE-WNW NGR SN 271525 274096		
Context Number	Description	Depth
1075	Topsoil	0.1m
1076	Grey, coarse sand/fine gravels; ore-processing waste.	0.4m
1077	Mixed deposit of clayey-sands and stone – possibly mine material. Weathered bedrock at 1.8m	1.8m

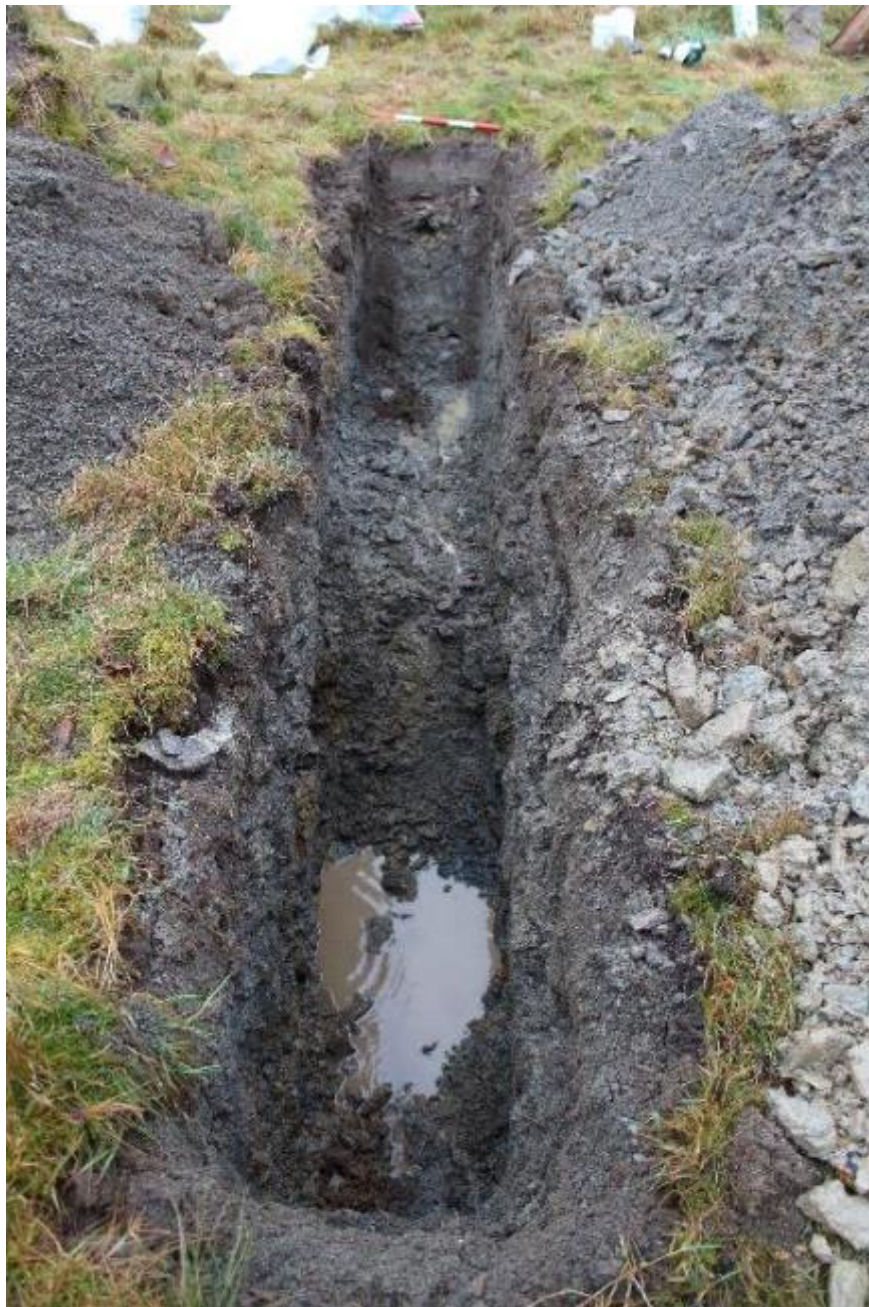
**Photograph 36:** View south: FP TP2 – 0.5m scale

FP TP2 (2m long x 0.5m wide x 1.5m deep) Aligned N-S NGR SN 271517 274086		
Context Number	Description	Depth
1078	Grey, coarse sand/fine gravels; ore-processing waste.	0.3m
1079	Buried topsoil	0.4m
1080	Mixed deposit of clayey-sands and small/medium stone with occasional large stone – mine material? Weathered bedrock at 1.5m	1.5m

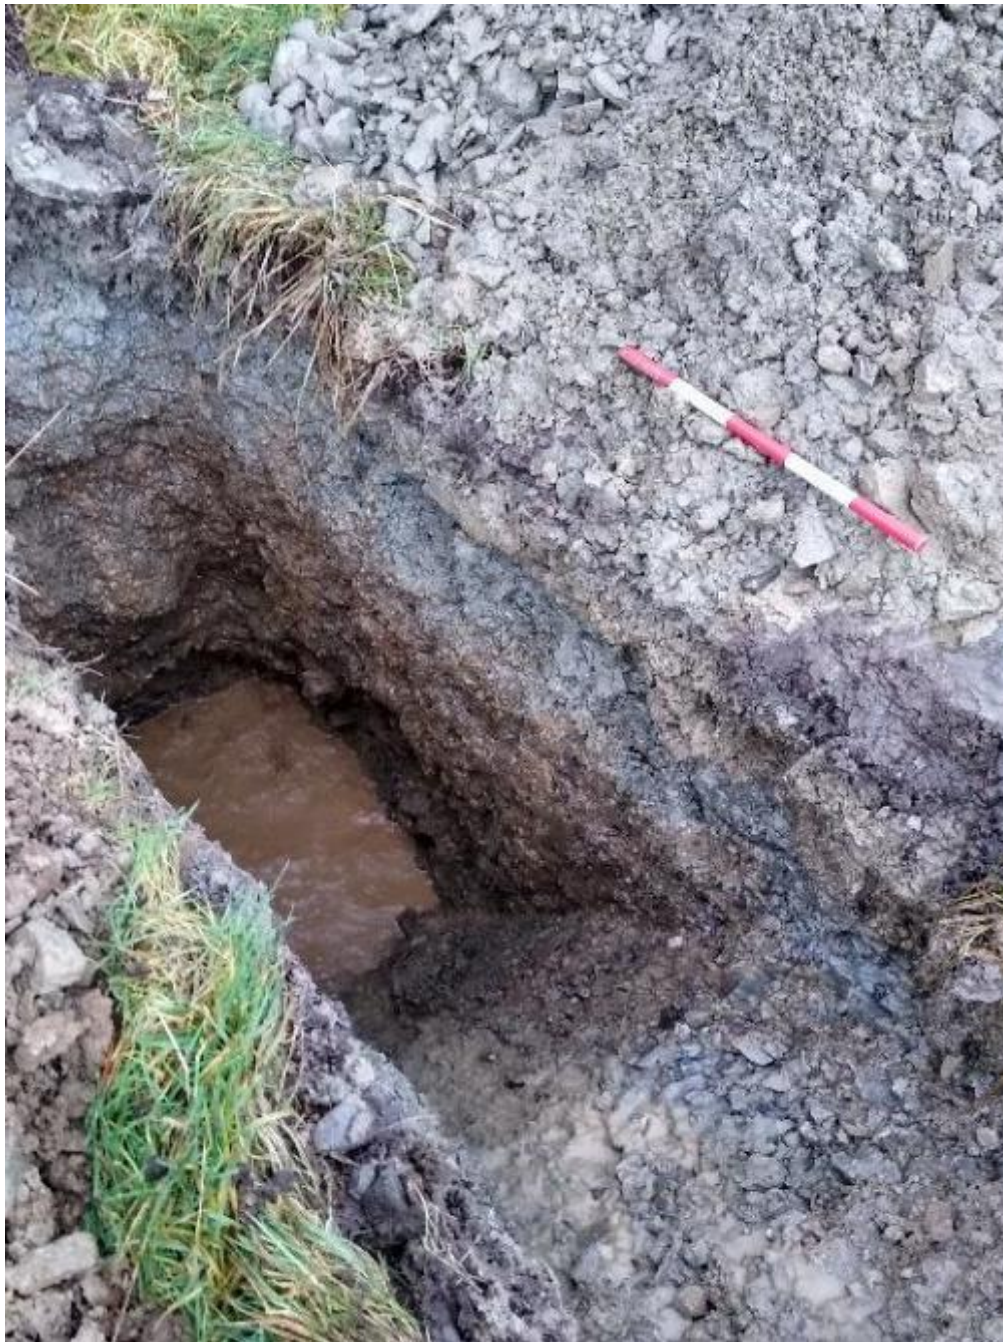
**Photograph 37:** View west: FP TP3 – 0.5m scale

FP TP3 (2m long x 0.5m wide x 1.4m deep) Aligned NW-SE NGR SN 271500 274098		
Context Number	Description	Depth
1081	Grey, coarse sand/fine gravels; ore-processing waste.	0.1m
1082	Gravelly, grey sandy clay	0.4m
1083	Orange-brown, sandy-clay, frequent small/medium stone – natural? Bedrock v at 1.4m.	1.4m

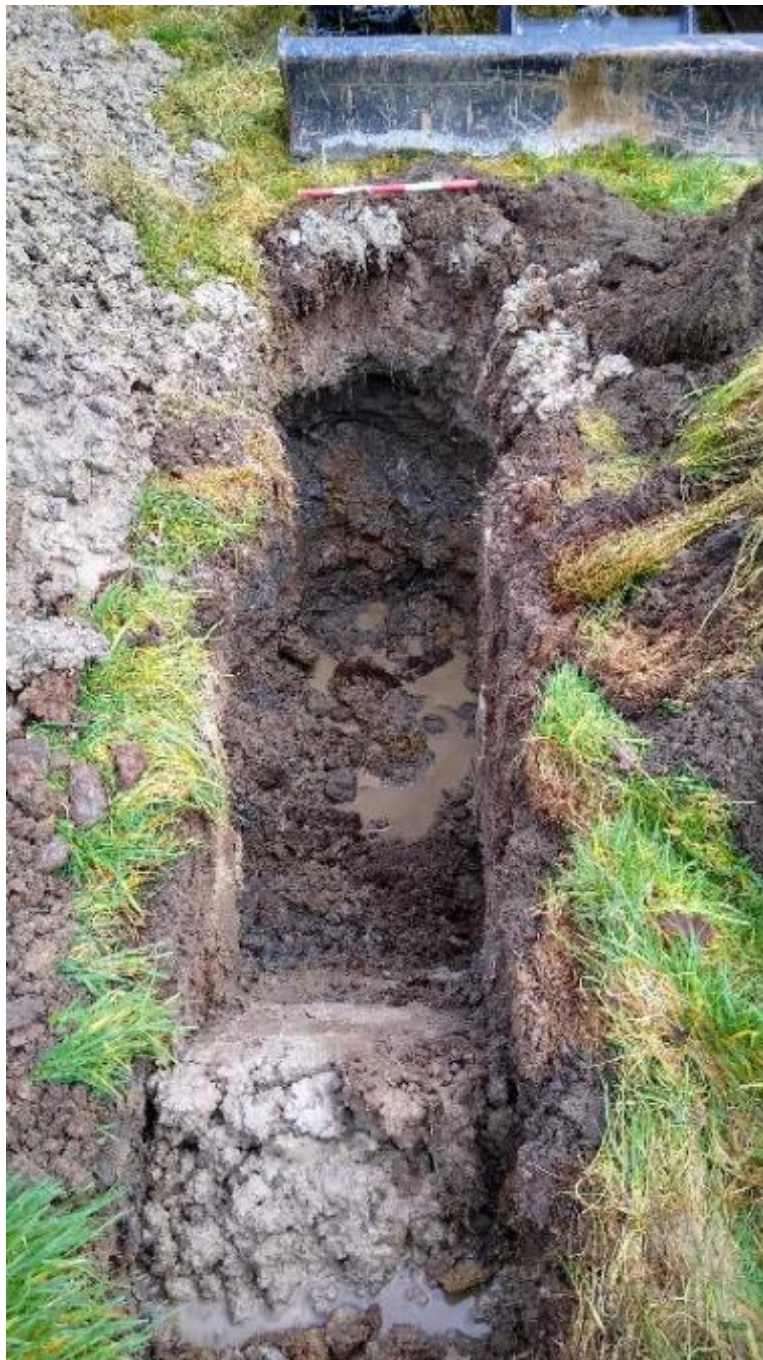
**Photograph 38:** View east: FP TP4 – 0.5m scale

FP TP4 (2m long x 0.5m wide x 1.3m deep) Aligned E-W NGR SN 271500 274087		
Context Number	Description	Depth
1081	Grey, coarse sand/fine gravels; ore-processing waste.	0.4m
1082	Dark grey sandy clay	0.6m
1083	Stony, clayey gravels; weathered bedrock visible at 1.3m	1.3m

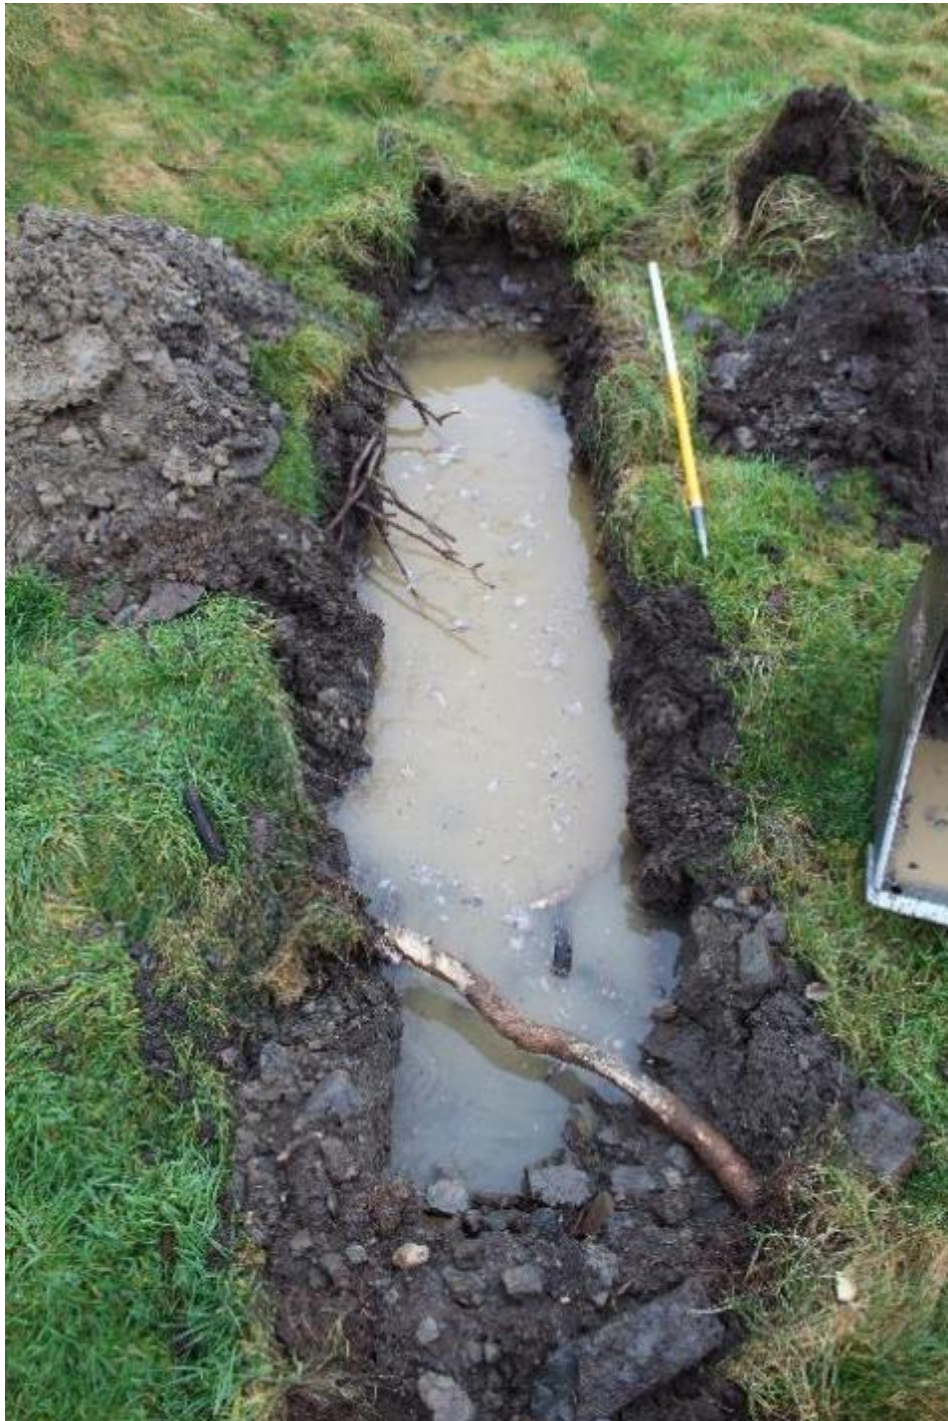
**Photograph 39:** View north: FP TP5 – 1m scale

FP TP5 (2m long x 0.5m wide x 0.4m deep) Aligned N-S NGR SN 271483 274094		
Context Number	Description	Depth
1084	Topsoil	0.25m
1085	Yellow-brown, sandy-clay, frequent small stones. Water ingress at 0.4m – test pit abandoned.	0.4m

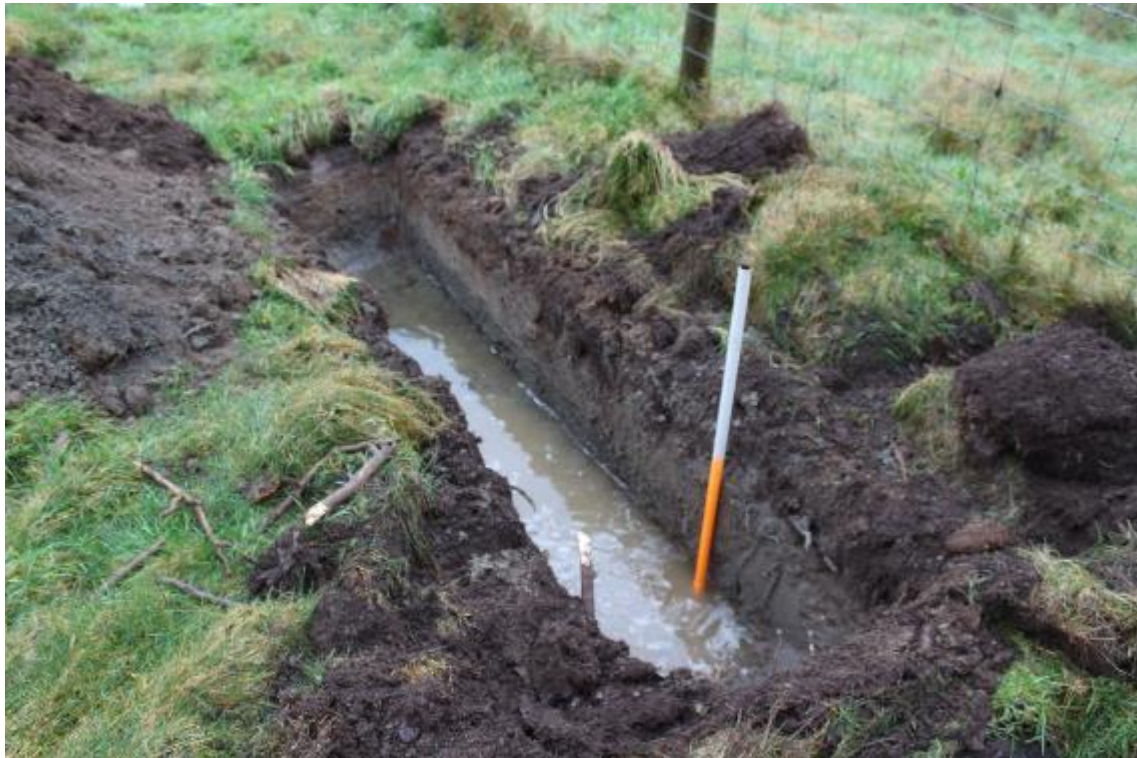
**Photograph 40:** View southeast: FP TP6 – 1m scale

FP TP6 (2m long x 0.5m wide x 0.7m deep) Aligned E-W NGR SN 271486 274088		
Context Number	Description	Depth
1086	Topsoil	0.15m
1087	Grey coarse sand/fine gravels and clay. Water ingress at 0.7m – test pit abandoned.	0.7m

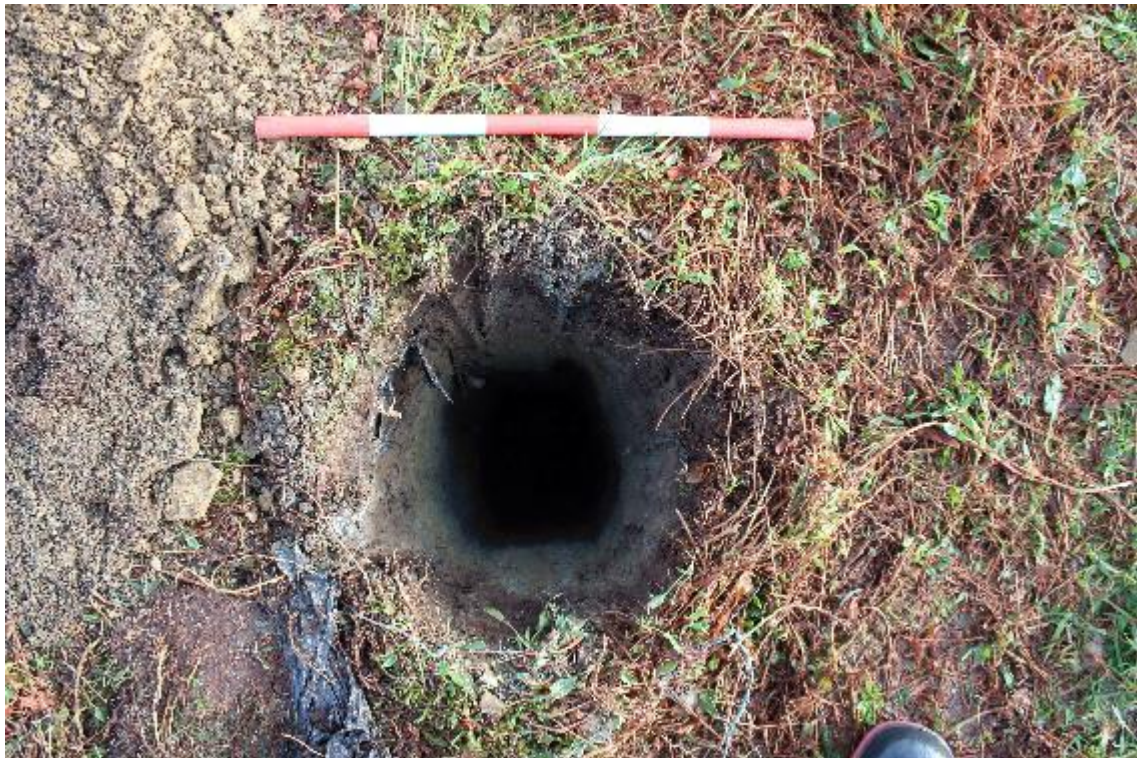
**Photograph 41:** View ESE: FSS IP1 – 0.5m scale

FSS IP1 (0.4m x 0.4m x 0.9m deep) NGR SN271220 274202		
Context Number	Description	Depth
1054	Topsoil	0.1m
1055	Grey, coarse sand/fine gravels; ore-processing waste.	0.4m
1056	Light brown, silty clay with moderate amount of small stone. Bedrock encountered at 0.9m	0.9m

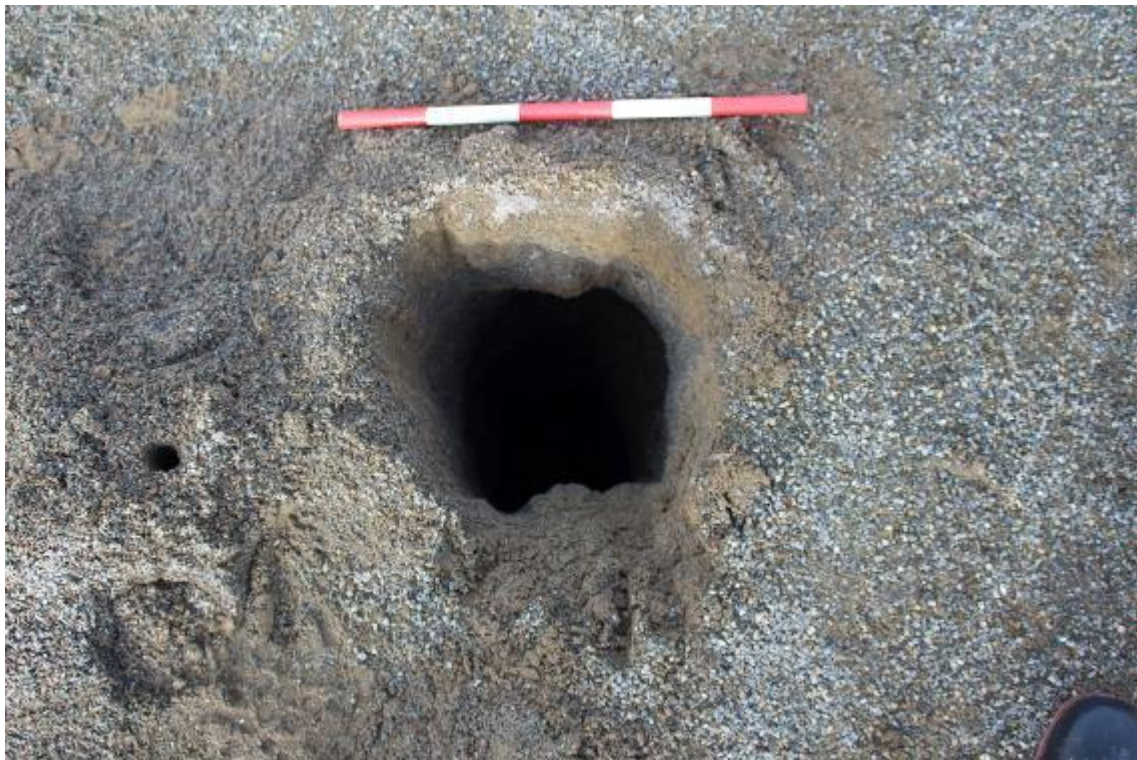
**Photograph 42:** View northeast: FSS IP2 – 0.5m scale

FSS IP2 (0.4m x 0.4m x 1.2m deep) NGR SN271230 274221		
Context Number	Description	Depth
1057	Grey, coarse sand/fine gravels; ore-processing waste.	1.2m

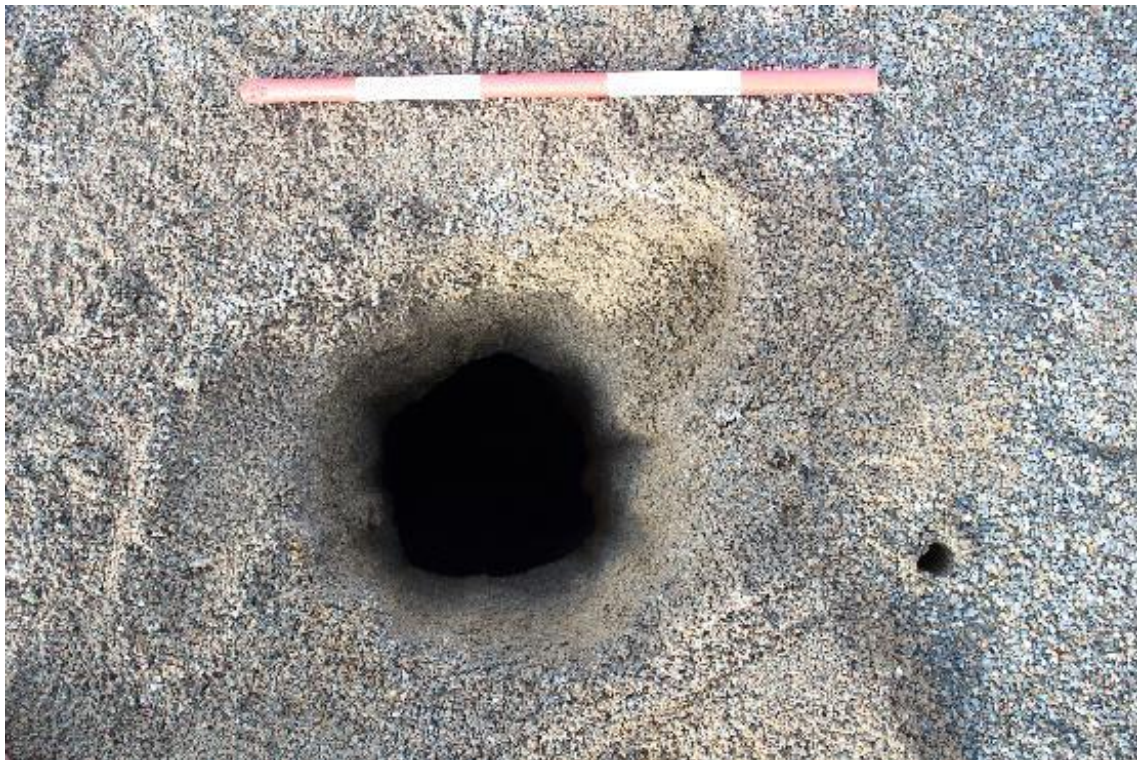
**Photograph 43:** View northwest: FSS IP3 – 0.5m scale

FSS IP3 (0.4m x 0.4m x 1.2m deep) NGR SN 271206 274224		
Context Number	Description	Depth
1058	Grey, coarse sand/fine gravels; ore-processing waste.	1.2m

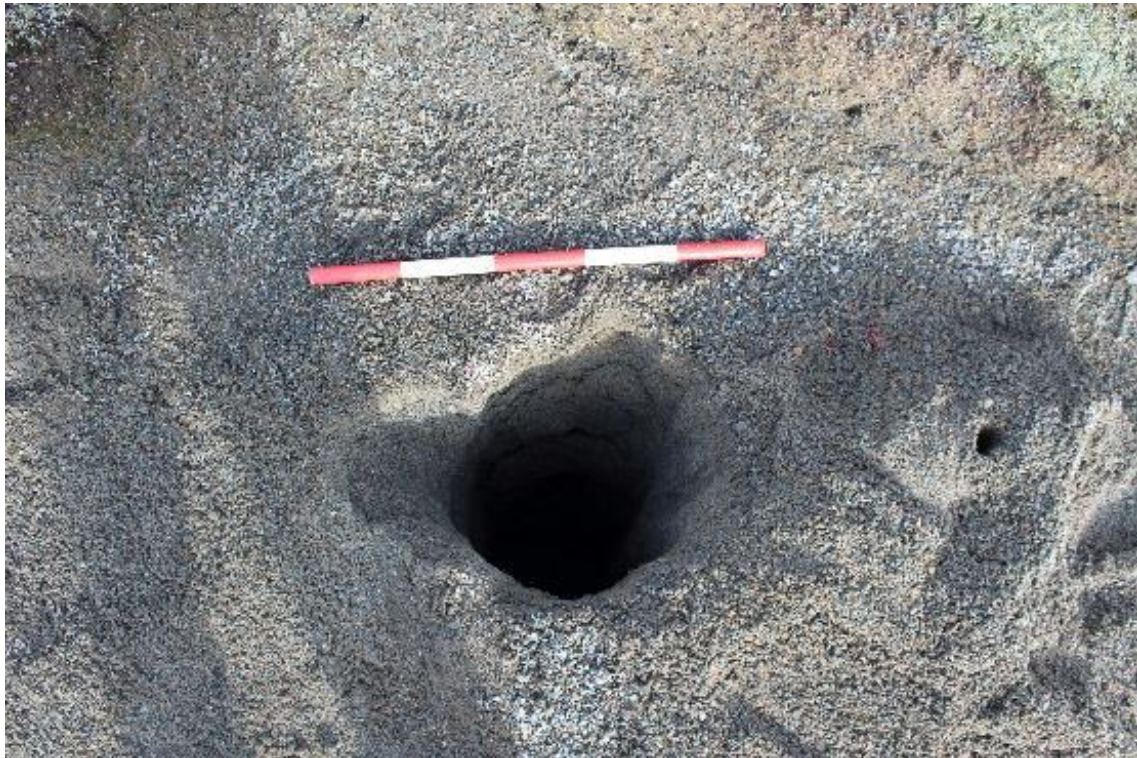
**Photograph 44:** View north: FSS IP4 – 0.5m scale

FSS IP4 (0.4m x 0.4m x 1.2m deep) NGR SN 271192 274220		
Context Number	Description	Depth
1059	Grey, coarse sand/fine gravels; ore-processing waste.	1.2m
