# WEMYSS METAL MINE, CEREDIGION: ARCHAEOLOGICAL WATCHING BRIEF

REPORT NO. 2021-43  
EVENT RECORD NO. 125987

**WEMYSS METAL MINE, CEREDIGION:  
ARCHAEOLOGICAL WATCHING BRIEF**

*DAT Archaeological Services were commissioned to undertake a watching brief in January 2021 during groundworks associated with geotechnical investigational works at Wemyss Metal Mine, Ceredigion (NGR SN 71579 74089).*

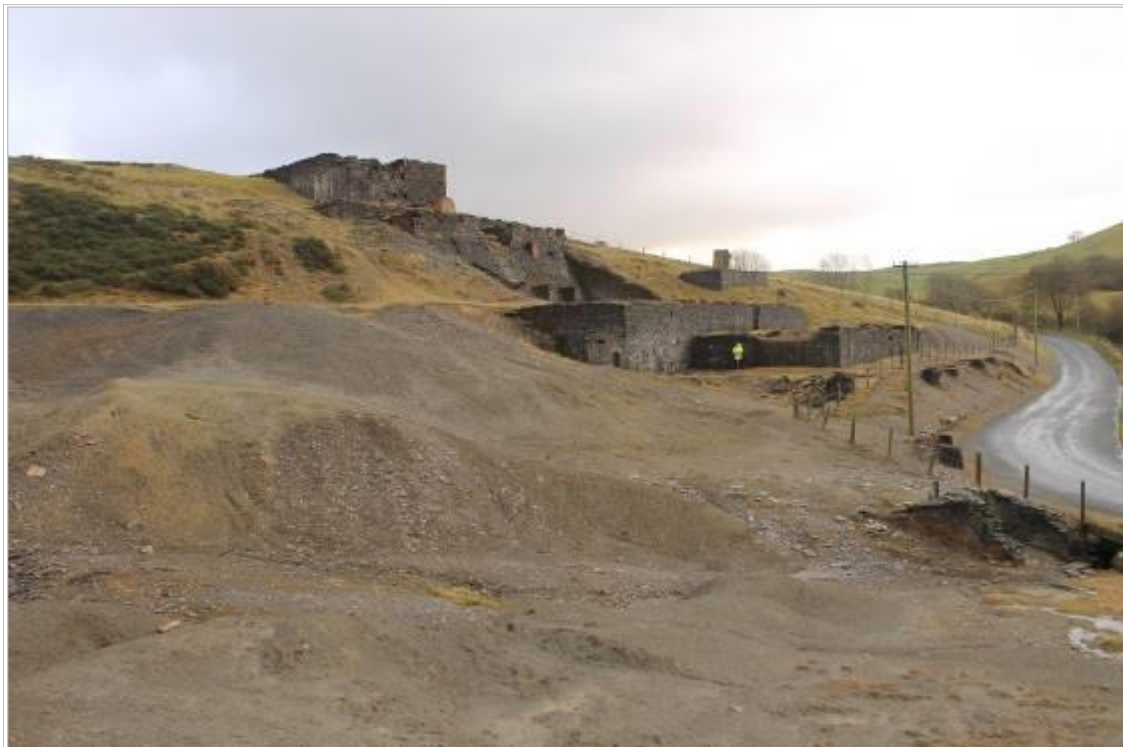
**Photo 1:** Remains of the dressing mill (PRN 96323). Minor road that bisects site can be seen to right.

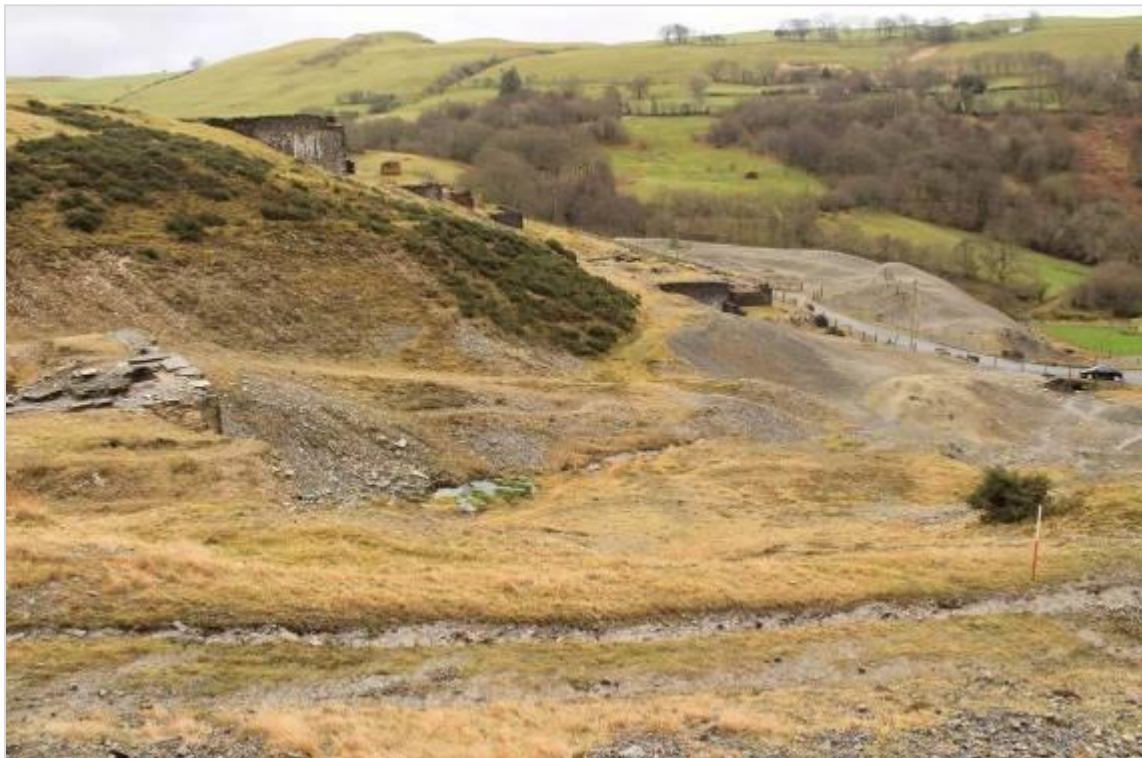
**Photo 2:** Overview shot looking south. The remains of the former dressing mill (PRN 96323) can be seen in the background; top of wheel pit (PRN 96318) is visible in left foreground. 1m scale.
