# **PROPOSED AGRICULTURAL FEED SHED AT MERRYBOROUGH FARM, WISTON, PEMBROKESHIRE: HISTORIC ENVIRONMENT DESK-BASED ASSESSMENT**

REPORT NO. 2021-68  
PROJECT NO. 126605

July 2021

DAT Archaeological Services were commissioned to undertake an Historic Environment Desk Based Assessment on a proposed new agricultural feed shed at Merryborough Farm, Wiston, Pembrokeshire

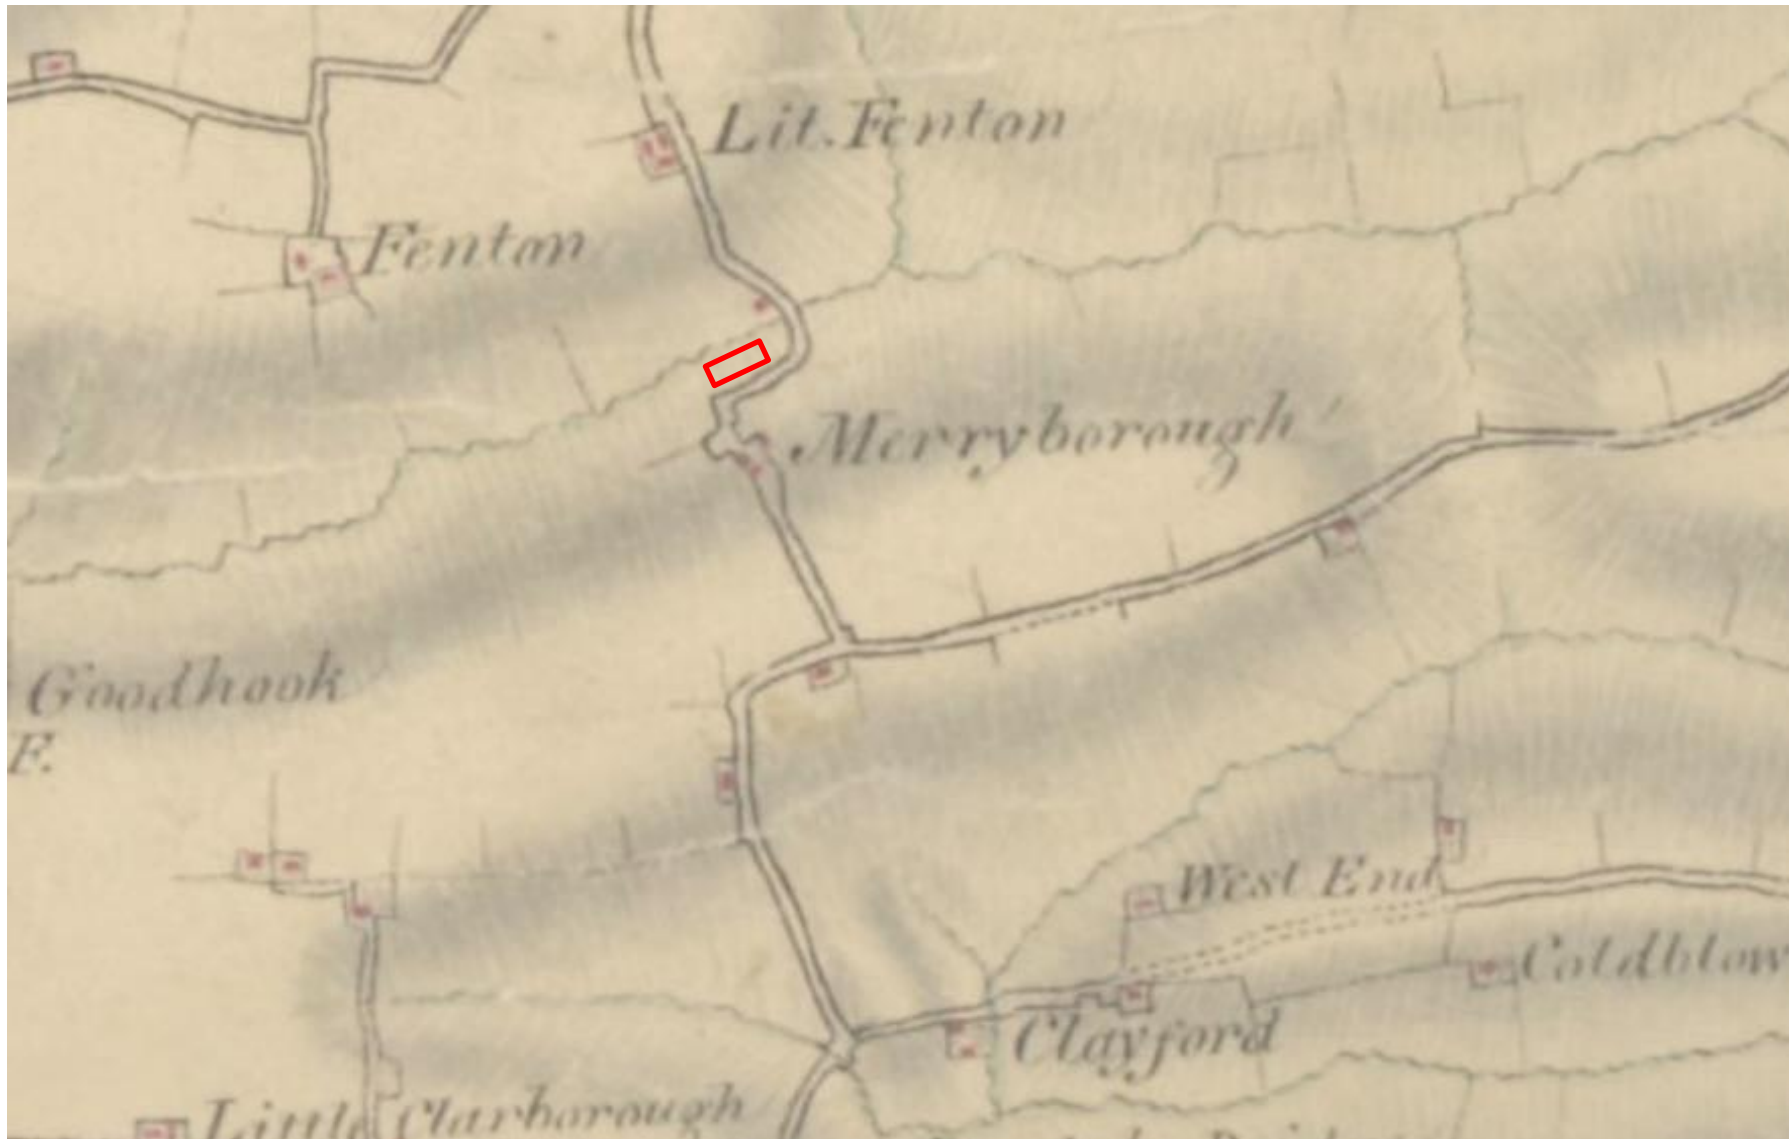
**Figure 5:** Map by Thomas Budgen 1810. Approximate location of development area shown in red.

#### Map by Thomas Budgen 1810 (Figure 5)

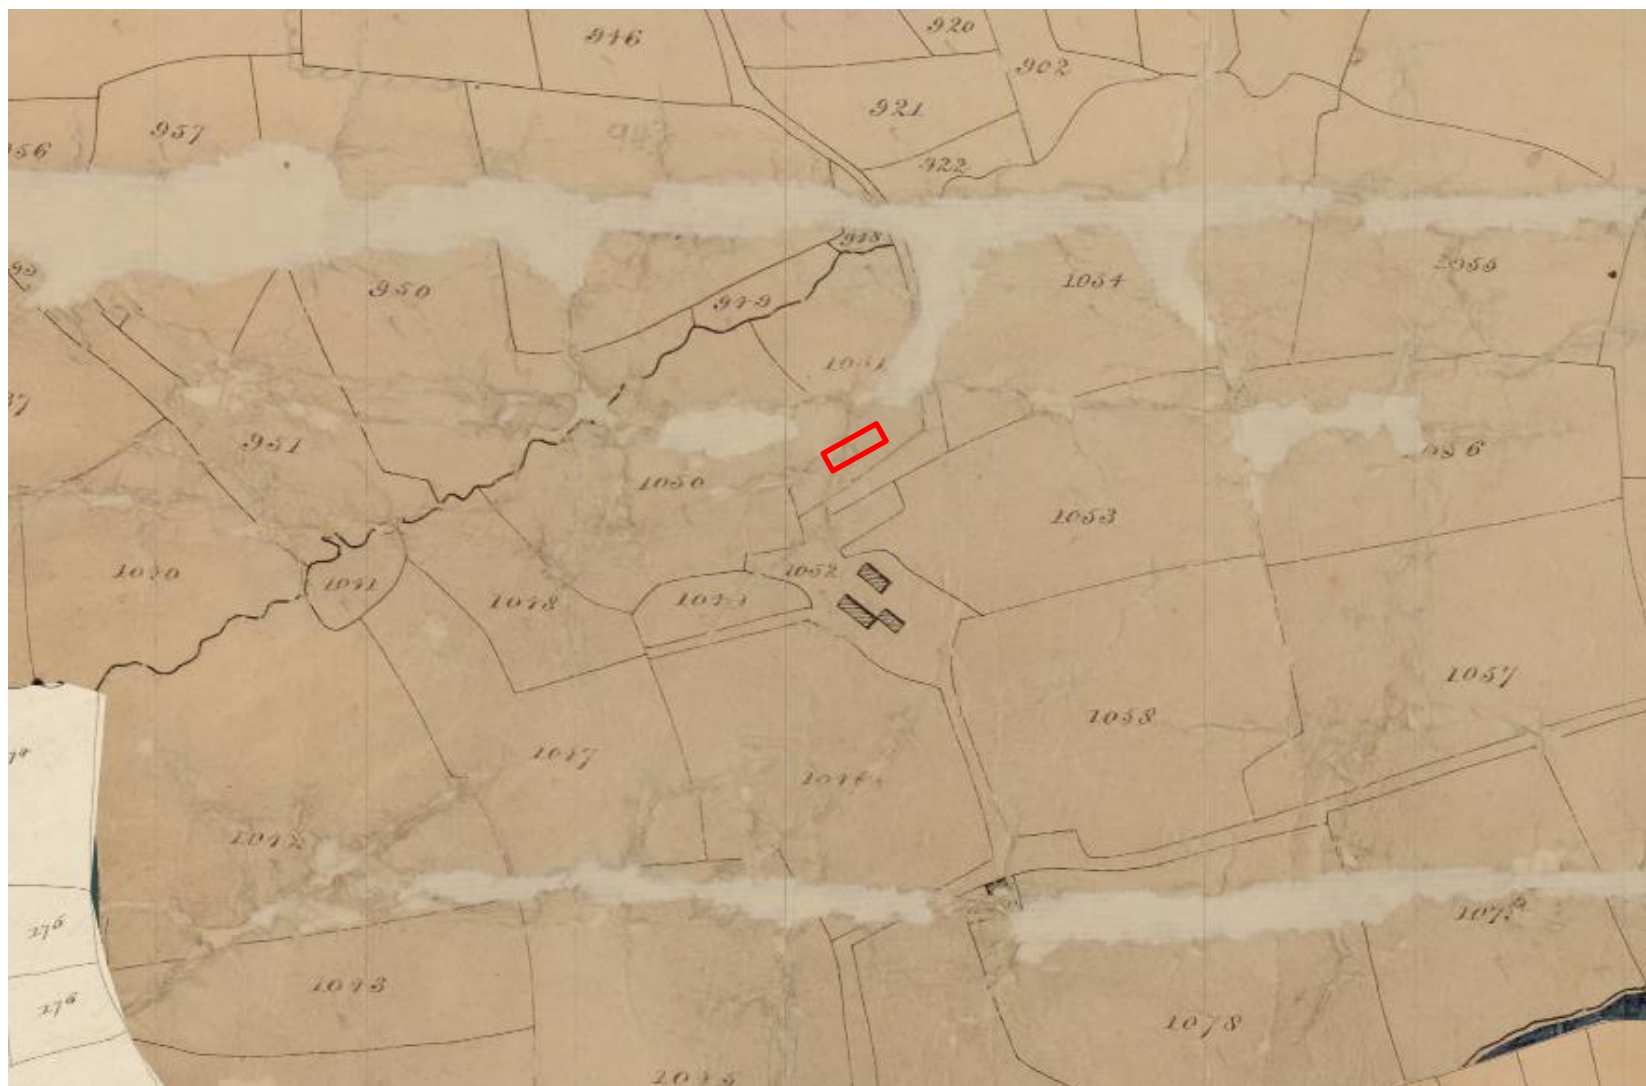
**Figure 6:** 1842 Wiston parish tithe map. Approximate location of development area shown in red.

#### 1844 tithe map of Wiston parish (Figure 6)

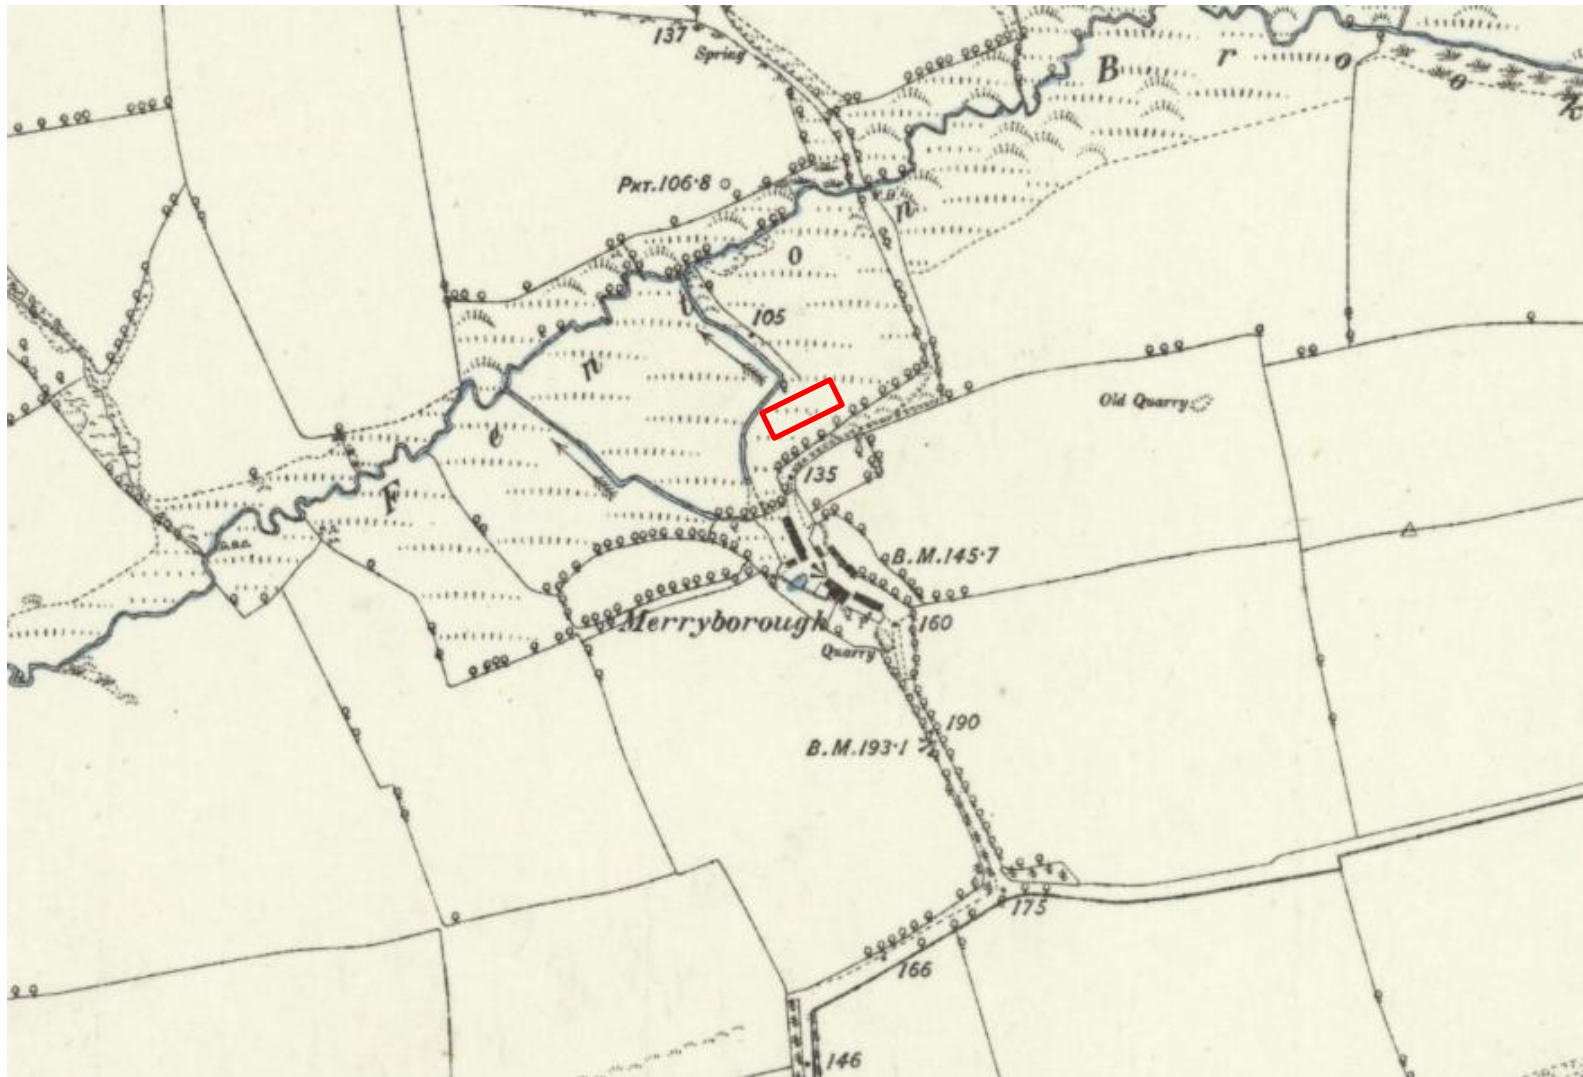
**Figure 7:** Extract of the 6inch 1st edition Ordnance Survey map published in 1897.  
Approximate location of development area shown in red.

#### 1897 1st edition Ordnance Survey Map of England and Wales (Figure 7)

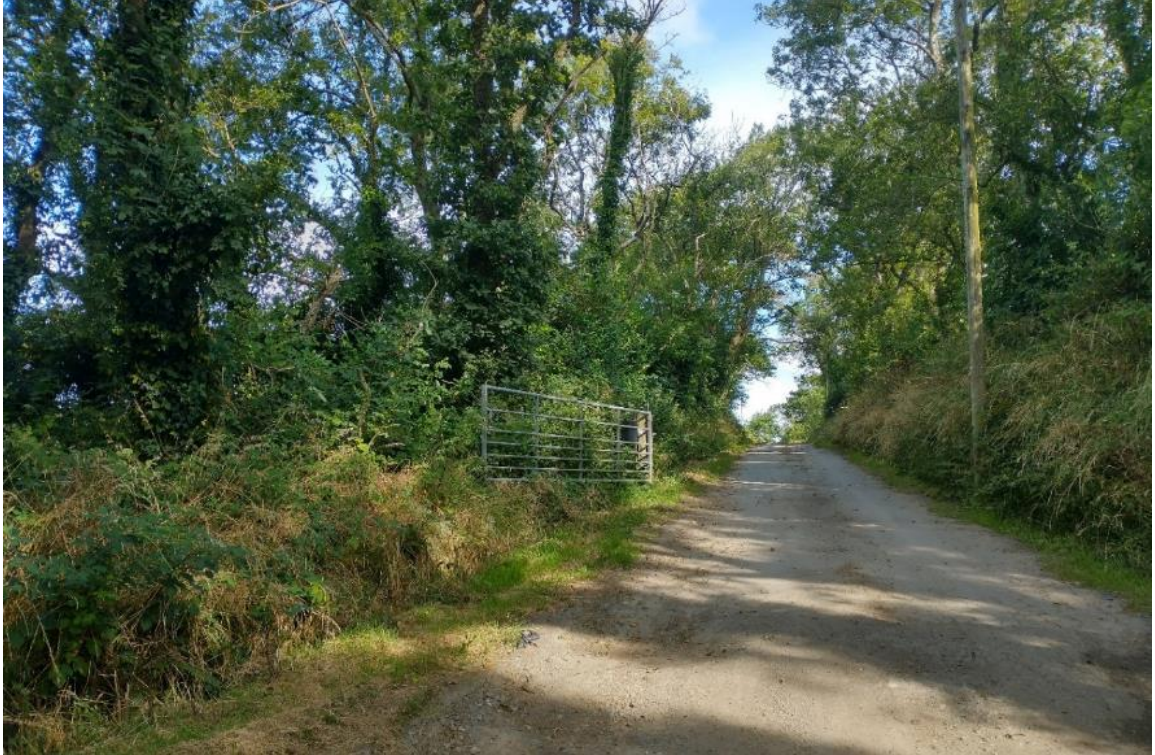
**Photograph 1:** Approach to Merryborough Farm from the south over crest of hill. Also, approximate location of Hillcrest enclosure (PRN 35768)

- 7.5.1 A site visit was undertaken on the Thursday the 27<sup>th</sup> of July 2021. The weather conditions were fair and dry with good visibility.
- 7.5.2 The farm is accessed along a private track running from an unnamed road, not far to the north of the A40 (Photograph 1). This track runs over the crest of a ridge before gradually falling into the small valley of Fenton Brook which runs east/west across the northern boundary of the farm.

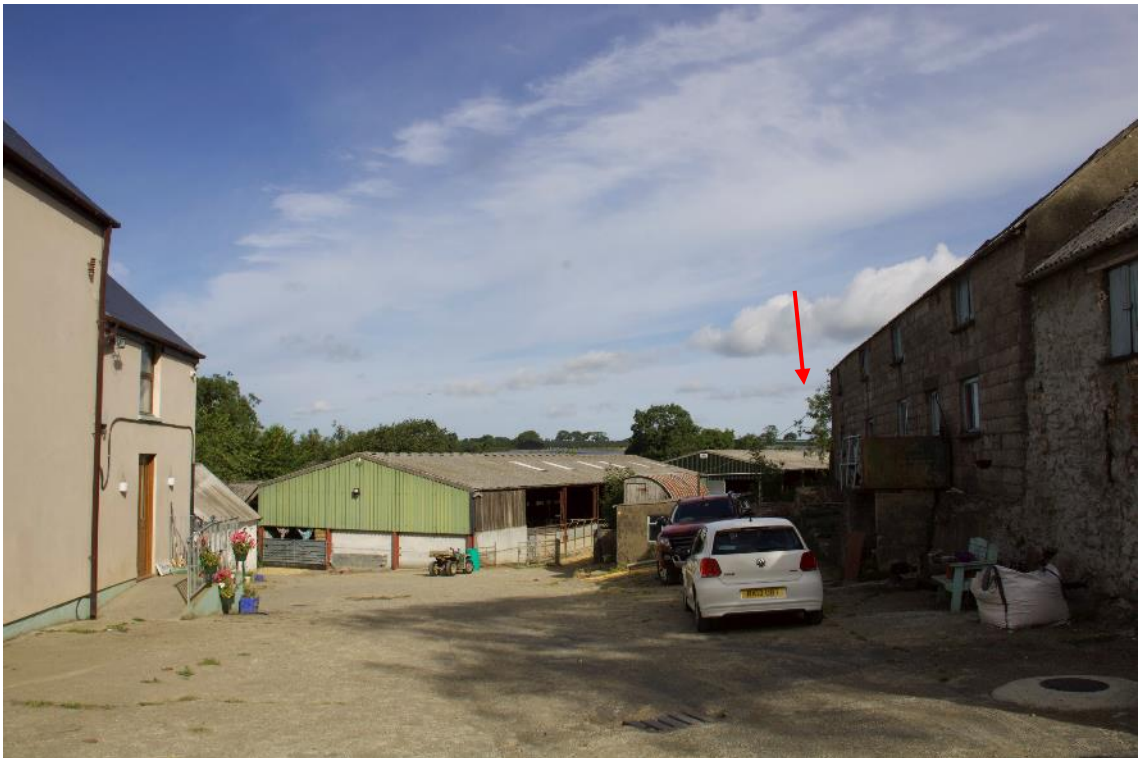
**Photograph 2:** Looking north entering the current modern Merryborough farmyard. Modern farm buildings in the distance. Proposed location of feed store marked by red arrow.

- 7.5.3 Approximately 0.2km along the descending track is a slight plateau in which the current Merryborough farmyard is situated approximately 20m above the valley bottom (Photograph 2).

- 7.5.4 The farmyard is somewhat linear in nature running approximately north/south (Photograph 2). The southern part of the present farmyard is made up of older buildings including the current house and two likely 19<sup>th</sup> century sheds (Photographs 2, 3 and 4). It is possible that the two older farm buildings are those shown and described in the Wiston Parish tithe map described in Section 7.4. The current farmhouse is thought to be modern in date. The northern part of the farmyard is made up of modern cow/machinery sheds along its western edge and a silage clamp to the east (Photograph 2).

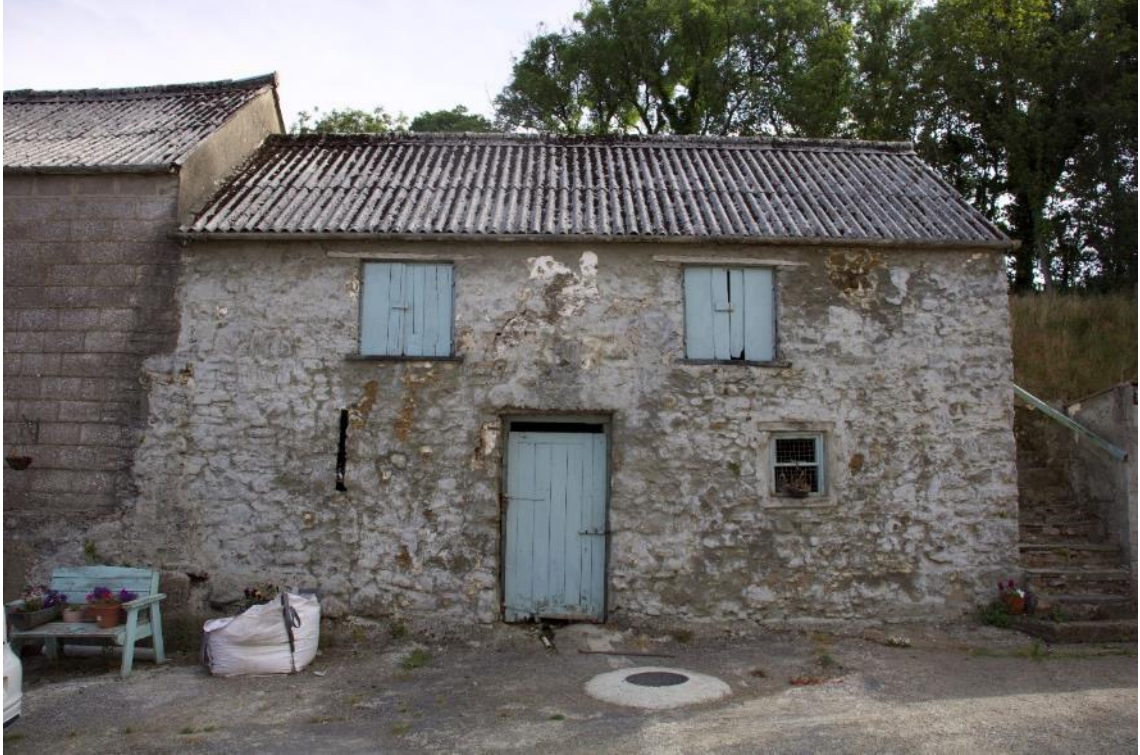
**Photograph 3:** 19<sup>th</sup> century cow shed in south-eastern part of farmyard. Looking east.

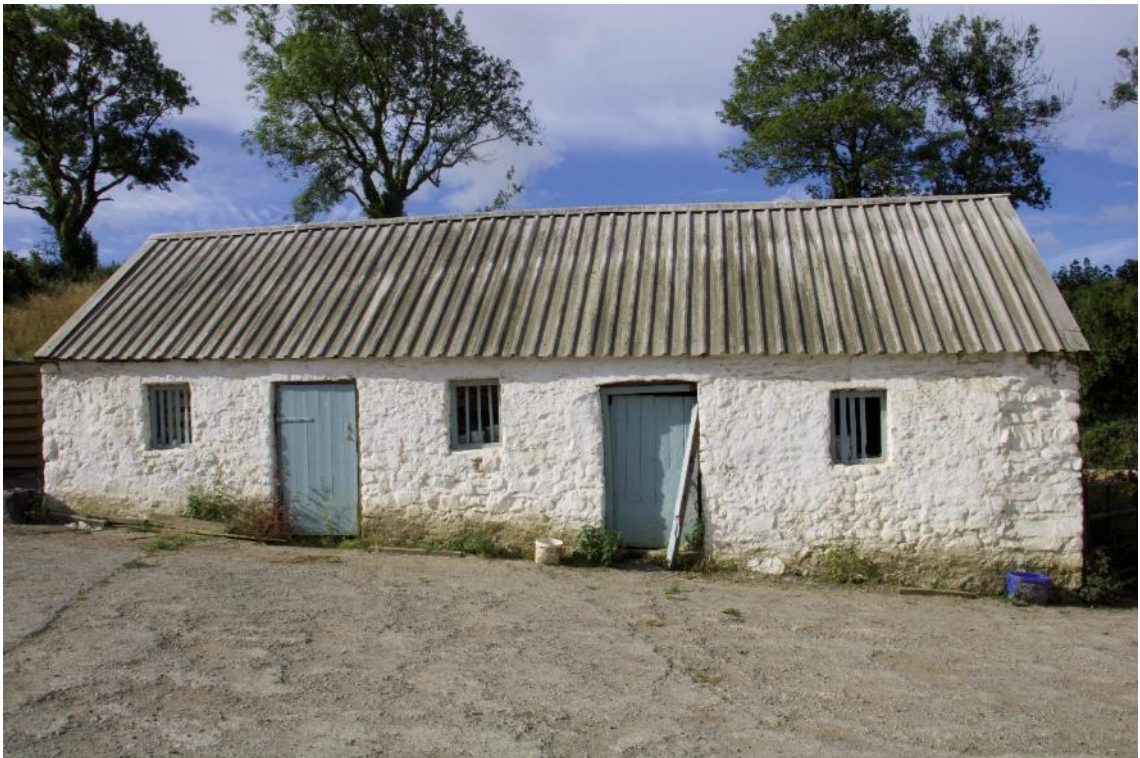
**Photograph 4:** Possible old stable on western part of farmyard. Looking west.

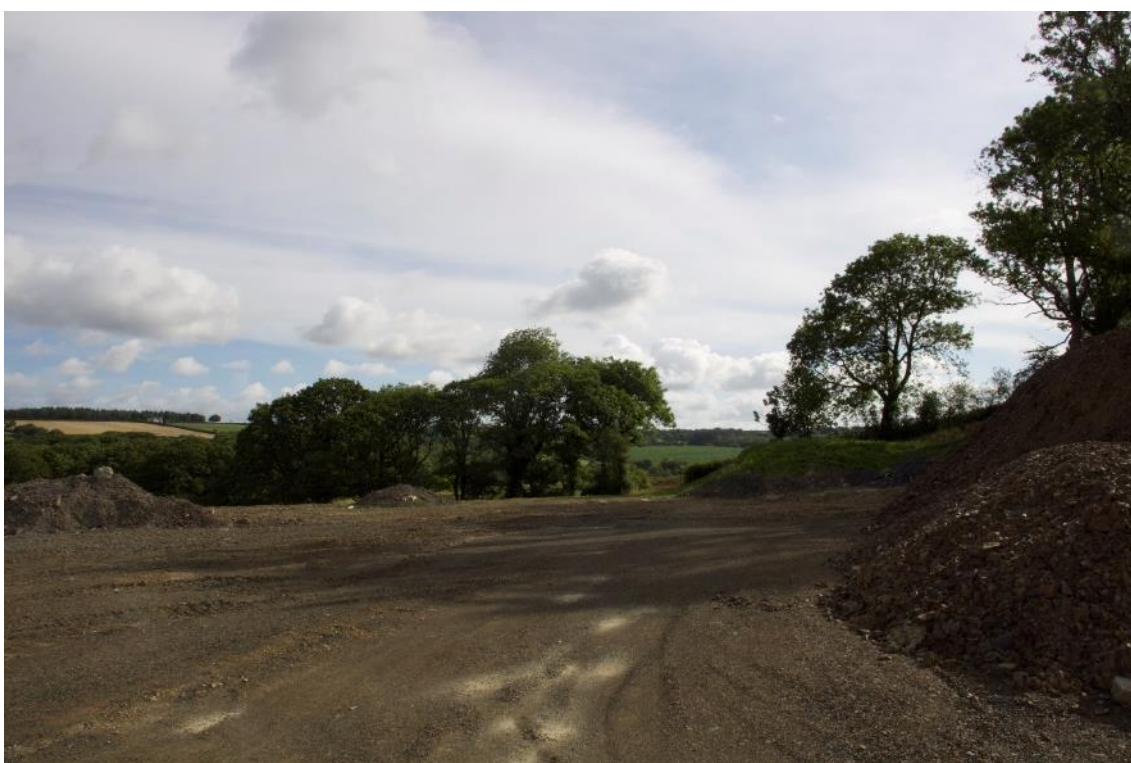
**Photograph 6:** Proposed development area. Currently a hardstanding of made ground. Looking northeast.

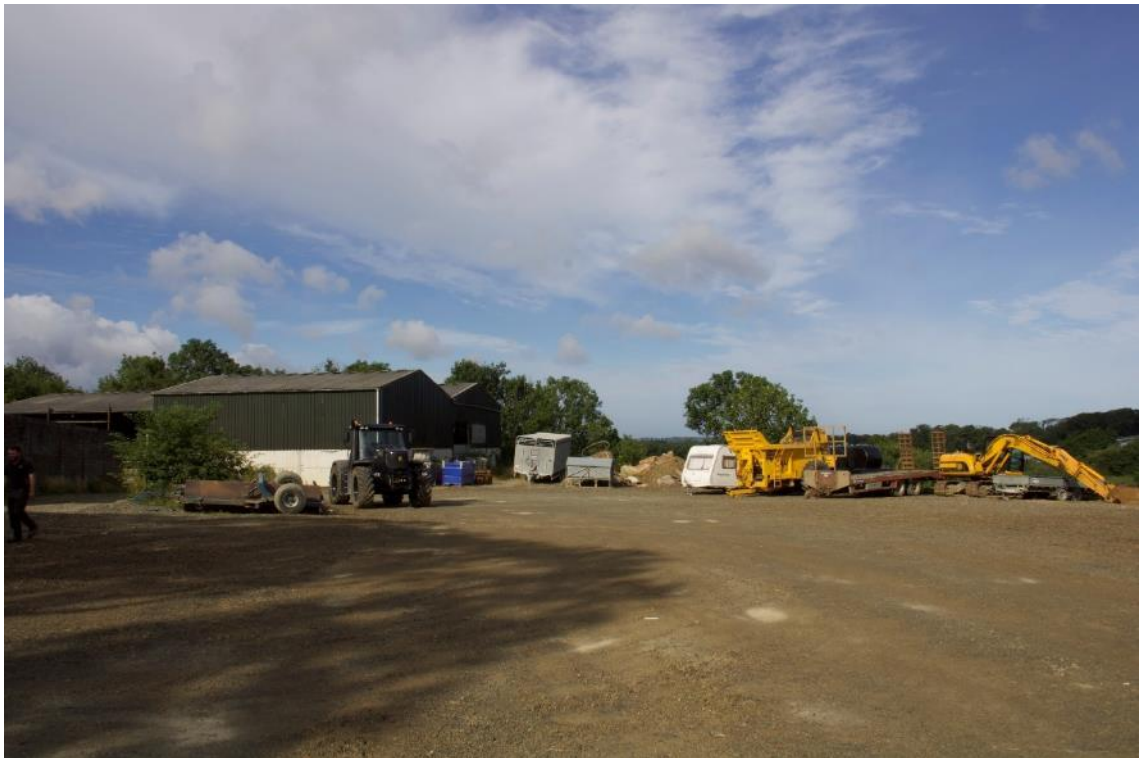
**Photograph 7:** Proposed development area. Looking northwest.

- 7.5.5 The proposed development area can be accessed through the current farmyard to which it would act as a northern extension (Photographs 6, 7, and 8). Currently the proposed development area comprises a roughly rectangular area of made ground sitting approximately 20m above the valley floor.

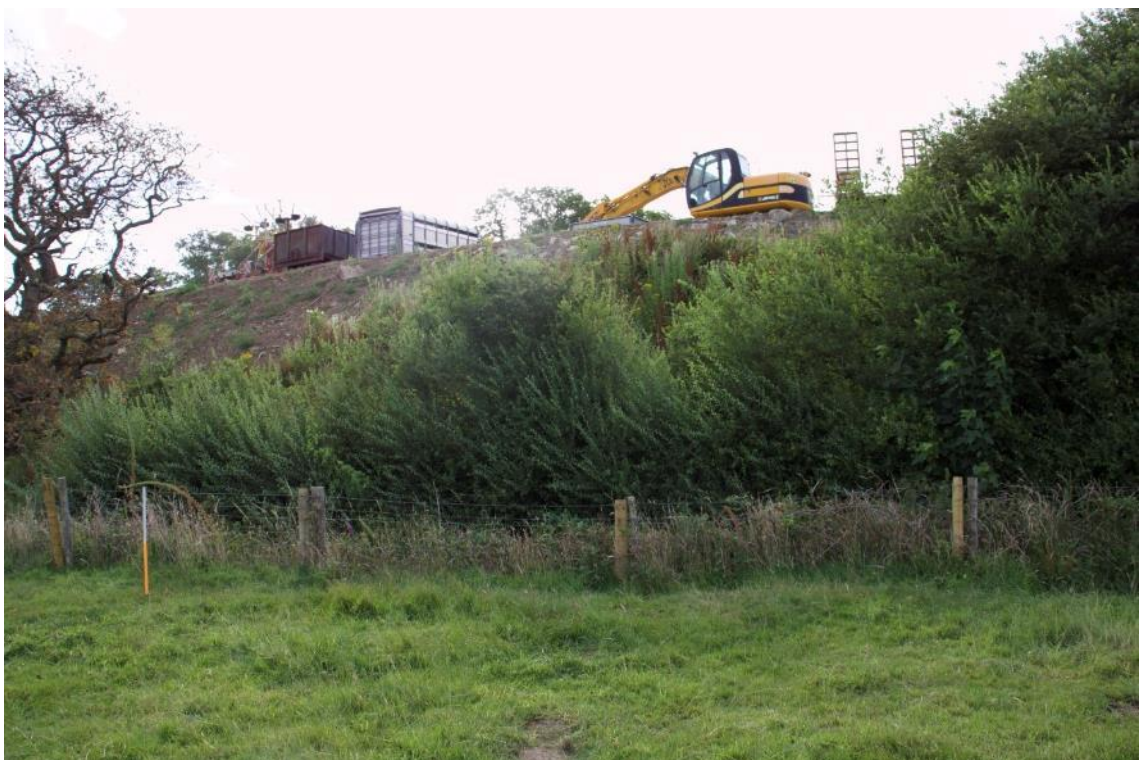
**Photograph 8:** Proposed development area from the north. Note raised hardstanding area approximately 20m above valley bottom.

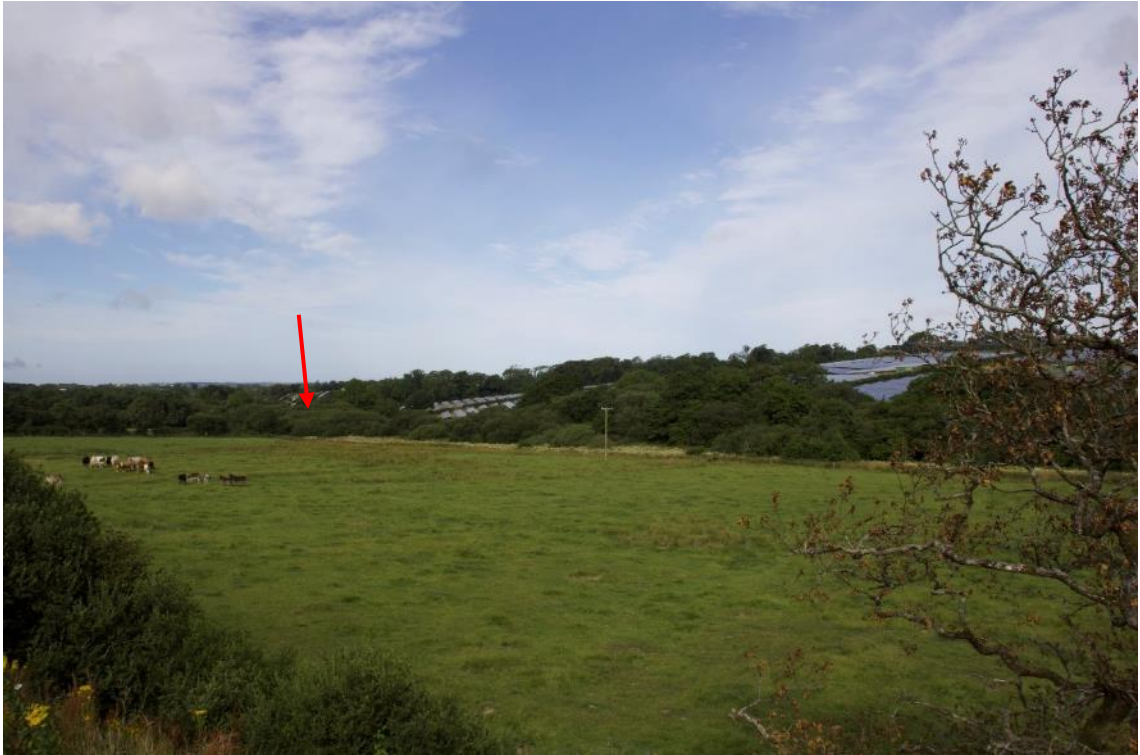
**Photograph 9:** Looking northwest towards Merryborough Moated Farmstead (PE 465) from proposed development area. Location of moated farmstead marked by red arrow.

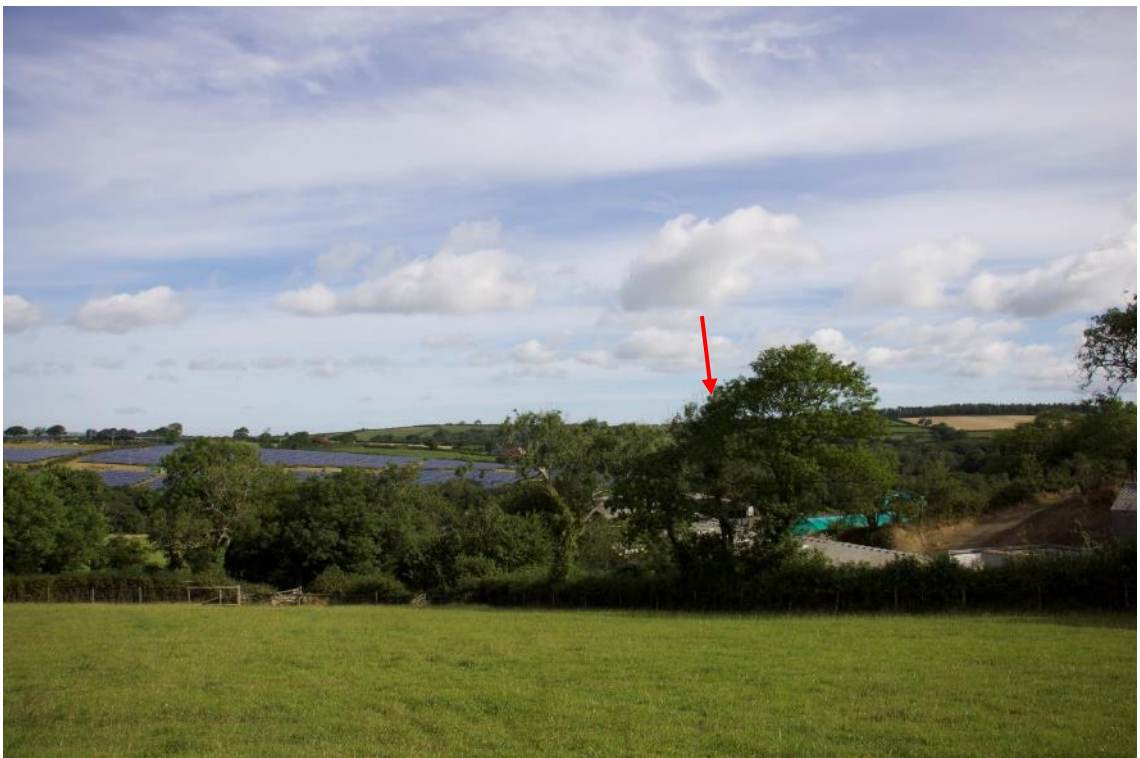
**Photograph 10:** Looking northeast towards proposed development area (red arrow) from approximate location of Merryborough Moated Farmstead (PE 465).

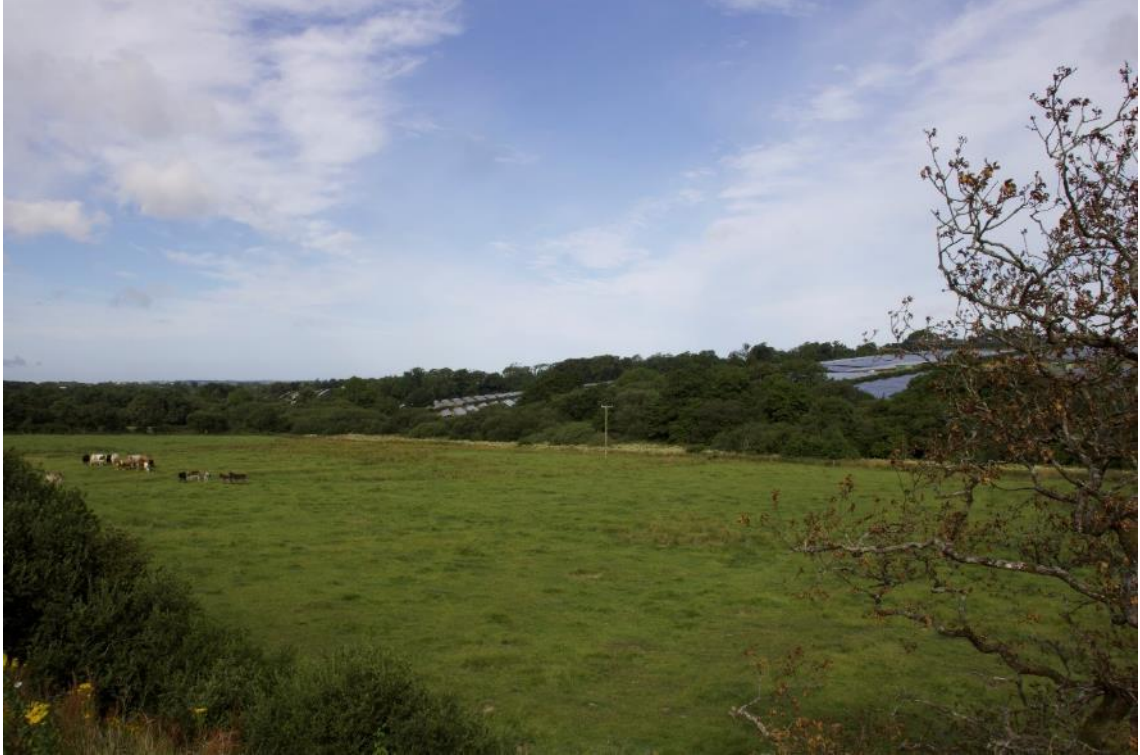
**Photograph 12:** View from the proposed development towards the pasture field that contains Merryborough Moated Farmstead (PE 465). Fenton brook beyond.

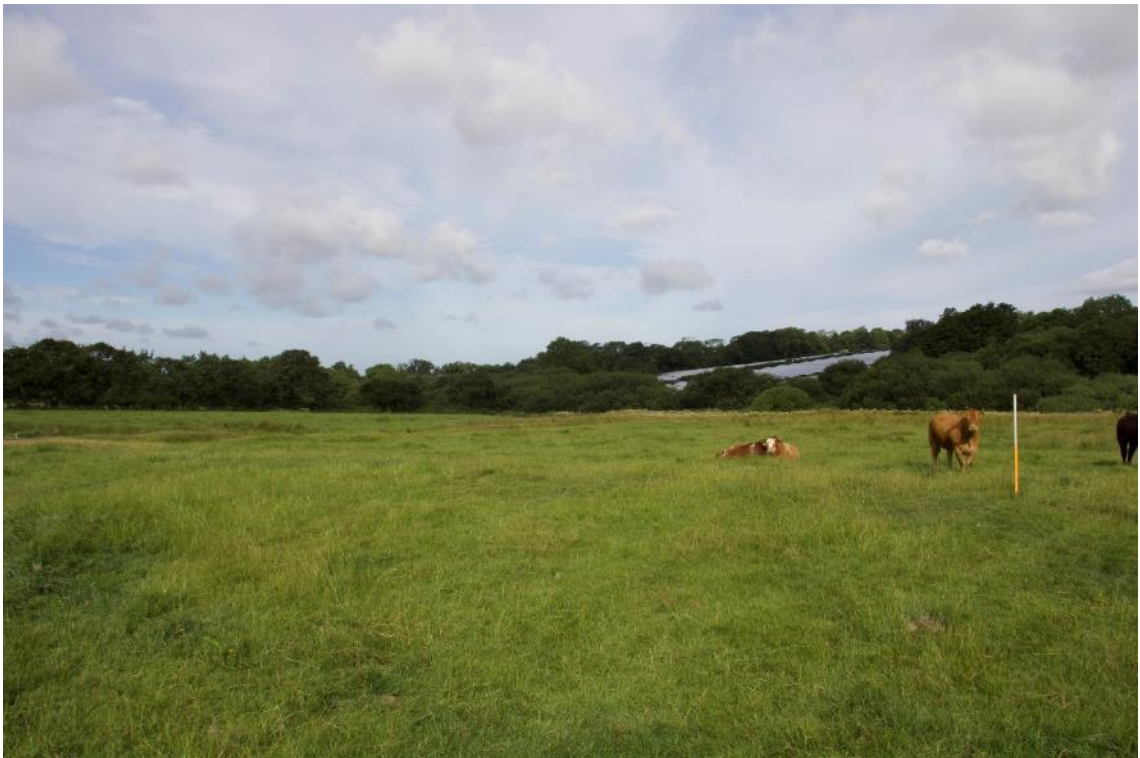
**Photograph 13:** Looking northwest across earthworks of Merryborough Moated Farmstead (PE465). Fenton brook beyond. 1m scale

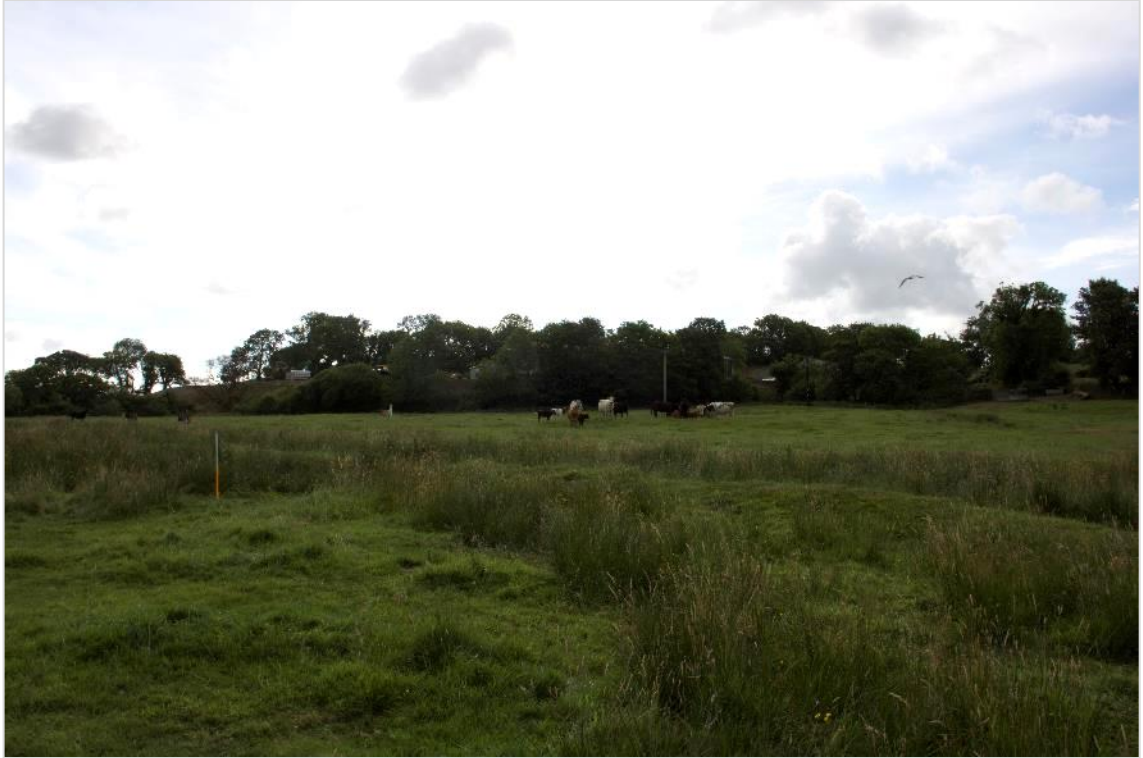
**Photograph 14:** View southeast towards development area from within earthworks of Merryborough Moated Homestead (PE 465). 1m scale.

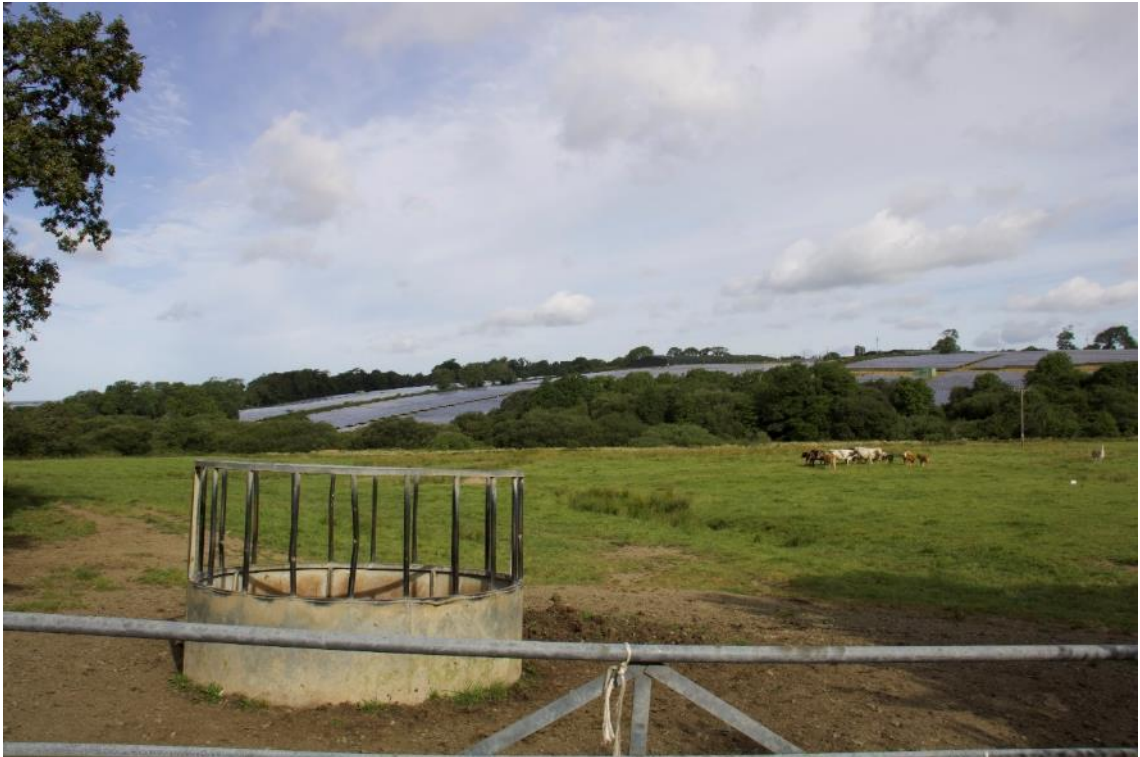
**Photograph 15:** View of solar farm approximately 50m to the north of Merryborough Moated Farmstead.
