PROPOSED TIDAL FLOOD ALLEVIATION SCHEME, CARDIGAN, CEREDIGION: HISTORIC ENVIRONMENT DESK-BASED ASSESSMENT UPDATE 2021

Prepared by DAT Archaeological Services
For: Binnies UK Ltd

REPORT NO. 2021-77
PROJECT NO. 126652

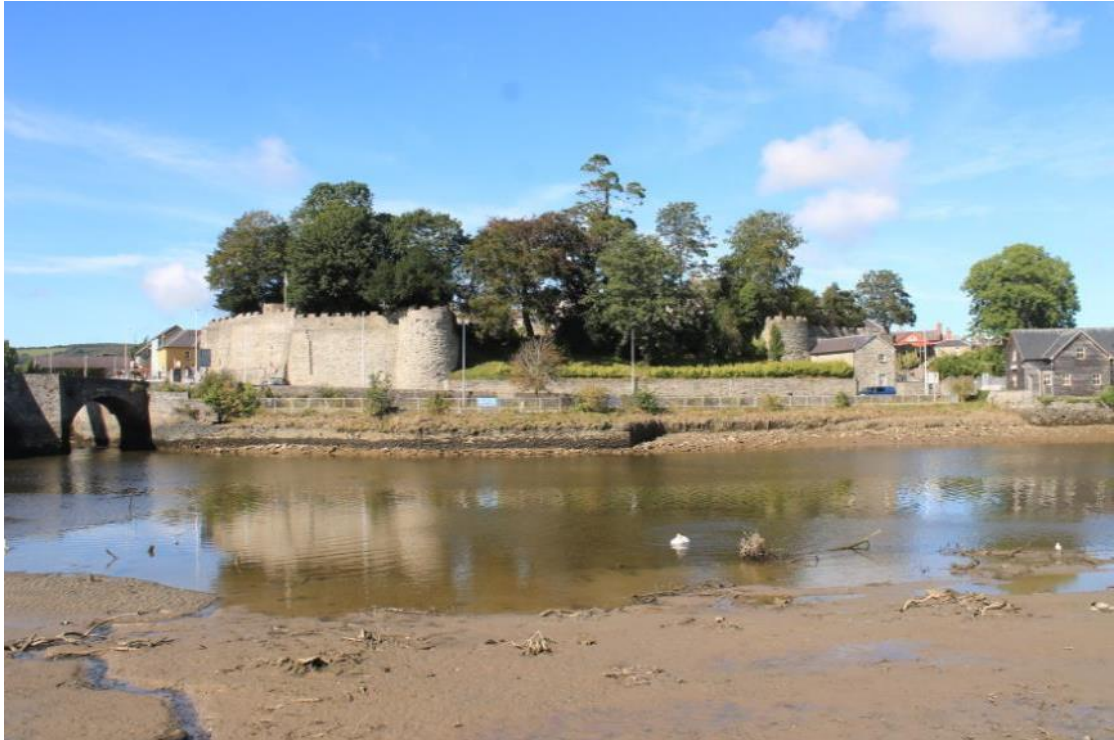
Photo 1: The north bank of the Teifi, as viewed from the south. Cardigan Bridge is visible on the left, Cardigan Castle to the rear, and the new Bathroom Showroom on the right.

- 6.4.2 The present edge of the Teifi directly east of Cardigan Bridge comprises a raised paved area directly next to the Teifi, with a wall running along the southern edge of the footpath around the Strand. This was constructed in the 1970s, replacing the former late 18th to early 19th century Castle Terrace indicated on earlier maps. The Strand was slightly widened after the buildings were demolished and the existing wall built. The river wall at this point forms a continuous stone wall from the bridge for approximately 50m, on a line that is similar, but with distinct differences, from that shown on late 19th to early 20th century maps, suggesting an area of rebuild. During the geotechnical works undertaken in this area the paved area above was seen to lie on a thick layer of concrete, although the full depth of the concrete was not established. It is uncertain what lies beneath this concrete layer but will presumably be levelling material used for the bases of the previous buildings that stood on the site. At lower depths estuarine silts may be present.

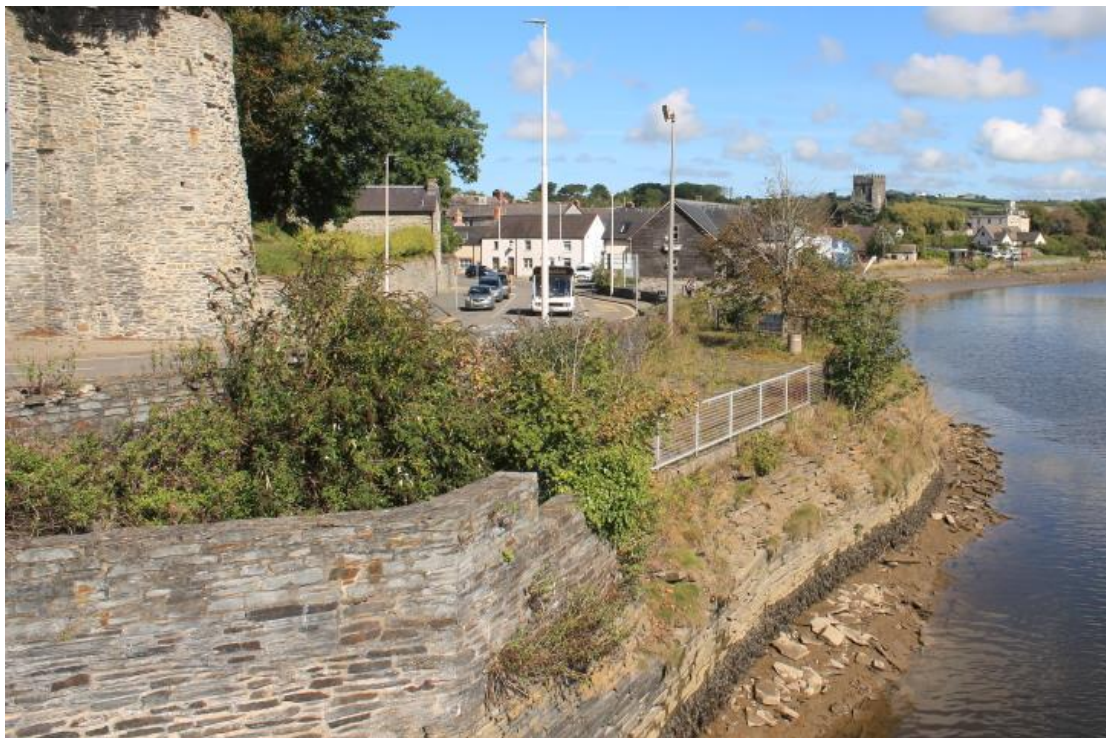
Photo 2: View east from Cardigan Bridge along The Strand, showing the area of the former Castle Terrace, remodelled in the early 1970s.

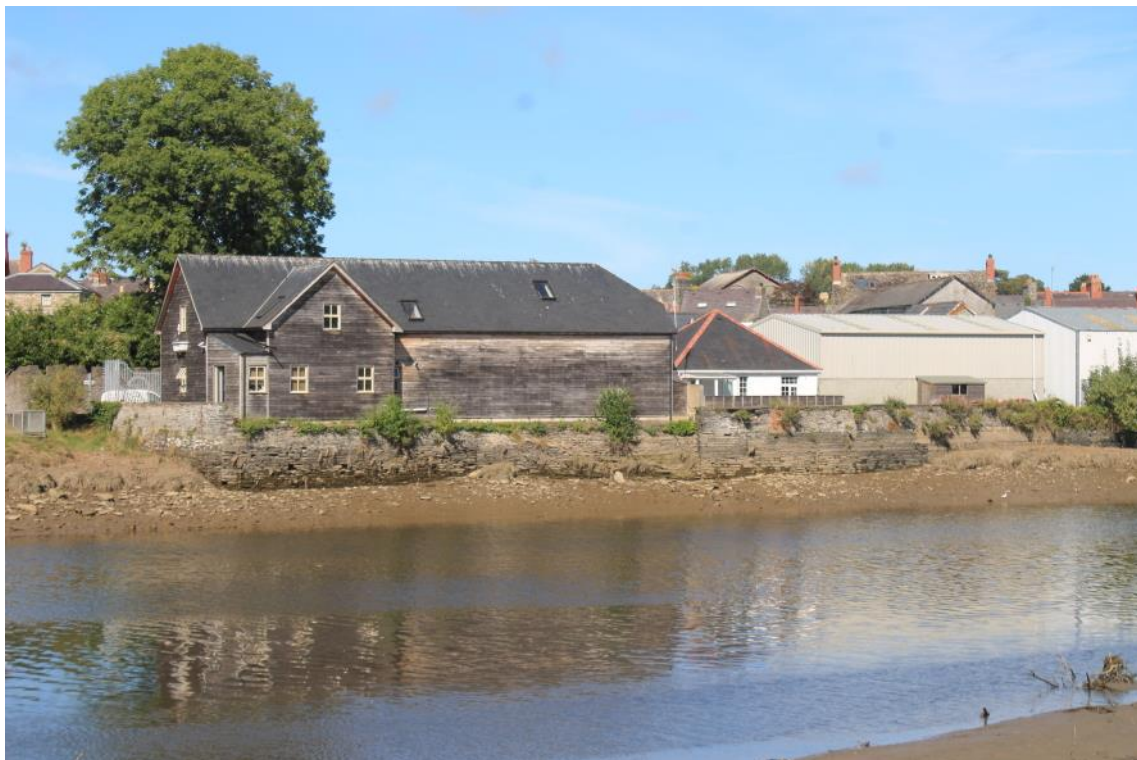
Photo 3: *The Bathroom Showroom on the left, built partly on an older wharf to the left, with 20th century infill on the right. The small bungalow lies to the right of the showroom, with a modern storage shed adjacent. Viewed from the south.*

- 6.4.3 The river wall continues on a recessed alignment to the east as far as the Cardigan Bathroom Centre and a stone wharf structure on which it is built. A small slipway lies to the west of this wharf which appears to align with a slope leading down from within the yard area of the outbuildings and stable blocks within the castle grounds to the north of The Strand, which

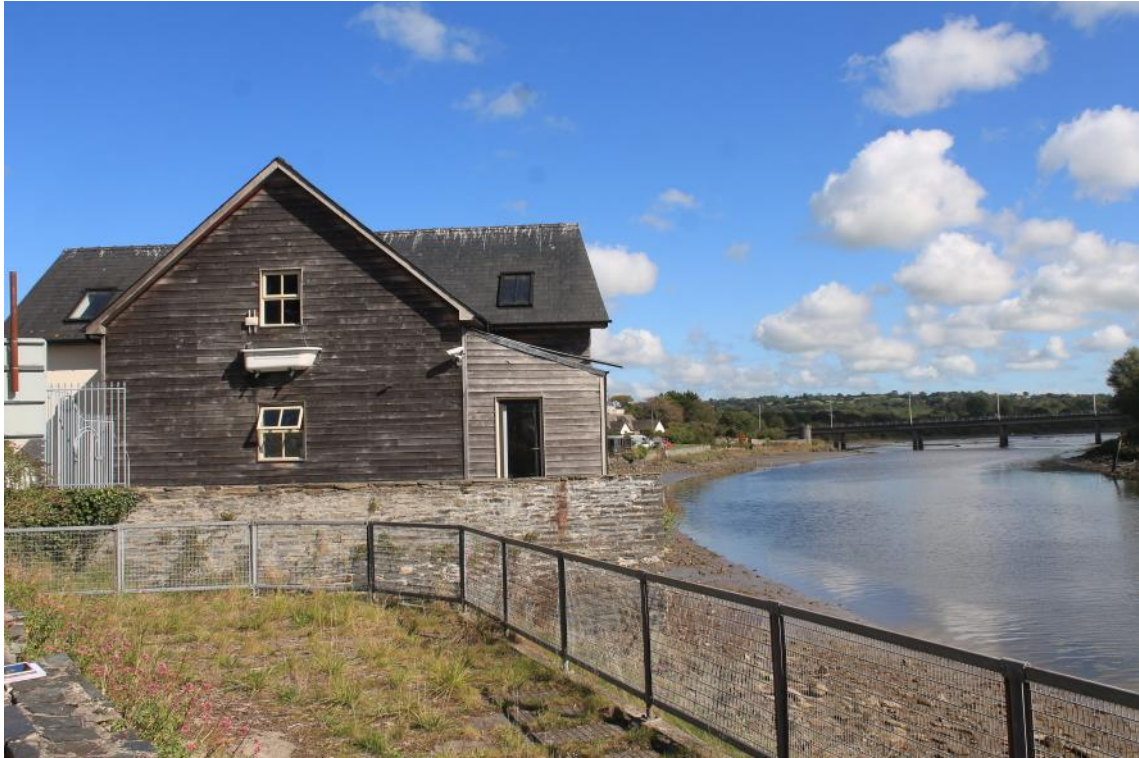
Photo 4: *The bathroom showroom as viewed from the west, sat upon an earlier wharf walling.*

- 6.4.4 A test pit was excavated against the western side of the stone wharf on which the Cardigan Bathroom Centre was built. The test pit was located some midway along its side (Photo 6). The wall of the wharf had a number of different phases of construction and repair, as could be seen in the different styles of construction and joints in the stonework. This appears to correspond to the mapping and photographic history, which indicates the western half of the bathroom centre is built on an older wharf or free-standing building in the silts, with later infilling walling to the east. It was evident that the upper 1.5m of the wall in this part of the wharf had been rebuilt (or repointed) recently, presumably at the same time as the bathroom centre was constructed. The wall of the wharf was raised some 2.49m above ground level on its western side, with 0.86m depth below ground level to a stone built offset footing of 0.11m depth. A further test pit was excavated on the southern side of this stone wharf (Photo 7), which indicated a possible footing at some 0.92m depth below the top of the estuarine silts (although this could not be clearly seen). The height of the wall in this area was only around 1.8m from the top of the estuarine silts, somewhat lower than that to the west, likely corresponding to the 20th century infilling in this area.

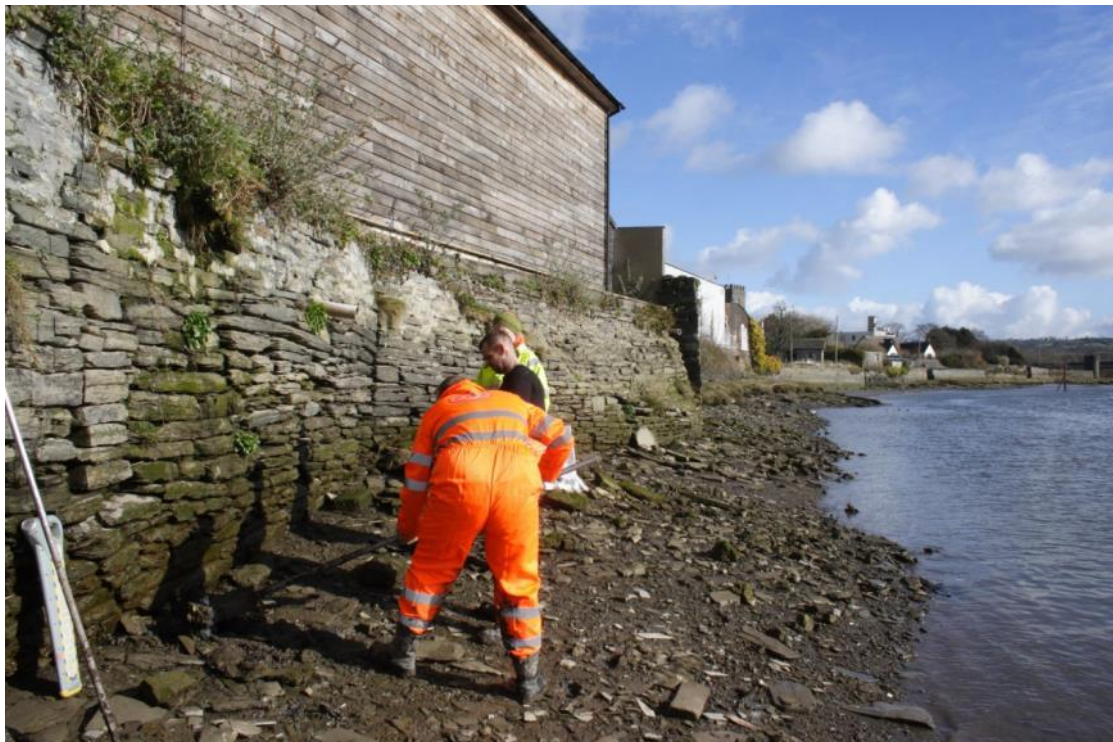
Photo 7: Excavation of test pit (Meek 2015) on southern side of Cardigan Bathroom Centre

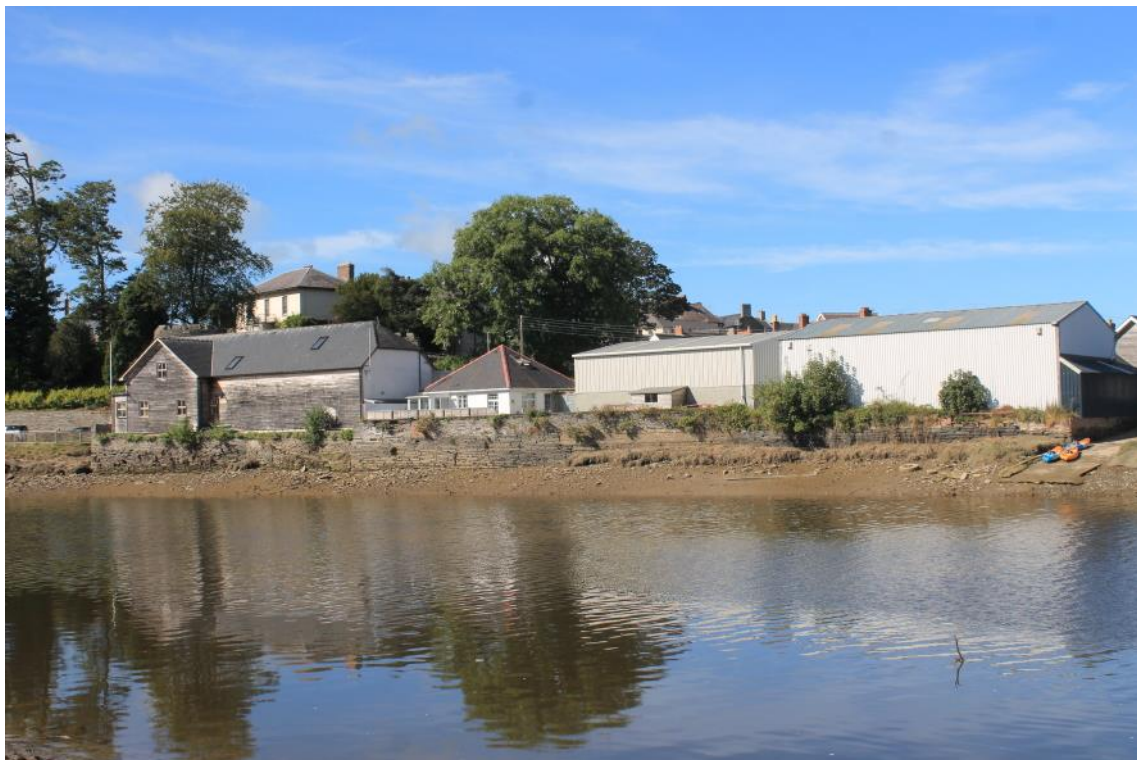
Photo 8: The north bank of the Teifi with the bathroom showroom on the right, modern bungalow, recent bathroom store and J&M Garage on the right, with the slipway emerging adjacent to the garage.

- 6.4.7 Looking to the west from the slipway it was possible to see the various stone wharfs that had been built along the north bank of the Teifi from the bathroom centre to the slipway. Several phases of construction, repair and patching were visible.

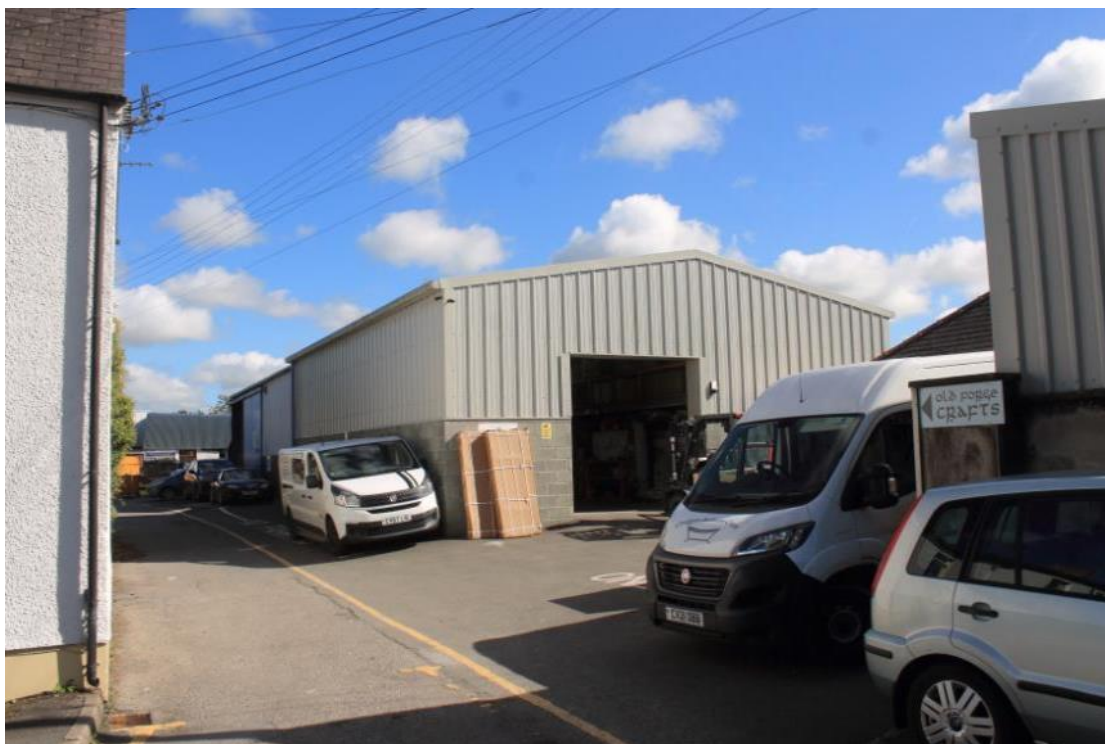
Photo 10: The Strand, as viewed from the west, showing the modern bathroom store replacing any previous structures.

- 6.4.5 East of the bathroom showroom lies a mid-20th century bungalow, and a modern steel-framed warehouse, built after the previous assessment in 2015 (and not appearing on modern mapping). These buildings have replaced any previous structure on this site, including any remains of the U-shaped building visible on historic map sources, and the Old Presbytery. Similarly, to the east lies the J&M Garage, a modern steel-framed structure replacing a previous 19th century warehouse, of which no above ground trace remains.

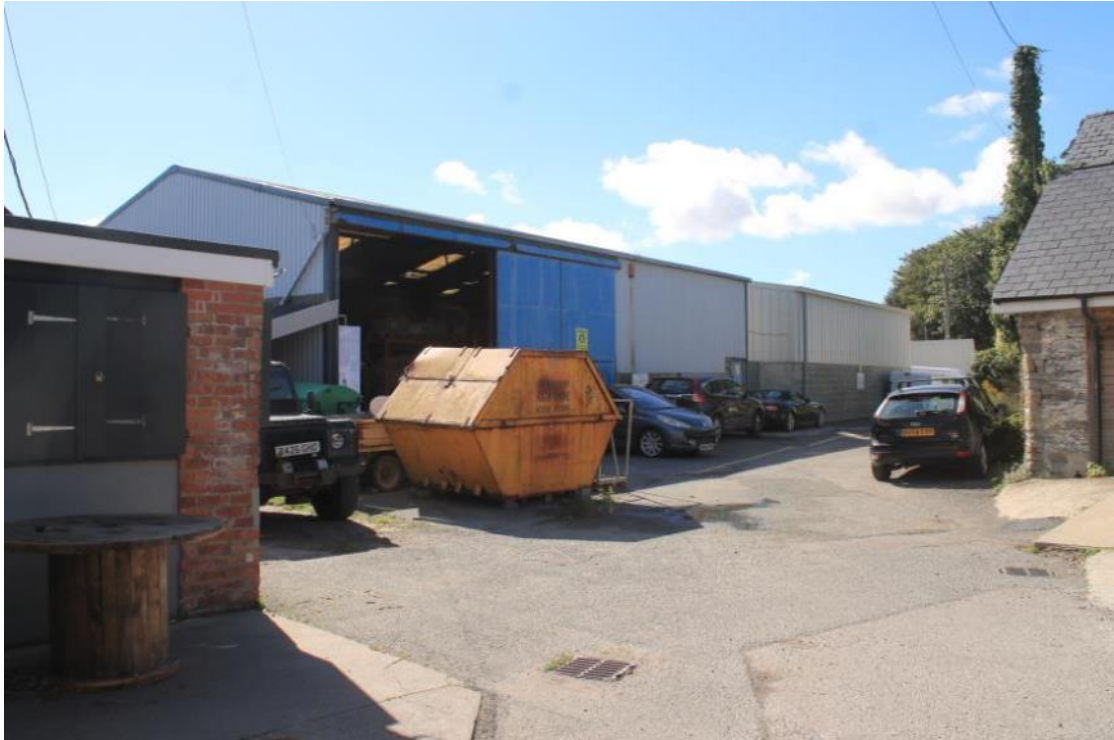
Photo 11: *The Strand, as viewed from the east, showing the modern buildings of the J&M garage with the blue door, and the bathroom store beyond.*

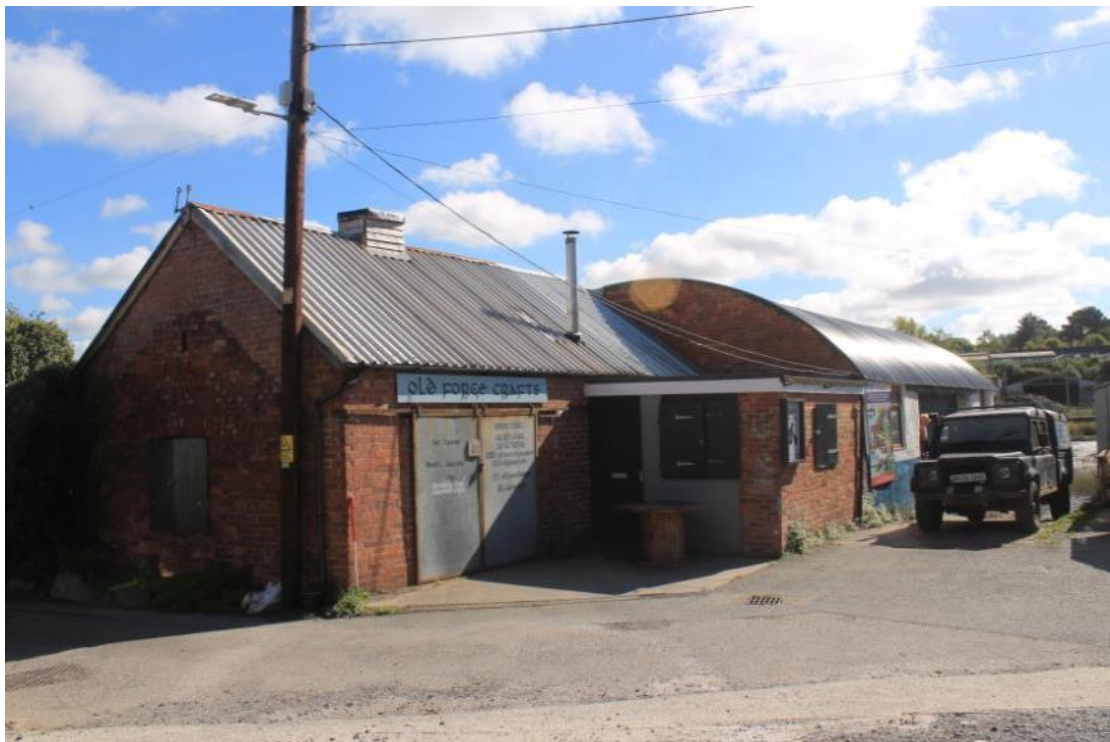
Photo 13: Southeast facing shot of the Old Forge Crafts building and adjacent Scout Boathouse, the presumed site of the former blacksmiths and foundry (NPRN 40392).

century Ordnance Survey maps as a 'Smithy' (Figures 8 & 9) and may therefore relate to the NMR record of a foundry (NPRN 40392).

- 6.4.9 The foundry was assumed to relate to the large yard to the east, which now contains the Scout Hut at its eastern end. This area is largely turf covered and sits atop a riverside wall appearing to comprise a single phase of construction, using machine-cut slate blocks, very different in comparison to the neighbouring stone wharfs. Although modern in appearance, this walling is visible on photos from the 1930s. Also of note in this area was the fact that the estuarine silts were at a lower level for the length of this wall, with far fewer stones than in other places on the foreshore. This may indicate that it had been cleared or dredged far more recently than elsewhere (possibly in the 1950s before it closed). The northern side of the yard enclosure was bounded by a high stone wall, likely of mid to late 19th century origin. A number of blocked openings within this wall has led to the suggestion that this may have been the frontage of buildings. The openings do not however appear to relate to domestic structures, and the wall appears of one build, and the openings may therefore be associated with the ranges of glasshouses that stood along the south side of the wall depicted on late 19th and early 20th century mapping.

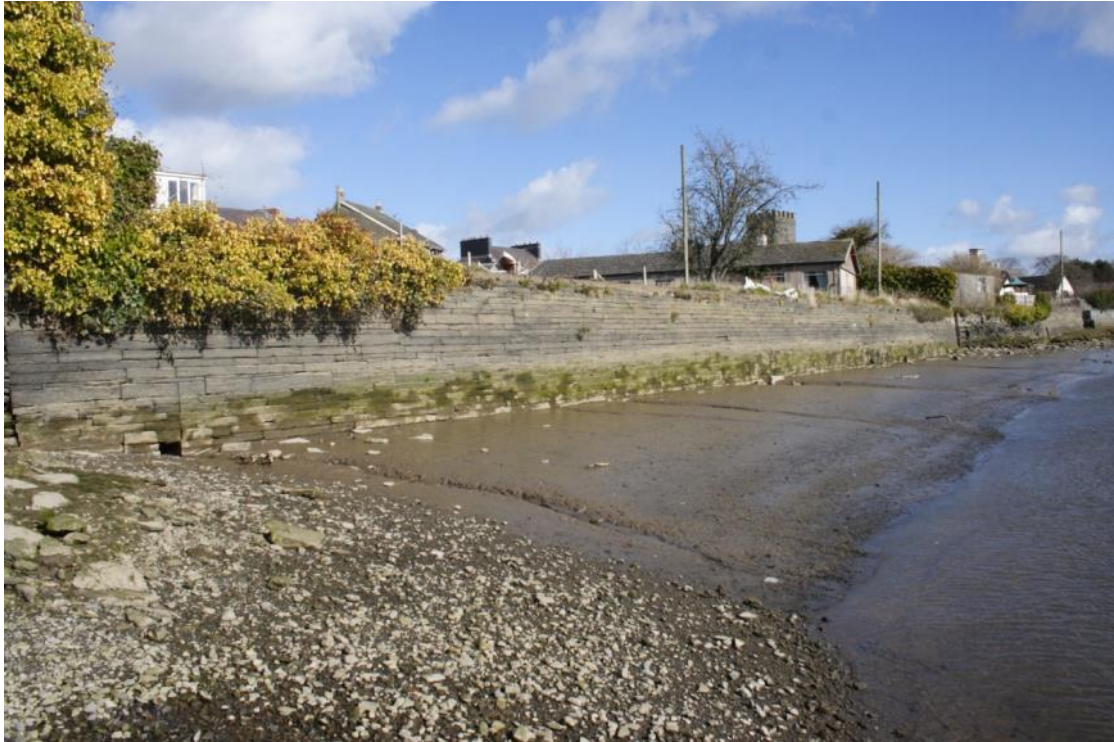
Photo 14: View east from the slipway showing the wharf in front of the Scout enclosure, and the lower silt level.

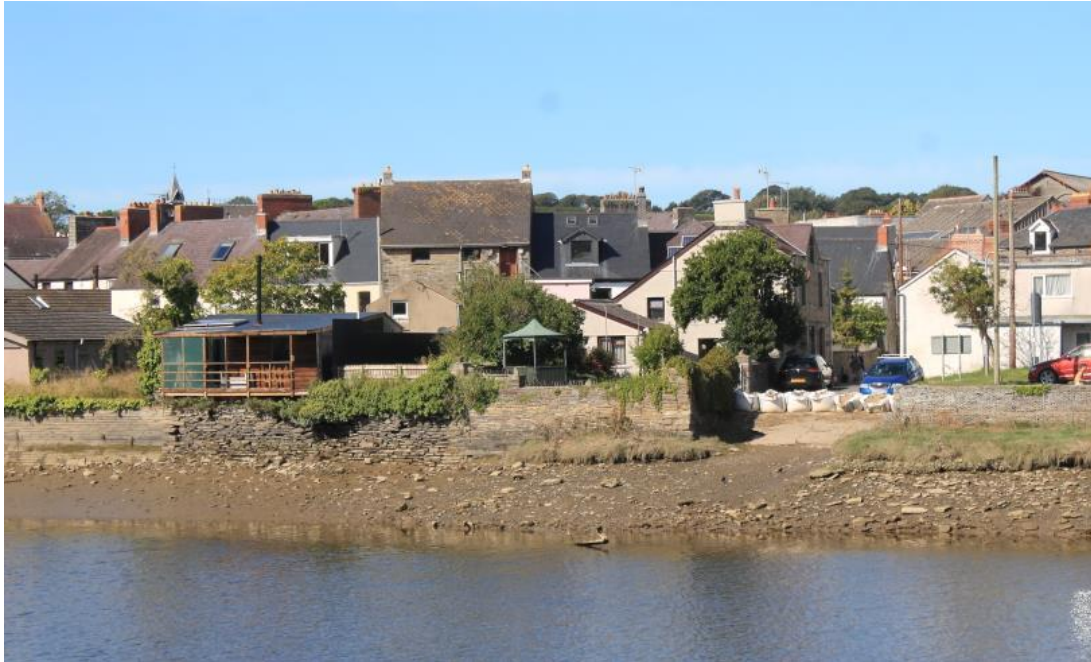
Photo 18: The slipway and adjacent properties, as viewed from the south.

- 6.4.12 The adjacent slipway to the east is where there is a possibility of an earlier river crossing (although not proven). The slipway is now concreted. Potentially earlier slipway surfaces could be present beneath the concrete, or timber elements associated with the former ferry that crossed here or even associated with an earlier bridge, however the bridge theory is doubtful, and early photographs suggest that prior to the concrete, the slipway comprised a rough gravel slope.

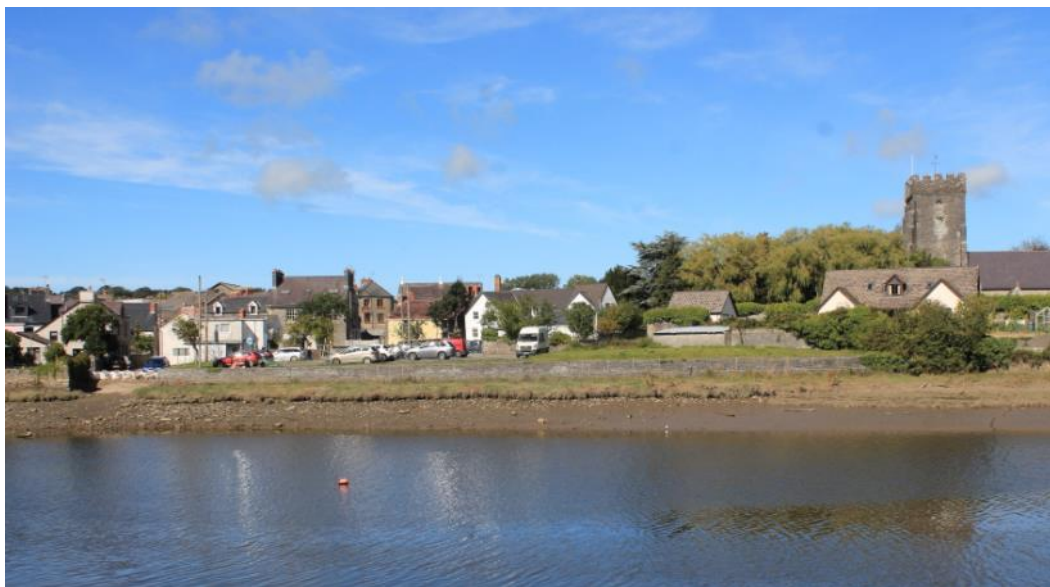
Photo 21: *The Gloster Row Car Park, as viewed from the south, with St Mary's Church in the background.*

6.4.13 To the east of the slipway lies the Gloster Row Car Park, a relatively recent construction. The riverside is formed by numerous stone-filled gabion baskets with ground infilled to the rear, and now covered by either tarmac surfacing, or open rough ground. The Car Park is backed by a mixture of boundaries to the north and east. To the northwest lies a modern pumping house, bounded by low modern brick walling. East of this lie stone-built garden walls to Church Street properties, potentially 19th century or earlier. To the northeast the car park is open to a rough drive back by a stone-built structure, possible remnants of the late 19th century blacksmiths marked in this area. The east side of the Car Park is bounded by a modern property boundary of concrete breeze blocks.

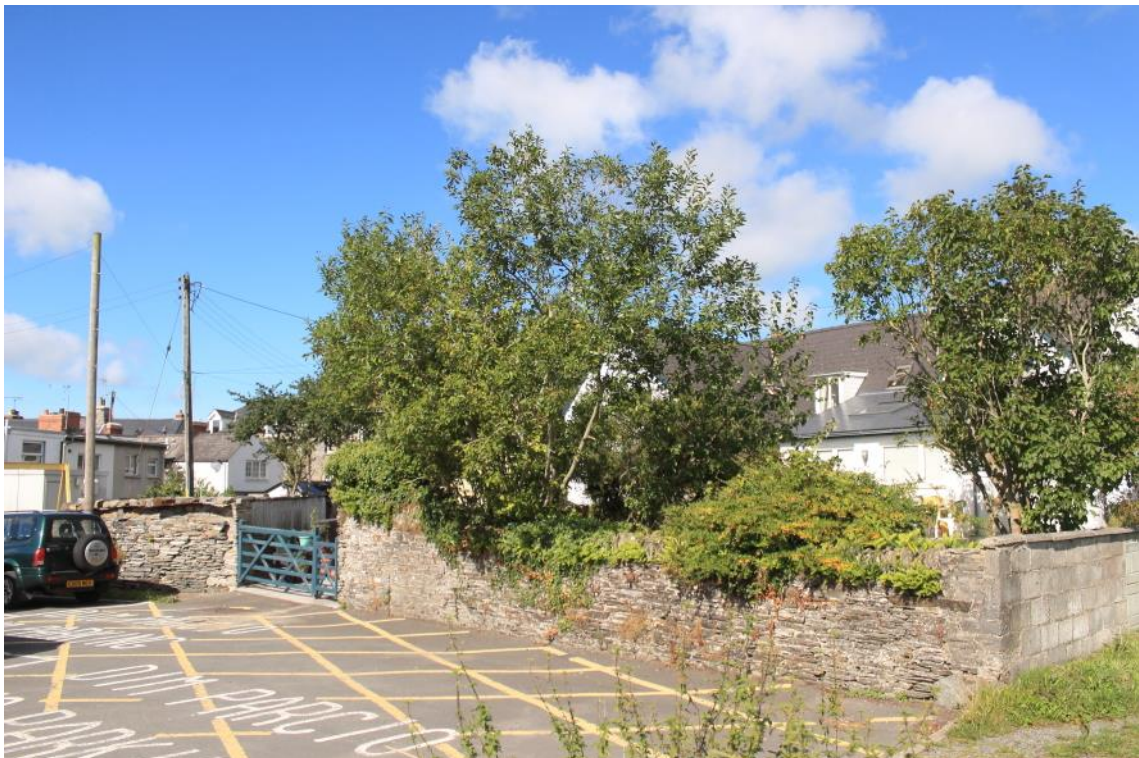
Photo 23: *Garden boundary walls around the northern edge of Gloster Row Car Park.*
