ST ISSELLS CHURCH, SAUNDERSFOOT, PEMBROKESHIRE: ARCHAEOLOGICAL WATCHING BRIEF 2021

Prepared by DAT Archaeological
Services
for: The Church of Wales

REPORT NO. 2021-91 EVENT RECORD 127333

November 2021

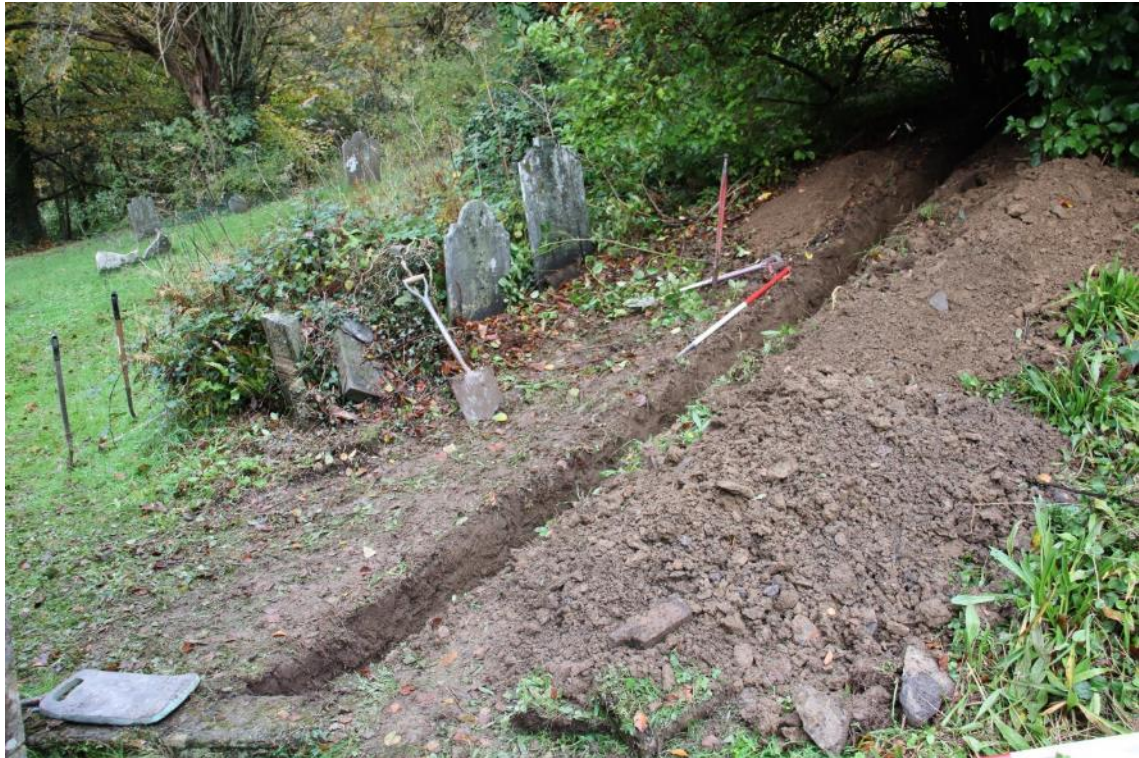
Photograph 2: Completed section of pipe trench. View roughly north. 1m scale

- 4.3 The overlying topsoil was a dark brown, silty clay (**1000**) which had been heavily rooted and was roughly 0.31m in depth throughout the confines of the trench (Photo 2). This deposit contained the remains of one hand-made post-medieval brick, several fragments of 19th-20th century decorated china, one neck of a late 18th-century wine bottle and a single fragment of black, unworked flint (Photo 3).

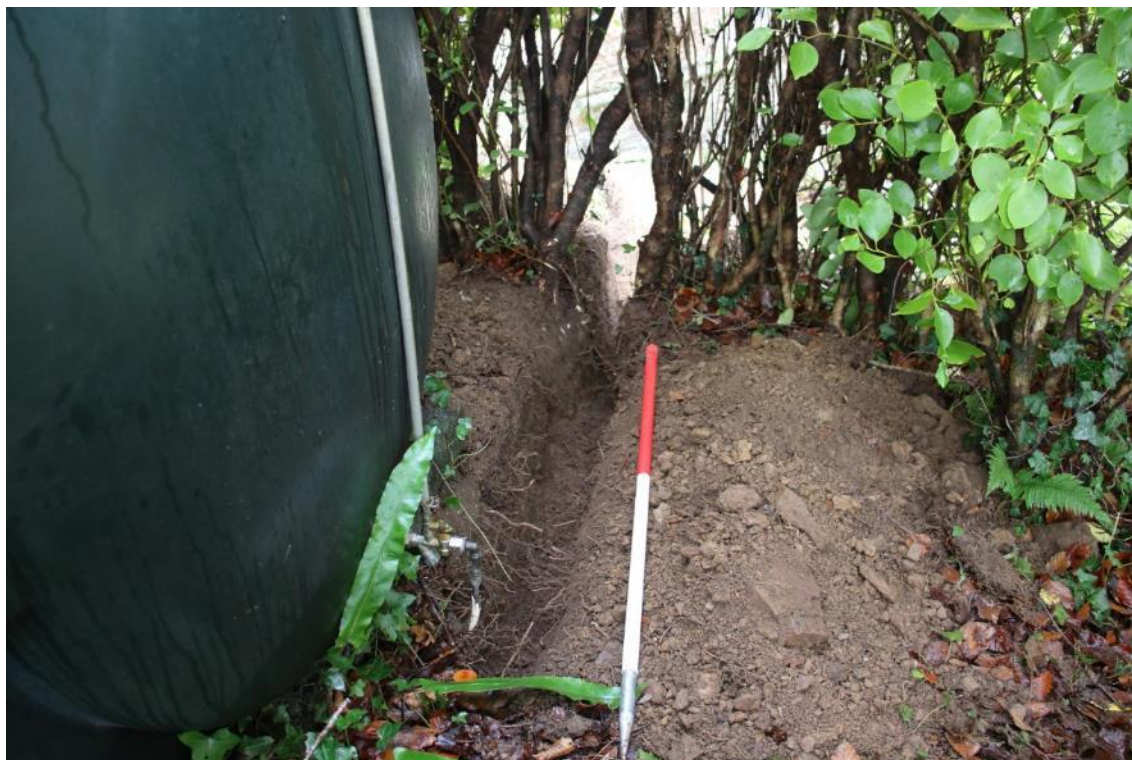
Photograph 4: Completed section of pipe trench where it met the existing oil tank. View northeast. 1m scale

- 4.4 Directly below the topsoil was a light yellowish-grey clay (**1001**) which contained frequent small pieces of shale and continued for 0.16m in depth to the base of the trench (Photo4).

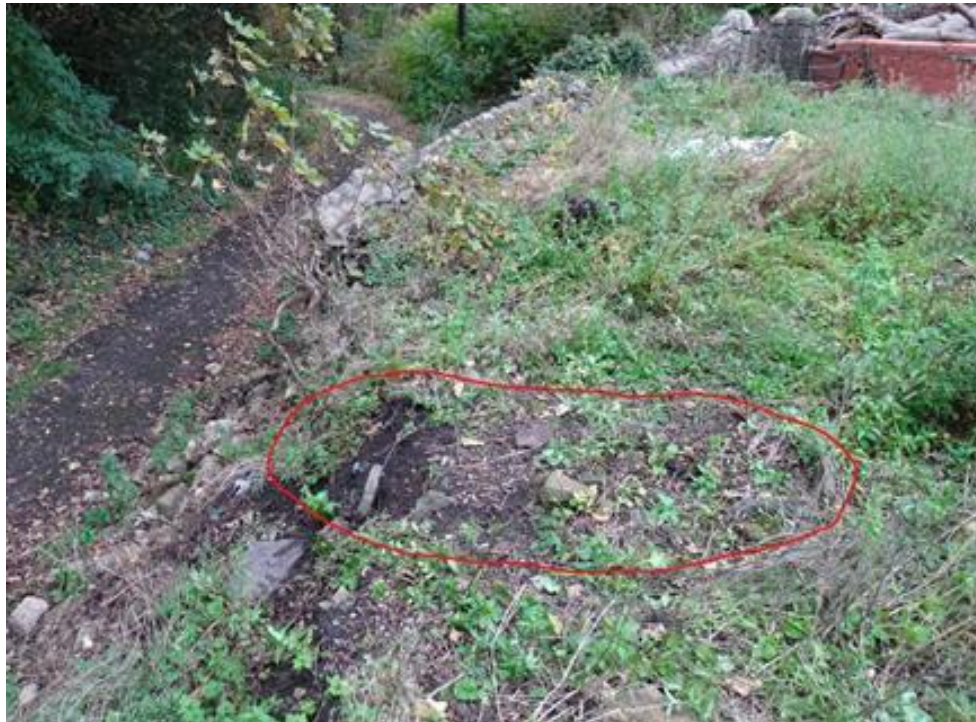
Photo 1: Grave marked by a small headstone within the area of ground reduction works.

- 4.6 One east-west grave has been identified within the area where ground reduction works are due to take place (Photo 1, Figure 3). It is probable that this burial no later than 19th century in date as the cemetery closed in 1907.

- 4.7 There is potential for more unmarked burials to lie within the area where ground reduction works are taking place. If any articulated (complete) inhumations are encountered, then every attempt shall be made to leave these intact and in-situ.
