HAVERFORDWEST CASTLE FLAGSHIP DEVELOPMENT, HAVERFORDWEST, PEMBROKESHIRE: STATEMENT OF SIGNIFICANCE

Prepared by DAT Archaeological Services
For: Pembrokeshire County Council

REPORT NO. 2021-101

March 2022

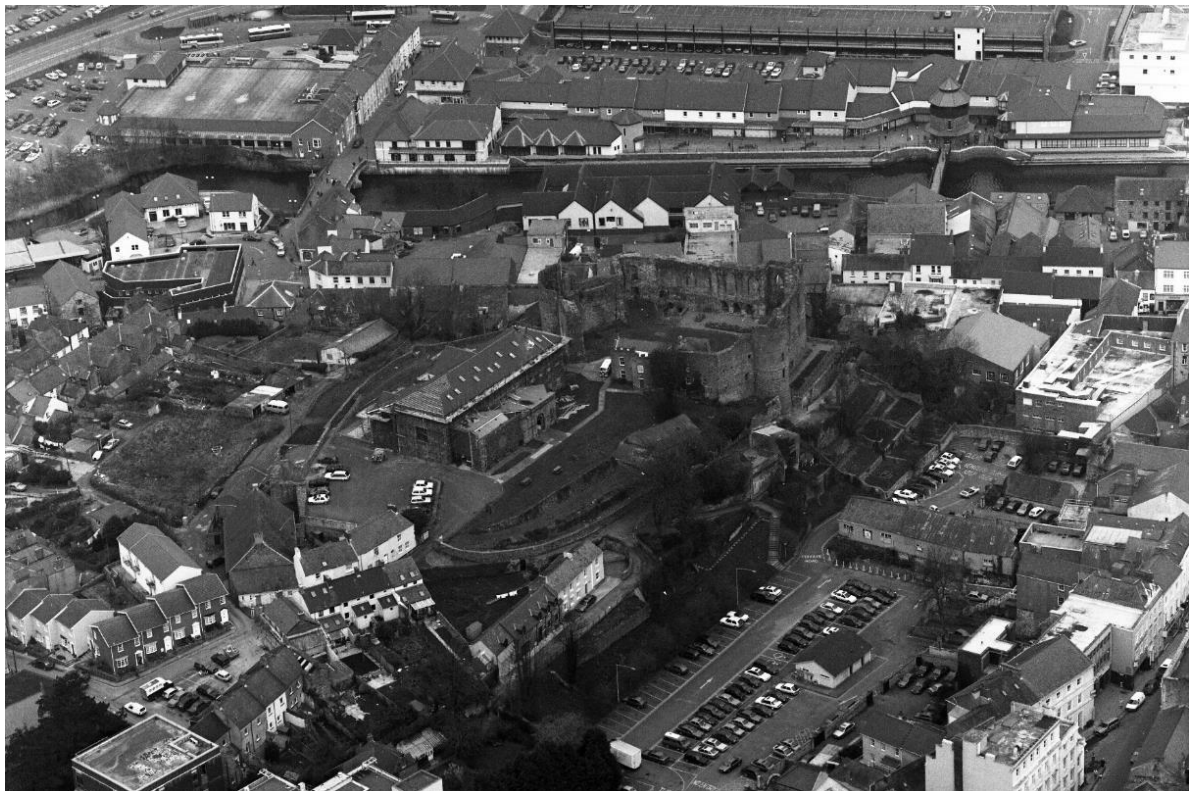
Figure 1: Aerial photograph, as viewed from the southwest, taken in 1983 of Haverfordwest Castle (© DAT AP93-3.44)

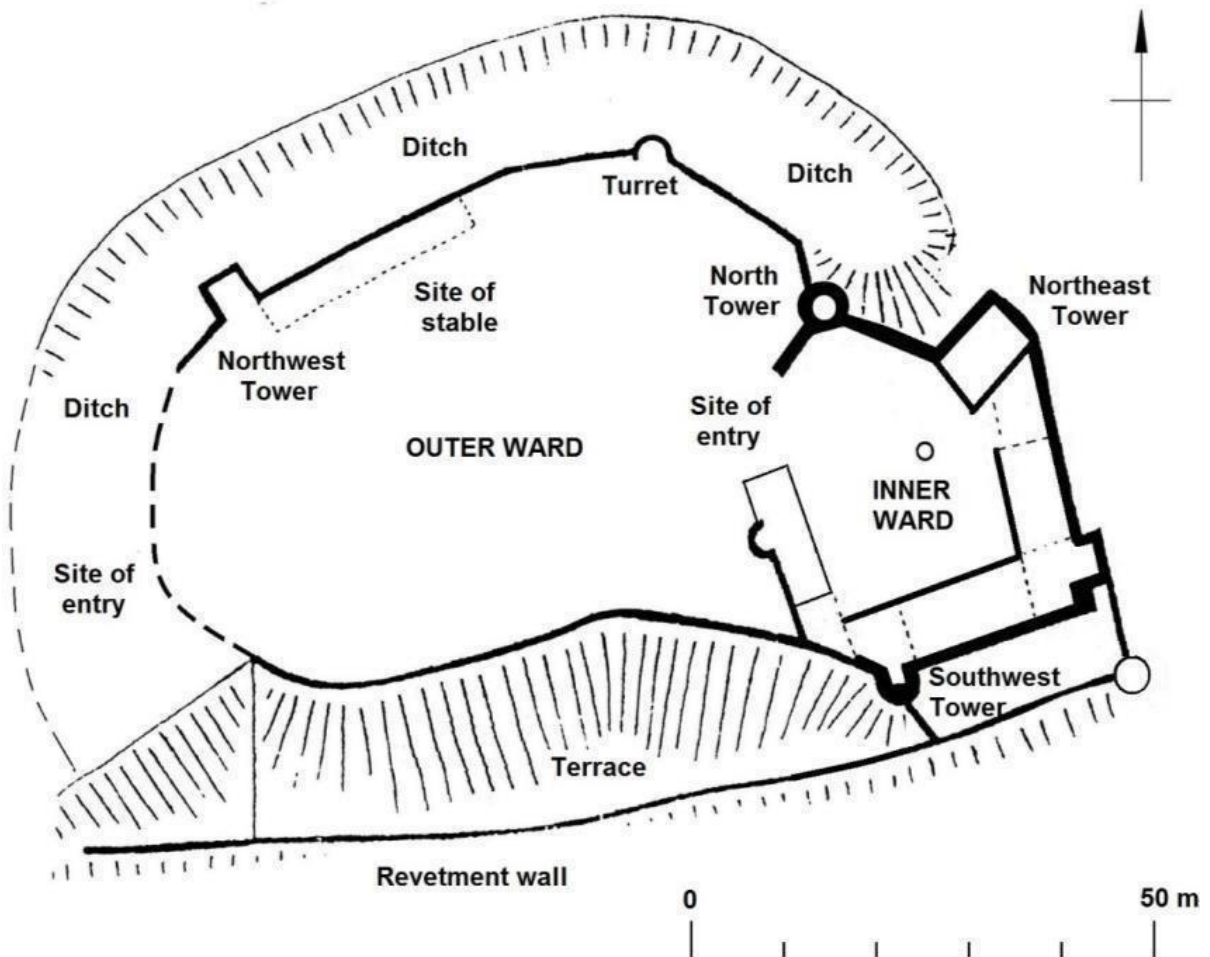
Figure 4: Sketch plan of the medieval remains at Haverfordwest Castle (adapted from Ray 1969).

- There are distinct elements within these remains, including two towers, one of which was known as the Brehinock Tower the other North Tower retains some internal features, the original keep, a high status east and south range with a projecting chapel turret, and an unusual Queens Arbour area to the exterior. Internal remains of these features were lost to 17th, 18th and 19th century development, as was the entire west range and main entrance gateway into the inner ward. 19th and 20th century developments have included repair works to the visible remains, including window infill, repointing and some rebuilding, such as the crude squaring off of the northern wall of the Inner Ward, all of which has adversely impacted upon the significance.

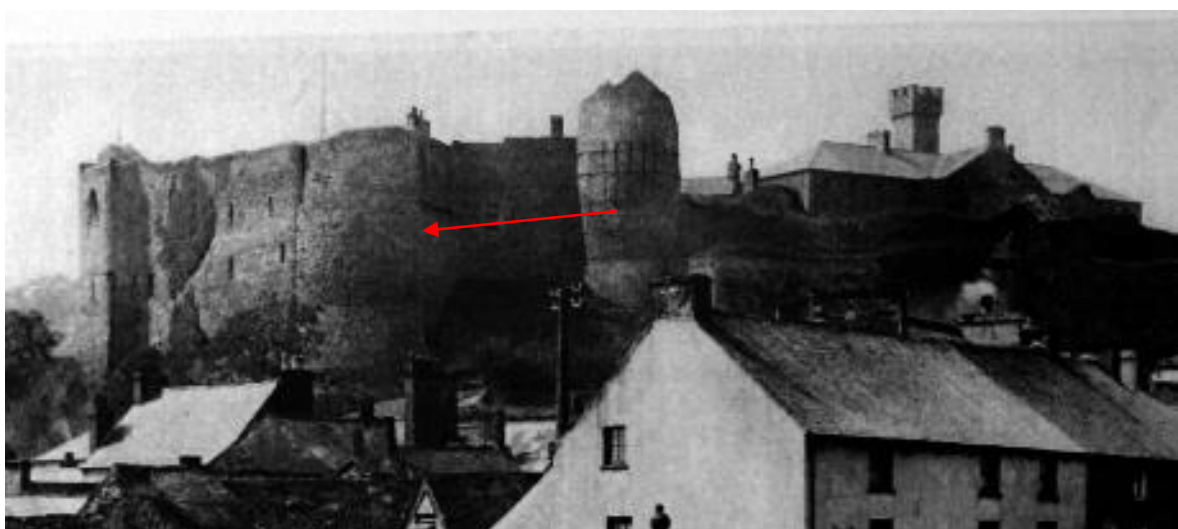
Figure 9: Photo of circa 1900 showing the keep as a more solid projecting bastion, with a upper line in keeping with the surrounding walling. (Haverfordwest Town Museum).

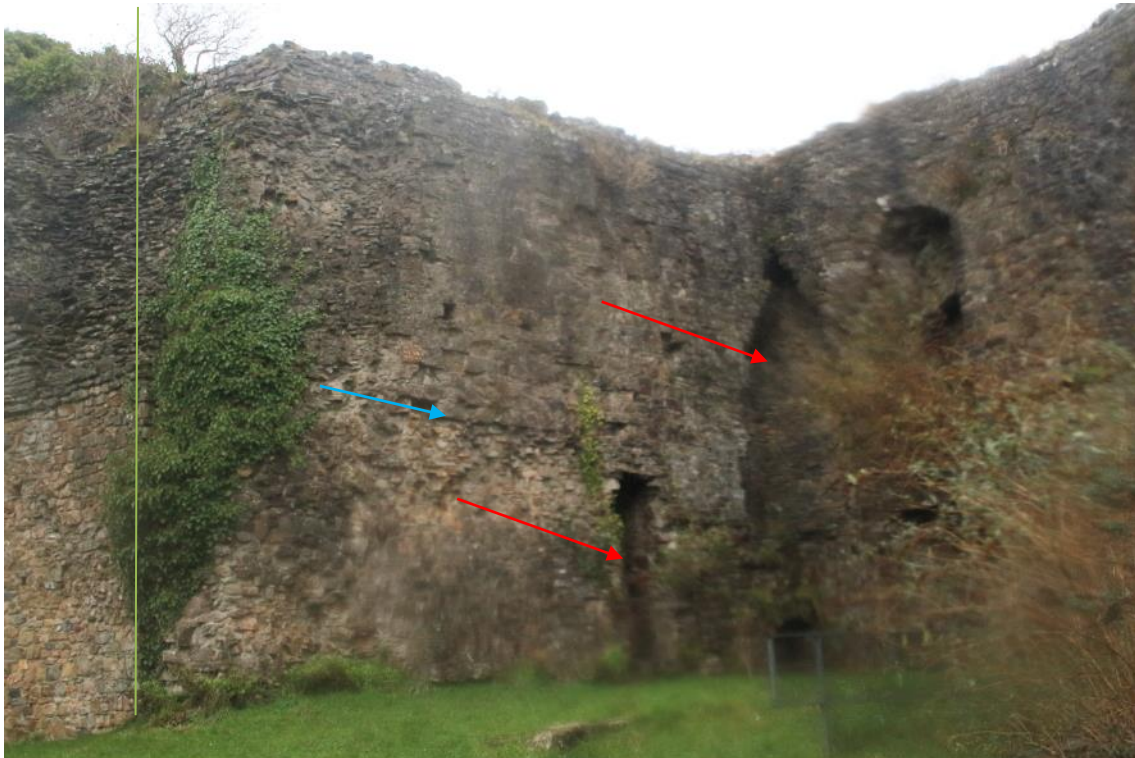
Figure 10: The internal face of the north wall of the keep, to the right of the green line, with the fireplaces highlighted in red, and the 1st floor level in blue.

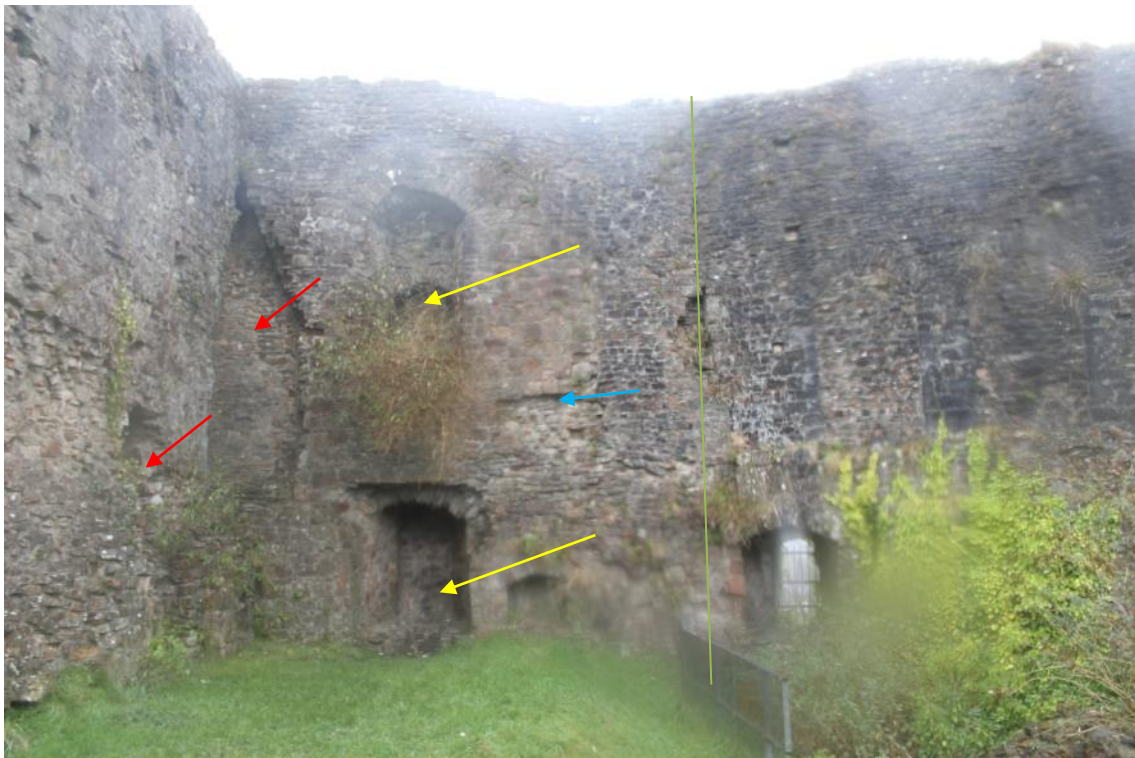
Figure 11: The internal face of the east wall of the keep to the left of the green line, with fireplaces highlighted in red, 1st floor level in blue, and blocked windows in yellow.

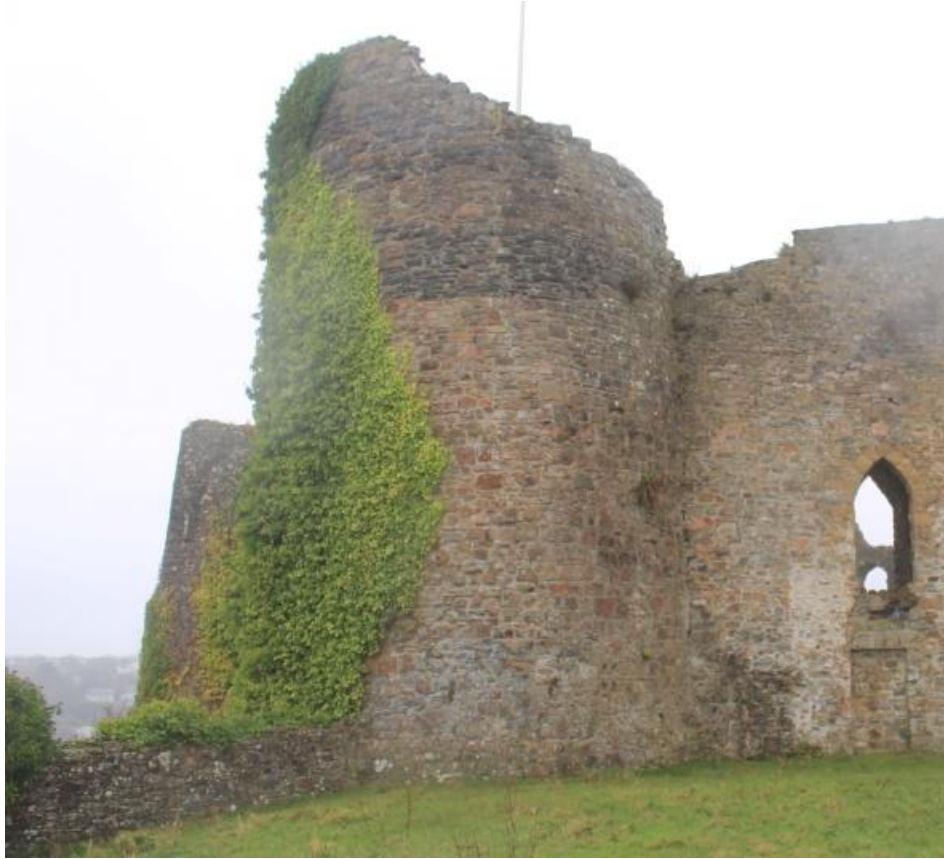
Figure 13: The external face of the North tower.

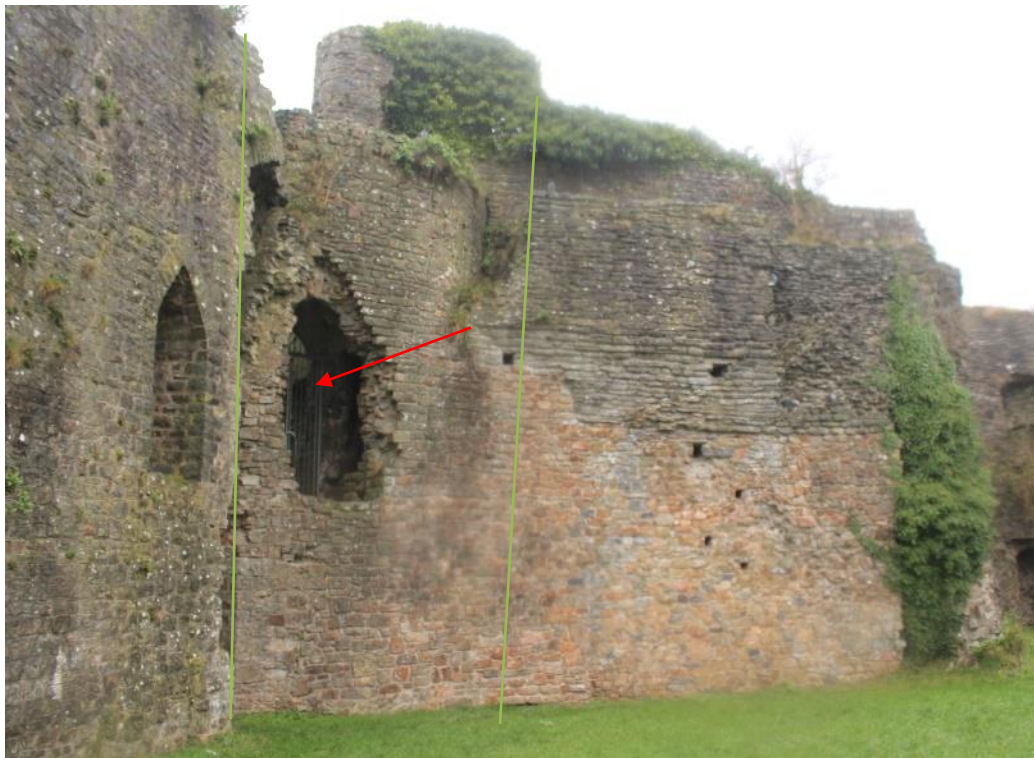
Figure 14: The internal face of the North tower, between the green lines. The original entrance to the first floor level is shown in red.

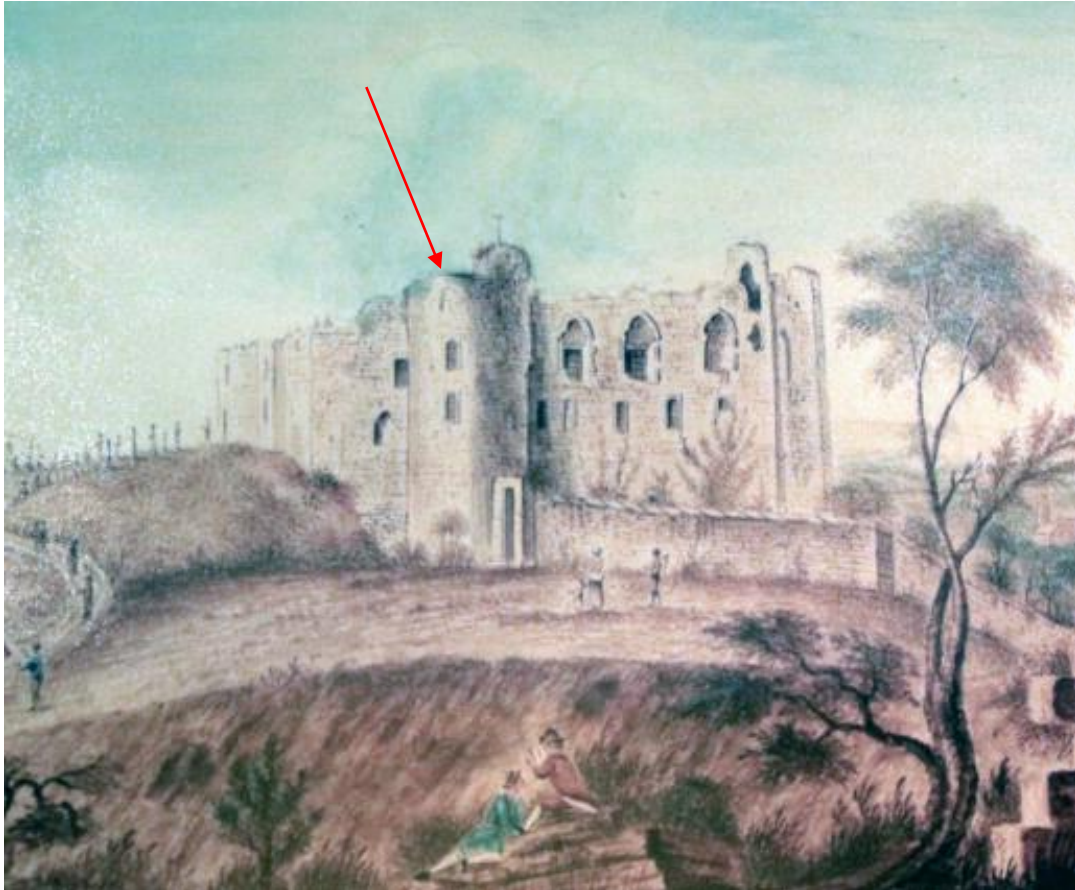
Figure 16: Painting of Haverfordwest castle from the south, southwest tower in red. Undated, but late 18th – early 19th century.

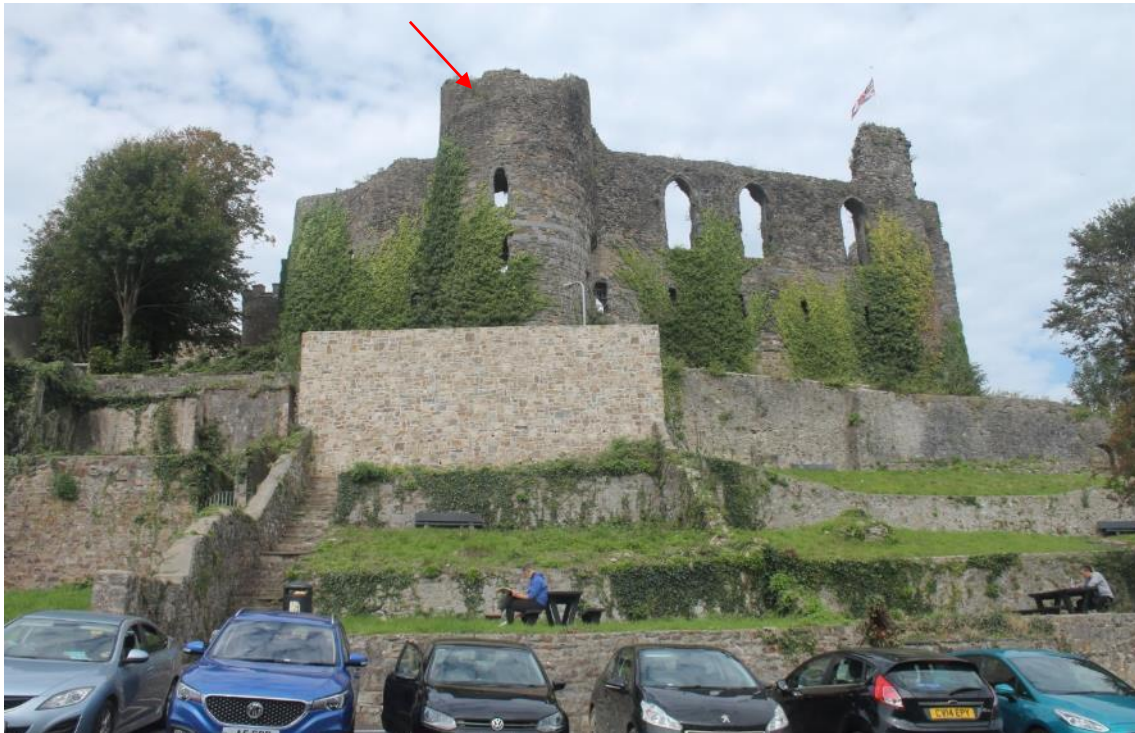
Figure 18: Exterior of the Inner Ward from the south, with the Southwest tower in red.

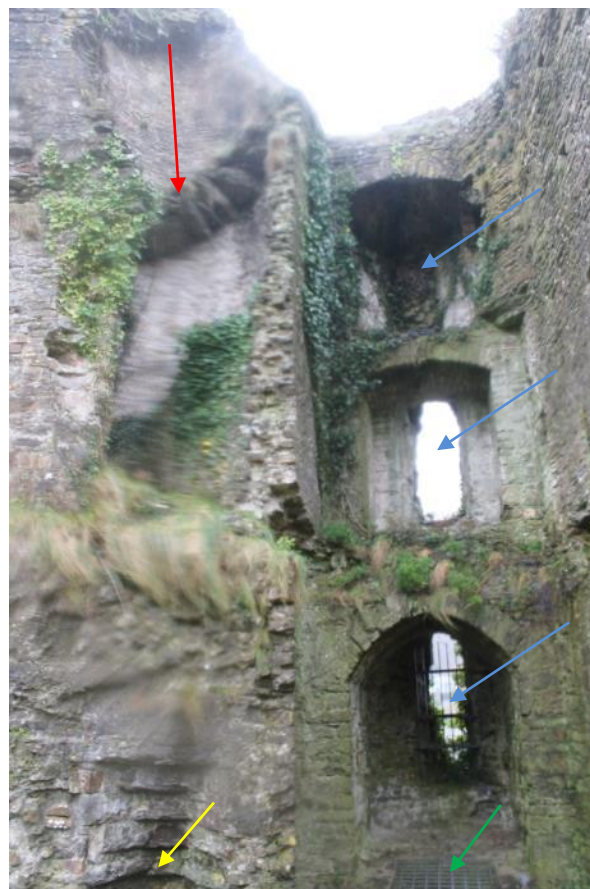
Figure 19: Interior of the Southwest tower, looking south. Features of note include the spiral stair in red, windows in blue, basement shaft in green and the stair to garden/queens arbour in yellow.

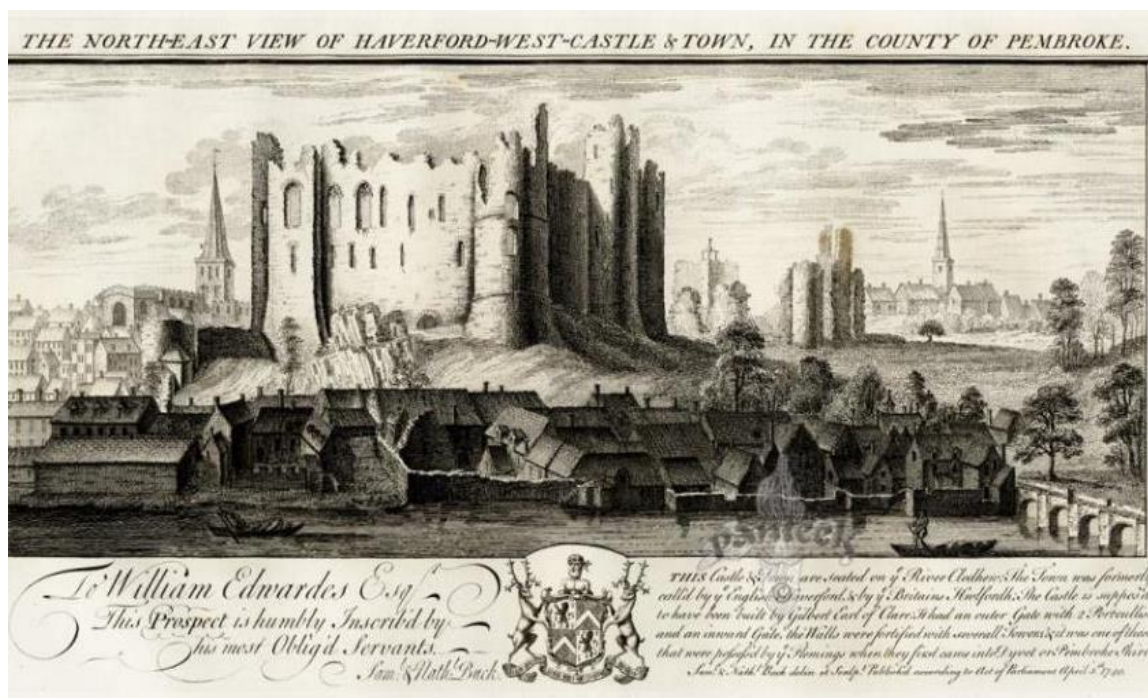
Figure 21: Buck print of Haverfordwest from 1740, showing exterior of east range between the squared chapel turret on the left, and the rounded keep on the right.

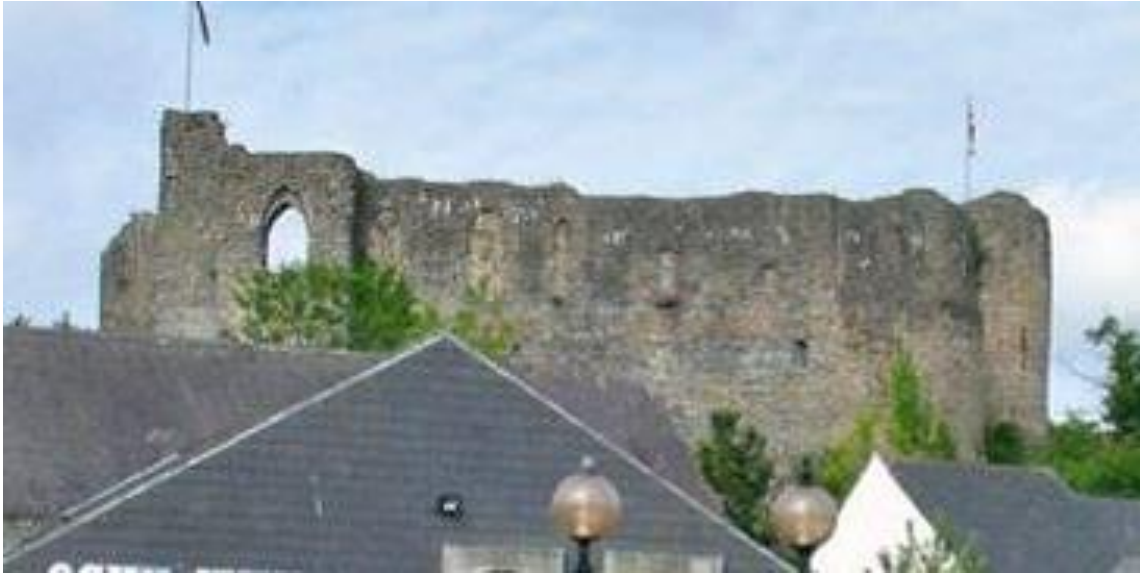
Figure 22: East Range, exterior view. The square chapel turret is on left, and the slightly rounded keep on right, with north tower projecting.

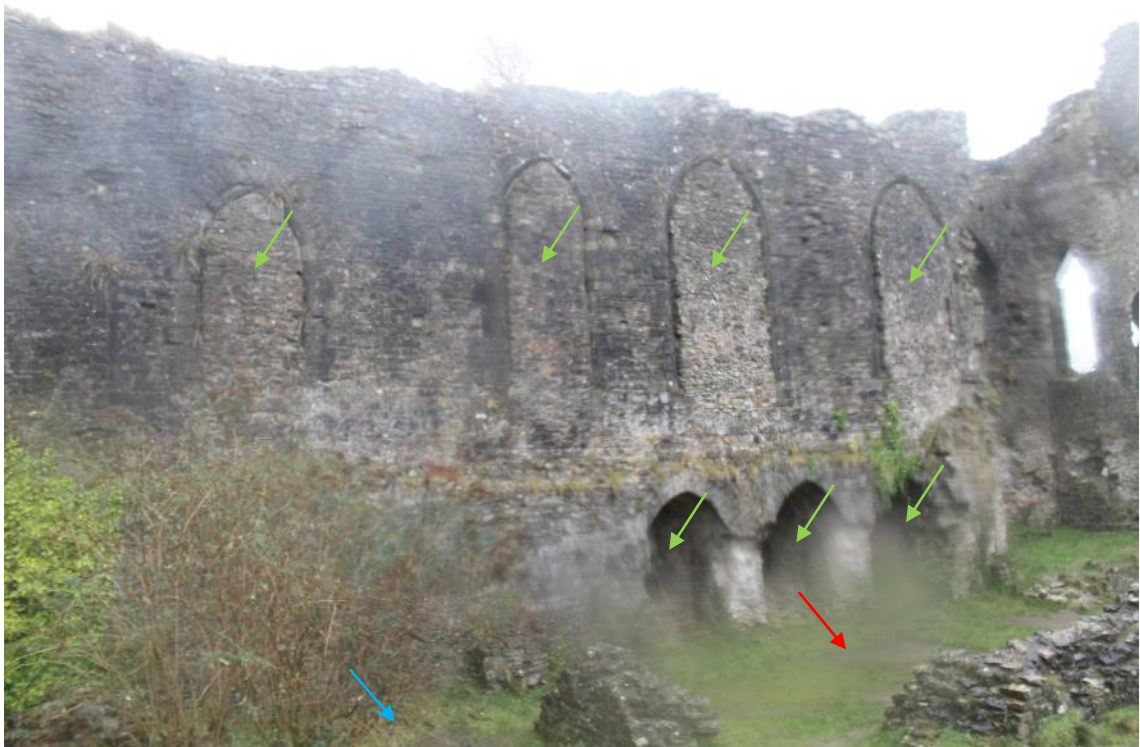
Figure 23: The East Range, interior view. The large 4 bay room with great chamber above is marked in red, a smaller room with a chamber above is in blue, with the latrine chamber (with offices above) just to the left of the small trees visible on the left. Window openings are marked in green.

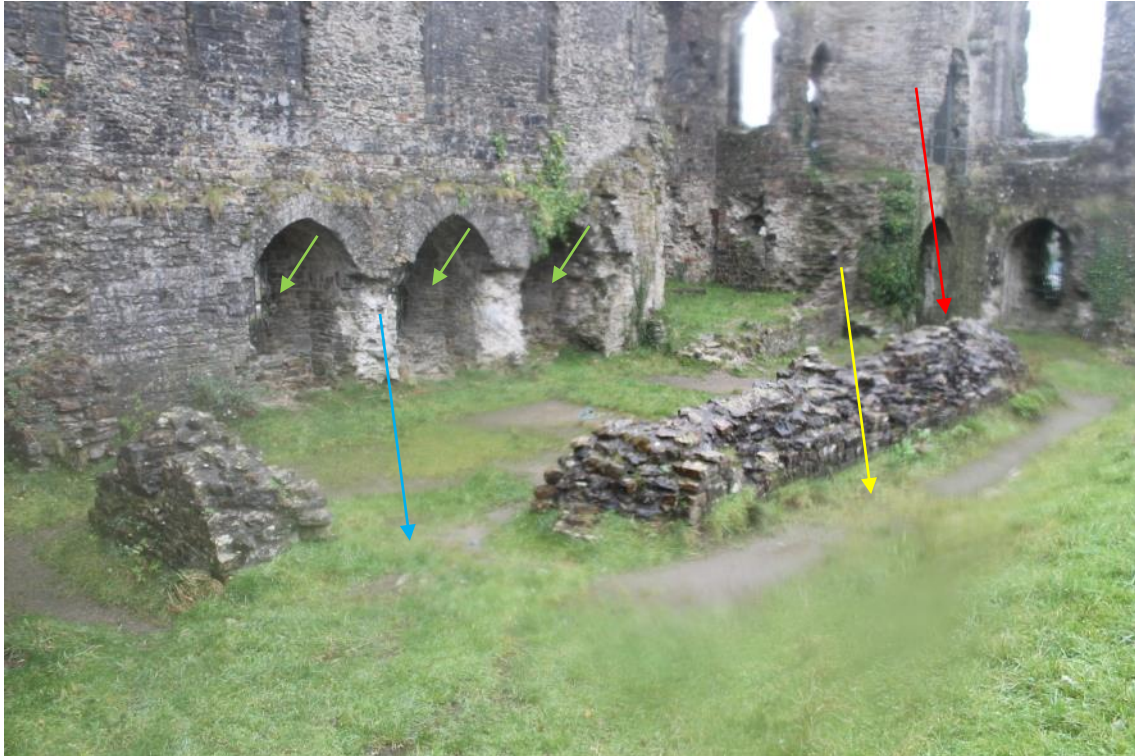
Figure 24: The East Range, interior view showing the 4-bay southern room (with Great Chamber above). The location of a possible spiral staircase is marked in red, the possible entrance in blue, windows in green and an external passage (represented by a low revetment wall to the grassed central area) in yellow.

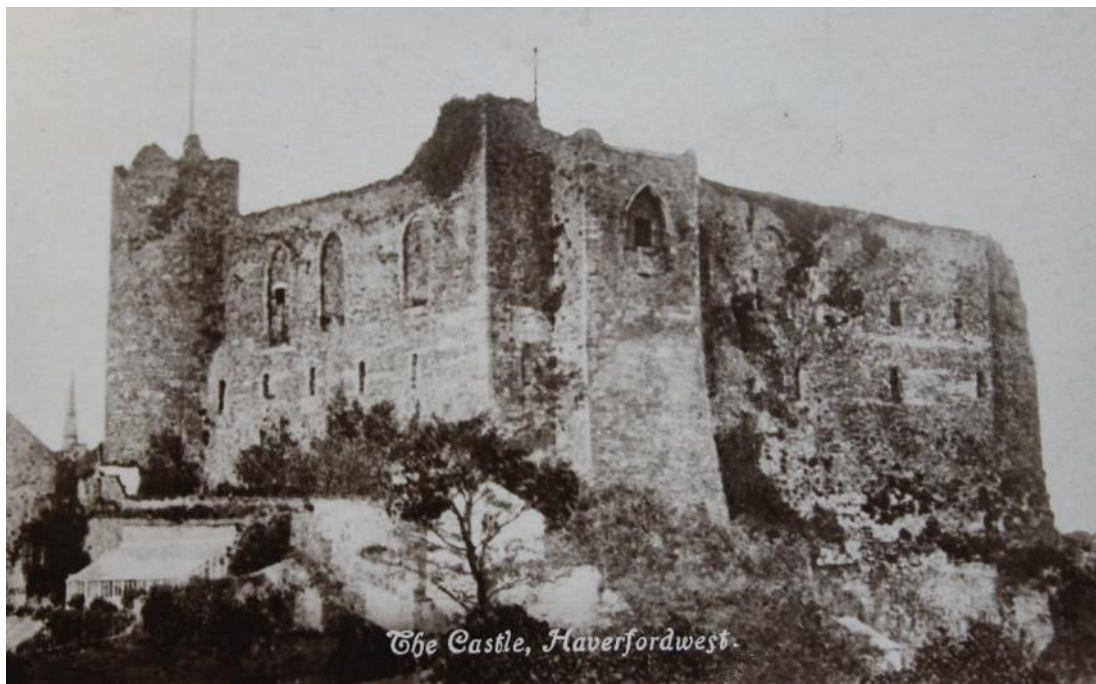
Figure 26: Undated photograph, showing the projecting chapel in the central square turret, with the South Range to the left. At this point the upper windows were blocked. (Haverfordwest Town Museum).

- 6.6.5 The eastern area formed a discrete functional space which can be identified, from architectural and documentary evidence, as the castle chapel. Its 'chancel' occupied the projecting turret at the east end, the east wall of which is pierced by a very large window, now open, originally of three or even four lights but now without its tracery. Its pointed rear arch was replaced in brick, presumably after the gaol period when it had been blocked (unblocked in 1912; RCAHMW) 1925, 109); the sharply-pointed external surround is formed of two chamfered orders, apparently without capitals and said to be of Caen stone (*Pembroke County Guardian*), beneath a similar drip-mould. The north and south walls of the turret are each pierced by a window, only slightly smaller, both now weathered but retaining fragments of their pointed, single-chamfered surrounds. A further, blocked window was said to be visible externally and to belong to a basement-level space (*Pembroke County Guardian*); this has not been seen by the author (Ludlow 2021) and is mentioned in no other sources. The south wall of the 'nave', which stood on the west side of the chancel, shows a window like those in the central room of the range. A spiral stair to parapet level occupies the thickened section of wall at the southeast corner, and its caphouse oversails the south range and chapel as a small square turret along the south face (labelled 'Turret' on old maps and plans; also see Phillips 1922, 450, 453).

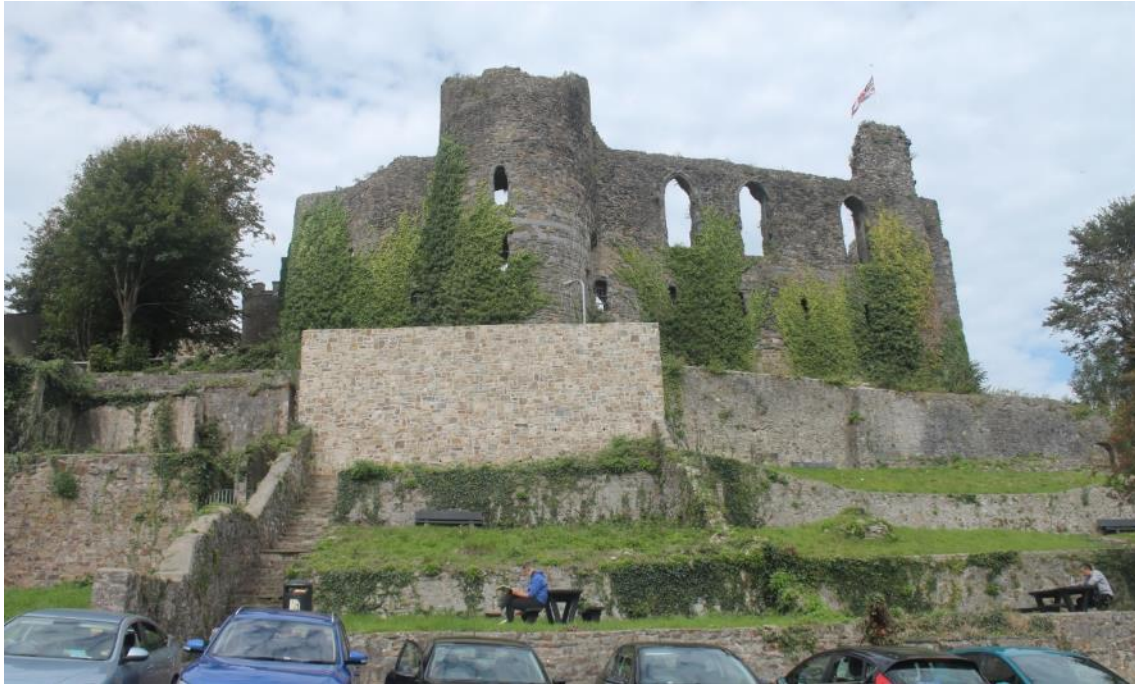
Figure 27: An external view of the South Range at present, with the Southwest Tower projecting.

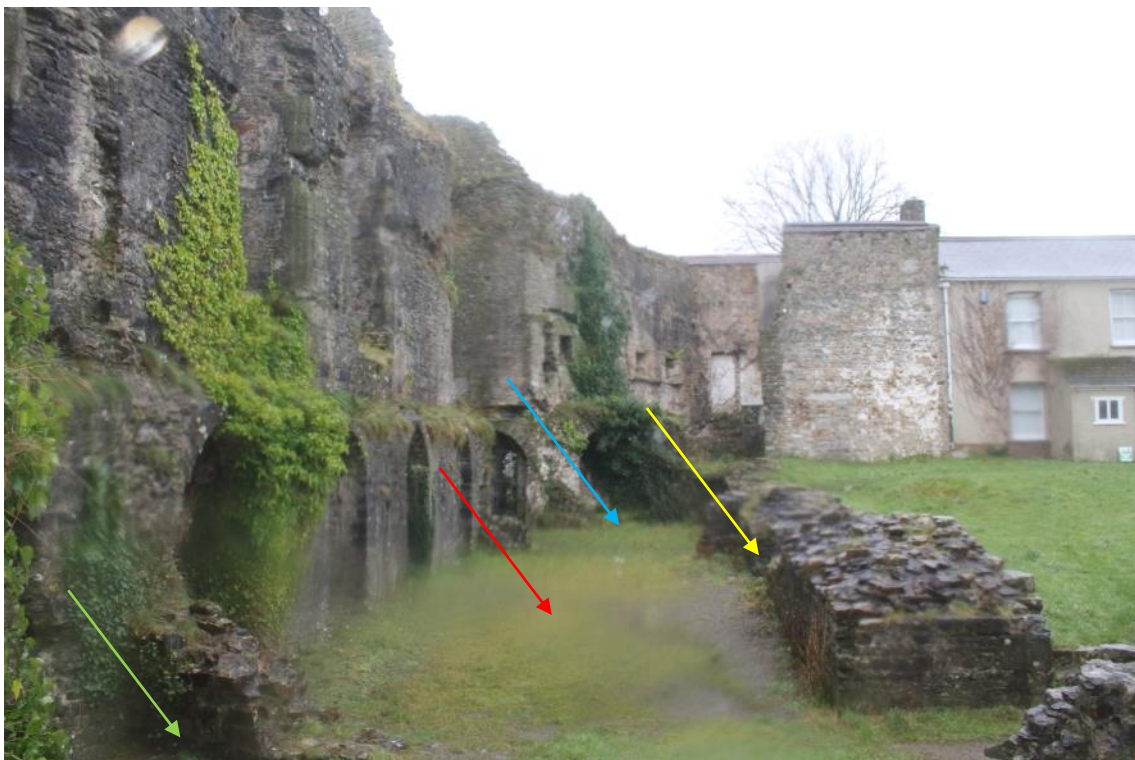
Figure 28: The South Range viewed from the east. The central 4-bay room is marked in red (hall at 1st floor) with the fireplace set in a curve in the wall in yellow, the west room in blue, the east room in green.

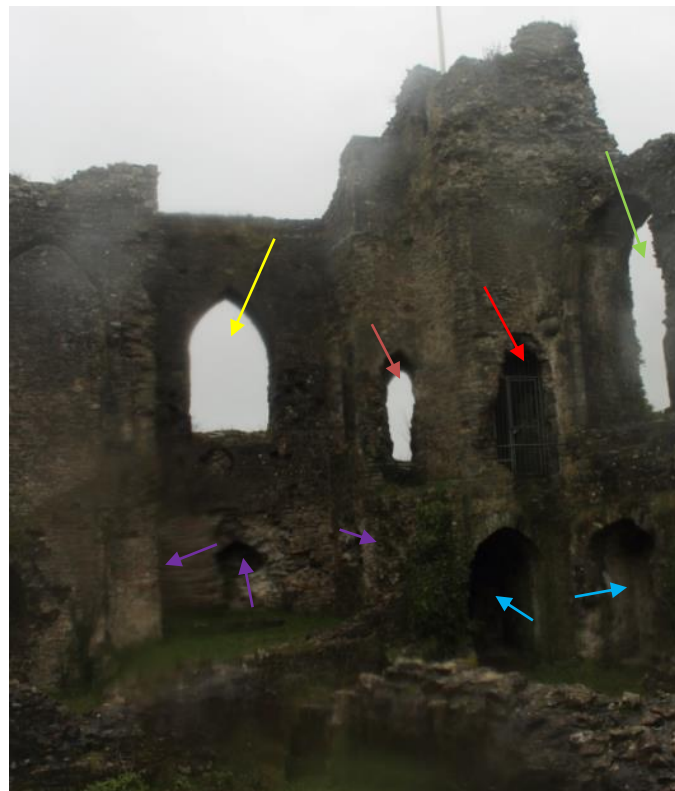
Figure 30: A view of the chapel from the west, unfortunately taken in poor weather conditions. Ground floor open windows are marked in blue, the left one being within an enclosed room, blocked windows are marked in purple. Chapel chancel east window is marked in yellow, the chancel south window in brown, nave south window in green. The Chapel spiral stair is marked in red.

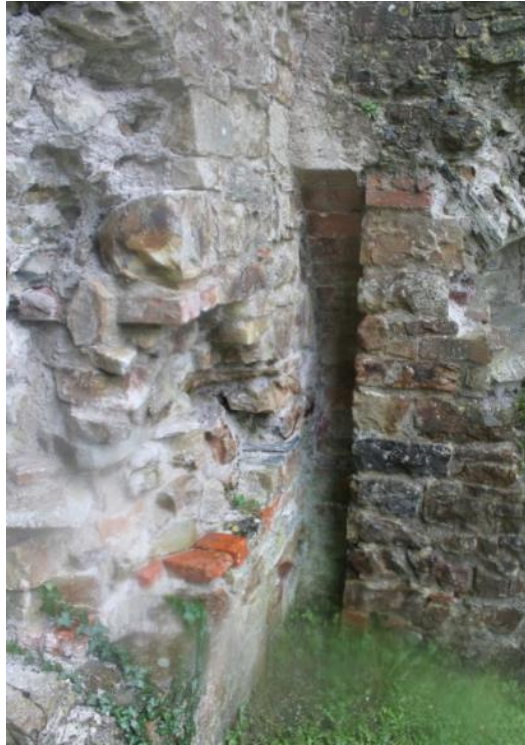
Figure 31: A curved recess at ground level in the south wall of the chapel, presumably associated with the 19th century treadwheel.

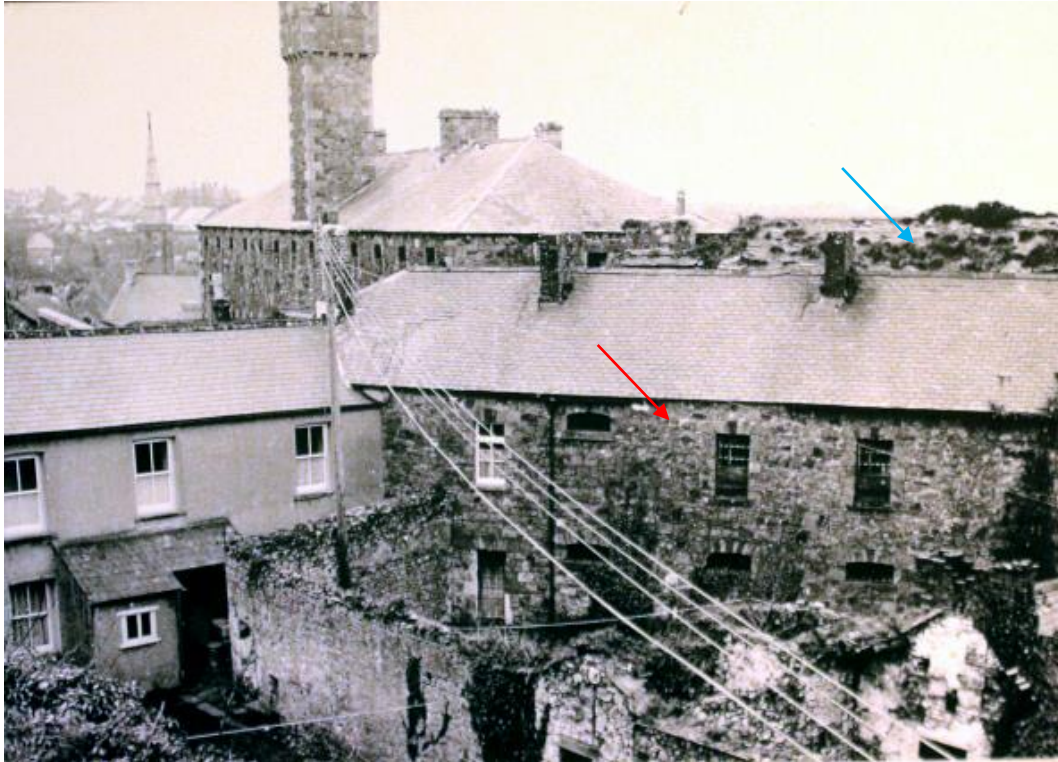
Figure 33: View northeast, showing the female wing of the gaol marked in red, which was built against north curtain wall, the upper courses of which are marked in blue. (Haverfordwest Town Museum).

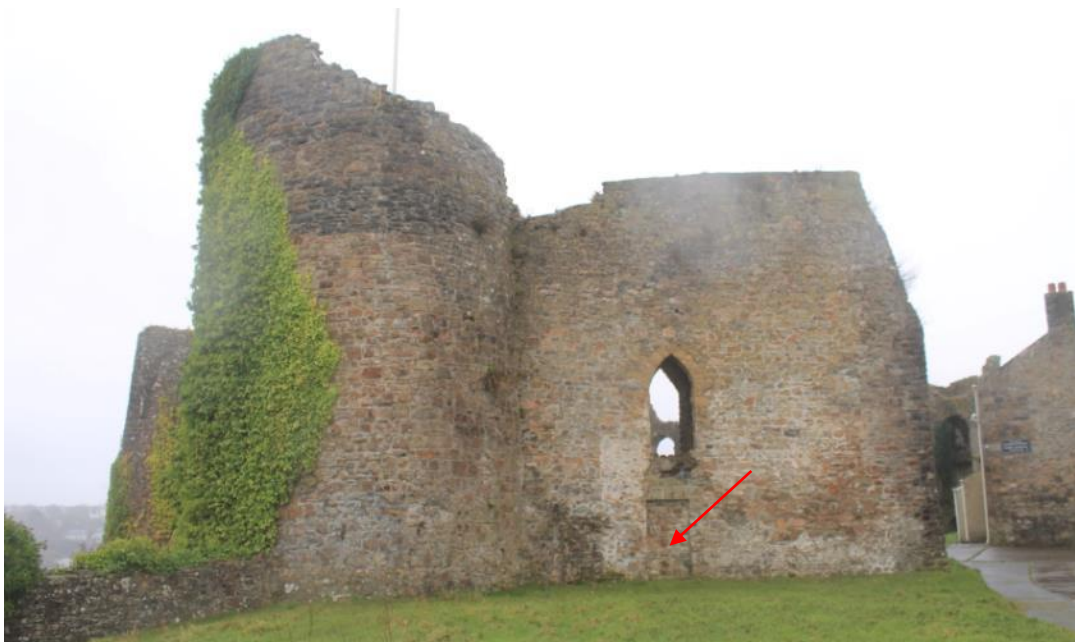
Figure 34: The external face of the north curtain wall. The blocked gaol-era door is marked in red, with the 1st floor access above.

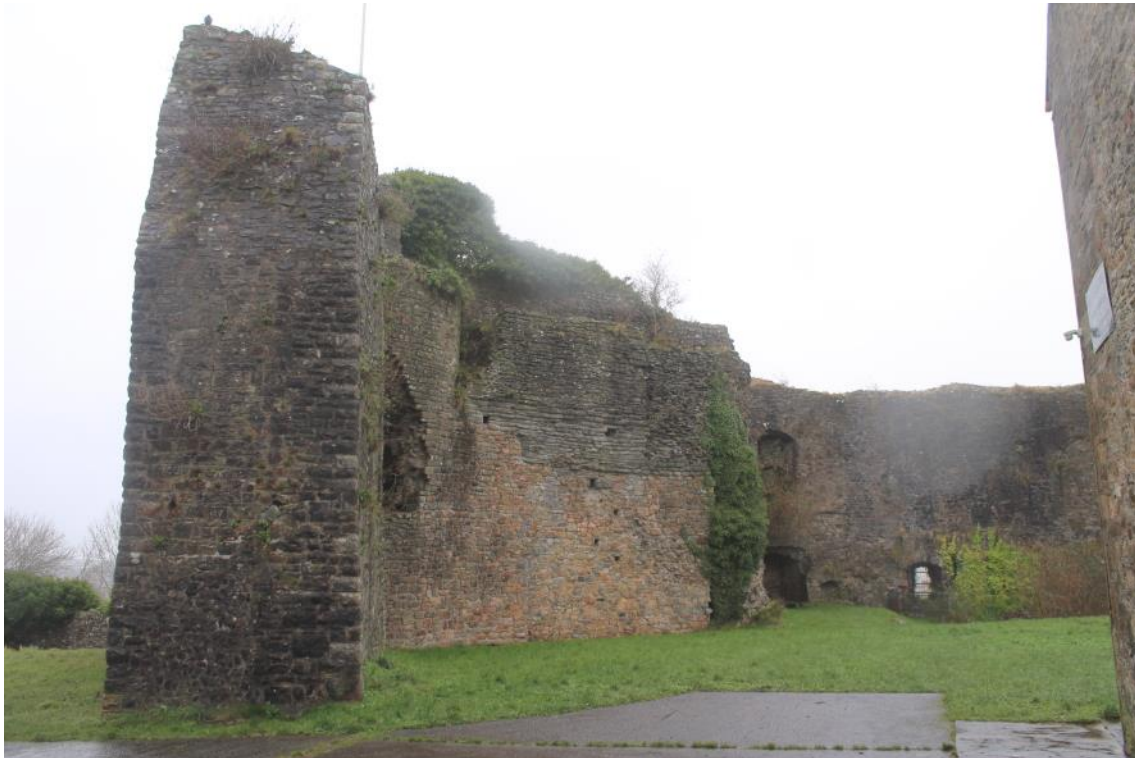
Figure 35: View east of the north curtain wall. The stonework on the end face dates to post-gaol restoration, the curtain wall east of the north tower is visible behind, showing the two phases of stonework.

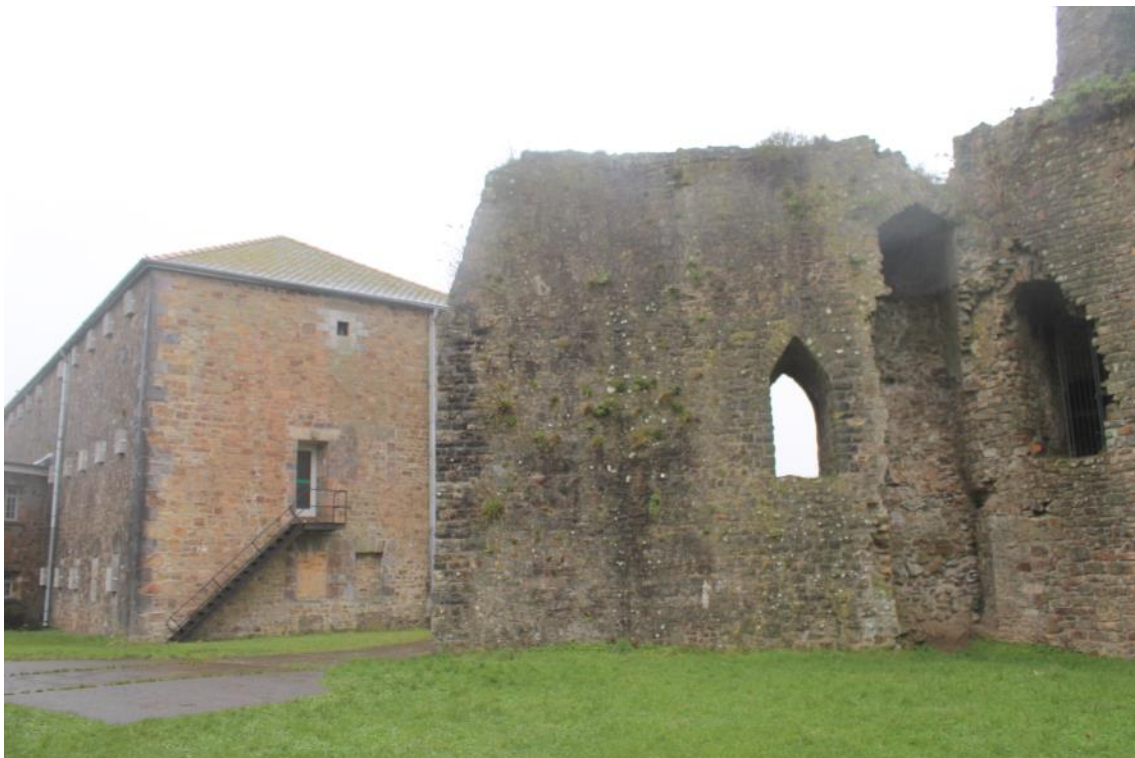
Figure 36: The internal face of the north curtain wall, with the gaol building to the left. The 1st floor opening is visible, with the internal recess visible on the right. The opening on the right is part of the North Tower.

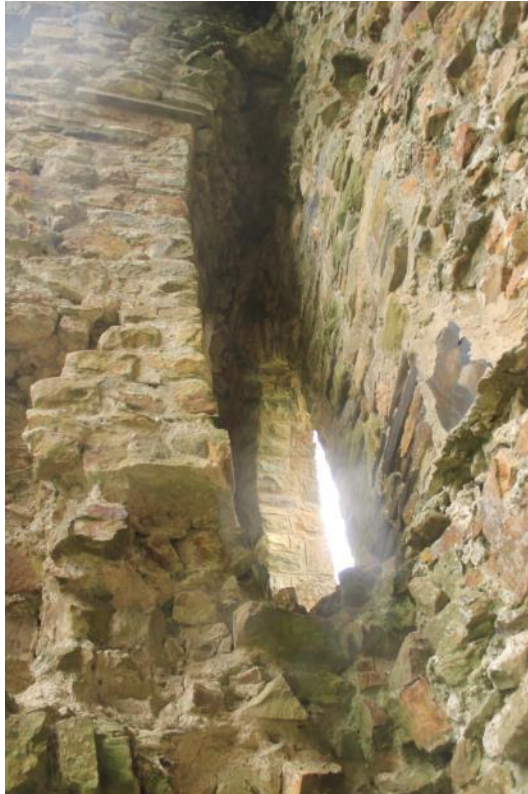
Figure 37: North curtain wall, internal recess, looking up at the open through-passage.

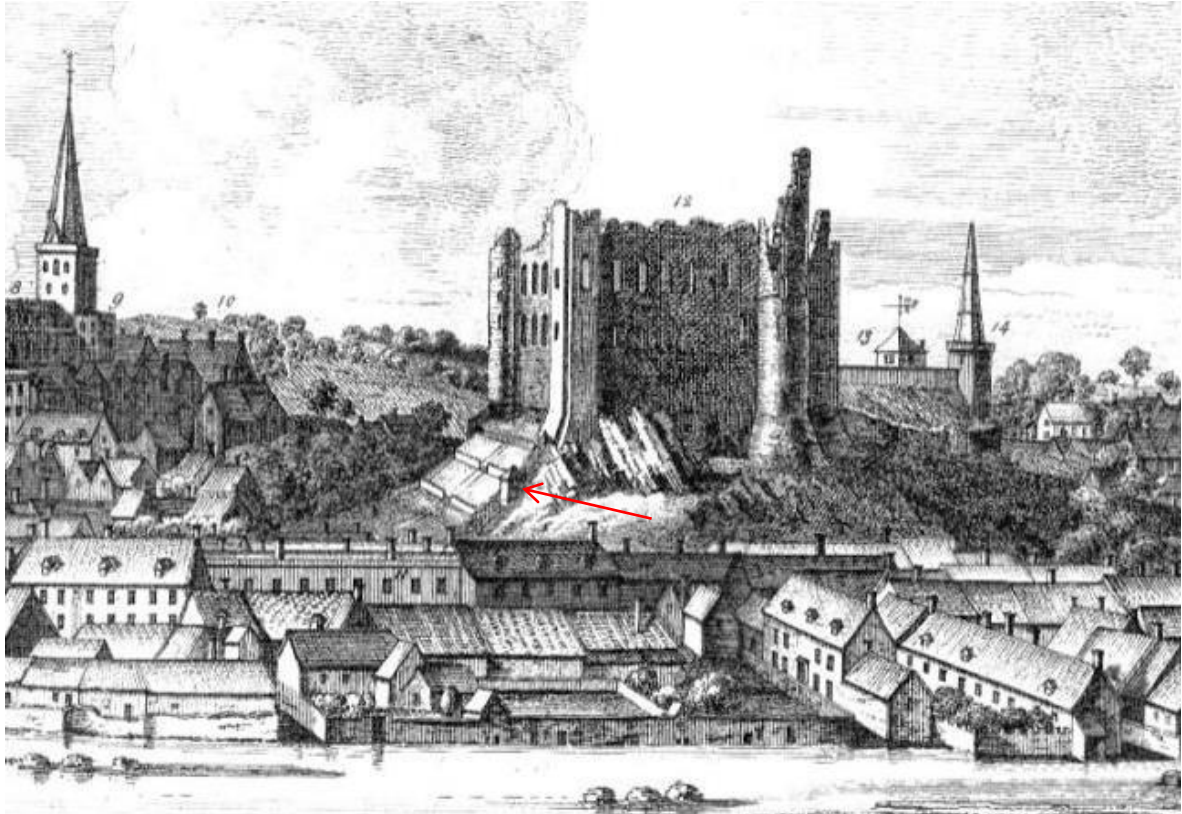
Figure 42: Detail from the Buck print of 1748, showing stylised garden terraces including the Queens Arbour, with the corner turret marked in red.

- 6.10.4 The garden terrace survives as a recognisable feature, although the surrounding walling may have been extensively restored and the corner turret appears to be missing. The internal arrangements of the terrace are not known, and the site has not been investigated archaeologically, but there remains a potential for below-ground archaeological remains to exist. The form of the terrace is an unusual feature, and as outlined above this can be compared with other known examples at similar medieval castles.
- 6.10.5 The site is mentioned in some documentary sources, although not in detail. It appears on some early paintings, prints and drawings of the castle, although generally it appears stylised and accurate representations appear rare.

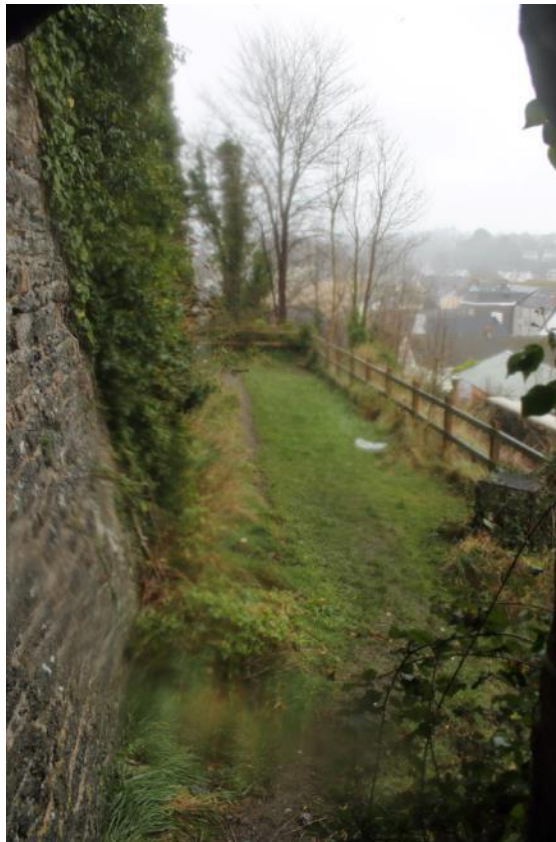
Figure 43: View east across the Queens Arbour garden terrace from the entrance stair.

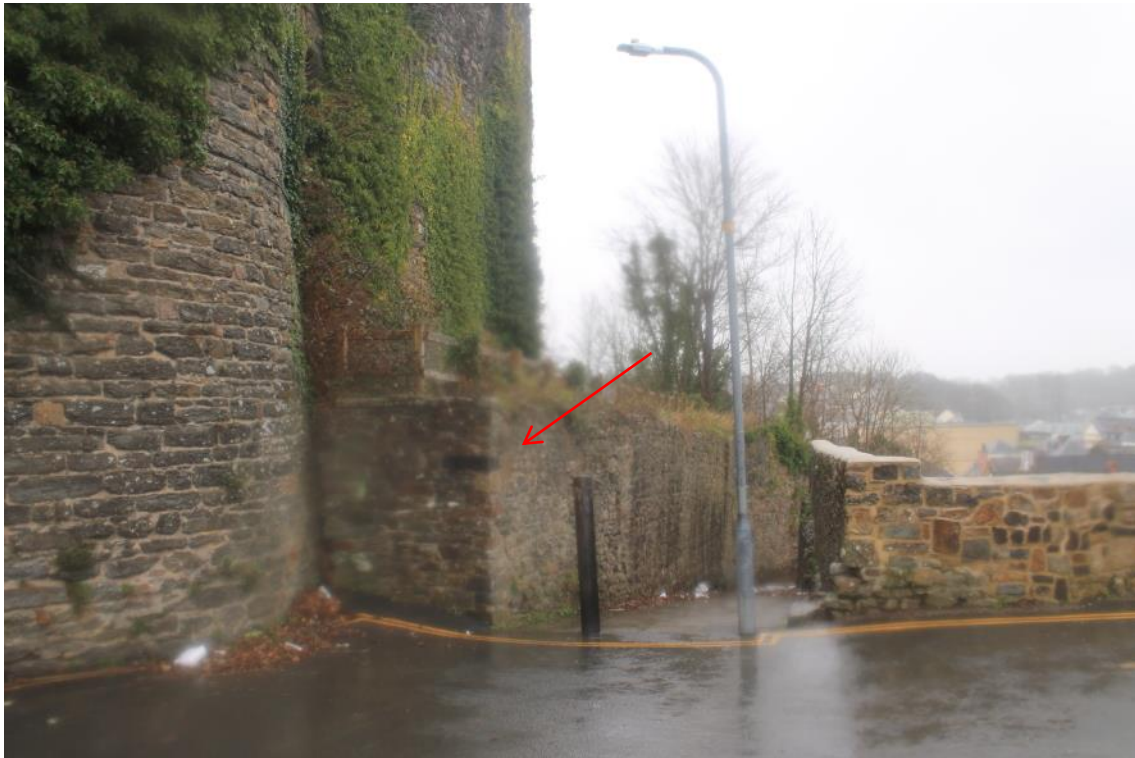
Figure 44: View of the Queens Arbour garden terrace from the Castle Back Street to the west. The terrace walling is marked in red.
