HAVERFORDWEST CASTLE FLAGSHIP DEVELOPMENT, HAVERFORDWEST, PEMBROKESHIRE: STATEMENT OF SIGNIFICANCE

Prepared by DAT Archaeological Services
For: Pembrokeshire County Council

REPORT NO. 2021-101

March 2022

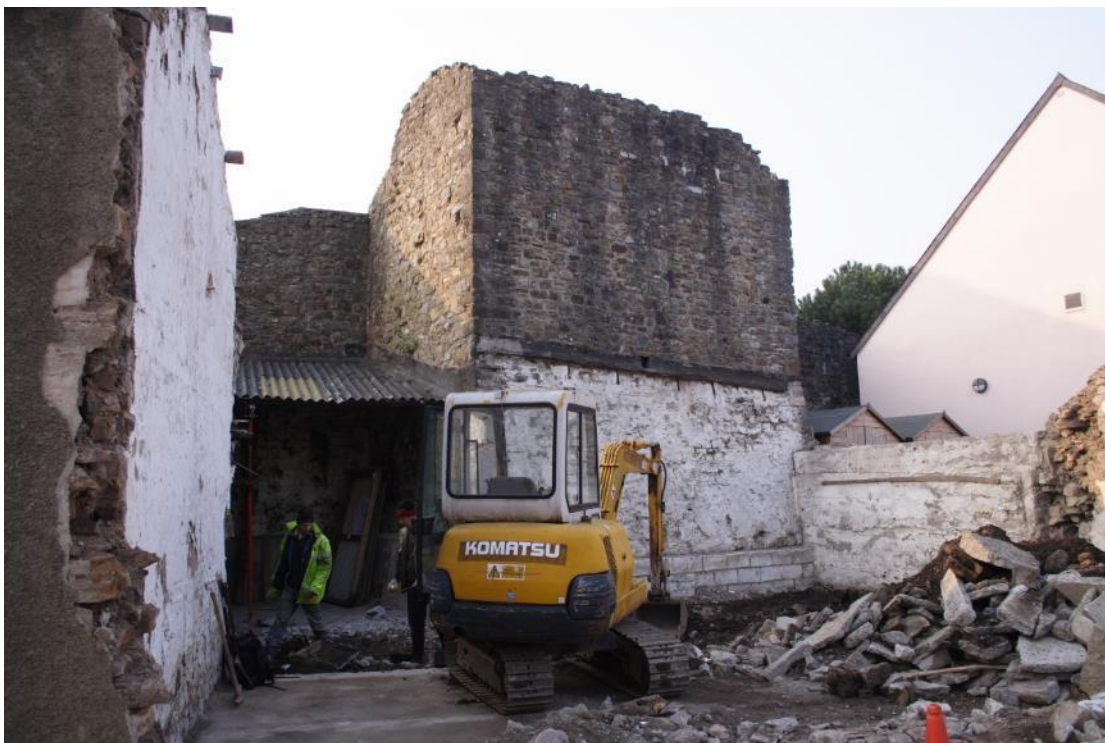
Figure 47: Exterior of the square tower, revealed during demolition works in 2008.

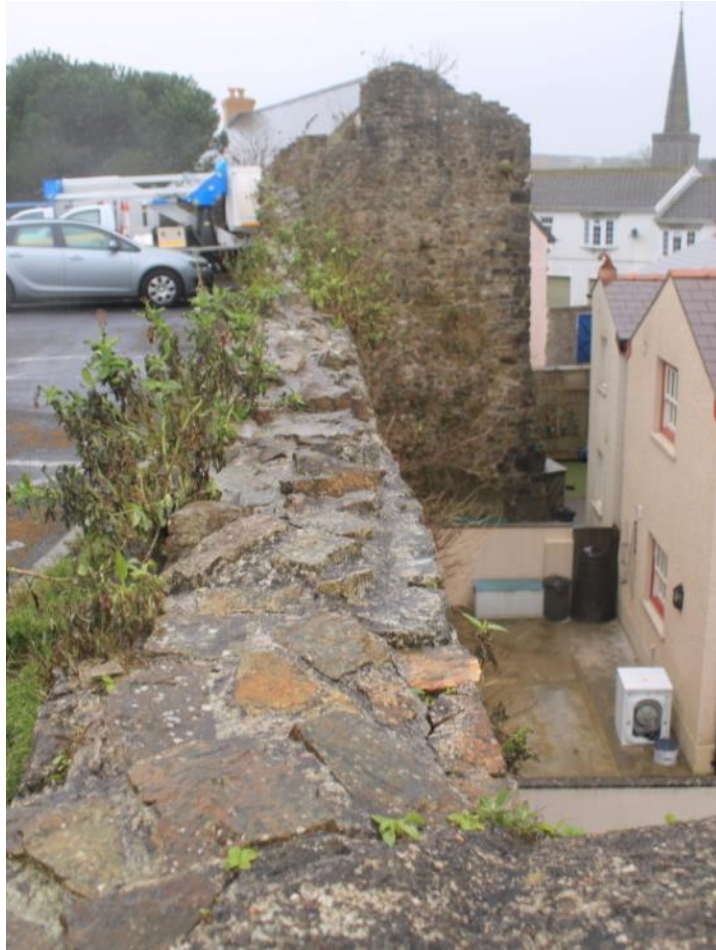
Figure 48: The curtain wall, and square tower, viewed from the east.

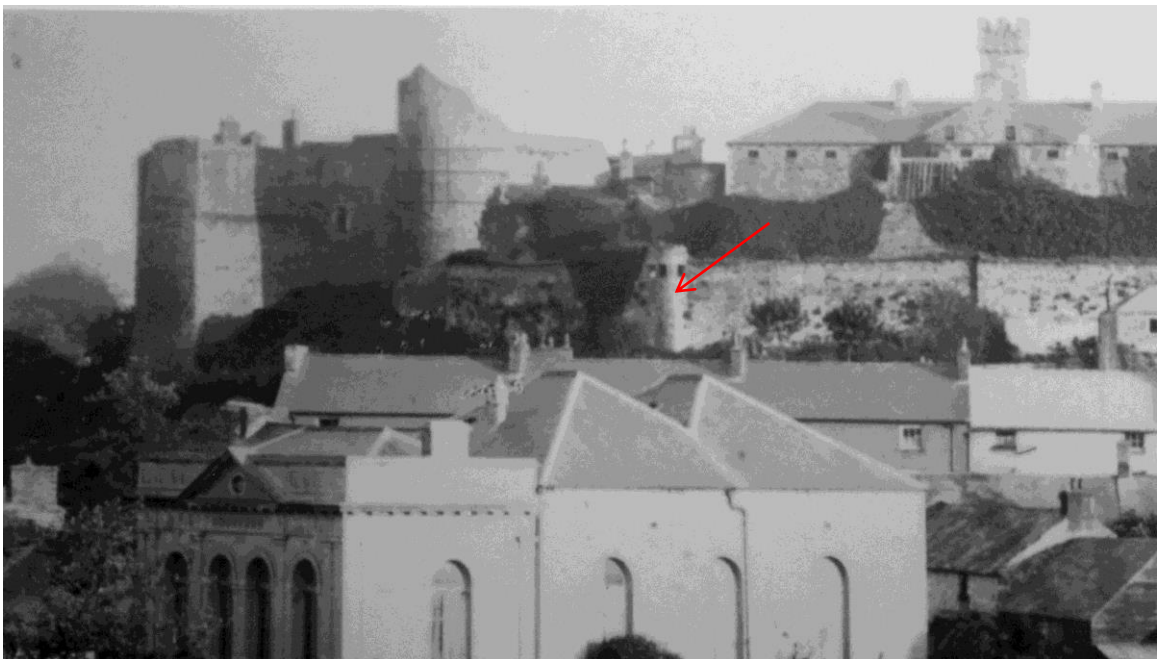
Figure 49: Photograph from 1935 (Haverfordwest Town Museum) showing the northern curtain wall and rounded turret in red, with openings visible in the upper levels.

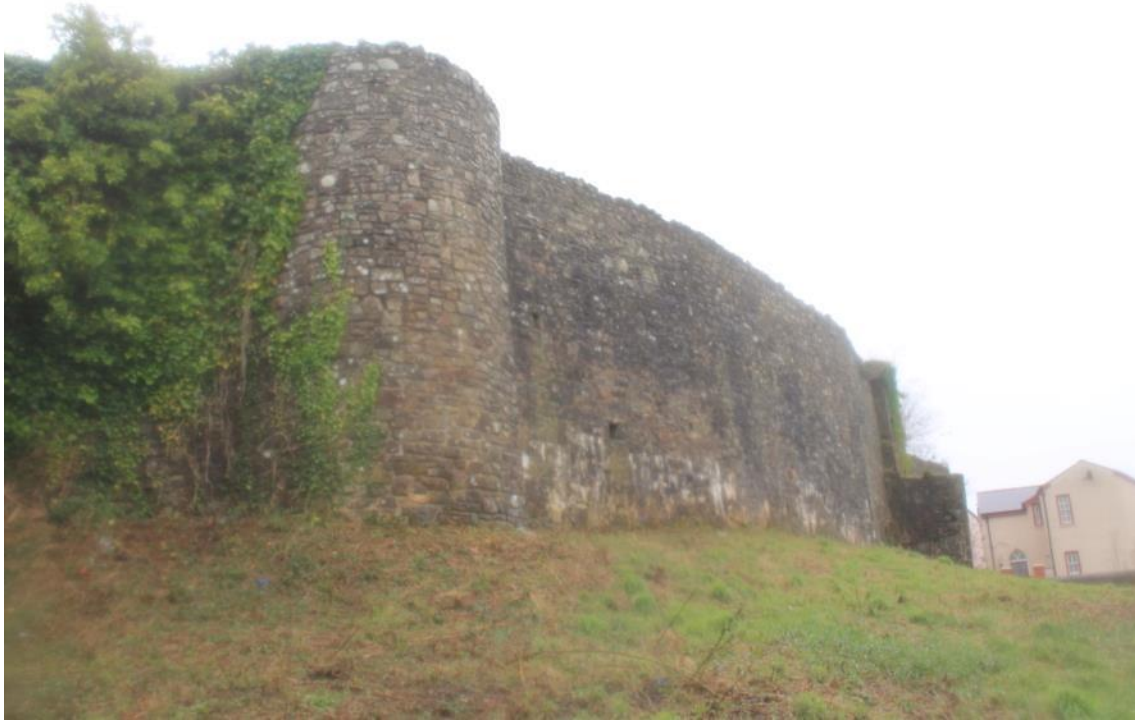
Figure 50: The exterior of the curtain walling and round turret, viewed from the northeast.

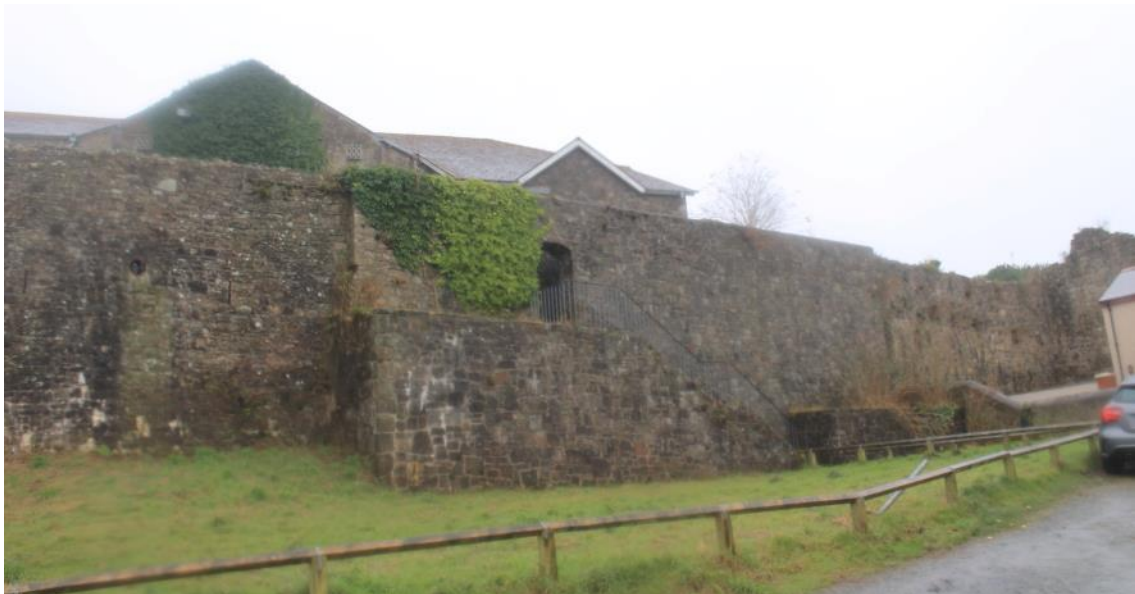
Figure 51: The inserted modern staircase in the curtain walling.

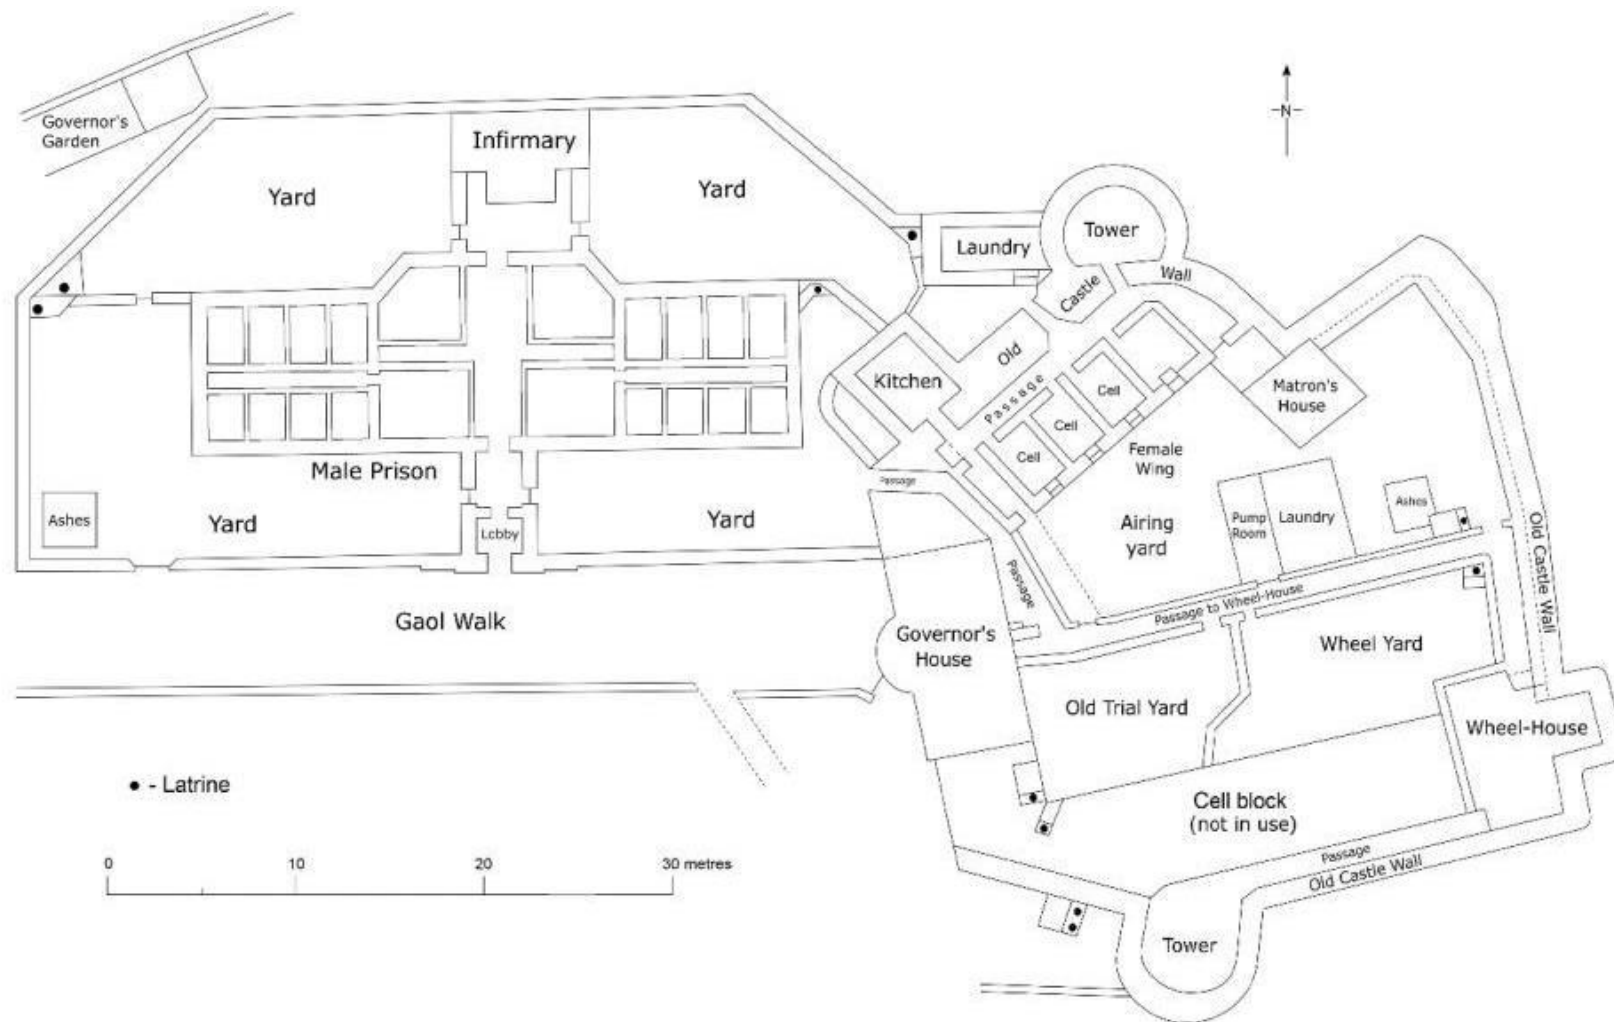
Figure 56: Schematic plan of Haverfordwest Gaol in c.1870
(adapted from plans held in Pembrokeshire Record Office, PCC/SE/77/39).

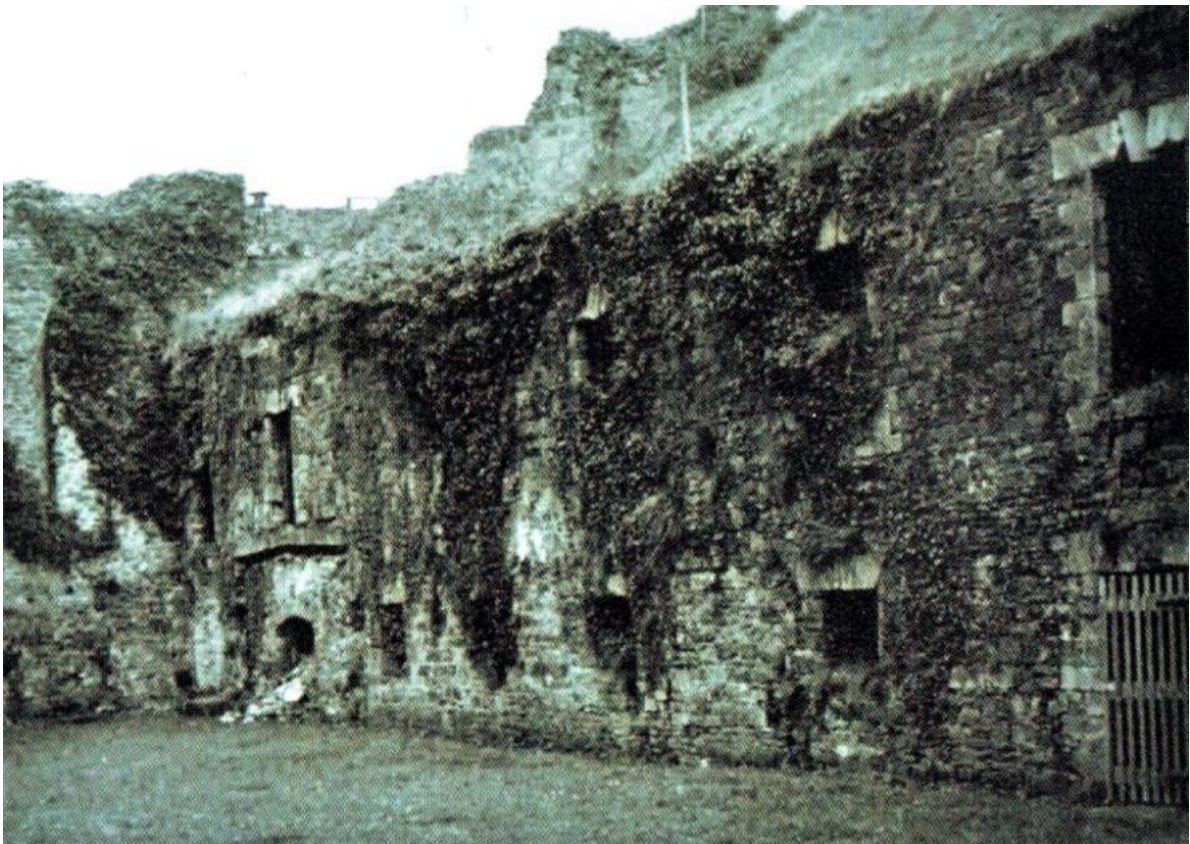
Figure 58: Undated photograph of the 1780 cell-block north wall, possibly showing the profile of the medieval East Range ground-floor vault at the east (left) end (Pembrokeshire Record Office, PCC/SE/77/39).

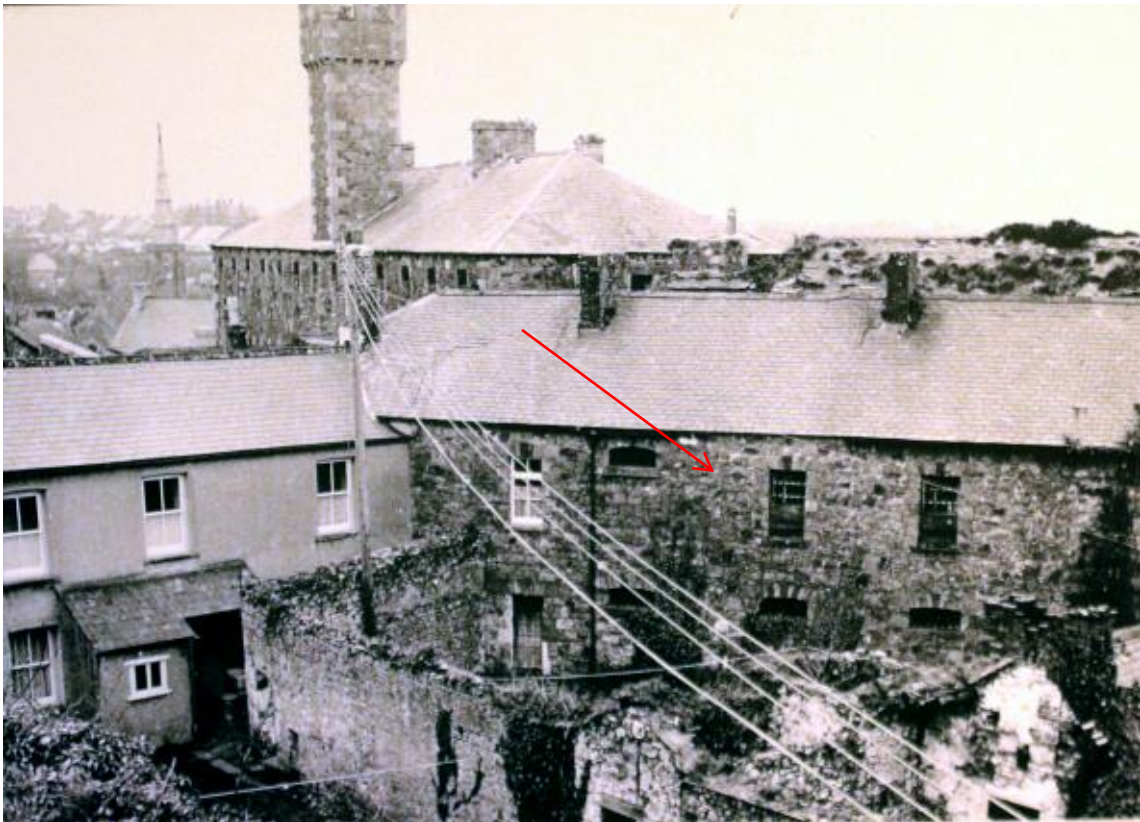
Figure 60: The Female Wing highlighted in red, built against the medieval walling that rises above the roofline, with the lower Governor's House on the left, and the 1820 gaol to the rear. (Haverfordwest Town Museum).

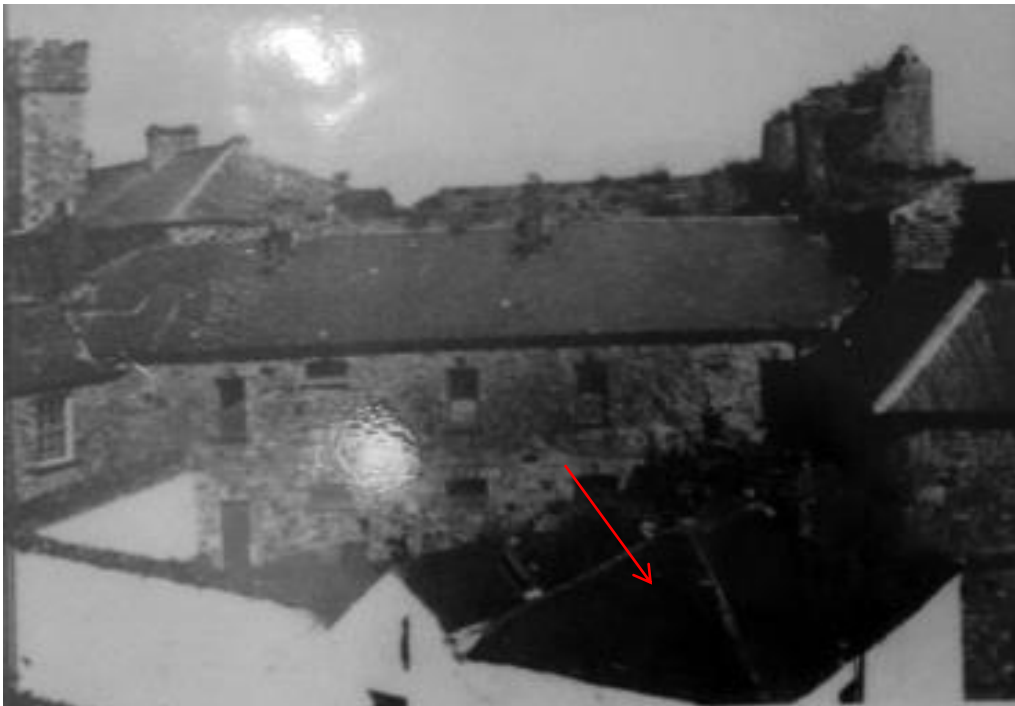
Figure 64: View of the Female Wing of the gaol, with the whitewashed passageway wall in the foreground, incorporating the hipped roof of the laundry shown in red. The laundry roof is also visible in the foreground of Figure 61. (Haverfordwest Town Museum).

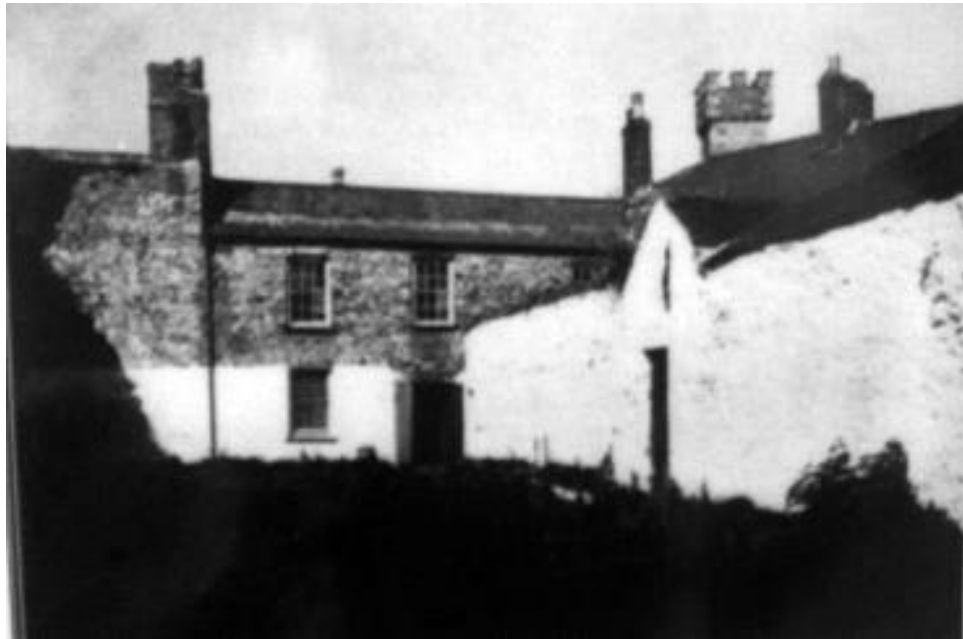
Figure 66: Undated photograph showing the whitewashed north wall of the passage on the right, with the Governor's House to the rear. (Haverfordwest Town Museum)

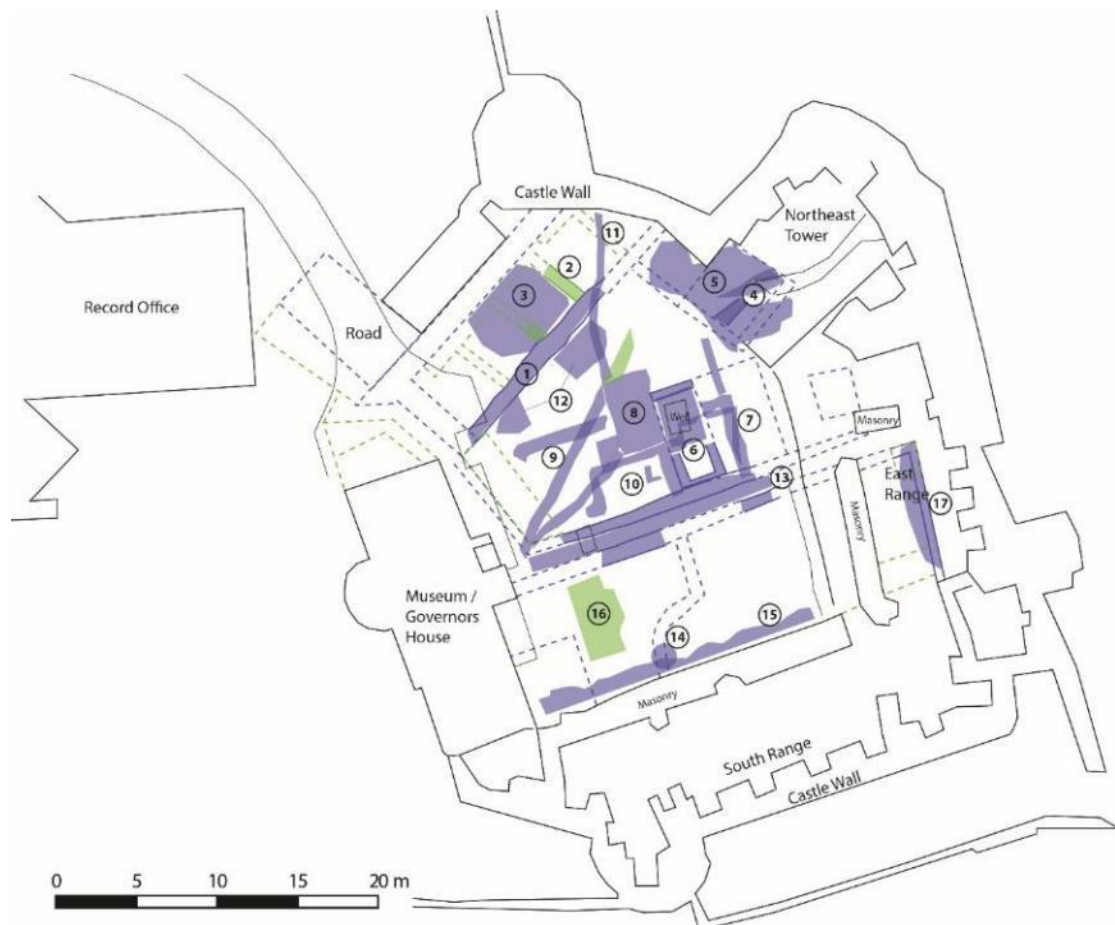
Figure 67: Interpretation layer from the various geophysical surveys, depicting features (in blue and green) likely to relate to the 18th and 19th century gaol and police station. The numbers relate to descriptions in the survey report (Poucher 2020).

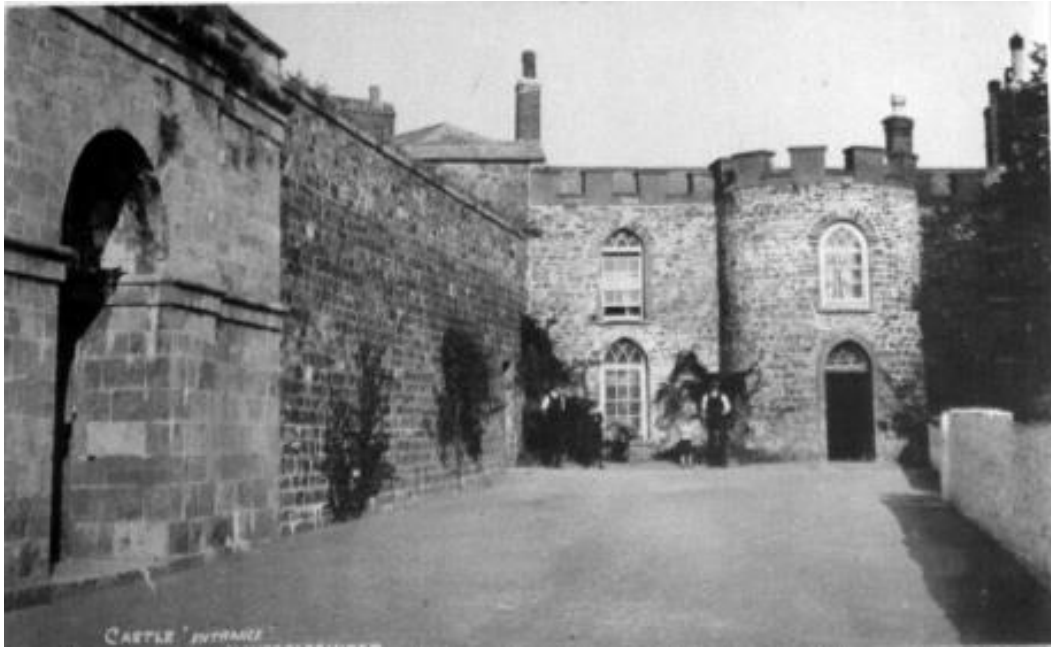
Figure 69: Postcard image from 1910 showing the west face of the Governor's House and the attached gaol walling.

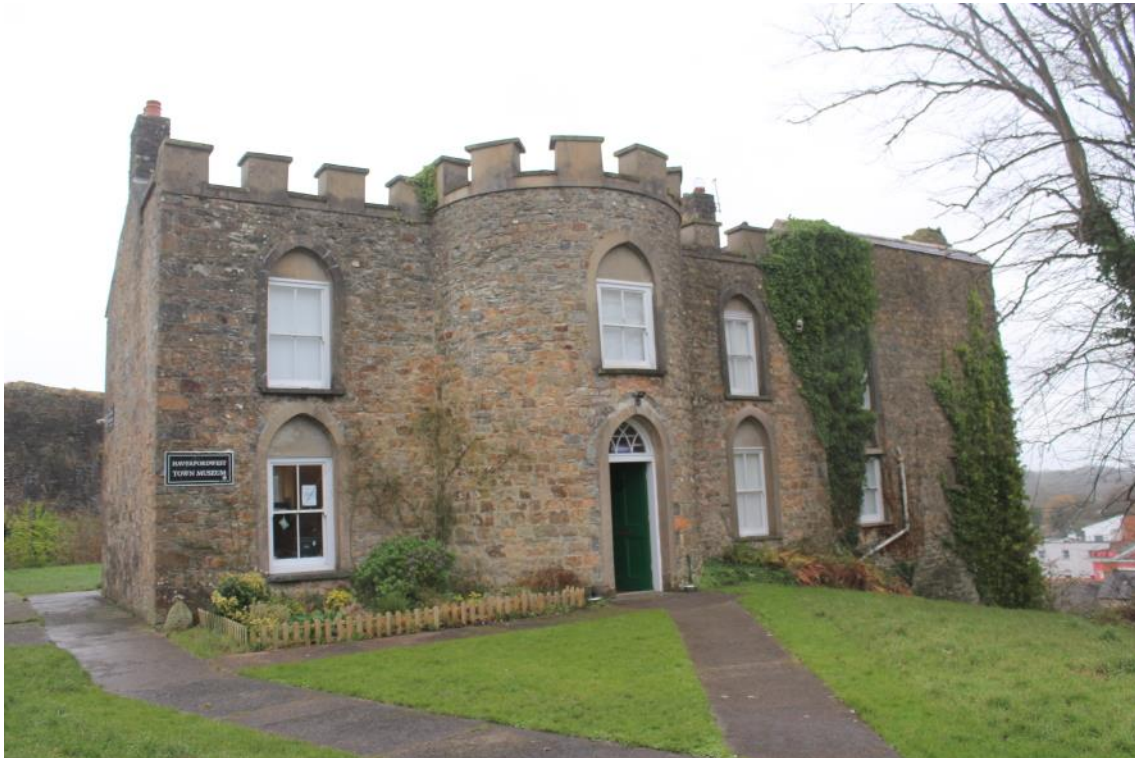
Figure 71: Current view of the west face of the Governor's House.

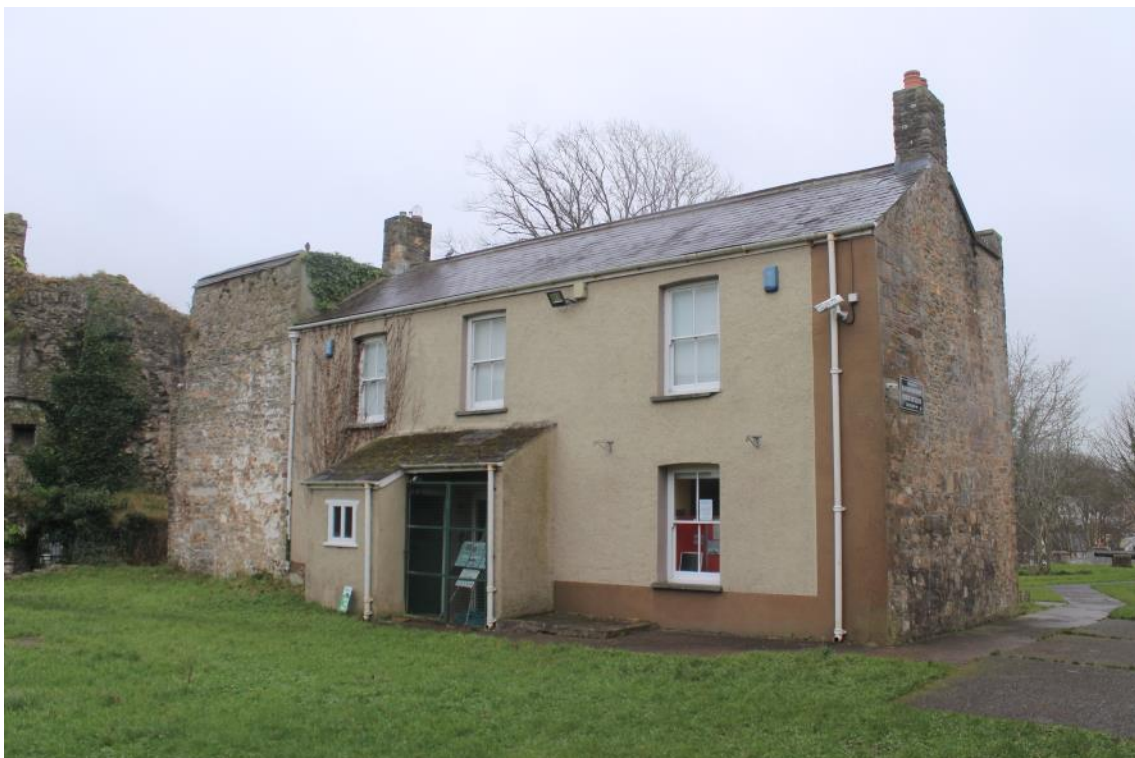
Figure 72: The rendered rear face of the Governor's House.

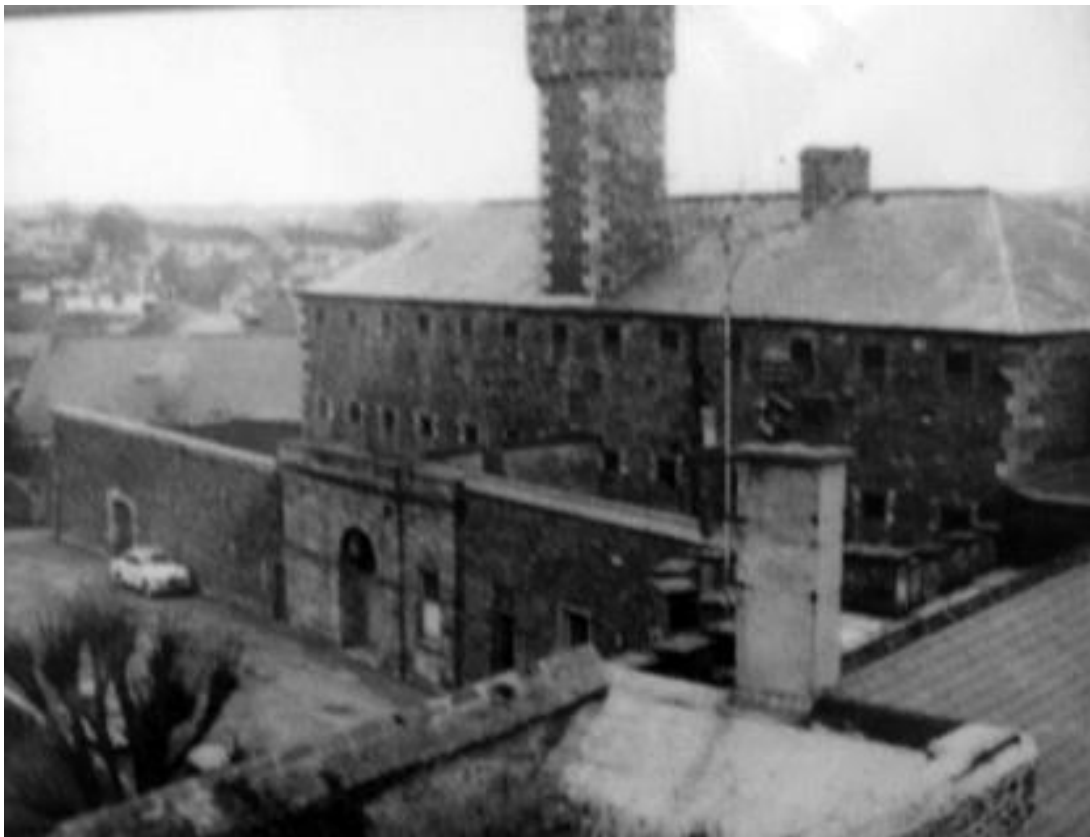
Figure 74: View from the roof of the Governor's House of the south face of the gaol building, also showing now-removed features such as the flanking walling to either side of the entrance, and the tall watchtower projecting from the roof. (Haverfordwest Town Museum).

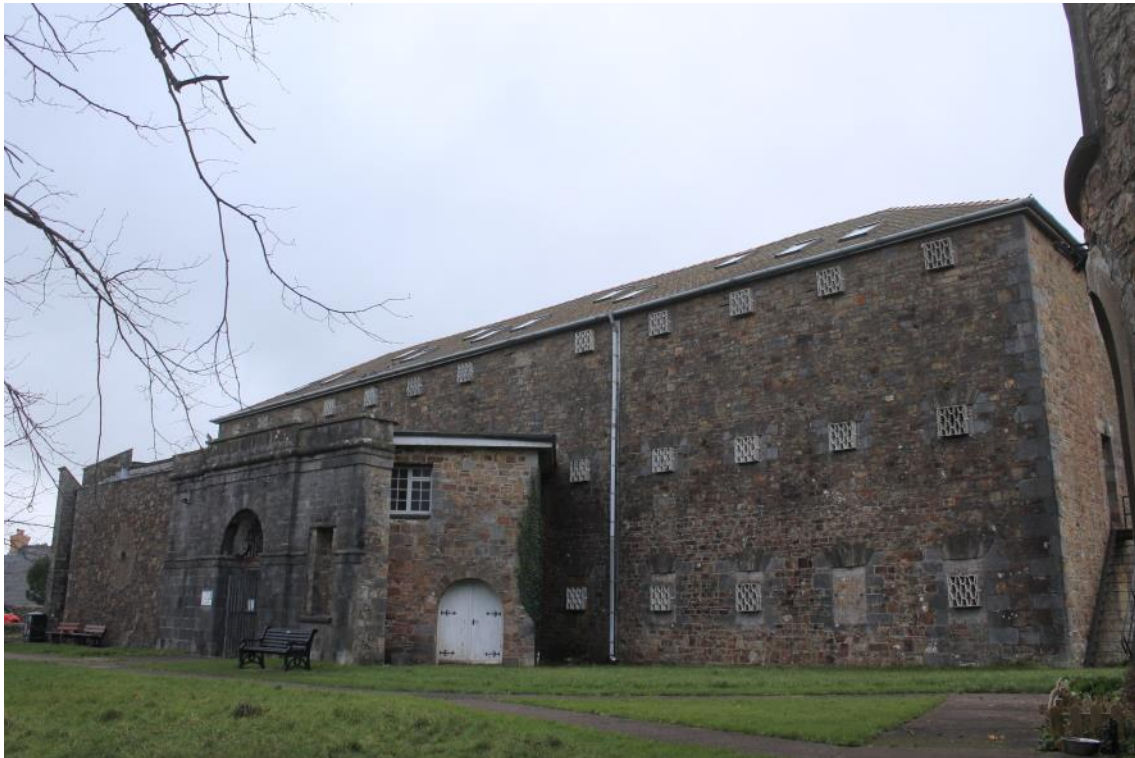
Figure 75: The current southern face of the building, showing the 1960s additions between the entrance and the main building, and the flanking walling to the west.

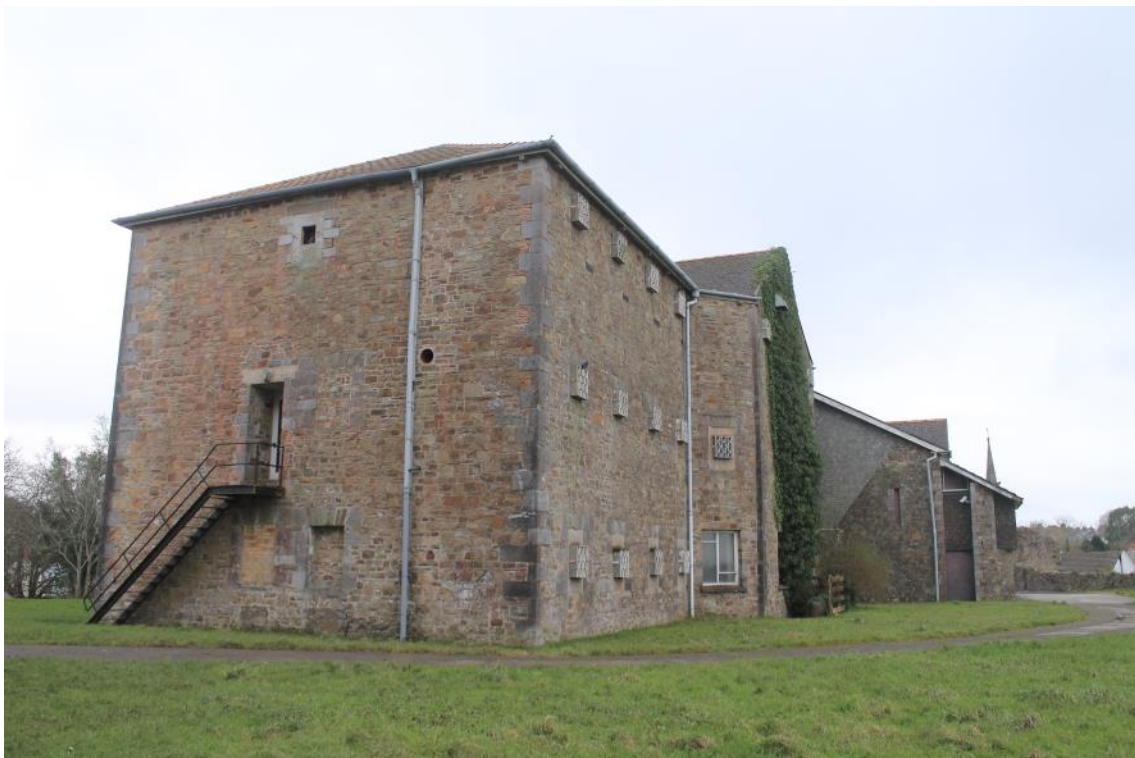
Figure 76: The east and north elevations of the building, showing the modern extension on the northwest corner.

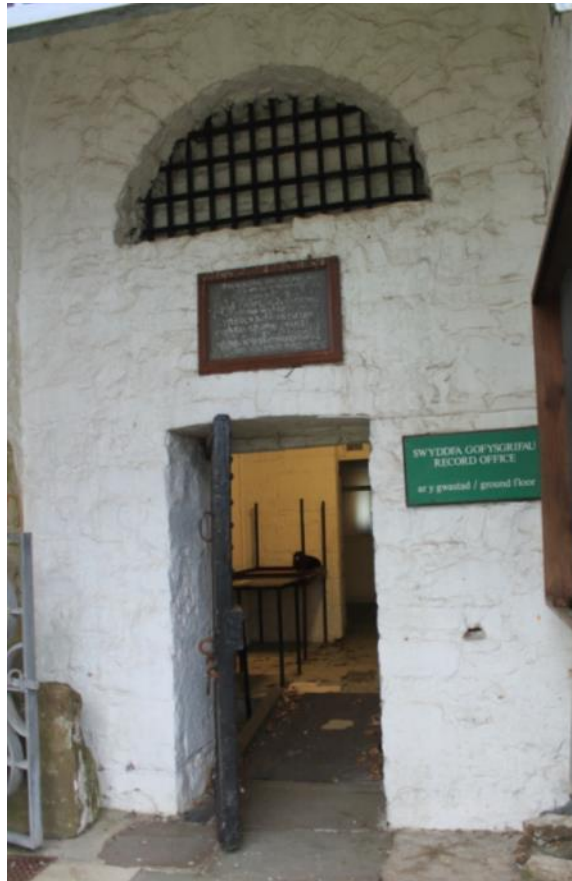
Figure 77: The inner entrance to the building, retaining the original openings and gaol-era door.

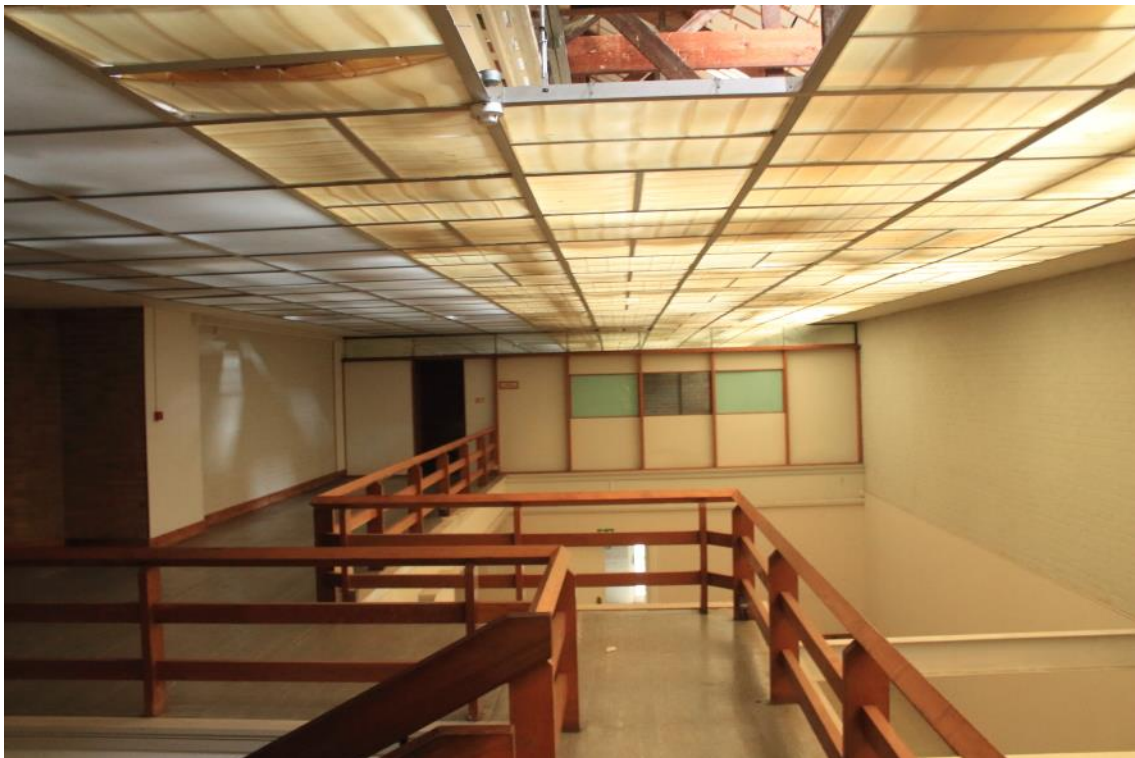
Figure 78: The interior at 1st floor level, showing the modern mezzanine flooring and lowered ceiling.

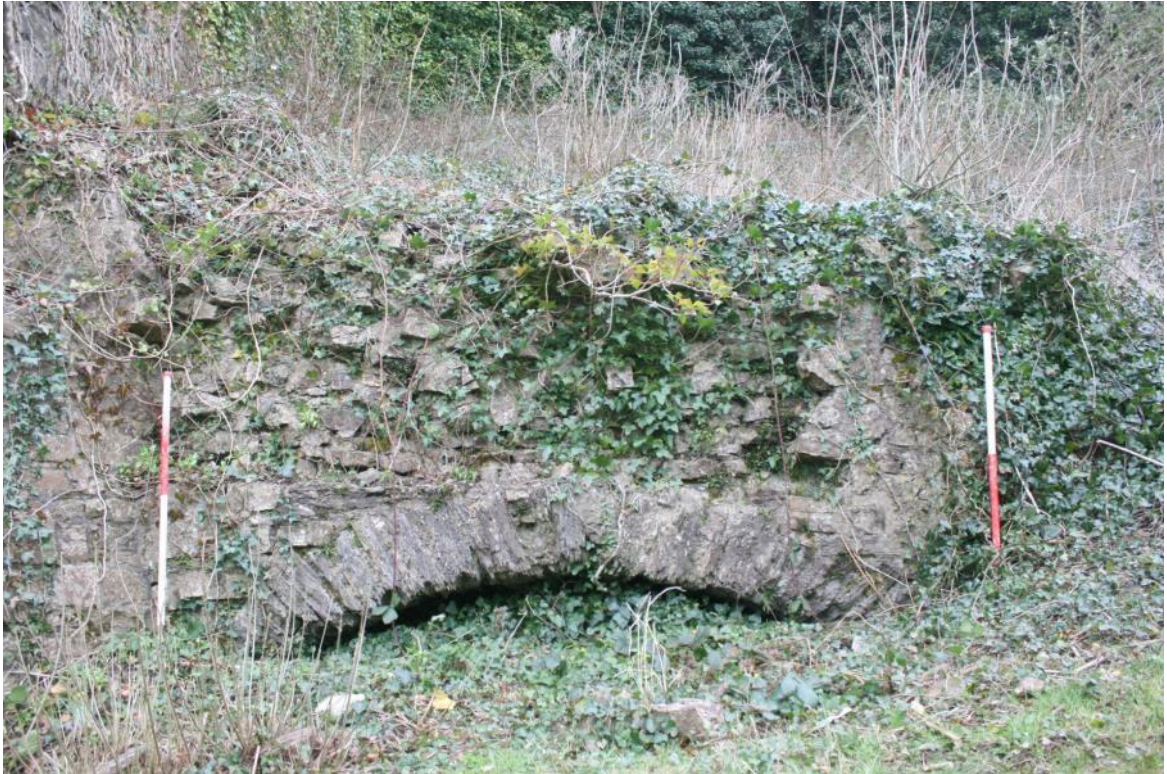
Figure 81: The segment of potential town wall, containing the low arch, adjacent to the castle.

- 9.2.3 In 2021, moreover, a section of substantial masonry walling was observed by Andy Shobbrook, of DAT, adjoining the Northeast Tower of the castle and running northwest for 5 metres before petering out. Probably truncated and formerly higher, it contained an archway, 3.10 metres wide but perhaps always low, with a segmental head of plain voussoirs; all were of convincingly medieval date. It appears in none of the published descriptions of the castle and town seen by Ludlow (Ludlow et al 2021), but can be identified on the OS 1:500 map of Haverfordwest, of 1889, on which it is labelled 'Arch'. The remains of a return at its northwest end correspond with the 90° turn shown on the map, which depicts the walling as continuing north-eastwards. It is possible that the walling represents the remains of the medieval town wall at

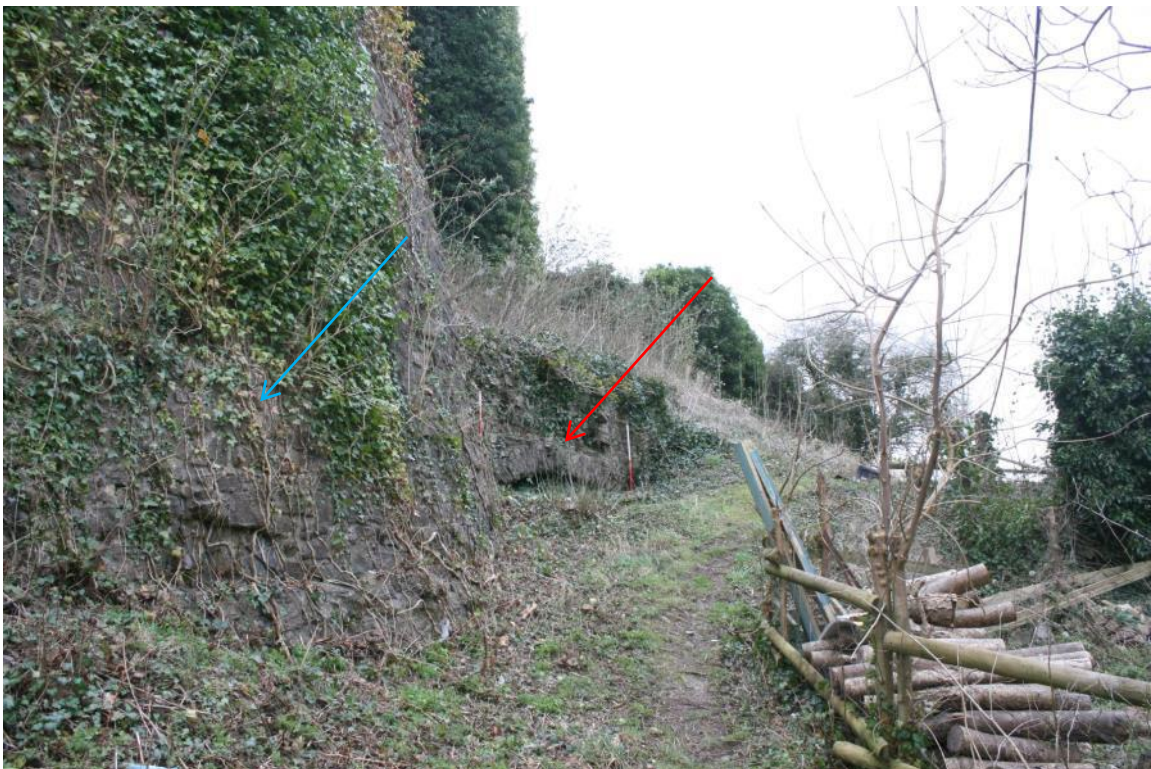
Figure 82: The segment of wall in red, adjacent to the outer face of the Northeast Tower/Keep in blue.

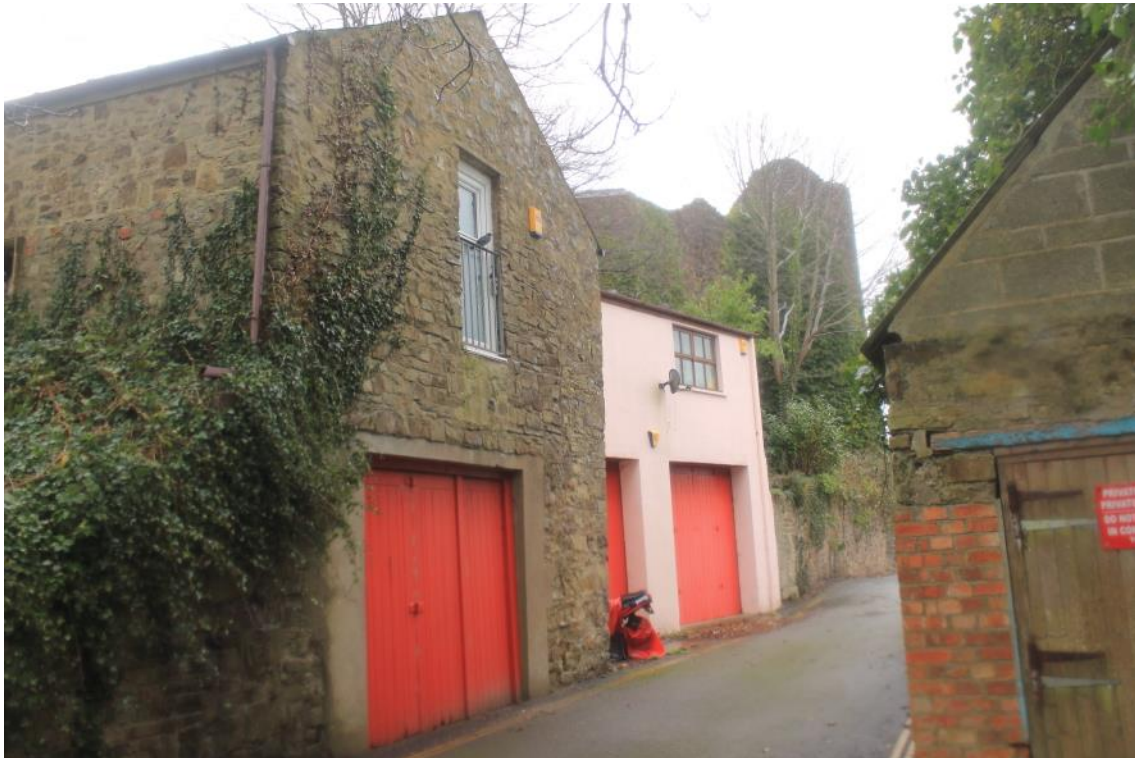
Figure 88: View east along Castle Back, showing the 19th century buildings built into the south side of the castle ground, with the wall of the Inner Ward visible to the rear. West of this point views of the medieval castle become obscured.

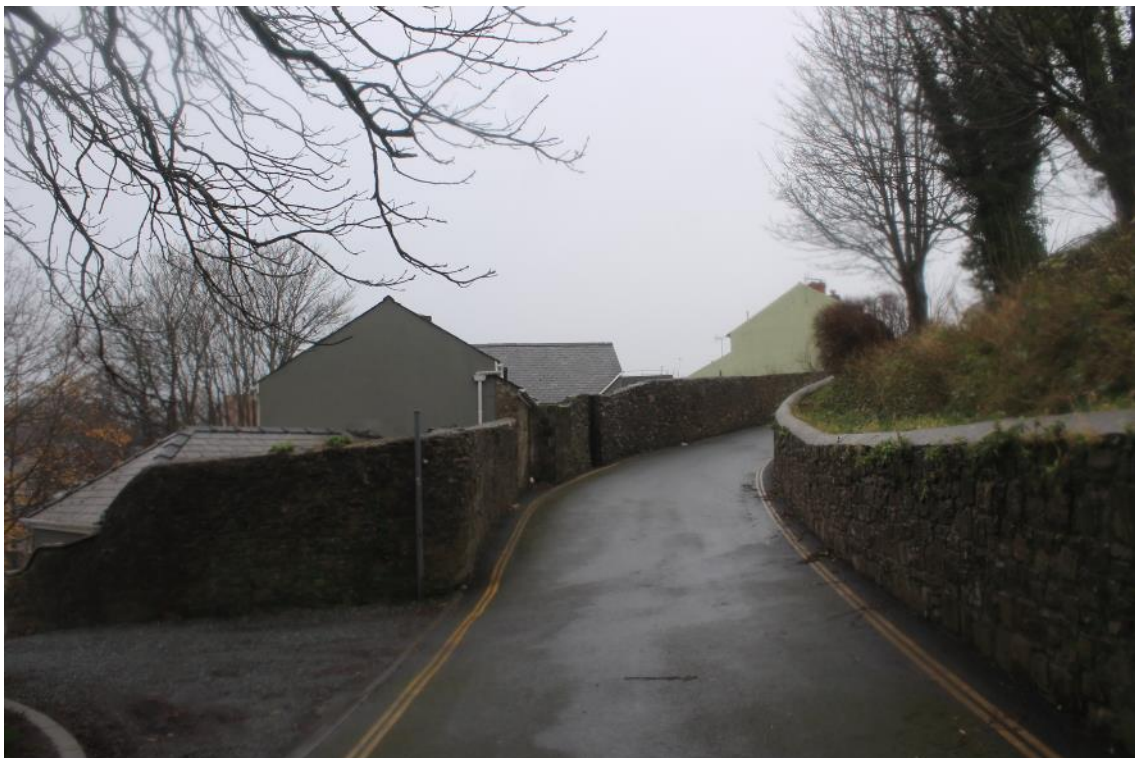
Figure 89: View west along the western end of Castle Back. The boundary walls appear largely late post-medieval and modern in date, but may contain some medieval fabric at lower levels.

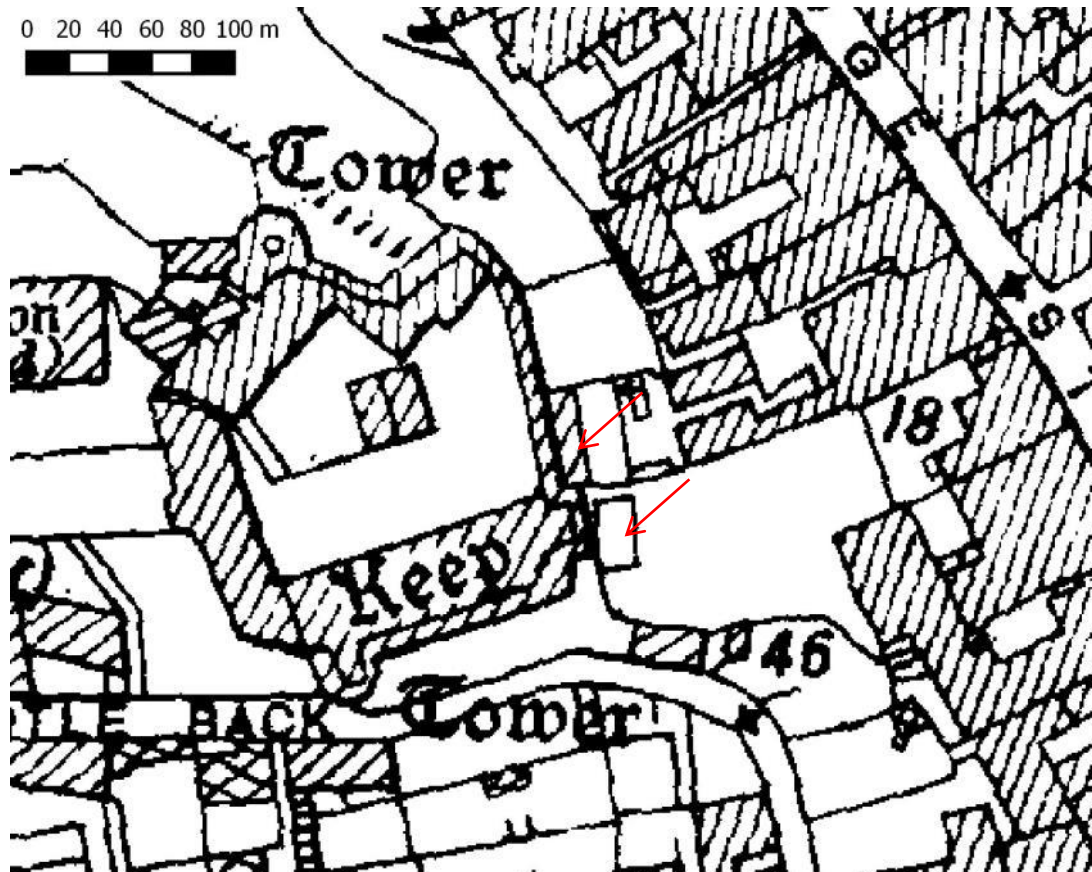
Figure 92: Extract from the Ordnance Survey map of 1907, showing structures in red, built against the rock face below the castle walls.

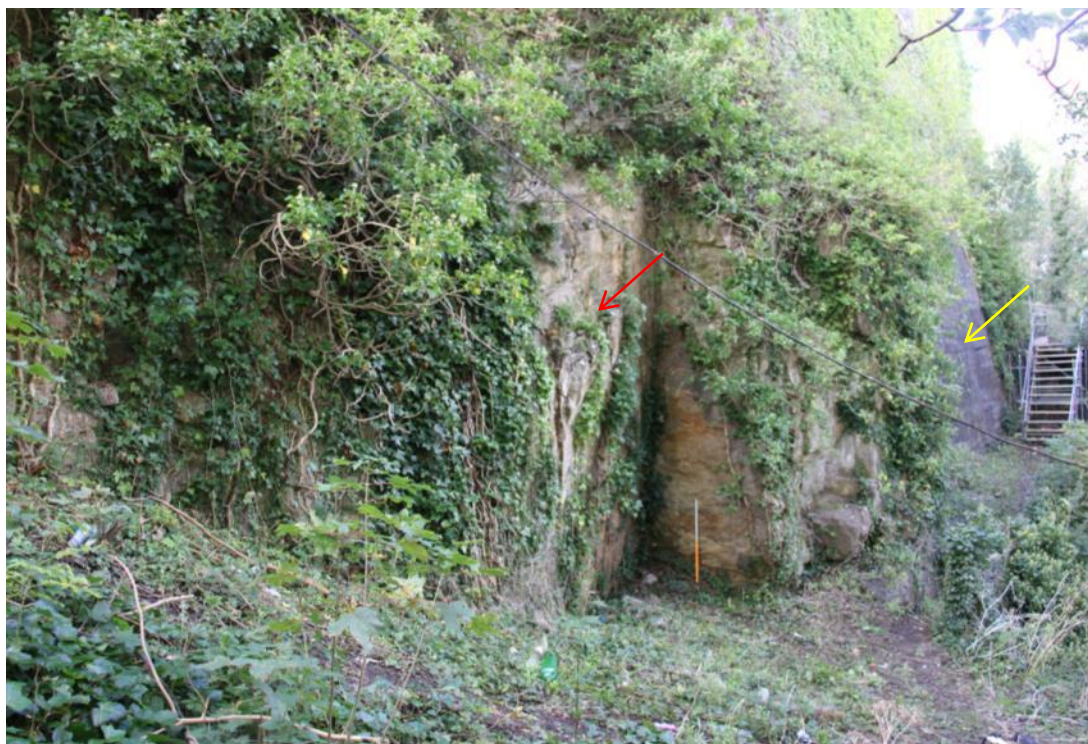
Figure 93: North face photo showing the quarried rock face with roof line visible in red, accommodating the northernmost of the two structures visible on the previous figure. 20th century concrete revetment visible to the rear in yellow.
