HAVERFORDWEST CASTLE FLAGSHIP DEVELOPMENT, HAVERFORDWEST, PEMBROKESHIRE: STATEMENT OF SIGNIFICANCE

Prepared by DAT Archaeological Services
For: Pembrokeshire County Council

REPORT NO. 2021-101

March 2022

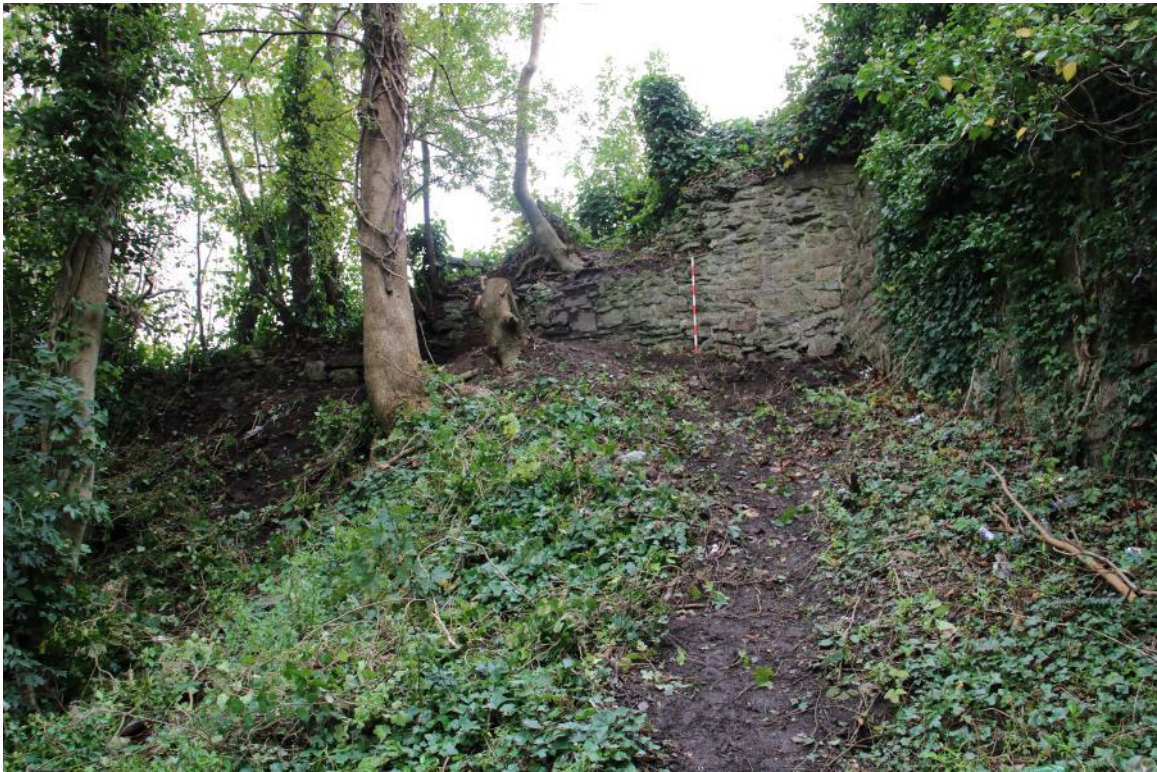
Figure 94: South facing show showing some exposed later post-medieval masonry on the slopes to the east of the castle.

- 9.5.5 Recent geotechnical investigations and clearance work in this area demonstrates the survival of later post-medieval archaeological remains,
