# **DYNAMIC DUNESCAPES, PEMBREY: ARCHAEOLOGICAL WATCHING BRIEF 2021**

*PRN 105937 Wing Markers Shelter No.1*

**REPORT NO. 127944  
EVENT RECORD NO. 2022-01**

*DAT Archaeological Services were commissioned by Natural Resources Wales to undertake an archaeological watching brief during the mechanical removal of sea buckthorn in two areas of Pembrey Burrows.*

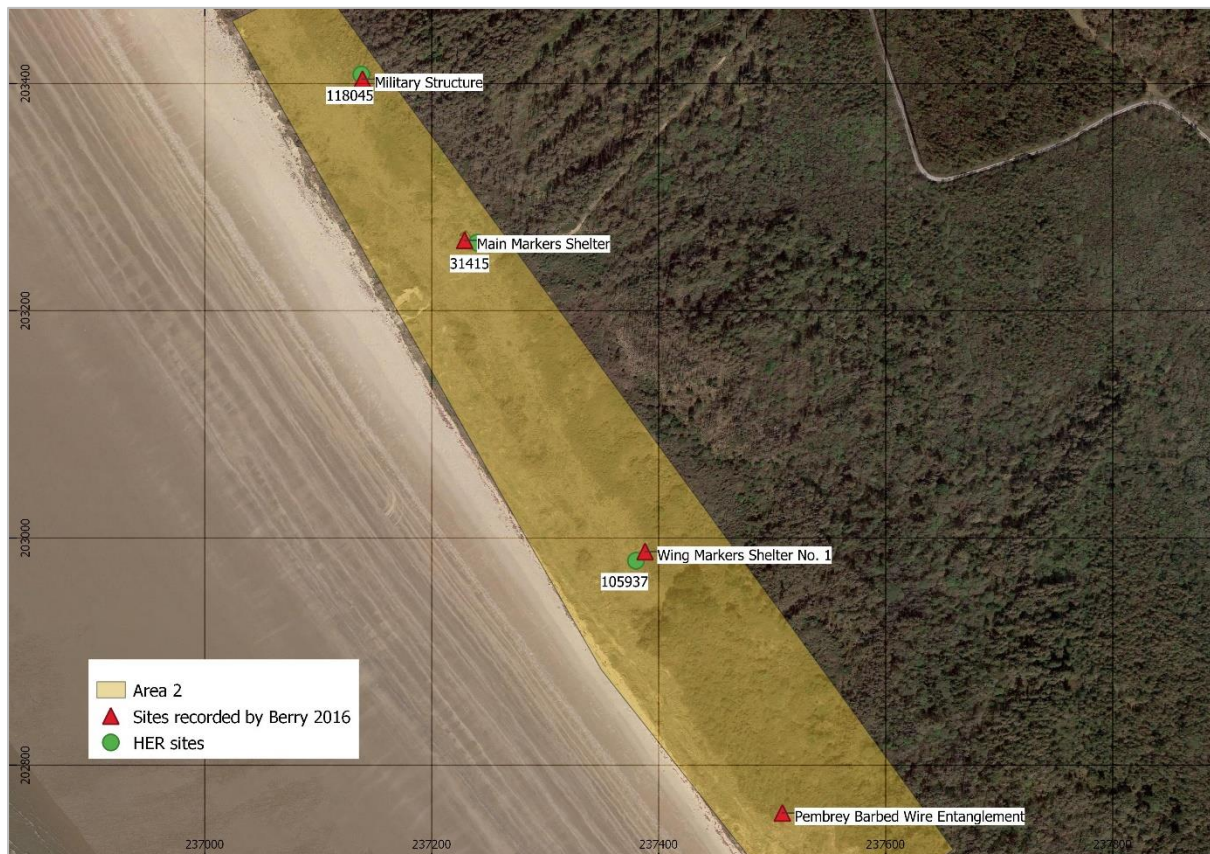
**Figure 3:** Known historic assets within Area 2.

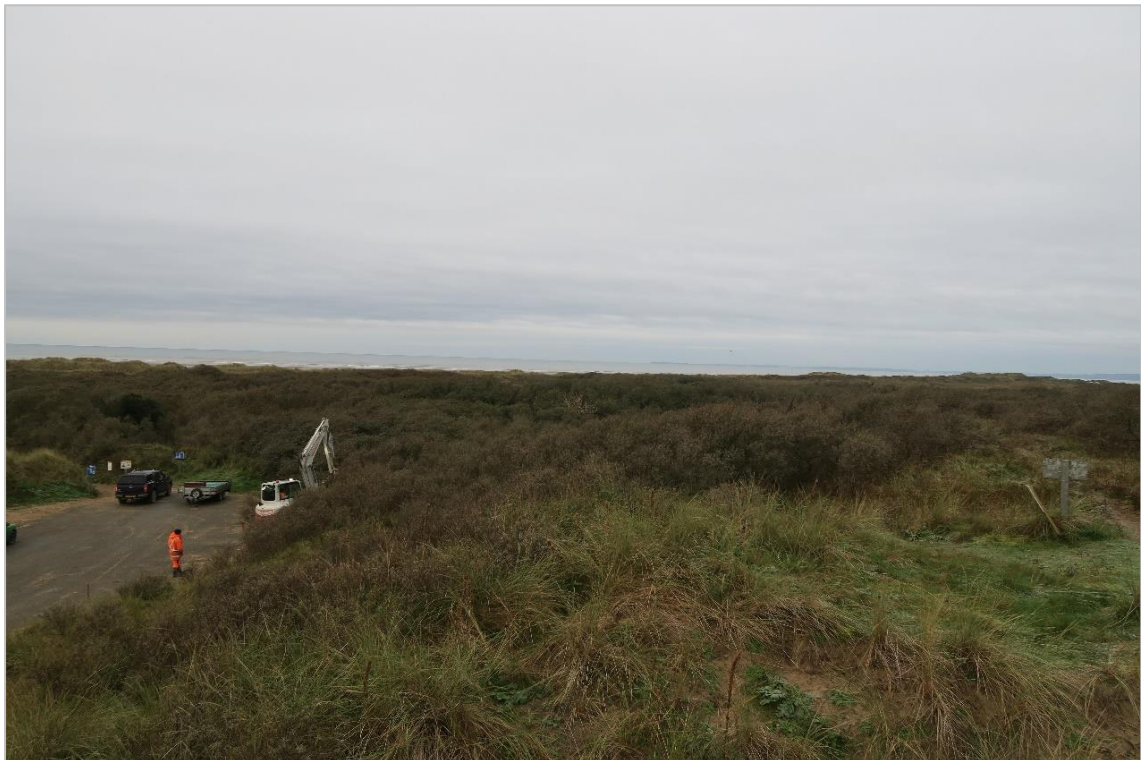
- 5.1.1 The density of sea buckthorn in area 1 prevented a walkover survey of the site before the mechanical excavators moved in (See Photo 1).
- 5.1.2 The buckthorn was cleared using a mechanical excavator equipped with a tree shear attachment (See Photo 2). The plants were cut at ground level leaving the roots and stumps remaining, the arisings were removed from the area to the nearby fisherman's car park for chipping.
- 5.1.3 As areas were cleared of buckthorn it was possible to carry out a walkover survey. Although some detritus was left behind (Photo 3) any upstanding archaeological remains should have been visible.
- 5.1.4 No archaeological remains were observed in Area 1.

**Photo 1:** Area 1 prior to clearance.

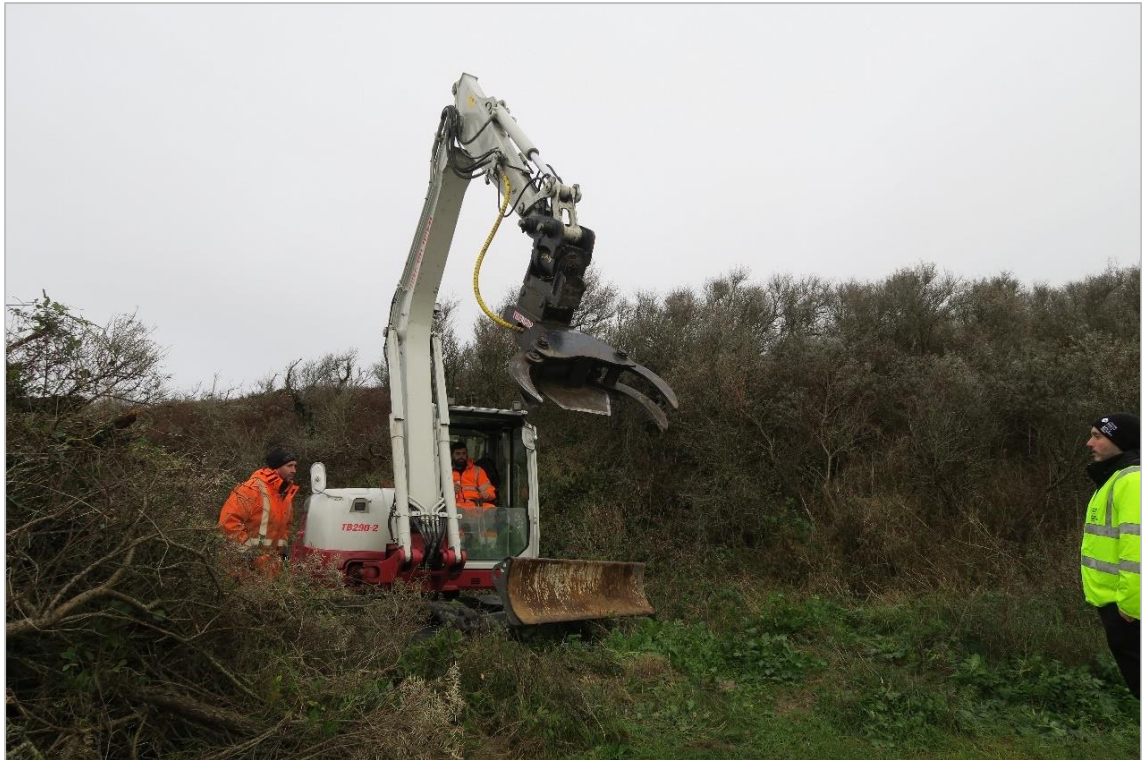
**Photo 2:** The mechanical excavator is equipped with a tree shear attachment for cutting the buckthorn.

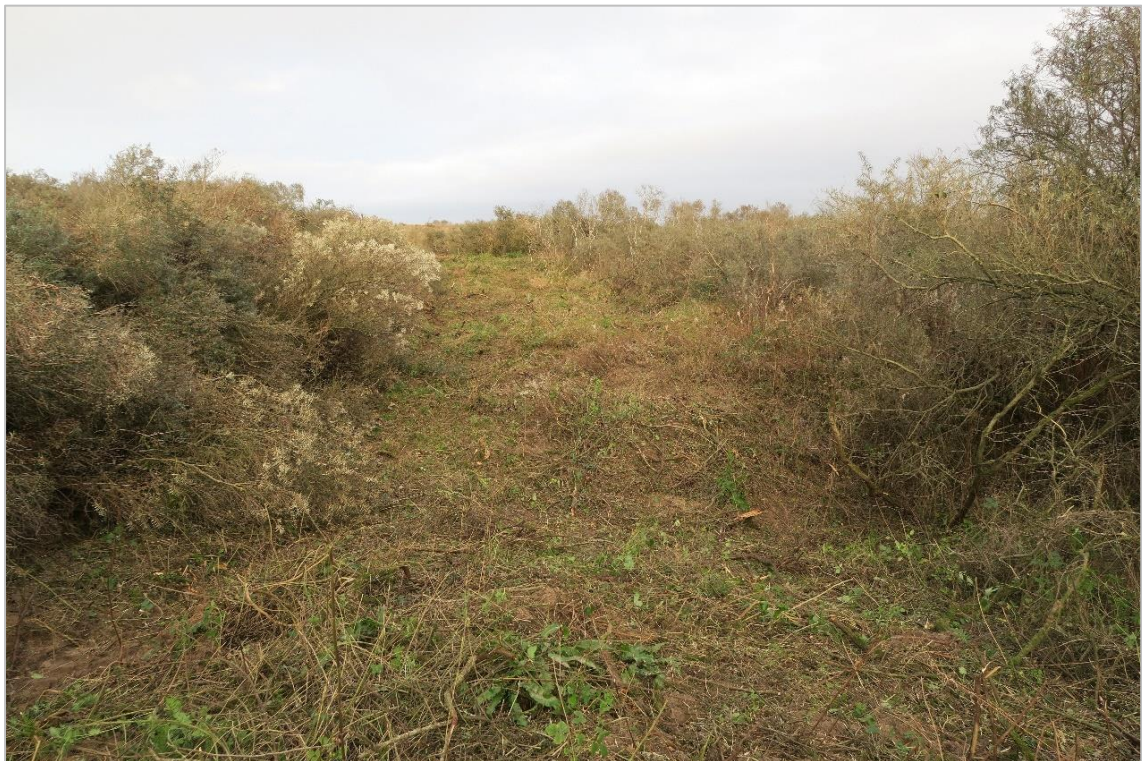
**Photo 3:** An example of an area following clearance.

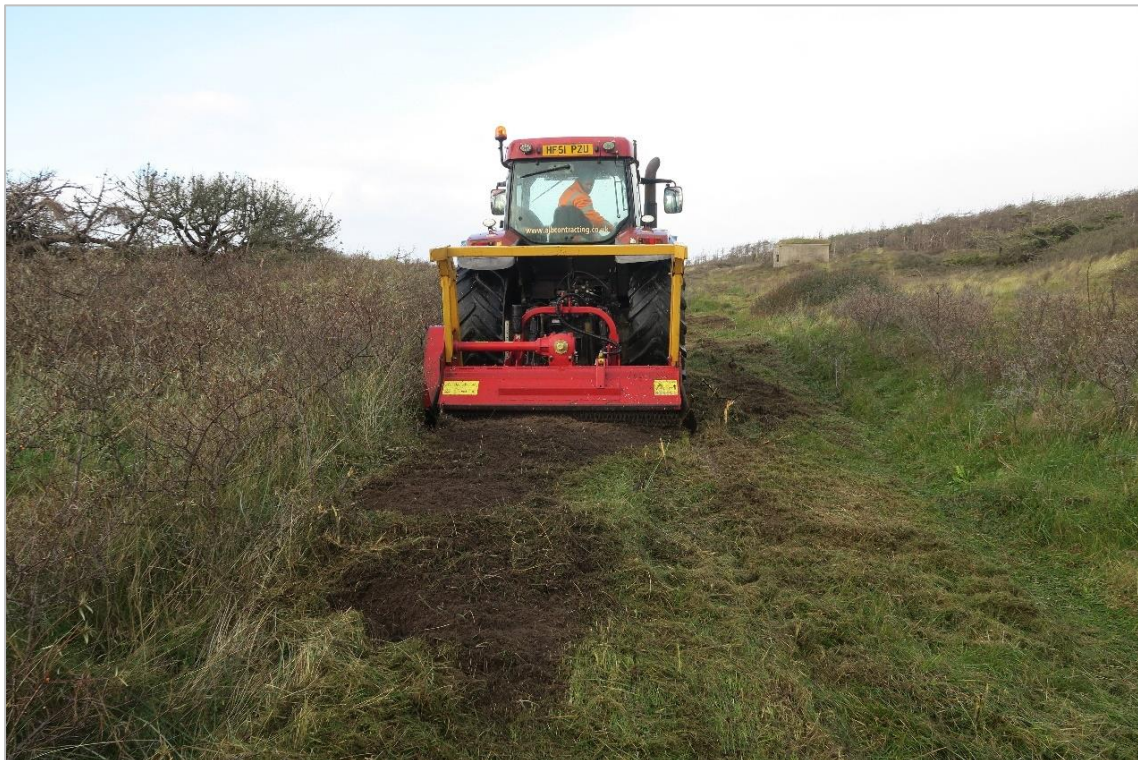
- 5.2.1 In Area 2 the sea buckthorn consisted of low-lying medium to small stands and was mulched in-situ using a tracked tractor with a mulching attachment (Photo 4).

**Photo 4:** The tracked tractor with a mulching attachment used to clear buckthorn in Area 2.

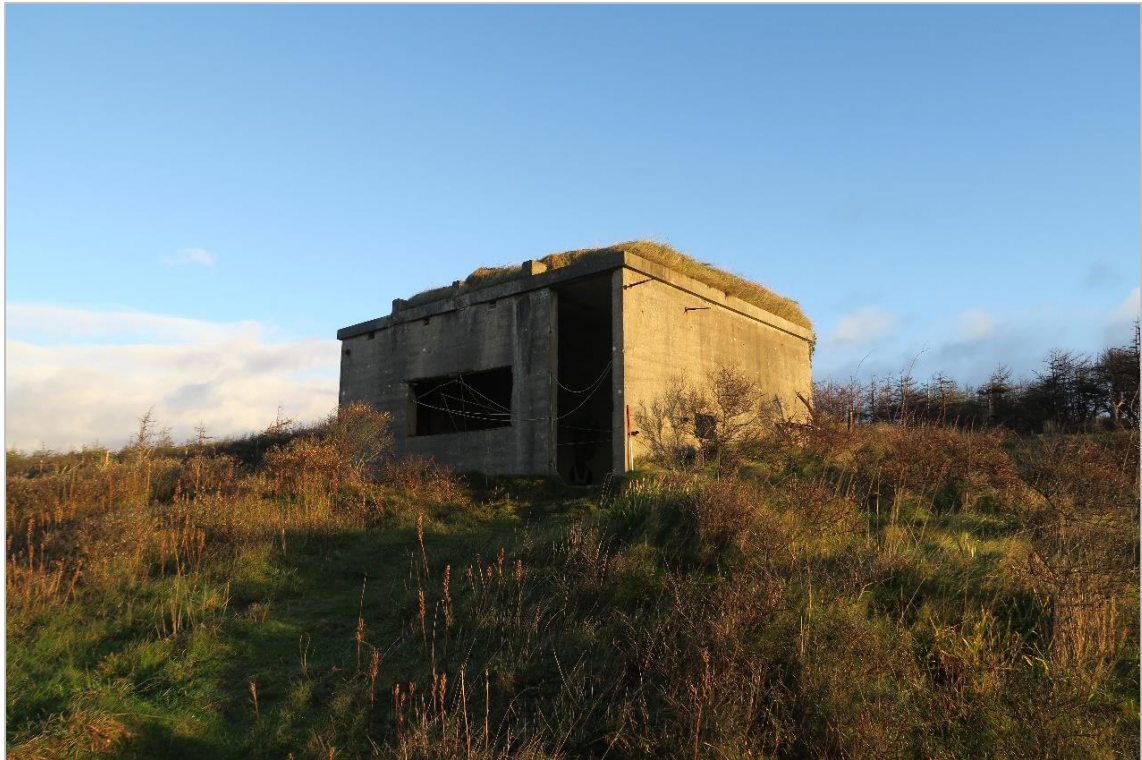
- 5.2.2 During the watching brief in Area 2 PRNs 31415, 105937 and 110845 were all recorded. PRN 31414 was also seen but it was located just beyond the most northern edge of the mulching area on MOD property. The barbed wire entanglement noted by Berry (2016) was not seen. The location of each historic asset is shown in Figure 3. Photos 5 - 8 show the condition of each asset at the time of the watching brief. PRNs 31415 and 105937 were largely clear of buckthorn and other vegetation growth. They are exposed to the elements but appear to be in a good and stable condition. PRN 118045 is located on top of a dune and is largely obscured from view by vegetation and the build-up of sand around it. The entrance is partially buried and the pillbox is filling with sand inside, but it is uncertain to what depth.

**Photo 5:** PRN 31415 Main Markers Shelter. View NNW.

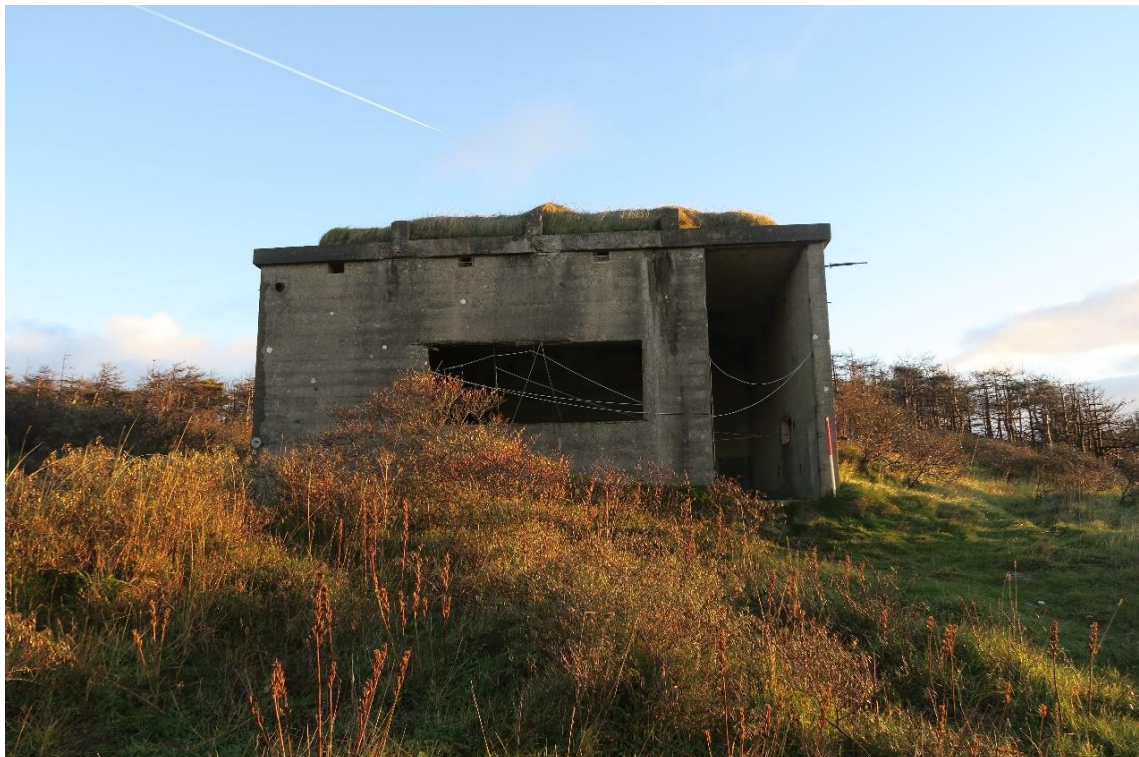
**Photo 6:** PRN 31415 Main Markers Shelter. Southwest facing (seaward) elevation.

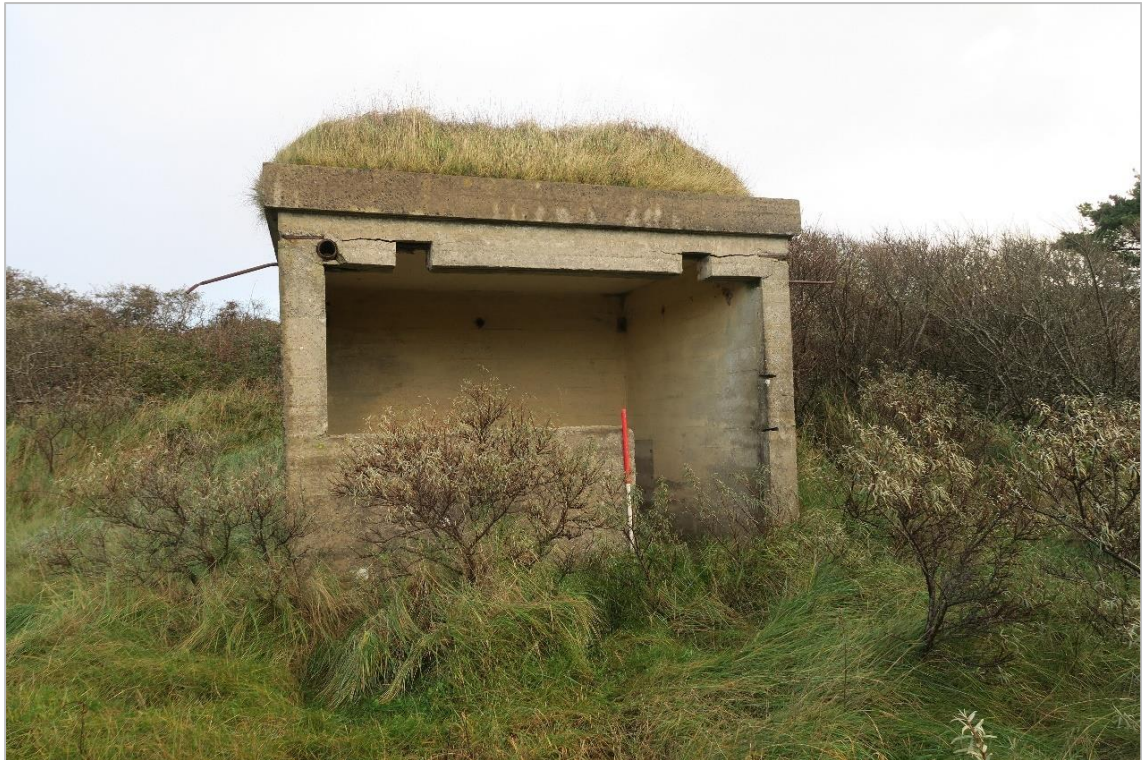
**Photo 7:** PRN 105937 Wing Markers Shelter No.1. Southwest facing (seaward) elevation.

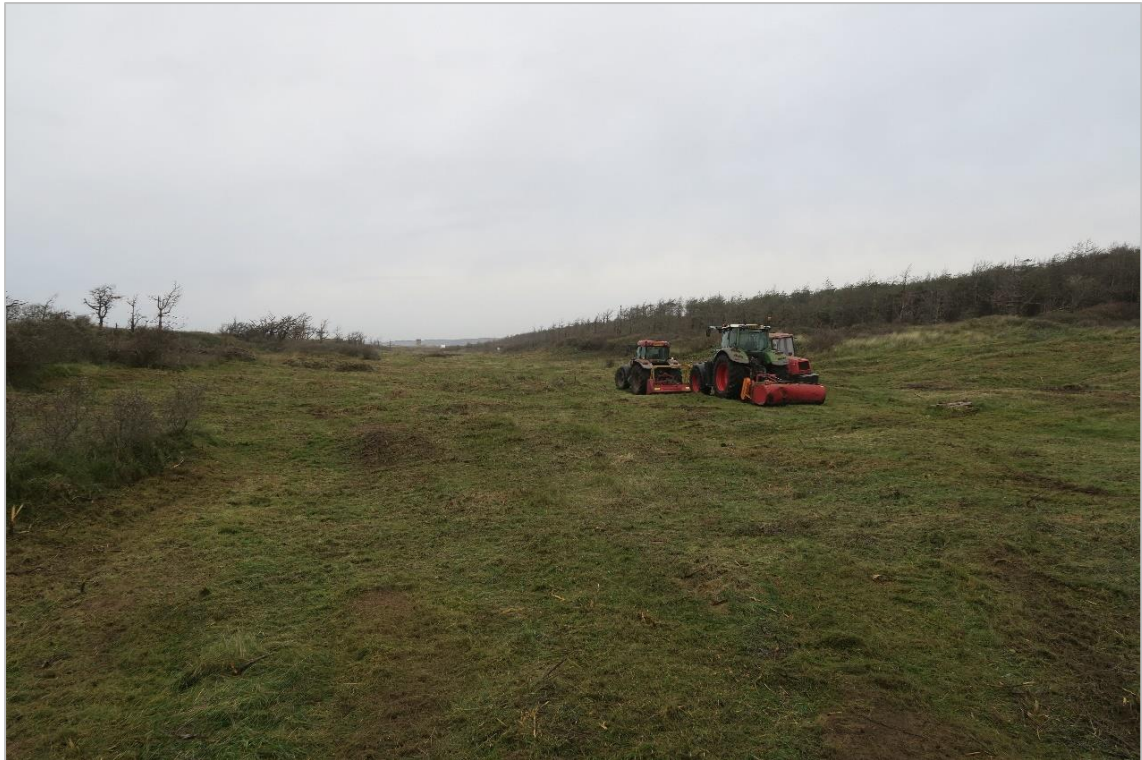
- 5.3.3 Photo 9 shows area 2 looking northwest after the buckthorn had been cleared.

**Photo 9:** Area 2 looking northwest after buckthorn had been removed.

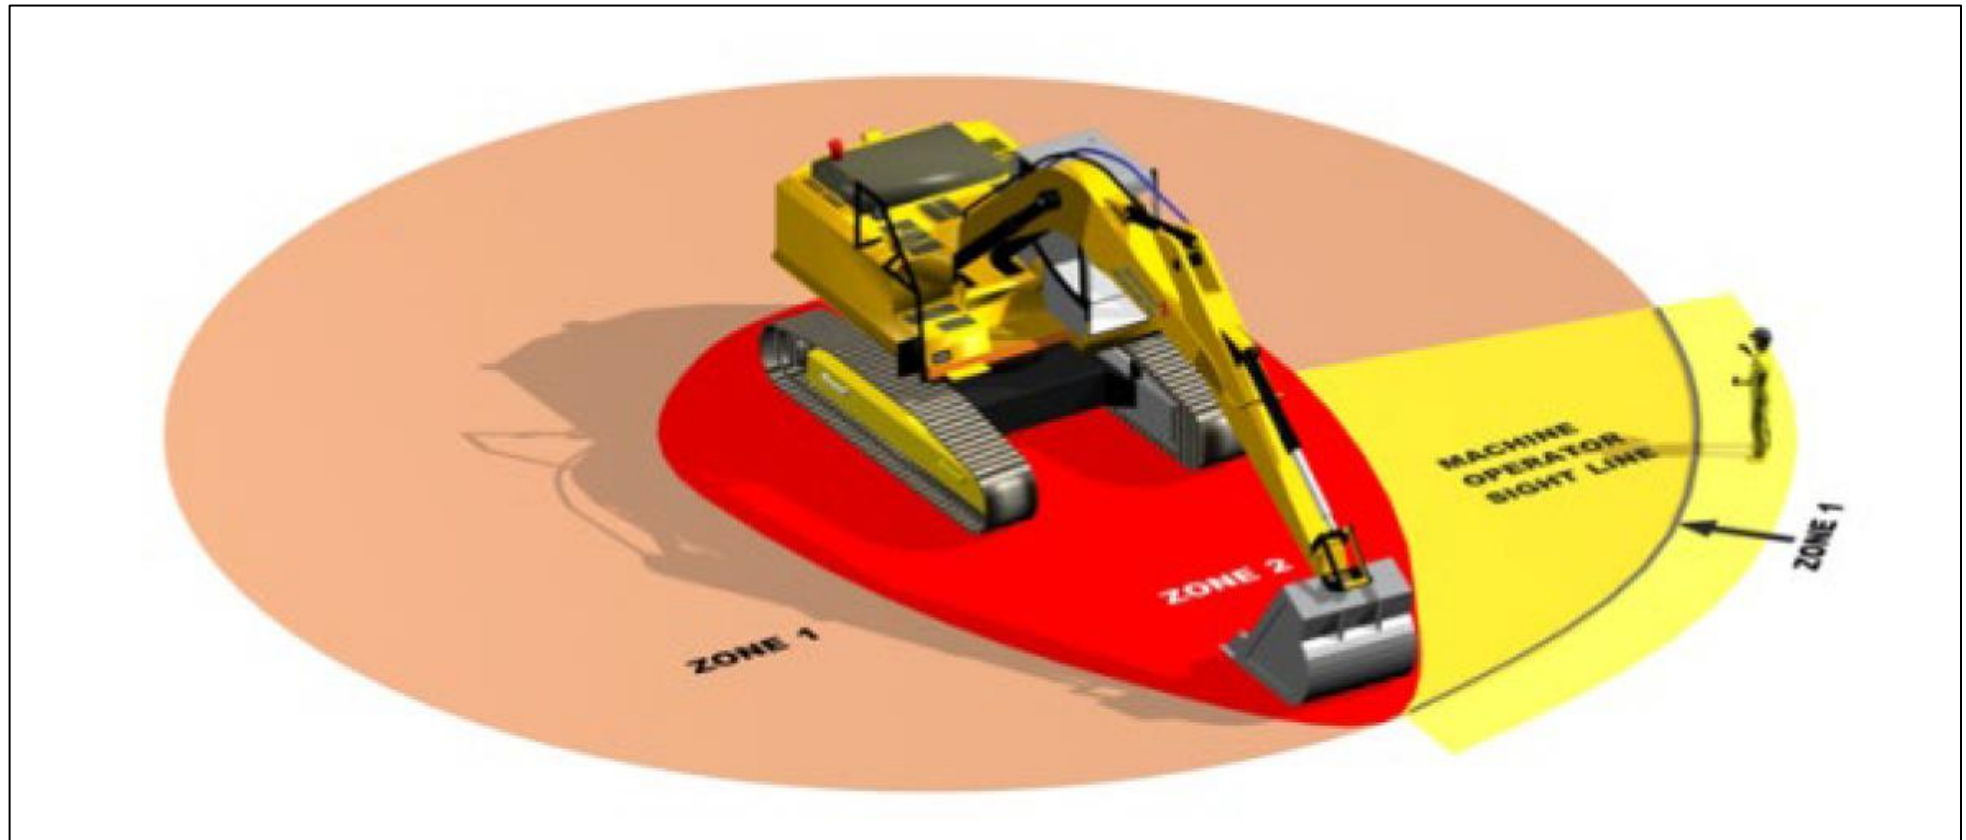
**Figure 2:** Hazard Zones when conducting UXO banksman duties.

- 3.4 RPS recommends that an UXO consultant is present during any excavation work, to act as a UXO banksman. The UXO consultant will conduct an enhanced visual inspection, with a magnetometer, prior to each removal and confirm the identity of any suspicious objects noted during the clearance. The UXO consultant will maintain a visual overwatch of the clearance as detailed in Figure 2, for the duration of the work.

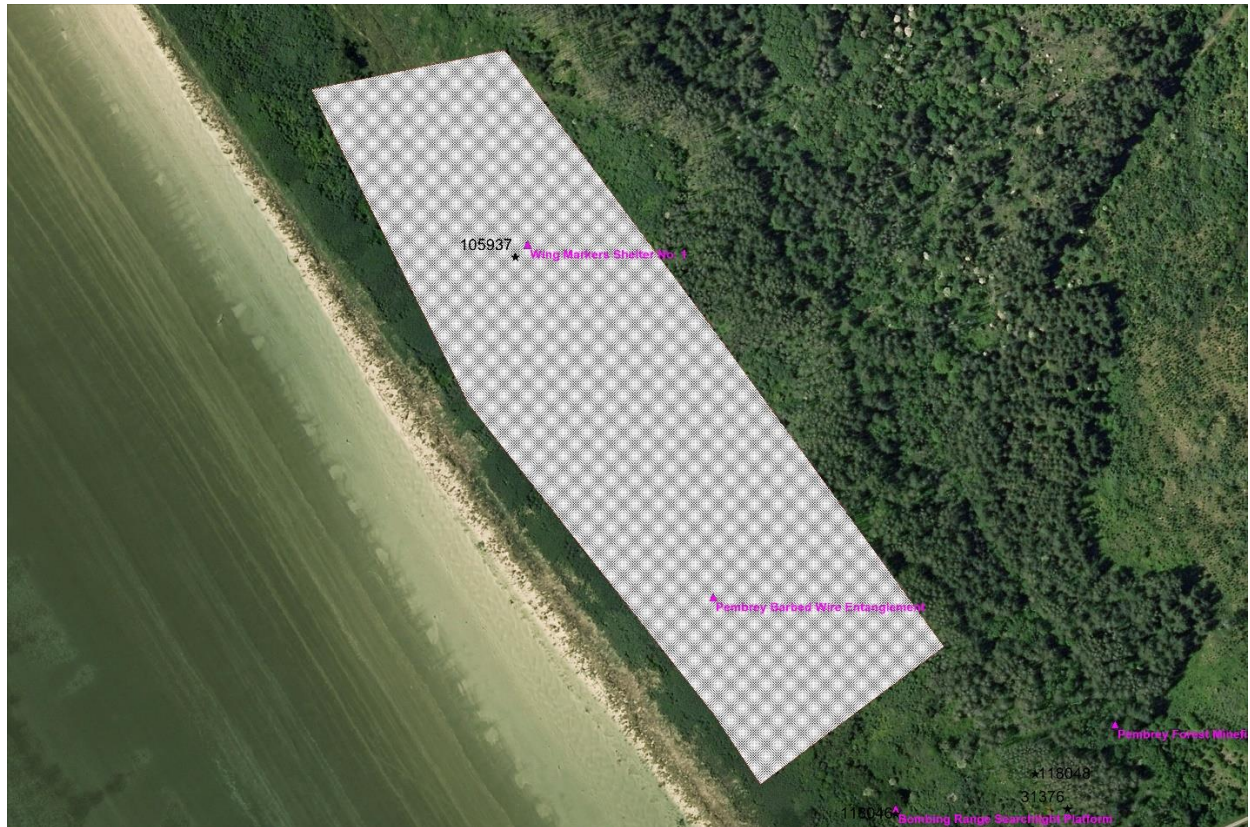
**Figure 3:** Known archaeological assets within Area 2.
