# **CLIFTON ROCK, TENBY, PEMBROKESHIRE: ARCHAEOLOGICAL WATCHING BRIEF (NGR SN 1320 0062)**

REPORT NO. 2022-14  
EVENT RECORD NO. 128289

## CLIFTON ROCK, TENBY, PEMBROKESHIRE: ARCHAEOLOGICAL WATCHING BRIEF

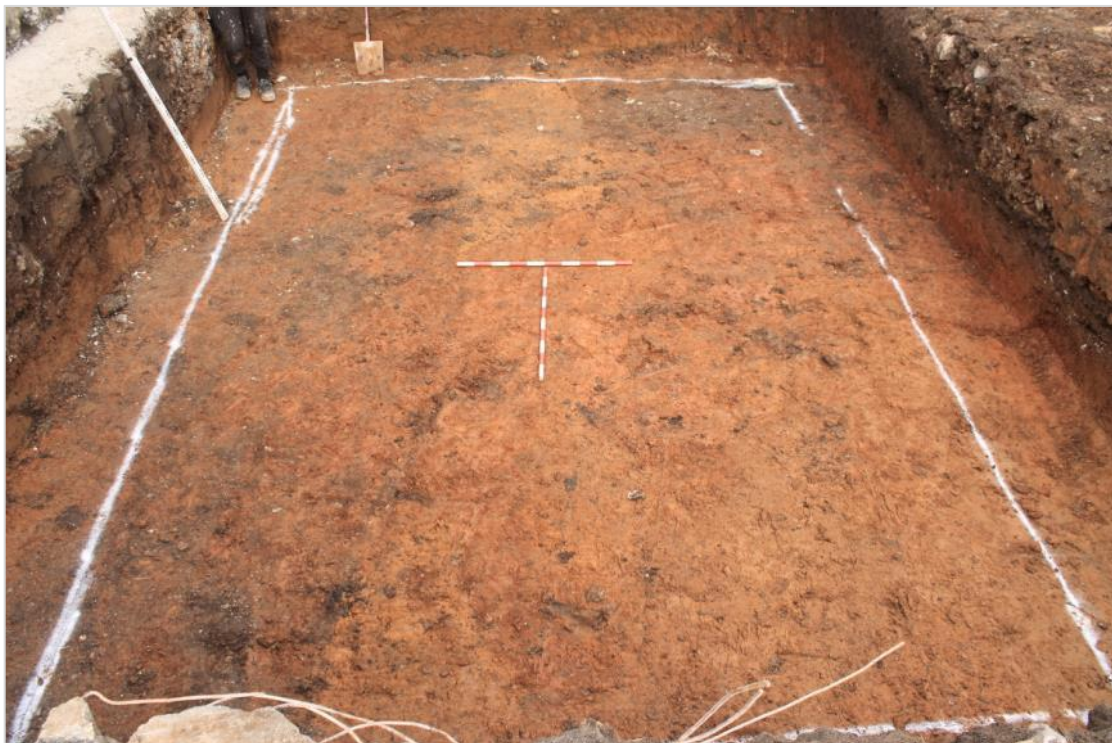
- 4.2 Excavations within the pool area revealed two naturally occurring deposits. The earliest was a firm layer of light yellow-grey sand (100), revealed at a typical depth of 1.1m. This was overlaid by a 0.3m thick layer of firm mid orange-brown clayey-sand (101), with small angular stone inclusions. This was revealed at a typical depth of 0.8m (Photos 3 – 7).

**Photo 3:** View northeast of the excavated pool area, showing natural deposit (100). 1m scales.

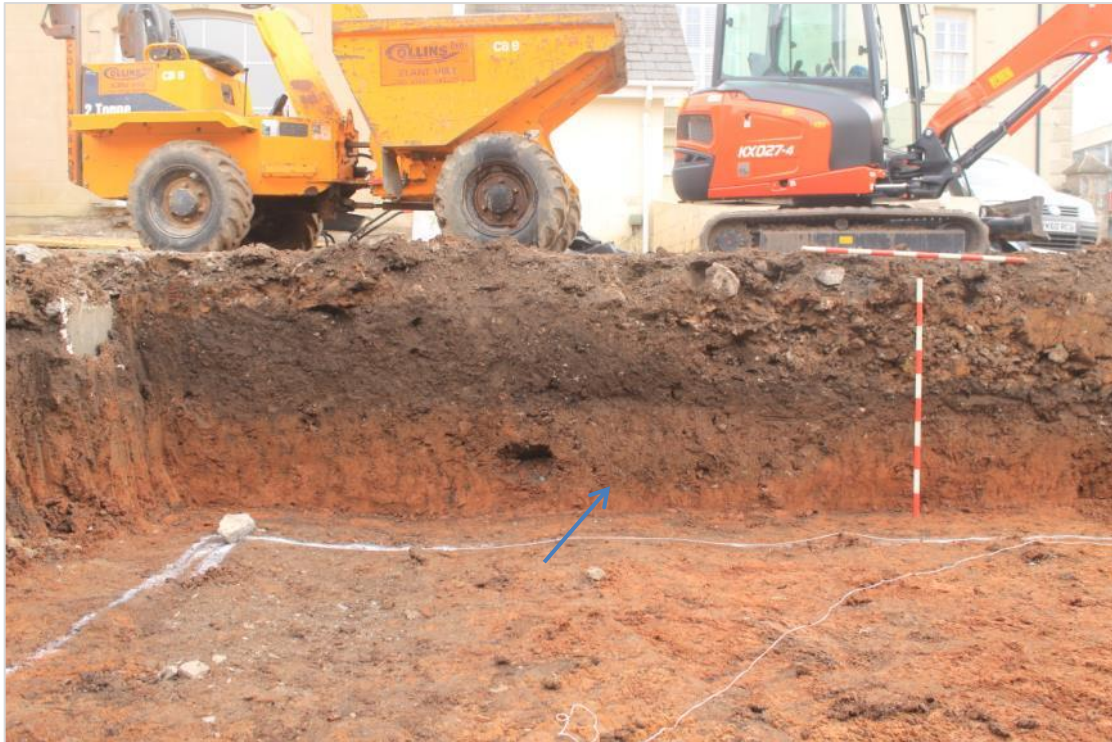
- 4.4 Within the centre of the site the fragmentary remains of a wall were revealed cutting into layer (102), first uncovered at a depth of 0.65m below the current ground surface. The construction cut [103] for the wall comprised a 1.6m wide linear trench, with a flat to slightly concave base, and a moderate break of slope to a concave side on the west, with a sharper break of slope to a stepped eastern side (Photo 4). The wall {104} was approximately 0.5m wide and was built along the eastern edge of the construction cut, and comprised large unworked blocks of local limestone set within a soft lime mortar with small coal inclusions (Photo 8 & 9). No facing stones were present, and the stones appeared to be roughly packed into the mortar. Both the wall and the construction cut were aligned northwest – southeast, parallel to the existing boundary walls and the road. Only a height of 0.3m of the wall survived, which was located 5.8m from the east boundary wall, 9.1m from the west boundary wall. A length of approximately 1m of the wall was exposed, which appeared to stop 3.7m from the northern boundary wall. The construction cut was infilled with a friable, mid grey-brown clayey-silt (105) with common medium sub-angular stone inclusions and the occasional small fragment of coal and lime mortar.

**Photo 4:** View southeast showing the section of the pool area excavation, and the construction cut [103] for wall {104} (arrow). 1m scales.

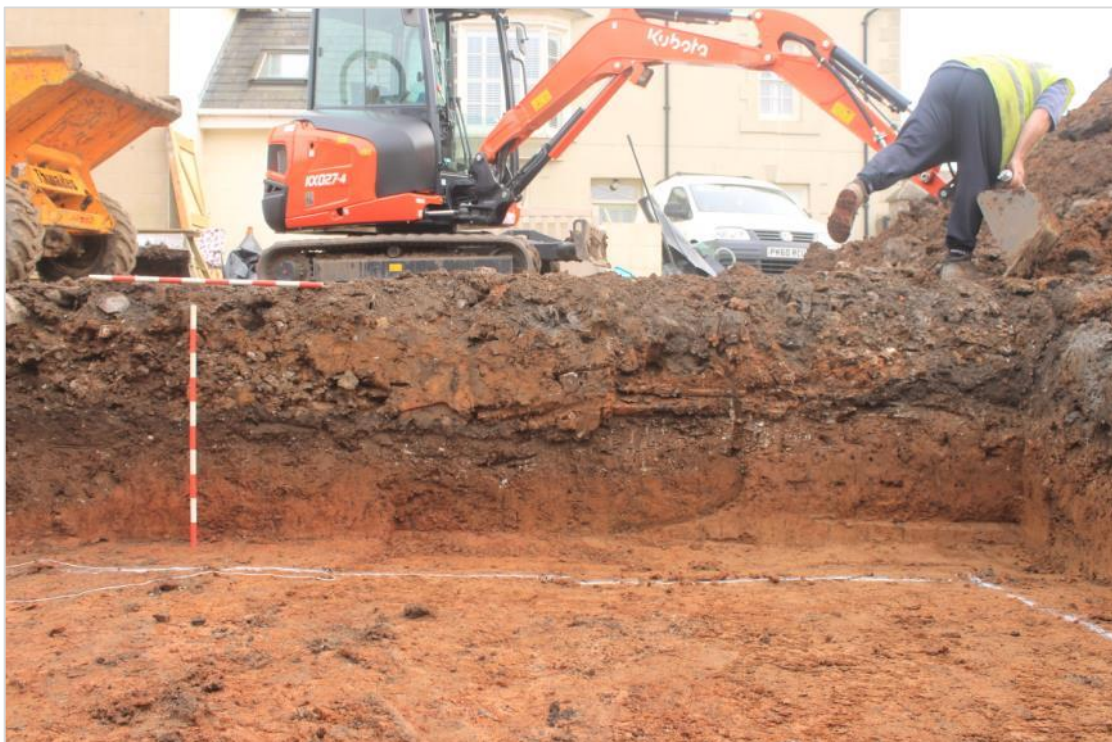
**Photo 5:** View southeast, showing the rest of the section of the pool area excavation. 1m scales.

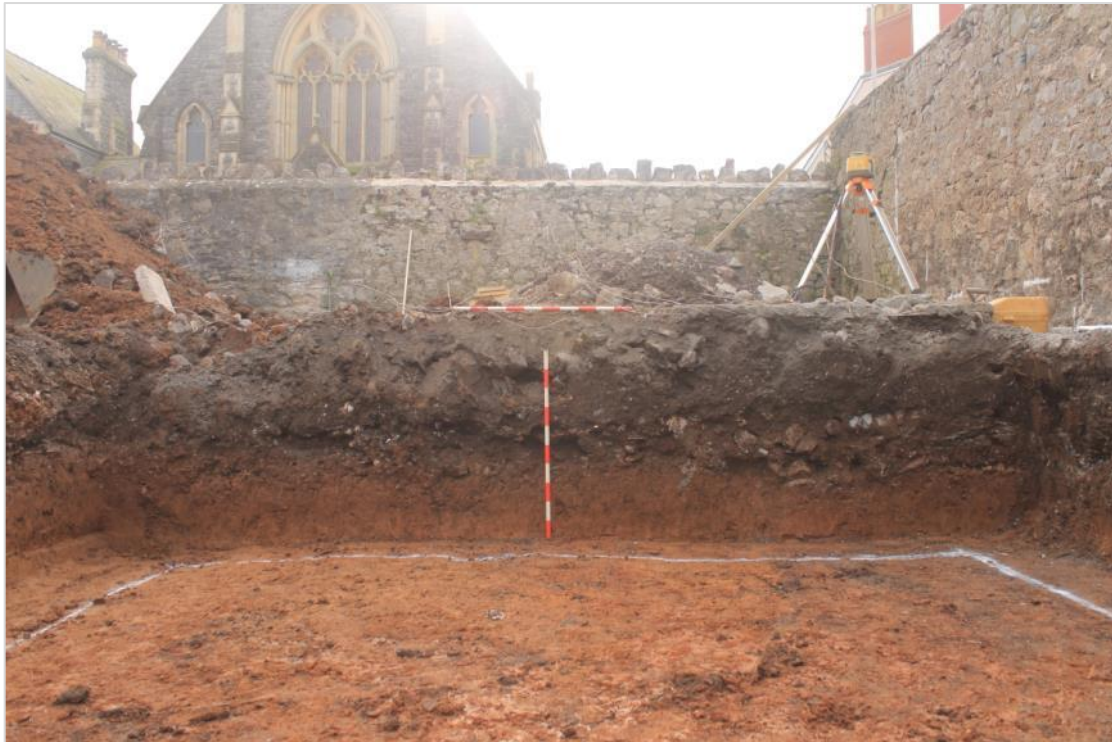
**Photo 6:** View southwest of the section of the pool area excavation. 1m scales.

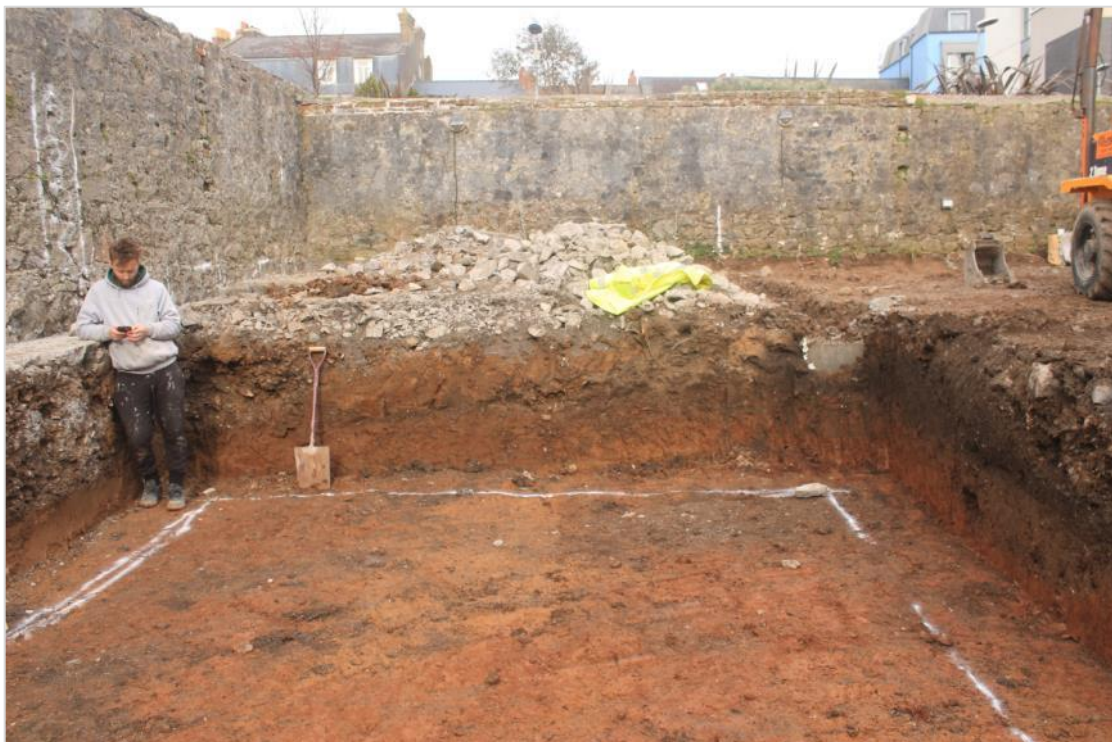
**Photo 7:** View northeast of the section of the pool area excavation.

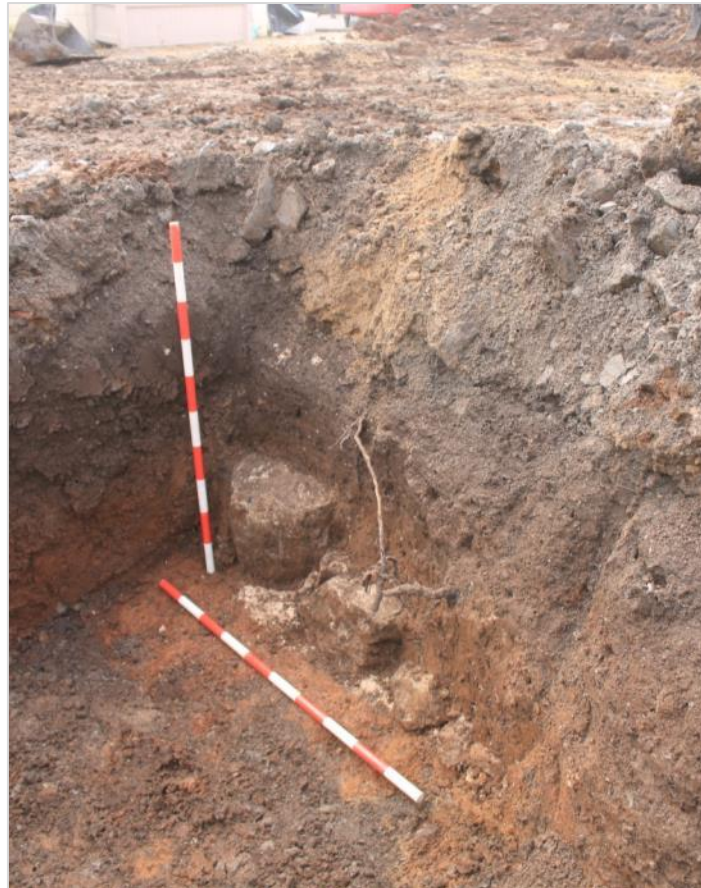
**Photo 8:** View south. The remains of wall {104} revealed during excavation. 1m scale.

- 6.3 A fragment of walling {104} was uncovered in the centre of the site, running parallel to existing property boundaries. The rough nature of the remains suggests they represent buried foundation deposits, no facing stones or dressed stonework was uncovered. The presence of coal within the lime mortar would suggest a post-medieval date for the walling. The overlying deposit (106), which was spread to the west of this wall, contained large quantity of stone, along with ash and broken roofing slate, all typical of a demolition deposit or construction debris. This material may have, at least in part, come from whatever structure is represented by the walling. The nature of this structure is unclear however, no related walling, or wall return, was uncovered, and it may have represented a simple boundary feature.

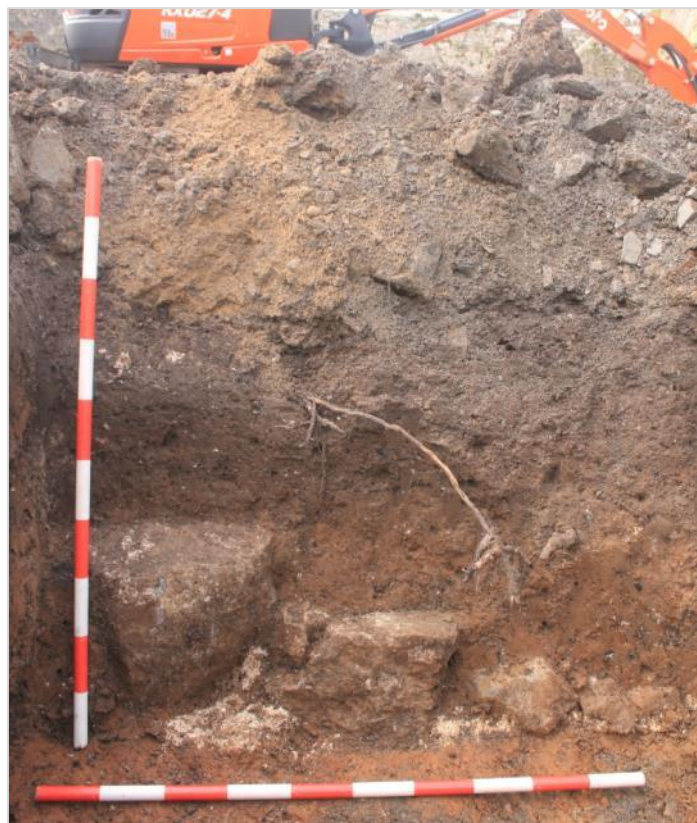
**Photo 9:** View southwest. Profile of wall {104}. 1m scales.

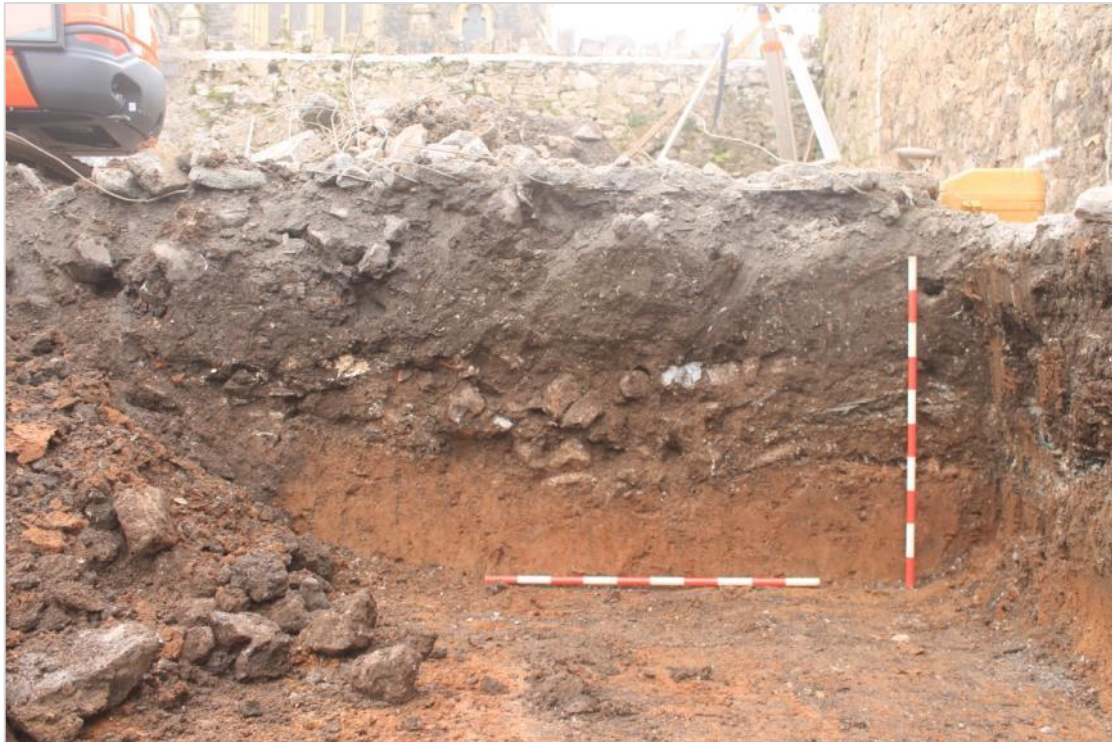
**Photo 10:** View southwest, showing detail of stony deposit (107) between the orange natural deposits below, and the darker garden soils above. 1m scales.

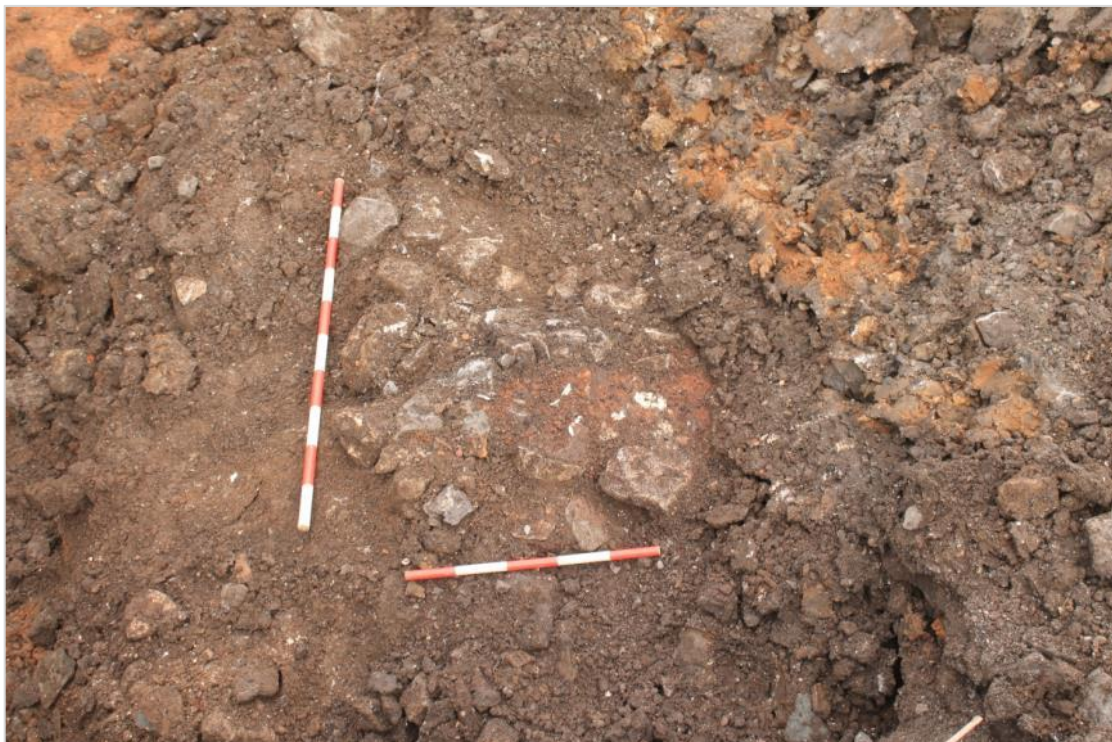
**Photo 11:** View east. Showing the surface of deposit (107) in plan during excavation. 1m & 0.5m scales.

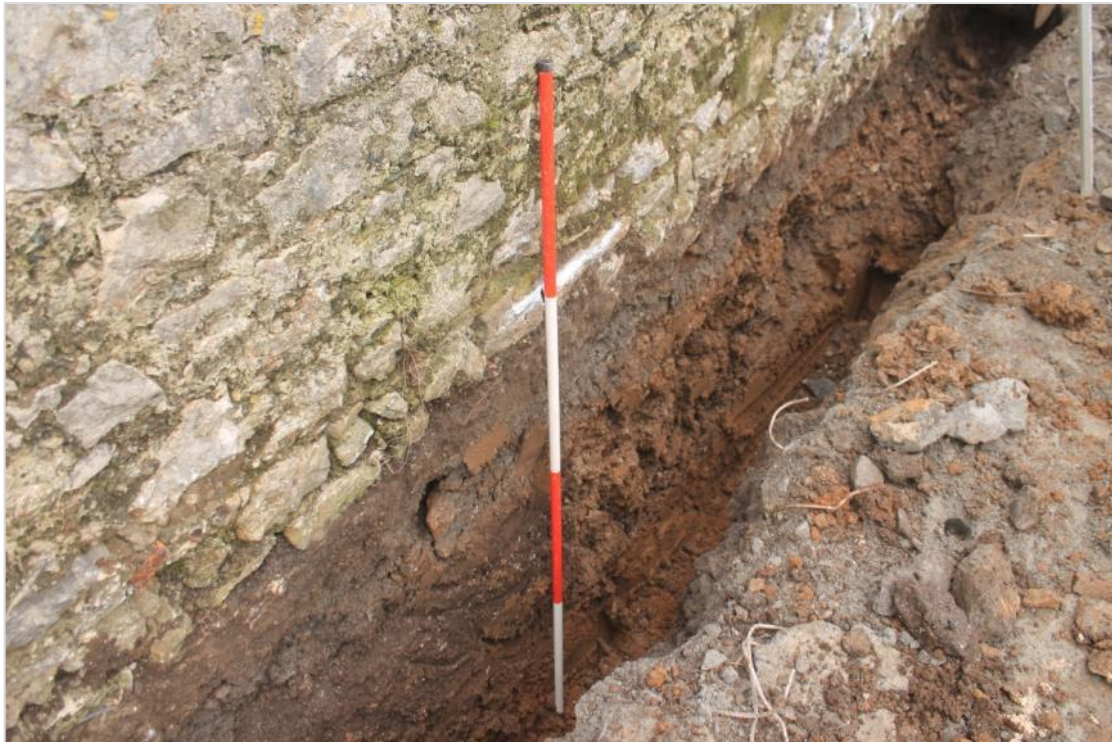
- 4.7 To the north a large pit was revealed cutting into deposit (108). This pit [109] was 2.8m wide, its length was not recorded, although it extended below and beyond the northern garden wall (Photo 12). The pit had steep

straight sides, and a flat base, 0.75m deep. It was filled with a single deposit of loose, mid grey-brown stony silty-clay (110).

**Photo 12:** View north, showing pit [109] underneath the rear garden wall {112}, infilled by the loose material (110) to the right of the scale. 2m scale.

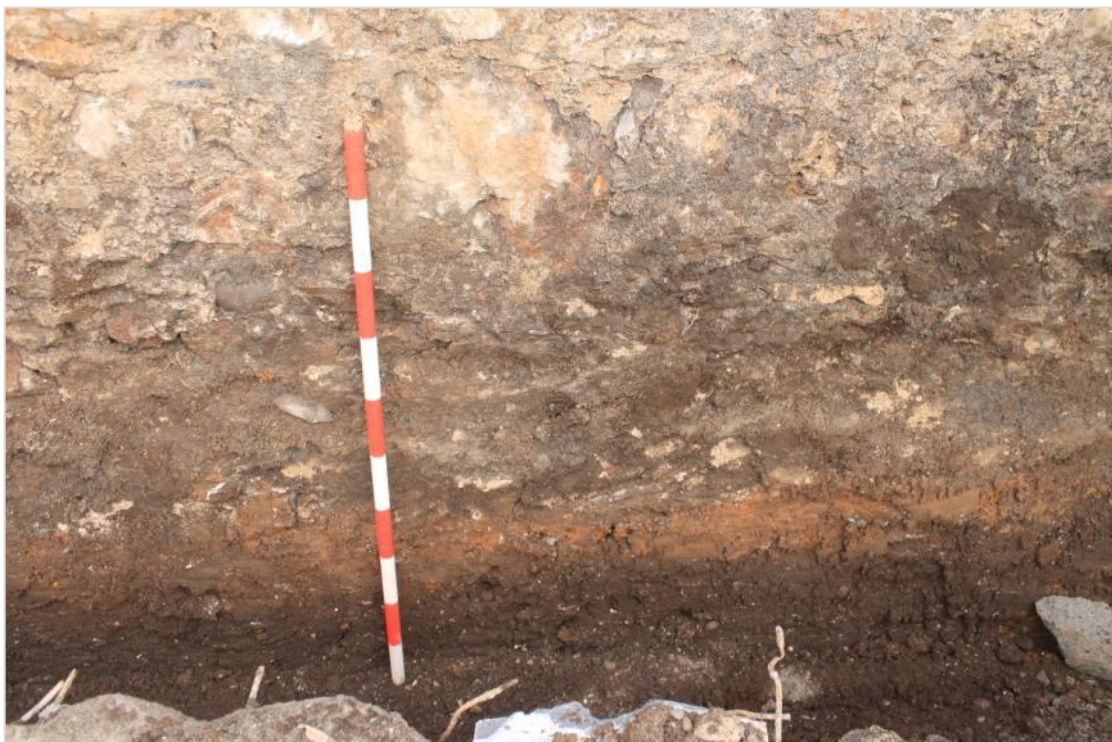
- 4.8 The trench along the inner face of the northern garden wall revealed the wall appeared to cut into, or partly sit upon, the dark soil deposit (108), as well as overlying pit [109] (Photos 12 & 13). Overlying both deposit (108) and (110) (fill of pit [109]) in this area was a 0.15m thick layer of firm mid orange-brown silty-clay (111). This appeared to act as the base layer for the garden wall, which rested upon it. The garden wall {112} was 2.7m high, only the lower 0.35m being buried and acting as the foundations (Photos 1 & 14). The wall was built of random rubble, with brick inclusions, with concrete coping, and set within a solid mortar which had largely being repointed in cement mortar. The wall butted against the Grade II listed roadside wall, but otherwise formed a continuous L-shaped line to enclose the northern and eastern edges of the garden.

**Photo 13:** View northwest, showing the base of the rear garden wall {112} sat upon orange clay deposit (111), with darker soil deposit (108) below that. 1m scale.

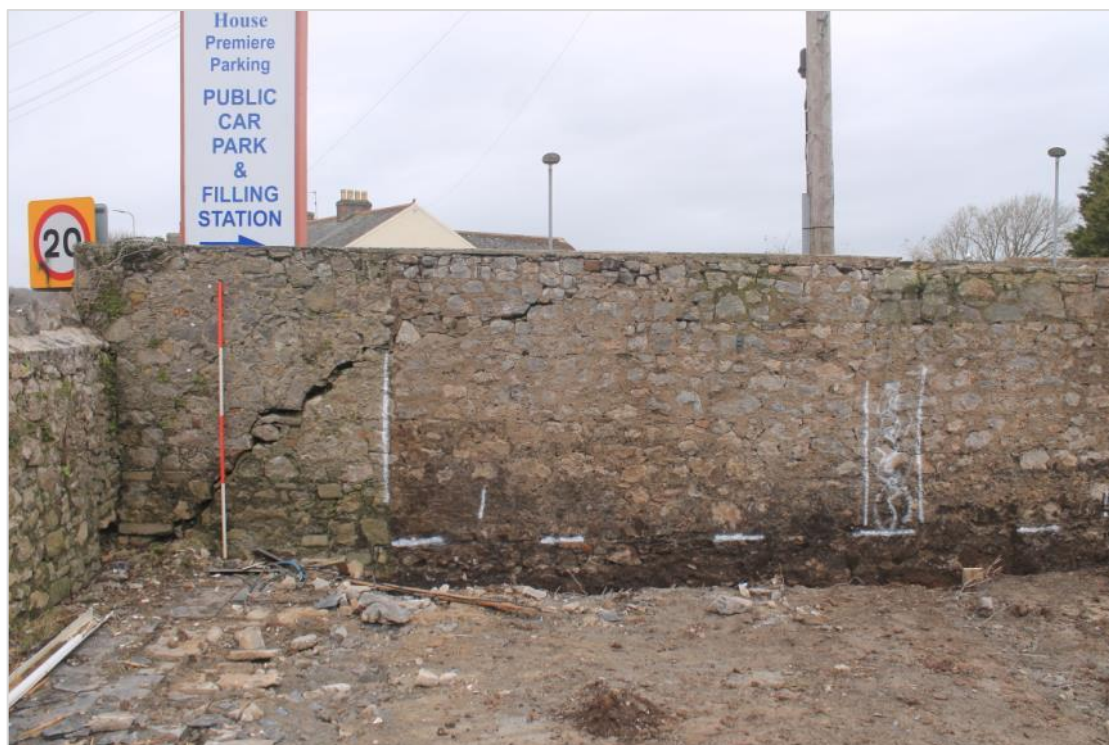
**Photo 14:** View northwest, showing detail of rear garden wall {112}. 2m scale.

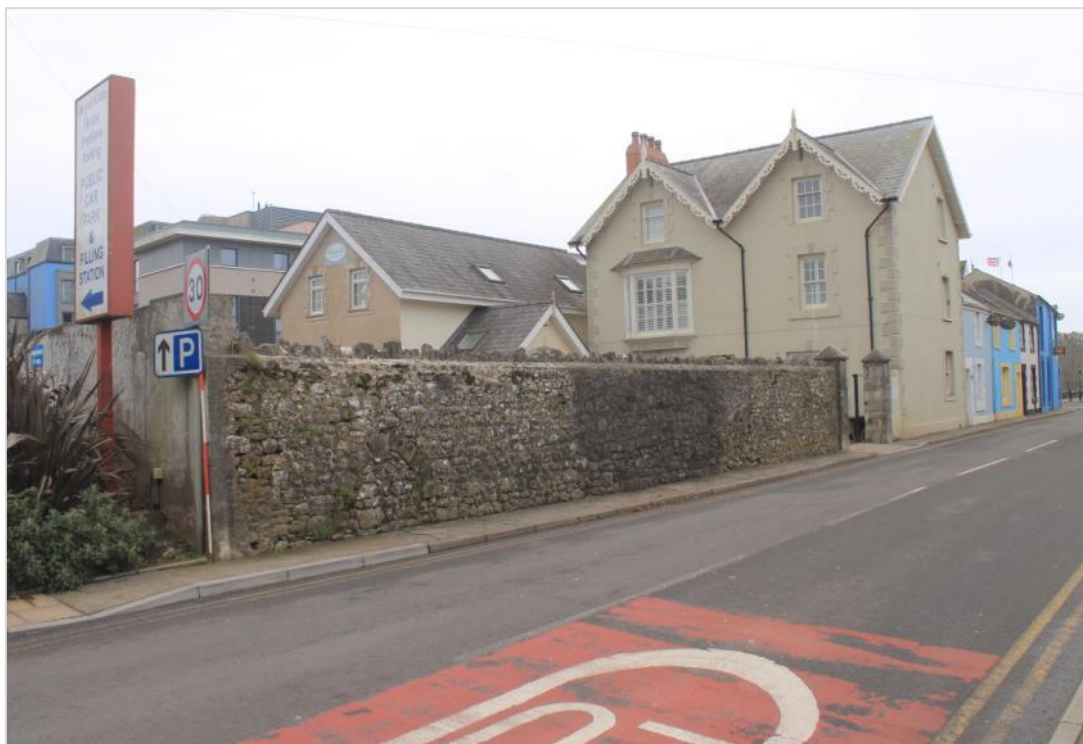
- 4.10 The Grade II listed roadside wall remained unaffected by the groundworks. The wall was approximately 19m long, and stood 1.8m high to the road, 1.6m high to the interior (Photos 15 – 17). A blocked doorway was visible on both faces at the northwest end of the wall, although lintel stones were only visible to the exterior. The doorway extends approximately 1m above the current interior ground level. A protruding stone lies approximately 1.4m south of the doorway on the interior face. The remaining wall was not examined in detail, but it appears to have been repointed on this interior face, and later concrete coping has also been added.

**Photo 15:** View east of the exterior of the Grade II listed wall, with Clifton Rock to the rear. 2m scale.

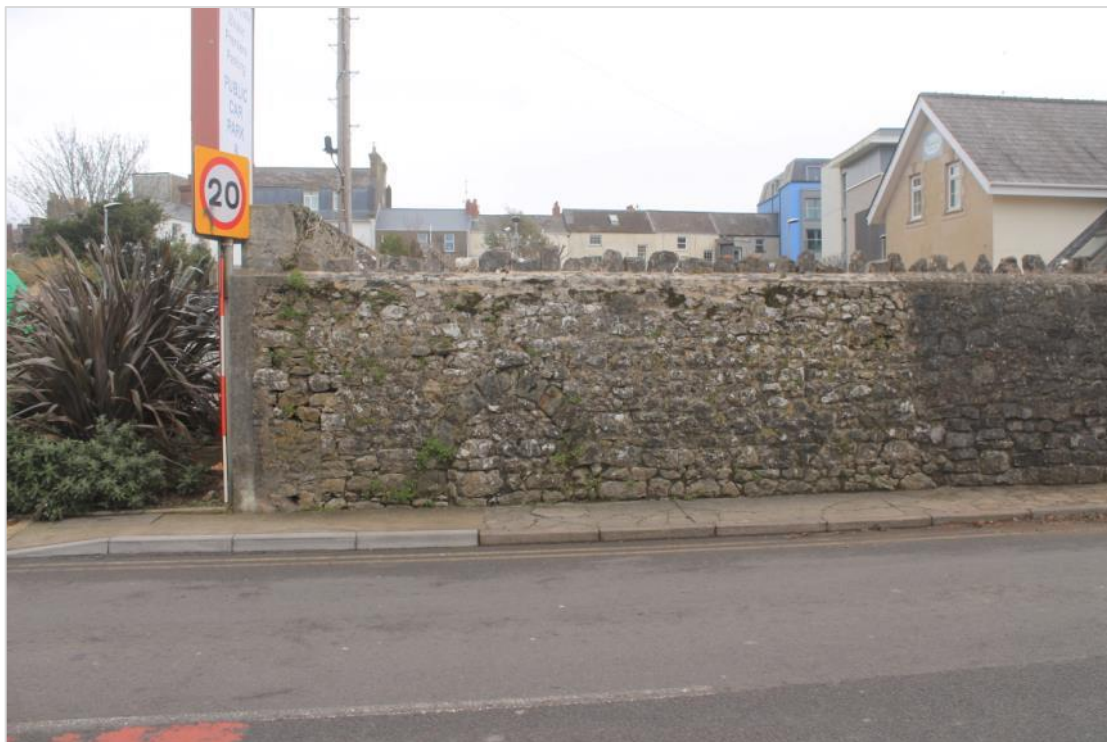
**Photo 16:** View northeast, showing detail of Grade II listed wall and blocked opening. 2m scale.

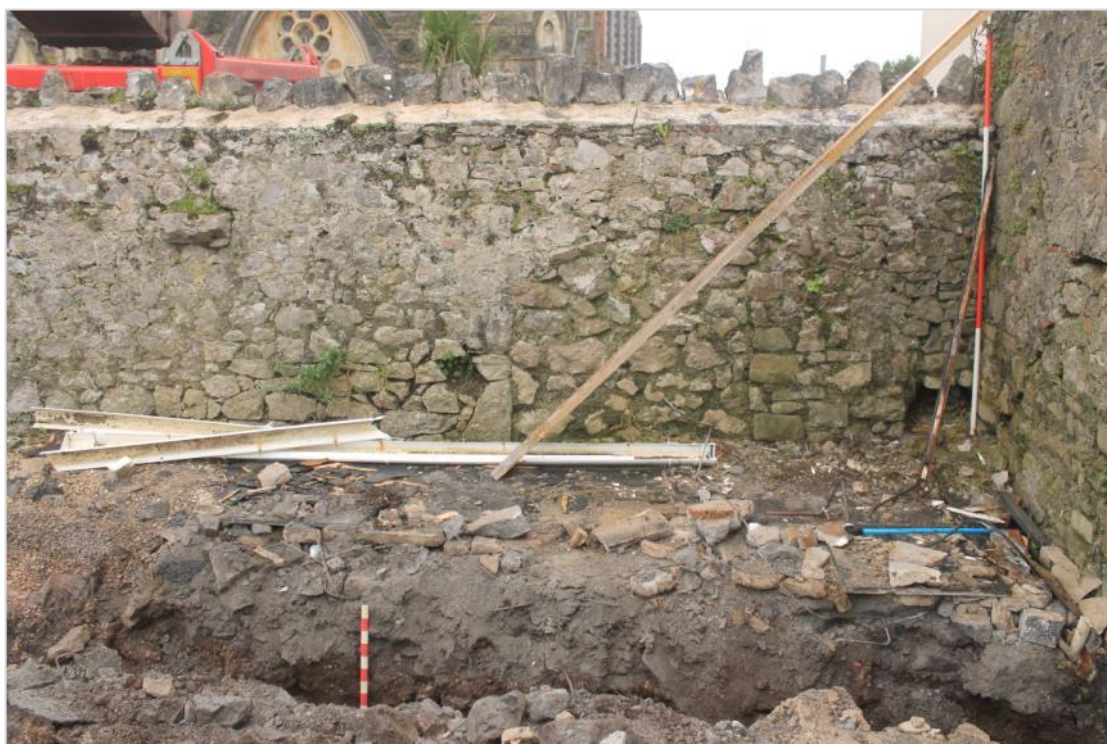
**Photo 17:** View southwest, showing detail of the interior of the Grade II listed wall, with blocked opening evident, including excavated foundation trench in the foreground. 2m & 0.5m scales.

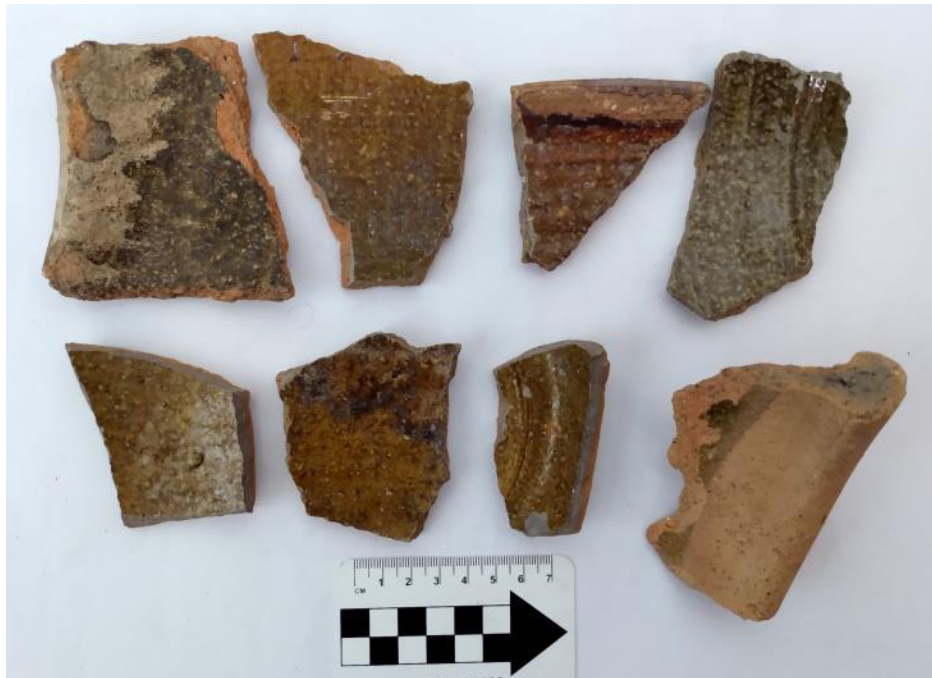
- 5.2 The bulk of the pottery assemblage comprised gravel-tempered red earthenware with an internal glaze either brown, olive green or dark green in colour (Photo 18). The pottery fragments include rim, base and body fragments from a range of vessels, including jugs and bowls, that appear to be general kitchen and dairy vessels. The pottery is typical of north Devon gravel-tempered wares, which have their origins in the later medieval period, but these vessels likely date to the late 17<sup>th</sup> and 18<sup>th</sup> century, which was their main period of importation into this area of Wales.

**Photo 18:** Selection of the North Devon gravel-tempered ware pottery recovered from the site.

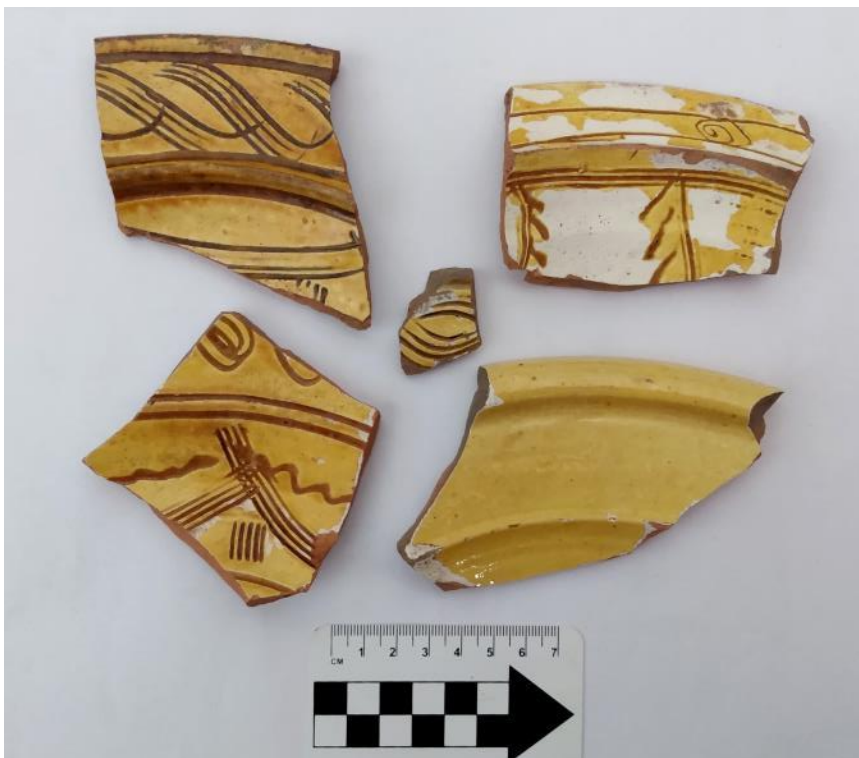
- 5.3 Other earlier pottery also from north Devon was a selection of sgraffito-ware, comprising fragments from large shallow bowls (Photo 19). The 'sgraffito' designs are created by incising lines through the white slip to expose the red earthenware below, all then covered in a lead glaze making the slip appear yellow, and the incised lines a dark brown. This pottery also dates to the later 17<sup>th</sup> and into the mid-18<sup>th</sup> century.

**Photo 19:** Examples of the North Devon Sgraffito-ware pottery from the site.

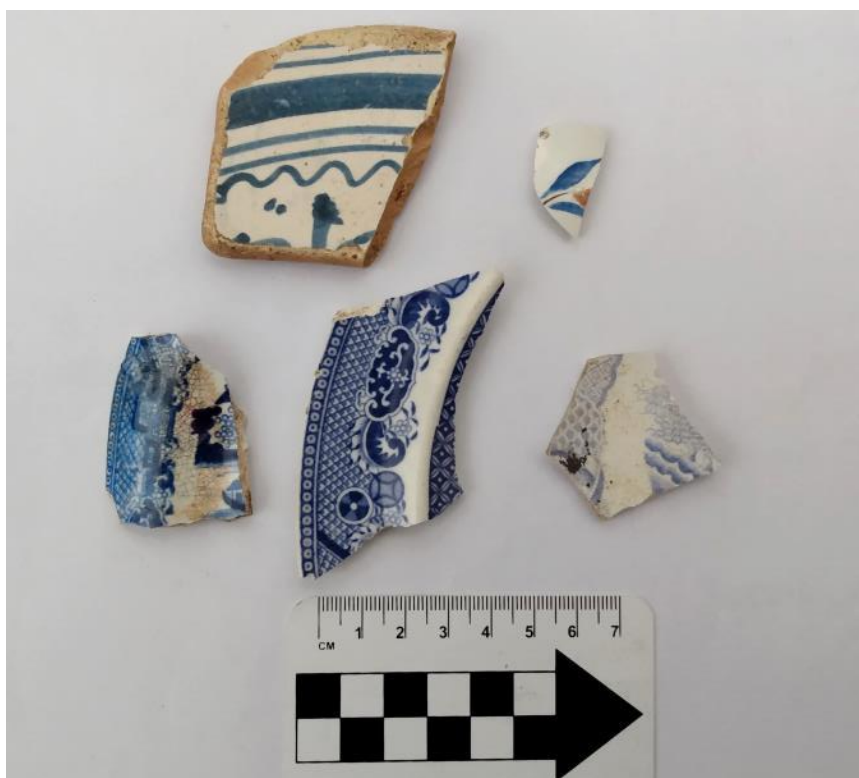
**Photo 20:** Examples of the blue & white glazed pottery from the site.
