# **RITEC CULVERT REPAIRS, TENBY, PEMBROKESHIRE: HISTORIC ENVIRONMENT DESK-BASED ASSESSMENT**

REPORT NO. 2022-05  
PROJECT NO. 128799

March 2022

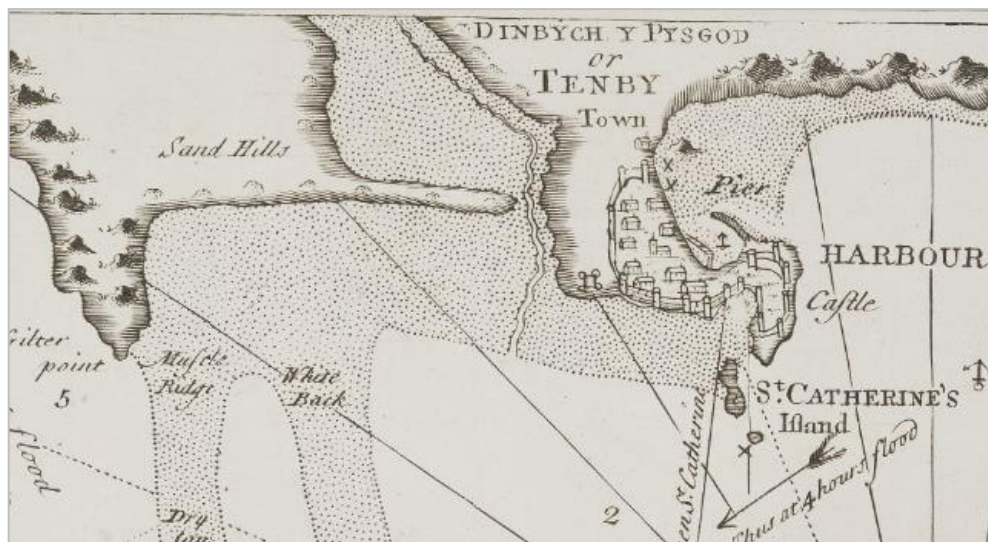
**Figure 5:** Extract from Morris plan of 1748, showing Tenby and the mouth of the Ritec. National Library of Wales.

- 6.3.1 These early nautical charts do not provide great detail, but depict the area prior to enclosure and reclamation, showing the natural line of the Ritec, hugging the base of the cliffs to the north and east of the marshes. A substantial sand bar had already partly enclosed the mouth of the estuary, likely backed by salt marsh. A fort (PRN 120806/120807) appears to overlook the South Beach to the west of the walled town of Tenby.

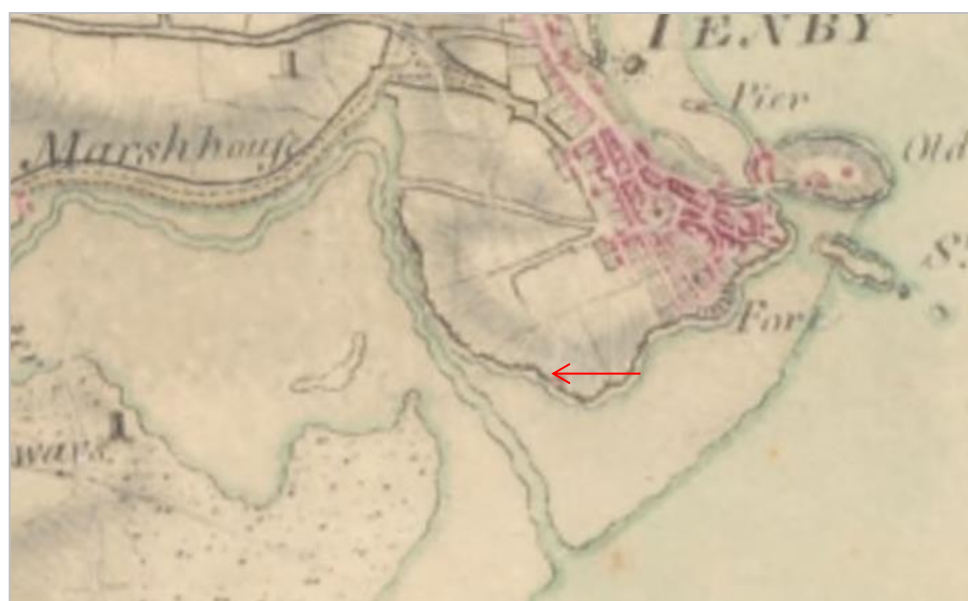
**Figure 6:** Extract from the Ordnance Survey drawing of 1809. Possible mill site marked.

- 6.3.2 This map provides a little more detail of the land based topography at the start of the 19<sup>th</sup> century. The river still appears to follow a course hugging the northern and eastern cliff line. The current line of Park Road is marked, which appears to access the riverside just after the bend in the river around The Salterns. Also of note is a small building on the northeast bank of the river as it emerges onto South Beach. There is no indication as to what this structure represents, but it may be approximately in the area of the former mill (PRN 33769). This appears too early to be described as the 'new steam mill' referenced in the 1840s, but may therefore be a forerunner. Alternatively, it may not be a mill building at all, the detail does not allow any definitive conclusions to be drawn.

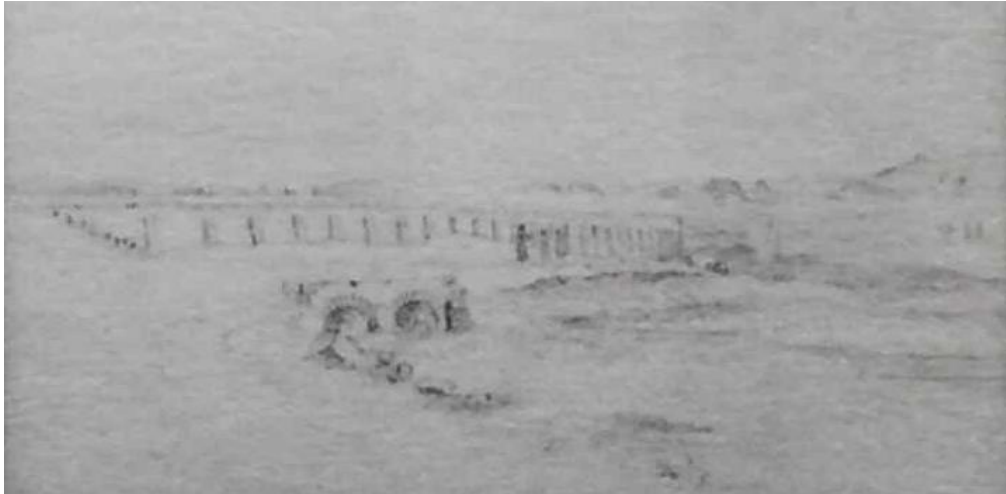
**Figure 9:** Drawing by Charles Norris dated 1840, of either the seawall at South Beach, or the embankment across the Ritec.

- 6.3.6 Issues with the enclosure are captured in images labelled 'Ruined floodgates' in 1836 and 1837, and the final enclosure of the marshland is also illustrated in one drawing, dated August 18, 1840, labelled 'The Seawall on the South Sands within about 3 days of its completion', and in another dated August 26, 1840, labelled 'Embankment at Tenby Marsh shortly before its second enclosure'. Images of the ruined floodgates have not been examined, and it is unclear where the 'Seawall' is, but the latter presumably refers to the Mathias embankment, later strengthened and adapted for use by the railway. One of the image copies examined is reproduced below (Figure 9), but it is unclear whether this particular image is of the seawall or the embankment.

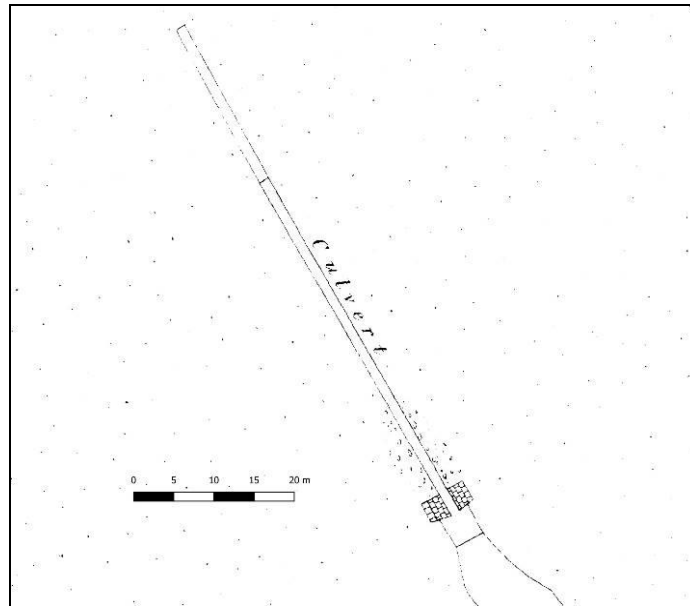
**Figure 12:** Detail from the 1:500 Ordnance Survey plan of Tenby in 1889, showing the outlet for the culvert at low water.

6.3.9 Tenby was mapped in detail by the Ordnance Survey in the later 1880s. This map depicts the line of both the Orielsont embankment and the Owen embankment (PRNs 115089 / 115083), both by this time being re-used as railway embankments (PRN 115092). The river enters a culverted section (PRN 29927) on the northern edge of the current railway embankment, via a flood gate. This takes the line of the river slightly west of its original course; an old disused flood gate can be seen on the south side of the railway embankment, which would have discharged the river along its original course. The line of the culvert is presumably marked by a line of three air shafts (PRN 29928). The first is close to the embankment. The second, larger, airshaft lies in front of the quarry now occupied by a car park. This quarry still appears to be in use at the time of the mapping, but is fronted by a disused limekiln (NPRN 524995), now gone. The windmill (NPRN 524976) stands on the hilltop above the quarry, but this too was disused by this time. Slightly further down river stands the mill (PRN 33769), also disused, but marked as a large rectangular building with a series of buttresses along the riverside face. The final air shaft lies on the edge of the beach, with no further structures in the surrounding area. The outlet of the culvert is marked around the low tide mark, as an open channel with a built structure at the end (Figure 12), indicating the current iron outfall pipe is a later feature.

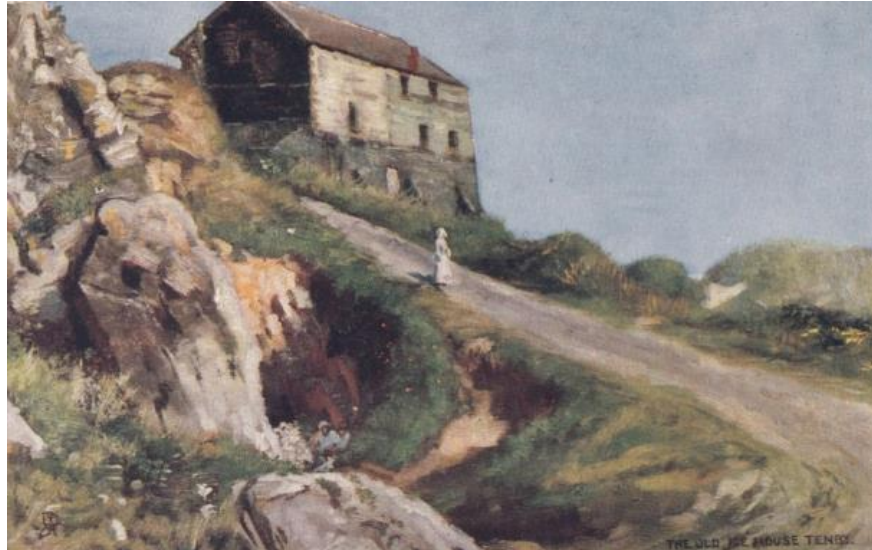
**Figure 13:** Undated postcard labelled 'The old ice house Tenby', potentially showing the former corn mill adjacent to the development site.

- 6.4.2 There is an early (1890s) photograph of Tenby taken from the Burrows to the south (not reproduced here, see Francis Frith website). This image looks over the sand dunes and shows the quarried hillslope (now housing a car park) and the mill building still standing. The mill was presumably out of use by this time, and seemingly without its adjacent chimney. It stands on a buttressed base, potentially sea-washed. The building appears similar in appearance to one shown on an old postcard of Tenby, entitled 'The Old Ice House' (Figure 13). This is uncertain, as the ice house has not been positively identified and located, but the similarities suggest the old mill building may have been repurposed as an ice house during the later 19<sup>th</sup> century. This may also explain why the structure appears to have survived for some time despite being labelled as 'disused' on Ordnance Survey maps of the late 19<sup>th</sup> and early 20<sup>th</sup> century.

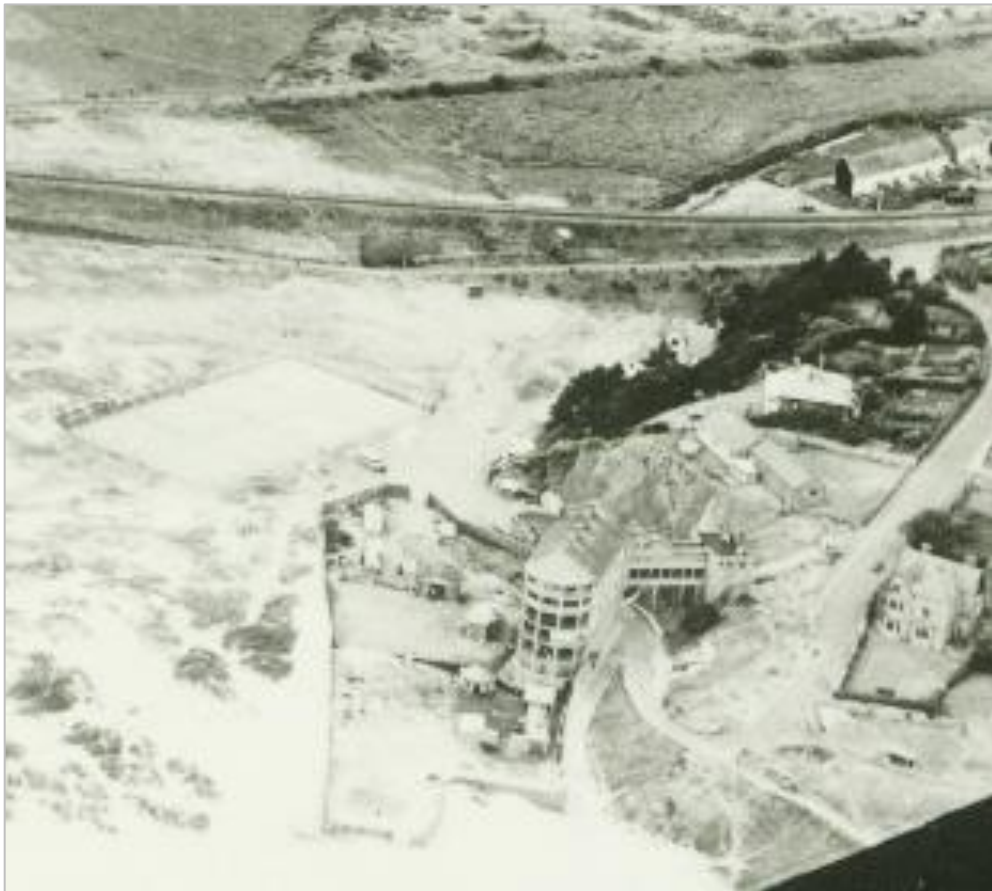
**Photo 2:** RAF aerial photograph of 1940, showing Shanly's/South Beach Pavilion, possible tennis courts to the left, and the open river beyond the railway embankment to the top.

- 6.4.4 An aerial photograph from 1940 (Photo 2) shows the pavilion without the name on the roof. It also captures the elaborate entrance to the pavilion, via an entrance tower built into the hillside and an enclosed walkway across Battery Road. To the southwest of the building (and across the line of the culvert) lies a fenced enclosure, with a scattering of outbuildings within, the function and purpose of which is unclear. A landscaped rectangular area lies to the west, possibly the later tennis courts associated with the pavilion. No evidence of the culvert is visible, but the open line of the river is visible beyond the railway embankment. Of the dwellings that currently line the track between the railway embankment and the pavilion, The Pines, Fairway, Woodfield and Maytree Cottage are all visible by 1940/1. Little change is subsequently noted until 1949/50, when the seaward boundary of the enclosure associated with the pavilion appears to have been rebuilt, possibly enlarged westward, with internal covered seating areas rearranged (Photo 3).

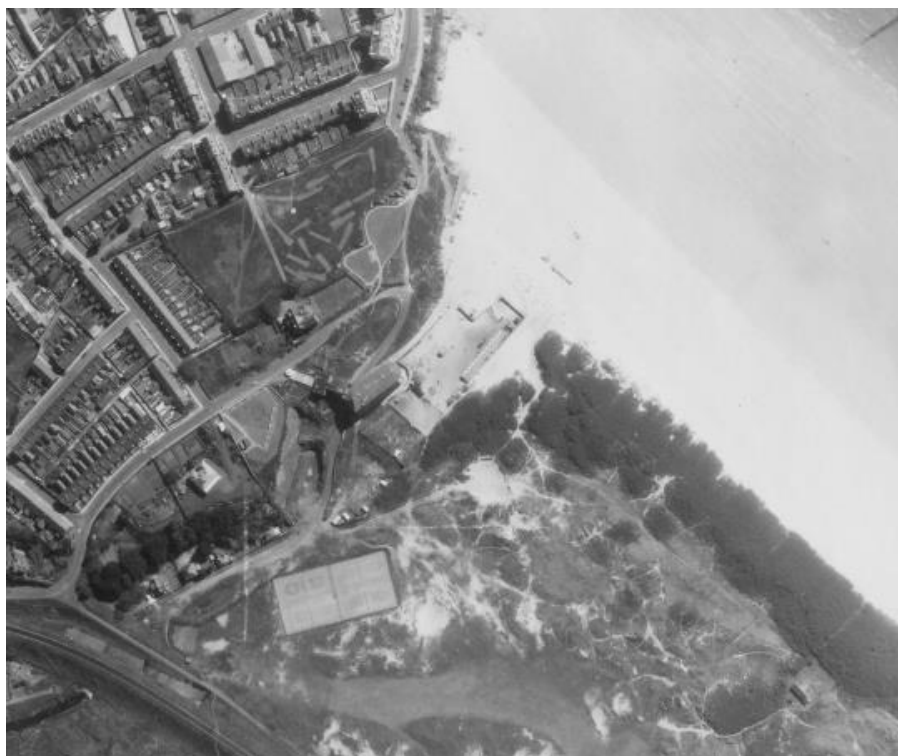
**Photo 3:** RAF aerial photograph of 1951 showing the development area including part of the outfall pipe to the top right.

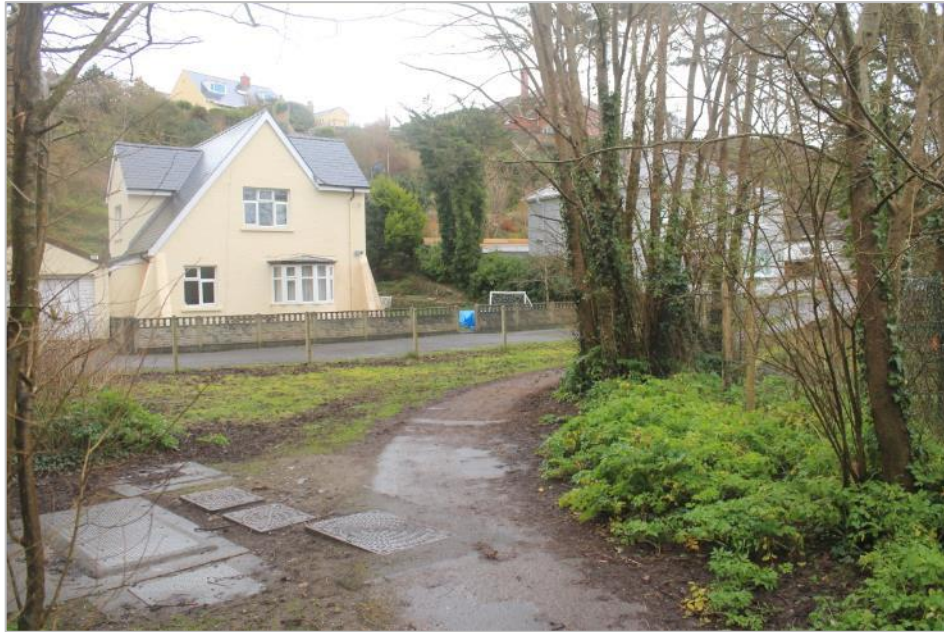
**Photo 4:** View east showing the access hatches to the culvert at the base of the southern side of the railway embankment.

- 6.6.1 A site visit was initially undertaken on the 9<sup>th</sup> March 2022. Weather conditions were cloudy and windy, although visibility was fair. A subsequent visit was made on the 15<sup>th</sup> March during bright sunny weather. There was open access up to the proposed development area between the railway embankment boundary fence and the beach.
- 6.6.2 The river runs along an open channel adjacent to Quarry Cottage before entering the culvert on the north side of the railway embankment. The inlet was not closely examined.
- 6.6.3 The southern side of the railway embankment is scrub-covered, traversed by the access road to Tenby Golf Club. A footpath runs along the base of the embankment, providing access to the row of dwellings and South Beach car park beyond. A row of manhole covers lies adjacent to the footpath, likely denoting the line of the culvert (Photo 4).

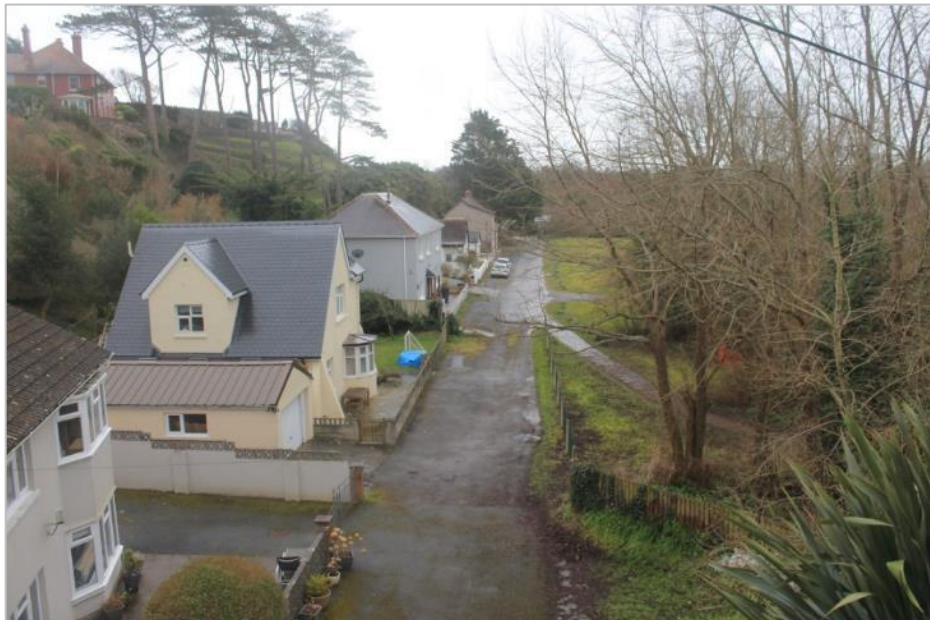
**Photo 5:** View southeast along the row of dwellings to the south of the railway embankment. The line of the culvert runs under the lawned area to the right.

6.6.4 The line of the culvert passes under an area of open ground that fronts these dwellings, comprising maintained lawns and planting areas, with a stand of trees and scrub at the northwest end (Photo 5). Areas of subsidence are visible within the scrub, marking the route of the culvert (Photo 6). These areas are currently fenced off, but no structural element is visible at the surface. To the west lies the maintained lawns of the golf club (Photo 7).

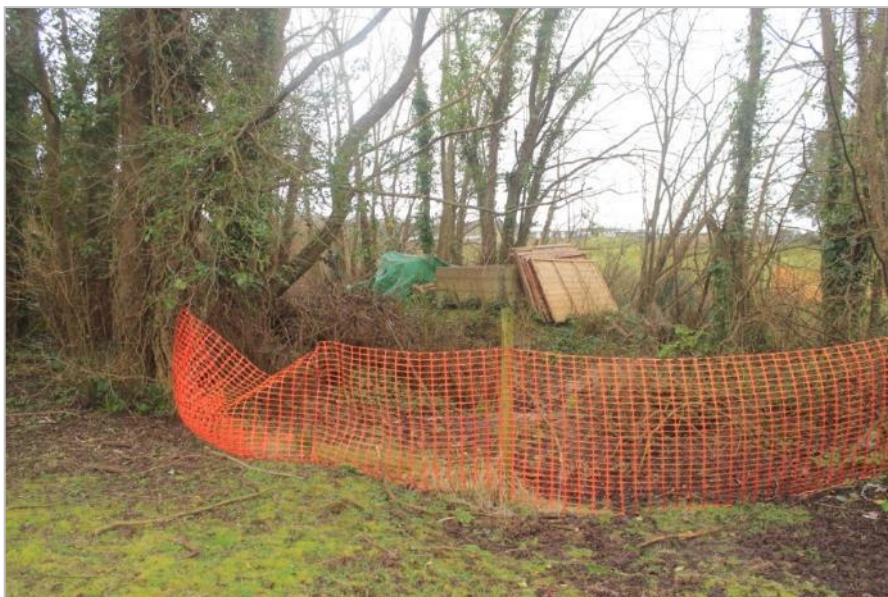
**Photo 6:** View southwest of the area of subsidence towards the northern end of the culvert.

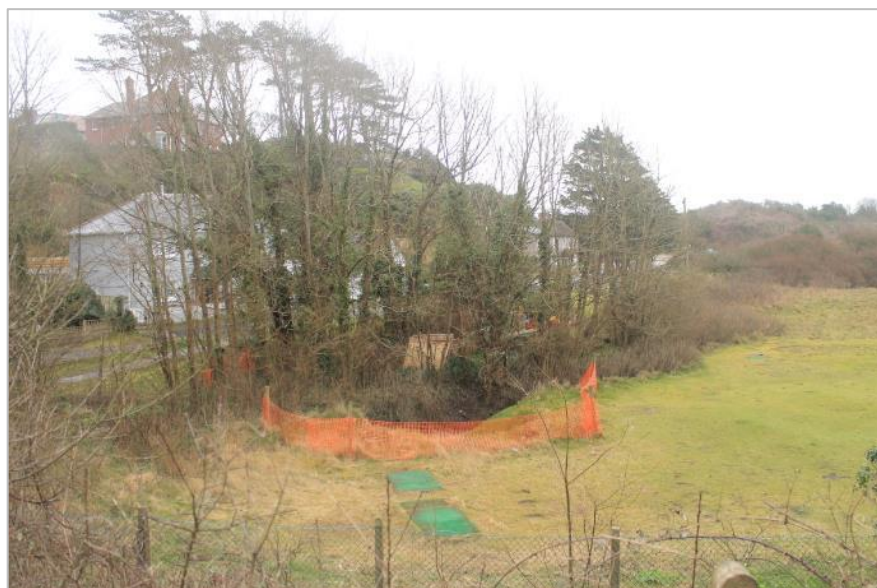
**Photo 7:** View southeast of areas of subsidence along the edge of the golf course (to the right).

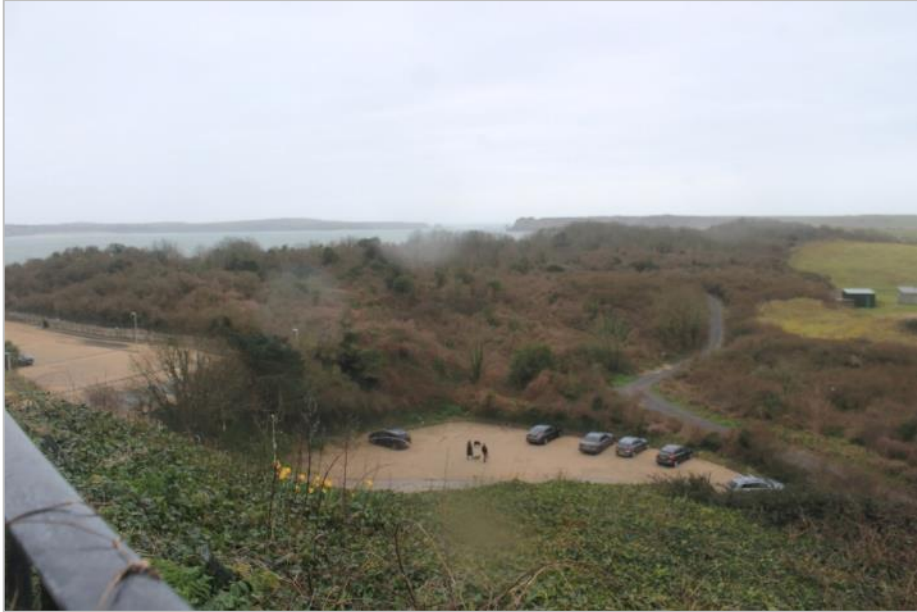
**Photo 8:** View southwest across the South Beach car park with the scrub-covered sand dunes beyond, and the golf club lawns to the right.

6.6.5 Beyond these lawns the route then passes under the South Beach car park, an area of tarmac roads and modern hard standing surfaces (Photo 8). To the northeast lies a former quarry, the steep limestone quarry-face clearly visible, cutting back into the hillside, the base of the quarry now occupied by an extension to the car park (Photo 9). The line of the culvert is marked by a square modern manhole cover (Photo 10).

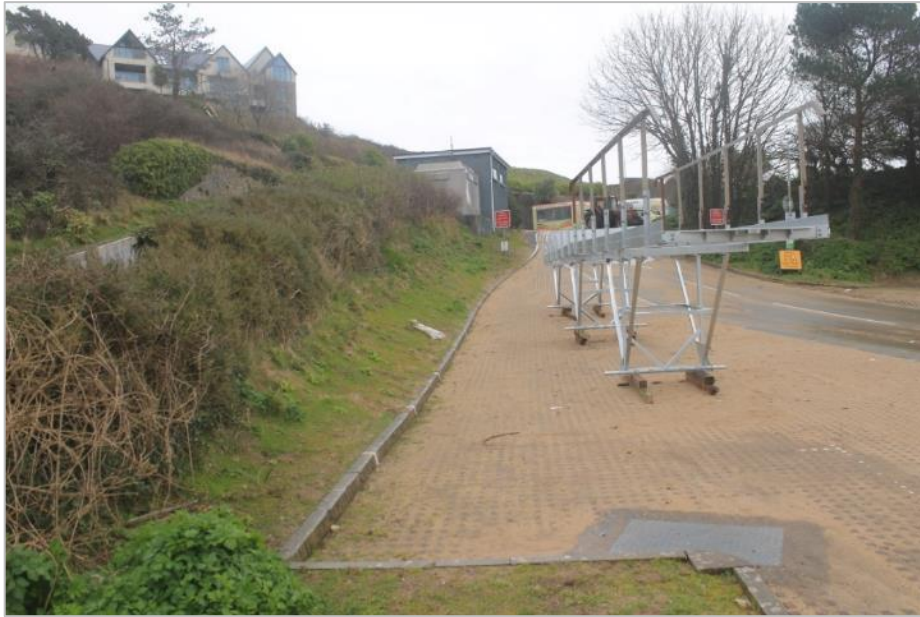
**Photo 10:** View south along the line of the culvert, marked by the manhole cover in the foreground.

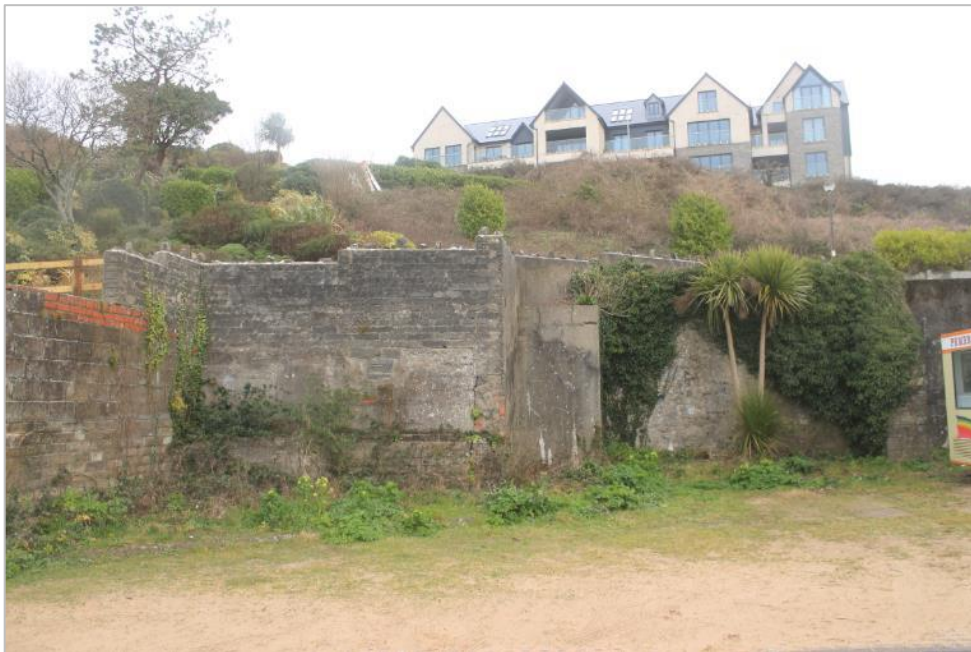
**Photo 12:** View northeast of revetment walling for Battery Road behind the modern buildings, presumably incorporating elements of Shanly's Pavilion.

6.6.6 The level of the car park then rises to the south, the culvert presumably now at a greater depth from the ground surface. Along the east side of the car park are a number of single-storey modern structures, housing storage, a sewage pumping station, and public conveniences (Photo 11). At the northeast corner, behind these buildings, the rising ground is fronted by walling, built largely of coursed roughly dressed stone blocks with brick inclusions and concrete block infill (Photo 12). The wall is concrete rendered in places, and also incorporates exposed bedrock in others. Areas of infill and changes in alignments indicate that the wall was not originally constructed as a simple buttress for the rising ground, but presumably represents remnants of the former Shanly's Pavilion. It is possible this includes elements of the former mill site, but no clear evidence of this was identified. Beyond the modern buildings alongside the car park lies a café complex, which includes a variety of buildings and private car park areas, fronted by beach-side walkways to the southeast. The cast iron beacon (PRN 59844), Grade II listed, lies alongside these walkways (Photo 13), as the car park opens out onto the beach (Photo 14). Behind these buildings the ground rises rapidly, traversed by Battery Road. At the top of the rising ground a series of mortared limestone walls define footpaths and potentially mark the site of a former gun battery (PRN 120806-7). The rising ground is then topped by a small enclosed park and seating area, with the former Rectory building on the opposite side of Battery Road.

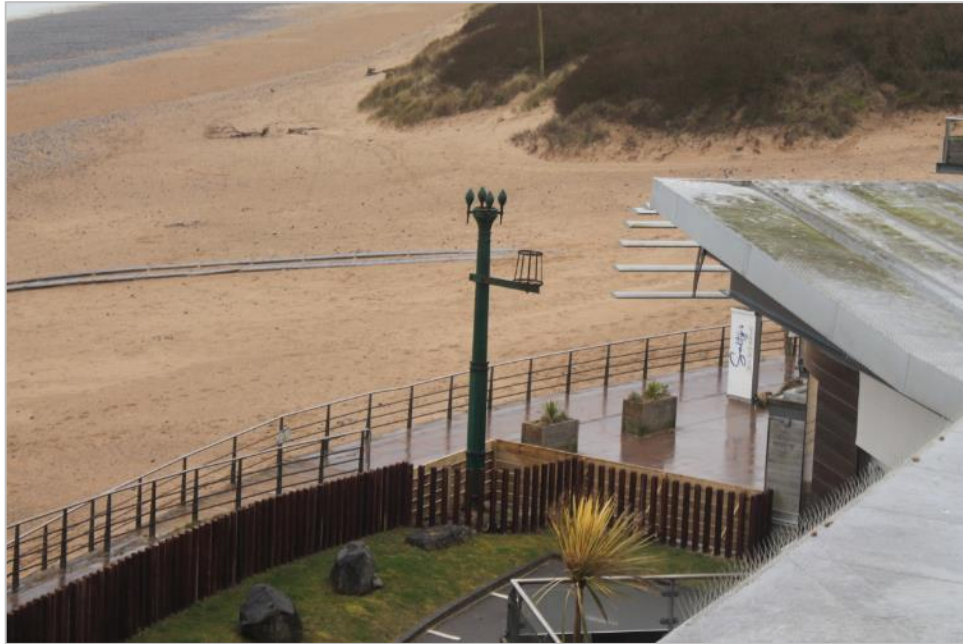
**Photo 13:** View west of the Grade II listed Festival of Britain beacon, with the entrance to South Beach car park and line of the culvert beyond.

- 7.2.5 For Listed Buildings the closest site to the proposed development is that of the Grade II listed Festival of Britain beacon (LB 26328) (Photo 13). The original setting of this structure has clearly changed, as it no longer stands in its original location, and indeed may have moved again in recent years and is now backed by modern development. It now has a less prominent situation (in terms of its function as a beacon) close to the water level, although is a distinctive feature on publically accessible beachside walkways, and is visible from South Beach itself.

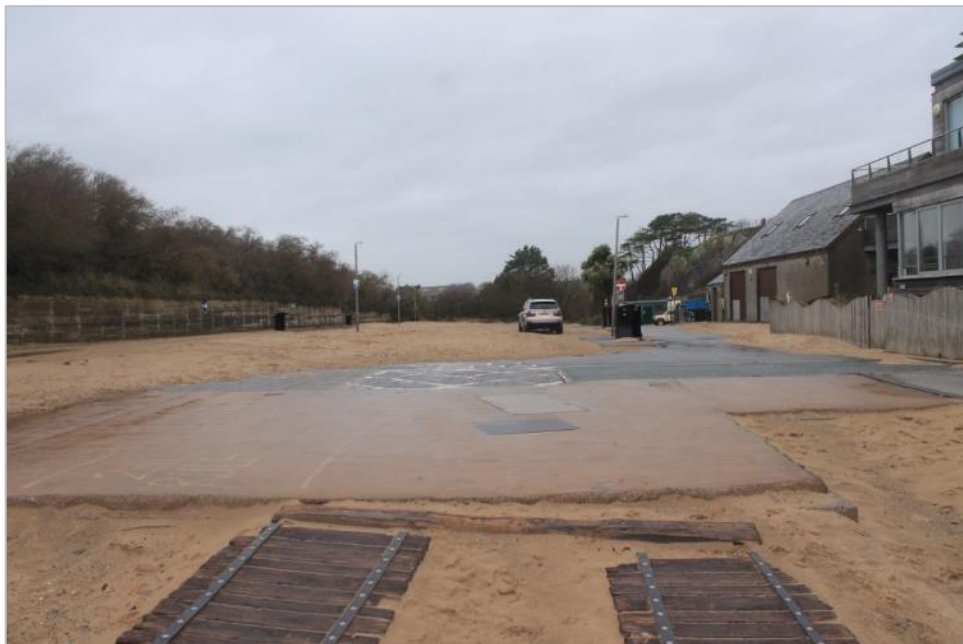
**Photo 14:** View northwest from the beach side of South Beach car park along the line of the culvert, marked by manhole covers in the foreground.

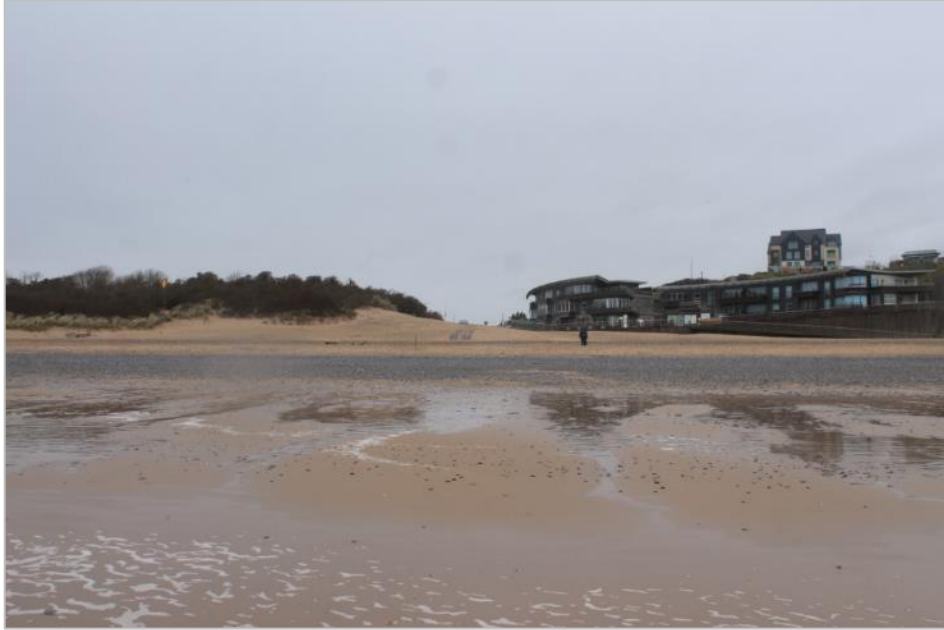
**Photo 15:** View northwest along the approximate line of the culvert on south beach, looking towards the car park entrance.

- 6.6.7 On the opposite side of the car park the land rises into scrub-covered sand dunes. The southeast end of the car park opens out onto the sandy beach, with sand clearly accumulating within the car park as well (Photo 15). To the northeast the beach is backed by rocky cliffs, with potential evidence of quarry faces (Photo 16). To the southwest the beach is backed by the scrubby sand dunes. The outlet for the culvert lies close to the low water mark, and was not examined during the site visit. Images of the outlet indicate that the line is marked by a series of concrete blocks (Photo 17), with a buoy marking the end.

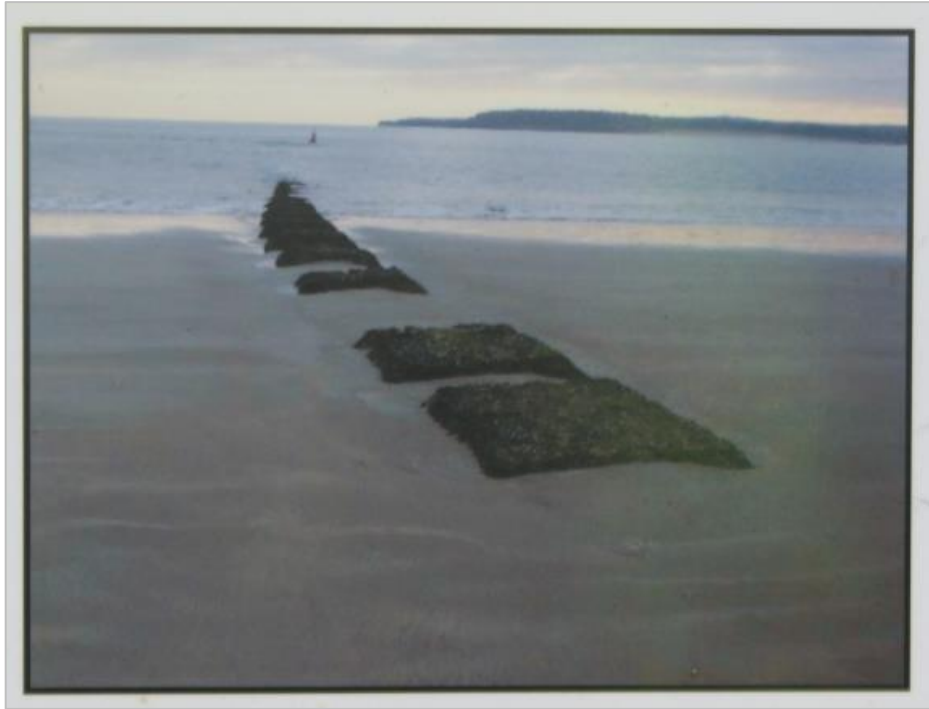
**Photo 17:** Image of the concrete blocks marking the piped outlet of the culvert at low tide.
