**SOUTH QUAY REDEVELOPMENT PHASE I,
PEMBROKE, PEMBROKESHIRE:
ARCHAEOLOGICAL WATCHING BRIEF
PLANNING APPLICATION NO
20/0304/PA**

Prepared by Dyfed Archaeological Trust
For: Lloyd & Gravell Ltd

REPORT NO. 2022-23
EVENT RECORD NO. 128824

May 2022

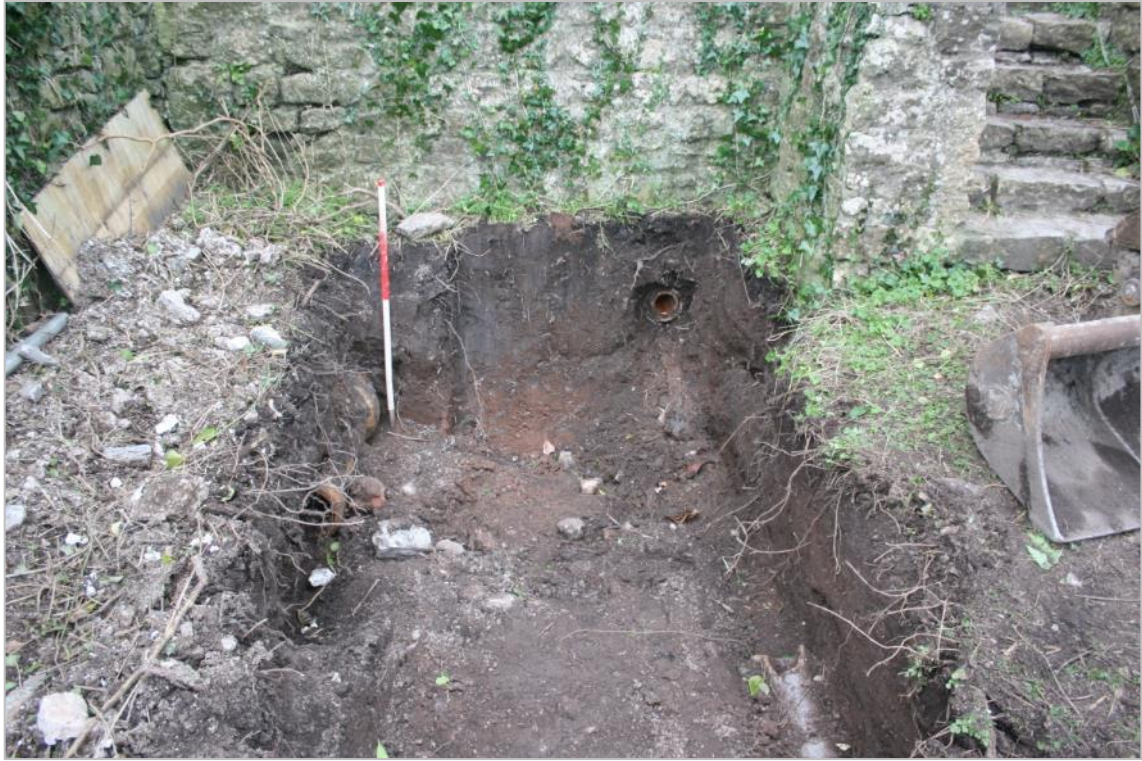
- 4.8.1 A trench measuring 3m north/south by 1.2m east/west and 0.78m deep was excavated to the rear of No. 6 Castle Terrace, directly below a revetment wall for a raised platform (Fig 3, TR01). The natural geology, a reddish-brown silty clay, was encountered at 0.63m below the turf level, underlying a mid-blackish brown, silty clay garden soil (Photo 1). No archaeological features were observed in the trench.

Photo 1: Trench 01, post-excitation showing broken drainpipe and garden soil above natural geology. View south, 1m scale.

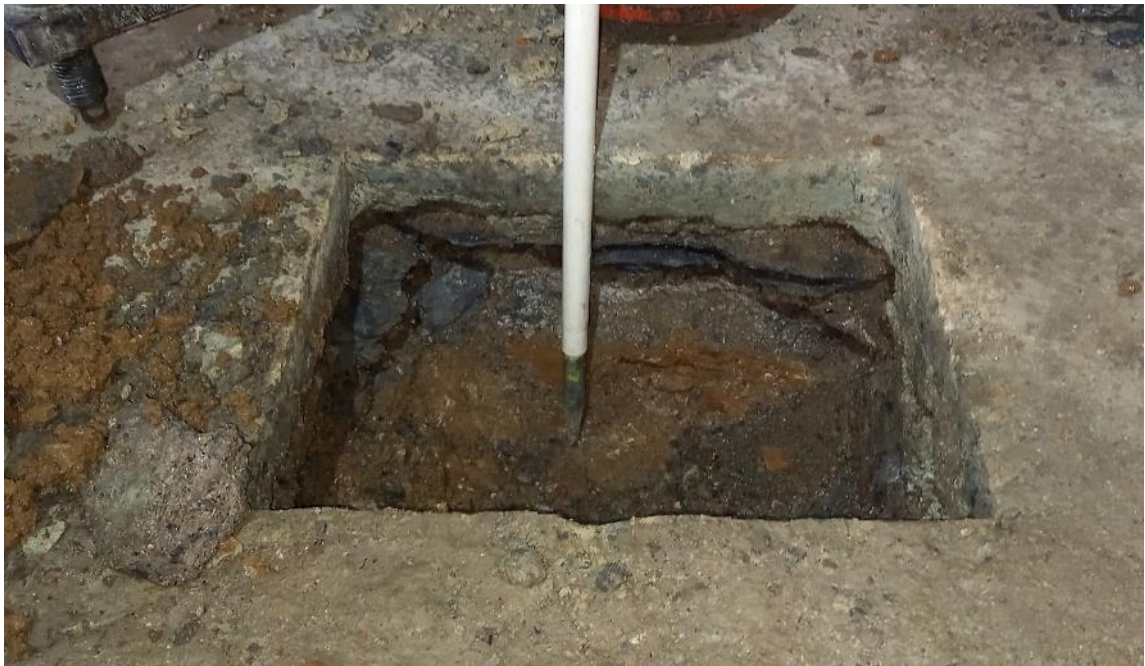
- 4.9.1 **WS01:** This window space, which was excavated through an existing concrete floor inside No. 5 Castle Terrace, measured 0.48m by 0.36m by 0.38m deep (Photo 2).

Photo 2: WS01 within No. 5 Castle Terrace showing stratified deposits. Looking east, 1m scale.

- 4.9.2 Above the red clay natural, of which c.0.09m was exposed in section, was a c.0.07m deep mid-brown soil. This soil was below a thin layer of lime mortar which varied in depth from c.0.01m to c.0.04m. Above the lime mortar was a c.0.07m deep deposit of slate fragments, some of which appeared in section to be of a size approaching that of modern roofing slates, and above them was the 0.08m deep modern concrete floor. No artefacts were present within WS01.

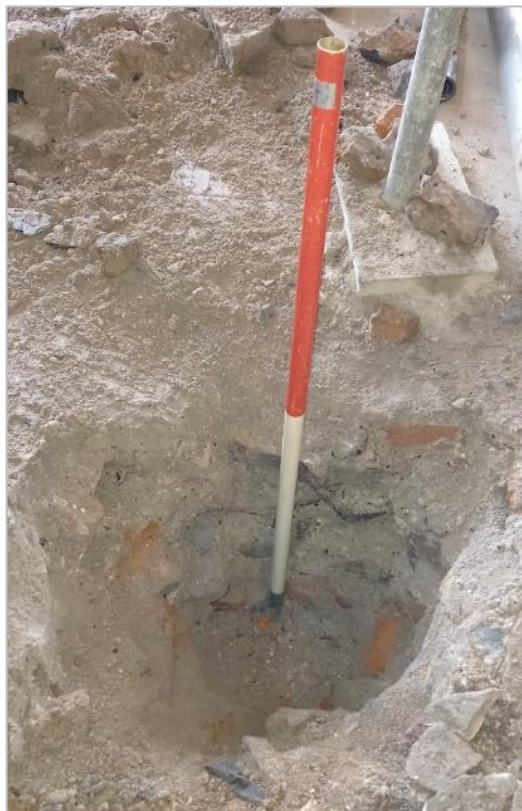
- 4.9.3 **WS02:** This window space measured 0.64m by 0.60m by 0.59m deep and was located within No. 5 Castle Terrace. It was excavated through a layer of demolition debris associated with the recent removal of a tiled floor to create a firm footing for scaffolding (Photo 3). Below the modern floor level, a single layer of made-up ground was revealed to a depth of 0.59m, comprising randomly layered brick fragments, limestone rubble and occasional slate fragments.

Photo 3: Building debris in WS02, within No. 5 Castle Terrace. Looking west, 1m scale

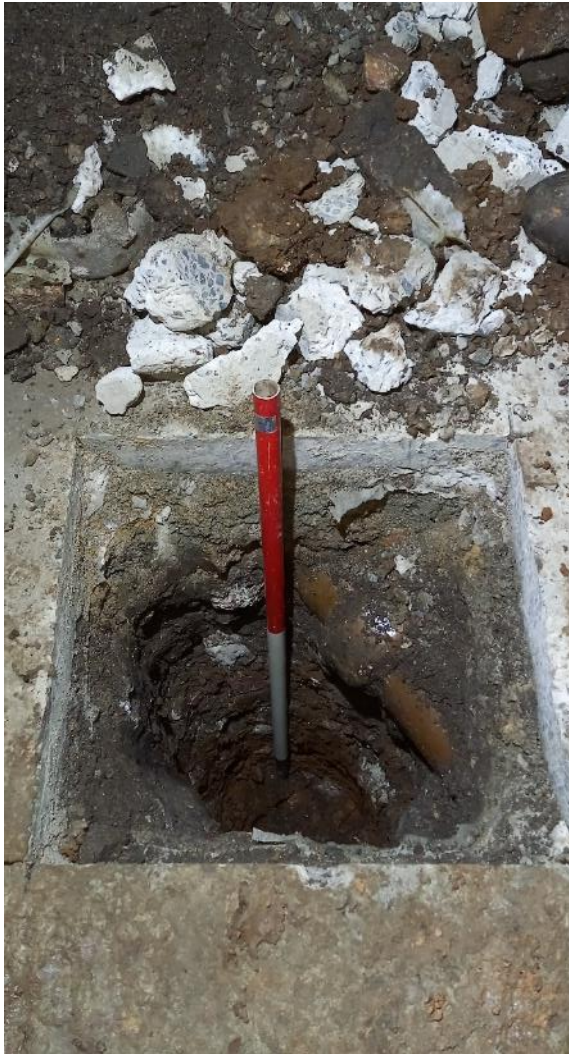
- 4.9.4 **WS03** measured 0.50m by 0.45m by 1.10m deep and was excavated through a 0.08m deep modern concrete floor within a room at the rear of No. 6 Castle Terrace (Photo 4). Above the red clay natural, which was encountered at a depth of c.0.54m, was a c.0.38m deep, dark brown, friable silty soil containing frequent small to large sub-angular stones and occasional medium sized rounded stones. A c.0.16m deep, mid-yellowish-brown, friable silty soil containing a modern clay drainpipe was above this and directly below the modern floor.

Photo 4: Deposits and features in WS03, within No. 6 Castle Terrace.

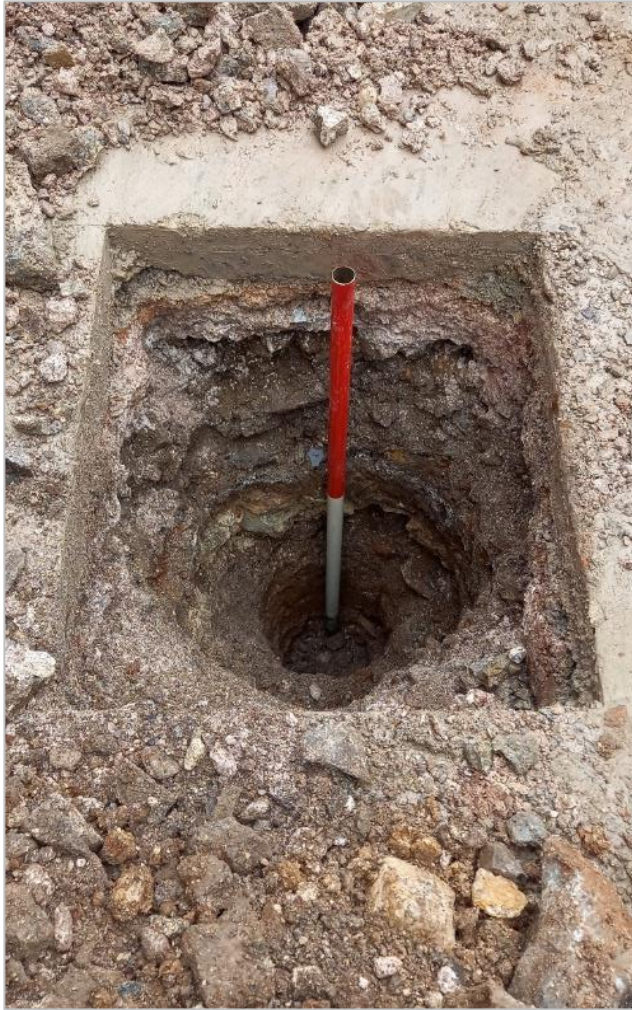
- 4.9.5 **WS04:** This window space measured 0.50m by 0.56m and was 1.2m deep (Photo 5). It was located north-west of the rear of No. 7 Northgate Street and was dug through the same modern concrete floor as WS01 (above), which in this location was c.0.10m deep. Above the red clay natural, which was encountered at c.0.91m, was c.0.22m of a mid- to dark brown, silty soil with frequent medium to large sub-angular stones. Above that was a c.0.12m layer of very light yellowish sand with very frequent medium to large limestones – the sand probably being degraded limestone. Above the limestone layer was a c.0.34m deep, mid-brown, friable sandy silt with very frequent small to medium sub-angular stones and one fragment of ceramic building material, and above that was between 0.10m and 0.13m of pinkish concrete, possibly the same layer as seen in WS01. The modern concrete floor was above this pinkish concrete.

Photo 5: Stratified deposits in WS04 to the rear of No. 7 Northgate Street.

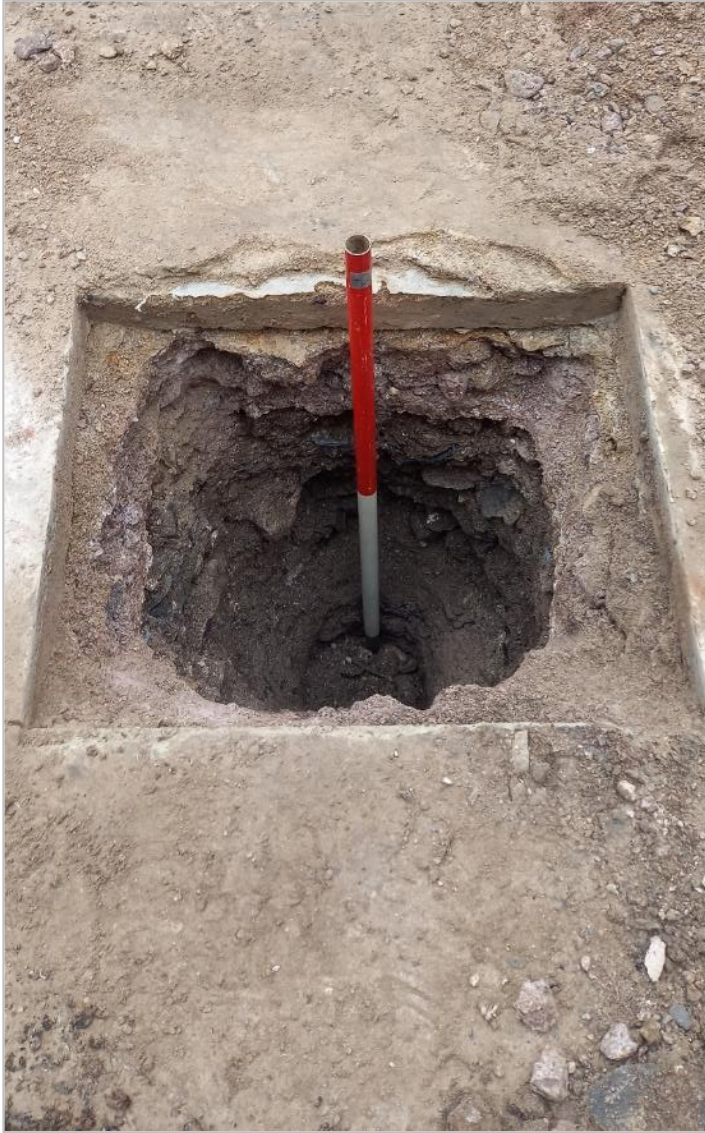
- 4.9.6 **WS05:** This window space measured 0.60m by 0.46m and was 1.2m deep. It was excavated through a c.0.08m deep modern concrete surface north-west of the rear of No. 7 Northgate Street (Photo 6). The lowest deposit was a dark, blackish brown, very gritty silty clay containing numerous small pieces of slag. The exposed depth of this deposit was 0.39m but its full depth is not known as the excavation terminated at the required test pit depth of 1.2m. The deposit was below c.0.62m of a dark brown, friable sandy silt with frequent small to medium and occasional large sub-angular stones and slate fragments. One oyster shell and two fragments of glazed, post-medieval pottery were recovered from this layer. Above it was a 0.19m deep layer of pinkish concrete containing frequent small sub-angular stones and above that was the c.0.06m deep, modern, grey concrete yard surface.

Photo 6: Deposits in
WS05 to the rear of
No. 7 Northgate Street.
Looking east, 1m scale

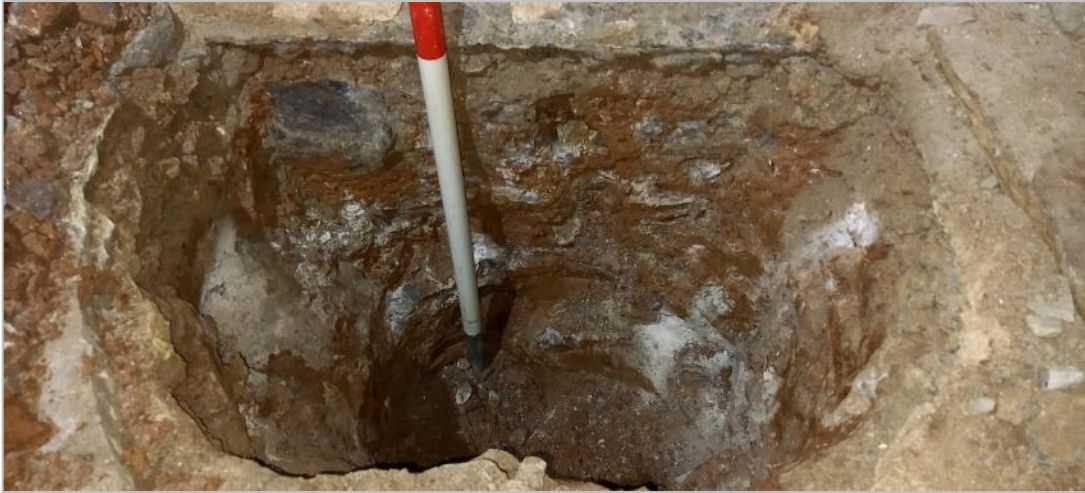
4.9.7 **TP01** was excavated to investigate the footings of the party wall between Nos. 4 and 5 Castle Terrace. TP01 measured c.0.63m by c.0.61m and was 0.50m deep. The west-facing footing of the stone-built party wall was present to a depth of c.0.30m below the modern floor level. The wall had been constructed on top of the limestone bedrock, within which fissures of the red clay natural were observed (Photo 7). Where they were exposed, the wall footings were constructed using small to medium limestones, ranging in size from c.0.05m by 0.06m to 0.10m by 0.12m. The bonding appeared to be lime mortar.

Photo 7: Exposed wall footings within TP01, inside No. 5 Castle Terrace. Looking east, 1m scale

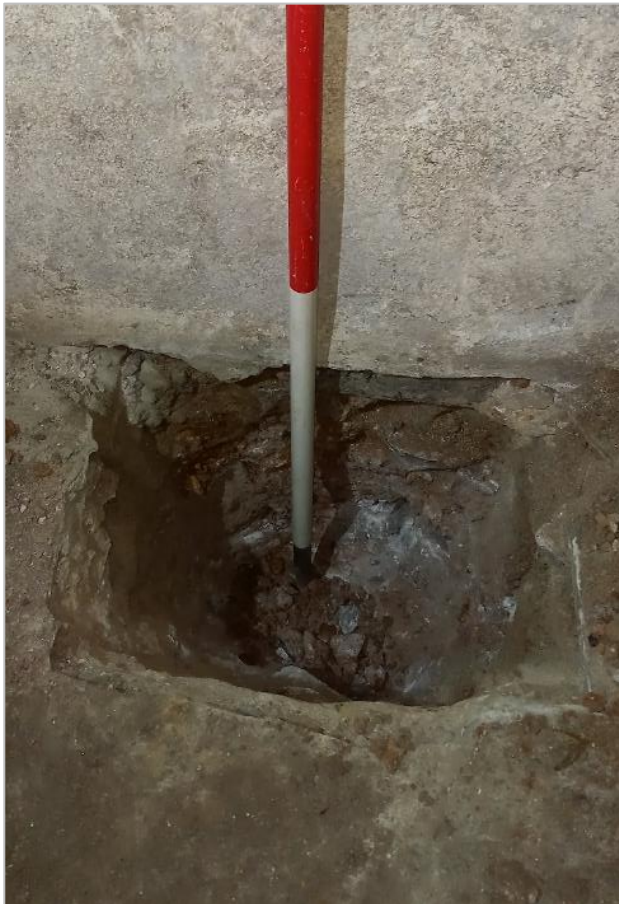
4.9.8 **TP02** measured 0.37m by 0.48m and was 0.50m deep. It was also excavated to investigate the footings of the party wall between Nos. 4 and 5 Castle Terrace. The west-facing footing of the stone-built party wall was present to a depth of between c.0.20m and 0.23m below the modern floor level. The wall had been constructed on top of the limestone bedrock, within which fissures of the red clay natural were observed (Photo 8). Where they were exposed, the wall footings were constructed of small to medium limestones, ranging in size from c.0.05m by 0.06m to 0.08m by 0.12m.

Photo 8: Exposed wall footings within TP02, No. 5 Castle Terrace. Looking east, 1m scale

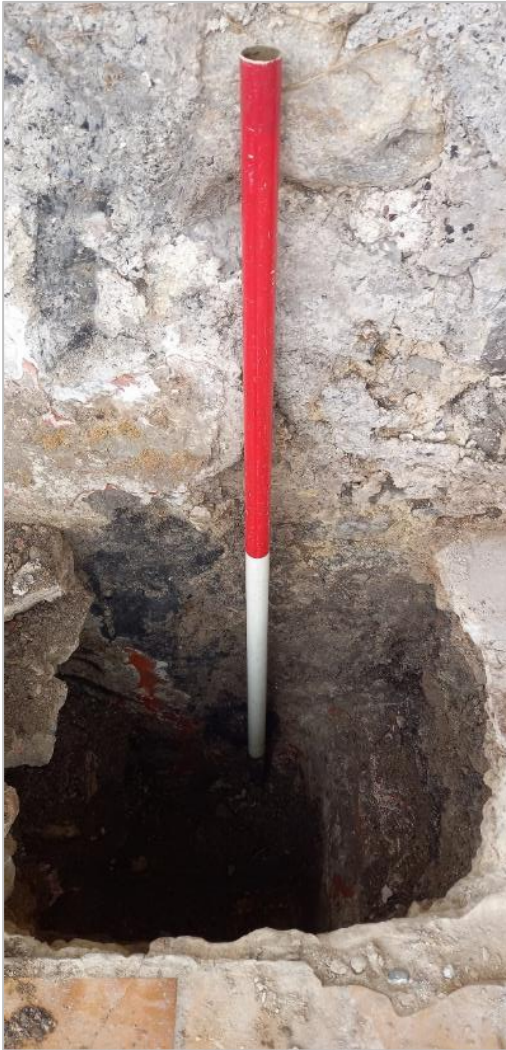
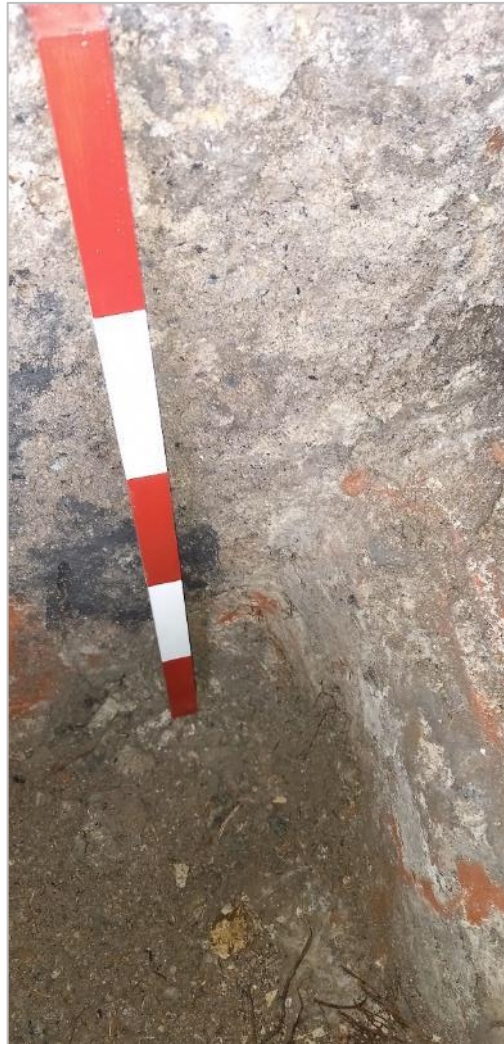
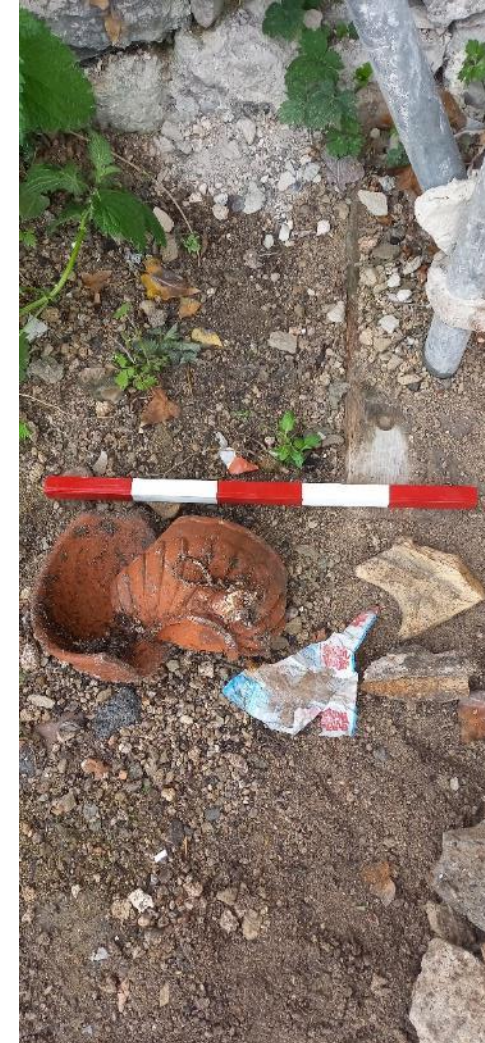
- 4.9.9 **TP03** measured 0.48m by 0.40m and was 0.32m deep. It was located adjacent to the former rear (north) wall of No. 4 Castle Terrace, with the aim of characterising the wall footings. TP03 was cut through the remains of a tiled floor associated with a modern extension that had been demolished during the current development. The footings of the stone-built rear wall of No. 4 Castle Terrace Wall {001} were present to c.0.62m below the level of the tiled floor (Photo 9). In the western half of the test pit, a second, very low (c.0.22 to 0.25m high) wall was revealed at c.0.37m below floor level Wall {002}. Both walls had been rendered and it was not possible to tell whether Wall {002} abutted Wall {001} or was keyed into it, because the render had been applied in a continuous layer to both and covered the top of Wall {002} (Photo 10). Both walls were constructed directly onto the limestone bedrock.

- 4.9.10 A c.0.13m to c.0.38m deep layer of mixed sand, broken brick and other ceramic building material, including tile fragments overlay the bedrock and Wall {002} in TP03. A relatively modern ceramic planter was recovered from within this layer, which also contained a 1970s Golden Wonder salt and vinegar crisp packet at a depth of 0.032m, c.0.05m above Wall {002} (Photo 11). Above this layer was a c.0.18m to 0.19m deep deposit of slate chippings, presumably bedding for the tiled floor of the demolished extension.

Photo 9 (left): TP03 showing below-ground, rendered footings of the rear (north facing) of No. 4 Castle Terrace (Wall {001}). Wall {002} is visible to the right. Looking south, 1m scale. **Photo 10 (middle):** Close-up of TP03 showing continuity of render on Walls {001} and {002}. **Photo 11 (right):** Modern artefacts recovered from TP03. 0.5m scale.

- 5.11 An interesting feature was observed within TP03, adjacent to the original rear (north) wall of No. 4 Castle Terrace. A very low wall abutting or, potentially, keyed-in to the rear wall was present below ground at a level well below that of the medieval cellar within the adjacent building. Due to the small size of the test pit, it was not possible to determine the extent of this feature, or to characterise it, but its stratigraphic depth and clear association with the original rear wall of the building are of interest.

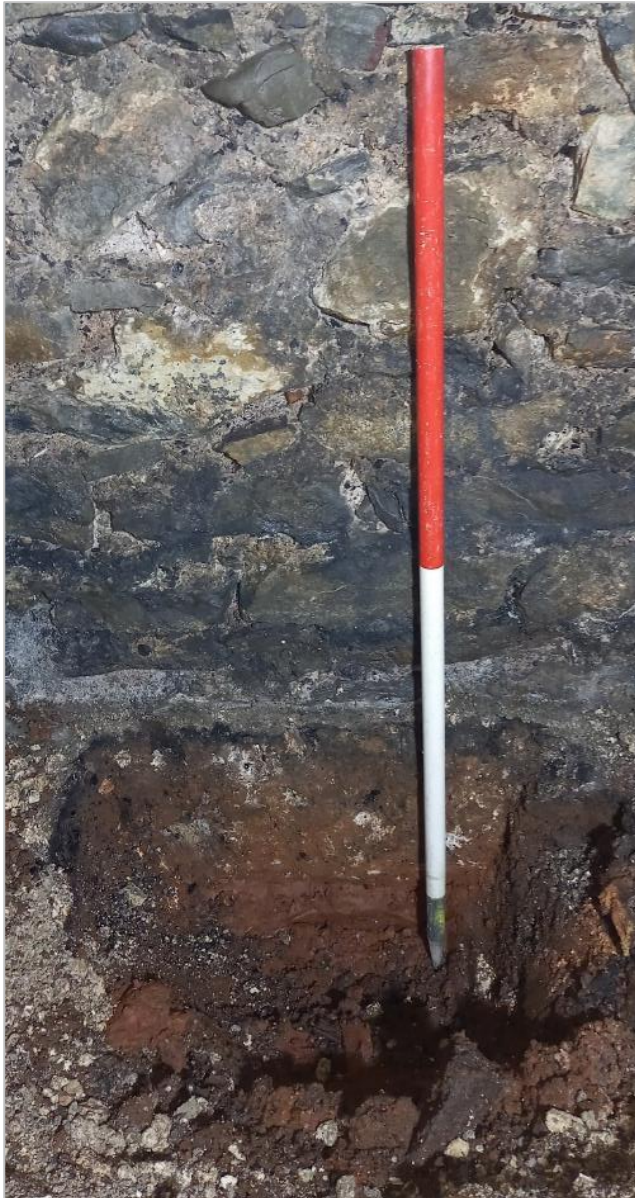
4.9.12 **TP04** measured 0.50m by 0.60m and was 0.42m deep (Photo 12). Above the red clay natural was a c.0.20m deep, dark brown, friable silty soil containing frequent small to medium sub-angular stones, brick fragments, occasional marine mollusc shells and one fragment of animal bone. Overlying this was the c.0.05m cobbled floor of the basement, which contained a great deal of coal dust. The north wall of the basement was present to 0.28m below floor level and was sitting on the natural.

Photo 12: Wall footings exposed in TP04, below the basement in No. 7 Northgate Street. Note the visible coal 'scar' at floor level and continuing up the wall.
Looking north, 1m scale

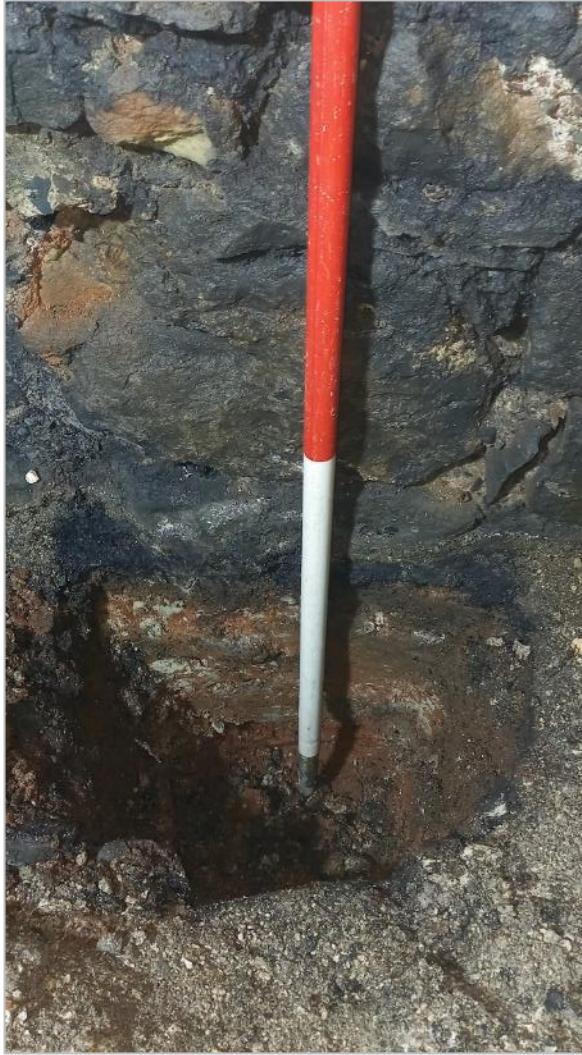
4.9.13 **TP05** measured 0.46m by 0.28m and was 0.48m deep (Photo 13). Above the natural red clay was c.0.30m of mid-brown, friable silty soil containing frequent small to medium stones, brick fragments and two shells. The c.0.11m deep cobbled floor overlay this soil and again contained a great deal of coal dust. The footings of the south wall of the basement were

present to 0.43m below the floor level and were constructed directly onto the red clay natural.

Photo 13: Wall footings exposed in TP05, below the basement in No. 7 Northgate Street. Note the visible coal 'scar' at floor level.

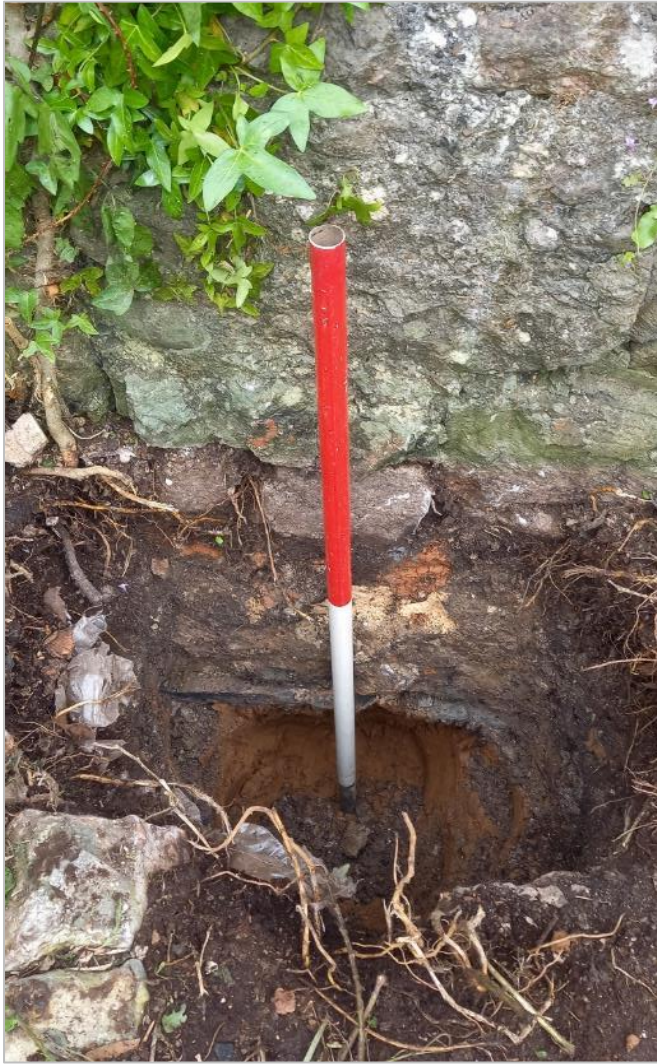
- 4.9.14 **TP06** measured 0.62m by 0.36m by 0.63m deep and was excavated adjacent to a stone-built garden wall to the north-west of No. 7 Northgate Street (Photo 14). Above the red clay natural was a dark brown, sandy soil containing frequent small to medium sub-angular stones, occasional coal and brick fragments and a Bobby's Beef Grills Packet with a best before date of 2014. The footings of the garden wall were present to 0.42m below ground level and were constructed directly onto the orangey clay natural.

Photo 14: Garden wall footings in TP06 to the north-west of No. 7 Northgate Street. Looking north-west, 0.5m scale.

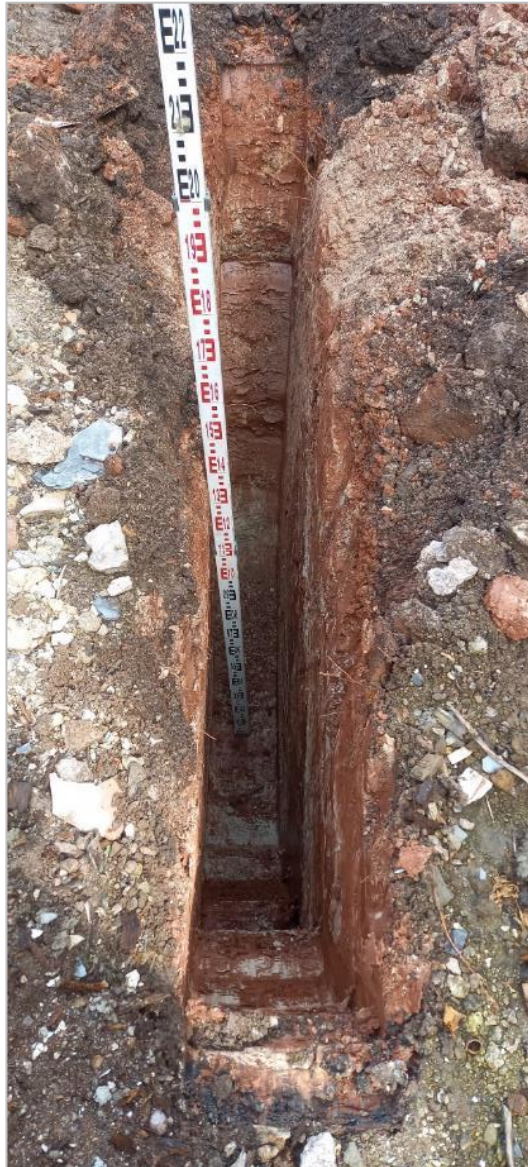
4.9.15 **SA01** measured 2.36m by 0.40m and was 1.7m deep. It was located to the rear of No. 7 Northgate Street and was excavated to investigate ground permeability in that area. Below an extremely thin (c.0.01m to c.0.03m) layer of mingled soil and demolition debris, the red clay natural was immediately present (Photo 15). This clay was shown in section to be interspersed with occasional bands of light grey sand that varied in depth from c.0.02 to 0.05m.

Photo 15: Red clay natural interspersed with bands of grey sand in SA01.

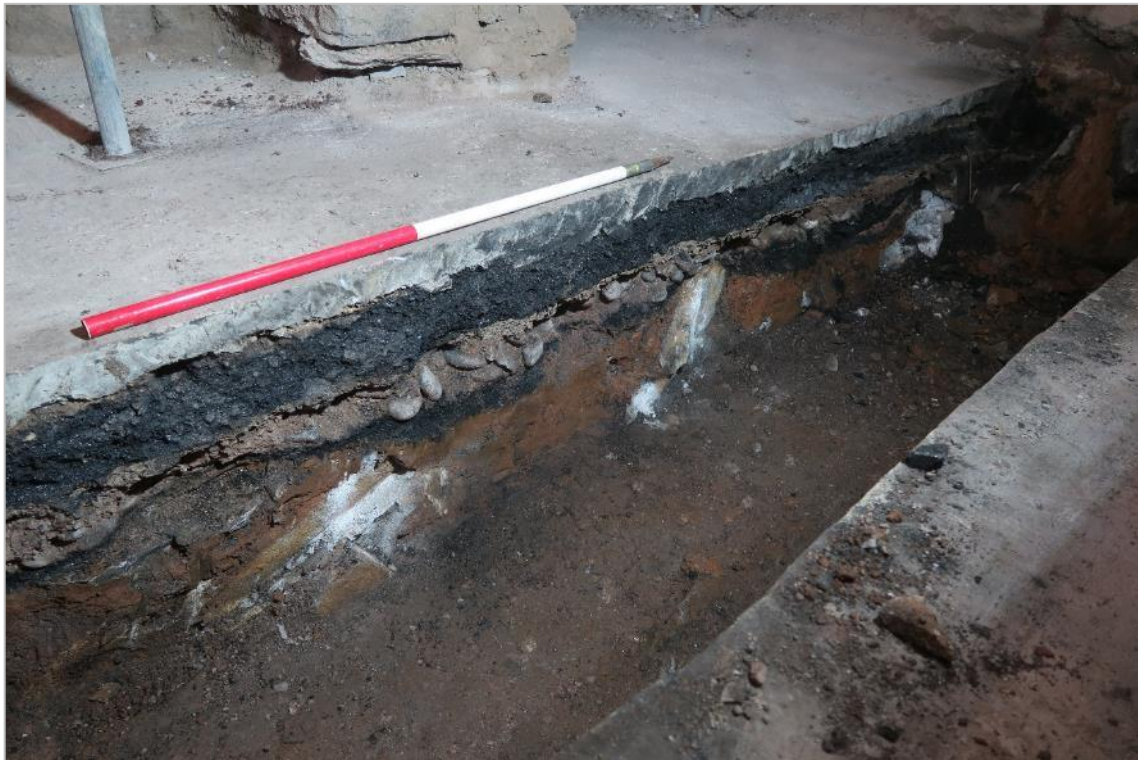
4.10.3 **Southern end of TR02** - a 0.04m to 0.12m deep deposit of coal dust and small coal fragments directly overlay the natural, which in this area was an orangey-brown, sticky clay interspersed with outcrops of limestone bedrock. In section, a 0.01m to 0.05m deep and c.0.2m long lens of a pinkish, silty material was observed within the coal deposit.

4.10.4 Above the coal deposit was a 0.04 to 0.08m deep deposit of medium to large river-worn pebbles within a mid-brown, dry, silty clay matrix. A fragment of post-medieval, white glazed ceramic with two thin, parallel bands of red glaze decoration was found within this deposit, probably a fragment of an egg cup or a small teacup. An earlier, pinkish, mortar/cement floor, c.0.04m deep had been laid on the river cobbles. Above that floor was a 0.11m to 0.14m deep deposit of coal dust containing occasional larger coal fragments. A complete glass bottle that had formerly contained Nujol mineral oil was found within this deposit, which extended for approximately 3.78m from the south wall of the building. A thin (max. 2cm deep) layer of sand overlay the coal deposit, above which was the modern concrete floor.

Photo 16: Showing deposits in TR02 overlying the natural in the southern two thirds of the trench. Looking south-east, 1m scale.

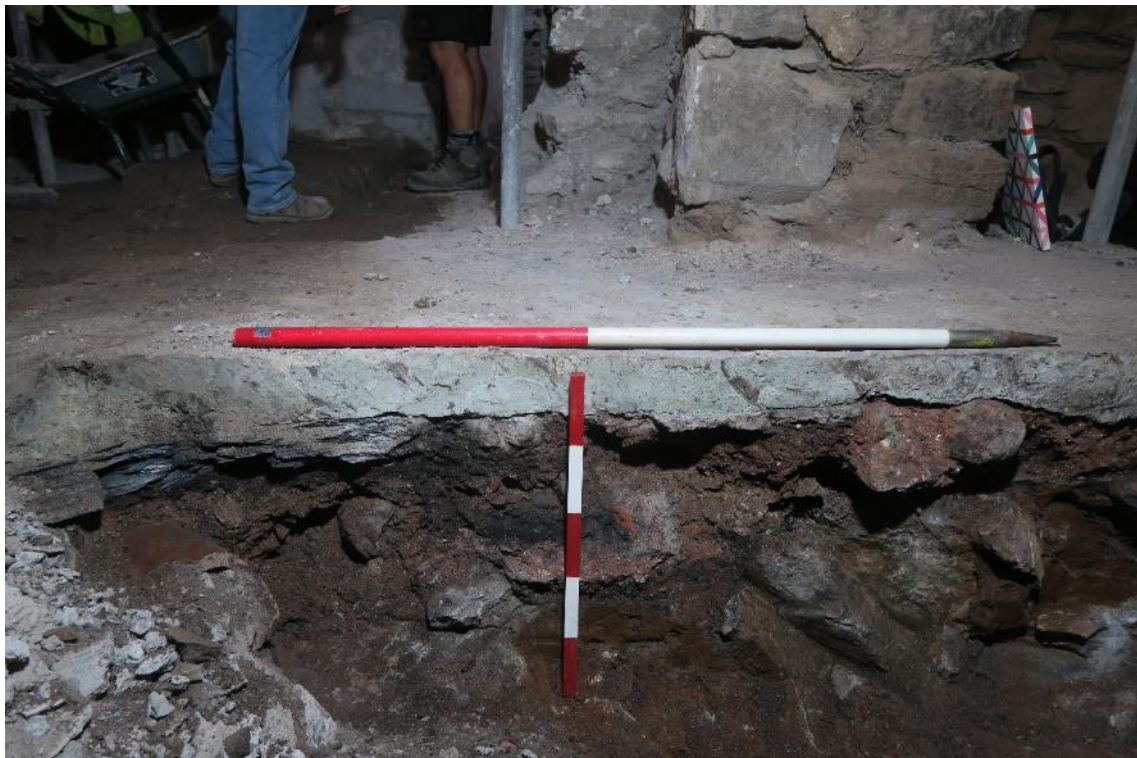
- 4.10.6 At the very northern end of the trench (the last 0.5m) the tiled floor had been replaced by a slate flagged surface (Photo 17). It appeared that the tiled floor had been truncated by the cut for a ceramic drainpipe that was encountered on a north-east/south-west alignment across the trench at this end. The fill around the drainpipe was a c.0.3m deep deposit of small to medium, river-worn stones, brick fragments and slate fragments in a silty, mid-brown clay. The slate flags that replaced the tiled floor sealed this fill. Their full dimensions were not visible, but they were 0.07m thick. The modern concrete floor, which was 0.06m to 0.1m thick, directly overlay both the tiled and flagged surfaces. No artefacts were recovered from the deposits at this end of the trench.

Photo 17: Showing deposits and features in TR02 at the northern 1.6m of the trench, including the cut for a drainpipe beneath a slate flag floor. Note the change from tiles to flags either side of the upright scale. Looking east, 0.5 and 1m scales.

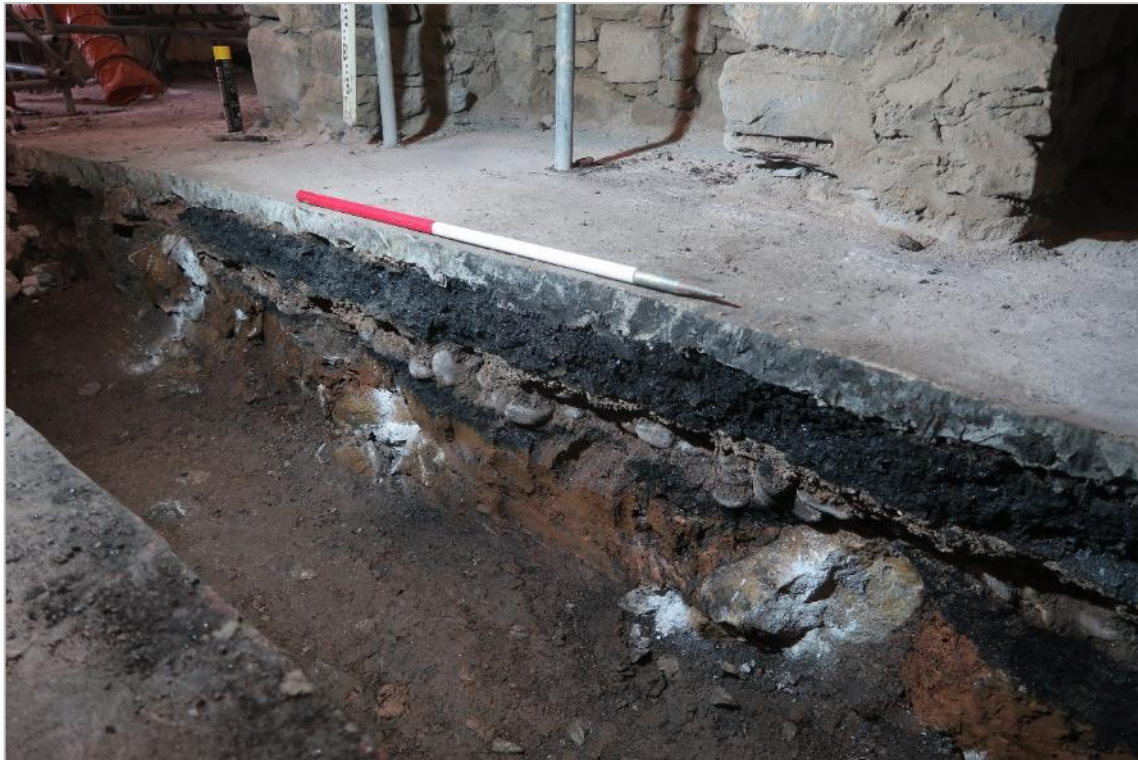
- 4.10.7 The interface between the deposits in the northernmost and southernmost ends of the trench was a very clearly defined change from the coal deposit in the southern end to the pinkish mortar below the tiled floor in the northern end. This change occurred directly adjacent to one of two projections in the party wall (Photo 18).
- 4.10.8 Throughout the trench the natural was encountered between 0.19m and 0.34m below the modern concrete floor level.

Photo 18: Showing the change in the character of deposits in TR02 either side of a projection in the party wall (far left of shot). Looking north-east, 1m scale.

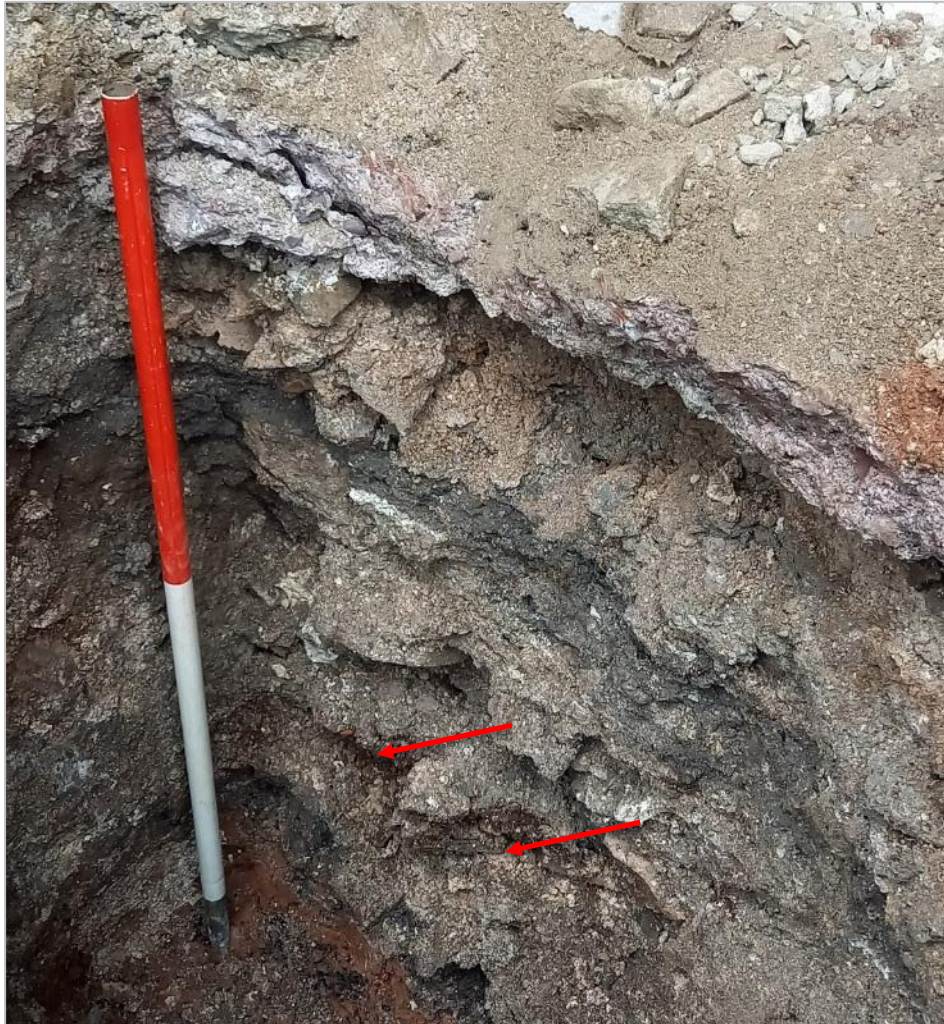
Photo 19: Deposits in the western half of TP07. The arrows indicate a lens of humic material and glass fragments. View south-west, 1m scale.

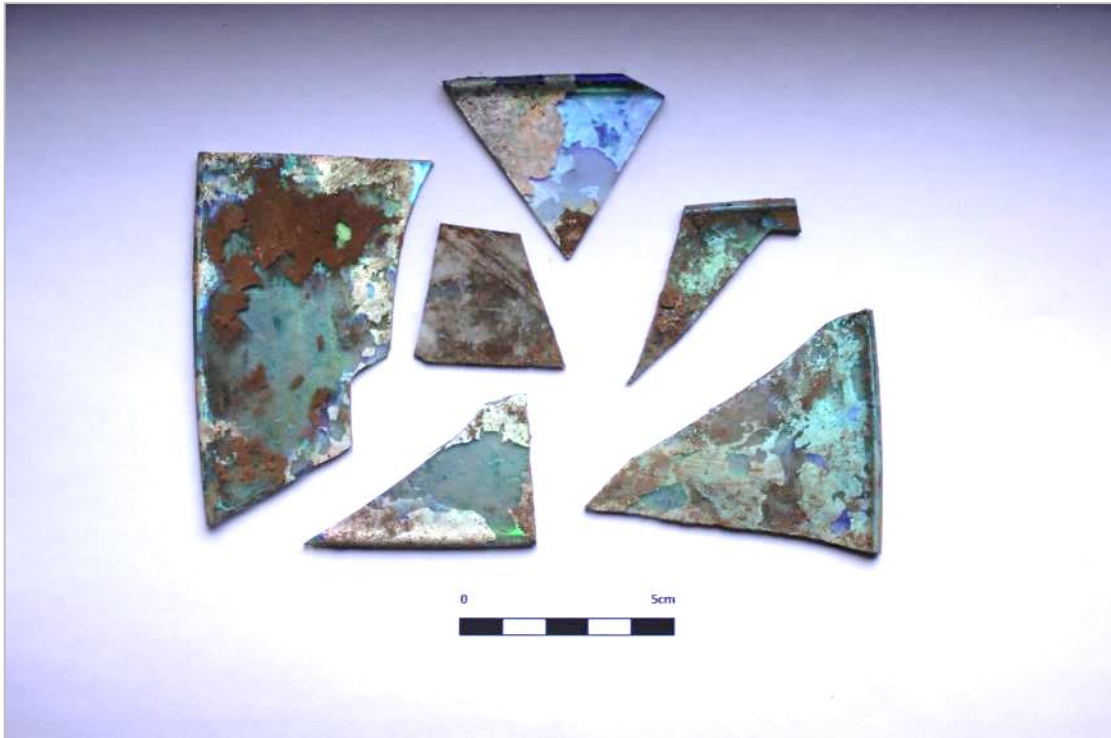
Photo 20: A selection of glass recovered from TP07. Note the distinct raised edge on most shards.

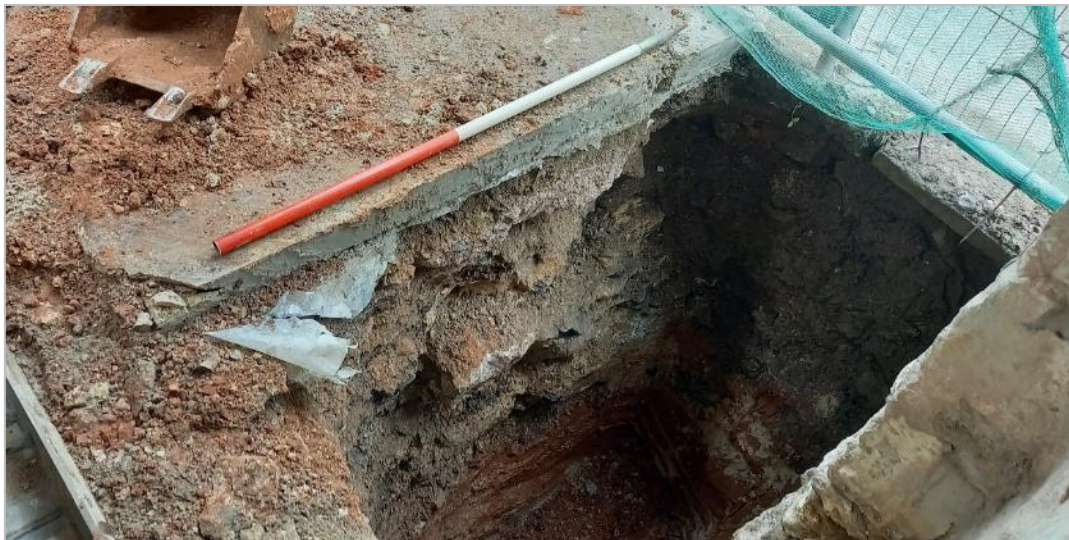
constructed on top of it. The wall was 0.4m wide by c.0.4m deep and was first encountered 0.5m down, below layers of light yellowish silty clay, pinkish concrete, made-up ground and the modern concrete.

Photo 21: Showing deposits overlying a section of wall in the eastern half of TP07. View north-east, 1m scale.

- 5.9 The section of wall revealed on a north/south alignment below ground in TP07 may be evidence for a demolished structure that formerly occupied the land between Nos. 7 and 8 Northgate Street. The discovery of a deposit containing broken glass fragments may support this. The fragments are of late-eighteenth or early nineteenth century cylinder window glass – the distinct raised edge being created by the cutting of the cylinder – and are probably waste from on-site glazing (pers. comm. Hugh Wilmott 2022). There are no windows in either the north wall of No. 7 or the south wall of No. 8 Northgate Street, therefore the fragments may be further evidence that a structure with windows on the street frontage formerly stood where the opening between the buildings is today.

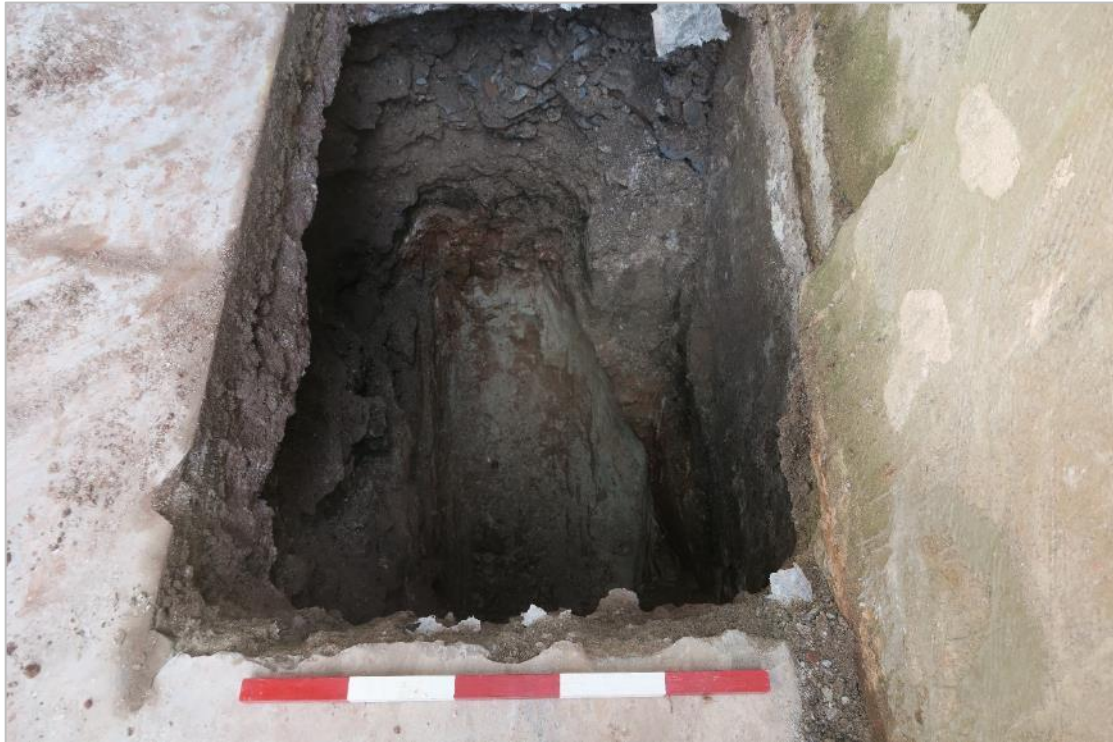
- 4.11.5 Footings of the north wall of No. 7 Northgate Street continued to c.0.75m below the modern floor level and were sat directly on the natural. A large stone observed towards the base of the footings in the west-facing section of the test pit may represent buttressing, but this could not be determined due to the restrictions imposed by the confines and depth of the excavation.

Photo 22: Showing deposits above the natural in TP08. Note the possible buttressing represented by a stone in the south-east corner of the pit. View east, 0.5m scale.

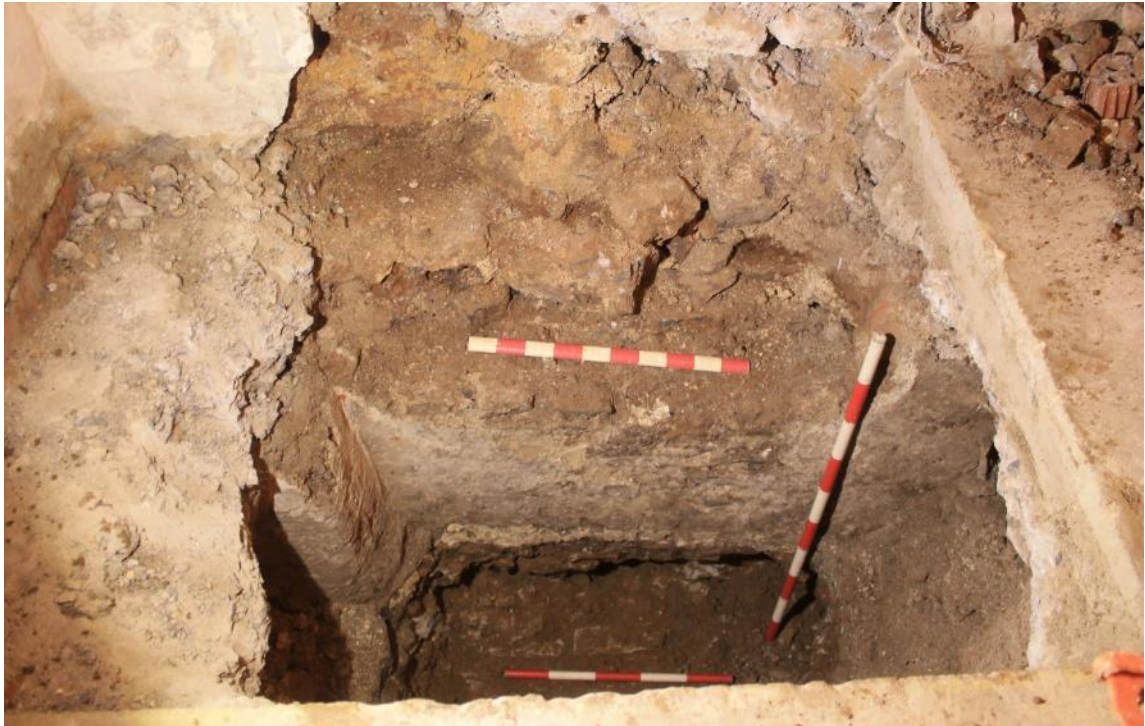
Photo 23: West facing shot of TP09 showing the exposed bedrock at the base and earlier side wall section. 1m (vertical) and 0.5m (horizontal) scales.

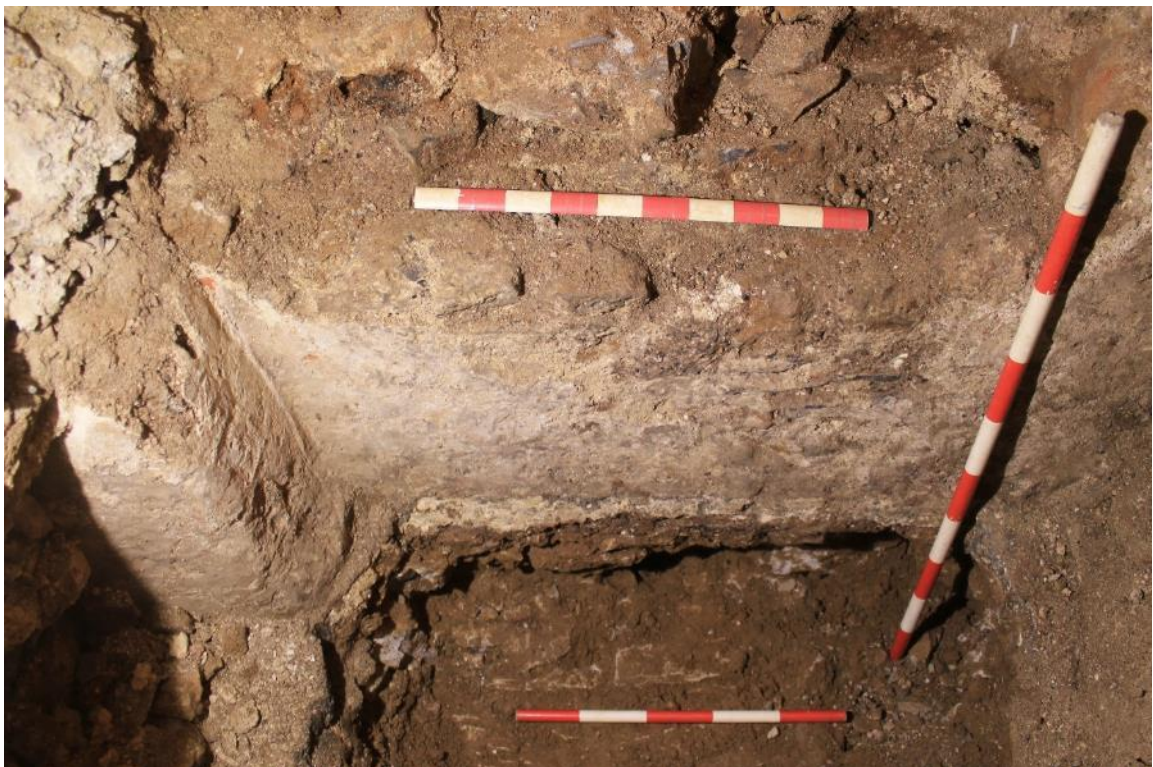
Photo 24: Detailed shot of the section of earlier side wall within TP09. Note the slightly splayed opening to the front wall on the left, which extends down to the removed mortar floor level. 1m (vertical) and 0.5m (horizontal) scales.

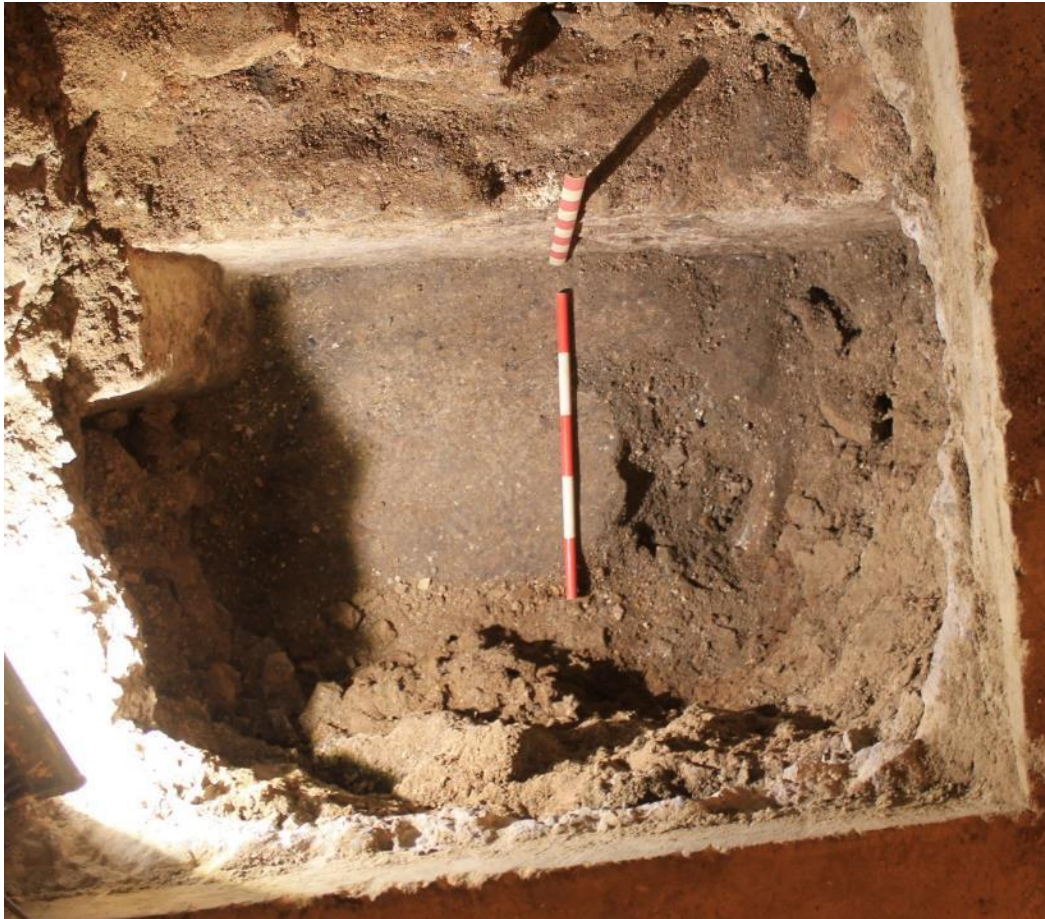
4.12.5 The test pit was stepped away (by 0.3m) from the southern wall, therefore the lower levels of this wall were not revealed. On the west side however a 0.06m thick deposit of dark reddish-brown clayey-sand, with abundant coal, mortar and small stone fragments, had been laid over the natural subsoil. This appeared to be a bedding deposit both for the foundations of an earlier west wall and an overlying mortar floor. The base of this earlier west wall was revealed at a depth of 1.04m below the current concrete floor surface. This was a random rubble wall held in lime mortar with coal fragment inclusions, with an internal lime-mortar render, stepping out 0.25m from the line of the current west wall above. There was a short return at the south end for 0.2m before it the headed back towards the front south wall at an angle, possibly representing the splayed edge of an earlier door opening below the current front wall window (Photo 24). This wall survived for a height of around 0.4m, with a further 0.35m of disturbed walling above that before it stepped back to act as the foundation base for the current wall (0.25m below the current concrete floor surface). The exposed mortar floor appeared to be partly tied into, and therefore contemporary with, this earlier wall. The floor comprised a 0.06m thick layer of compacted lime-mortar with coal fragment inclusions, initially encountered at a depth of 0.9m below the current concrete floor surface (Photo 25).

Photo 25: TP09 in plan, west to the top of the shot, showing the earlier mortar floor. 0.5m scales.
