**SOUTH QUAY REDEVELOPMENT PHASE I,
PEMBROKE, PEMBROKESHIRE:
ARCHAEOLOGICAL WATCHING BRIEF
PLANNING APPLICATION NO
20/0304/PA**

Prepared by Dyfed Archaeological Trust
For: Lloyd & Gravell Ltd

REPORT NO. 2022-23
EVENT RECORD NO. 128824

May 2022

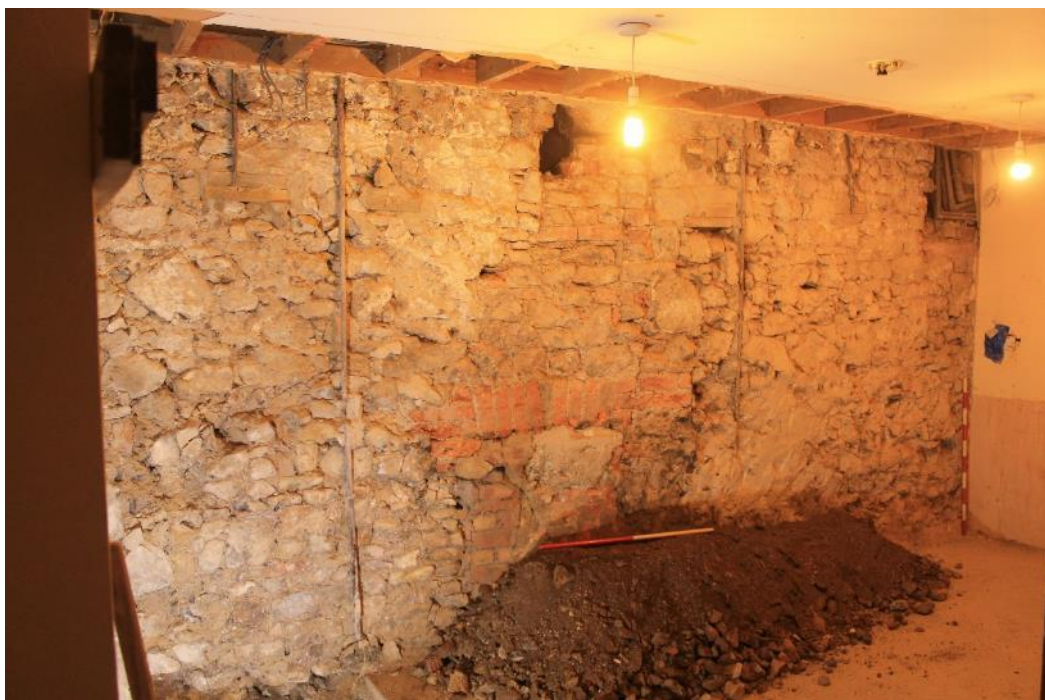
Photo 26: Oblique shot of the exposed west wall in the front of No.6 Castle Terrace. 1m scales.

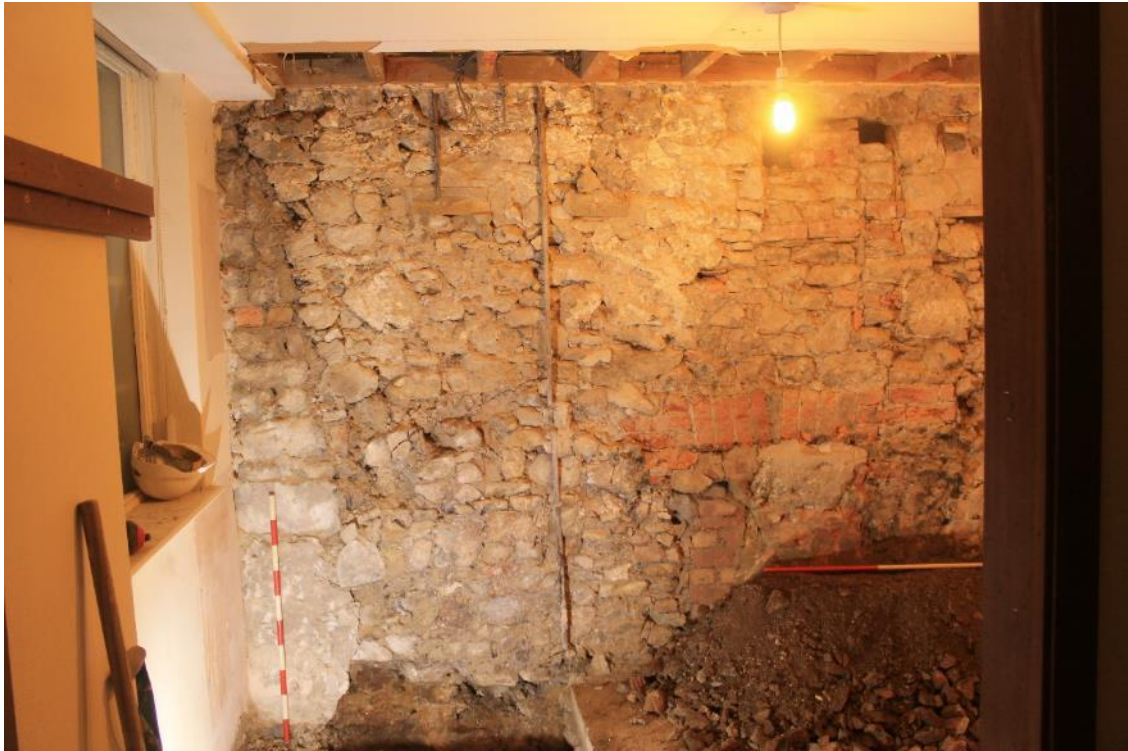
Photo 27: West facing shot showing the current wall above TP09 (visible bottom left). Note the segment of regularly coursed walling on the left and brick-headed fireplace to the right. 1m scales.

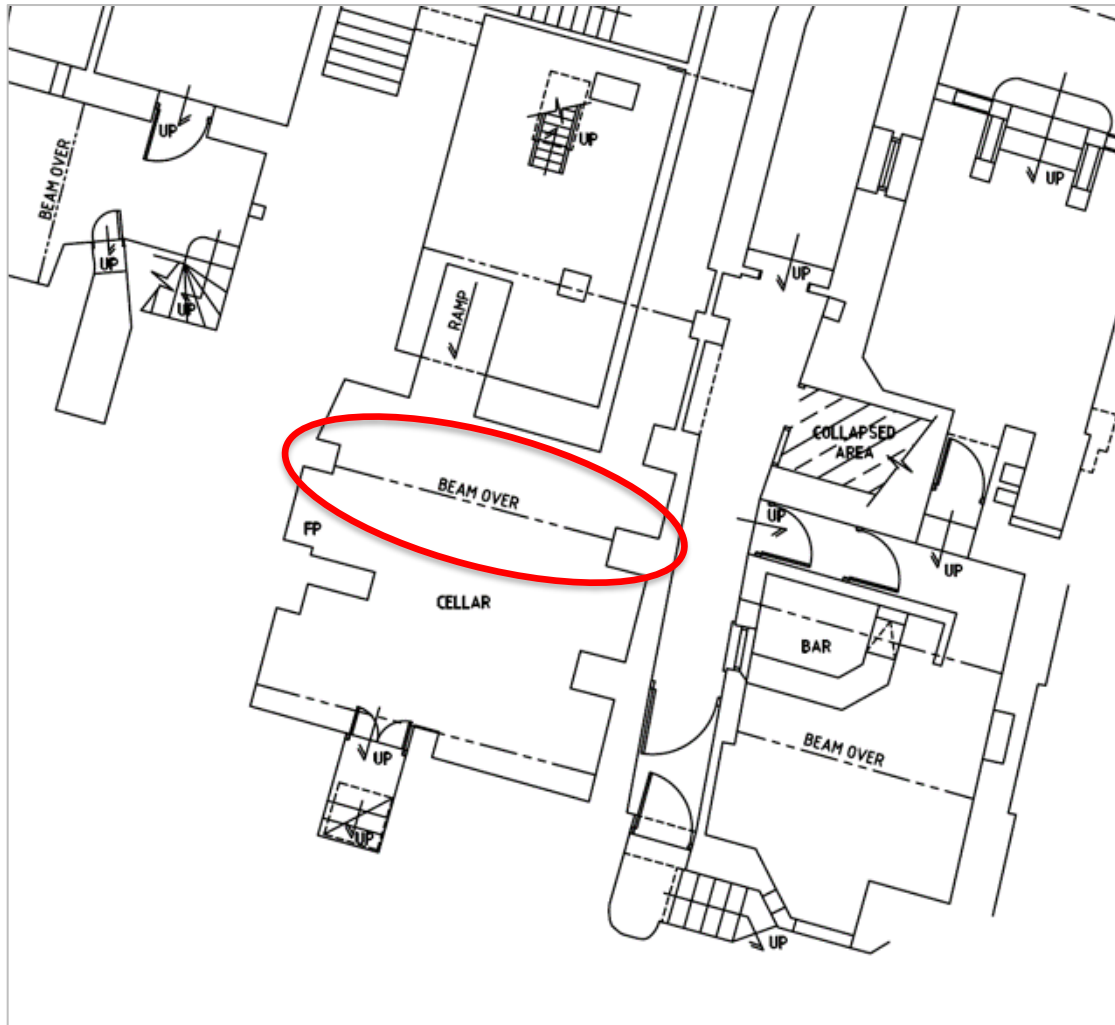
- 5.6 Internally, evidence for past use within the properties was revealed during the works. In No.7 Northgate Street it was evident that the basement had formerly been a coal cellar. Similarly, considerable deposits of coal dust in the southern end of TR02, within No. 5 Castle Terrace, revealed the location of a former coal cellar in the basement. However, the presence of an empty Nujol oil bottle along with evidence for an inserted drainpipe suggest that a toilet could have occupied another room in that basement; Nujol oil being a 'curative' oil that was taken as a laxative during the early twentieth century (ANTIQUÉ-BOTTLES 2021). Although no evidence of surviving internal partitions within the basement area was recorded during the watching brief, a plan of the buildings reveals that a beam once spanned the space between the wall and the opposite (western) party wall (Fig 4). This beam would have been directly above the location of the change in deposits recorded in TR02 and suggests that an internal partition once existed.

Figure 4: Extract from a plan of the basement area of No. 5 Castle Terrace, showing the location of a former beam between wall projections (plan supplied by Pembrokeshire County Council).

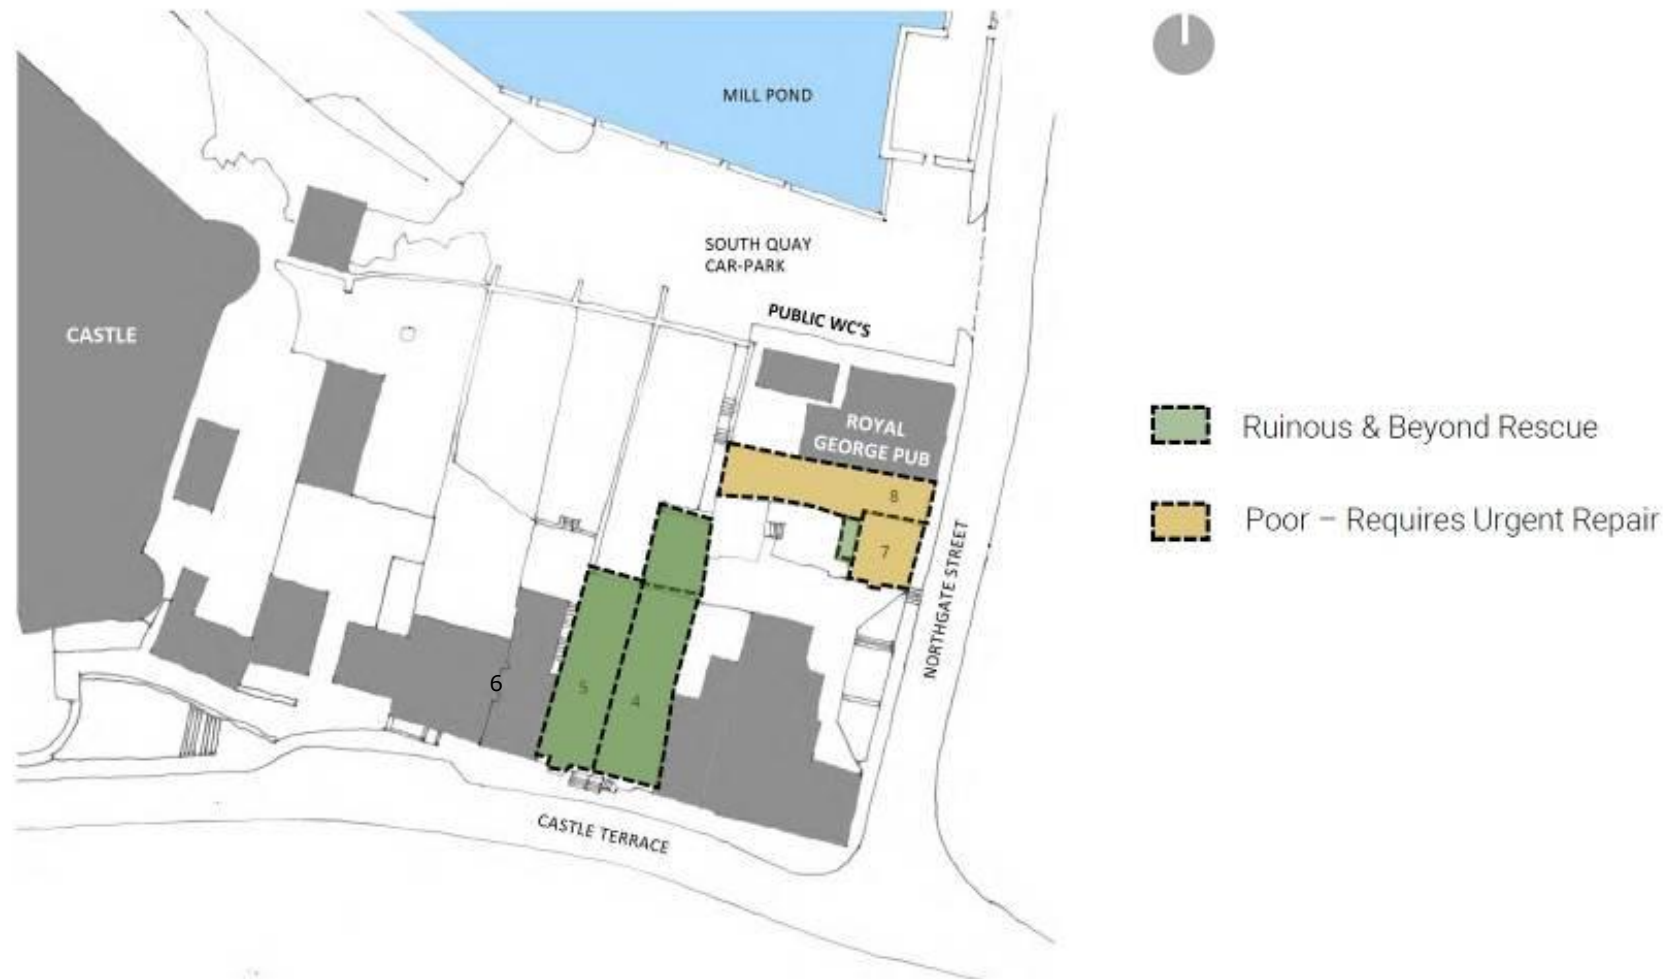
Figure 3: Plan showing current condition of 5 and 6 Castle Terrace and 6 and 7 Northgate Street, taken from the public consultation document (February 2020)

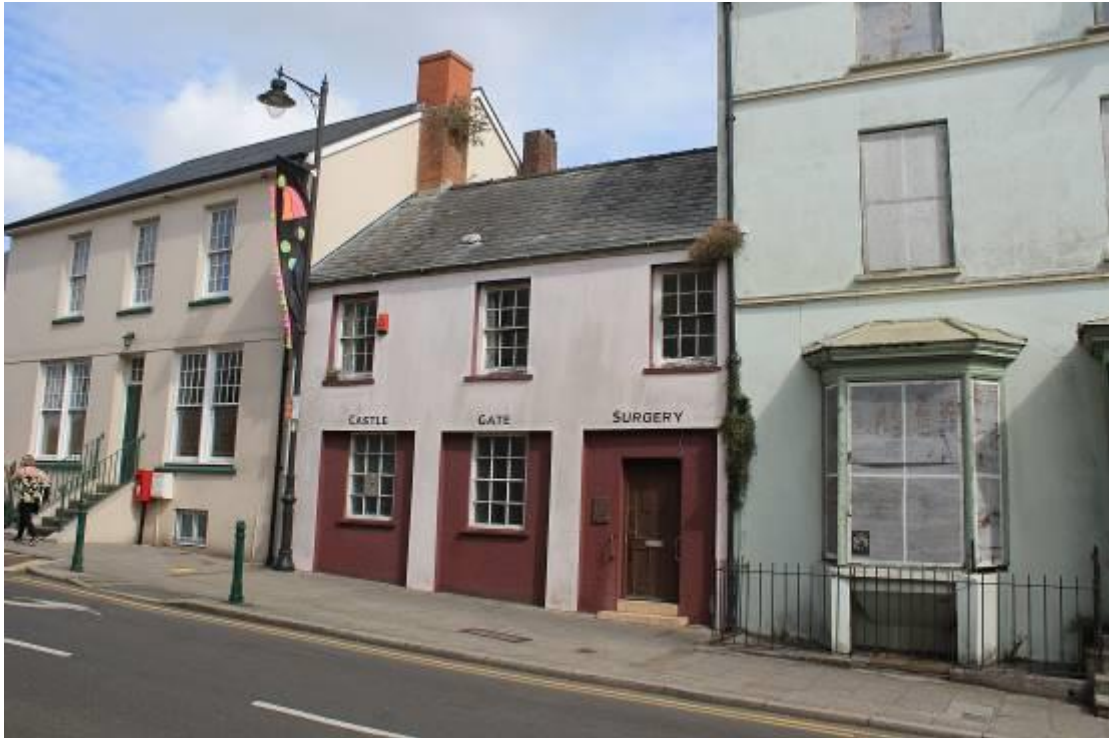
- 1.4 In brief the properties comprise:
- 1.5 **Castle Gate Surgery – No 6 Castle Terrace (Photo 1):** The façade of the building has been significantly altered. It appears to be a single pile building erected on the main medieval street frontage. It survives as thick stone walls built upon bedrock, and has an early cellar or sunken building to the rear, again cut into the bedrock. The original walls of the building have been altered with insertions of new windows, especially at ground floor level, but much original fabric likely survives. There are a few timbers in the roof that may be quite early, which are retained but have been made redundant by more recent trusses. The rear part of the building is a late 20th century brick built extension.

Photo 1: View of the northern façade of the Castle Gate Surgery, Pembroke, with part of No 4 Castle terrace to the right

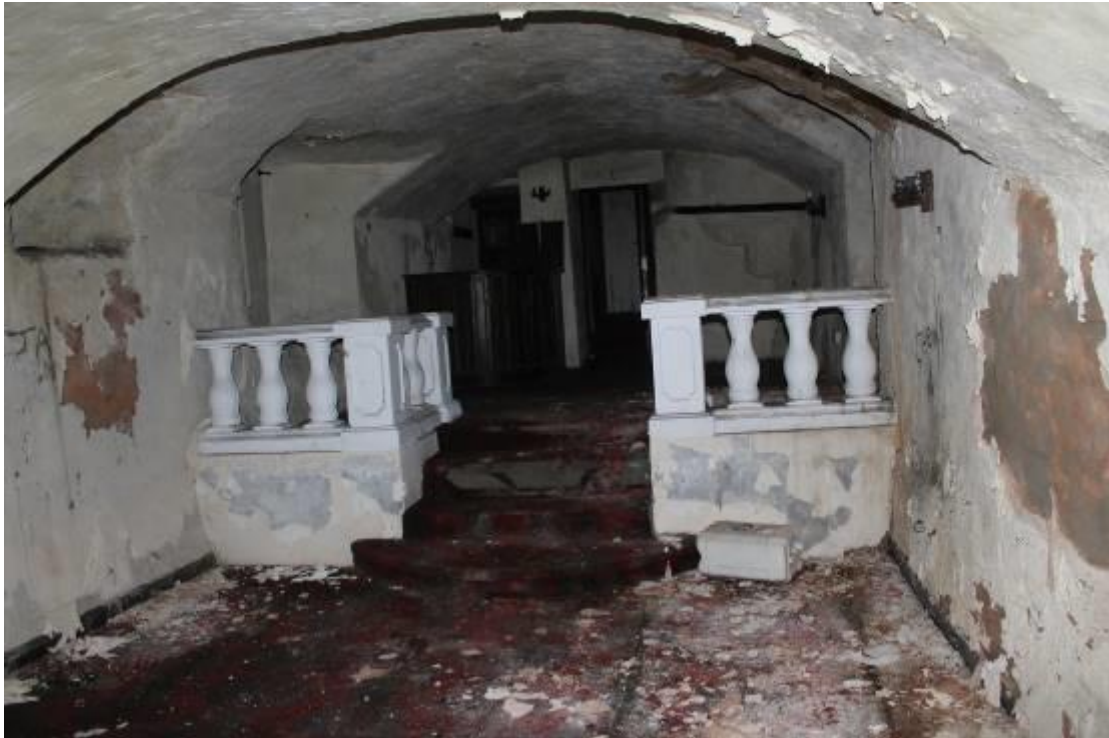
Photo 3: Vaulted cellar beneath No 4 Castle Terrace (with 20th century embellishments)

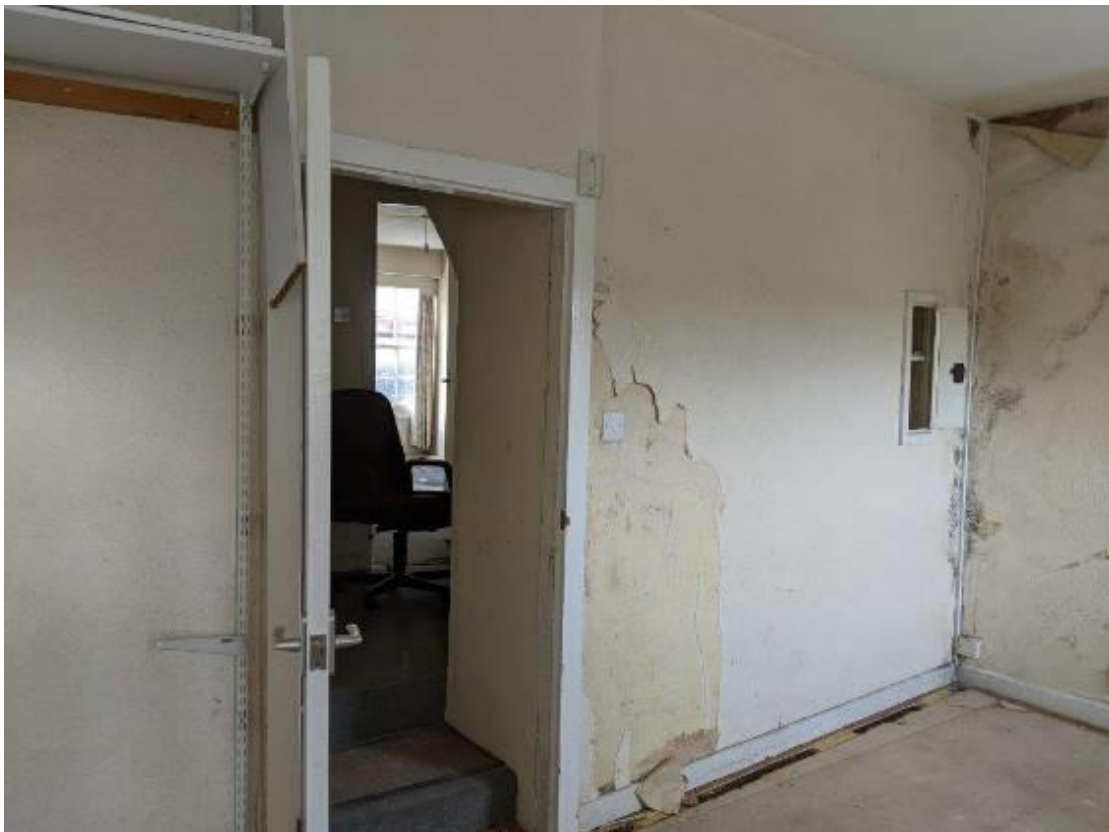
Photo 4: The medieval wall at first floor level identified in No 6 Castle Terrace, with small original opening (now a cupboard) to the right (see Photo 5).

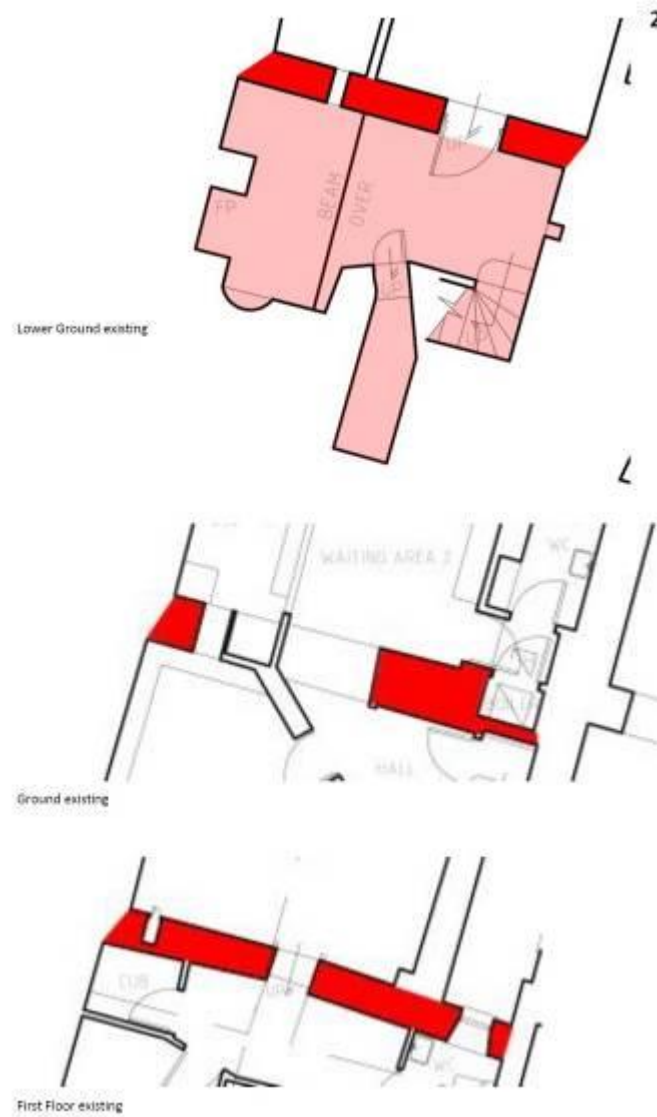
Figure 5: Plans of medieval wall at No 6 Castle Terrace

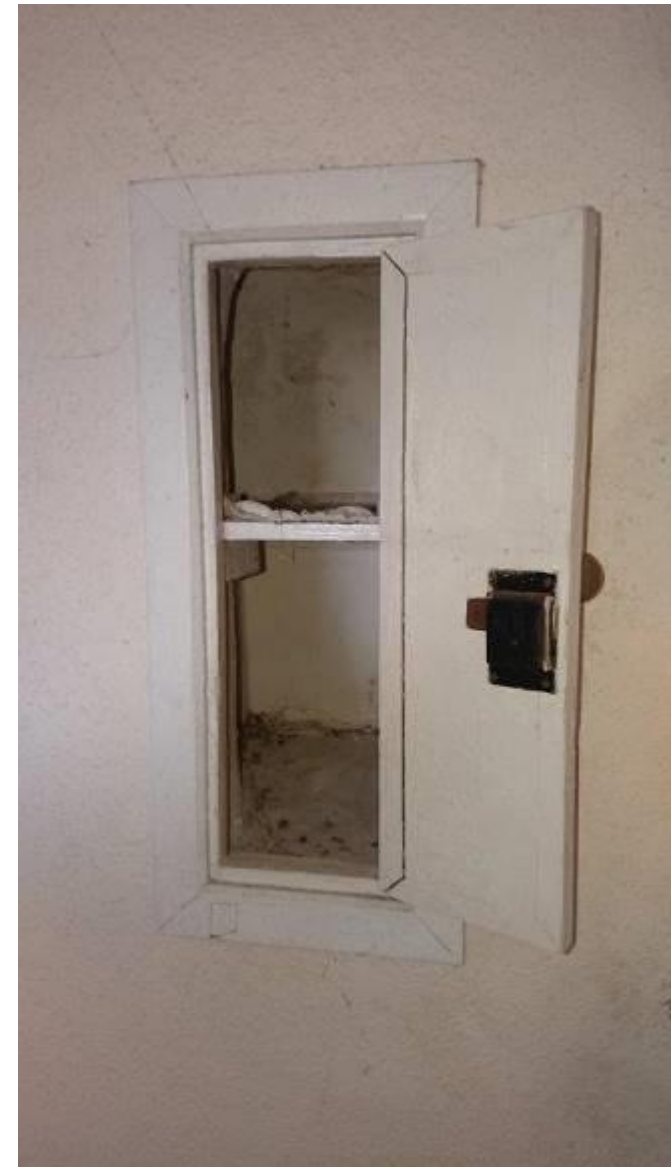
Photo 5: Detail of original opening in medieval wall at first floor level.
