WESTERN QUAYSIDE DEVELOPMENT, HAVERFORDWEST, PEMBROKESHIRE: HISTORIC ENVIRONMENT DESK-BASED ASSESSMENT - UPDATE

REPORT NO. 2022-26
PROJECT NO. 128830

June 2022

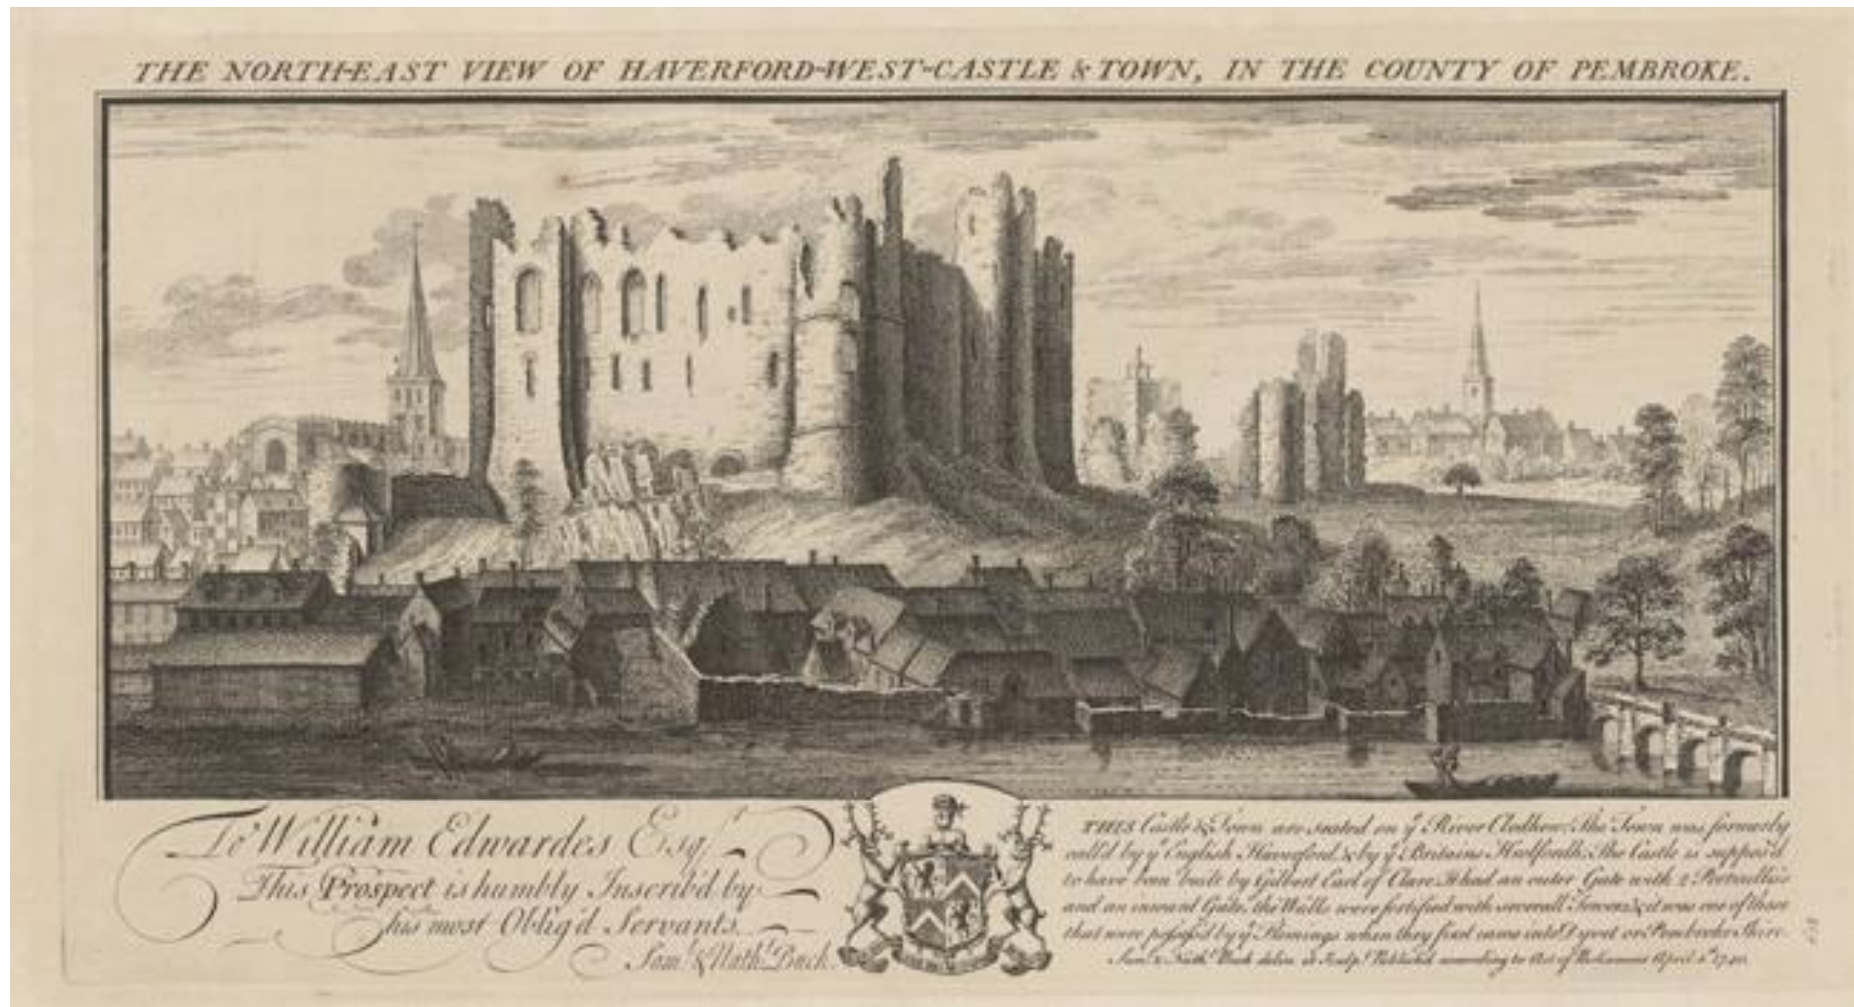
Figure 5: Engraving of Haverfordwest town and castle by Nathaniel and Samuel Buck, 1740. The development site is likely to lie centrally, or just to the left of centre. The image predates the southern New Bridge, but the current Old Bridge is visible to the right.

- 6.3.1 Haverfordwest Castle has been the focus of many 18th and 19th century engravings and paintings, with many including depictions Bridge Street. The Buck engravings of the 1740s are probably the most widely reproduced and detailed, and these have been used to inform the historical development of the site (see section 5.7, Figures 5 & 6). A painting by William Pitt has also provided useful information on the Foundry site (see section 5.7, Figure 7).

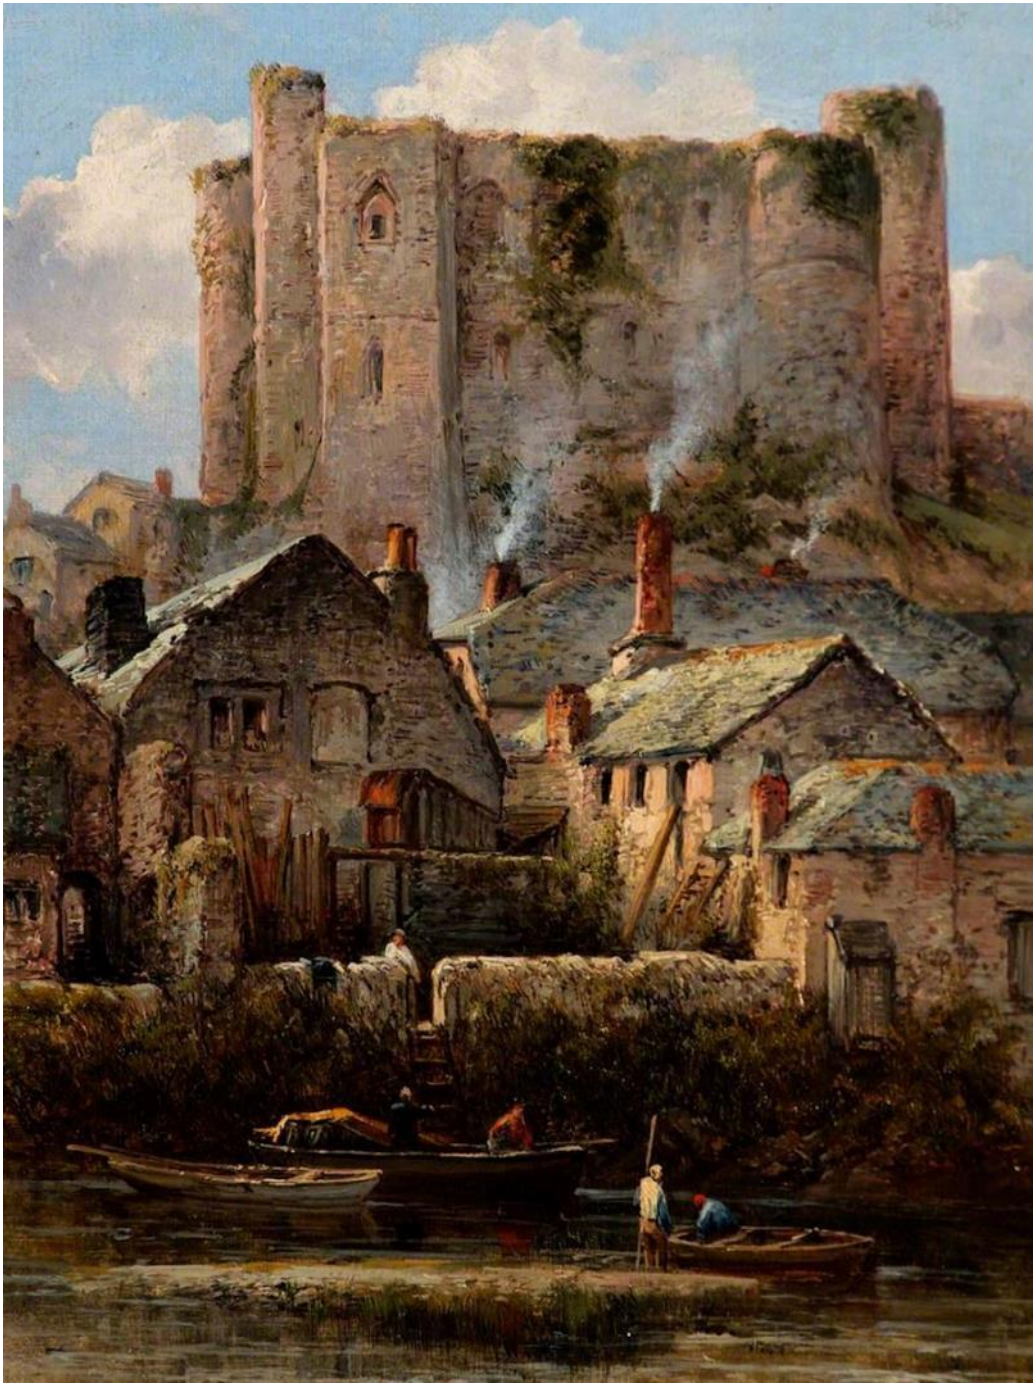
Figure 7: Painting of Haverfordwest Castle by William Pitt, 1872, showing Marychurch Foundry in the foreground. The Phase 2 development site lies just to the right of the picture.

- 5.7.6 There is a painting of Haverfordwest Castle in 1872 by William Pitt, which purportedly displays the Marychurch Foundry in the foreground in some detail (Figure 7). The painting appears accurate, although comparisons with later mapping suggests only the southern half of the foundry complex is shown. A two-storey building, orientated east – west, occupies the site of the main former Ocky-White building, distinctive with its relatively shallow pitched roof. A yard fronts the river, enclosed by a riverside wall through which is a narrow gap giving access to boats on the river. North of this is a slightly lower two-storey building on the same alignment, with a tall chimney at the west gable end. This tall chimney may indicate the location of the main foundry. This building is fronted on the riverside by a perpendicular single-storey structure along the riverfront. Both these buildings are no longer present on site, the possible foundry building replaced by a modern extension (and rear entrance) to the Ocky White's store. The standing building within the Phase 2 development area, which is thought to be a remnant of the Foundry, is unfortunately not visible within this painting. This layout is shown in plan on the detailed Ordnance Survey map of Haverfordwest in 1889 (Figure 8). The Ocky White store and adjacent storehouse stand in their current positions. Behind them, along the riverside, lies the 'Cleddau Iron Works' (formerly the Marychurch Foundry). The main foundry building is an irregular range adjoining the rear of the Ocky White's building, then continuing in an L-shape along the river frontage. A small yard fronts the river, as visible on the Pitt painting, with another internal yard accessed from the Hole in the Wall Lane. The current standing building in the Phase 2 area is depicted, identifiable by the distinctive chamfered southwest corner. This forms the northern side of the foundry yard. The Hole in the Wall Lane then runs around the north side of this, with access to the river at the end. North of this stands a Malthouse and associated buildings, an area now cleared, used as a car park and currently used as the site compound for the Phase 1 development works. A photograph of c1890 depicts the full site, as viewed from across the river (Photo 1). The site remains as described above, comprising an amalgamation of adjoining structures, with the addition of a new structure along the waterfront, enclosing the yard.

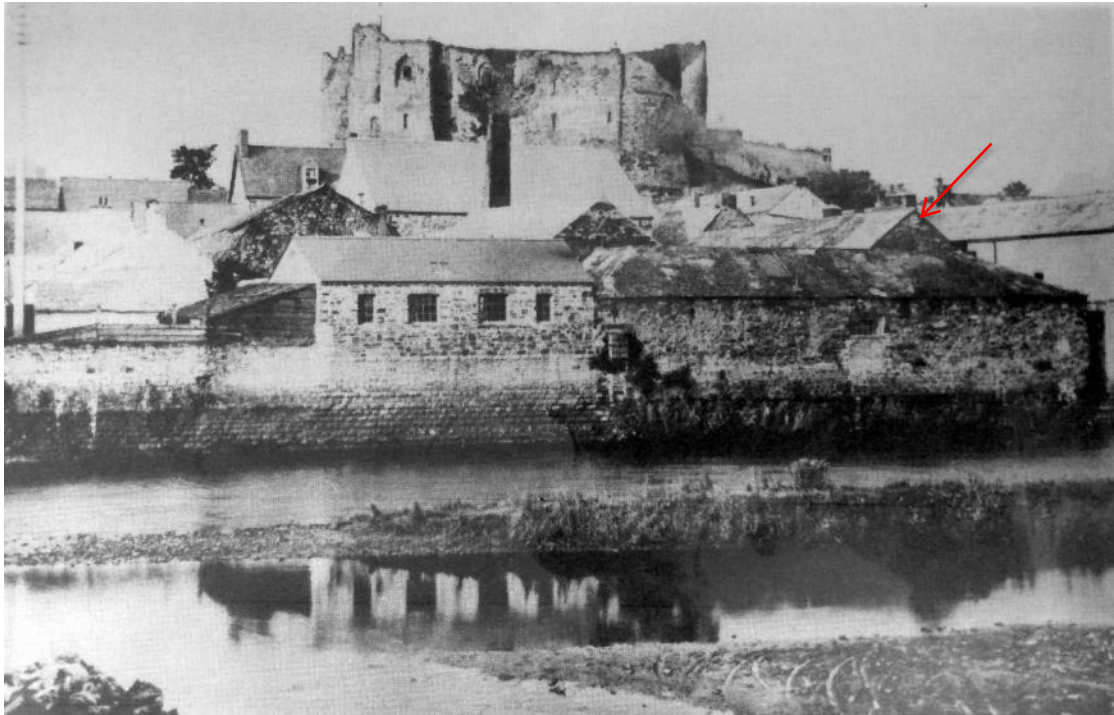
Photo 1: The Foundry with the castle in the background, viewed from the opposite banks of the river in *circa* 1890. The former foundry building that still stands on the site is highlighted, only the top of the gable wall being visible.

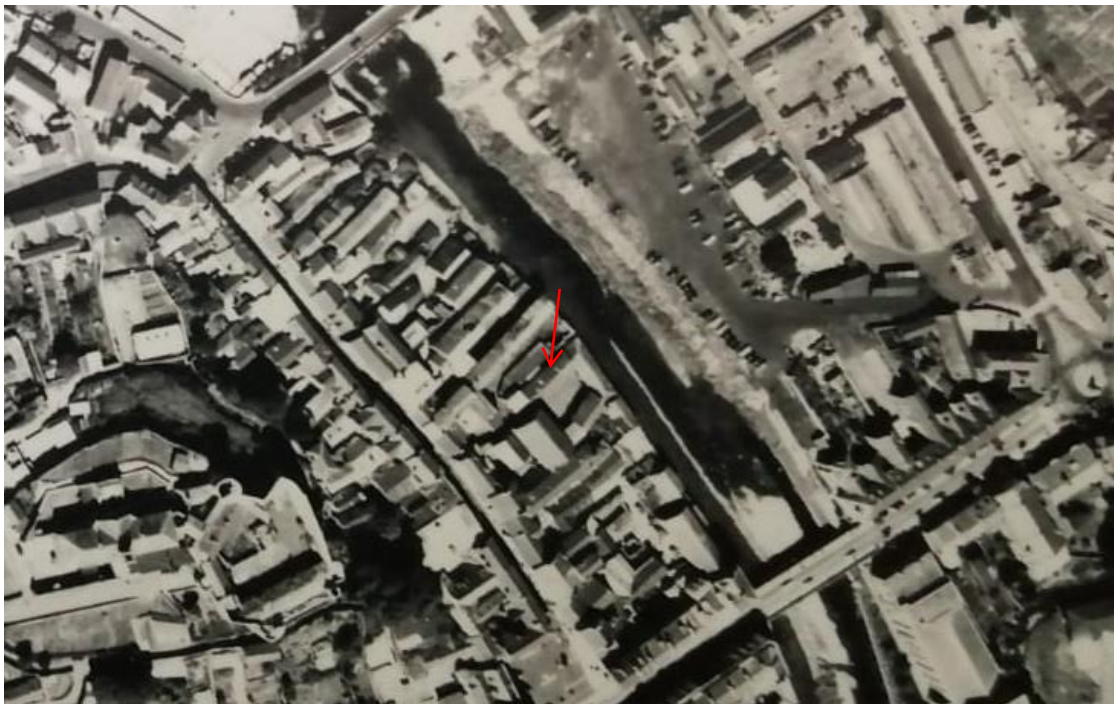
Photo 2: Aerial image of the site from 1955. The remaining building is indicated by the arrow, showing the main department store building fronting Bridge Street to the left, the storehouse to the north, and the former foundry buildings along the riverside. Meridian Airmaps.

- 6.5.3 In 1950 there is little obvious change to the layout of the development area, the plot appears generally quite well-developed (Photo 2). The former malthouse and brewery structures to the north also appear unchanged from the form depicted on late 19th century mapping. The waterfront foundry structures are captured on an image of the Old Bridge, lining the waterfront (Photo 3). Modern satellite images capture the site in its present form subsequent to the Phase 1 development.

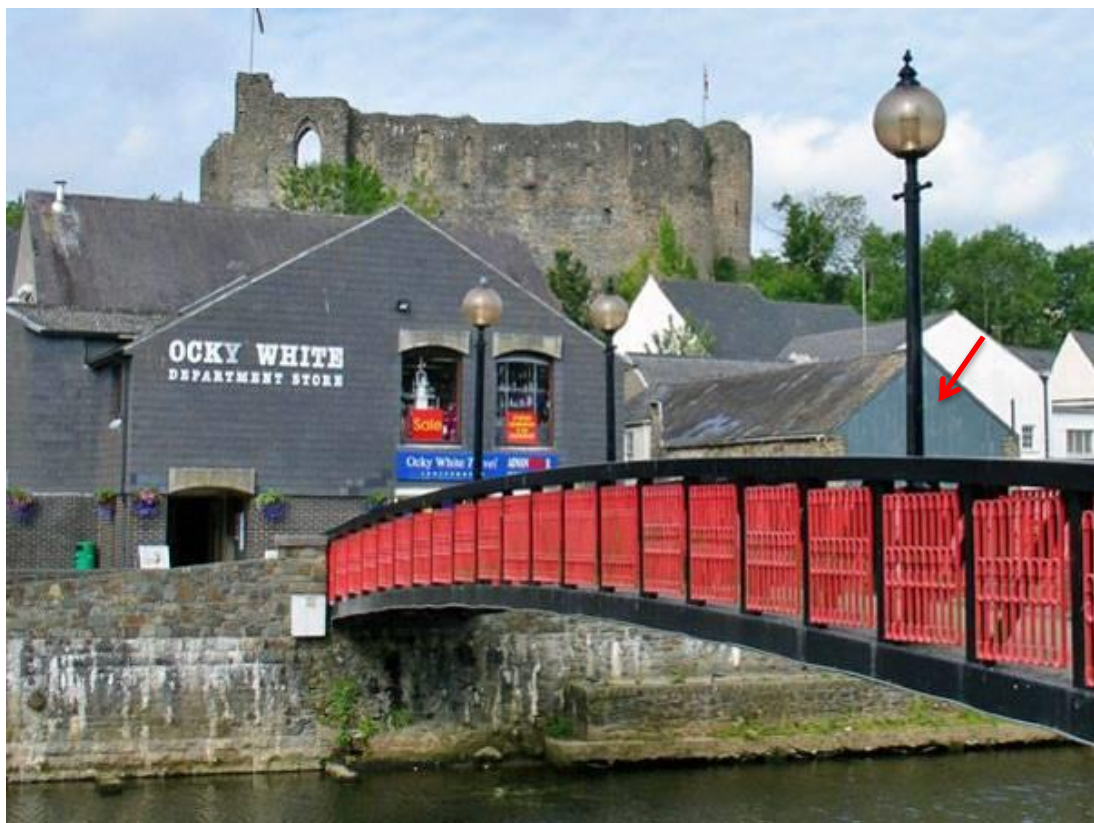
Photo 4: View of the site from the opposite banks of the river, with the castle in the background. Taken prior to Phase 1 development works commencing. The modern extension with the 'Ocky White' name on it has since been removed. Remaining building marked. Looking west.

- 6.6.3 At present the area to the south of the building was clear of structures, the modern eastern extension to the former Ocky White's store having been removed (Photos 4, 5 & 9), with riverside structures beyond. To the north lies a small car park, currently used as the constructor's compound. There is access to the area via the Hole in the Wall Lane to the west of the building (Photo 12), and via a road to the rear of Bridge Street properties, accessed from Swan Square to the northwest. A large modern riverside structure lies to the north, the river lying 10m to the east, with a footbridge providing access from the opposite bank.

- 6.6.5 There are views of the site from the footbridge crossing the river (Photos 4 & 5), and more limited views from the modern development along the eastern side of the river. There are also views from the rear road access to the north, and to a limited extent along the Hole in the Wall Lane (Photo 12). Further afield there are some partial views from the New Bridge (Grade II* listed, 12020) to the south, and the grounds of Picton House (Grade II listed, 12201), but these only take in the eastern gable end of the building (Photos 13 & 14). Other views of the site are blocked by surrounding development.

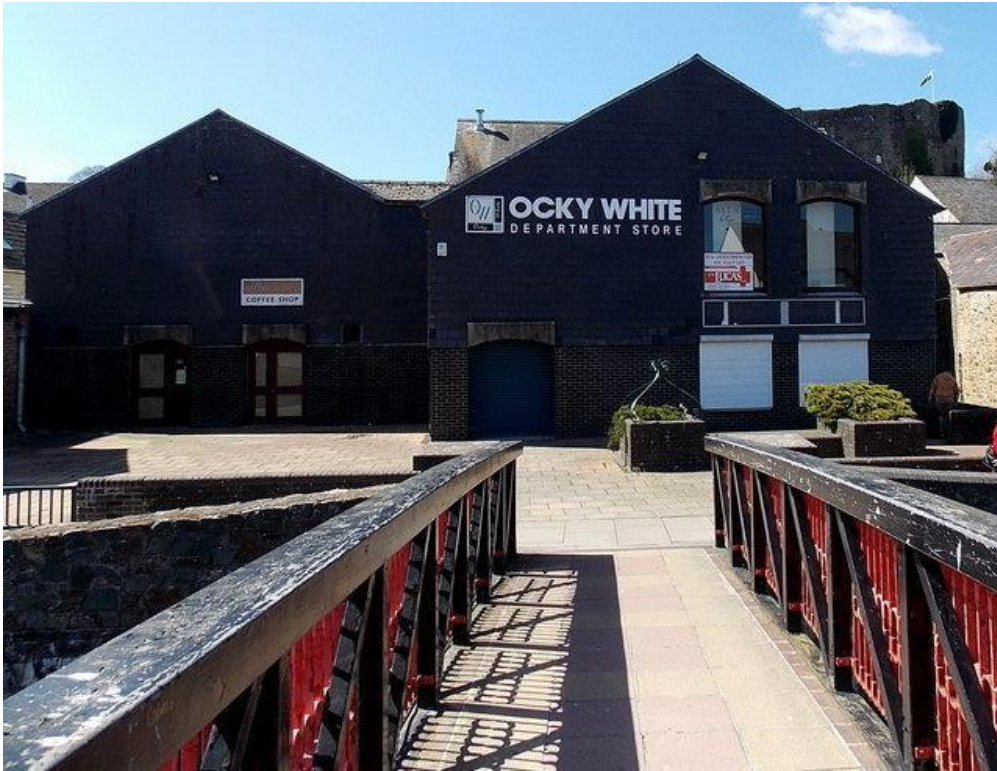
Photo 5: View of the site from the footbridge access across the river, with the castle visible to the rear. Taken prior to Phase 1 development works. The main department store gable is visible to the left, a modern extension lies to the right (since removed), potentially developed upon the site of the former foundry.

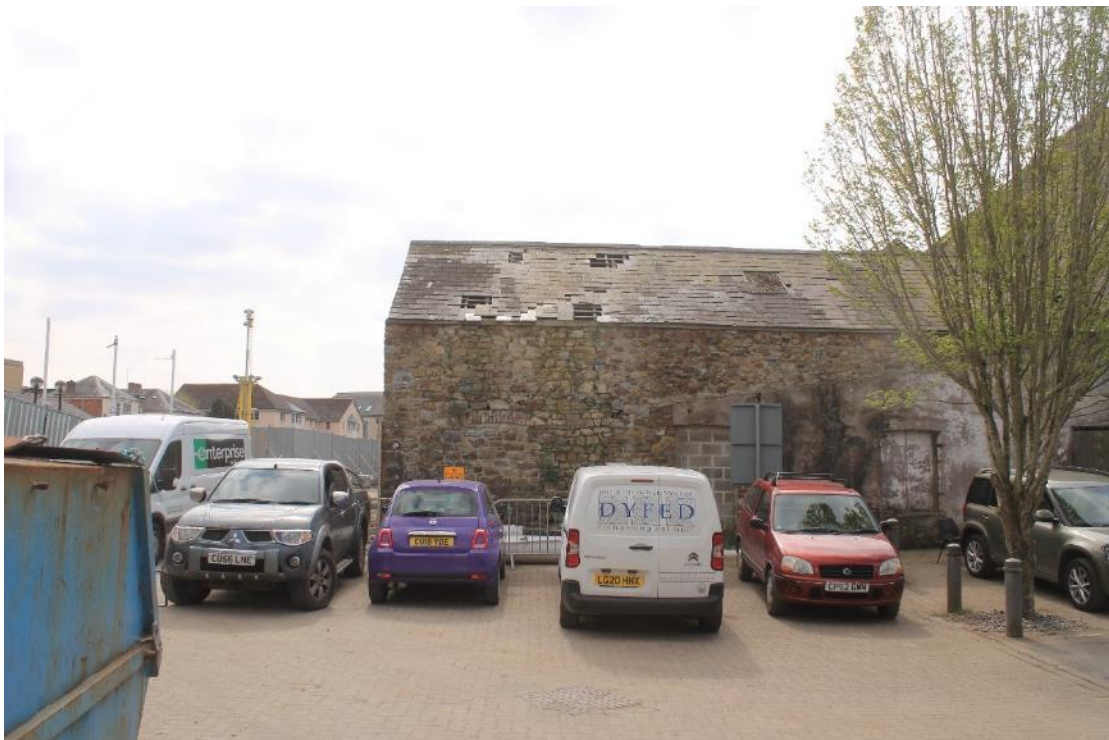
Photo 6: View SSE across the Phase 2 development area, with the standing foundry building in the centre and the riverside to the left.

- 6.6.2 The focus of the proposed development is a former storage building that once formed part of the iron foundry operating along the waterfront (Photos 6 – 10). This building comprises a single to one-and-a-half storey mortared-masonry building with a slate gable roof, attached to adjoining buildings to the west. These adjoining buildings continue west to form the northern side of the Hole in the Wall Lane running between Bridge Street and the riverside. The north face of the structure is built of very roughly coursed, almost random, rubble stone, roughly faced with the occasional brick inclusion, and possible evidence of heightening below the current roof line. This face has an offset doorway, flanked by two windows, all with low-arched brick voussoirs. All three openings are blocked, the northern window in stone, the door in breezeblock, and the east window has been rendered over. At the west end of the face is a door under a squared lintel, leading to a through-passage. The western half of the wall face is covered in cement render, with a pitched roofline visible demonstrating an attached lean-to building has been removed. The south face has a distinct angled return at its western end to allow access into the Hole in the Wall Lane. This face is built in similar random rubble style with the occasional brick inclusion, with a central section re-built from floor to roofline. There are two brick-edged windows in the eastern half of the face, with low arched brick voussoirs, originally taller with stone and brick infill visible below earlier voussoirs. A former brick surround is visible edging the central rebuild, indicating a third opening, possibly also a window, lost to the rebuild. At the western edge of the rebuilt section is a square-headed doorway, the western edge of the doorframe suggesting it may have been part of the original walling to the west of the rebuild. A small square window, now blocked, sits in the angled face at the western end. The east

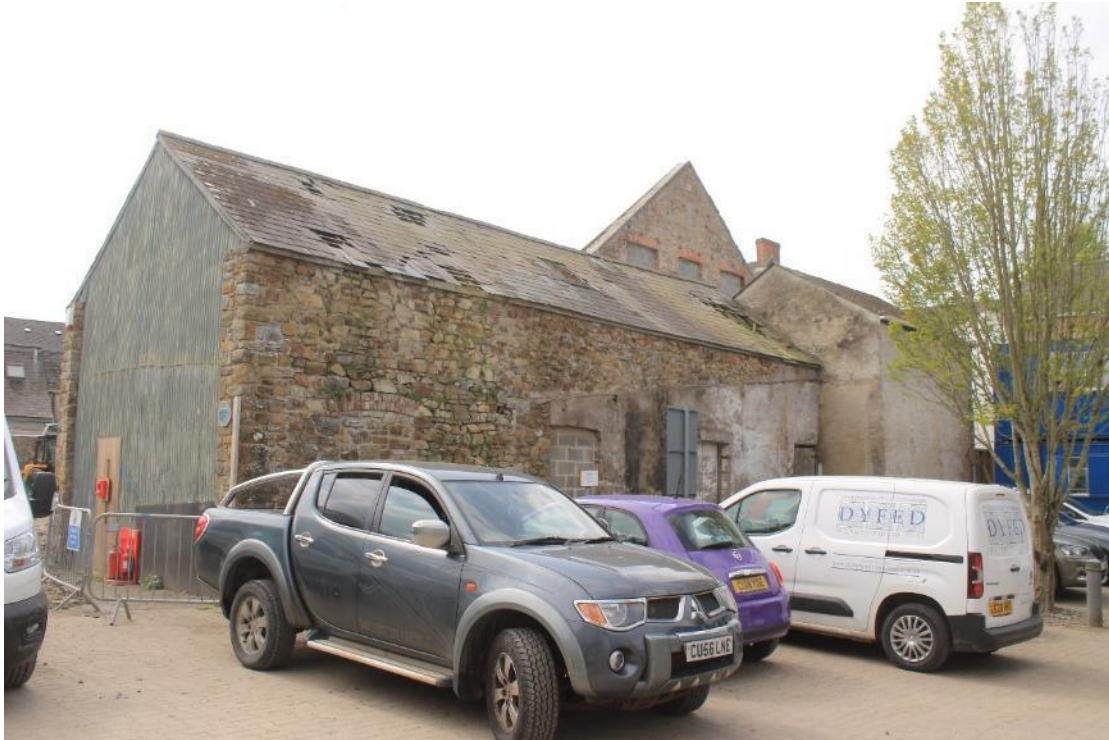
Photo 7: View SSW of the standing foundry building, with attached building to the right, and the gable end of part of the former Ocky White complex to the rear.

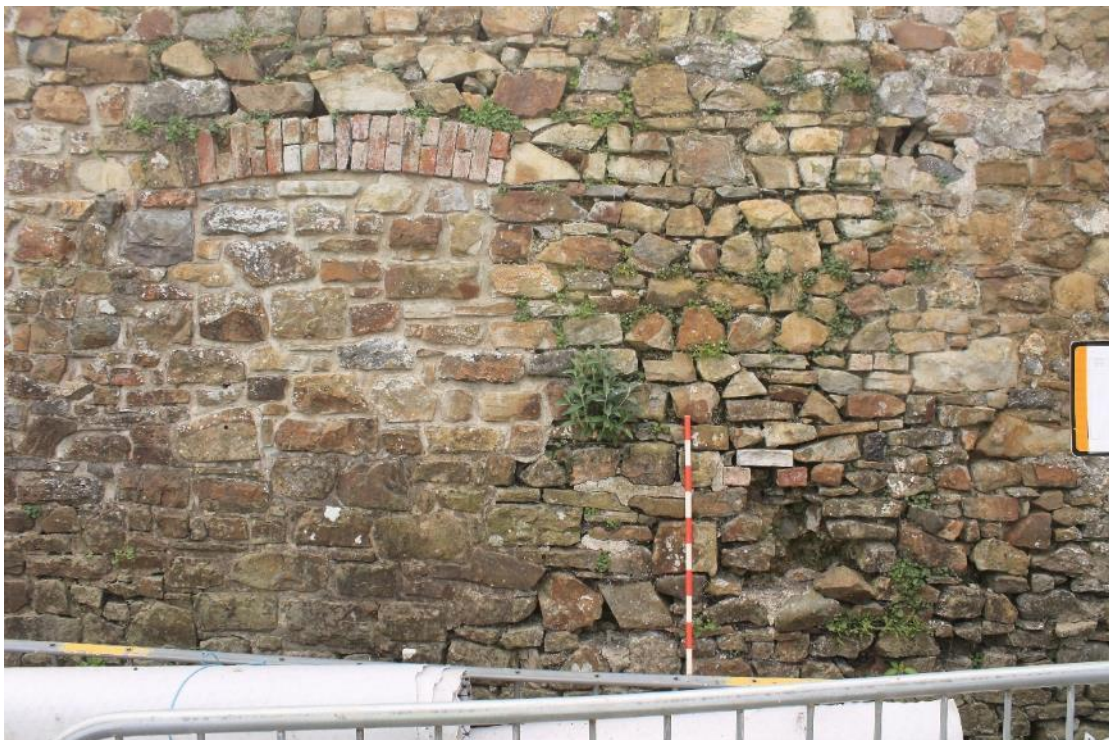
Photo 8: View SSE showing detail of the standing foundry building, including general building style and a blocked window. 1m scale.

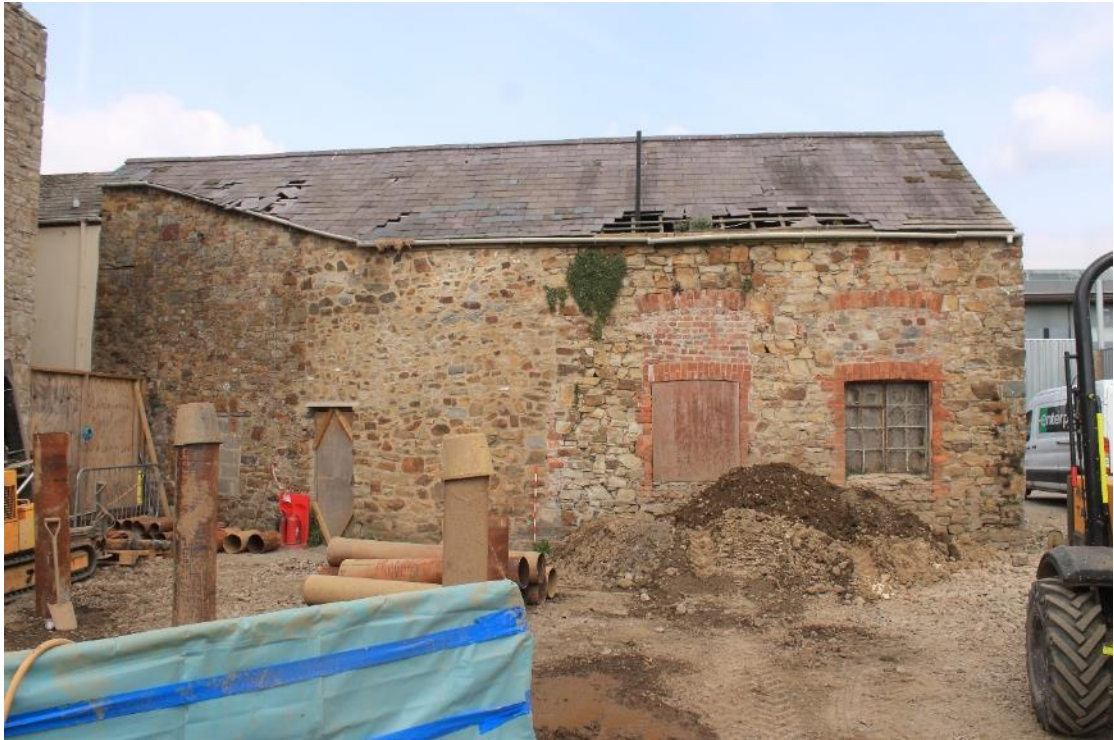
Photo 9: View NNW of the southern elevation of the standing foundry building.
1m scale.

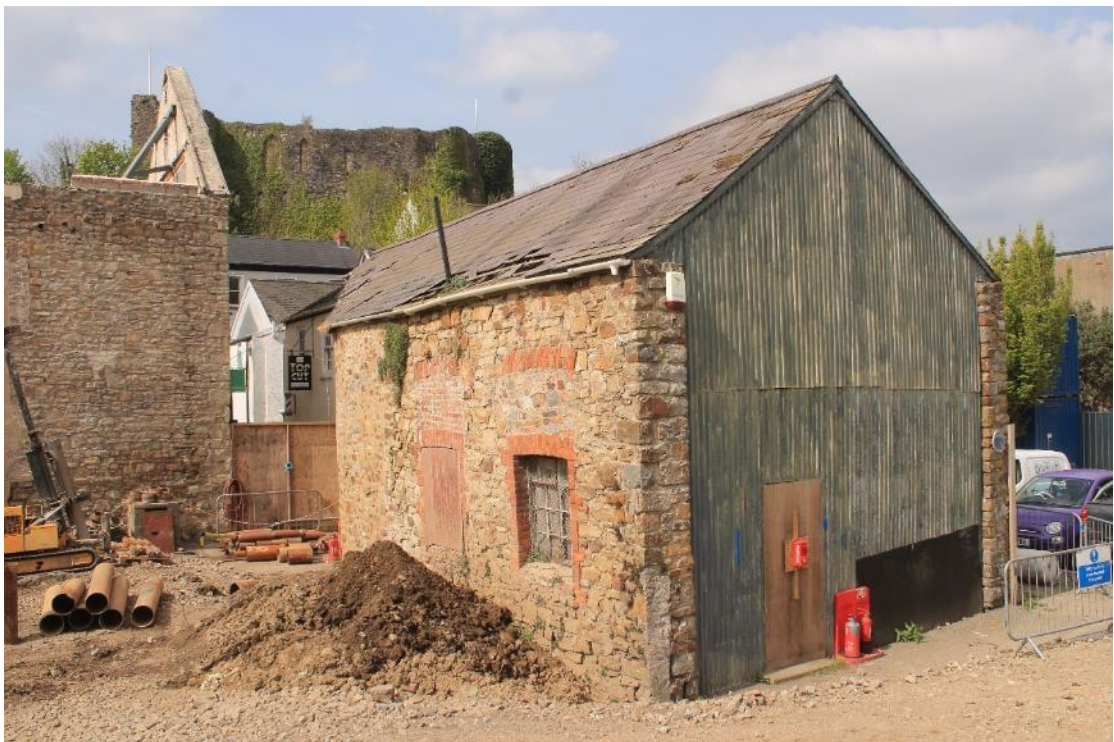
Photo 10: View west showing the standing foundry building with Haverfordwest Castle to the rear.

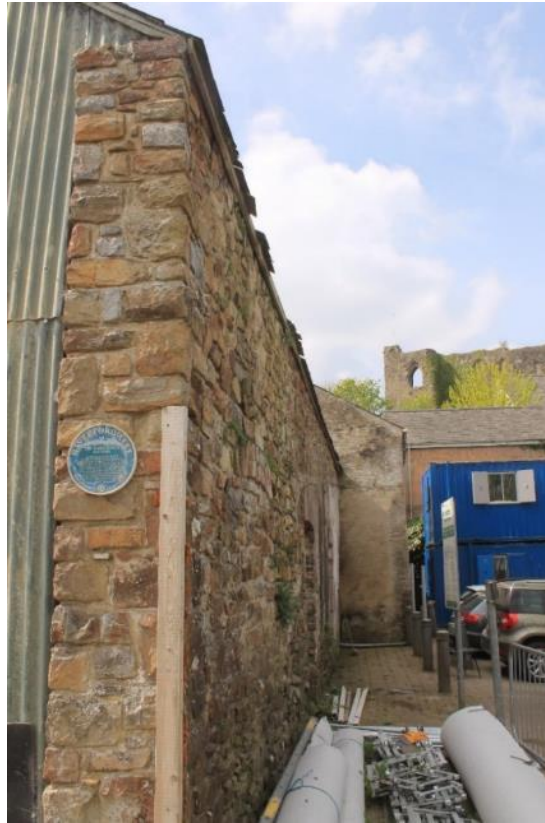
Photo 11: View SW alongside the standing foundry building with Haverfordwest Castle visible above the rooftops to the rear.

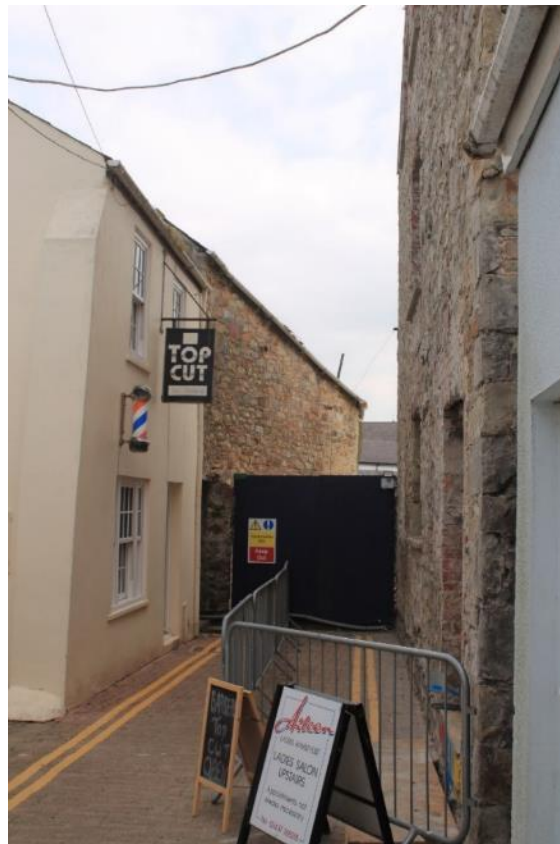
Photo 12: View ENE down The Hole in the Wall lane, with the standing foundry building to the rear.

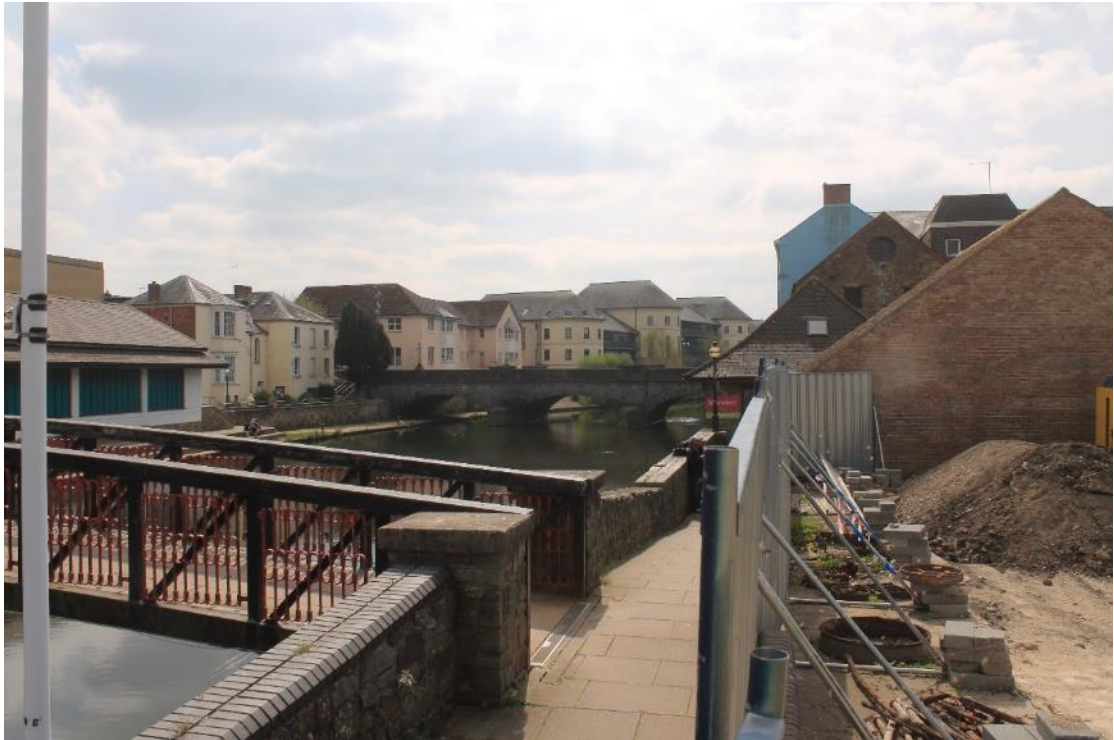
Photo 13: View SE from the edge of the Phase 2 development area looking down the river, with the New Bridge visible, and Picton House to the left.

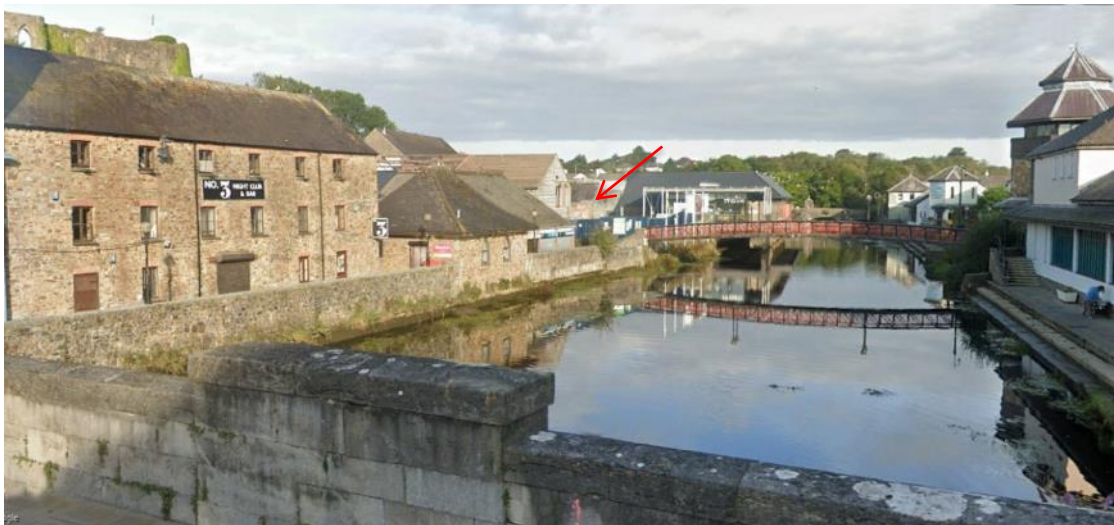
Photo 14: View of the site from New Bridge to the south. Photo taken during Phase 1 development, standing foundry building marked. © Google Earth.

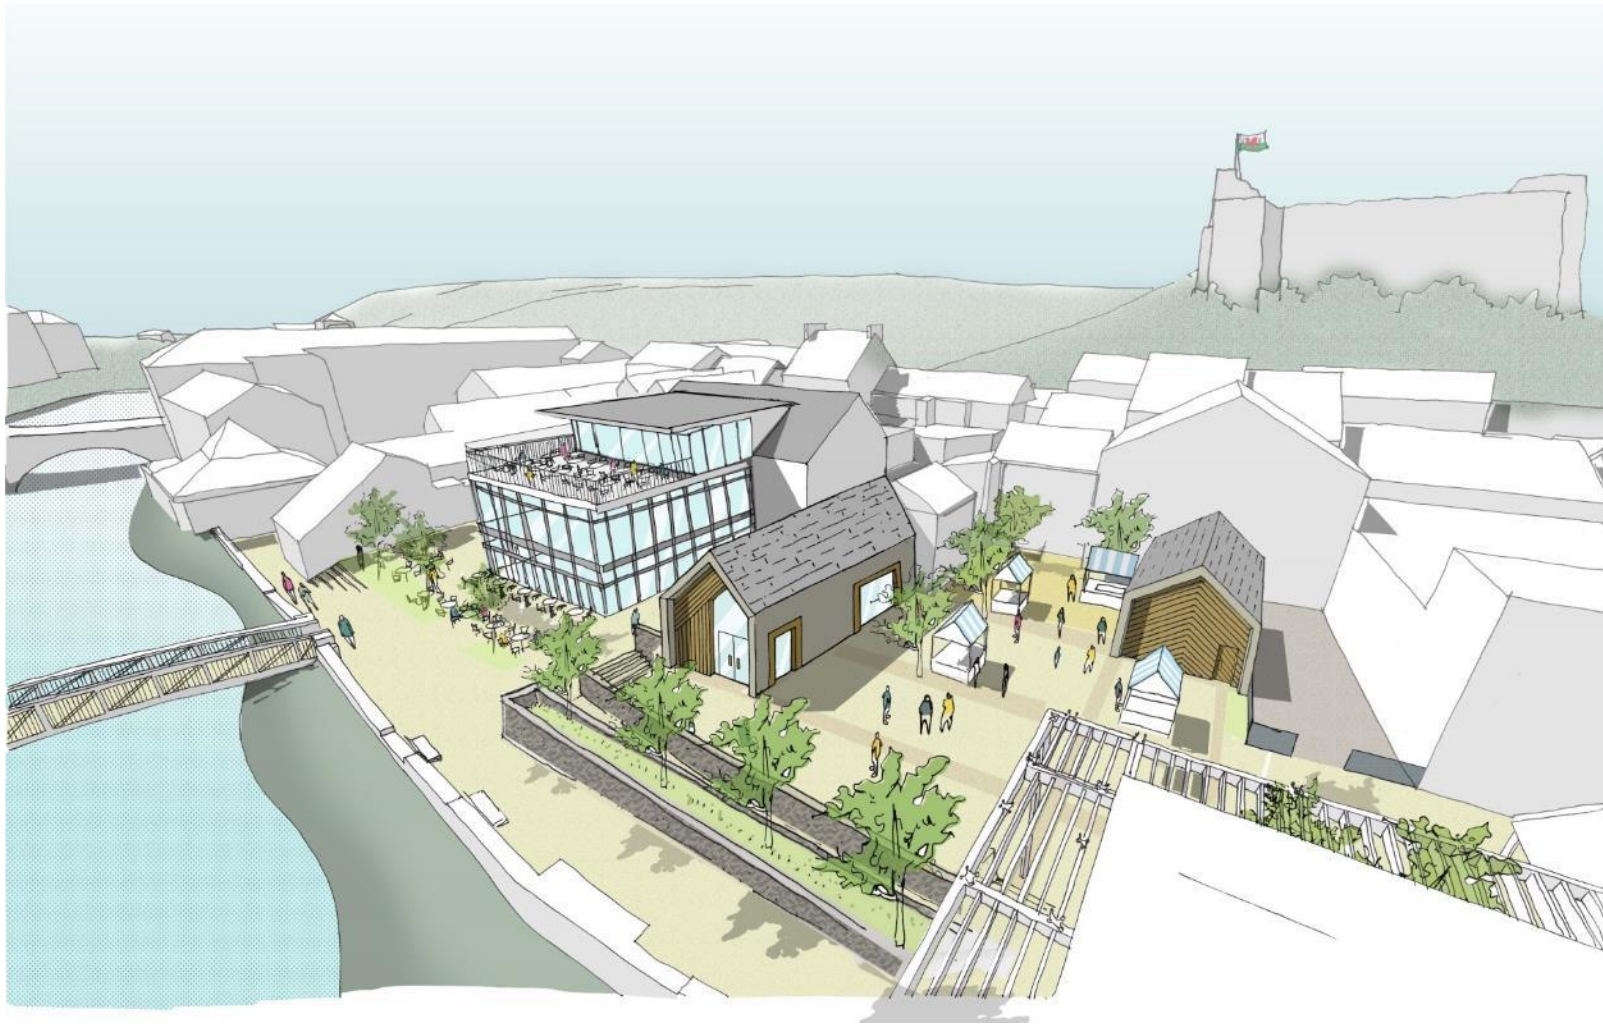
Figure 9: Outline development plan of the Phase 2 development.

- 8.2.1 The Phase 1 development are covered in the previous assessment. The Phase 2 development is focused on the redevelopment of the former Foundry warehouse.

- 8.2.3 The open area fronting the river will be resigned, potentially including levelling activity and resurfacing.
- 8.2.4 The following construction activities are all likely to be undertaken to some extent, all of which have the potential to expose, damage or destroy archaeological remains if present at the site. These activities include:
