HAFAN MINE, CEREDIGION: HISTORIC ENVIRONMENT DESK-BASED ASSESSMENT

REPORT NO. 2022-29
PROJECT NO. 128834

July 2022
Gorffennaf 2022

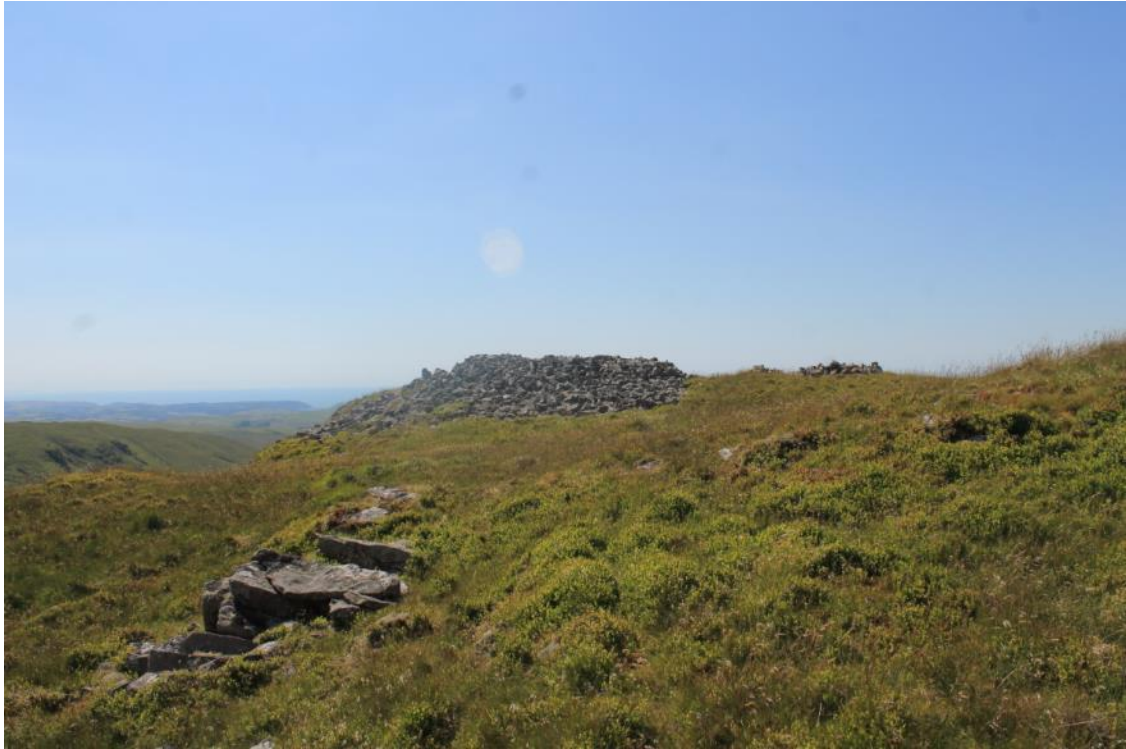
Photo 1: View SW of CD045 Carn Owen occupying its prominent location on Cerrig yr Hafan.

- 4.2.2 There is one Scheduled Monument (SM) within the 1km radius study area: **CD045 Carn Owen, Cerrig y Hafan** (Photos 1 – 5). This site lies around 160m to the north of the nearest identified mine element, occupying the high point of Cerrig yr Hafan. The site is recorded on the Dyfed Historic Environment Record as PRN 4127. The following is the SM description:

The monument comprises the remains a burial cairn, probably dating to the Bronze Age (c. 2300 - 800 BC), located on the highest point of Cerrig yr Hafan. It measures c.10m in diameter and up to 1.5m high, but has been extensively disturbed. The interior has been hollowed and shelters have been built at its western edge and to its immediate north. Cairn material has also spilt down the steep slope to its south-east. A small satellite cairn or cairns have been noted to the north-east.

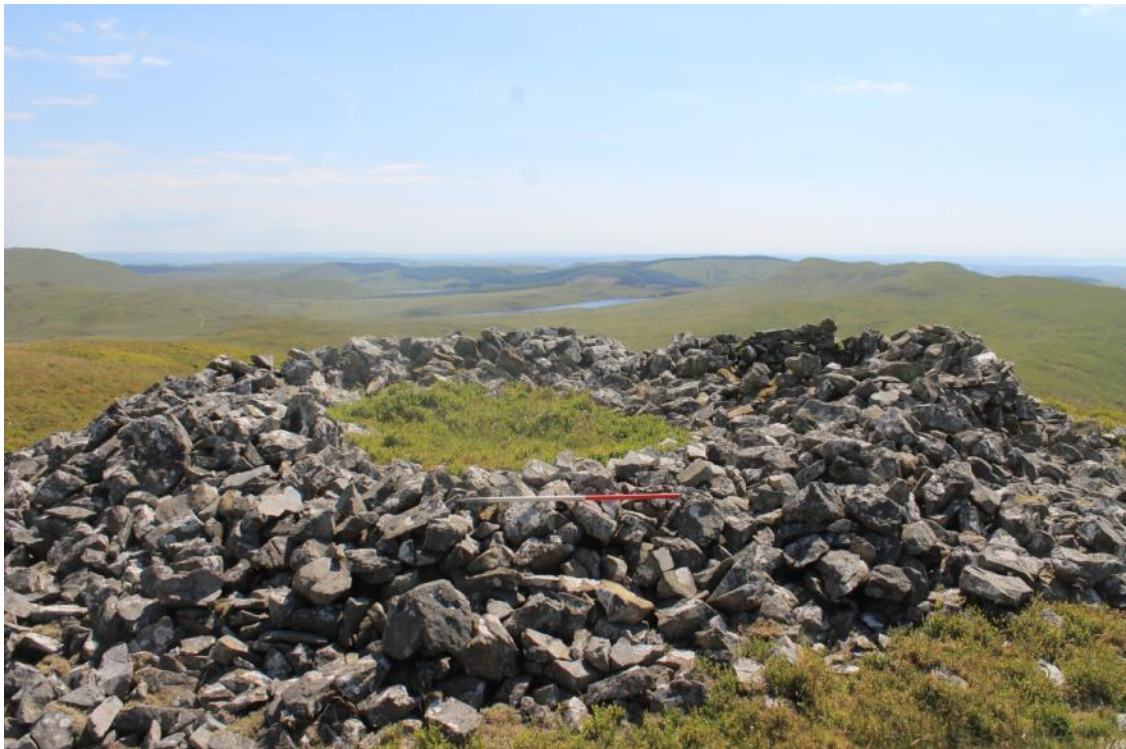
Photo 2: View SW of the hollowed-out interior of CD045 Carn Owen. 1m scale.

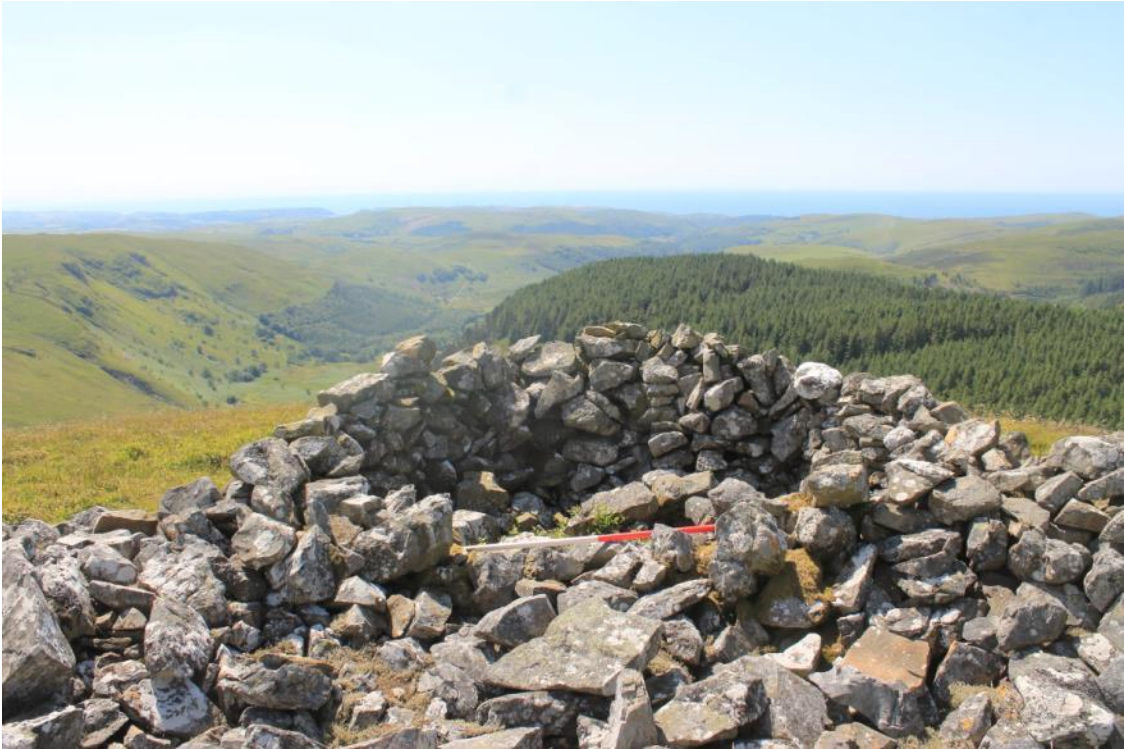
Photo 3: View W from the interior of CD045 Carn Owen, showing a later stone shelter built on its western edge, and looking out towards the coastline. 1m scale.

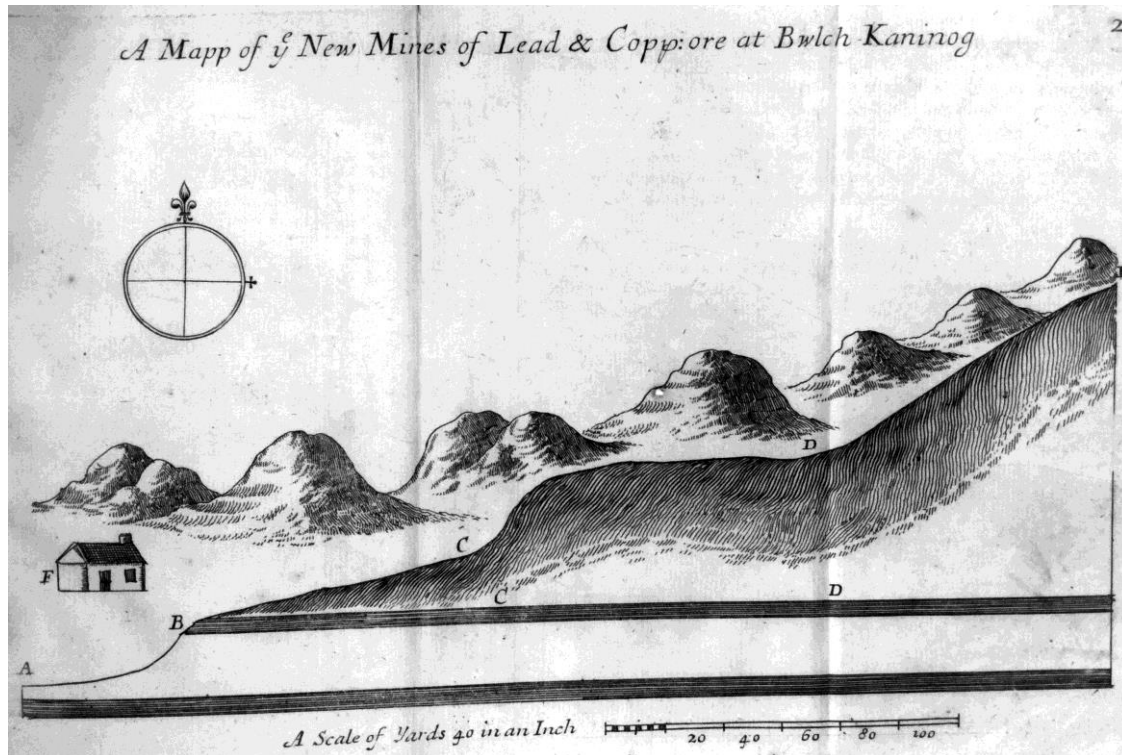
Figure 5: Waller's map of the mine workings in the early 18th century. (A) marks the lowest part of the site, (B) Level entrance, (C) start of the mine stopes, (D) the ore begins to widen, (E) top of the hill, and (F) the 'Smiths Forge'.

- 6.3.1 There are no records of the earliest potential workings at Hafan in the 17th century, however Waller, in his *Description of the Mines of Cardiganshire* does include a plan of the early 18th century workings at Hafan (Figure 5), named 'Bwlch Kaninog' by Waller. This information is already included in the general archaeological and historical background, but it shows the main level starting either close to the base of the slope, or roughly midway up, and also indicates a Smiths Forge / Smelt Mill building stood close to the base of the slope.

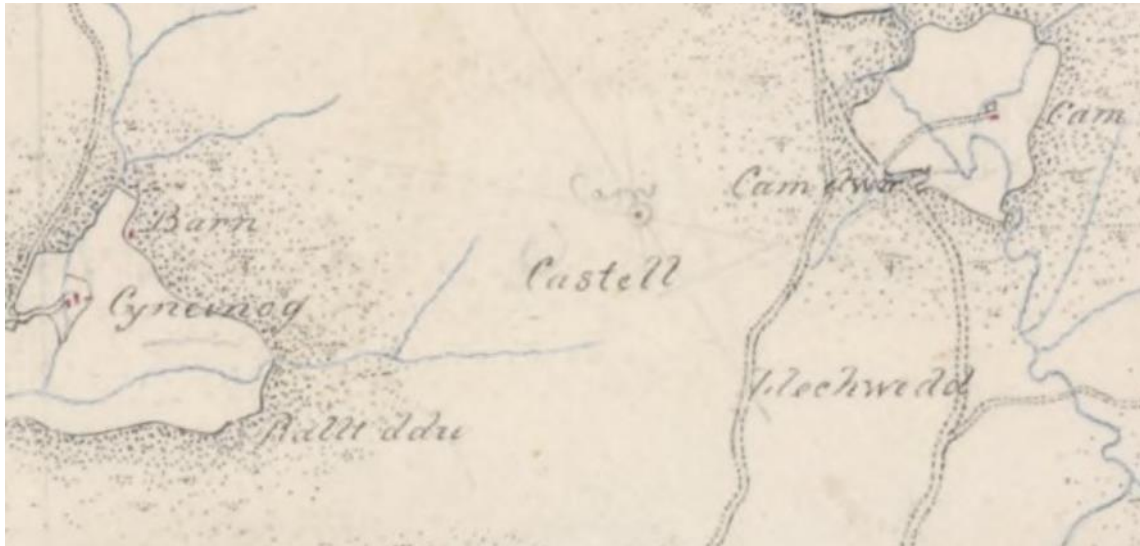
Figure 6: Extract from the Ordnance Survey map of 1833 showing the name 'Castell', and the later faint annotation of Carn Owen cairn above it, and a possible enclosure just above the 'C'. The Hafan Mine site lies along the stream line shown below the name.

6.3.2 The early Ordnance Survey drawings of the area (Giles 1833) note some interesting details in the local landscape, but the mine itself is not marked (Figure 6). Of interest however is the annotation of 'Castell' on the ridgetop to the north. It is assumed that this refers to the cairn site of Carn Owen, although such a name, in such an upland setting as this, often references prehistoric enclosures such as Iron Age hillforts or defended enclosures, and a seemingly later annotation appears to mark the cairn site, with another enclosure to the west. No such prehistoric enclosure has ever been identified here, although there is the potential that it may have been lost to quarrying activity in the 1960s. The site lies in an open upland area, with the lower slopes to the west part of the enclosed farmland around Cyneiniog Farm, the boundaries of which have remained the same.

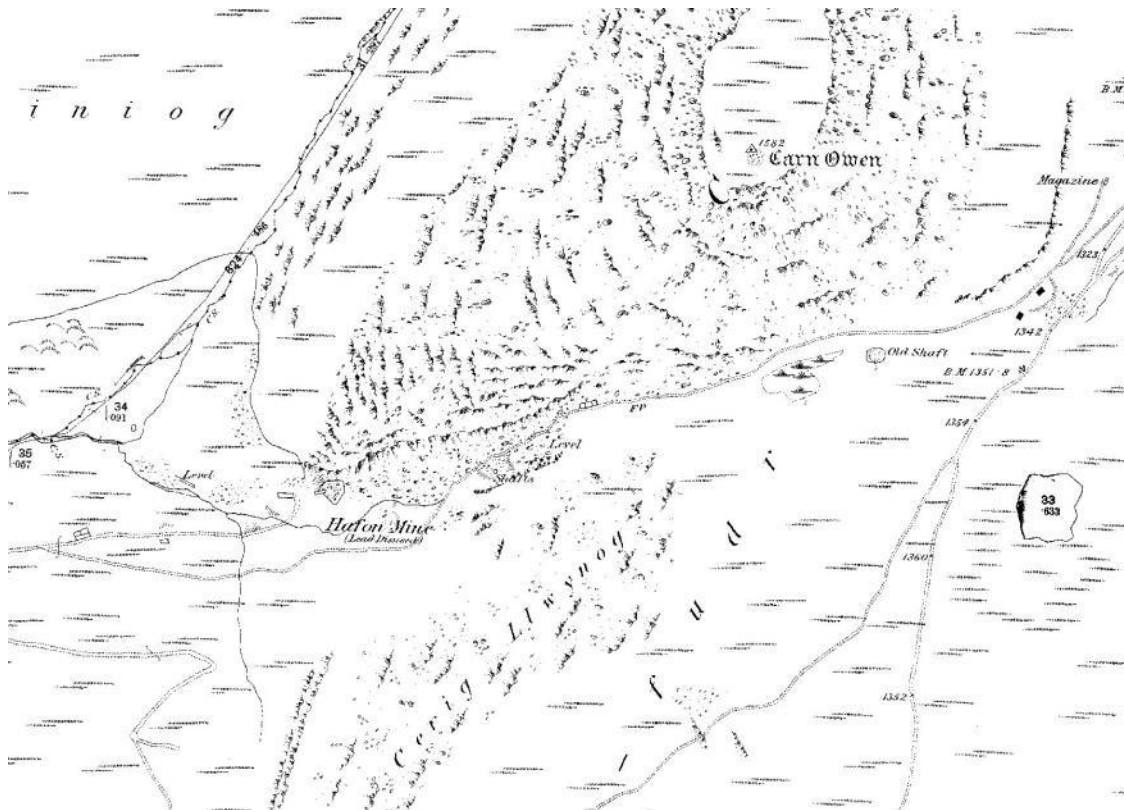
Figure 7: Extract from the Ordnance Survey map of 1888 showing the layout of the Hafan Mine.

- 6.3.5 The mine workings are spread across almost 1km, with a small concentration of activity on the higher ground to the northeast, but the main area of activity on the sloping ground to the west. To the northeast one, potentially two, shafts are noted, along with an old shaft, some spoil heaps, a magazine building, and a variety of trackways. To the west a structure is marked at the head of the slope, with a level and shafts alongside an open cutting along the south side of the cleft, a shaft and building close to the wheelpit, and a level towards the base of the slope. Further structures are shown on the lower ground, two alongside the main trackway from the wheelpit, presumably associated with the mine workings, and one close to the junction of two watercourses, presumably related to the 'dairy' PRN 126439.

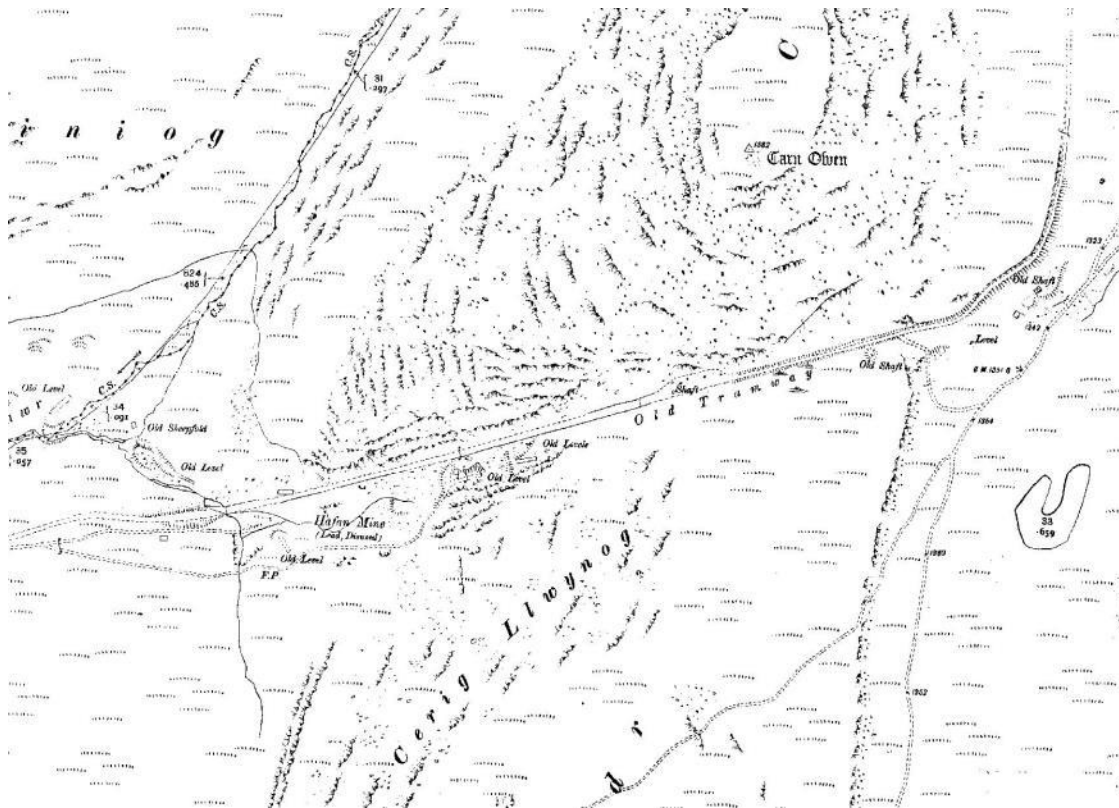
Figure 8: Extract from the 2nd edition Ordnance Survey map of 1905 showing the layout of Hafan Mine and tramway.

- 6.3.7 The subsequent Ordnance Survey map captures the site after the construction, and abandonment, of the tramway, and the establishment of the White Stone quarry at the northern end of the Cerrig yr Hafan ridge. To the northeast a new level is marked on the higher ground, presumably therefore one of the later workings on the site. A new shaft is also marked at the top of the sloping ground, on the line of the tramway, potentially therefore a very recent addition. Further detail is marked around the old levels in the rock cleft midway down the slope, and the tramway has cut across the site of a former shaft close to the wheelpit. An old level is marked to the south of the wheelpit, not shown on the previous map. To the northwest another old level is marked, beyond the old sheepfold, identified as a later slate working. To the west the tramway has removed one of the building sites at the base of the slope. Other than the quarrying activity to the north, the remaining landscape appears relatively unchanged.

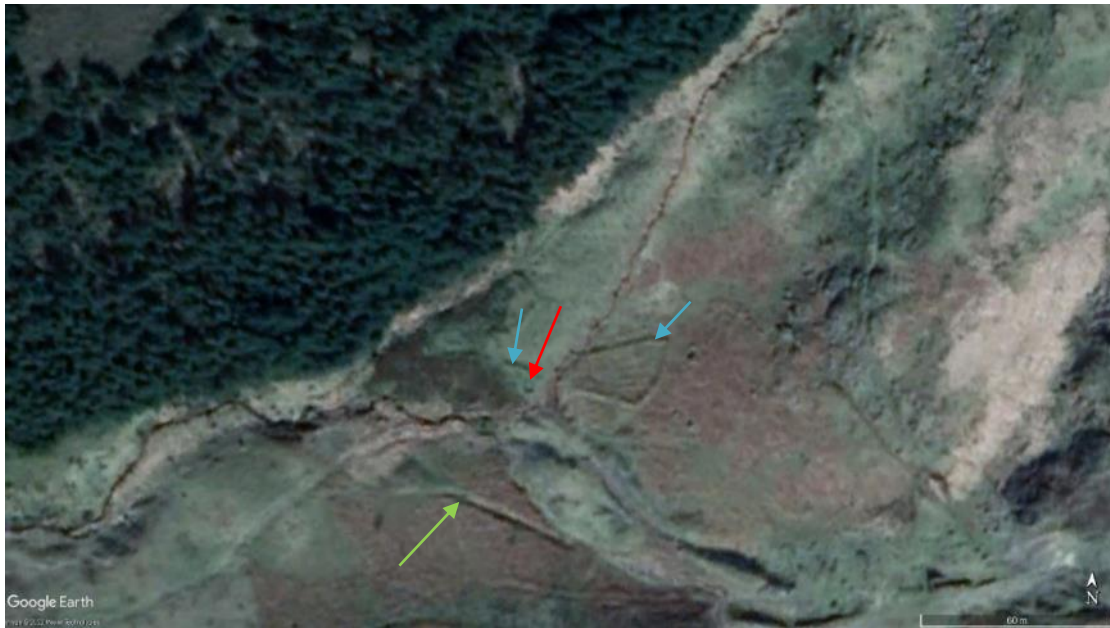
Photo 6: Extract from the 2012 satellite imagery, showing the remains of PRN 126439 (red arrow), with associated enclosure banks (blue arrows). Additional potential mine level and spoil heap also visible (green arrow) © Google Earth.

- 6.4.2 Modern satellite imagery from 2006 provides a clearer image of the site, as do a series of photographs taken by the RCAHMS (NPRN 33878). The satellite images confirm much of what is visible at ground level, but also provides a clearer indication of activity around the 'dairy' site PRN 126439 (Photo 6). This indicates that the building remains are only one part of the complex, with boundary banks visible to the north, and a larger enclosure on the opposite bank of the stream to the east. An unmarked trackway also appears to connect this site to Allt Ddu (PRN 125326) to the west. An additional potential mine level and spoil heap is also shown at the western end of the mining complex (Photo 6). Also of interest, but not seemingly related to the mine site, is the potential for structural remains on the ridge top to the north of the site. Two possible rectilinear features are visible on the satellite images approximately 60m to the west of Carn Owen, seemingly tucked against a west facing outcropping stony ridge (Photo 7). The provenance of these features has not been tested on the ground, but they may represent sheep shelters or similar utilising the readily available stone, but the proximity to Bronze Age monument of Carn Owen is of interest.

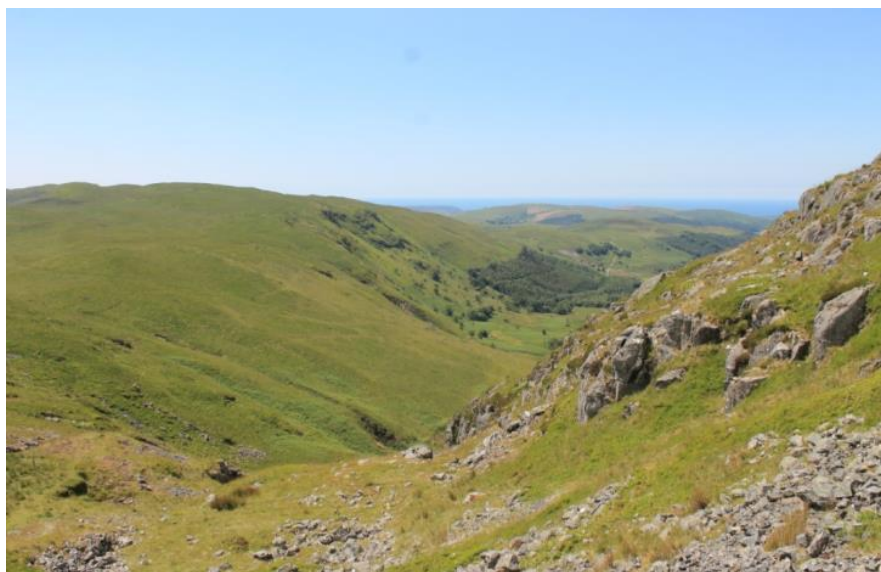
Photo 8: General view west from the top of the sloping ground containing the bulk of the mining remains.

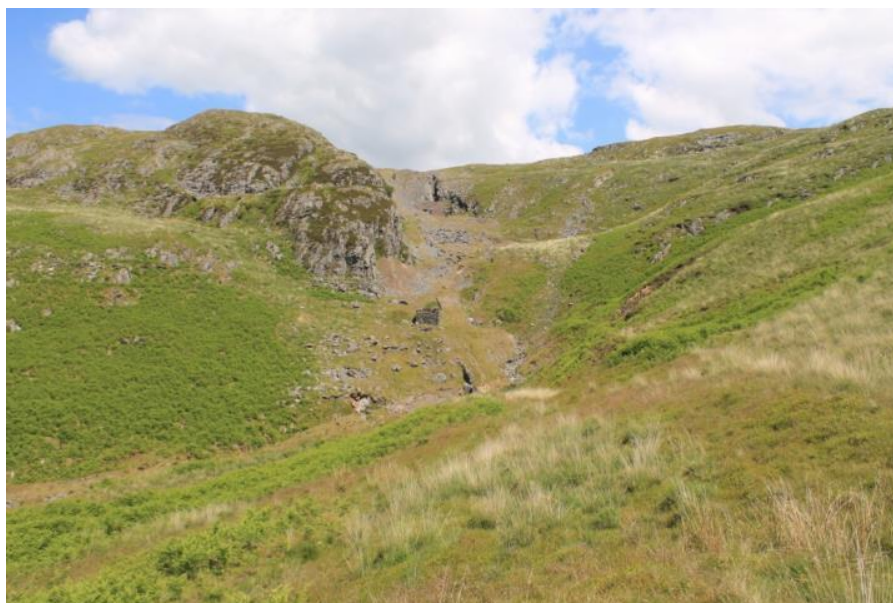
Photo 9: View east from the base of the slope looking at the Hafan Mine complex running up the slope.

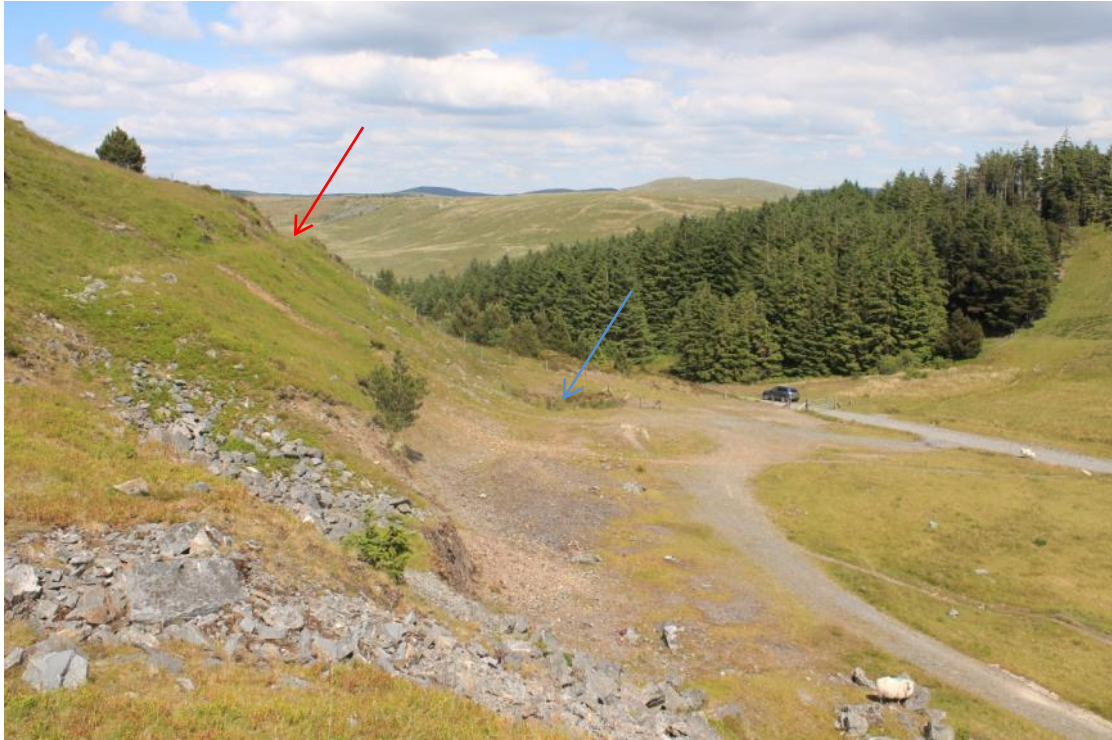
Photo 10: View N showing the eastern end of the Hafan Mine complex. The route of Tramway PRN 38234 is visible terraced into the side of Cerrig yr Hafan on the left (red arrow), the fenced and blocked mine shaft PRN 38235 lies at the foot of the slope (blue arrow). Shaft PRN 95901 and Spoil Heap PRN 95902 lie adjacent to this shaft, but surface elements appear to have been terraced away. Level PRN 38236 would lie in the level turf-covered area on the right, but is also no longer visible. Spoil Heap PRN 95900 would lie on the lower edge of the tree line to the rear.

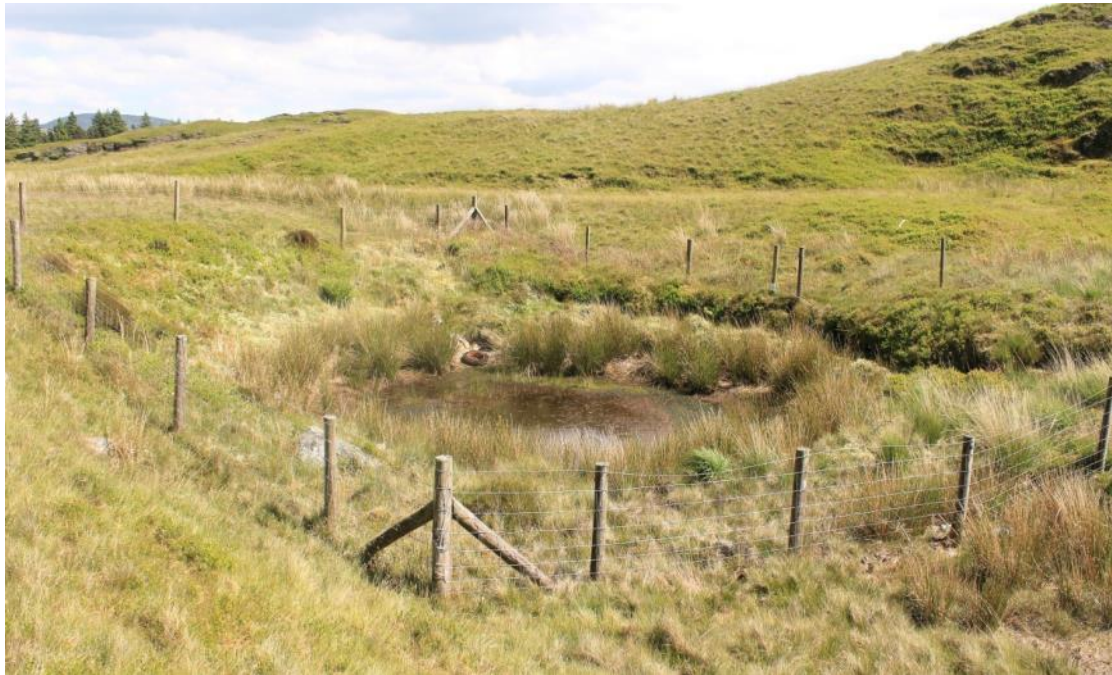
Photo 11: View SE of fenced off and water-filled Shaft PRN 38237.

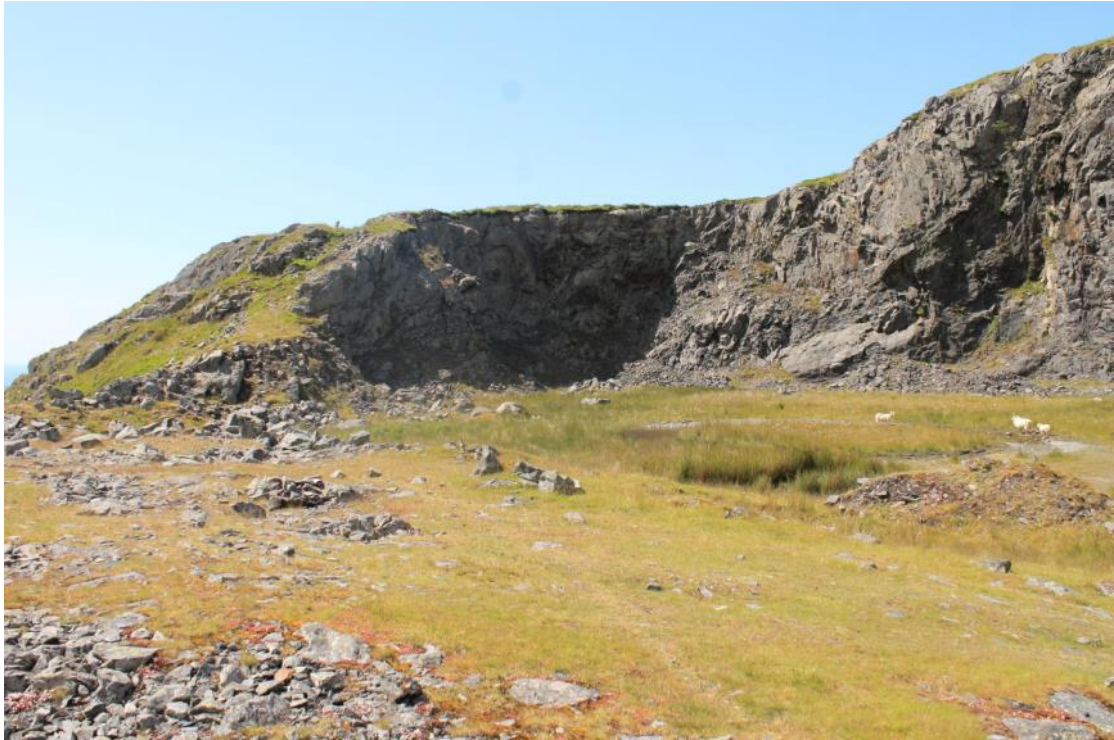
Photo 12: View W across the level area at the top of the slope, with the rocky face of the modern quarry forming the background. The approximate location of Shaft PRN 38238 would lie on the left.

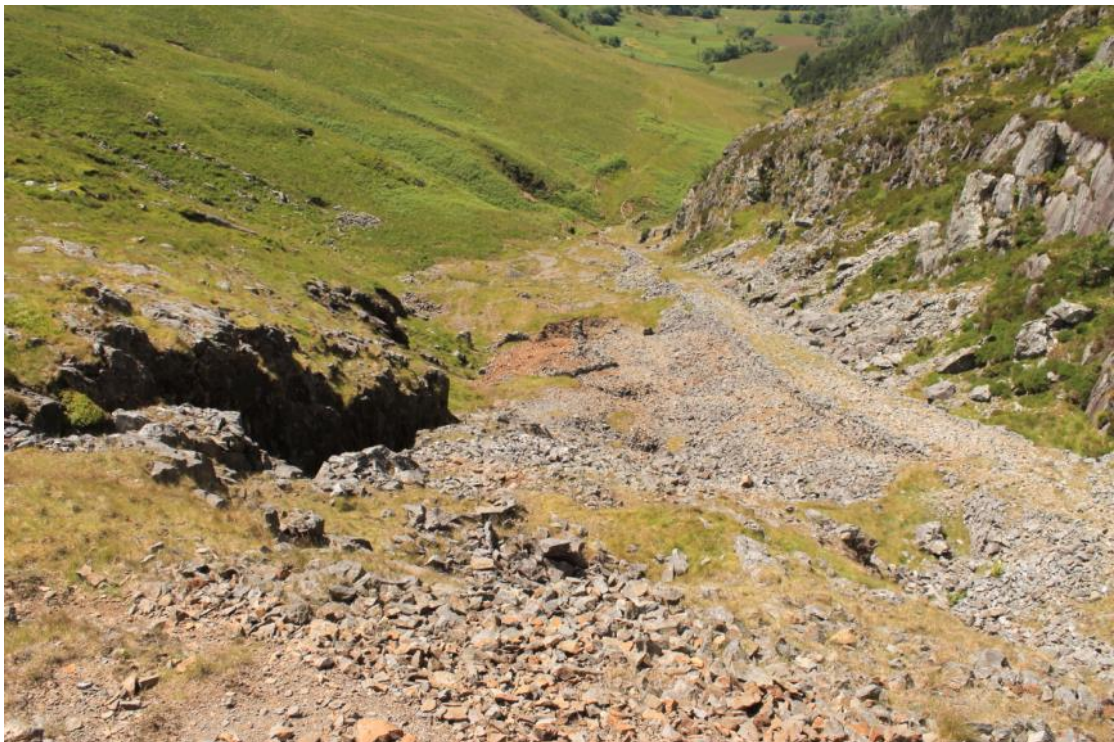
Photo 13: View W down the sloping ground, showing the incline of the Tramway PRN 38239 on the right. Levels PRN 38240 / 95905 lie in the shadow on the left.

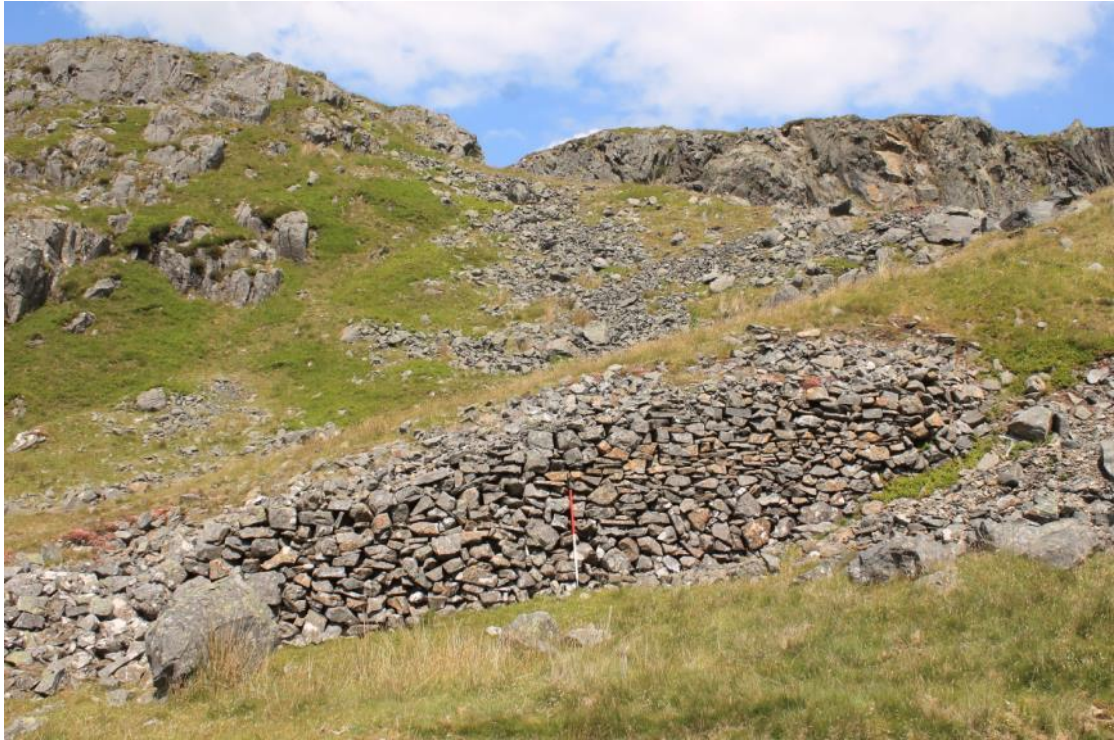
Photo 14: View N showing a section of the drystone wall revetment of Tramway PRN 38239 towards the top of the incline. 1m scale.

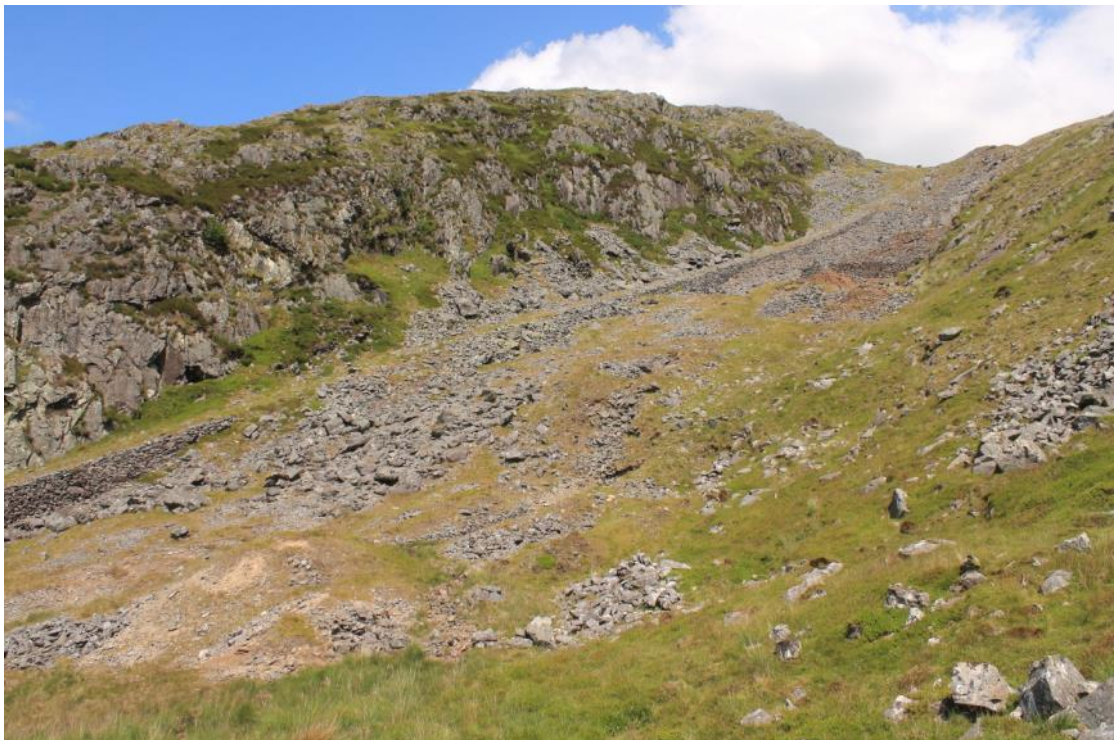
Photo 15: View NNW showing the incline of Tramway PRN 38239. Spoil Heap PRN 95906 also lies centrally within this shot.

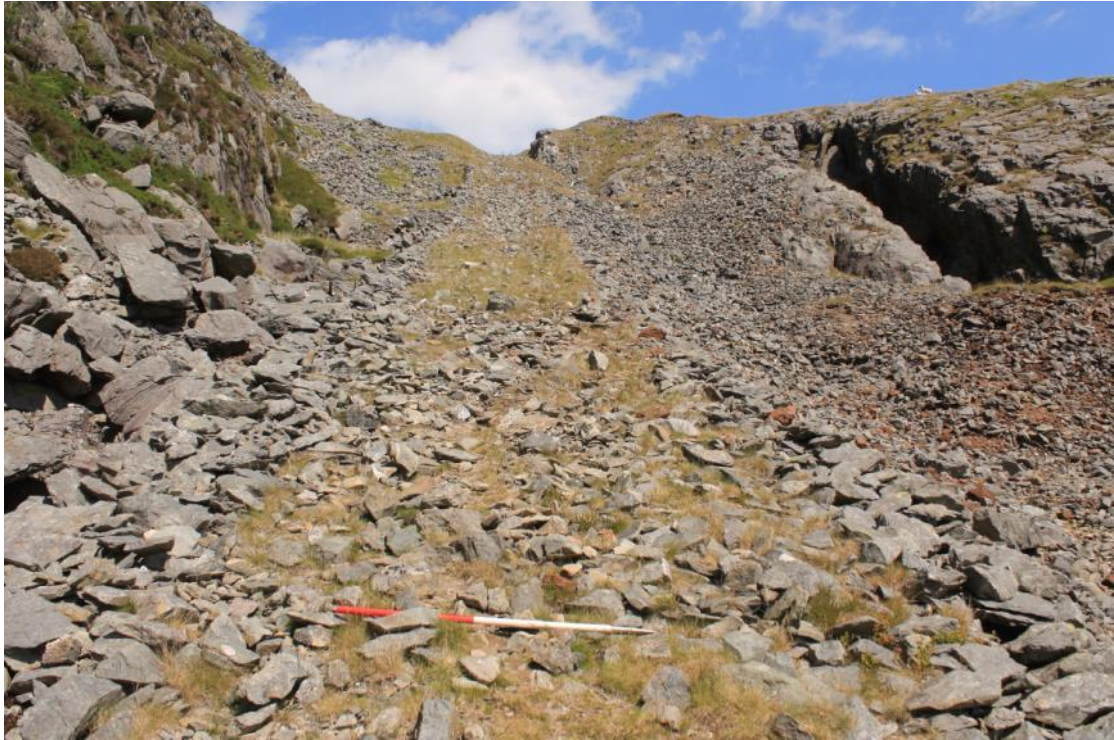
Photo 16: View ENE up the incline of Tramway PRN 38239. 1m scale.

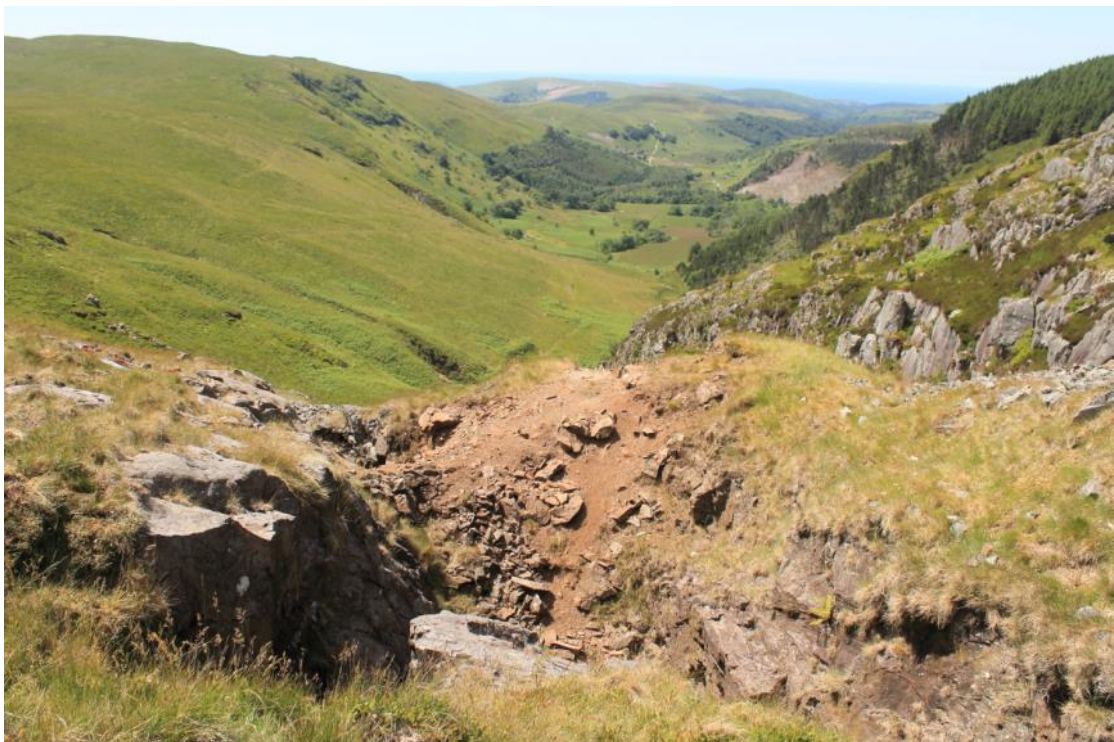
Photo 17: View W from the top of a series of Levels PRN 38240 / 95905 cut into the hillside.

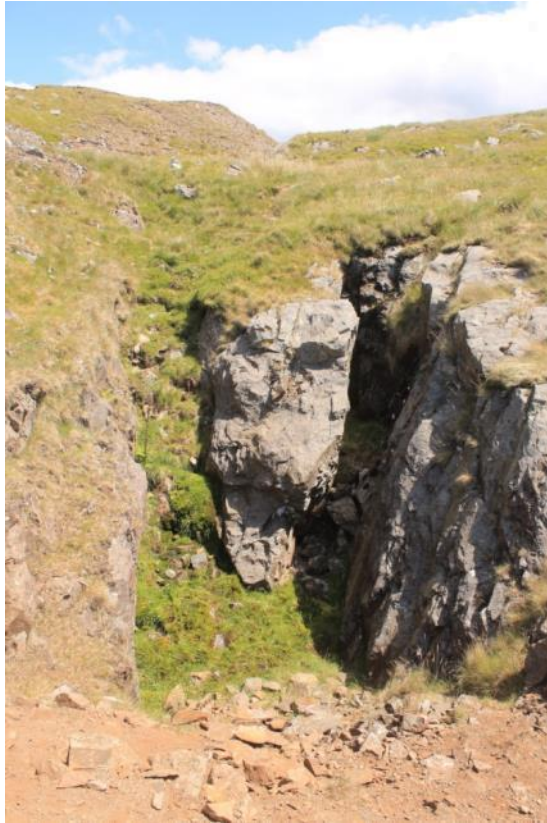
Photo 18: View E, looking back from the bare ground visible in the previous photo, showing two infilled levels, part of Levels PRN 38240 / 95905.

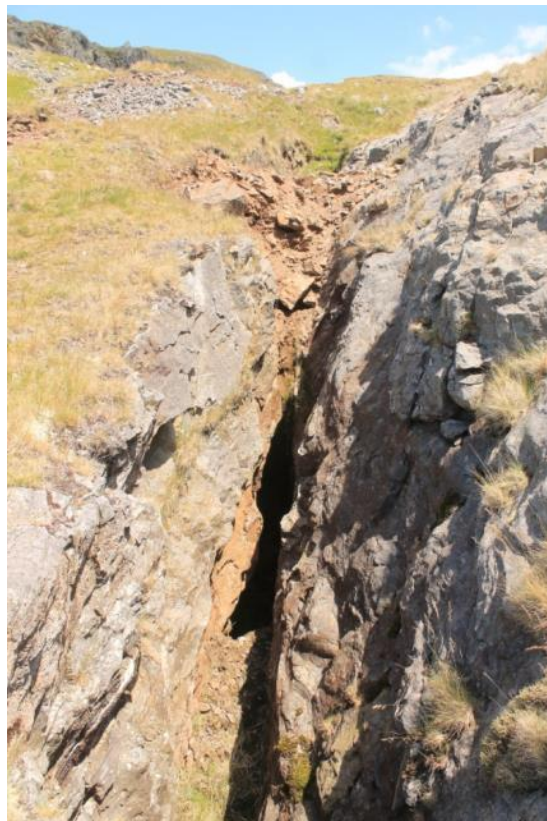
Photo 19: View E at the middle of three main level cuttings forming Levels PRN 38240 / 95905,

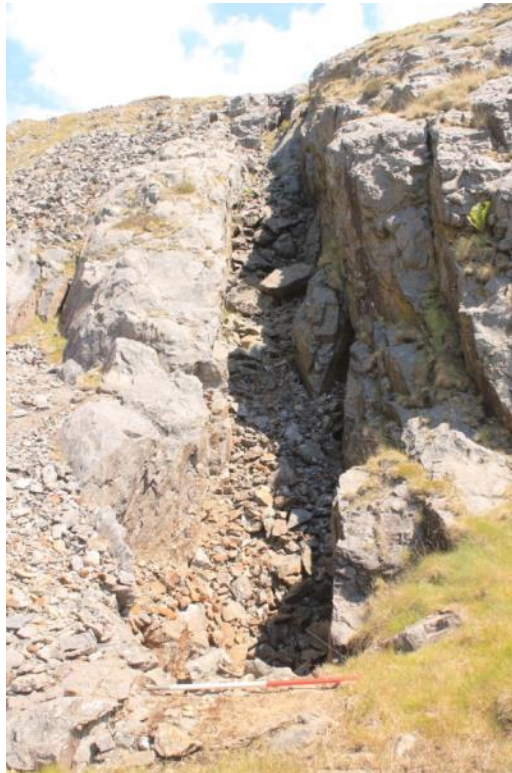
Photo 20: View E at the lower of three main rock-cut levels forming Level PRN 38240 / 95905. 1m scale.

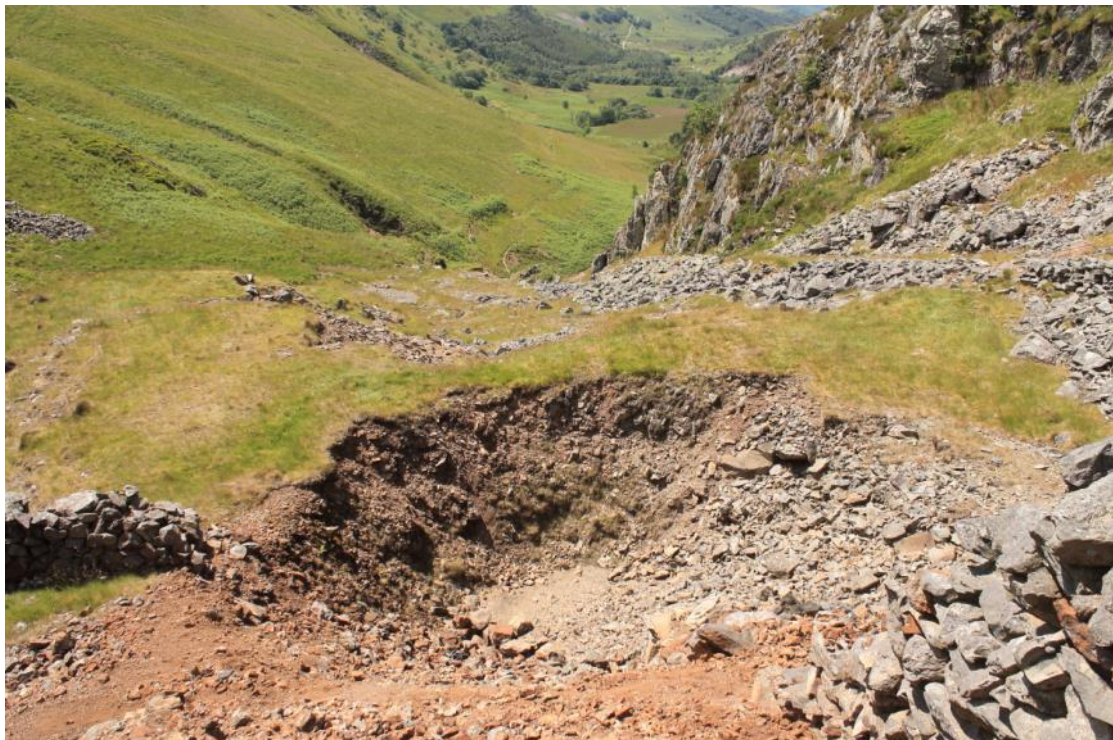
Photo 21: View W, showing collapsed Mine Shaft PRN 38241 in the foreground.

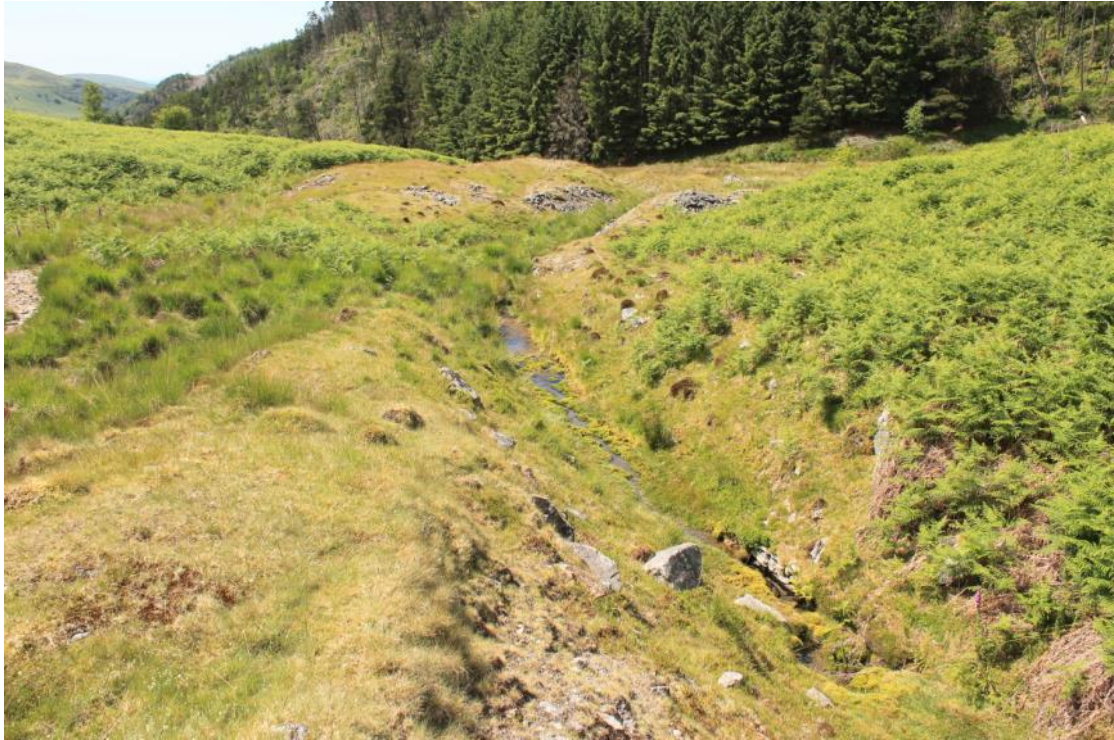
Photo 22: View WNW along the approach to Level PRN 38242. The level entrance lies at the bottom right, with the water in the centre running along the drystone-walled approach.

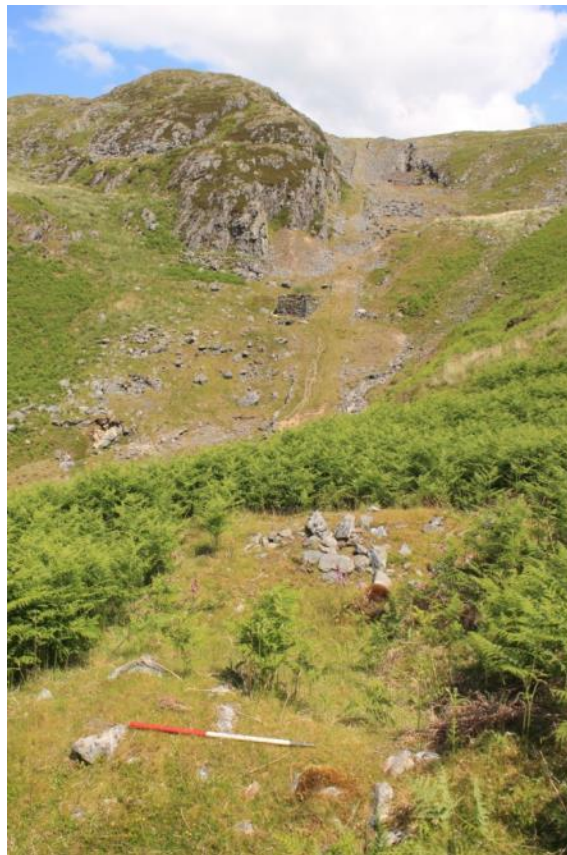
Photo 23: View E showing the remains of Structure PRN 38243 in the foreground (the rectangular area within the bracken) with Hafan Mine workings on the incline in the background. 1m scale.

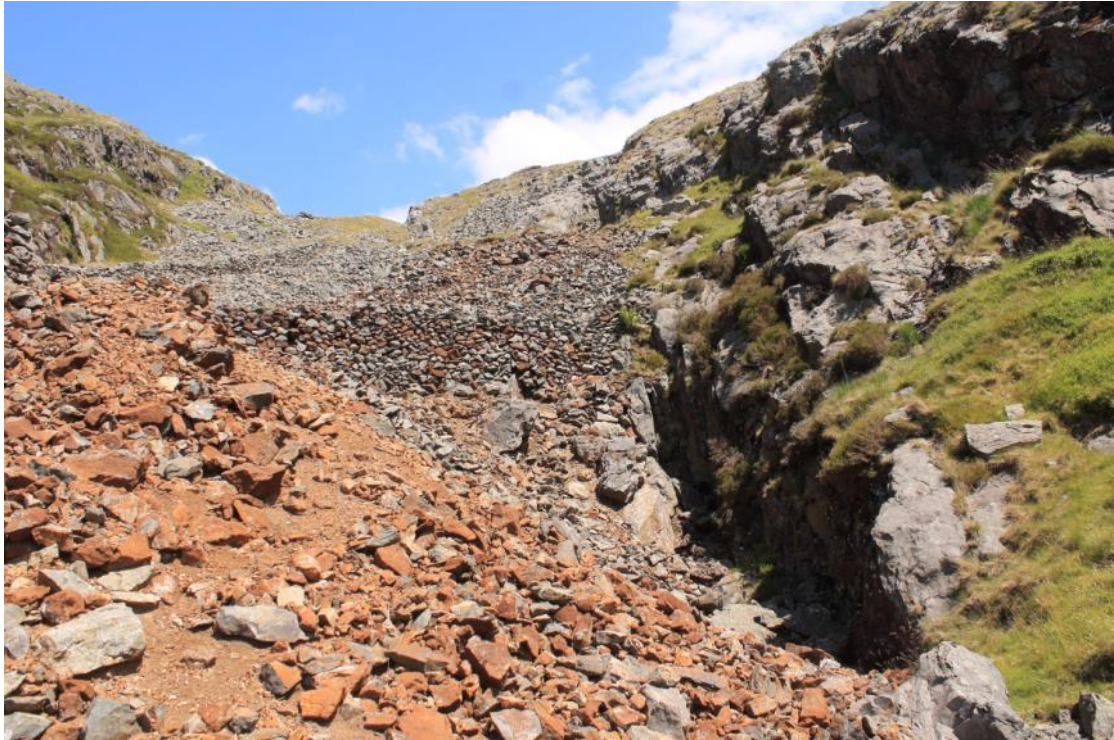
Photo 24: View ENE up the slope showing the extensive Spoil Heap PRN 95904. The distinctive brown oxidised rock is visible in the foreground. Mine Level HM06 is visible as the open cutting to the right of the brown rock.

95904	SN7302087970	Spoil Heap	<p>Large spoil heap</p> <p>Located midway down the incline, a large spread of loose stone, with distinctive deposits of brown spoil collected within structure PRN 95907. Largely associated with level PRN 95903. Also visible as a series of steps alongside the level, therefore potentially originating from a variety of other workings as well, and the spoil itself may have been reworked.</p>	24 & 25
95905		Level	See PRN 38240	
95906	SN7296787952	Spoil Heap	<p>Spoil Heap associated with shaft PRN 38241, and possibly Level HM06.</p> <p>It may partly cover the site of a run-in level PRN 95919 (RPJ survey 1993, No.33) as well. PRN 95919 not shown on the accompanying maps as it no longer appears to be visible at ground level, and the description does not appear to correspond to two levels that were visible (PRN 95918).</p>	15
95907	SN72998796	Structure	<p>Walled enclosure</p> <p>Irregular three-sided walled enclosure, likely enclosing the dressing floor at the base of the main mine levels, where the mined material would be sorted to extract the good ore from the dead rock containing no ore. The enclosure first appears on the 2nd edition OS map of 1906, so likely part of the late 19th/early 20th century workings.</p> <p>Visible as a drystone built wall, up to 1.2m high externally, 2.2m high internally. Collapsed into a former adit (PRN 38241) in the northwest corner, containing and partly buried by mining spoil (PRN 95904).</p>	21, 24, 26 & 27

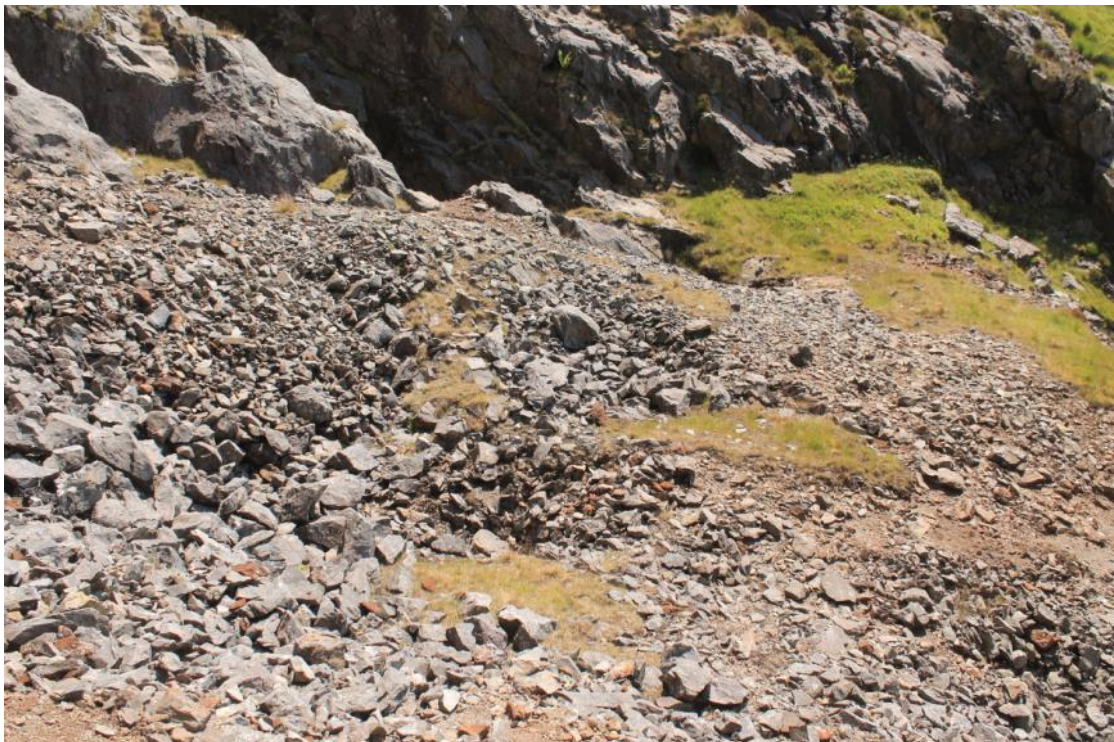
Photo 25: View SW downslope across the upper part of Spoil Heap PRN 95904. The small grassy areas picking out steps in the spoil.
