HAFAN MINE, CEREDIGION: HISTORIC ENVIRONMENT DESK-BASED ASSESSMENT

REPORT NO. 2022-29
PROJECT NO. 128834

July 2022
Gorffennaf 2022

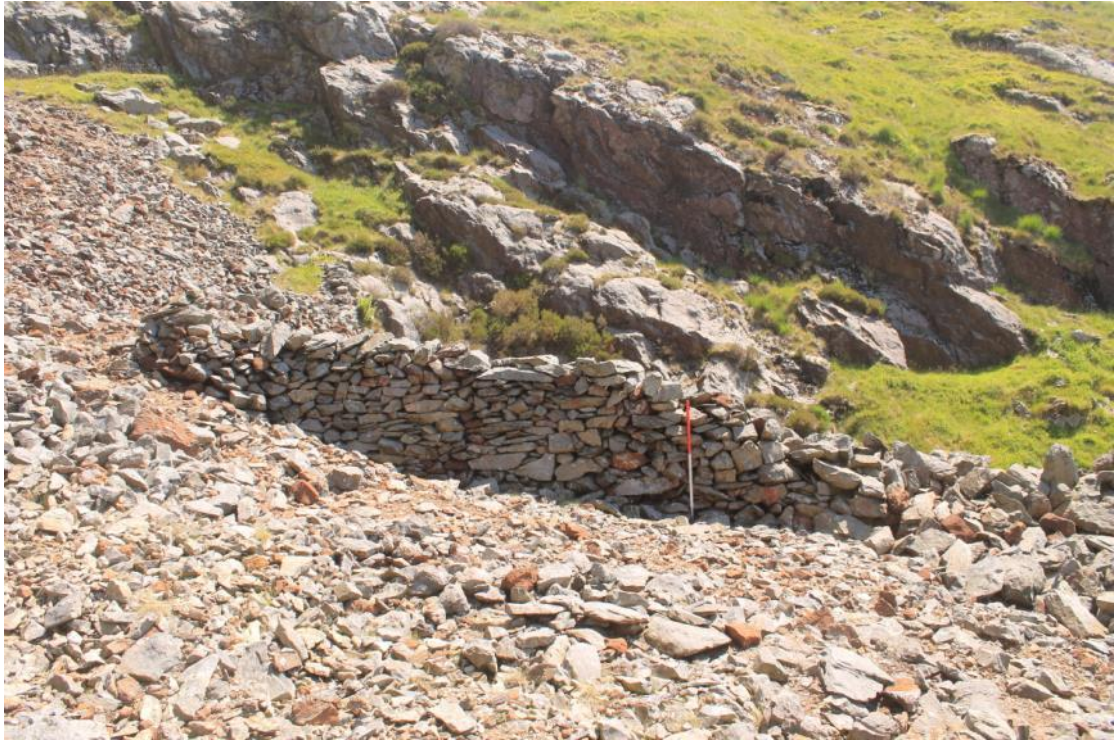
Photo 26: View S showing the external face of Structure PRN 95907. 1m scale.

95904	SN7302087970	Spoil Heap	<p>Large spoil heap</p> <p>Located midway down the incline, a large spread of loose stone, with distinctive deposits of brown spoil collected within structure PRN 95907. Largely associated with level PRN 95903. Also visible as a series of steps alongside the level, therefore potentially originating from a variety of other workings as well, and the spoil itself may have been reworked.</p>	24 & 25
95905		Level	See PRN 38240	
95906	SN7296787952	Spoil Heap	<p>Spoil Heap associated with shaft PRN 38241, and possibly Level HM06.</p> <p>It may partly cover the site of a run-in level PRN 95919 (RPJ survey 1993, No.33) as well. PRN 95919 not shown on the accompanying maps as it no longer appears to be visible at ground level, and the description does not appear to correspond to two levels that were visible (PRN 95918).</p>	15
95907	SN72998796	Structure	<p>Walled enclosure</p> <p>Irregular three-sided walled enclosure, likely enclosing the dressing floor at the base of the main mine levels, where the mined material would be sorted to extract the good ore from the dead rock containing no ore. The enclosure first appears on the 2nd edition OS map of 1906, so likely part of the late 19th/early 20th century workings.</p> <p>Visible as a drystone built wall, up to 1.2m high externally, 2.2m high internally. Collapsed into a former adit (PRN 38241) in the northwest corner, containing and partly buried by mining spoil (PRN 95904).</p>	21, 24, 26 & 27

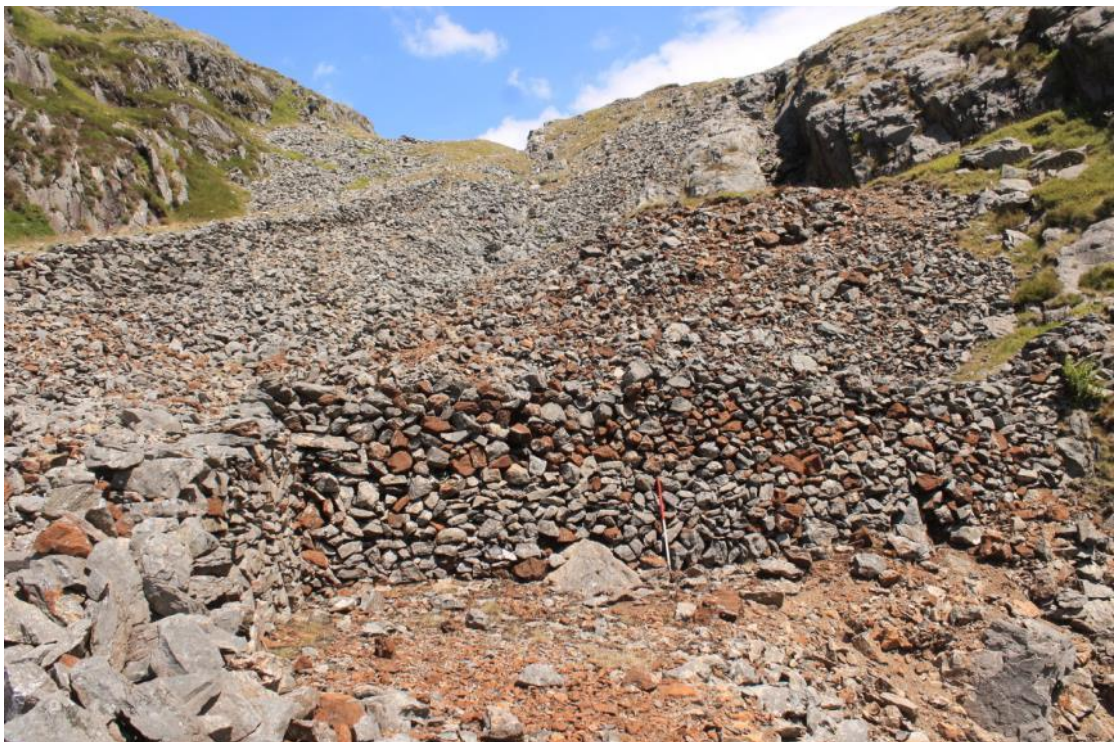
Photo 27: View ENE showing the internal face of the upper wall of Structure PRN 95907. Somewhat difficult to pick out the drystone construction against the background of loose stone from Spoil Heap PRN 95904. 1m scale.

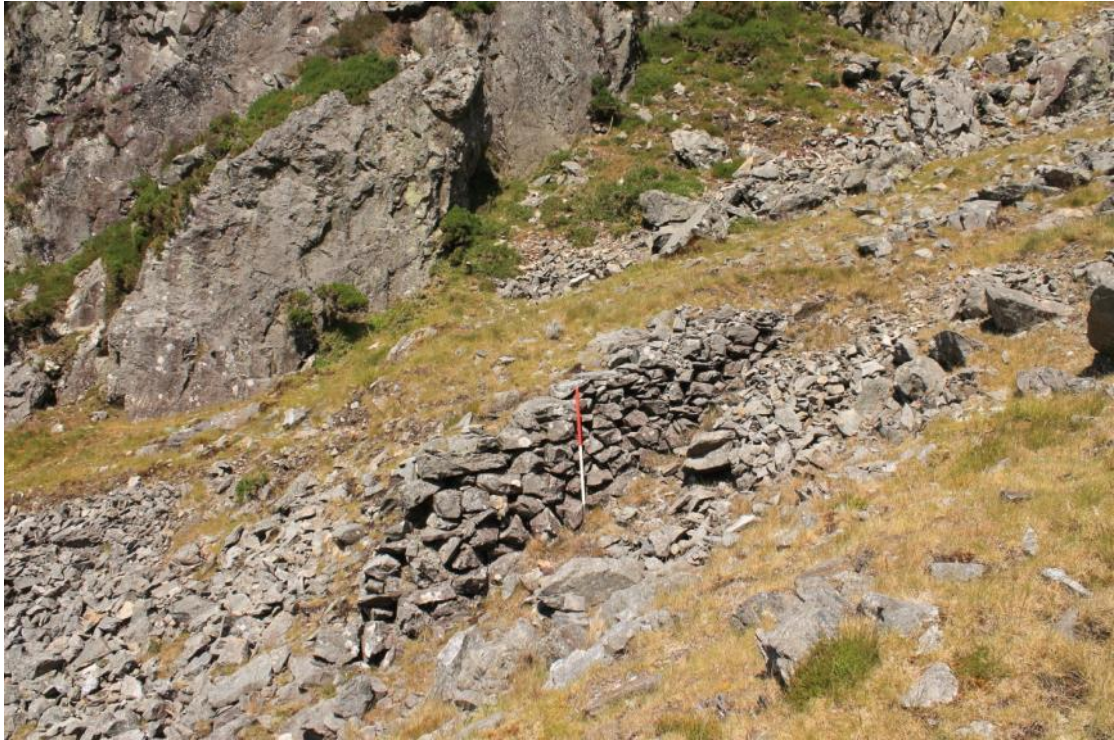
Photo 28: View N of fragment of retaining wall PRN 95908. 1m scale.

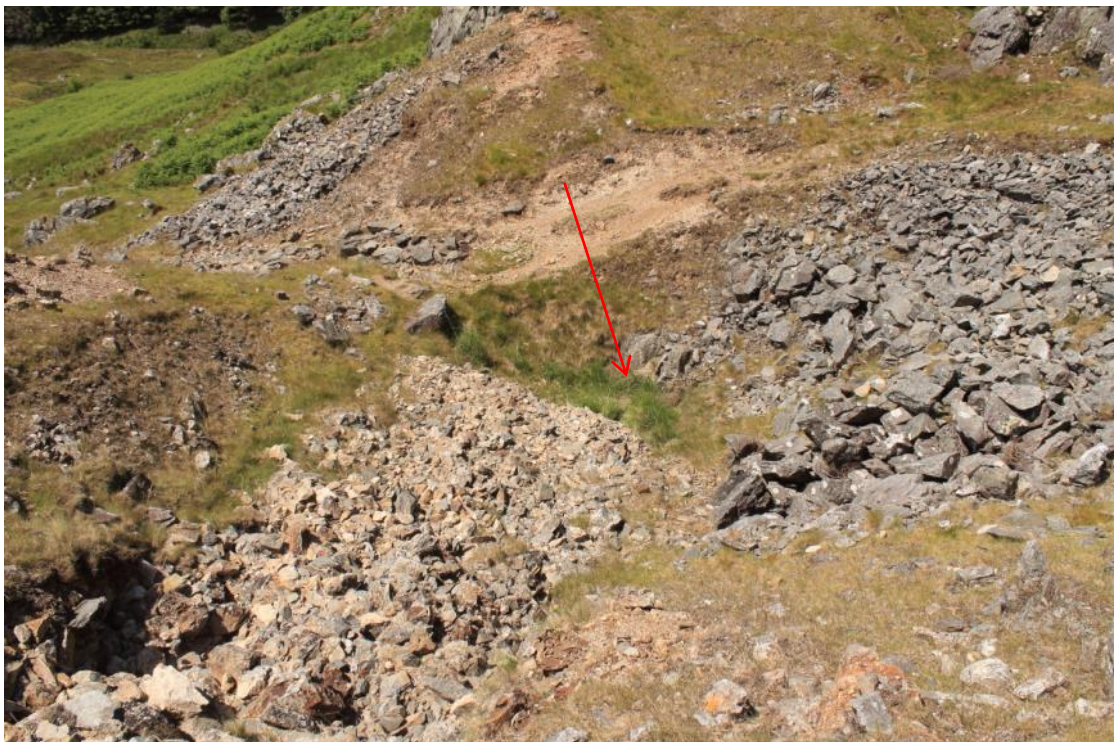
Photo 29: View W showing the collapsed mine shaft PRN 95909 (arrow) with the tramway across the top, and retaining wall PRN 95908 on the right.

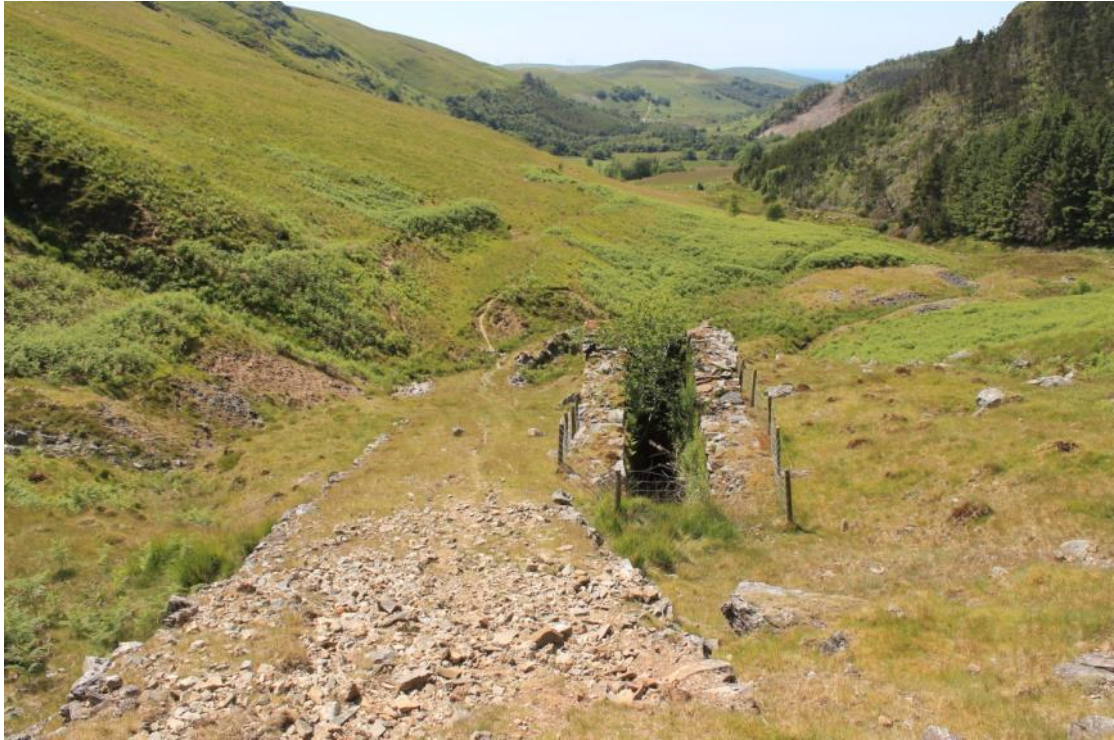
Photo 30: View W along the valley showing the Wheelpit PRN 95911, currently fenced off. The later Tramway PRN 38239 runs alongside to the left.

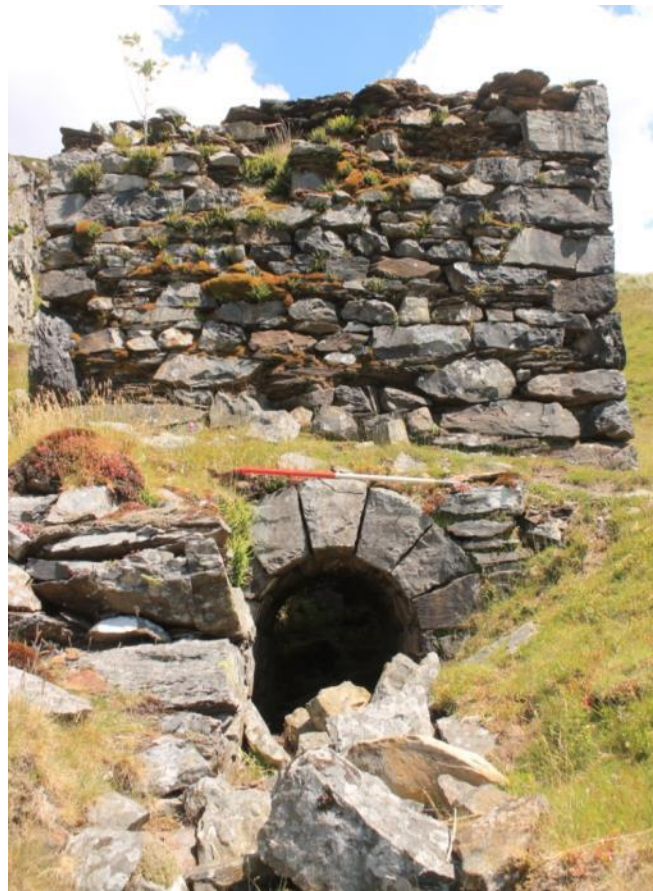
Photo 31: View E of the lower outer face of Wheelpit PRN 95911, with arched tailrace at the base. 1m scale.

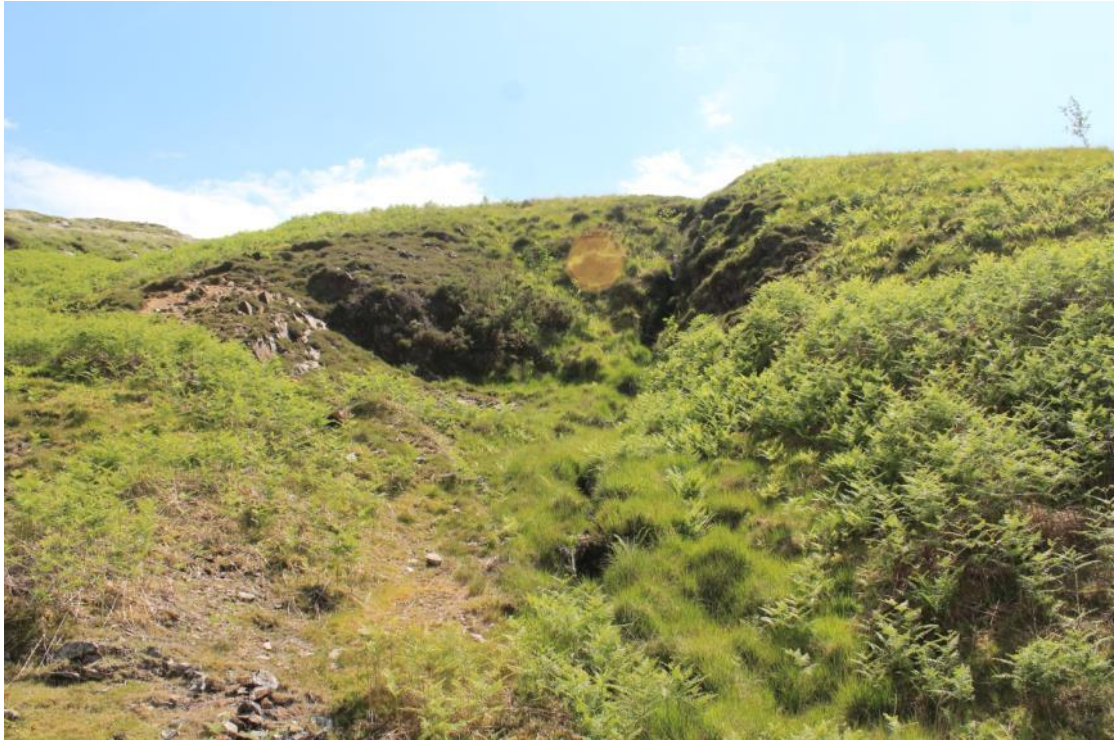
Photo 32: View S, showing approach to overgrown Mine Level PRN 95912.

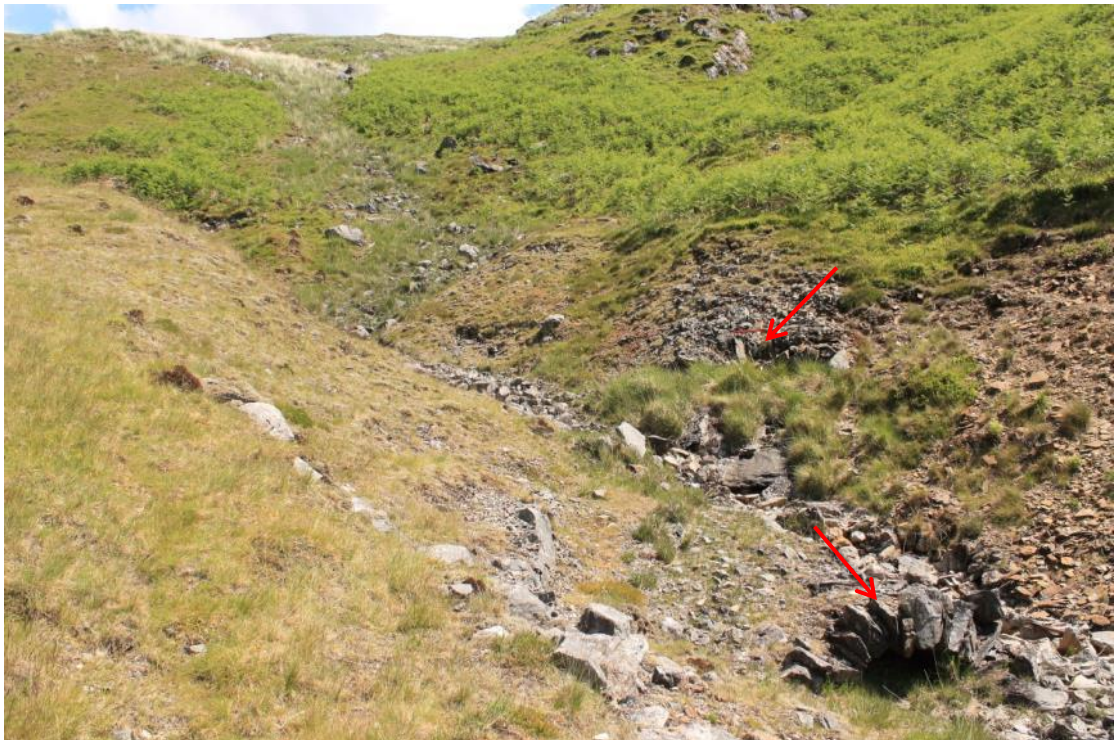
Photo 33: View SE showing the two Culverts/Mine Levels PRN 95913 (red arrows).

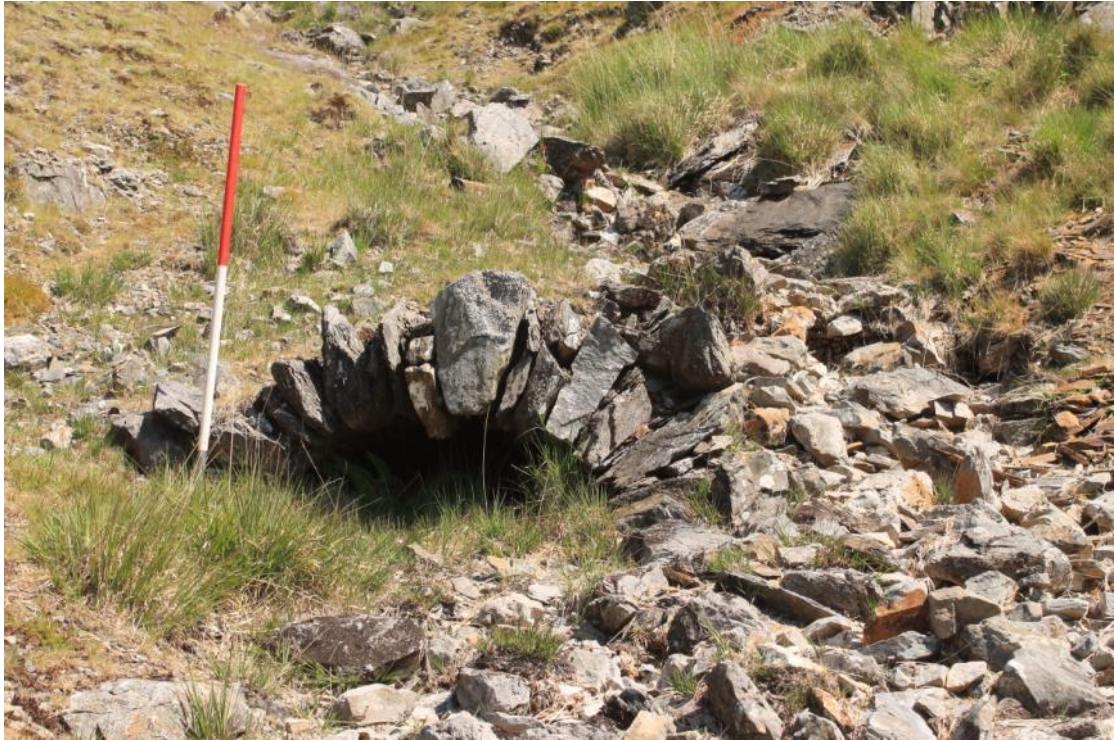
Photo 34: View E, detailed shot of the lower, northernmost, of the two Culverts/Levels PRN 95913. 1m scale.

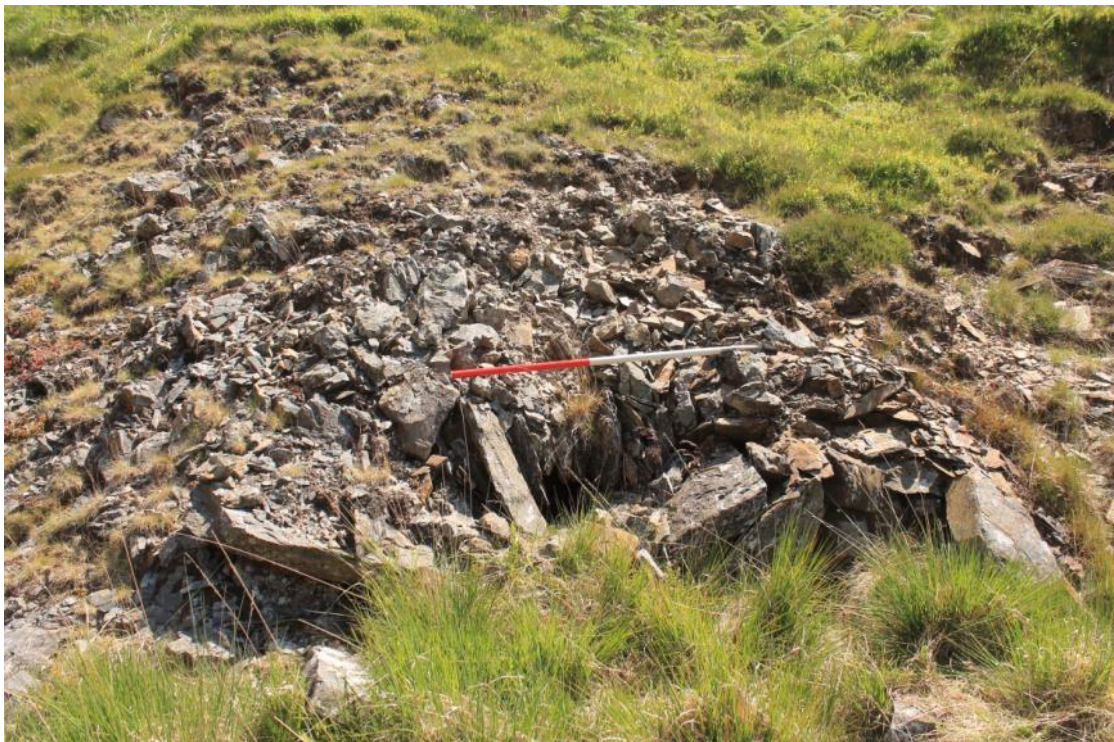
Photo 35: View ESE, detailed shot of the higher, southernmost, of the two Culverts/Levels PRN 95913. 1m scale.

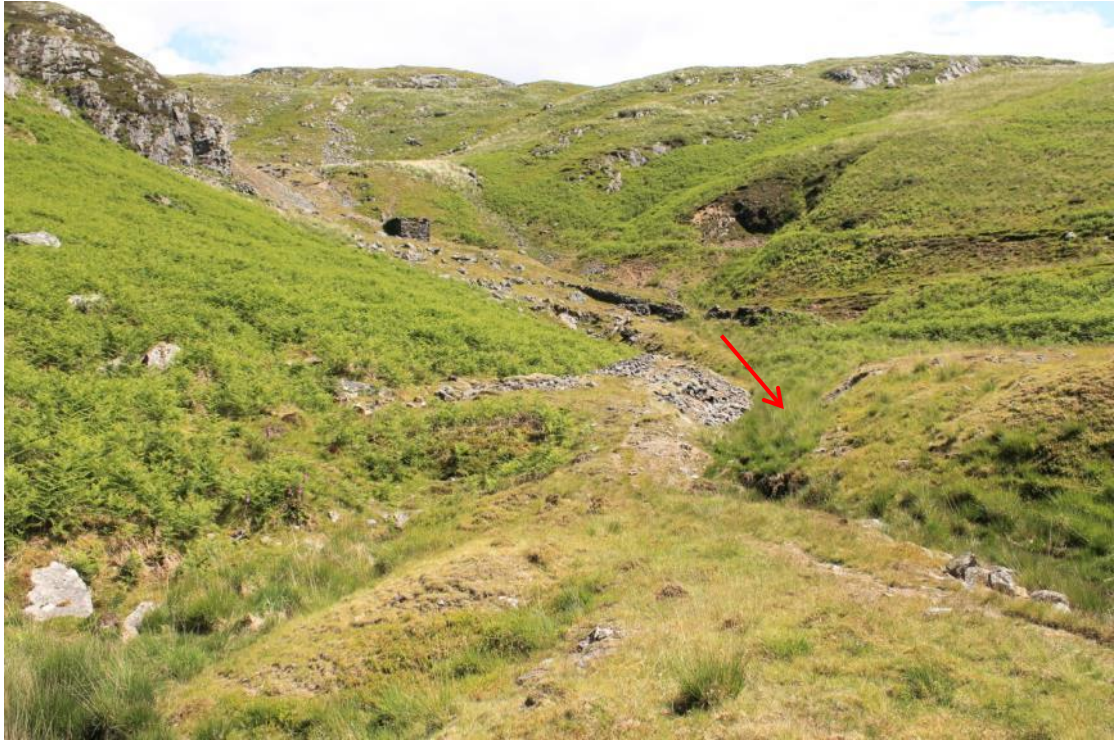
Photo 36: View SE along the gulley (arrow), part of Gully & Spoil Heap PRN 95914.

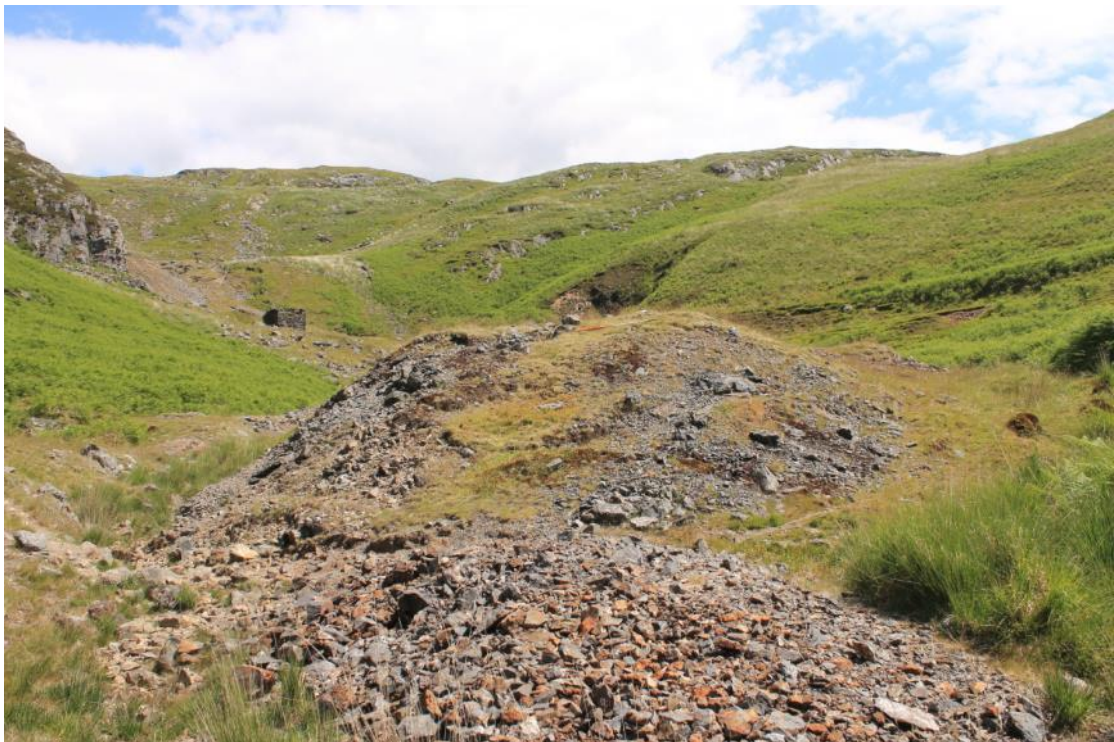
Photo 37: View SE, the large spoil heap at the base of the slope, part of Gully & Spoil Heap PRN 95914.

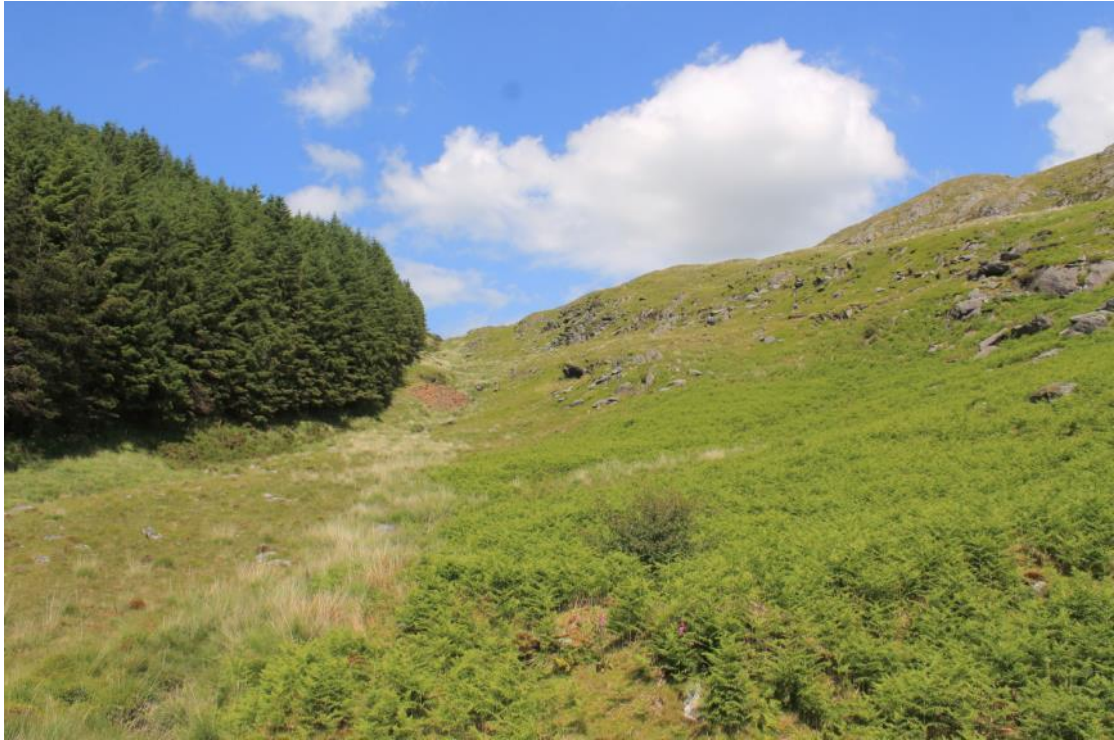
Photo 38: View NE looking up an adjacent stream valley, the stream running close to the tree line, and general site of mine level PRN 95915 towards the top of the slope. Not located during survey.

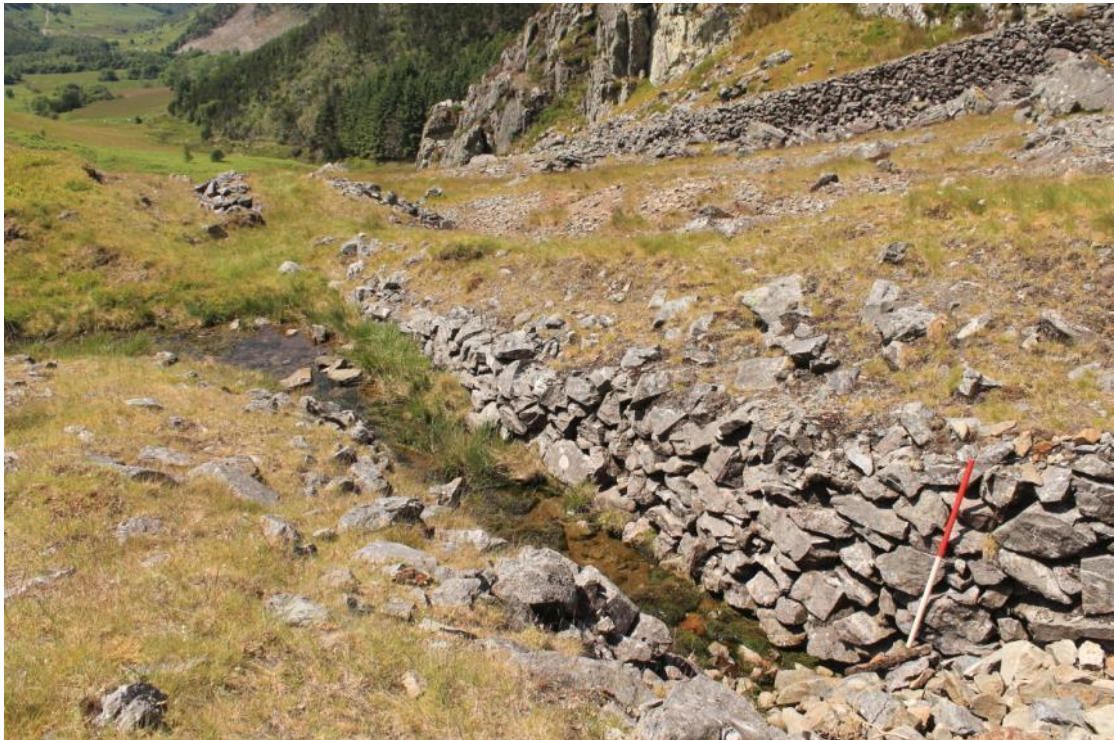
Photo 39: View NW across the northernmost Level PRN 95918 with its drystone walled approach currently channelling water. The stone wall revetment to the Tramway is visible to the rear. 1m scale.

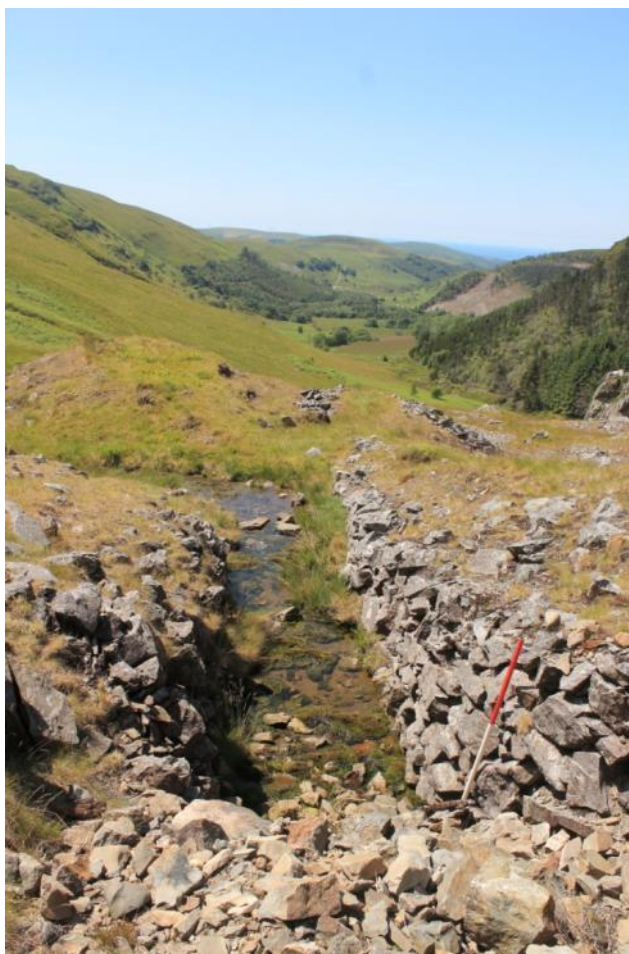
Photo 40: View W down Level PRN 95918, with Spoil Heap HM08 visible beyond and to the left. 1m scale.

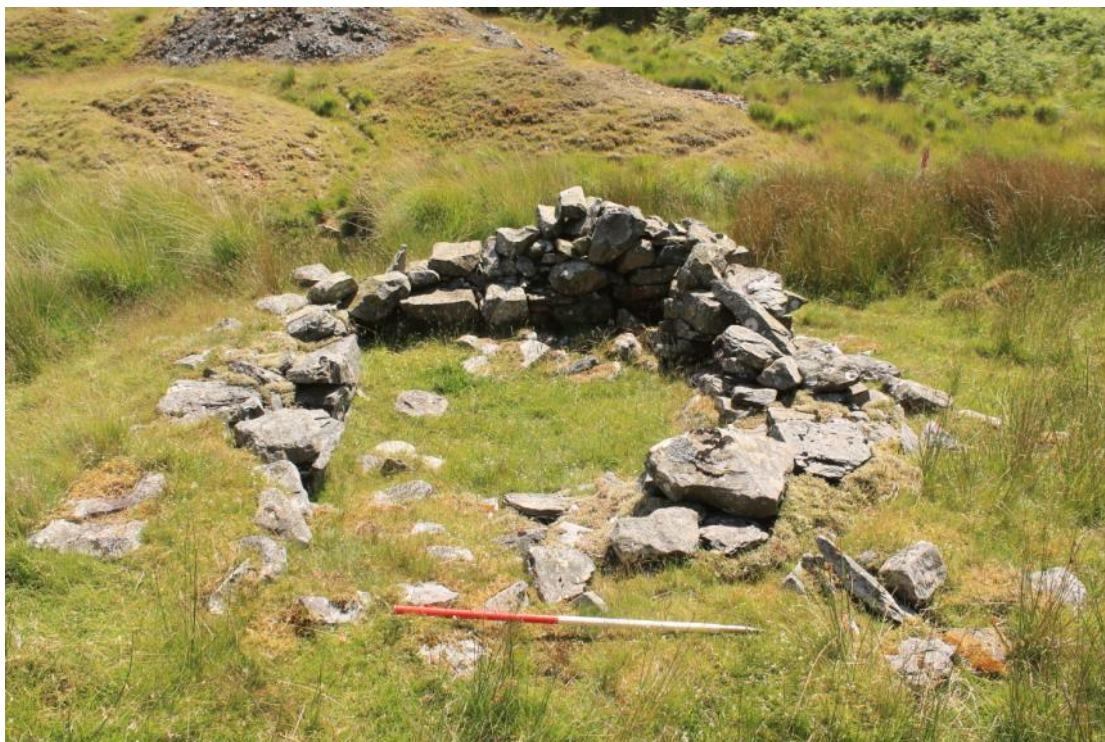
Photo 41: View SE of Dairy Store or Shelter PRN 126439. 1m scale.

95920	SN73528820	Magazine	<p>Mining Magazine Store.</p> <p>Small square structure on the eastern edge of Hafan mining complex (PRN 9166) recorded on the 1888 1st edition Ordnance Survey map as the magazine, storing the mine explosives, hence its isolation from the main mine areas.</p> <p>Not visited during current survey, but previous surveys have noted no surviving above-ground elements.</p>	-
126439	SN7270187996	Shelter	<p>Dairy Store / shelter / structure and enclosures.</p> <p>Previously recorded as a circular dairy store of medieval date, shown as a rectangular structure on the 1st edition OS map of 1888, and marked on the 2nd edition OS map (1906) as 'Old Sheepfold'. It was also noted during a previous survey (Sambrook 2002) as a possible deserted rural settlement, including sheepfold, enclosures and a sheep dip.</p> <p>The site comprises remains of a simple drystone built rectangular structure, approximately 2m by 4.5m, with walls 0.5/0.6m thick. Aerial photographs indicate the structure stood within a small enclosure, a second enclosure lying to the east, separated by a stream which may have been deliberately channelled from the north. This may be associated with the adjacent mine workings (operated intermittently between the early 17th and early 20th centuries), and indeed some former Smelt Mill/Smith Forge mine buildings in the Yorkshire Dales contained sunken areas that were later re-used as sheep dips, however this simple structure appears more agricultural in nature, possibly as a small shelter and sheep enclosure, later re-used as a sheepfold.</p>	41

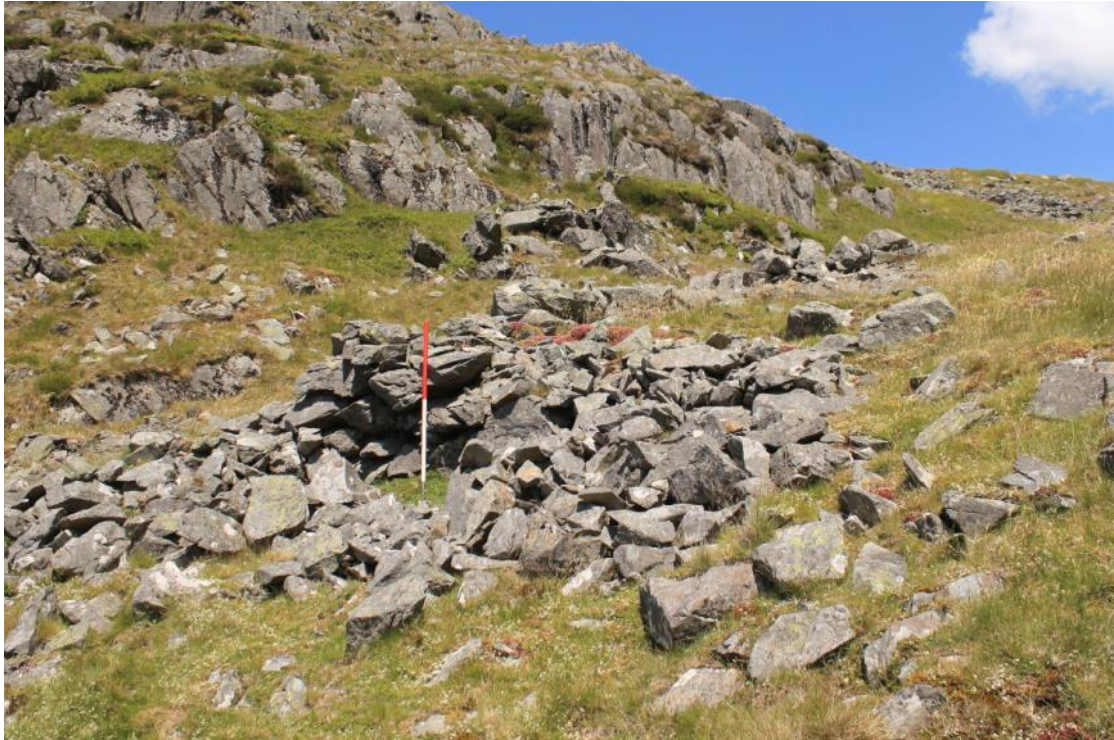
Photo 42: View NE of remains of building HM02. Roughly built drystone wall stands behind the 1m scale.

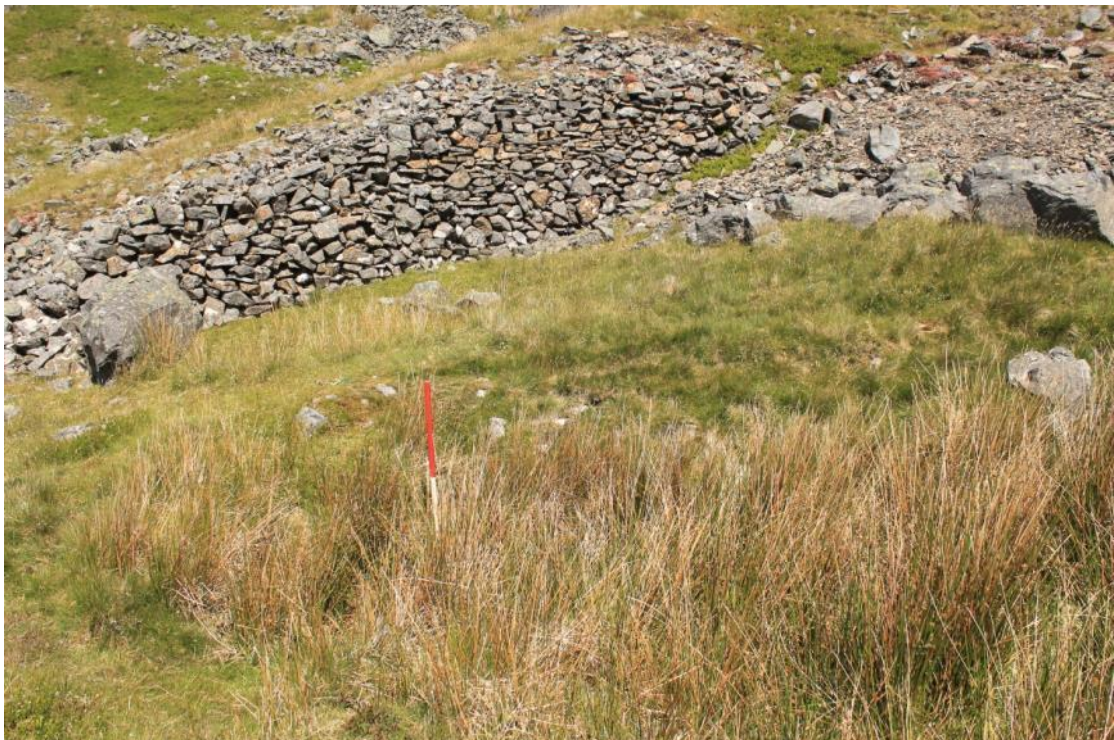
Photo 43: View N of reed-filled hollow possible representing an infilled Mine Shaft HM03. The Tramway revetment wall lies in the background. 1m scale.

covered in loose stone.	
HM03	SN7310888007	Shaft?	<p>Possible infilled shaft.</p> <p>Area of marshy ground with aa slight central depression, lying close to the top of the slope a short distance south of the Tramway revetment wall. It possibly represents an infilled shaft given the context of the site, although it has not been identified on previous surveys and no feature is marked at this point on historic mapping.</p>	43
HM04	SN7306088002	Shaft?	<p>A largely buried mine shaft, or possible level.</p> <p>Lies on the rising rocky ground to the north of the Tramway, visible as part of an opening below exposed bedrock. The opening is largely filled by loose scree on the hillslope, leaving a narrow gap approximately 0.8m wide and 0.3m high.</p> <p>Not marked on any maps, and part buried by the late 19th century tramway.</p>	44
HM05	SN7300987958	Shaft	<p>Mine shaft</p> <p>Marked on the 1st edition OS map of 1888. Not marked on the subsequent map of 1906.</p> <p>Area now covered in loose mine waste/scree.</p>	-

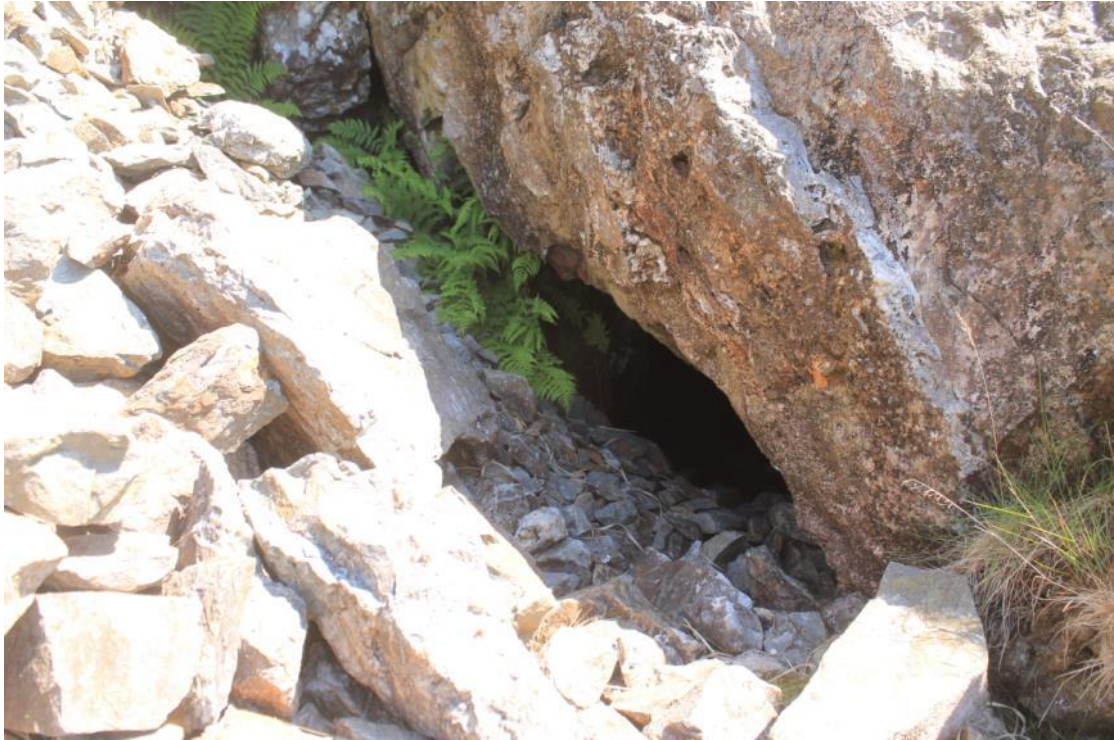
Photo 44: View NE of narrow opening below exposed bedrock, potentially representing a partially infilled shaft or level HM04

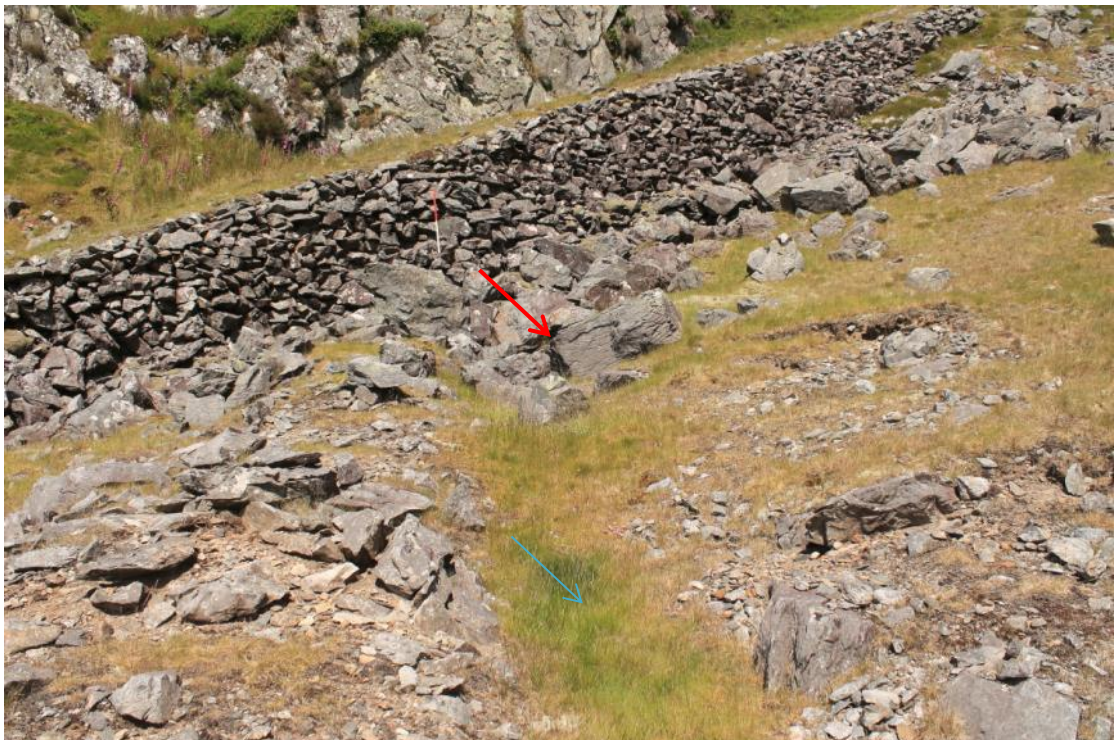
Photo 45: View N of potential infilled shaft HM09 (red arrow). Visible as a boulder-filled hollowed, with a turf-covered channel (blue arrow) running into the foreground.

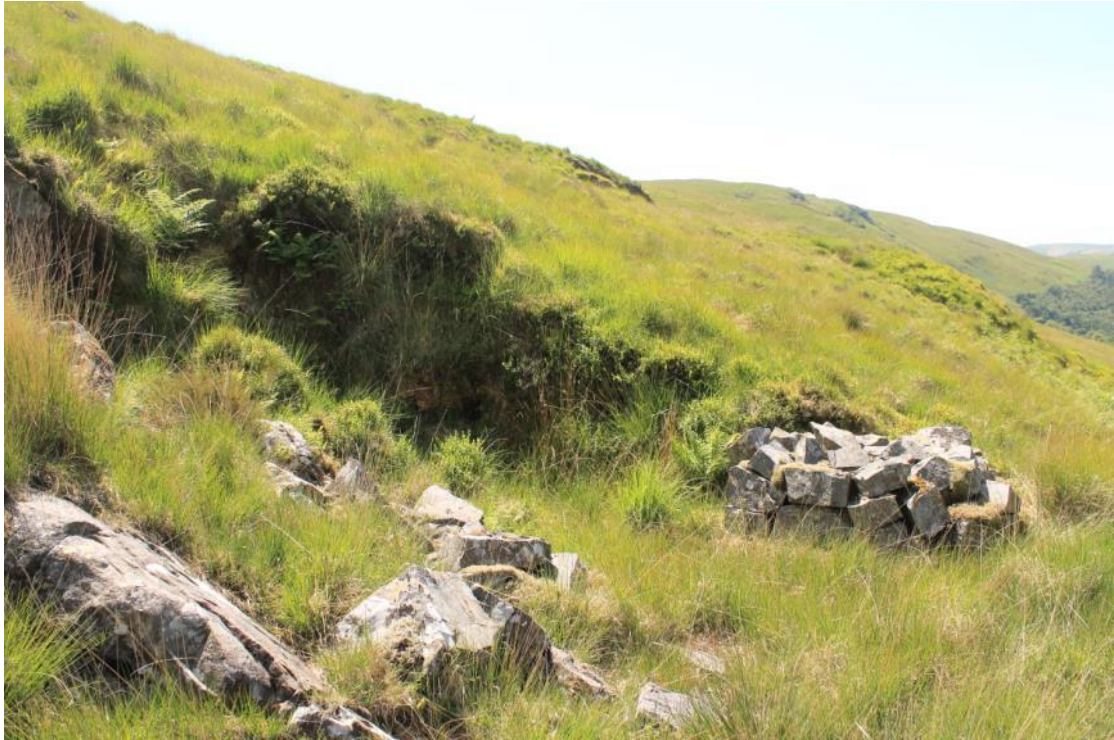
Photo 46: View SW of entrance to Level HM10, cutting into the hillside on the left, with a section of drystone walling at the entrance on the right.

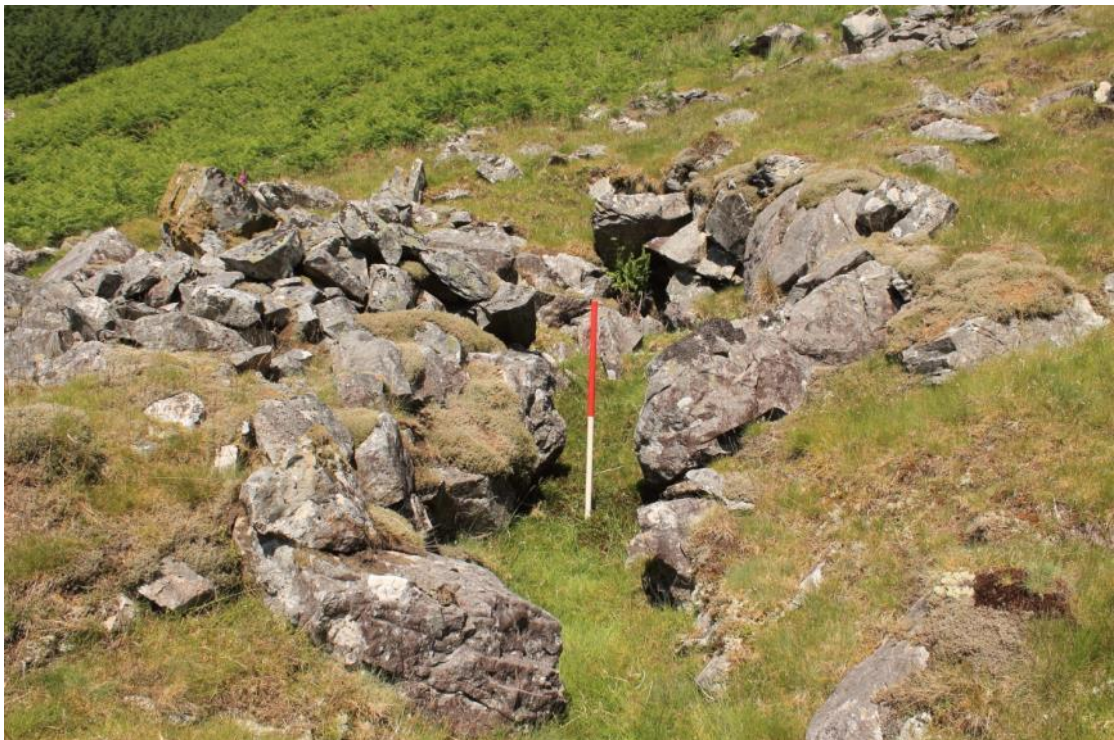
Photo 47: View N of approach to uncertain infilled shaft or level HM11. 1m scale.
