HAVERFORDWEST RIVERSIDE DEVELOPMENT, PEMBROKESHIRE: HISTORIC ENVIRONMENT DESK-BASED ASSESSMENT

REPORT NO. 2022-38
PROJECT NO. 129037

August 2022

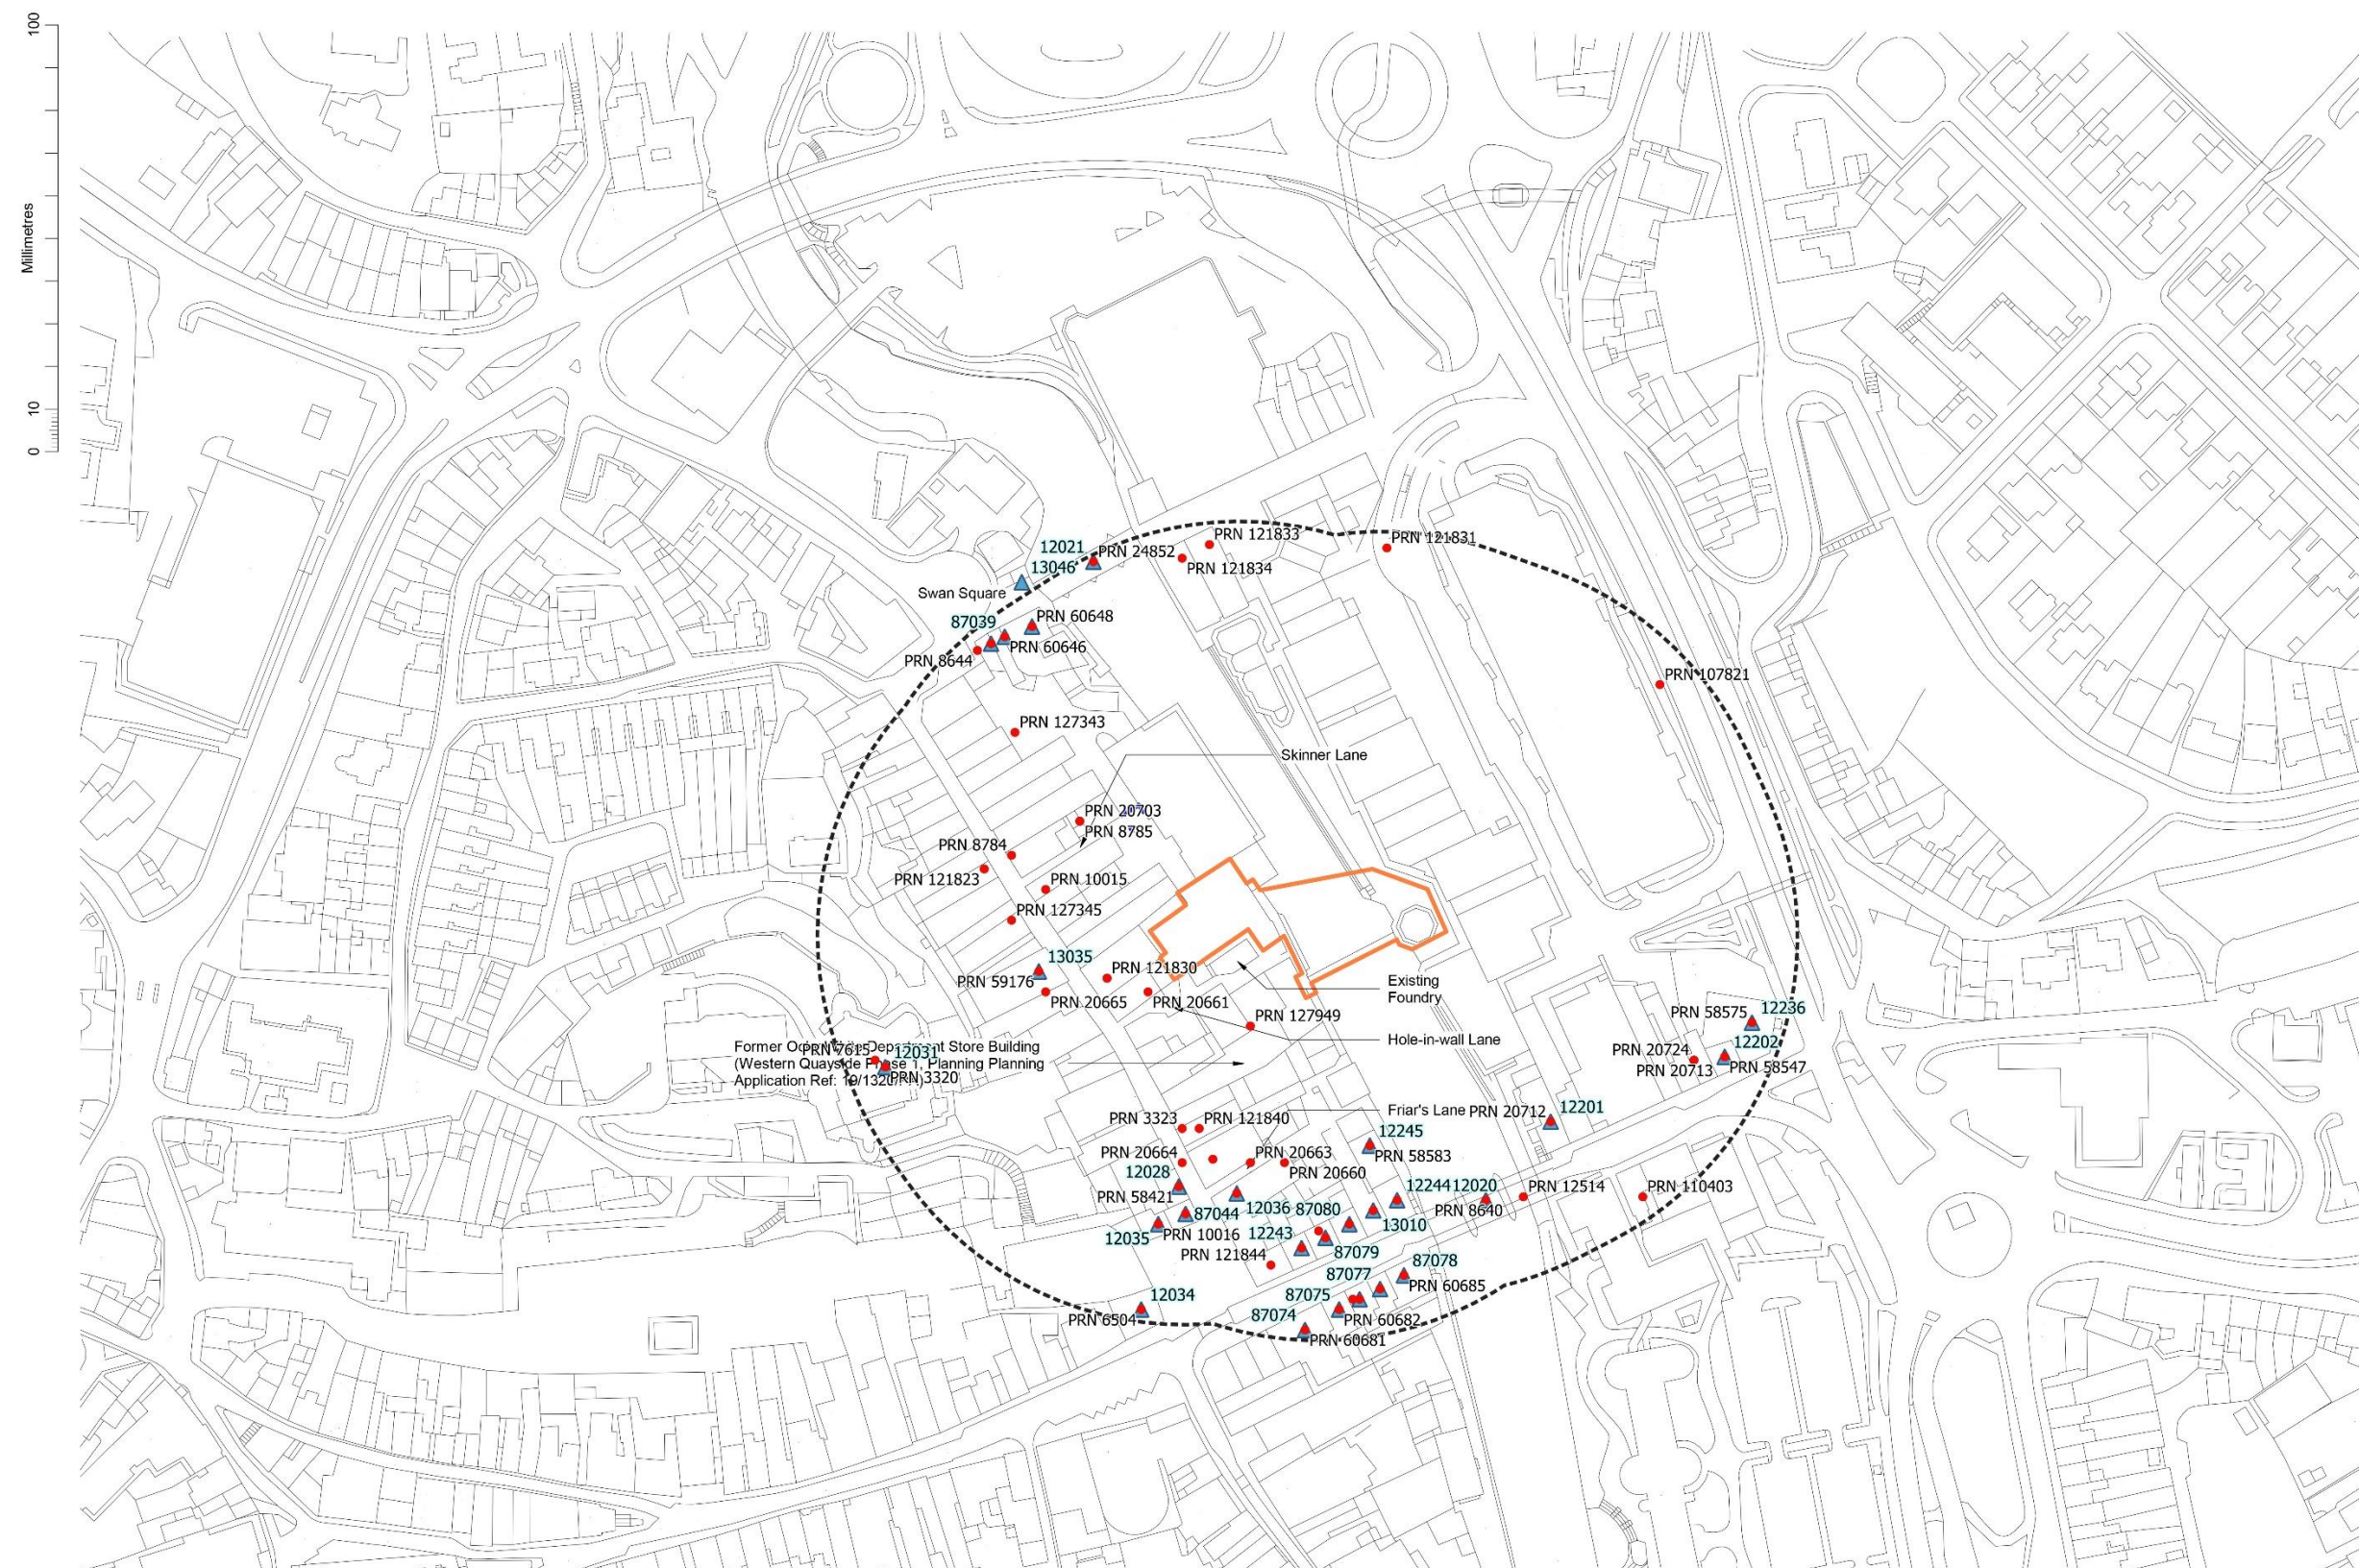
Figure 4: Location of sites recorded on the HER (red), labelled by PRN, with Listed Buildings shown in blue. Overlaid on an outline plan provided by the client (see Figure 2), but not reproduced to the original scale.

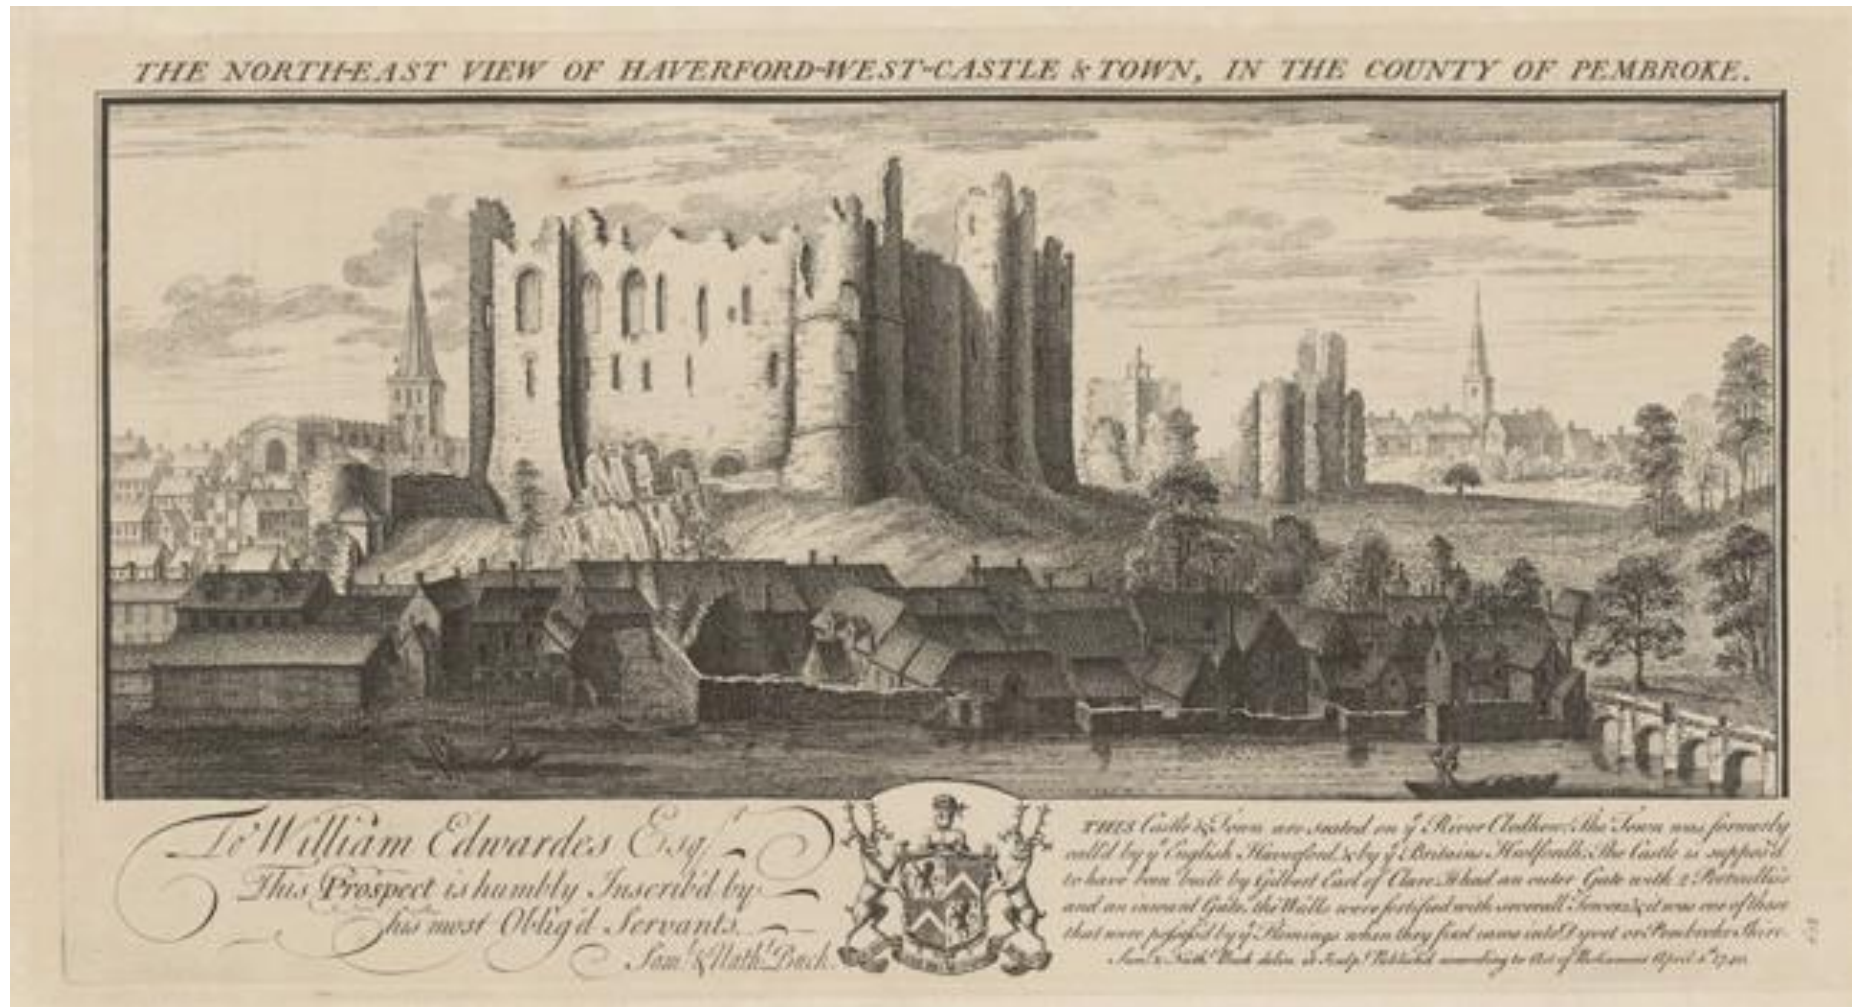
Figure 5: Engraving of Haverfordwest town and castle by Nathaniel and Samuel Buck, 1740. The current footbridge is likely to lie centrally, or just to the left of centre. The image predates the southern New Bridge, but the current Old Bridge is visible to the right.

- 6.3.1 Haverfordwest Castle has been the focus of many 18th and 19th century engravings and paintings, with many including depictions Bridge Street. The Buck engravings of the 1740s are probably the most widely reproduced and detailed, and these have been used to inform the historical development of the site (see section 5.7, Figures 5 & 6). A painting by William Pitt has also provided useful information on the Foundry site (see section 5.7, Figure 7).

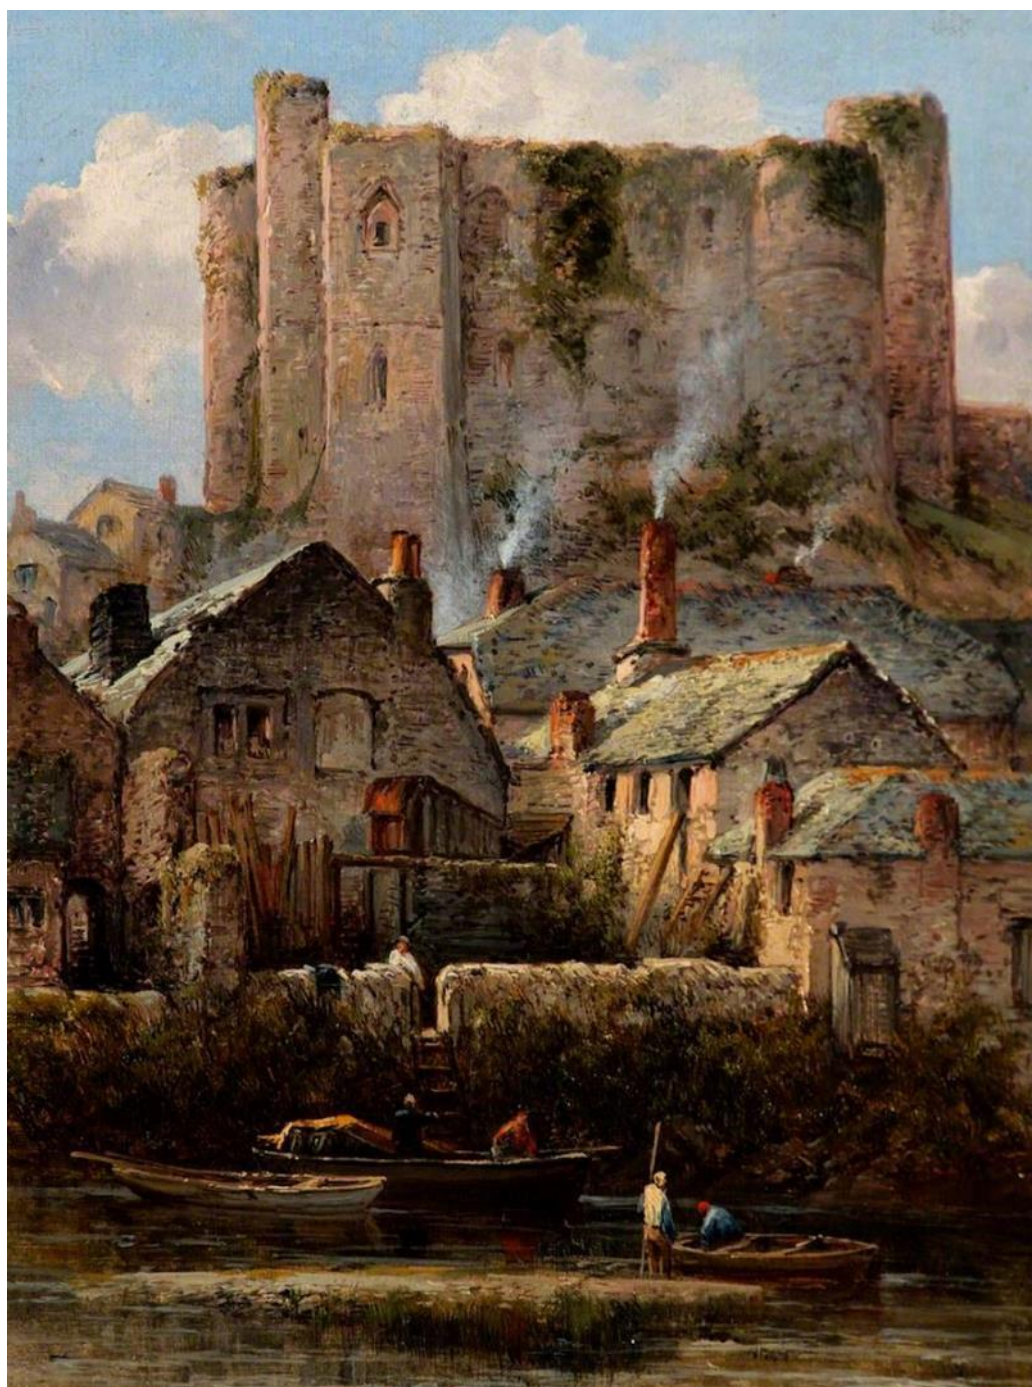
Figure 7: Painting of Haverfordwest Castle by William Pitt, 1872, showing Marychurch Foundry in the foreground.

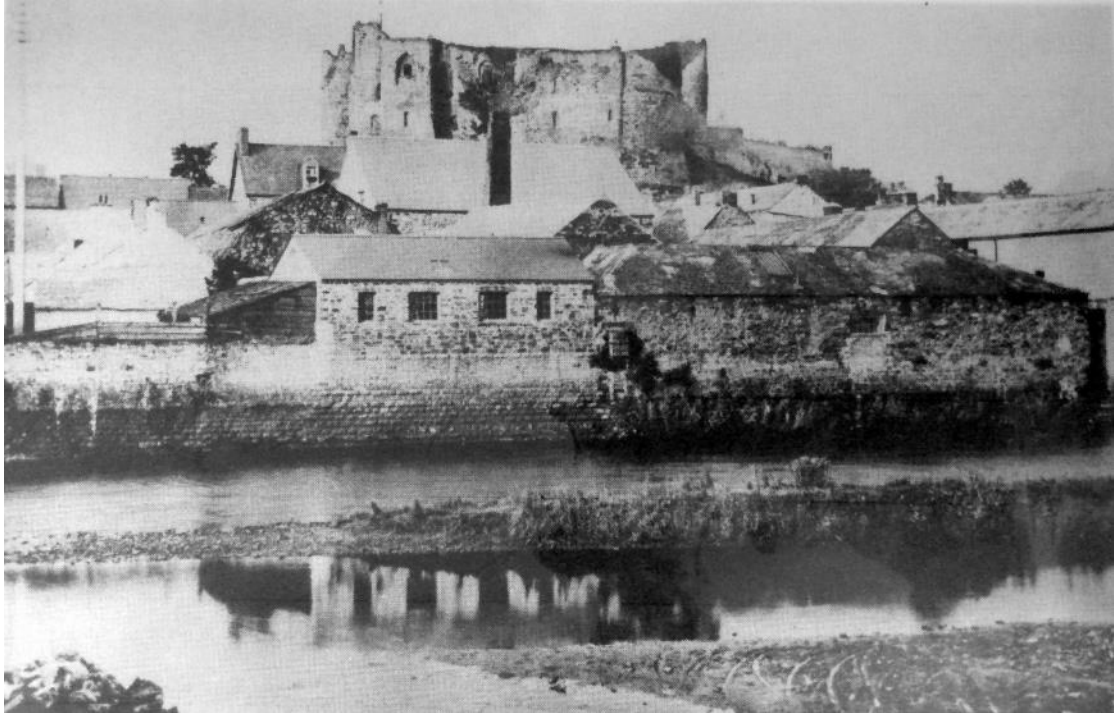
Photo 1: The Foundry with the castle in the background, viewed from the opposite banks of the river in *circa* 1890. The current footbridge crosses centrally, the east bank still comprising flooded marshland at this time.

- 5.7.5 It is during this period, whilst fashionable gentry houses were being built elsewhere, that an iron foundry appears to have been established on the west banks of the river at this site. The foundry history is detailed in the previous assessment (Poucher 2022) but it was reputedly founded in the mid-18th century and operated into the early 20th century, and possibly on into the mid-20th century. Plans and paintings show 19th century foundry structures and yards extending to the riverside, with a riverside wall along which boats could tie up. The main furnace appears to have been located within the Phase 1 development area, although little direct evidence of it came to light during current archaeological investigations. This layout is shown in plan on the detailed Ordnance Survey map of Haverfordwest in 1889 (Figure 8). One former foundry building remains standing, incorporated into the Phase 2 development plans. This formed the northern side of the foundry yard. The Hole in the Wall Lane ran around the north side of this, with access to the river at the end. North of this stood a Malthouse and associated buildings, an area now cleared, used as a car park and currently used as the site compound for the Phase 1 development works. A photograph of *circa* 1890 depicts the full site, as viewed from across the river (Photo 1).

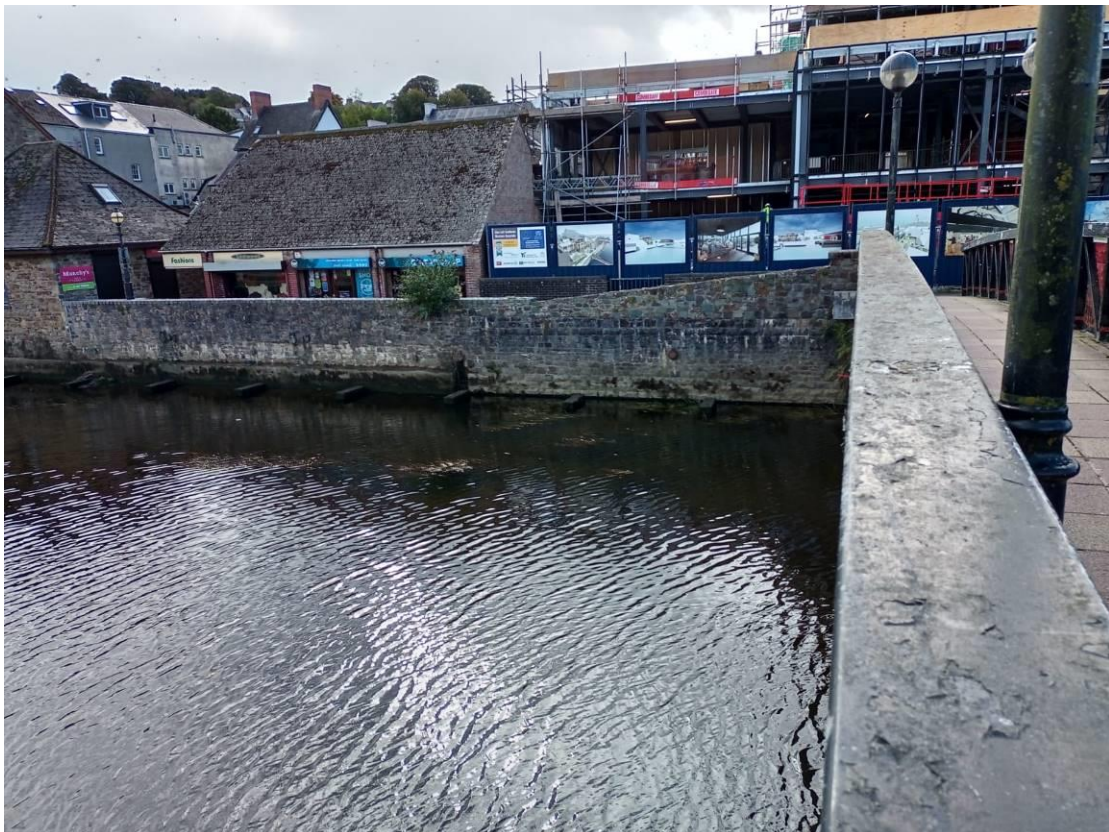
Photo 4: View of the western bank to the south of the current footbridge, as seen from the footbridge. Looking west.

- 6.6.3 To the west the river is fronted by vertical masonry walling. This walling runs continuously from the current footbridge to butt against the Café building on the riverside, and appears to sit on concrete foundations, suggesting a modern structure although potentially older masonry footings lie closer to the bridge. To the north of the bridge there is a lower step out in the river frontage, masonry built and topped with possible grey brick. Above this lies a modern masonry wall set slightly back.

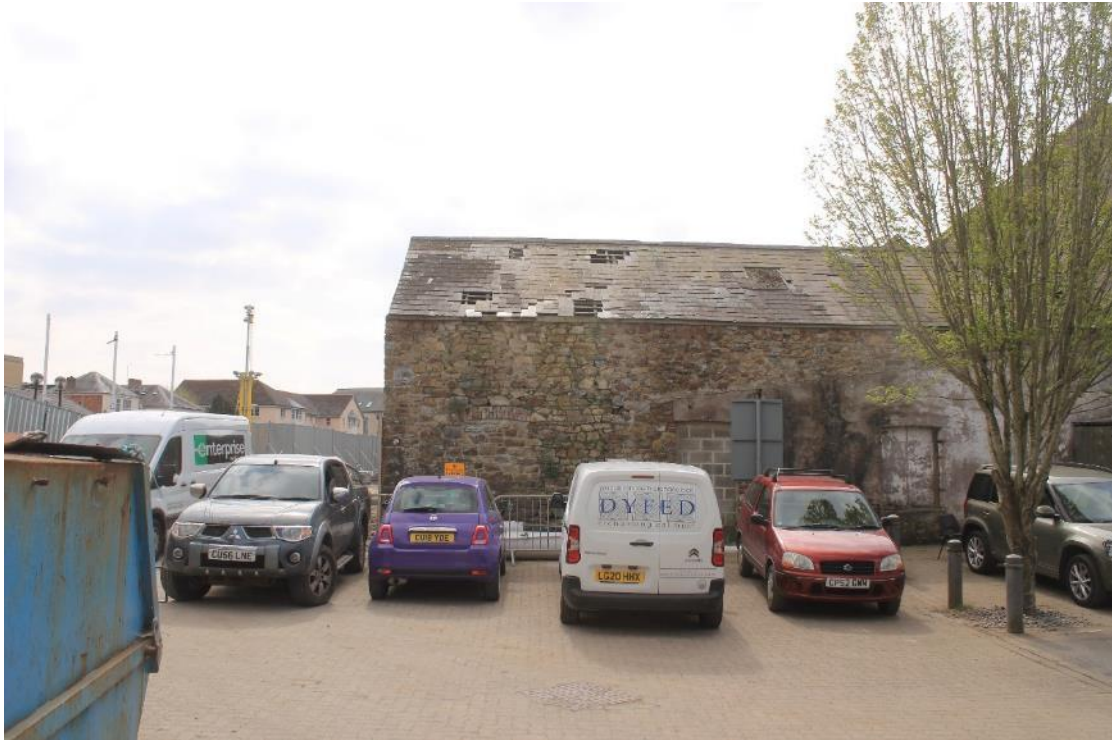
Photo 7: View SSE across the Phase 2 development area, with the standing foundry building in the centre and the riverside to the left.

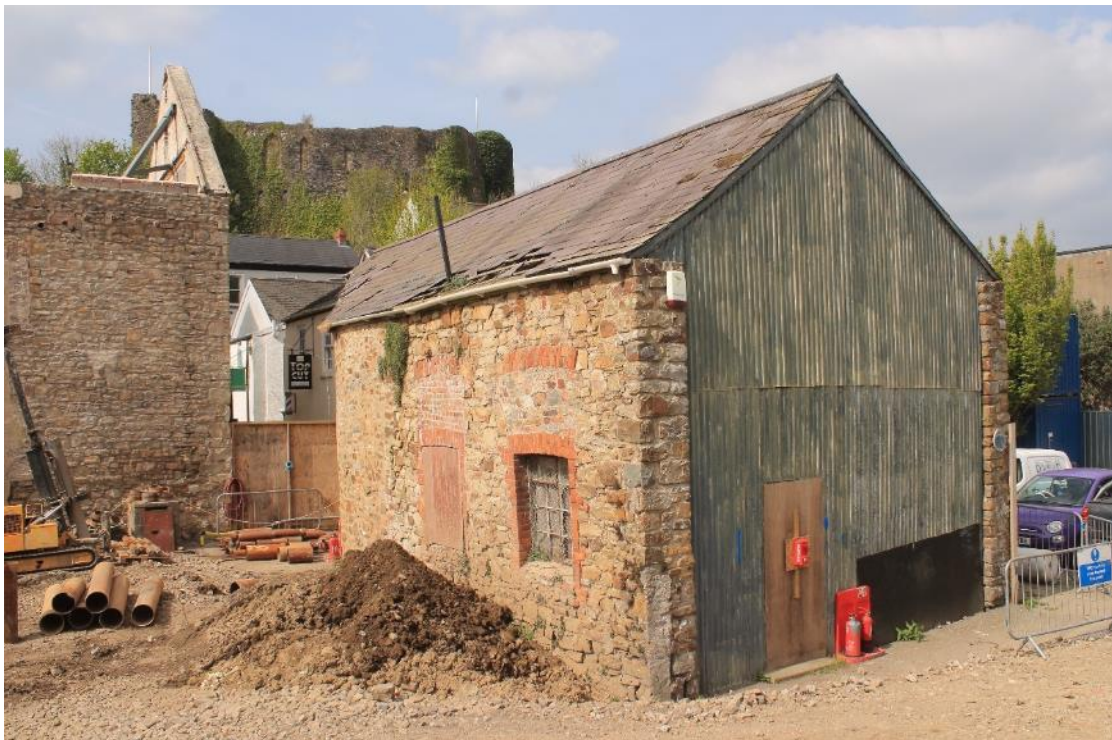
Photo 8: View west showing the standing foundry building with Haverfordwest Castle to the rear.

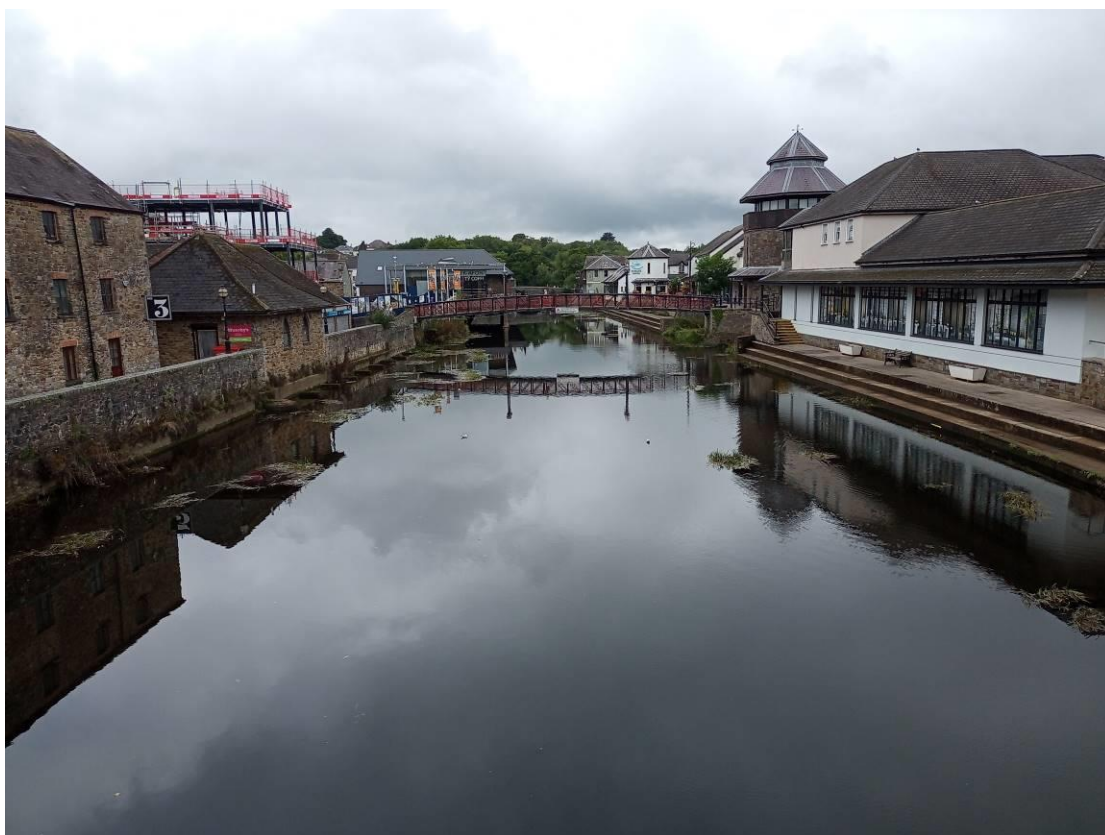
Photo 10: View of the site from New Bridge to the south, showing the current footbridge.

- 6.6.6 The river is crossed by a single-span, narrow, steel pedestrian footbridge, with open panels to the side at mid-height, infilled with thinner uprights. The bridge is lit by two lampposts along its span.

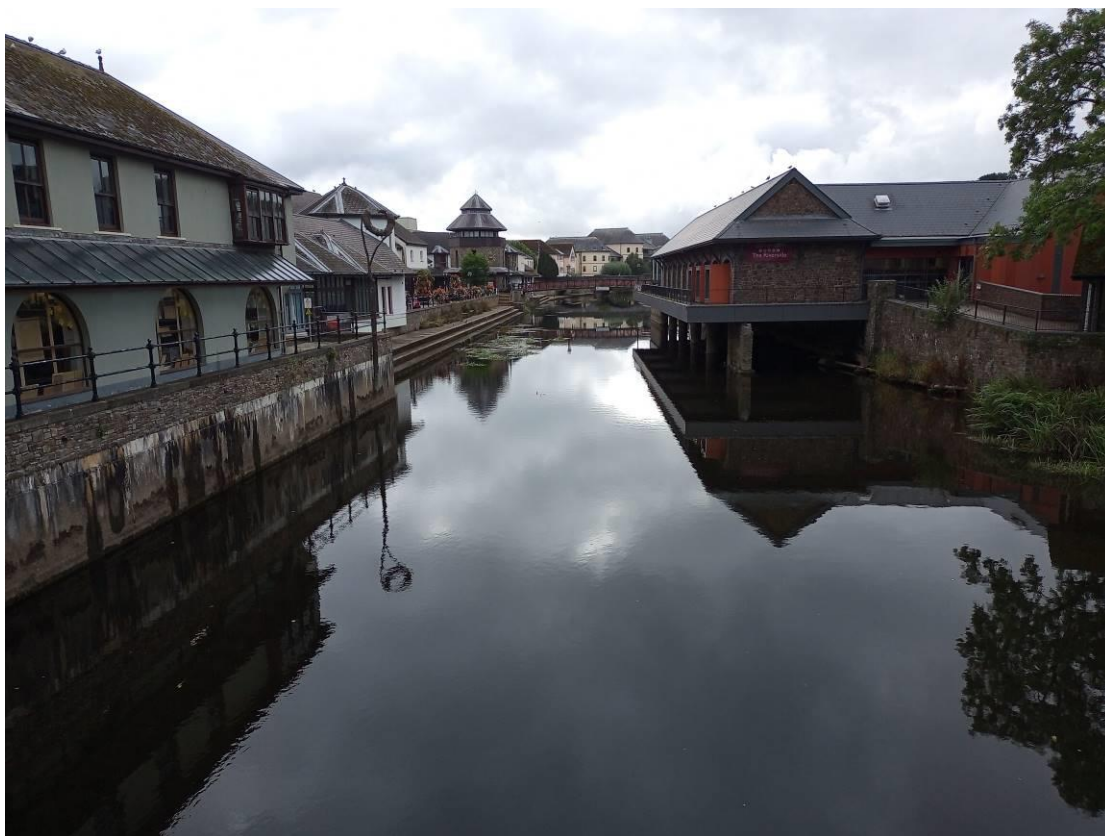
Photo 11: View of the site from Old Bridge to the north, showing the current footbridge.

- 6.6.7 There are clear views of the proposed development site from the New Bridge, Picton House and No.12 Victoria Place to the south, slightly more obscured from the warehouse to the rear of No.12 Victoria Place. Views from the Old Bridge to the north are semi-obscured by the protruding market and library building.

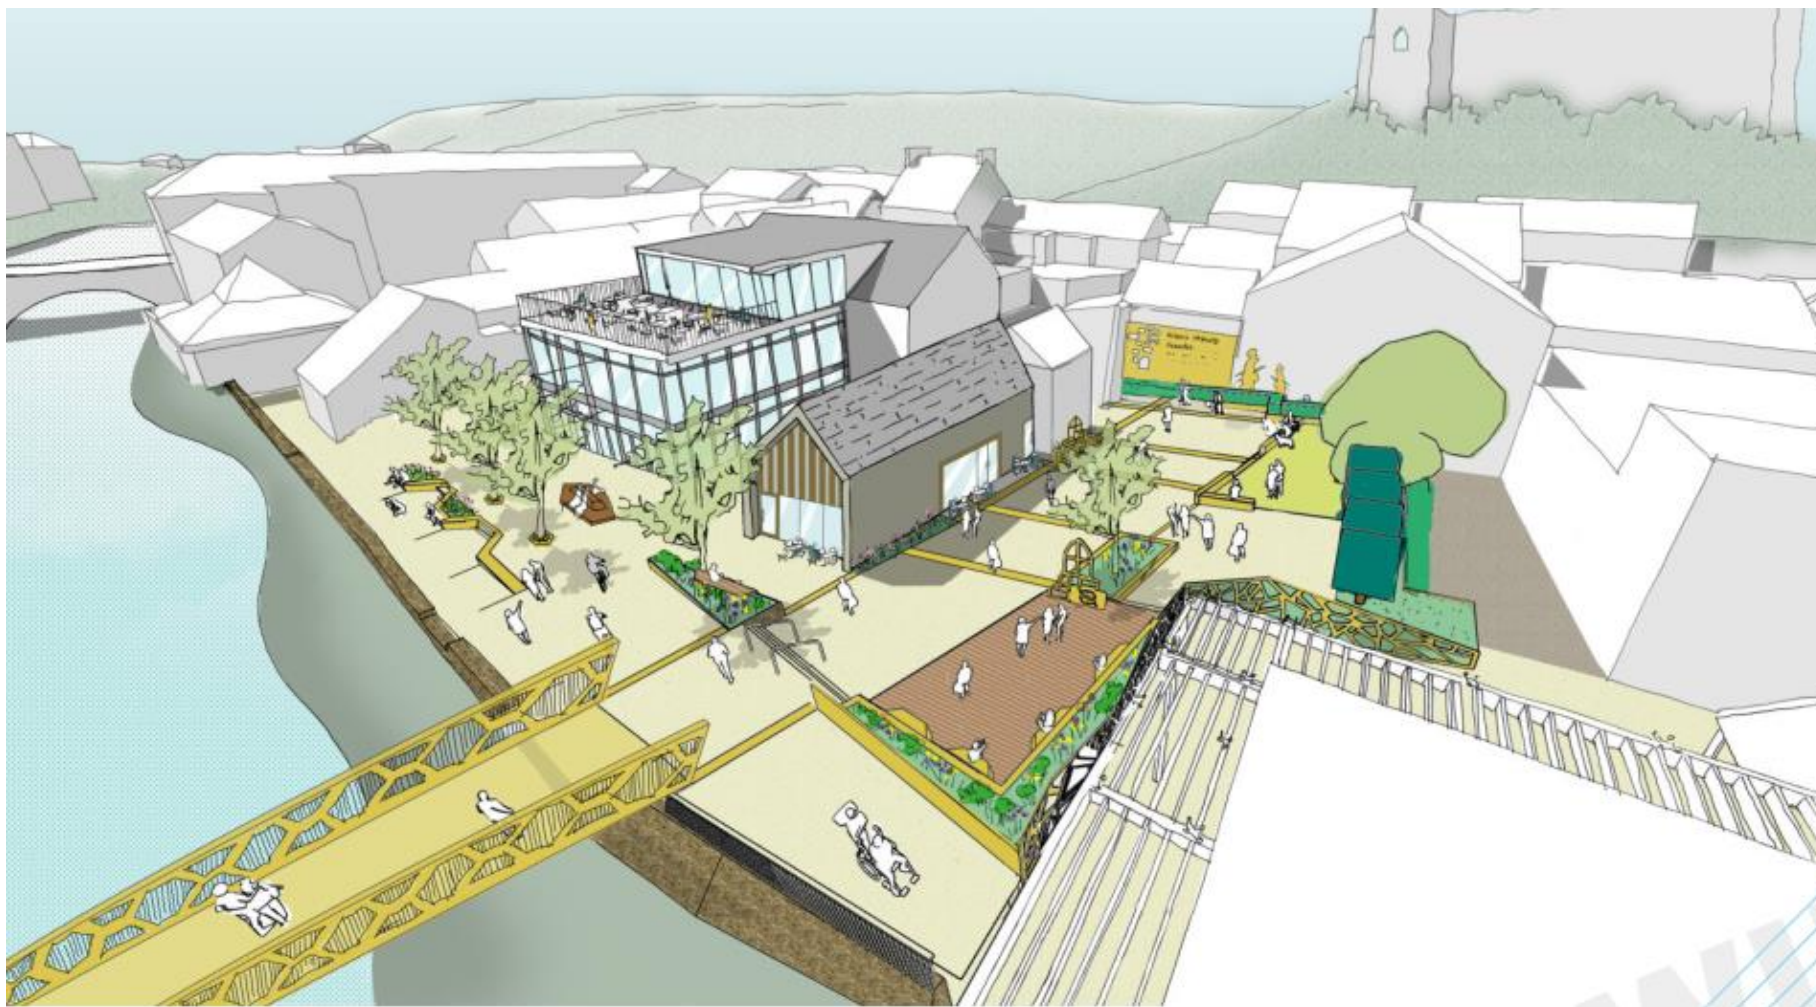
Figure 10: Concept designs for the proposed new footbridge on the western bank of the river. Illustration provided by the client.
