DYNAMIC DUNESCAPES, PEMBREY BURROWS: ARCHAEOLOGICAL WATCHING BRIEF 2022

Prepared by DAT Archaeological Services
For: Natural Resources Wales

**REPORT NO. 129710
EVENT RECORD NO. 2022-49**

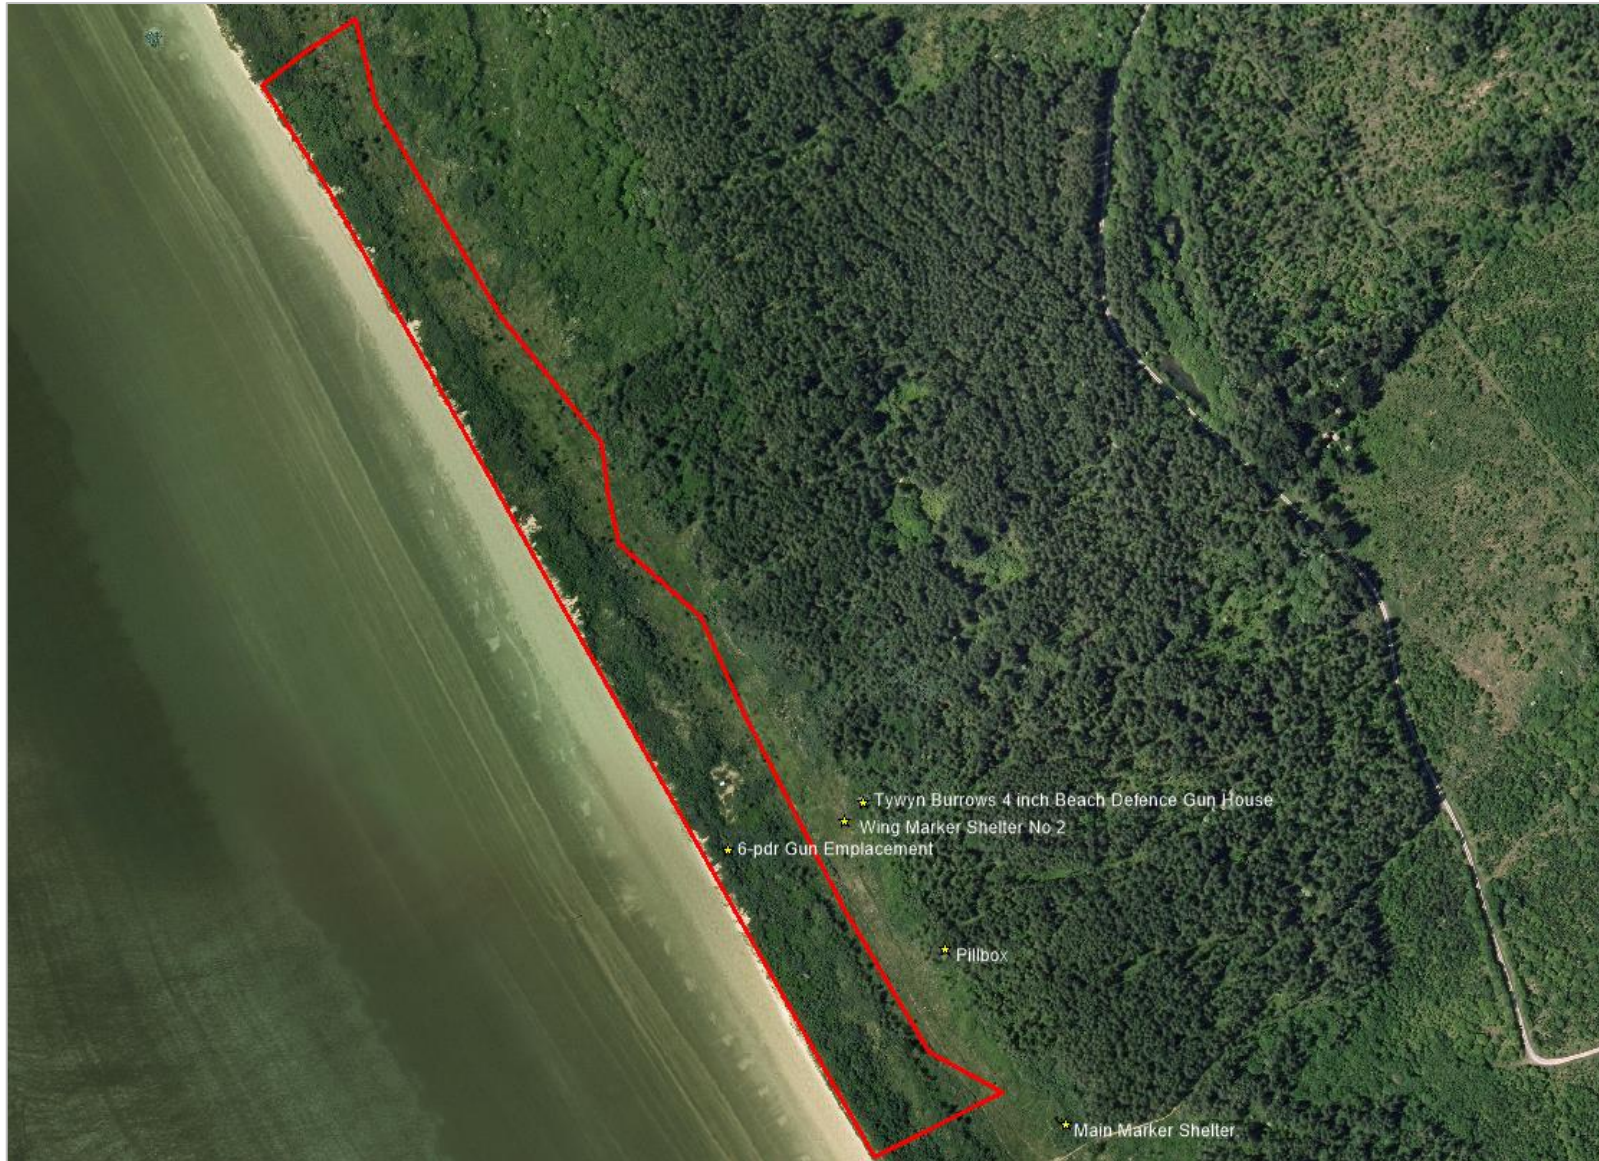
Figure 4: Historic assets recorded within, or close to, Area 2 (aerial photography © Google).

Table 2: Historic assets within, or close to, Area 2 (mapped in Figure 4).

PRN	REF	NAME	TYPE	SUMMARY	EVIDENCE	NGR
31414		Wing Marker Shelter No 2.	Wing marker shelter	Wing Marker Shelter No 2. A small concrete rectangular plan shelter with a turf covered concrete roof.	A Pyper site visit; M. Bell site visit	SN 37053 03516
31415		Main Marker Shelter	Gun emplacement	A concrete rectangular plan shelter with a turf covered concrete roof.	A Pyper site visit; M. Bell site visit	SN 37240 03260
112367		Tywyn Burrows 4 inch Beach Defence Gun House	Gun emplacement	A Second World War gun emplacement overlooking Cefn Sidan beach.	A Pyper site visit; M. Bell site visit	SN 37069 03532
118045		Pillbox	Pillbox (variant)	A pillbox constructed in brick with a shuttered concrete roof.	A Pyper site visit; M. Bell site visit	SN 37138 03408
	J Berry 2016	6-pdr Gun emplacement	Gun emplacement		J Berry plotted from secondary source	SN 36955 03492

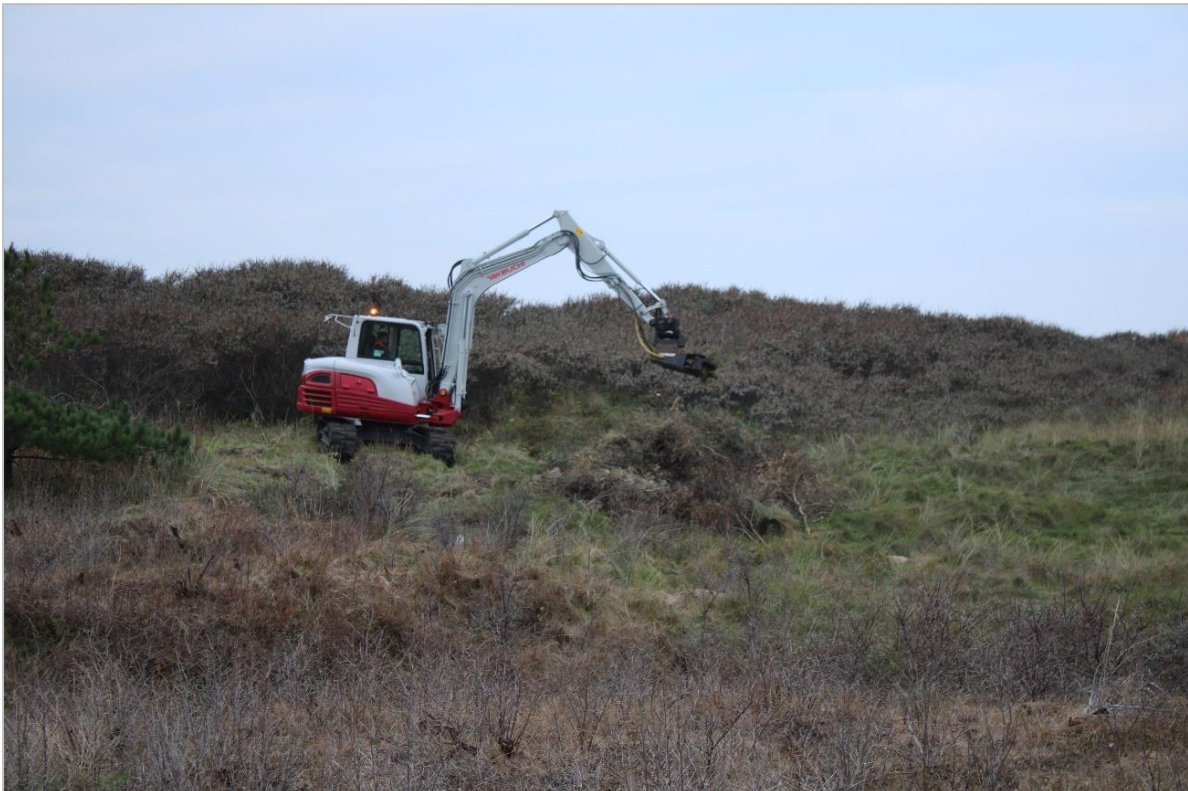
- 5.1.1 The density of sea buckthorn to be removed in Area 1 prevented a walkover survey of the site before the mechanical excavators moved in (Photo 1).

Photo 1: Area 1, looking south-west with sea buckthorn removal just getting underway

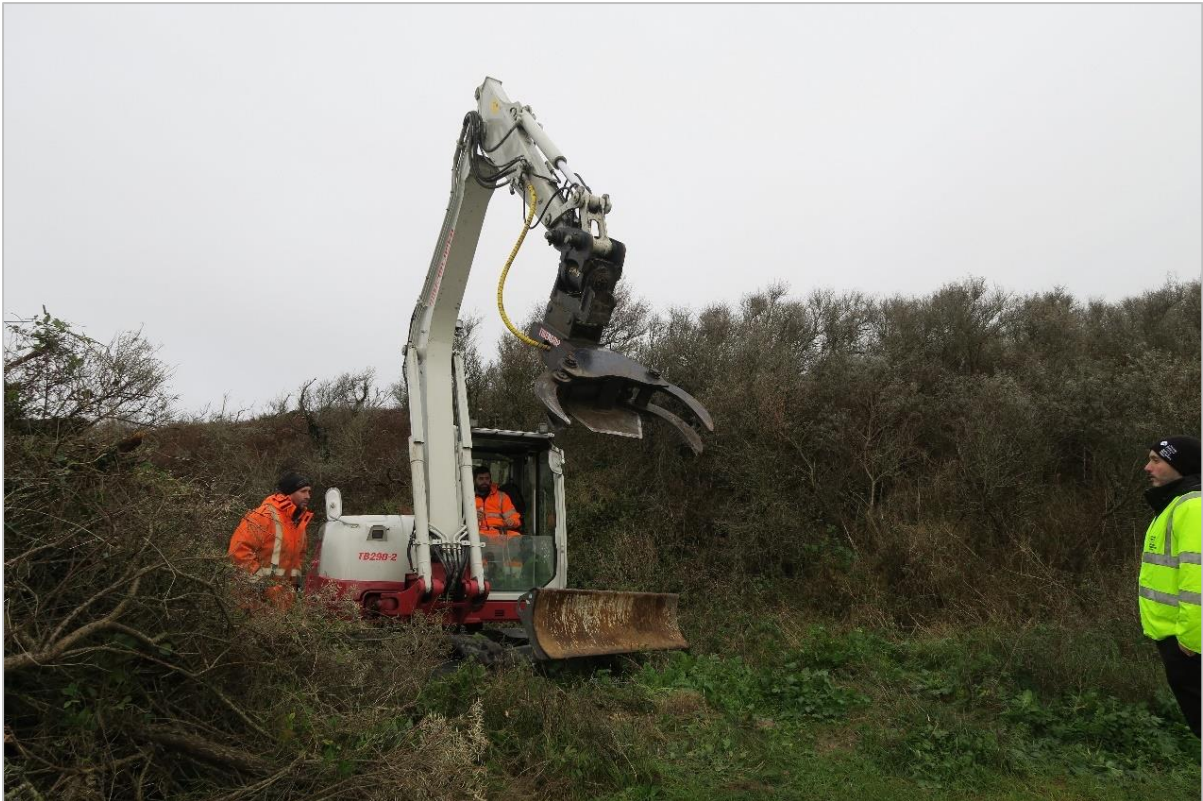
Photo 2: A mechanical excavator equipped with a tree shear attachment (photo by C. Enright, 2021).

- 5.1.2 The buckthorn was removed using mechanical excavators equipped with tree shear attachment (Photo 2). The plants were cut at ground level leaving the roots and stumps. The arisings were removed to a nearby car park for mulching using a tracked telehandler with a grabbing attachment.

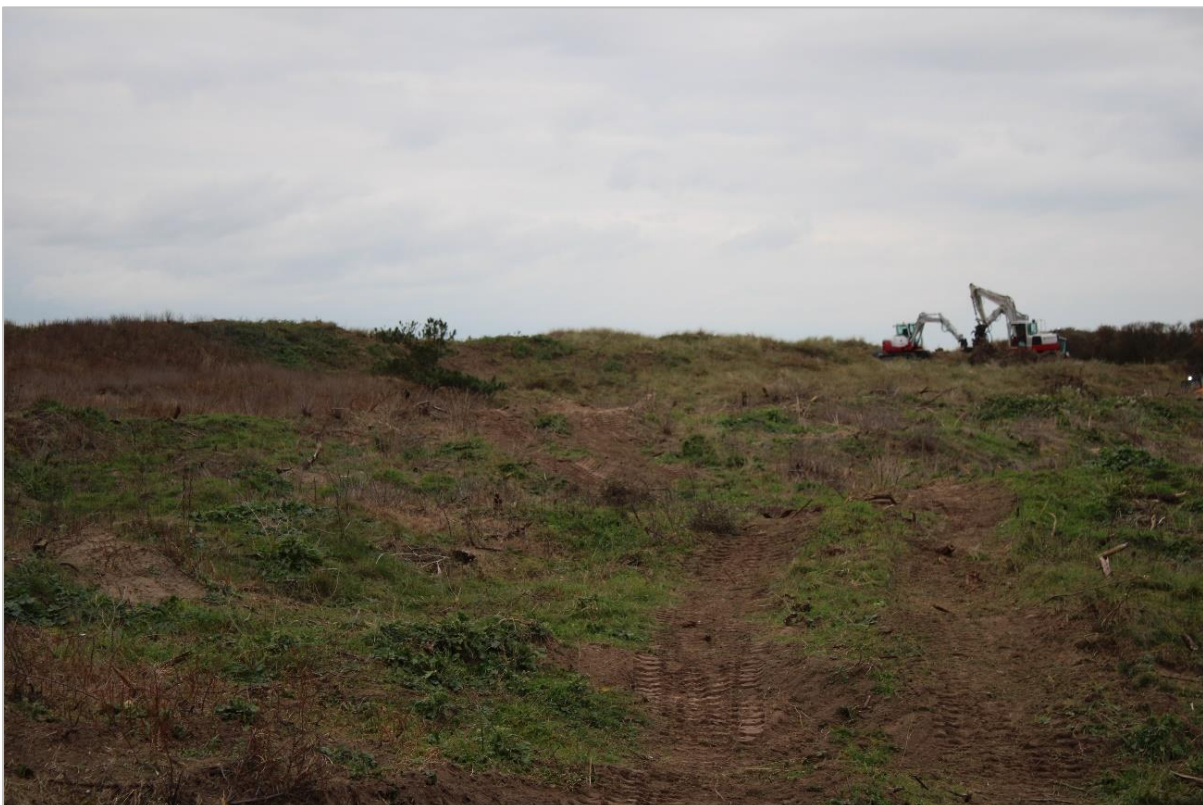
- 5.1.3 As areas were cleared of buckthorn it was possible to carry out a walkover survey. Although some detritus was left behind (Photo 3) any upstanding archaeological remains should have been visible.

Photo 3: Dune habitat in Area 1, looking south-west following sea buckthorn removal.

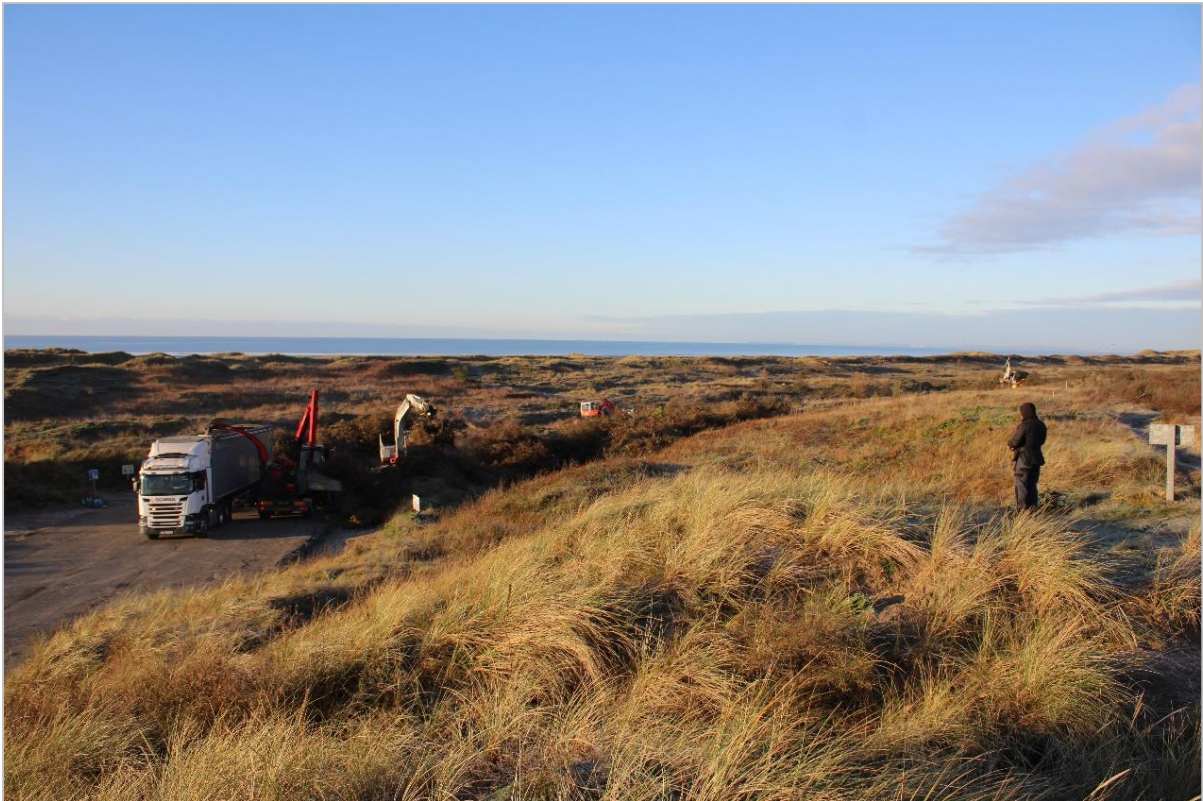
- 5.1.4 No archaeological remains were observed post-clearance in Area 1 (Photo 4).
- 5.1.5 While observing the mulching of arisings from a footpath overlooking the car park, a number of archaeological features were seen in the dunes (Photos 5–6). A pair of rectangular concrete blocks, with the remains of iron fixings at each end, and a pair of iron bars set into concrete plinths represent the remains of possible WW2 defensive structures. These were recorded in the Dyfed HER (PRNs 129713 & 129714).

Photo 4: Overview of Area 1 following sea buckthorn removal and showing arisings being mulched in the car park. Looking south-west.

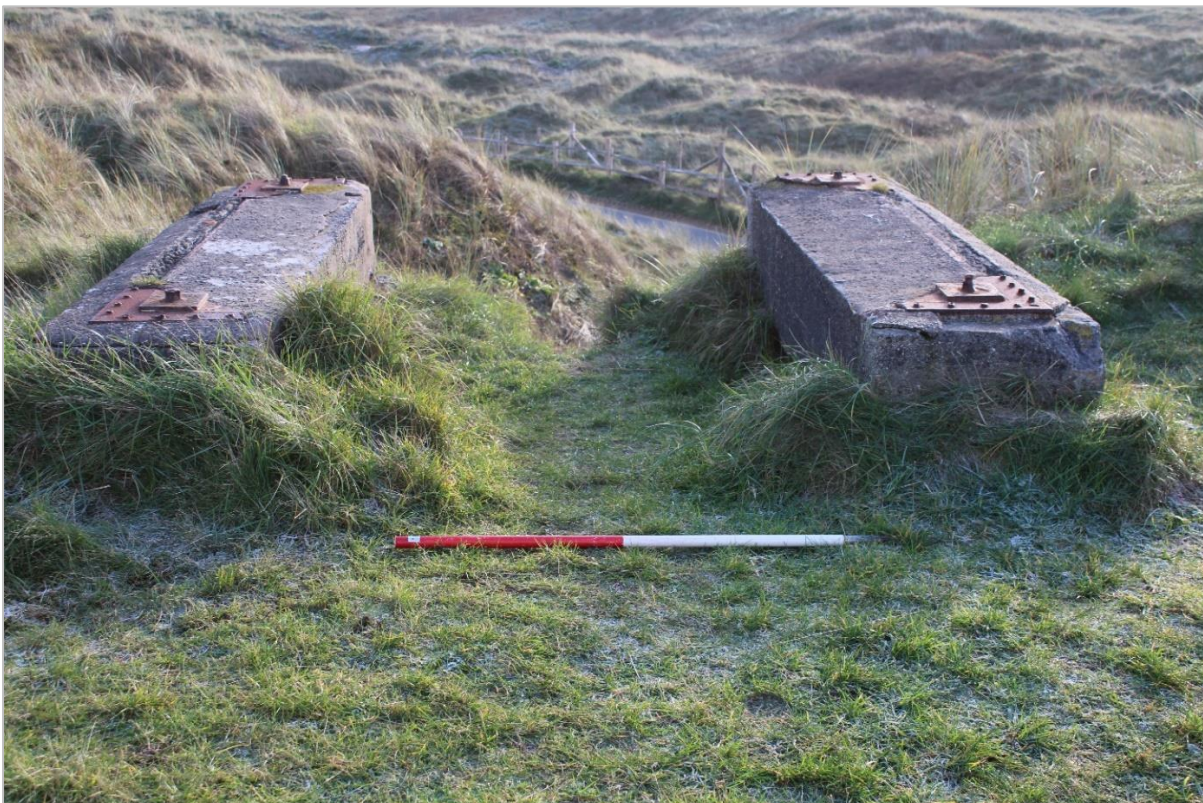
Photo 5: Concrete structure (PRN 129713) recorded adjacent to the footpath near the fisherman's car park. Looking south-east, 1m scale.

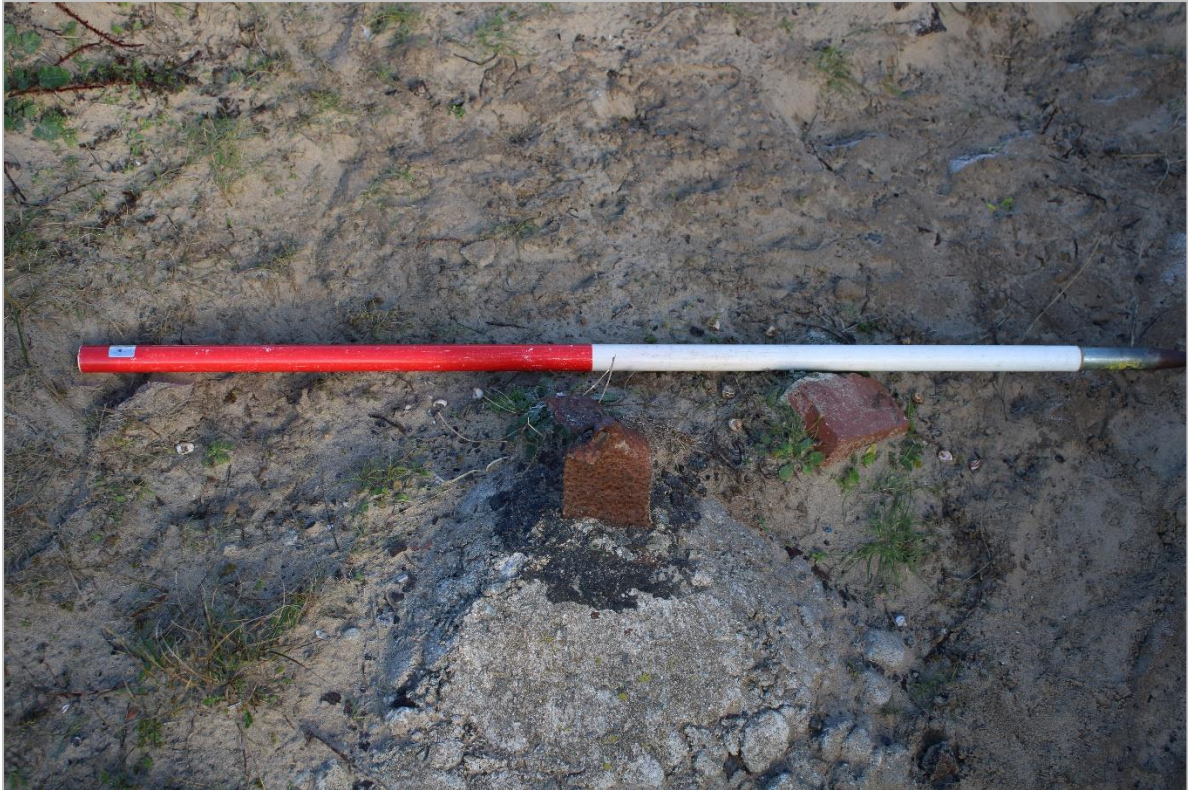
Photo 6: One of a pair of former metal posts (PRN 129714) set into concrete, recorded adjacent to the footpath overlooking the fisherman's car park. Looking south, 1m scale.

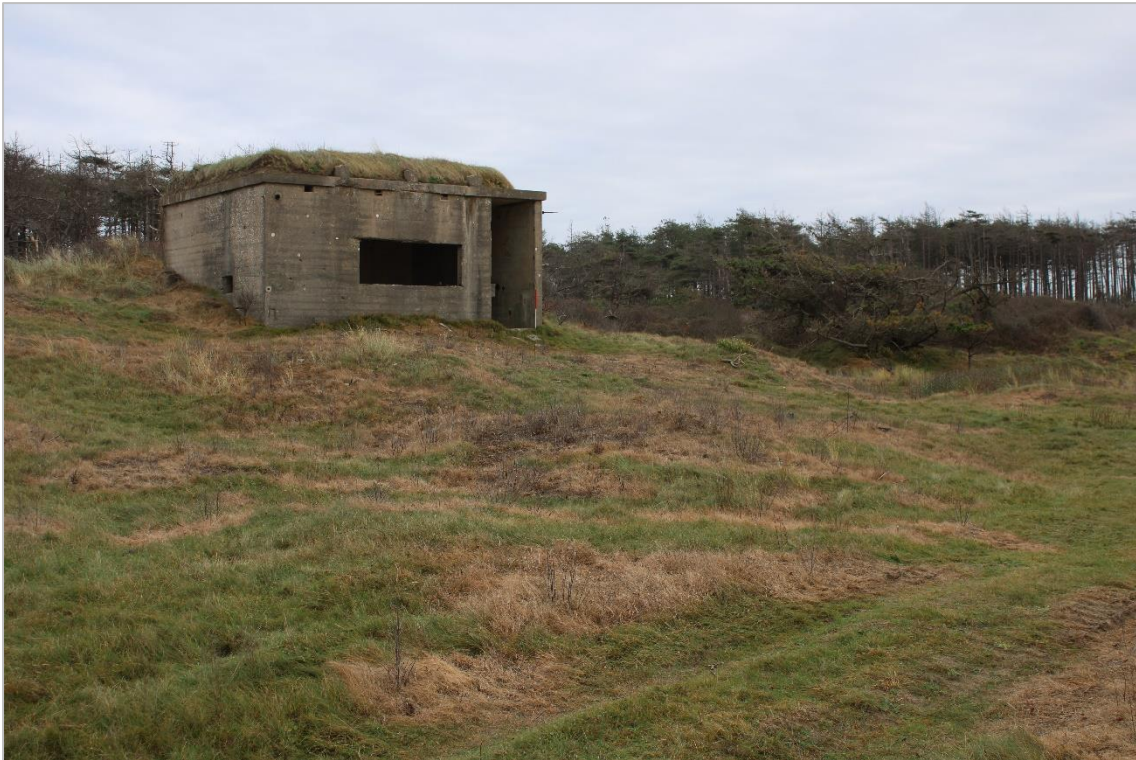
- 5.2.1 During the watching brief in Area 2 PRNs 31414, 118045 and 112367 were all observed. PRN 31415 was also seen but it was located just beyond the eastern boundary of the area (Photo 7). A 6pdr Gun Emplacement recorded by Berry (2016) was not seen. The location of each historic asset observed is shown in Figure 3. Photos 7–10 show the condition of each asset at the time of the watching brief. PRNs 31414 and 31415 were clear of buckthorn and other vegetation growth. Both are exposed to the elements but are currently a good and stable condition.

Photo 7: Main Marker Station PRN 31415, just to the east of Area 2.
Looking east, 1m scale.

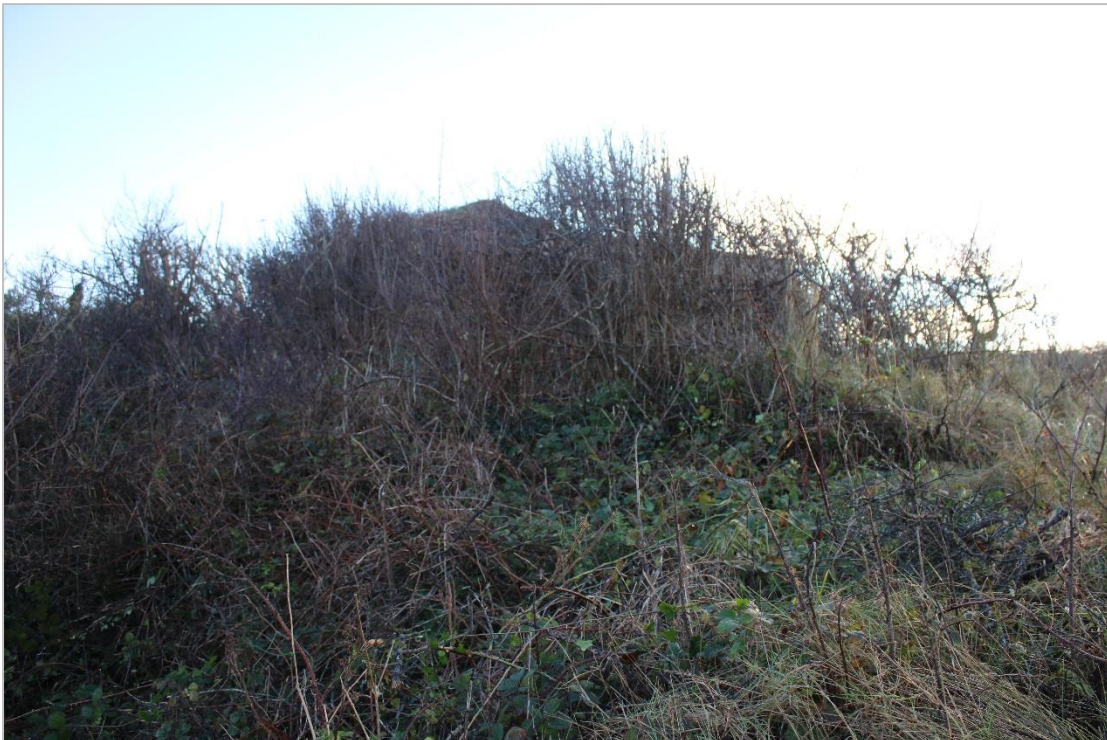
- 5.2.2 The brick pillbox (PRN 118045) is as described by Enright (2021), i.e., largely obscured from view by vegetation and the build-up of sand around it (Photo 8). It was not possible to get close to the structure, but it did appear to be in a stable condition.

Photo 8: Pillbox PRN 118045 looking north-east, no scale.

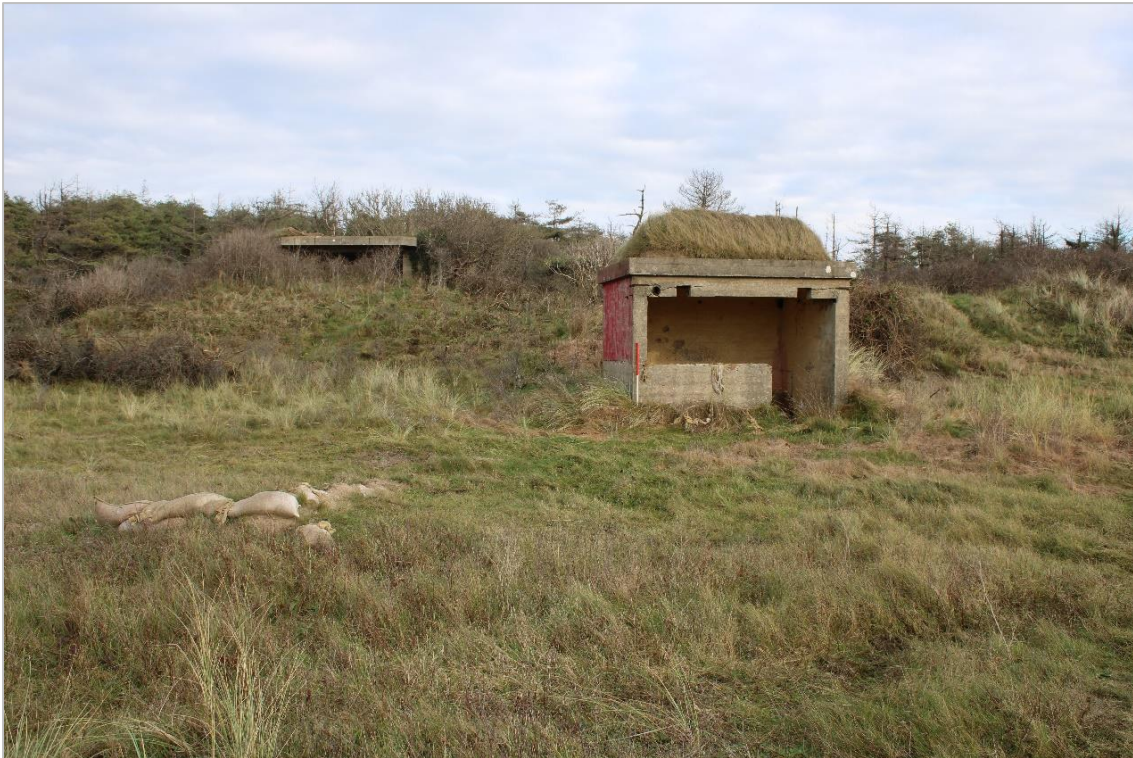
- 5.2.3 Tywyn Burrows 4" Beach Defence Gun House (PRN 112367) remained surrounded by low-lying stands of hawthorn and scrub following removal of stands of buckthorn. Nonetheless it was possible to get close to the structure, which appears in a good and stable condition (Photos 9–10).

Photo 9: Wing Marker Shelter No. 2 (PRN 31414) with PRN 112367 visible to the rear. Looking north-east, 1m scale.

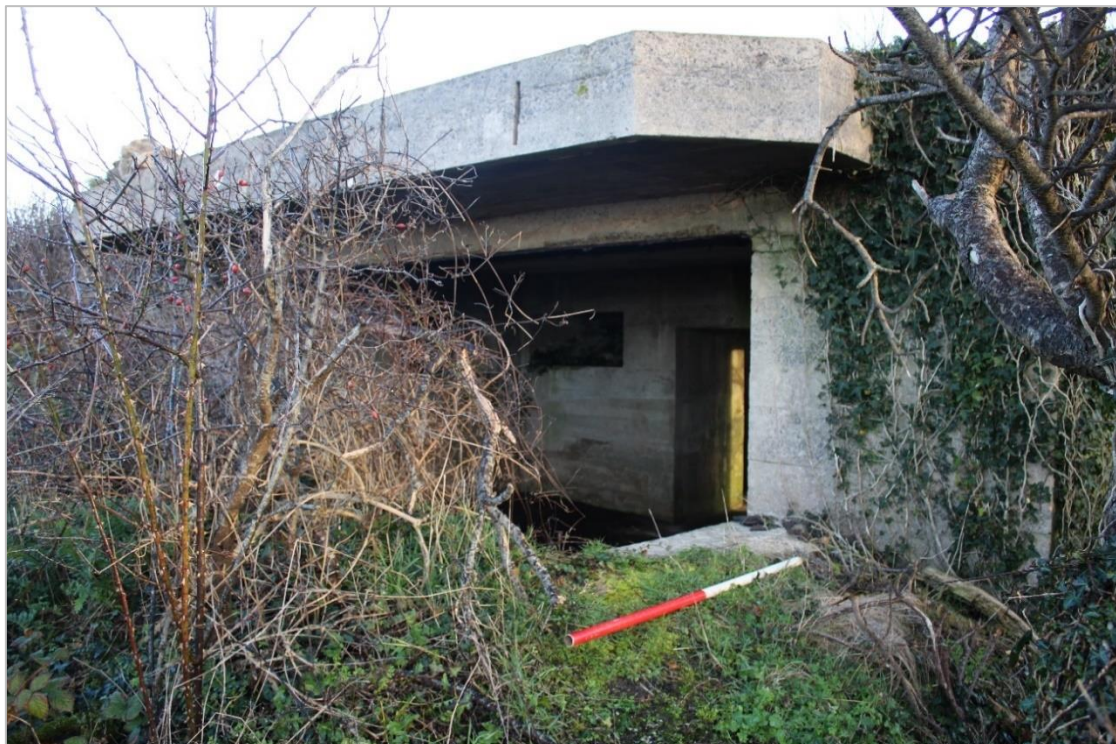
Photo 10: Tywyn Burrows 4" Beach Defence Gun House (PRN 112367). Looking north-east, 1m scale.

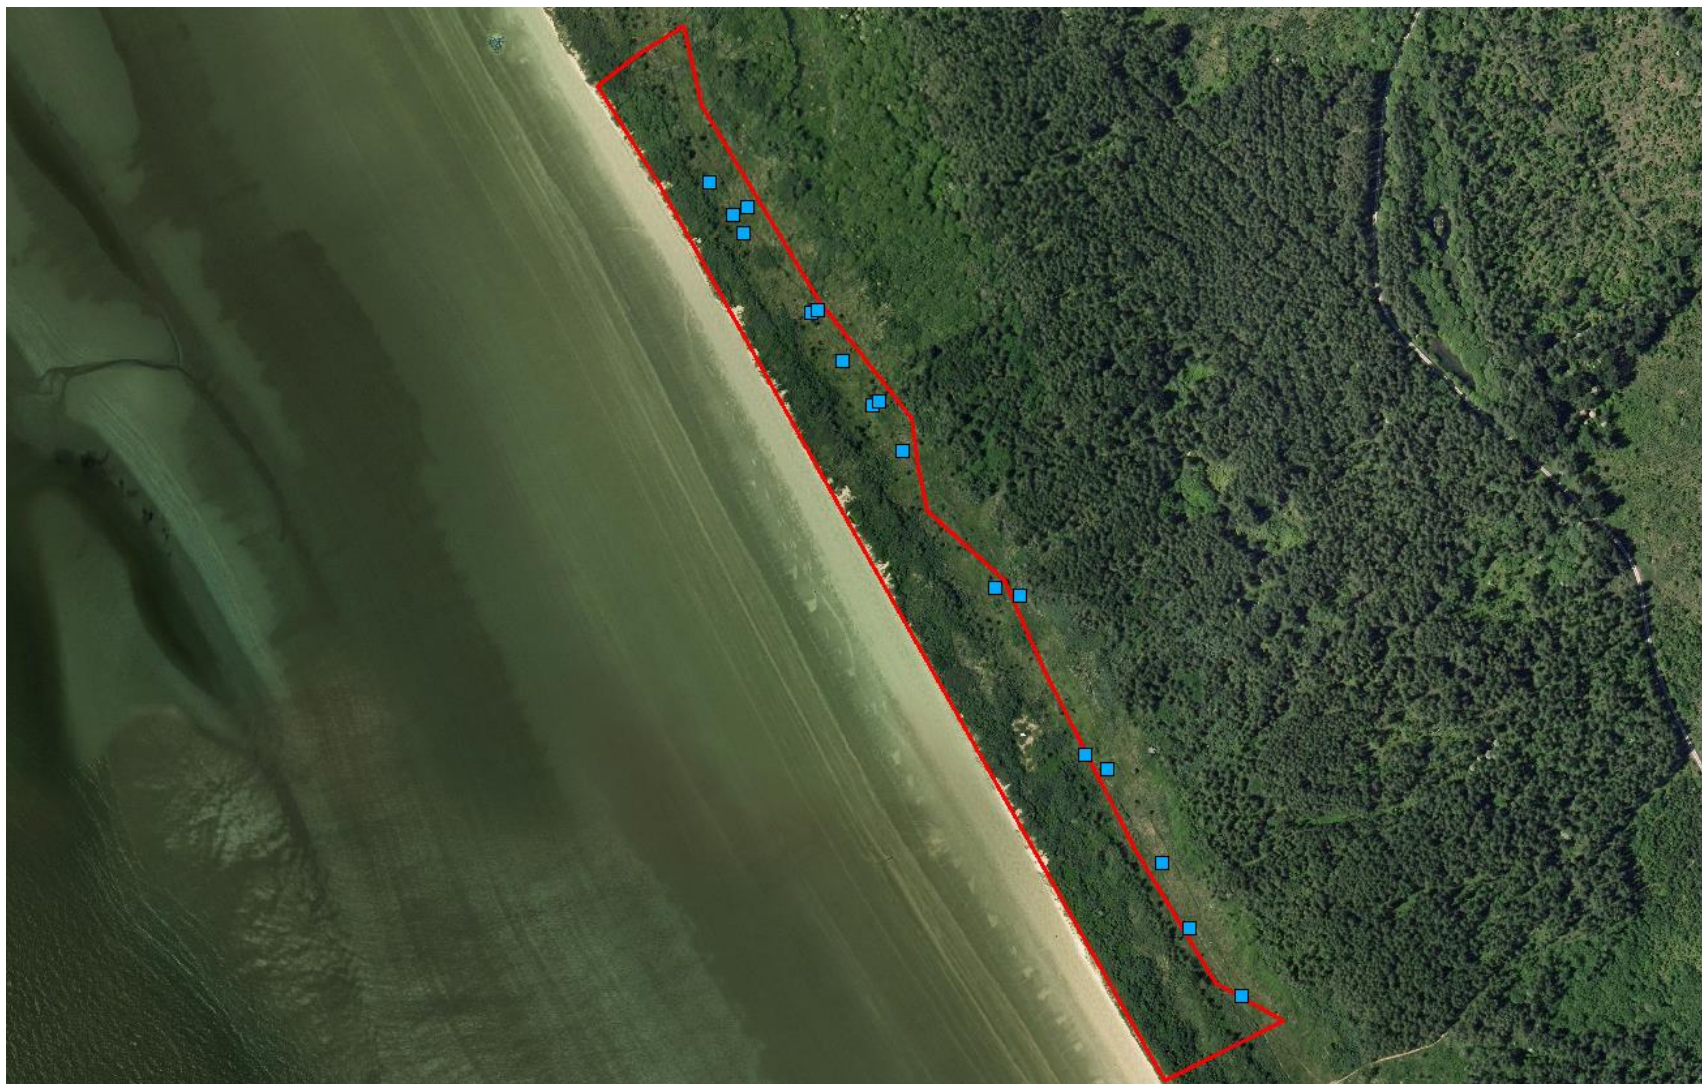
- 5.2.4 Following the removal of buckthorn in Area 2, a line, or possibly two lines, of concrete fence posts was visible roughly parallel with the shore line (Figure 5 and Photos 11–12). These had not previously been observed. Their positions were recorded using GPS surveying equipment and a record of them created on the regional HER (PRN 129715). The easternmost fence post had a visible height of c.1.2m and bore the letters GPO (General Post Office) ; the remainder were taller, c.1.3m, and thinner, with no lettering. At the time of the watching brief, some of the fence posts were still intact and upright, some were recumbent and some broken. In three locations, a pair of fence posts was located either side of a path through the dunes.

Figure 5: Showing the locations of fence posts (blue dots) observed following removal of buckthorn in Area 2 (red outline) (aerial photography © Google).

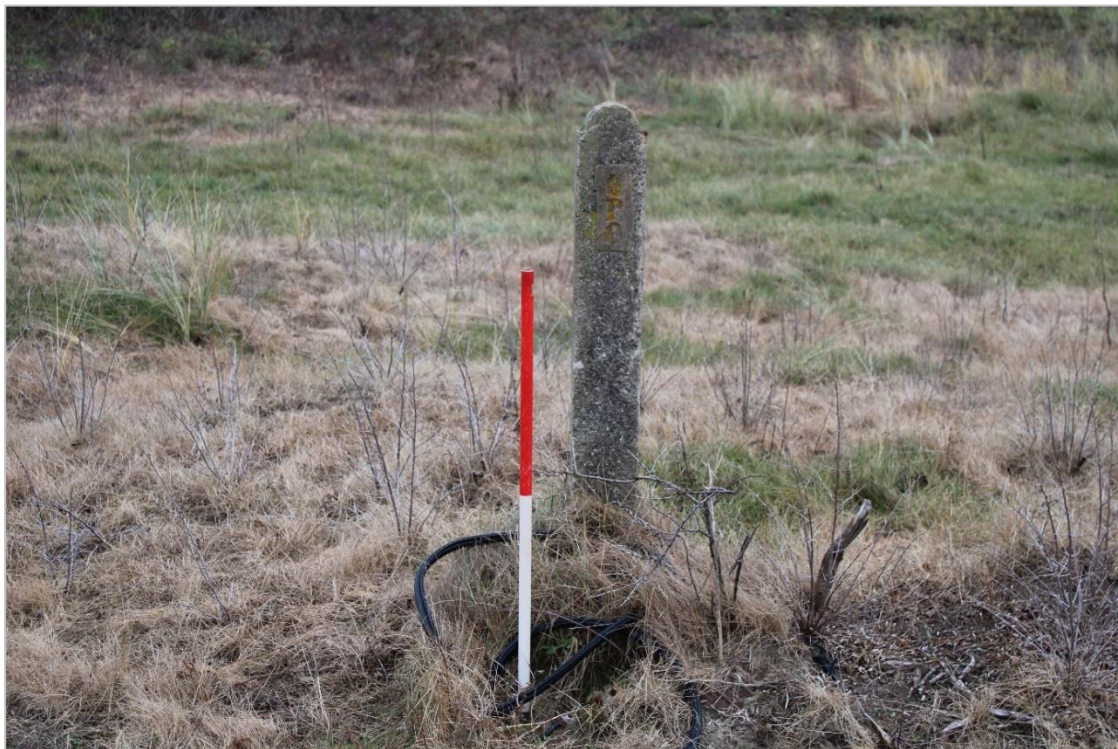
Photo 11: Concrete fence post bearing the letters GPO. Looking north, 1m scale.

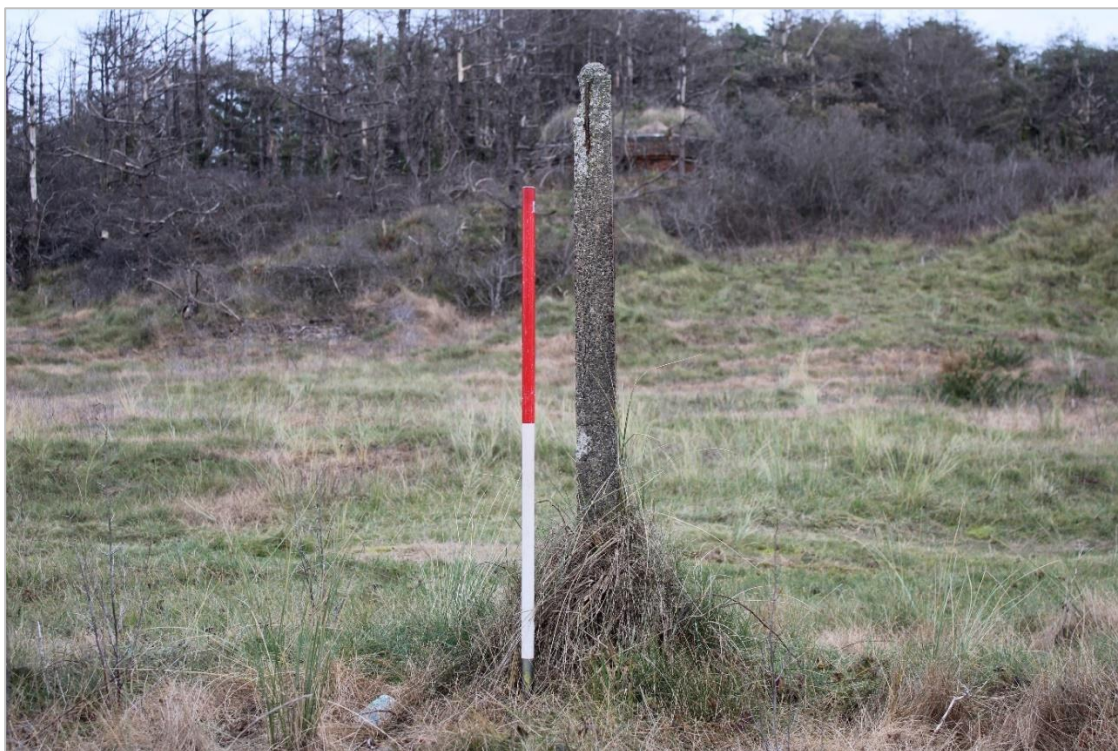
Photo 12: One of a line of concrete fence posts observed in the dune system between Pembrey Forest and the beach. PRN 118045 visible to the rear. Looking north-west, 1m scale.

- 6.4 A line of previously undiscovered concrete fence posts was recorded during the watching brief in Area 2. These are likely to be mid-twentieth century in origin and associated with the WW2 defences. The fence, or possibly pair of fences, that they represent was probably intended to prevent access to the bombing range (PRN 30076) from the beach, and the GPO example associated with communication to/between the defensive structures along the burrows.

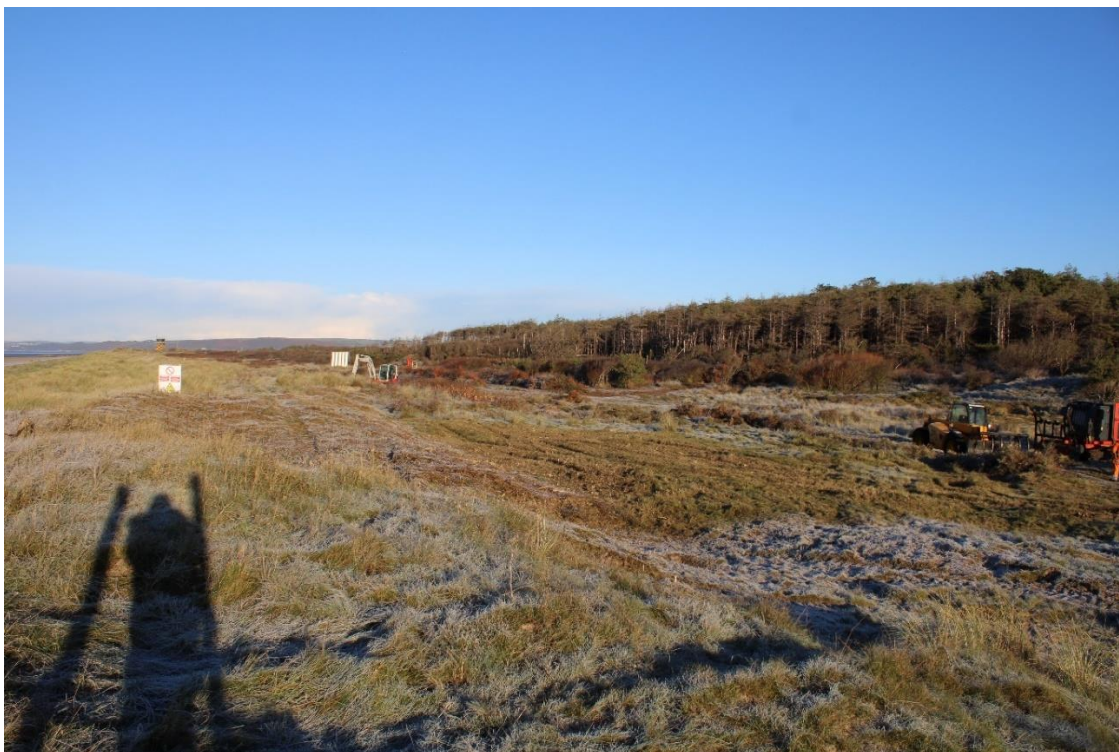
Photo 13: Area 2 looking west after almost all the buckthorn had been removed.

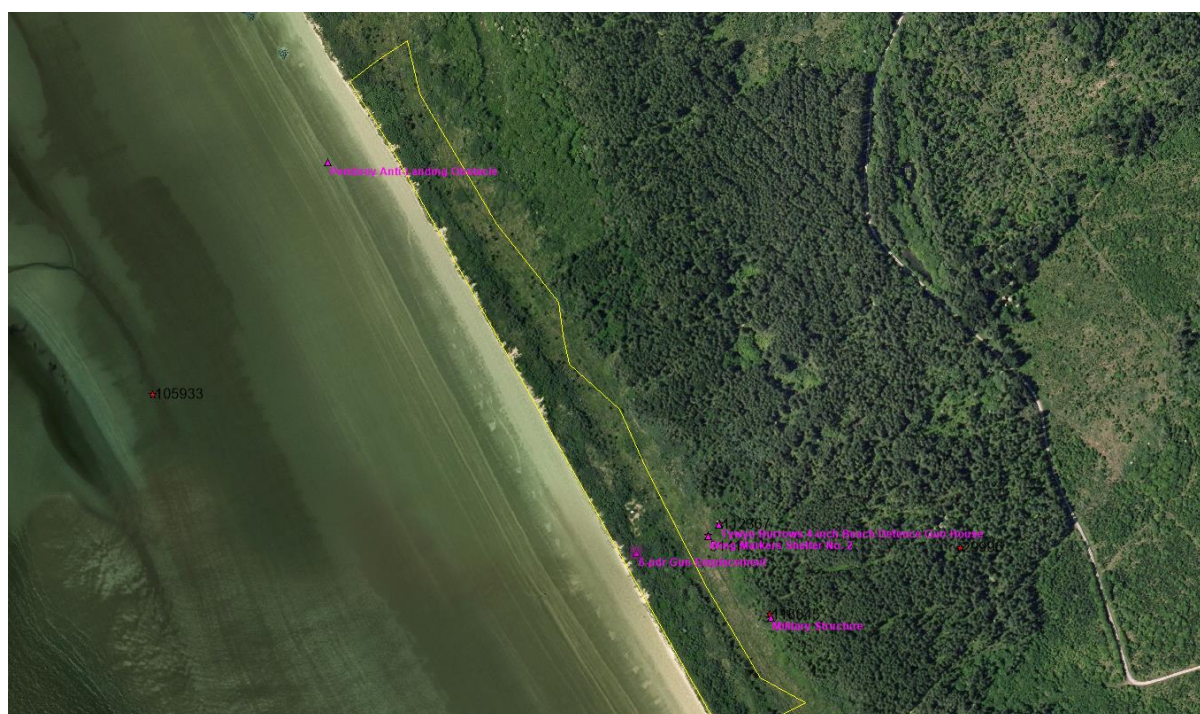
Figure 4: Known archaeological assets within or near to Area 2.

Table 1: Known archaeological assets within and in the vicinity of the Area 2 (locations shown in Figure 4).

PRN	REF	NAME	TYPE	SUMMARY	EVIDENCE	NGR
31414		Wing Marker Shelter No 2.	Wing marker shelter	Wing Marker Shelter No 2. A small concrete rectangular plan shelter with a turf covered concrete roof.	A Pyper site visit.	SN 37053 03516
112367			Gun emplacement	A Second World War gun emplacement overlooking Cefn Sidan beach.	A Pyper site visit.	SN 37069 03532
118045			Pillbox (variant)	A pillbox constructed in brick with a shuttered concrete roof.	A Pyper site visit.	SN 37138 03408
	J Berry 2016	Wing Marker Shelter No 2.	Wing marker shelter	Duplication of PRN 31414	J Berry site visit	
	J Berry 2016	Tywyn Burrows 4 inch beach defence gun house	Gun emplacement	Duplication of PRN 112367	J Berry site visit	SN 37068 03531
	J Berry 2016	Military structure	Coastal defences	Duplication of PRN 118045	J Berry site visit	SN 37139 03404

J Berry 2016	6-pdr Gun emplacement	Gun emplacement		J Berry site visit	SN 36955 03492
	J Berry 2016	Pembrey anti-landing obstacle	Anti-landing obstacle		J Berry site visit	SN 36531 04028
