HAVERFORDWEST CASTLE GAOL, PEMBROKESHIRE: ARCHAEOLOGICAL MONITORING 2022

Prepared by DAT Archaeological Services
For: Pembrokeshire County Council

EVENT RECORD NO: 129716

REPORT NO: 2022-51

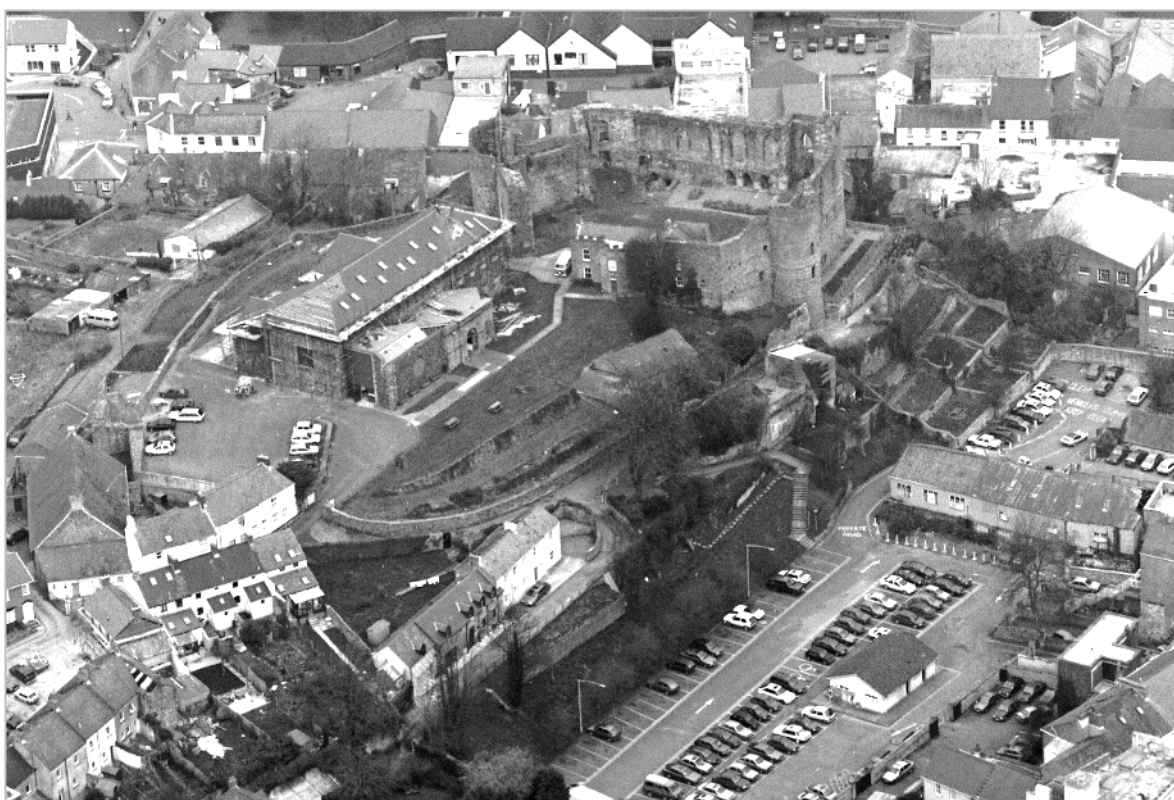
Photo 1: Aerial view of the gaol building and castle from the south-west, taken in 1993
(© DAT).

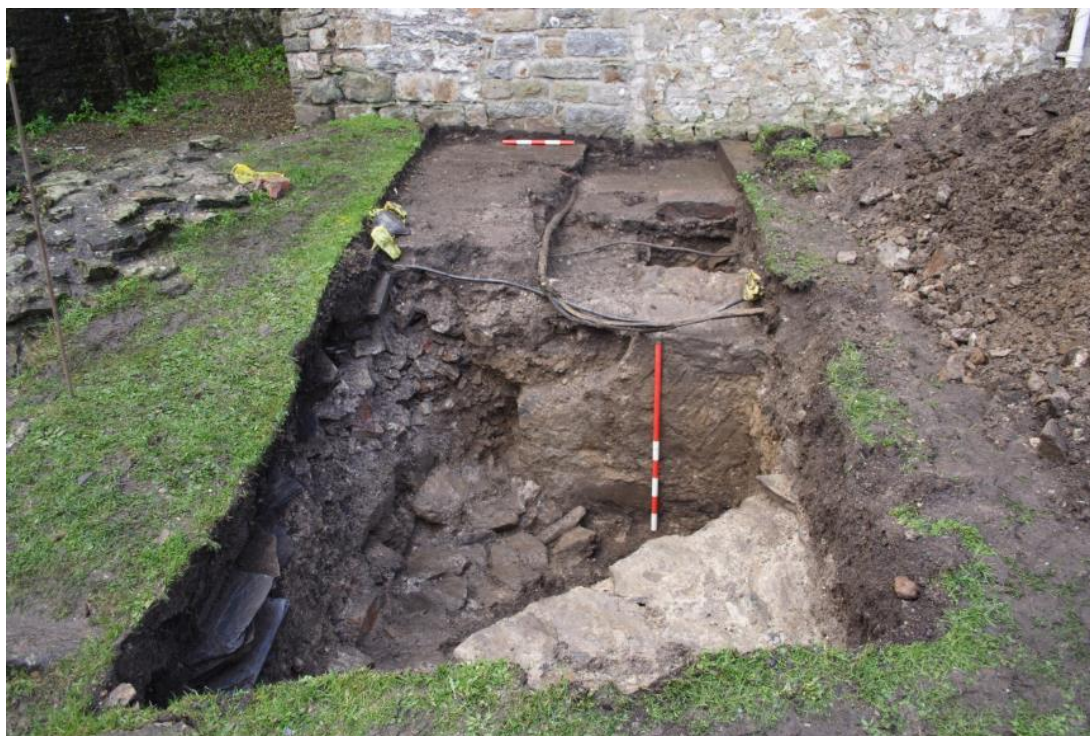
Photo 2: West facing view of 2008 Evaluation Trench 1 with a masonry block in the foreground, and wall (111) behind the 1m scale, both considered to be medieval in date.

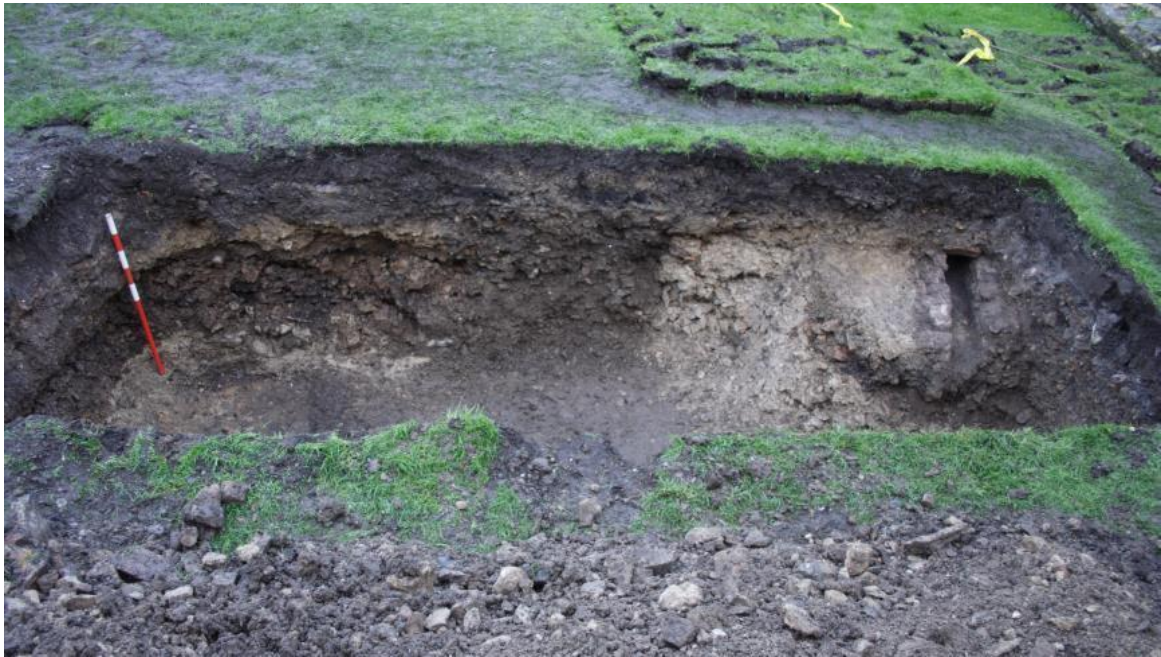
Photo 3: East facing view of 2008 Evaluation Trench 2, the later stone-lined drain visible on the right. 1m scale.

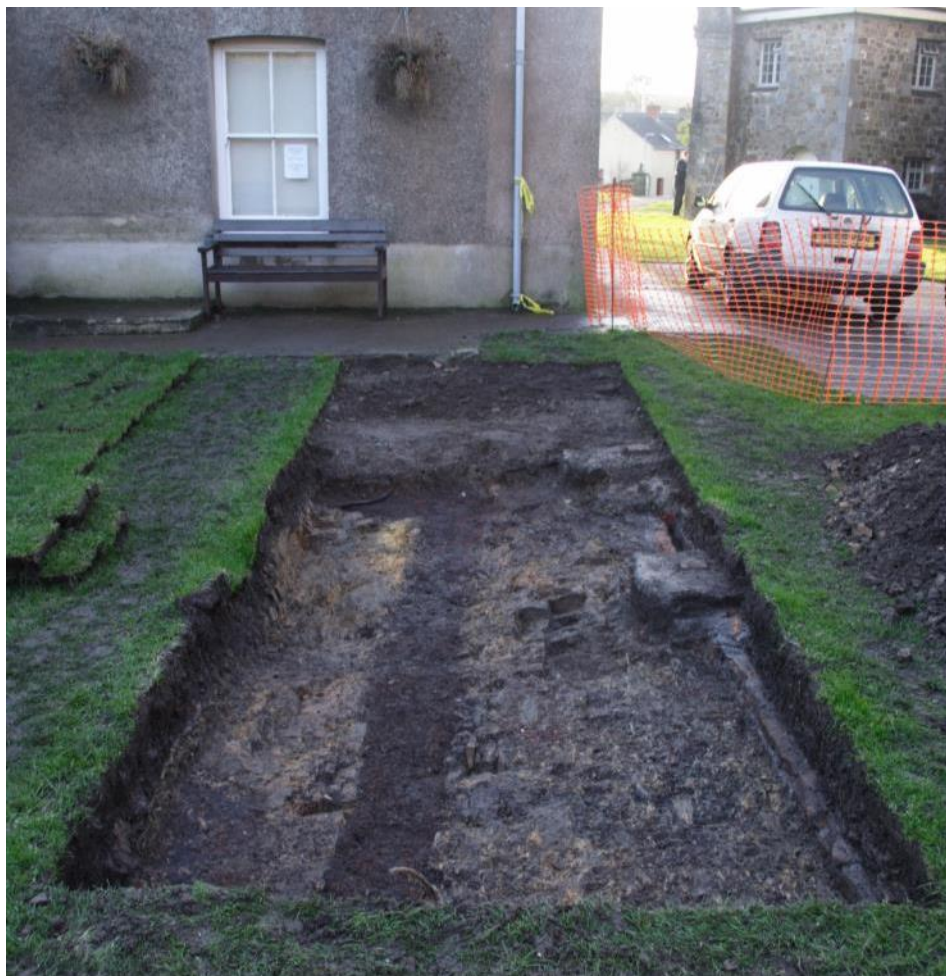
Photo 4: West facing view of Evaluation Trench 3 (Crane 2008), the lead-pipe trench visible along the centre of the trench, and brick wall to the right. Outcropping bedrock was recorded in this trench.

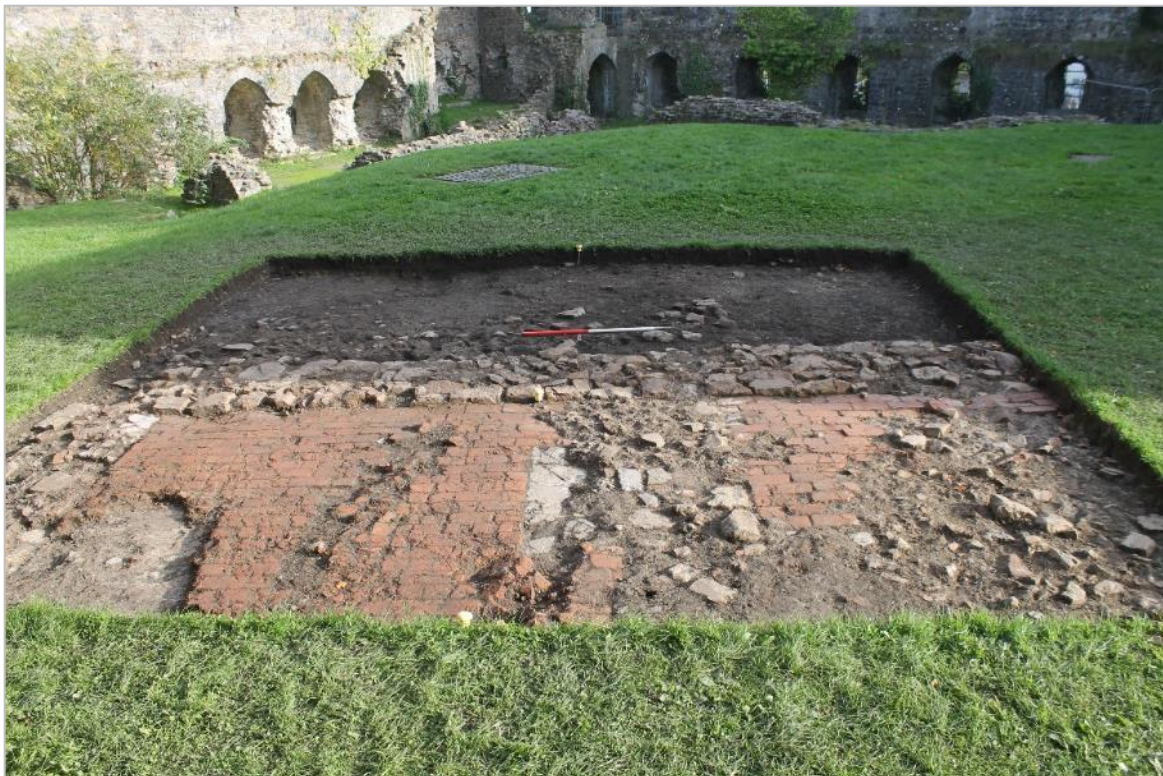
Photo 5: View of 2022 evaluation trench showing floors relating to the female block of the former gaol.

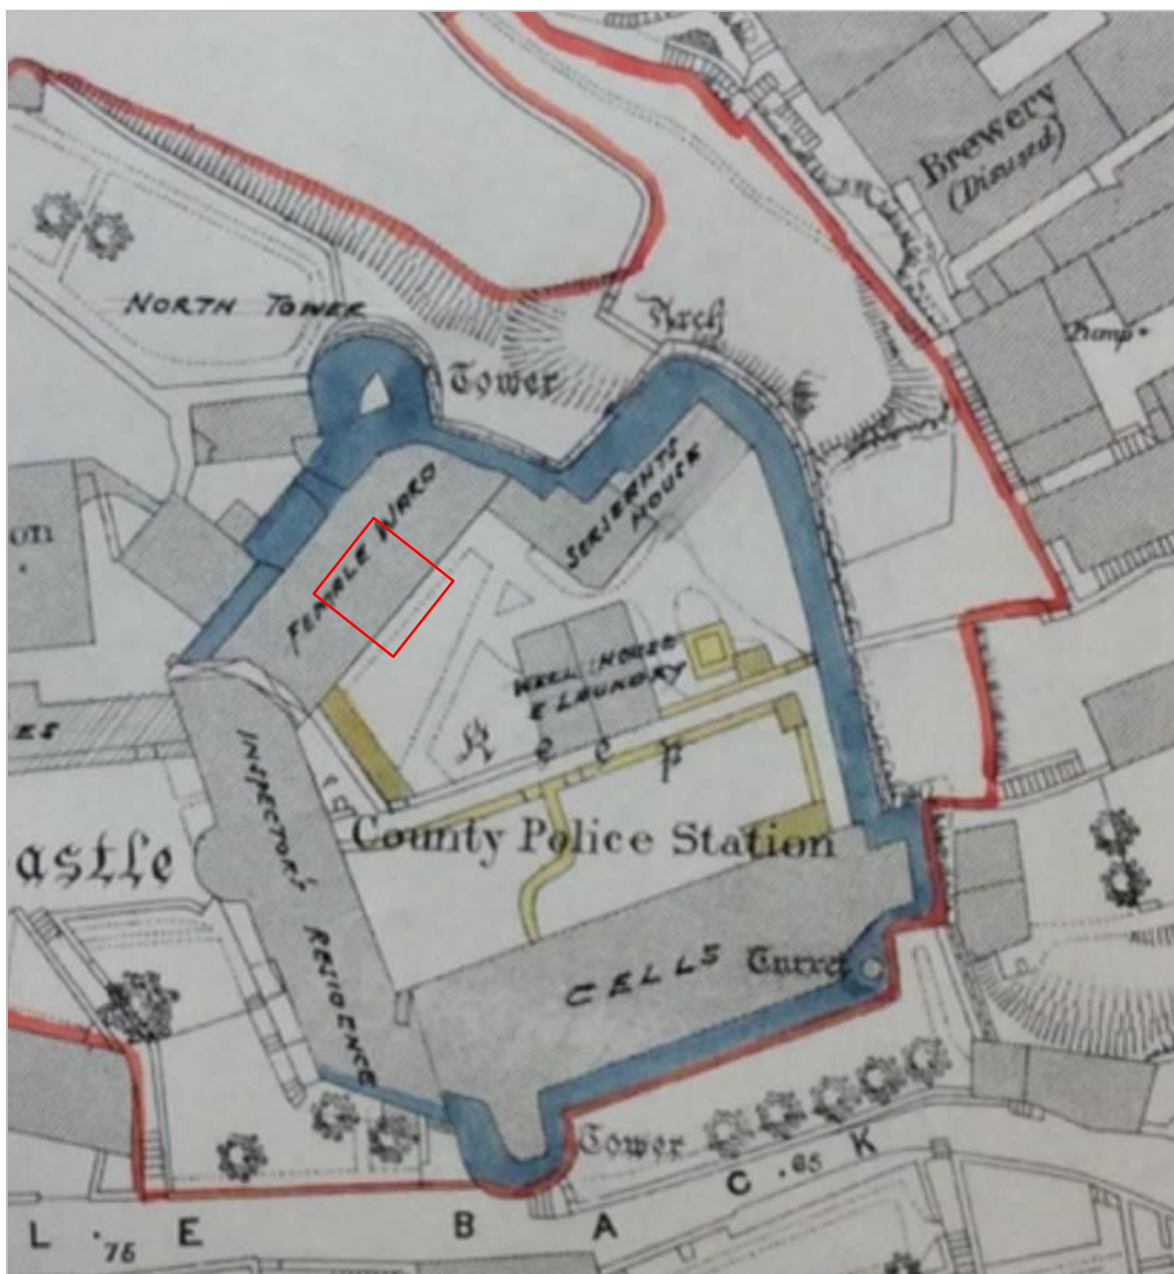
Figure 6: Plan of Haverfordwest County Police Station shortly after its establishment within the inner ward, adapted from the Ordnance Survey 1:500 plan of 1889. , showing the approximate location of the 2022 evaluation trench outlined in red.

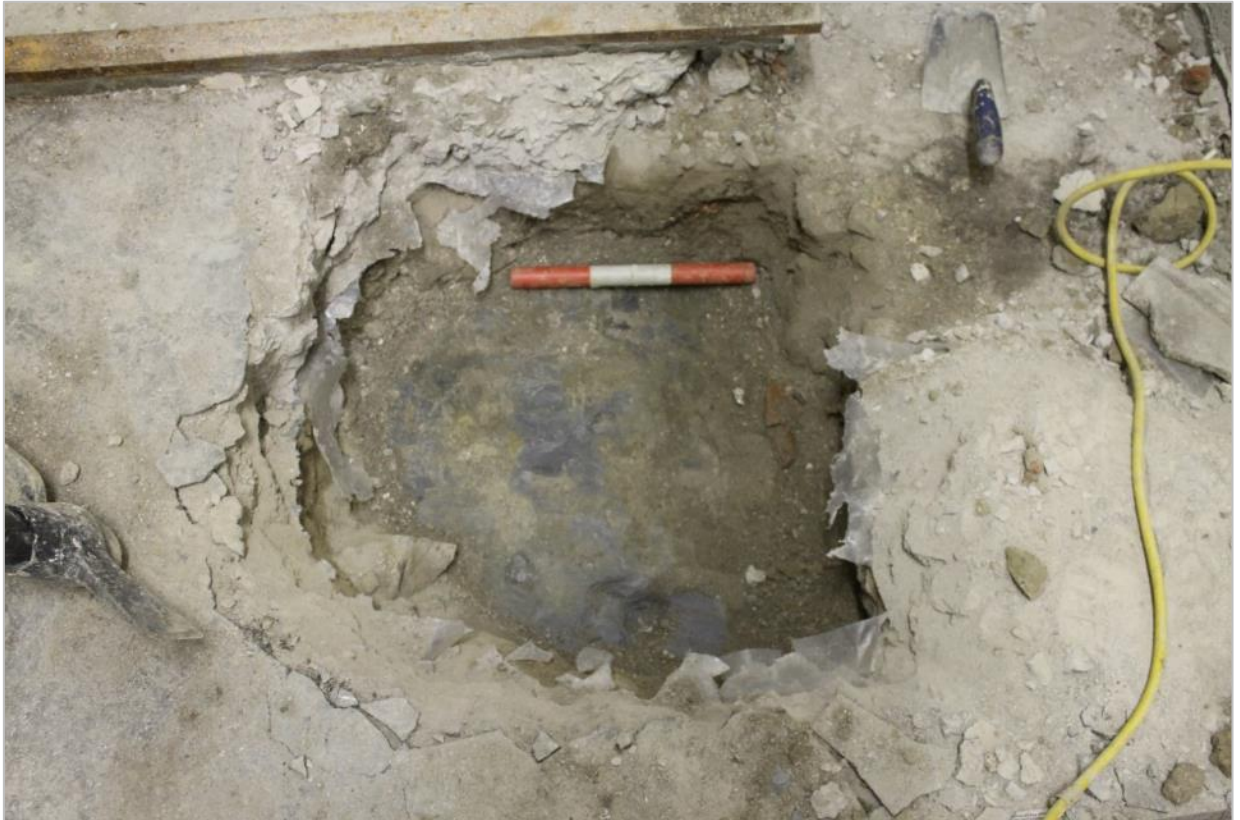
Photo 6: Showing a slate slab revealed below the modern floor in Test Pit 8. Looking north, 0.3m scale.

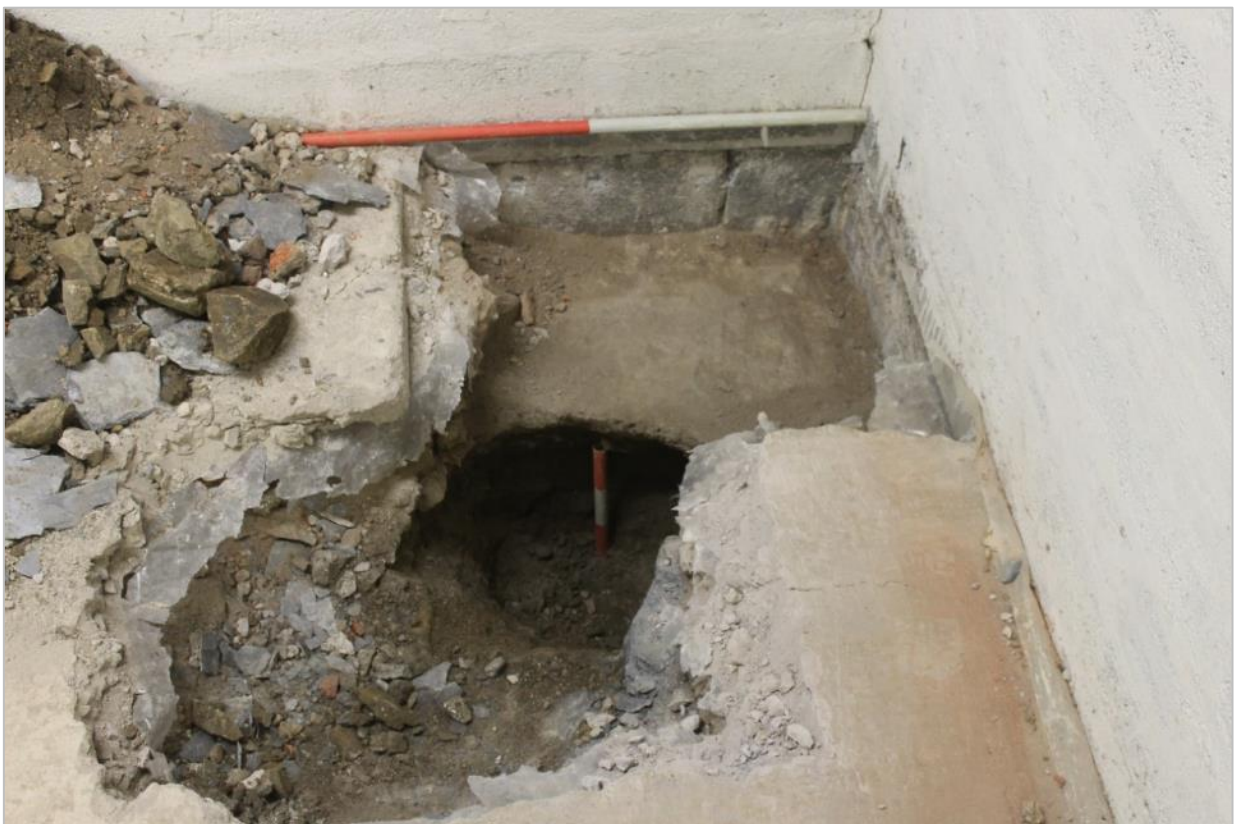
- 5.1.2 Test Pit 9 was located in the south-east corner of strong room 4, with a depth of 0.79m (Photo 7). Below 0.08m of modern concrete floor was a plastic membrane (<0.01m deep) which overlay 0.1m of concreted levelling for the floor above. The concrete levelling overlay a slate slab floor. A 0.3m diameter trial hole through this slate floor revealed that it overlay at least 0.3m of a loose, mid-brown clay silt with frequent small to medium stone fragments.

Photo 7: Showing earlier slate floor surface with soil below, revealed below the modern floor in Test Pit 9. Looking east, 1m and 0.3m scales.

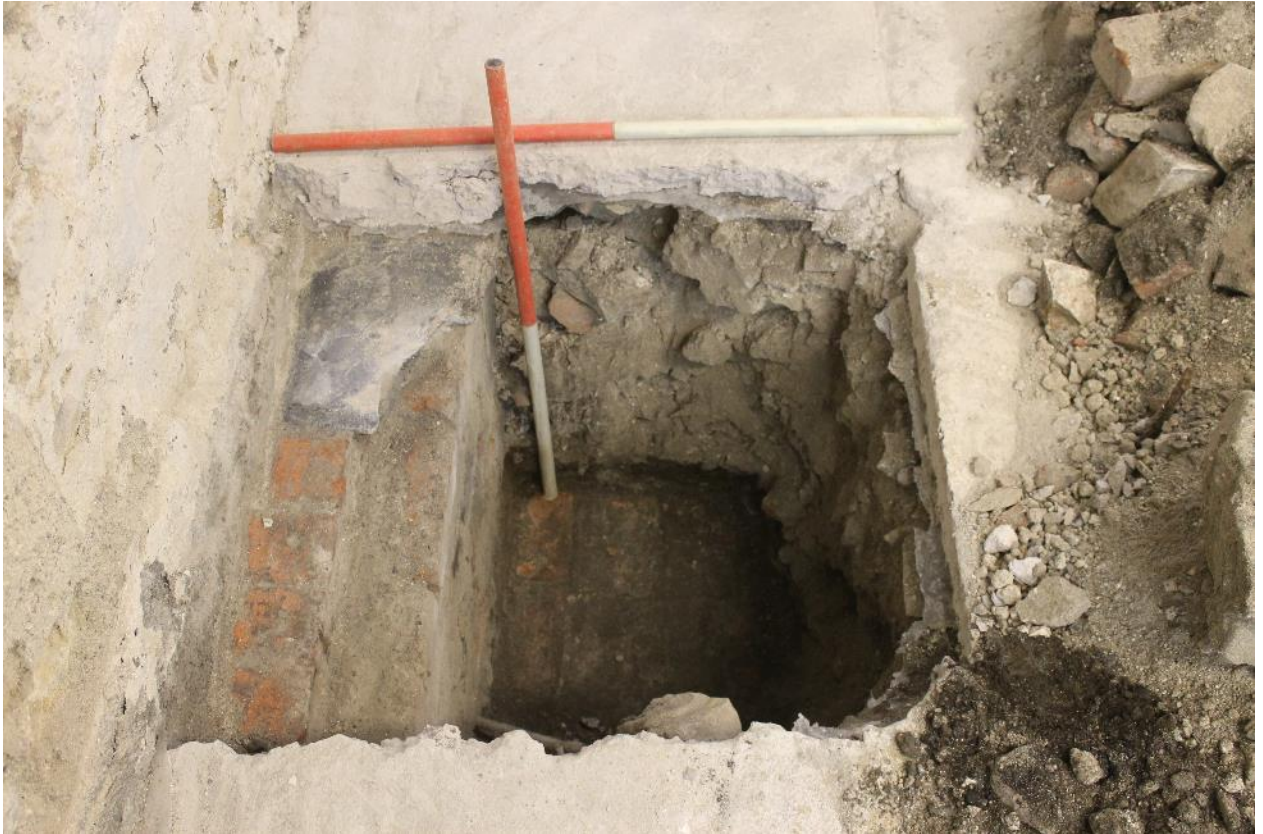
- 5.1.3 Test Pit 10 was located against the south side of an east/west aligned wall dividing strong rooms 4 and 5 (Photo 8). The diameter of Test Pit 10 was 0.8m by 0.7m, with a depth of 1.14m. Below 0.1m of modern concrete floor and a sheet of plastic membrane was the 0.06m deep remains of a slate slab floor. Below the slate, what at first appeared to be a section of brick wall was revealed. This had a visible width of c.0.2m (two bricks) and was 0.68m high (4 courses). To the south of both the wall and the slate slab above it was a 0.74m deep rubble deposit comprising a loose, light grey, dusty mortar with frequent brick and stone fragments. A brick surface below this deposit was not excavated. Investigation of the area between the brick wall and the dividing wall of the strong room revealed a void, within which the wall of the strong room could be seen continuing behind the bricks. The brick structure was revealed to be a free-standing structure associated with the brick surface.

Photo 8: Showing brick structure and its association with the brick surface, in Test Pit 10. Looking north, 2x1m scales.

- 6.1.3 The freestanding brick structure revealed in Test Pit 10 was one of a pair of heating flues shown in Figure 10. Comparison with the pre police station plan (Figure 9) reveals that this heating system was not original but inserted to heat the police station. This explains why it was freestanding in Test Pit 10, and not keyed into the wall between strong rooms 4 and 5.

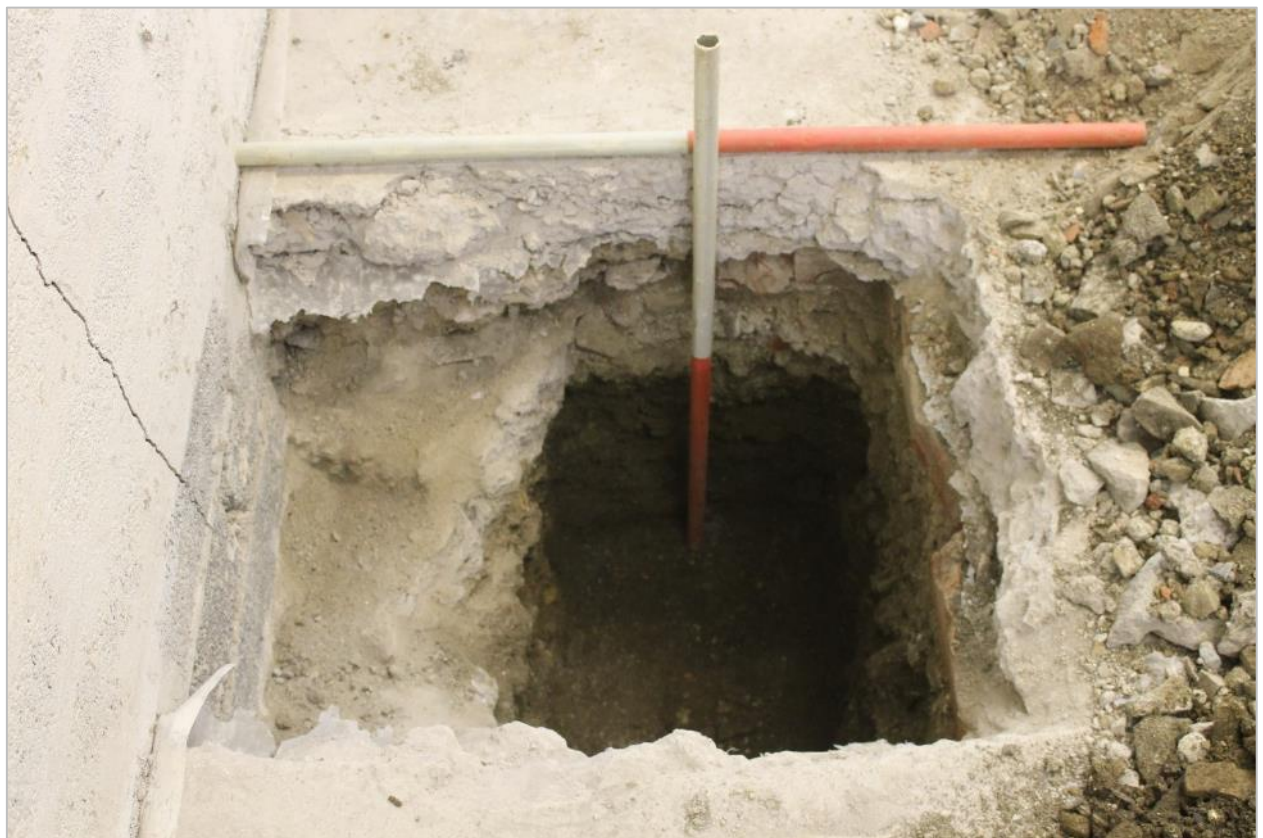
- 5.1.4 Test Pit 11 was located centrally against the internal (north facing) elevation of the south wall of the strong room (Photo 9). The diameter of test Pit 11 was 0.8m by 0.7m, with a depth of 0.86m. Below 0.12m of modern concrete floor and plastic membrane a 0.07m deep red brick floor was revealed. This was bedded on a 0.34m deep deposit of loose mortar with small to medium stones and brick fragments. Below this bedding was a buried soil comprising a mid- to dark brown slightly clay silt with frequent very small slate fragments, occasional small sub-angular stones and flecks of lime mortar. To the south, the brick floor had been truncated by the foundation cut for the south wall of strong room 4, which in this location was of modern breeze block construction.

Photo 9: Showing earlier red brick floor and concrete bedding below the modern floor in Test Pit 11. Looking west, 2 x 1m scales.

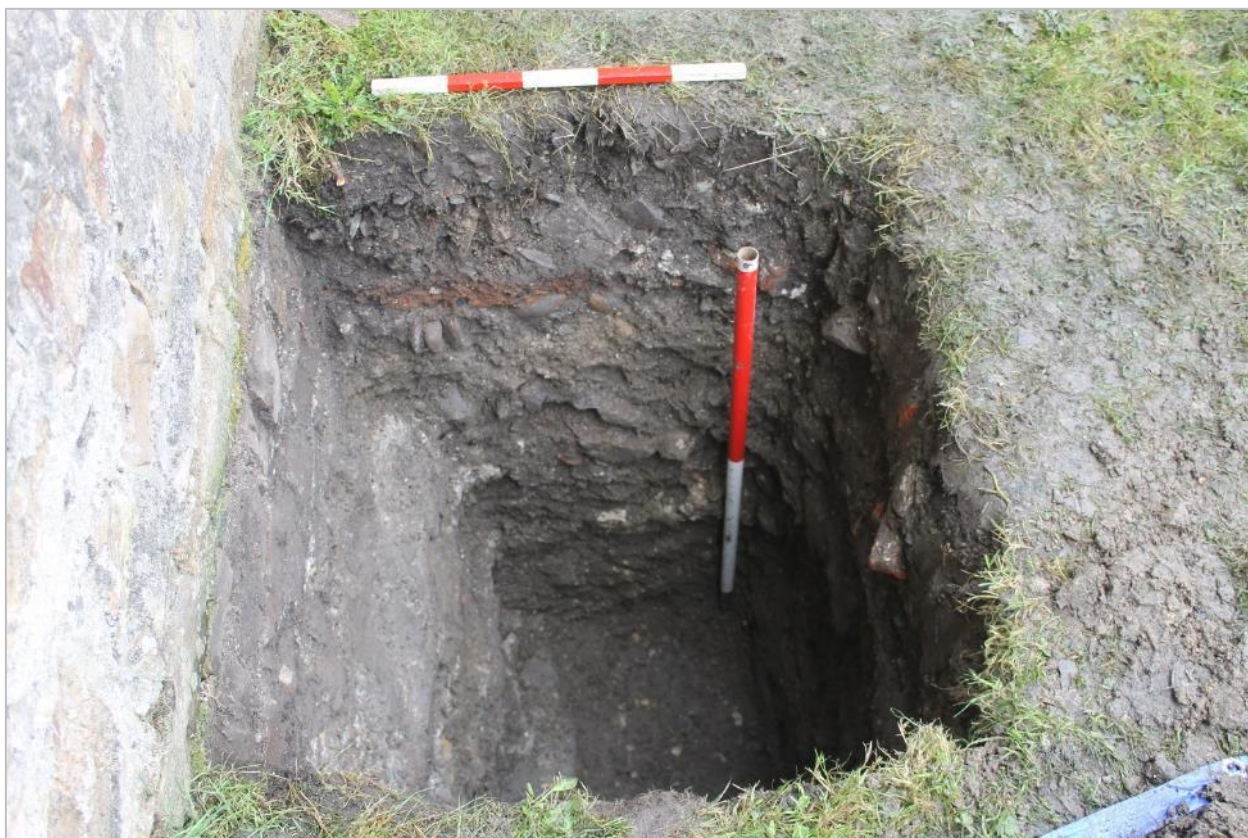
- 5.2.2 Test Pit 1 measured 0.8m by 0.8m, with a depth of 1.2m. Below the turf in Test Pit 1 (Photos 10-11) c.0.1m of mid- to dark brown topsoil with frequent small angular stones overlay a very compact layer of rab and building rubble with small to medium angular stones, ceramic building material (CBM) and pieces of lime mortar. Directly below this rubble layer, a thin (c.0.01m to c.0.04m) deposit of orangey-red burnt clay with small pieces of coal and cinders overlay a compact, light grey-brown clay silt, approximately c.0.4m to 0.7m deep, with frequent angular and sub-angular stones (average 0.08cm), frequent lime mortar flecks and occasional fragments of roof slate and CBM. At the top of this layer a deposit of possible cobblestones was observed near the wall of the gaol. The stratigraphically lowest deposit to be seen in section in this test pit was a very soft, light grey-brown silty clay with frequent small flecks of lime mortar, small, gritty angular inclusions and occasional bone fragments. However, in the west facing section, a lens of very compact, sandy coloured mortar between c.0.12, and 0.03m deep, with rounded stones was observed, while at the base of the test pit, a yellowy brown sandy clay with oyster shells and probable demolition rubble was seen, but not excavated. Two fragments of animal bone and a small ceramic stick with a bevelled end were recovered from this test pit.

Photo 10: Showing deposits adjacent to the north wall of the gaol in Test Pit 1.
Looking west, 1m & 0.5m scales.

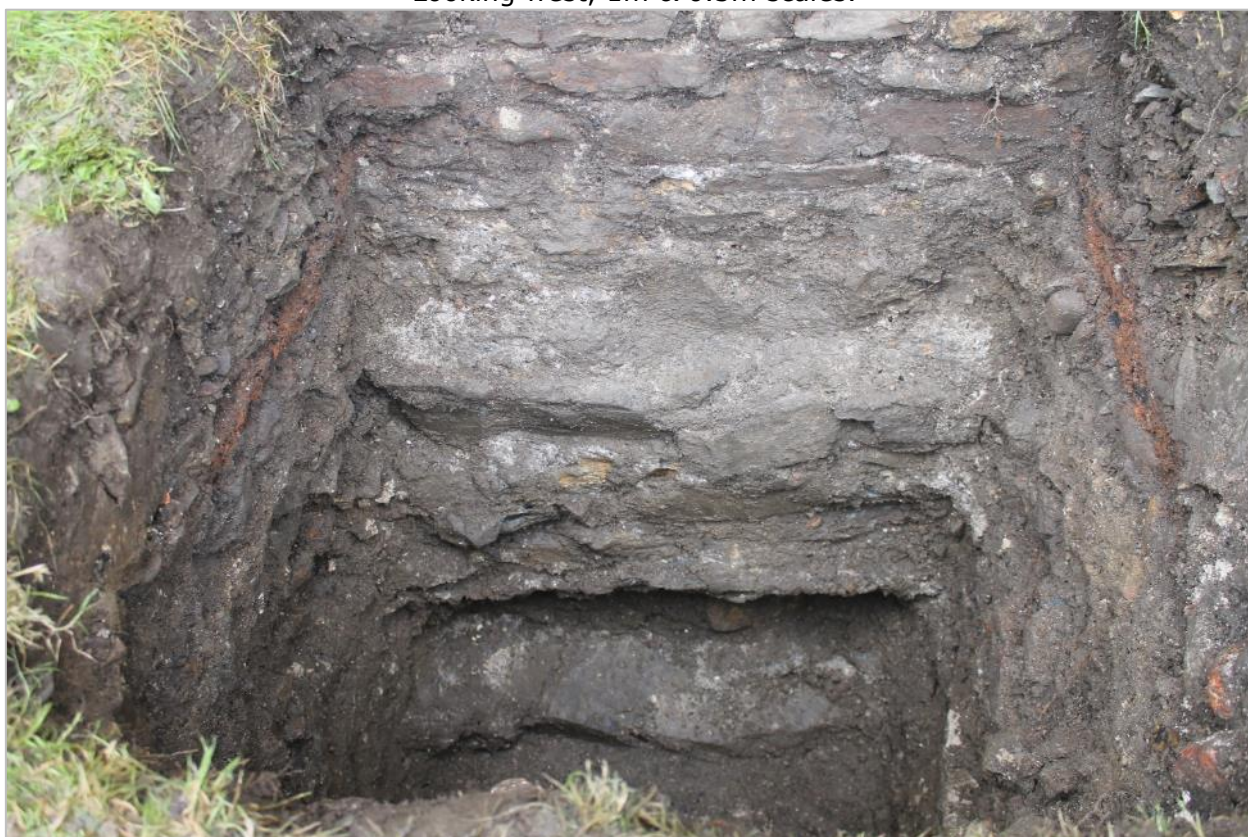
- 5.2.4 In in both Test Pits 1 and 2 the gaol wall was observed to be flush from approximately the level of the cobble stones. Below this, the foundation was of rougher construction and in Test Pit 2, the foundation stones appeared weathered, suggesting that they had formerly been exposed to the elements. In Test Pit 1, the foundation appeared to sit atop an earlier wall (Photo 11).

Photo 11: Close-up of the relationship between the gaol wall and an earlier wall in
Test Pit 1. Looking south, no scale.

- 6.2.3 In Test Pits 1 and 2, it appeared that the gaol wall sat atop the remains of an earlier wall on the same north/south alignment, while in Test Pit 4, a section of earlier wall on a north-east/south-west alignment was recorded. Within such small test pits these features are difficult to interpret but, as Photo 28 shows, the gaol building stood within the outer ward of the castle and therefore they may represent medieval buildings that formerly stood there. Similarly, the presence of sandstones with mortar adhering, recorded in Test Pit 2, adds weight to the interpretation of sandstone blocks, recorded in Test Pit F, as an *in-situ* wall.

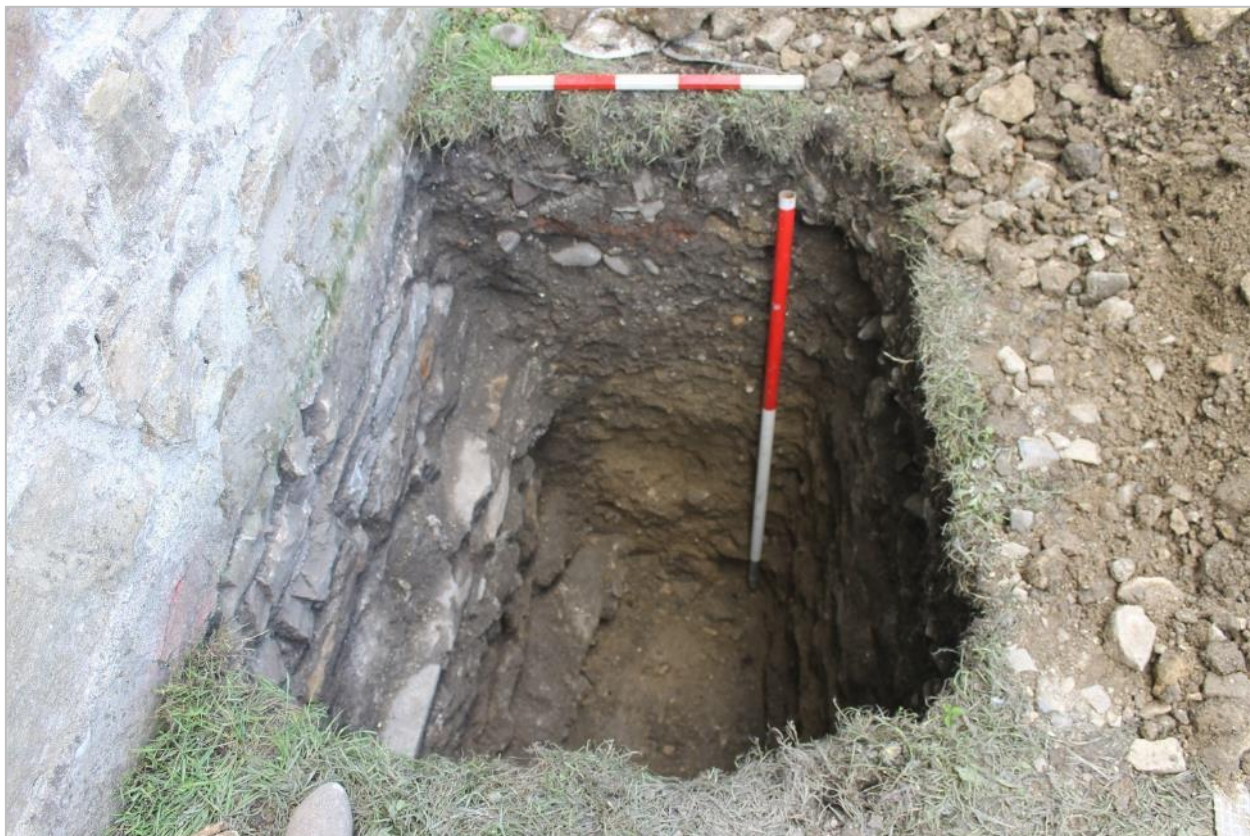
- 5.2.3 Test Pit 2 had a depth of 1.12m, below the turf in Test Pit 2 (Photos 12-13) the topsoil was 0.17m deep with frequent small to medium angular stones and pieces of CBM. This mostly overlay c.0.1m of mid-grey sandy silt with the remains of cobbles. However, a c. 0.05m deep lens of orangey red burnt clay with coal ash inclusions was observed in the east (west-facing) section. Below this were two deposits. A soft, mid- yellow-brown sandy clay had frequent inclusions of small mortar flecks and fairly frequent angular sandstones (average size 0.2m x 0.15m x 0.1m), many with mortar adhering to them. Near to the wall of the gaol this layer, which was not fully excavated but was at least 0.6m deep, had been cut and subsequently backfilled with a c.0.30m to 0.8m deep compact, friable mid-brown sandy silt with frequent small pieces and flecks of mortar, fairly frequent small angular stones and coal fragments. This appeared to be the foundation cut for the wall; the backfilled material mostly overlay the sandy clay deposit but was present between it and the wall in the area of the backfilled cut (Photo 12). Six sheep phalanges and six fragments of unidentified animal bone were present in the sandy clay, and a deposit of oyster shells towards the lowest excavated level. Also towards the base, voids began to appear in section, indicative of larger rubble inclusions at that level.

Photo 12: Showing the relationship between deposits in the east-facing section in Test Pit 2. Looking west, 1m & 0.5m scales.

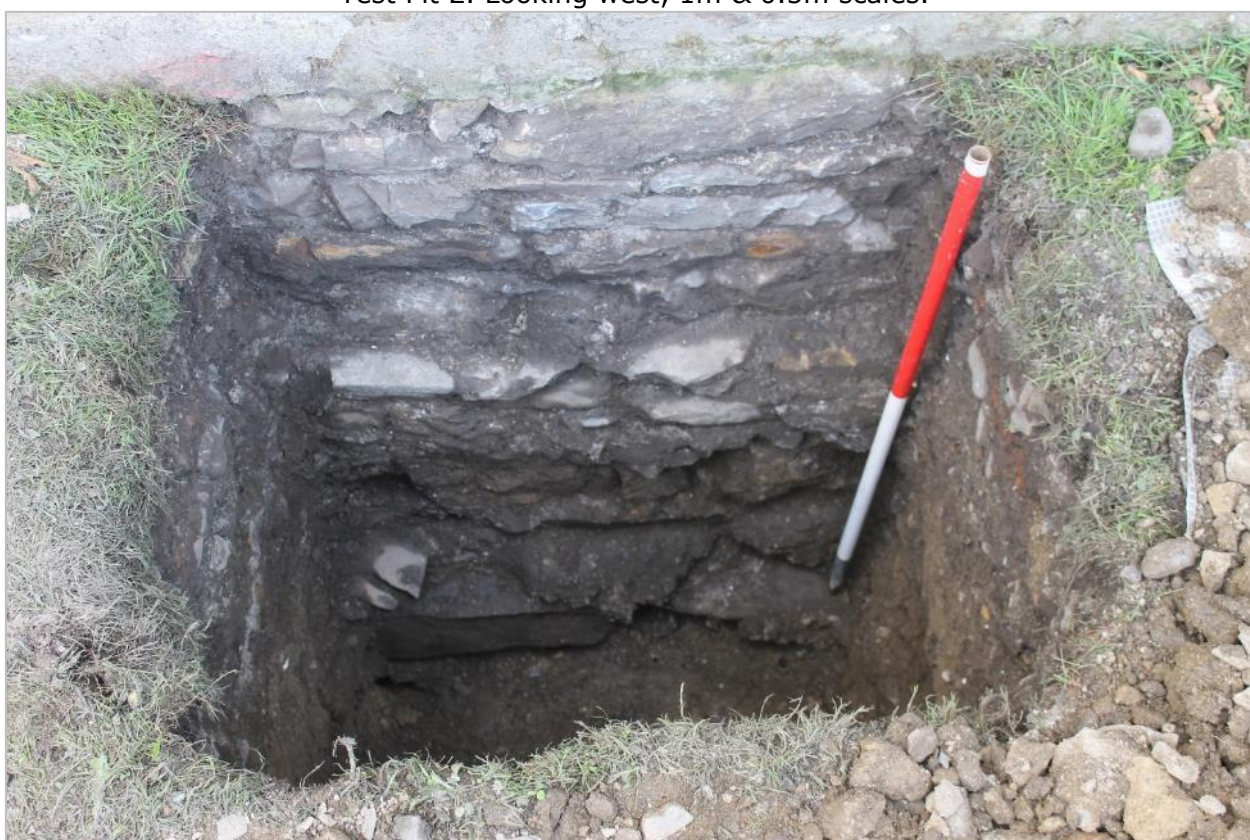
Photo 13: Showing the foundation of the north-facing elevation of the gaol in Test Pit 2. Looking south, 1m scale.

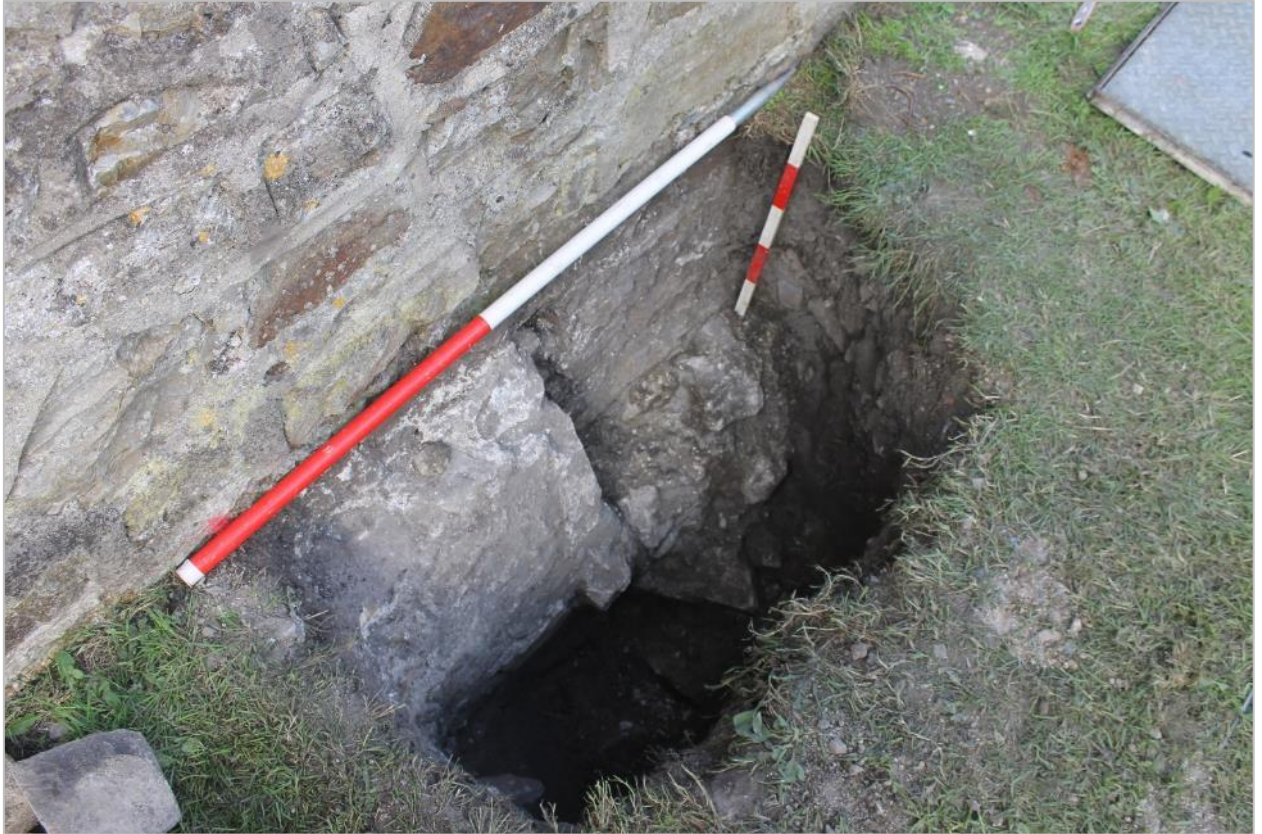
- 5.2.6 Below the turf in Test Pit 3 the mid-brown topsoil was up to 0.25m deep, with frequent small stones and rare medium stones. Below it was a mid- to light brown silty clay with fairly frequent medium to large angular stones and broken brick. This deposit was not excavated further than c.0.8m below the turf line.
- 5.2.7 Exposure of the gaol wall in this Test Pit revealed a buttress of rough stone and a friable grey-white lime mortar that extended up to 0.35m from the wall and was c.0.85m high (Photo 14). Although less strongly built than the gaol wall above, it nonetheless appeared integral to it.

Photo 14: Showing the buttress revealed in Test Pit 3. Looking north-west, 1m & 0.5m scales.

- 6.2.2 Test Pits 1–7 also revealed the foundation of the gaol building. Of interest was a poorly blocked up hole for a drainpipe that had exited the building below-ground in Test Pit 5, and a small buttress seen in Test Pit 3. Presumably, the wall foundation needed additional support at this point, though the reason for this was unclear.

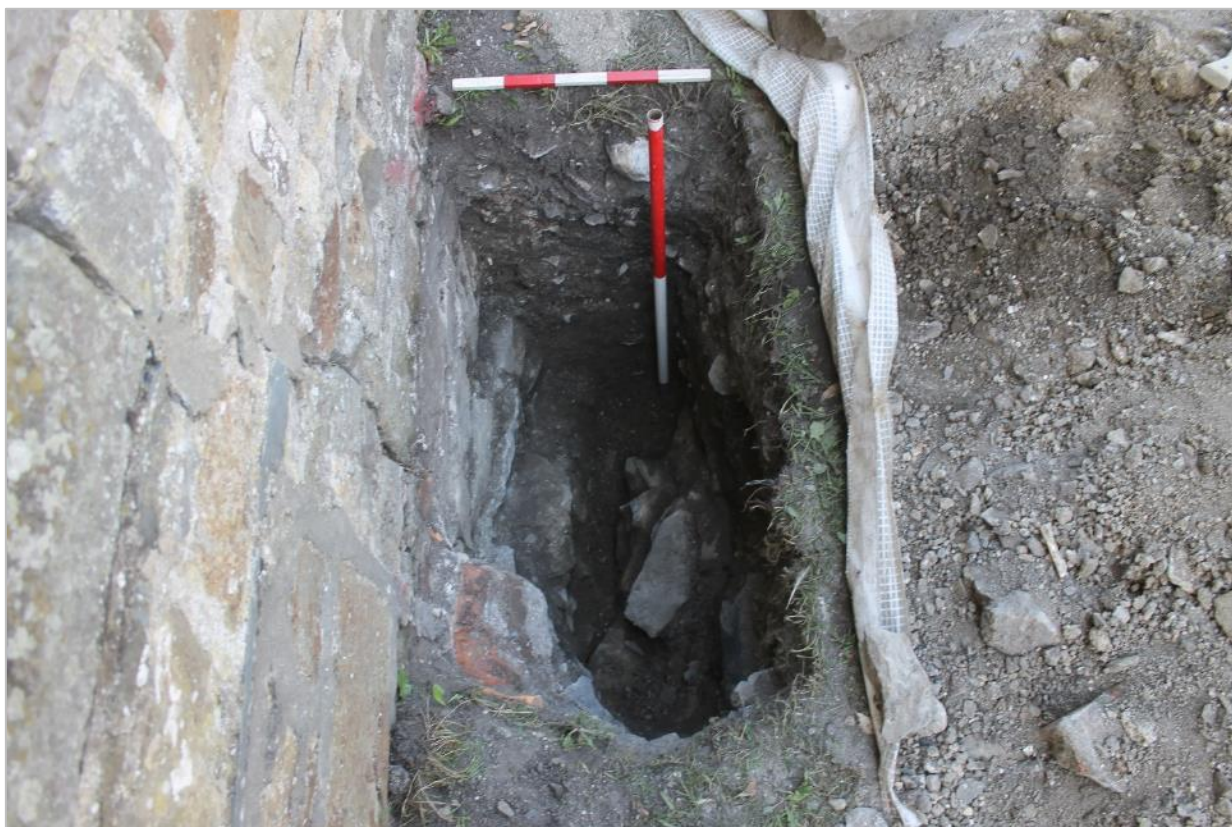
- 5.2.10 Where the gaol wall was exposed in Test Pit 4 it was revealed to have a rough stone foundation. A foundation cut was visible in the sandy yellow clay deposit at the bottom of the test pit (Photo 15).

Photo 15: Showing deposits in the south facing section of Test Pit 4, along with the section of earlier wall. Looking north, 1m & 0.5m scales.

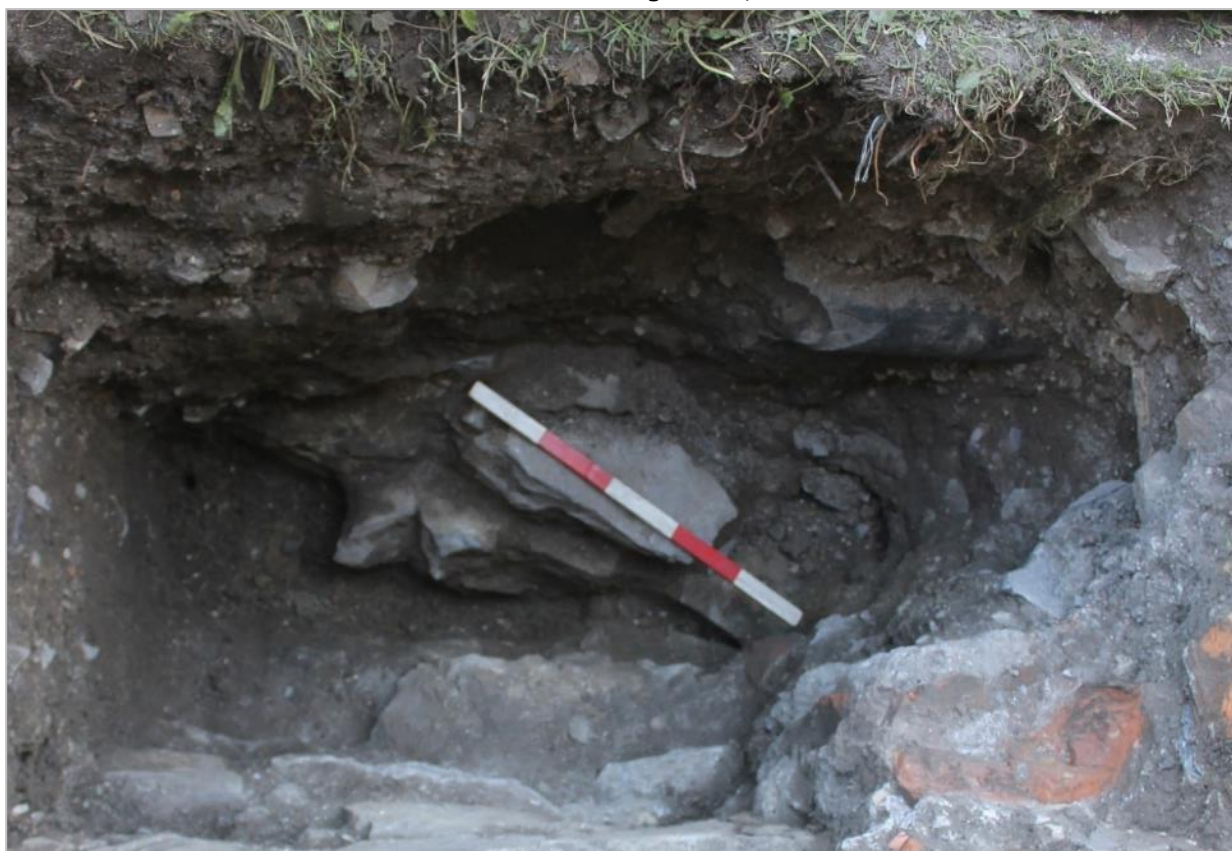
Photo 16: Showing a section of earlier wall revealed in Test Pit 4. Plan view, 0.5m scale.

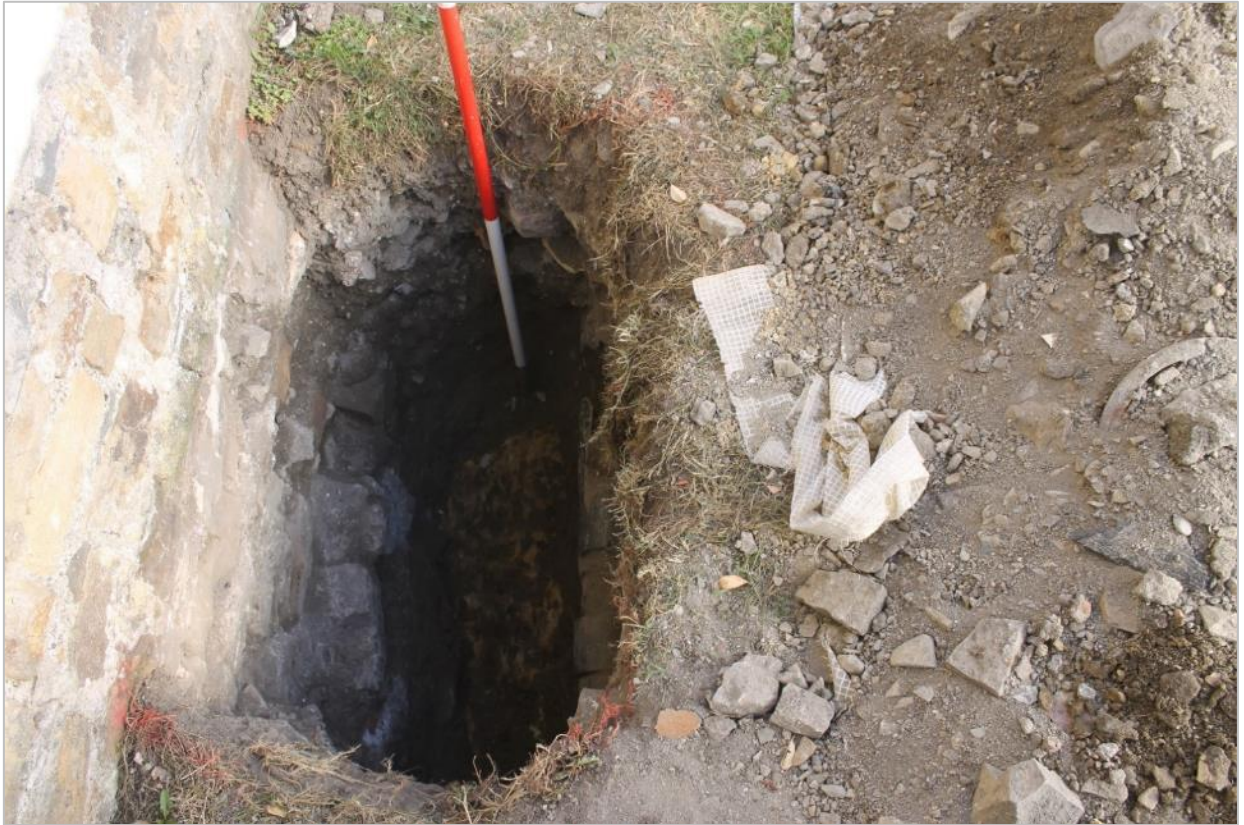
- 5.2.12 The cut for the ceramic drainpipe had truncated the deepest deposit encountered in Test Pit 5, which was a firm, pale yellowy clay that had a very compact thin (0.05m) layer of small angular stones with occasional mortar and coal fragments overlying it. This was not bottomed.

Photo 17: Showing deposits, foundation cut and drainpipe cut revealed in Test Pit 5:
Looking north, 1m scale.

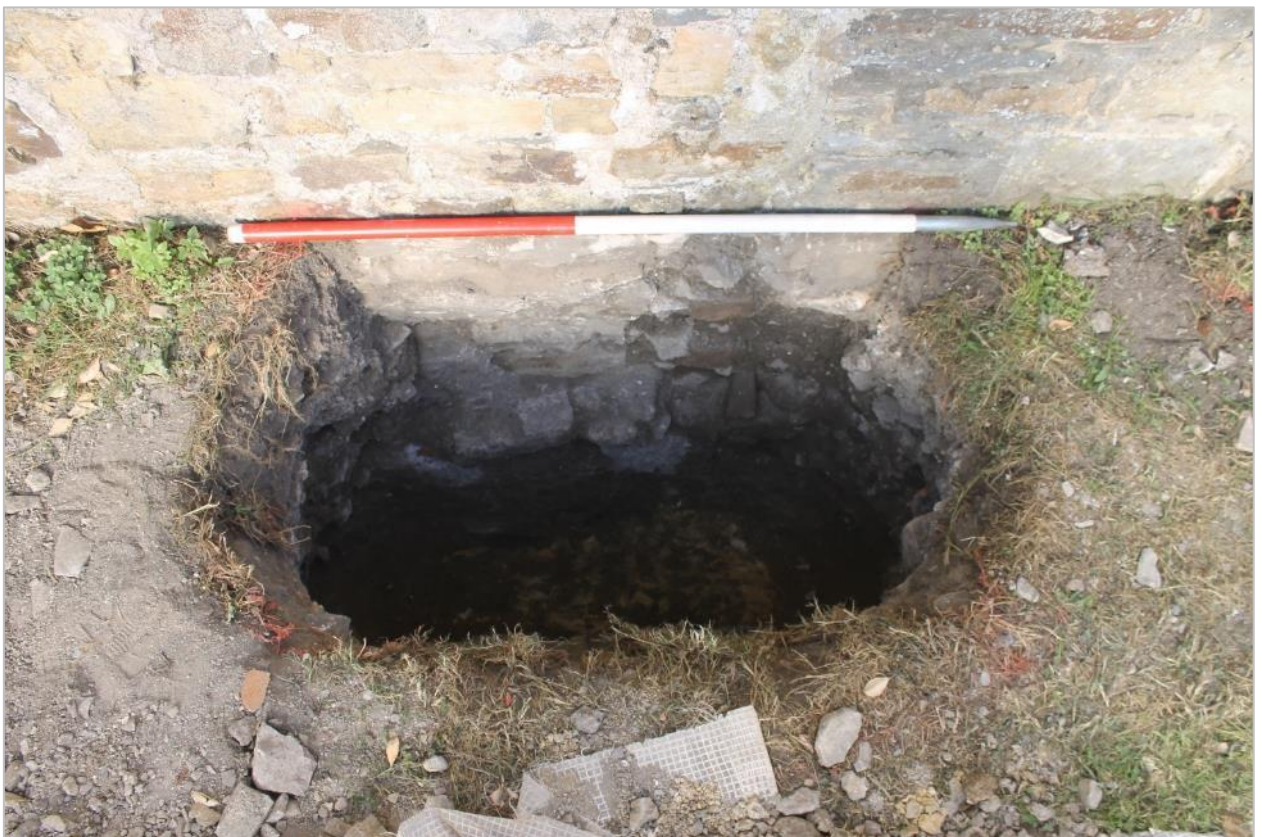
was apparent that the ceramic pipe had exited the gaol through an irregular hole at least 0.5m in diameter cut below ground level through the eastern gable wall (Photo 18). This hole had been poorly blocked with broken brick.

Photo 18: Test Pit 5, showing a poorly bricked up hole in the eastern gable wall of
the gaol. Looking west, 1m scale.
