HAVERFORDWEST CASTLE GAOL, PEMBROKESHIRE: ARCHAEOLOGICAL MONITORING 2022

Prepared by DAT Archaeological Services
For: Pembrokeshire County Council

EVENT RECORD NO: 129716

REPORT NO: 2022-51

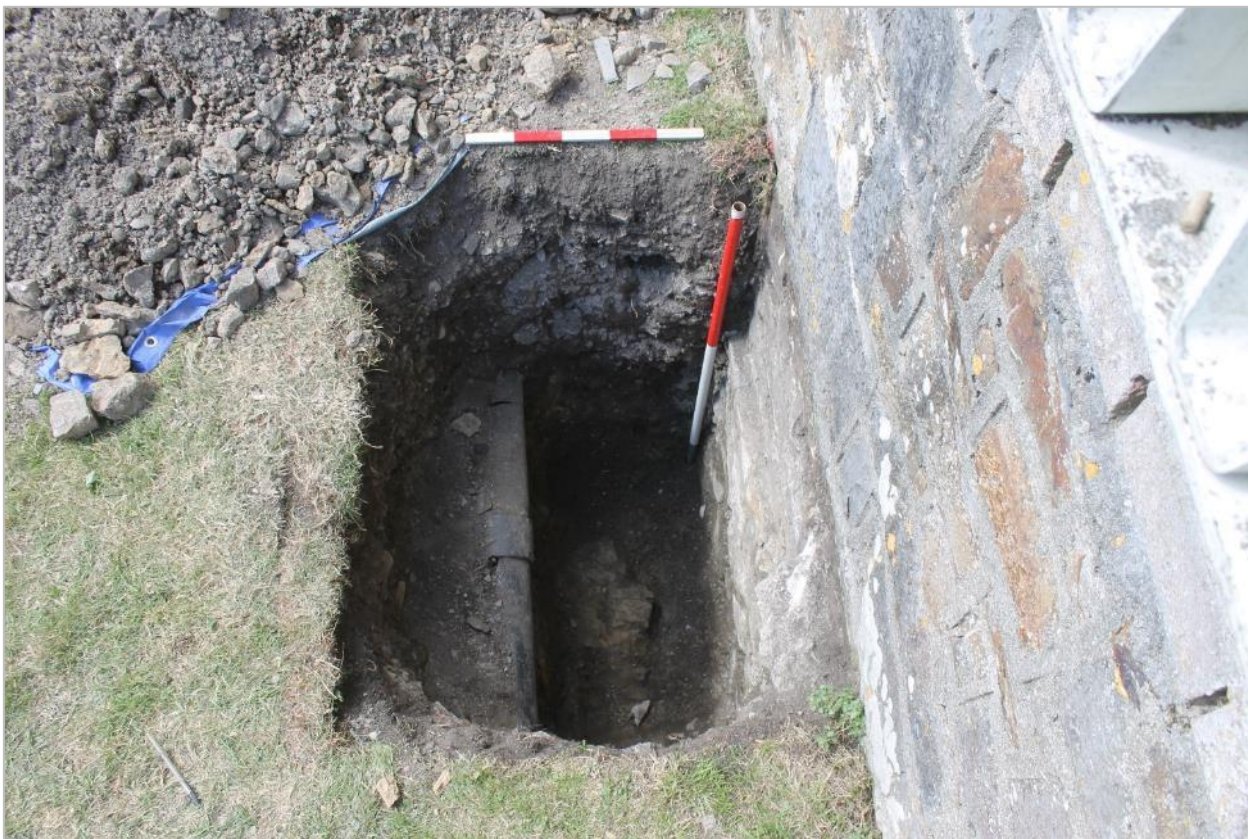
Photo 19: Showing deposits and drainpipe in Test Pit 6. Looking west, 1m & 0.5m scales.

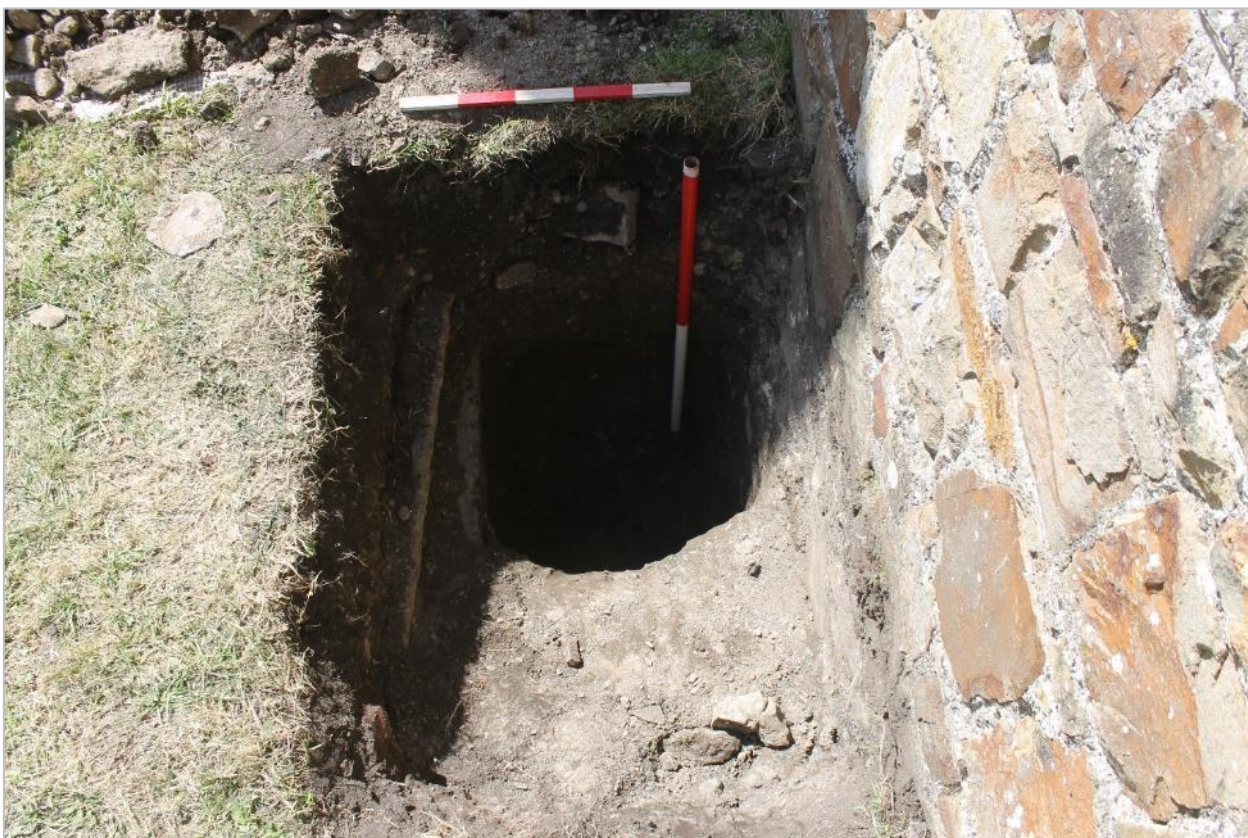
5.2.15 Test Pit 7 was 1.2m deep. Below the turf was c.0.13m of mid-brown topsoil with frequent small stones (Photo 20). This overlay the c. 0.6m deep backfill for a drain pipe which is as described in section 5.2.8. Below that, a deposit of light yellowish brown, sandy clay, with lime mortar flecks and with frequent oyster shells overlay demolition layers comprising a layer of medieval roof slates over a layer of mortar fragments. This deposit was not bottomed at 1.2m.

Photo 20: Showing deposits and drainpipe in Test Pit 7. Looking west, 1m & 0.5m scales.

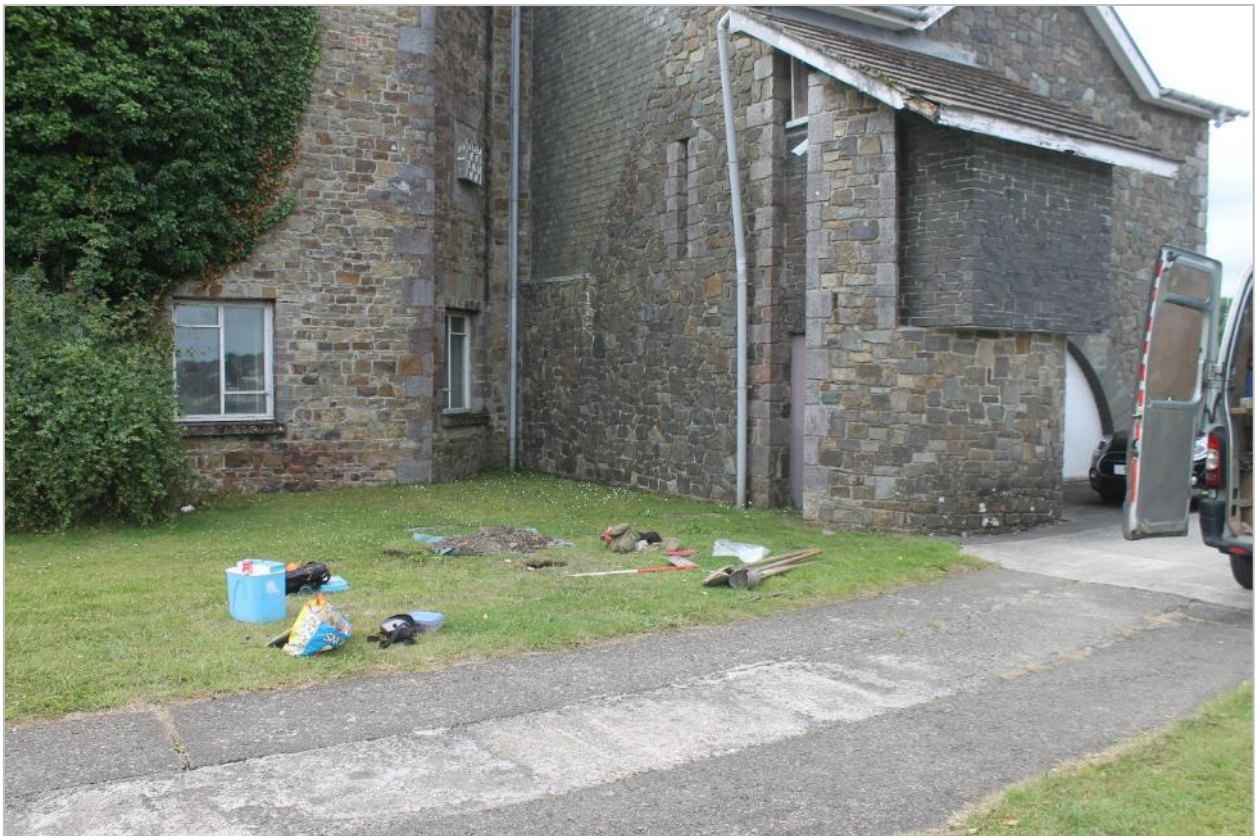
5.2.16 Test Pit A measured 1.04m deep. Test Pit A was located 6.7m north of the north wall of office 7 (Photos 21–22). The topsoil here comprised 0.3m deep compact and friable mid-brown clay silt, with frequent specks of burnt clay, coal flecks and small, grey mortar flecks in the lower 0.15m. Below the topsoil was an extremely compact, 0.27m deep layer of dark brown, sandy silt with very frequent (c.70%) inclusions of red brick, stone, grey mortar and coal. That in turn overlay a 0.17m deep compact, mid-brown clay silt with frequent, mostly small, angular and sub-angular stones. Below that was a 0.08m deep, very compact, homogenous band of light yellow-brown, sandy clay with small angular stones (Photo 22). The lowest deposit, which was not bottomed, was a mid-brown clay silt, at least 0.3m deep, with occasional slate fragments, coal flecks and some white mortar flecks. Three sherds of coarse, post-medieval glazed pottery, one fragment of clay pipe stem and one perforated iron disc were recovered from this test pit,

Photo 21: Showing the location of Test Pit A. Looking south-west, 1m scale.

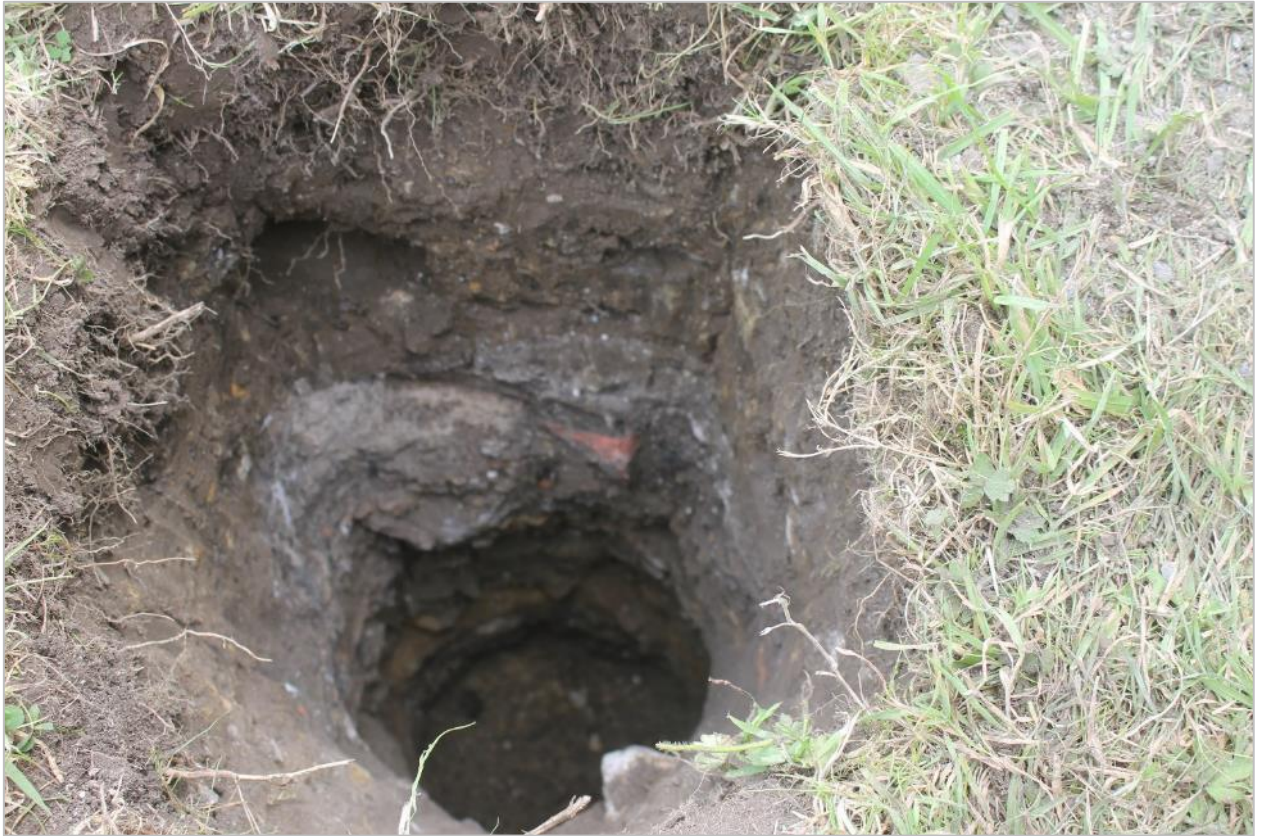
Photo 22: Close up of west-facing section in Test pit A, showing possible former surface (band of yellow clay). Looking east, no scale.

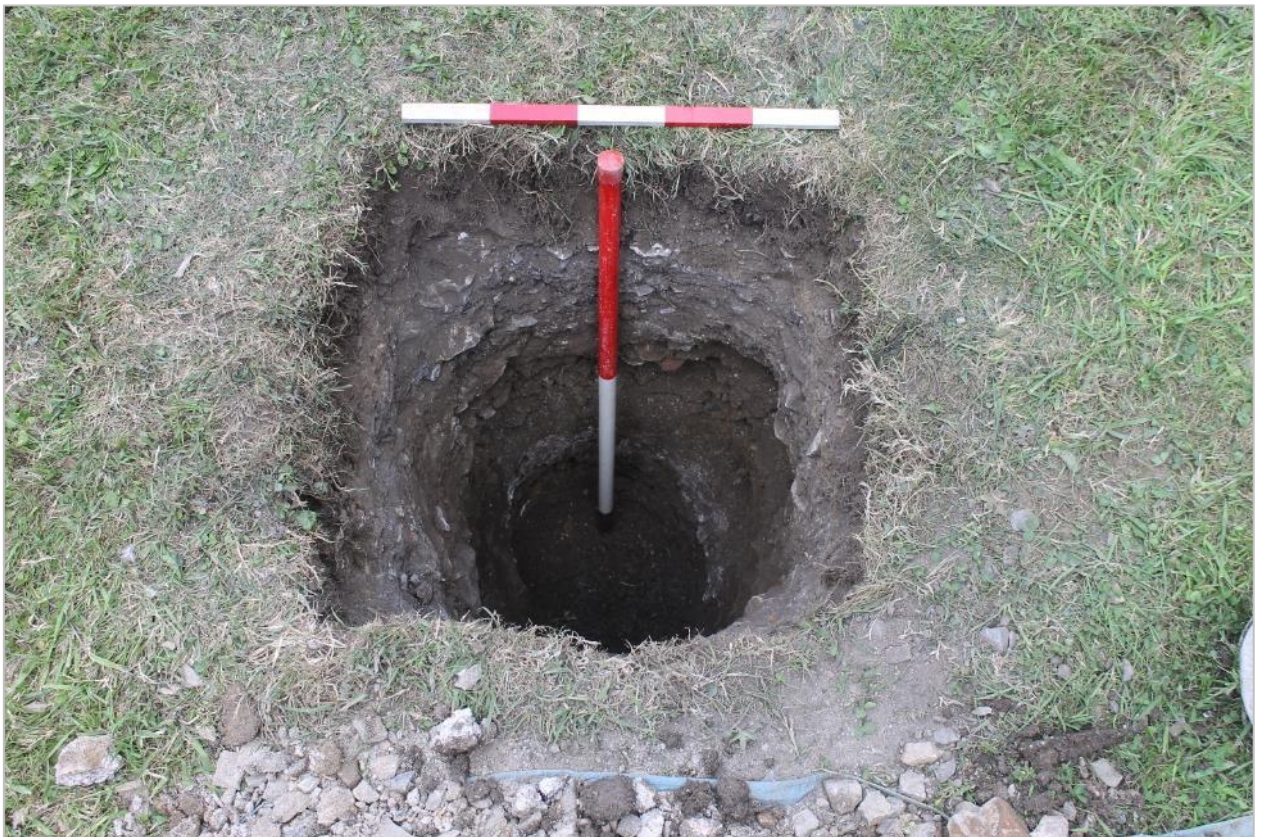
5.2.17 Test Pit B measured roughly 0.9m deep. Test Pit B was located 6.7m north of the north wall of Research room 6 (Photo 23). Below 0.2m of friable, mid-brown clay silt topsoil was a 0.12m deep, extremely compact but friable layer comprising a mixture of ash, mortar fragments, coal fragments, CBM and small, angular stones. This overlay a 0.5m deep compact layer almost entirely comprising small angular stones in a light brown, sandy clay matrix with occasional flecks of mortar and rare pieces of CBM. Below that was a 0.08m deep, very hard band of off-white lime mortar, with small angular stones. The lowest deposit, which was not bottomed, was a light brown, gritty silt clay with occasional mortar flecks and rare distinct pieces of mortar. One sherd of post-medieval glazed pottery and one sheep/goat phalange were recovered from this test pit.

Photo 23: Showing deposits in Test Pit B. Looking west, 0.5m & 1m scales.

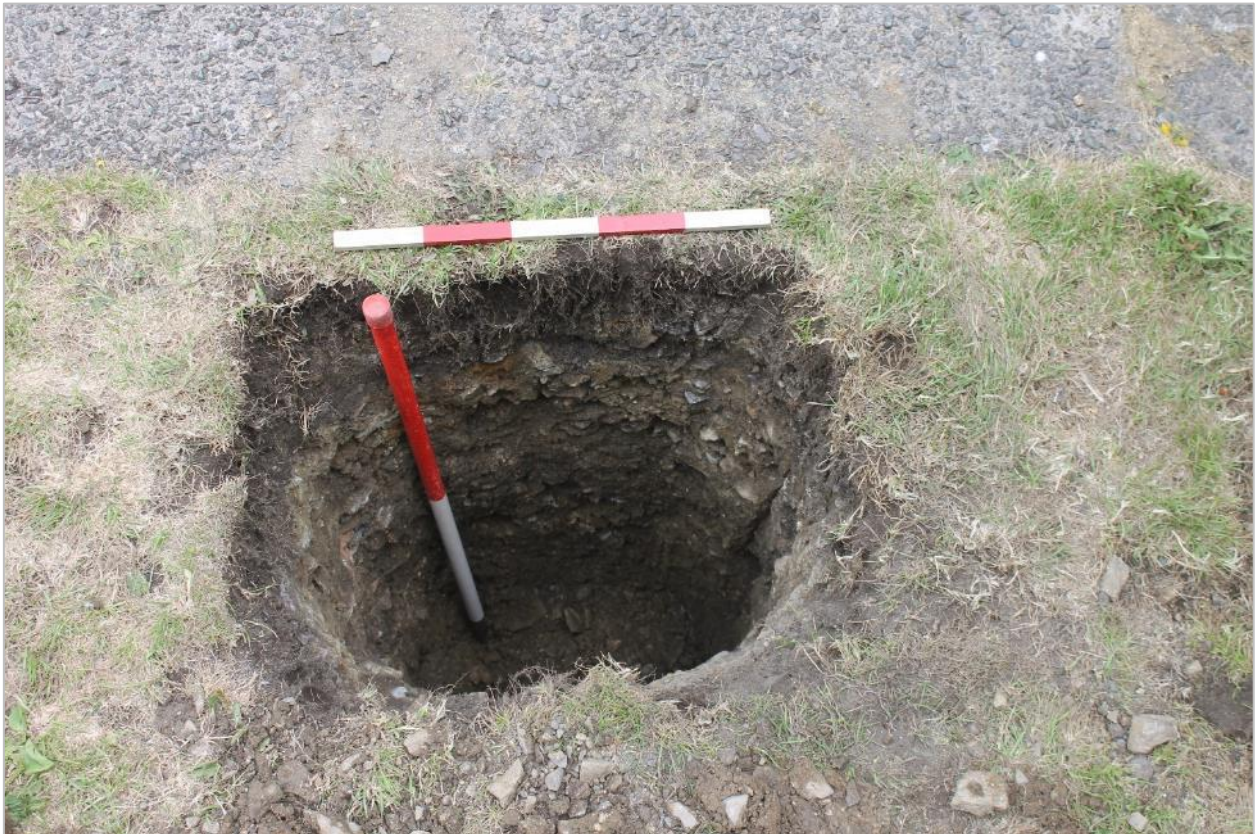
5.2.18 Test Pit C measured 1.2m deep. Test Pit C was located c.0.5m from the south wall of Store 31 (Photo 24). Below the turf 0.1m of loose, dark brown sandy silt overlay a maximum 0.3m of pale, greyish yellow compact stone, with almost no soil matrix. This layer contained clear tip lines and varied, due to tipping, in both depth and make-up. One bovine talus (ankle bone) was recovered from this layer. Below it, the lowest excavated layer, which was not bottomed, was a mid-to dark brown silty clay with frequent small angular stone inclusions, occasional larger angular inclusions, rare flecks of coal, small discrete pieces of lime mortar and occasional oyster shells.

Photo 24: Showing deposits in Test Pit C. Looking south, 0.5m & 1m scales.

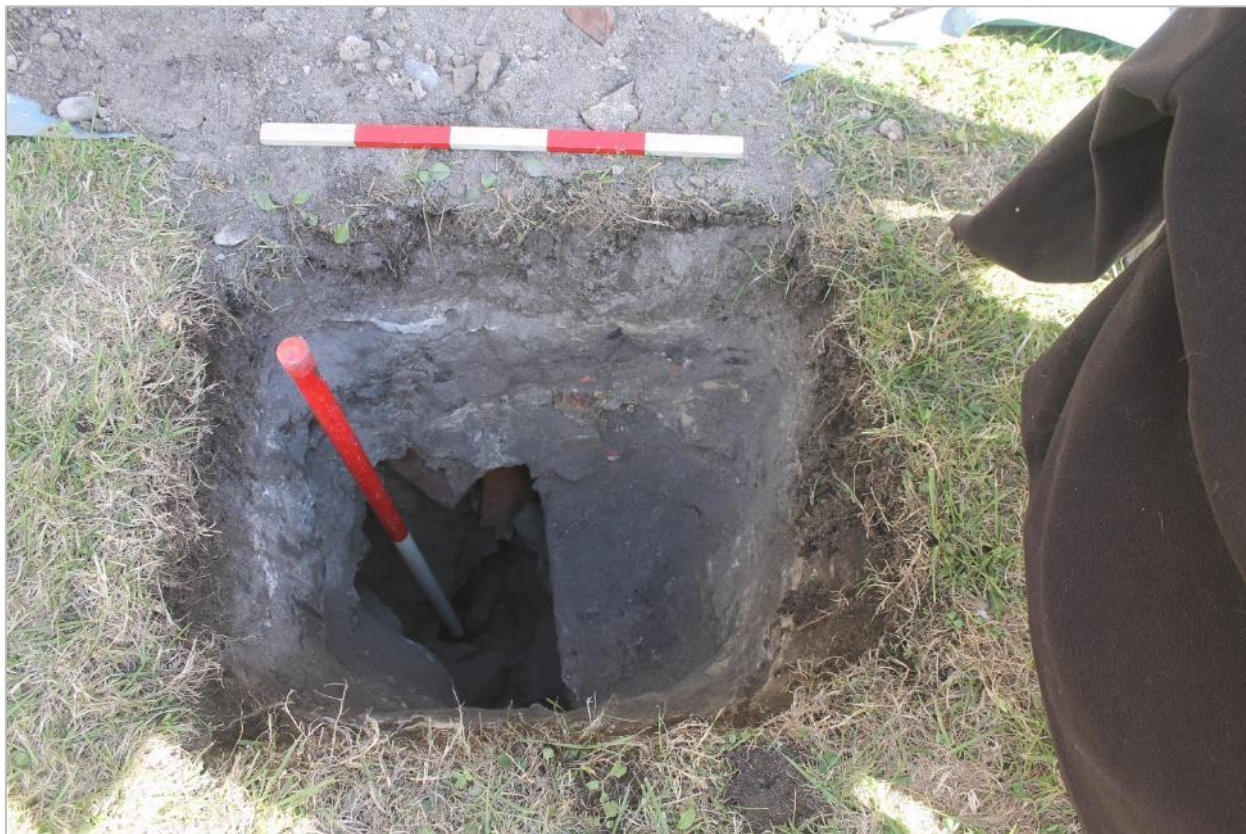
5.2.19 Test Pit D measured approximately 0.9m deep. Test Pit D was located 9.2m south-west of the south-east corner of strong room 4 (Photo 25). Below 0.2m of dark brown sandy silt topsoil was a 0.04m deep band of grey-white concrete with angular aggregate. The concrete overlay 0.08m of very compact, dark grey-brown sandy silt with frequent small flecks of CBM and mortar. Below that was a 0.2m deep, very hard and compact lime mortar rubble with broken brick, CBM and angular sandstone. A loose rubble with voids was below this layer. The rubble had been piled up and capped by modern tiles on a concrete bedding.

Photo 25: Showing a void revealed below concrete in Test Pit D. Looking north, 0.5m & 1m scales.

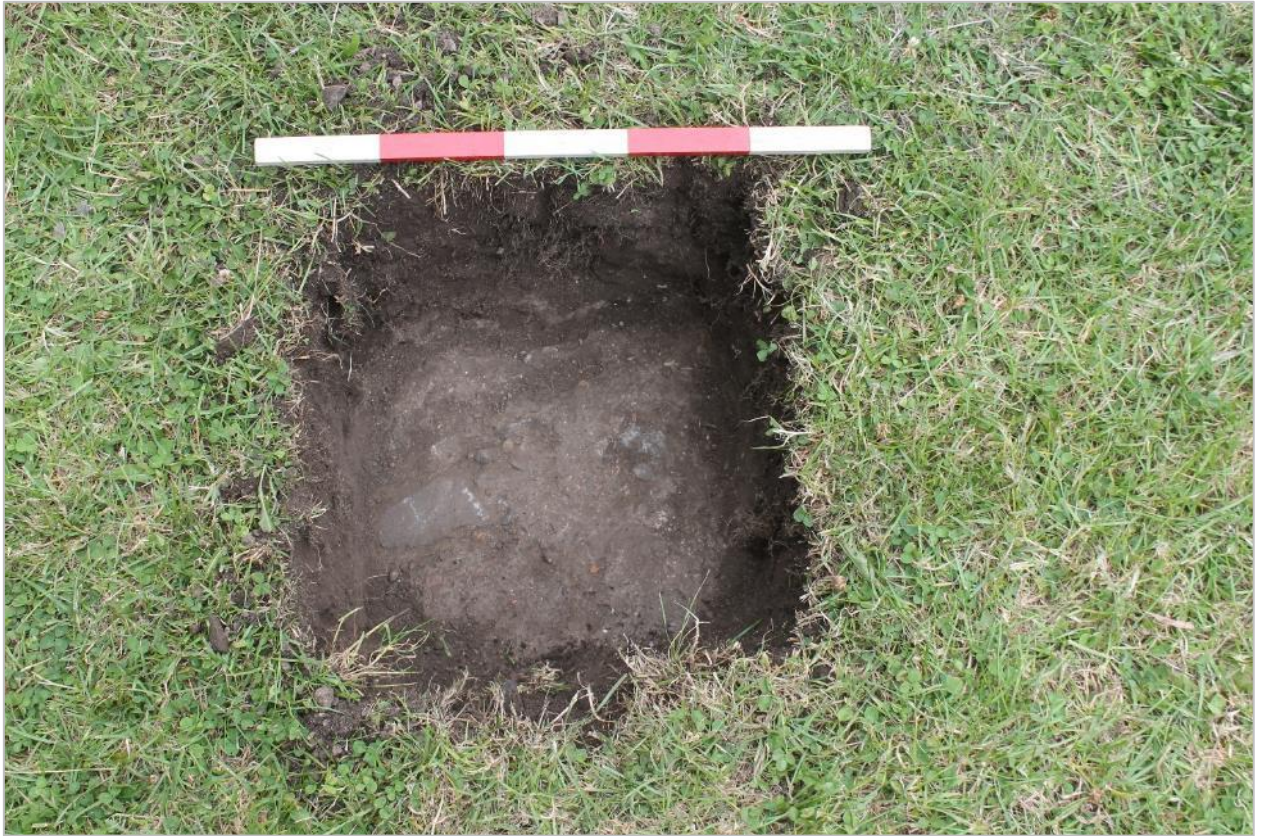
5.2.20 Test Pit E was an additionally excavated pit to those planned. It measured roughly 0.25m deep. Test Pit E was located 2m east of the south-east corner of strong room 4 (Photo 26). Below 0.15m of mid- to dark brown clay silt topsoil was a 0.1m deep, extremely compact deposit of light grey ash which broke to dust when impacted. A sherd of post-medieval blue and white glazed pottery was recovered from the upper level. Beneath the ash deposit was solid stone and lime mortar masonry that could not be damaged by the wrecking bar, thus preventing further excavation. Due to the limited size of the test pit it was not possible to characterize the masonry feature.

Photo 26: Showing masonry revealed in Test Pit E. Looking east, 0.5m scale.

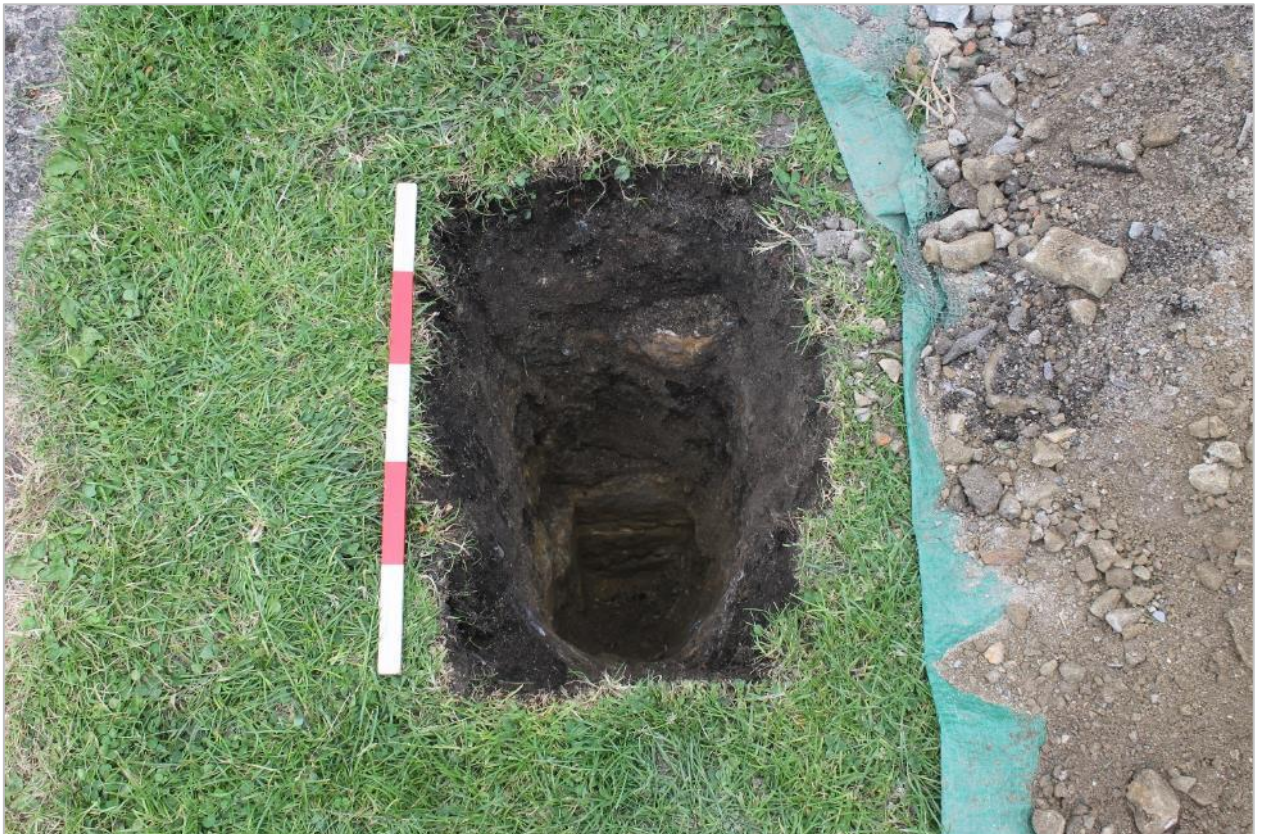
5.2.21 Test Pit F was an additionally excavated pit to those planned. It was located 4.9m south-east of the south-east corner of strong room 4 (Photo 27). Below c. 0.25m of mid- to dark brown clay silt topsoil was a compact mixture of dark brown clay silt soil, CBM, small stone chips and mortar. Below this, in the north- and west-facing sections was either the corner of a masonry feature comprising tightly jointed sandstone blocks, or a cut in the sandstone bedrock. In the north-facing section this feature was encountered 0.4m below the turf and was 0.6m deep.

Photo 27: Showing a possible wall revealed in Test Pit F. Looking south, 0.5m scale.

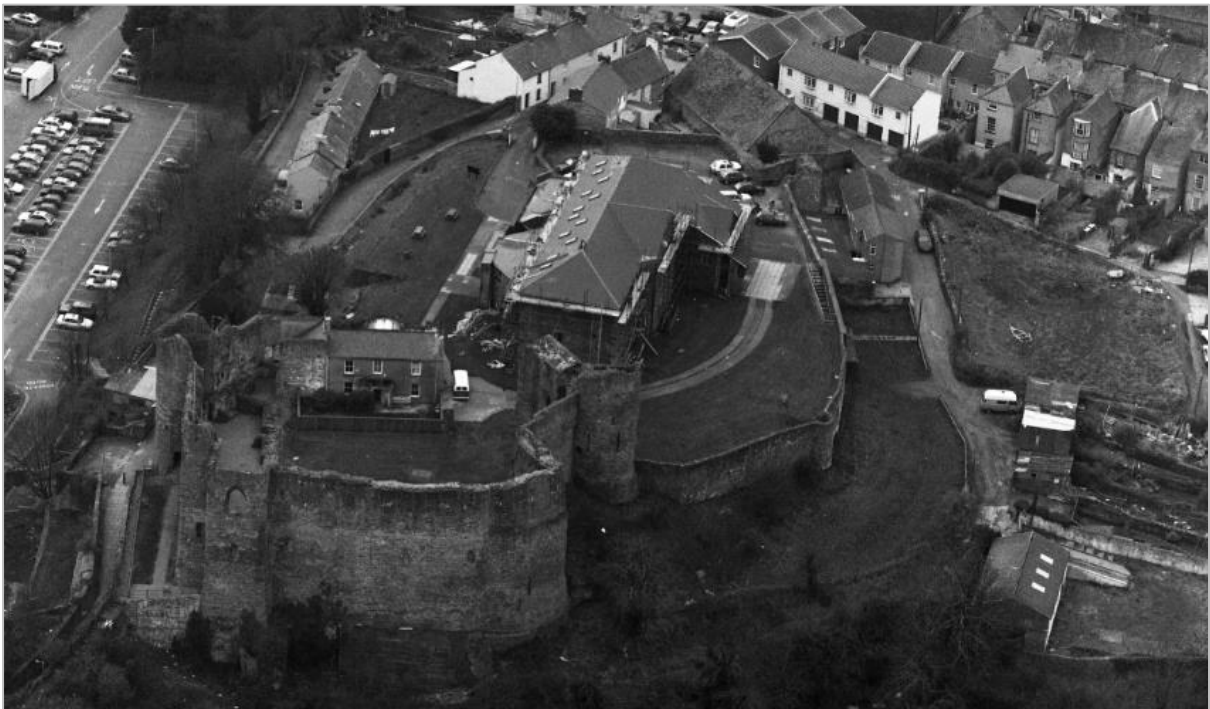
Photo 28: 1993 aerial photograph showing the location of the former gaol building within the outer ward of the castle. Looking west-south-west. © DAT
