HISTORIC FARMSTEAD RECORDING

CONDITION SURVEY 2023

REPORT NO. 2023-13
EVENT RECORD NO. 129735

**HISTORIC FARMSTEAD RECORDING:
Condition Survey 2023**

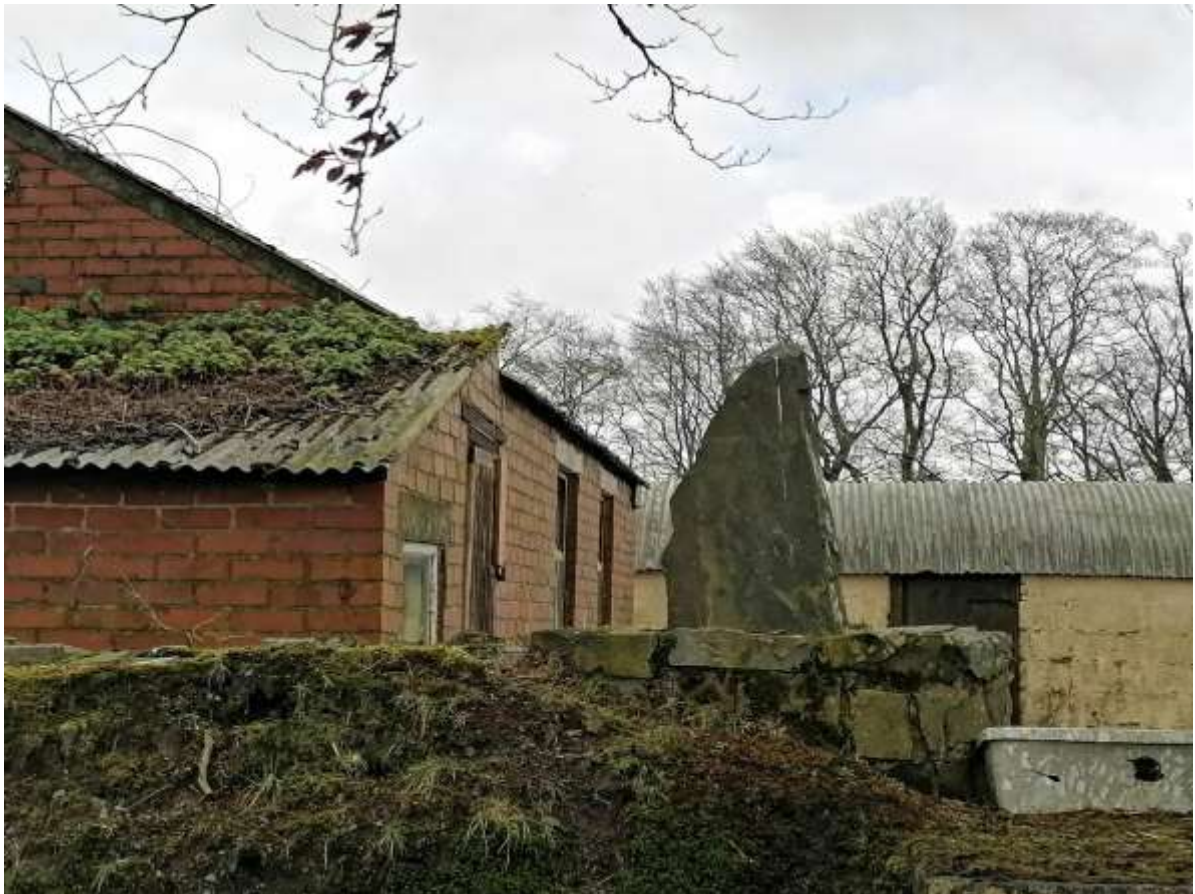
Photograph 1: Farmstead in Ceredigion (area 5), with various 20th century outbuildings, all in use. There is also a standing stone in the entrance to the yard.

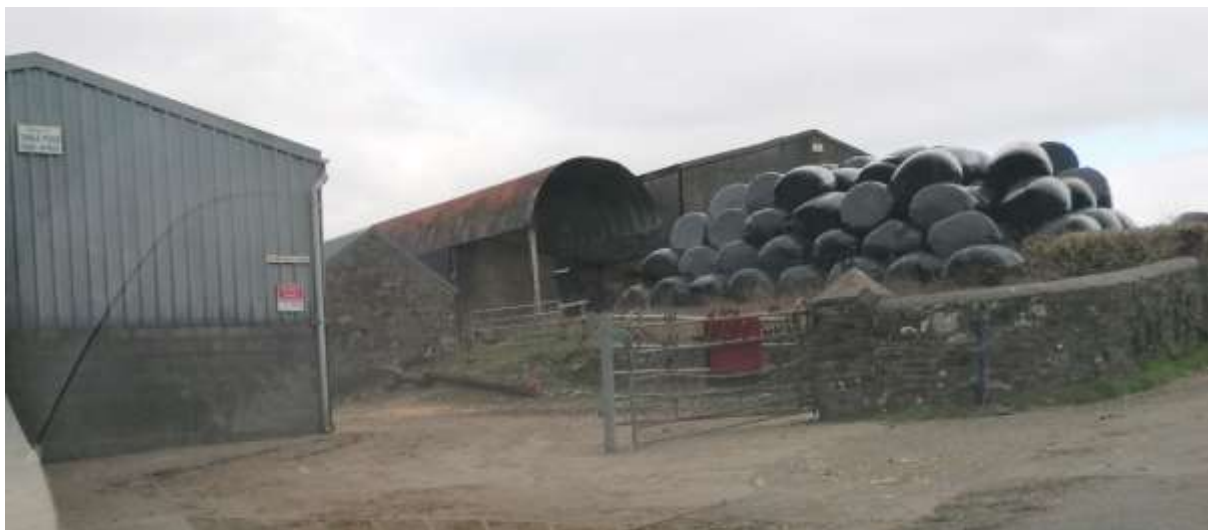
Photograph 2: Cwm Howell Farm (PRN 116140) in area 4, showing a range of modern and traditional outbuildings on a very large working farm.

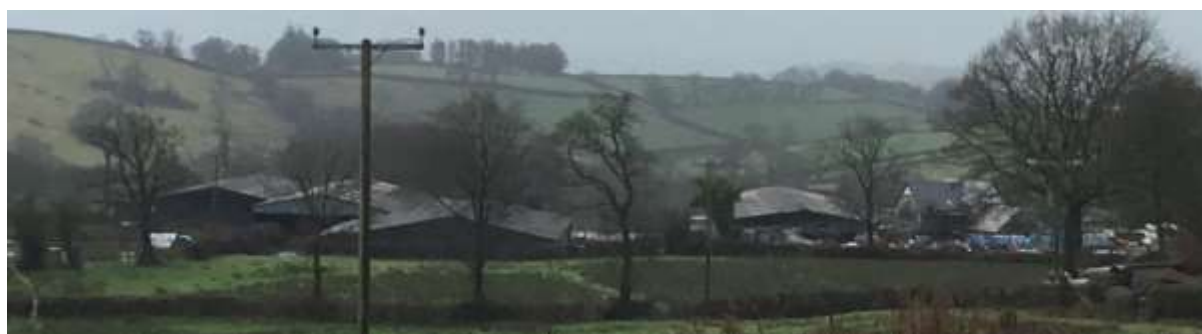
Photograph 3: Area 1. Ceunant Farm. A large range of modern outbuildings with newbuild farmhouse on the right of the picture (PRN 115898). Typical of the large farms in this area.

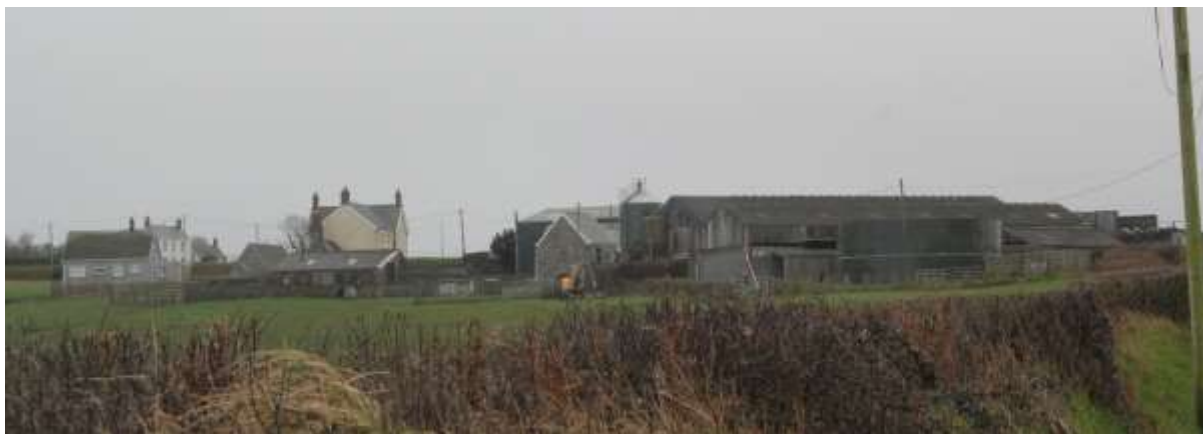
Photograph 4: A large working farm in the Cardigan area (area 2), showing traditional and modern buildings in good condition.

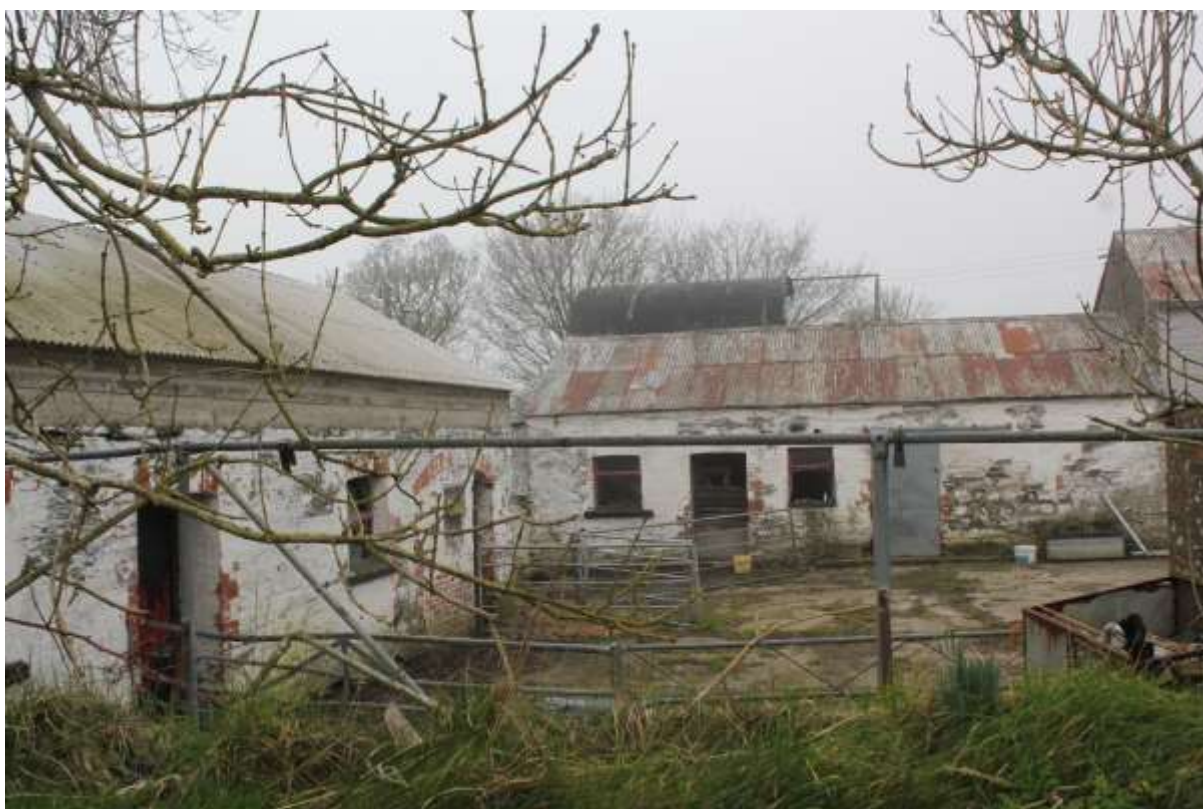
The condition of pre-1914 outbuildings on working farms is variable. At one farm they are in very poor condition and likely to collapse or be demolished in the near future. Generally, at other farms one or two ranges (occasionally all buildings) of pre-1914 are well maintained, but other ranges/individual buildings less so, with slates missing of roofs, windows missing and stonework in poor condition.

Photograph 5: A range of historic outbuildings in poor condition (area 2).

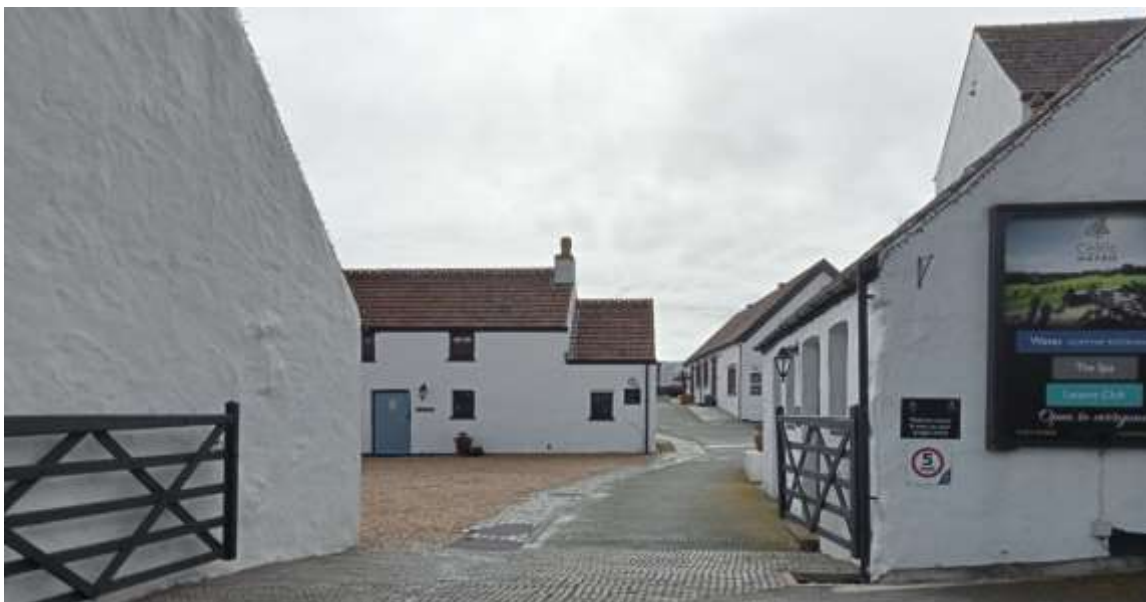
Photograph 6: Celtic Haven Self-Catering Holiday Cottages. Historic farm now converted. (PRN 121062, area 3).

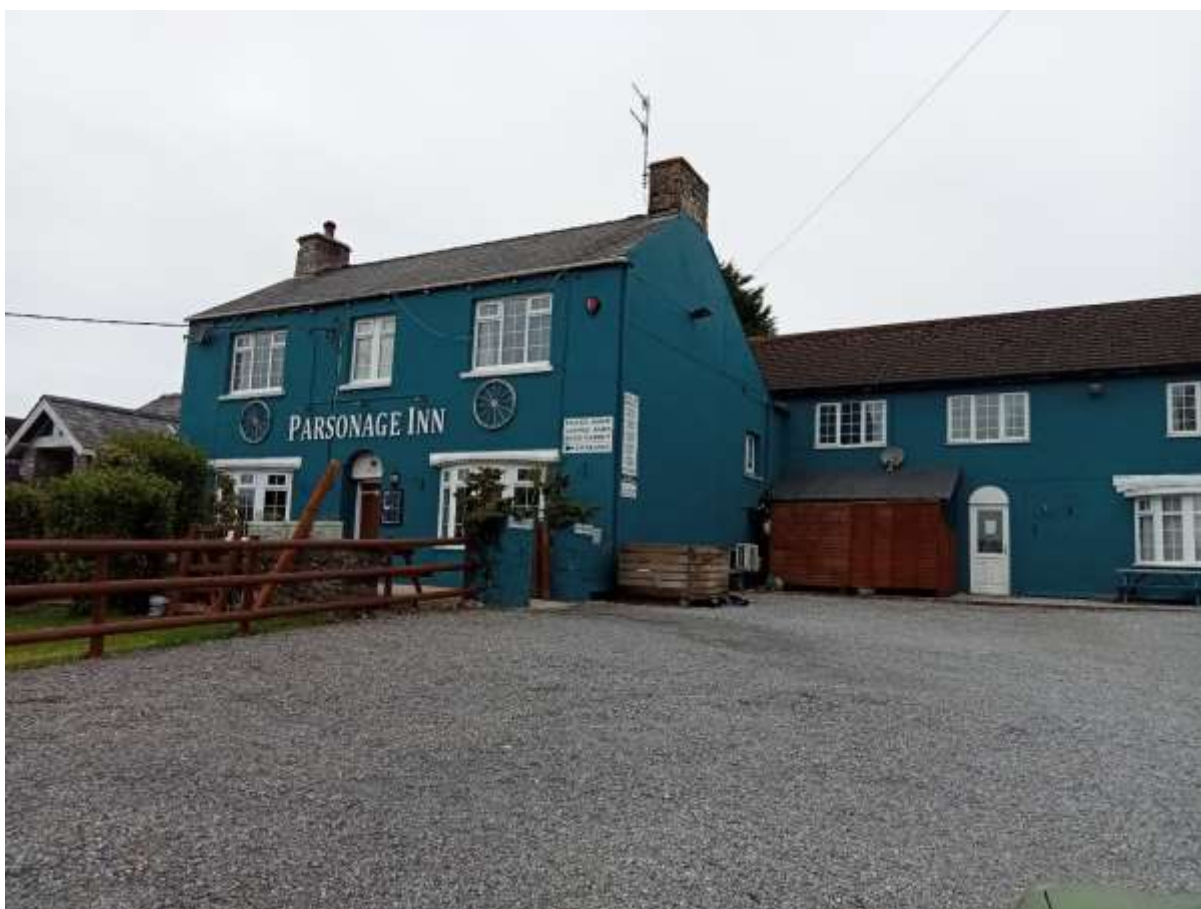
Photograph 7: Glebe Farm (area 3, PRN 119165), converted to Parsonage Inn.

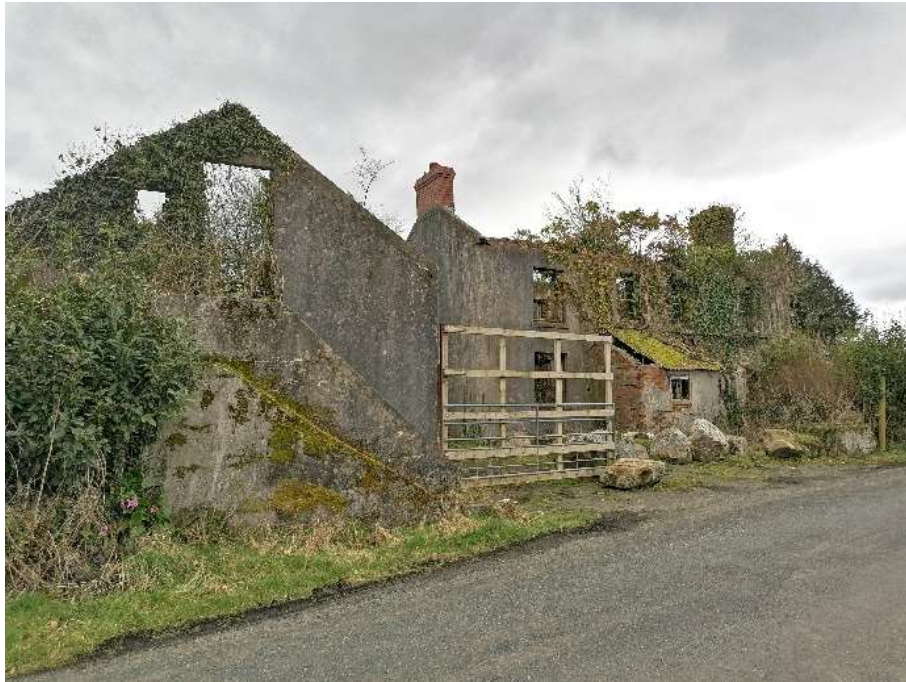
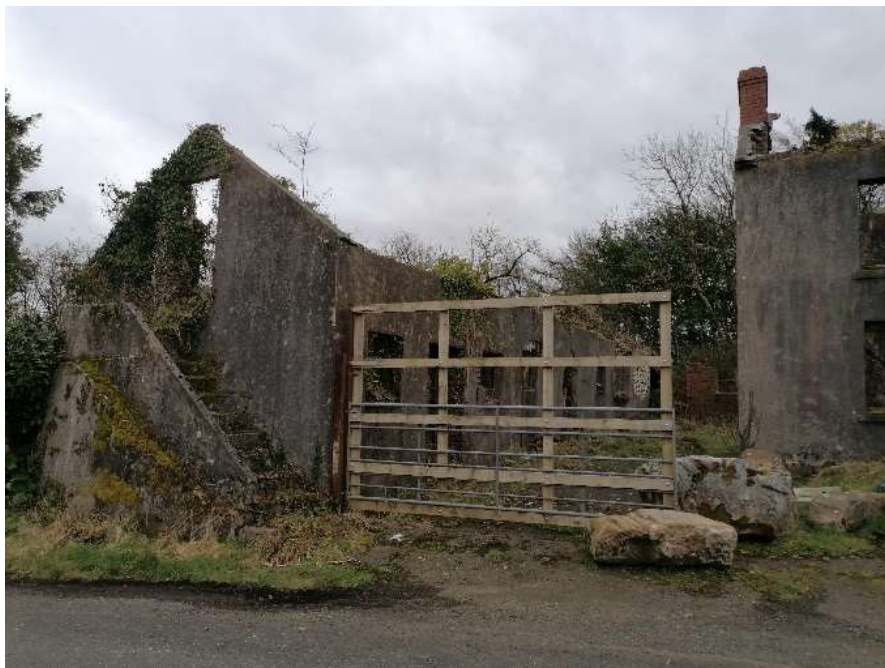
Photograph 8: PRN 53261, derelict (area 4).

Photograph 9: PRN 53261, derelict (area 4).

Llanelli area had the lowest number of historic farms still in existence, and evidence was seen to suggest a lack of funding for the upkeep of the buildings in this area. Unless something is done many more of these farm buildings will fall into disrepair and eventually disappear from the landscape altogether (see photographs 8 and 9).

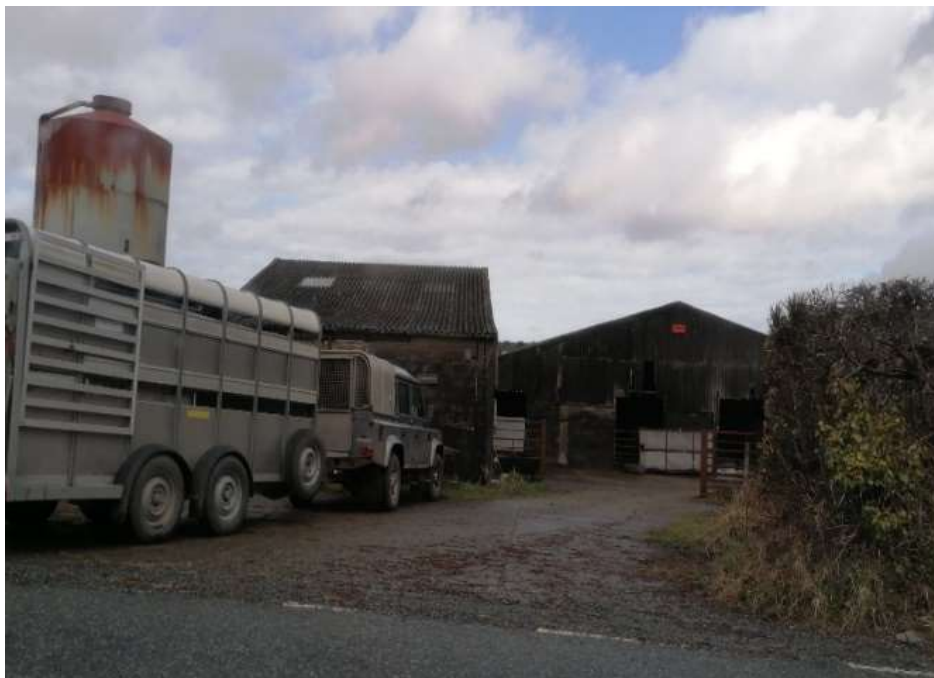
Photograph 10: A working farm from area 5.

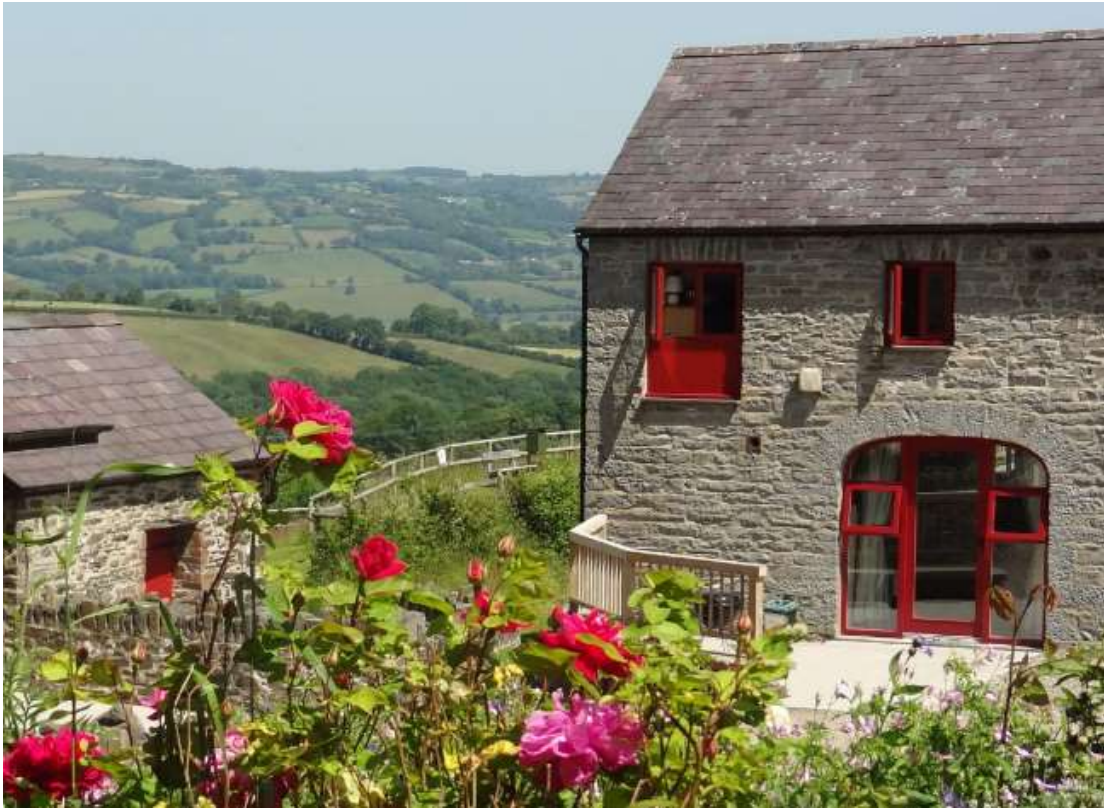
Photograph 11: Treberfedd farm (PRN 119255). Now a small working organic farm, holiday let business, and wedding venue. Photo courtesy of Treberfedd farm website.

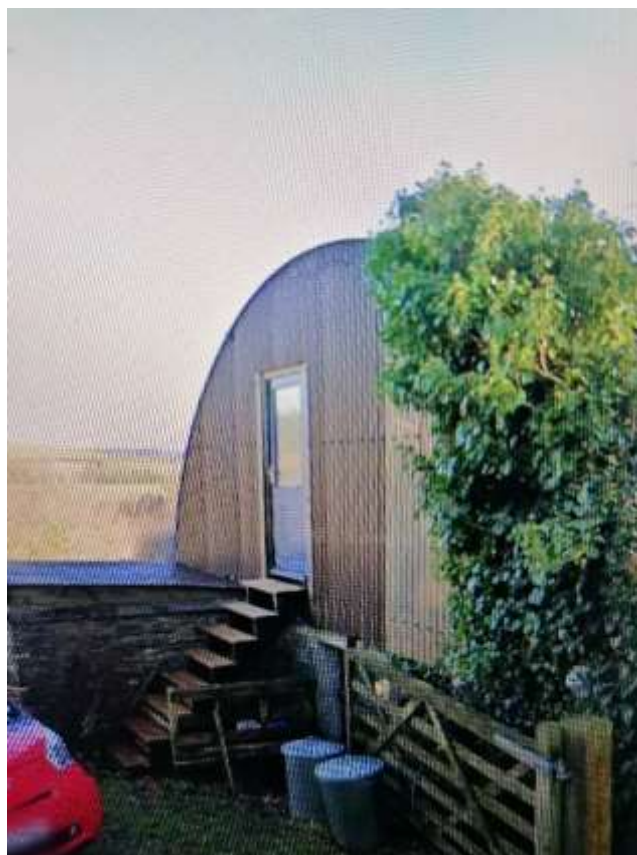
Photograph 12: Prn 51478. Converted to a domestic dwelling? Photograph courtesy of Google Streetview
