# MARLOES MERE, MARLOES, PEMBROKESHIRE:

# HISTORIC ENVIRONMENT DESK-BASED ASSESSMENT

REPORT NO. 2023-20 PROJECT NO. 129781

DAT Archaeological Services were commissioned to prepare a Historic Environment Desk-Based Assessment for proposed wetland restoration at Marloes Mere, Trehill Farm, Marloes, Pembrokeshire (SM 7753 0803).

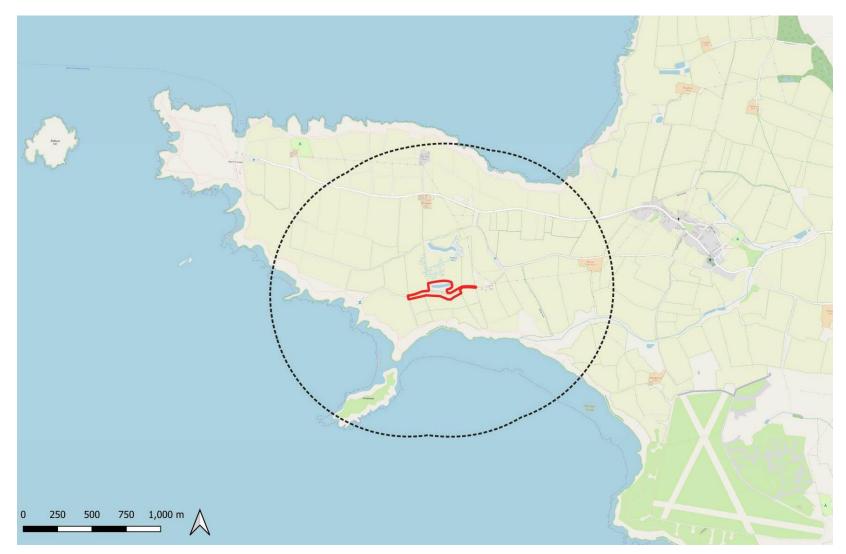
Figure 1: Location of development area showing the proposed development site in red, with the dotted line representing the 1km study area.

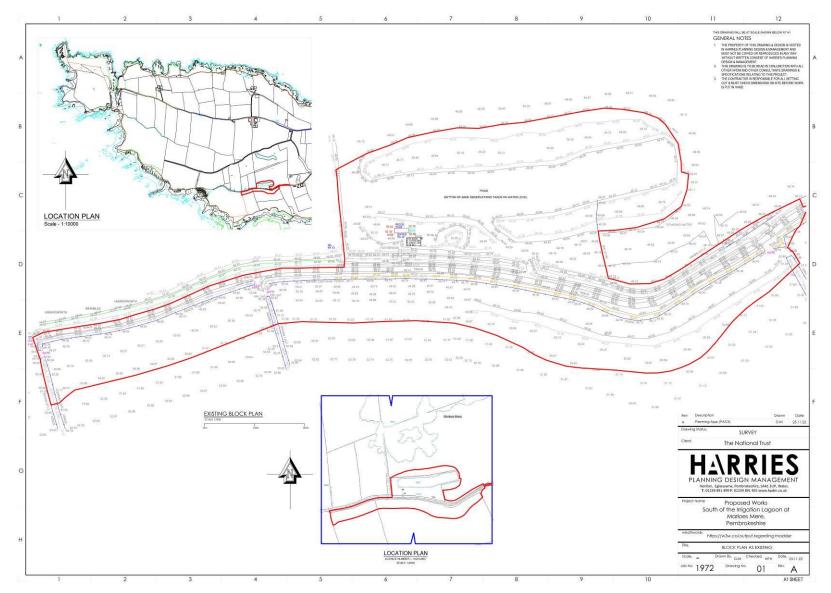
Figure 2: Detailed site and development location plan. Plan provided by the client, not reproduced to original scale.

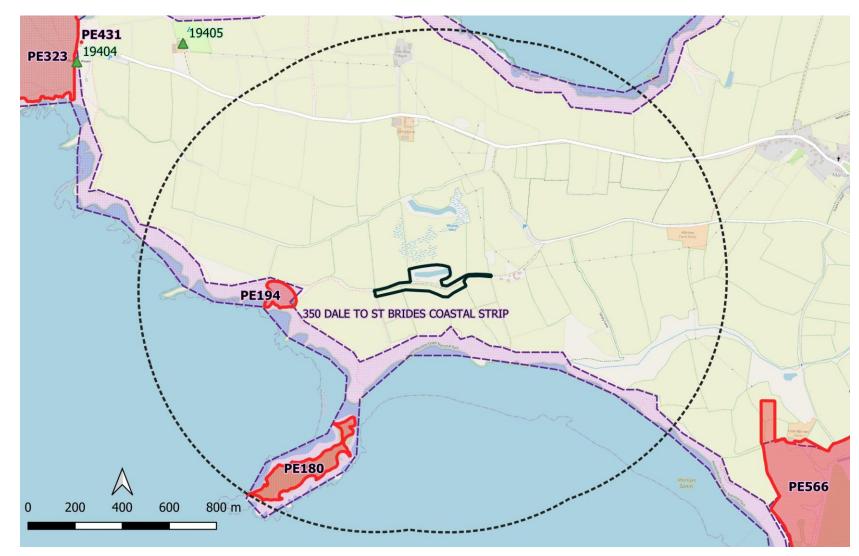
Figure 3: Map showing the proposed development site and all designated assets within the 1km radius study area (dotted line). Scheduled monuments are marked in red, listed buildings in green, and the Historic Landscape Character Areas in purple.

# 4 DESIGNATED HISTORIC ASSETS (Table 2 and Fig 3)

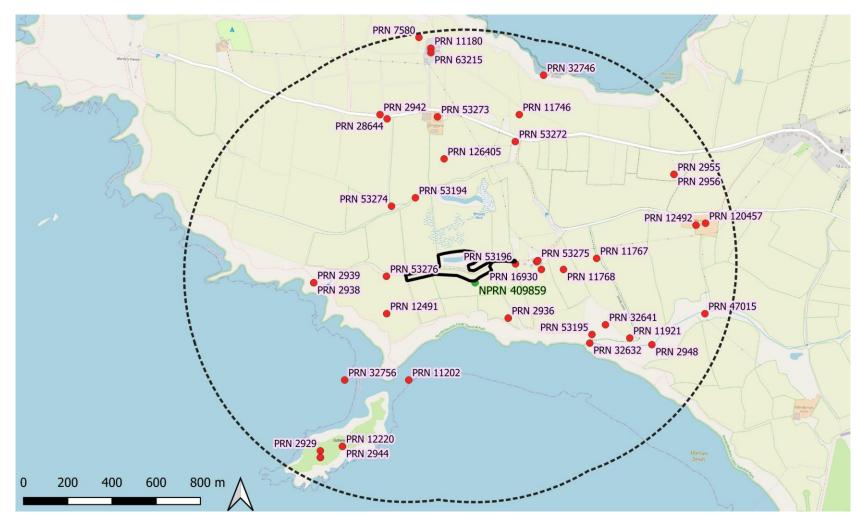
**Figure 4:** Map showing the proposed development site and the 1km radius study area (dotted line), together with non-designated assets recorded on the regional HER, labelled by PRN and the additional site recorded on the NMR, labelled by NPRN.

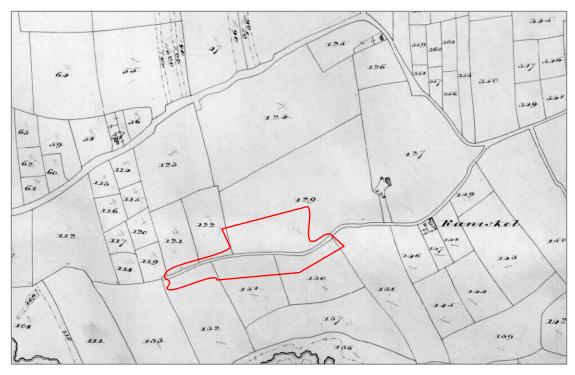
Figure 5: Extract from the 1843 parish tithe map. Approximate location of development site in red.

subsequently abandoned. The southern pond lay in a larger field named 'South Mier', farmed by James Dean Wathan of Marloes Court. To the south of the trackway the former large field named 'Halflin Piece' on the 1767 estate map is now subdivided into 'Bramble Hoffland' 'North Hoffland' and 'South Hoffland', all owned by 'Allen' and farmed by William Bevan of 'Raniskel'. The field to the southeast was still part of Lord Kensington's land, farmed from Marloes Court.

- 6.3.8 The track (MM01) is shown throughout the development area and is possibly marked because land on the Mere to the north has been enclosed. The route is marked as far as the western end of the development area. The line beyond that point is suggested by a narrow strip of land on the approach to Watery Rath which is labelled 'No.109 Slang' (an old English word referring to a narrow piece of land).
- 6.3.9 To the east, the farmstead of 'Raniskel' is shown (PRN 53275) as is Trehill Farm (PRN 53273) to the north, with some remnants of the strip field surviving to its south. Varna Cottage is marked on the east side of the Mere as is the cottage further to the north which was also indicated on the previous map (occupied at this time by John Morris). To the northwest Boggy Lodge (PRN 53274) is indicated, home to Margaret Phillips.

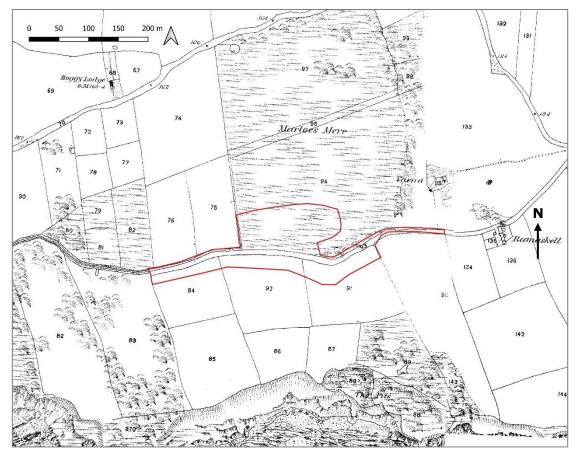
**Figure 6:** Extract from the Ordnance Survey map of 1875. Site boundary shown in red.

it appears to sit in a slight cutting. It stops as it reaches the rough coastal fringes, but a water channel continues the line to Watery Bay Rath (PRN 2939). This would appear to line up with a possible entrance in the defences around the site, however this last stretch of water channel is very straight and is presumably an artificial drain. It lines up with boundaries down the centre of the Mere and is presumably therefore part of the 19<sup>th</sup> century attempts to drain the Mere. A small rectangular structure or enclosure is marked on the south side of the lane (PRN 53276), of unknown function.

6.3.11 The surrounding settlement pattern remains the same. 'Ramaskell' farmstead (PRN 53275) comprises a linear range of buildings, presumably with the farmhouse in the centre and a threshing barn to the north with a circular horse gin on the east side. To the north lies Varna Cottage, Boggy Cottage (PRN 53274) is to the northwest and Trehill Farm (PRN 53273) to the north. However, the little cottage along the lane to the northeast has gone. Green Mire Cottage on Sandy Lane is shown for the first time.

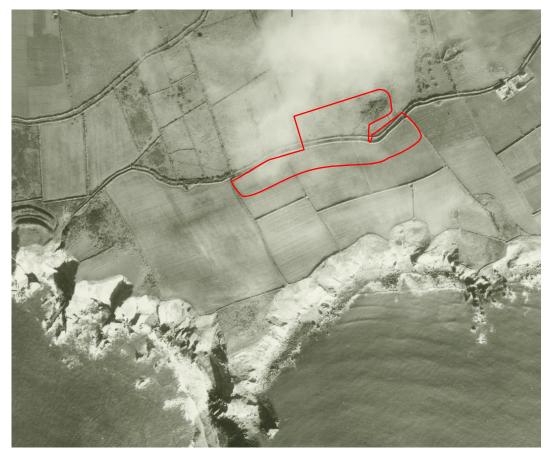
**Photo 1:** Aerial photograph taken by the RAF in 1941. Showing the full length of the trackway from Runwayskiln to Watery Bay Rath, approximate site area shown in red.

- 6.4.2 The initial RAF images from 1941 (Photo 1) show the Mere as sub-divided land, but generally rough and presumably boggy ground, prior to the construction of the reservoirs in the 1970s. The trackway around the southern edge (MM01) is well-defined by hedgerows, extending between the enclosed land to the coastal fringe immediately in front of Watery Bay Rath (PRN 2939). The land to the south of the trackway is cultivated, but otherwise nothing of archaeological interest is noted. The rectangular structure (PRN 53276) to the west is visible as a built structure, presumably an outlying agricultural building.

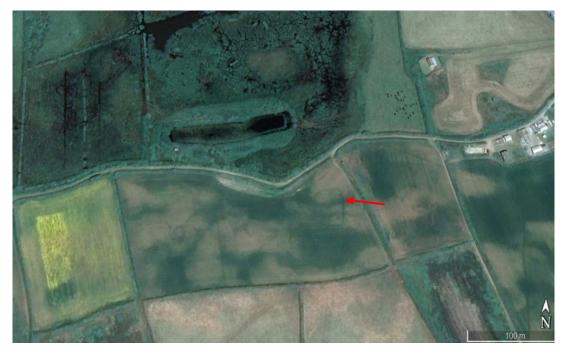
**Photo 3:** Google Earth satellite image taken in 2018. The cropmarked enclosure, forming part of NPRN 409859, is marked to the east. © 2023 CNES/Airbus

6.4.4 The RCAHMW (T Driver) flew over the site in 2006 and identified a spread of features recorded as NPRN 409859; the aerial images are available to view on Coflein. Of particular note are features in the field to the south of the pond. At the eastern end of the field, two sides of a possible enclosure are visible and in the centre of the field a smaller curvilinear feature can also be clearly seen. Alongside these a number of other less readily identifiable features are visible, largely clustered on the rising ground that defines the southern edge of the proposed development area and beyond, spreading into the fields to the east and west. These features do appear to have characteristics similar to some prehistoric settlement sites. The larger eastern enclosure is also visible on later satellite imagery (Photo 3).

- 9.2.2 Cropmarks visible on aerial photography have suggested the presence of archaeological remains associated with NPRN 409859 that may extend into the proposed development area. The full extent of these features is unclear at present. Geophysical surveying may offer a technique through which further remains could be identified. It should be noted however that the relatively limited area available between the existing trackway boundary and the edge of the proposed development area would make any results from such a survey difficult to interpret.

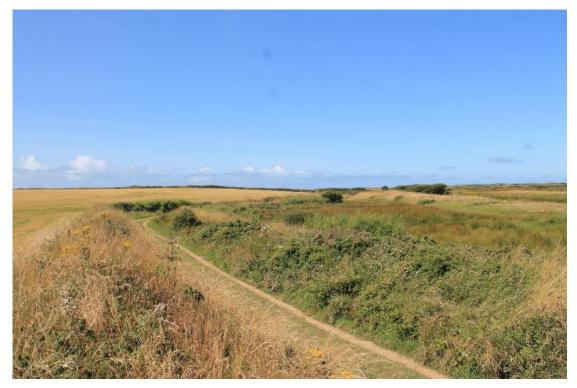
**Photo 4:** View west across the proposed development area with wetland area on the right, the current footpath in the centre, and fields to the left.

- 6.6.2 The Mere lies in a shallow saddle of land between raised ground to the east, rising terrain to the north and the trackway (MM01) along the southern side (Photos 4–7). The trackway sits within this saddle, with ground beginning to rise slightly in the fields to the south, suggesting the original natural extent of the wetlands may well have extended a short distance to the south of the track before the terrain rises again and dries out. Field boundaries within the mere, as depicted on 19<sup>th</sup> and 20<sup>th</sup> century maps and mid-20<sup>th</sup> century aerial photographs, are no longer readily identifiable, and the wetland area now extends further west, covered in low wetland vegetation and (at the time of the visit) grazed by a small number of cattle. The southern reservoir is a rectangular pond, retained by embanked material to all sides, with a wooden bird-hide hut on the southern bank. The wetland is contained by post-and-wire fencing and grown-out hedgerows.

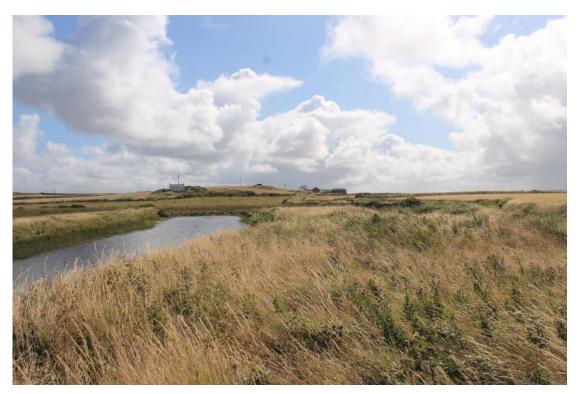
**Photo 5:** View east across the Mere and the southern reservoir, with Varna Cottage and Runwayskiln (PRN 53275) in the background.

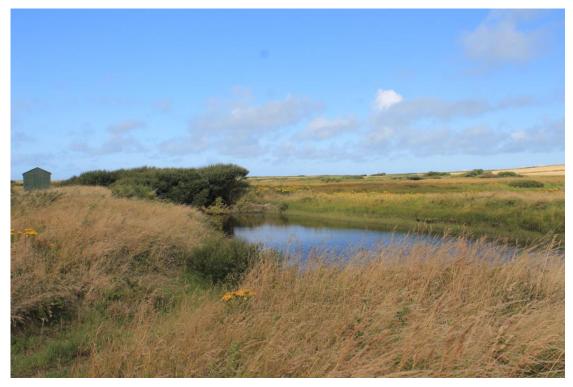
Photo 6: View west across the southern reservoir with the Mere extending beyond.

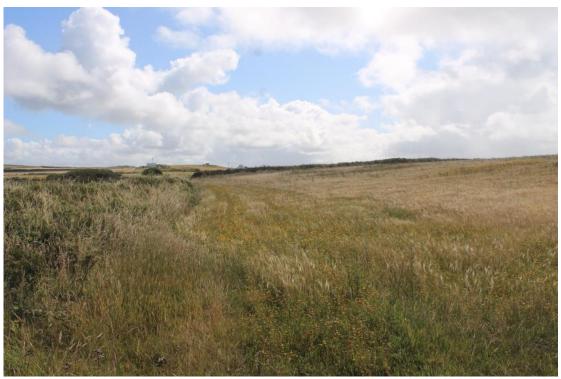
**Photo 7:** View east across the proposed development area to the south of the trackway, showing the rising ground to the south.

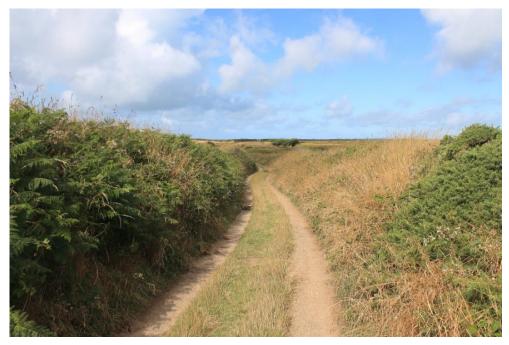
**Photo 8:** View southwest along the current trackway (MM01) through the proposed development area.

6.6.3 The trackway (MM01) runs to the south of the wetlands (Photos 8 and 9). The route is tarmacked up to Runwayskiln Farm (PRN 53275), with stone packing beyond, up to the western edge of the proposed development area. The track is approximately 4m to 8m wide (enough for farm vehicle access), enclosed by hedgerows and some banking. Drainage trenches are partially visible alongside the track. At the western end the visible line of the track disappears (Photo 10) but the public footpath access continues across the field both west to Watery Bay Rath (PRN 2939) and south to the coastal path.

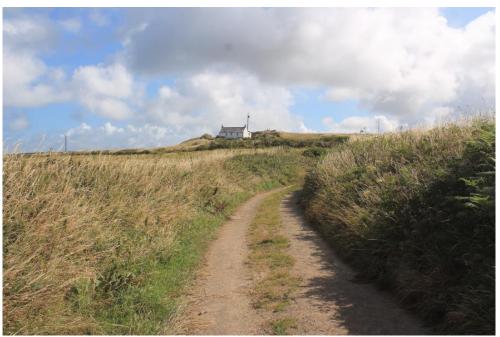
**Photo 9:** View northeast along the current trackway (MM01) through the proposed development area, with Varna Cottage in the background.

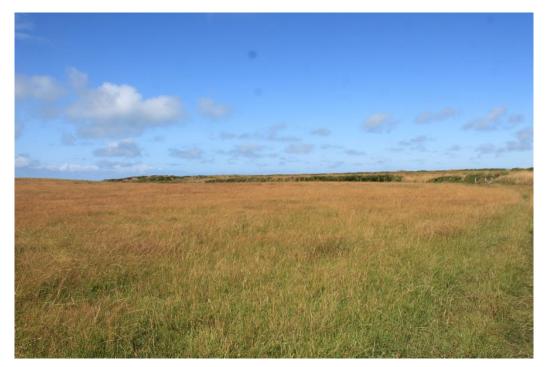
- Photo 10: View west from the western end of the proposed development site. Trackway MM01 runs around the field boundary in the greener grass to the right, with Watery Bay Rath PRN 2939 on the horizon left of centre.
- 6.6.4 The fields to the south lie on gently rising land to a low ridgeline along their southern end (Photo 11), parallel to the slight kink in the trackway line and meeting the slightly rising ground immediate to the east of the proposed development area. The fields were under a light crop and low meadow vegetation, enclosed by hedgerows, but no features of archaeological interest were visible at ground level.

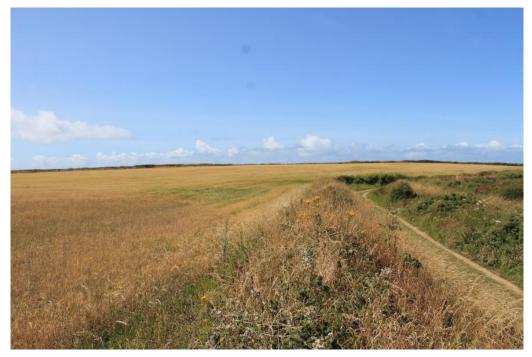
**Photo 11:** View southwest across the proposed development area on the south side of the track.

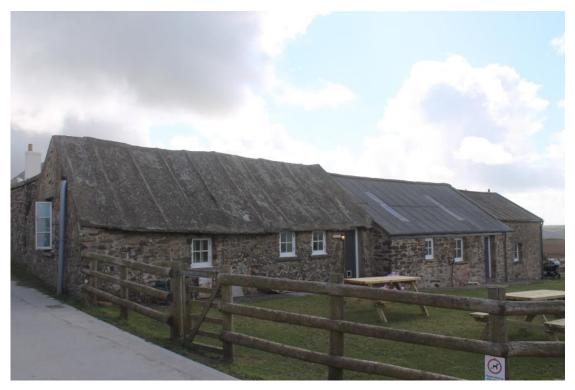
**Photo 14:** View southeast of a farm building range at Runwayskiln Farm PRN 53275. This would appear to be the original range of the farm, with domestic accommodation to the centre.

6.6.5 To the east of the Mere the ground rises to a slight knoll, on which Varna Cottage has been built, overlooking the wetlands (Photo 12). This is a small single-storey, masonry-built cottage with slate gable roof. Runwayskiln farmstead (PRN 53275) lies on the track to the east (Photos 13 and 14). The farmhouse lies on the east side of the farmstead complex, two-storey white-washed masonry with brick gable-end chimney stacks through the lime-washed slate roof which extends over a single storey extension on the north side. The farmstead lies to the west, enclosed by an L-shaped arrangement of two ranges. The western range comprises three adjoining single-storey masonry building, a lime-rendered roof to the north, corrugated panelled roofing to the south. The southern range is singlestorey masonry building with a slate gable roof. To the west lies a detached two-storey masonry threshing barn with hay loft and the remains of a former building on its west side. A modern wooden agricultural shed lies to the south. All buildings have been converted for various use by the National Trust. The concrete footings for a structure to the west (PRN 53196) are used for car parking (Photo 15). There is no clear indication at ground level in the surrounding fields of former field boundary remnants of the open field system (PRN 11768).

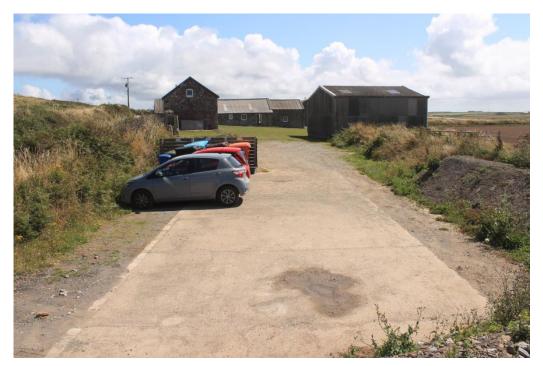
**Photo 15:** View east across the concrete footings for PRN 53196, with Runwayskiln Farm PRN 53275 in the background.

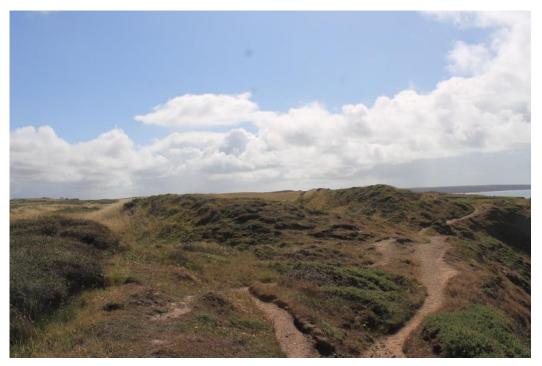
Photo 16: View southeast across the defensive banks and ditches of Watery Bay Rath PRN 2939.

6.6.6 To the west the footpath continues to Watery Bay Rath (PRN 2939). The site is readily identifiable by the prominent banks and ditches that enclose its landward side (Photo 16). There appears to be an entrance through these defences to the northeast, roughly lining up to the end of the trackway, although the trackway itself is not a visible feature in this area (Photo 17).

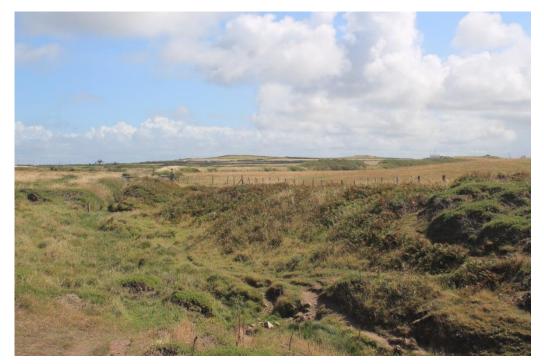
**Photo 17:** View northeast along the outer ditch and entrance to Watery Bay Rath PRN 2939.

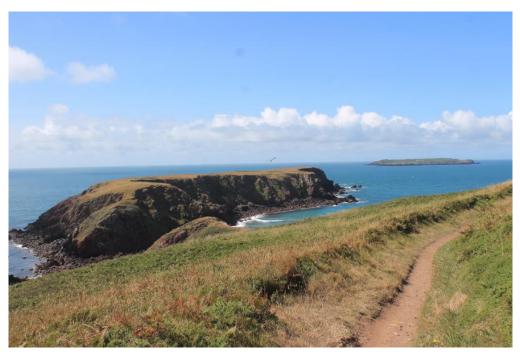
**Photo 18:** View southwest from the coastal path looking at Gateholm Island with Skokholm in the background.

6.6.7 To the south lie enclosed agricultural fields up to the coastal fringe, along which runs the coastal path (Photo 18). Modern footpaths cut back through these fields to the trackway around Runwayskiln. The coastal path descends to sea level at Marloes Sands. A path then cuts back up a stream valley (Sandy Lane), past a small 19<sup>th</sup> century cottage (Green Mire Cottage, Photo 19) and back up to the local road to the east of Runwayskiln.

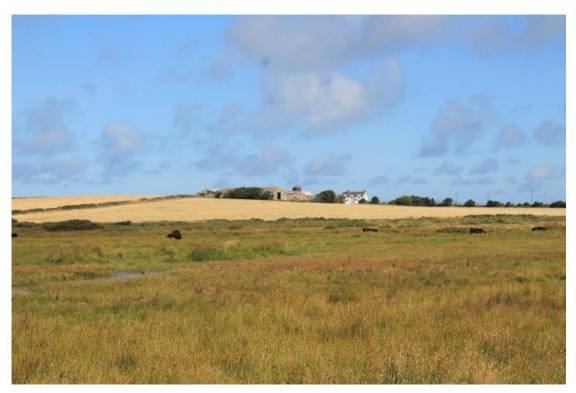
Photo 20: View northwest across Marloes Mere with Trehill Farm PRN 53273 in the background.

6.6.8 To the north of the Mere, the land rises onto a low ridge. Enclosed farmland covers the rising ground and Trehill Farm (PRN 53273) lies on this ridge (Photo 20). This area was not visited.

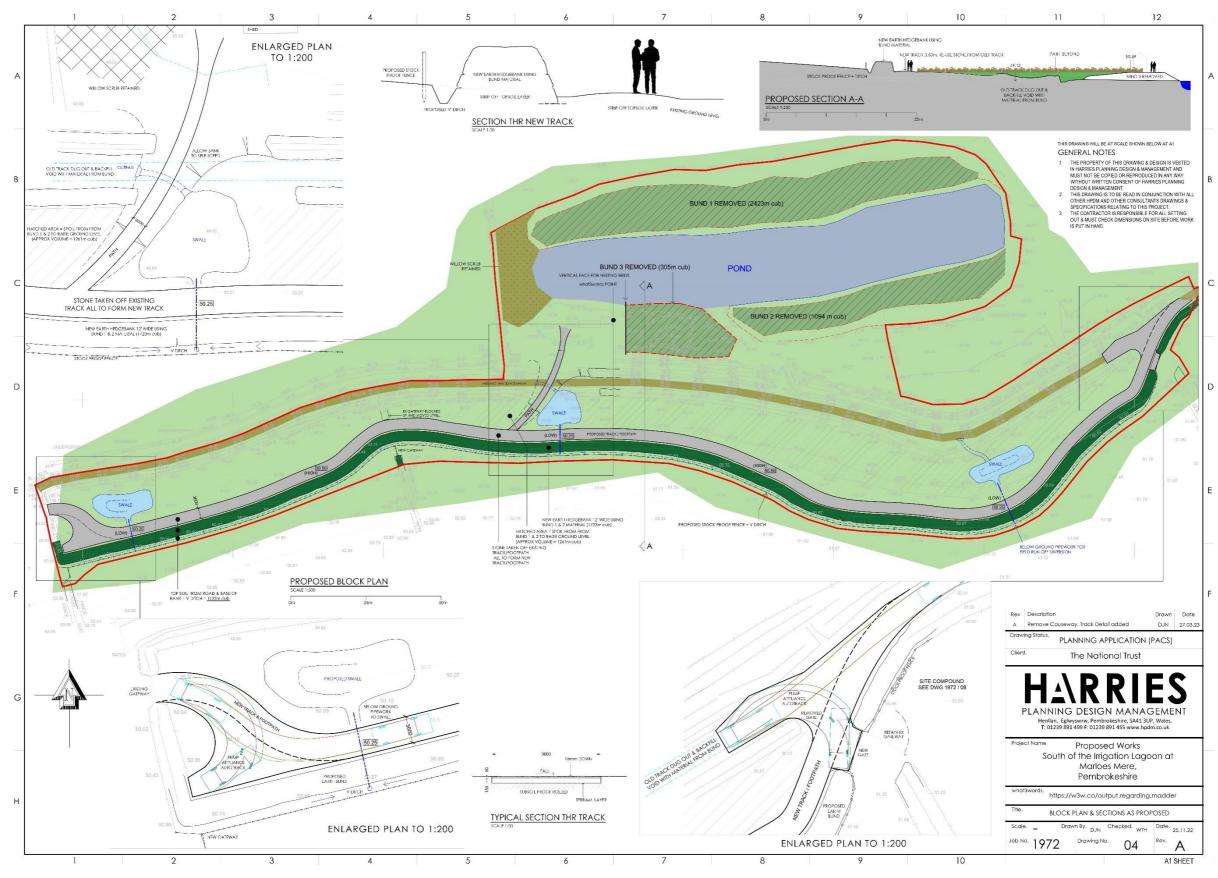
Figure 7: Proposed block plan, showing the development layout and details. Plan provided by the client, not reproduced to scale.

- 8.1.1 The development proposals are illustrated in Figure 7, their purpose being to restore and improve the wetland habitats in the locality. This will be achieved through the removal of the southern reservoir's bunds, the relocation of the existing trackway onto higher ground to the south, bounded by a new hedgerow, with a new causeway path linking to an existing bird hide and the installation of a new gateway.
