TIDAL EMBANKMENT, MWCHE FARM, LLANYBRI, CARMARTHENSHIRE: HISTORIC ENVIRONMENT DESK-BASED ASSESSMENT

REPORT NO. 2023-22

TIDAL EMBANKMENT, MWCHE FARM, LLANYBRI, CARMARTHENSHIRE:

HISTORIC ENVIRONMENT DESK BASED ASSESSMENT

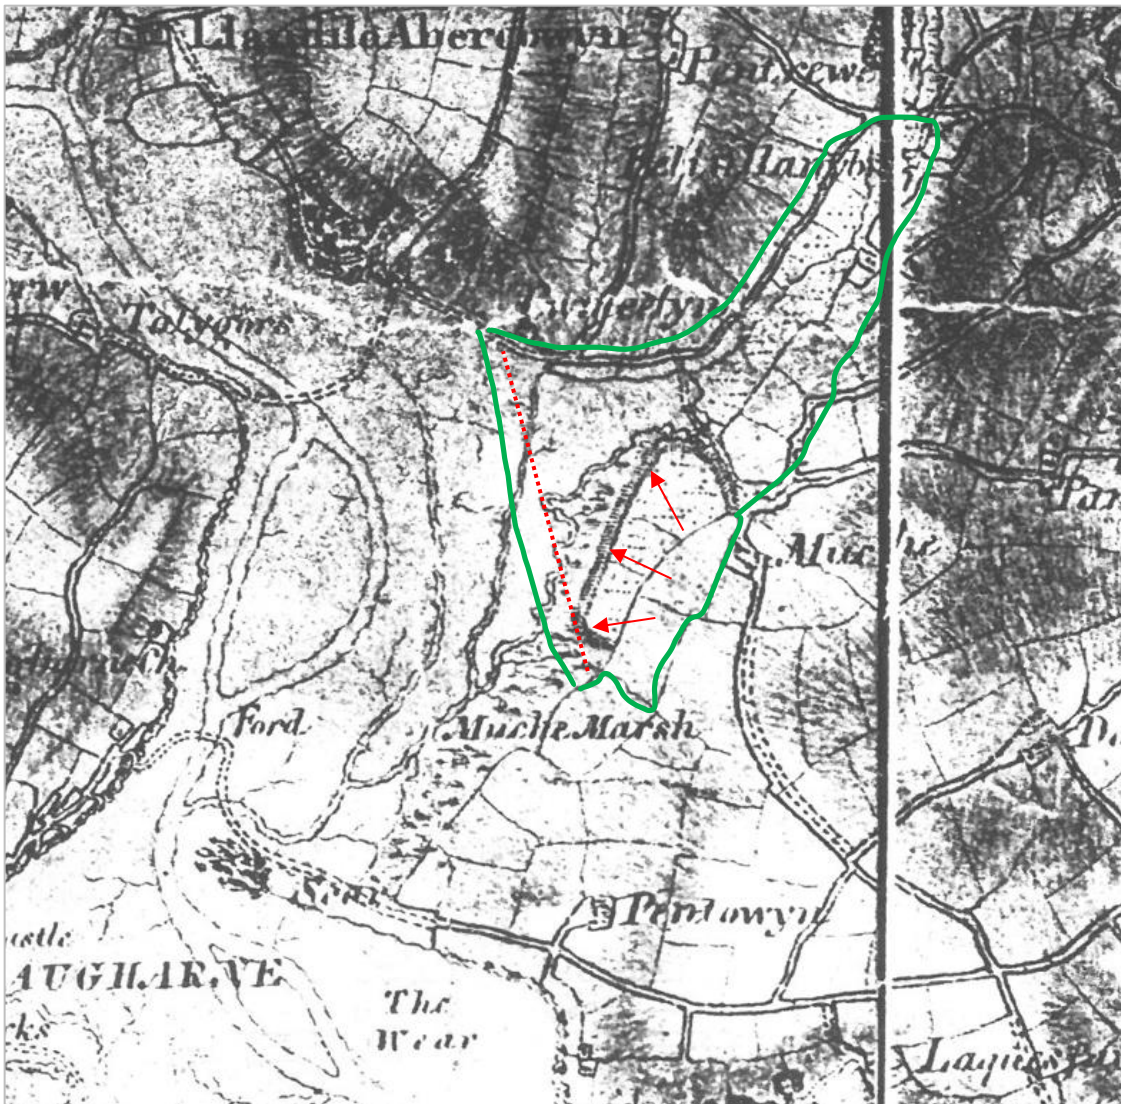
Figure 5: Extract of the original OS surveyors' drawing of 1811-12. Approximate study area boundary in green. Dotted red line shows the approximate location of the later flood defence, arrows point to an earlier defensive bank protecting Mwche Farm. Tracks extending north and south from Mwche Farm will later become the present minor road that passes the farm.

- 6.3.1 The earliest cartographic evidence depicting the study area is the original Ordnance Survey (OS) surveyors' drawing of 1811-12. This map pre-dates the construction of the Taf flood defence (PRN 29979). According to the HLCA description, Mwche (shown as 'Muche') Farm was acquired by the Morris family in 1791, and the flood defence constructed by them shortly after 1812. Clearly this took place after the OS cartographers had surveyed the area. However, the OS drawing appears to show that the new flood defence replaced an earlier, slightly smaller defensive earthwork protecting the farm buildings. Mwche marsh is depicted to the west of this feature, with a watercourse west of that.

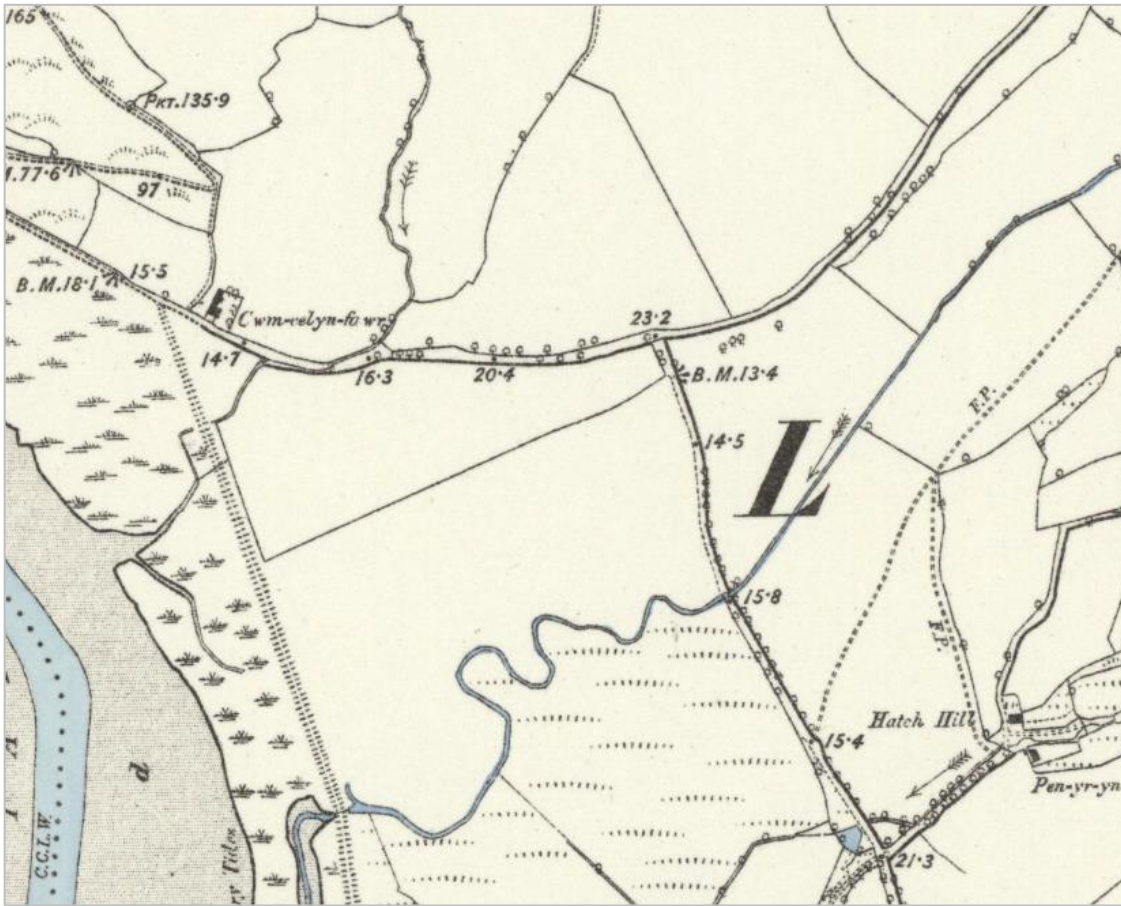
Figure 8: Close up of the 1888 first edition OS map, showing a road crossing the stream east of Cwm Celyn and the stream passing under the Taf flood defence bank. The line drawn across the bank to the south appears to depict a land division.

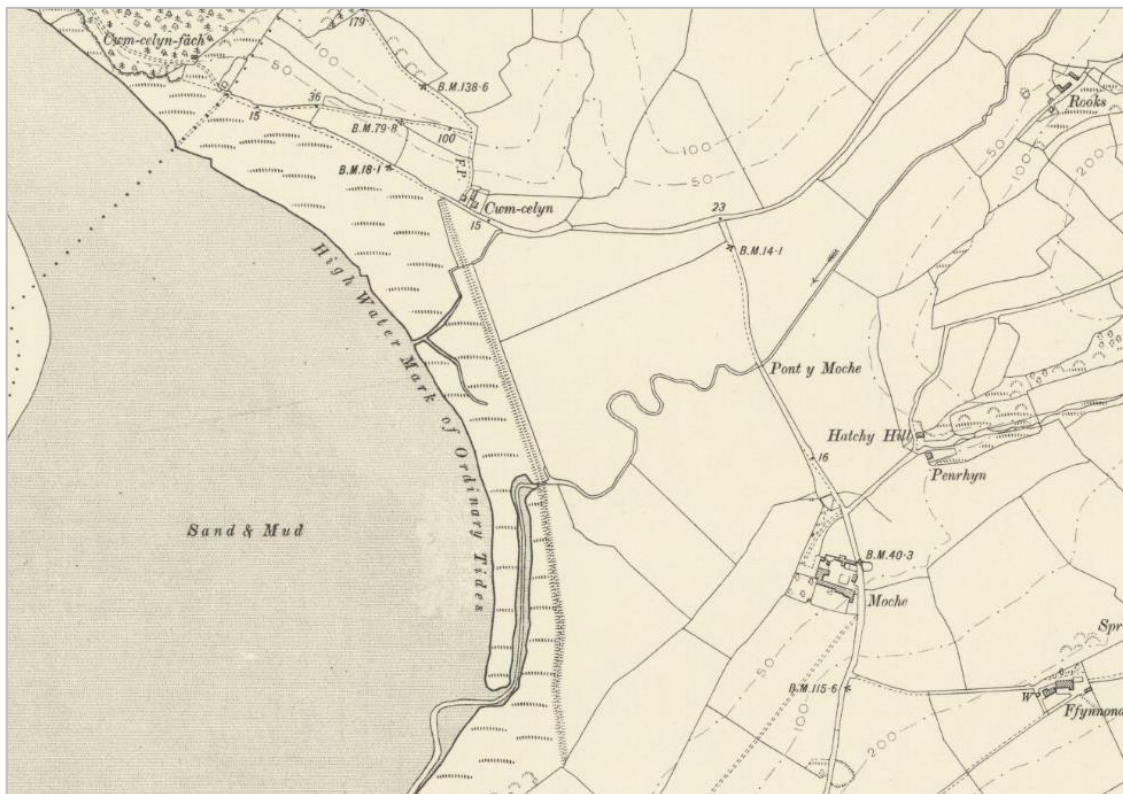
Figure 9: Extract from the 1907 Ordnance Survey map. The two fords have been replaced by a culvert east of Cwm Celyn and Pont y Moche bridge north of 'Moche'. Three marshy fields depicted south of the Brook on the previous edition are no longer shown as marsh.

- 6.3.9 The revised second edition of the OS map was surveyed in 1905 and published in 1907. By this time, the stream to the east of Cwm Celyn Farm has been diverted under the road, and the three fields south of the Brook are no longer depicted as marsh, indicating that the process of land reclamation took almost a century to complete following the construction of the Taf flood defence bank in 1812. As the road crosses the Brook it is now labelled as 'Pont y Moche', which may be an indication that the bridge was recently added.

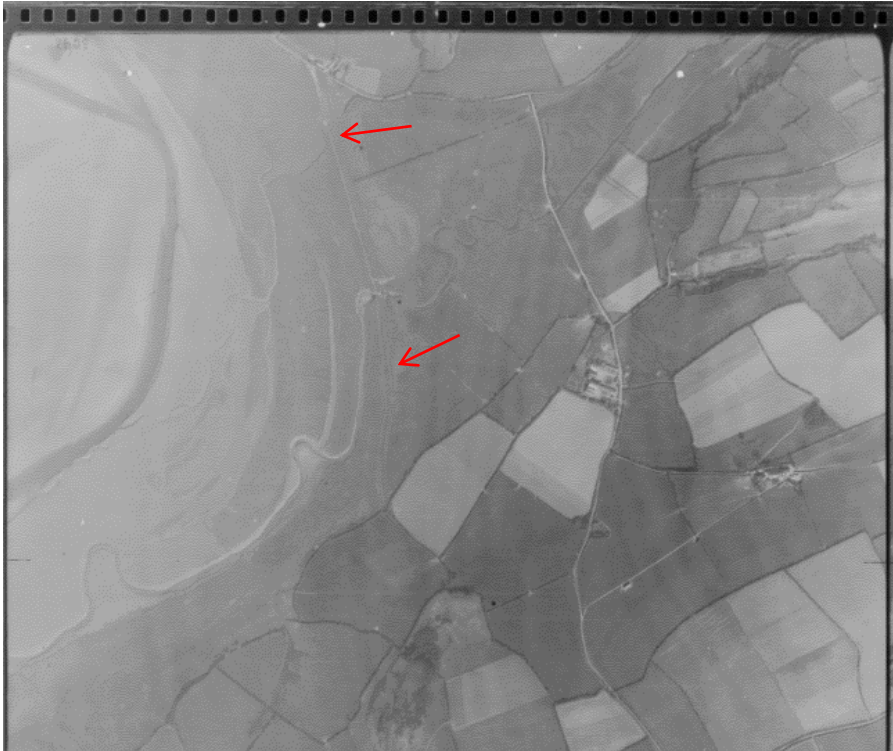
Photo 01: Aerial photograph taken by the RAF on 11th April 1946. Line of flood defence bank indicated by red arrows.

- 6.4.2 Two images were taken three months apart during 1946 (Photos 01 and 02). Both show the Taf flood defence, the Brook and the two farms quite clearly, although the photograph dated 8th July (Photo 02) is of better quality. This photograph also shows evidence for recent ditch clearance in the area of land north of the Brook.

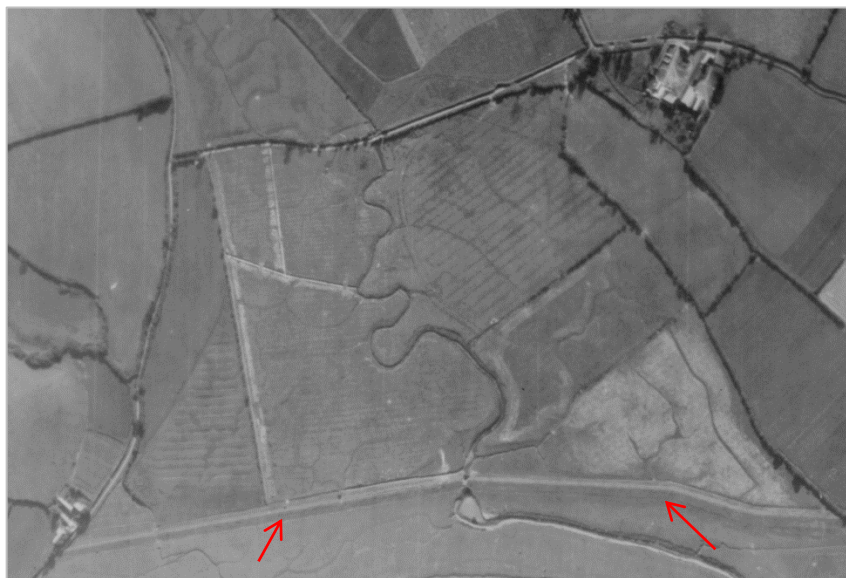
Photo 02: Close up extract from aerial photograph taken by the RAF on 8th July 1946. Line of flood defence bank indicated by red arrows. Work (possibly ditch clearing) has recently taken place in the area north of the Brook. North is to the left of the photograph.

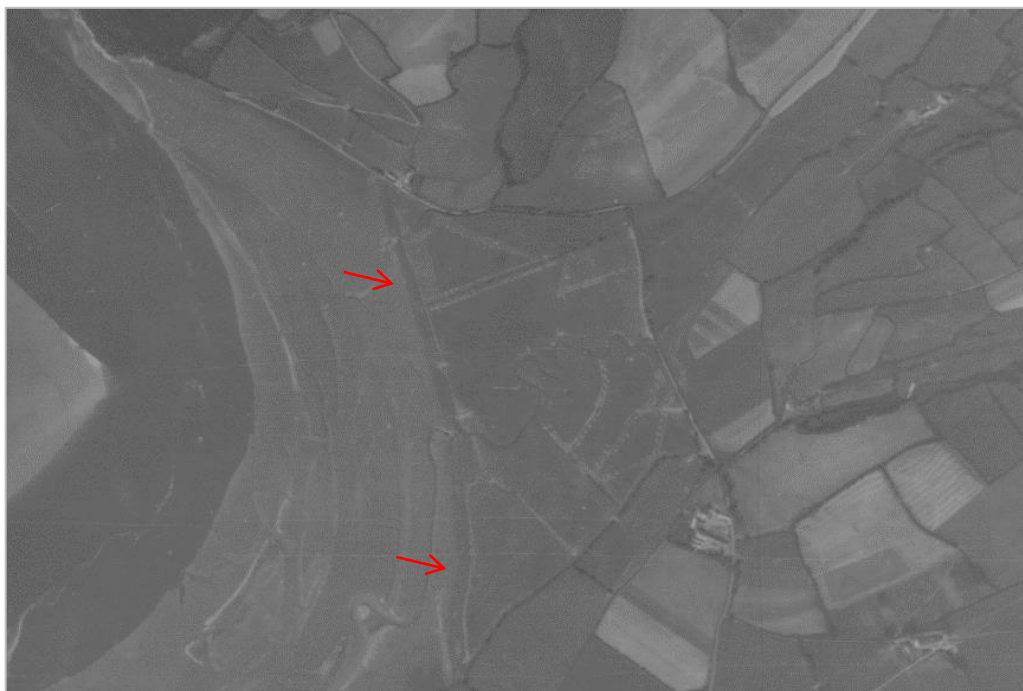
Photo 03: Extract from aerial photograph taken by the RAF on 27th August 1947. Line of flood defence bank indicated by red arrows. Ditch clearing has recently taken place in the area south of the Brook.

- 6.4.3 Recent ditch clearance, this time in the field south of the Brook, is evident on a photograph taken on 27th August 1947 (Photo 03). Close inspection of the image shows that material from within the ditches had been piled up in small heaps alongside their length.

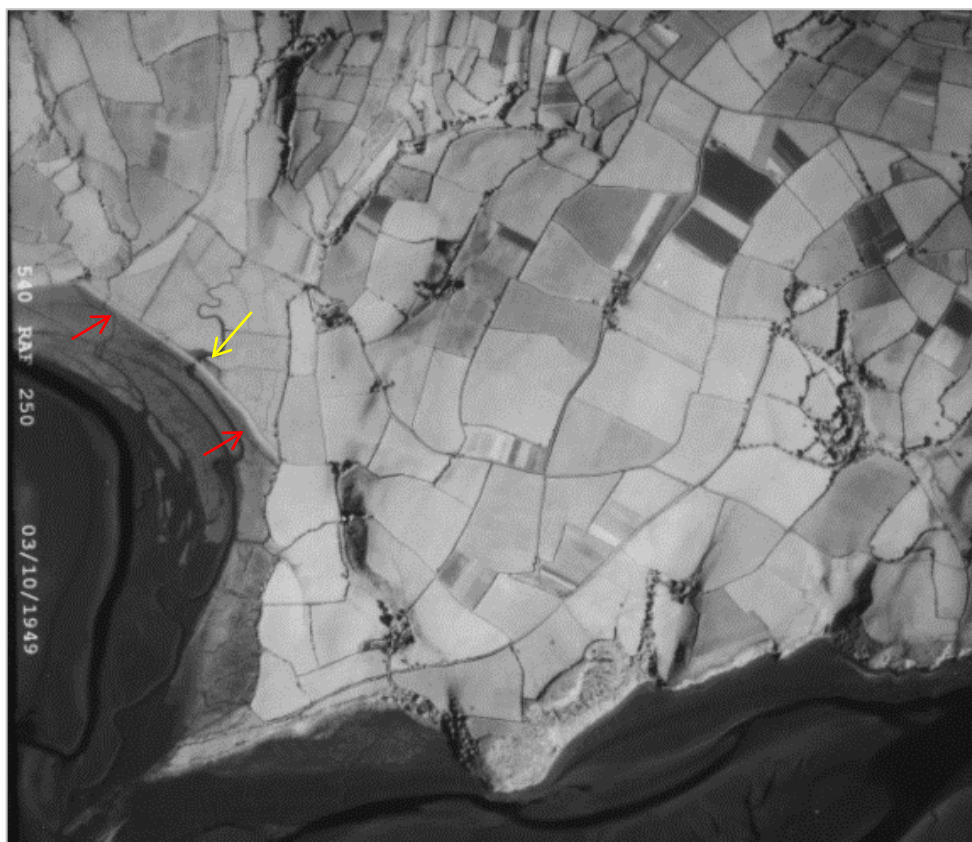
Photo 04: Extract from an RAF aerial photograph taken during a high tide on 10th October 1949. North is to the top left-hand corner. Line of flood defence bank clearly indicated by high water line (red arrows). The Brook appears to have burst its banks near the culvert (yellow arrow).

- 6.4.4 An RAF photograph taken on 10th October 1949 shows a small area of flooded land just east of the flood defence, where the Brook flows through the culvert (Photo 4). The photograph seems to have been taken during a high tide, as it appears to show the river coming right up to the flood defence bank. Presumably the high tide caused the Brook to burst its banks close to the culvert, and this event has been captured on the image.

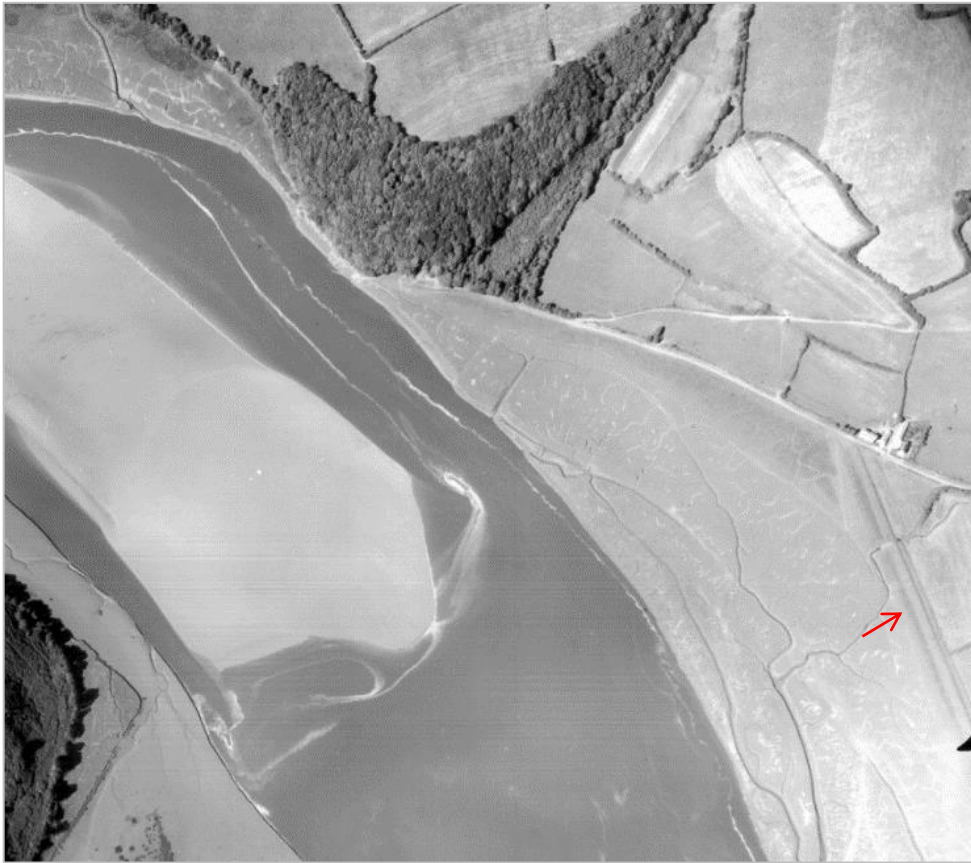
Photo 05: Extract of Meridian Air Photograph taken in 1954 or '55. Part of the flood defence bank is just visible (red arrow).

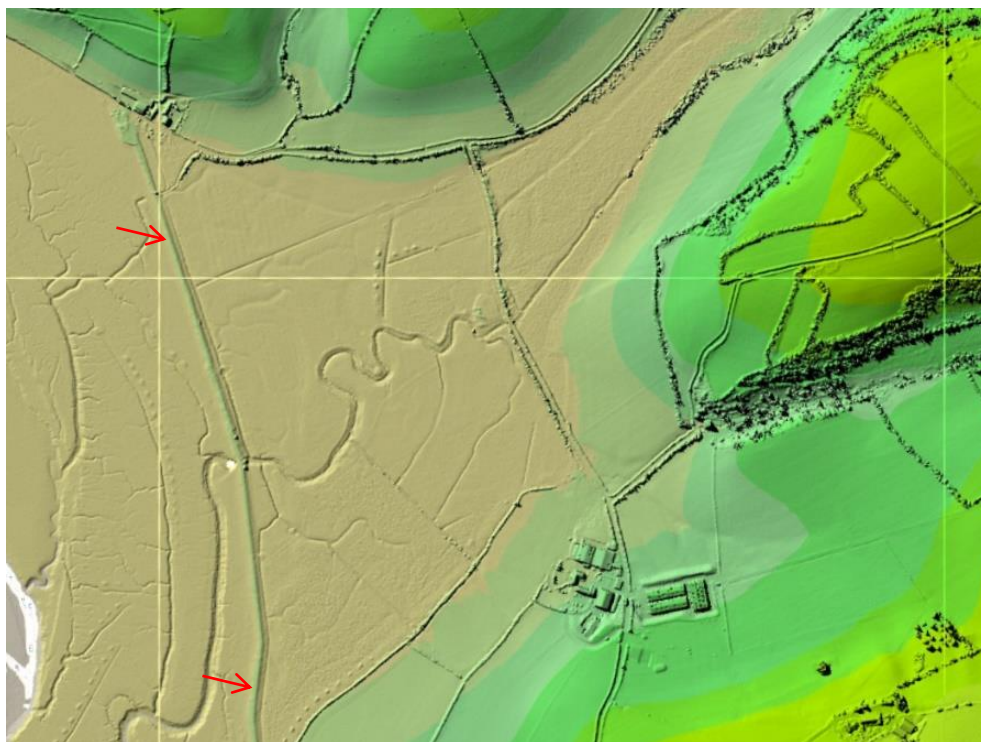
Figure 10: Lidar data at 1mDSM showing the proposed study site depicted in grey-brown, crossed by a series of drains and water channels. The flood defence bank is indicated by the red arrows.

6.5.1 Archive LiDAR data at 1mDSM and DTM is available for the study area (Figures 10 and 11). The LiDAR data confirms the mapping evidence depicting the enclosure and drainage of the reclaimed land. The line of the earliest embankments around Mwche Farm, visible on the 1811-12 OS map are visible as a slight earthwork along the south side of the Brook. The water channels as depicted on the tithe map of 1841 can also be traced, as well as a series of presumably earlier natural water channels meandering across the reclaimed land. Straight-sided drainage ditches are clearly visible that appear to post-date the establishment of the main embankment, and the Brook to the east of the road has also clearly been straightened to encourage the drainage of the surrounding land. Areas of more recent ditch clearance can be seen as a series of mounds alongside the drainage ditches, particularly on the wetlands to the west of the embankment. Some plough lines are visible to the south of Cwm Celyn Farm, but no further features of interest are noted.

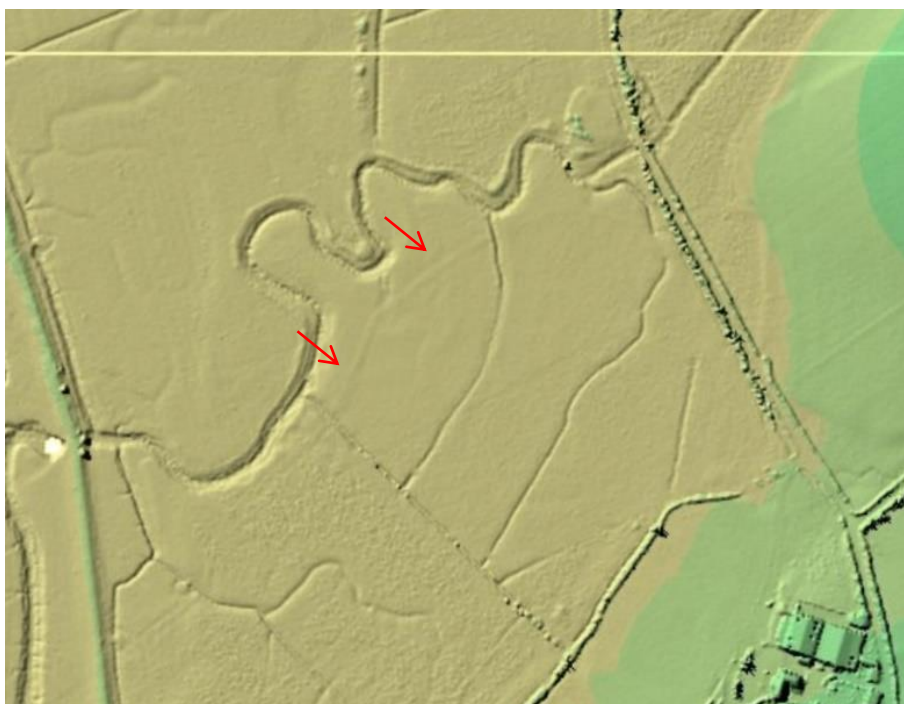
Figure 11: Detail from the LiDAR data show the line of the original, pre-1812, flood defences around Mwche Farm, indicated by the red arrows.

- 7.1.4 An earlier, pre-embankment PRN 29979 line of flood defence on the south side of the Brook within the project area has been identified from historic mapping and LiDAR data, although this appears largely indistinguishable on the ground. Given its current condition this is considered to be of Low archaeological importance.

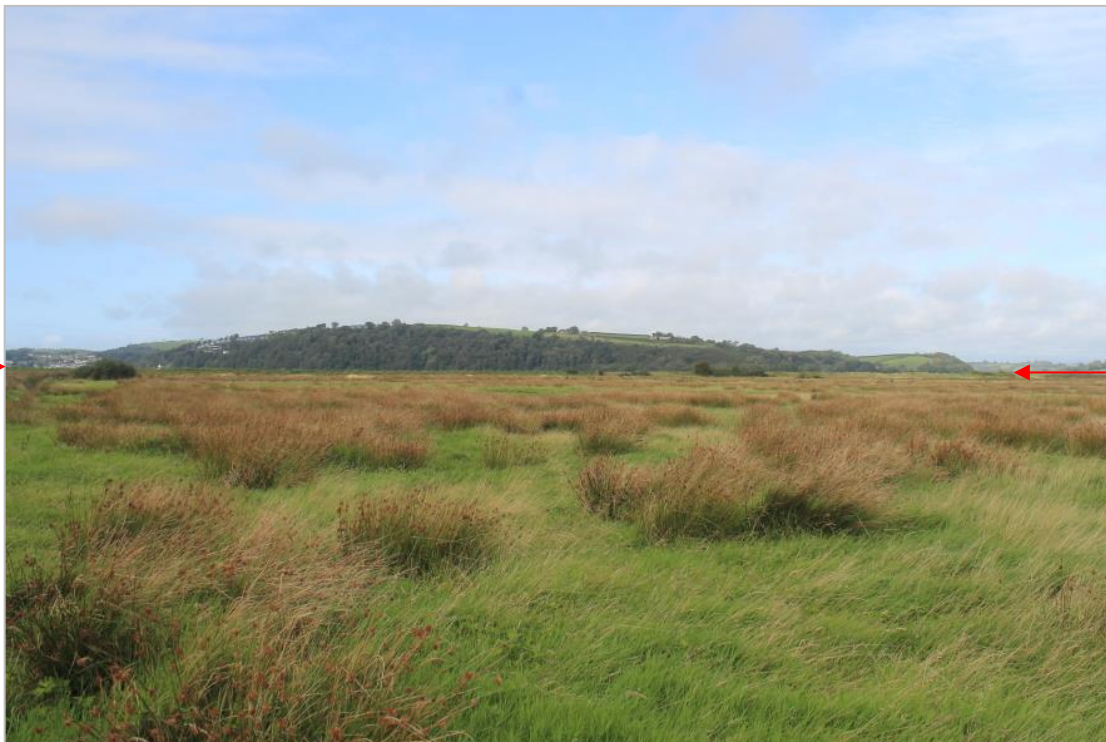
Photo 06: View west across the reclaimed farmland, showing the line of the flood defence bank (indicated by red arrows), with the land beyond rising on the other side of the River Taf.

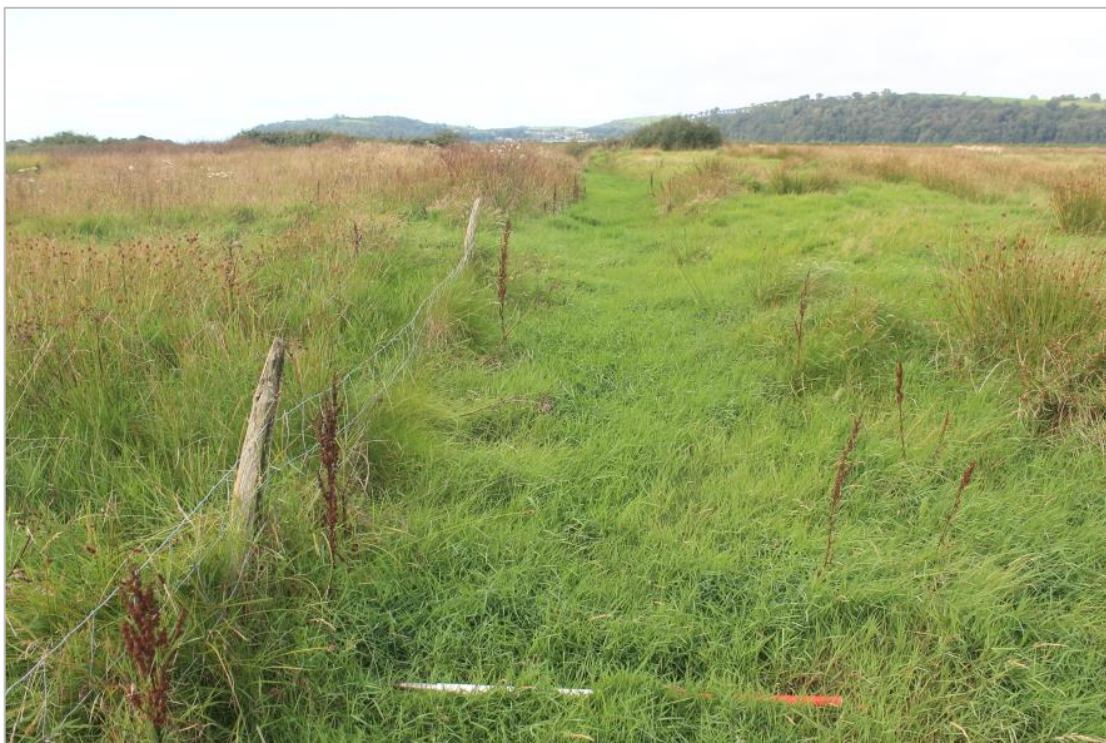
Photo 09: View east showing stock fencing alongside an unmaintained ditch within reclaimed farmland south of the Brook. 1m scale.

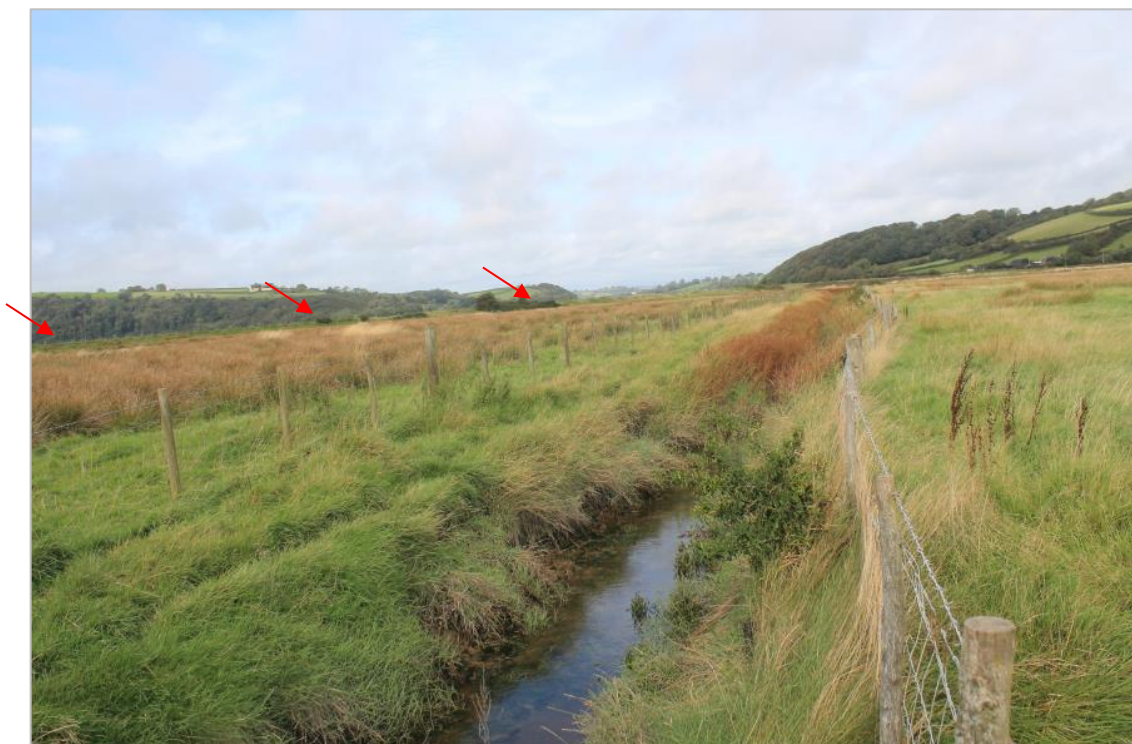
Photo 10: View north showing a fenced off ditch within reclaimed farmland just east of the flood defence bank (red arrows).

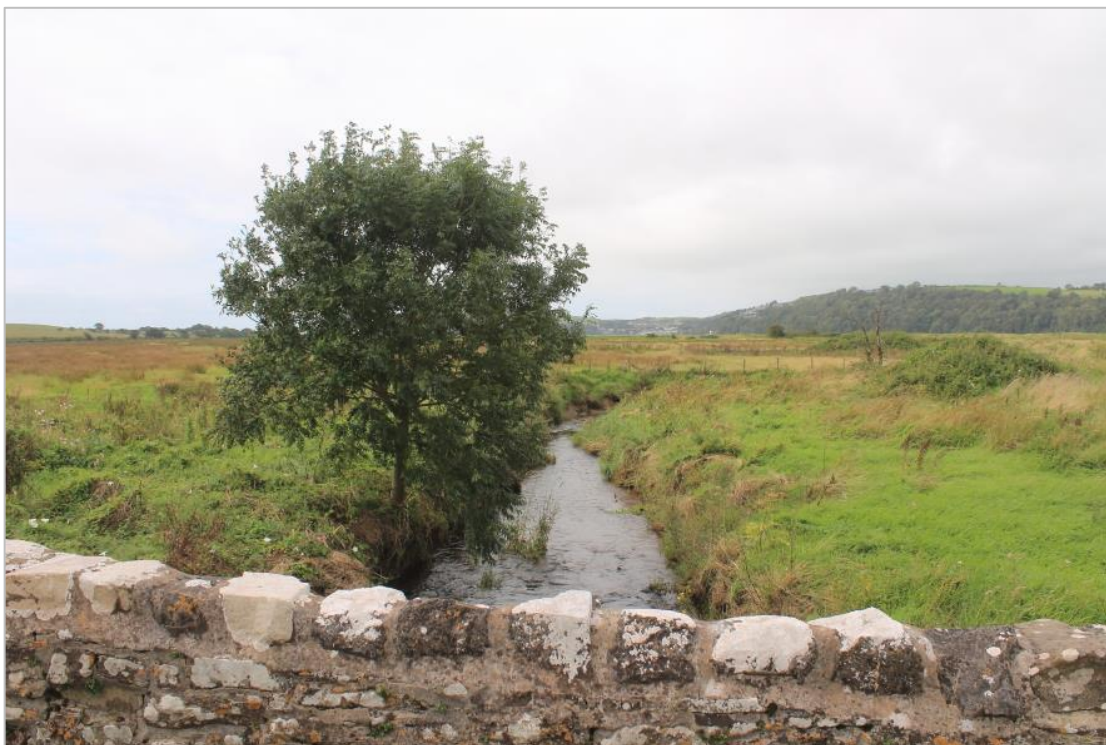
Photo 11: View west from Pont y Moche showing the Brook dividing the northern and southern areas of reclaimed land.

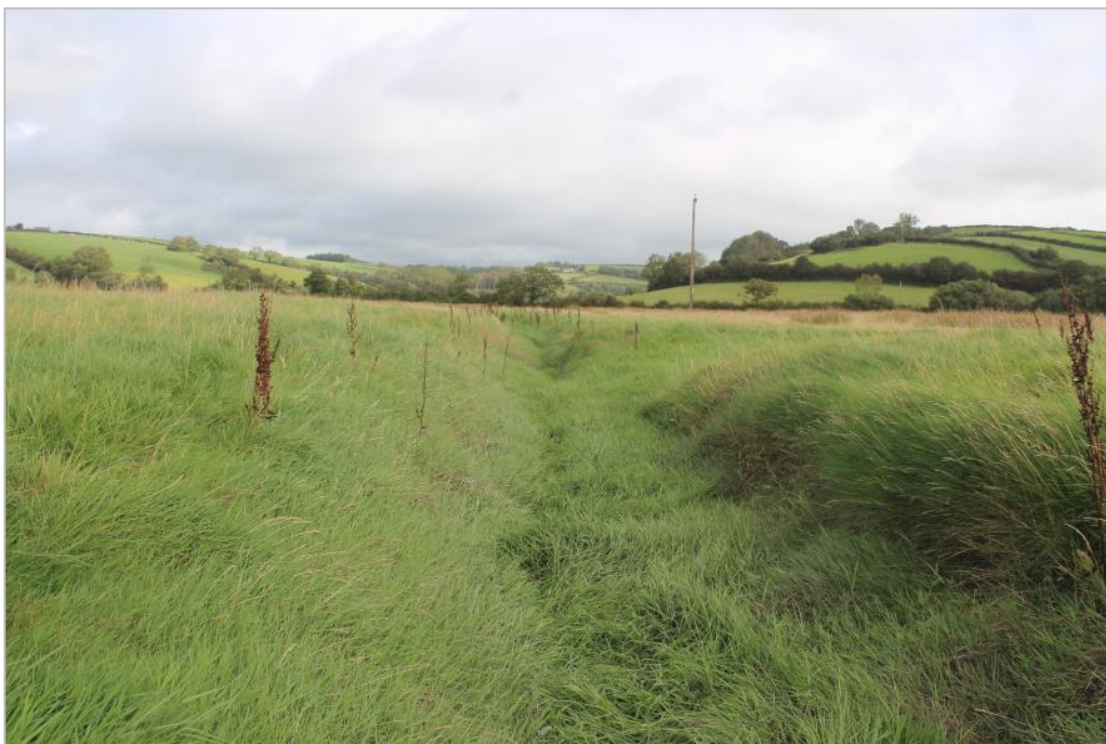
Photo 12: View west along an unmaintained drainage ditch within reclaimed land south of the Brook.

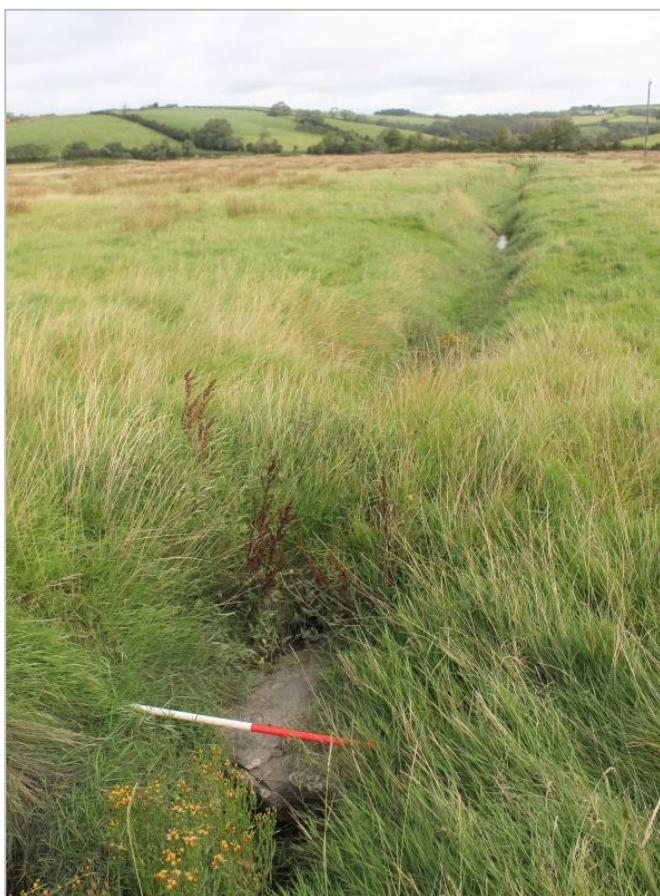
- 6.6.4 Two of the wider drainage ditches had small bridges across them. The first of these was simply a large, flat stone measuring c.0.9m by 0.9m and 0.2m thick (Photo 13). The second was a small, earth- and stone-built structure with a concrete pipe set into it to allow water through (Photo 14).

Photo 13: View west showing a large stone bridging a ditch within reclaimed land south of the Brook. 1m scale.

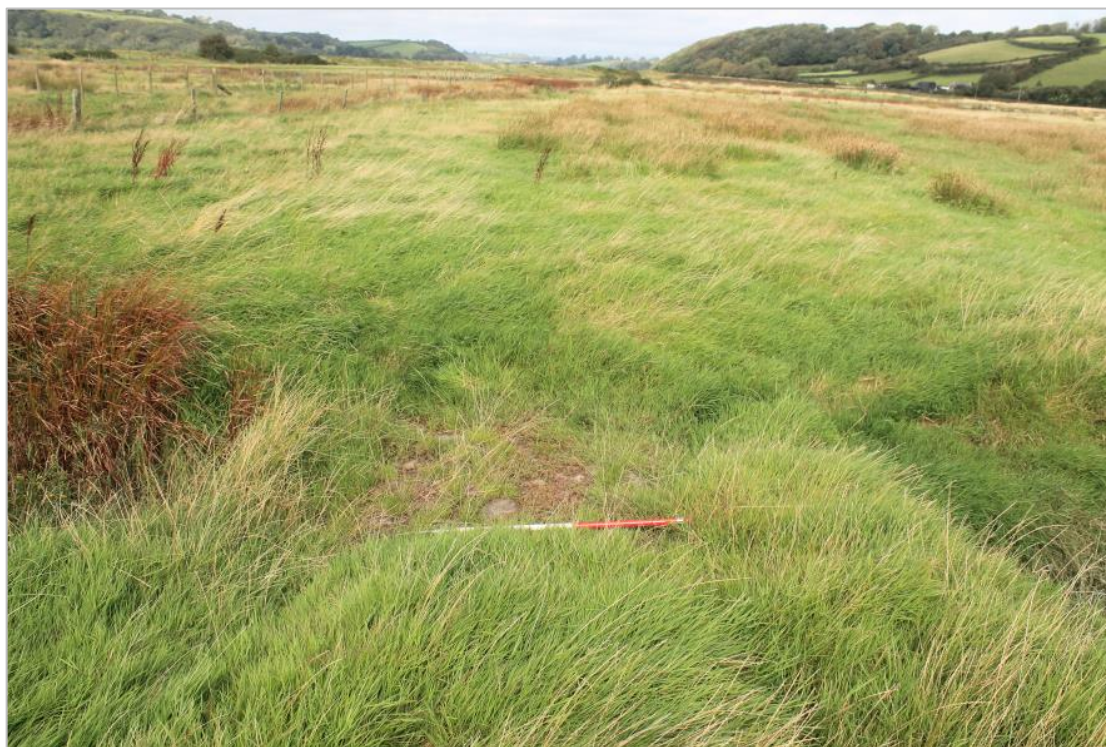
Photo 14: View north showing an earth- and stone-built bridge over a concrete pipe culverting a drain within reclaimed land south of the Brook. 1m scale.

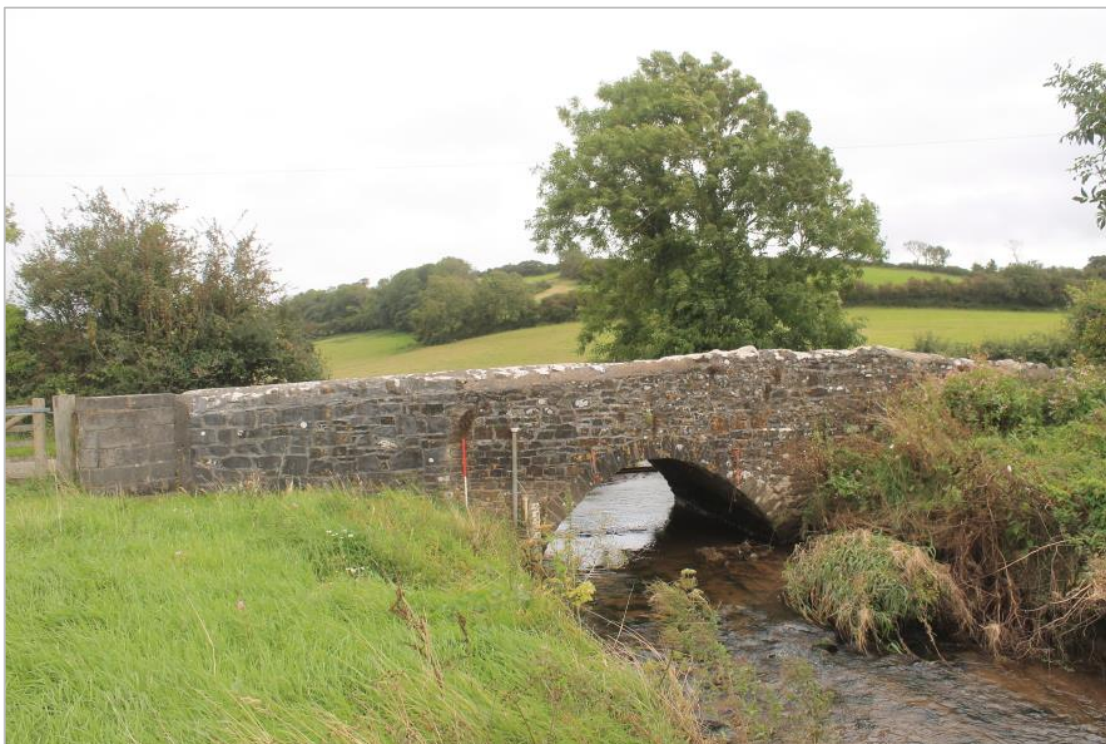
Photo 15: Pont y Moche bridge, showing a change in the stonework of the western wall, either side of the 1m scale. View east.

- 6.6.5 The minor road between Mwche Farm and the road to Cwm Celyn Farm is carried over the Brook on a bridge named Pont y Moche on the historic OS maps (see Section 6.3). Pont y Moche (PRN 15733) is a small, stone-built, single arched structure that is 14m long and 6m wide, with walls that are a maximum of c. 2.5m high (Photos 15–16). An iron bar gives additional strength to the arch below the structure (Photo 16). A change in the stonework was observed towards the northern end of the western wall of the bridge, suggesting that it may have been damaged and repaired in the past (Photo 15). A scale for measuring the water level was observed attached to the western wall of the bridge, adjacent to the arch (Photo 16).

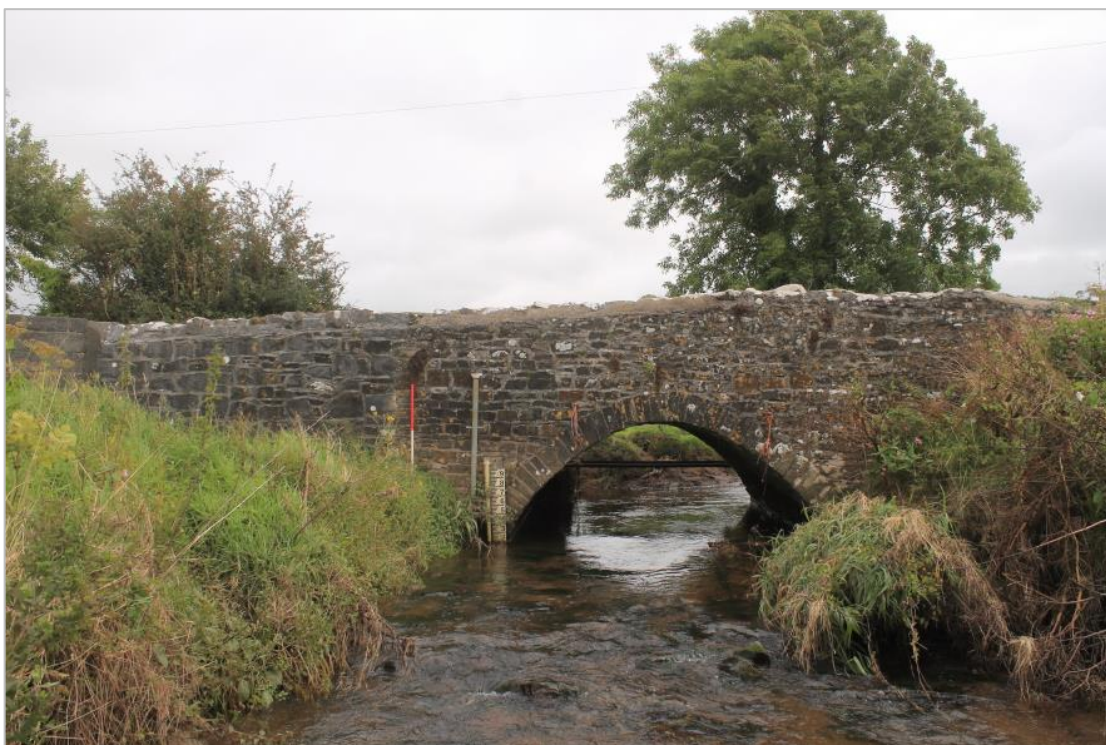
Photo 16: Pont y Moche bridge, showing a scale for measuring the water level and an iron bar set below the arch. View east, 1m scale.

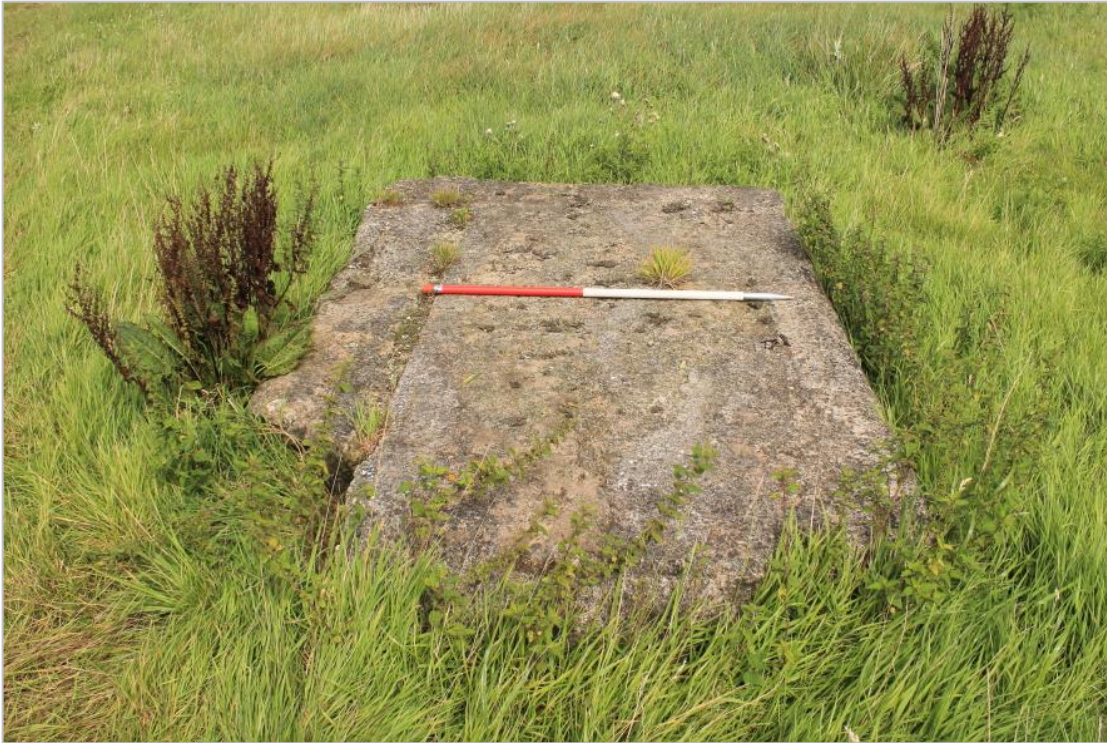
Photo 17: View north showing a recumbent concrete slab on reclaimed land near Pont y Moche. 1m scale.

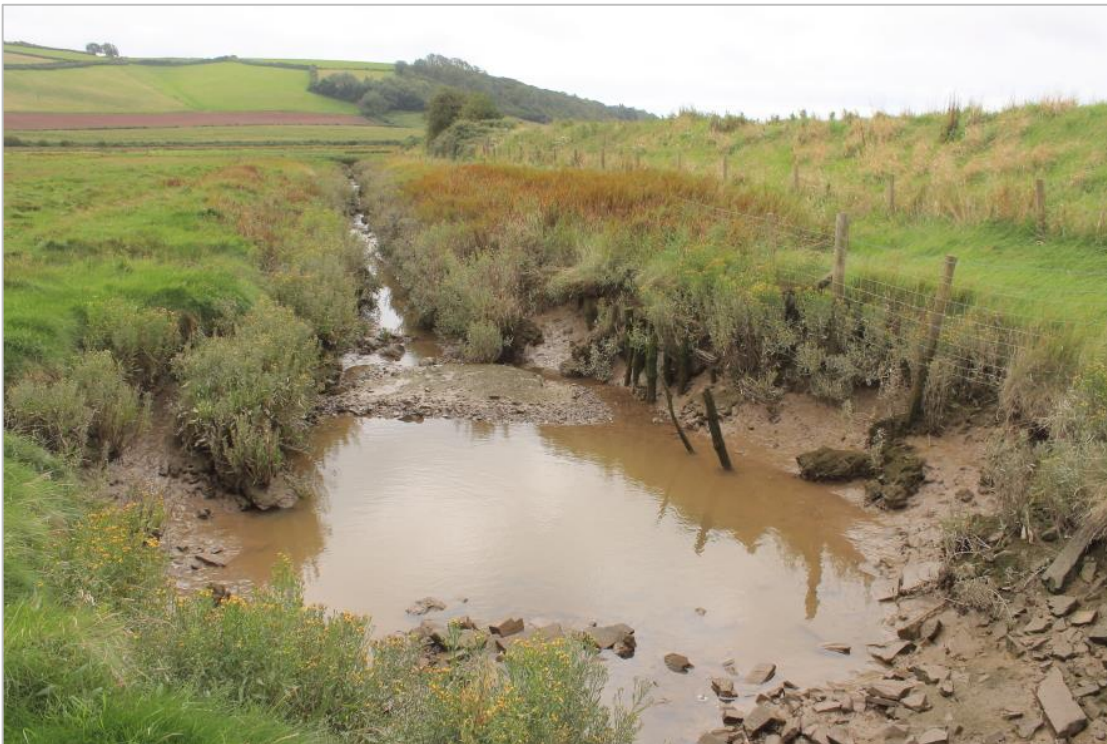
Photo 18: View south from a modern crossing of the main ditch to the east of the flood defence bank, showing wooden posts on the western side of the ditch.

- 6.6.7 A large ditch runs parallel to the eastern side of the flood defence bank. A line of wooden posts was observed along the western edge of the ditch (Photo 18). Access to the bank is via a modern crossing over the ditch. The ditch drains into the Brook further to the south (Photo 19).

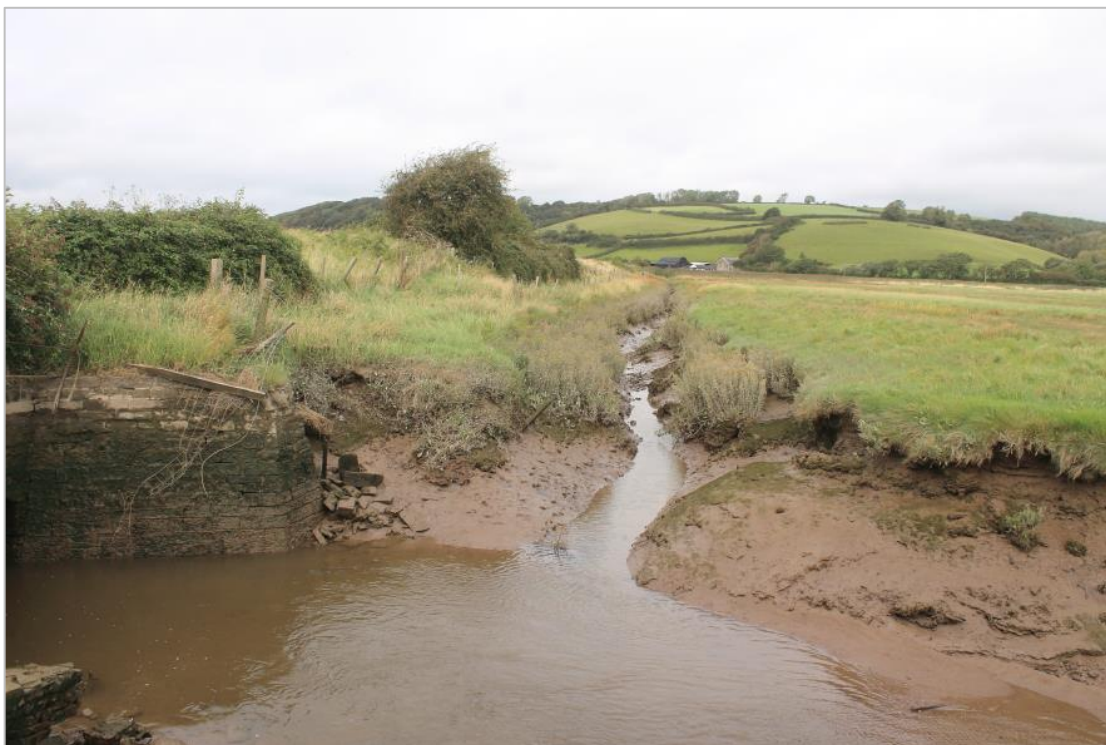
Photo 19: View north of the main ditch flowing into the Brook just east of the sluice gate.

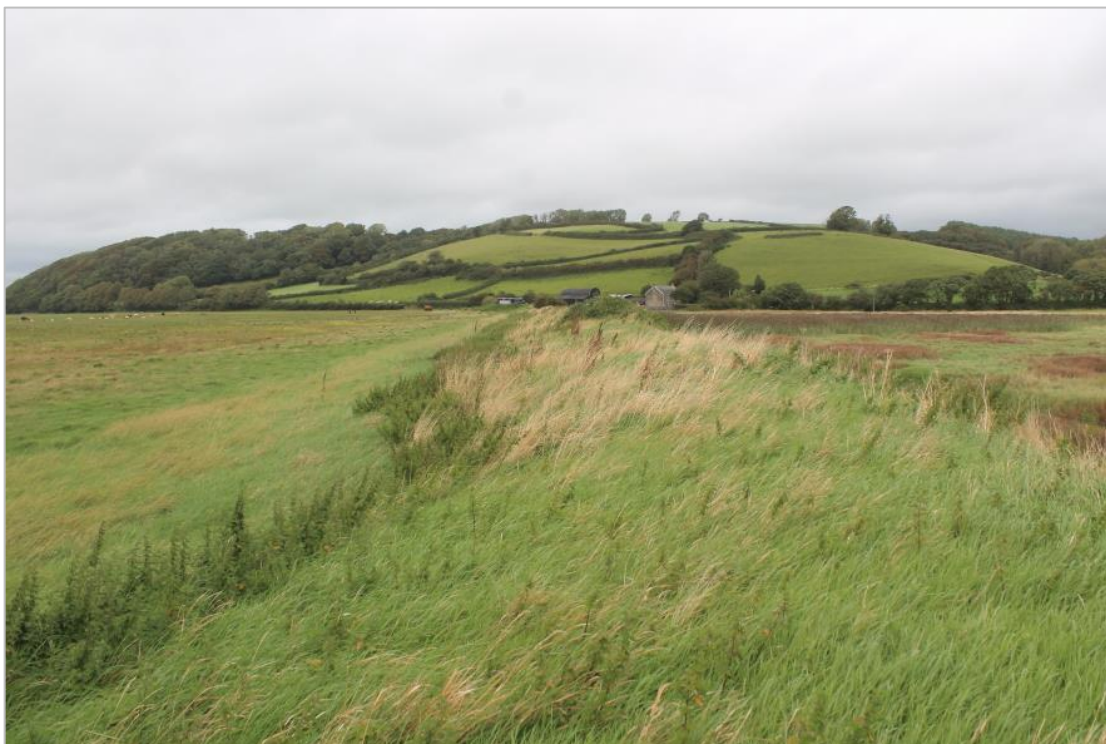
Photo 22: View north along the flood defence bank, towards Cwm Celyn Farm.

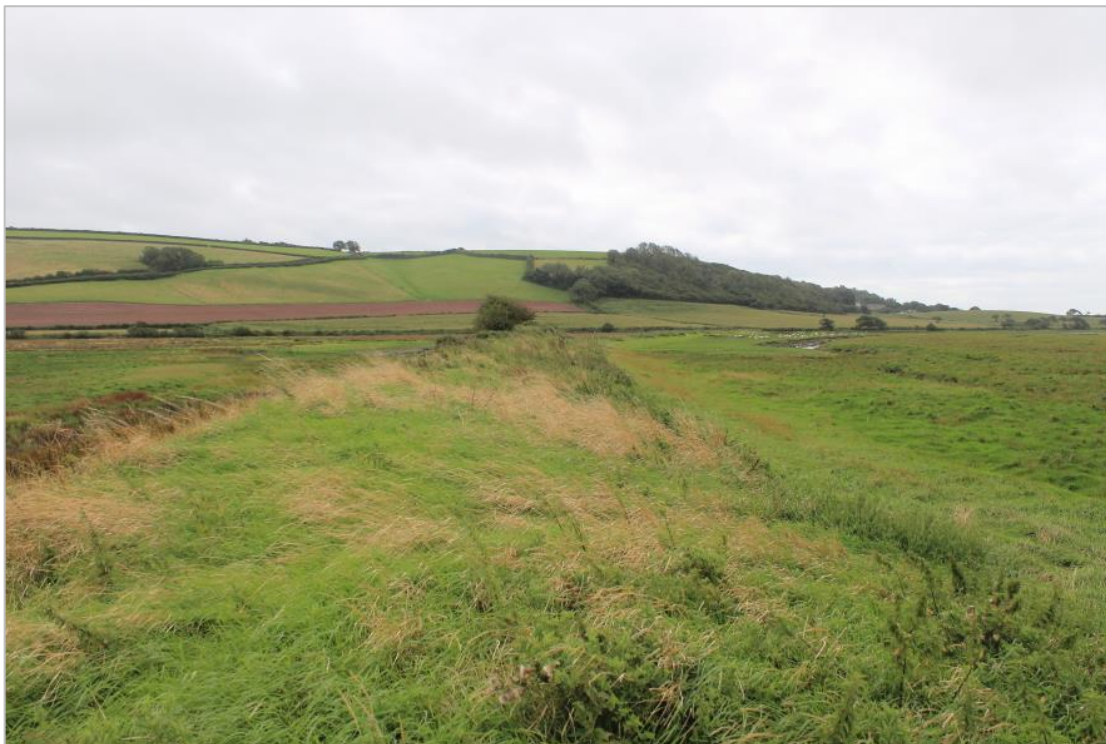
Photo 23: View south along the flood defence bank.

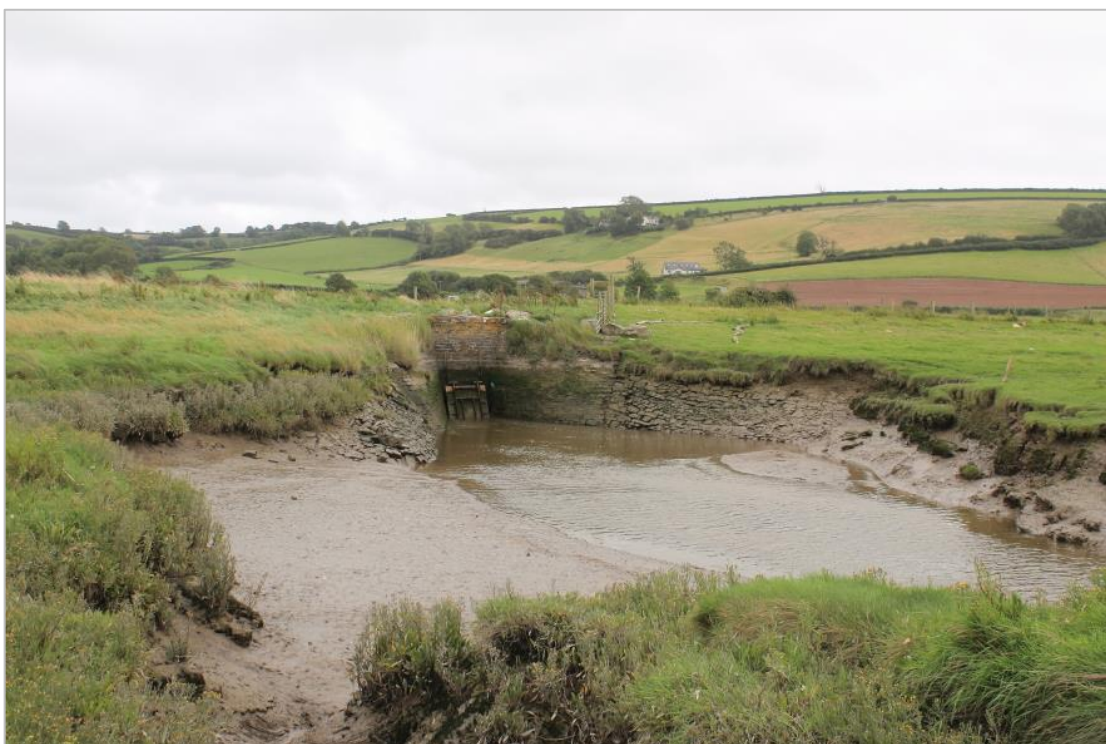
Photo 24: View south-east showing the sluice gate on the western side of the flood defence bank. 1m scale (on top of structure).
