TIDAL EMBANKMENT, MWCHE FARM, LLANYBRI, CARMARTHENSHIRE: HISTORIC ENVIRONMENT DESK-BASED ASSESSMENT

REPORT NO. 2023-22

TIDAL EMBANKMENT, MWCHE FARM, LLANYBRI, CARMARTHENSHIRE:

HISTORIC ENVIRONMENT DESK BASED ASSESSMENT

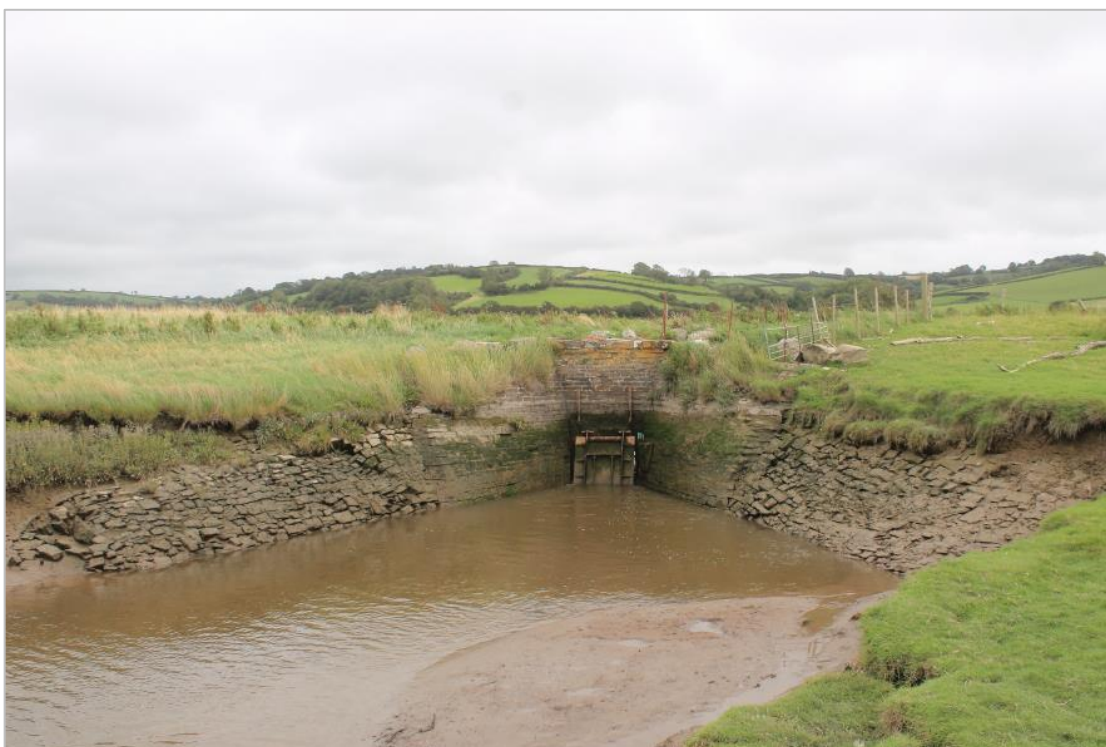
Photo 25: View east, showing the iron sluice gate hung within the stone-revetted V-shaped opening in the flood defence bank. Note a pair of iron runners mounted on the wall above the gate.

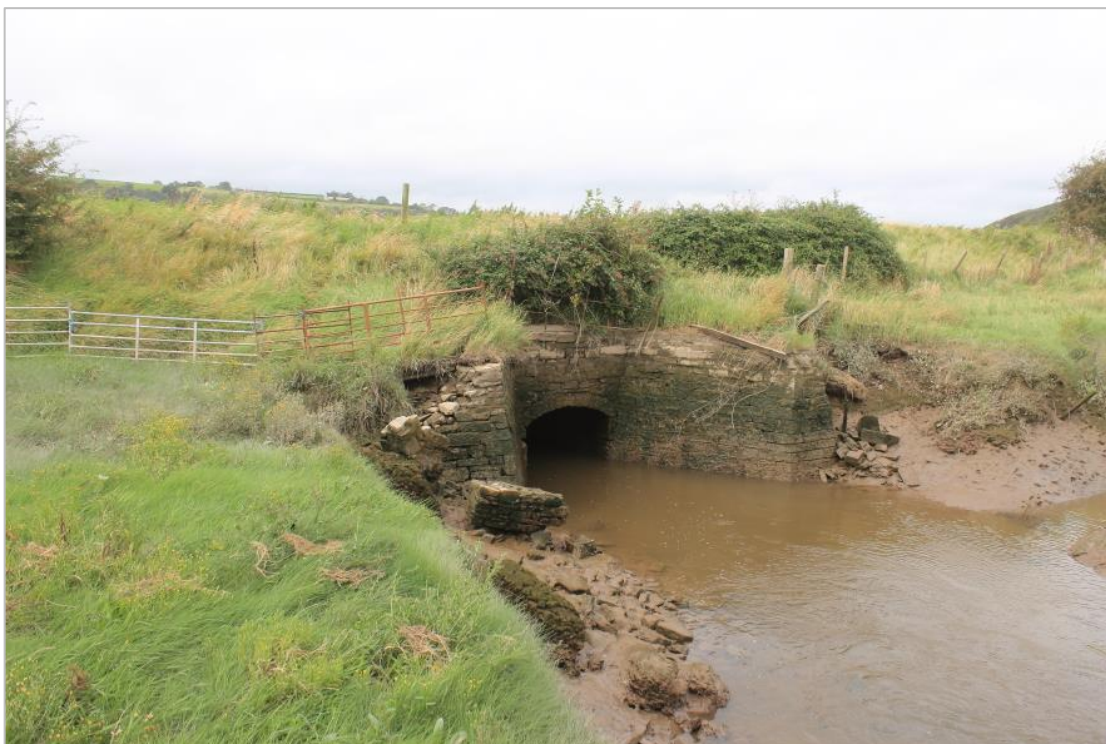
Photo 26: View north-west, showing the stone-revetted opening of the sluice gate in the eastern side of the flood defence bank.

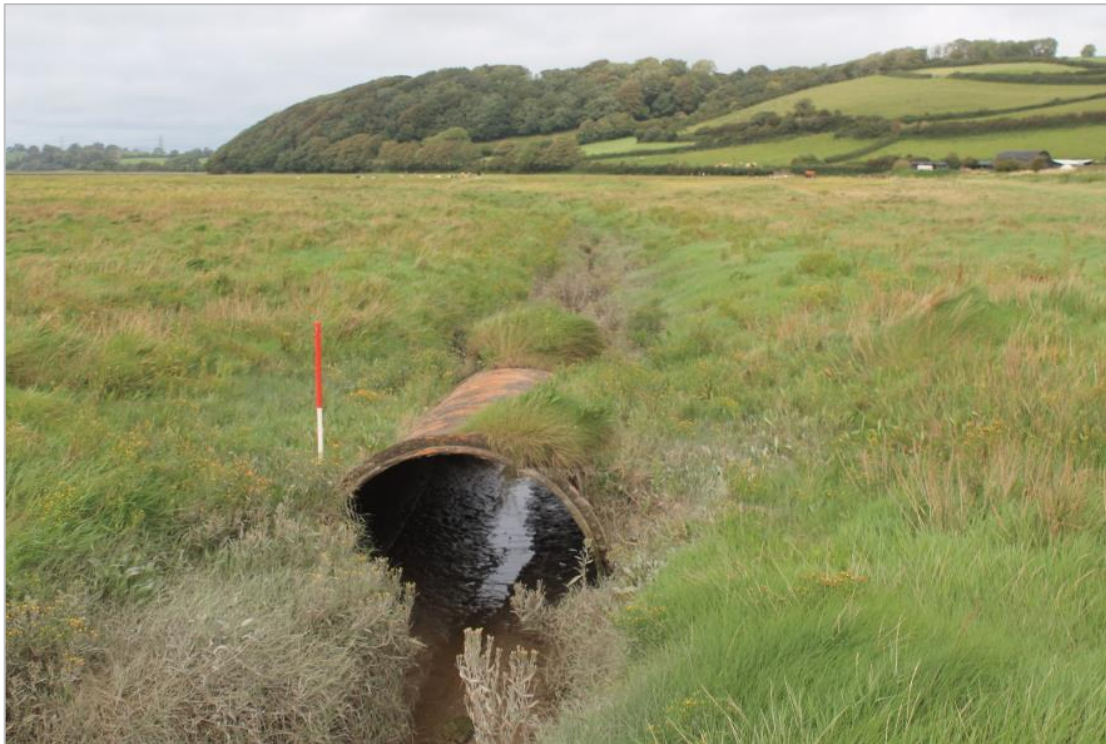
Photo 27: View north, showing a cast iron cylinder bridging a small stream to the west of the flood defence bank.

- 6.6.11 A network of small ditches or creeks criss-crosses the area west of the flood defence bank. During the site visit, a cast iron cylinder, possibly once part of a boiler, was recorded in use as a bridge across one of these streams (Photo 27).

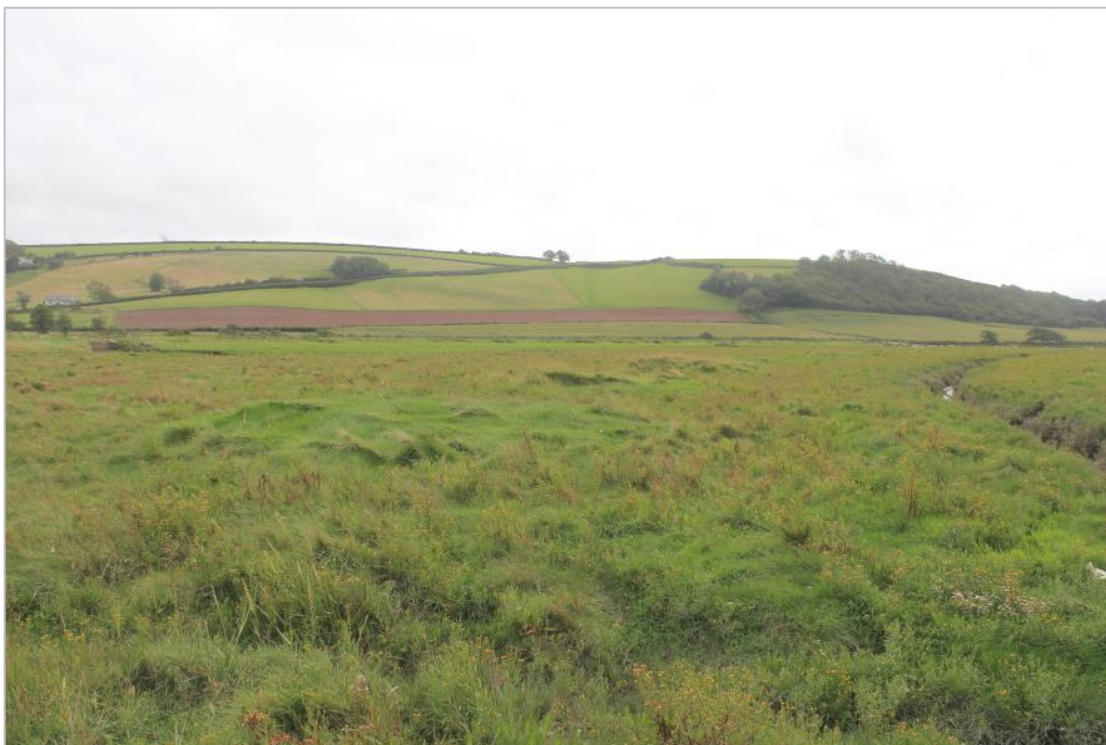
Photo 28: View south-east showing a line of small earthworks on land west of the flood defence bank.

- 6.6.12 A line of grass-covered mounds was observed on a north/south orientation within the area west of the flood defence bank (Photo 28). LiDAR data suggests these may represent ditch clearance upcast, probing suggested these do not contain stonework.
