UNION HILL, HAVERFORDWEST, PEMBROKESHIRE: ARCHAEOLOGICAL WATCHING BRIEF

Prepared by DAT Archaeological Services

REPORT NO. 2023-28

SEPTEMBER 2023

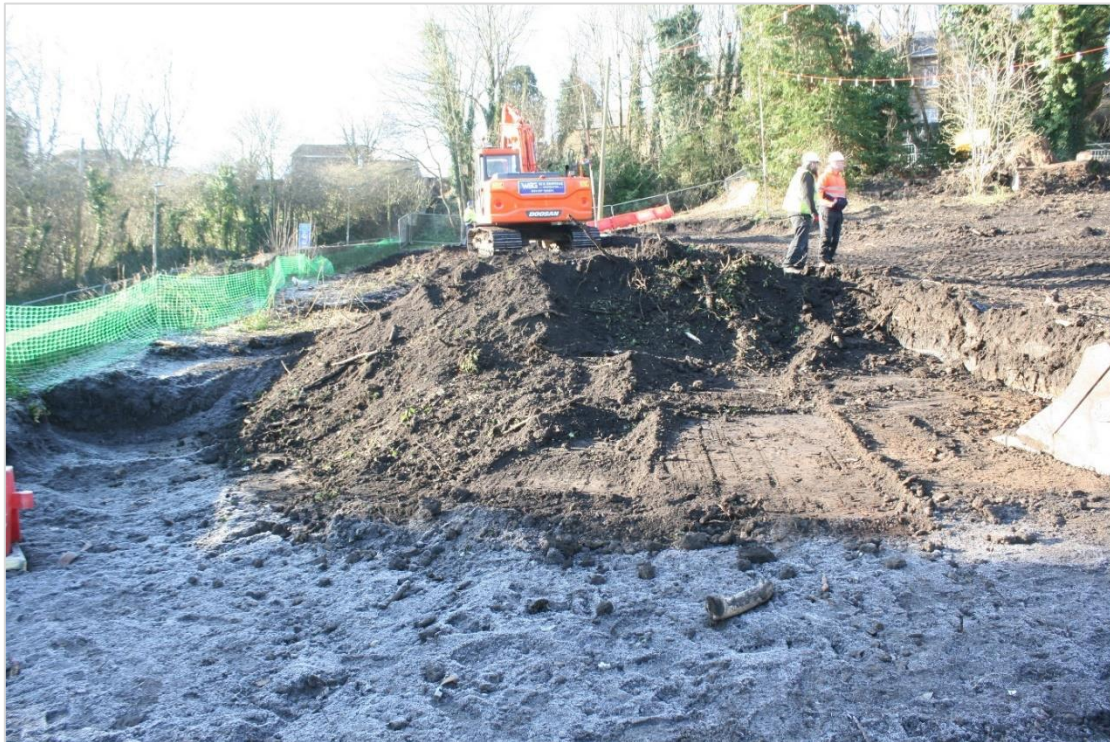
Photograph 1: View east of first area of site where ground reduction took place.

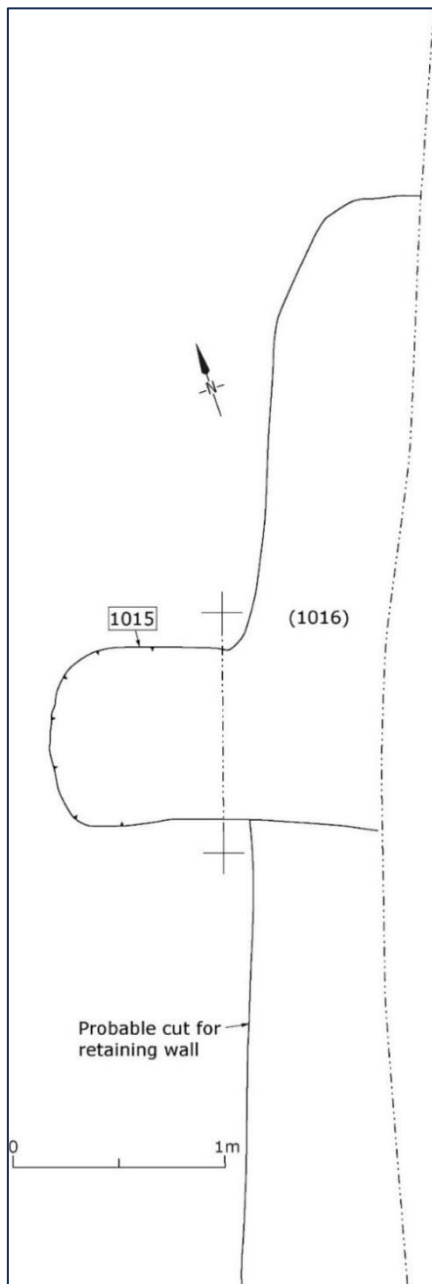
Figure 4: Plan of possible soakaway running along part of the revetment wall.

4.2.1 During the removal of topsoil to the immediate rear of the Union Hill revetment wall, the remains of an L-shaped post medieval exploratory trench were revealed [1015] (Fig 4 and Photo 2).

4.2.2 A small investigative sondage was placed over the northwest terminus of the trench, revealing that at this point it measured around 0.4m deep by 0.8m wide and had sharply cut sides leading to a slightly flattish base cut into the natural (1002). Within the confines of the cut a blackish brown silty clay had been deposited (1016) which contained frequent small pieces of animal bone, ash and several sherds of late 19th/early 20th century pottery. During further removal of topsoil, it was revealed that the cut followed the western rear side of the revetment wall northwards for around 3m.

- 5.6 To the rear of the revetment wall an L-shaped cut was revealed. This is considered to be the remains of a post medieval exploratory trench which may have been excavated originally to, for example, locate a broken drainage pipe.

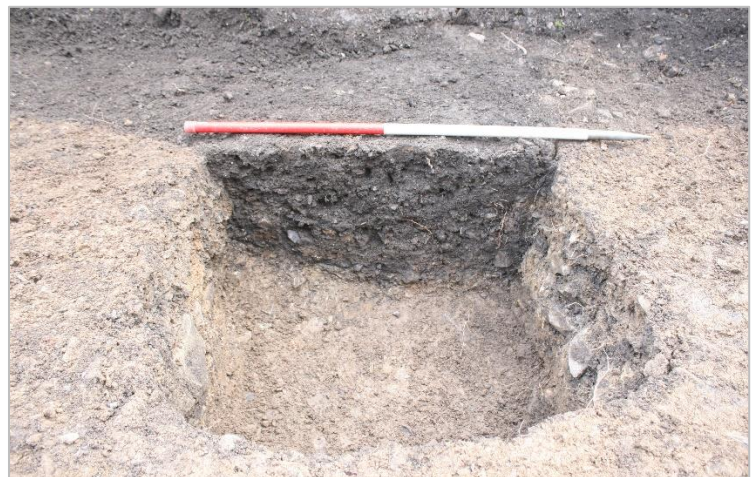
Photo 2: West facing section of sondage in terminus of L-shaped cut [1015]. 1 x 1m scale.

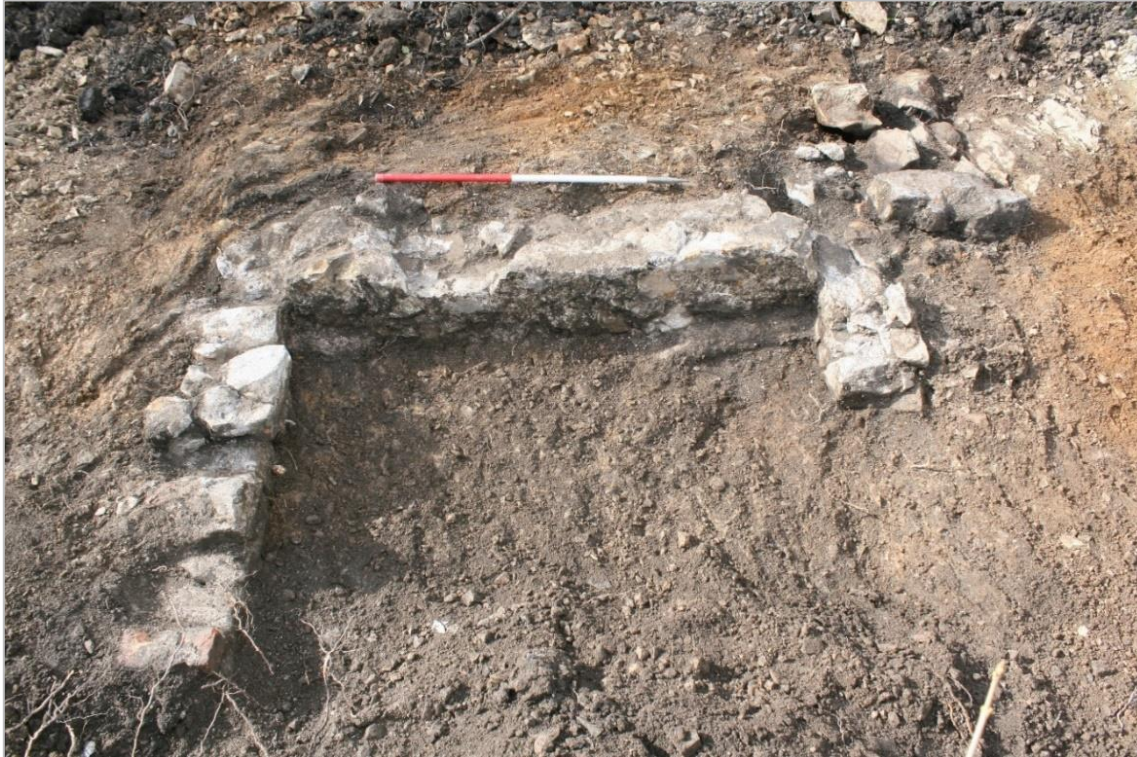
4.3.1 Situated just to the rear of the revetment wall and within the middle area of the site were the remains of a rectangular stone footprint of walling [1003] (Photo 3) which had been constructed upon the natural soil horizon (1002). The structure, thought to be the foundations of a glasshouse, was heavily eroded with a gap on its eastern corner, probably caused through robbing.

- 4.3.2 The walls of the structure [1003] were constructed using rough unshaped limestone blocks laid in a randomly coursed fashion and bonded with a white greyish lime mortar. A single handmade clay brick was found in the southern wall of the foundation and there was a slight pinkish lime render adhering to the internal side of the western wall.

Photo 3: View west of glasshouse foundation. 1 x 1m scale.

- The foundations of a glasshouse
 - The stone capped drain
 - The agricultural ditch and isolated post hole
 - The area of made up ground
- 5.2 The earliest detailed historic map source for this area is the Ordnance Survey 1:500 map of Haverfordwest published in 1889, as shown in Figure 3. This mapping indicates that the structure associated with stone foundation [1003] and thought to be a glasshouse was present at this time. A Victorian date for the structure is supported by finds which include a Victorian copper alloy belt buckle and base of a champagne or wine glass flute. Given its proximity to the former workhouse, which was built in 1837-1839 and was used as such until the onset of the Second World War when it was utilised as a hospital, it is possible that the glasshouse was associated with this institution.

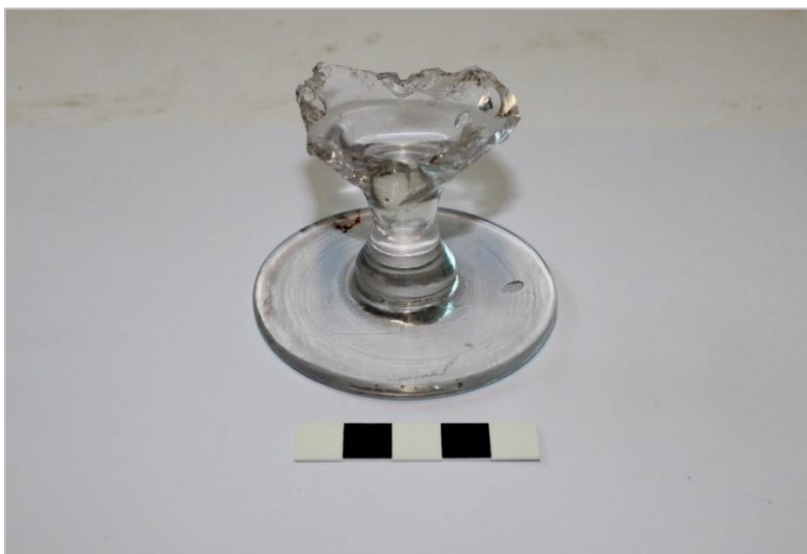
- 4.3.3 A blackish brown silty clay deposit (1007) was found within the interior of the stone foundation. It contained small pieces of brick, frequent pieces of glass including the base of a wine or champagne glass (Photo 4) and a copper alloy belt buckle (Photo 5), both Victorian in date.

Photo 4: View of Victorian wine glass found in deposit (1007).

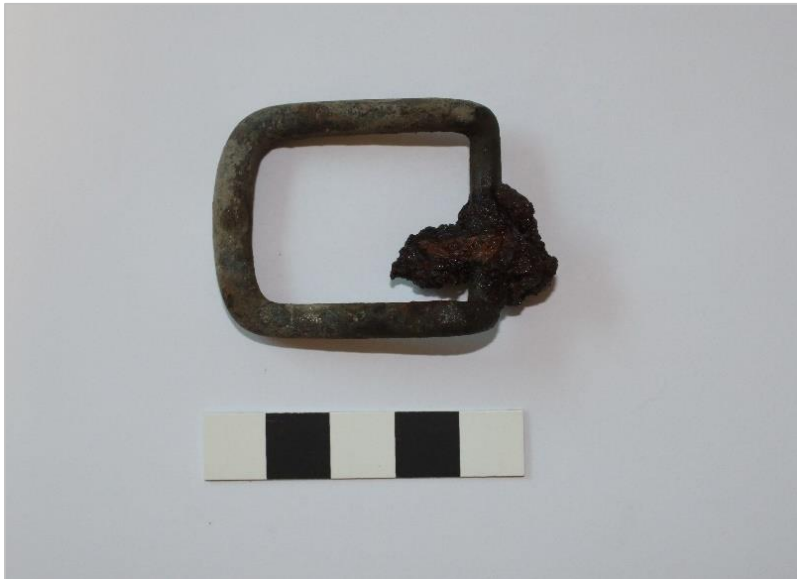
Photo 5: View of Victorian copper alloy belt buckle found in deposit (1007).

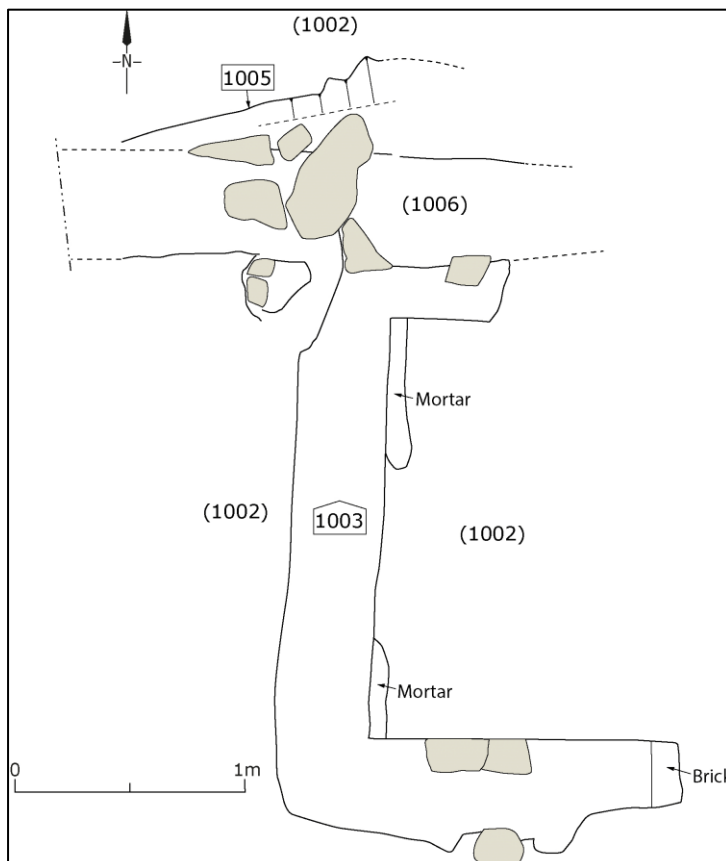
Figure 5: Plan showing glasshouse foundation [1003] and drain [1005].

- 4.4.1 The remains of a stone capped drain [1005] had partially removed the external face of the northern wall of the structure described in 4.3 above (Fig 5 and Photo 6). Like the glasshouse foundation, this feature was also in a poor condition and only survived in length for around 1m and measured 0.6m wide. The drain, which contained a blackish brown silty clay (1006), had been cut into the natural (1002) and was oriented in an east-west alignment.

- 5.3 There is no evidence to link the two drains found on site; Figure 6 shows the trajectory of [1018] would likely cause it to bypass the glasshouse foundations whereas [1005] actually cuts its northern edge. This does enable us to establish that the latter drain is later than the glasshouse. It is quite possible however that either one or both drains were associated with the workhouse.

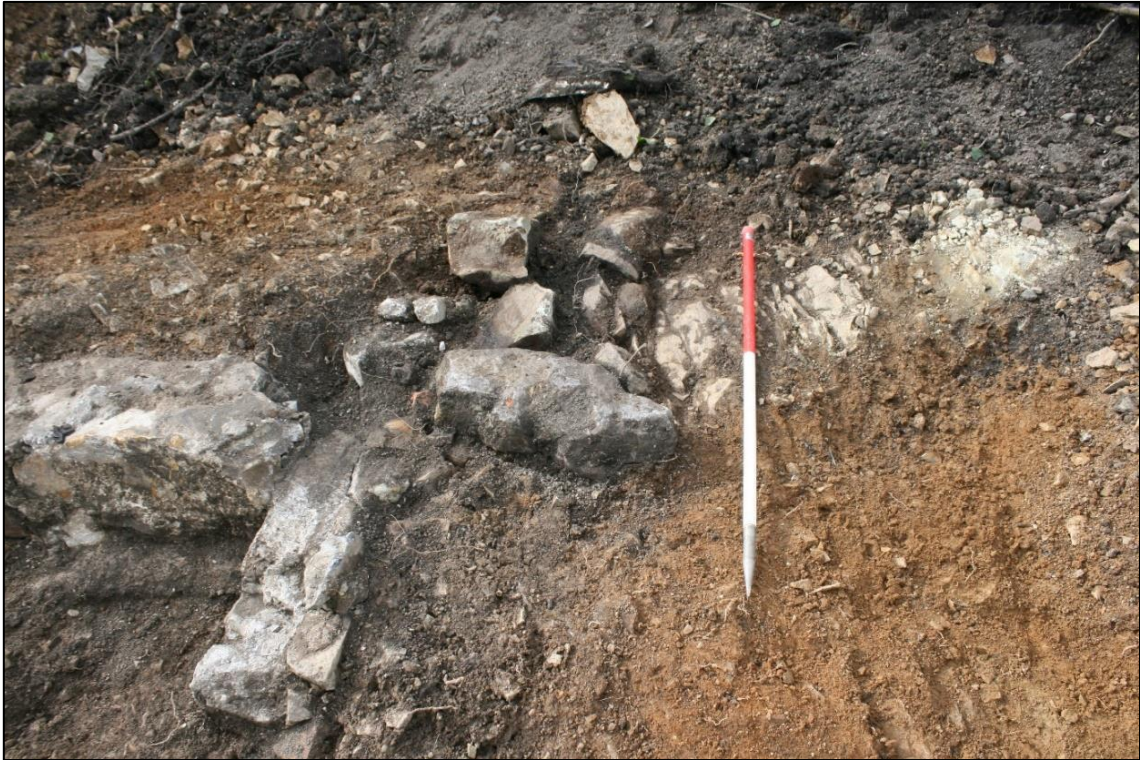
Photo 6: View west of drain [1005] cutting along the northern edge of stone foundation [1003]. Scale: 1 x 1m.

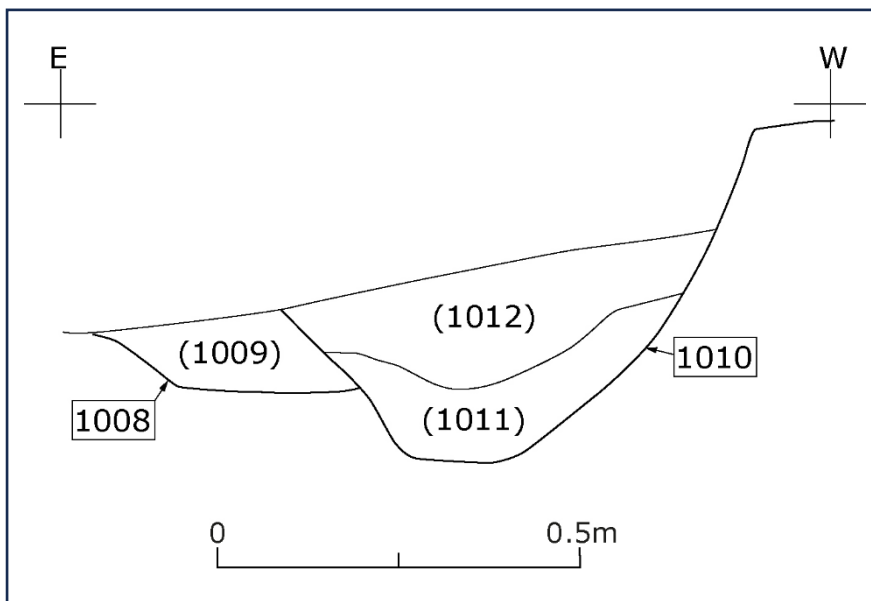
Figure 6: Section across ditch displaying evidence of two phases of ditch cut.

- 4.5.1 A relatively large ditch was observed whilst the topsoil was being removed, which, it is suggested, may be part of a former field system. The ditch displayed both a primary [1008] and secondary [1010] cut containing fills (1009), (1011) and (1012). Figure 6 and Photo 7 depict a section recorded across the ditch.

- 4.5.2 The basal fill of recut [1010] was a mid grey silty clay containing occasional fragments of coal and frequent sub-angular stones (1011). Its top fill (1012) comprised light greyish brown silty clay with occasional small sub-angular stones and frequent pieces of charcoal. The fill of the original cut (1009) was a light greyish dark brown silty clay.
- 4.5.3 Running roughly east-west across the site the ditch curved on itself, appearing to continue in a more southeasterly direction (Fig 7). Approximately 0.9m deep, the width at the point of the section was more than 1.9m (Photo 8).

- 5.4 Drain [1018] appears to be earlier than the landscaping events leading to the addition of built up of soil across the eastern areas of the site.
- 5.5 The ditch is thought to be agricultural in origin, running through a surviving section of what is probably a late medieval field system which may relate to the final years of the Augustinian priory which is situated immediately to the east of the site. It was found in an area where large ditches have been previously observed (Fig 2, Table 2 and Section 3.4). Little is known other than they were uncovered during road building in 1976 (Rees, 1992) and whilst it is thought that their true location may be further south, it is not impossible that the ditch observed during the watching brief is related to them in some way.

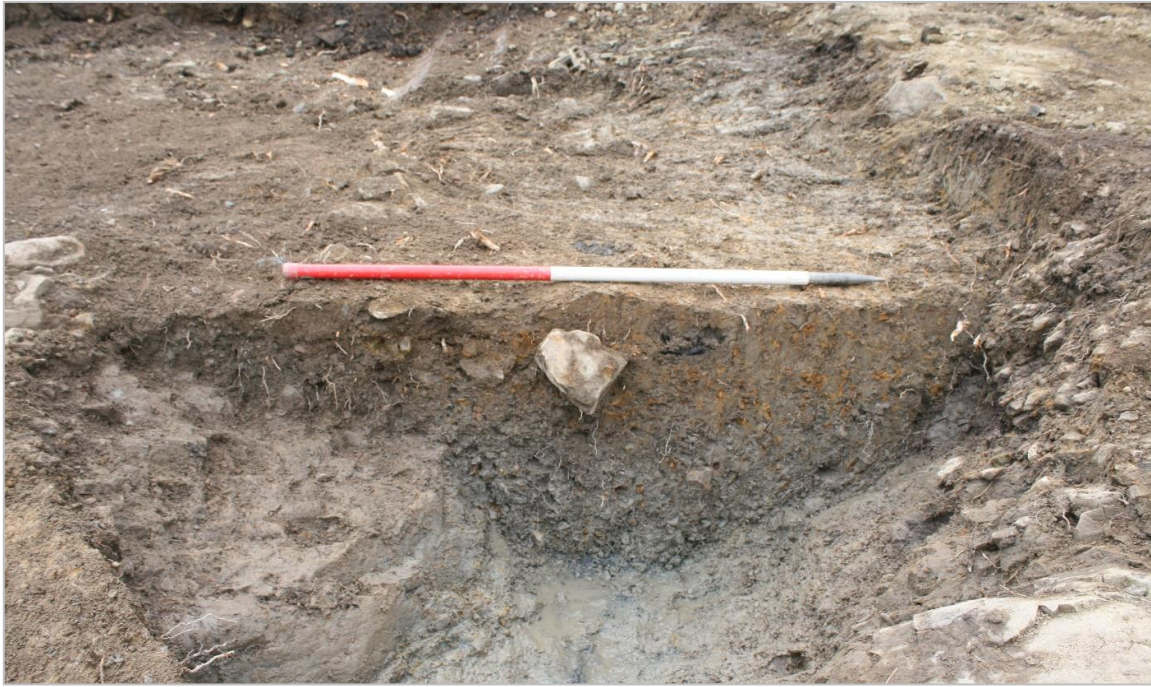
Photo 7: South facing section of ditch showing recut. Scale: 1x1m

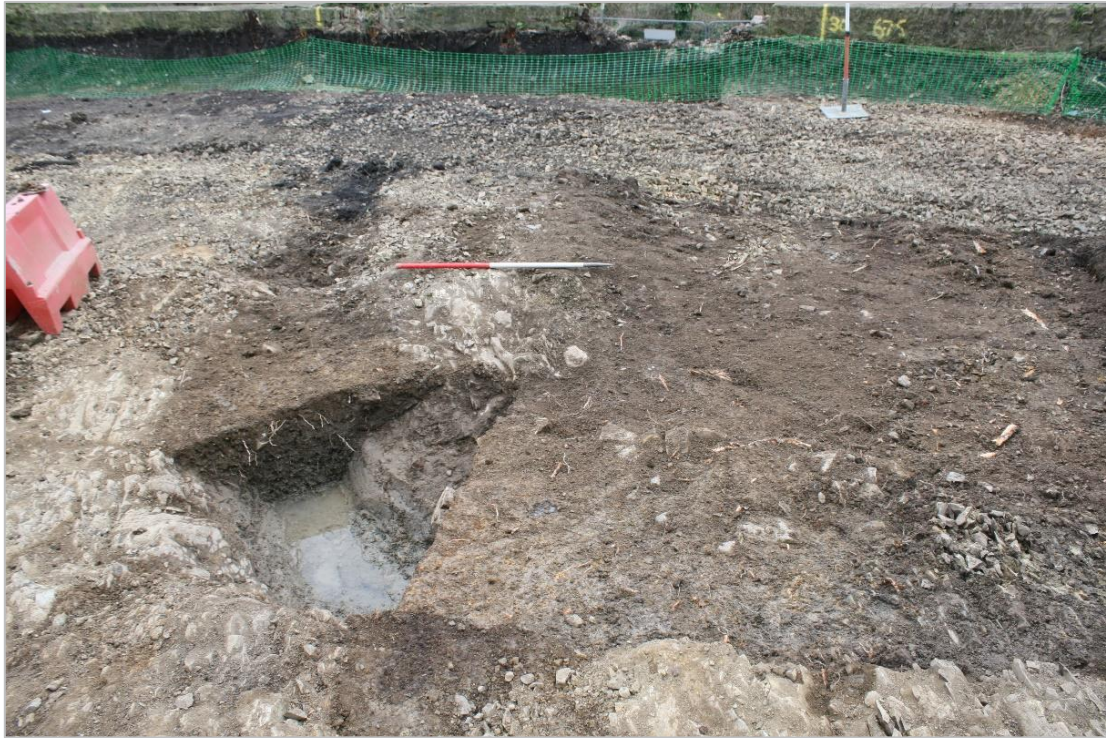
Photo 8: View eastwards showing excavated segment of ditch [1008]. Scale: 1x1m.

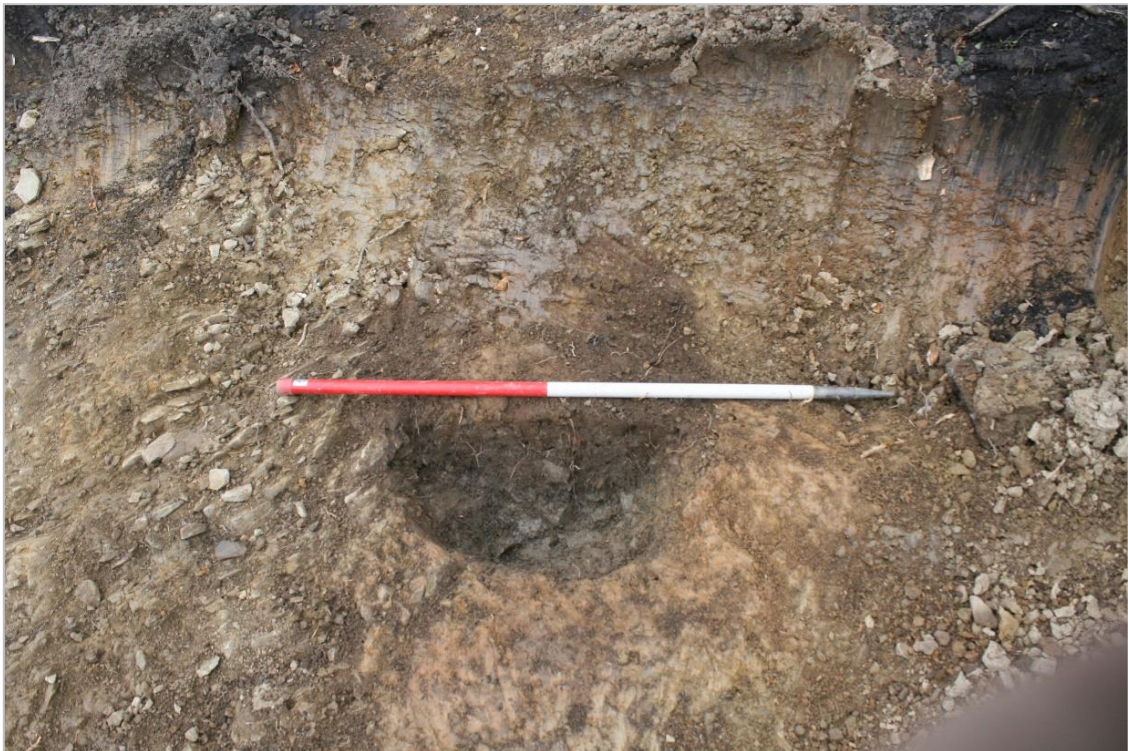
- 4.6.1 A small post hole [1013], clipped by the site edge, was found adjacent to the ditch, about 2.3m to the west (Photo 9). Its dimensions were 0.55m wide and 0.2m deep; its function is unknown.

Photo 9: Excavated post hole [1013]. Scale 1x1m.

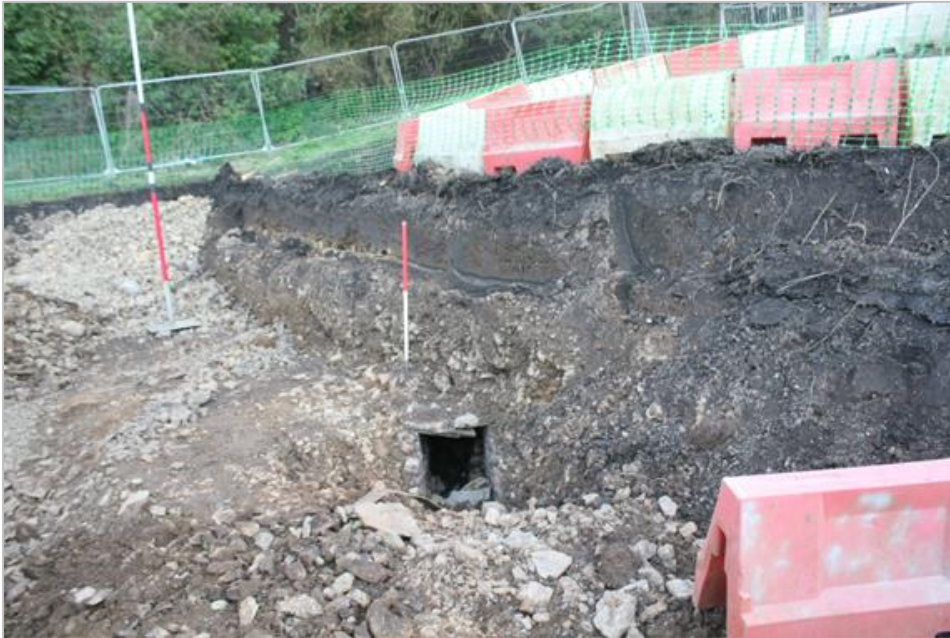
- 4.7.1 The remains of a second stone covered drain [1018] were found running in a roughly northeast-southwest direction and beneath the eastern baulk (Photo 10).
- 4.7.2 The drain measured 0.6m deep and 0.5m wide and was exposed at a depth of 1.4m, beneath the made-up ground discussed in 5.8 below.

Photo 10: View northeast of stone covered drain [1018]. Scale: 1x1m.

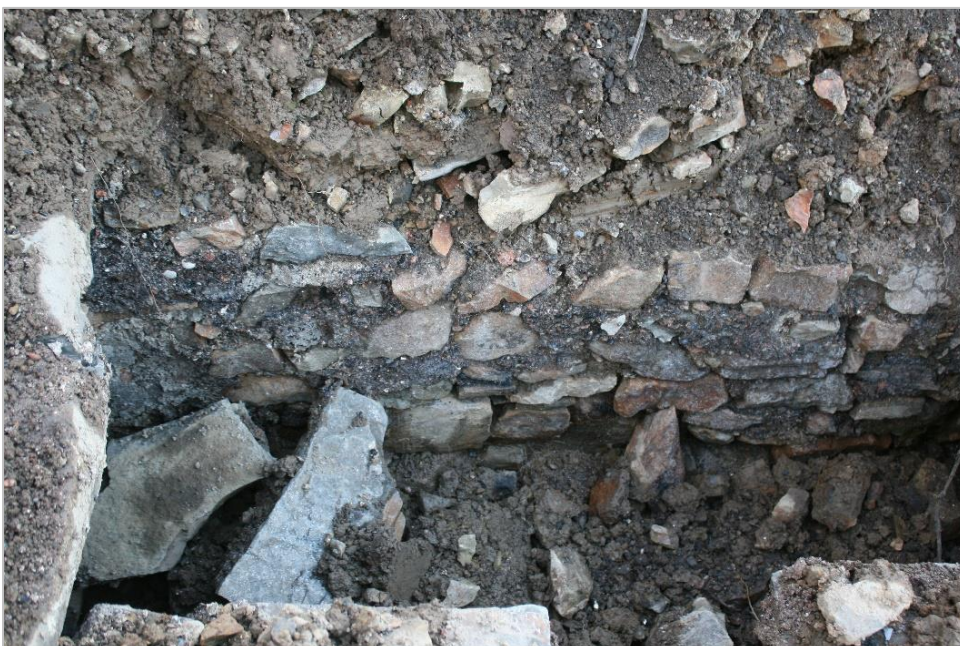
- 4.7.3 Constructed of unshaped stone blocks (Photo 11), the drain was sealed by a large capstone. The drain was still running, displaying no evidence of silting. Its placement on site suggests it may be related to the former Union Workhouse. There is no evidence to link this feature to the drain cutting the northern edge of the glasshouse and its trajectory (as seen on Fig 6) bypasses the stone foundations of the glasshouse.

Photo 11: View of the construction materials of the stone capped drain [1018].

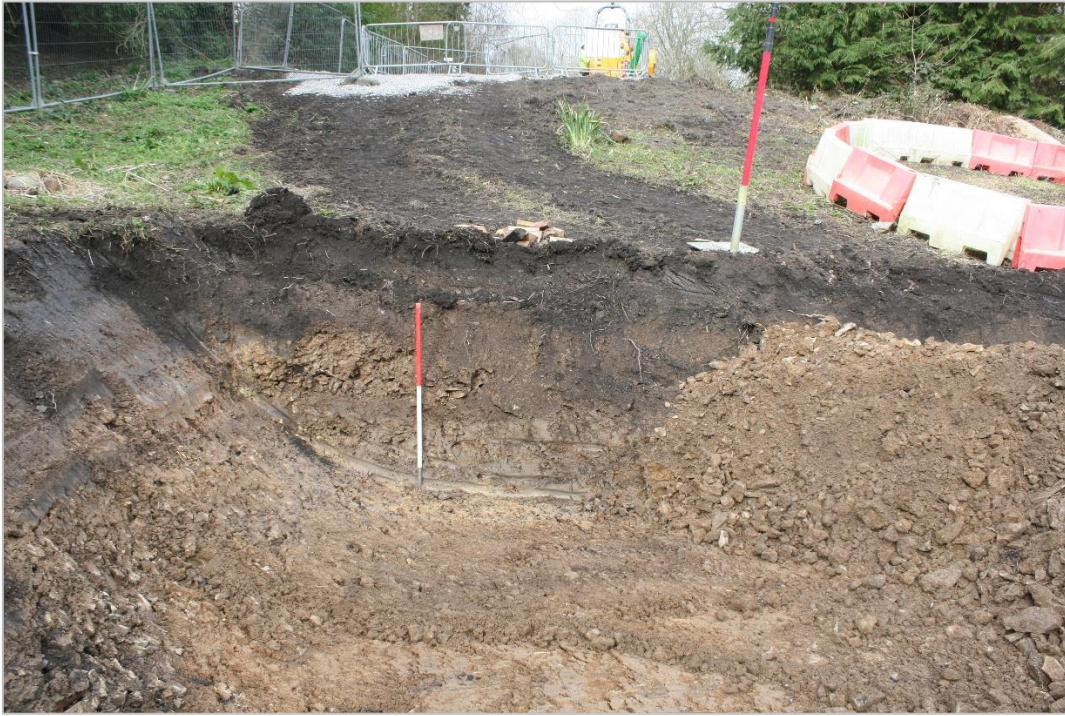
- 4.8.1 Within the southeastern and mid-eastern areas of the site large accumulations of made-up ground were encountered (Photos 12 and 13) comprising light to mid brown clay (1017) which measured up to 1.4m deep in places and overlay the natural ground horizon (1002).

Photo 12: East facing section of landscaped deposits (1017). Scale 1x1m.

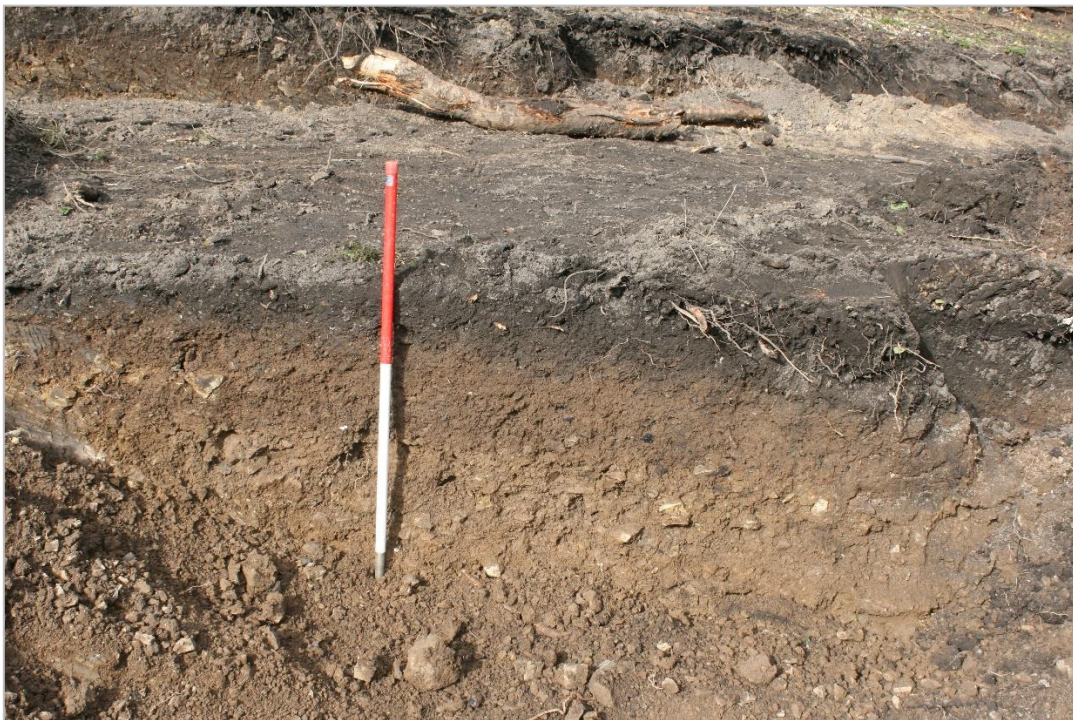
Photo 13: View west of made-up ground stratigraphy. Scale: 1x1m
