# **SURVEY AND RECORDING AT PICTON CASTLE, PEMBROKESHIRE, 2023**

Prepared by Heneb – Dyfed Archaeology  
For: Castle Studies Trust

RHIF YR ADRODDIAD / REPORT NO. 2023-32

RHIF Y DIGWYLLIAD / PROJECT NO. 130011

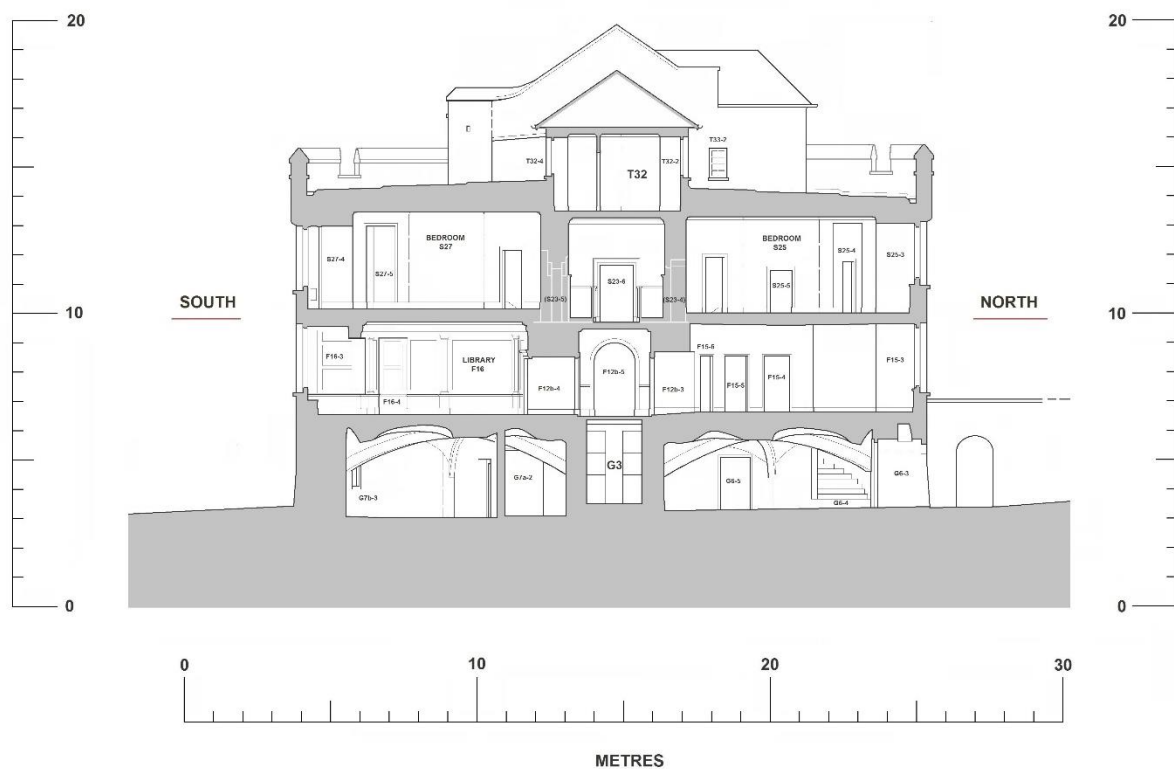
*Fig. 5: Transverse section through Picton Castle east towers, facing west*

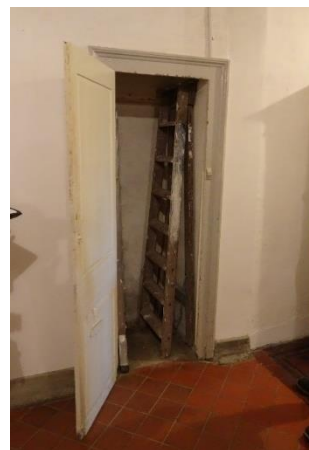
*Fig. 86: Cupboard (former entry) G11d-1 at the east end of corridor G11d, facing east*

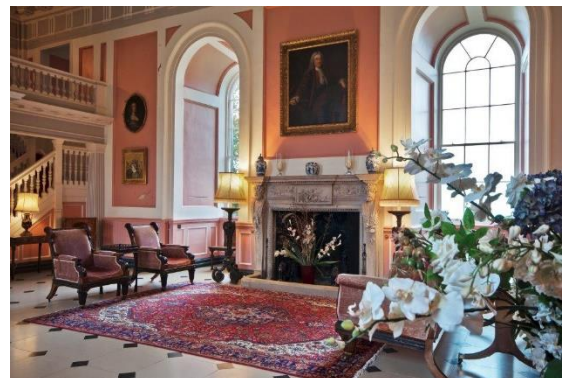
*Fig. 103: Great Hall south wall, showing windows F17-9 and F17-10, and fireplace F17-11*

West of the screens passage, the hall proper is lit by a two tall windows in each of the side walls (F17-7 – F17-10; Fig. 103). From the 1790s in their present form (see Sections 6.4 and 6.5.3), they were adapted from late fifteenth-century windows shown in c.1740, 1779 and c.1794 (Figs. 8, 11 and 12) and described in Section 4.5.1 below. Two-centred (relieving) arches are visible externally, above the two north wall windows (Fig. 24), but while windows were clearly part of the early fourteenth century design, the shape and size of these arches suggest they may relate to the fifteenth-century refenestration. They presumably replaced windows in the same location, which may have been somewhat smaller; there is no evidence for any further Hall windows in the fabric.

Between the two southern windows is a fireplace F17-11, with a mid-eighteenth-century chimneypiece (Fig. 103). We cannot be certain that it replaces a medieval original; the

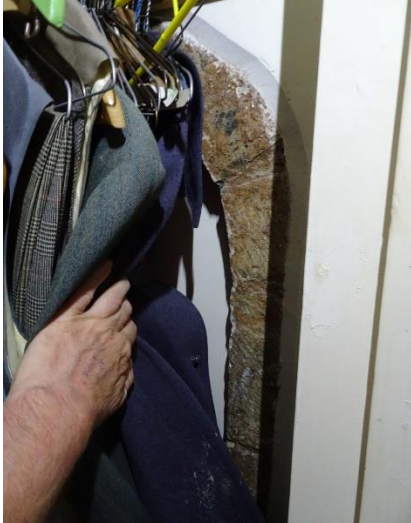
*Fig. 139: The head of blocked medieval passage doorway S26-2, now in a cupboard in room S25, looking northwest*

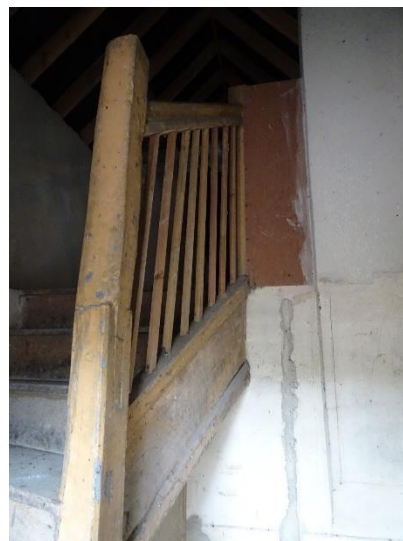
*Fig. 167: Continuation of spiral stair SSB towards attic, looking southeast*

At this level, the stair now features an inserted entry T33-1 from the eighteenth-century additional storey (Fig. 164), above which it continues for half a turn towards the Northeast Tower parapet; the risers have been replaced in timber (Figs. 166-7). Midway up is an internal recess in the west wall of the caphouse, representing the blocked medieval doorway onto the Great Hall north wall parapet (Fig. 166); the parapets appear to have occupied the same level throughout the castle, meaning the doorway must have incorporated three steps up. A small slit-light SSB-4 in the same wall, with a splayed, segmental-headed embrasure, appears to be medieval (Figs. 23 and 166). The stair emerges onto the Northeast Tower parapet through a plain doorway in the north wall (Fig. 166); this wall is thin, and entirely modern (twentieth century?), but presumably replaces a medieval predecessor. The stair now continues upwards towards the later attic, with timber risers (Figs. 166-7).

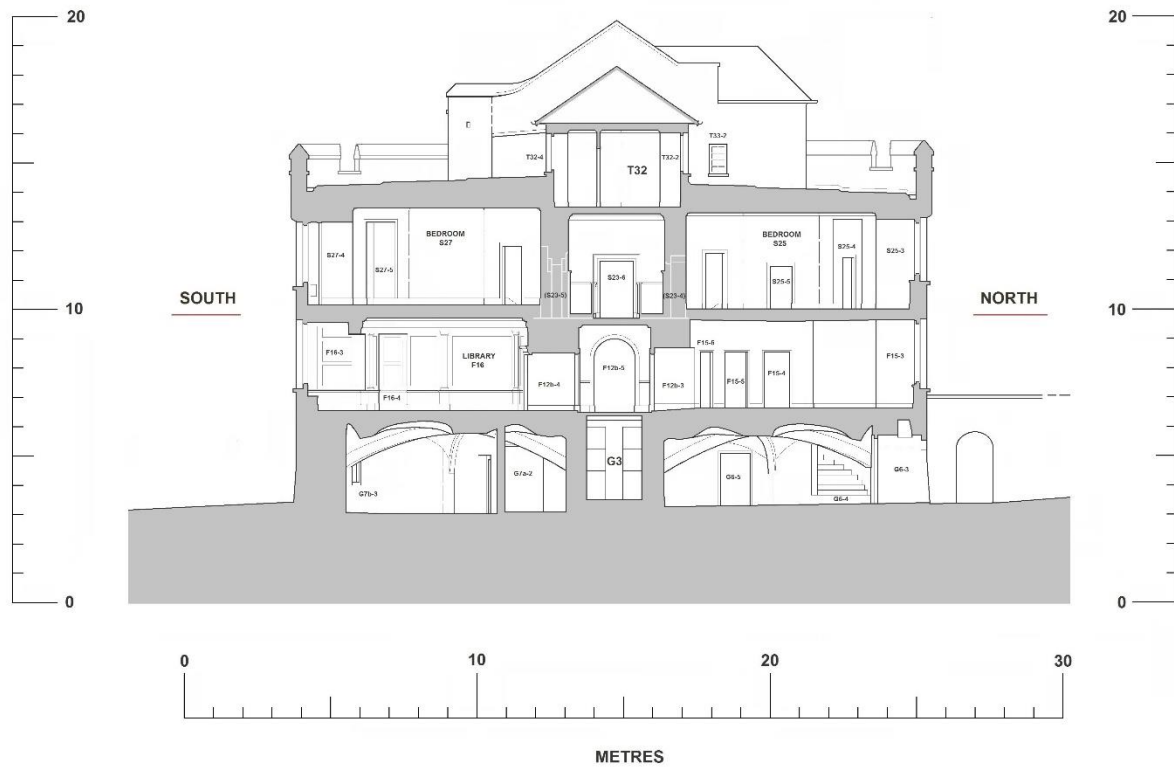
*Fig. 178a: Transverse section through Picton Castle east towers, facing west – modern*

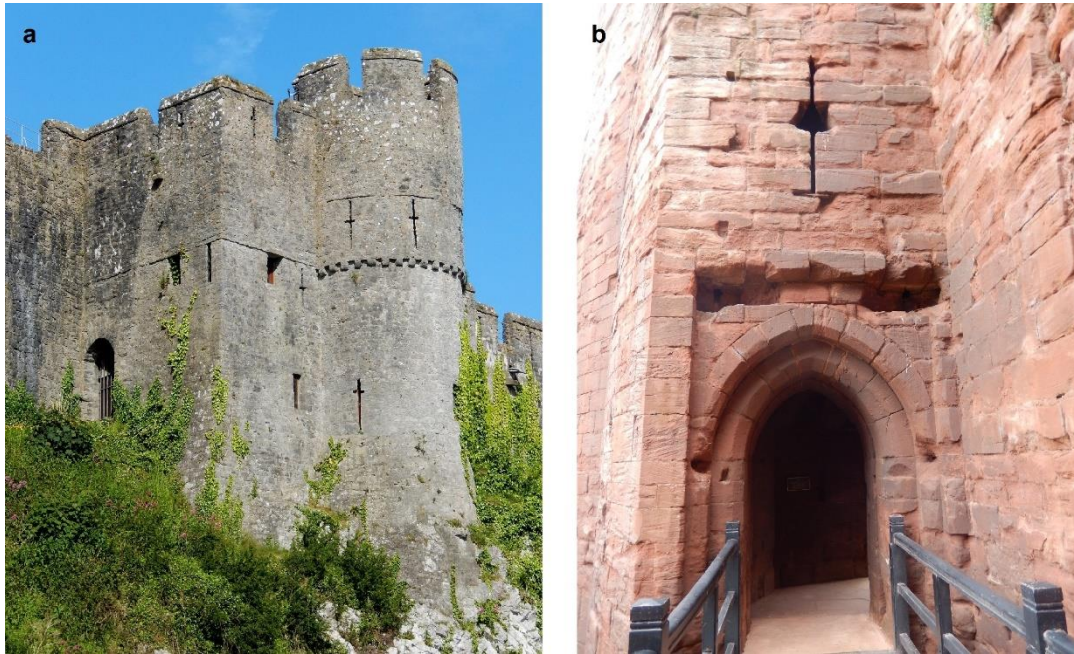
*Fig. 195: Cruciform loops in Aymer de Valence's castles at a) Pembroke (St Ann's Bastion); b) Bothwell, Lanarks. (donjon). Both c.1300-10*

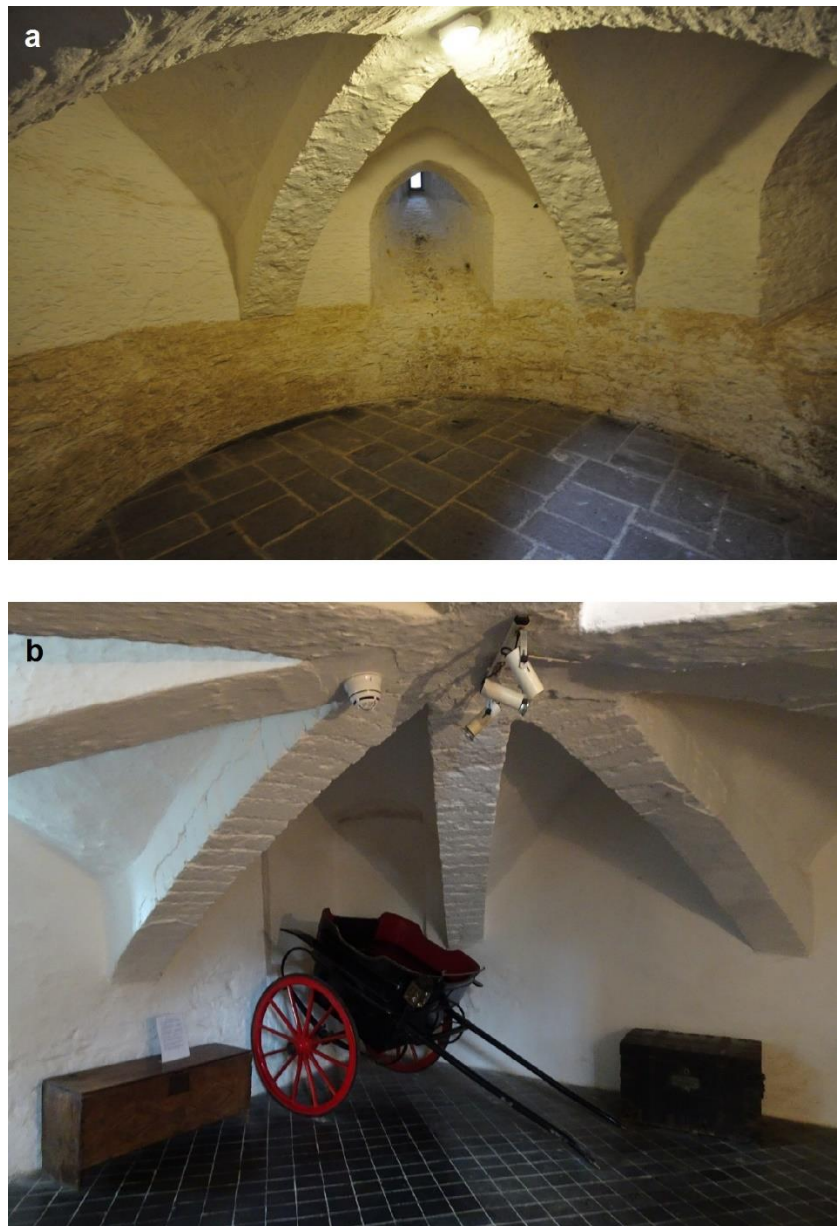
*Fig. 196: Low rib-vaults with a deep extrados at a) Castell Coch (Glam.), late 1260s-70s;  
b) Picton Castle northeast tower*

The closest comparanda for the low undercroft vaults in Picton's east towers are at Gilbert de Clare's Castell Coch, Glam., from the late 1260s-70s (Davis 2000, 213; McLees 2005, 9). The Kitchen Tower there shows a low quadripartite vault with robust, square-sectioned ribs, as at Picton, while in both castles the extrados of each rib is built up for some distance before the springing of the vault panel (Fig. 196). Broadly comparable vaulting was also employed by Clare in the inner west gatehouse at Caerphilly, Glam., perhaps from c.1271 when the castle was started anew (Renn 2018, 229). Rib-vaulting, during this period, was otherwise very infrequent in west Wales – an exception is work from c.1300-10 at Newport, Pembs. (Fig. 197) – and where employed could sometimes take the form of superficial, 'bastard ribs', as in the Chapel Tower at Carew Castle, from c.1300 (discussed in Ludlow, forthcoming).

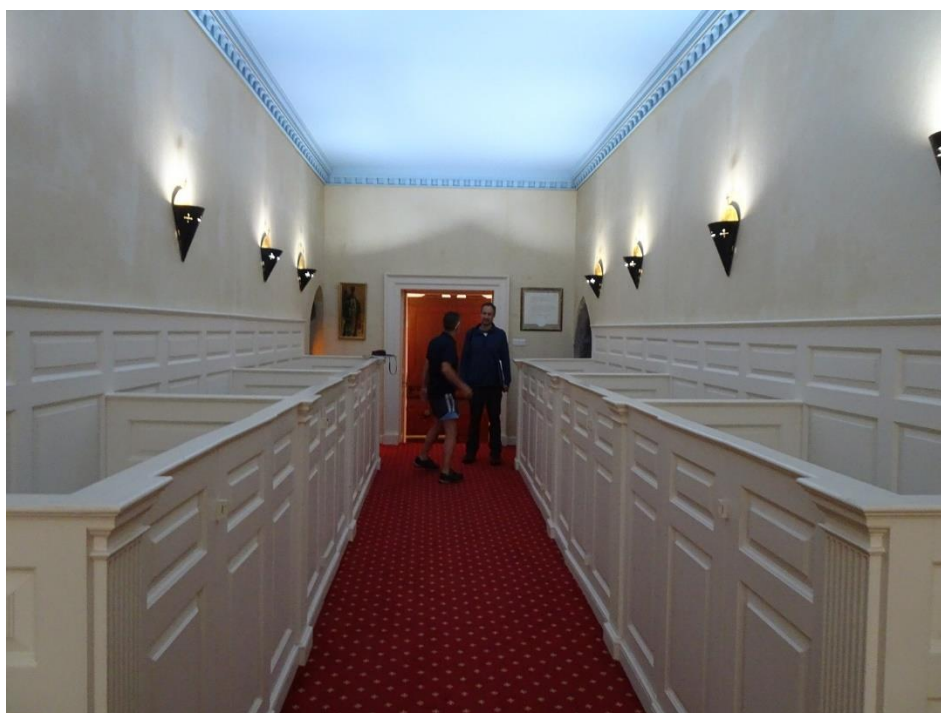
*Fig. 224: Chapel S23, with fittings from 1749-52, looking west*

The chapel was entirely refitted. A new entry S23-6 from the Hall gallery, with a pedimented doorcase, was inserted in the west wall (Fig. 224), while the late-medieval east window S23-1 was replaced by a finely-detailed Venetian window (now gone; Fig. 13), which filled the gateway's medieval outer arch flush with wall-face. Any internal partition between schoolroom and chapel proper was removed, as the interior was panelled throughout in mahogany (Fenton 1811, 279), up to dado level, following the Classical detailing elsewhere; box pews were fitted on each side-wall, facing inwards (Fig. 224). The contemporary altar rails have turned balusters (Fig. 123). The bellcote had been removed before 1805 (Fig. 13), probably as part of this work. The joinery, by James Rich of London, was one of the last tasks undertaken during this phase, in 1752 (Garner 2000, 3.3.30; Lloyd *et al.* 2004, 362). The present ceiling is from 1884-97.
