FORMER COUNTY GAOL, HAVERFORDWEST, PEMBROKESHIRE HISTORIC BUILDING RECORDING

REPORT NO. 2023-40
EVENT RECORD No. 130139

November 2023

**FORMER COUNTY GAOL, HAVERFORDWEST,
PEMBROKESHIRE:
HISTORIC BUILDING RECORDING**

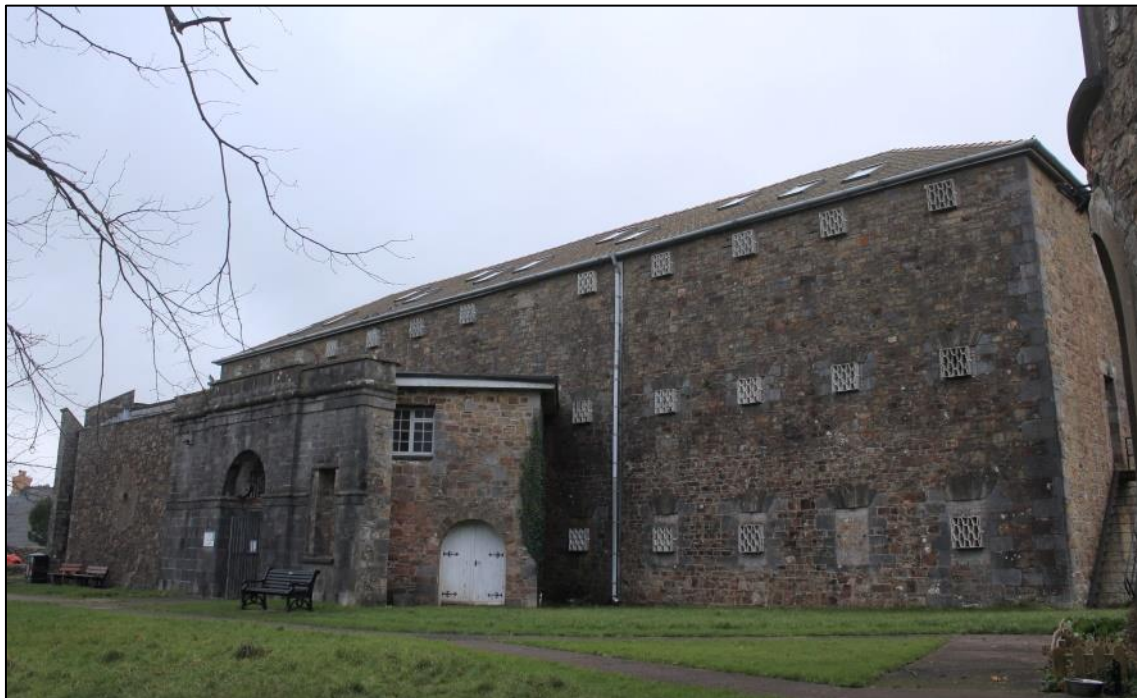
Photo 1: The former gaol building, looking northwest, showing the building frontage and surrounds.

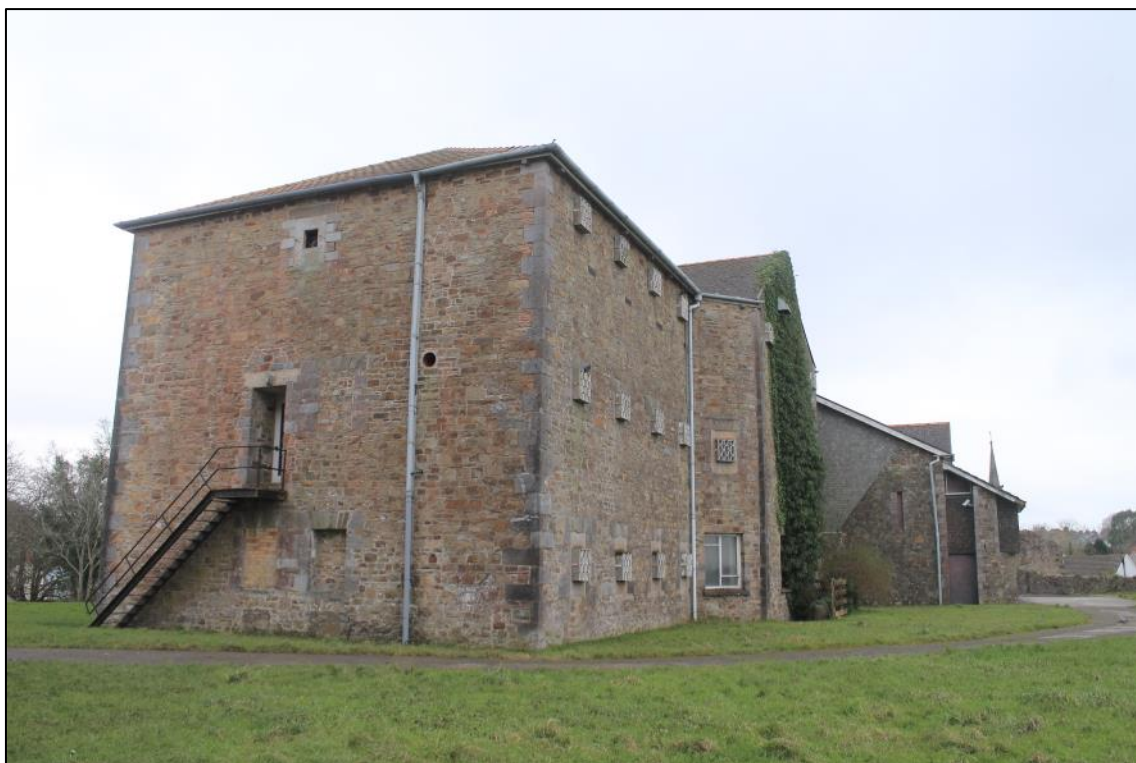
Photo 2: *The former gaol building, looking southwest, showing the rear of the building.*

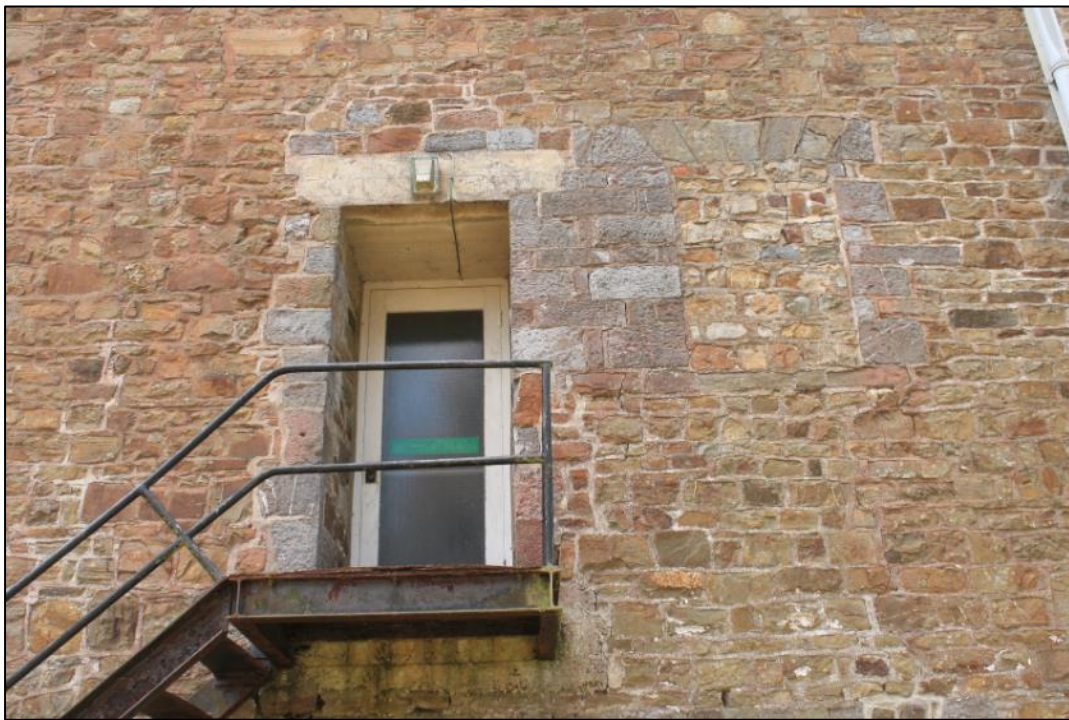
Photo 34: View west showing detail of the first floor openings, with inserted doorway.

similar to that on the east face. At first floor level a large door opening has been inserted, containing concertina timber doors with replaced dressed stone quoins, concrete sill and lintel. This replaced a pair of windows seen on aerial photographs of the 1950s. Squared stonework indicates the upper storey has been entirely rebuilt, although dressed quoins have been retained or replaced. A central opening at second floor level mirrors that on the east face. To the south the modern extension brings the rubblestone wall around for approximately 2m, framed in limestone quoins (Photo 38). The remainder, up to the original gaol building, then comprises a timber fronted ground floor with vented double doors, topped by a large slate-tile panel. Similar materials are used in the west elevation of the northern extension which is recessed slightly from the rest of the west face (Photo 39). A rubble stone wall covers the ground floor level and angles up to first floor level at the north end, incorporating a narrow ventilation light in a dressed stone surround. The remainder of the first floor level is covered in a slate-tile panel topped by a pitched roof. This is repeated on the opposing elevation of the modern extension.

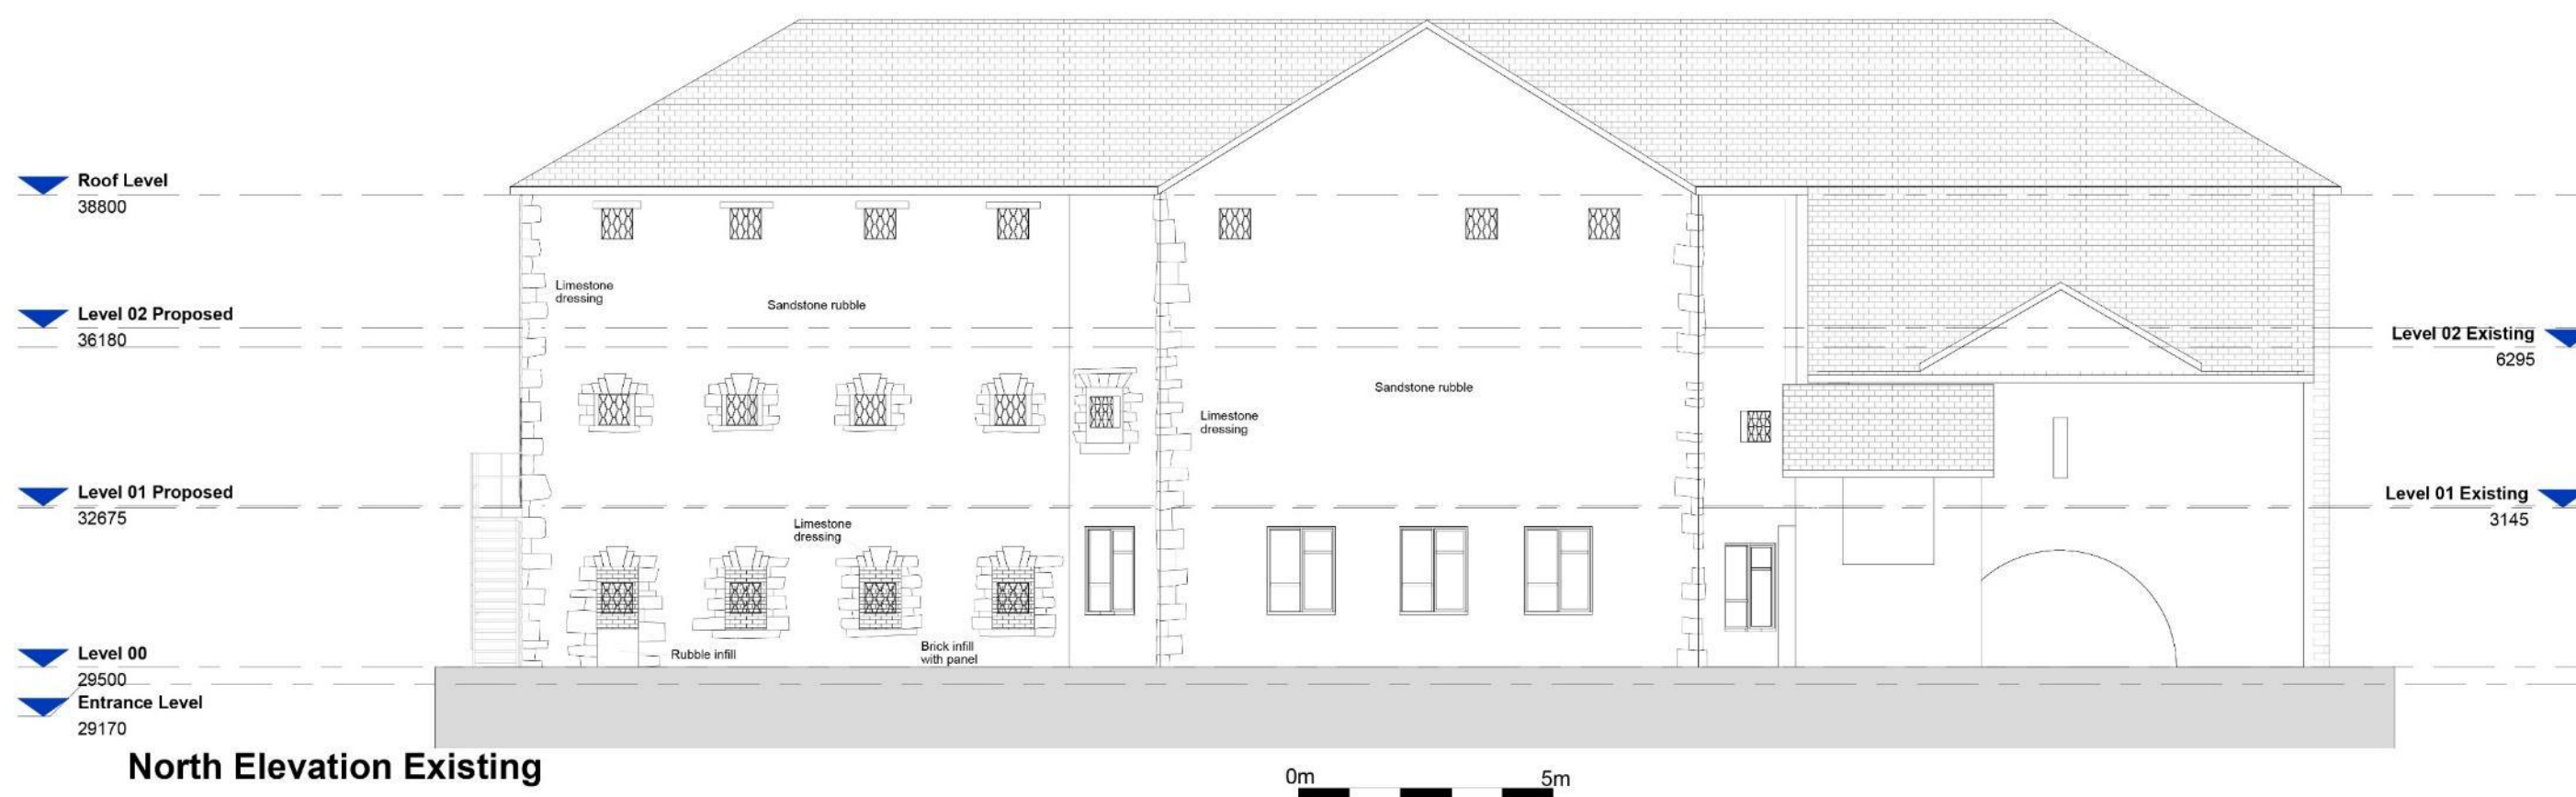
Figure 13: North (rear) elevation of the former gaol building. Based on drawings produced by DB3 (07/07/22) for Pembrokeshire County Council, drawing 15389-DB3-B01-ZZ-DR-A-20022, with adjustments and annotations by DAT-AS. Not reproduced to the original scale.

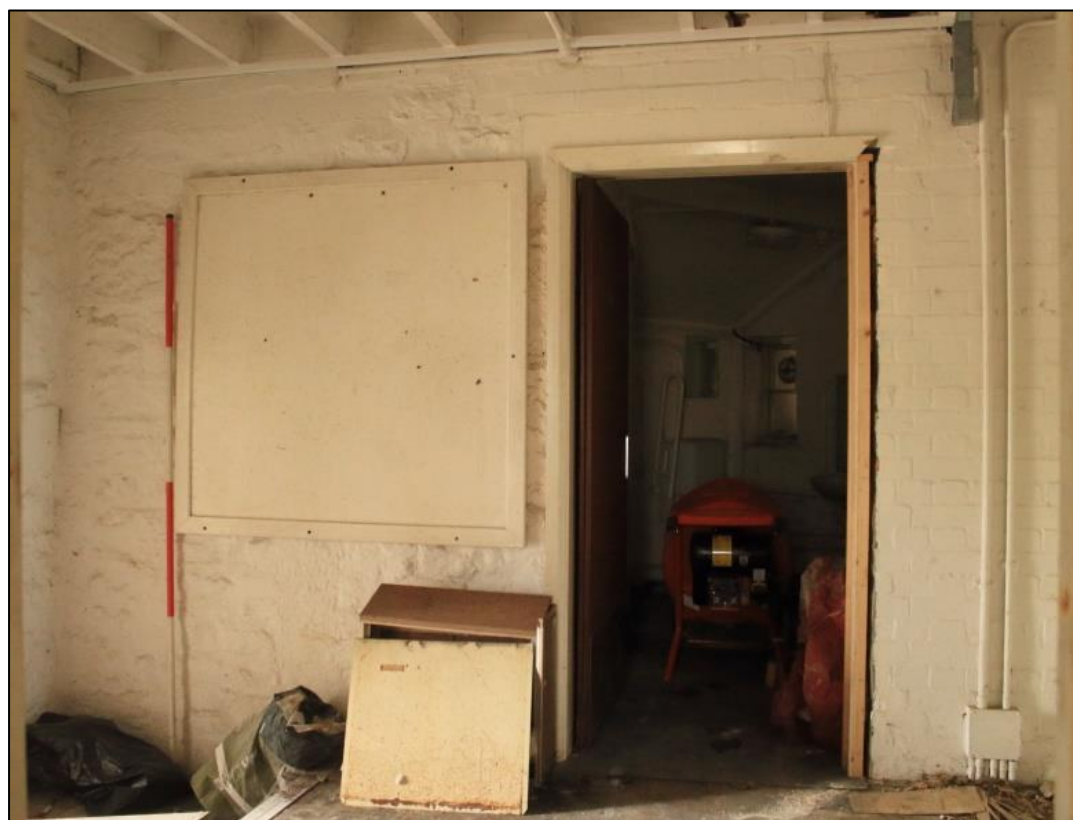
Photo 52: View west, showing the inserted opening and brick surround on the west side of the lobby. 2m scale.

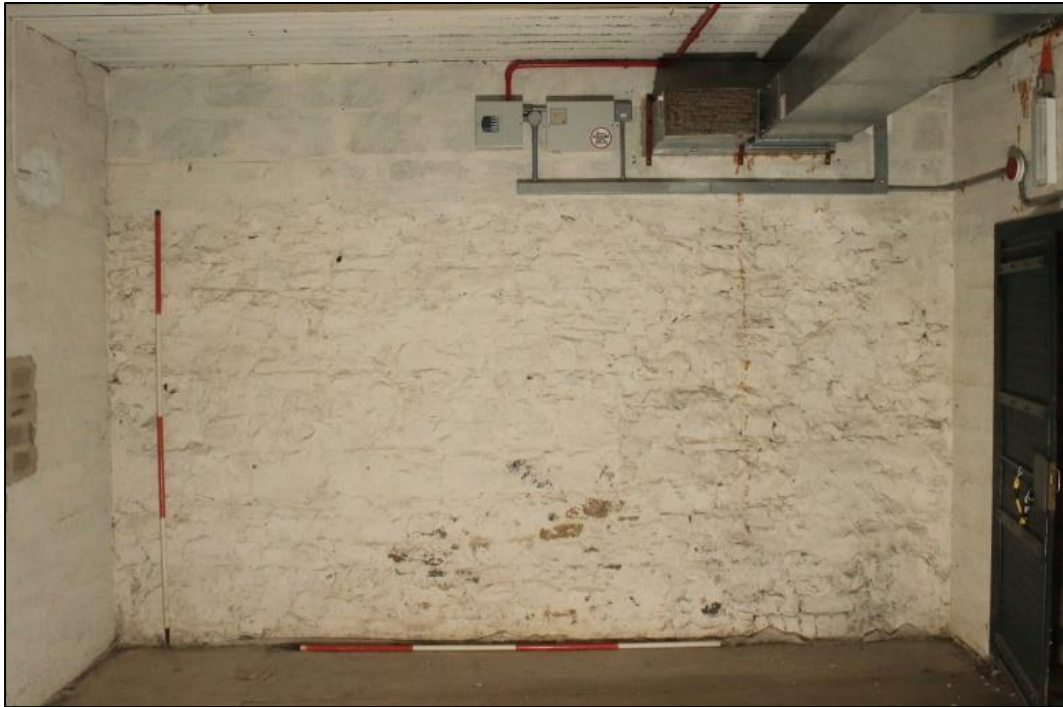
Photo 71: View west, showing the west wall of the large southeast strongroom. The brick header to the heating system is visible at ground level on the right. 2m scales.

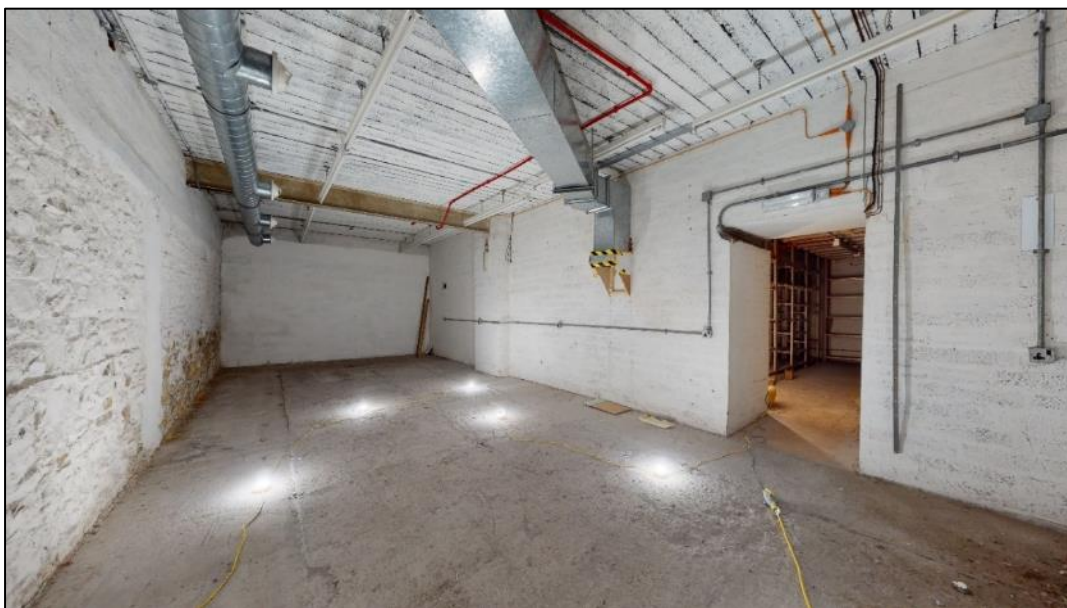
4.2.13 The northernmost strongroom (Photo 88) has an area of repair in the centre of the south masonry wall, covered in plasterwork (Photo 89). The east wall is half masonry topped by shuttered concrete to the north and half breezeblock around the steel door entrance (Photo 90). An infilled fireplace, 0.8m wide, lies in the northern part of the wall with a large stone lintel (Photos 90 and 91). The opening appears to initially have been narrowed to 0.65m in brickwork and then completely infilled in similar brickwork. The north and west walls are breezeblock inserts with a doorway opening in brickwork to the north. The floor and ceiling are concrete with steel beam supports.

Photo 88: View west, showing the northernmost of the two western strongrooms.

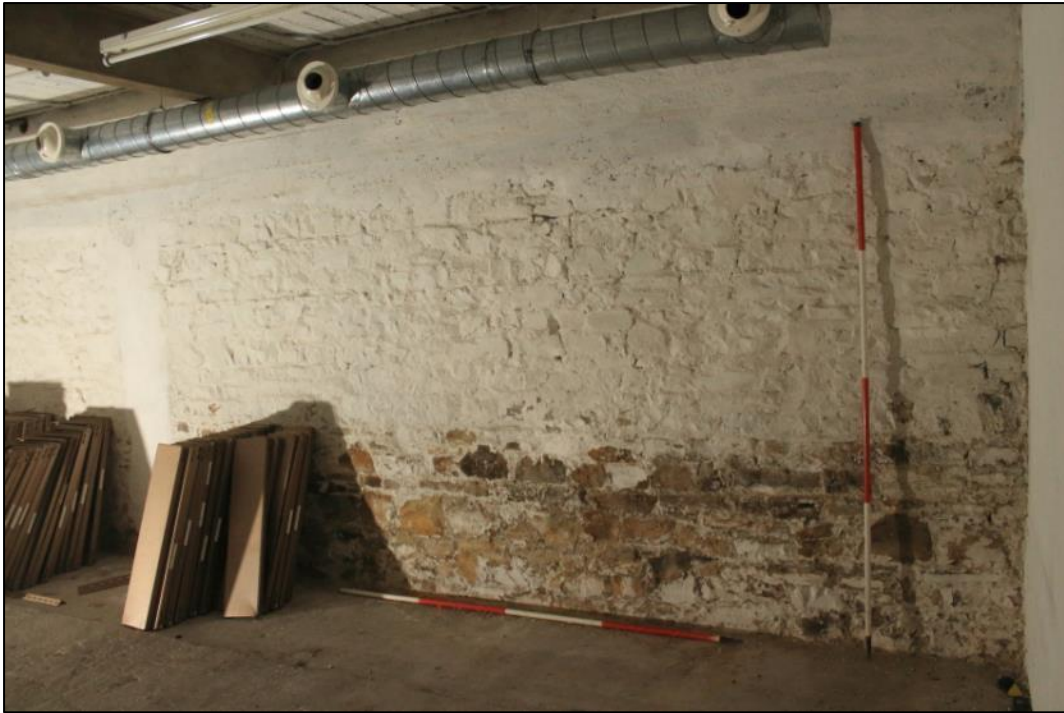
Photo 89: View south from the northernmost of the two rooms, showing the dividing wall between the two western strongrooms with an area of repair covered in plasterwork to the left of the photo. 2m scales.

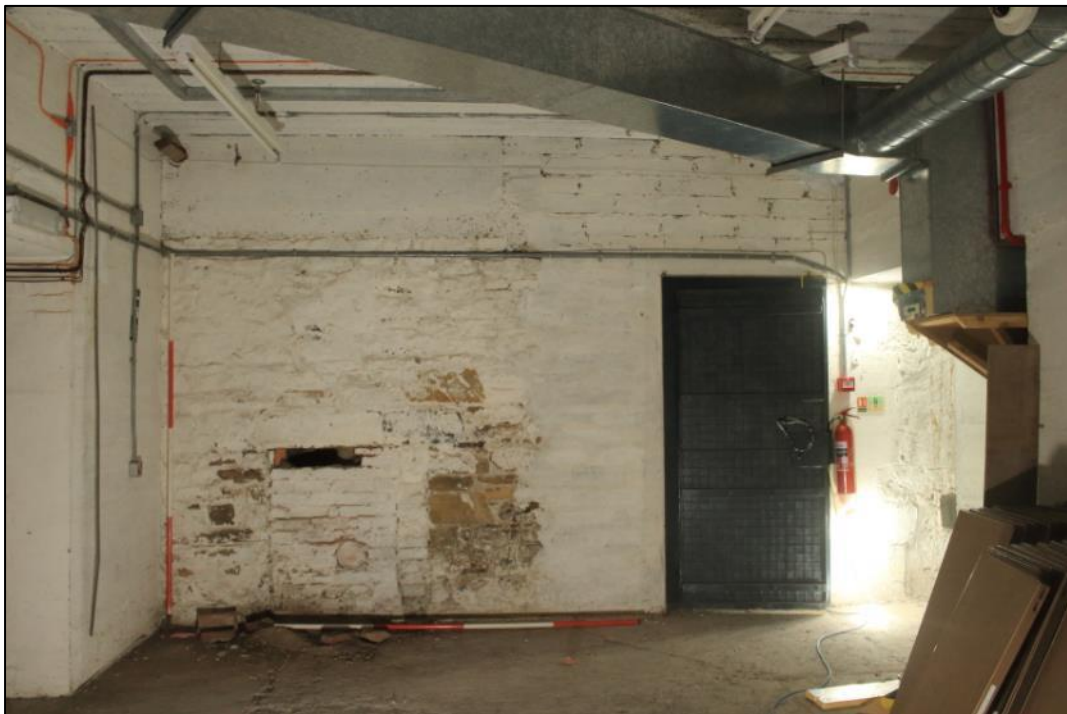
Photo 90: View east, showing the eastern wall of the strongroom, with blocked fireplace on the left and inserted steel door on the right. 2m scales.

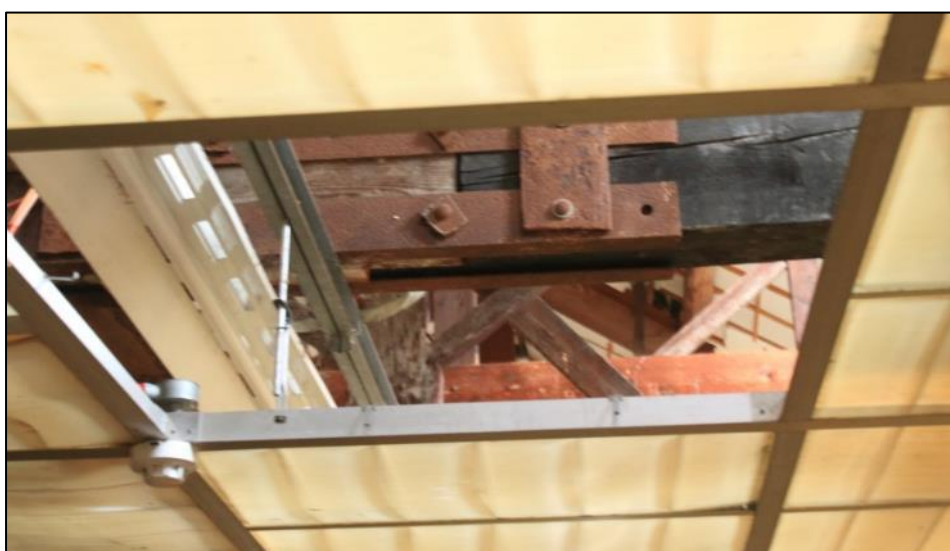
- 4.3.7 The second floor is accessed via the central stairs. A gallery level with vinyl tiled floor occupies the main space along the northern half of the building and is enclosed by timber railings (Photos 109 and 110). At the west and east ends narrow rooms are subdivided by a thick timber frame with part-glazed panelling in between (Photo 111). A lowered ceiling lies above this floor, largely comprising translucent panelling, with solid panels against the north wall. Missing panels reveal a roof structure above of timber beams with iron bracing panels (photo 112).

Photo 112:
*View east
through a
missing
ceiling tile at
part of the
roof
structure
beyond.*
