Manor House Farm, Stackpole, Pembrokeshire

March 2009
1:50

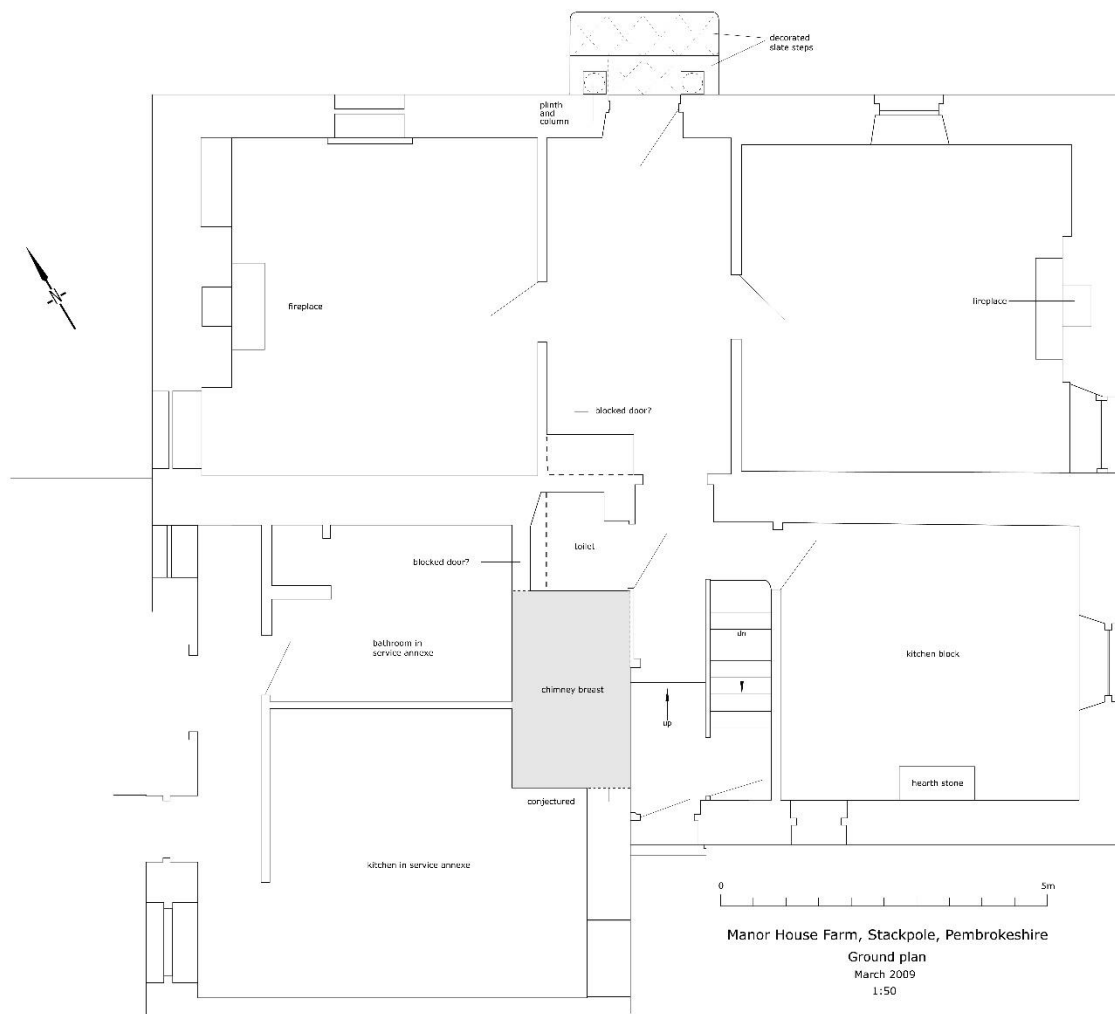
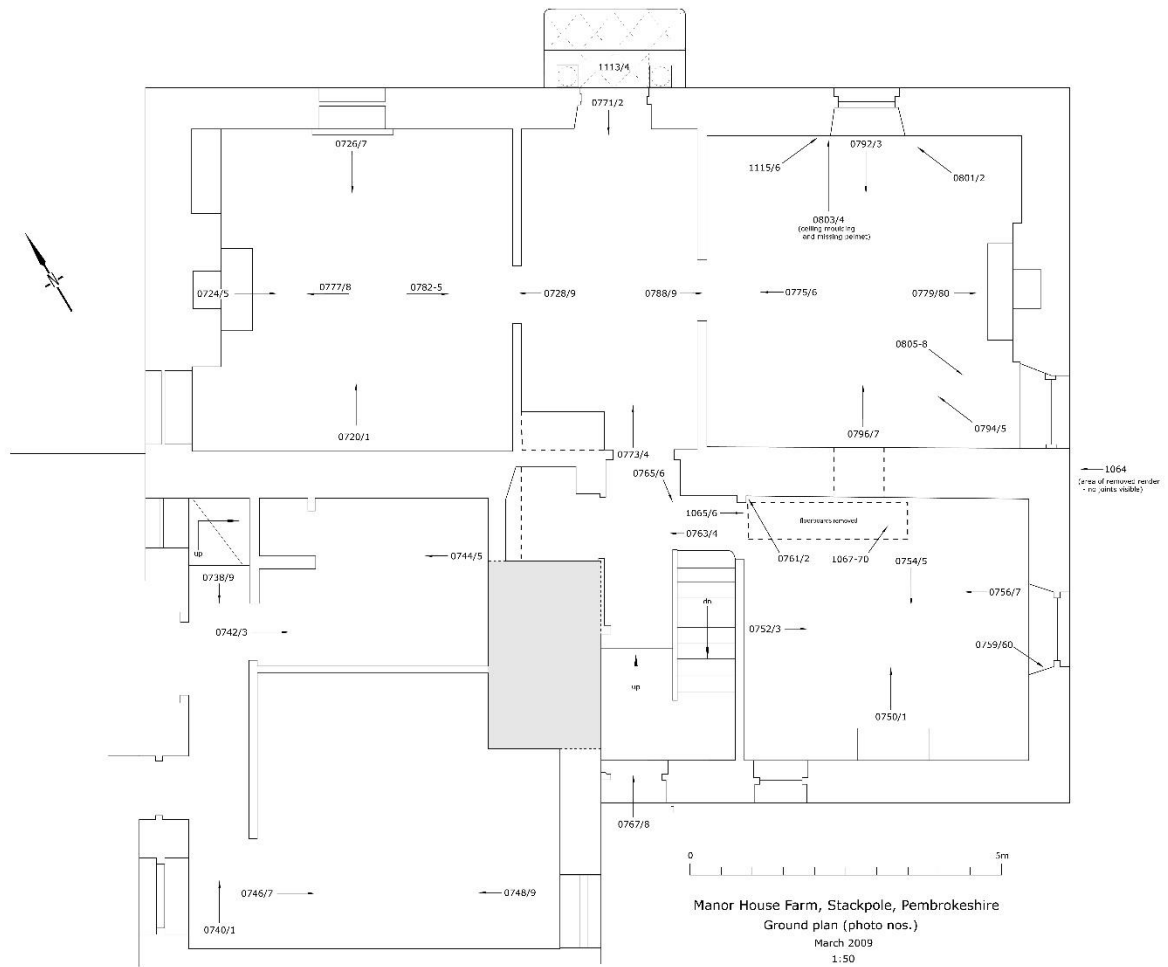
Internal details

Mullion moulding of front east window, ground floor

Mullion moulding of 'kitchen' east window

'Kitchen' wall moulding

'Kitchen' skirting board - west wall
