**FORMER SHIP & ANCHOR PUBLIC HOUSE,
FISHGUARD, PEMBROKESHIRE
HISTORIC BUILDING RECORDING
(NGR SM 9567 3693)**

REPORT NO. 2024-31
EVENT RECORD No. 130823

June 2024

**FORMER SHIP & ANCHOR PUBLIC HOUSE,
FISHGUARD, PEMBROKESHIRE:
(NGR SM 9567 3693)
HISTORIC BUILDING RECORDING**

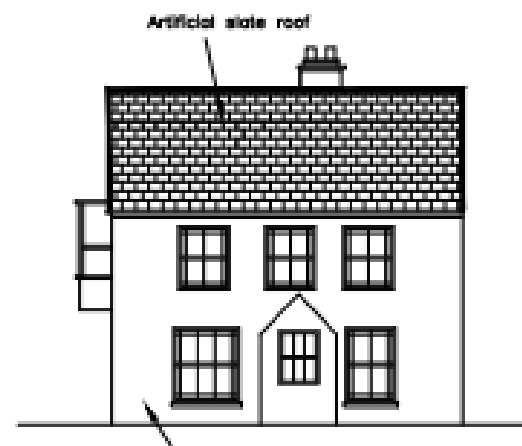
Figure 10: Eastern elevation of former Ship and Anchor public house. Supplied by client.

- 4.1.4 The eastern block faces east towards a pedestrian thoroughfare, its northern extent once abutted the former library building now demolished. Again, the block is built of stone now rendered with modern concrete (photo 5), with a gabled slate roof. The eastern façade has a modern central porch, accessed from the south with sash windows to each side and above (photo 6). The sash windows on this façade are more traditional timber framed panelled sashes. The southern gable end of the eastern block includes a 1st floor bay window of Victorian date, subsequently replaced to form much of the character of the southern façade with the western block.

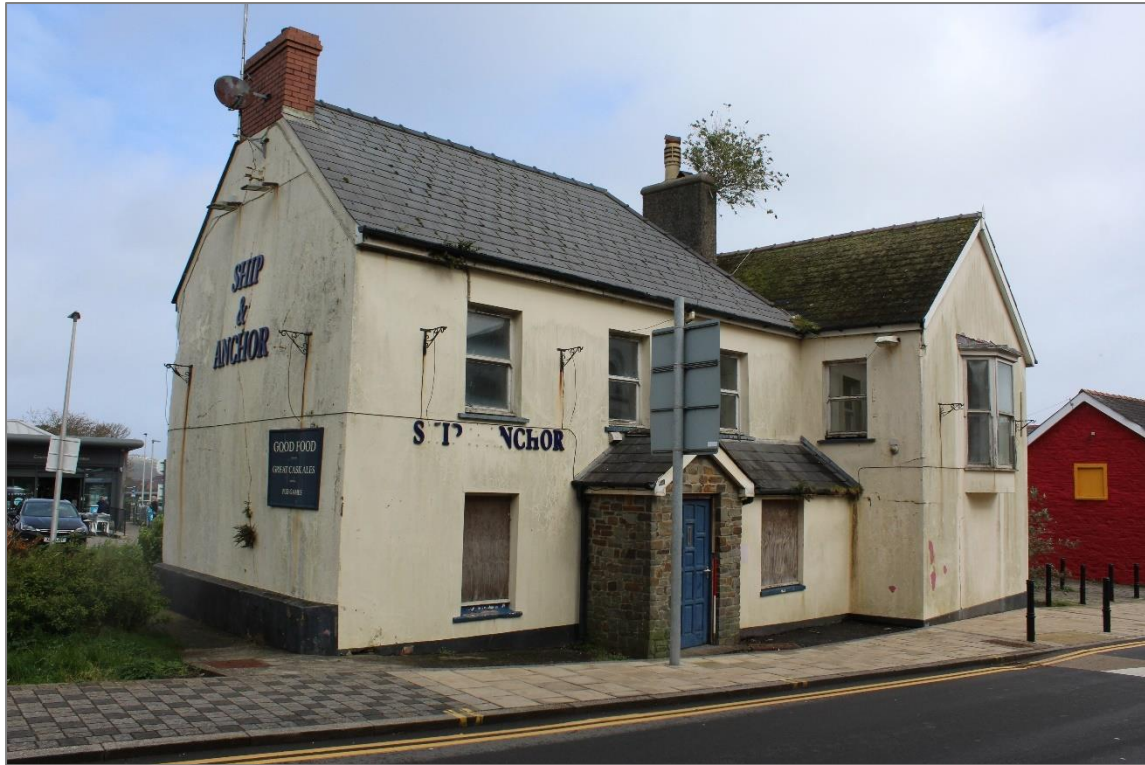
Photo 2: View northeast, showing the L-shaped layout of two blocks. The western block lies to the left, and eastern block on the right. 1m scale.

- 4.1.1 The former Ship and Anchor public house has a backwards L-shaped plan comprising of a two similarly sized two-storied blocks. Its modern form is the result of many alterations in the past, both during the construction of the new Chimneys Link road when the public library to the north, a Victorian wing, and modern function hall were demolished, and during its time as a public house which changed or removed much of its original layout.

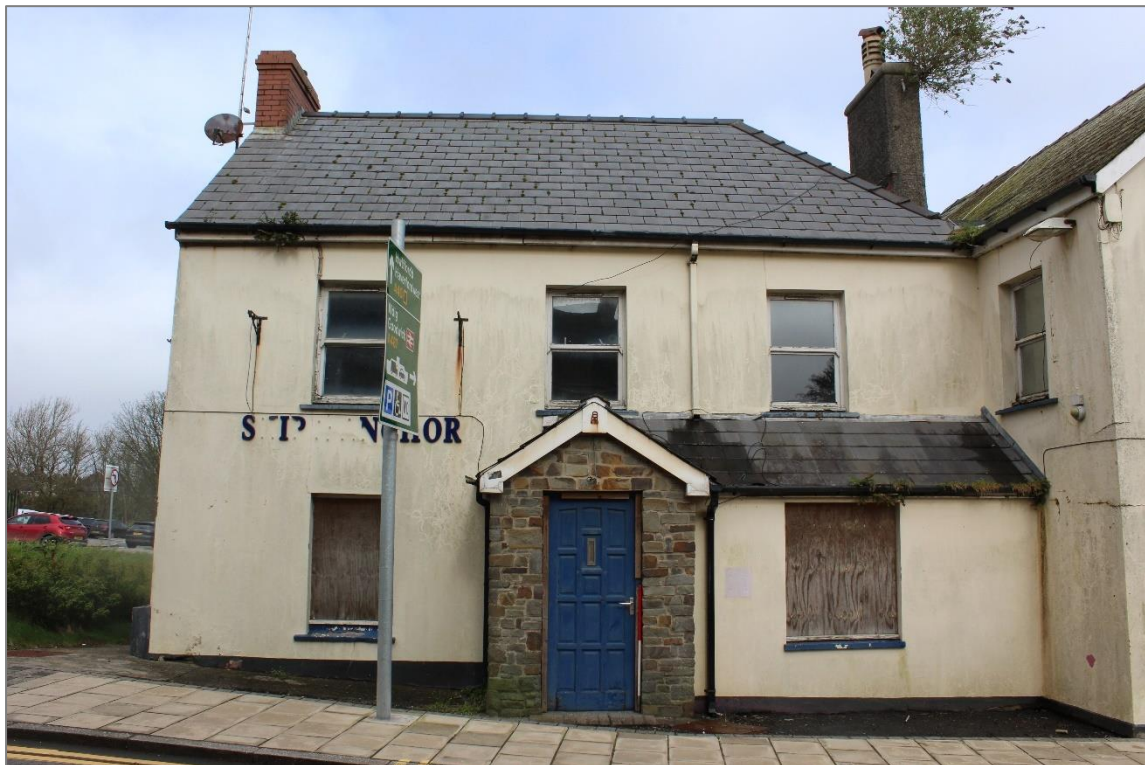
Photo 3: View north of the front (south) face of the western block. 1m scale. Note modern porch and extension to the right.

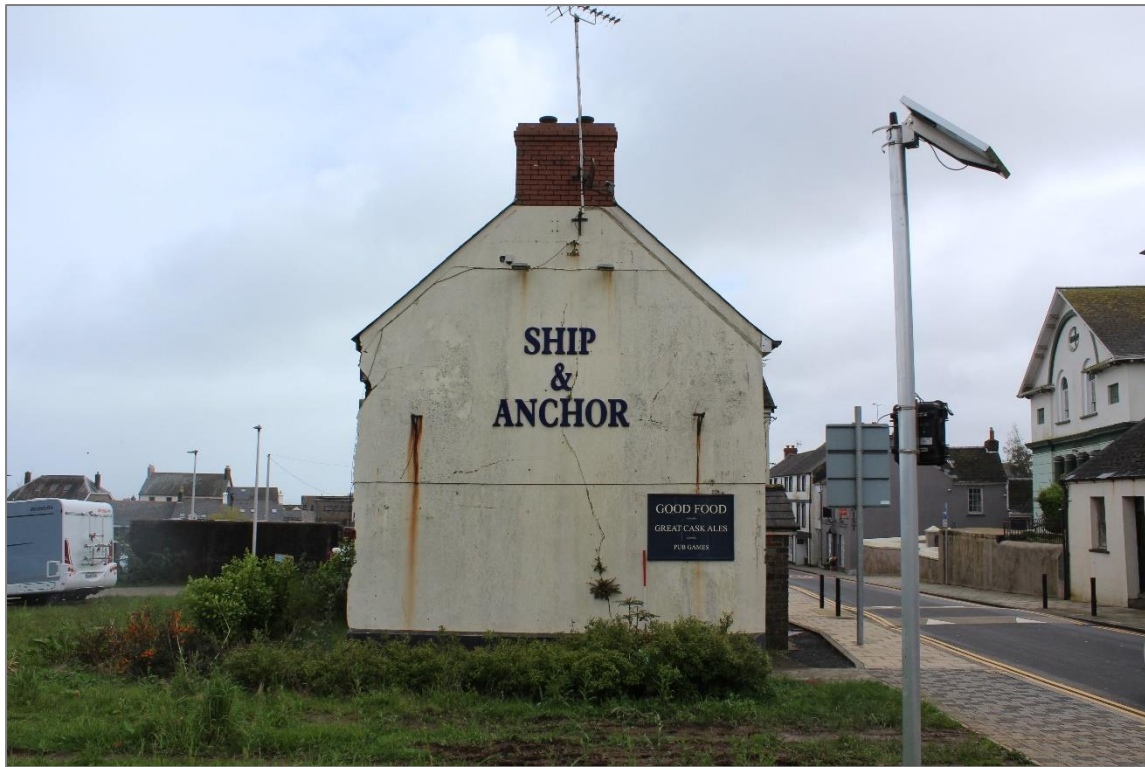
Photo 4: View east, showing gable end of western block. 1m scale. Note brick chimney.

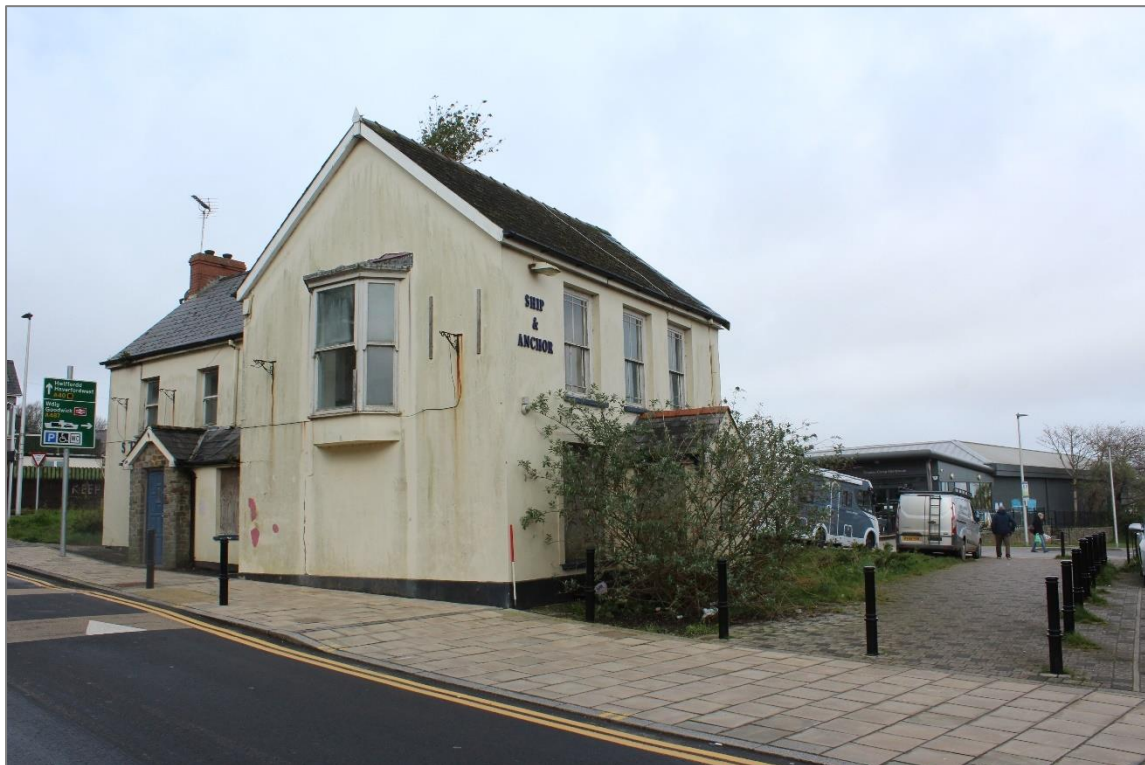
Photo 5: View northwest, showing southern façade to the left and eastern façade to the right. 1m scale. Note bay window added to the gable end of the eastern block.

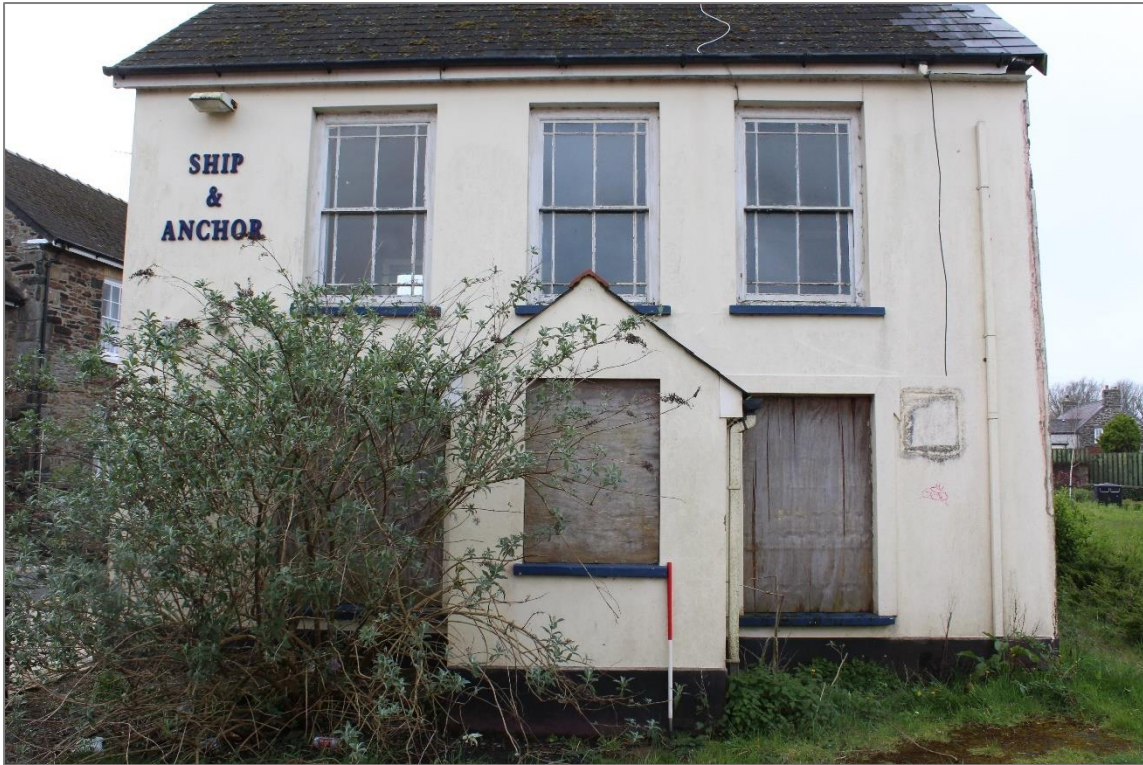
Photo 6: View west, showing eastern facade of eastern block. 1m scale. Note symmetrical design

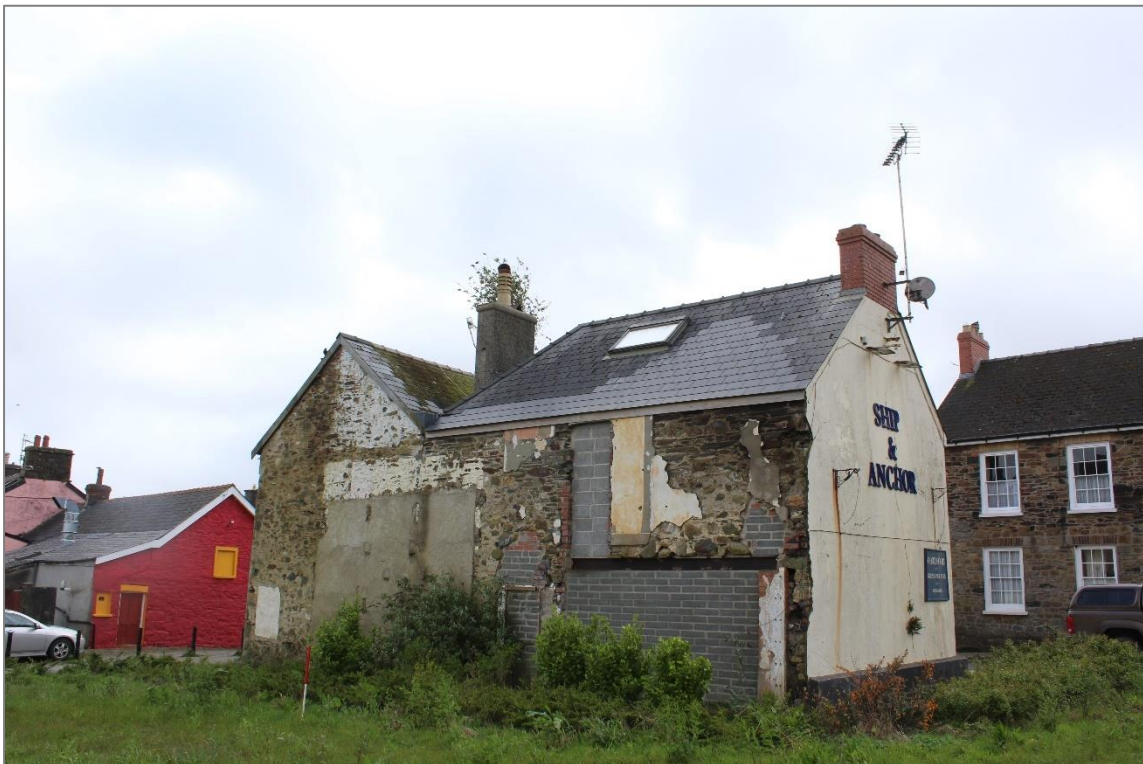
- 4.1.5 The northern face of the building shows the extent of the modifications to the building as a part of the chimneys Link bypass (photo 7). The western block showing the entrances at both ground and 1st floor level to its Victorian wing and function room, subsequently infilled with concrete breezeblock, and the eastern block showing the scar of the now demolished public library covered in a plain concrete render. The remainder of the north face is unrendered, revealing the masonry construction of mortared random rubble.

Photo 7: View southeast of the north face of the building. Note extent of modification to the northern edge of the building after demolition of former public library and Victorian wing/function hall. 1m scale.

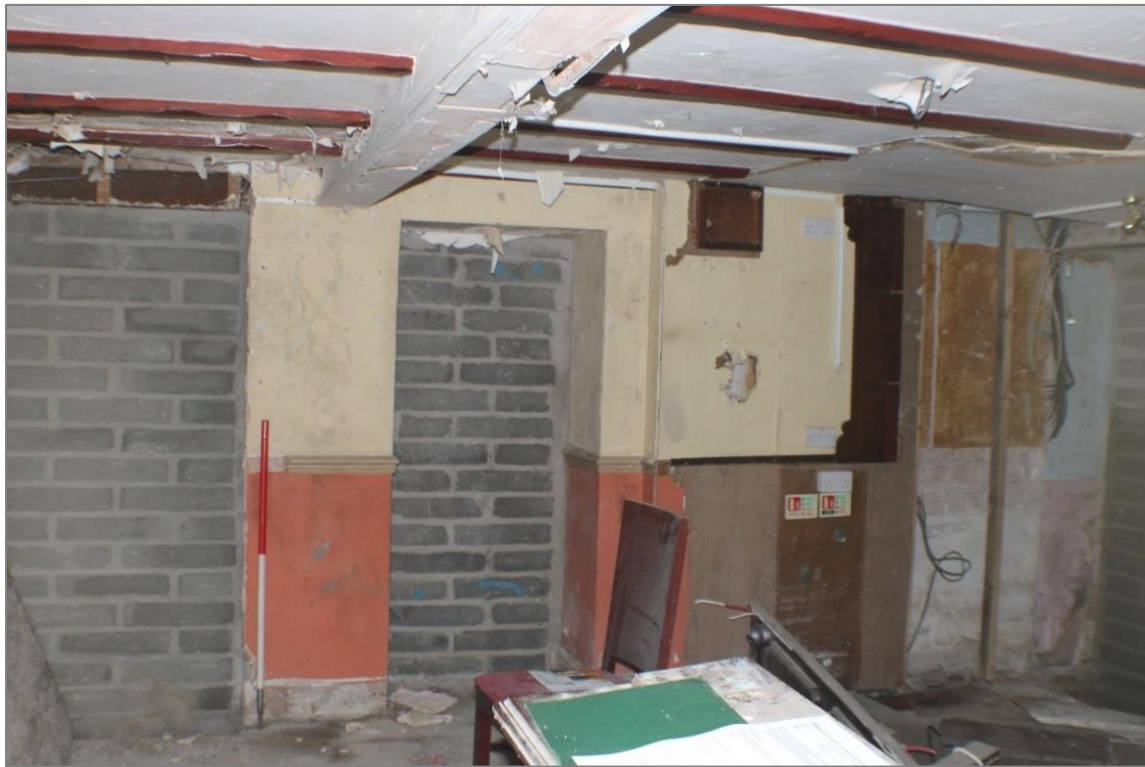
Photo 8: Showing view from southern entrance porch (G01) into room G02. Note entrances into now demolished Victorian extension and function room to the north. Looking northwest, 1m scale.

- 4.2.8 Along its northern wall were two openings, now blocked up, which originally adjoined the Victorian extension and modern function room to the north (photo 8). A further breeze block wall reduced the size of the opening between this room (G02) and room G03, implying that these rooms would have been mostly connected when in use (photo 9).

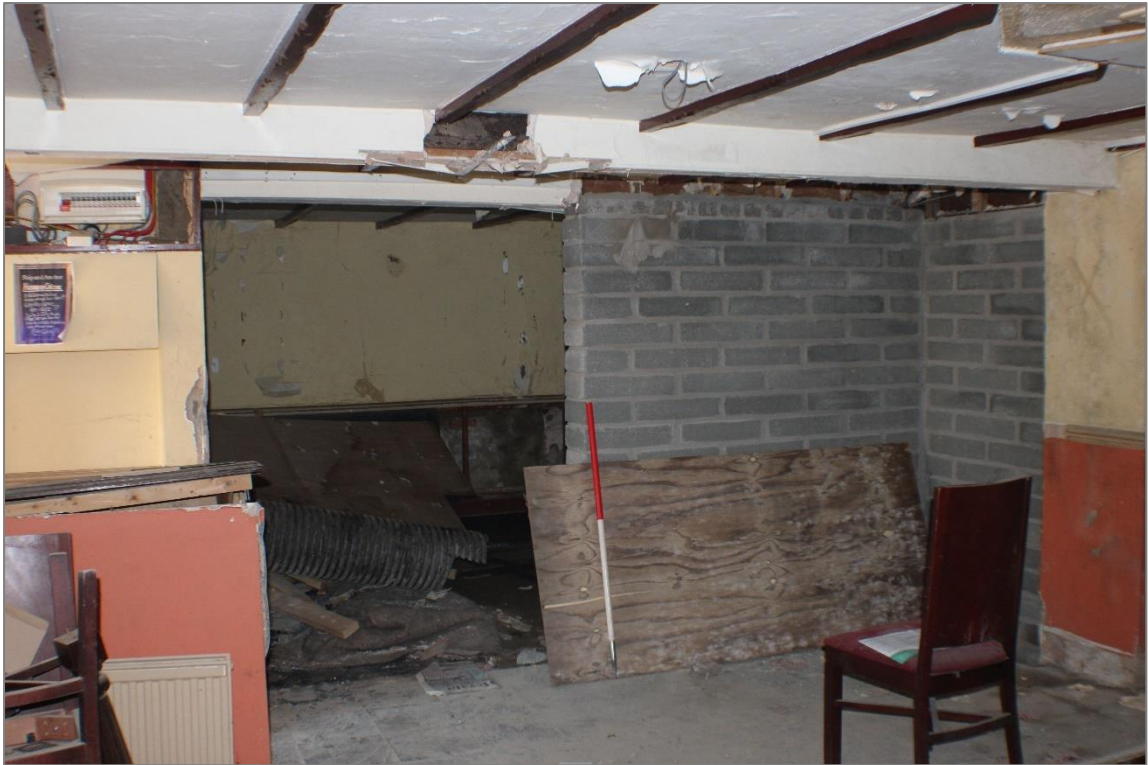
Photo 9: Looking west from room G02 to room G03 beyond. 1m scale.

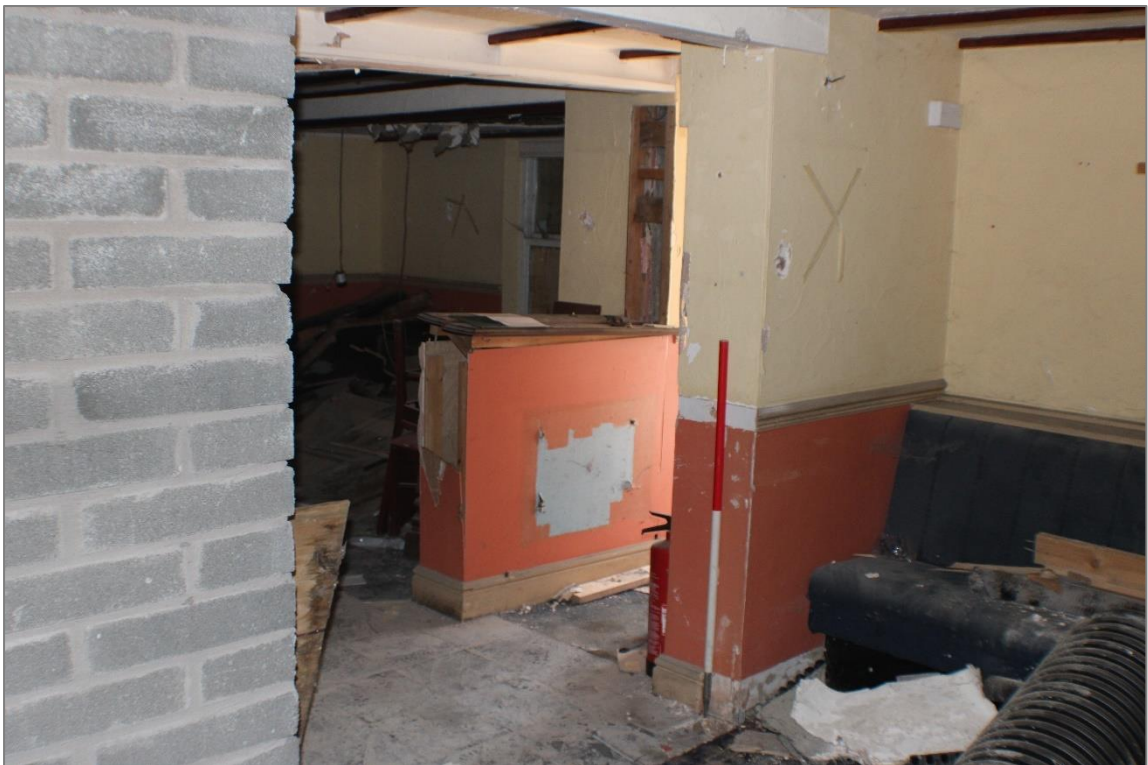
Photo 10: View back towards room G02 from room G03. Looking southeast, 1m scale.

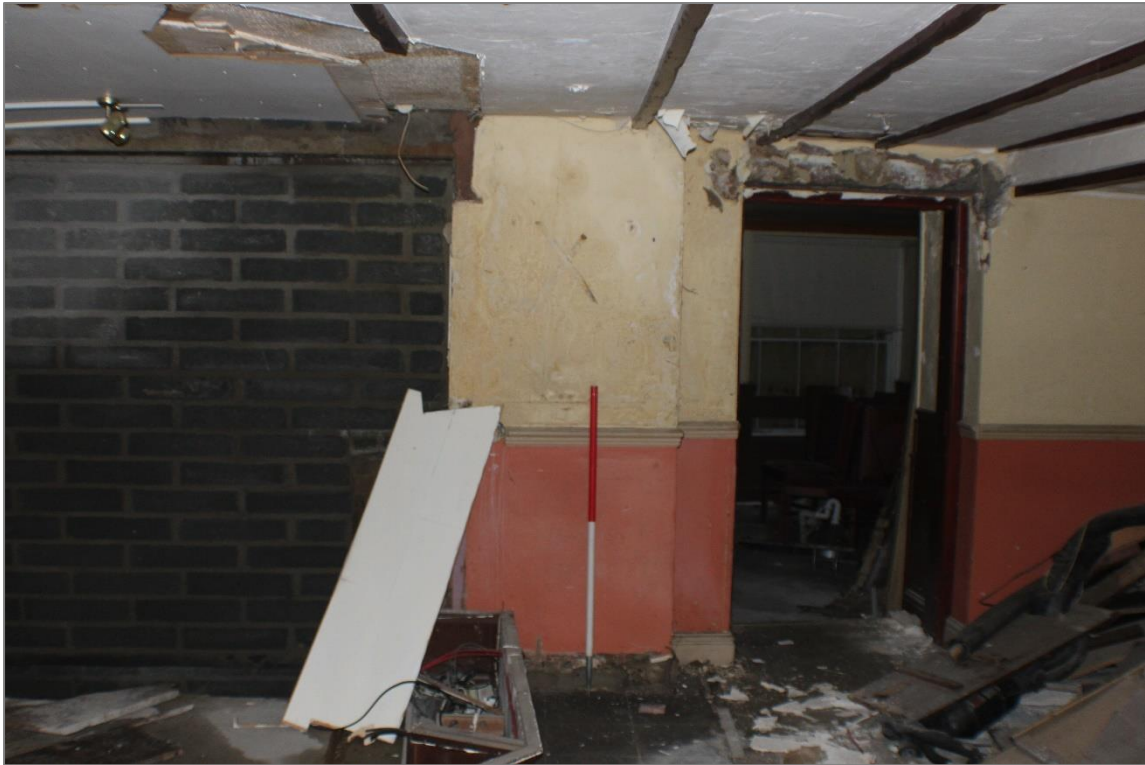
Photo 11: Looking from room G02 east towards room G04. Note the now blocked bar area to left and narrow doorway to right. 1m scale.

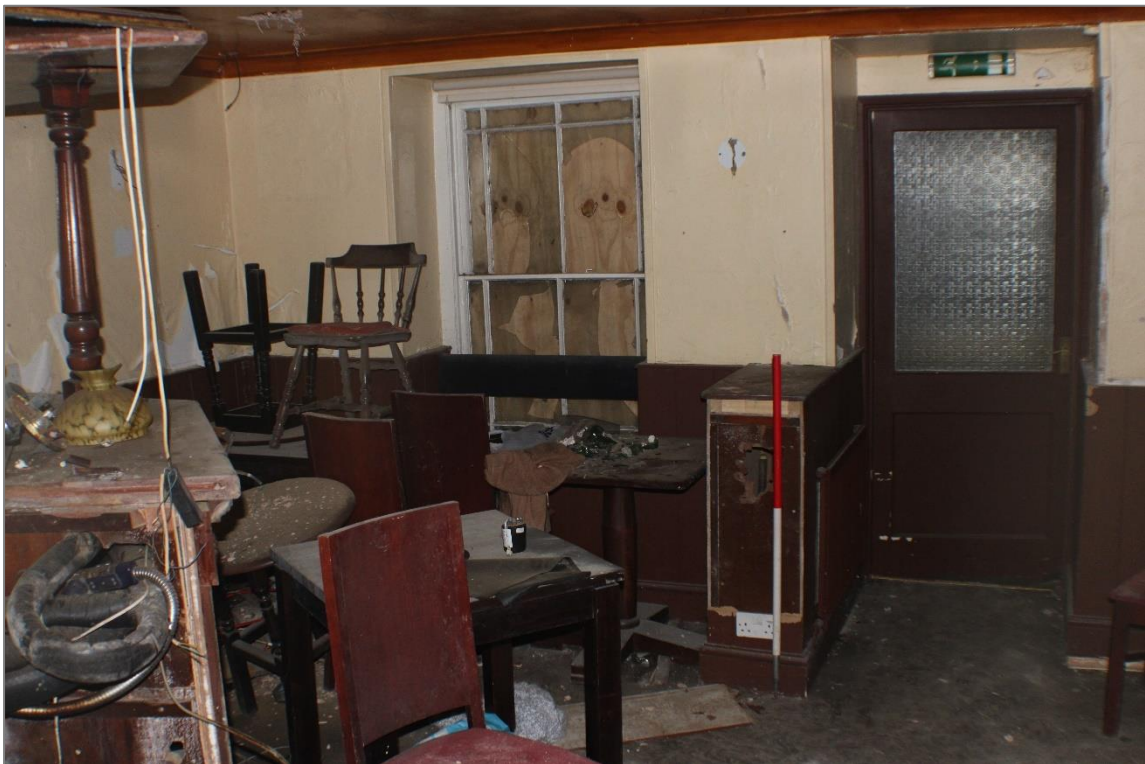
Photo 12: Showing room G04. Looking east, 1m scale. Note doorway towards porch G05.

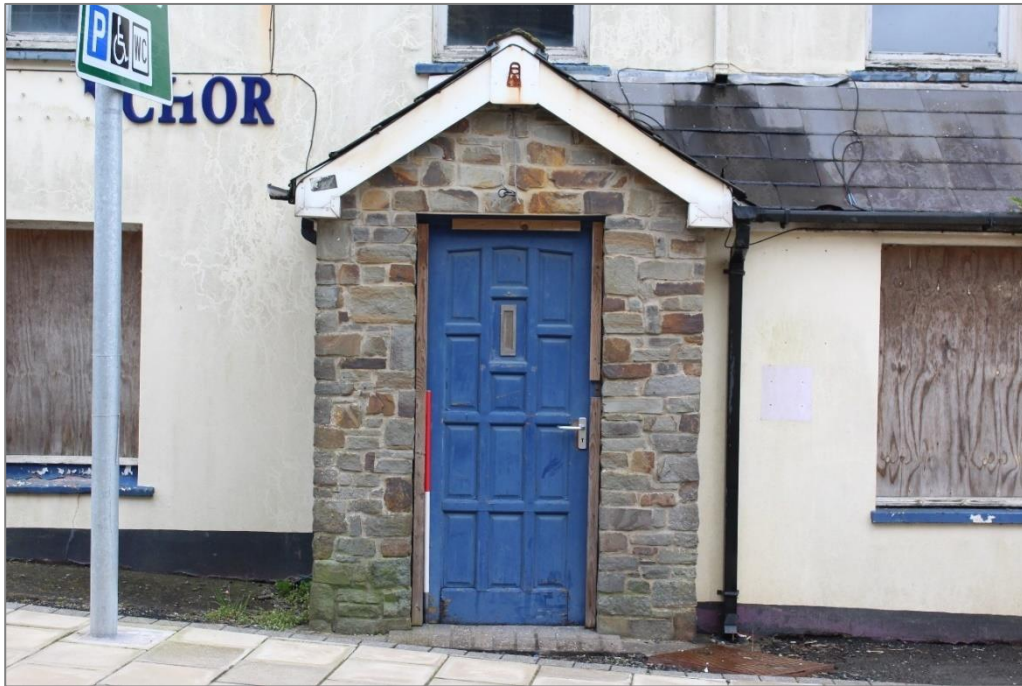
- 4.2.4 A small modern single storied stone clad modern porch with pitched roof. adjoined by a modern extension to the east. Internally it was plastered with modern plaster and a carpeted floor. No significant architectural features present. It was not possible to photograph the internal area of the porch after access was gained.

Photo 13: Photo of porch G01 from the exterior. 1m scale.

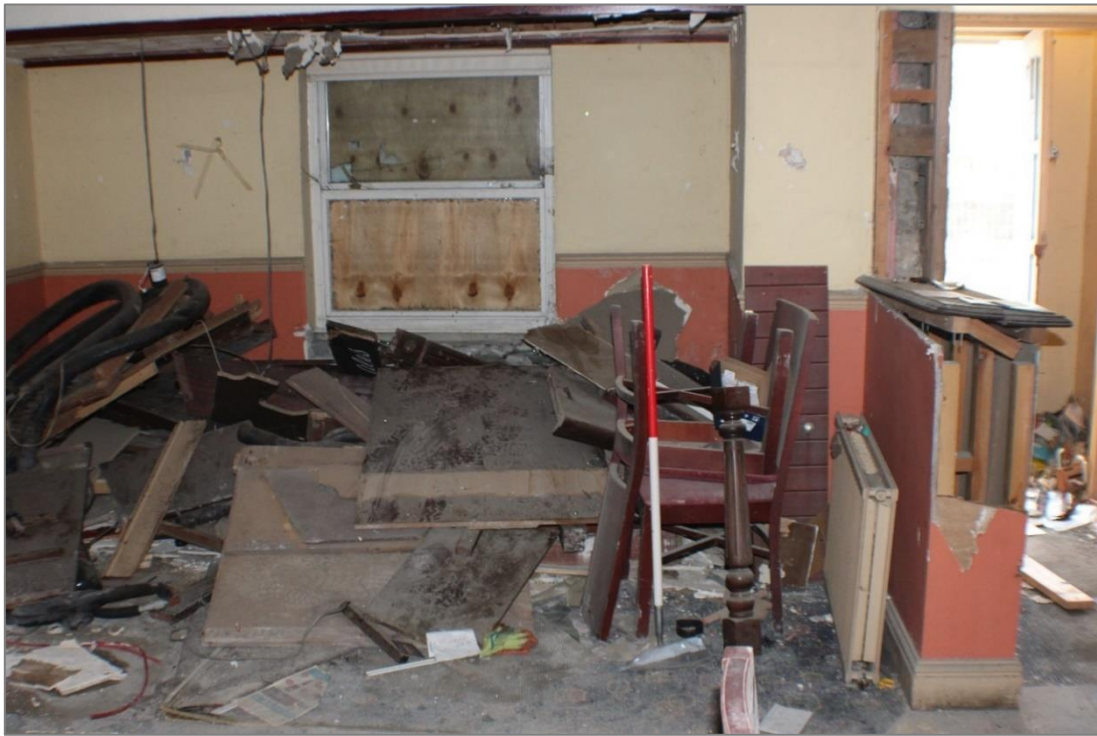
Photo 14: Looking south in room G02, Note entrance through porch G01 and awning window in modern lean-to extension. 1m scale.

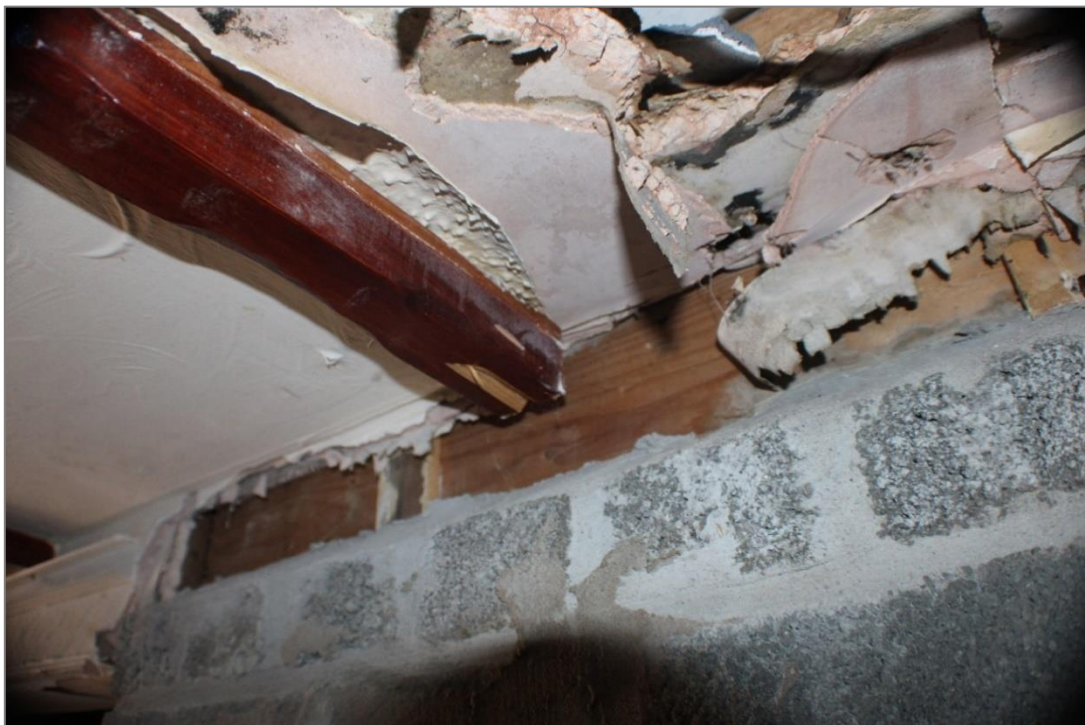
- 4.2.9 Though partially stripped out some of the modern interior features were still present. The ceiling had false beams with plaster board and papered partitions (photo 15). The walls were plastered and subsequently papered then painted and included a dado rail and modern varnished skirting boards.

Photo 15: Detailing false beams portioned with plastered and papered partitions.
G03 (Figure 11, Photo 16)

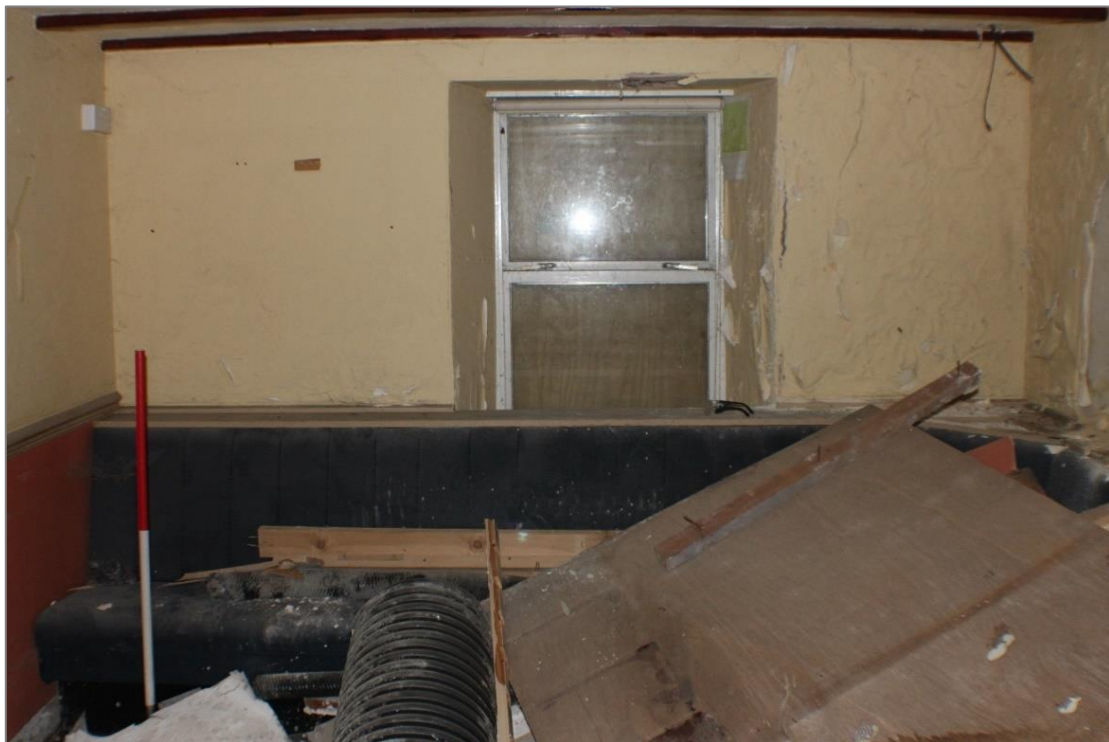
- 4.2.10 This room occupies the western end of the western block of the building. It was smaller than room G02, and as mentioned above was likely mostly interconnected when in use.
- 4.2.11 The south wall of this room contained a modern awning window, now boarded up set within a slightly splayed, plain, opening. The north wall of the room, like room G02, was the former location of one of the entrances into the Victorian wing to the north.
- 4.2.12 The interior has painted plastered walls and a false beamed ceiling with plasterboard and papered partitions. Along the southern and western wall was built-in upholstered seating from its use as a bar.
- 4.2.13 On the exterior of the building a chimney is visible on the western gabled end of this room. However internally a fireplace was not visible.

Photo 16: Looking south towards the window in southern wall of room G03. 1m scale. Note built in seating.

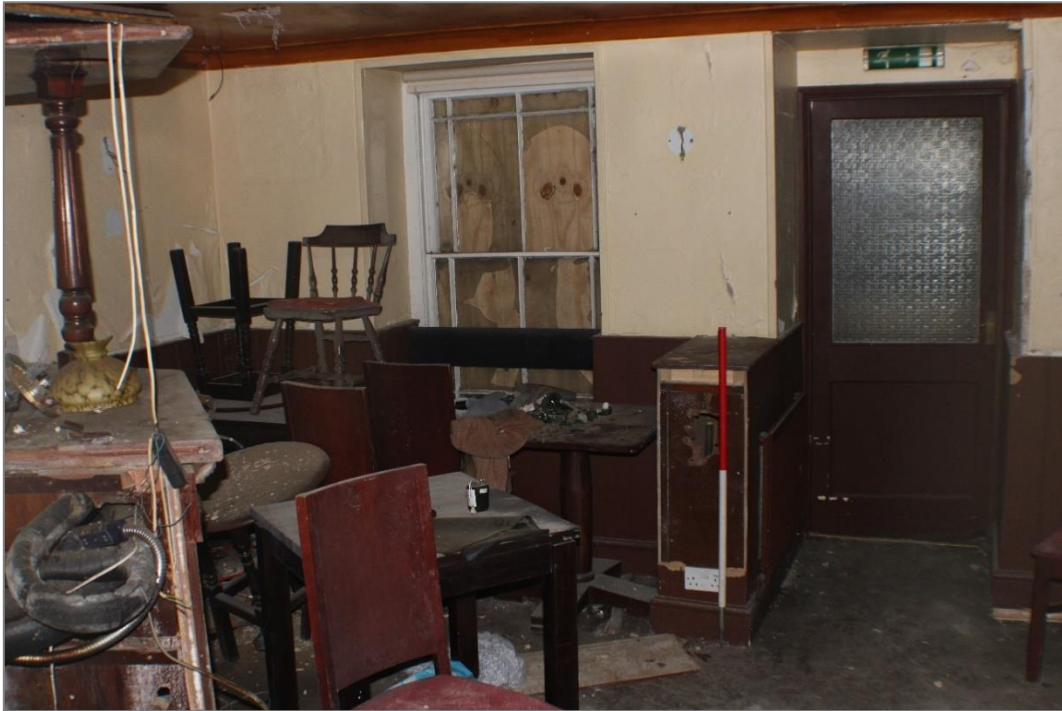
Photo 17: Looking east from entrance to room G03. Note entrance to modern porch (right) and sash window (left). 1m scale.

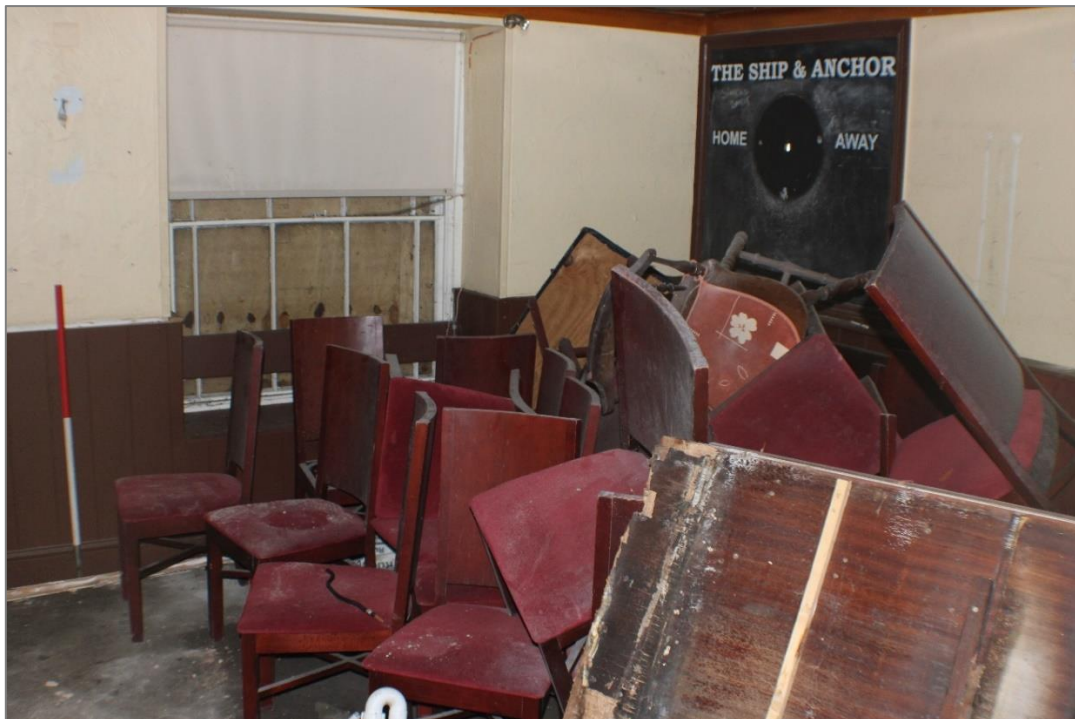
Photo 18: Looking southeast in room G04. Note darts board on southern wall. 1m scale.

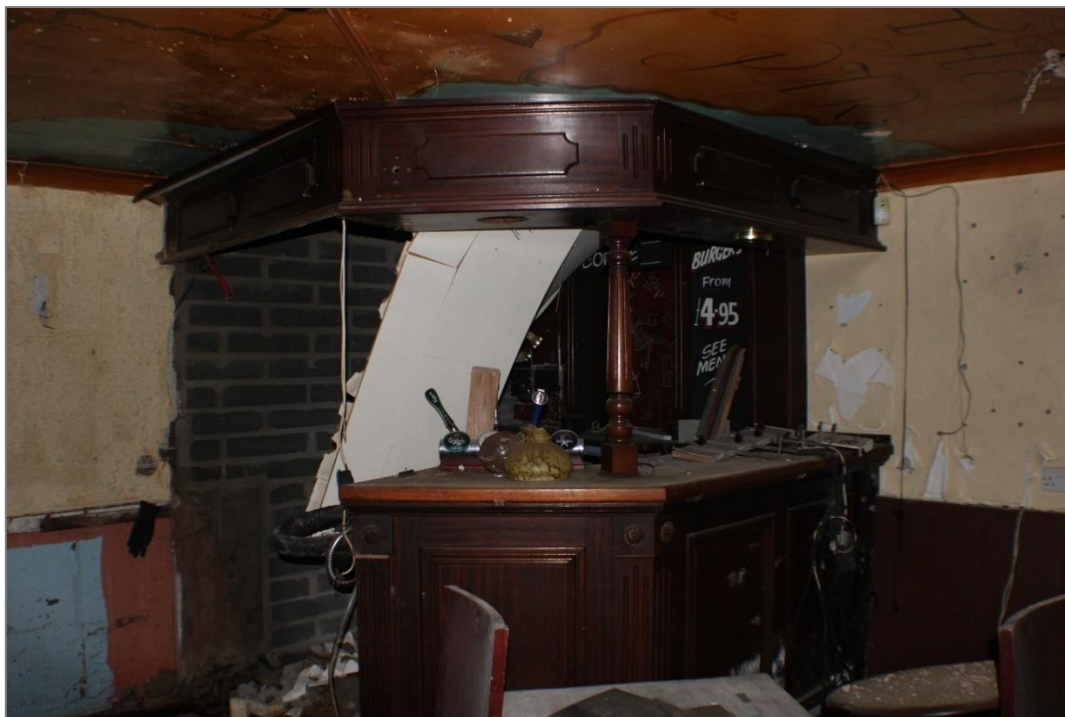
Photo 19: Showing bar once adjoining the bar in room G02 in northwestern corner of room G04.

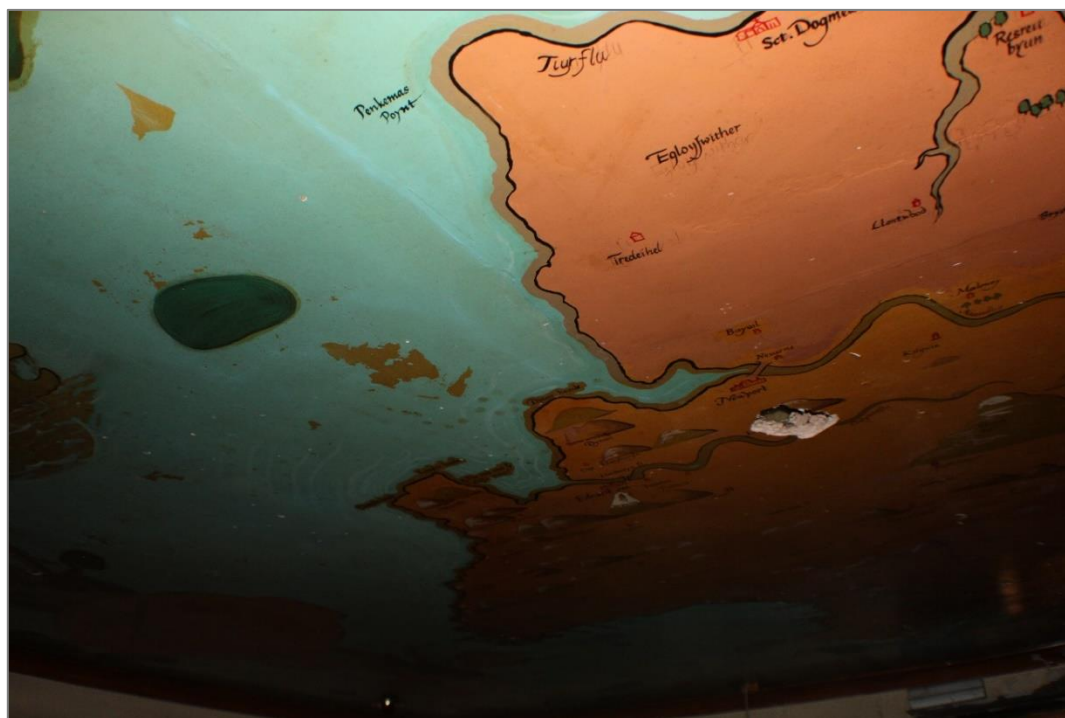
ornately painted with a map showing the early place names of Pembrokeshire (photo 20).

Photo 20: Showing ceiling plastered and painted as map of Pembrokeshire with ancient placenames.

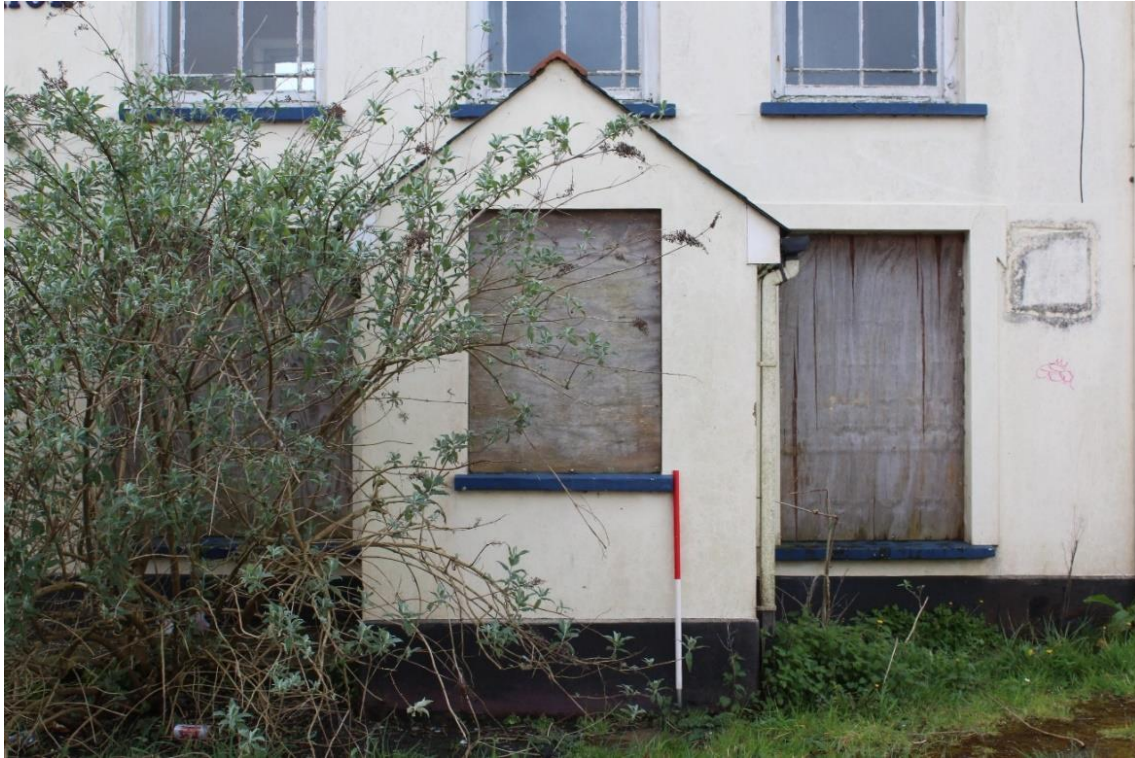
4.2.17 Room G05 was a small modern porch with a pitched roof on the eastern façade of the eastern block of the building (photo 21). It was not accessible from either the interior or exterior. Described from the outside it is a small roughly square porch with an entrance to the south, with a modern wooden door and a small window in its eastern wall.

Photo 21: Showing small modern porch G05 on eastern façade of the building. 1m scale.

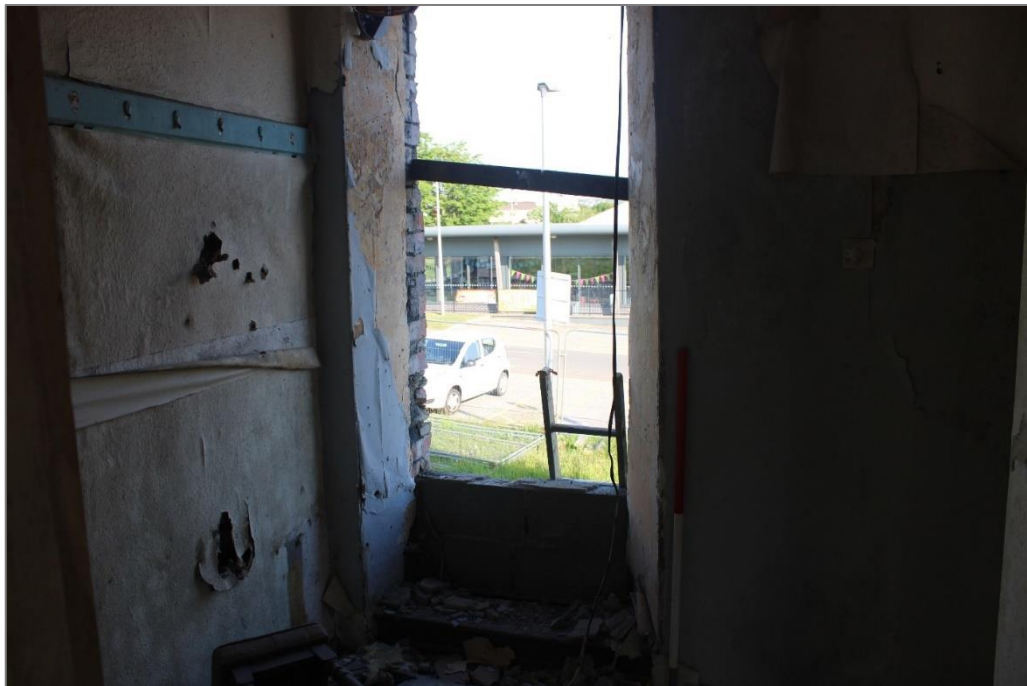
Photo 22: Showing access into the upstairs of the former Ship and Anchor public house via ladder. Looking north, 1m scale.

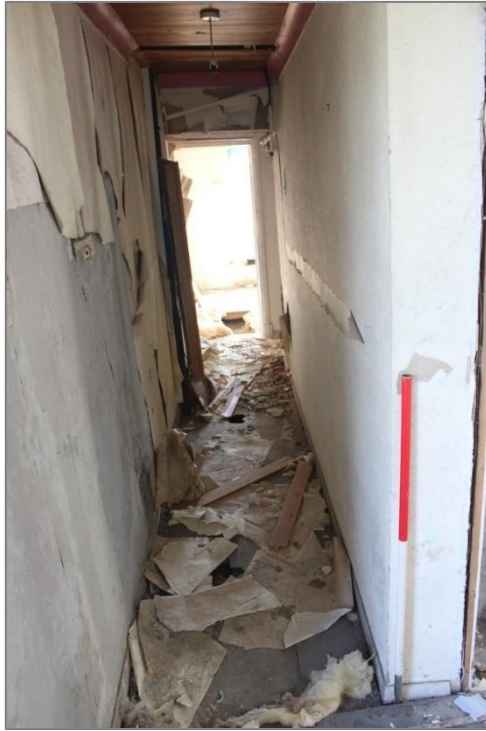
- 4.3.4 This room is a connecting corridor between the four residential rooms on the 1st floor of the building. The corridor forms a backwards L-shape approximately 1.4m wide broadly mirroring the shape of the building.
- 4.3.5 Corridor 101 and the wider layout of the 1st floor is a relatively modern partition with any non-structural walls constructed of timber formed plasterboard. The corridor narrows slightly where it passes between the two blocks of the building.
- 4.3.6 At the western end of the corridor are two doors leading to rooms 102 and 103, placed at 45 degrees to one another where the corridor broadens slightly to form a small hall. Walking east through the corridor are a further two doors, facing east and north leading to rooms 104 and 105 respectively.

Photo 23: Looking east along corridor 101. 1m scale.

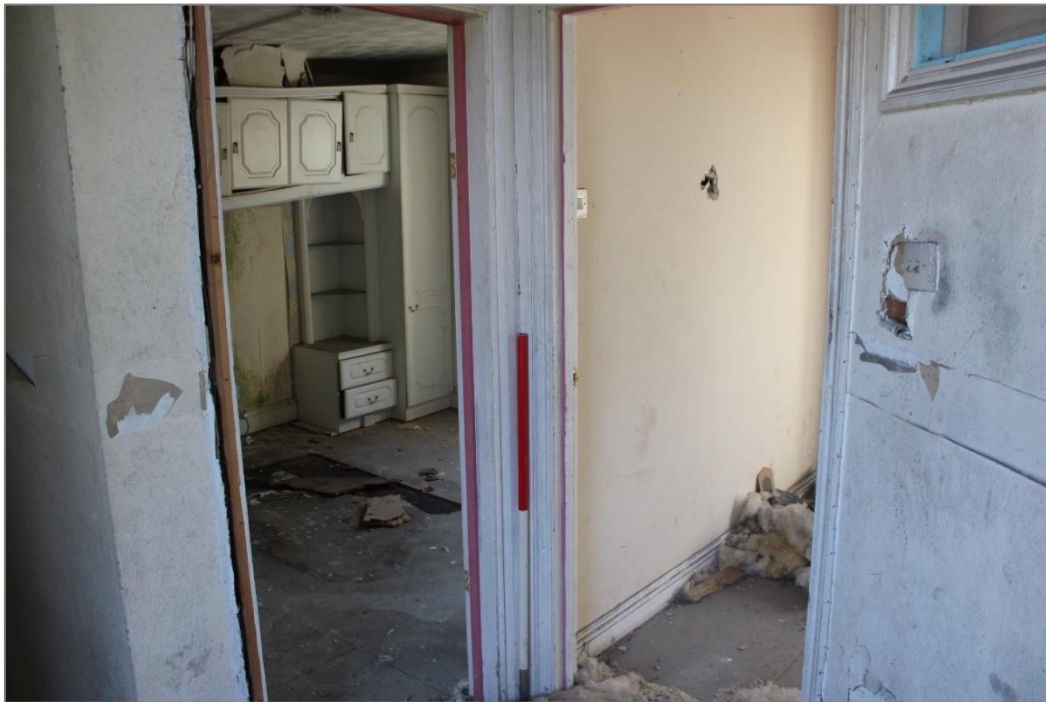
Photo 24: Looking south into rooms 102 and 103 from western end of corridor 101. 1m scale.

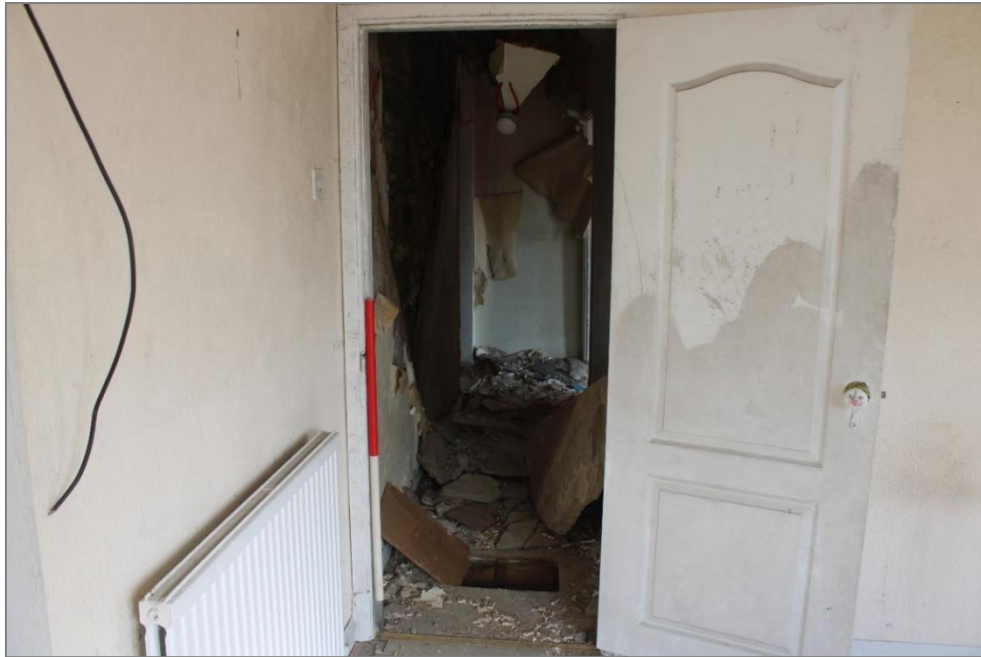
Photo 25: View north across along eastern end of corridor 101 1m scale.

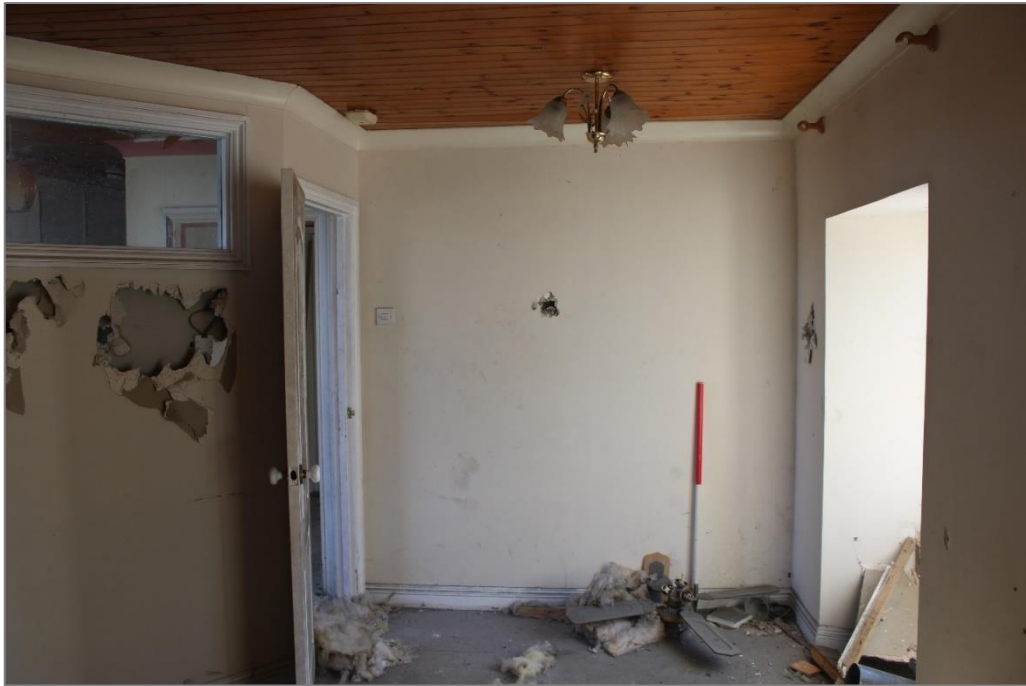
- 4.3.10 Its southern wall is the longest wall in the room and contains two awning windows approximately 0.40m from the ground which have been replaced in modern times (photo 27). The eastern windows sill had been dropped to ground level. The western wall includes a chimney/fireplace towards its southern edge which had at some stage been fitted with a back boiler, though it appears to have been boarded up and mostly removed until the most recent phase of demolition (photo 28). The chimney which serves this fireplace can be seen on the western gable of the building and appears to be in relatively good condition. The only other architectural feature was a small windowlight intended to feed light to corridor 101 located to the northwest of the door (photo 26).

Photo 26: Looking east towards door in room 102. 1m scale. Note windowlight above door through to corridor 101.

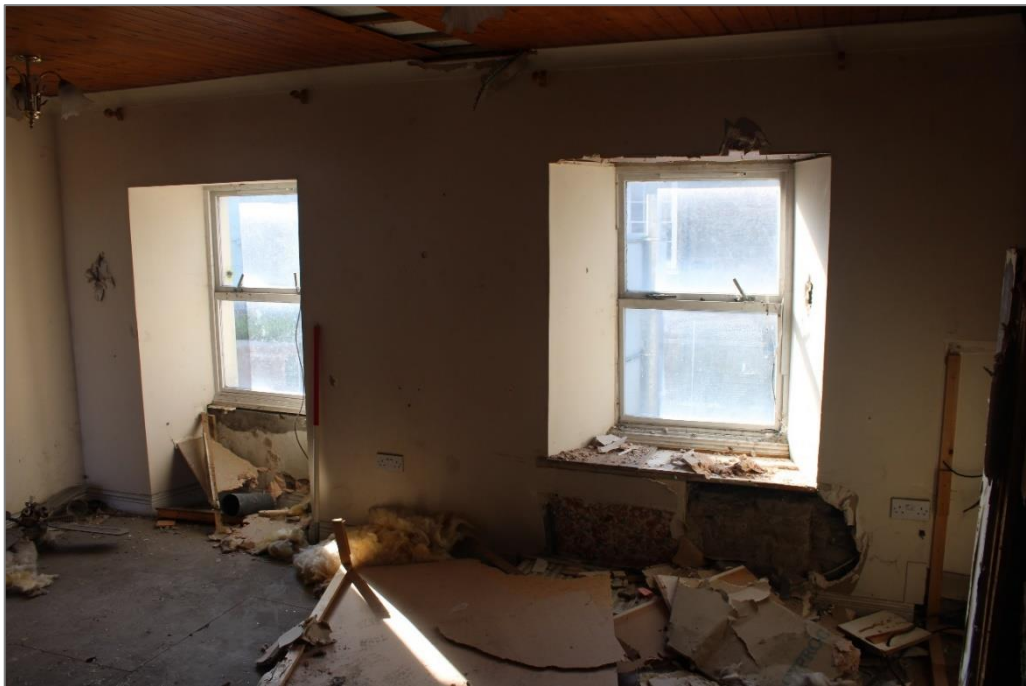
Photo 27: Looking south in room 102. 1m scale.
