**FORMER SHIP & ANCHOR PUBLIC HOUSE,
FISHGUARD, PEMBROKESHIRE
HISTORIC BUILDING RECORDING
(NGR SM 9567 3693)**

REPORT NO. 2024-31
EVENT RECORD No. 130823

June 2024

**FORMER SHIP & ANCHOR PUBLIC HOUSE,
FISHGUARD, PEMBROKESHIRE:
(NGR SM 9567 3693)
HISTORIC BUILDING RECORDING**

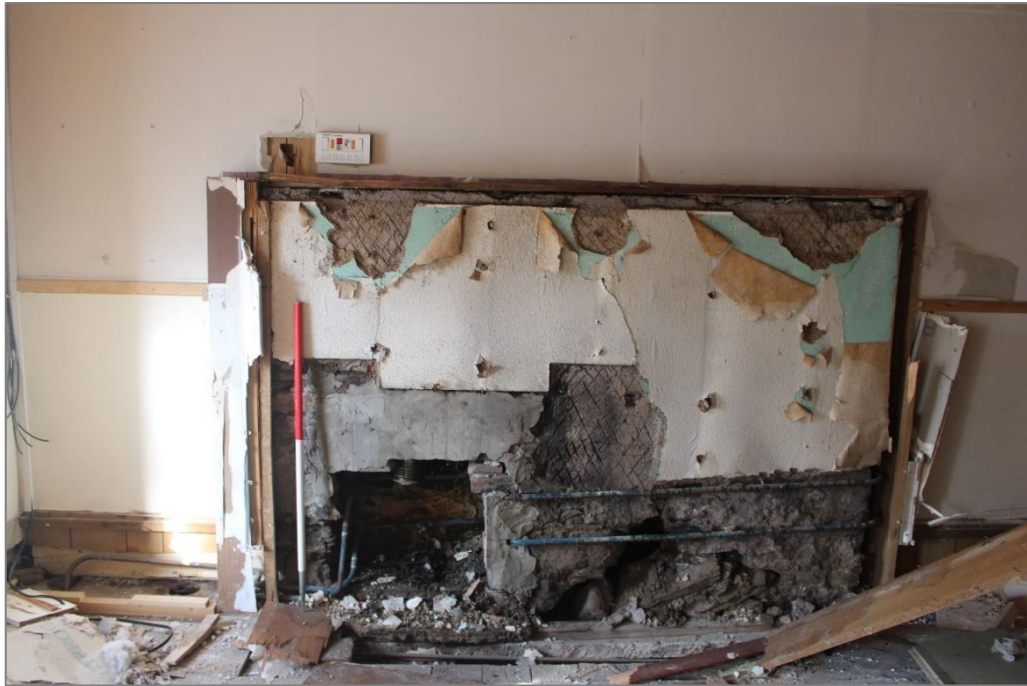
Photo 28: Looking at former fireplace with remains of back boiler on western wall of room 102. Looking west, 1m scale.

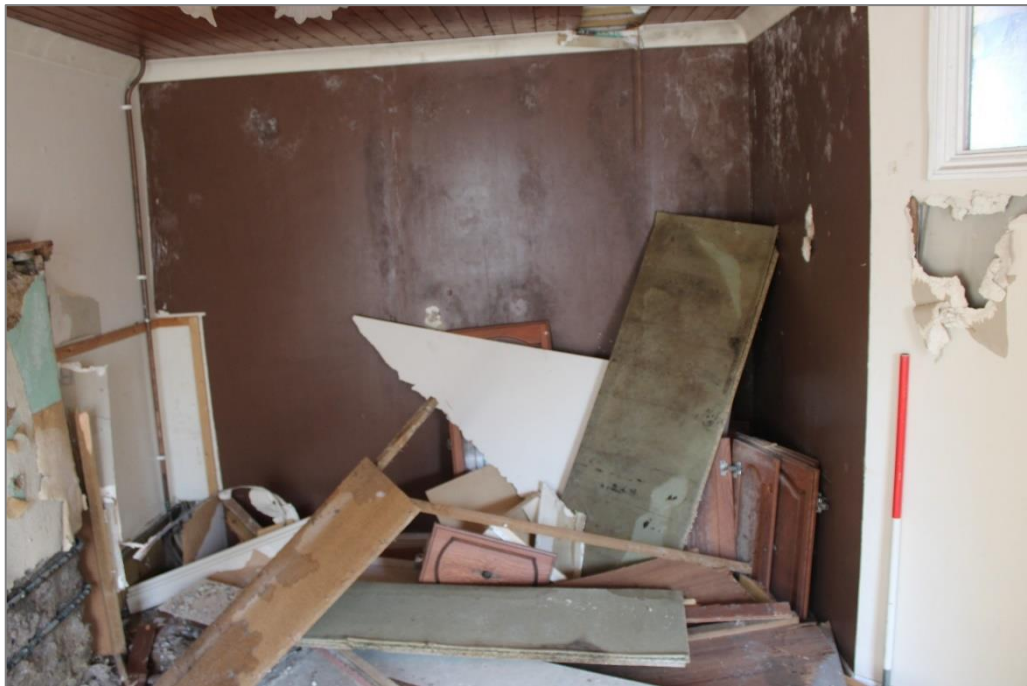
Photo 29: Northern part of room 102. Looking north, 1m scale.

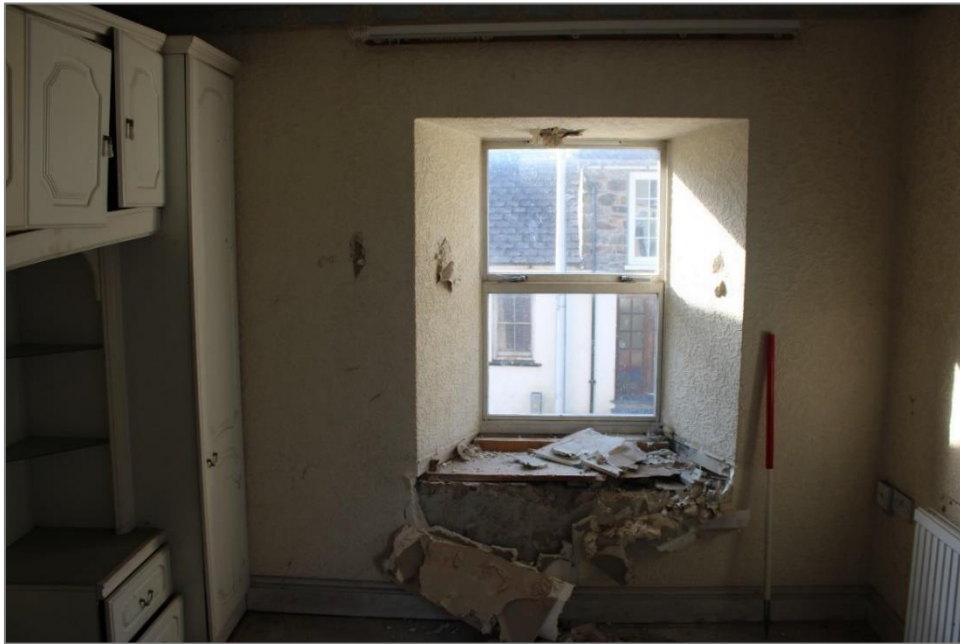
- 4.3.12 This room occupied the eastern part of the western block the building. It was somewhat smaller than room 102 and had clearly most recently been used as a bedroom.
- 4.3.13 The room is entered via a doorway in the northwest corner offset obliquely to the room. The southern wall of the room was taken up mostly by a window identical to that found in room 102, again making up part of the southern façade (photo 30). Its eastern wall is taken up by a wardrobe and bed surround of typical 1980s design (photo 31).
- 4.3.14 The room was formerly carpeted; this had now been removed showing the chipboard floor. It had patterned papered walls and ceilings finished with a modern skirting and cornicing. A brass wall light hung from the northern wall.

Photo 30: Showing southern wall of room 103. Looking south, 1m scale.

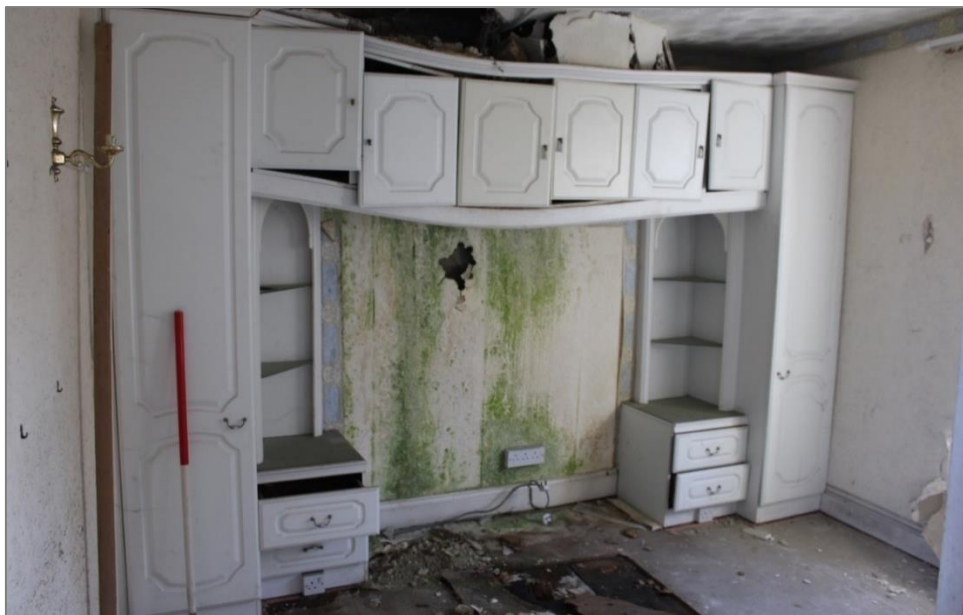
Photo 31: Eastern wall of room 103. Looking east, 1m scale.

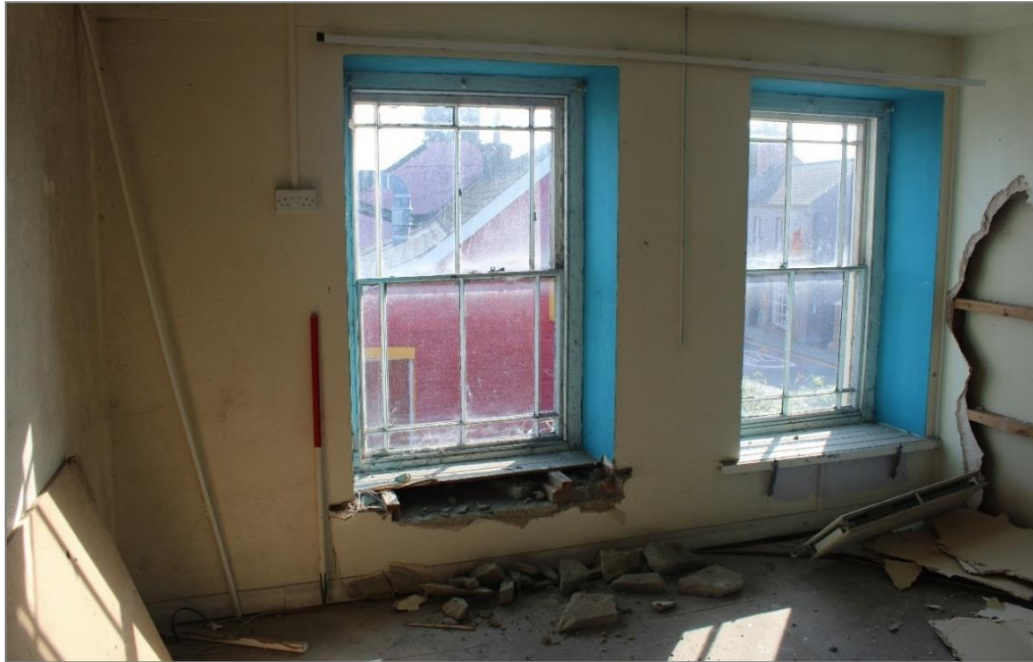
- 4.3.15 This room occupied the northern part of the eastern block the building. It was entered from the northwest via a doorway leading corridor 101. The partitioning between this room and corridor 101 and room 105 is entirely of wood and plasterboard implying that that it may be a very modern layout.
- 4.3.16 This room had two sash windows somewhat elaborate in design skewed slightly to the south along its eastern wall which form part of the eastern façade (photo 32). This room was otherwise entirely devoid of other architectural details with a chipboard floor, no coving and simply painted plaster walls.

Photo 32: Looking east towards sash windows in room 104. 1m scale.

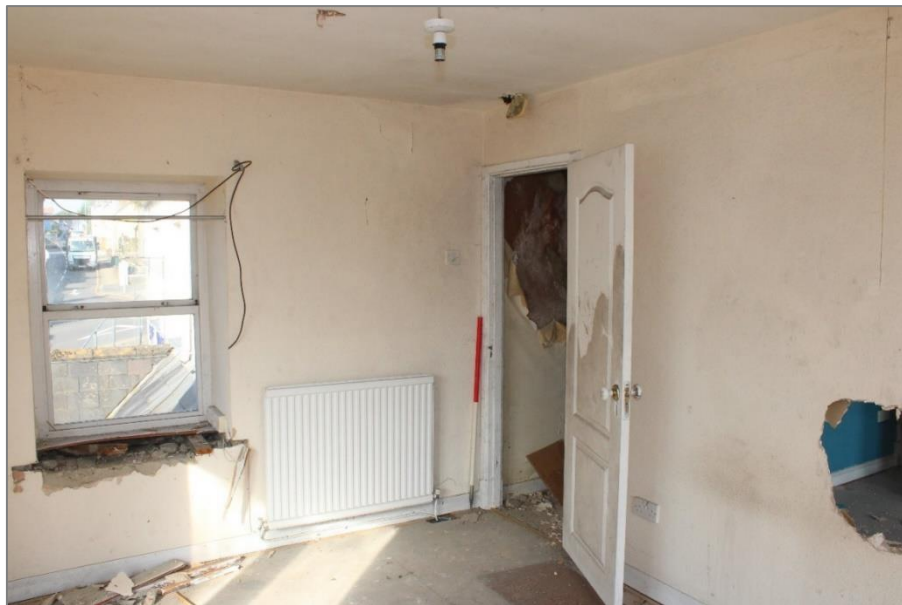
- 4.3.17 This room occupied the southern part of the eastern block the building and was the most intact of the rooms on the 1st floor. It is entered from the northwest from corridor 101 and bounded by a plaster board partition wall shared with room 104 (photo 34).
- 4.3.18 The room itself is rectangular and has a window on all three external sides. Its eastern wall has a somewhat ornate sash window matching those in room 104 which form part of the eastern façade of the building (photo 35). Its western wall contained a small awning window that had been renewed in modern times (photo 36). Its southern wall contained a large bay with sash windows, though seemingly renewed in modern times (photo 37).
- 4.3.19 The room has a chipboard floor, had wallpaper which was later painted and modern doors, reveals, skirting boards and cornicing.

Photo 34: Looking towards doorway in northwest corner of room 105. 1m scale.

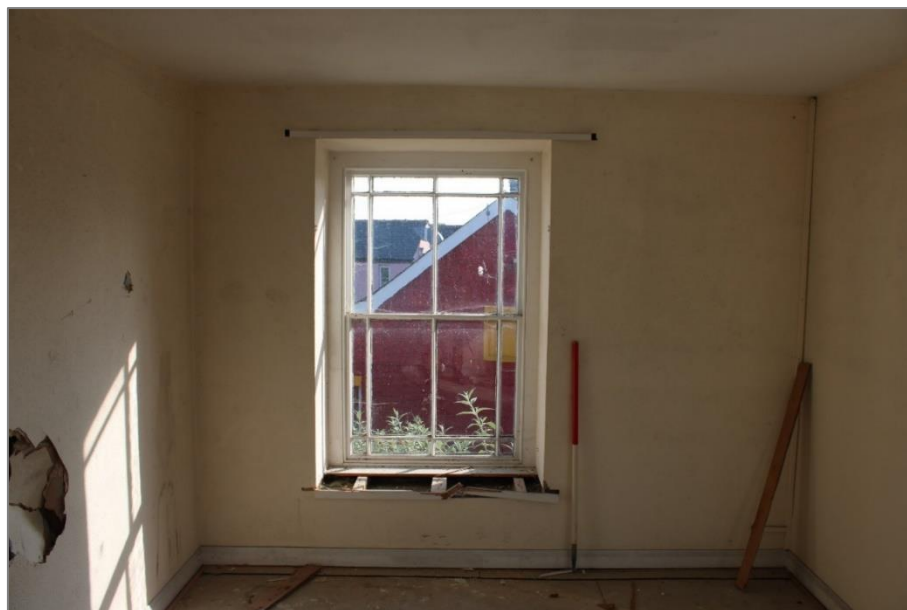
Photo 35: Looking east towards sash window in room 105. 1m scale.

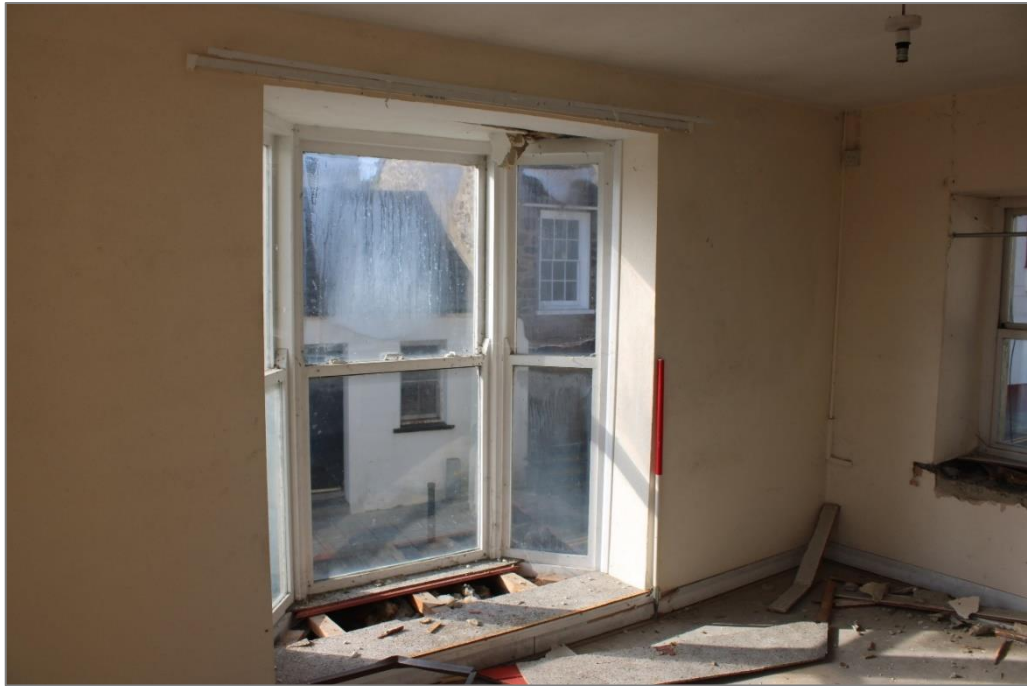
Photo 36: Looking southwest towards bay window in room 105. 1m scale.

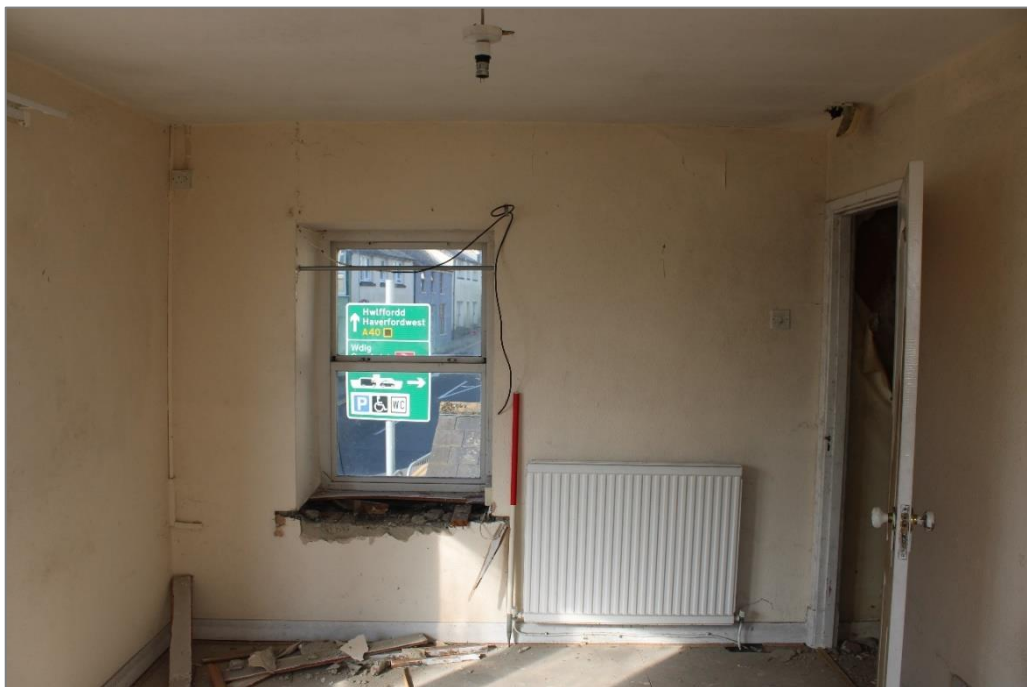
Photo 37: Looking west towards small window in western wall of room 105. 1m scale.
