# **LLYN BRIANNE**

## **UPLANDS SURVEY**

ARCHAEOLOGICAL SURVEY  
Project Record No. 29800  
MARCH 1995

**Report by: P. Crane. B.A.Hons.**  
*of*  
**Dyfed Archaeological Trust Ltd**  
**The Shire Hall**  
**8 Carmarthen Street**  
**Llandeilo**  
**Dyfed SA19 6AF**

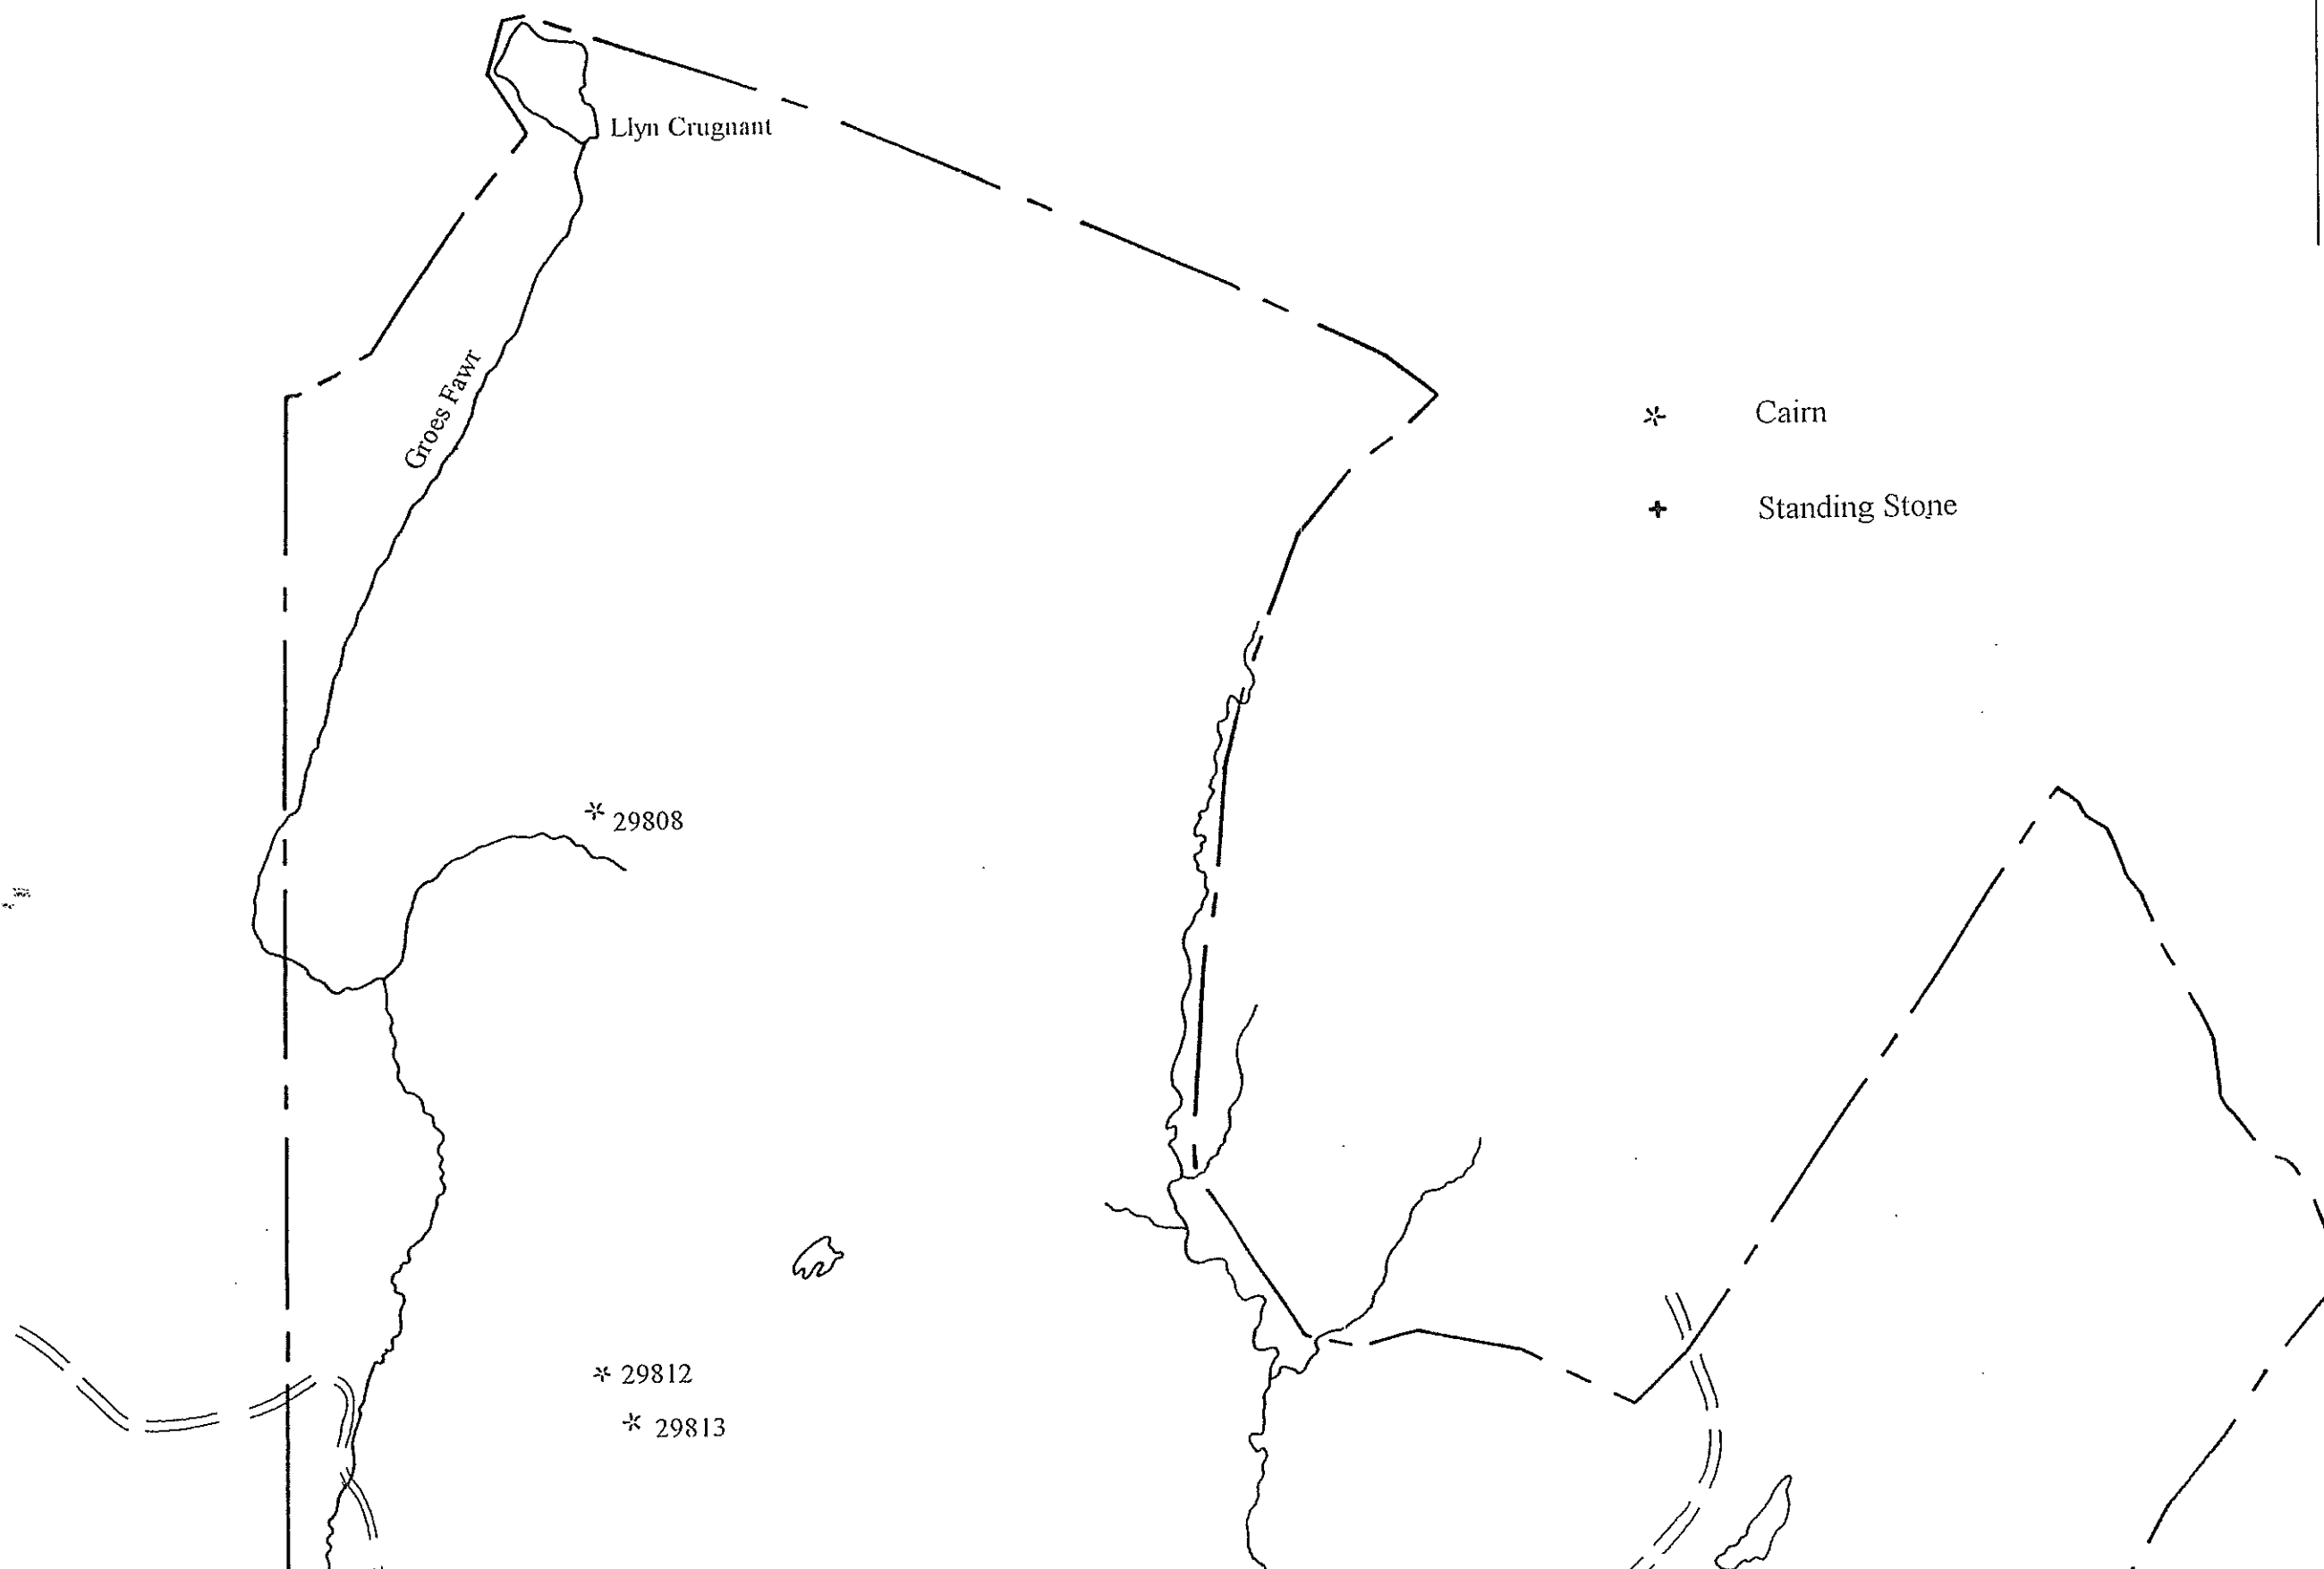
Figure 3

6.9.2 There were five previously recorded Prehistoric sites within this survey area (all Prehistoric Sites on figure 3): a Standing Stone PRN5553, and four Round Barrows/Cairns (figure 30): PRN5551 (figure 12), PRN5552 (figure 27), PRN8524 (figure 28) and PRN9018. No site was found at the location previously recorded for PRN9018, but a site was found 165m away, PRN29829 (figure 22). This is almost certainly a re-recording of this site.

6.9.3 The additional prehistoric sites recorded in this survey total six (all Prehistoric Sites on figure 3). These consisted of a possible fallen Standing Stone PRN29819 (figure 21), and five Round Barrow/Cairns (figure 30), including the re-recording PRN9108/29829: PRN29808 (figure 13), PRN29812 (no sketch plan), PRN29813 (figure 16), PRN29830 (figure 23).

## PREHISTORIC SITES

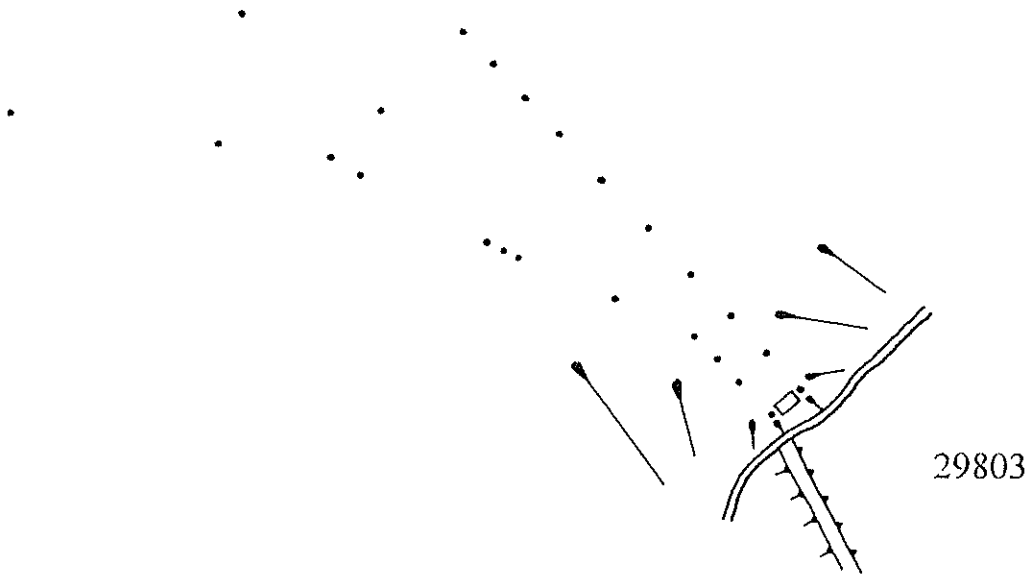
Figure 7

6.9.7 Recorded with these additional Medieval/Post Medieval sites, but of probable late or later date are four sites; one, a Pit/Quarry PRN29842 is modern (i.e. post-1900). Three sites are probable Post Medieval or modern, a Sheep Pen/dip and Probable Dam PRN29803 (figure 7), an "L"-shaped boundary PRN29828, and a Quarry PRN29833 (figure 24). The Farmstead Nant-y-Maen, PRN29848 is still in use, but must date back to at least the Post Medieval period, as indicated on the Tithe map (figure 5).

Photo: 3  
Site: PRN29803  
Description: Sheep pen and Dip  
Media: CS/Mono  
Direction: E  
Scales: 2m

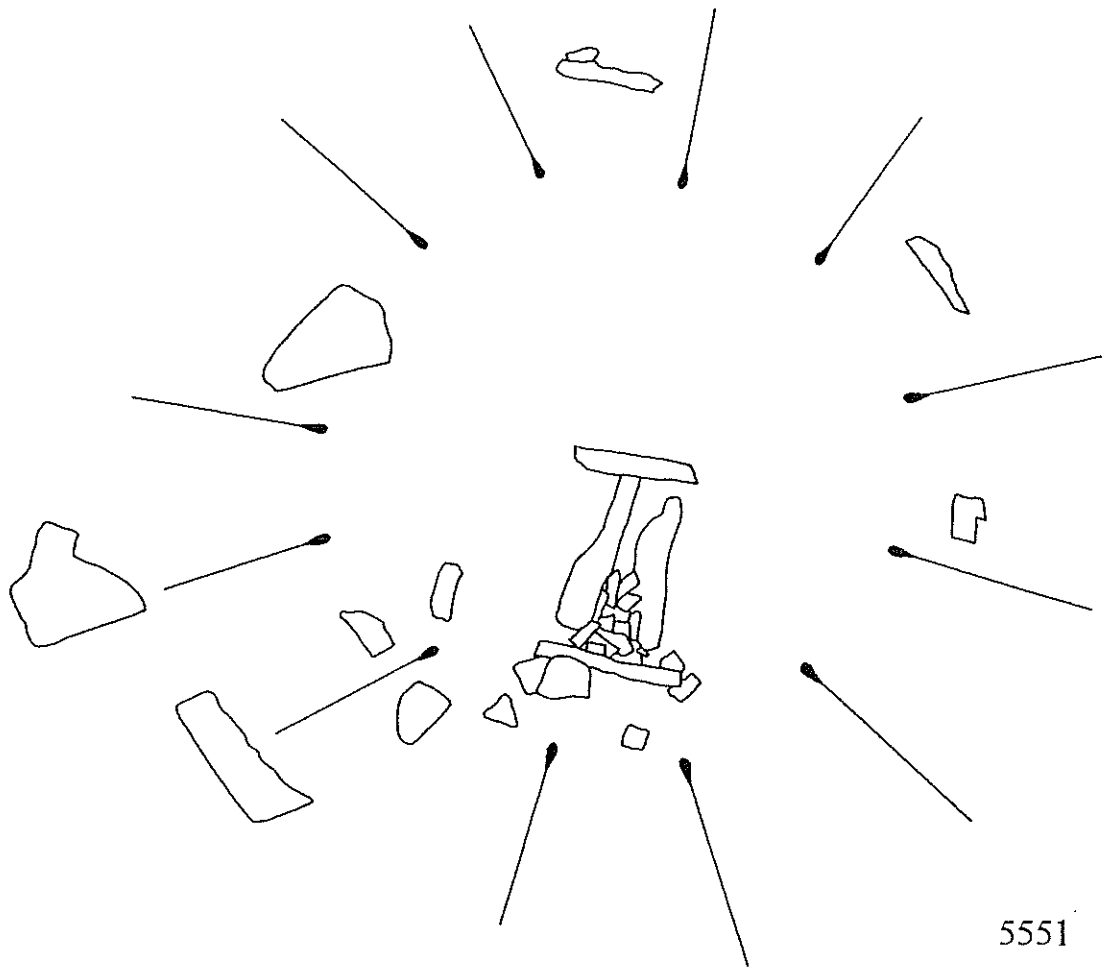
Figure 12

Site No: 5551  
NGR: SN75165891  
Site Name: Blaen Camddwr  
Generic Type: Round Barrow  
Period: Bronze Age  
Desc.Type: Cairn-Circular  
Form/Condition: Earthwork-C  
Altitude: 427  
Notes: Cairn 7m N-S x 5.5. Cairn in poor condition. Central stone cist showing. Cist aligned N-S, length 1.25m x 0.5m depth 0.3m.  
Threat Category: B/1995  
Photo. No: 29800/7  
Aerial Photo No: 29800/7792265  
Drawing No: 29800/108

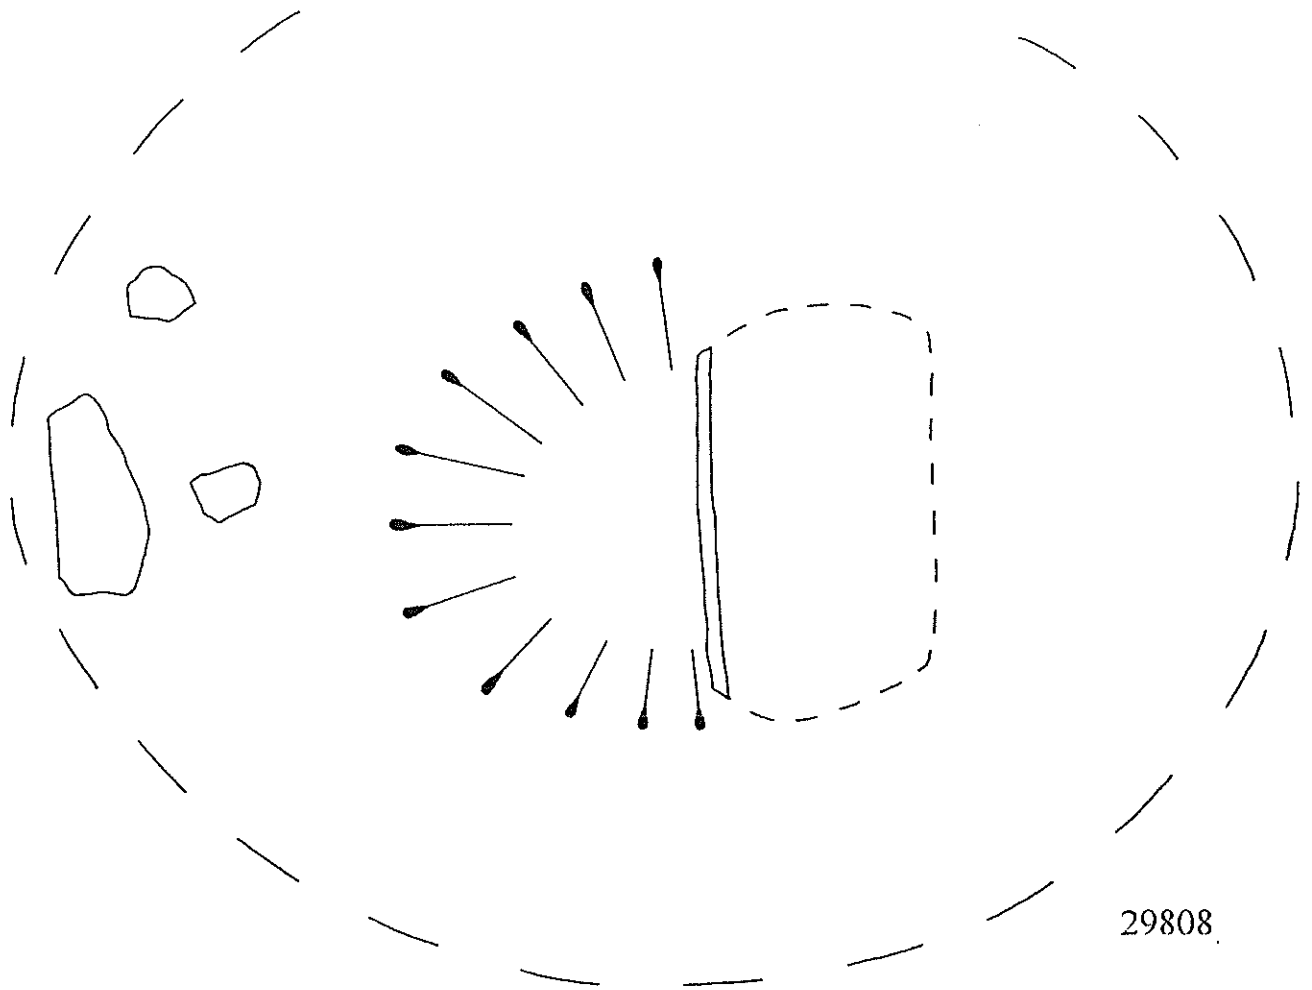
Figure 13

Site No: 29808  
 NGR: SN75456021  
 Site Name:  
 Generic Type: Cairn  
 Period: Bronze Age  
 Desc.Type: Cairn-Circular  
 Form/Condition: Earthwork-C  
 Altitude: 485  
 Notes: Cairn with cist. Constructed on top end of small sub-promontory. A few stones with one long flat stone with adjacent hollow (cist?). Suggestions of barrow outline. Dia. 3.5m. Length of cist 0.7m x 0.5m and aligned N-S.  
 Threat Category: B/1995  
 Photo. No: 29800/8  
 Aerial Photo No: 29800/11892105  
 Drawing No: 29800/109

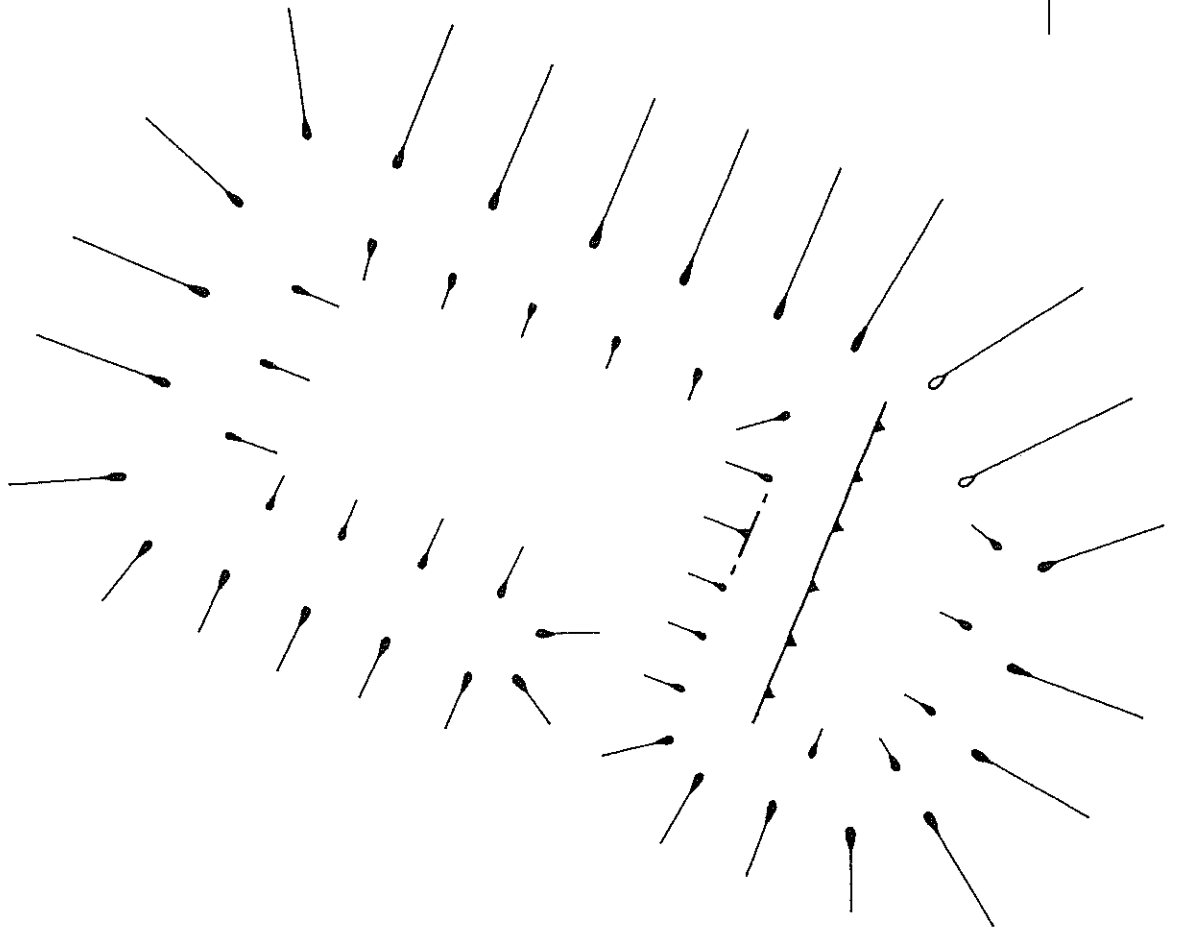
Figure 14

Period: Medieval?;Post Med?  
 Desc.Type: Building-Rectangular  
 Form/Condition: Building-C  
 Altitude: 405  
 Notes: Long Hut with annex at SE end. Constructed on rock outcrop above stream. Aligned NW-SE, total length 15.5m, width 10m, remaining height <1.0m. Entrance in south corner of main room.  
 Threat Category: B/1995  
 Photo. No: 29800/11;22  
 Aerial Photo No: 29800/7792265  
 Drawing No: 29800/111

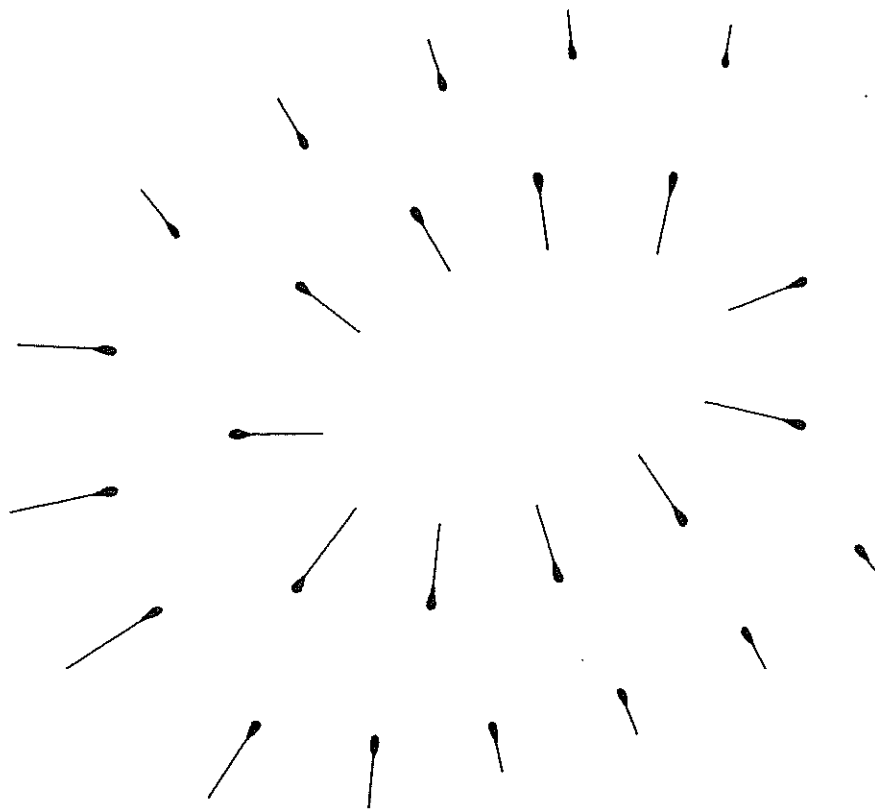
Figure 15

Site No: 29811  
 NGR: SN75355870  
 Site Name:  
 Generic Type: Long Hut?  
 Period: Medieval?;Post Med?  
 Desc.Type: Building-Subrectangular  
 Form/Condition: Building-D  
 Altitude: 415  
 Notes: Probably complete in plan. Long Hut? dug into side of hill at bottom of slope. Building aligned E-W, 6.0m long x 4.8m wide x 0.6m high. Stone constructed but no walls remain above surface.  
 Threat Category: C/1995  
 Photo. No: 29800/12  
 Aerial Photo No: 29800/7792265  
 Drawing No: 29800/112

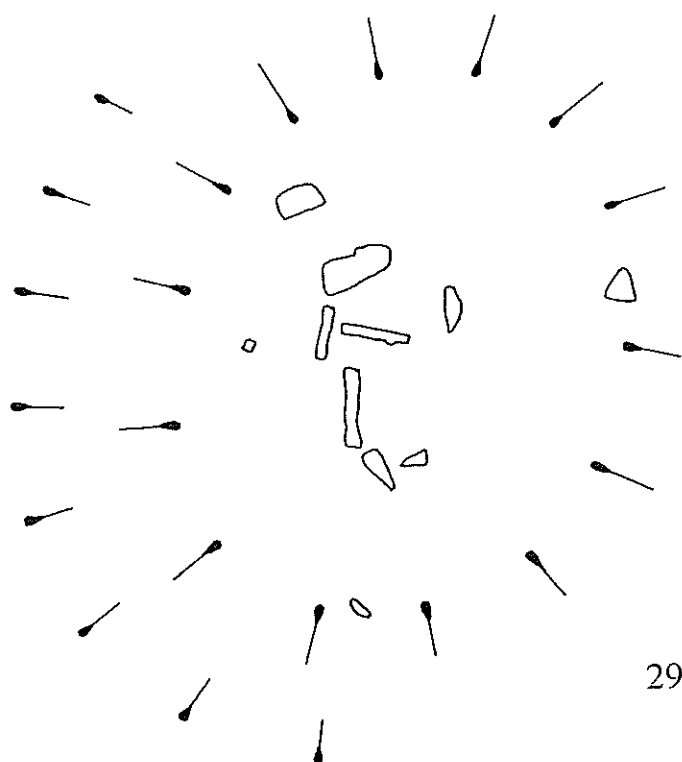
Figure 16

Site No: 29813  
 NGR: SN75505927  
 Site Name:  
 Generic Type: Cairn  
 Period: Bronze Age  
 Desc.Type: Cairn-Circular  
 Form/Condition: Cairn-D  
 Altitude: 490  
 Notes: Cairn with central N-S cist and signs of ring ditch. Cairn max height 0.4m, dia. 4.5m. Cist 1.0m long, width approx. 0.5m.  
 Threat Category: B/1995  
 Photo. No: 29800/14  
 Aerial Photo No: 29800/11892105  
 Drawing No: 29800/113

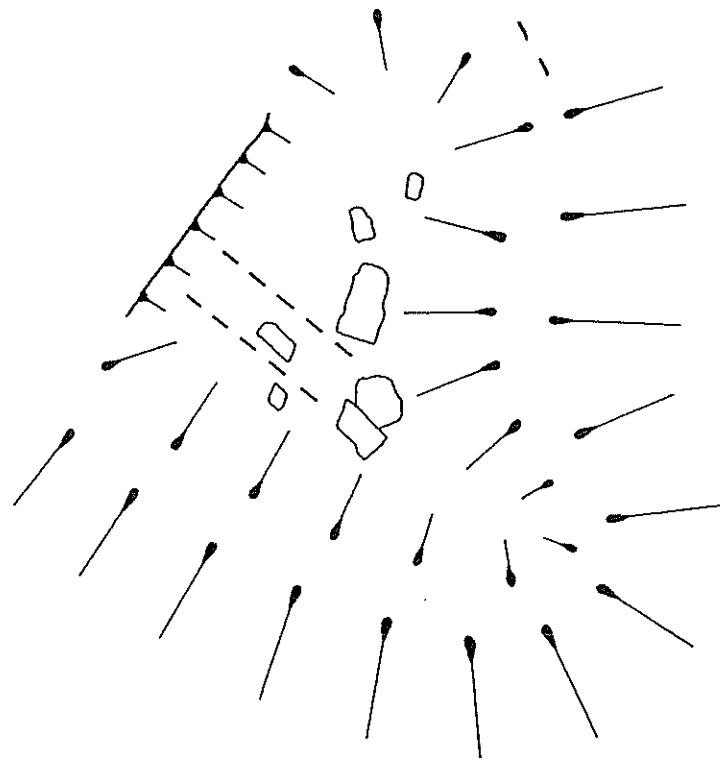
Figure 17

Site No: 29814  
 NGR: SN75385862  
 Site Name:  
 Generic Type: Long Hut?;Quarry?;Building?  
 Period: Medieval?;Post Med?  
 Desc.Type: Hollow "L" shaped  
 Form/Condition: Earthwork-C  
 Altitude: 410  
 Notes: Hollow interior with earth banks, except where cut into side of hill. Probably associated with PRN29810 as outbuilding or quarry and possibly with trackway PRN29815. May have remains of wall? or floor? in lower interior. There is a lot of stone left over for a quarry. Banks approx. 1m high. Arm lengths 8m NNE-SSW, and 8m ENE-SSW.  
 Threat Category: E/1995  
 Photo. No: 29800/15;16;22  
 Aerial Photo No: 29800/7792265  
 Drawing No: 29800/114

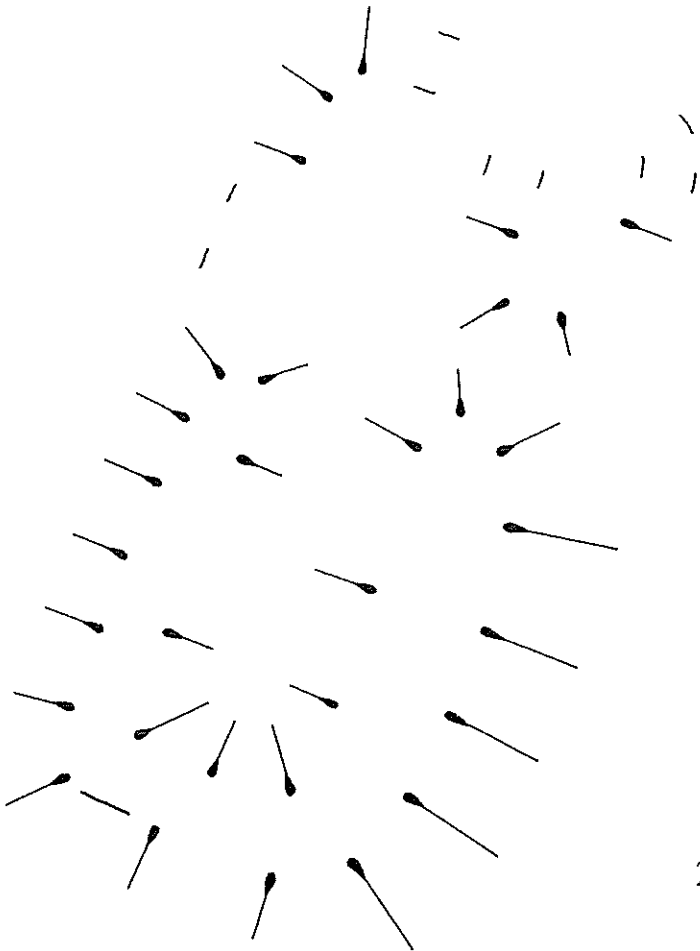
Figure 18

Site No: 29816  
 NGR: SN76286014  
 Site Name:  
 Generic Type: Long Hut  
 Period: Medieval?;Post Med?  
 Desc.Type: Building-Rectangular  
 Form/Condition: Building-D  
 Altitude: 480  
 Notes: Long Hut, slight banks, but looks to be complete in plan. Aligned NNE-SSW. Total length 12.5m, width 6.8m, height max. 0.5m. Constructed on slight ridge and slightly sheltered by the highest part of ridge to south. Stone showing through grass, with odd bit of probable wall face at north end. Only one course seen. Probable entrance on east side 3/4 way from south end. Northern end not clear. Possibly associated with probable quarry PRN29817 approx. 100m to south-west.  
 Threat Category: C/1995  
 Photo. No: 29800/17  
 Aerial Photo No: 29800/7692009  
 Drawing No: 29800/115

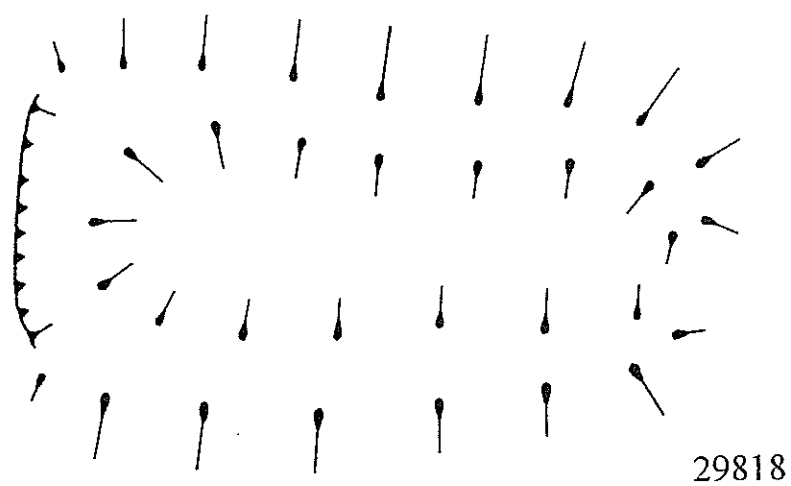
Figure 20

Site No: 29818  
 NGR: SN75785794  
 Site Name:  
 Generic Type: Long Hut  
 Period: Medieval?;Post Med?  
 Desc.Type: Building-Rectangular  
 Form/Condition: Building-D  
 Altitude: 430  
 Notes: Long Hut of drystone construction with tumbled walls. Constructed partly into base of slope of hill. Aligned E-W. Length 9.0m, width 6.0m, Bank/wall height 0.6m.  
 Threat Category: C/1995  
 Photo. No: 29800/19  
 Aerial Photo No: 29800/7792265  
 Drawing No: 29800/117

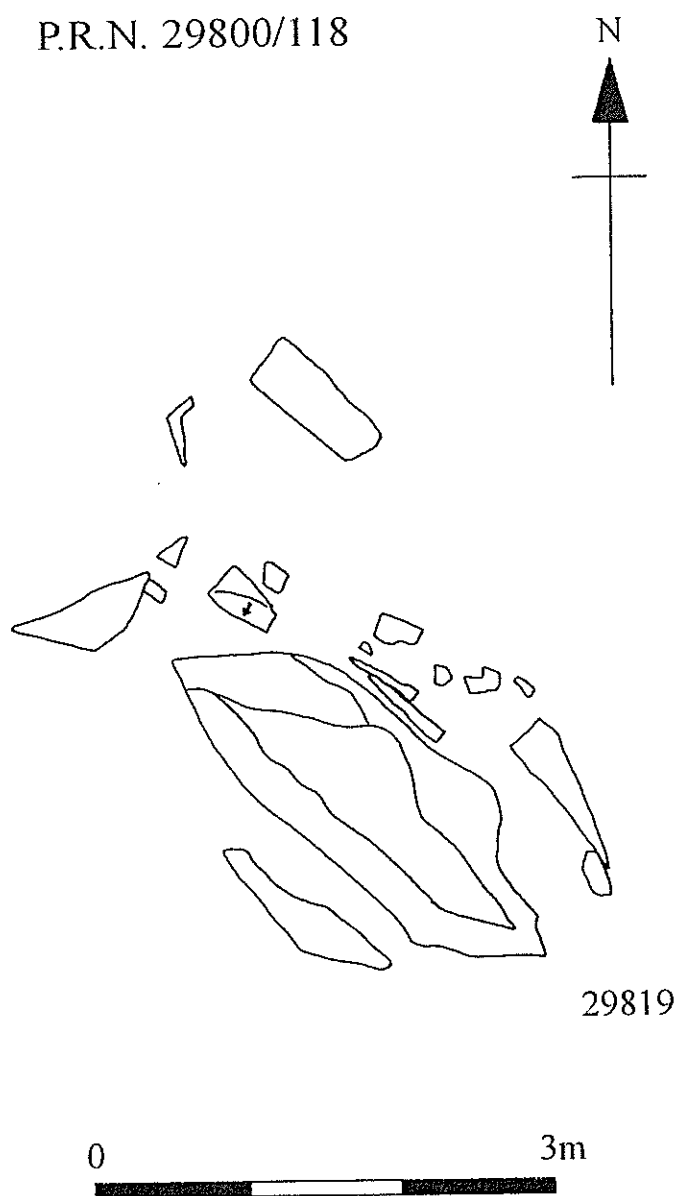
Figure 21

Site No: 29819  
 NGR: SN756957773  
 Site Name:  
 Generic Type: Standing Stone?  
 Period: Prehistoric  
 Desc.Type: Stone Block-Recumbent  
 Form/Condition: O.Struct-D  
 Altitude: 440  
 Notes: Possible fallen standing stone or collapsed burial chamber. Large stone flat on ground. Aligned NW-SE, 3m long x 0.9m wide and 0.4m high. Surrounded by smaller stones, which could be packing or part of burial chamber. Probable archaeological site but cannot be certain.  
 Threat Category: E/1995  
 Photo. No: 29800/20  
 Aerial Photo No: 29800/7792265  
 Drawing No: 29800/118

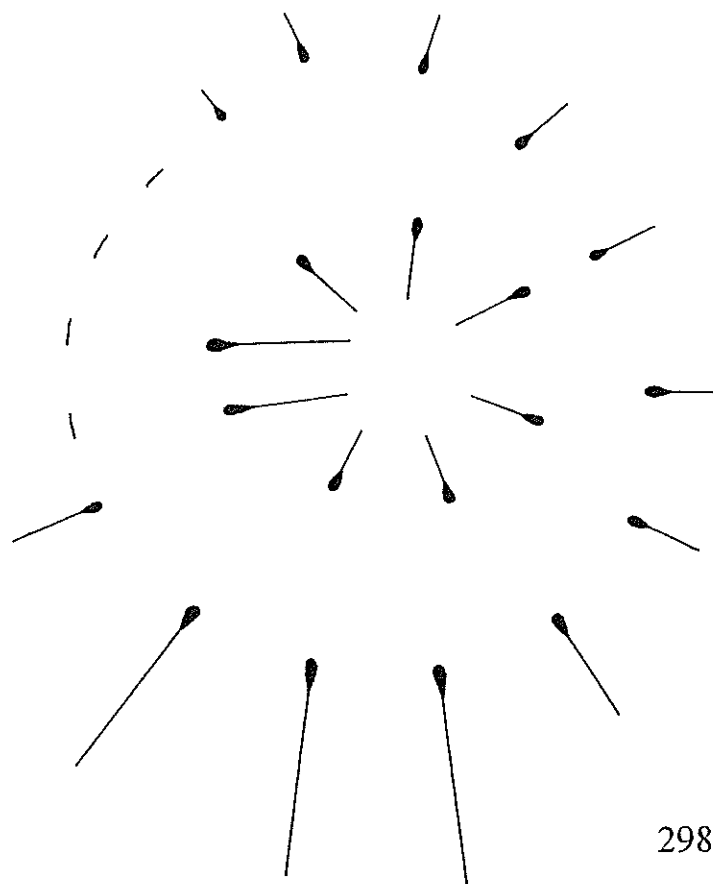
Figure 22

Site No: 29829  
NGR: SN77325887  
Site Name:  
Generic Type: Cairn  
Period: Bronze Age  
Desc.Type: Cairn-Circular  
Form/Condition: Earthwork-D  
Altitude: 523  
Notes: Slight remains of very probable cairn. External dia. 4.0m with internal hollow dia. 1.4m, possibly robbing. Height of bank 0.3m. Only a very little stone showing through grass. Probably the same as PRN9019 which is plotted in the wrong position.  
Threat Category: C/1995  
Photo. No: 29800/23  
Aerial Photo No: 29800/7792268  
Drawing No: 29800/119

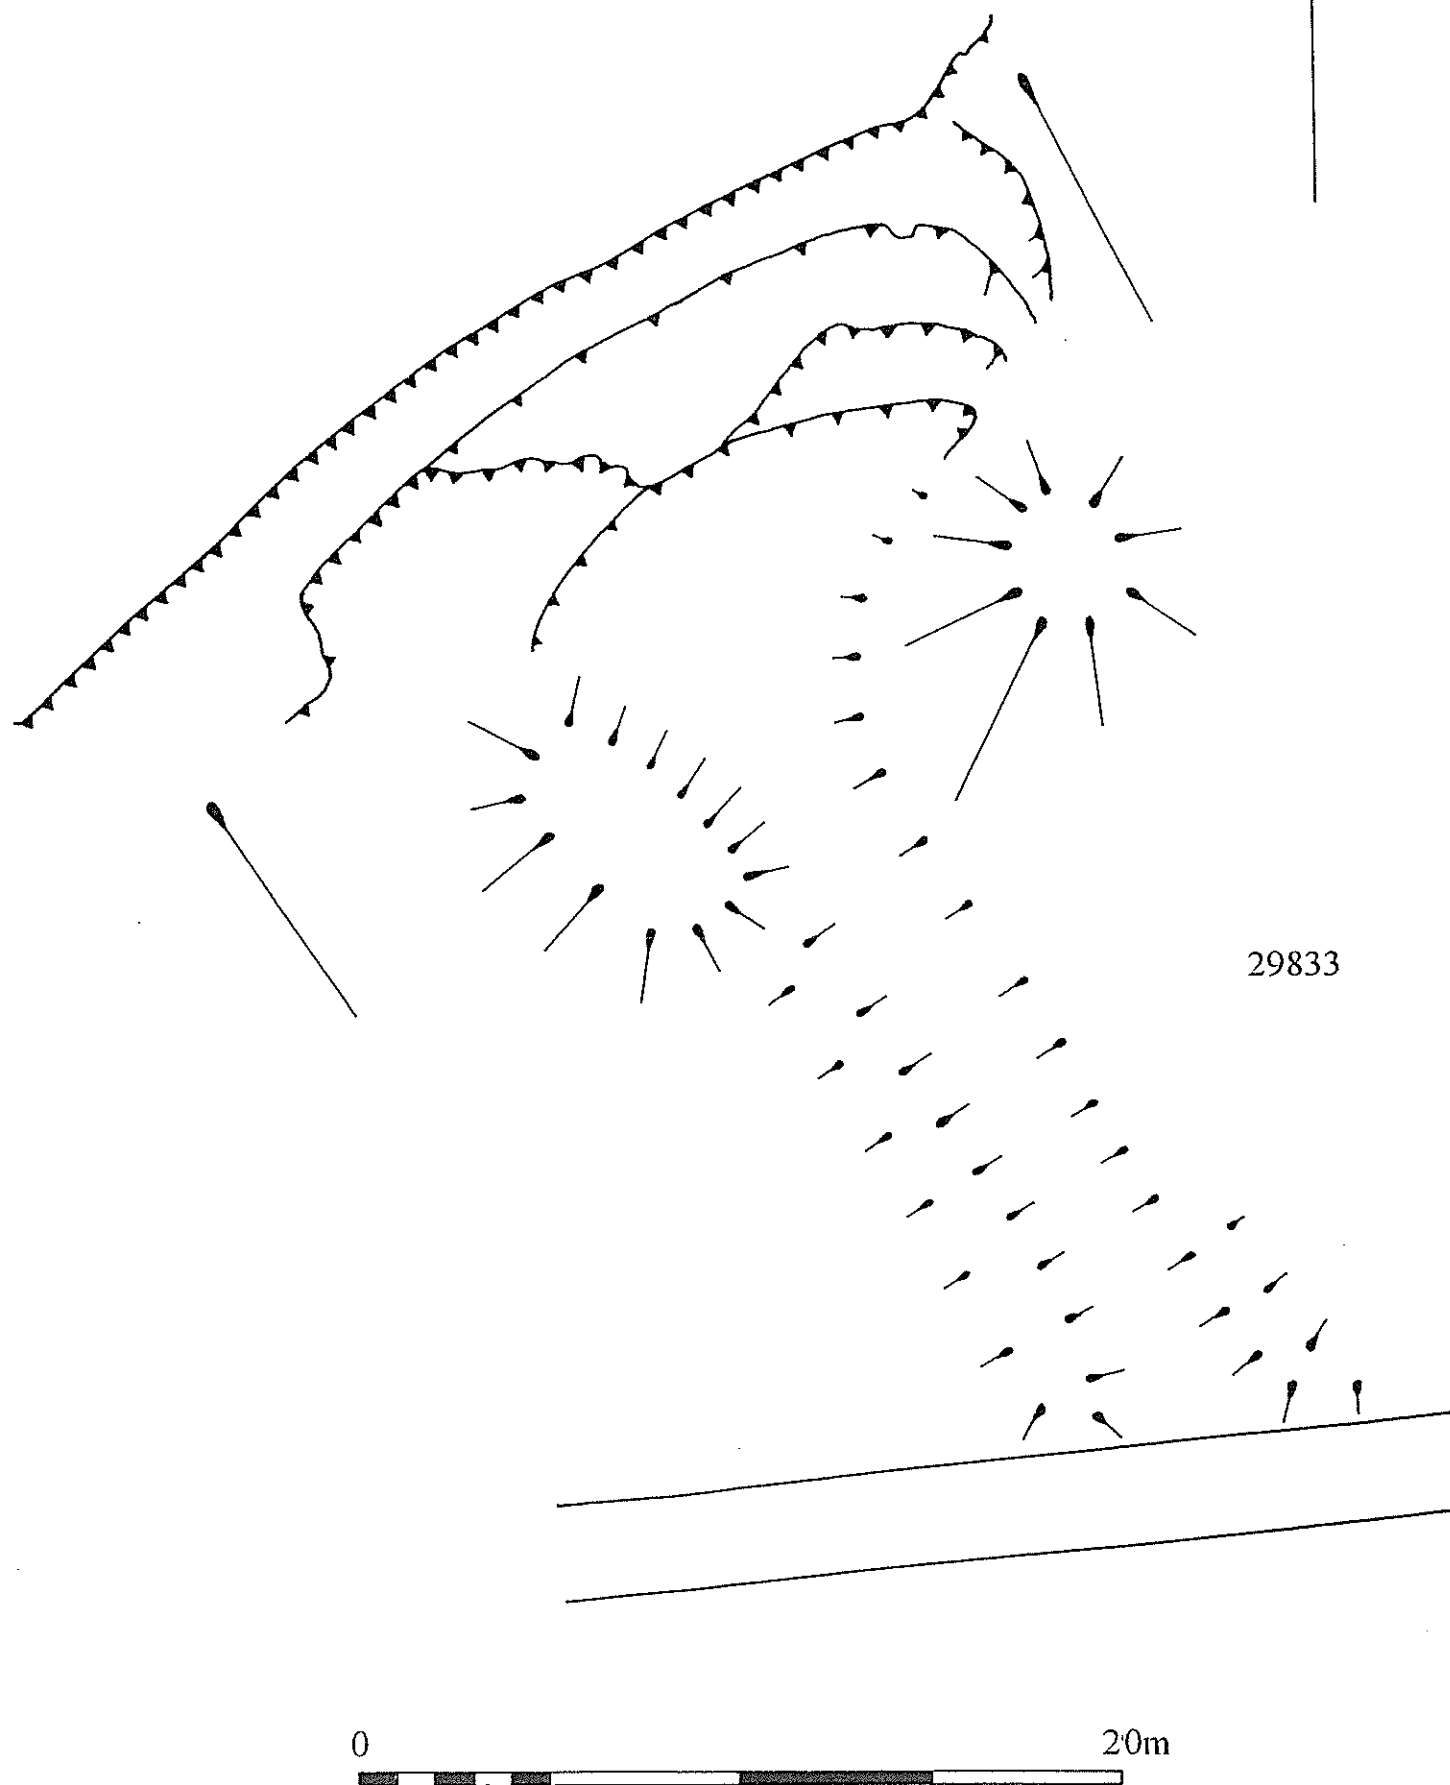
Figure 24

Site No: 29833  
NGR: SN76635756  
Site Name:  
Generic Type: Quarry  
Period: Post Med?;Modern?  
Desc.Type: Hollow-Linear  
Form/Condition: Earthwork-B  
Altitude: 415  
Notes: "I"-shaped quarry with track forming upright of "I" and runs from present road. Trackway aligned NW-SE and approx. 2m wide by 30m long to lower face. Spoil tips on either side. 3 main steps in quarry face, with total height approx. 6m. Not shown on tithe map so could be later.  
Threat Category: D/1995  
Photo. No: 29800/30  
Aerial Photo No: 29800/7792267  
Drawing No: 29800/121

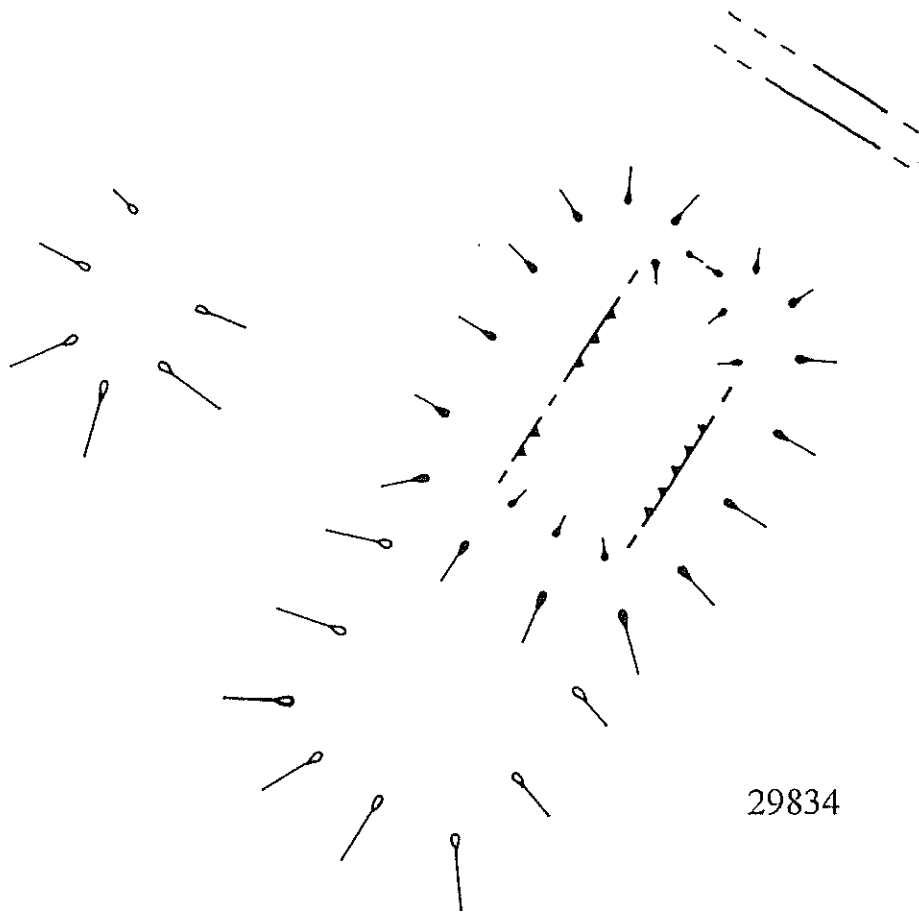
Figure 25

Site No: 29834  
 NGR: SN76445908  
 Site Name:  
 Generic Type: Long Hut  
 Period: Medieval?; Post Med?  
 Desc.Type: Building-Rectangular  
 Form/Condition: Building-C  
 Altitude: 440  
 Notes: Long Hut which appears to have associated features. Location 15m north of stream bend and constructed on old stream bed. Tumbled stone walls of main structure, with some evidence of faces. 6.2m long and aligned NE-SW. 5.0m wide. Another wall approx. 1.8m to the north of main structure. Possible annex or platform extending 4m to the south. Probable mound (midden?) 4.0m to the north-west. Site marked on tithe map.  
 Threat Category: B/1995  
 Photo. No: 29800/31  
 Aerial Photo No: 29800/7792267  
 Drawing No: 29800/122

7.13 The following sites are to be recommended for consideration for scheduling:  
PRN5553 Standing Stone likely to have ritual burials around base and possibly a ring ditch. PRN5551 Cairn with Cist. PRN5552 Large prominent ridge Cairn. PRN8524 Large ridge Cairn. PRN9108 Farmstead, Post Medieval, with additional buildings and associated field system. PRN29813 Round Barrow/Cairn with Cist and signs of a ring ditch. PRN29805 Hafod/Long Hut with annex. PRN29834 Hafod/Long Hut with annex and possible other adjacent features.

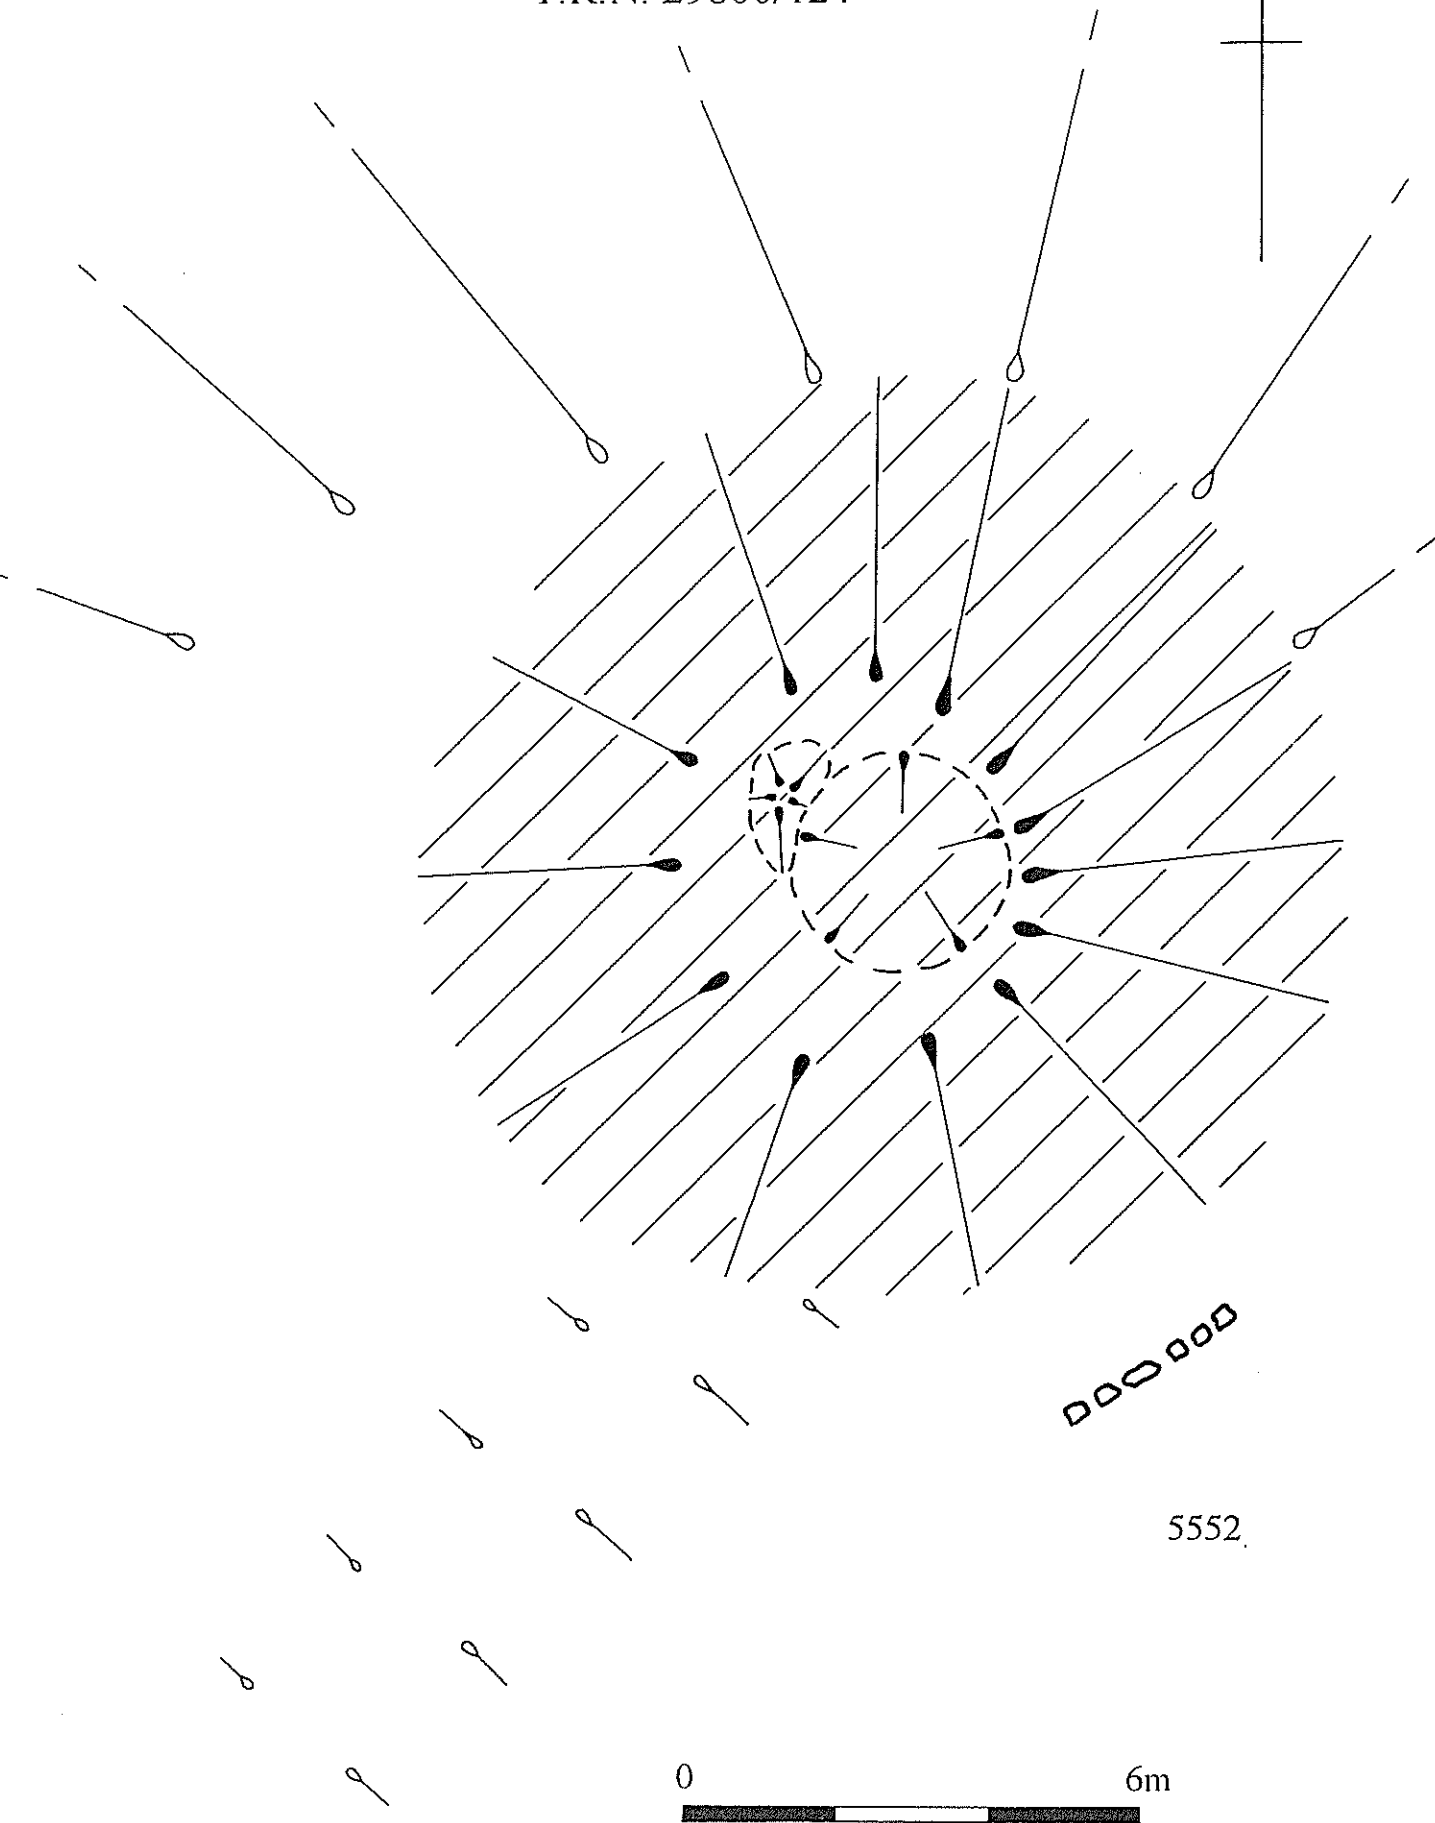
Figure27

Site No: 5552  
NGR: SN76715833  
Site Name: Cefncerrig  
Generic Type: Round Barrow  
Period: Bronze Age  
Desc.Type: Cairn-Circular  
Form/Condition: Earthwork-C  
Altitude: 480  
Notes: Cairn partly constructed on outcrop on top of ridge. There is a little quartz or quartz-covered stone in construction, diameter approx. 7.5m+ and approx. 1.3m high. Cairn has suffered damage on south side recently, the stone removed has been used to place a small "walkers" cairn 1.2m high on top of cairn, to lay out a disc of stones to the SE, and a line of stones resembling a wall. Damage to cairn pre-1992 as it appears on Aerial Photo 77 92 267 There is possibly other modern construction around this cairn.  
Threat Category: B/1995  
Photo. No: 29800/25;26  
Aerial Photo No: 29800/7792267  
Drawing No: 29800/124

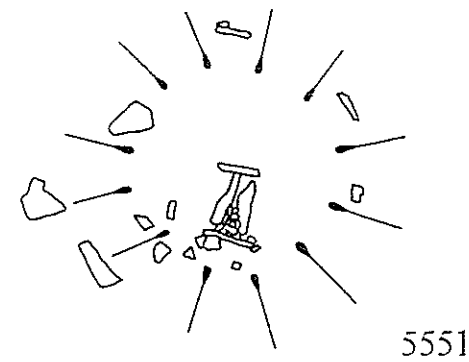
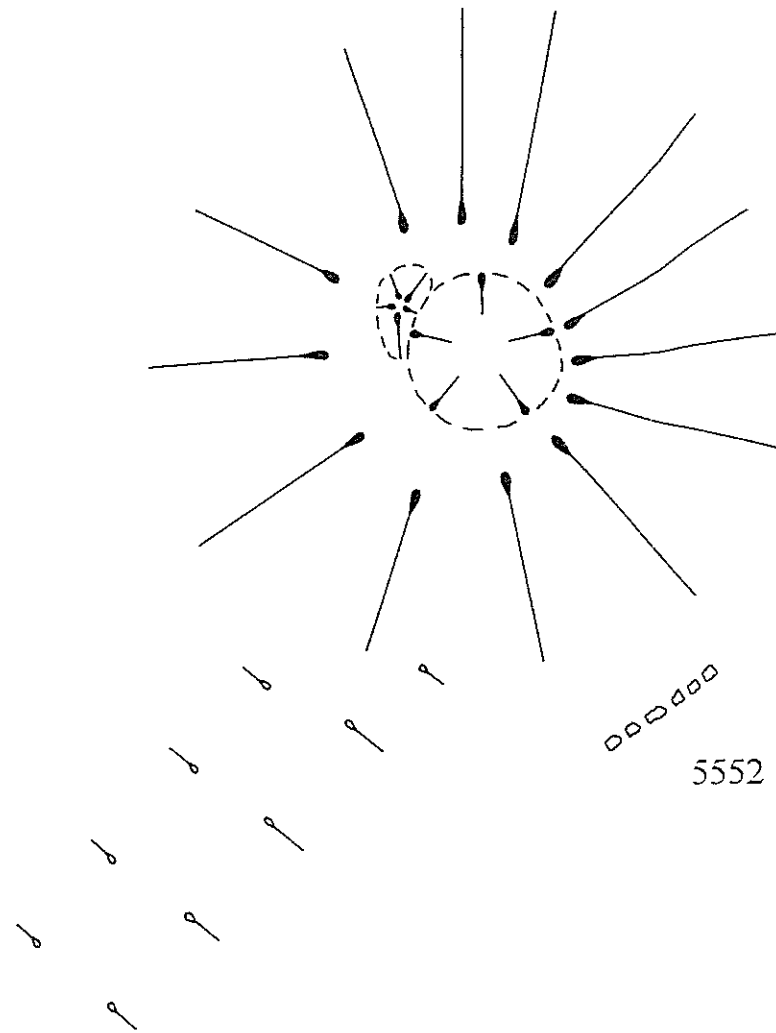
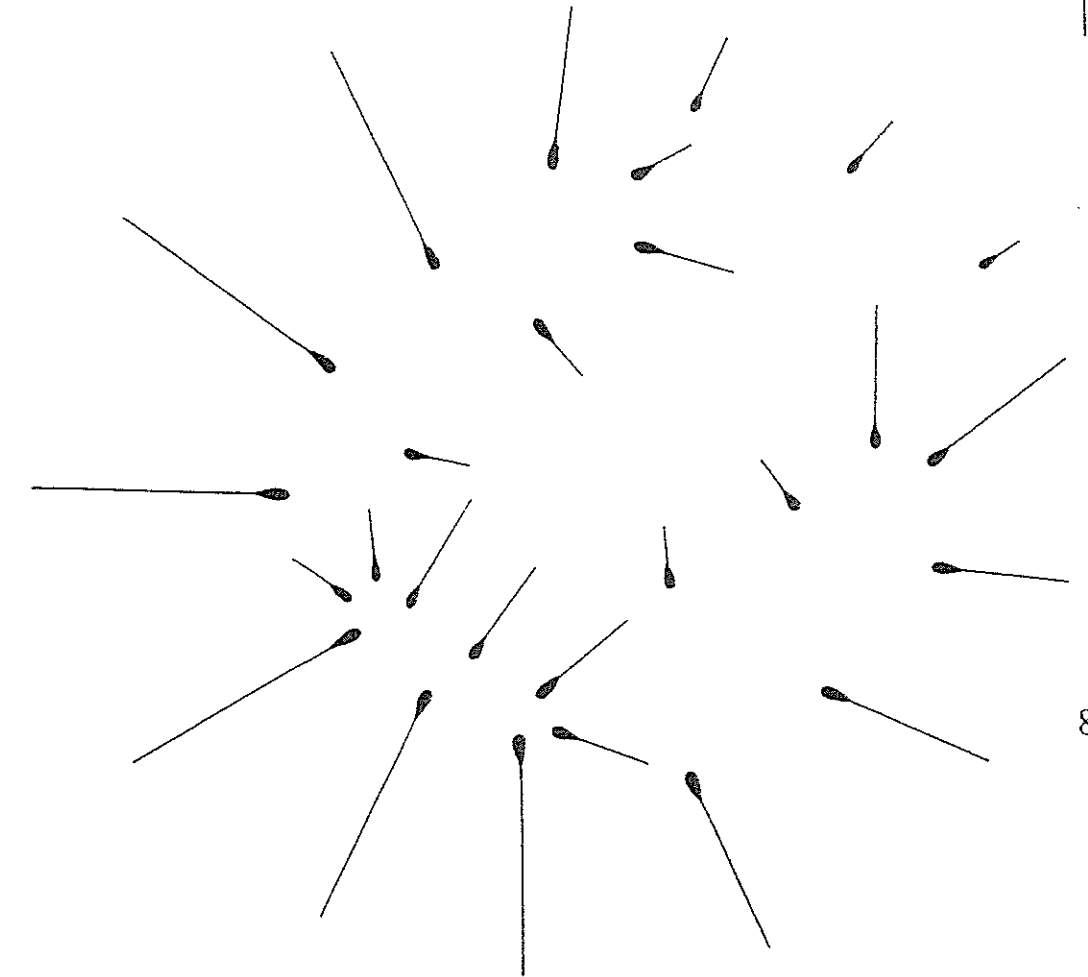
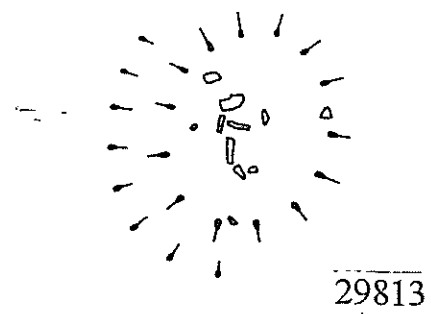
Figure 30

and PRN8524, both located on a ridge, being considerably more massive (figure 30). Cairn PRN29813 is the only one to show signs of a remaining ring ditch. Three of these sites show remains of central cists (see 6.9.4) which are all aligned north-south. With only three such sites found here it is impossible to say whether this cist alignment is significant, without undertaking a comparative study of such sites elsewhere.
