**WATER MAINS RENEWAL
AT
PUMPSAINT,
CARMARTHENSHIRE**

**ARCHAEOLOGICAL WATCHING BRIEF
Project Record No. 30673
SEPTEMBER 1995**

REPORT ON AN ARCHAEOLOGICAL WATCHING-BRIEF CARRIED OUT DURING THE
REPLACEMENT OF A WATERMAIN AT PUMPSAINT, DYFED

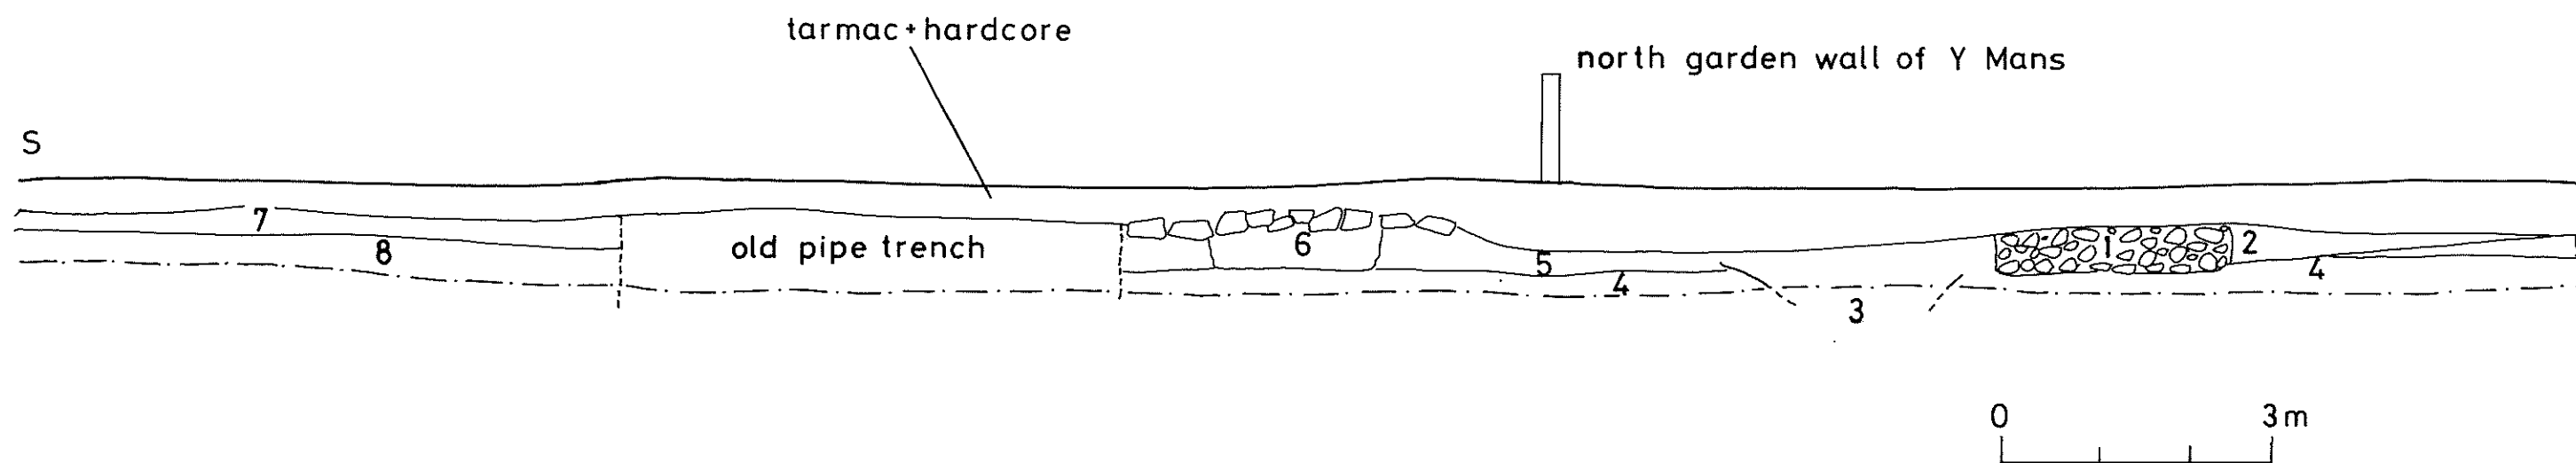
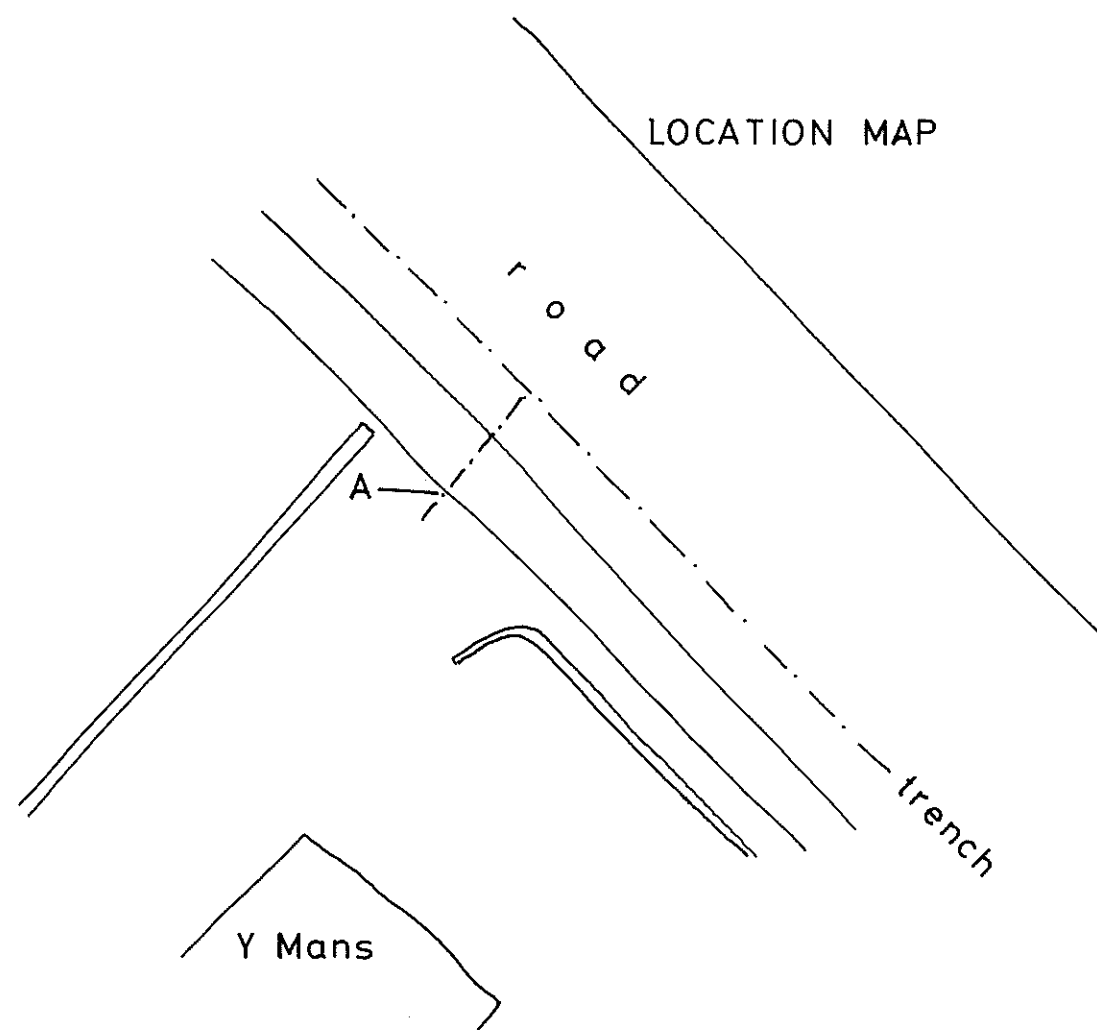
PUMPSAINT EAST FACING SECTION OF WATERMAIN TRENCH JUNE 1995

At the southern end of the village opposite Y Mans more complex and interesting archaeological deposits were revealed in the trench cutting (Fig. 2). A substantial cut, 1, containing cobbles and boulders packed into white clay was butted on its north side

by orange-brown clay, 2, and to the south by a possible ditch, 3. To the south what appears to be a clay-filled trench, 6, was overlain by a single course of massive masonry. A Roman road surface lay to the south of this.

Sketch section

1. White-grey clay with cobbles and rounded boulders - foundation trench
 2. Stone free orange-brown clay
 3. Possible pit or ditch. Loose gravel fill in a dark brown silty loam
 4. Subsoil. Orange-brown compact gravel in a silty matrix
 5. Possible archaeological deposits/redeposited subsoil
 6. Stone free pale yellow/white-grey clay. Foundation trench. Overlain by a single course of masonry consisting of very large angular stones bonded with a mid-brown silty clay
 7. Very compact gravel layer - possible Roman road surface
 8. Buried soil - orange-brown silty clay loam, stone free
- A. In side trench. Immediately below the pavement. A deposit of white clay, stone free. Possible rampart material?

The archaeological deposits described above seem to be the remains of clay ramparts and foundation trenches for revetment walls and/or stone gates; they are consistent with deposits interpreted as ramparts and gates on the northern side of the fort excavated in the early 1970s and 1989. Indeed, the watermain trench passed through an 1970s excavation trench on the site of the north gate. If the interpretation of the deposits described above as gate and rampart is correct, and it must be stressed that conditions were not ideal for archaeological recording, then the southern line of the fort's defences as suggested following the 1970s excavations is incorrect - the actual line lies 20-30m north of that shown on Figure 1.

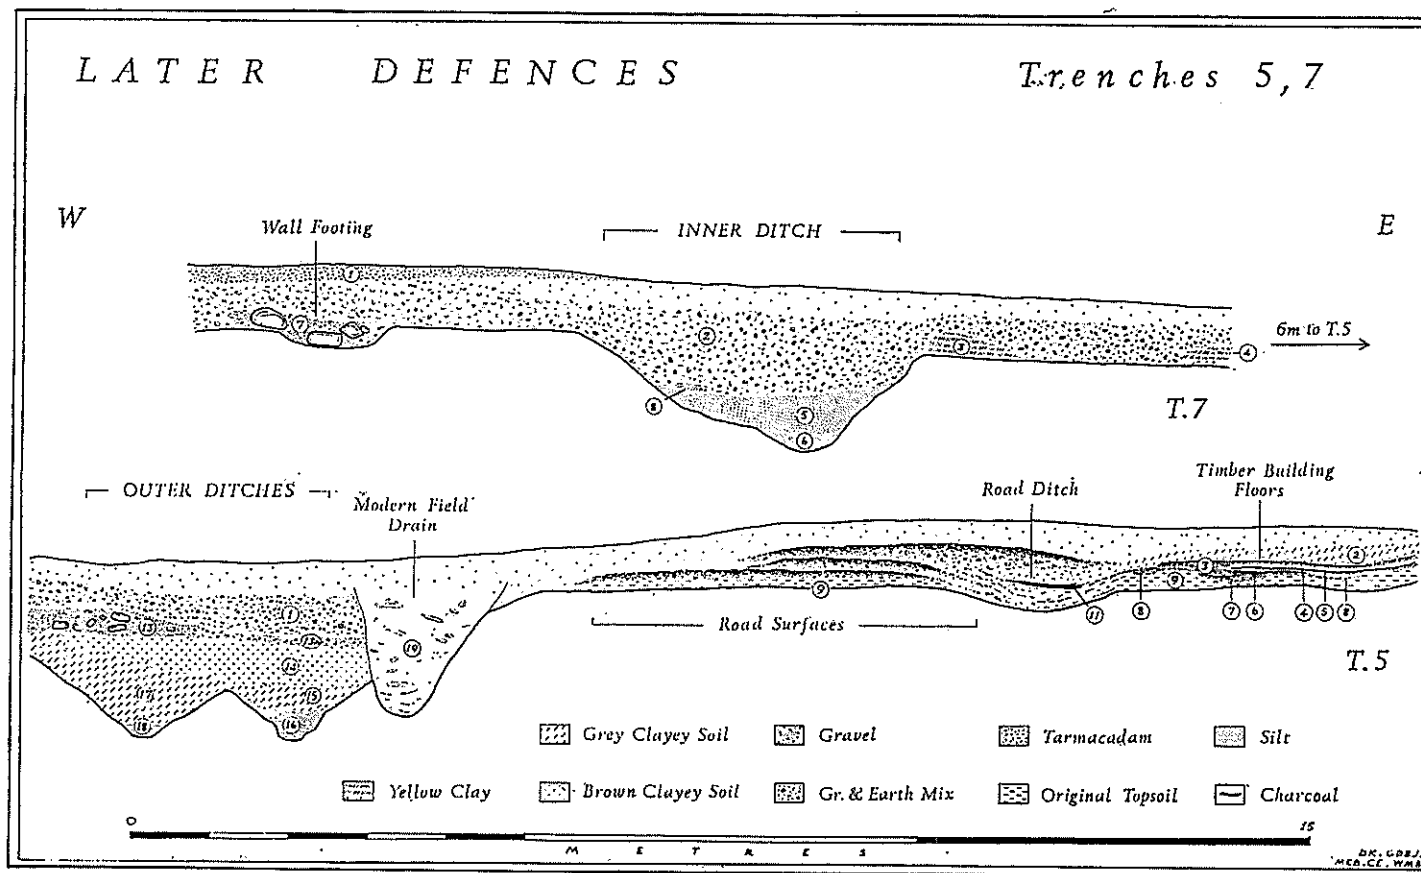
Figure 6. Composite section across reducing defences of fortlet (T.5, 7).

This same factor explains the strength of the fortlet ditches on the eastern side, as revealed in T.5 and T.7 (fig. 6). Traces of timber buildings had been located on the inside edge of the intervallum road to the east. The eastern side of T.5 revealed similar features (features 3-8) abutting the major north-south road forming either the *via principalis* or the *via quintana* of the original fort. Three surfaces (9a-c) were differentiated with a drain (11) to the east. The western edge of the road, however, was cut away by a double ditch system, itself partly disturbed by a modern field drain (19). The two ditches were both slightly over 3m. in width with an infilling of clayey grey soil (1, 15) over the silted sumps (16, 18). From the western end of the double ditch an interval of 6m. occurred before T.7. This was placed in the only possible space between the barn and the village hall. No other position was available on the eastern edge of the present main road and unfortunately the amount of surviving stratigraphy was limited. Nonetheless the two principal features emerged in the form of the inner ditch and the line of a robbed wall footing. The former was 4.25m. across with a rather flattened profile probably indicative of re-cutting (sump 6). The construction trench for the wall footing was represented by a cut in the natural subsoil c. 1.45m. across. In it lay three heavy sandstone blocks, the sole survivors of the stone revetment to the rampart of the fortlet. This is now known to correspond with the evidence of the fortlet defences at the north gate as a result of work in Easter 1973. Unfortunately it was not possible to expand T.7 in any way without encroaching on to the modern road or threatening the collapse of the barn. As fig. 1 shows, the position of the intervallum and lateral drain belonging to the fortlet period allow its eastern rampart to have been as much as ten metres wide.

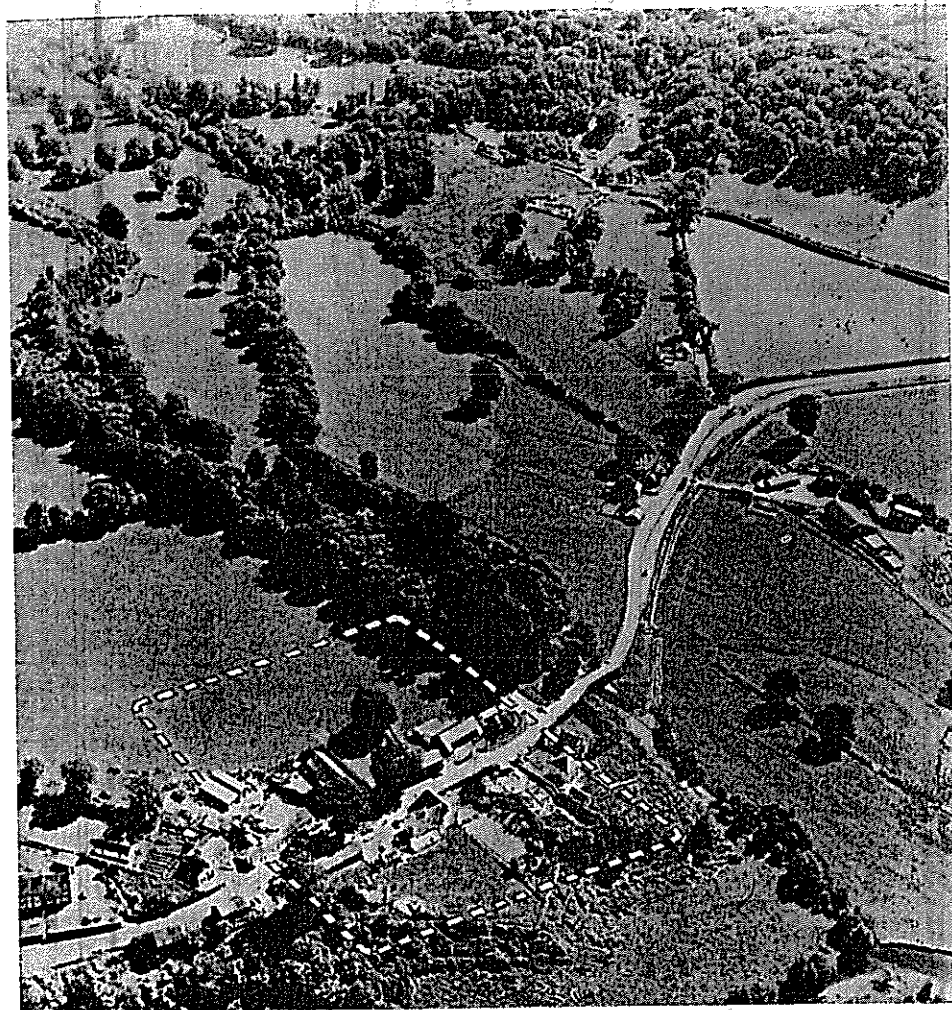
Plate I. Aerial view of Pumpsaint village from the north-west. The area of the fort is indicated by the broken white line (v. fig. 1) and the main opencast appears at top centre.

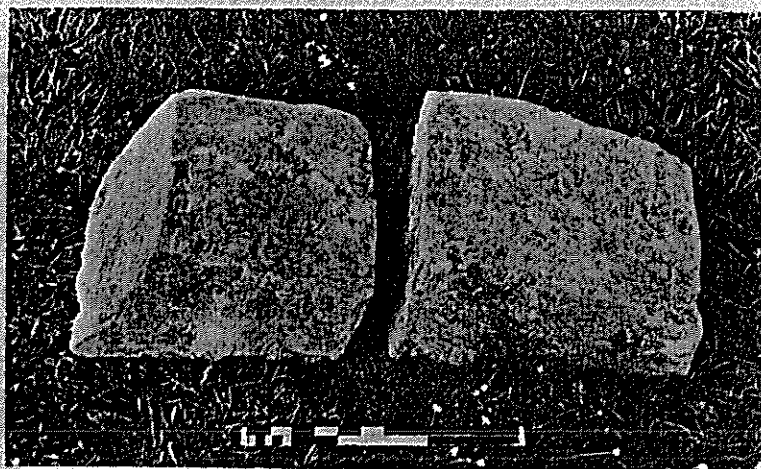
Plate IIa. Ashlar limestone blocks recovered from the robber trench of the stone revetment of Per. II (T.6), v. p. 6, fig. 2.

In the second period the inner ditch had been filled in with a stabilising mass of heavy river pebbles (4), bound in stiff grey clay whose function was to form the foundation for the stone rampart revetment of the second period defences, the evidence for which survived in the form of ashlar blocks at the base of a robber trench (3). The inner edge of the robber trench was clearly defined and showed that a clay pack (2) had been used to fill the intervening space between the stone revetment and the core of the primary rampart. There was also evidence of the insertion of a timber corduroy between layers of clay designed to stabilize the break between primary and secondary periods. The corduroy, which was also observed in the section cut through the western defences was represented by clay dumps (5, 7, and 8), interspersed with timber strips (6 and 9). Also, on the eastern side of the section at this point there appeared a sump (20) which provisionally might be identified as the posthole for one of the uprights of an interval tower inserted into the Period I rampart. On the outer side of the stone revetment a clay spread, similar to the intermediate dumps filling the primary ditches, formed a 'berm' between the revetment and the second period ditch (Ditch III). The line of the berm could then be traced

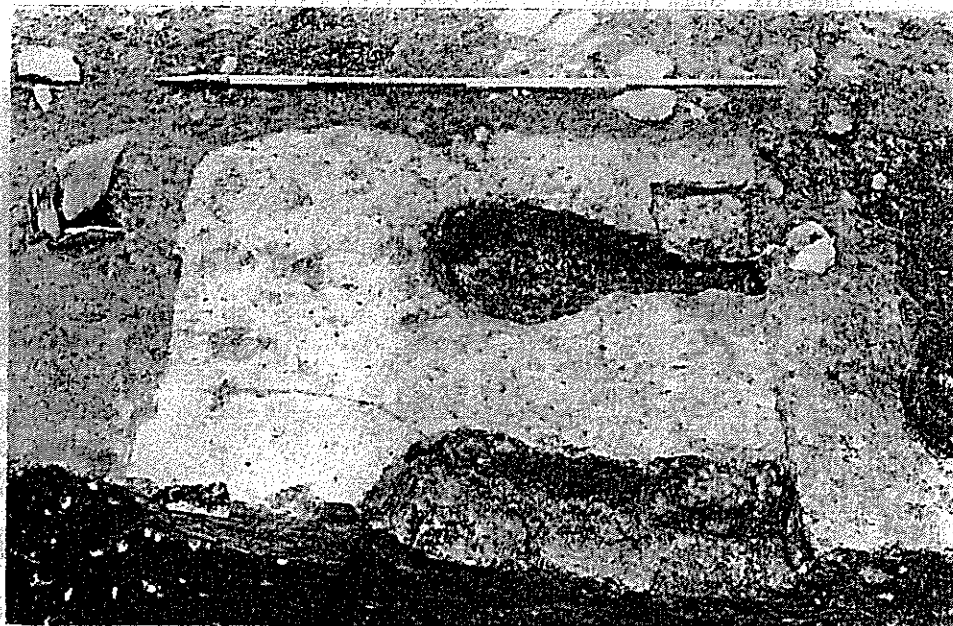
Plate IIb. Twin furnaces on a clay base (T.2, 3a, b), v. p. 10, fig. 4.

The later barrack block appeared to have been demolished in the early years of the second century A.D. to make way for a series of three structures whose function was very different from that of their predecessors. These can probably be identified as *fabricae*, workshops, from the nature of their plans and associated features. The earliest of the *fabricae* (Per. IC) was delineated by construction trenches (T.4.35, and 24 with T.2.24). The structure was divided by two partition walls (T.2.24 and T.4.44), with which were associated a number of postholes, (T.4.45 and T.2.21), dividing the area into working rooms. This plan was retained on almost the same lines by the second *fabrica* (Per. ID). T.2.26 and T.4.26 formed a broad construction trench on the eastern side matched by T.2.28 and T.4.8 marking an area in which no less than five furnaces were identifiable. The best preserved of these were formed by T.2.3 being a clay base forming the seating for two bowl furnaces (pl. IIB). To the north T.2.7 formed the foundation of a

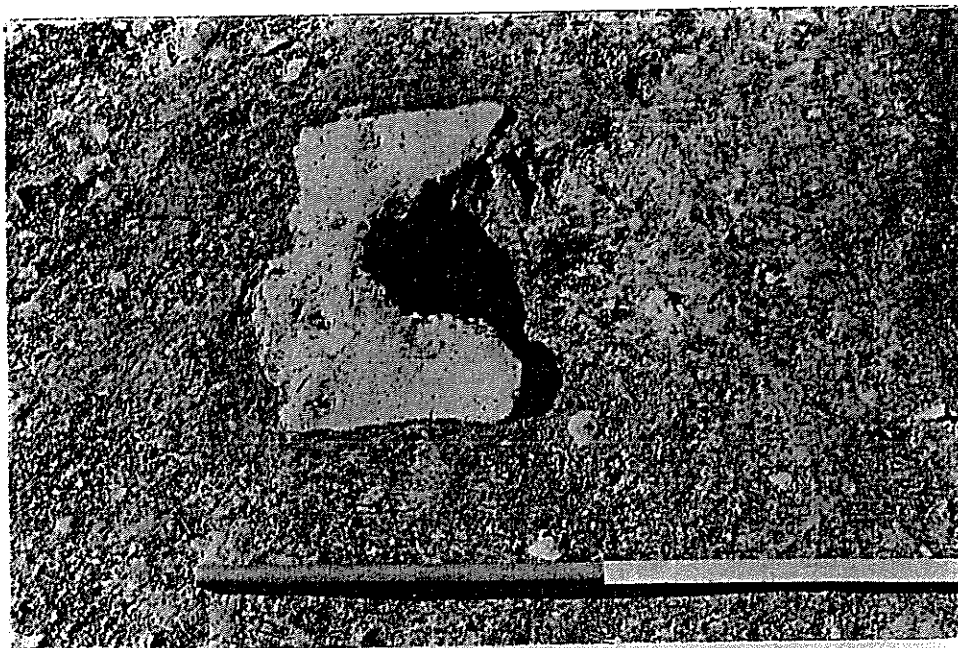
Plate IIIa. Single furnace on a clay base (T.4.43), v. p. 11, fig. 4.

similar furnace largely destroyed by the activity surrounding its southern neighbours ; and T.2.8 was another bowl furnace in this case capped by a large stone when it fell out of use. The best examples lay to the north where T.4.42 and 43 consisted of the clay bedding for two smaller furnaces. In the latter case the furnace floor had been removed, but the former contained three cracked tiles set in position as the base of a small bowl furnace in which nails had either been worked or reworked from a bent state, as again was the situation in T.2.3. (Pl. IIIB).

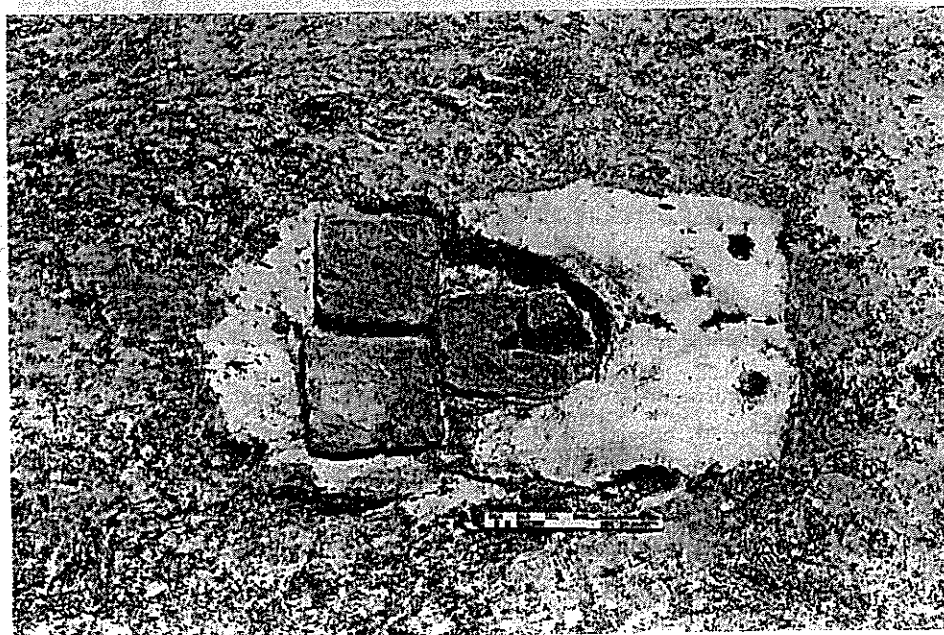
Plate IIIb. Single furnace on a clay base with tiles (T.4.42), v. p. 11, fig. 4.

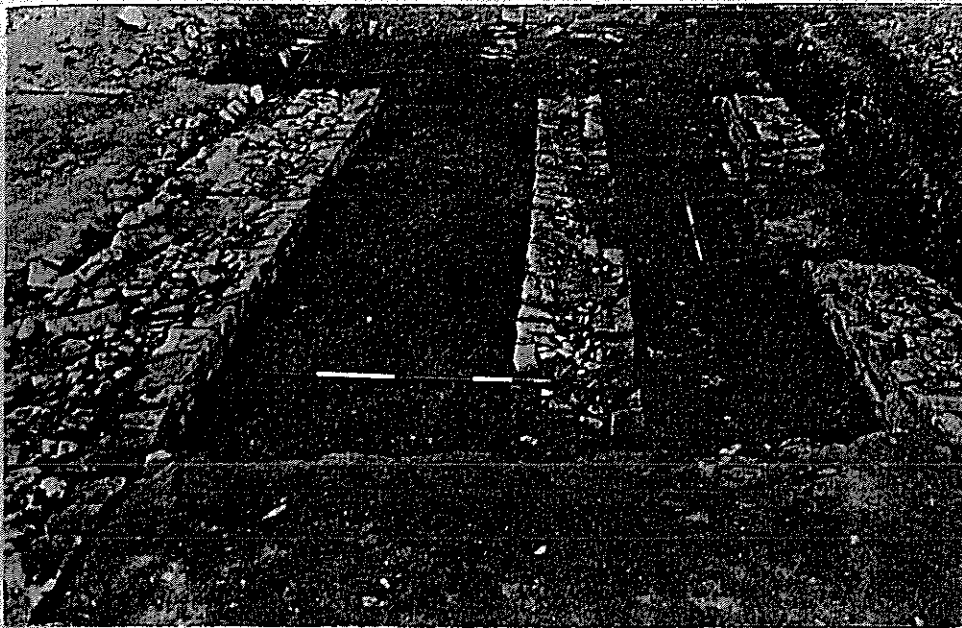
Plate IVa. General view of granary in final stages of excavation showing post-pits alongside external and one internal wall. View from south, v. p. 11 and fig. 4.

The area east of the main north-south road was filled by a stone building on a massive scale identifiable from its structural characteristics as a granary or similar store room (Pl. IV A). The principal remains comprise a massive external wall (23), bordered by a drain (33), and strengthened by a series of three buttresses which impinged on the road surface (25) (Pl. VA). The smaller internal walls are represented by 35 and 22 and a cross-wall (34) that was contemporary with the construction of the wall 35 (Pls. IVB and VB). On the eastern side a number of intrusions, (T.1 11, 26 and 27) had carried away the eastern wall (22), but little of the plan had suffered as a result, although the northern wall of the building (15) had been effectively robbed. The course of the north wall was shown by the clay bonding that underpinned the wall and ran east-west at the northern side of the trench. Alongside the wall to the east (23) and alongside the western edge of (T.1 22/25), a series of massive postholes were uncovered at intervals of 1.25m. to suggest some hint of the timber-frame structure which must have been used either to tie the roof beams, or, to support

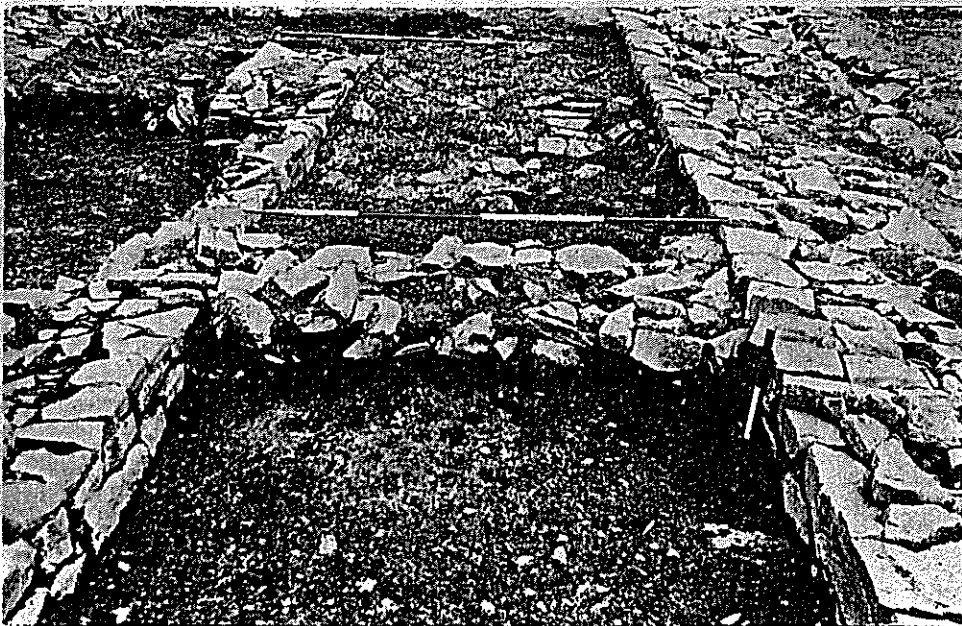
Plate IVb. Granary interior with crosswall (34) still in position.

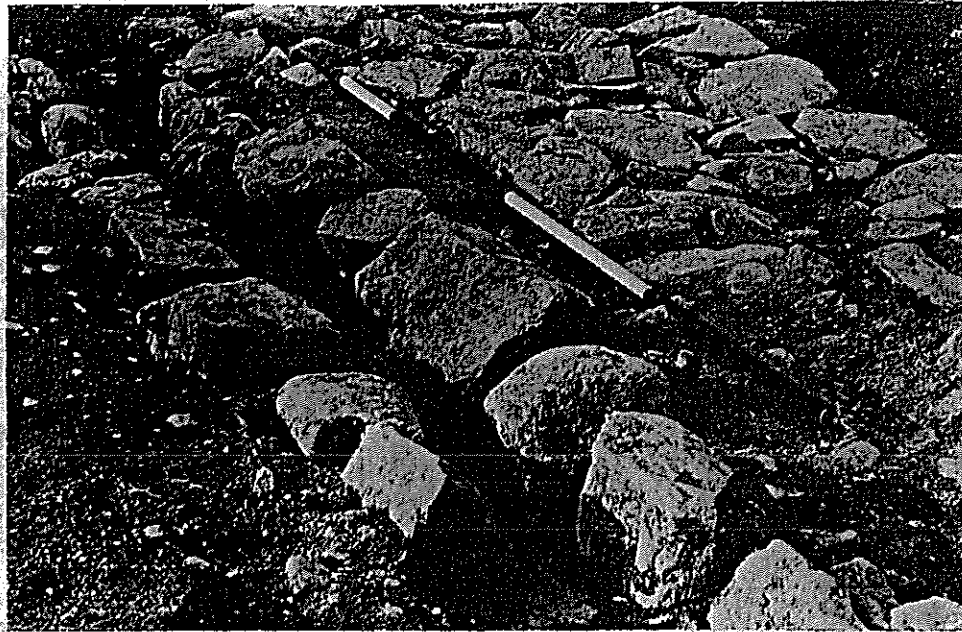
Plate Va. Western external wall of granary with drain (33).

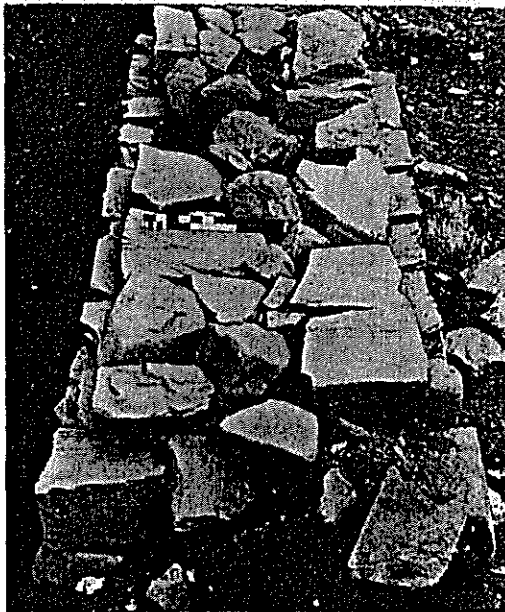
Plate Vb. Internal wall (22) of granary showing double effect to carry raised floor.

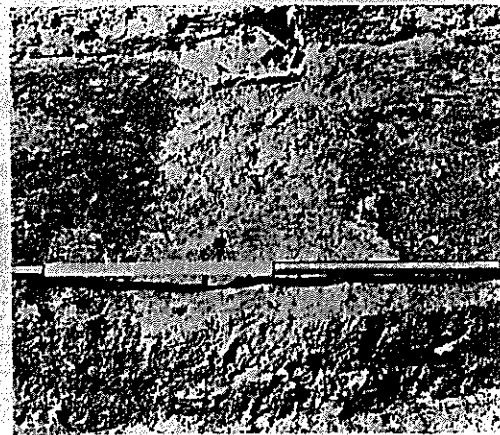
Plate Vc. Construction trench (59) of Flavi timber granary as seen beyond north wall (15) of stone granary, v. 12, fig. 4.

Beneath the stone granary lay the remains of its timber predecessor. (Pl. VC). This was indicated on the northern edge of the excavated area by the construction trenches T.1 53, 57, 58 and 59, four parallel trenches which suggest the existence of a timber built granary on the same site before the surviving stone one. It should again be emphasised that the life-span of the two granaries occupied the same period as the rapidly changing sequence of building to the western side of the road. There is little evidence currently available for the date of the stone built granary within the relative sequence. Unfortunately the west wall was robbed at the point in T.2A where it met the north-south road so a precise stratigraphic link could not be made.

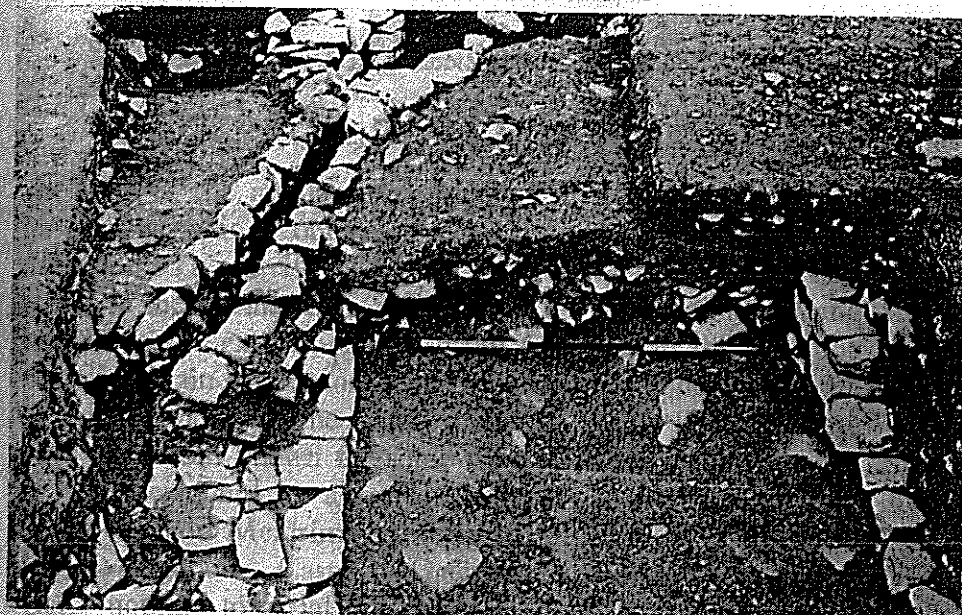
Plate VIa. General view of T.1B looking south. The demolished granary walls (to lower right and left) are overlaid by the grit-paved intervallum of the fortlet (above scale pole). The later road is flanked by a deep, stone-lined drain running into a latrine, v. p. 13, fig. 4.

The south-east corner of the excavated granary area (T.1B) provided the final resolution of the problem of the discrepancy between the defence sections on the south and west, and those on the east and north-east. Above the stone building debris, sandwiched into the interstices between the granary's internal walls a gravel road surface, (T.1B 8a and b) was located, into which, on the eastern side, a stone lined drain had been cut leading into a stone lined latrine (T.1B 10). This, together with the road, was running at an oblique angle to the main axis of the granary in such a way to demonstrate conclusively that the granary had been deliberately demolished to make way for the defences and intervallum road⁸ of a second period fort planned on a greatly reduced scale at its south-eastern corner (Pl. IVA).

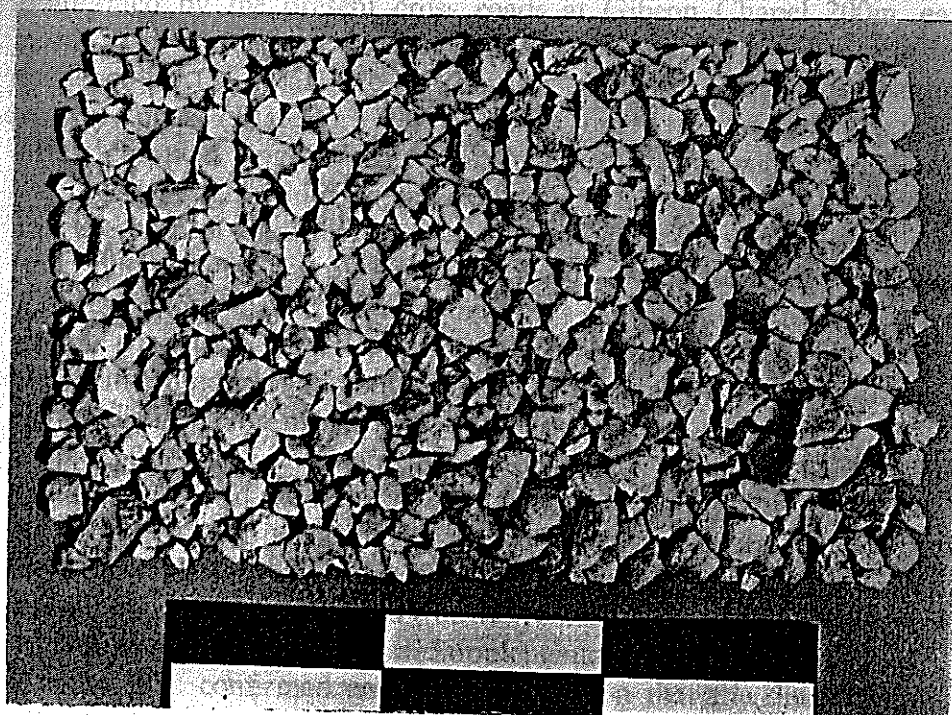
Plate VIb. Crushed quartz with an average size of 0.6cm. across from the processing floor located west of Ogofau Lodge, v. p. 14. The scale is in 5cm. units.

Through the courtesy of Mr. Davies of Ynysau Uchaf, Dr. P. R. Lewis was able to conduct two exploratory excavations in the field 175m. west of Ogofau Lodge close to the line of the minor road leading up to the opencast. Exploration in the immediate vicinity of Ogofau Lodge has already produced evidence of grinding implements associated with the crushing of auriferous quartz.⁹ Actual evidence of processing, particularly the washing of crushed quartz, was to be expected in the same area. The likeliest position for this operation seemed to be the tongue of land projecting northwest from the Lodge area. Within this framework, therefore, Dr. Lewis supervised the cutting of two trenches, the lower of which proved uninformative. The upper trench, however, approximately 50m. north of the crossroads below the opencast produced evidence of a deliberate clay spread over the natural subsoil. Over the clay surface there still lay, despite damage from modern ploughing, a spread of crushed quartz fragments that were reduced to a width of approximately 0.6cm. (pl. VIB). Undoubtedly, these fragments represent the remains of ground quartz from the basic extraction process and the artificial clay floor may be provisionally interpreted as a working or washing surface. Dr. Lewis' discoveries open up a whole new field of possible exploration but one that can only yield significant results from stripping on a large scale.
