HENDRE QUARRIES: YSTRAD MEURIG QUARRY

REPORT ON ARCHAEOLOGICAL EVALUATION

OCTOBER 1993 PRN 32485

Report by: D G Benson MA & D G Phillips BA
Dyfed Archaeological Trust Ltd
The Old Palace, Abergwili, Carmarthen,
Dyfed SA31 2JR Tel 0267 231667

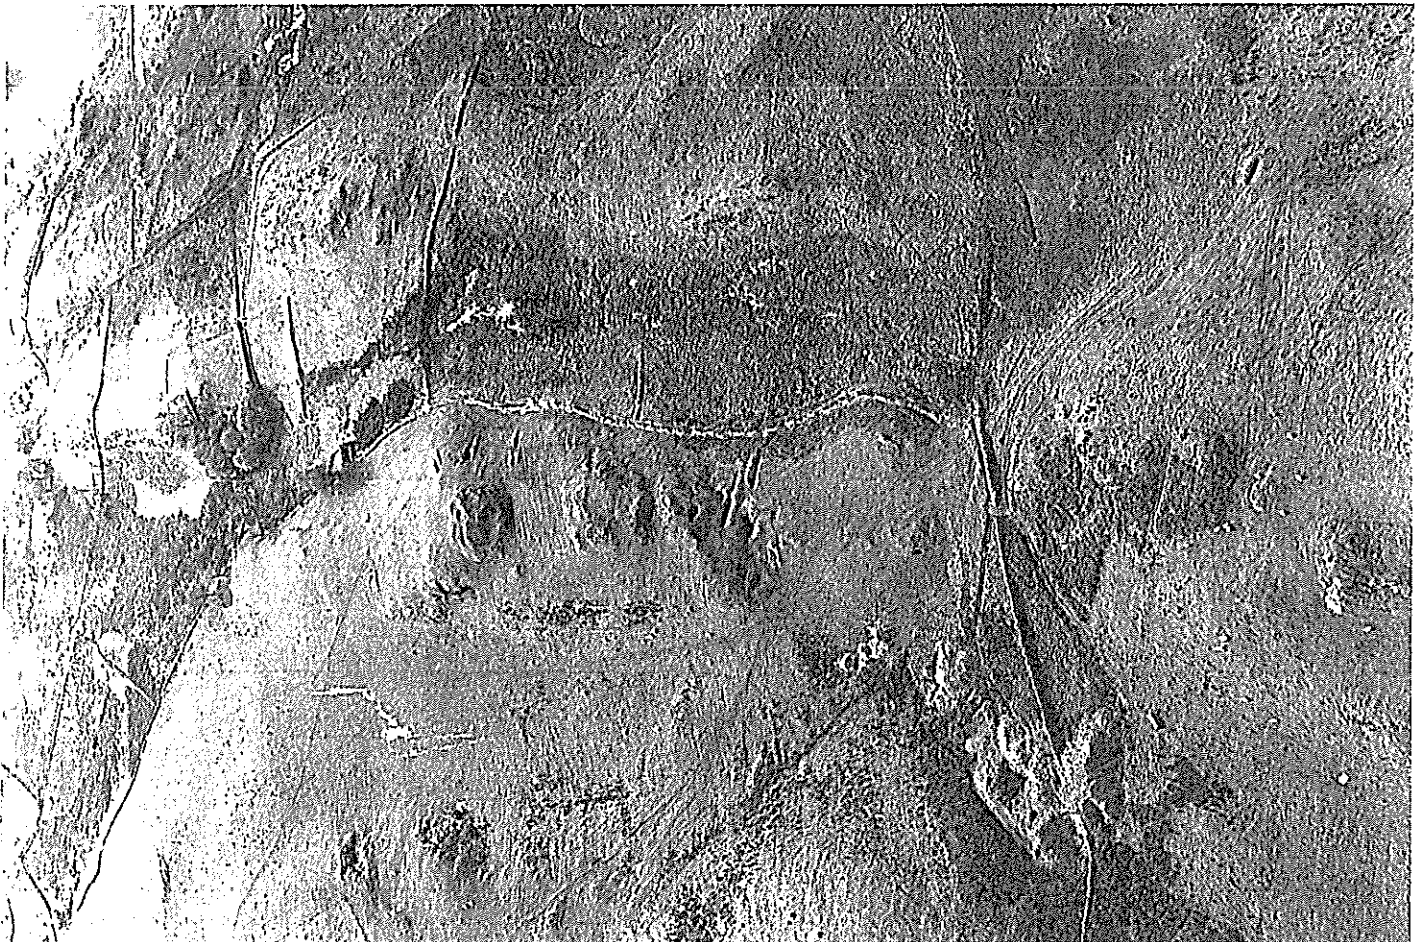
Photo 2. View from N. The north west corner of the application area is on the lower left. Centre, is Area D showing unsurveyed trial trenches. Photograph by C Musson RCAHM 1992. Reproduced by courtesy of RCAHM, Aberystwyth.

This area was not examined in the field. Recent oblique air photographs however show a number of features in this area (photo 1,2). These appear to be trial pits and trenches and should be regarded as part of the mine complex.

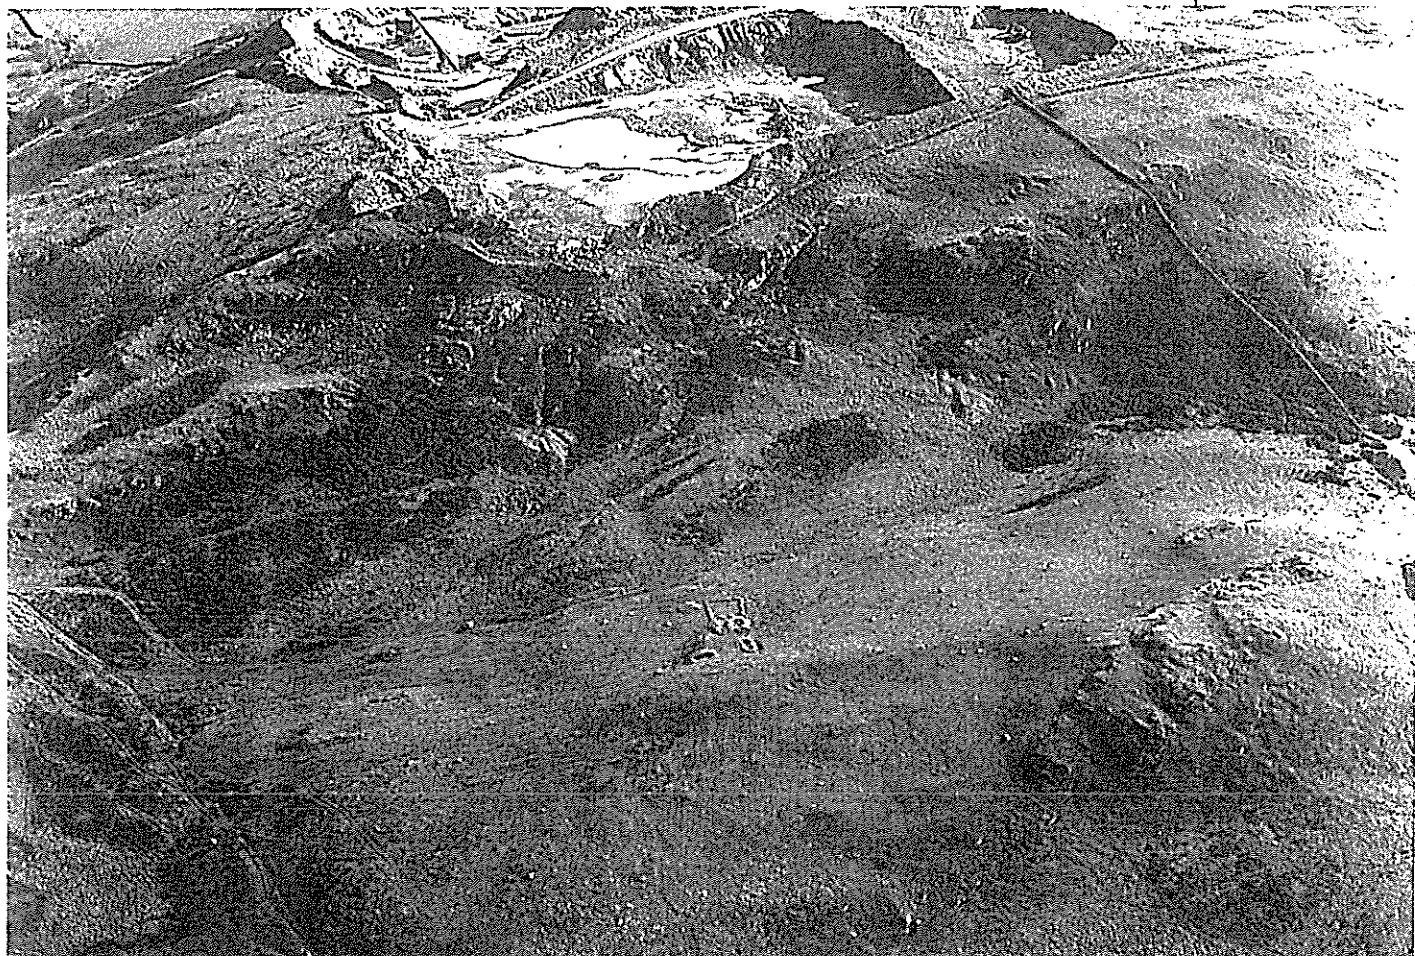
Photo 3. View from NW. Part of the west side of the application area is to the top right. Centre is area C, showing ruined buildings. Photograph by C Musson RCAHM.1992. Reproduced by courtesy of RCAHM Aberystwyth.

In this area (Fig 1, photo 3) are the remains of ruined buildings (20), a possible trial trench (21) and a number of field clearance cairns (22).

traces of cultivation (photo 3), and the cairns noted above probably represent a phase of field clearance. By 1904 at least, the buildings are depicted as roofless (OS 2nd Edit 1:2500).
