LAWRENNY CASTLE & GARDENS

LAWRENNY, PEMBROKE

ARCHAEOLOGICAL DESK-BASED ASSESSMENT

PROJECT RECORD No. 32570

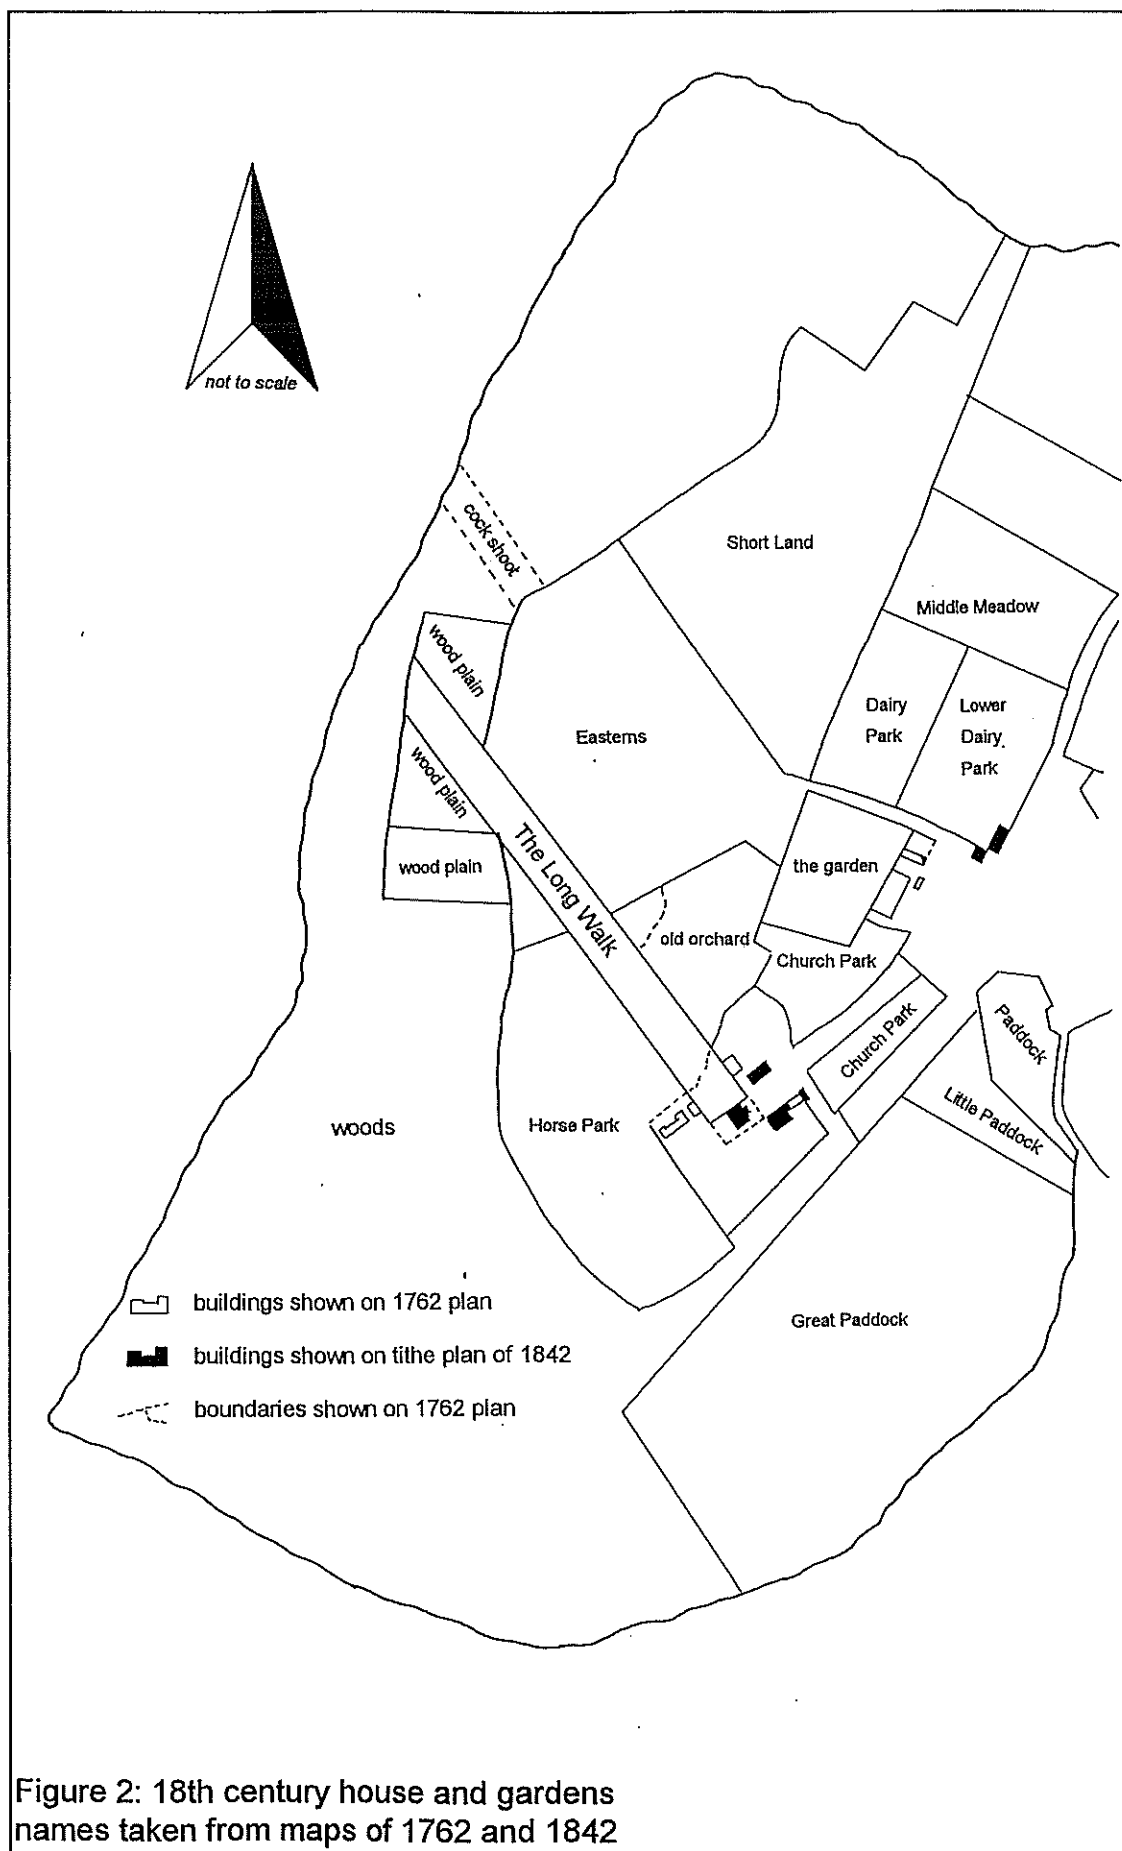
The garden (PRN 32575) constructed to go with the house of 1856 completely disregarded the existing garden. The new garden had a wall and outer ditch (PRN 32572; NGR SN 0147 0687 - SN 0138 0676 - SN 0147 0662) running from the southwest corner of the walled garden to the southern end of the terrace. Although partially overgrown the wall and ditch survive in excellent condition; in places the wall stands to a height of 1.3m. From a large terrace (PRN 32576; NGR SN 0149 0664) on the southeast of the house there are wonderful views towards Black Mixen Rock and the Cresswell and Carew rivers. The terrace also survives in good condition. To the south of the house was a semi-walled lawn. In the wall which has survived, is an alcove, which was possibly a seating point with a clear view down to the rivers. The walled garden (PRN 32573; NGR SN 0154 0695) survives, and even though the internal grid-pattern of paths and beds has been lost there is a chance that it may survive as sub-surface features.

The layout of paths into and through the rest of the garden is traceable, some of it has been incorporated into the car parking space for the picnic site.

The garden (PRN 32575) associated with the house of 1856 completely disregarded the existing garden. The new garden had a wall and outer ditch (PRN 32572; NGR SN 0147 0687 - SN 0138 0676 - SN 0147 0662) running from the southwest corner of the walled garden to the southern end of the terrace. Although partially overgrown, the wall and ditch survive in excellent condition; in places the wall stands to a height of 1.3m. From a large terrace (PRN 32576; NGR SN 0149 0664) on the southeast of the house there are wonderful views towards Black Mixen Rock and the Cresswell and Carew rivers. The terrace also survives in good condition. To the south of the house was a semi-walled lawn. In the surviving wall is an alcove, which was possibly a seating point with a clear view down to the rivers. The walled garden (PRN 32573; NGR SN 0154 0695) survives, and even though the internal grid-pattern of paths and beds has been lost there is a chance that it may be present as a sub-surface feature.

The original house was replaced in 1856 by a large "Victorian Fortress" (PRN 15212) ²⁰⁹⁸⁷ (Lloyd 1986, 73) which was built on what appears to have been the same site. This house lasted for less than 100 years before being demolished in 1954: a photograph (Pembrokeshire Records Office ref: D/Law/125) taken during the demolition shows much of the wood from the house, including a large staircase piled in front of the house, presumably ready to be taken away and reused. It is assumed that when the house was demolished the cellars, which were extensive, were filled with masonry and rubble, and then covered. Some intact masonry is now beginning to show through the turf of the picnic site. This is possibly the tops of the cellar walls, and foundations and lower courses of other walls not totally demolished in 1954. There are also remains of some outbuildings to the northeast of the house; these are now overgrown but some walls survive to a height of c. 1m.
