# THE SEA EMPRESS OIL SPILL

**ARCHAEOLOGICAL ASSESSMENT OF EFFECTS ON INTER-TIDAL  
& SHORELINE FEATURES.**

**PROJECT PRN 35242**

Final Report - June 1997.

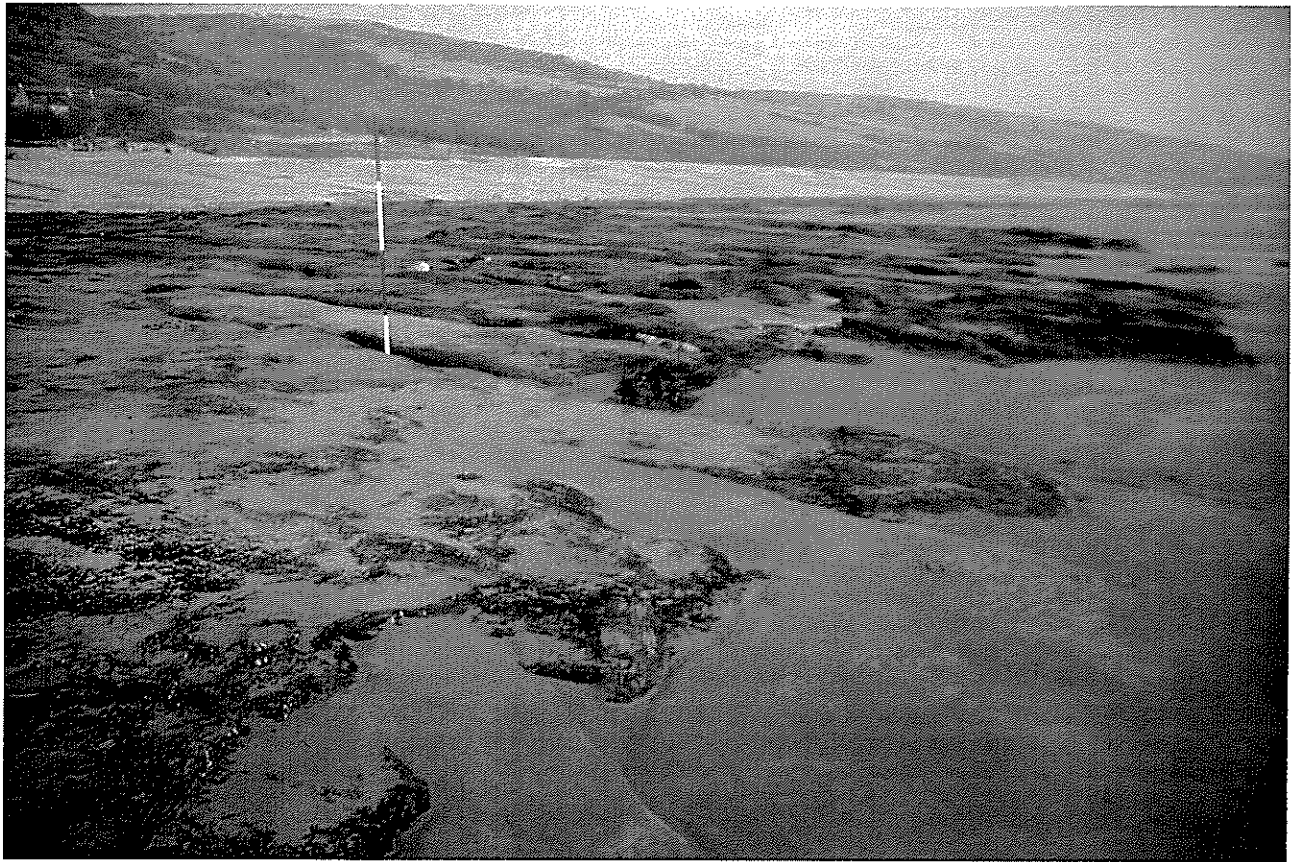
At Marros no damage or change in the condition of the submerged forest (a land-surface of c.3000 BC) was found that could be attributed to the beach cleaning procedures of moving beach pebbles to and from the tide line. (details from the AEA Reports). At Bluck's Pool and Frainslake, strict control of beach access had kept vehicles to the established tracks - a procedure principally intended for dune habitat protection that also protected prehistoric flint working floors and burial sites within the dunes and at the beach head. There has been a change in the condition of the Fish Trap at South Beach Tenby since spring 1995 - no wooden stakes are visible and the stone lines are much spread and broken up. But examination of reports from AEA Technology plc on beach cleaning operations and discussion with Jane Hodges, PCNPA, and Stephen Evans, CCW made it clear that there was no heavy plant operating so close to the low water mark. Changes are therefore attributed to wave action, scouring and sand-movements during the severe storms of autumn/winter 1996. It is a tribute to the handling of the clean-up operations within the massively oiled Tenby Harbour that no structural damage resulted from the deployment of so much heavy plant within confined conditions. No oil was observed on wrecks in Milford Haven, but heavy oiling of the seabed and around the remains of *HMS Tormentor* was recorded by NAS divers.

*Fig 3(a): Photo(s) of submerged forest, Marros Beach 11th March 1997, general view.*

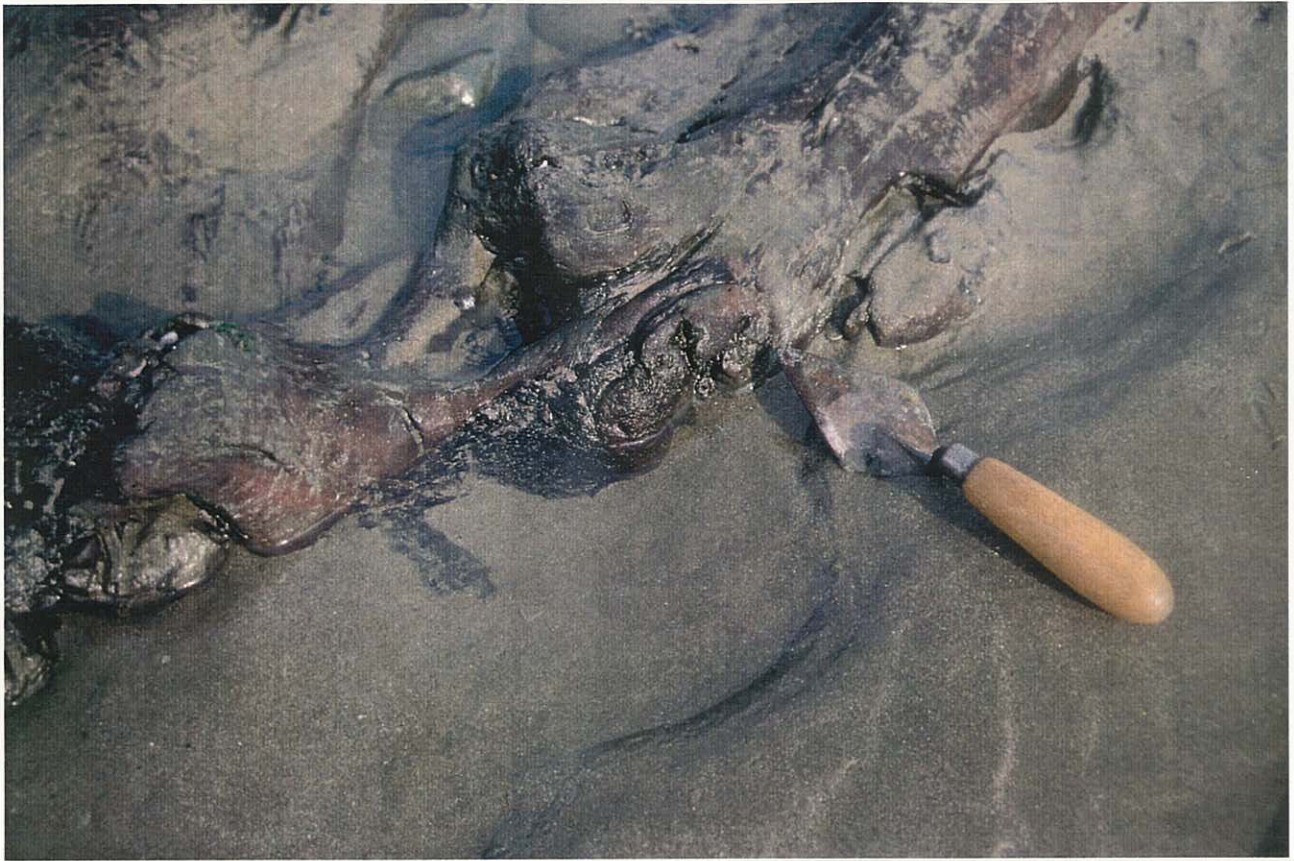
*Fig 3(b): Submerged forest, Marros Beach, 11th March 1997, detail of tree root.*

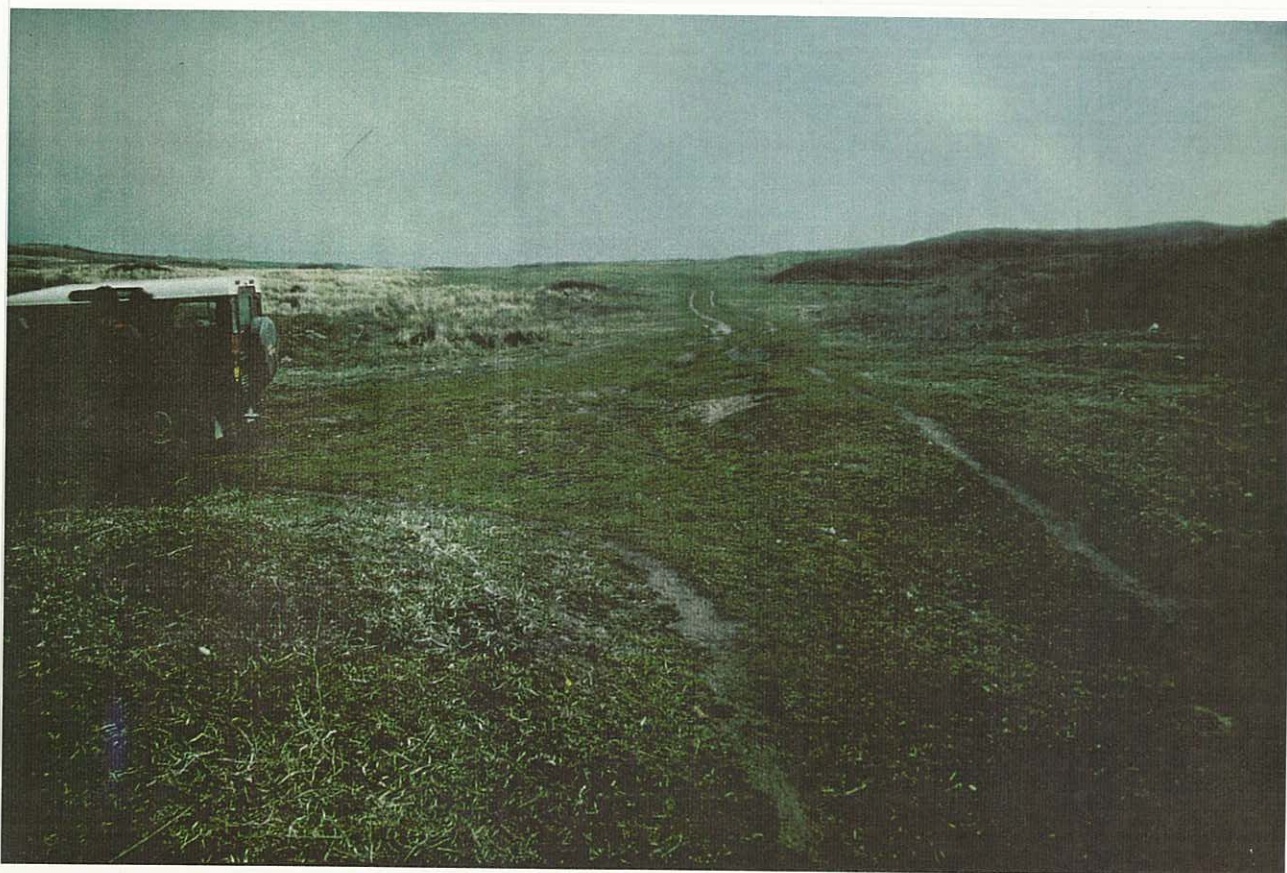
*Fig 5: Photo of access track to beach, Bluck's Pool, showing no difference in condition between foreground where no clean-up vehicles went, background when all traffic came in.*

The oiling was severe, but affected material was removed by manual bagging. No detrimental effect on archaeological sites and horizons from oiling or clean-up were identified.

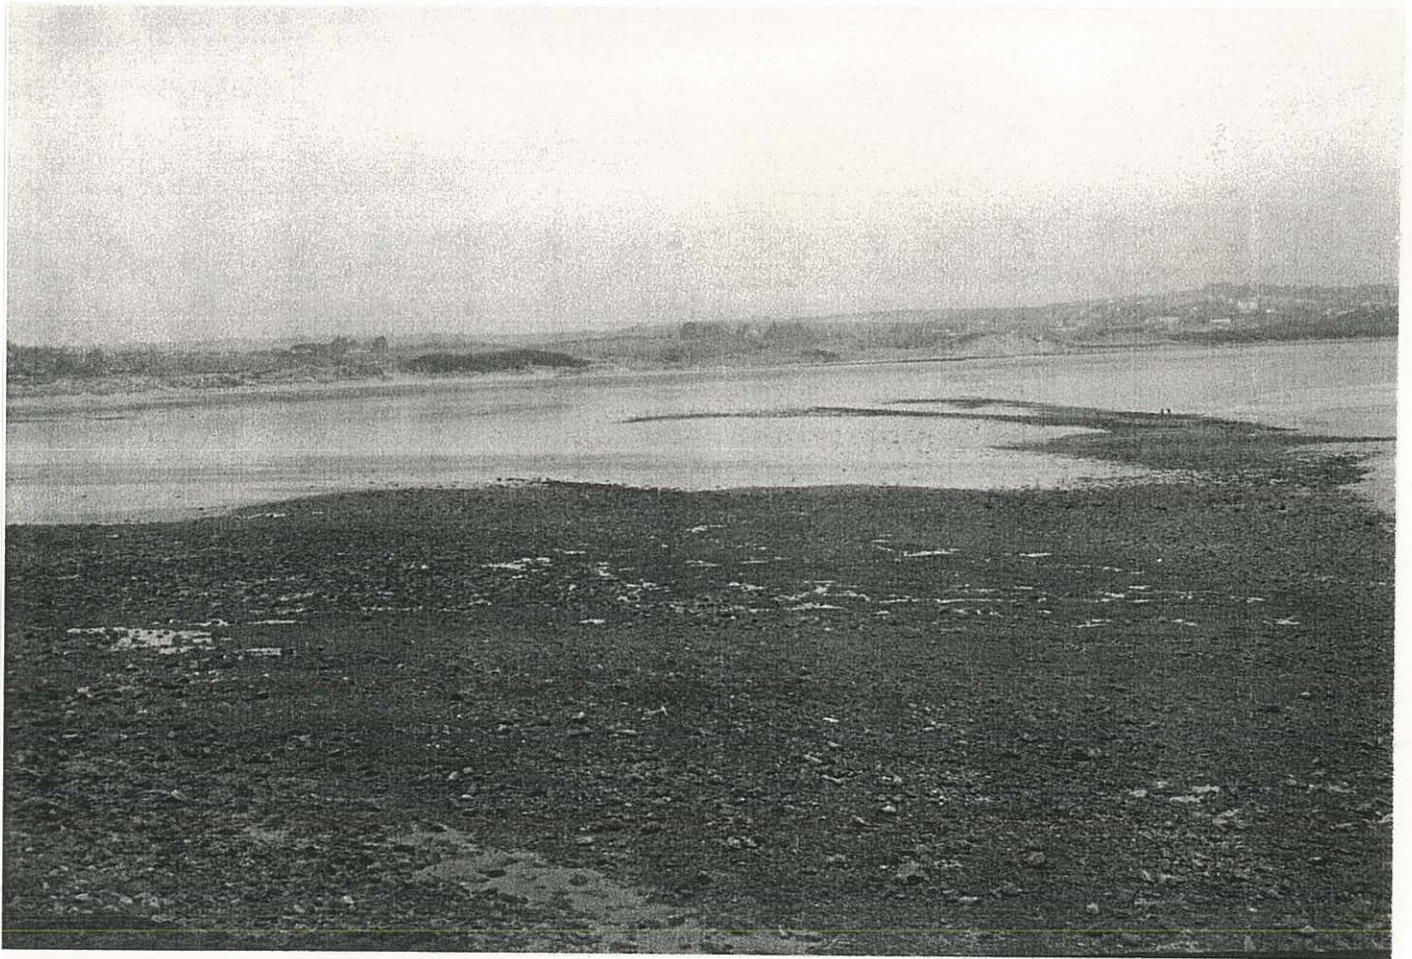
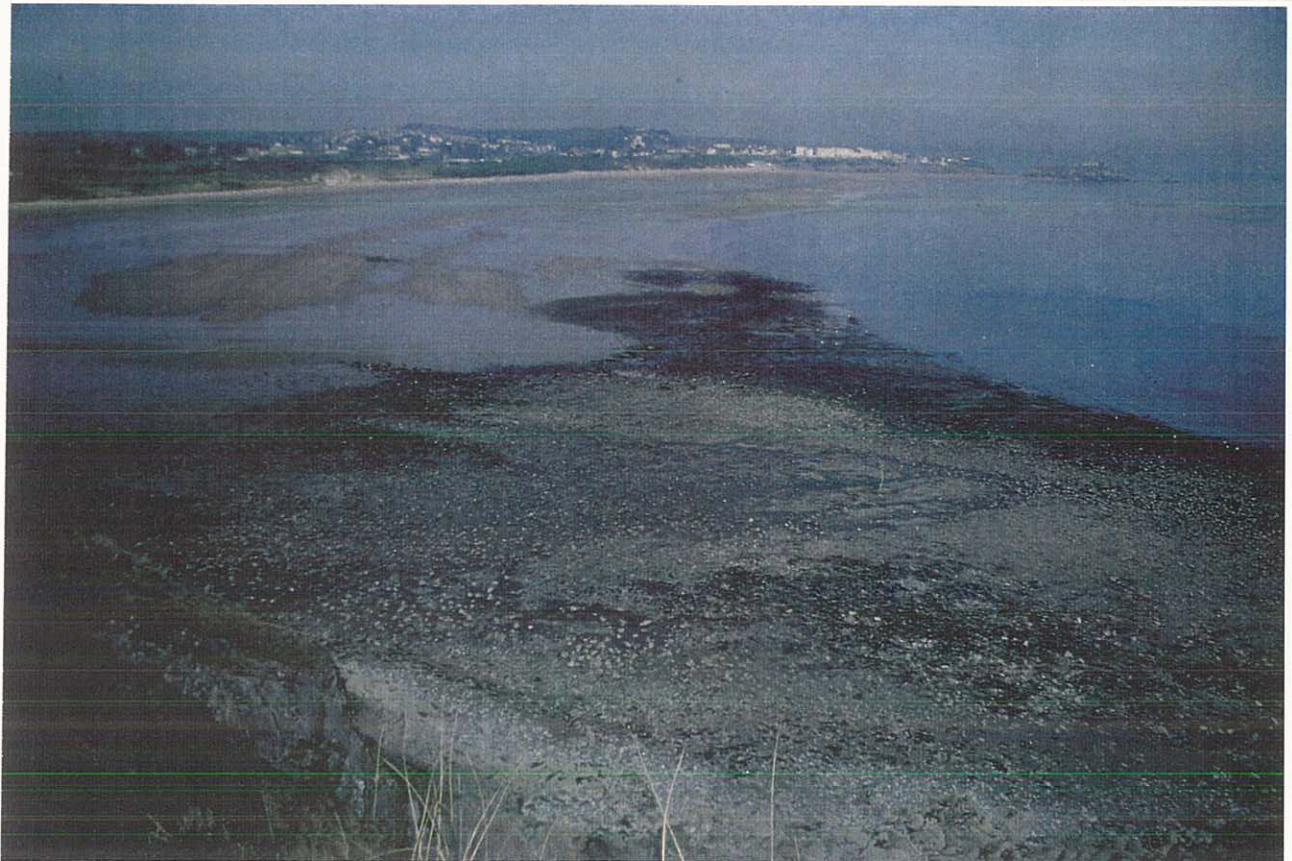
*Fig 8: Photos, Fish trap. South Beach Tenby from Giltar Point - top in February 1995, bottom in March 1997*

The first visit after the *Sea Empress* oil spill was made to the site in poor weather conditions at low water springs, when no stakes in the trap walls were visible, nor any continuous lines of stones discernable. A second visit in clear, calm conditions at low water springs on 9th April 1997 allowed a more extended inspection. This confirmed that the trap was no longer visible in the form recorded by Gale and Fenwick. No stakes were visible and instead of a line of stones there was a line of three low, oval heaps of stone. Colour slides were taken from sea level and from the elevated, though distant position of Giltar Point itself.

North and South Beach Tenby were both heavily oiled, but the southern end of South Beach not so totally as North Beach. Since the use of heavy plant in moving oily 'mousse' from the strand line to collection sumps had been observed on the beaches by the author of this report in March 1996, it was considered possible that the fish trap might have been disturbed by machine action. However, information from J. Hodges (PCNP) and S. Evans (CCW), subsequently confirmed by the AEA reports recently received confirm that there was no heavy plant operating so distant from the high water mark. It is concluded therefore that the damage to the fish trap is due to wave action and scouring during the severe storm of 8th Oct. 1996. There may have been sand movement to bury the stakes observed by Gale and Fenwick; further monitoring could provide answers (see recommendations)

It is recommended that the fish trap at South Beach, Tenby be monitored by means of two visits p.a. at low water springs early and late in the year in autumn/winter 1997; spring 1998 and later in 1998 to establish whether there is a cycle of exposure and besanding.

It is recommended that a radiocarbon determination be carried out on the sample stake from the fish trap, to indicate the date of the feature. If it were of early medieval date, statutory designation might be justified.

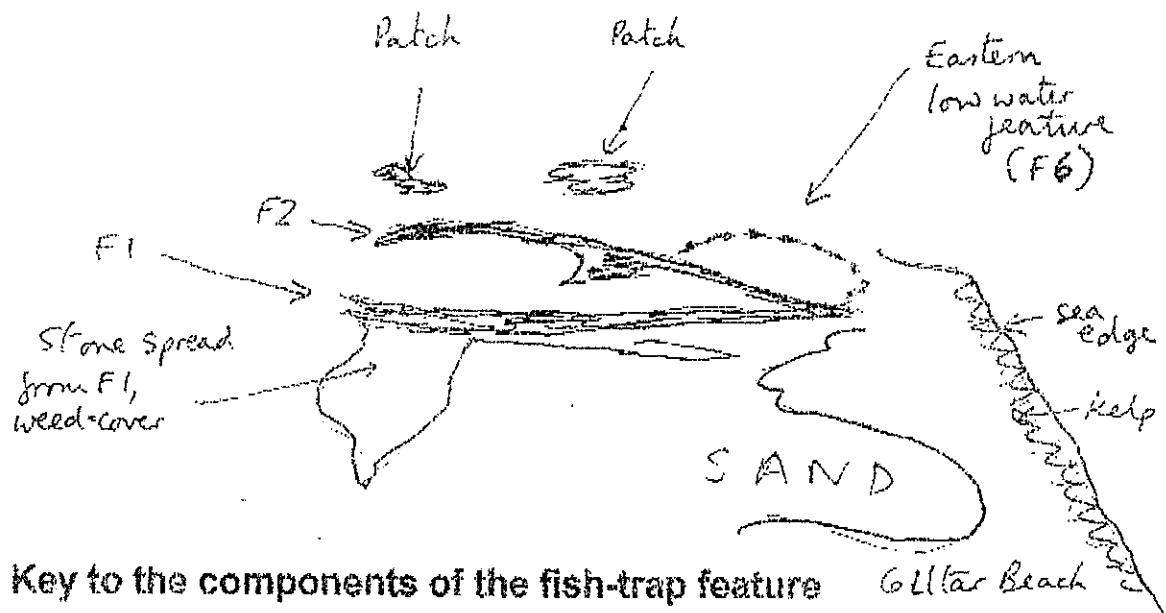
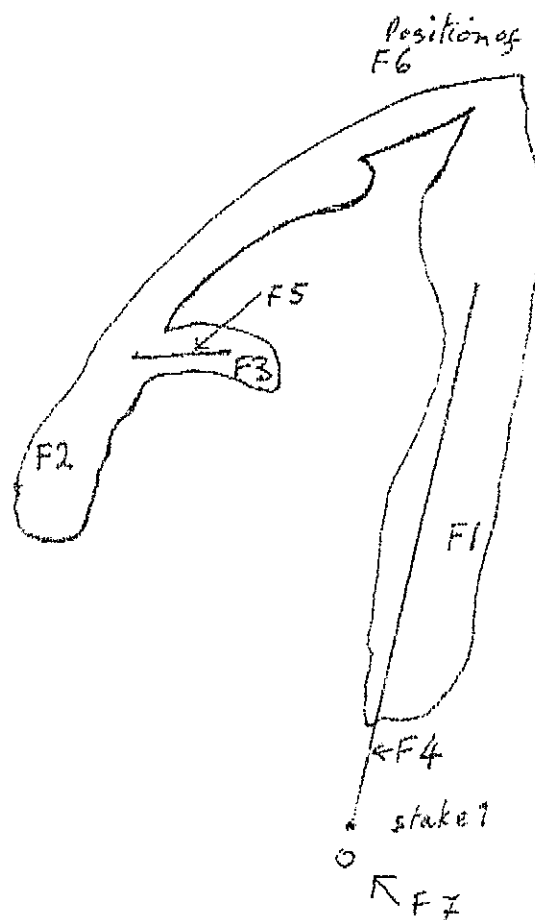
Fig. 9: Sketch Plan of fish trap prn 30040, courtesy of V. Fenwick.

Sketch of the Fish-trap feature from Giltar point looking north  
at low water springs on 15 April 1995

In February 1995 and 15th/18th April 1995 at low water springs, Gale and Fenwick recorded, planned and photographed a 'V' shaped arrangement formed by worn beach pebbles and boulders with some more angular stones (fig. 9), measuring some 125m. x 47m. overall. On both occasions the mobility of the beach was noted, since material was rearranged and sand both accumulated and was dispersed between tides. The western arm (F1) seemed better preserved than the eastern (F2). This latter feature had a curving line springing from within the 'V' shape (F3). Lines of wooden stakes were noted and recorded and samples taken where possible from F1 and F3.

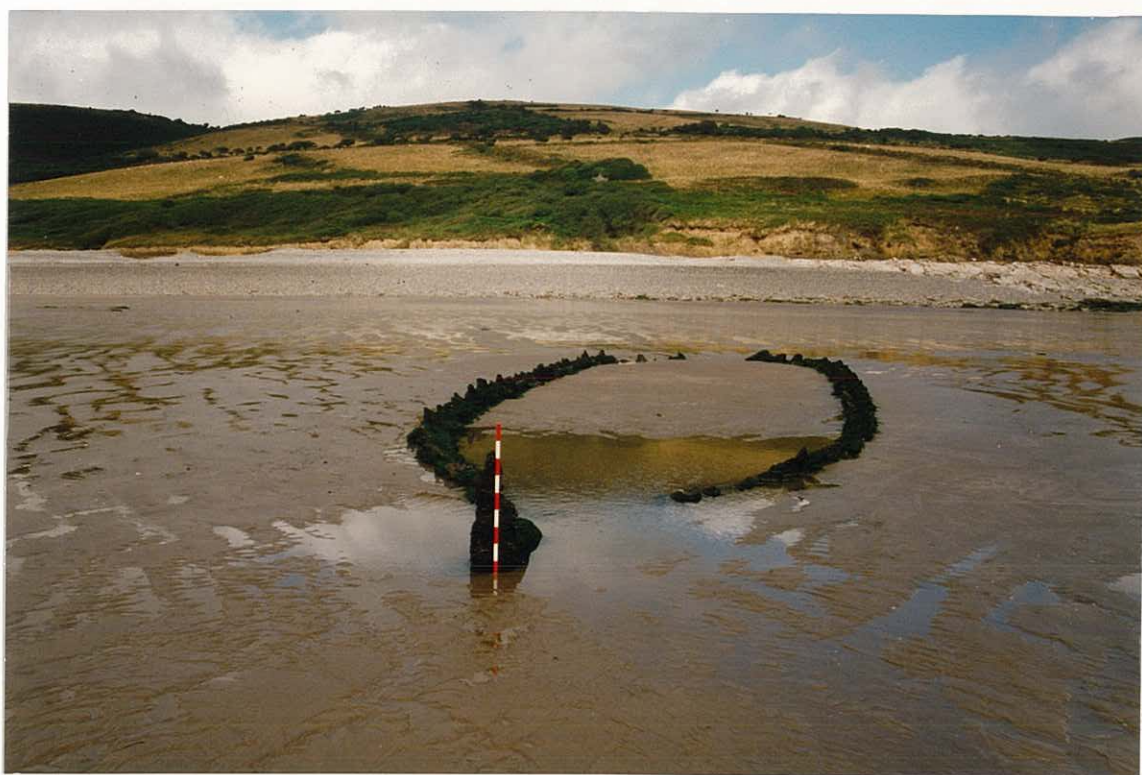
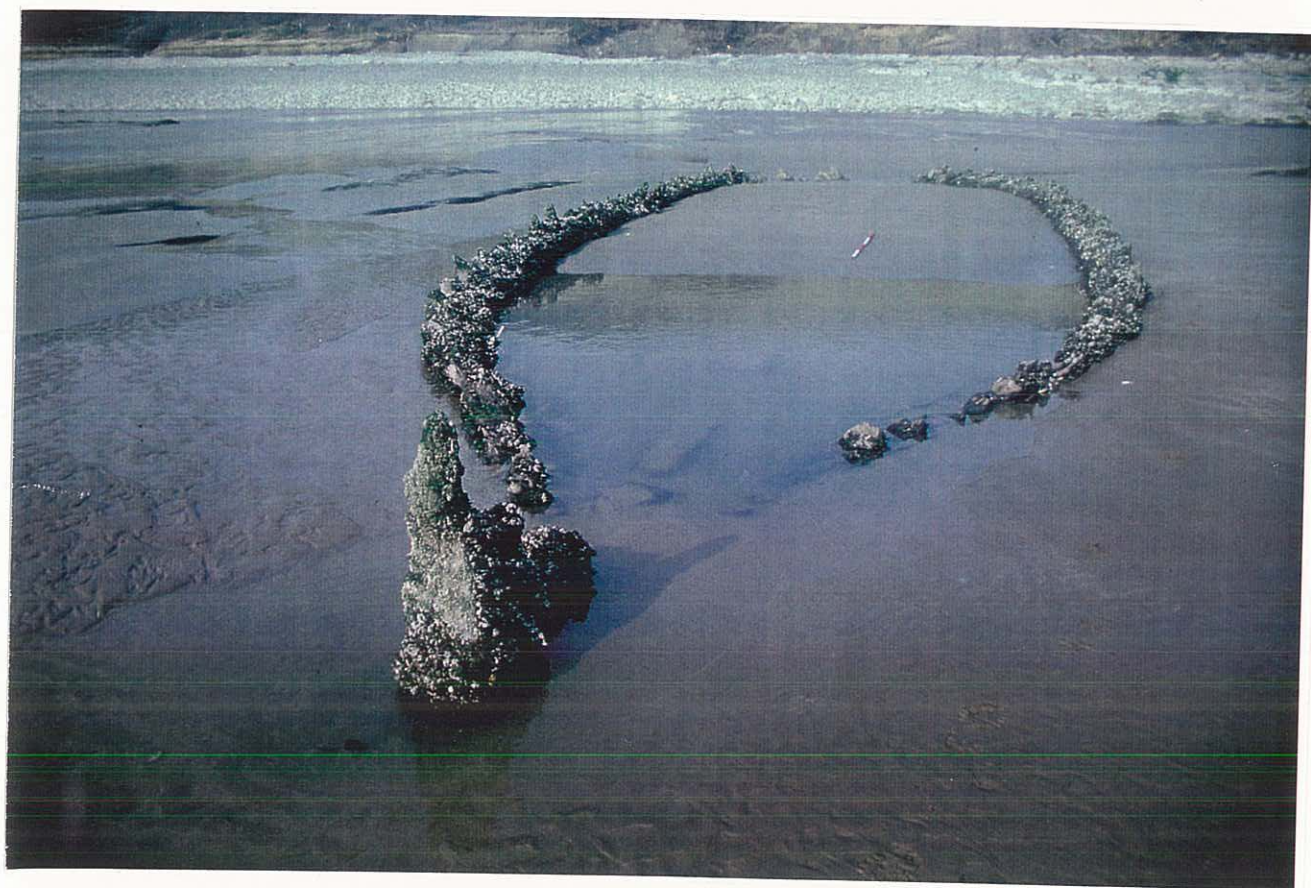
*Fig.10: Marros Beach wreck. (Treviga) top, in August 1993, bottom, March 1997*

On Marros beach, the sides and stern of a wooden, iron fastened ship of heavily laid up construction is visible with the bow either broken off or buried pointing towards the beach. The wreck is some 23 m. long and 5.5 m. long. She is said to be the *Rover*, wrecked in the 1870s and is exposed between tides. (prn 26518, SN212072).

No damage was identified to the inter-tidal and foreshore wreck sites of Pendine, Morfa Bychan or Marros. (see note for Marros submerged forest on clean-up operations.)

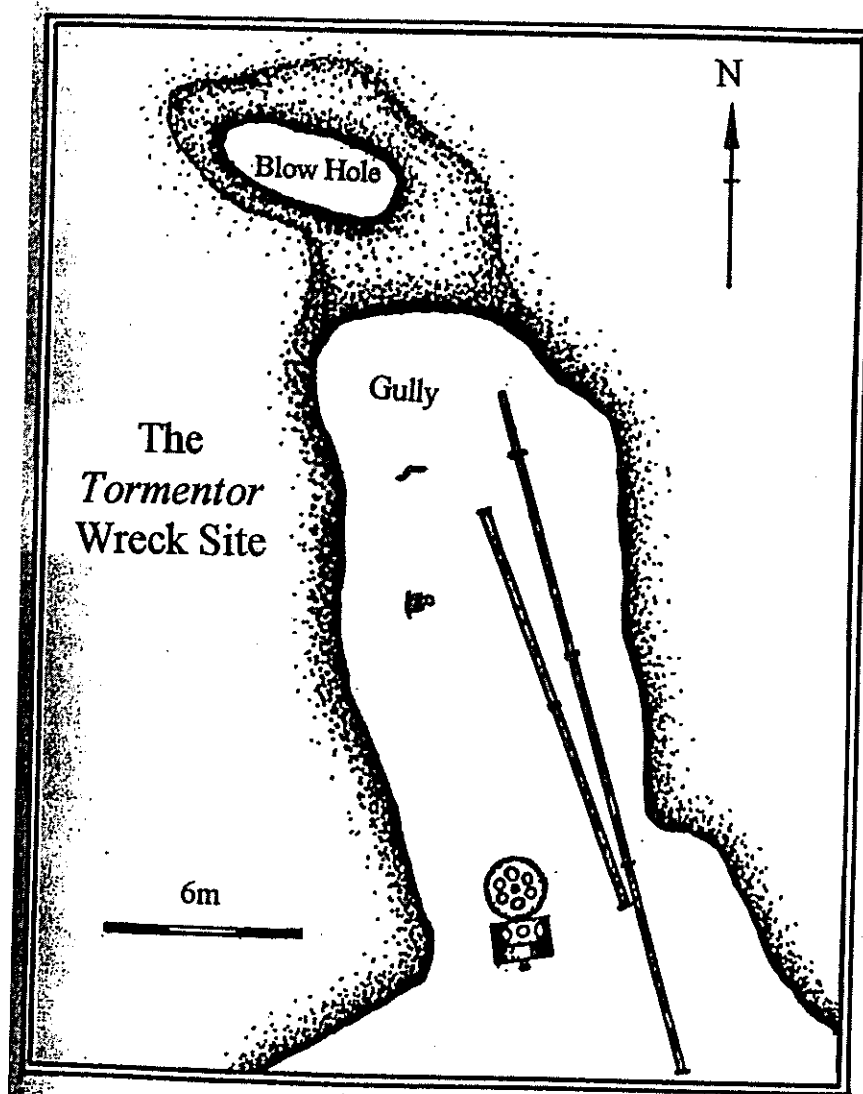
*Fig 12: Plan of HMS Tormentor wreck site, courtesy of the Nautical Archaeology Society.*

HMS *Tormentor* was built in 1916 and wrecked in 1923 on the cliffs near Manorbier. Today she is very broken and scattered in several adjacent gullies at the foot of the cliffs. Reproduced here is the NAS plan of the gully where many artefacts remain. Two large fly wheels are evident with a number of brass flanges and casings protruding from beneath the sand. Two propeller shafts lie along the gully, terminating near the entrance to a cave, where a number of items still remain. Much of the site however has been salvaged and many artefacts have been raised. The gully shown in the plan is some 20 m. long and 7-8 m. wide. The water depth is only a few metres at low water, but this is enough to cover the walls of the gully making it almost invisible from the surface.

On 15th September 1996 two dives were performed on HMS *Tormentor*. The aims of the dive were twofold. First the site was inspected for any signs of pollution resulting from the Sea Empress oil spill. Secondly a limited survey was conducted and a number of measurements were recorded. From this, a scaled plan was possible of an area within the wreck site. A number of photographs were taken to give an impression of site conditions and the preservation of artefacts therein. An inspection within the cave revealed a black deposit on the sea-bed, covering an area almost 2 m. square. Photographs were taken and a sample was retrieved for analysis\*

Whilst there does not appear to have been any damage as such to the wreck sites on the basis of the limited information from the sample dives, the lack of any subsequent monitoring means that it is not possible to arrive at a final conclusion on the impacts, if any, of the underwater archaeological resource.

It is recommended that a programme of dives be carried out in 1998 off Manobier, in and around Caldey Sound and Lydstep Ledge to compare wreck and seabed conditions with those on the sample dive.

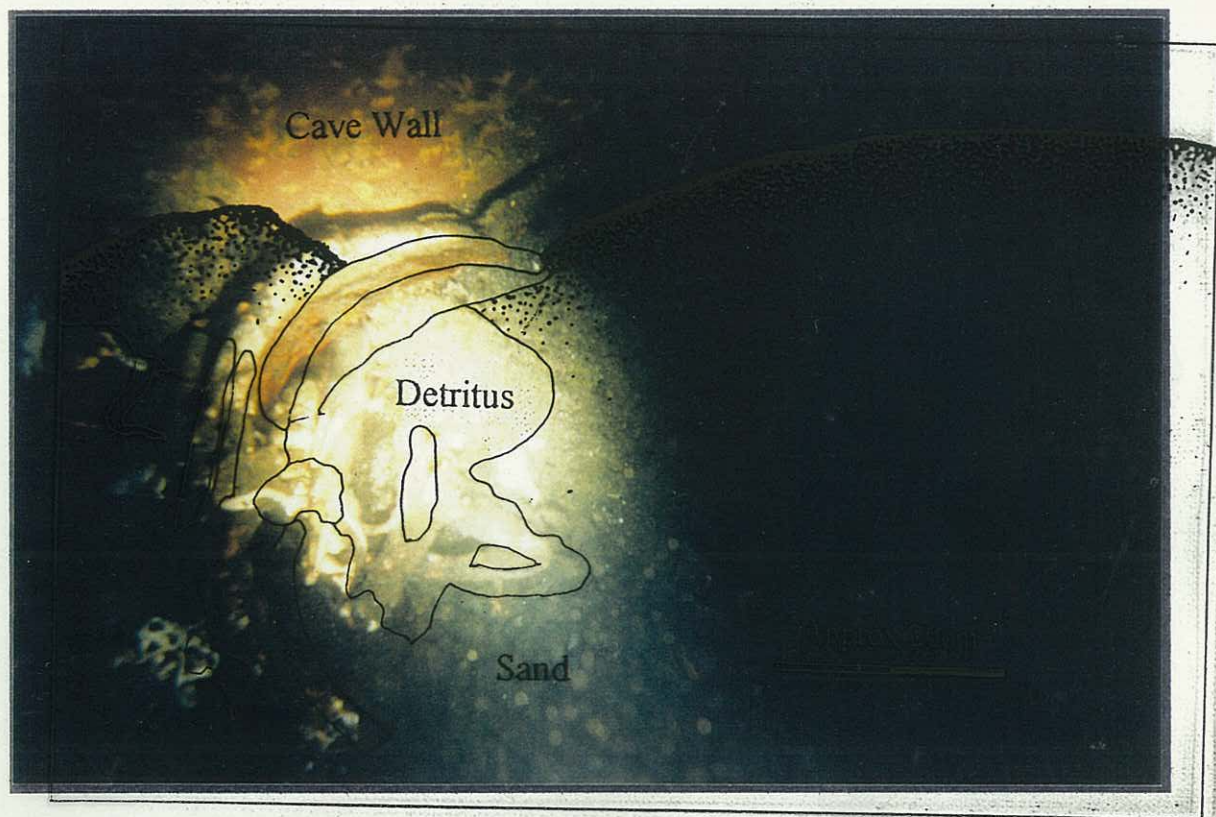
The torch illuminates dead crabs on the black, possibly oil stained sandy cave floor.

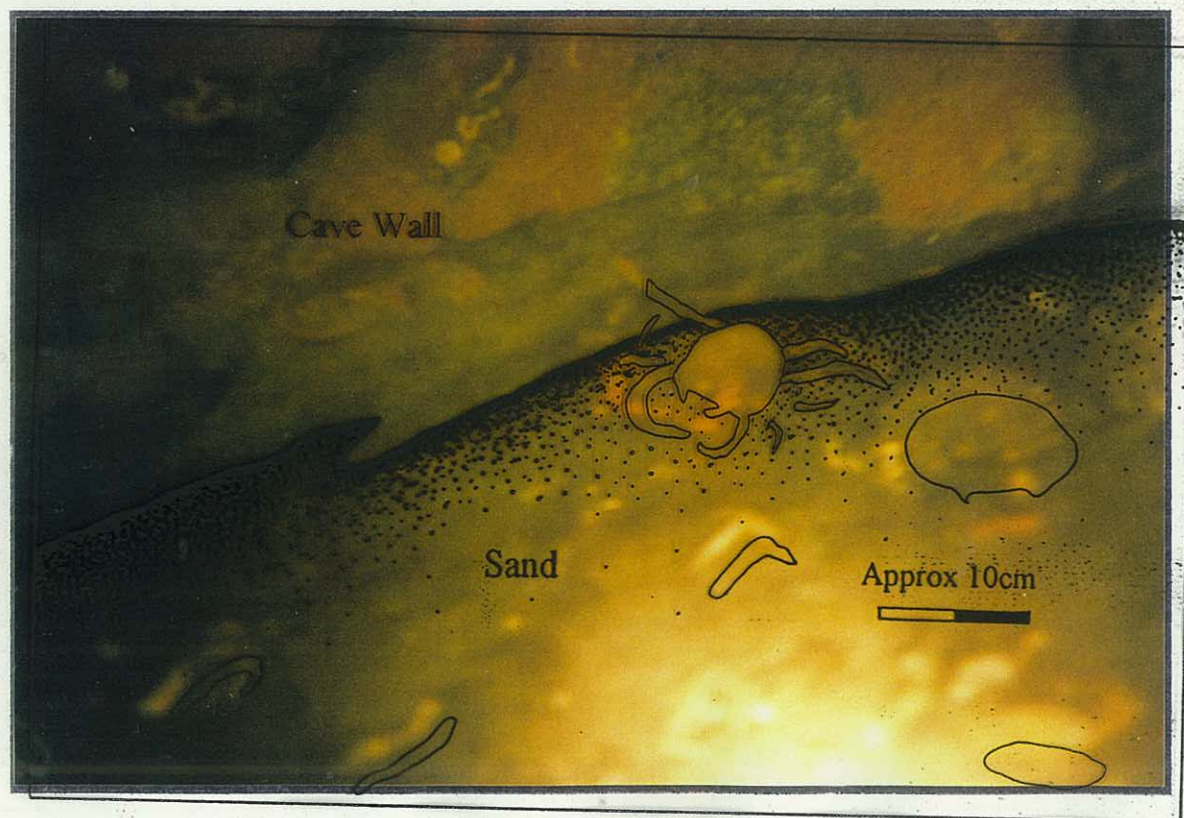
The black, stained cave floor is evident against the back of the cave.

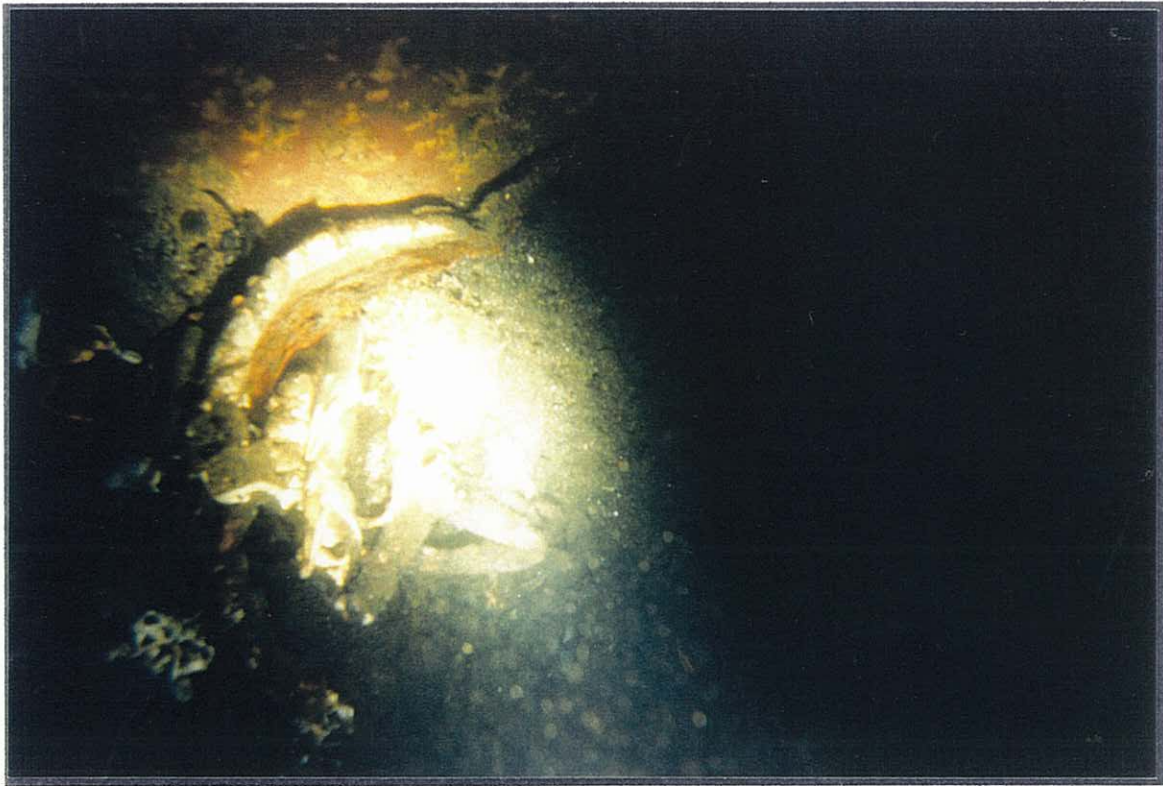
The torch illuminates dead crabs on the black, possibly oil stained sandy cave floor.

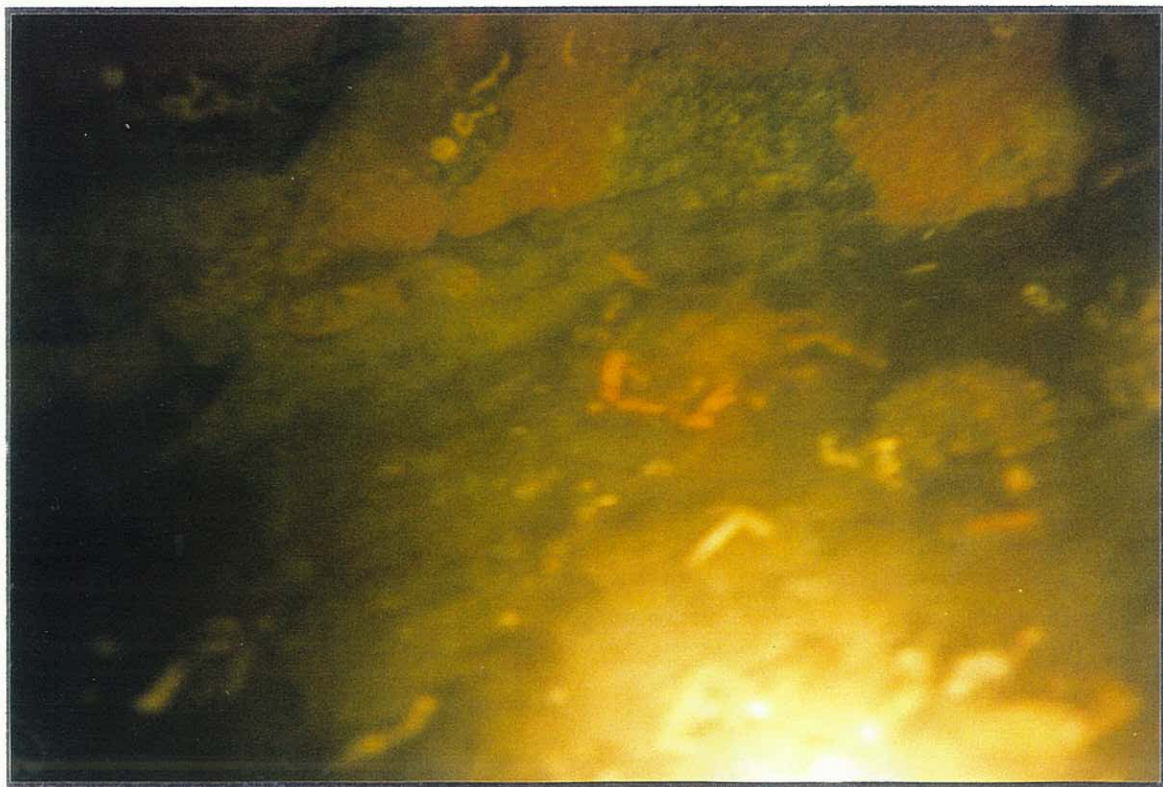
The black, stained cave floor is evident against the back of the cave.
