**THE BOX, ADPAR  
NEWCASTLE EMLYN  
CEREDIGION**

ARCHAEOLOGICAL RECORDING

DAT Primary Record Number 35706

February 1998

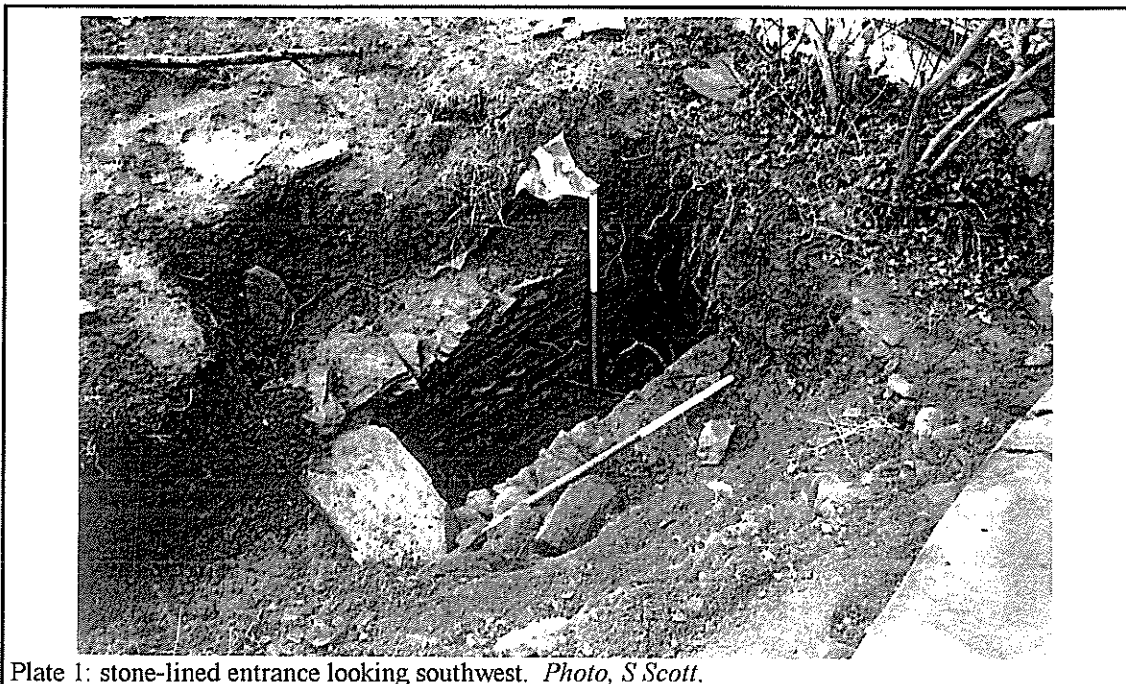
The passage was constructed from faced stones; this stone facing survived to 8 courses high on its southern side and 7 courses high on its northern side. It may have originally been capped, but it was disturbed during the 19th century when a retaining wall was constructed around the back of the house. The passage appeared to have been filled with rubble during construction of the retaining wall.

Plate 1: stone-lined entrance looking southwest. *Photo, S Scott.*

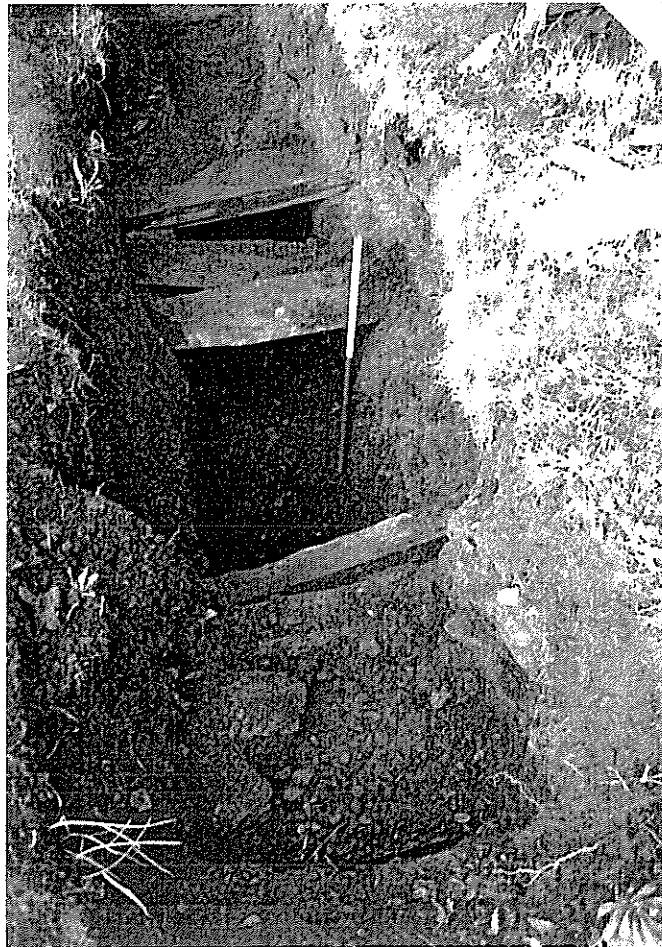
Plate 3: The chamber looking east. *Photo, S Scott.*
