Tro'r Derlwyn
Upland Farmstead
Near Brynamman, Carmarthenshire
1998

Project Record No. 35896
June 1999

Report by:
D Benson and P Crane *of*
Archaeoleg CAMBRIA Archaeology
The Shire Hall
8 Carmarthen Street
Llandeilo
Carmarthenshire
SA19 6AF

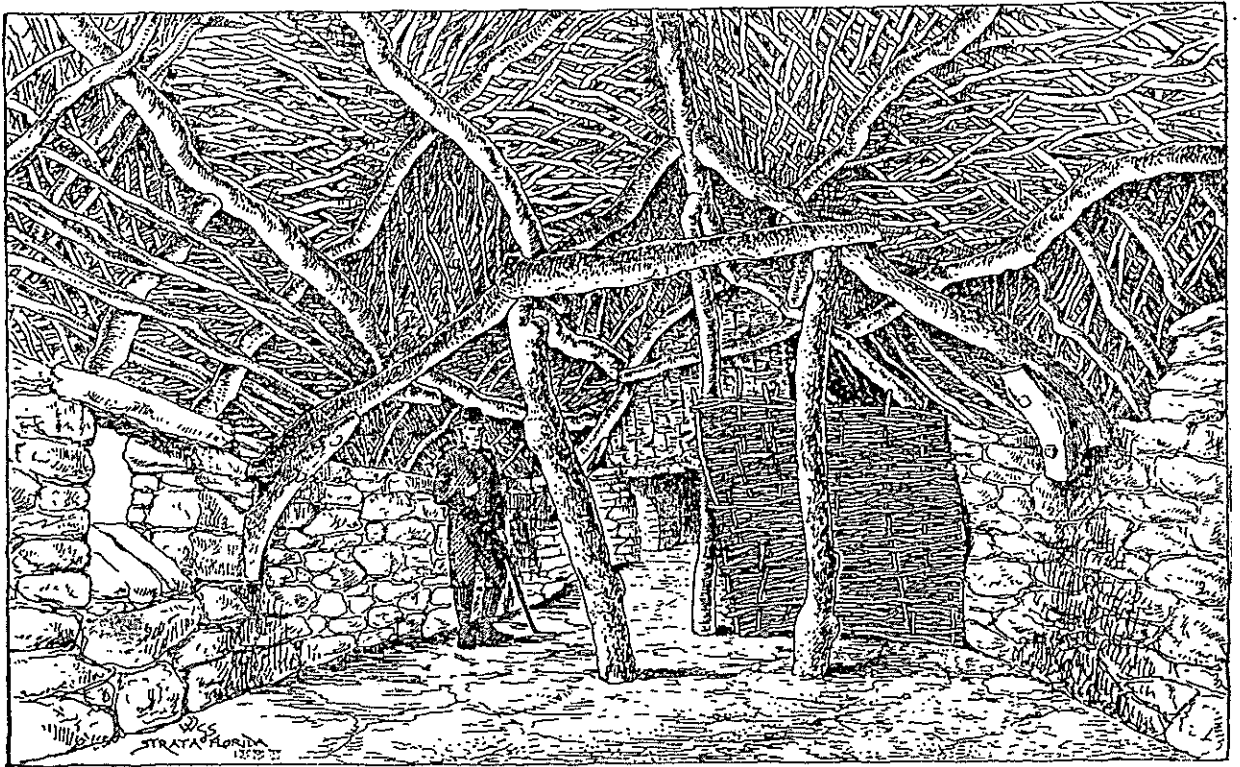
Figure 6. Farmhouse, Strata Florida, Carmarthenshire: interior (Peate 1946, p125-7)

The walls of all of the cells appeared to have been very low, although the north cell may have been higher than the others, but this does not preclude all three cells being roofed. Low walls are clearly illustrated by the drawing of the interior of a farmhouse near Strata Florida, sketched in 1888 (figure 6) (the picture also demonstrates the potentially negligible archaeological evidence for such features as internal wickerwork partitions). No evidence for roof supports or roof covering was found. The roofs were possibly thatched or more probably covered in turfs.

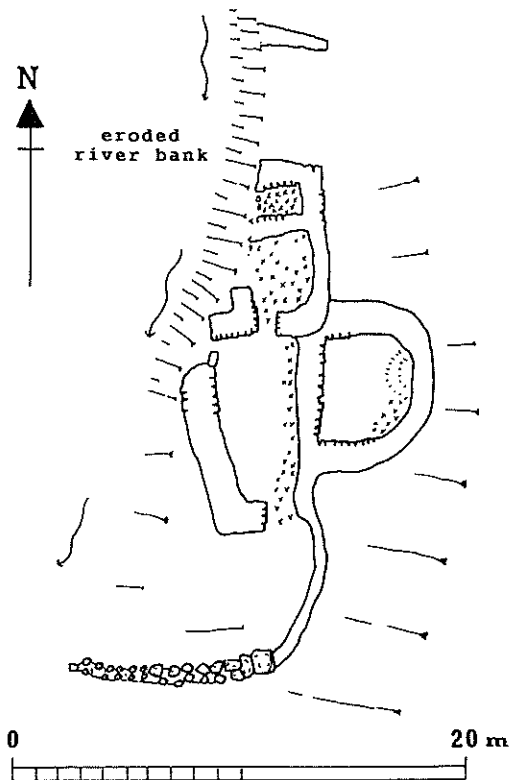
Figure 7. Tro'r Derlwyn house (Ward 1995, p28)

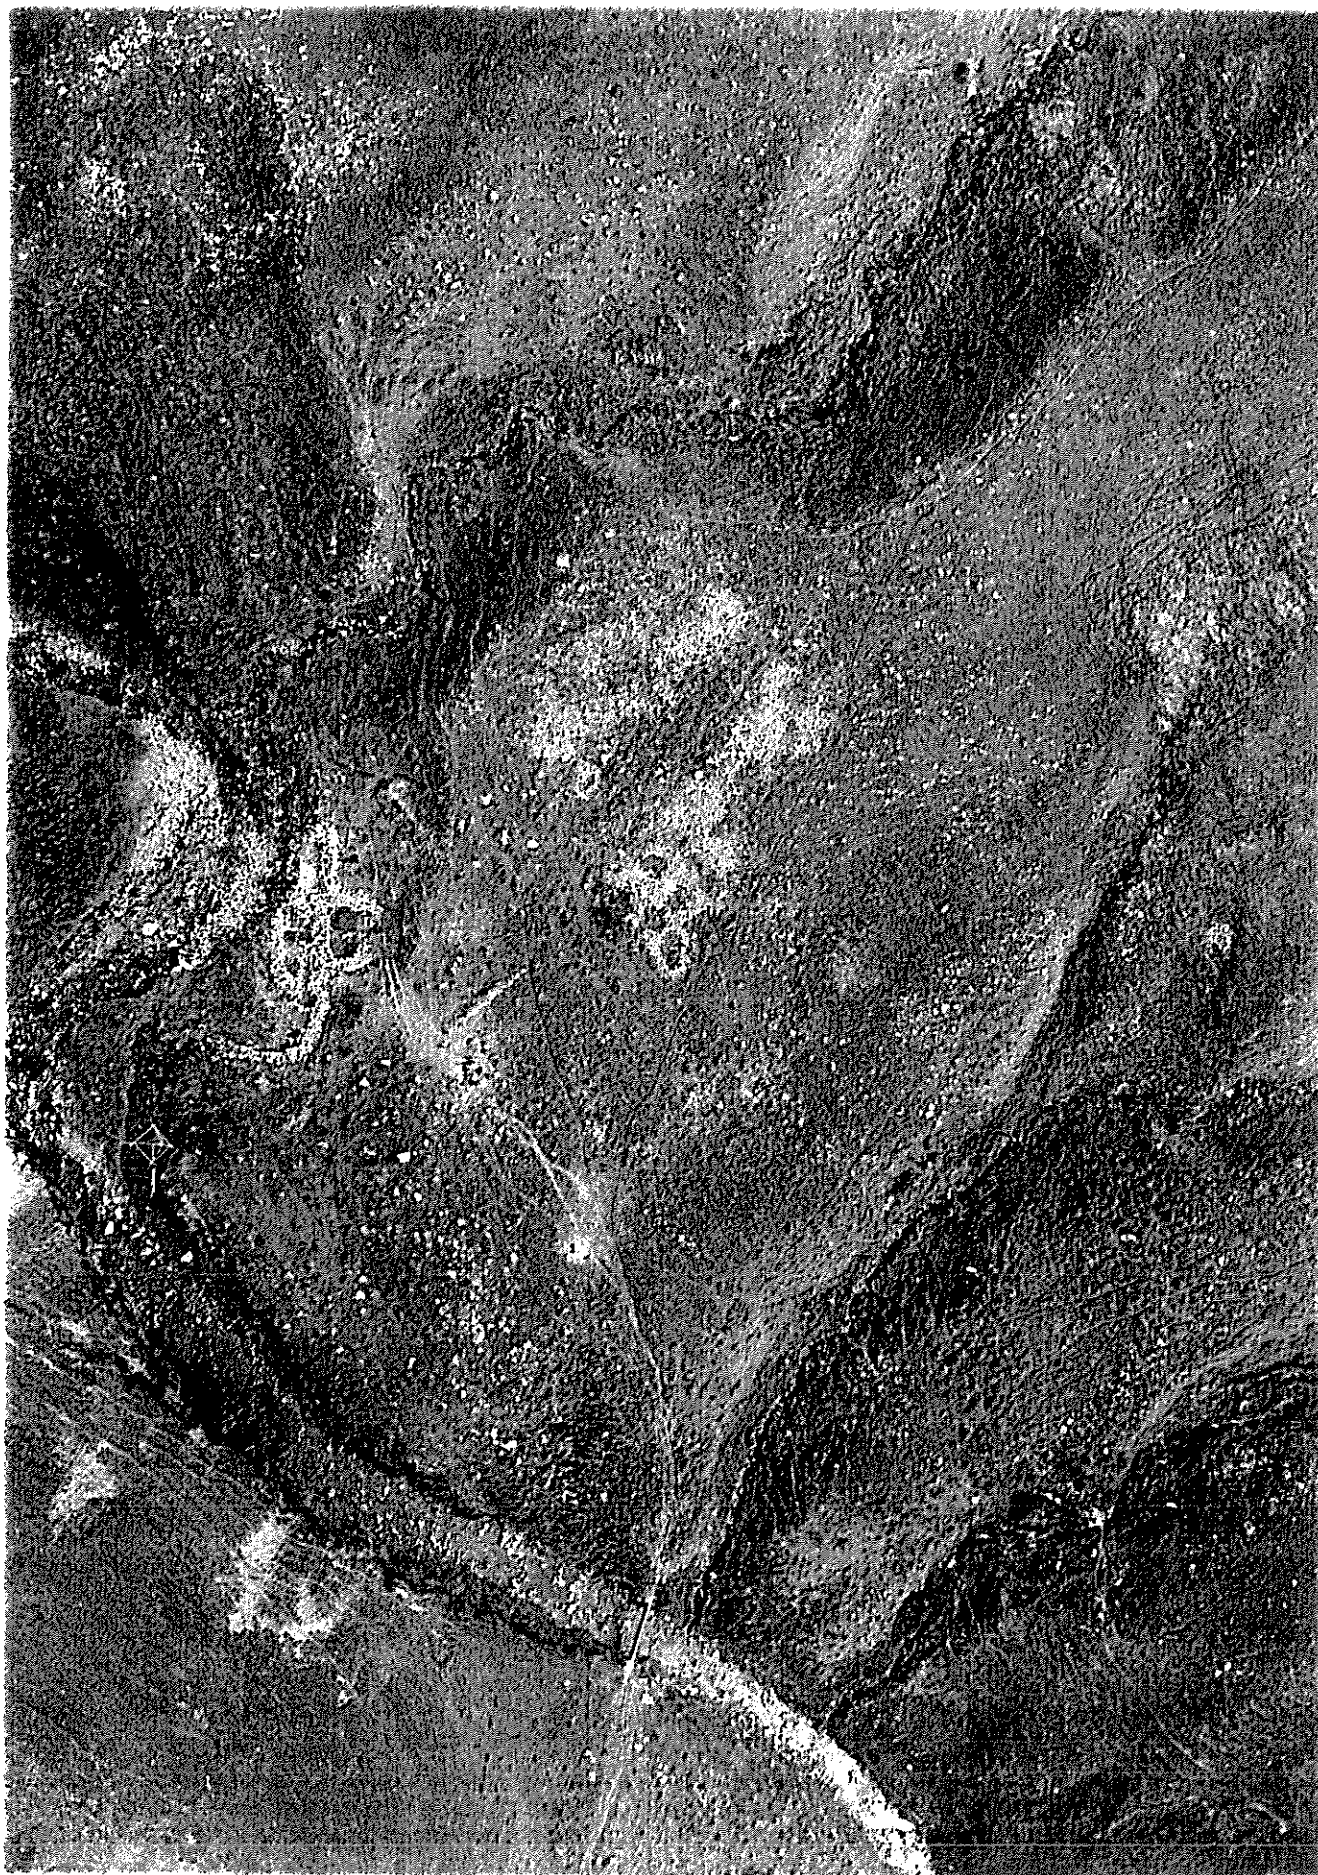
Plate I

Tro'r Derlwyn, aerial view, north to top. RCAHMW©

A low level aerial photographic record was made by the Air Photographic Unit of the RCAHMS at Aberystwyth, which was then rectified (plate I), using data supplied from the EDM survey. The results indicated some possible turf covered walls and plots that appeared to have been cleared of stones (A-F figure 4).

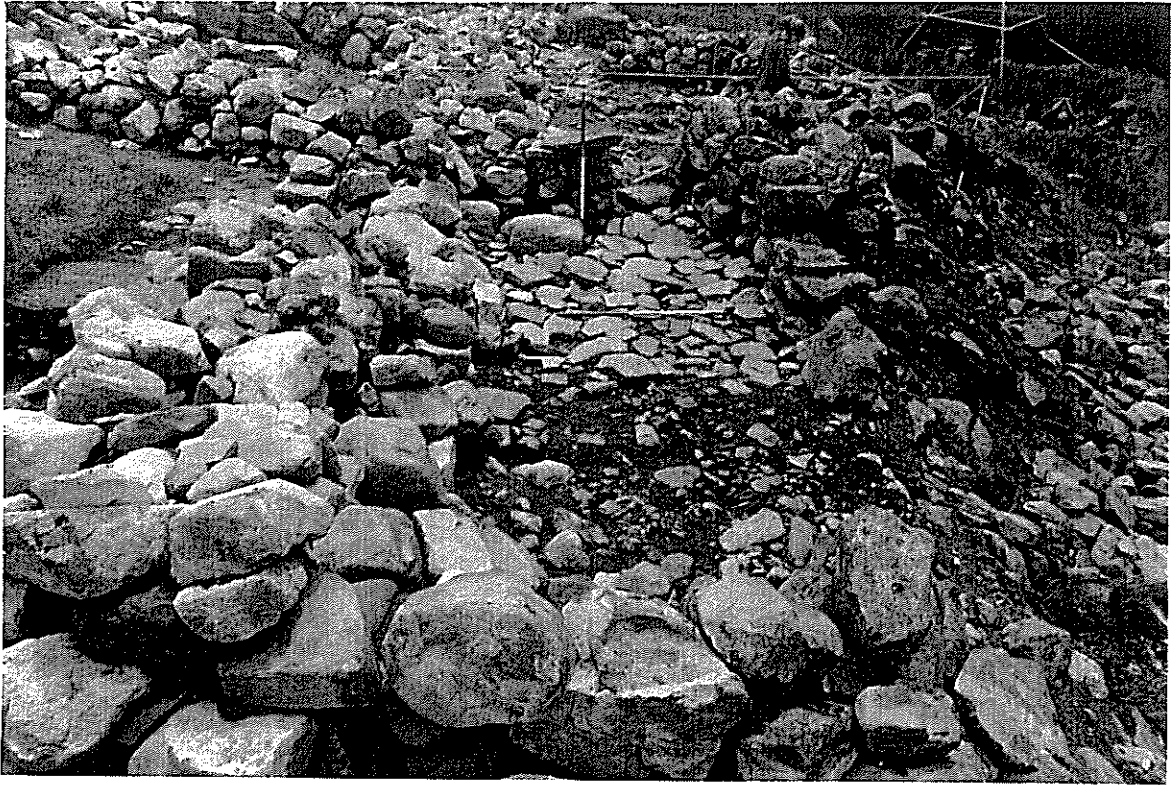
Plate II.

Cell 106, extent of excavation, view south

The west wall (121) had, for most of its northern part, been badly affected by the erosion of the river bank (plate II). The surviving portion appeared to be entirely of dry-stone construction, unlike the northern and eastern walls. The northern end of the west wall (121) stood on the upper geological deposit (133*), where this had been cut (162) to form a platform. The southern end may have been built over a different deposit although, as the wall was not dismantled, it was not possible to ascertain whether this was a natural layer or an artificial deposit. A short section of the east-west wall (138) appeared to butt the southern part of the west wall (121); however the upper section of both of these walls appeared to be contemporary. There may have been some later alterations to, or rebuilding of the northern upper part of this wall, although this area had partly collapsed.

There were two apparent layers of rough flat flagstone flooring, although the lower (144)(plate II) and upper (112*)(plate V) layers could be a levelling layer and surface stones respectively. The lower layer of flagstones appeared to lie below parts of the interior edges of the adjacent walls. The flags were possibly inserted under the lower edge of the eastern wall (119) or the wall had shifted slightly (see above). The southern and western walls (120 and 121) are unlikely to have moved but were thought to be a later rebuild, although there was no conclusive evidence for this.

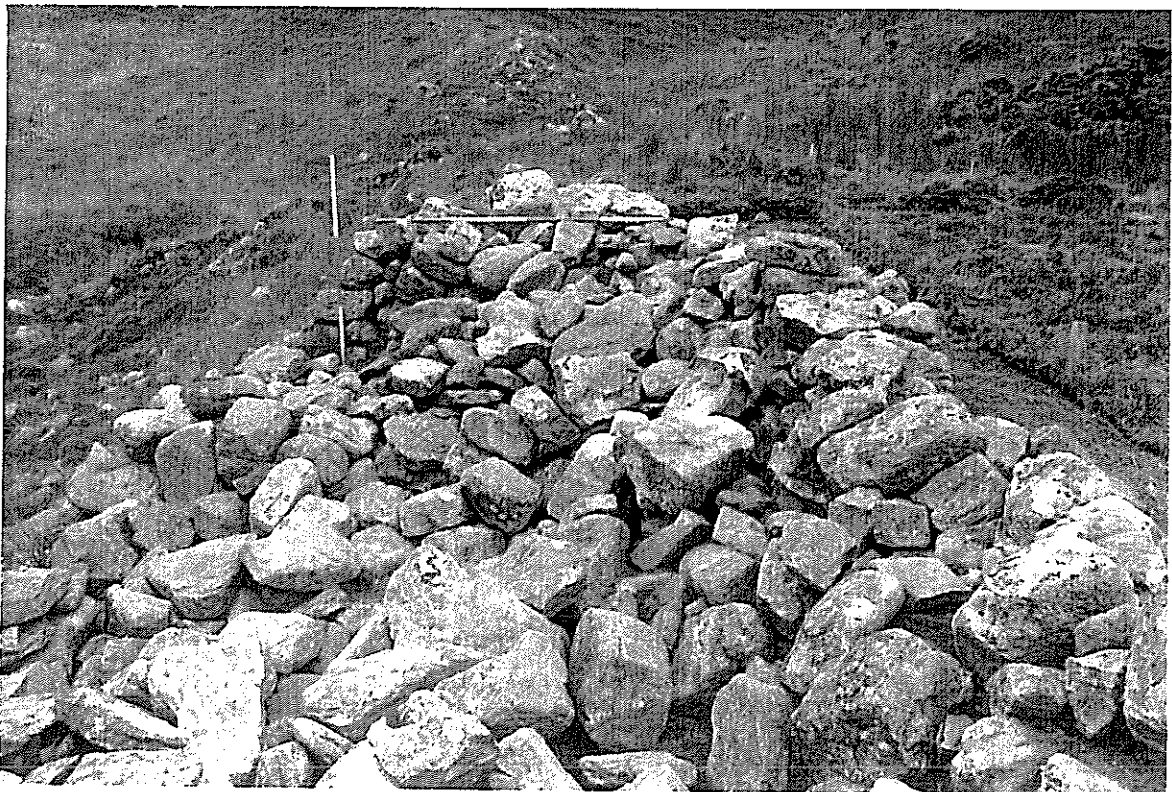
Plate III

Cell 106, rubble and walls after turf removed , view north

The inner face of the north wall was battered by about 15°; this was apparently an original feature, although some of the lower part of the eastern wall (119) appeared to have moved inwards after construction. On the interior corner of these walls there were slight indications of heat, although these did not appear to be substantial and were not seen in the underlying surface: it is therefore probable that this was due to a small fire at a later date rather than the location of a cooking hearth. The upper parts of both of these walls appeared to have been built up with un-bonded stones, the crude dry-stone walling surviving one or two courses high, above the later interior rubble (plate III).

Above these soil layers there was a substantial rubble layer of large stones (108*)(plate III), mostly voided. This rubble probably did not all accumulate at the same time and had been disturbed. A patch of rubble (117*) in the north-east corner was proven stratigraphically to be earlier than the adjacent material, although some of the general rubble (108*) could be of similar date. The north-western area had been cleared of all rubble; some of this stone had been deposited (116*) on the earlier rubble patch (117*) and a rough east-west retaining wall (115*) (approximately on the line of the northern edge of the flagstone floor) had been formed at the edge of this cleared area. The substantial large stone rubble layer (108*) had probably been disturbed again after the construction of the rough retaining wall, as there were articulated sheep bones and a strand of thick galvanised wire in the voided rubble; this disturbance was indistinguishable, however, from undisturbed areas of the rubble layer (108*).

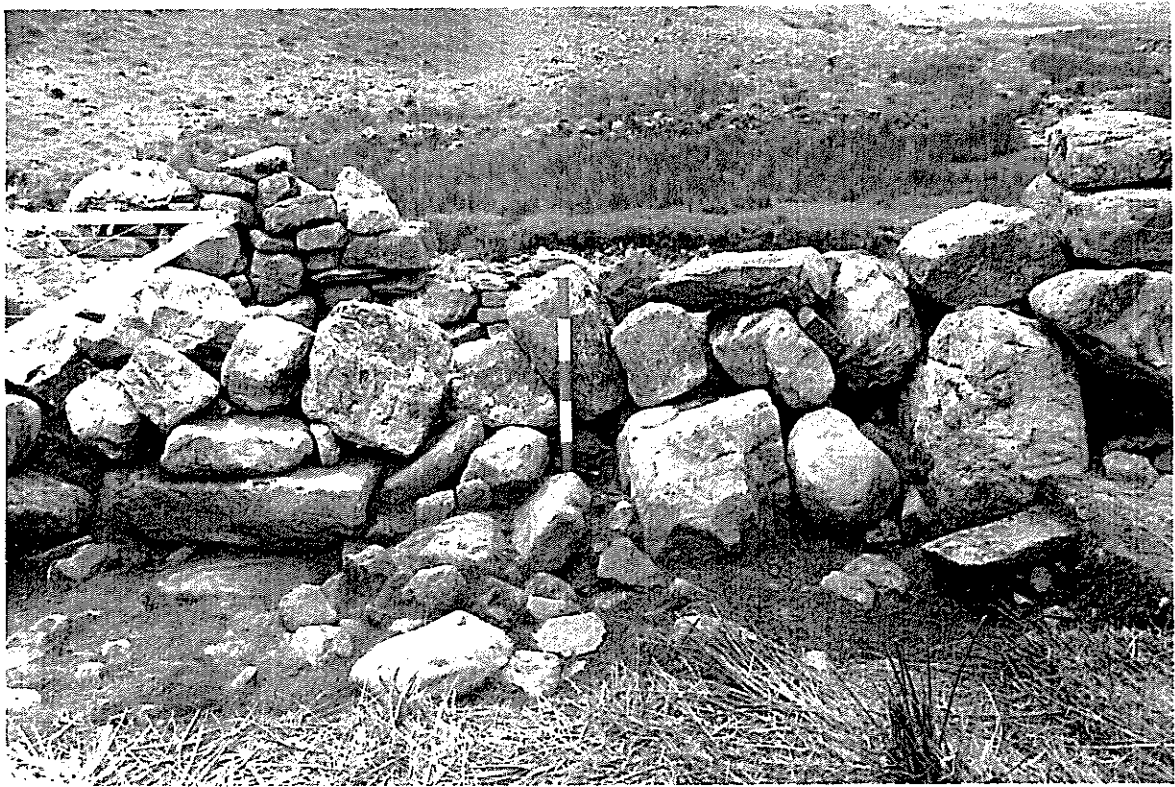
Plate IV

Cell 106, blocked doorway?
in east wall 119, view west

Towards the southern end of the eastern wall (119) there was a possible blocked doorway or low window (plate IV), although this "blocking" could be part of the crude dry-stone wall, or infilling of a later collapse in the wall. The junction of the east wall (119) with the southern wall (120) and the wall to the east (134) was not clear (dismantling of this section may resolve this, but time did not permit). The upper part of the southern wall was disturbed, while the lower part appeared to overlie the edge of the flooring inside; it is possible that this section, or part of it, had been rebuilt. A whetstone (object 503*) was found lodged on the interior face of the eastern wall, probably having been placed there, rather than being built into the wall. The whetstone is simple in form and not diagnostic.

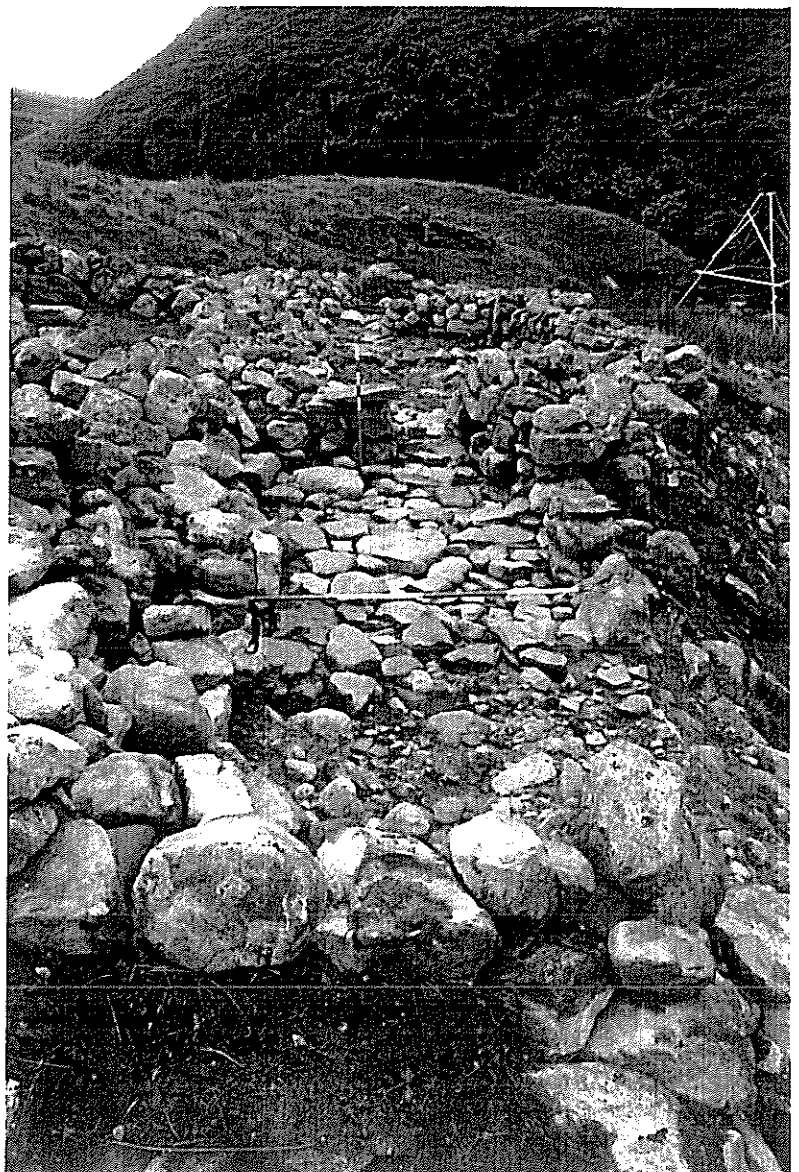
Plate V

Cell 106, later flagstone
floor 112, view south

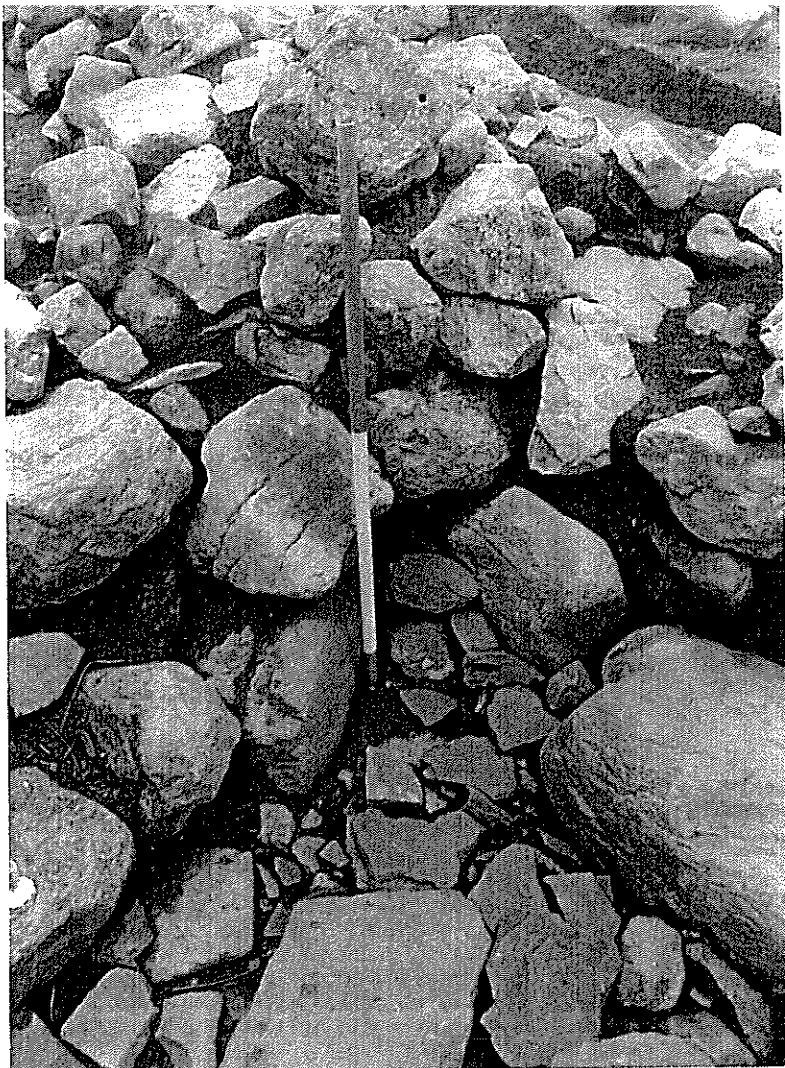
Plate VI

Cell 106, hearth? in
south-east corner,
view south-east

In the south-east corner there were some indications of a hearth with some possible reddening of the stone wall face and a very small deposit of charcoal black soil. Between this possible hearth and the entrance to the south there was one large stone, projecting 150-200mm above the floor surface (plate VI), which may have acted as one side of the possible hearth and as a work surface. This stone either pre-dated or was contemporary with the lower floor or levelling layer (144).

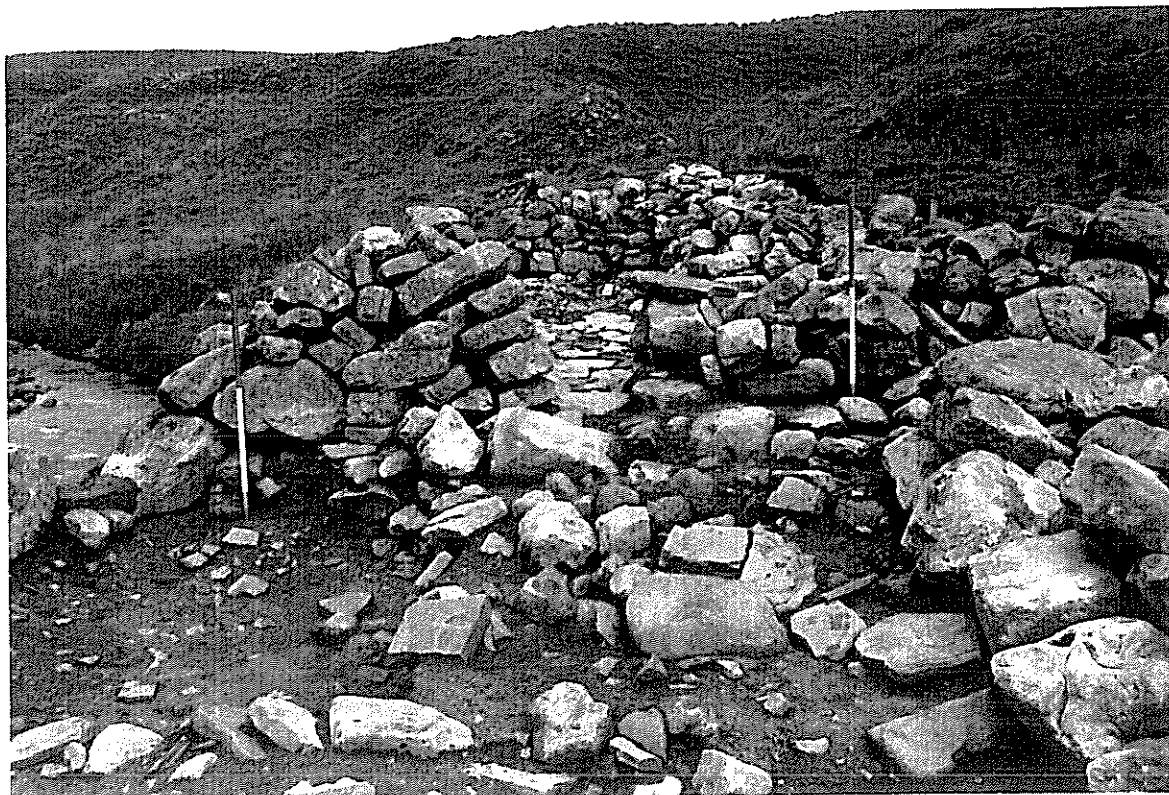
Plate VII

Cell 105, northern end

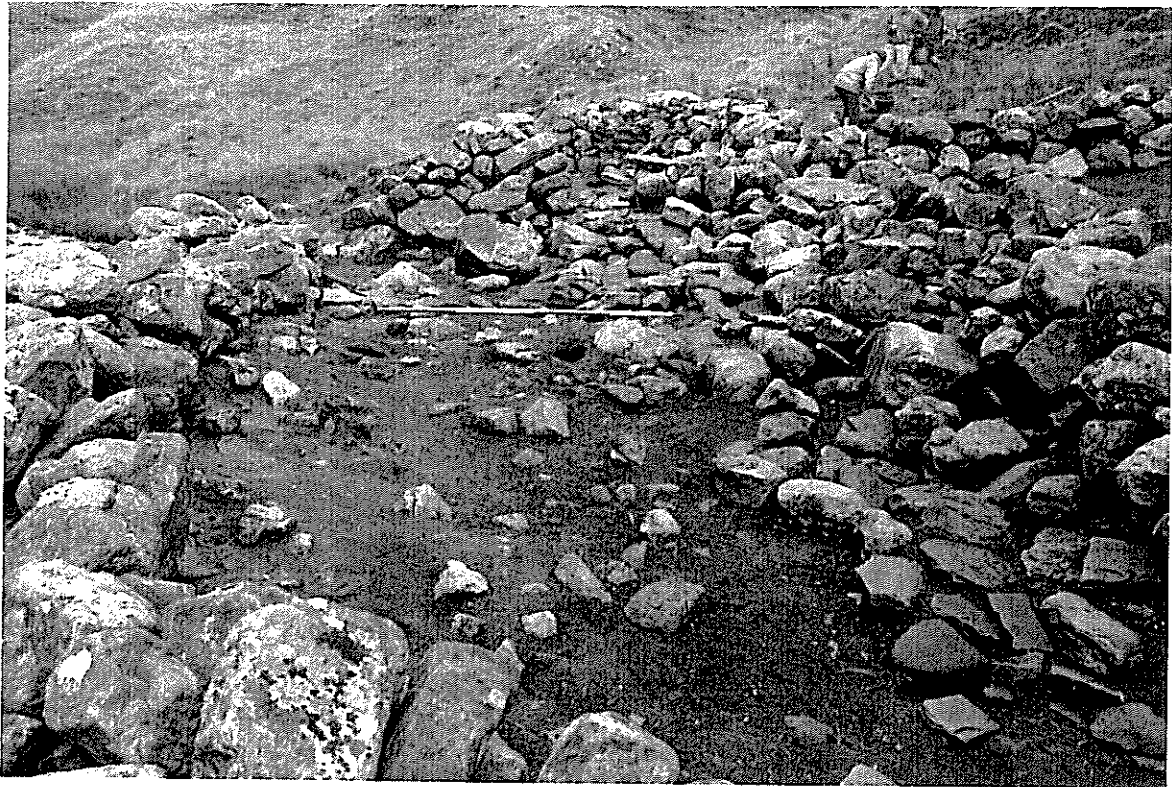
Plate VIII

Cell 105, interior surface (131) and path up east side, view north

The upper layer (131) formed the interior floor surface, which sloped quite steeply up by about 400mm from the southern entrance for roughly half the length of the cell, before becoming more level. On the rise from the southern entrance, along the eastern side, there were a number of flat stones that appeared to have been deliberately placed on the surface to form a stepping stone path (plate VIII). There was a deposit of charcoal below one of these path stones, samples of which were sent for radiocarbon analysis (sample 604*), giving a determination of 270 ± 60 BP (Beta -122921). A small fragment of clay pipe stem (object 509*) was recovered from just below the surface of this layer; it was not diagnostic but, given the exterior finish and diameter of the central hole, was probably late 17th to 18th century in date.

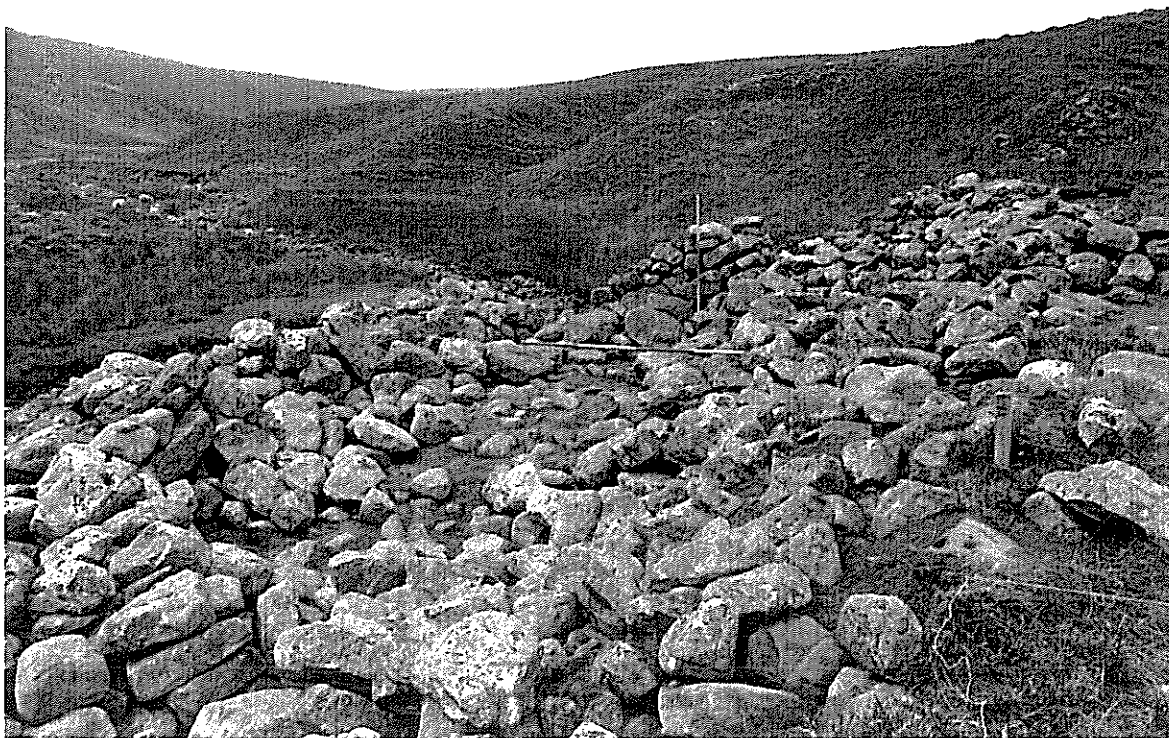
Plate IX

Cell 105, before removal of rubble, view north-north-west

Overlying most of the interior and walls was a layer of large rubble (109*)(plate IX), mostly voided but covered and in-filled with turf and a little soil. Assuming that all the rubble came from the adjacent walls, these would not have stood very high, possibly only to about 1.0m. Outside the southern section of wall (137) there was a pile of rubble (140*) which partly overlay the bones of a sheep carcass.

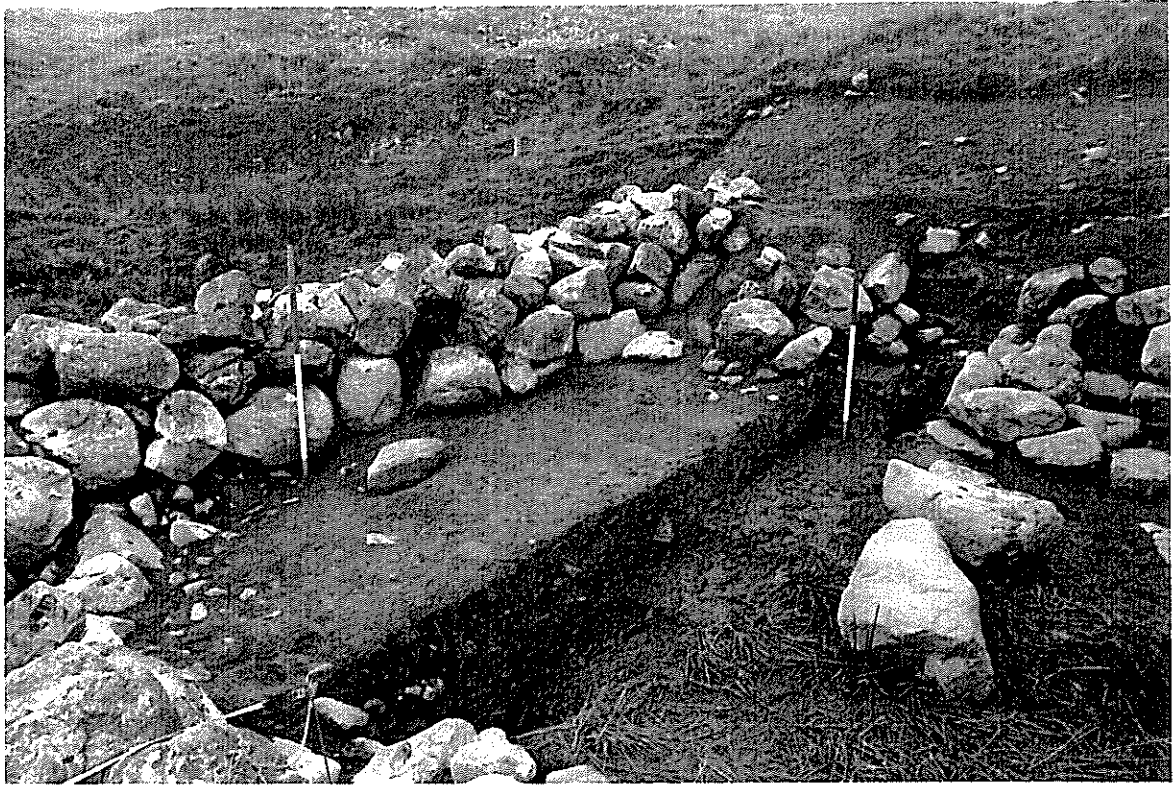
Plate X

Cell 104, northern part as excavated, view north-east

Most of the interior of this cell was excavated down to the geology and a trial trench dug into it and across the cell (plate X). The interior of the cell measured 9.6m by 6.4m. The exterior geological level was much higher and this cell had been cut into the hillside. The walls appeared to be clay bonded, quite low and partly acting as retaining walls. The only possible entrance was from the northern part of cell (105) to the west. There was no evidence of any internal activity or occupation build up.

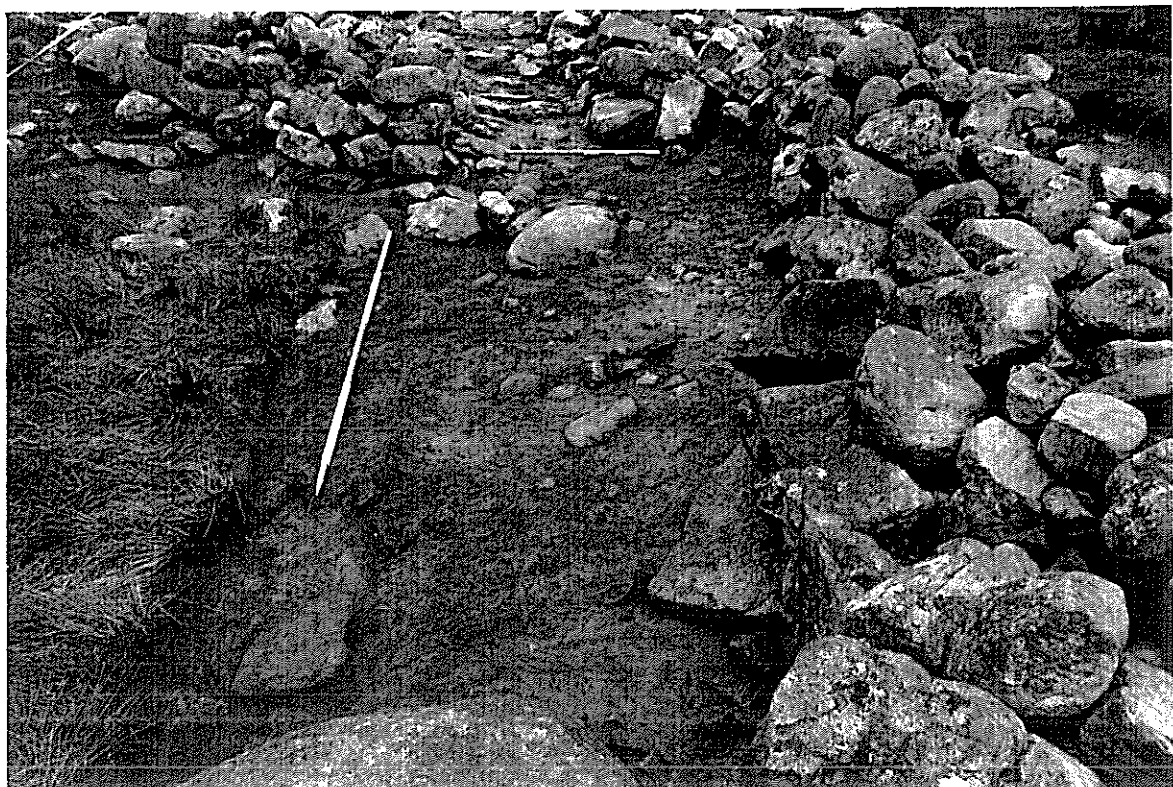
Plate XI

Annex 107, eastern area as excavated, view north

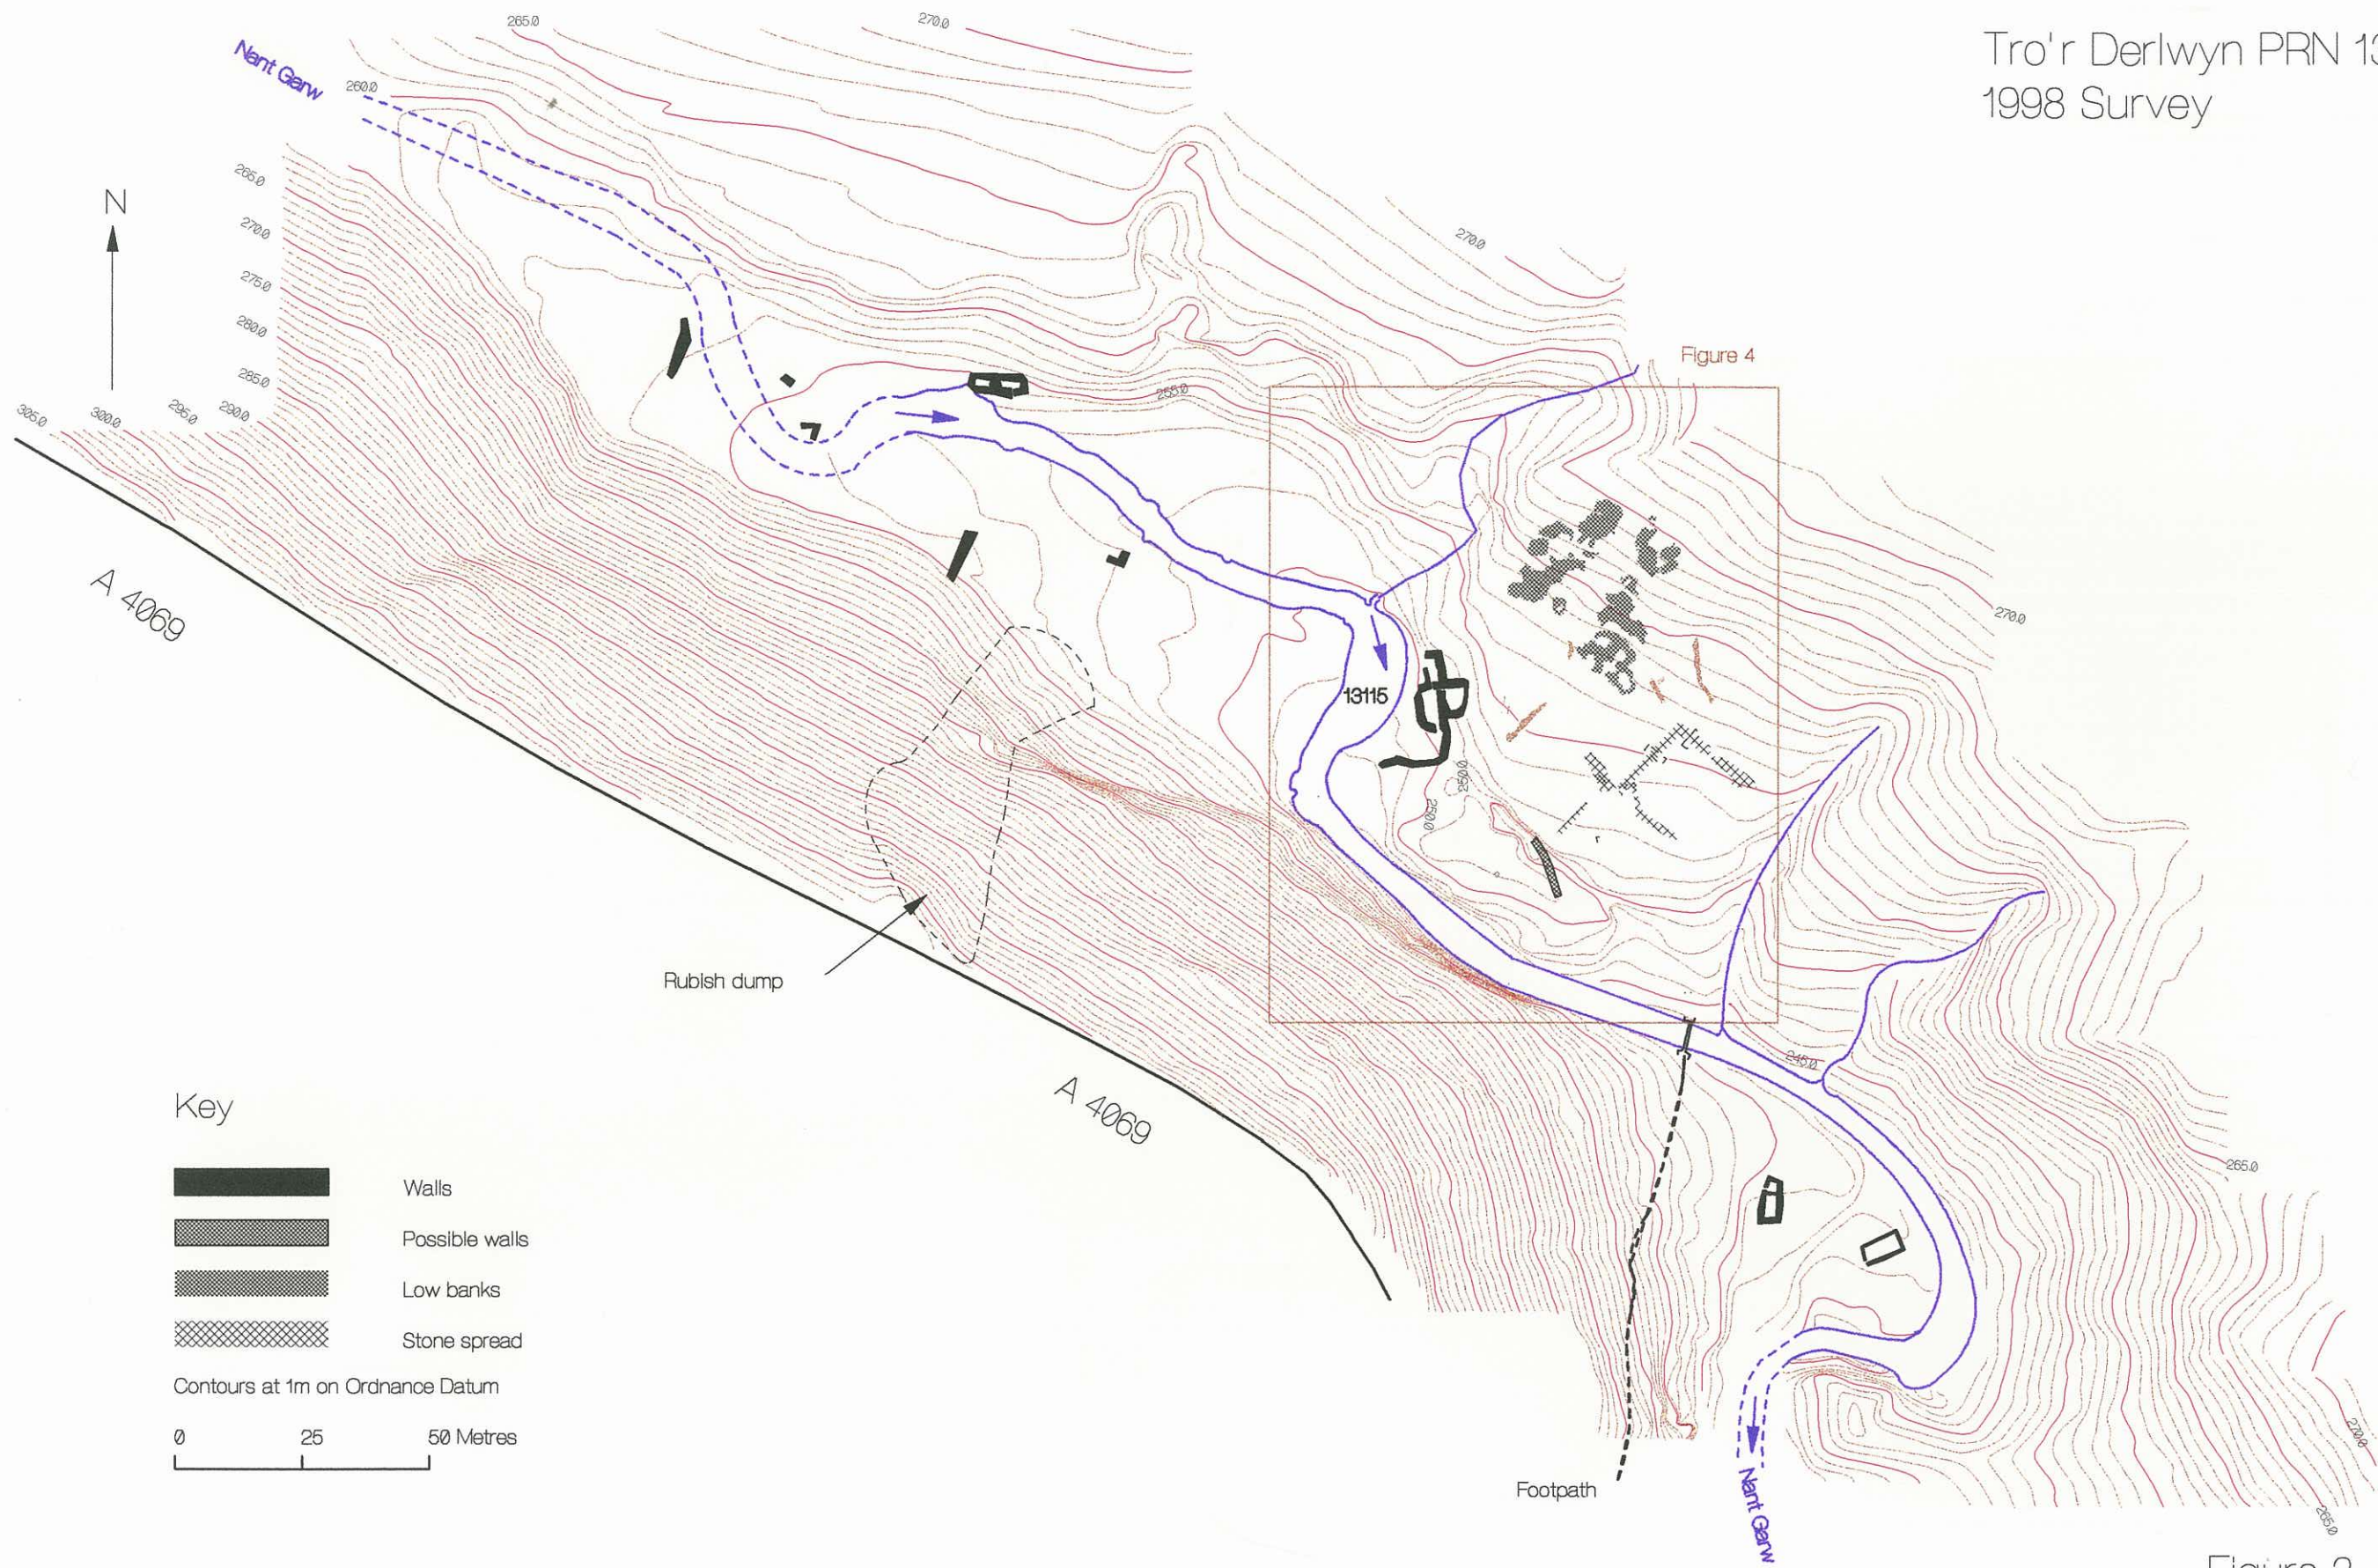
Figure 2

Sites in the Garw Valley were first mapped by RCAHMW (Leighton, Percival and Malaws 1987), subsequently by Morgan (1988) and Ward (1991, 1995). These sites (excluding later quarries) are shown in figure 2 and listed in Appendix 2. Although there are considerable visible remains, none of the sites can be securely dated without excavation. Ward (1995) was responsible for producing the first description of the site, accompanied by a sketch plan. In discussing the site, he drew attention to its complex nature, compared to other deserted settlements in the valley. He proposed a constructional sequence for the core dwelling complex and suggested that the modifications represented a seasonal outstation subsequently used for over-wintering – an incipient, but failed farmstead.

Appendix 2 (figure 2)
