**HAFOD**  
**An archaeological investigation of**  
**THE LADY'S WALK S4**  
**and**  
**THE COLD BATH**  
Report no. 35903

May-June 1988

Commissioned by: Hafod Trust

Report by: K Murphy BA MIFA  
Archaeoleg Cambria Archaeology  
The Shire Hall  
Carmarthen Street  
Llandeilo  
Carmarthenshire  
SA19 6AF  
01558 823121

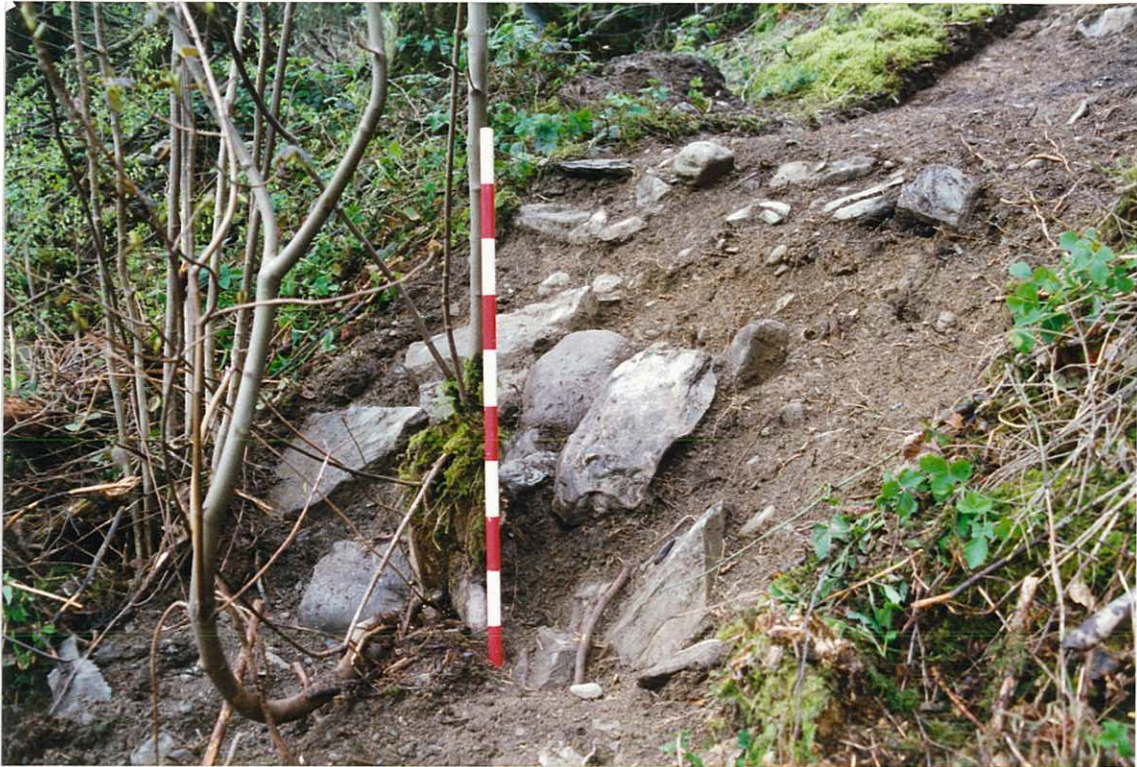
*13. Trench 3 showing collapsed revetment.*

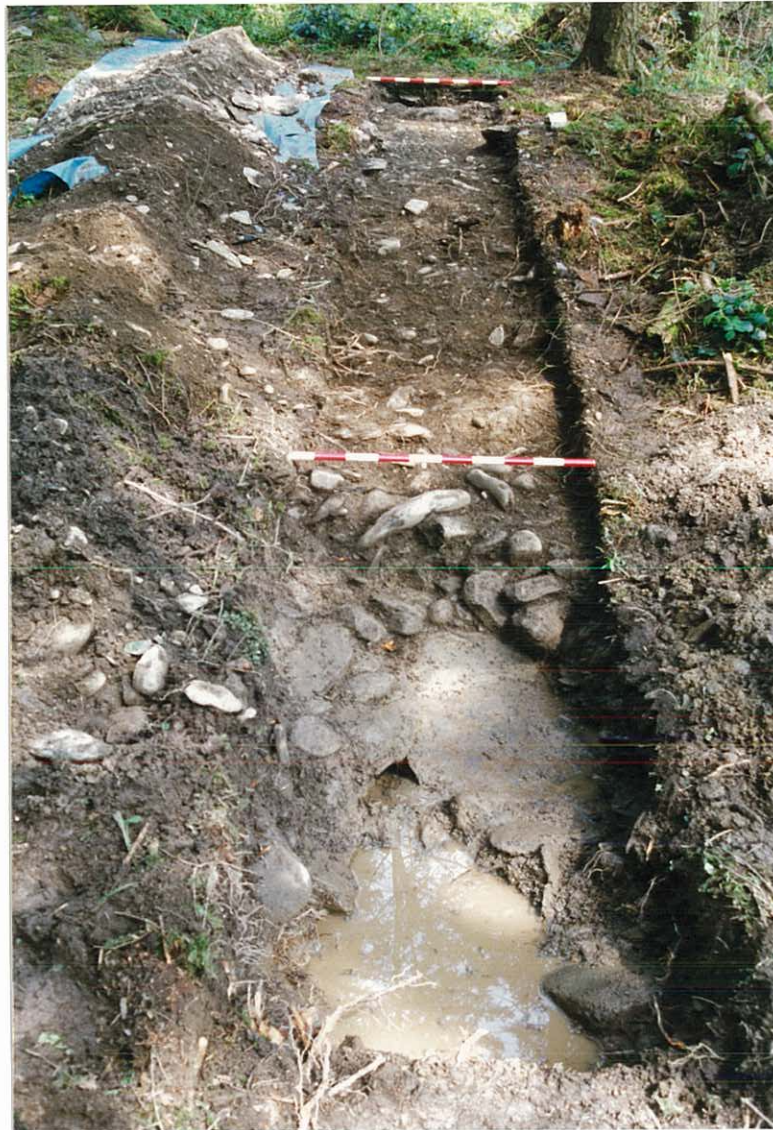
*18. Trench 5 after excavation showing culvert 26.*

century or 20th century date. At the central and eastern sections of the trench rubble or topsoil overlay banded fluvio-glacial sands and gravels. These ranged in size from coarse sands to cobbles. The culvert (26) was cut through these sands and gravels. This feature was not fully excavated, but sufficient work was carried out to establish its character. Gravels and cobbles, which resembled subsoil, had been packed over the stone slabs capping the culvert. Two of these slabs were lifted to reveal the channel of the culvert. This was choked with silts, but some water continued to flow in it. The slabs were then carefully replaced.

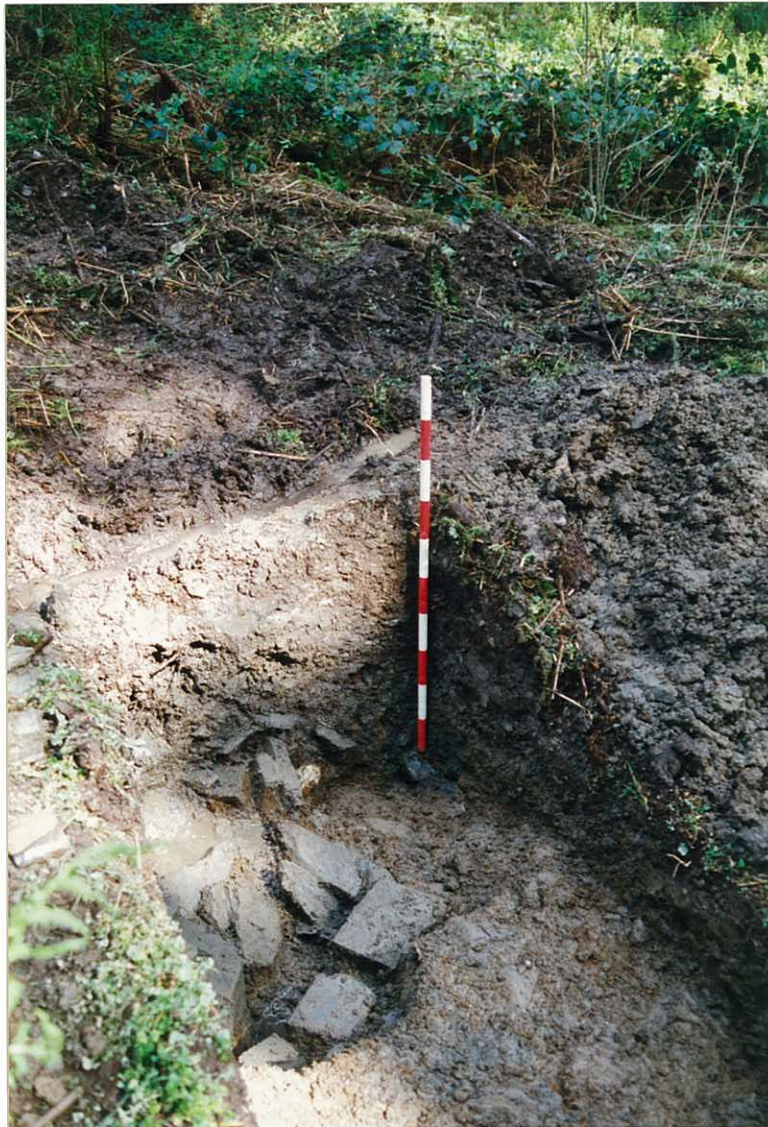
*24. Trench 6 showing exposure of drainage gullies.*

Three drainage gullies (35, 37 & 39) ran at right angles across the centre of the trench. The height from which they were cut and the deposits through which they were cut (see below) indicate that they are of relatively recent origin and post-date the disuse of the Cold Bath. Their function was to drain water down-slope away from the spring. Drain 35 contained conifer branches is therefore of modern date. Drain 39 cut 37. Both had similar fills: a dark-brown silty-clay-loam containing small- to large-sized angular, platy, local stones and fragments of undressed oolitic limestone. The top of a foundation trench was cut by drain 39 and possibly by 37. This foundation trench was not excavated, but fragments of undressed oolitic limestone were noted on the surface. It is not known whether the culvert excavated in Trench 5 lay beneath drainage gullies 37 and 39 as it was not possible to continue excavating due to the extremely wet conditions.

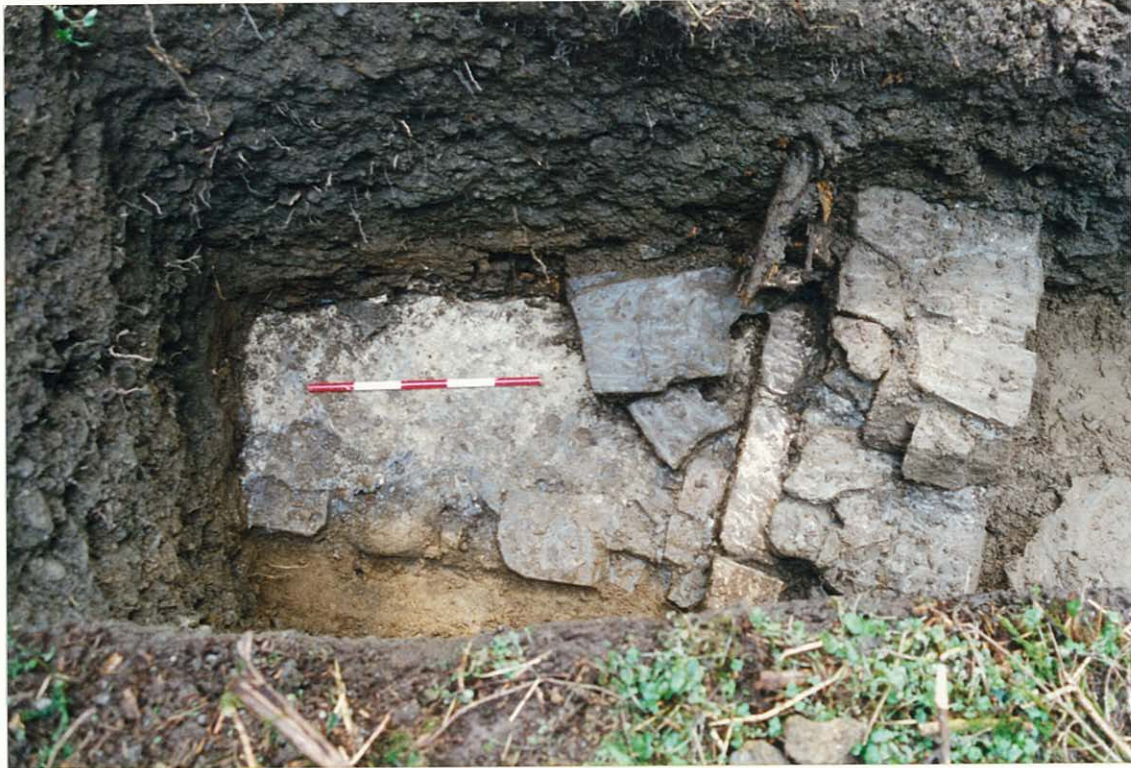
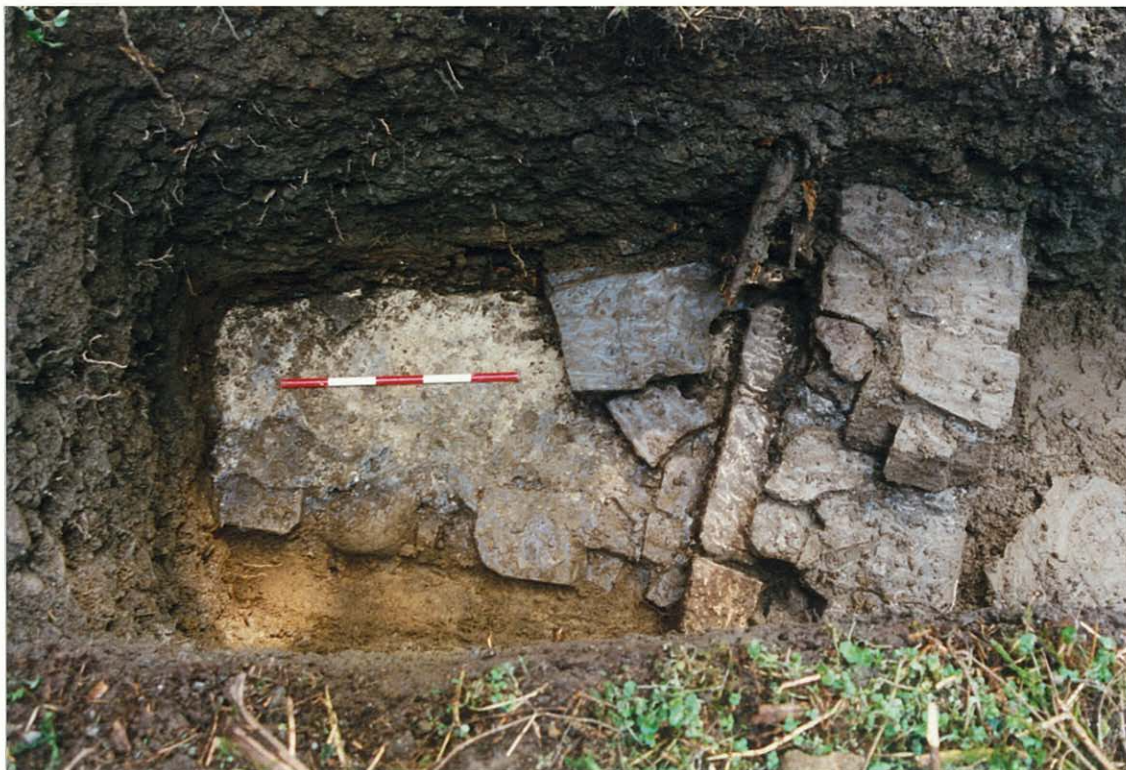
*25. Trench 6 showing wall 41 and sub-floor/wall 42.*

Wall 41, the east wall of the Bath House, comprised local stone bonded with a grey-white lime mortar. On the inner face a course of dressed oolitic limestone blocks was present. The wall was 0.50m wide. Bonded onto this wall was what a first was considered to be a just a sub-floor (42), but further, limited investigations revealed a wall-face to this descending on its northern edge. The ragged nature of this wall-face indicates that its facing stones have been robbed out. The sub-floor and wall-face was constructed from local stone bonded with grey-white mortar over which a skim of cream-coloured lime mortar had been laid. Sub-floor/wall 42 was bonded on its east side into wall 49, the east wall of the Bath House.

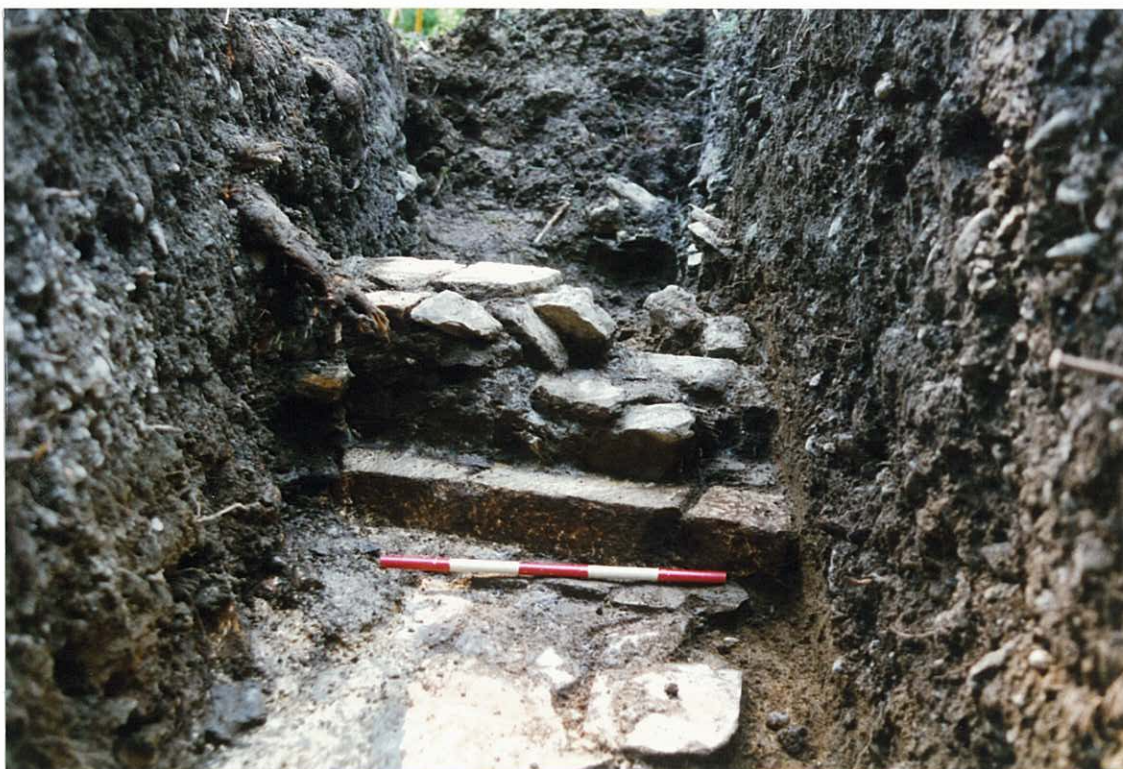
*28. Trench 6 showing wall 41, dressed stone detail.*

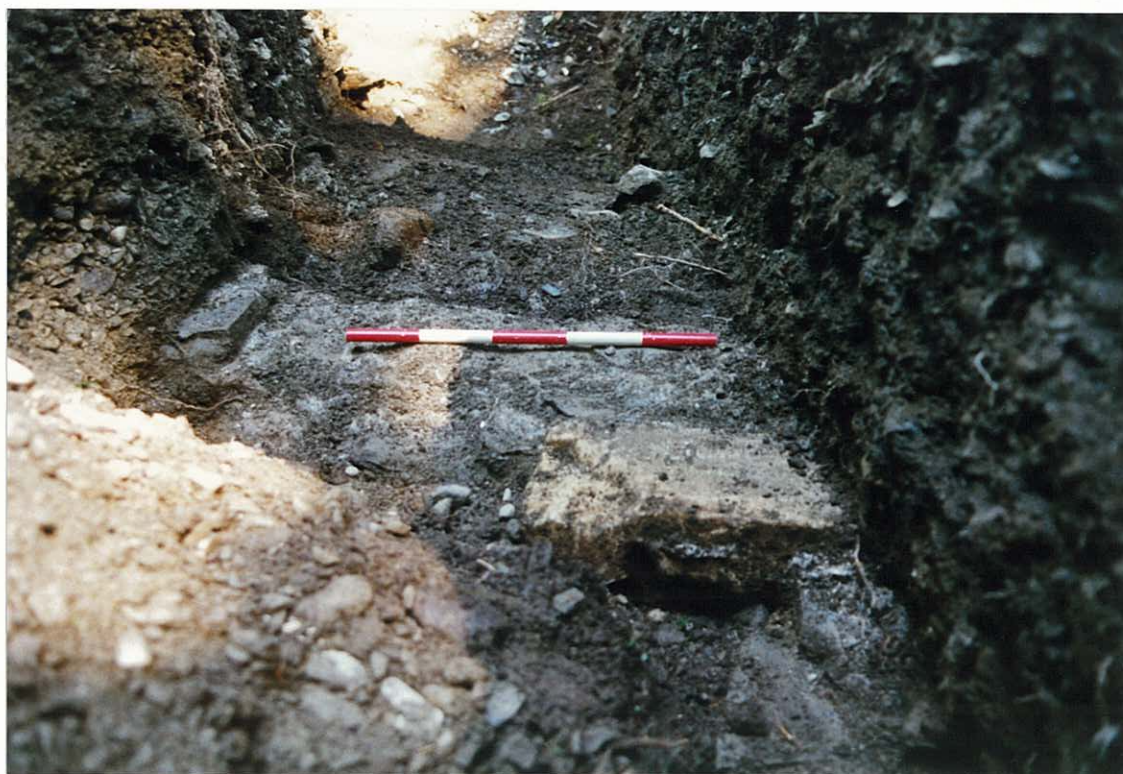
*29. Trench 6 showing wall 49, detail of dressed stone.*

Wall 49 was of similar construction and dimension to wall 41. A single, dressed, oolitic-limestone block was present on the wall's inner face. A step on the wall to the north of this block indicates that further oolitic blocks have been removed. A mortise cut into the west-centre of this oolitic block suggests that a course of dressed stone lay at right angles to wall 49 along the northern edge of the sub-floor/wall 42. Deeper, but limited, excavation against wall demonstrated that the gravel and sand layers 32, 43 and 44 continued down, and that facing stones of wall 49 have been robbed out. The core of wall 49 at this lower level was seen to consist of undressed oolitic limestone rubble.

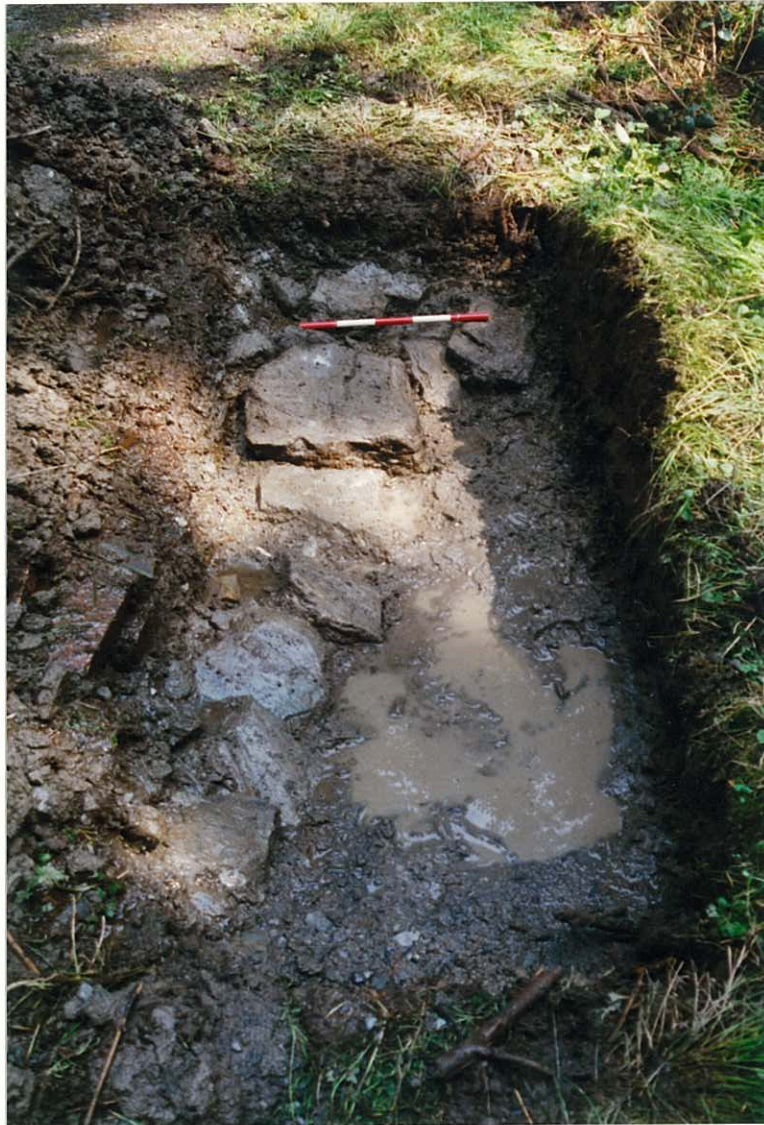
30. Trench 7 showing culvert base 34.

Immediately below these deposits lay an roughly east-west aligned line of large and very large, local stone-slabs (34). These were bedded into a compact, grey clay. The surface of the stones lay c. 1.50m above the level of the sub-floor within the Bath House. Because water was running across the surface of this trench, it was not possible to continue further investigation. The line of stones can be interpreted as the base of a culvert that fed water from the spring that rises to the north-west into the Bath House.
